SLBE Cycle 6

Final Report

Road Inventory and Condition Assessment of Paved Routes Sleeping Bear Dunes National Lakeshore

Report Date: August 2019

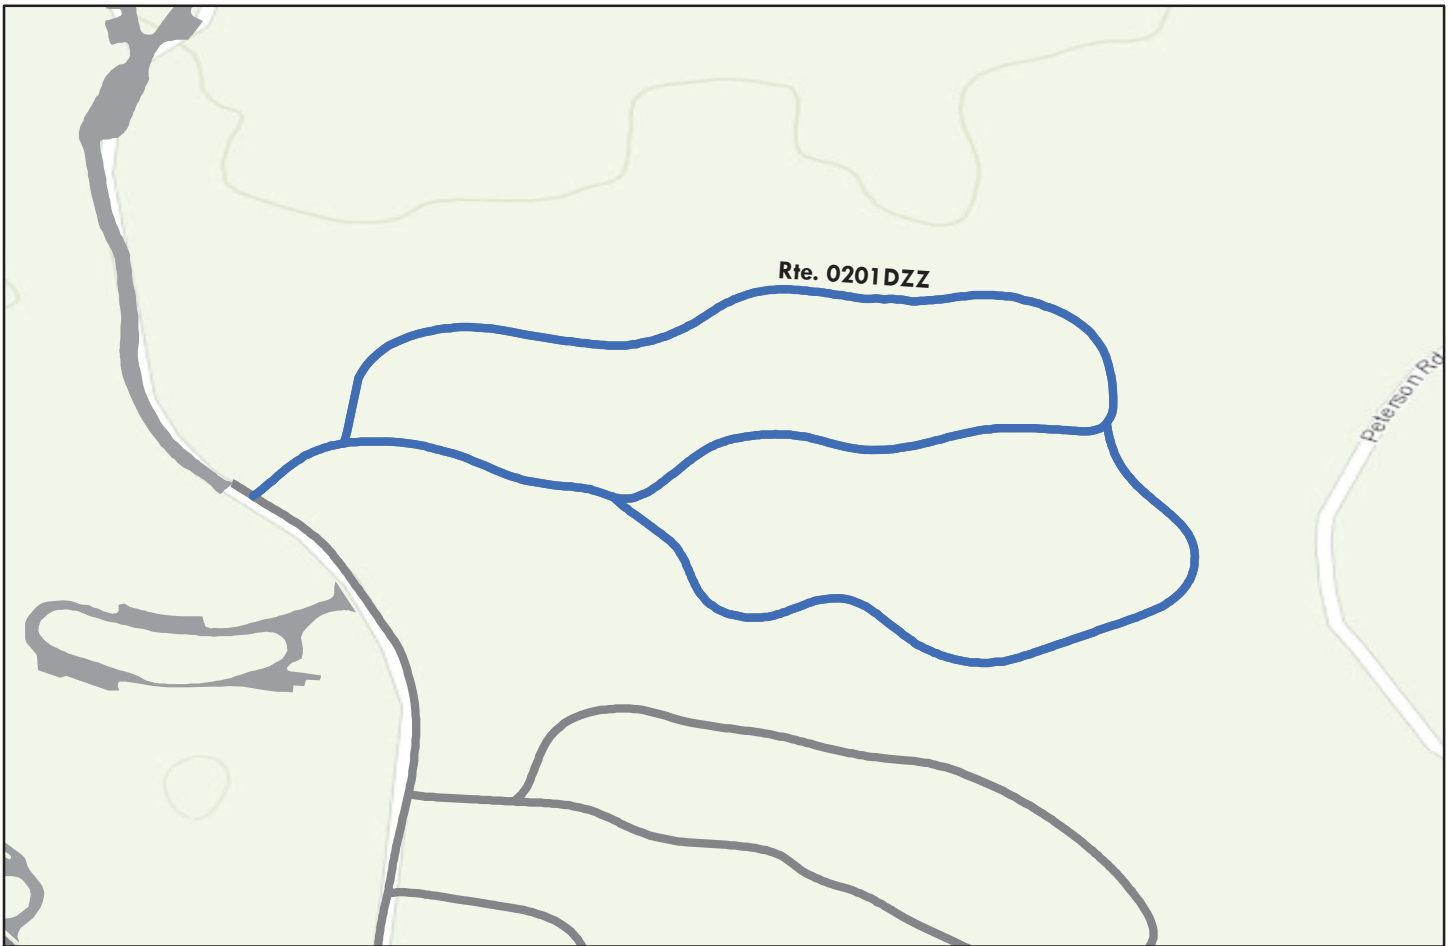
ROUTE 0201DZZ: PRCG LOOP 4 ROAD

Inspection Date:	10/16/2018						
Paved Length (Miles):	0.67						
Surface Type:	ASPHALT	Route Summary					
Roadway Condition Information							
Pavement Condition Rating (PCR)	99						
Lane & Width Information							
Number of Lanes	1						
Paved Width (ft)	15.9						
Lane Width (ft)	14.5

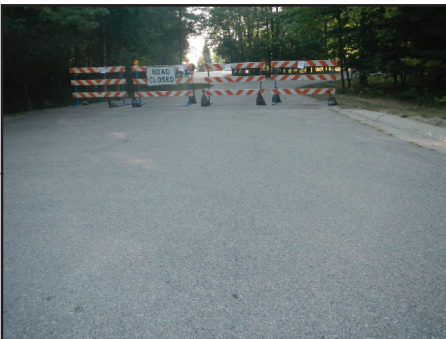
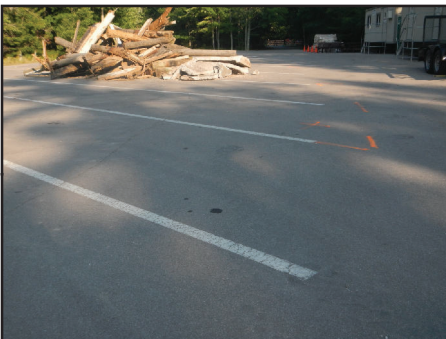
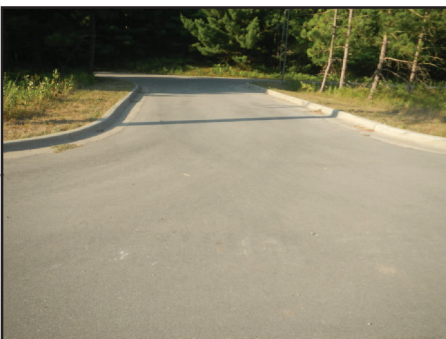
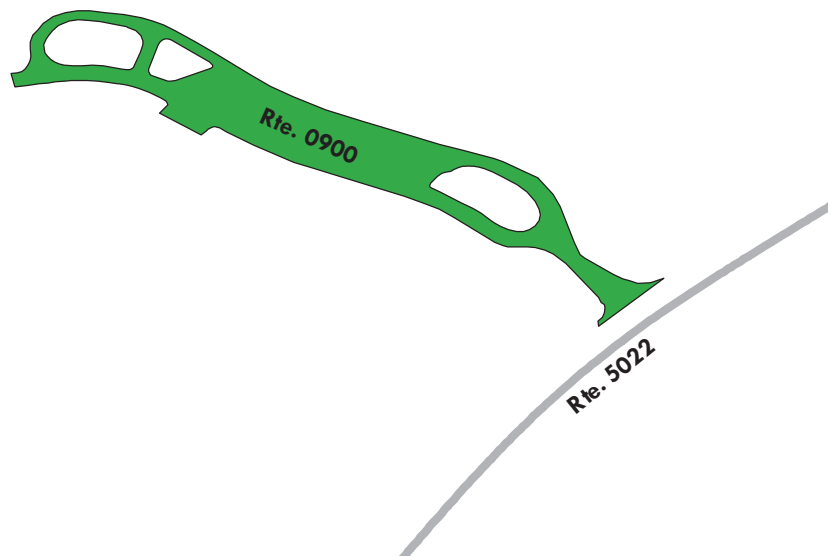
ROUTE 0901: PLATTE RIVER PICNIC AREA PARKING

Inspection Date	FMSS Number	User Access	Surface Type
8/11/2018	48186	PUBLIC	ASPHALT
Area (Sq. Ft.)	Lane Miles (11' Widths)	Curb Reveal (Inches)	Curb Recommendation
27,728	0.477	NOT APPLICABLE	DO NOTHING
Curb Type		Curb & Gutter Type	
NO CURB		CONCRETE	
Pavement Recommendation		Condition Rating / PCR	
PREVENTIVE MAINTENANCE		GOOD / 90

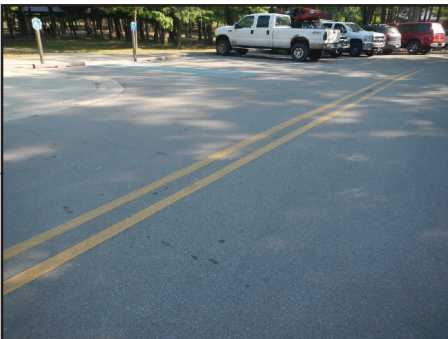
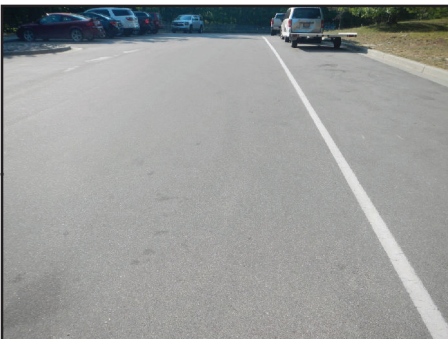
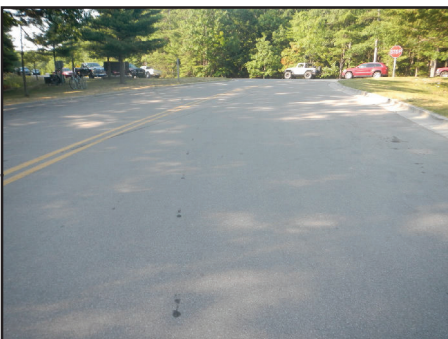
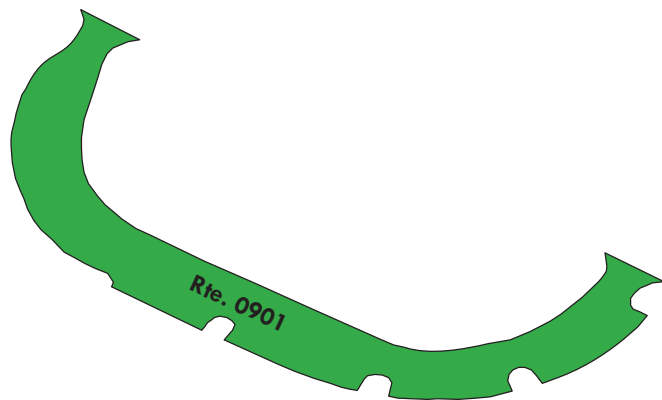
ROUTE 0902: EL DORADO PARK PARKING

Inspection Date	FMSS Number	User Access	Surface Type
8/11/2018	38948	PUBLIC	ASPHALT
Area (Sq. Ft.)	Lane Miles (11' Widths)	Curb Reveal (Inches)	Curb Recommendation
10,342	0.178	NOT APPLICABLE	DO NOTHING
Curb Type		Curb & Gutter Type	
NO CURB		CONCRETE	
Pavement Recommendation		Condition Rating / PCR	
PREVENTIVE MAINTENANCE		GOOD / 90

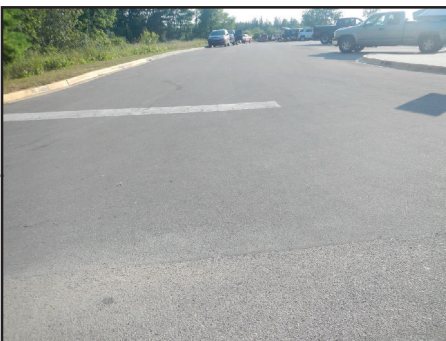
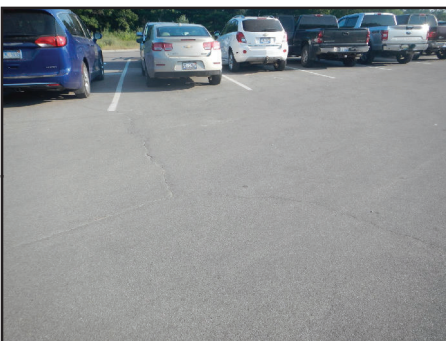
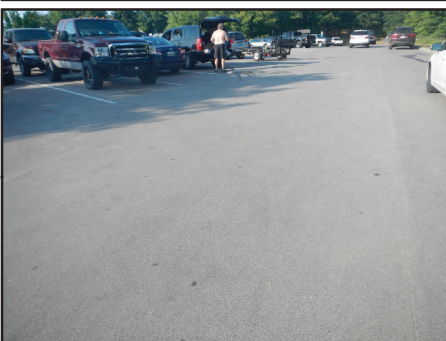
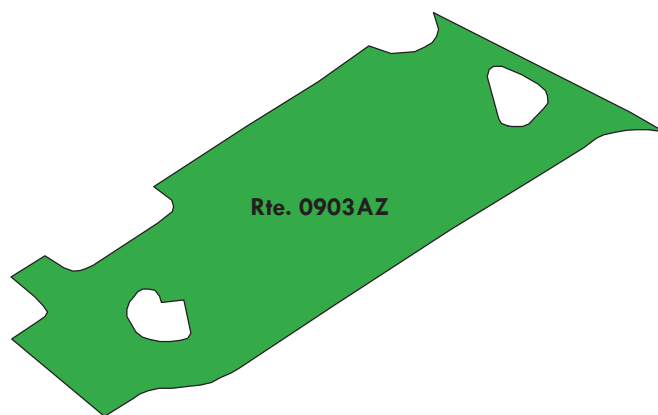
ROUTE 0903BZ: PLATTE POINT NORTH PARKING

Inspection Date	FMSS Number	User Access	Surface Type
8/11/2018	38954	PUBLIC	ASPHALT
Area (Sq. Ft.)	Lane Miles (11' Widths)	Curb Reveal (Inches)	Curb Recommendation
8,226	0.142	NOT APPLICABLE	DO NOTHING
Curb Type		Curb & Gutter Type	
NO CURB		CONCRETE	
Pavement Recommendation		Condition Rating / PCR	
DO NOTHING		EXCELLENT / 97

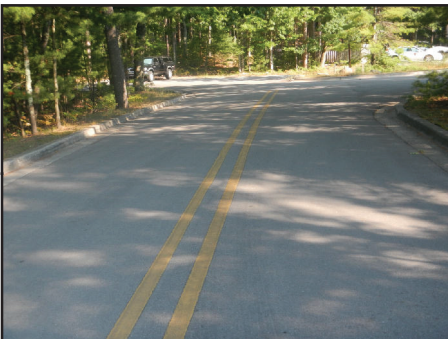
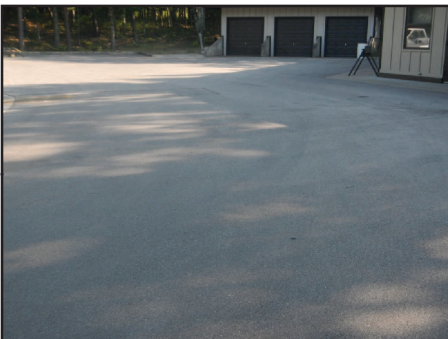
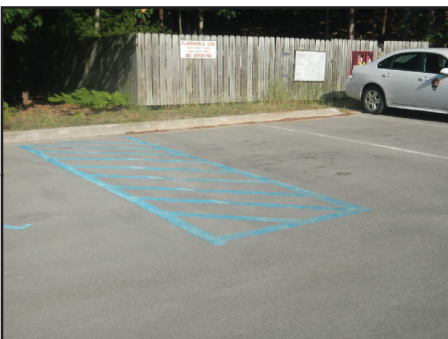
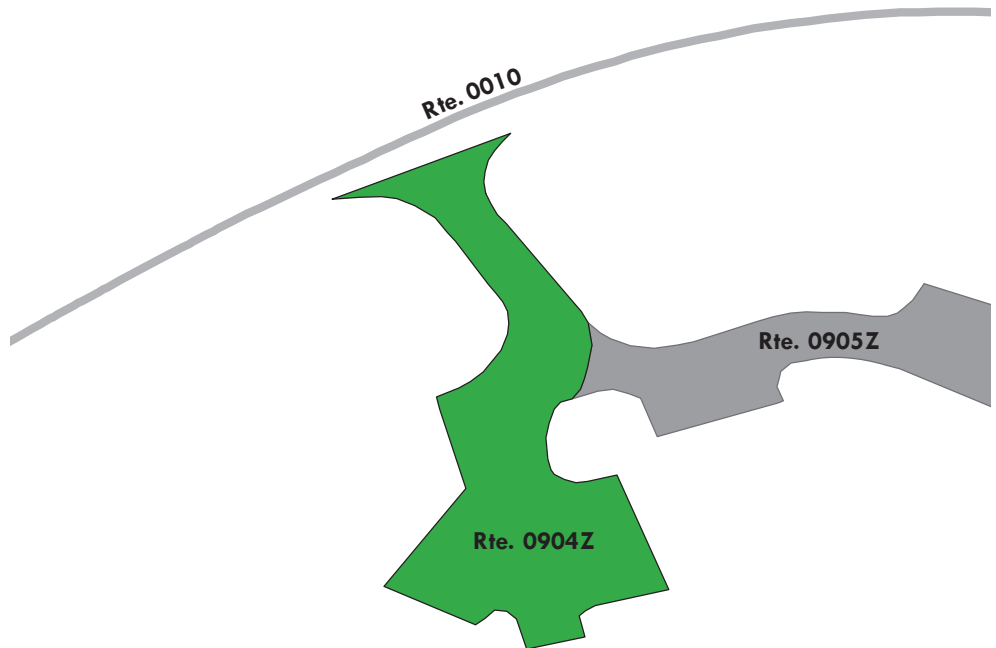
ROUTE 0905Z: PRCG RANGER STATION EMPLOYEE PARKING

Inspection Date	FMSS Number	User Access	Surface Type
8/11/2018	48178	PUBLIC	ASPHALT
Area (Sq. Ft.)	Lane Miles (11' Widths)	Curb Reveal (Inches)	Curb Recommendation
5,646	0.097	NOT APPLICABLE	DO NOTHING
Curb Type		Curb & Gutter Type	
NO CURB		CONCRETE	
Pavement Recommendation		Condition Rating / PCR	
PREVENTIVE MAINTENANCE		GOOD / 90

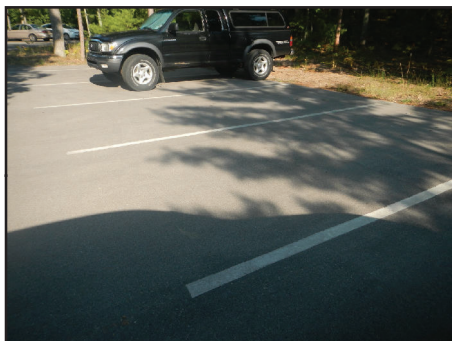
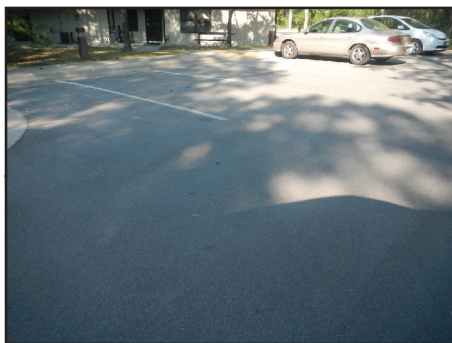
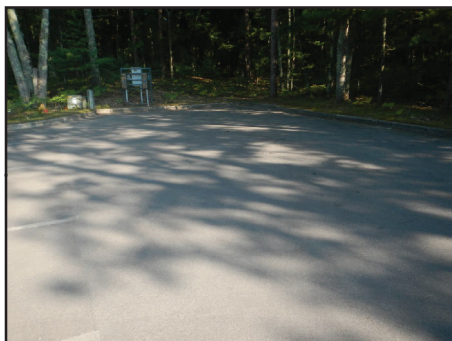
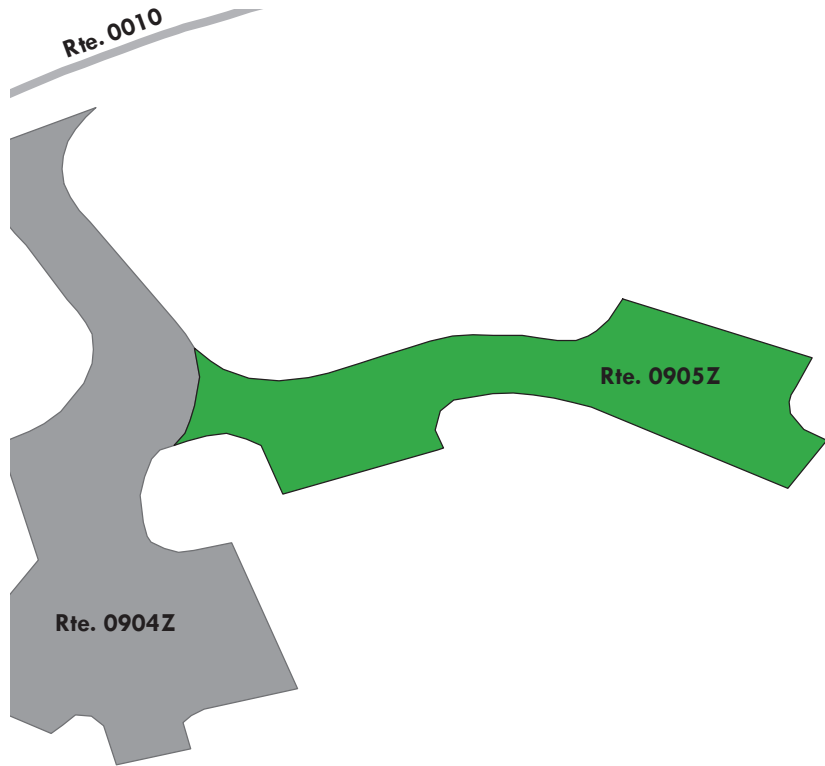
ROUTE 0906Z: PRCG RANGER STATION VISITOR PARKING

Inspection Date	FMSS Number	User Access	Surface Type
8/11/2018	48178	PUBLIC	ASPHALT
Area (Sq. Ft.)	Lane Miles (11' Widths)	Curb Reveal (Inches)	Curb Recommendation
11,594	0.2	NOT APPLICABLE	DO NOTHING
Curb Type		Curb & Gutter Type	
NO CURB		CONCRETE	
Pavement Recommendation		Condition Rating / PCR	
PREVENTIVE MAINTENANCE		GOOD / 90

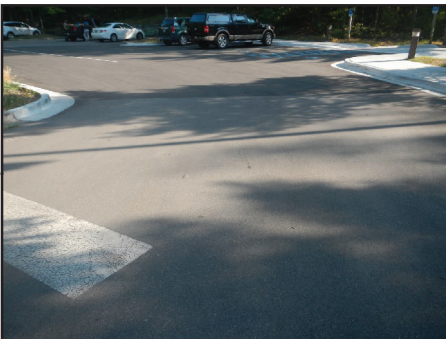
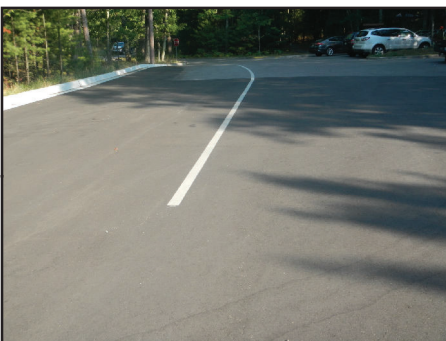
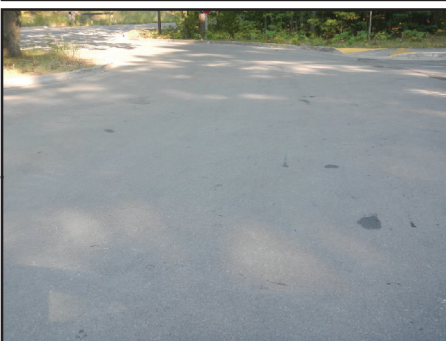
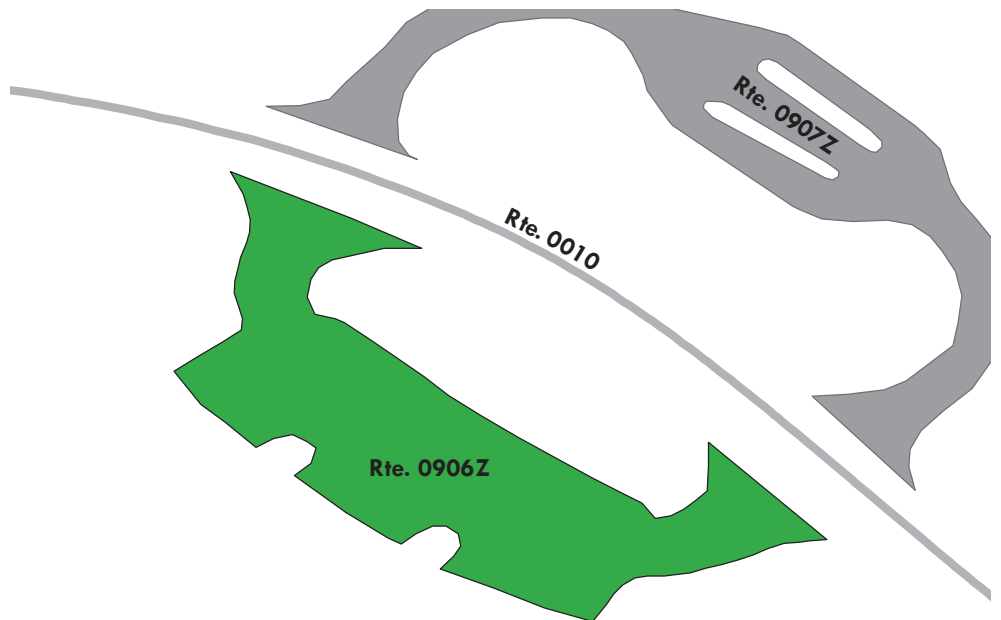
ROUTE 0907Z: PRCG DUMP STATION PARKING

Inspection Date	FMSS Number	User Access	Surface Type
8/11/2018	48178	PUBLIC	ASPHALT
Area (Sq. Ft.)	Lane Miles (11' Widths)	Curb Reveal (Inches)	Curb Recommendation
8,990	0.155	NOT APPLICABLE	DO NOTHING
Curb Type		Curb & Gutter Type	
NO CURB		CONCRETE	
Pavement Recommendation		Condition Rating / PCR	
PREVENTIVE MAINTENANCE		GOOD / 90

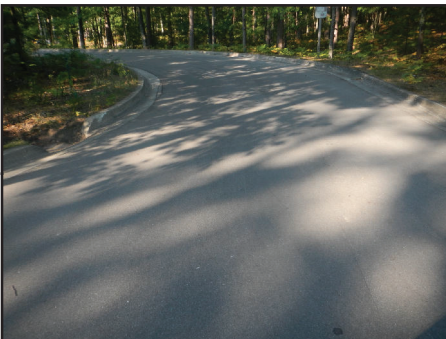
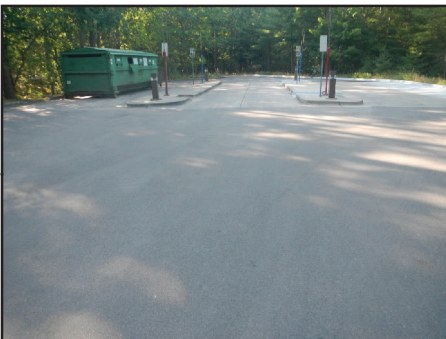
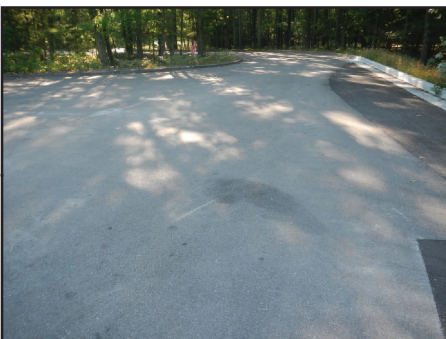
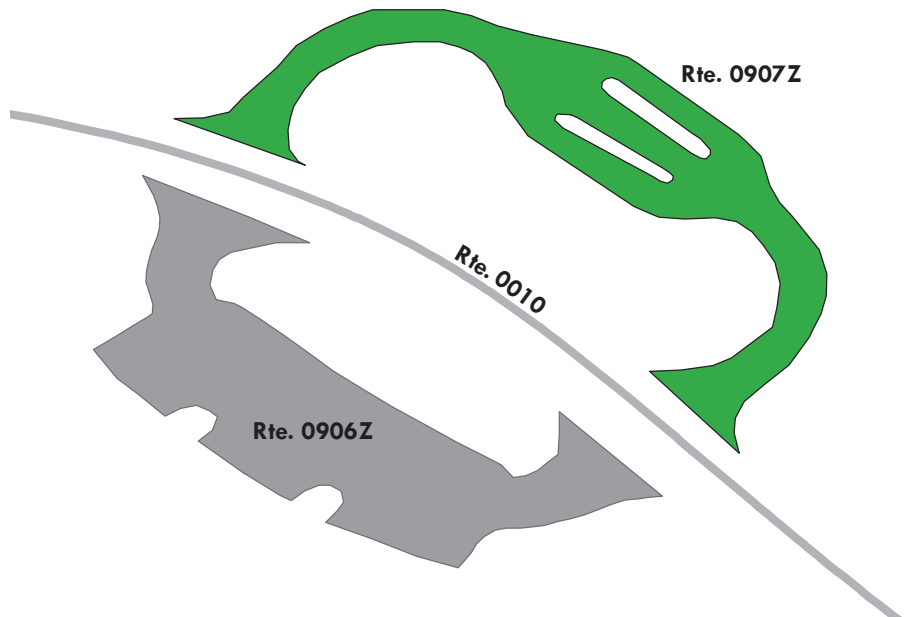
ROUTE 0908: PRCG HANDICAPPED AMPHITHEATER AND PUMP HOUSE PARKING

Note: Parking area consists of multiple surface types: 2 parts Asphalt at 6,459 square feet; 1 part Concrete at 2,531 square feet.

Inspection Date	FMSS Number	User Access	Surface Type
8/11/2018	48115	PUBLIC	ASPHALT
Area (Sq. Ft.)	Lane Miles (11' Widths)	Curb Reveal (Inches)	Curb Recommendation
18,331	0.316	NOT APPLICABLE	DO NOTHING
Curb Type		Curb & Gutter Type	
NO CURB		CONCRETE	
Pavement Recommendation		Condition Rating / PCR	
PREVENTIVE MAINTENANCE		GOOD / 90

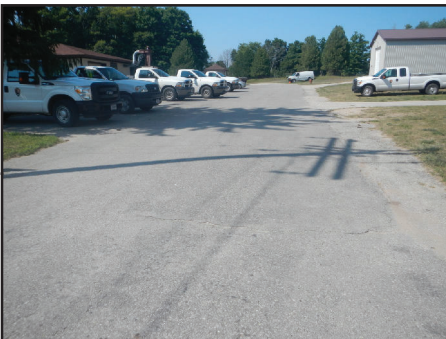
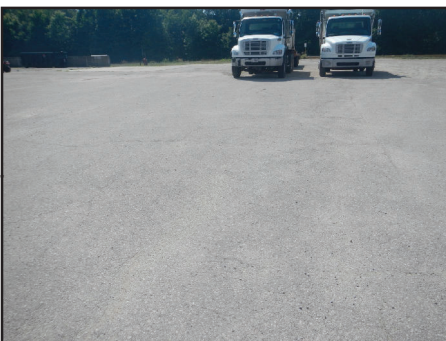
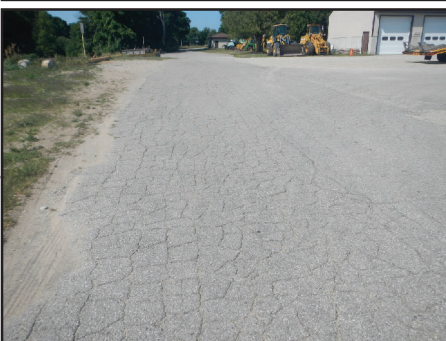
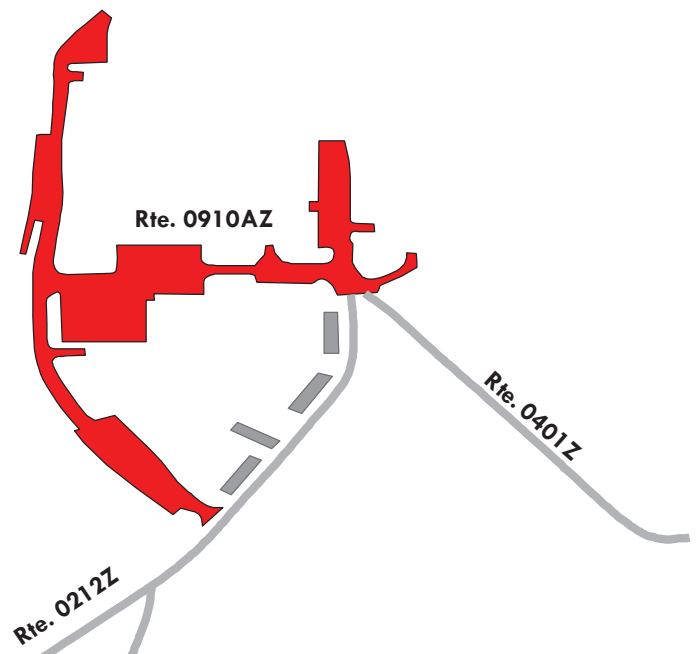
ROUTE 0910AZ: EMPIRE MAINTENANCE MAIN PARKING

Inspection Date	FMSS Number	User Access	Surface Type
8/11/2018	39165	NONPUBLIC	ASPHALT
Area (Sq. Ft.)	Lane Miles (11' Widths)	Curb Reveal (Inches)	Curb Recommendation
72,201	1.243	6	LIGHT REPAIR
Curb Type		Curb & Gutter Type	
ASPHALT AND WOOD		NO CURB AND GUTTER	
Pavement Recommendation		Condition Rating / PCR	
RECONSTRUCTION		POOR / 30

Note: Parking area consists of multiple surface types: 1 part Asphalt at 68,272 square feet; 7 parts Concrete at 3,929 square feet.

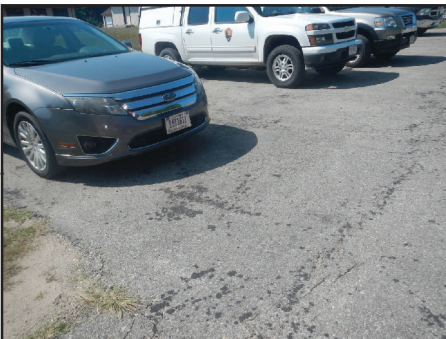
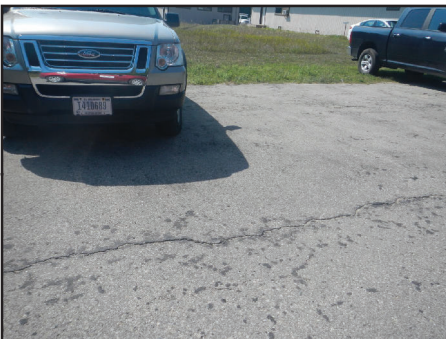
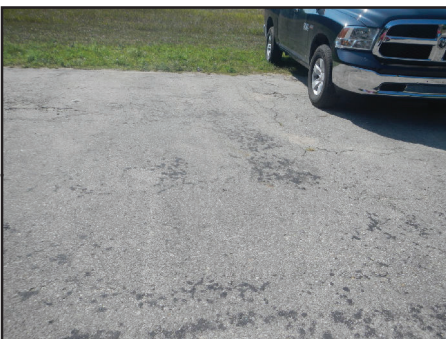
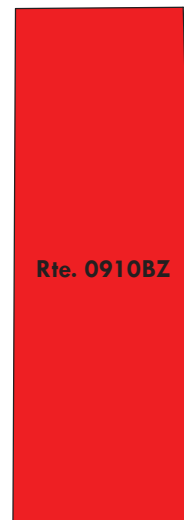
ROUTE 0910BZ: EMPIRE MAINTENANCE EMPLOYEE NORTH PARKING

Inspection Date	FMSS Number	User Access	Surface Type
8/11/2018	39165	NONPUBLIC	ASPHALT
Area (Sq. Ft.)	Lane Miles (11' Widths)	Curb Reveal (Inches)	Curb Recommendation
1,303	0.022	NOT APPLICABLE	NOT APPLICABLE
Curb Type		Curb & Gutter Type	
NO CURB		NO CURB AND GUTTER	
Pavement Recommendation		Condition Rating / PCR	
HEAVY 3R TREATMENTS		POOR / 53

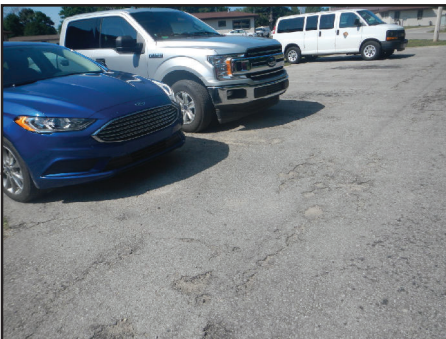
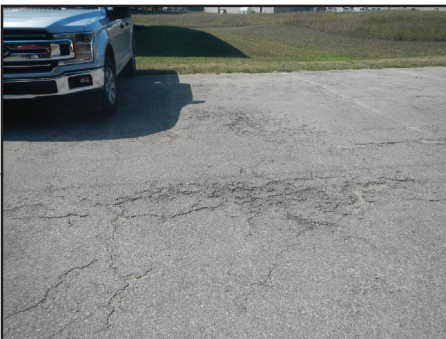
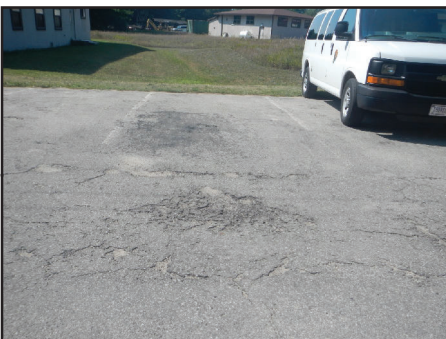
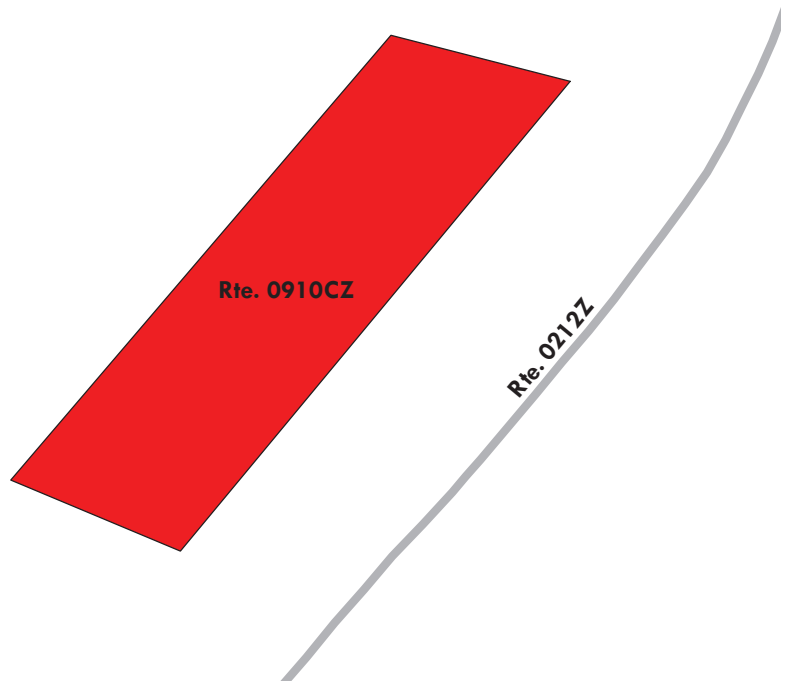
ROUTE 0910CZ: EMPIRE MAINTENANCE EMPLOYEE SOUTH PARKING

Inspection Date	FMISS Number	User Access	Surface Type
8/11/2018	39165	NONPUBLIC	ASPHALT
Area (Sq. Ft.)	Lane Miles (11' Widths)	Curb Reveal (Inches)	Curb Recommendation
1,451	0.025	NOT APPLICABLE	NOT APPLICABLE
Curb Type		Curb & Gutter Type	
NO CURB		NO CURB AND GUTTER	
Pavement Recommendation		Condition Rating / PCR	
HEAVY 3R TREATMENTS		POOR / 53

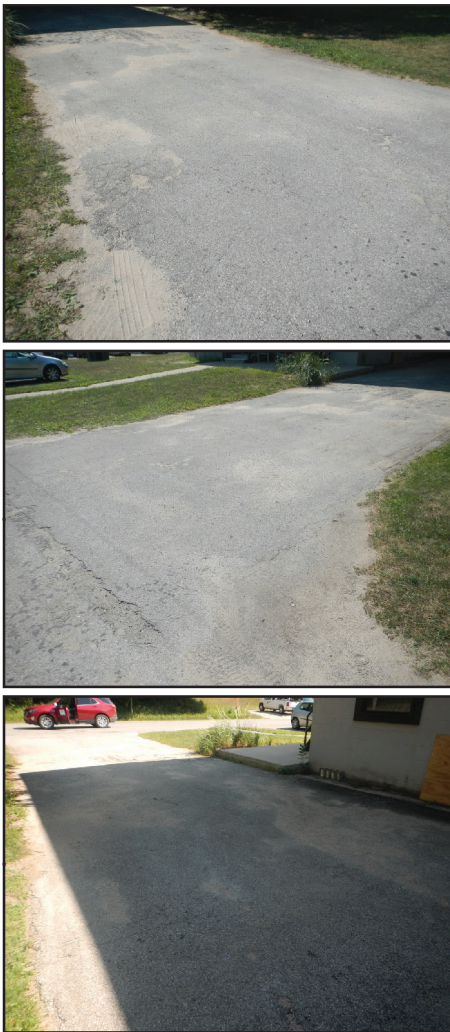
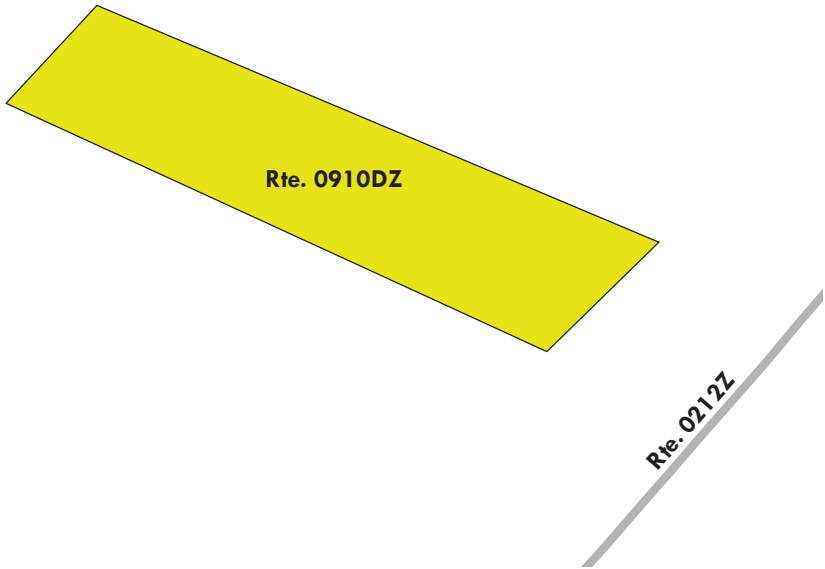
ROUTE 0910DZ: EMPIRE MAINTENANCE BOQ ENTRANCE PARKING

Inspection Date	FMSS Number	User Access	Surface Type
8/11/2018	39165	NONPUBLIC	ASPHALT
Area (Sq. Ft.)	Lane Miles (11' Widths)	Curb Reveal (Inches)	Curb Recommendation
1,069	0.018	NOT APPLICABLE	NOT APPLICABLE
Curb Type		Curb & Gutter Type	
NO CURB		NO CURB AND GUTTER	
Pavement Recommendation		Condition Rating / PCR	
LIGHT 3R TREATMENTS		FAIR / 73

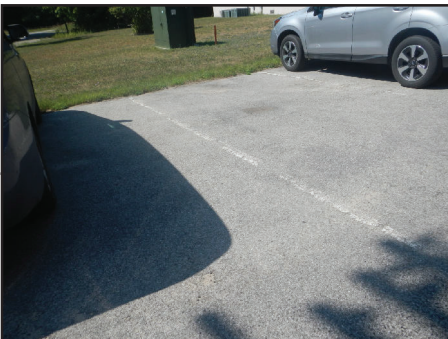
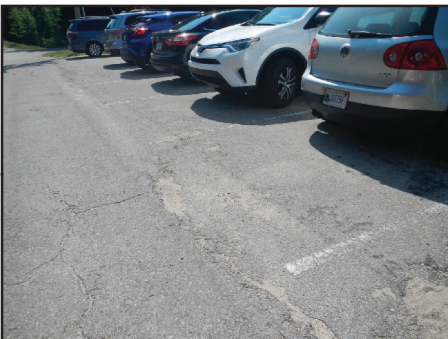
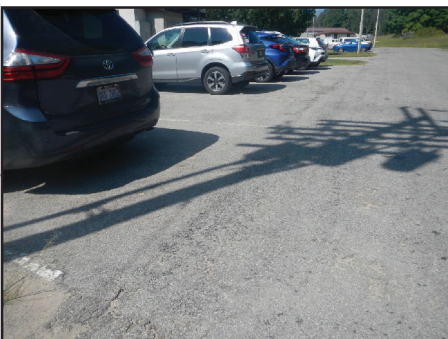
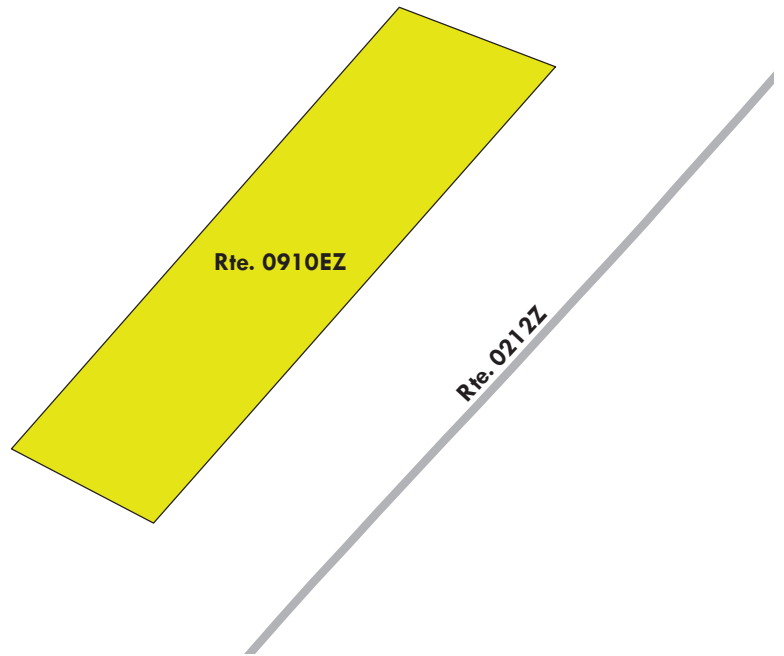
ROUTE 0910EZ: EMPIRE MAINTENANCE BOQ SOUTH PARKING

Inspection Date	FMSS Number	User Access	Surface Type
8/11/2018	39165	NONPUBLIC	ASPHALT
Area (Sq. Ft.)	Lane Miles (11' Widths)	Curb Reveal (Inches)	Curb Recommendation
1,235	0.021	NOT APPLICABLE	NOT APPLICABLE
Curb Type		Curb & Gutter Type	
NO CURB		NO CURB AND GUTTER	
Pavement Recommendation		Condition Rating / PCR	
LIGHT 3R TREATMENTS		FAIR / 73

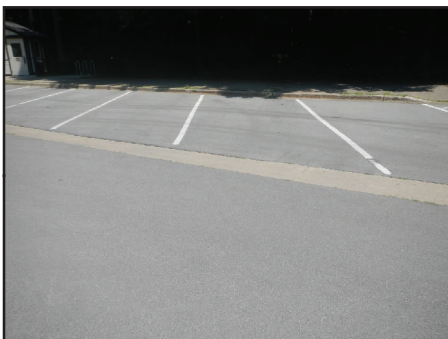
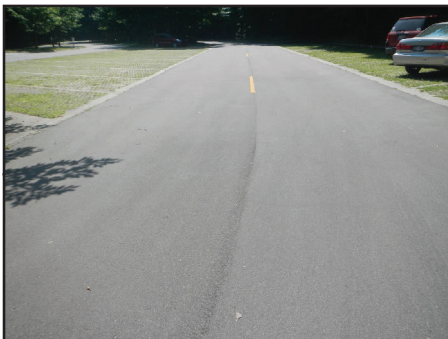
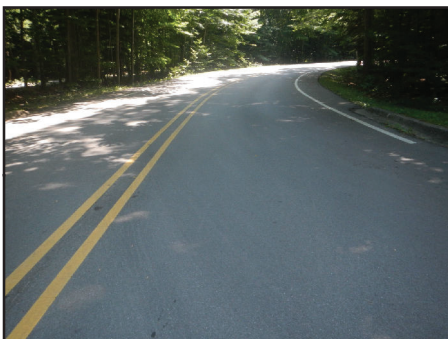
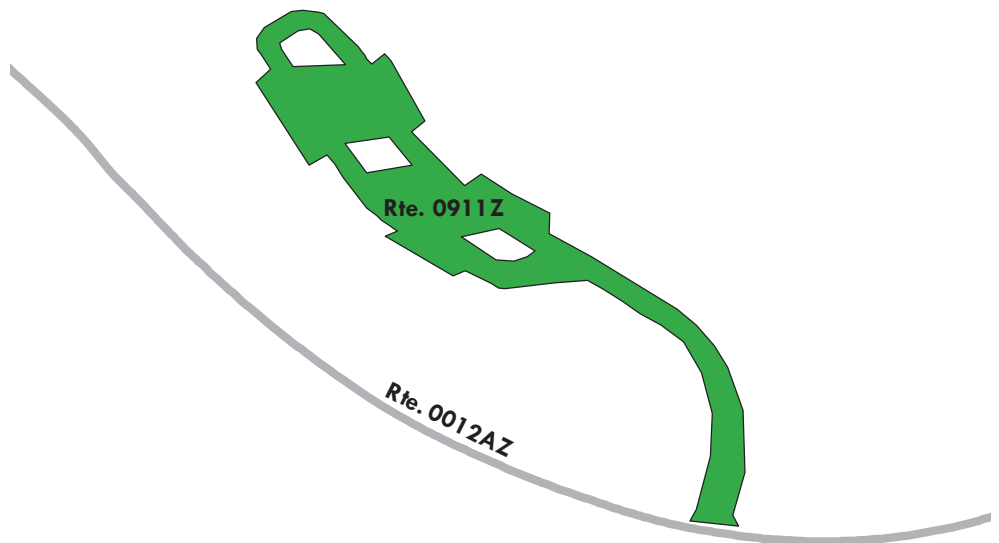
ROUTE 0911Z: SHAUGER HILL PARKING

Inspection Date	FMSS Number	User Access	Surface Type
8/11/2018	39083	PUBLIC	ASPHALT
Area (Sq. Ft.)	Lane Miles (11' Widths)	Curb Reveal (Inches)	Curb Recommendation
48,050	0.827	NOT APPLICABLE	DO NOTHING
Curb Type		Curb & Gutter Type	
NO CURB		CONCRETE	
Pavement Recommendation		Condition Rating / PCR	
PREVENTIVE MAINTENANCE		GOOD / 90

Note: Parking area consists of multiple surface types: 1 part Asphalt at 36,215 square feet; 4 parts Concrete at 11,835 square feet.

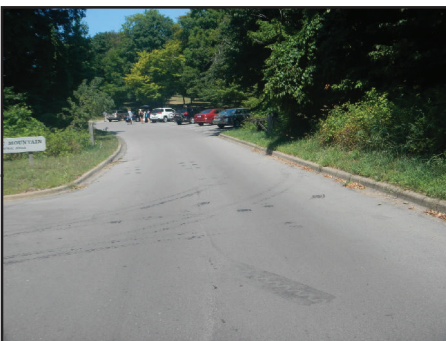
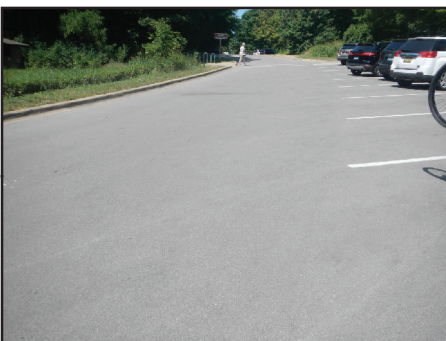
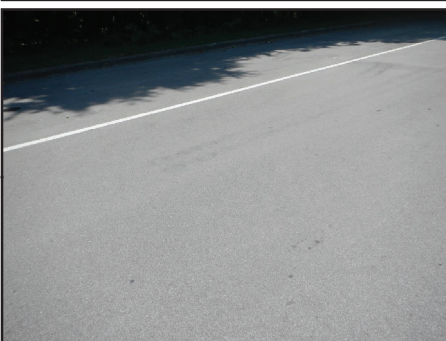
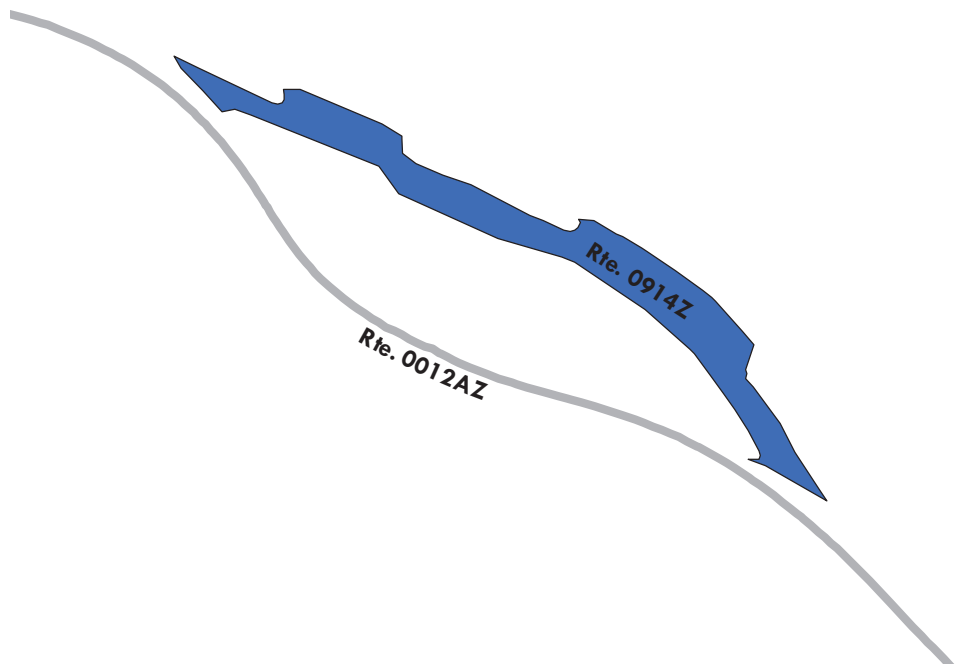
ROUTE 0914Z: PICNIC MOUNTAIN PARKING

Inspection Date	FMSS Number	User Access	Surface Type
8/11/2018	39083	PUBLIC	ASPHALT
Area (Sq. Ft.)	Lane Miles (11' Widths)	Curb Reveal (Inches)	Curb Recommendation
17,383	0.299	NOT APPLICABLE	DO NOTHING
Curb Type		Curb & Gutter Type	
NO CURB		CONCRETE	
Pavement Recommendation		Condition Rating / PCR	
DO NOTHING		EXCELLENT / 97

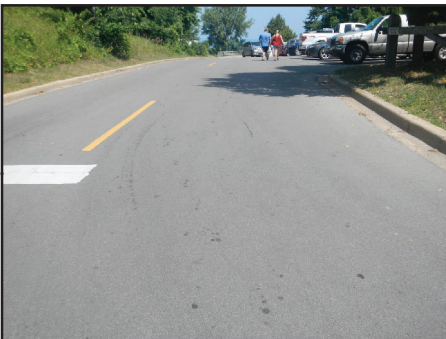
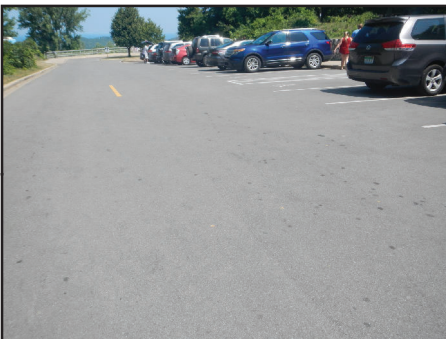
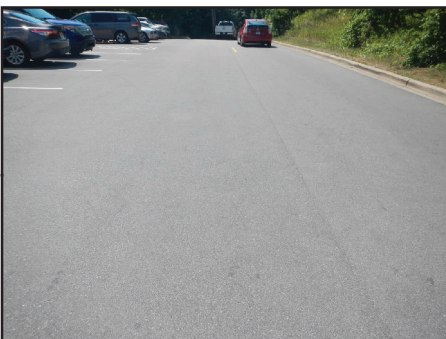
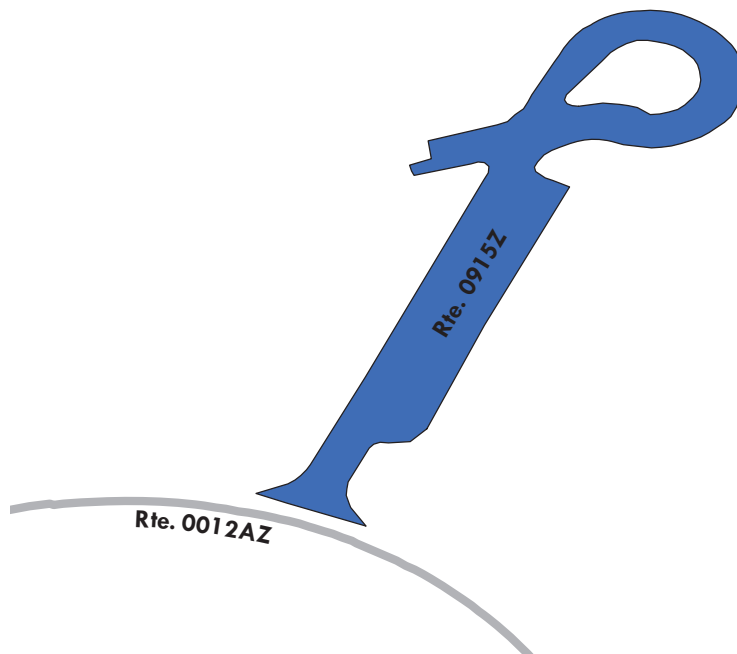
ROUTE 0915Z: DUNE OVERLOOK PARKING

Inspection Date	FMSS Number	User Access	Surface Type
8/11/2018	39083	PUBLIC	ASPHALT
Area (Sq. Ft.)	Lane Miles (11' Widths)	Curb Reveal (Inches)	Curb Recommendation
18,423	0.317	NOT APPLICABLE	DO NOTHING
Curb Type		Curb & Gutter Type	
NO CURB		CONCRETE	
Pavement Recommendation		Condition Rating / PCR	
DO NOTHING		EXCELLENT / 97

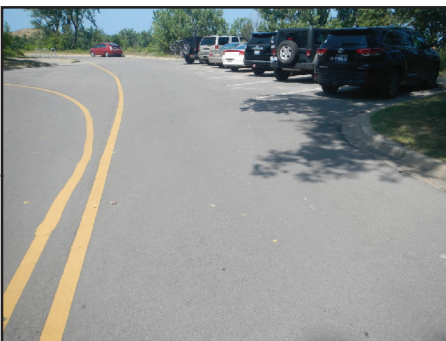
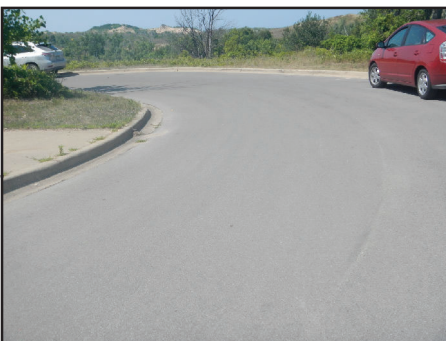
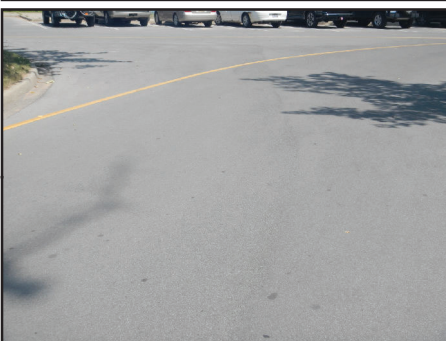
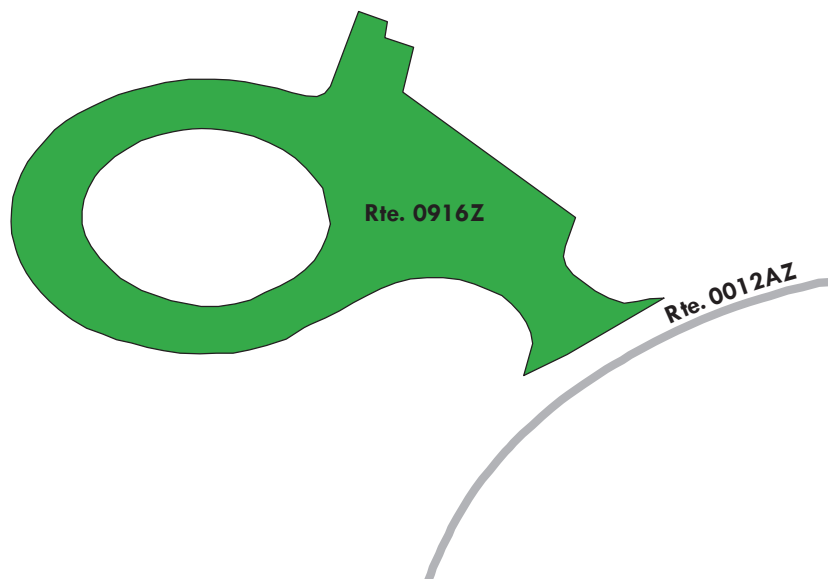
ROUTE 0916Z: COTTONWOOD TRAIL PARKING

Inspection Date	FMSS Number	User Access	Surface Type
8/11/2018	39083	PUBLIC	ASPHALT
Area (Sq. Ft.)	Lane Miles (11' Widths)	Curb Reveal (Inches)	Curb Recommendation
12,153	0.209	NOT APPLICABLE	DO NOTHING
Curb Type		Curb & Gutter Type	
NO CURB		CONCRETE	
Pavement Recommendation		Condition Rating / PCR	
PREVENTIVE MAINTENANCE		GOOD / 90

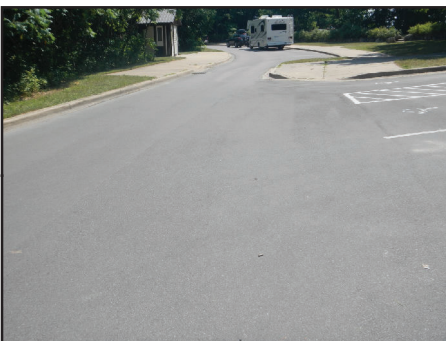
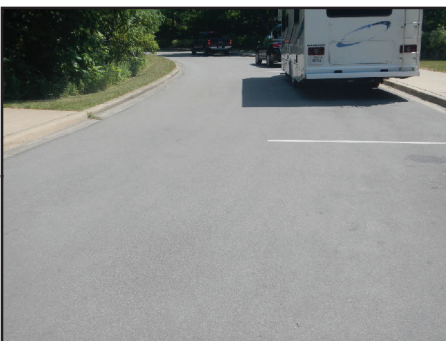
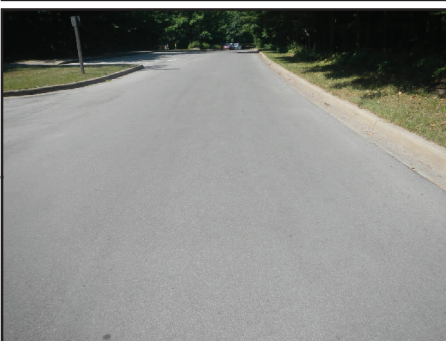
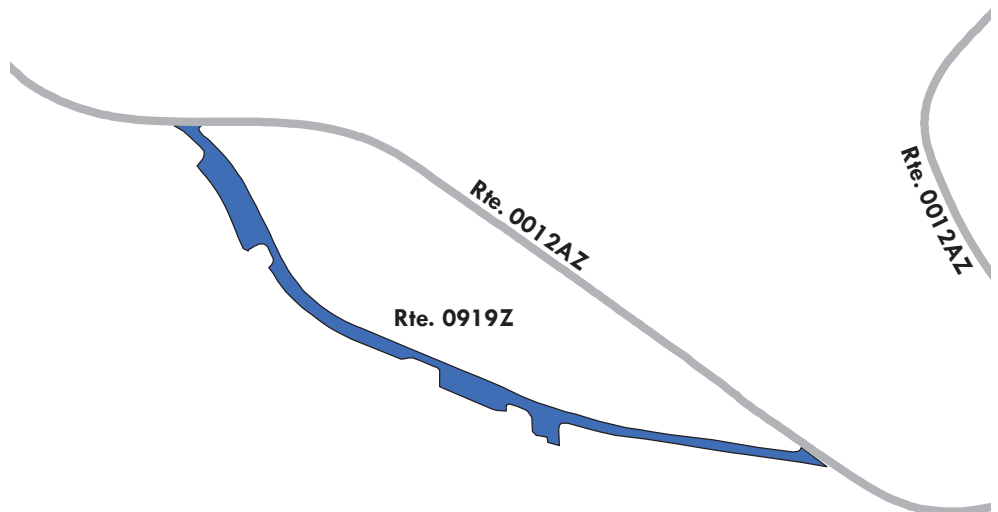
ROUTE 0919Z: NORTH BAR OVERLOOK PARKING

Inspection Date	FMSS Number	User Access	Surface Type
8/11/2018	39083	PUBLIC	ASPHALT
Area (Sq. Ft.)	Lane Miles (11' Widths)	Curb Reveal (Inches)	Curb Recommendation
27,902	0.48	NOT APPLICABLE	DO NOTHING
Curb Type		Curb & Gutter Type	
NO CURB		CONCRETE	
Pavement Recommendation		Condition Rating / PCR	
DO NOTHING		EXCELLENT / 97

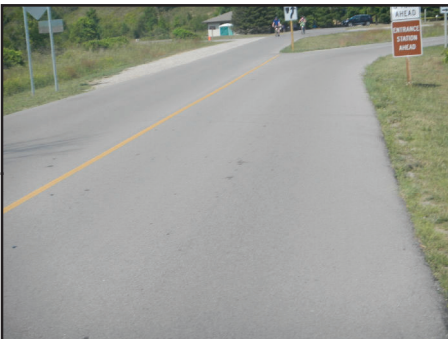
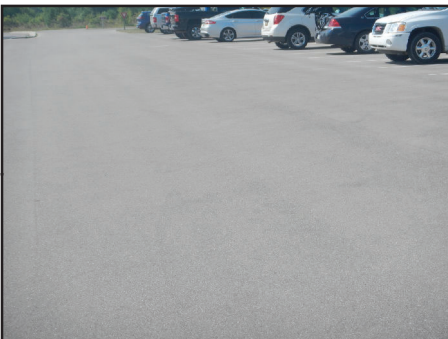
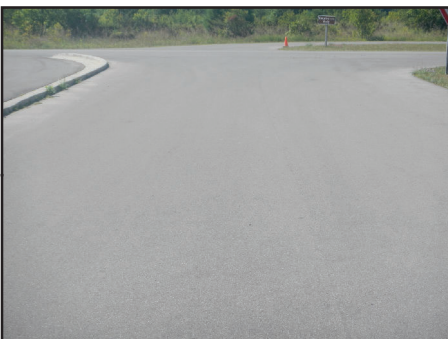
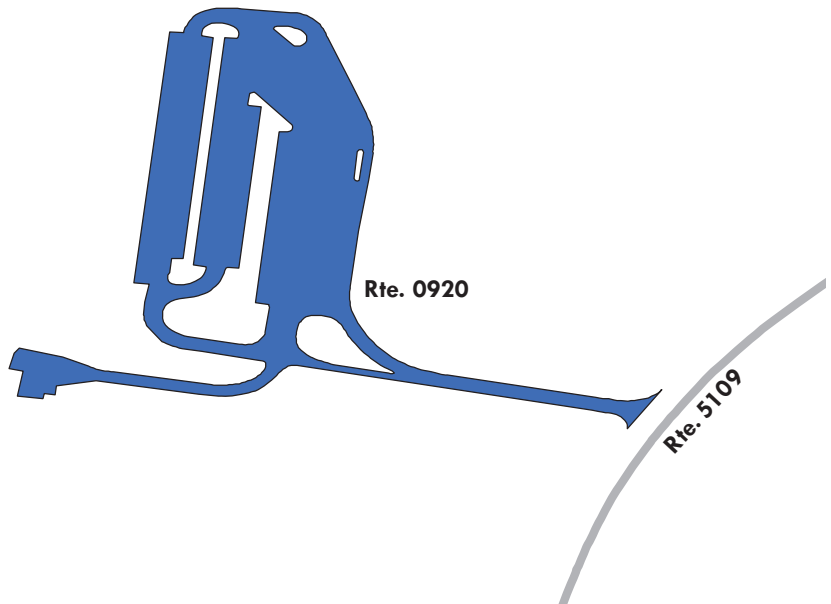
ROUTE 0920: DUNE CLIMB PARKING

Inspection Date	FMSS Number	User Access	Surface Type
8/11/2018	39056	PUBLIC	ASPHALT
Area (Sq. Ft.)	Lane Miles (11' Widths)	Curb Reveal (Inches)	Curb Recommendation
162,438	2.797	NOT APPLICABLE	DO NOTHING
Curb Type		Curb & Gutter Type	
NO CURB		CONCRETE	
Pavement Recommendation		Condition Rating / PCR	
DO NOTHING		EXCELLENT / 97

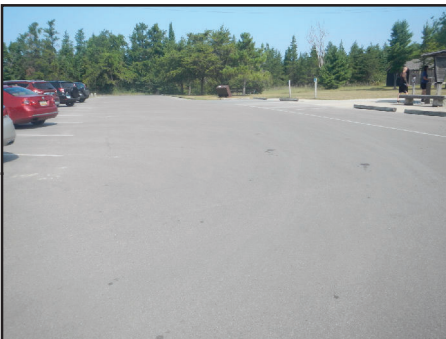
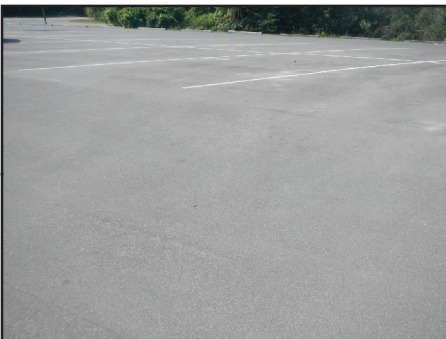
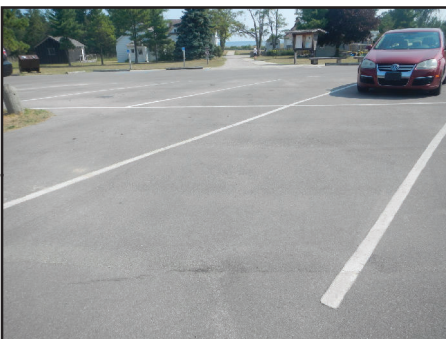
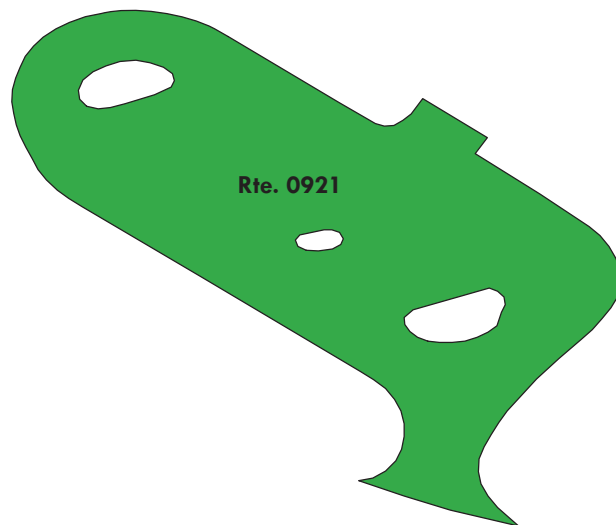
ROUTE 0921: SLBE USCGS PARKING

Inspection Date	FMSS Number	User Access	Surface Type
8/11/2018	27691	PUBLIC	ASPHALT
Area (Sq. Ft.)	Lane Miles (11' Widths)	Curb Reveal (Inches)	Curb Recommendation
20,485	0.353	NOT APPLICABLE	NOT APPLICABLE
Curb Type		Curb & Gutter Type	
NO CURB		NO CURB AND GUTTER	
Pavement Recommendation		Condition Rating / PCR	
PREVENTIVE MAINTENANCE		GOOD / 90

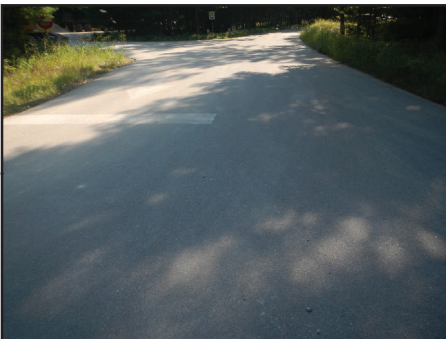
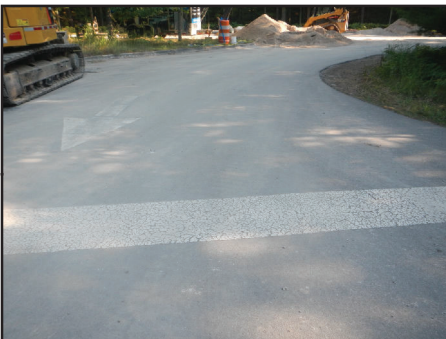
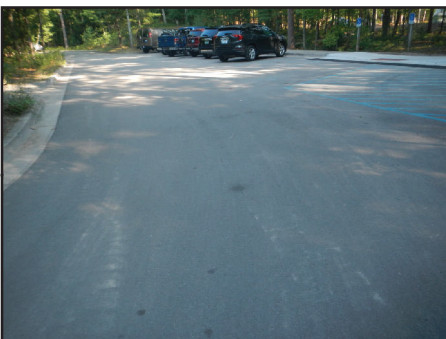
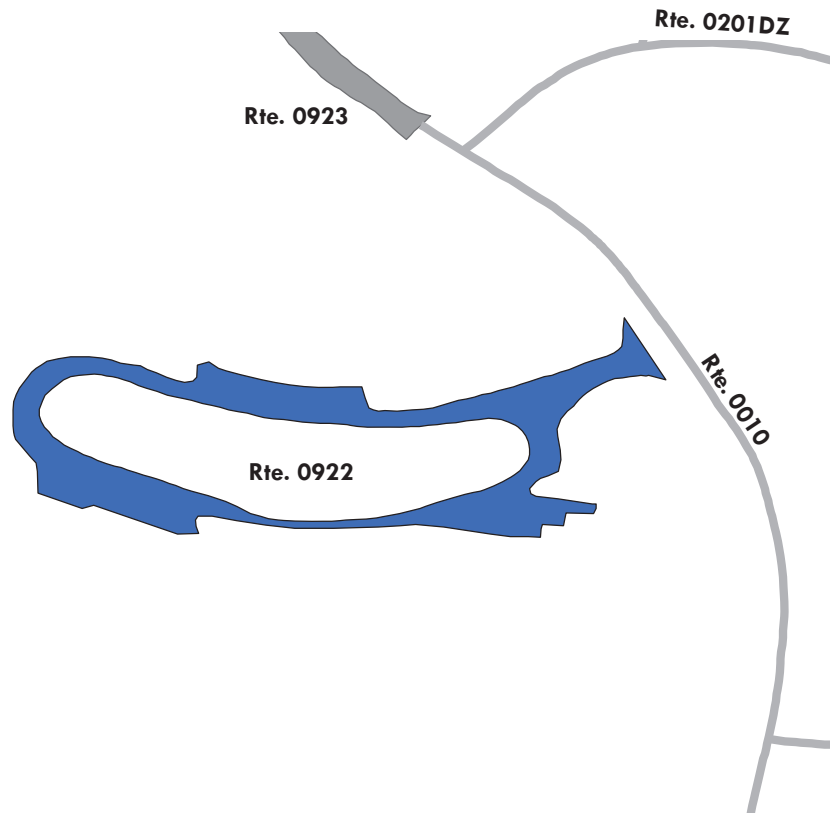
ROUTE 0922: PRCG GROUP SITES PARKING

Inspection Date	FMSS Number	User Access	Surface Type
8/11/2018	48164	PUBLIC	ASPHALT
Area (Sq. Ft.)	Lane Miles (11' Widths)	Curb Reveal (Inches)	Curb Recommendation
20,889	0.36	NOT APPLICABLE	DO NOTHING
Curb Type		Curb & Gutter Type	
NO CURB		CONCRETE	
Pavement Recommendation		Condition Rating / PCR	
DO NOTHING		EXCELLENT / 97
