SLBE Cycle 6

Final Report

Road Inventory and Condition Assessment of Paved Routes Sleeping Bear Dunes National Lakeshore

Report Date: August 2019

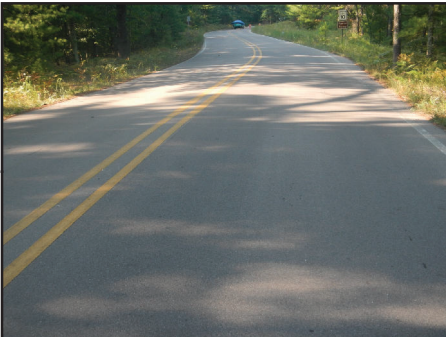
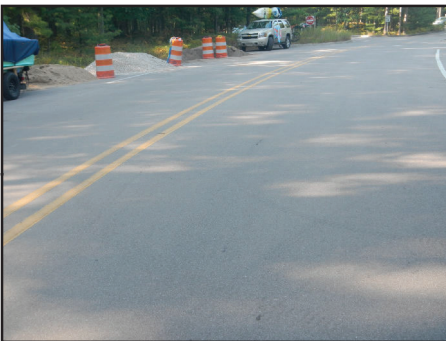
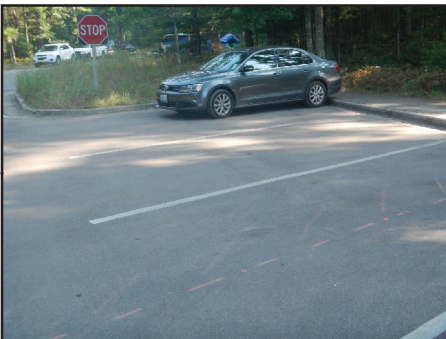
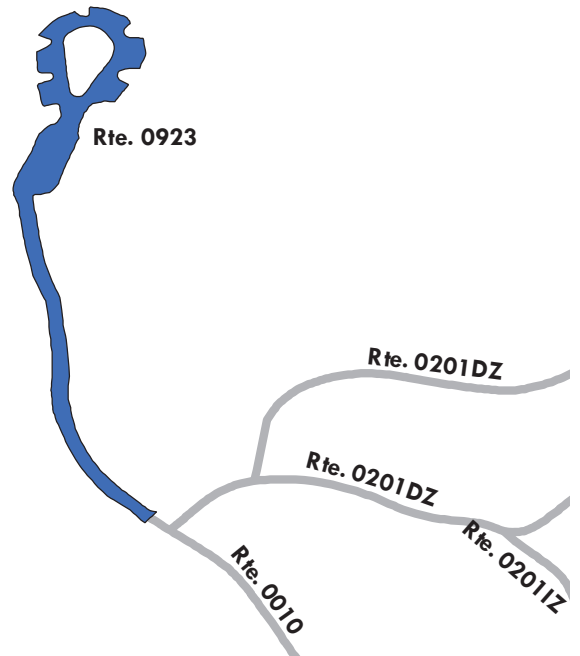
ROUTE 0923: PRCG WALK-IN SITES PARKING

Inspection Date	FMSS Number	User Access	Surface Type
8/11/2018	48195	PUBLIC	ASPHALT
Area (Sq. Ft.)	Lane Miles (11' Widths)	Curb Reveal (Inches)	Curb Recommendation
35,014	0.603	NOT APPLICABLE	DO NOTHING
Curb Type		Curb & Gutter Type	
NO CURB		CONCRETE	
Pavement Recommendation		Condition Rating / PCR	
DO NOTHING		EXCELLENT / 97

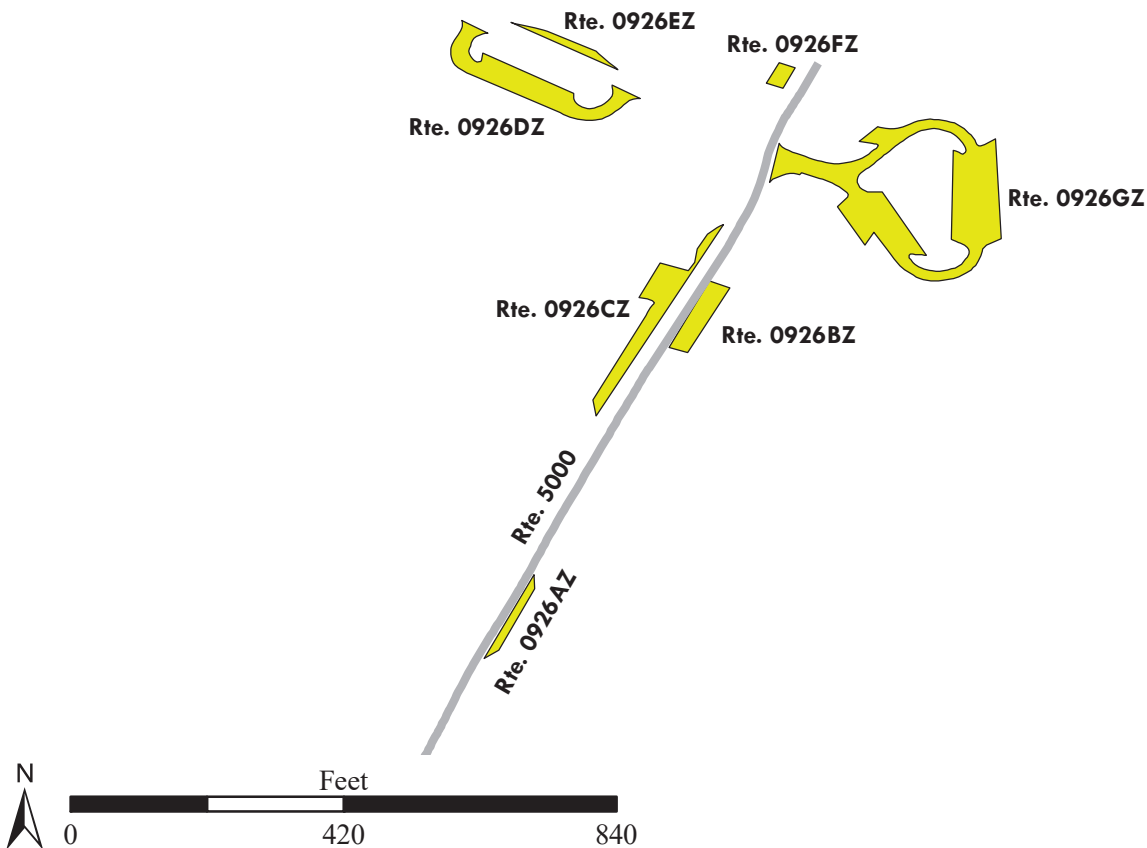
Rte. 0926ZZ (7 Subcomponents)

Inspection Date	FMSS Number	User Access	Surface Type
8/11/2018	48295	PUBLIC	ASPHALT
Area (Sq. Ft.)	Lane Miles (11' Widths)	Condition Rating / PCR	
38,720	0.667	SUMMARY / 73

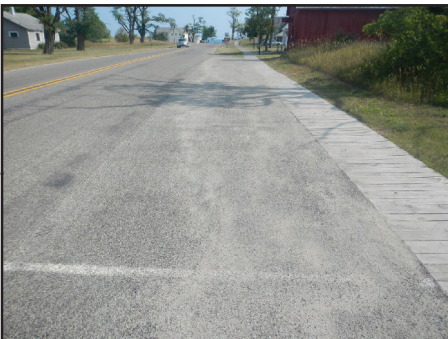
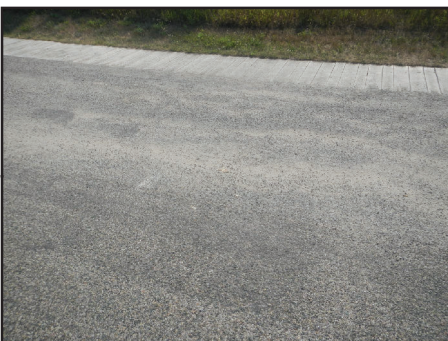
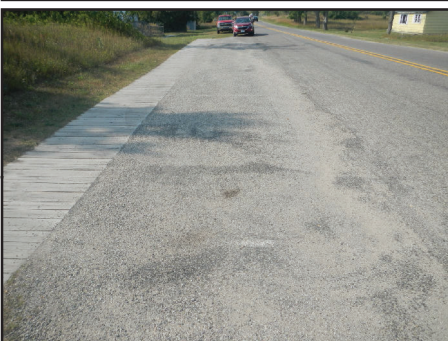
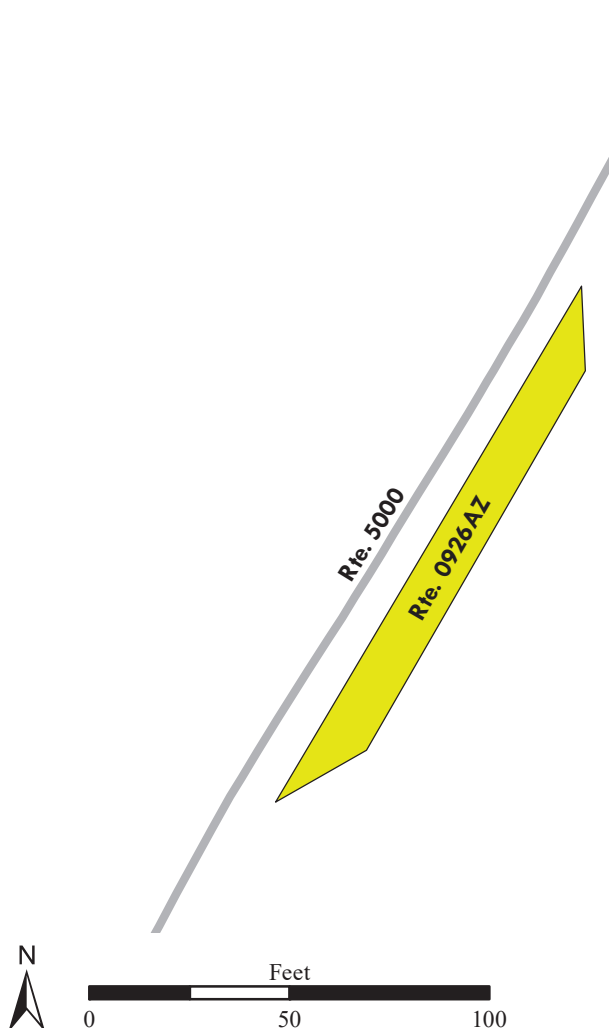
ROUTE 0926AZ: BLACKSMITH PARKING A

Inspection Date	FMSS Number	User Access	Surface Type
8/11/2018	48295	PUBLIC	ASPHALT
Area (Sq. Ft.)	Lane Miles (11' Widths)	Curb Reveal (Inches)	Curb Recommendation
1,123	0.019	NOT APPLICABLE	NOT APPLICABLE
Curb Type		Curb & Gutter Type	
NO CURB		NO CURB AND GUTTER	
Pavement Recommendation		Condition Rating / PCR	
LIGHT 3R TREATMENTS		FAIR / 73

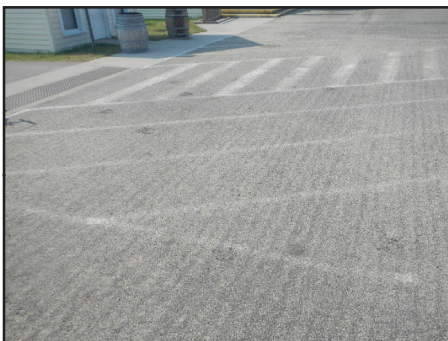
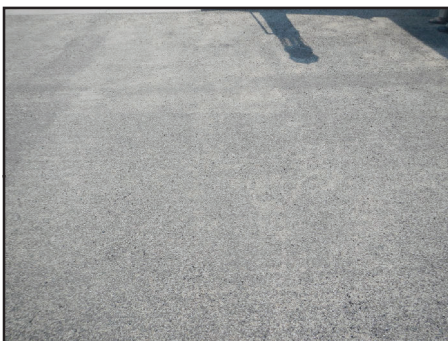
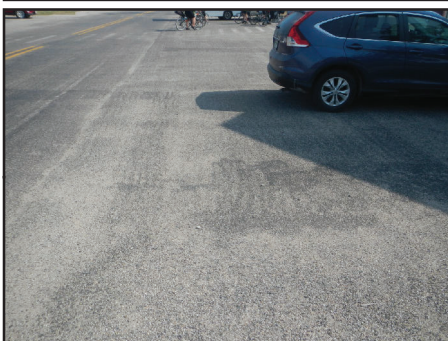
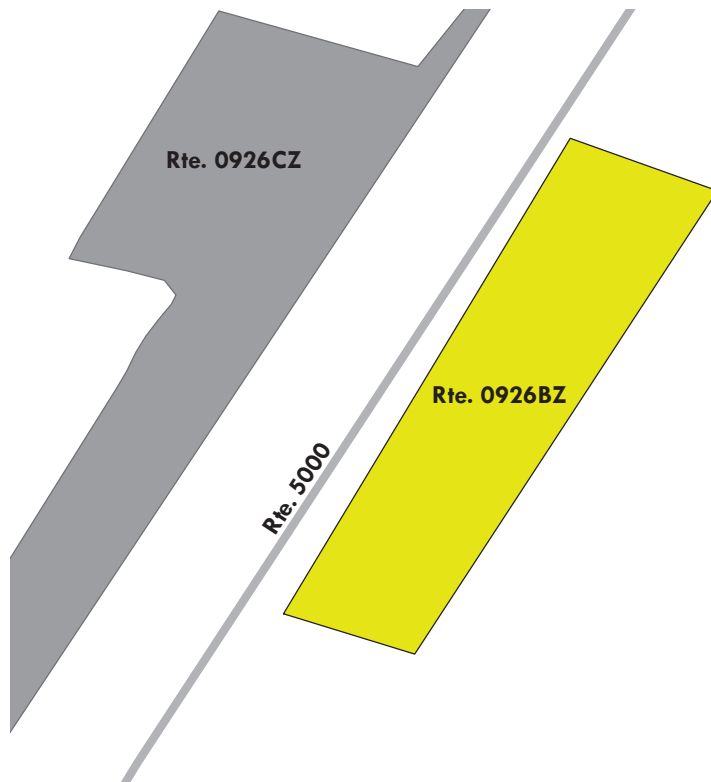
ROUTE 0926BZ: GENERAL STORE PARKING B

Inspection Date	FMSS Number	User Access	Surface Type
8/11/2018	48295	PUBLIC	ASPHALT
Area (Sq. Ft.)	Lane Miles (11' Widths)	Curb Reveal (Inches)	Curb Recommendation
2,599	0.045	NOT APPLICABLE	NOT APPLICABLE
Curb Type		Curb & Gutter Type	
NO CURB		NO CURB AND GUTTER	
Pavement Recommendation		Condition Rating / PCR	
LIGHT 3R TREATMENTS		FAIR / 73

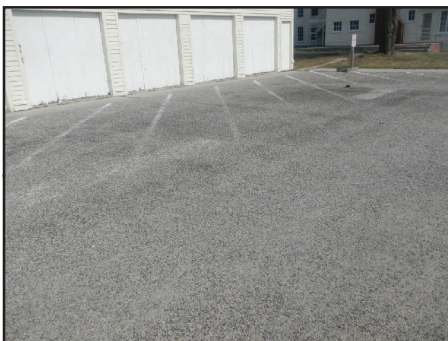
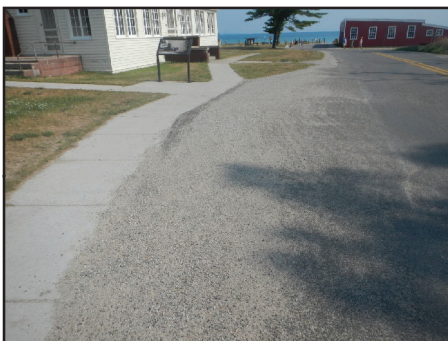
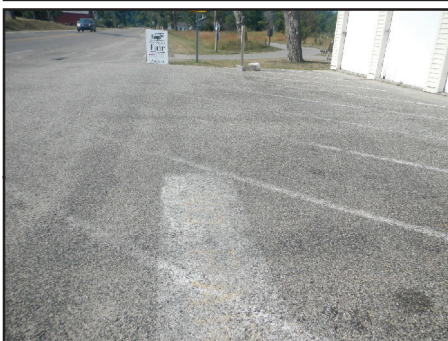
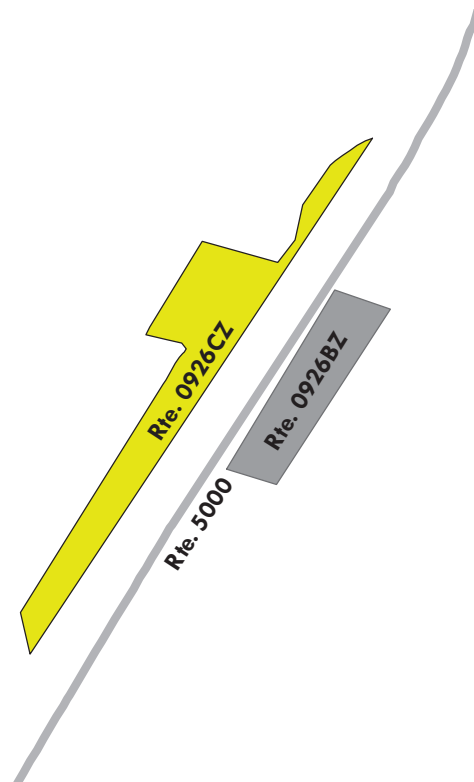
ROUTE 0926CZ: SLEEPING BEAR GARAGE PARKING C

Inspection Date	FMSS Number	User Access	Surface Type
8/11/2018	48295	PUBLIC	ASPHALT
Area (Sq. Ft.)	Lane Miles (11' Widths)	Curb Reveal (Inches)	Curb Recommendation
5,374	0.093	NOT APPLICABLE	NOT APPLICABLE
Curb Type		Curb & Gutter Type	
NO CURB		NO CURB AND GUTTER	
Pavement Recommendation		Condition Rating / PCR	
LIGHT 3R TREATMENTS		FAIR / 73

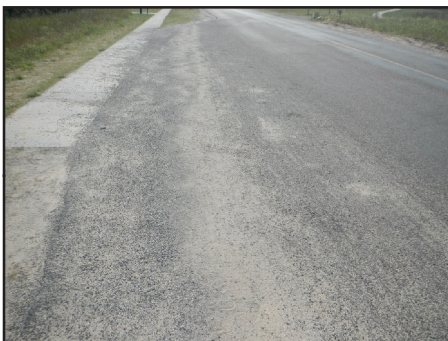
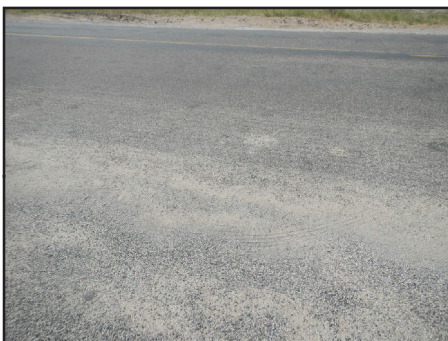
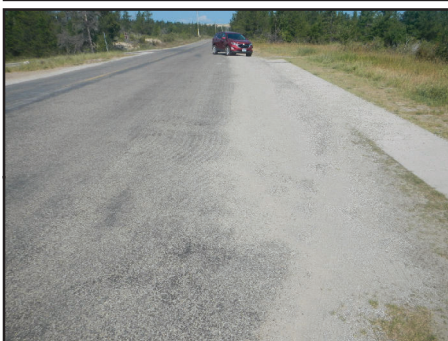
ROUTE 0926EZ: BUS PARKING E

Inspection Date	FMSS Number	User Access	Surface Type
8/11/2018	48295	PUBLIC	ASPHALT
Area (Sq. Ft.)	Lane Miles (11' Widths)	Curb Reveal (Inches)	Curb Recommendation
1,045	0.018	NOT APPLICABLE	NOT APPLICABLE
Curb Type		Curb & Gutter Type	
NO CURB		NO CURB AND GUTTER	
Pavement Recommendation		Condition Rating / PCR	
LIGHT 3R TREATMENTS		FAIR / 73

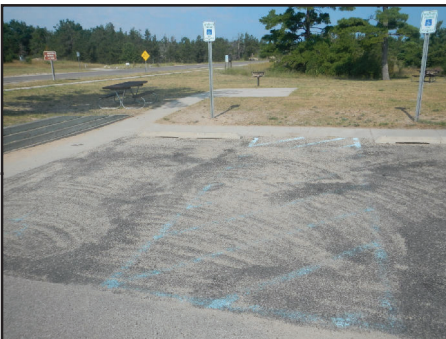
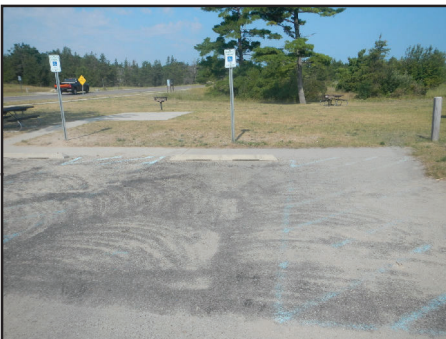
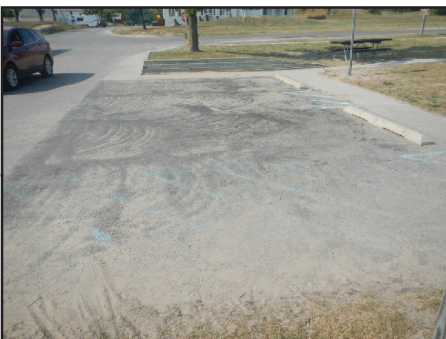
ROUTE 0926FZ: HANDICAP PARKING F

Inspection Date	FMSS Number	User Access	Surface Type
8/11/2018	48295	PUBLIC	ASPHALT
Area (Sq. Ft.)	Lane Miles (11' Widths)	Curb Reveal (Inches)	Curb Recommendation
681	0.012	NOT APPLICABLE	NOT APPLICABLE
Curb Type		Curb & Gutter Type	
NO CURB		NO CURB AND GUTTER	
Pavement Recommendation		Condition Rating / PCR	
LIGHT 3R TREATMENTS		FAIR / 73

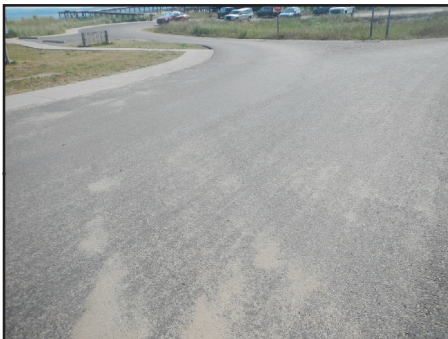
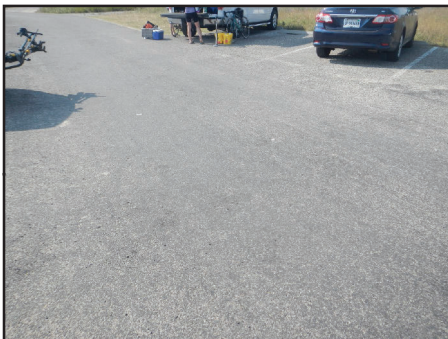
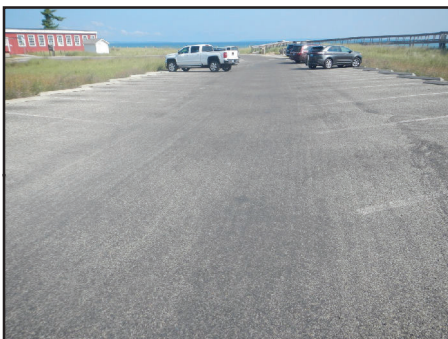
ROUTE 0926GZ: GLEN HAVEN PARKING G

Inspection Date	FMSS Number	User Access	Surface Type
8/11/2018	48295	PUBLIC	ASPHALT
Area (Sq. Ft.)	Lane Miles (11' Widths)	Curb Reveal (Inches)	Curb Recommendation
20,694	0.356	NOT APPLICABLE	NOT APPLICABLE
Curb Type		Curb & Gutter Type	
NO CURB		NO CURB AND GUTTER	
Pavement Recommendation		Condition Rating / PCR	
LIGHT 3R TREATMENTS		FAIR / 73

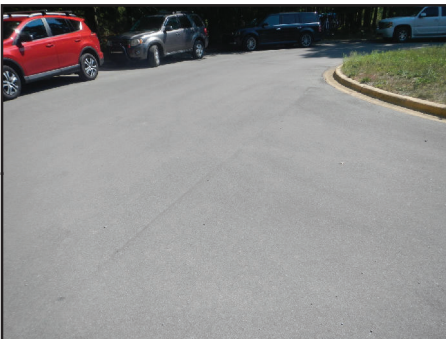
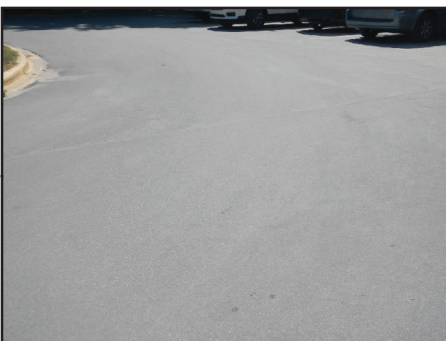
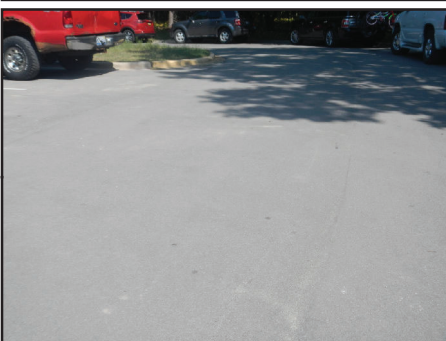
ROUTE 0940: NORTH BAR LAKE PARKING

Inspection Date	FMSS Number	User Access	Surface Type
8/11/2018	39115	PUBLIC	ASPHALT
Area (Sq. Ft.)	Lane Miles (11' Widths)	Curb Reveal (Inches)	Curb Recommendation
23,878	0.411	NOT APPLICABLE	DO NOTHING
Curb Type		Curb & Gutter Type	
NO CURB		CONCRETE	
Pavement Recommendation		Condition Rating / PCR	
PREVENTIVE MAINTENANCE		GOOD / 90

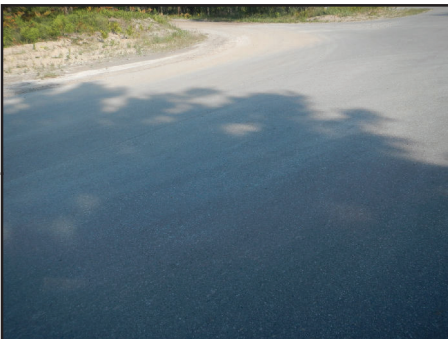
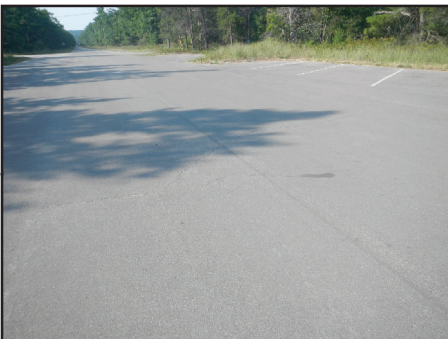
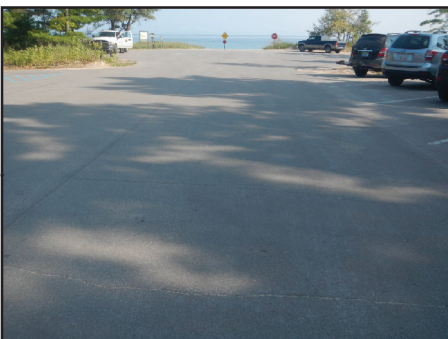
ROUTE 0944: 669 ACCESS PARKING

Inspection Date	FMSS Number	User Access	Surface Type
8/11/2018	237573	PUBLIC	ASPHALT
Area (Sq. Ft.)	Lane Miles (11' Widths)	Curb Reveal (Inches)	Curb Recommendation
27,967	0.482	NOT APPLICABLE	NOT APPLICABLE
Curb Type		Curb & Gutter Type	
NO CURB		NO CURB AND GUTTER	
Pavement Recommendation		Condition Rating / PCR	
PREVENTIVE MAINTENANCE		GOOD / 90

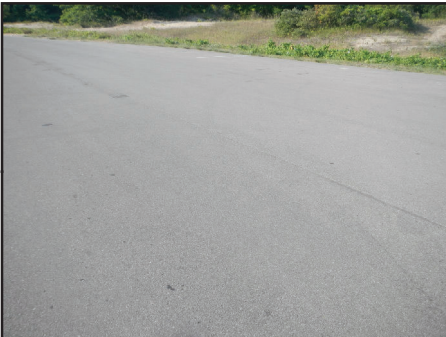
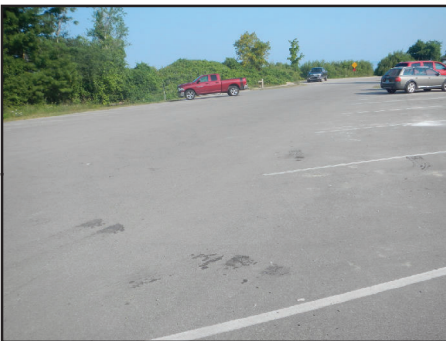
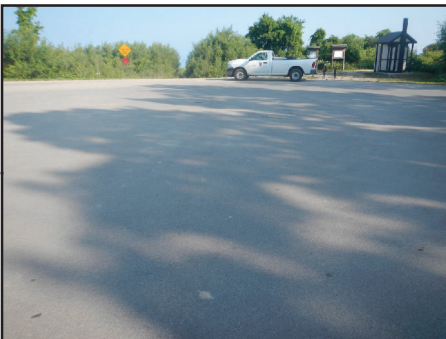
ROUTE 0945: 651 ACCESS PARKING

Inspection Date	FMSS Number	User Access	Surface Type
8/11/2018	237587	PUBLIC	ASPHALT
Area (Sq. Ft.)	Lane Miles (11' Widths)	Curb Reveal (Inches)	Curb Recommendation
33,807	0.582	NOT APPLICABLE	NOT APPLICABLE
Curb Type		Curb & Gutter Type	
NO CURB		NO CURB AND GUTTER	
Pavement Recommendation		Condition Rating / PCR	
PREVENTIVE MAINTENANCE		GOOD / 90

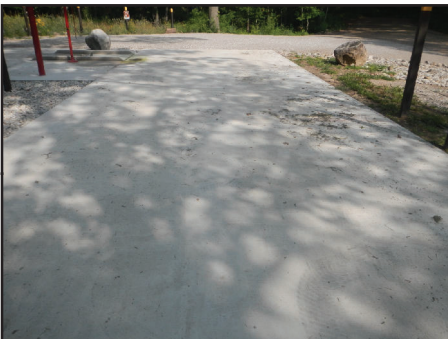
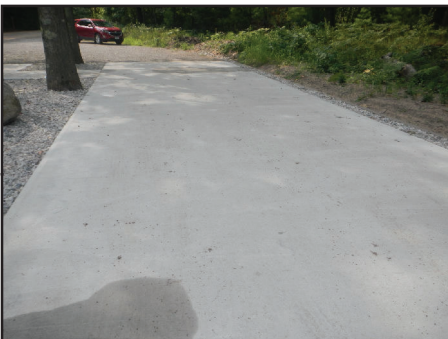
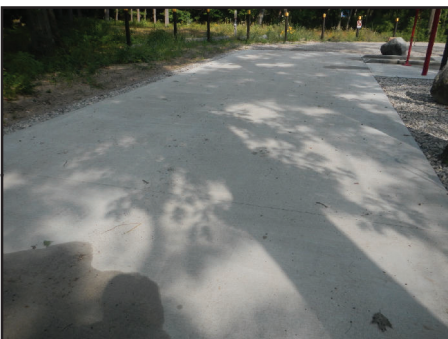
ROUTE 0946: D.H. DAY CAMPGROUND DUMP STATION

Inspection Date	FMSS Number	User Access	Surface Type
8/11/2018	N/A	PUBLIC	CONCRETE
Area (Sq. Ft.)	Lane Miles (11' Widths)	Curb Reveal (Inches)	Curb Recommendation
2,139	0.037	NOT APPLICABLE	NOT APPLICABLE
Curb Type		Curb & Gutter Type	
NO CURB		NO CURB AND GUTTER	
Pavement Recommendation		Condition Rating / PCR	
DO NOTHING		EXCELLENT / 97
