STE Cycle 6

Final Report

Road Inventory and Condition Assessment of Paved Routes Steamtown National Historic Site

Steamtown National Historic Site in Pennsylvania

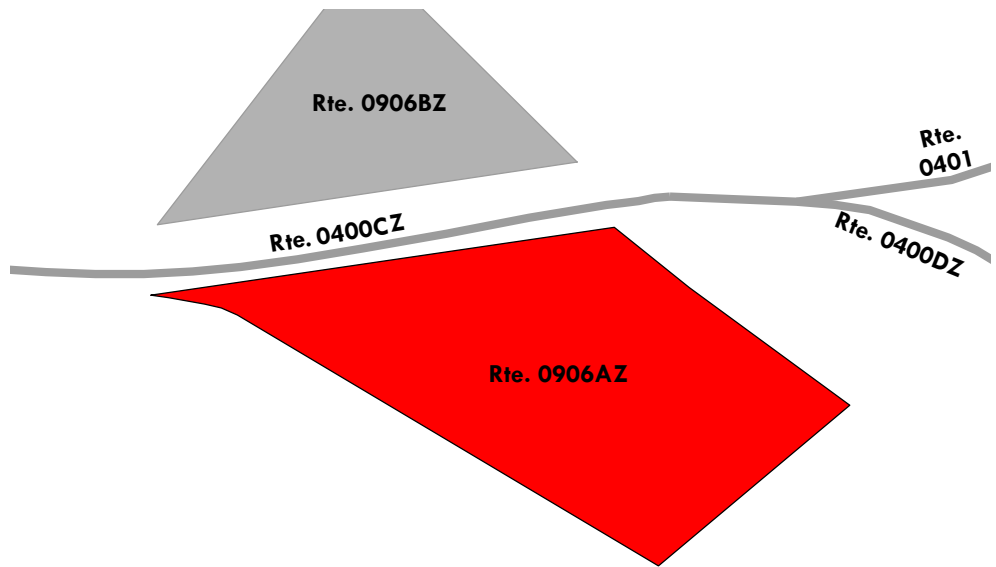
ROUTE 0906AZ: OFFICE AND STORAGE BUILDING PARKING A

Inspection Date	FMSS Number	User Access	Surface Type
8/20/2020	61119	NONPUBLIC	ASPHALT
Area (Sq. Ft.)	Lane Miles (11' Widths)	Curb Reveal (Inches)	Curb Recommendation
9,718	0.167	NOT APPLICABLE	NOT APPLICABLE
Curb Type		Curb & Gutter Type	
NO CURB		NO CURB AND GUTTER	
Pavement Recommendation		Condition Rating / PCR	
HEAVY 3R TREATMENTS		POOR / 53

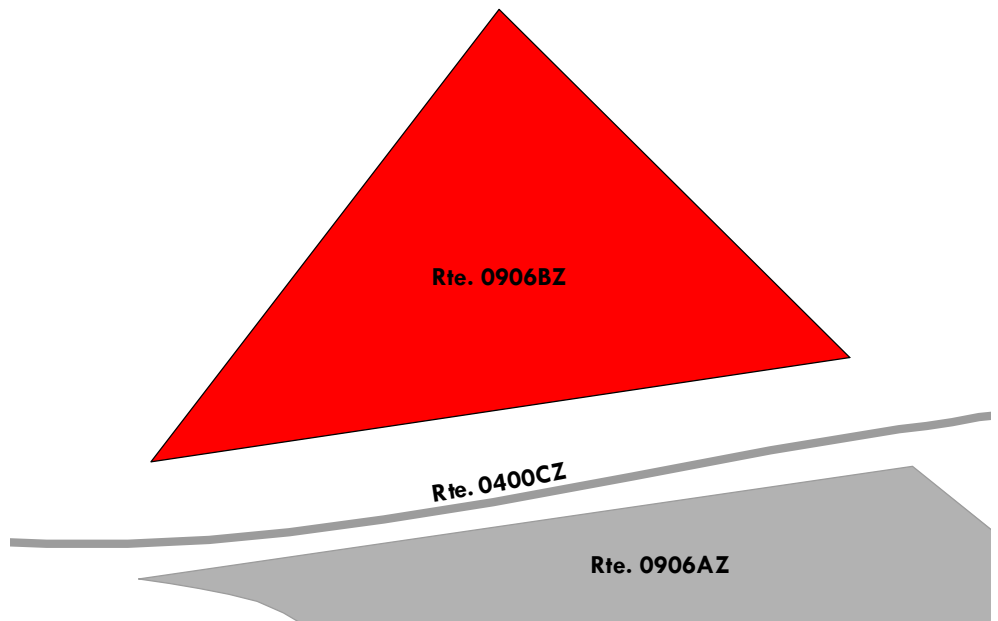
ROUTE 0906BZ: OFFICE AND STORAGE BUILDING PARKING B

Inspection Date	FMSS Number	User Access	Surface Type
8/20/2020	61119	NONPUBLIC	ASPHALT
Area (Sq. Ft.)	Lane Miles (11' Widths)	Curb Reveal (Inches)	Curb Recommendation
4,497	0.077	NOT APPLICABLE	NOT APPLICABLE
Curb Type		Curb & Gutter Type	
NO CURB		NO CURB AND GUTTER	
Pavement Recommendation		Condition Rating / PCR	
HEAVY 3R TREATMENTS		POOR / 53

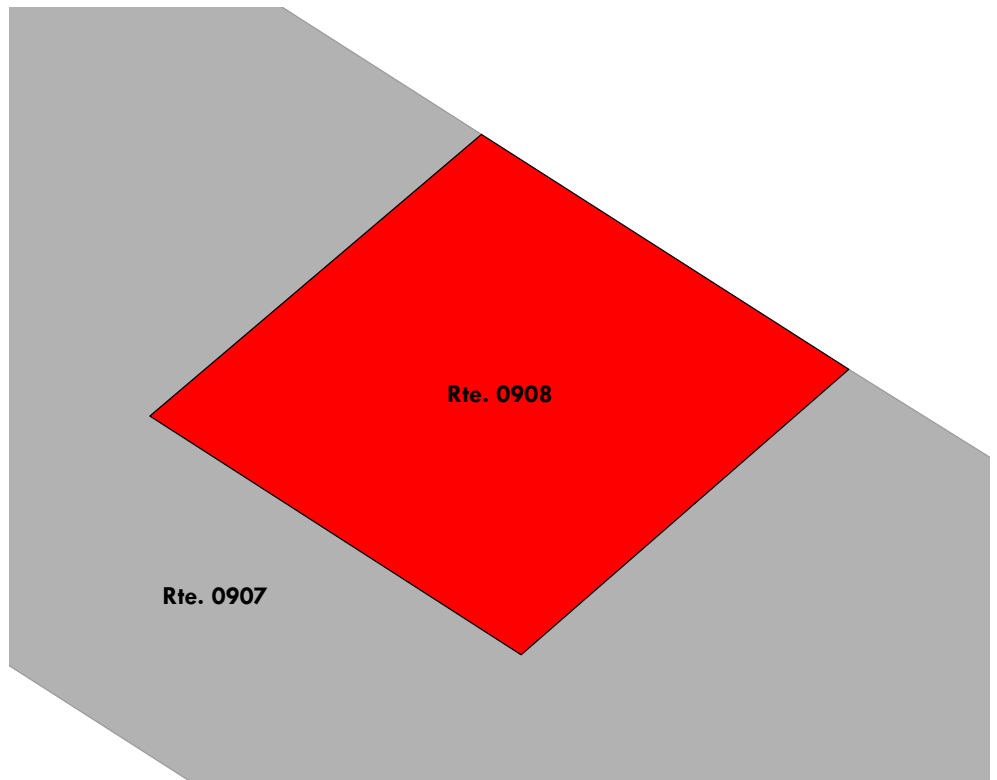
ROUTE 0908: MAINTENANCE AREA HANDICAPPED PARKING

Inspection Date	FMSS Number	User Access	Surface Type
8/20/2020	61121	NONPUBLIC	CONCRETE
Area (Sq. Ft.)	Lane Miles (11' Widths)	Curb Reveal (Inches)	Curb Recommendation
356	0.006	NOT APPLICABLE	NOT APPLICABLE
Curb Type		Curb & Gutter Type	
NO CURB		NO CURB AND GUTTER	
Pavement Recommendation		Condition Rating / PCR	
HEAVY 3R TREATMENTS		POOR / 53
