SUIT Cycle 6

Final Report

Road Inventory and Condition Assessment of Paved Routes Suitland Parkway *Part of the National Capital Parks - East*

Report Date: November 2019

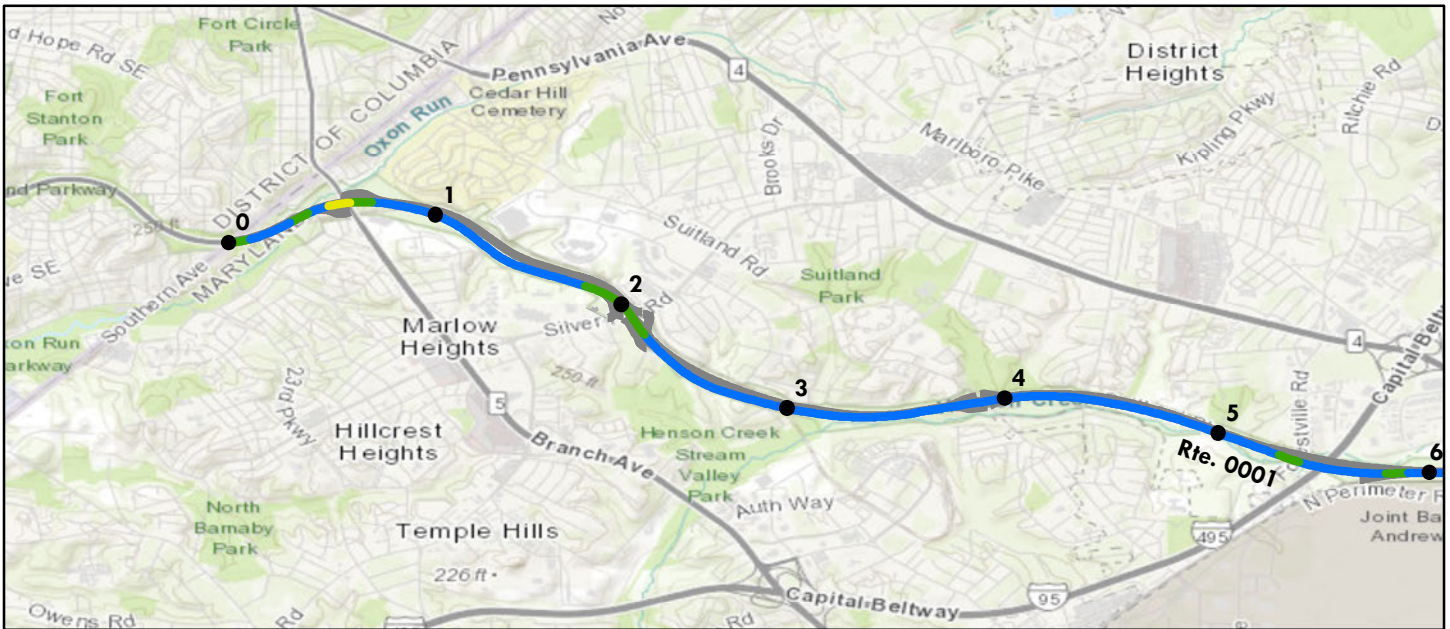
ROUTE 0001: EASTBOUND SUITLAND PARKWAY

Route Condition Legend – Pavement Condition Rating (PCR)						
Poor (0 - 60)	Fair (61- 84)	Good (85 - 94)	Excellent (95 - 100)	Not Rated		
Colors on map represent condition scores at 0.10-mile intervals. See Appendix for definitions and formulas.						
Inspection Date: 3/24/2018	Beginning Section MP	0	1	2	3	4
Paved Length (Miles): 6.44	Section Length (MI)	1	1	1	1	1
Surface Type: ASPHALT	Route Summary					
Roadway Condition Information						
Pavement Condition Rating (PCR)	98	95	96	98	98	98
Surface Condition Rating (SCR)	96	91	93	97	96	97
Roughness Condition Index (RCI)	100	100	100	100	100	100
Distress Index Values						
Structural Crack Index	96	91	93	97	96	99
Alligator Crack Index	100	100	100	100	100	100
Longitudinal Crack Index	96	91	93	97	96	99
Transverse Cracking Index	98	98	97	97	98	97
Patching Index	100	98	100	100	100	100
Rutting Index	97	92	98	100	100	99
International Roughness Index (IRI)	82	99	81	78	59	86

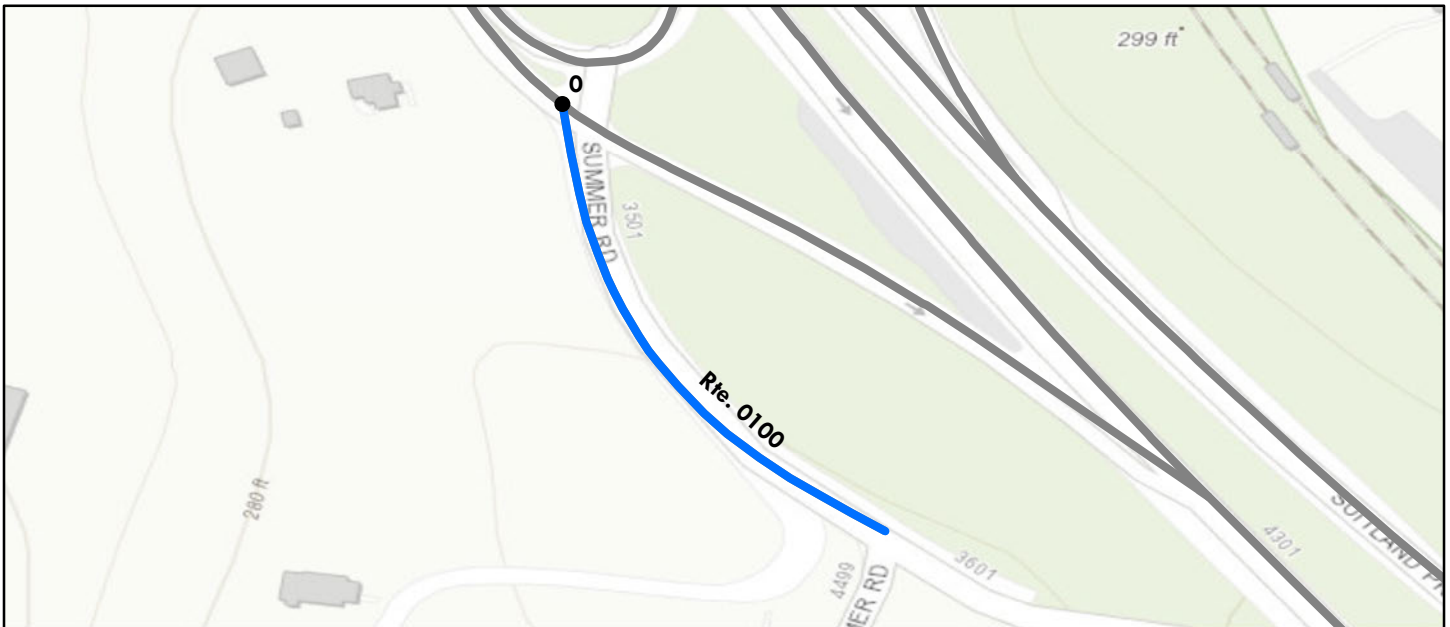
ROUTE 0100: SUMMER ROAD

Inspection Date:	3/24/2018	Beginning Section MP	0				
Paved Length (Miles):	0.08	Section Length (MI)	0.08				
Surface Type:	ASPHALT	Route Summary					
Roadway Condition Information							
Pavement Condition Rating (PCR)	99	99					
Surface Condition Rating (SCR)	99	99					
Roughness Condition Index (RCI)	N/A	N/A					
Distress Index Values							
Structural Crack Index	100	100					
Alligator Crack Index	100	100					
Longitudinal Crack Index	100	100					
Transverse Cracking Index	100	100					
Patching Index	100	100					
Rutting Index	99	99					
International Roughness Index (IRI)	N/A	N/A					
Lane & Width Information							
Number of Lanes	2	2					
Paved Width (ft)	28.8	28.8					
Lane Width (ft)	14.4	14.4

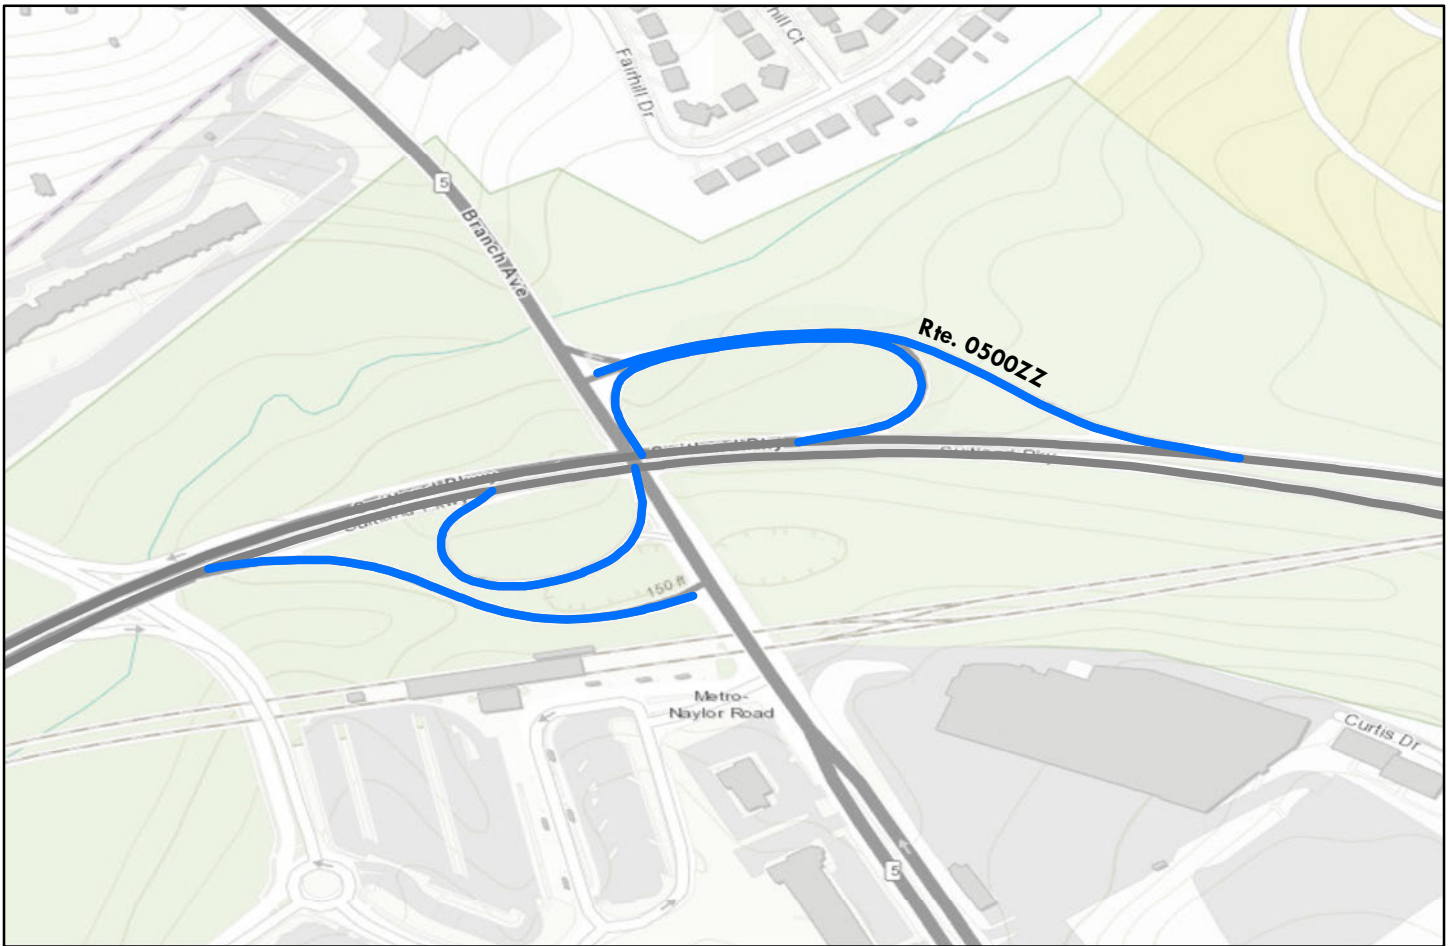
ROUTE 0500ZZ: BRANCH AVENUE INTERCHANGE RAMP

Route Condition Legend – Pavement Condition Rating (PCR)						
Poor (0 - 60)	Fair (61- 84)	Good (85 - 94)	Excellent (95 - 100)	Not Rated		
See Appendix for definitions and formulas						
Inspection Date:	3/24/2018					
Paved Length (Miles):	0.66					
Surface Type:	ASPHALT	Route Summary				
Roadway Condition Information						
Pavement Condition Rating (PCR)	96					
Lane & Width Information						
Number of Lanes	1					
Paved Width (ft)	16.1					
Lane Width (ft)	14.3

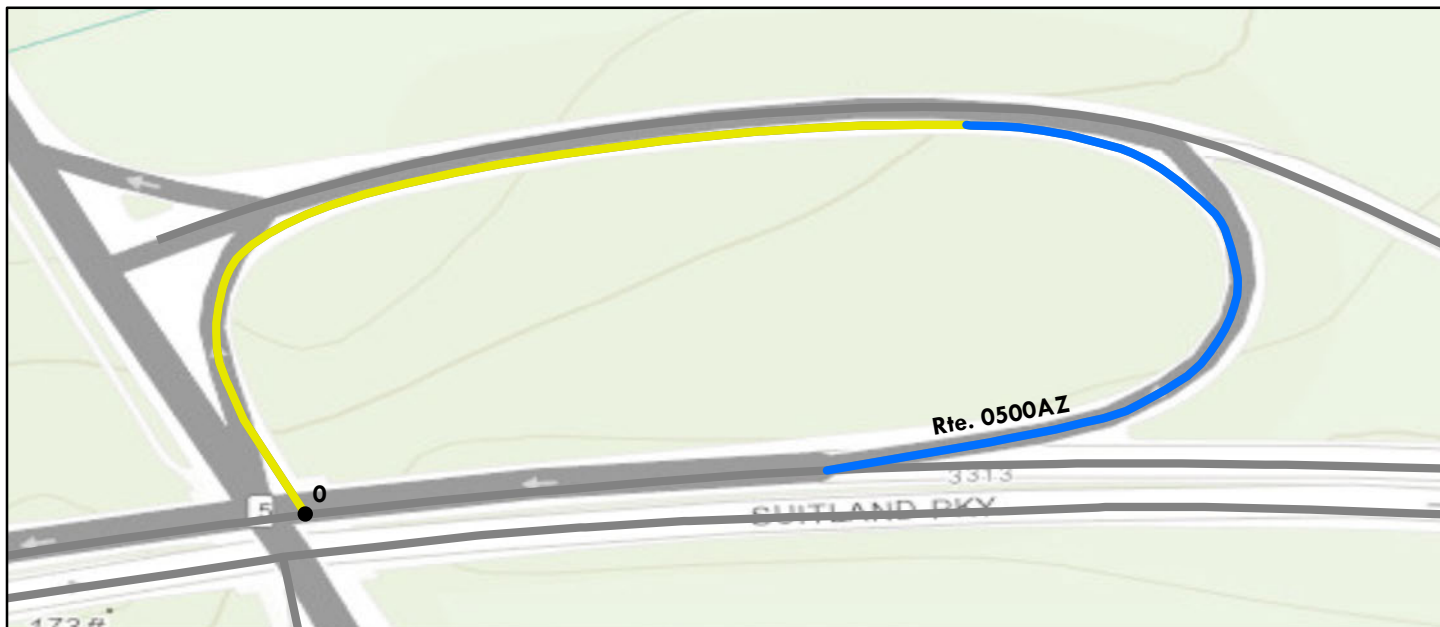
Subcomponent of Route SUIT-0500ZZ

Inspection Date:	3/24/2018	Beginning Section MP	0				
Paved Length (Miles):	0.18	Section Length (MI)	0.18				
Surface Type:	ASPHALT	Route Summary					
Roadway Condition Information							
Pavement Condition Rating (PCR)	89	89					
Surface Condition Rating (SCR)	89	89					
Roughness Condition Index (RCI)	N/A	N/A					
Distress Index Values							
Structural Crack Index	89	89					
Alligator Crack Index	95	95					
Longitudinal Crack Index	94	94					
Transverse Cracking Index	99	99					
Patching Index	100	100					
Rutting Index	98	98					
International Roughness Index (IRI)	N/A	N/A					
Lane & Width Information							
Number of Lanes	1	1					
Paved Width (ft)	16.2	16.2					
Lane Width (ft)	14.8	14.8

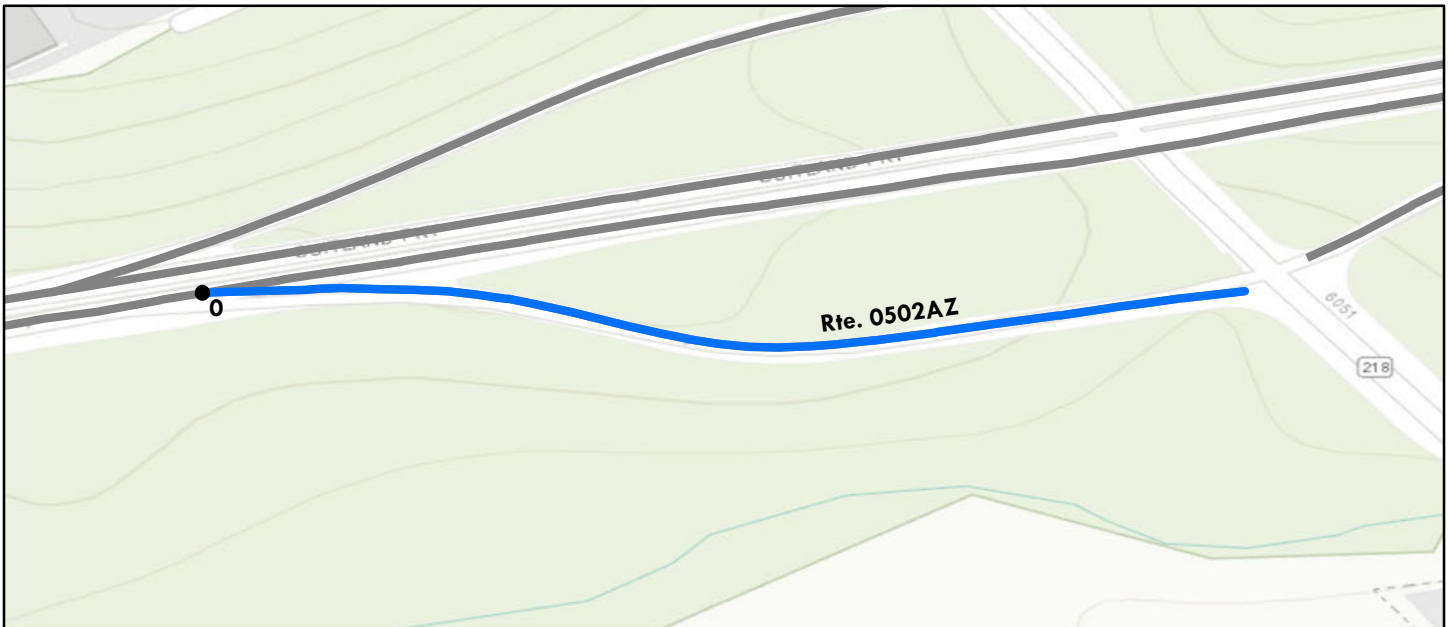
ROUTE 0502AZ: EB SUITLAND PARKWAY RAMP TO SUITLAND ROAD

Inspection Date: 3/24/2018	Beginning Section MP	0				
Paved Length (Miles): 0.16	Section Length (MI)	0.16				
Surface Type: ASPHALT	Route Summary					
Roadway Condition Information						
Pavement Condition Rating (PCR)	99	99				
Surface Condition Rating (SCR)	99	99				
Roughness Condition Index (RCI)	N/A	N/A				
Distress Index Values						
Structural Crack Index	100	100				
Alligator Crack Index	100	100				
Longitudinal Crack Index	100	100				
Transverse Cracking Index	100	100				
Patching Index	100	100				
Rutting Index	99	99				
International Roughness Index (IRI)	N/A	N/A				
Lane & Width Information						
Number of Lanes	1	1				
Paved Width (ft)	21.2	21.2				
Lane Width (ft)	15.5	15.5

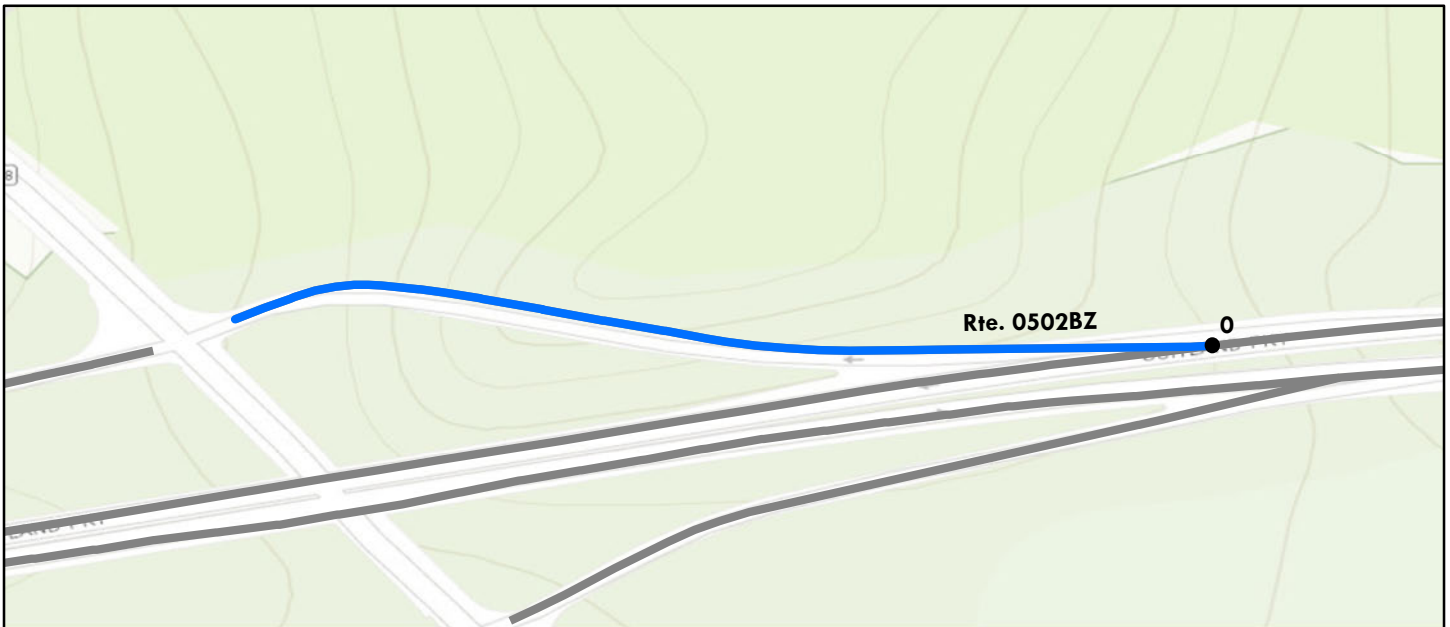
ROUTE 0502BZ: WB SUITLAND PARKWAY RAMP TO SUITLAND ROAD

Inspection Date: 3/24/2018	Beginning Section MP	0				
Paved Length (Miles): 0.15	Section Length (MI)	0.15				
Surface Type: ASPHALT	Route Summary					
Roadway Condition Information						
Pavement Condition Rating (PCR)	100	100				
Surface Condition Rating (SCR)	100	100				
Roughness Condition Index (RCI)	N/A	N/A				
Distress Index Values						
Structural Crack Index	100	100				
Alligator Crack Index	100	100				
Longitudinal Crack Index	100	100				
Transverse Cracking Index	100	100				
Patching Index	100	100				
Rutting Index	100	100				
International Roughness Index (IRI)	N/A	N/A				
Lane & Width Information						
Number of Lanes	1	1				
Paved Width (ft)	15.6	15.6				
Lane Width (ft)	13.5	13.5

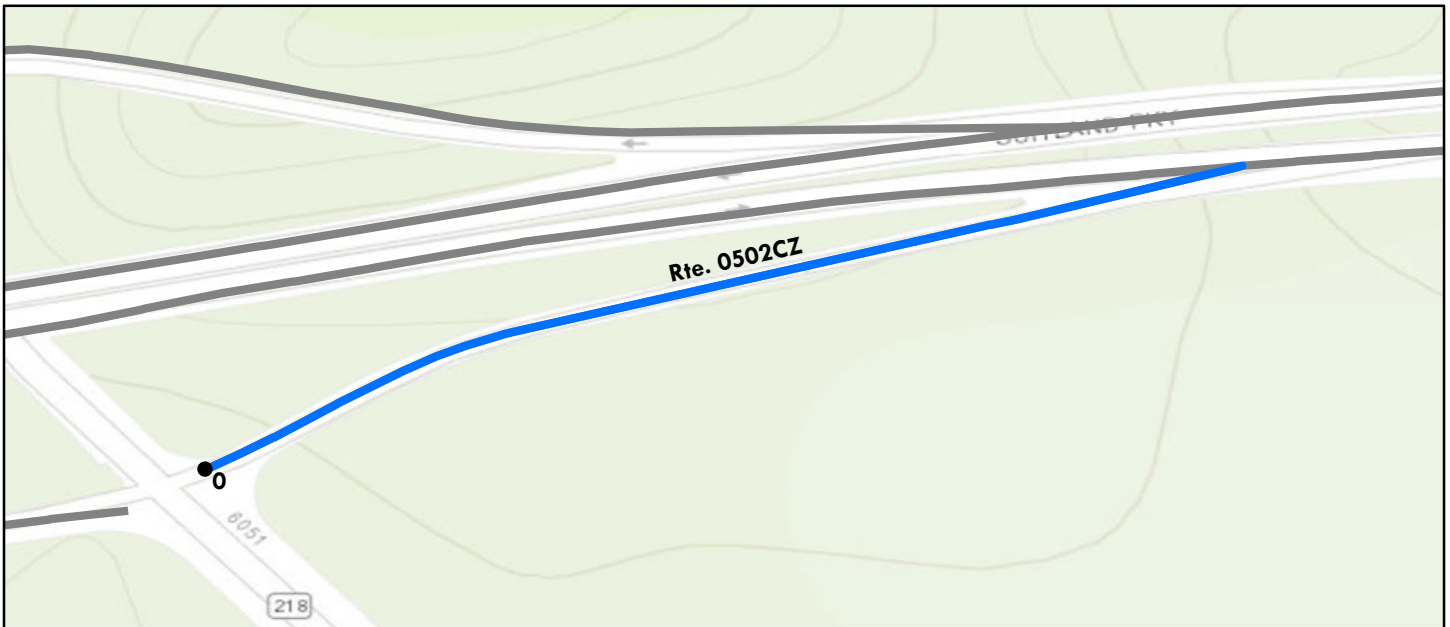
Inspection Date:	3/24/2018	Beginning Section MP	0				
Paved Length (Miles):	0.14	Section Length (MI)	0.14				
Surface Type:	ASPHALT	Route Summary					
Roadway Condition Information							
Pavement Condition Rating (PCR)	99	99					
Surface Condition Rating (SCR)	99	99					
Roughness Condition Index (RCI)	N/A	N/A					
Distress Index Values							
Structural Crack Index	100	100					
Alligator Crack Index	100	100					
Longitudinal Crack Index	100	100					
Transverse Cracking Index	100	100					
Patching Index	100	100					
Rutting Index	99	99					
International Roughness Index (IRI)	N/A	N/A					
Lane & Width Information							
Number of Lanes	1	1					
Paved Width (ft)	16.1	16.1					
Lane Width (ft)	15	15

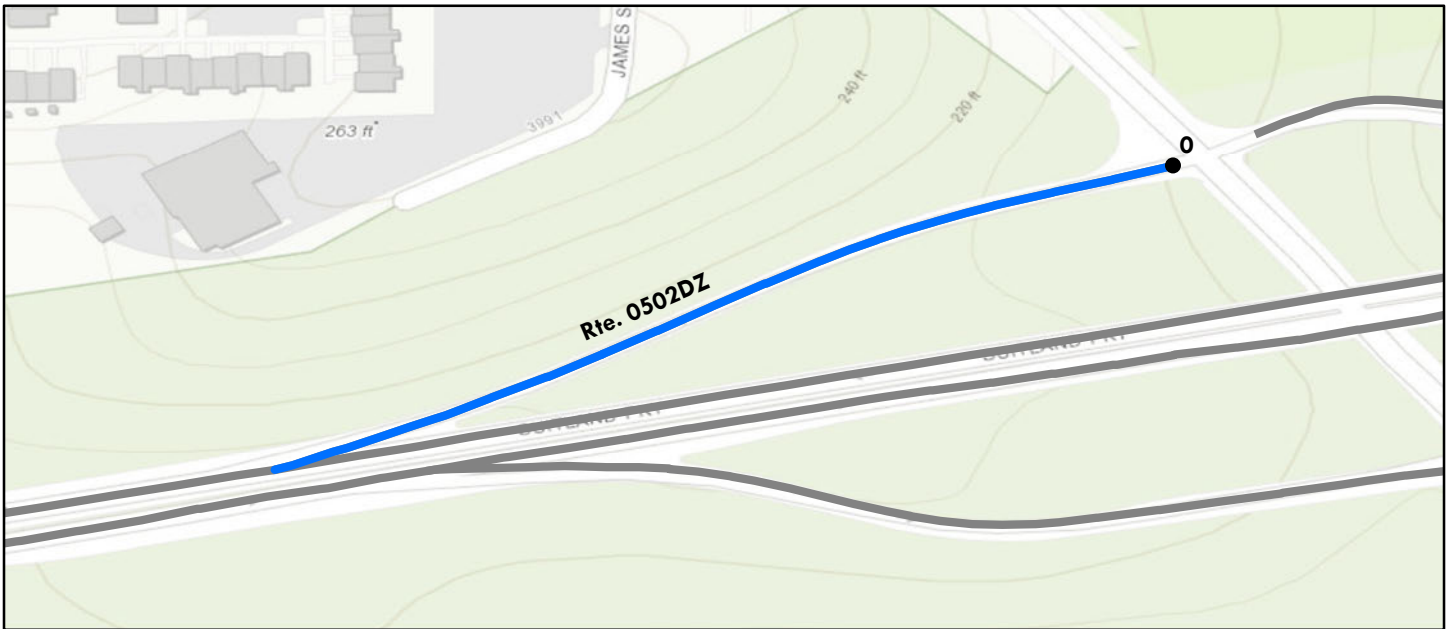
ROUTE 0502DZ: SUITLAND ROAD RAMP TO WB SUITLAND PARKWAY

Route Condition Legend – Pavement Condition Rating (PCR)							
Poor (0 - 60)		Fair (61- 84)		Good (85 - 94)		Excellent (95 - 100)	Not Rated
Colors on map represent condition scores at 0.10-mile intervals. See Appendix for definitions and formulas.							
Inspection Date:	3/24/2018	Beginning Section MP	0				
Paved Length (Miles):	0.15	Section Length (MI)	0.15				
Surface Type:	ASPHALT	Route Summary					
Roadway Condition Information							
Pavement Condition Rating (PCR)		100	100				
Surface Condition Rating (SCR)		100	100				
Roughness Condition Index (RCI)		N/A	N/A				
Distress Index Values							
Structural Crack Index		100	100				
Alligator Crack Index		100	100				
Longitudinal Crack Index		100	100				
Transverse Cracking Index		100	100				
Patching Index		100	100				
Rutting Index		100	100				
International Roughness Index (IRI)		N/A	N/A				
Lane & Width Information							
Number of Lanes		1	1				
Paved Width (ft)		15.9	15.9

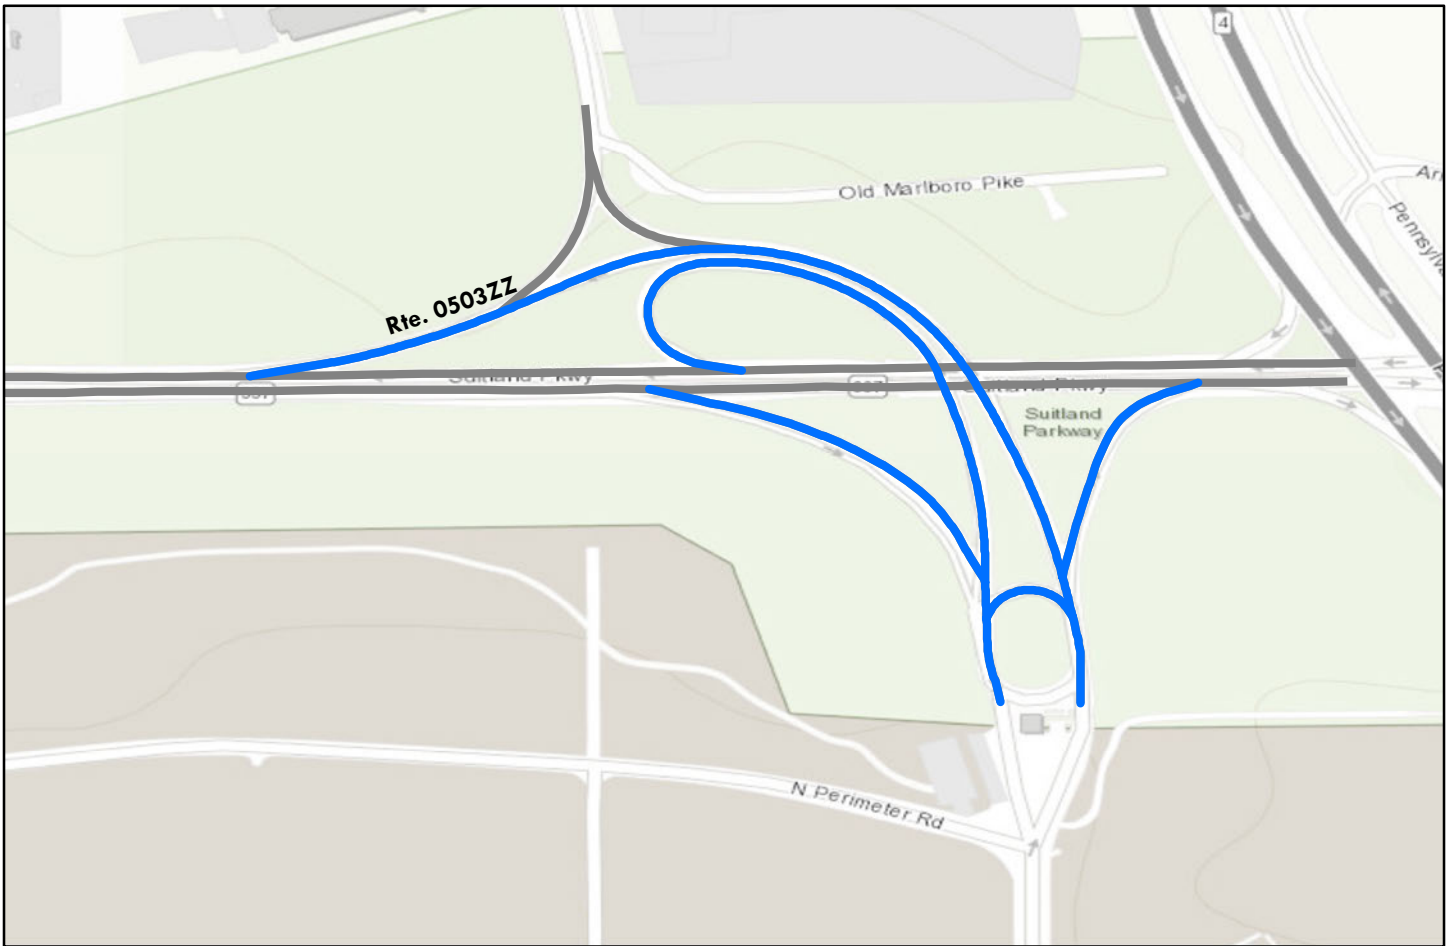
ROUTE 0503ZZ: ANDREWS AFB NORTH GATE INTERCHANGE RAMPS

Route Condition Legend – Pavement Condition Rating (PCR)						
Poor (0 - 60)	Fair (61- 84)	Good (85 - 94)	Excellent (95 - 100)	Not Rated		
See Appendix for definitions and formulas						
Inspection Date:	3/24/2018					
Paved Length (Miles):	0.85					
Surface Type:	ASPHALT	Route Summary				
Roadway Condition Information						
Pavement Condition Rating (PCR)	99					
Lane & Width Information						
Number of Lanes	1					
Paved Width (ft)	23					
Lane Width (ft)	21.8

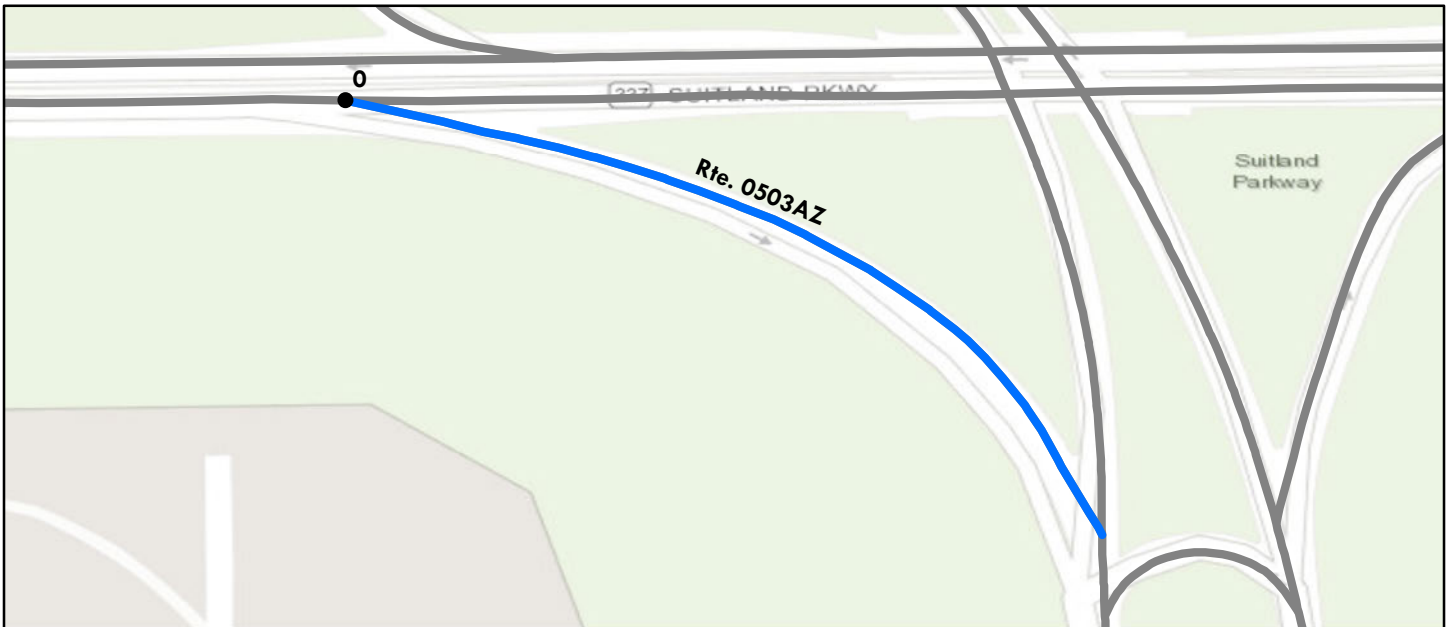
ROUTE 0503AZ: EB SUITLAND PARKWAY RAMP TO ANDREWS AFB NORTH GATE

Inspection Date:	3/24/2018	Beginning Section MP	0				
Paved Length (Miles):	0.12	Section Length (MI)	0.12				
Surface Type:	ASPHALT	Route Summary					
Roadway Condition Information							
Pavement Condition Rating (PCR)		100	100				
Surface Condition Rating (SCR)		100	100				
Roughness Condition Index (RCI)		N/A	N/A				
Distress Index Values							
Structural Crack Index		100	100				
Alligator Crack Index		100	100				
Longitudinal Crack Index		100	100				
Transverse Cracking Index		100	100				
Patching Index		100	100				
Rutting Index		100	100				
International Roughness Index (IRI)		N/A	N/A				
Lane & Width Information							
Number of Lanes		1	1				
Paved Width (ft)		22.3	22.3				
Lane Width (ft)		21	21

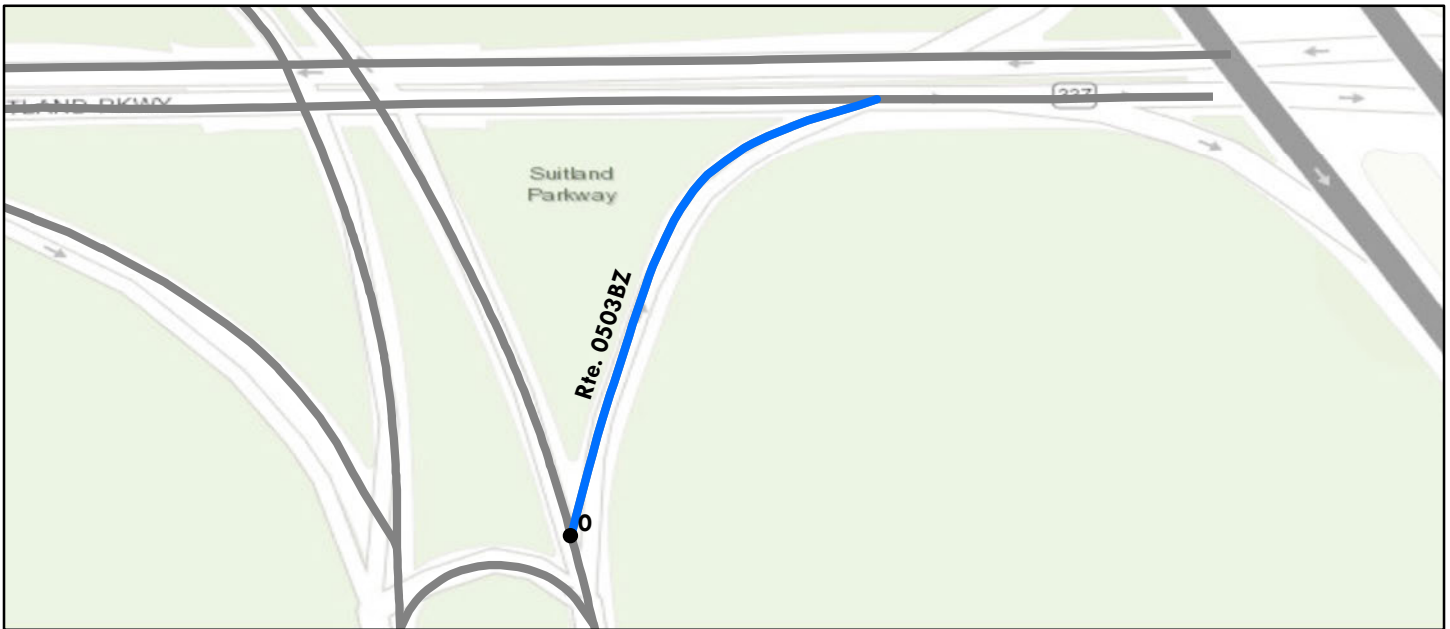
ROUTE 0503BZ: ANDREWS AFB NORTH GATE RAMP TO EB SUITLAND PARKWAY

Route Condition Legend – Pavement Condition Rating (PCR)										
Poor (0 - 60)		Fair (61- 84)		Good (85 - 94)		Excellent (95 - 100)		Not Rated		
Colors on map represent condition scores at 0.10-mile intervals. See Appendix for definitions and formulas.										
Inspection Date: 3/24/2018		Beginning Section MP		0						
Paved Length (Miles): 0.08		Section Length (MI)		0.08						
Surface Type: ASPHALT		Route Summary								
Roadway Condition Information										
Pavement Condition Rating (PCR)		99		99						
Surface Condition Rating (SCR)		99		99						
Roughness Condition Index (RCI)		N/A		N/A						
Distress Index Values										
Structural Crack Index		100		100						
Alligator Crack Index		100		100						
Longitudinal Crack Index		100		100						
Transverse Cracking Index		100		100						
Patching Index		100		100						
Rutting Index		99		99						
International Roughness Index (IRI)		N/A		N/A						
Lane & Width Information

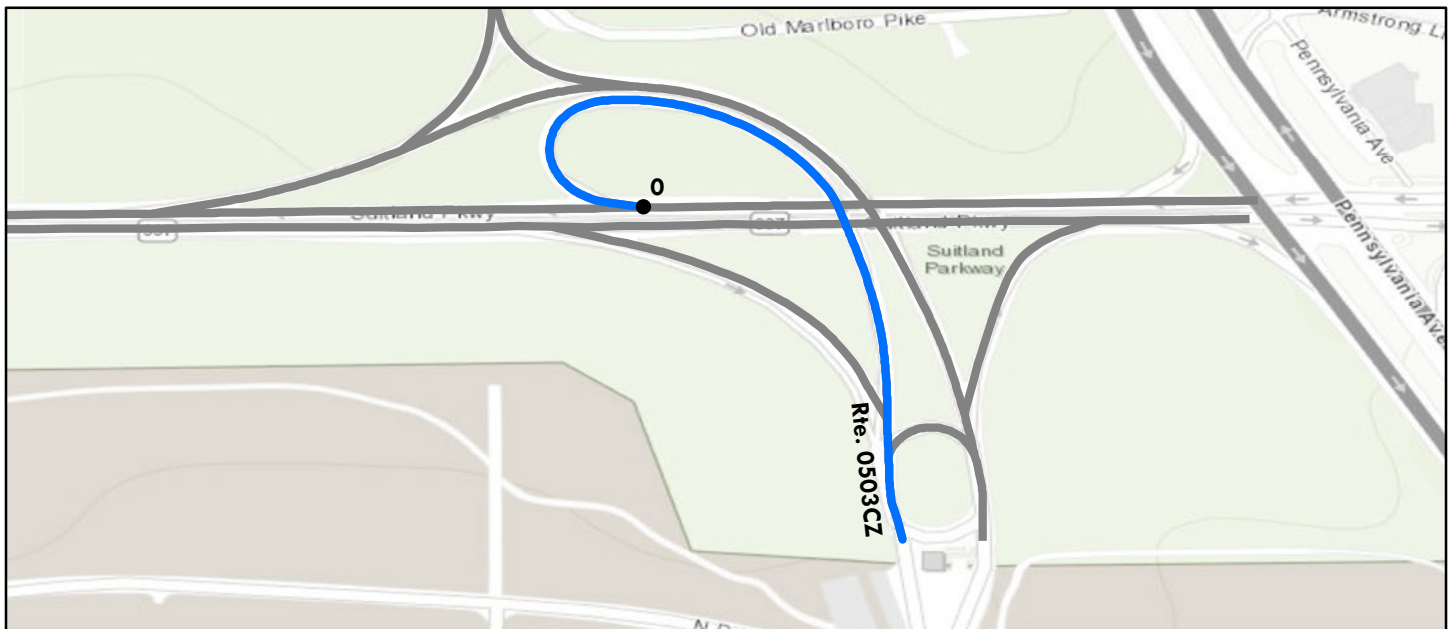
ROUTE 0503CZ: WB SUITLAND PARKWAY RAMP TO ANDREWS AFB NORTH GATE

Inspection Date:	3/24/2018	Beginning Section MP	0				
Paved Length (Miles):	0.27	Section Length (MI)	0.27				
Surface Type:	ASPHALT	Route Summary					
Roadway Condition Information							
Pavement Condition Rating (PCR)	99	99					
Surface Condition Rating (SCR)	99	99					
Roughness Condition Index (RCI)	N/A	N/A					
Distress Index Values							
Structural Crack Index	100	100					
Alligator Crack Index	100	100					
Longitudinal Crack Index	100	100					
Transverse Cracking Index	99	99					
Patching Index	100	100					
Rutting Index	100	100					
International Roughness Index (IRI)	N/A	N/A					
Lane & Width Information							
Number of Lanes	1	1					
Paved Width (ft)	24.6	24.6					
Lane Width (ft)	23.3	23.3

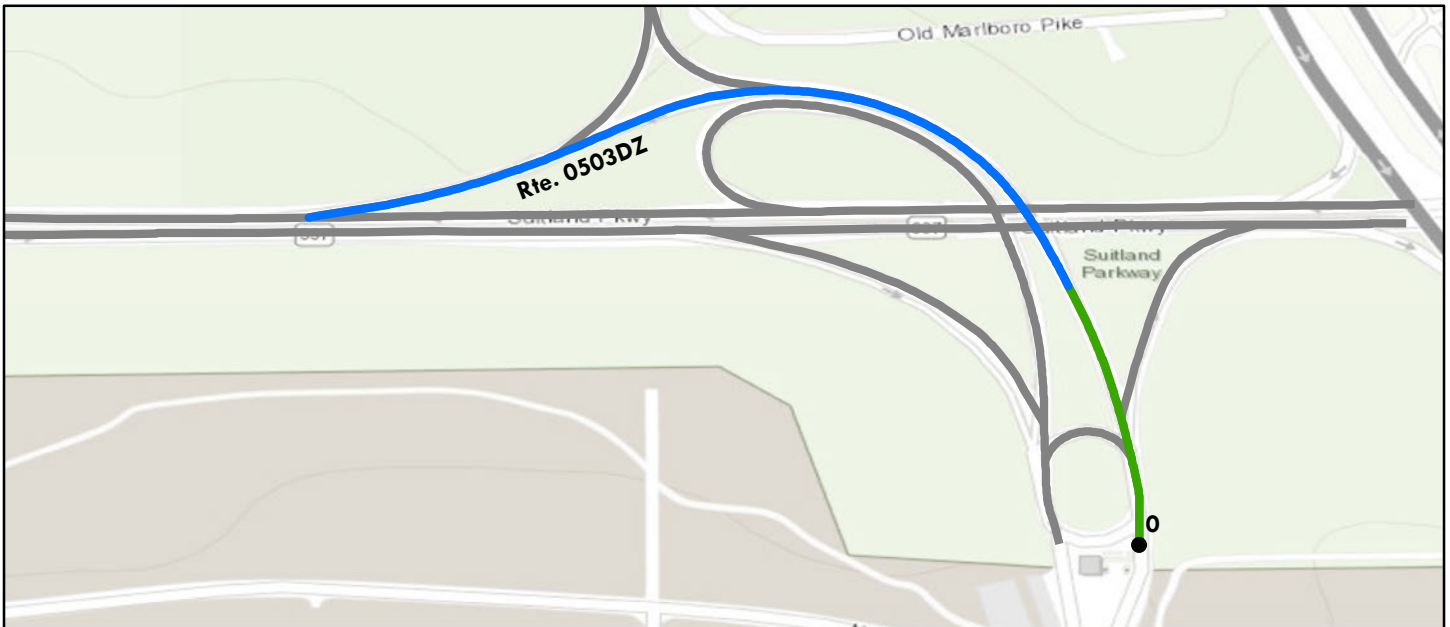
Inspection Date: 3/24/2018	Beginning Section MP	0				
Paved Length (Miles): 0.35	Section Length (MI)	0.35				
Surface Type: ASPHALT	Route Summary					
Roadway Condition Information						
Pavement Condition Rating (PCR)	98	98				
Surface Condition Rating (SCR)	98	98				
Roughness Condition Index (RCI)	N/A	N/A				
Distress Index Values						
Structural Crack Index	100	100				
Alligator Crack Index	100	100				
Longitudinal Crack Index	100	100				
Transverse Cracking Index	100	100				
Patching Index	100	100				
Rutting Index	98	98				
International Roughness Index (IRI)	N/A	N/A				
Lane & Width Information						
Number of Lanes	1	1				
Paved Width (ft)	23.1	23.1				
Lane Width (ft)	21.9	21.9

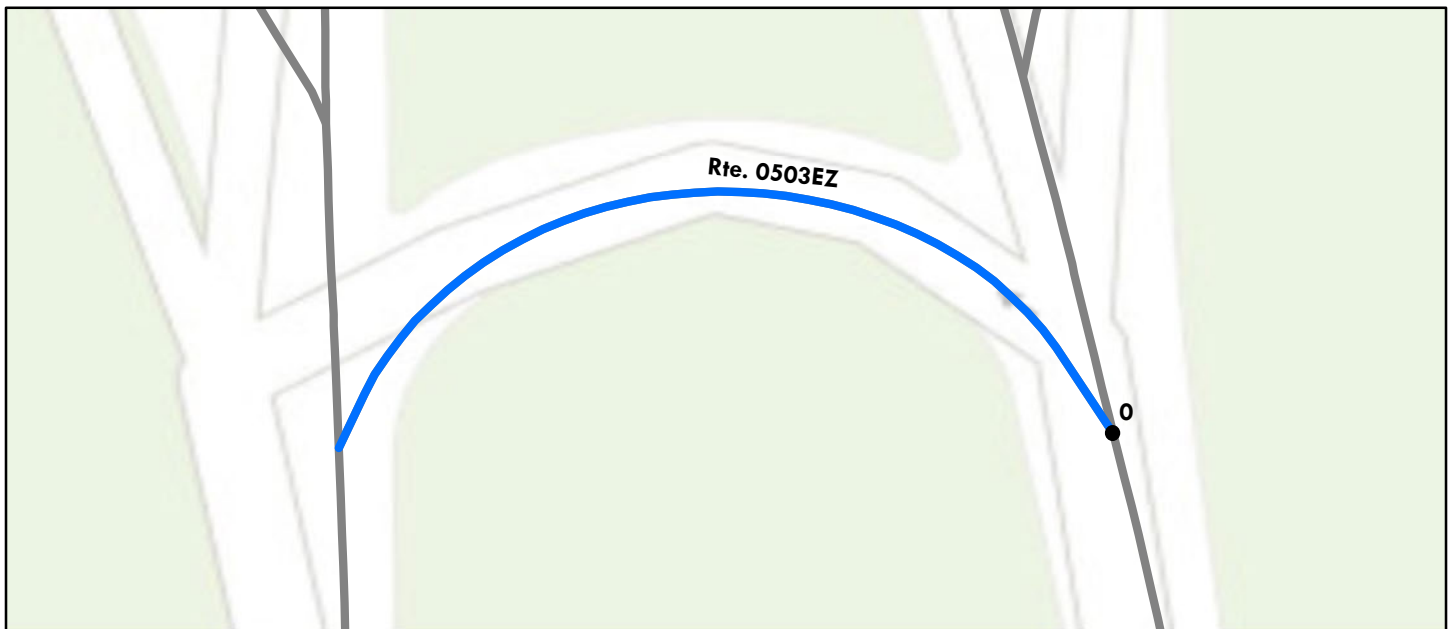
Inspection Date:	3/24/2018	Beginning Section MP	0				
Paved Length (Miles):	0.03	Section Length (MI)	0.03				
Surface Type:	ASPHALT	Route Summary					
Roadway Condition Information							
Pavement Condition Rating (PCR)	95	95					
Surface Condition Rating (SCR)	95	95					
Roughness Condition Index (RCI)	N/A	N/A					
Distress Index Values							
Structural Crack Index	100	100					
Alligator Crack Index	100	100					
Longitudinal Crack Index	100	100					
Transverse Cracking Index	98	98					
Patching Index	100	100					
Rutting Index	95	95					
International Roughness Index (IRI)	N/A	N/A					
Lane & Width Information							
Number of Lanes	1	1					
Paved Width (ft)	13.5	13.5					
Lane Width (ft)	13.5	13.5

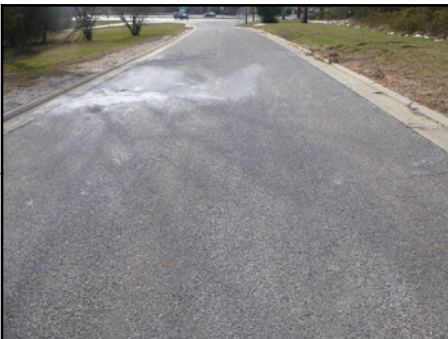
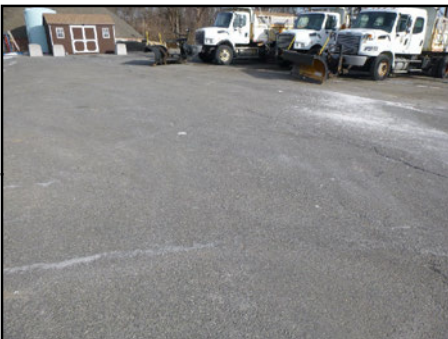
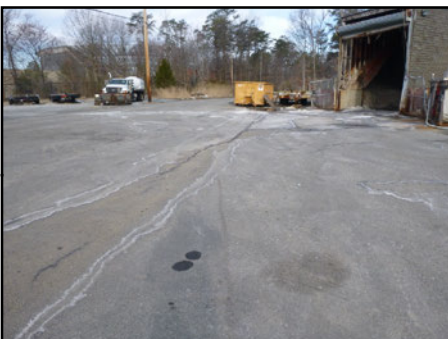
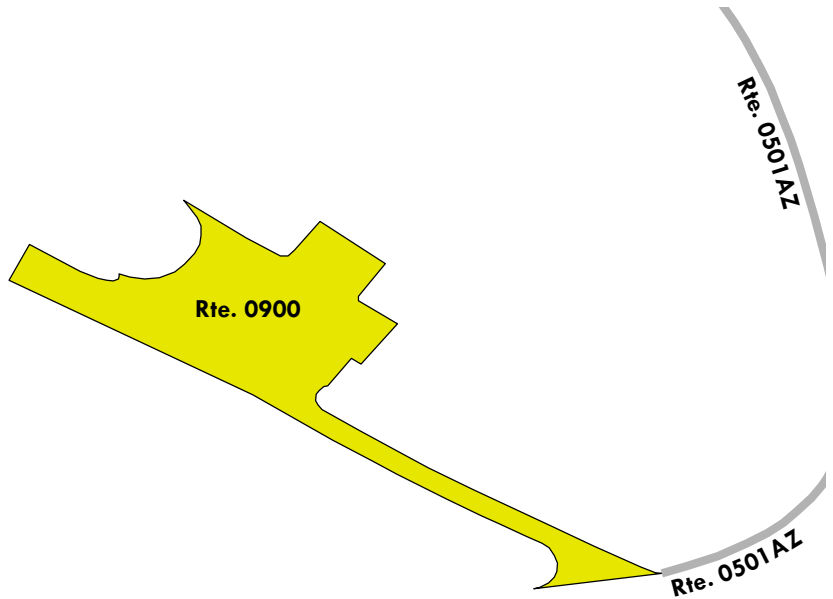
Inspection Date	FMSS Number	User Access	Surface Type
3/24/2018	52385	NONPUBLIC	ASPHALT
Area (Sq. Ft.)	Lane Miles (11' Widths)	Curb Reveal (Inches)	Curb Recommendation
38,041	0.655	NOT APPLICABLE	DO NOTHING
Curb Type		Curb & Gutter Type	
NO CURB		CONCRETE CURB AND GUTTER	
Pavement Recommendation		Condition Rating / PCR	
LIGHT 3R TREATMENTS		FAIR / 73
