VAFO Cycle 6

Final Report

Road Inventory and Condition Assessment of Paved Routes Valley Forge National Historical Park

**Federal Highway Administration
Eastern Federal Lands Highway Division
Road Inventory Program (RIP)**

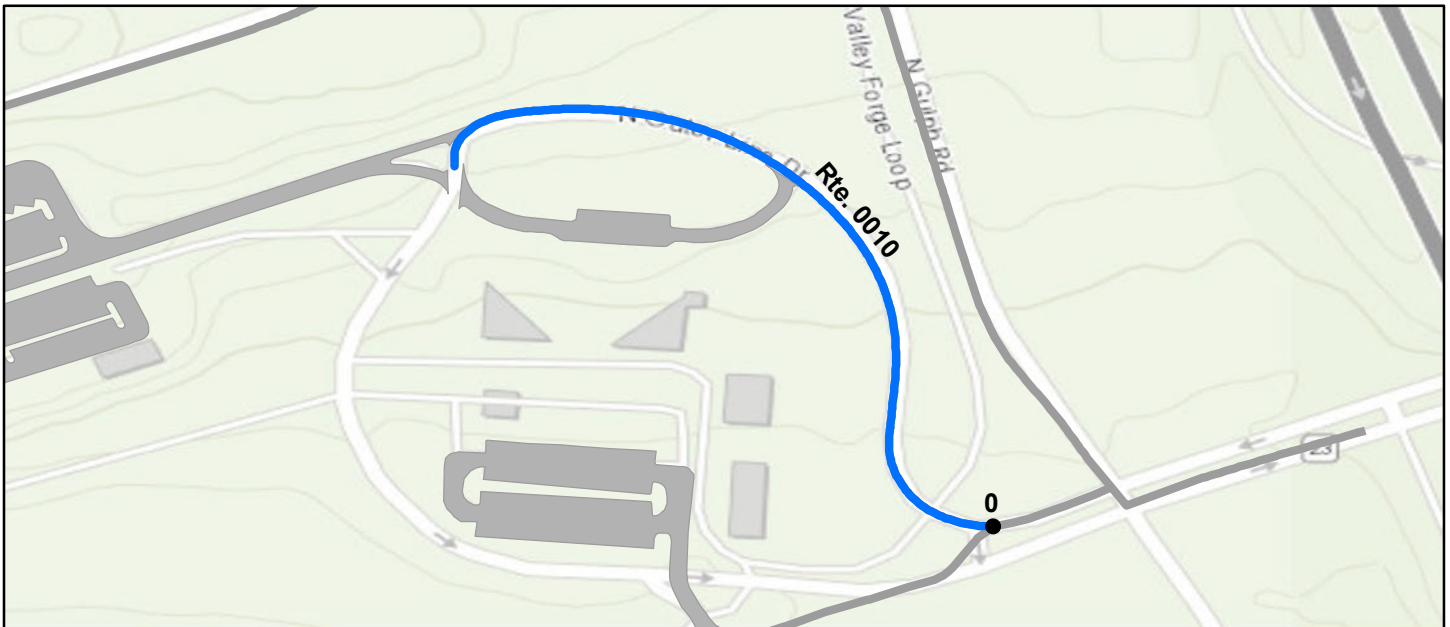
ROUTE 0010: VISITOR CENTER ACCESS ROAD

Route Condition Legend – Pavement Condition Rating (PCR)						
Poor (0 - 60)	Fair (61- 84)	Good (85 - 94)	Excellent (95 - 100)	Not Rated		
Colors on map represent condition scores at 0.10-mile intervals. See Appendix for definitions and formulas.						
Inspection Date: 11/20/2020	Beginning Section MP	0				
Paved Length (Miles): 0.21	Section Length (MI)	0.21				
Surface Type: ASPHALT	Route Summary					
Roadway Condition Information						
Pavement Condition Rating (PCR)	99	99				
Surface Condition Rating (SCR)	99	99				
Roughness Condition Index (RCI)	N/A	N/A				
Distress Index Values						
Structural Crack Index	99	99				
Alligator Crack Index	100	100				
Longitudinal Crack Index	99	99				
Transverse Cracking Index	99	99				
Patching Index	100	100				
Rutting Index	99	99				
International Roughness Index (IRI)	N/A	N/A				
Lane & Width Information						
Number of Lanes	2	2				
Paved Width (ft)	26.8	26.8				
Lane Width (ft)	13.1	13.1

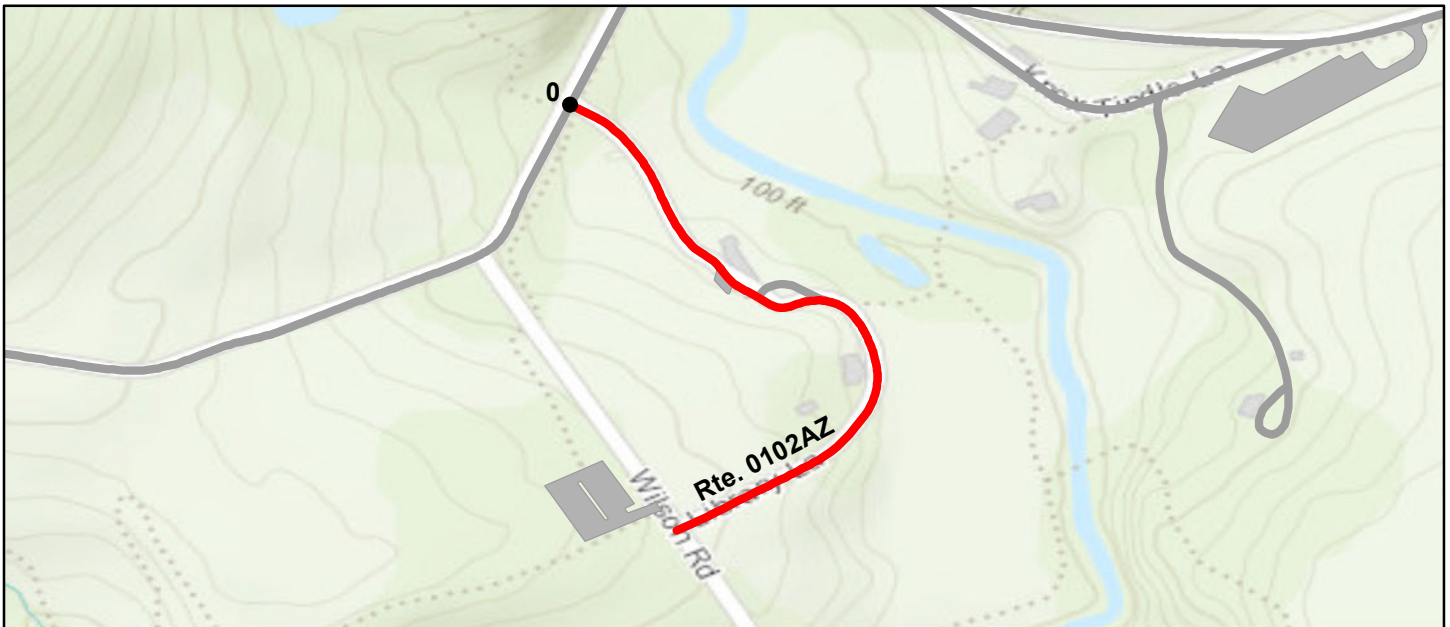
Subcomponent of Route VAFO-0102ZZ

Inspection Date: 11/20/2020	Beginning Section MP	0				
Paved Length (Miles): 0.3	Section Length (MI)	0.3				
Surface Type: ASPHALT	Route Summary					
Roadway Condition Information						
Pavement Condition Rating (PCR)	5	5				
Surface Condition Rating (SCR)	5	5				
Roughness Condition Index (RCI)	N/A	N/A				
Distress Index Values						
Structural Crack Index	5	5				
Alligator Crack Index	85	85				
Longitudinal Crack Index	20	20				
Transverse Cracking Index	49	49				
Patching Index	100	100				
Rutting Index	82	82				
International Roughness Index (IRI)	N/A	N/A				
Lane & Width Information						
Number of Lanes	1	1				
Paved Width (ft)	11.7	11.7				
Lane Width (ft)	11.7	11.7

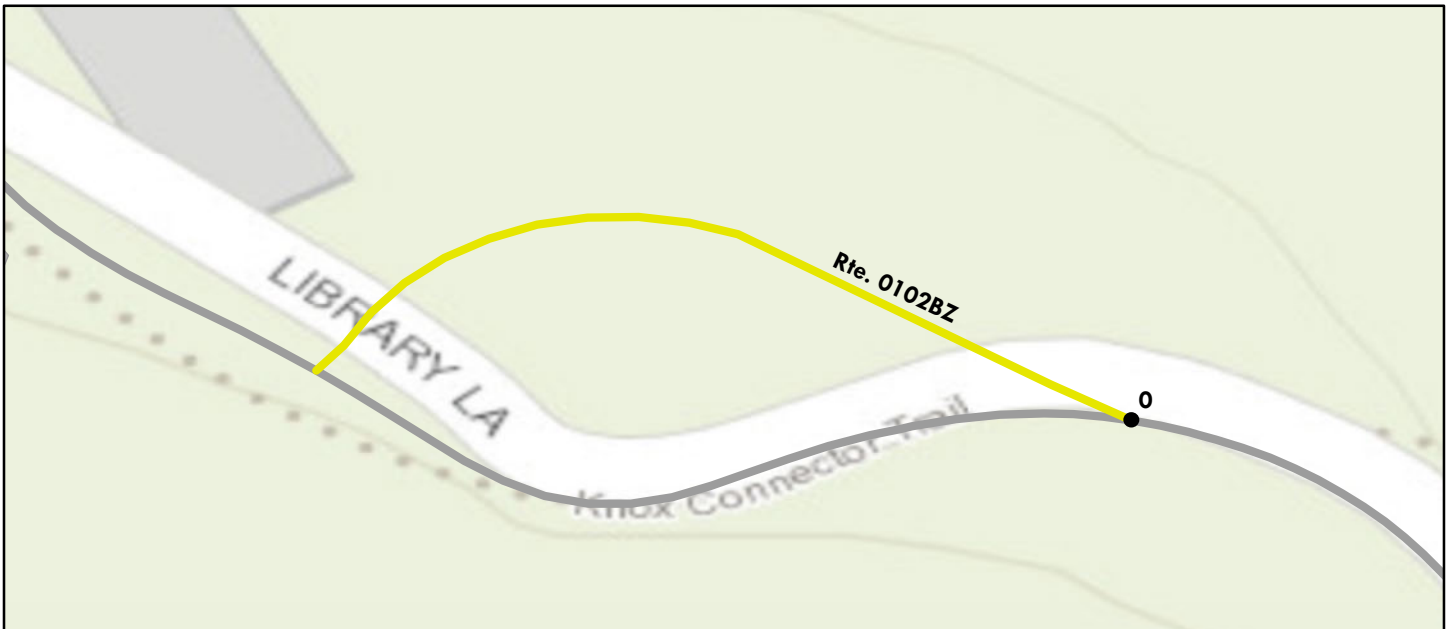
Subcomponent of Route VAFO-0102ZZ

Inspection Date:	9/27/2020	Beginning Section MP	0.00				
Paved Length (Miles):	0.03	Section Length (MI)	0.03				
Surface Type:	ASPHALT	Route Summary					
Roadway Condition Information							
Pavement Condition Rating (PCR)	73	73					
Surface Condition Rating (SCR)	73	73					
Roughness Condition Index (RCI)	N/A	N/A					
Distress Index Values							
Structural Crack Index	N/A	N/A					
Alligator Crack Index	73	73					
Longitudinal Crack Index	90	90					
Transverse Cracking Index	90	90					
Patching Index	97	97					
Rutting Index	90	90					
International Roughness Index (IRI)	N/A	N/A					
Lane & Width Information							
Number of Lanes	1	1					
Paved Width (ft)	12	12					
Lane Width (ft)	12	12

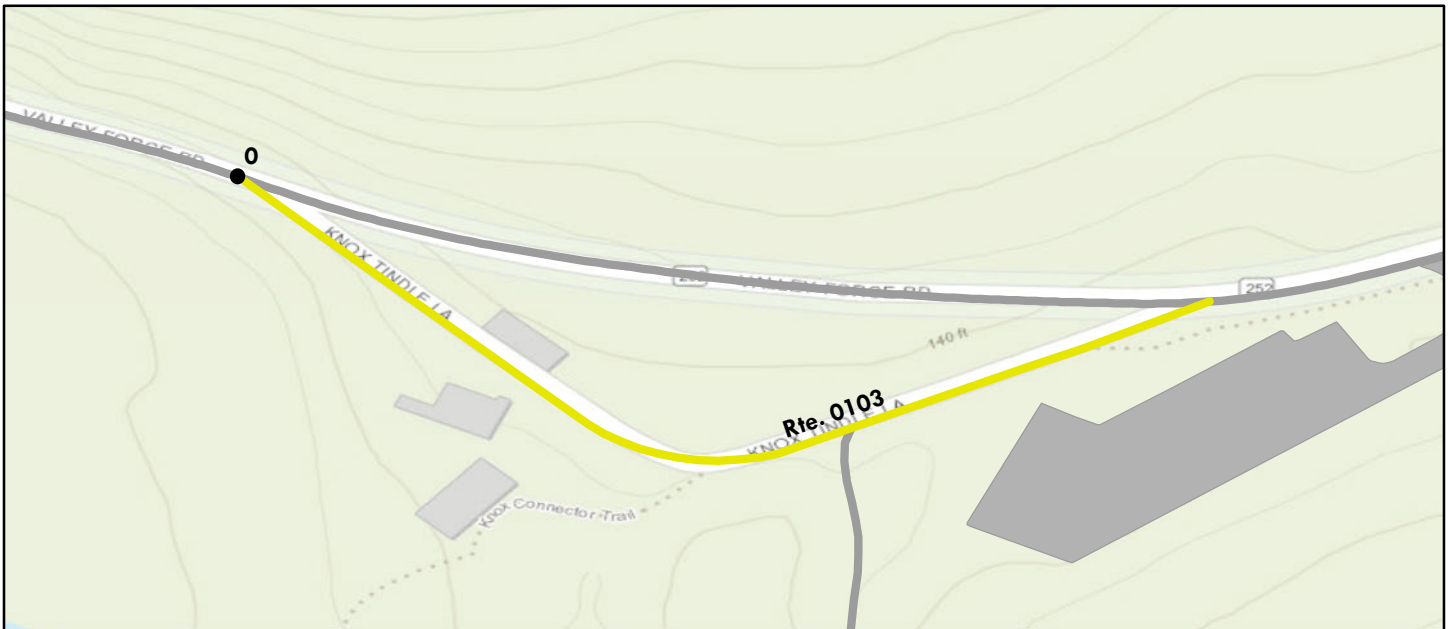
ROUTE 0103: KNOX'S QUARTERS ACCESS ROAD

Route Condition Legend – Pavement Condition Rating (PCR)						
Poor (0 - 60)	Fair (61- 84)	Good (85 - 94)	Excellent (95 - 100)	Not Rated		
See Appendix for definitions and formulas						
Inspection Date: 9/27/2020	Beginning Section MP	0.00				
Paved Length (Miles): 0.18	Section Length (MI)	0.18				
Surface Type: ASPHALT	Route Summary					
Roadway Condition Information						
Pavement Condition Rating (PCR)	73	73				
Surface Condition Rating (SCR)	73	73				
Roughness Condition Index (RCI)	N/A	N/A				
Distress Index Values						
Structural Crack Index	N/A	N/A				
Alligator Crack Index	73	73				
Longitudinal Crack Index	90	90				
Transverse Cracking Index	90	90				
Patching Index	90	90				
Rutting Index	73	73				
International Roughness Index (IRI)	N/A	N/A				
Lane & Width Information						
Number of Lanes	1	1				
Paved Width (ft)	10	10				
Lane Width (ft)	10	10

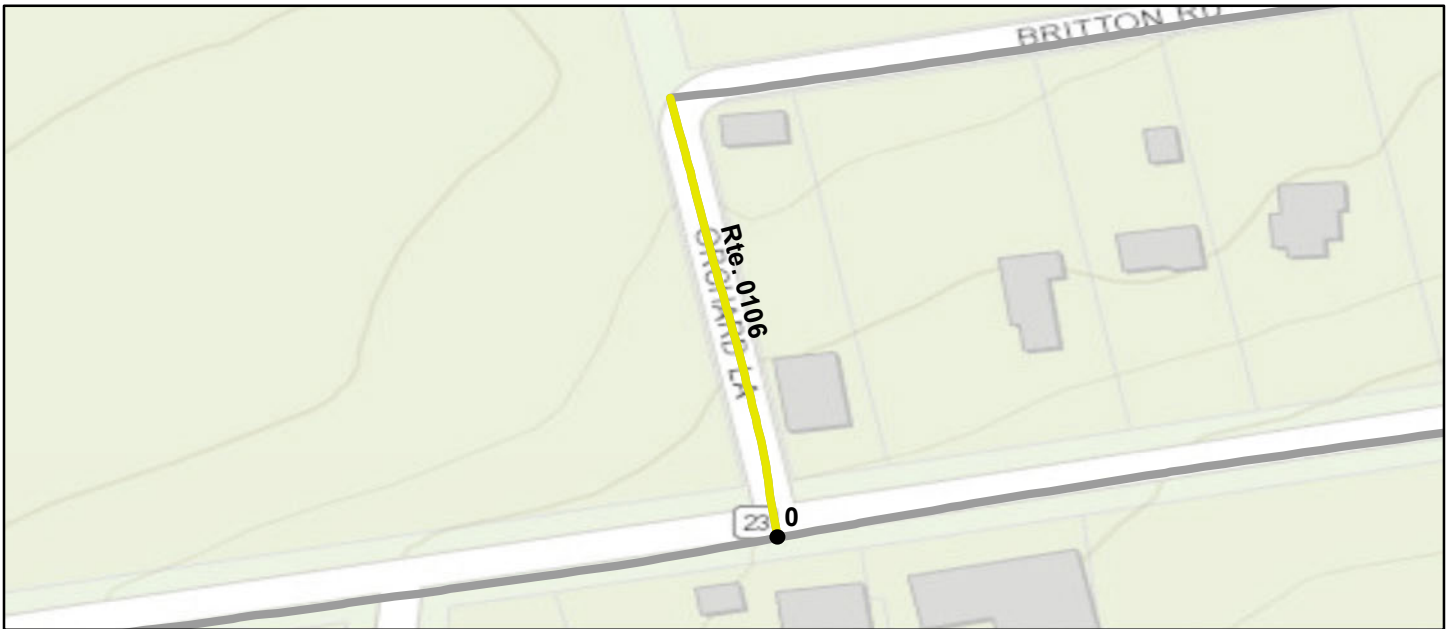
ROUTE 0106: ORCHARD LANE

Route Condition Legend – Pavement Condition Rating (PCR)						
Poor (0 - 60)	Fair (61- 84)	Good (85 - 94)	Excellent (95 - 100)	Not Rated		
Colors on map represent condition scores at 0.10-mile intervals. See Appendix for definitions and formulas.						
Inspection Date: 11/20/2020	Beginning Section MP	0				
Paved Length (Miles): 0.05	Section Length (MI)	0.05				
Surface Type: ASPHALT	Route Summary					
Roadway Condition Information						
Pavement Condition Rating (PCR)	78	78				
Surface Condition Rating (SCR)	78	78				
Roughness Condition Index (RCI)	N/A	N/A				
Distress Index Values						
Structural Crack Index	90	90				
Alligator Crack Index	100	100				
Longitudinal Crack Index	90	90				
Transverse Cracking Index	78	78				
Patching Index	100	100				
Rutting Index	94	94				
International Roughness Index (IRI)	N/A	N/A				
Lane & Width Information						
Number of Lanes	1	1				
Paved Width (ft)	13.3	13.3				
Lane Width (ft)	13.3	13.3

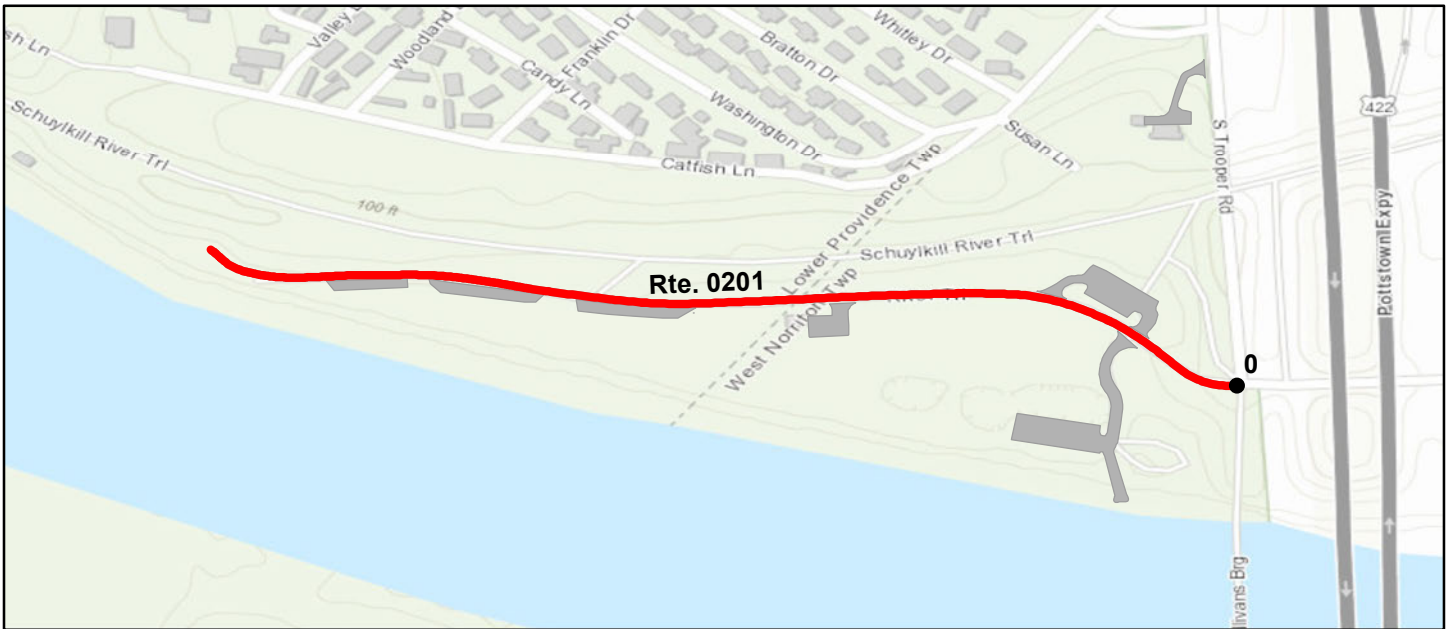
ROUTE 0201: BETZWOOD PICNIC AREA ROAD

Inspection Date: 11/20/2020	Beginning Section MP	0				
Paved Length (Miles): 0.34	Section Length (MI)	0.34				
Surface Type: ASPHALT	Route Summary					
Roadway Condition Information						
Pavement Condition Rating (PCR)	0	0				
Surface Condition Rating (SCR)	0	0				
Roughness Condition Index (RCI)	N/A	N/A				
Distress Index Values						
Structural Crack Index	0	0				
Alligator Crack Index	55	55				
Longitudinal Crack Index	0	0				
Transverse Cracking Index	18	18				
Patching Index	94	94				
Rutting Index	94	94				
International Roughness Index (IRI)	N/A	N/A				
Lane & Width Information						
Number of Lanes	2	2				
Paved Width (ft)	25.7	25.7				
Lane Width (ft)	12.3	12.3

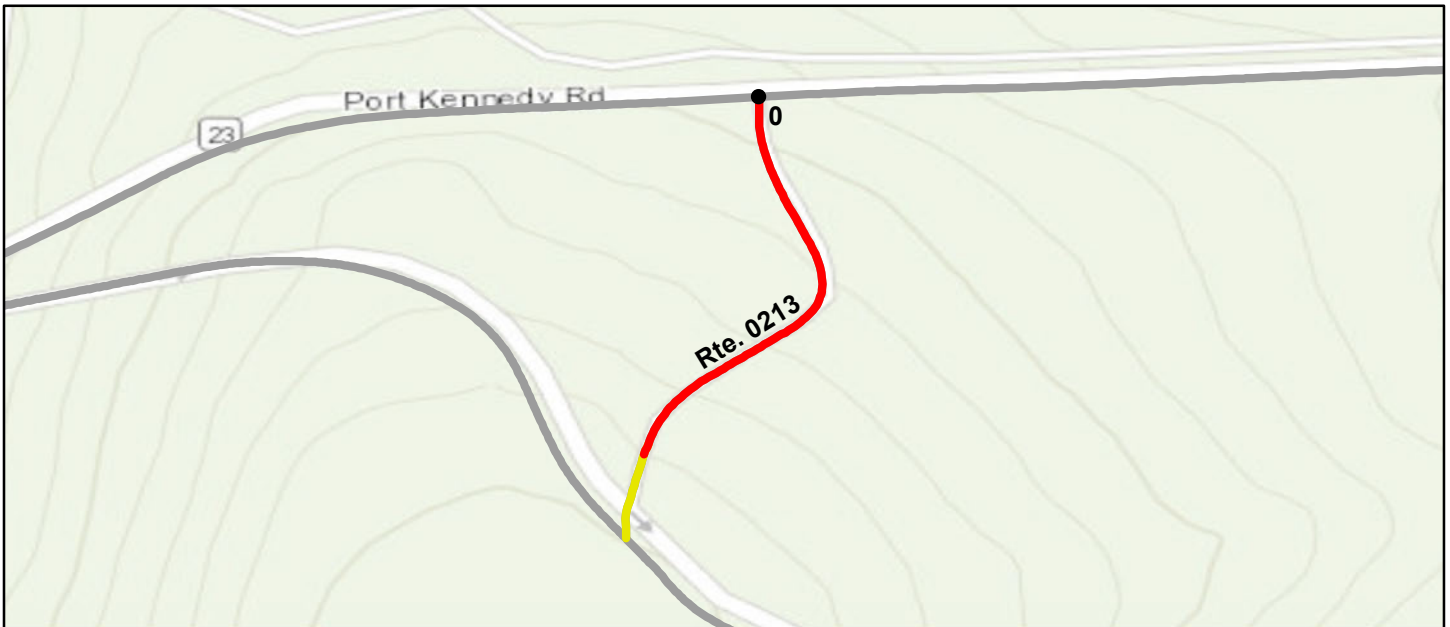
ROUTE 0213: INNER LINE SPUR

Inspection Date:	11/20/2020	Beginning Section MP	0				
Paved Length (Miles):	0.12	Section Length (MI)	0.12				
Surface Type:	ASPHALT	Route Summary					
Roadway Condition Information							
Pavement Condition Rating (PCR)	23	23					
Surface Condition Rating (SCR)	23	23					
Roughness Condition Index (RCI)	N/A	N/A					
Distress Index Values							
Structural Crack Index	23	23					
Alligator Crack Index	85	85					
Longitudinal Crack Index	38	38					
Transverse Cracking Index	59	59					
Patching Index	97	97					
Rutting Index	86	86					
International Roughness Index (IRI)	N/A	N/A					
Lane & Width Information							
Number of Lanes	2	2					
Paved Width (ft)	21.1	21.1					
Lane Width (ft)	10.5	10.5

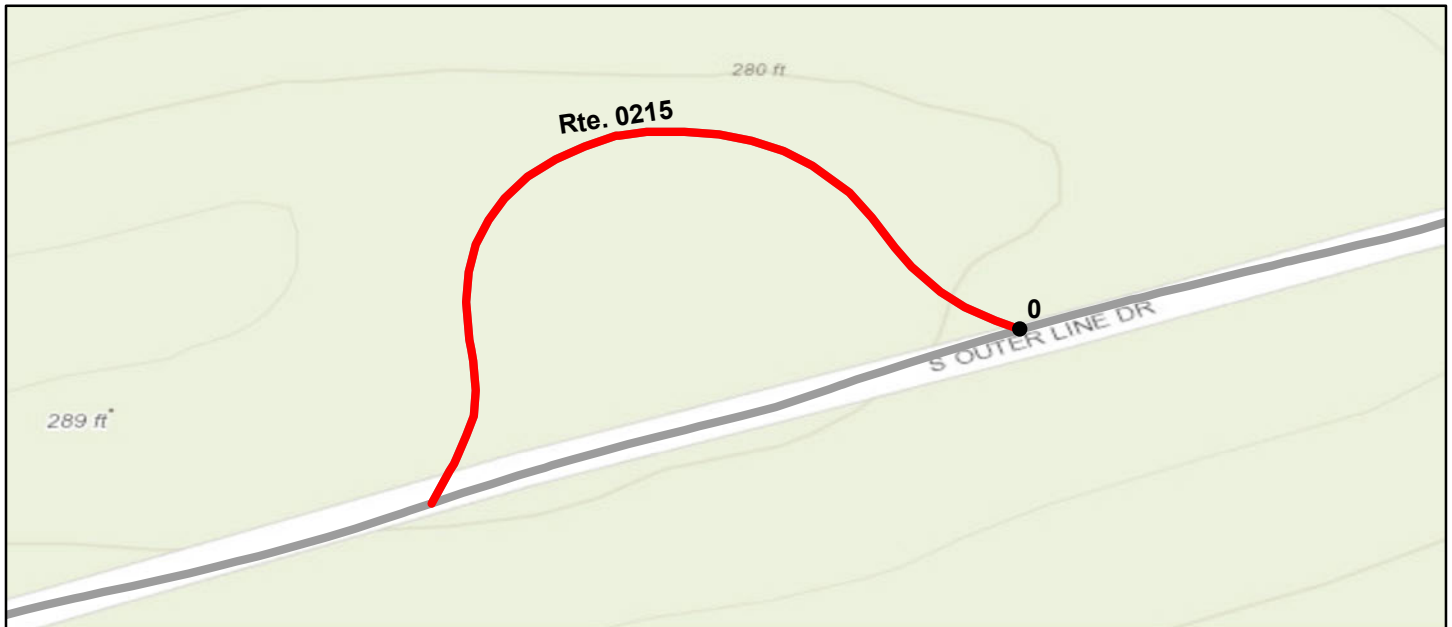
ROUTE 0215: WAYNE'S STATUE SPUR

Inspection Date:	11/20/2020	Beginning Section MP	0				
Paved Length (Miles):	0.06	Section Length (MI)	0.06				
Surface Type:	ASPHALT	Route Summary					
Roadway Condition Information							
Pavement Condition Rating (PCR)	45	45					
Surface Condition Rating (SCR)	45	45					
Roughness Condition Index (RCI)	N/A	N/A					
Distress Index Values							
Structural Crack Index	81	81					
Alligator Crack Index	100	100					
Longitudinal Crack Index	81	81					
Transverse Cracking Index	45	45					
Patching Index	100	100					
Rutting Index	98	98					
International Roughness Index (IRI)	N/A	N/A					
Lane & Width Information							
Number of Lanes	1	1					
Paved Width (ft)	19.6	19.6					
Lane Width (ft)	19.6	19.6

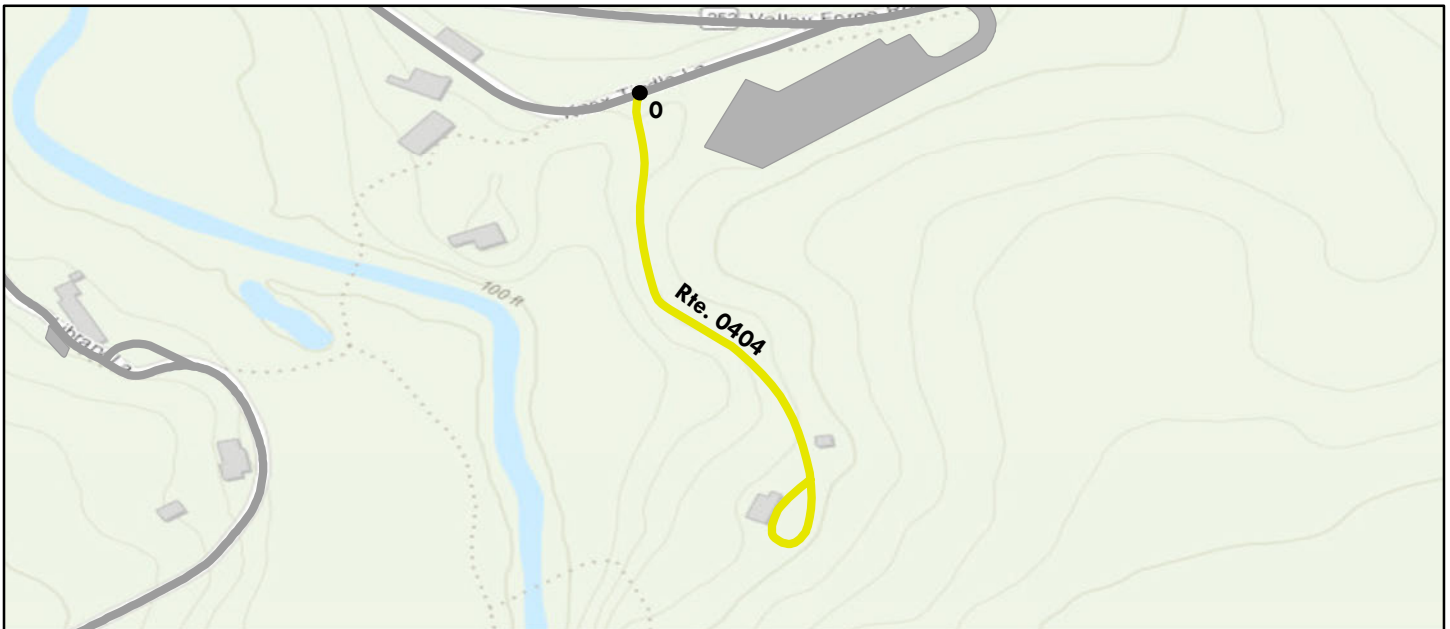
ROUTE 0404: KNOX TINDLE HOUSE ACCESS ROAD

Inspection Date: 9/27/2020	Beginning Section MP	0.00				
Paved Length (Miles): 0.21	Section Length (MI)	0.21				
Surface Type: ASPHALT	Route Summary					
Roadway Condition Information						
Pavement Condition Rating (PCR)	73	73				
Surface Condition Rating (SCR)	73	73				
Roughness Condition Index (RCI)	N/A	N/A				
Distress Index Values						
Structural Crack Index	N/A	N/A				
Alligator Crack Index	73	73				
Longitudinal Crack Index	90	90				
Transverse Cracking Index	90	90				
Patching Index	97	97				
Rutting Index	90	90				
International Roughness Index (IRI)	N/A	N/A				
Lane & Width Information						
Number of Lanes	1	1				
Paved Width (ft)	14	14				
Lane Width (ft)	14	14

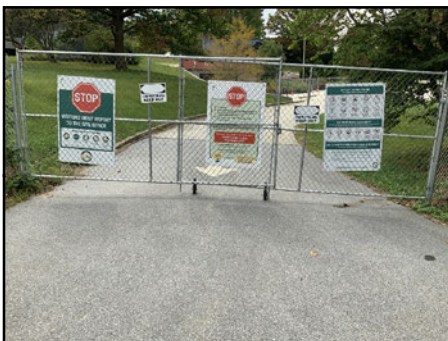
NOTE: NOT RATED - UNDER CONSTRUCTION

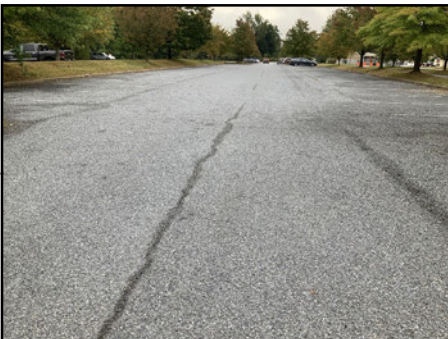
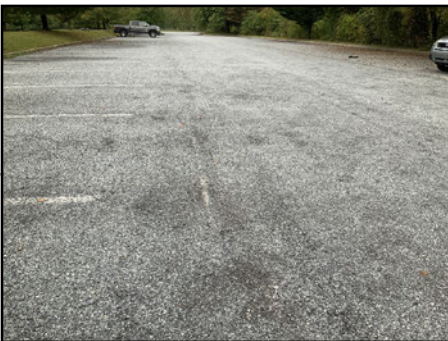
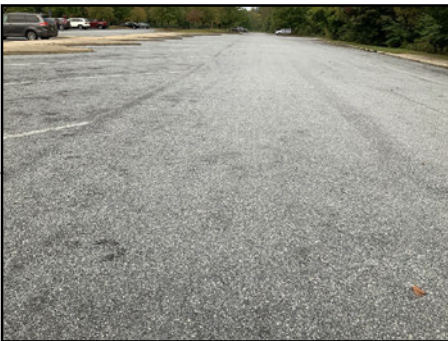
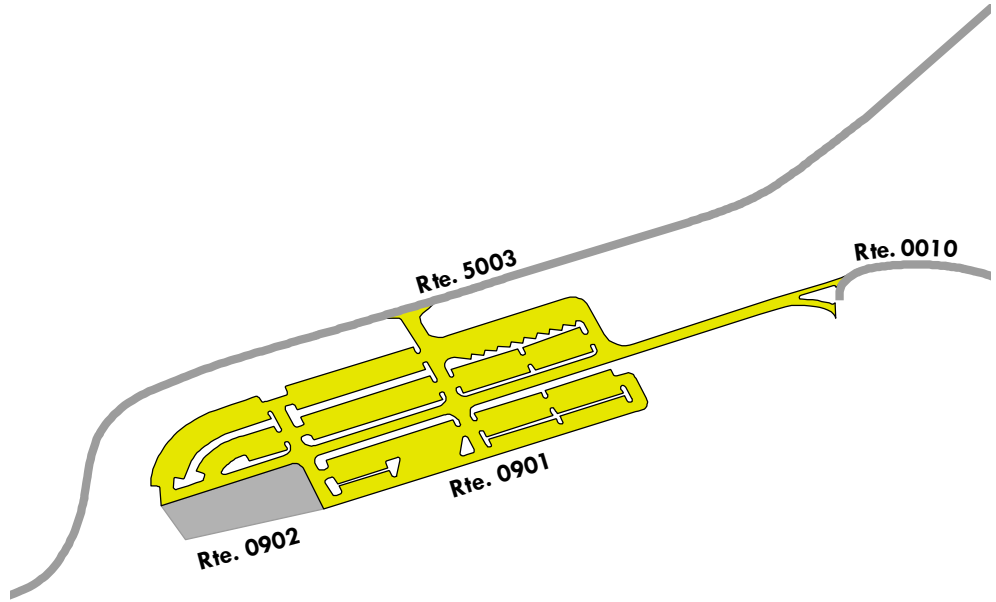
ROUTE 0901: VISITOR CENTER PARKING

Inspection Date	FMSS Number	User Access	Surface Type
9/27/2020	39877	PUBLIC	ASPHALT
Area (Sq. Ft.)	Lane Miles (11' Widths)	Curb Reveal (Inches)	Curb Recommendation
205,576	3.54	4	DO NOTHING
Curb Type		Curb & Gutter Type	
CONCRETE		NO CURB AND GUTTER	
Pavement Recommendation		Condition Rating / PCR	
LIGHT 3R TREATMENTS		FAIR / 73

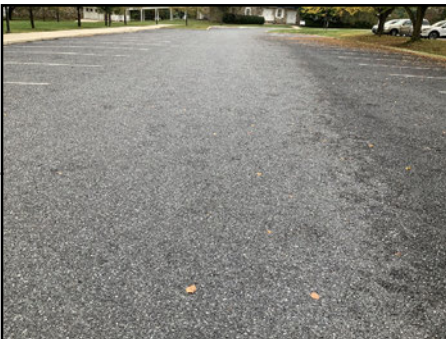
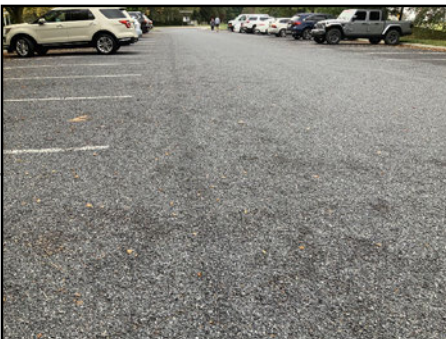
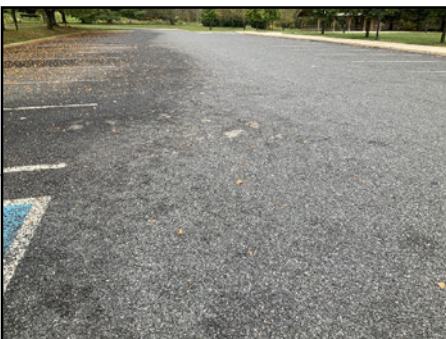
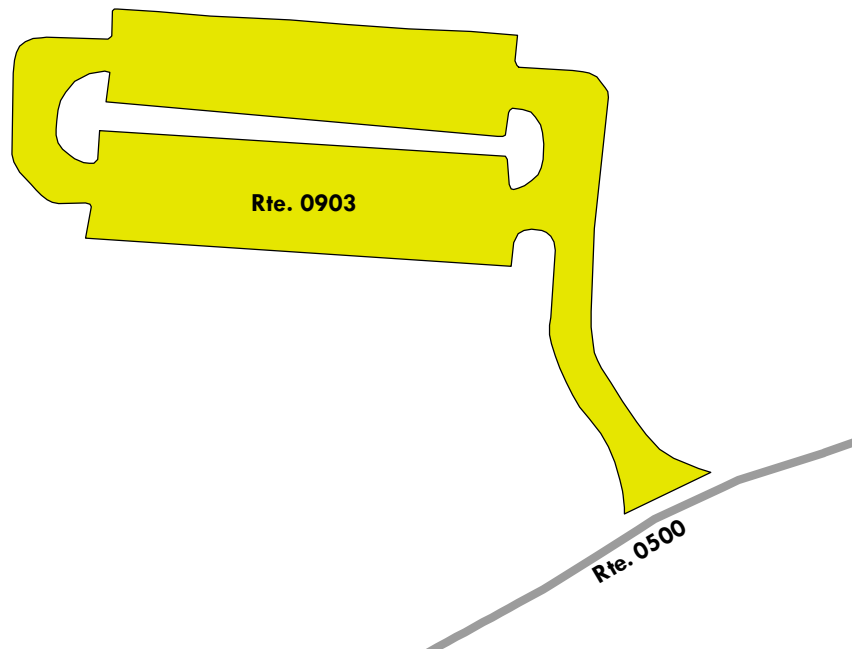
ROUTE 0903: ADMINISTRATIVE PARKING

Inspection Date	FMSS Number	User Access	Surface Type
9/27/2020	39878	PUBLIC	ASPHALT
Area (Sq. Ft.)	Lane Miles (11' Widths)	Curb Reveal (Inches)	Curb Recommendation
37,389	0.644	3	DO NOTHING
Curb Type		Curb & Gutter Type	
CONCRETE		NO CURB AND GUTTER	
Pavement Recommendation		Condition Rating / PCR	
LIGHT 3R TREATMENTS		FAIR / 73

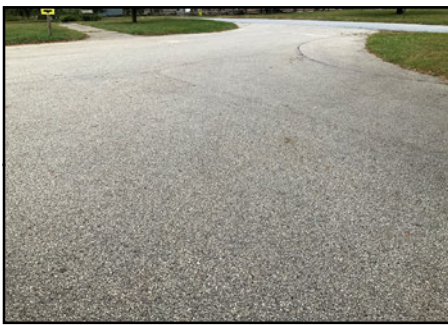
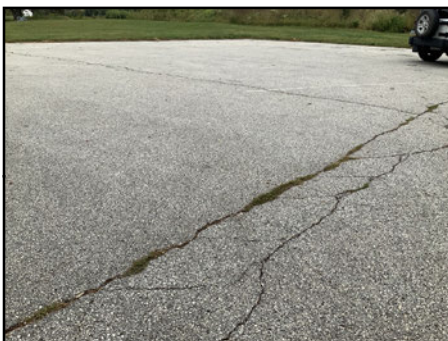
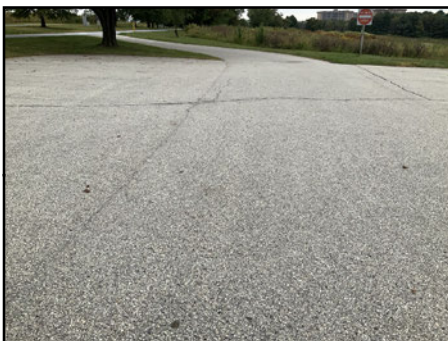
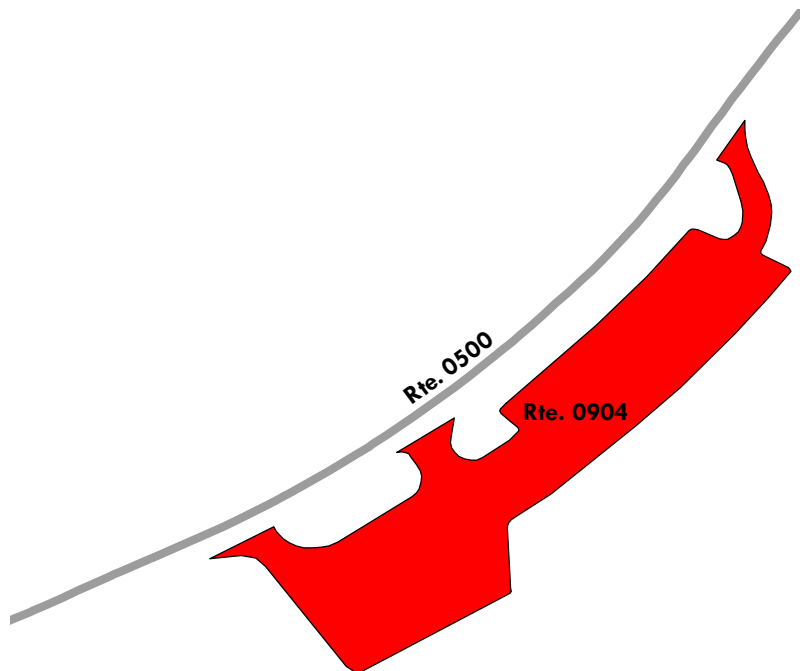
ROUTE 0904: MUHLENBERG'S BRIGADE PARKING

Inspection Date	FMSS Number	User Access	Surface Type
9/27/2020	39866	PUBLIC	ASPHALT
Area (Sq. Ft.)	Lane Miles (11' Widths)	Curb Reveal (Inches)	Curb Recommendation
25,386	0.437	3	DO NOTHING
Curb Type		Curb & Gutter Type	
STONE		NO CURB AND GUTTER	
Pavement Recommendation		Condition Rating / PCR	
HEAVY 3R TREATMENTS		POOR / 53

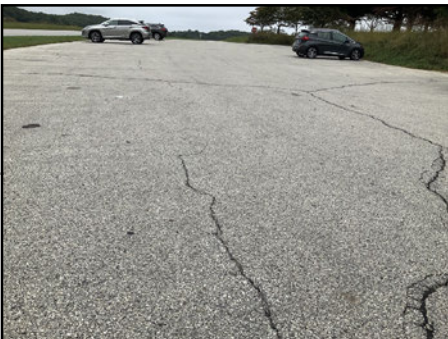
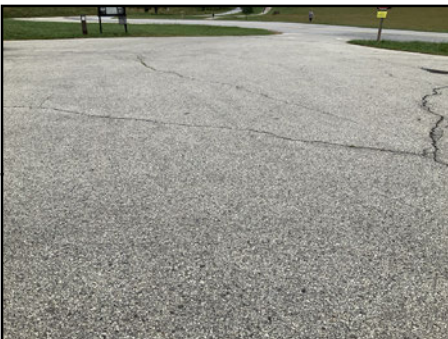
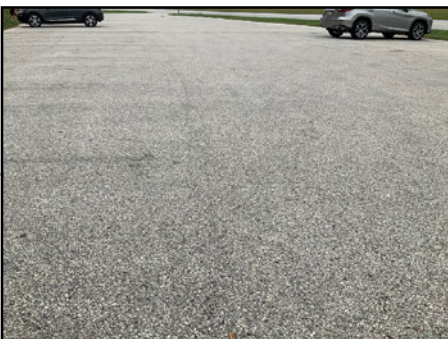
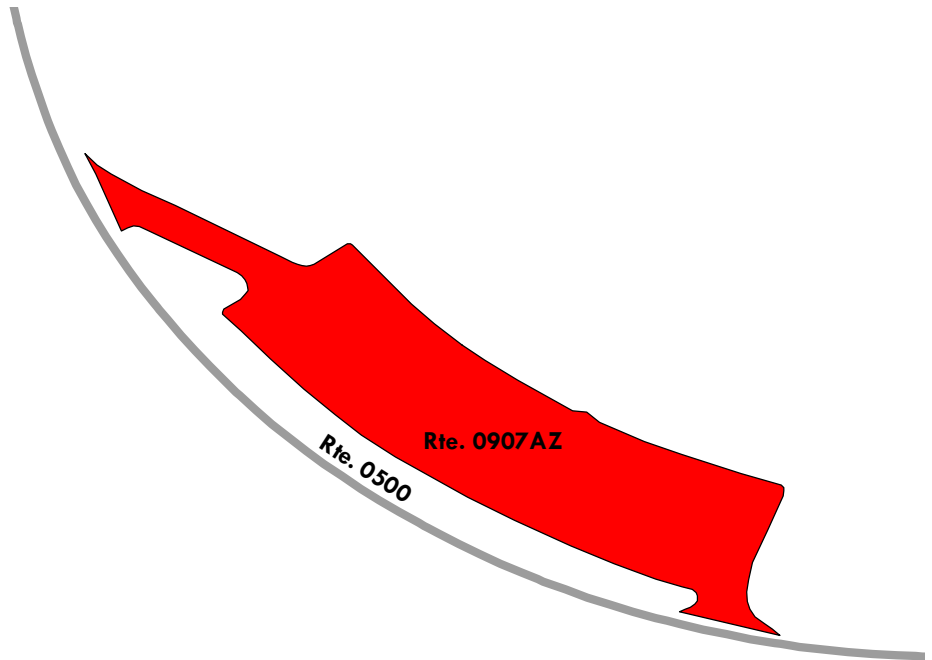
ROUTE 0907AZ: NATIONAL MEMORIAL ARCH PARKING A

Inspection Date	FMSS Number	User Access	Surface Type
9/27/2020	39874	PUBLIC	ASPHALT
Area (Sq. Ft.)	Lane Miles (11' Widths)	Curb Reveal (Inches)	Curb Recommendation
16,213	0.279	NOT APPLICABLE	NOT APPLICABLE
Curb Type		Curb & Gutter Type	
NO CURB		NO CURB AND GUTTER	
Pavement Recommendation		Condition Rating / PCR	
HEAVY 3R TREATMENTS		POOR / 53

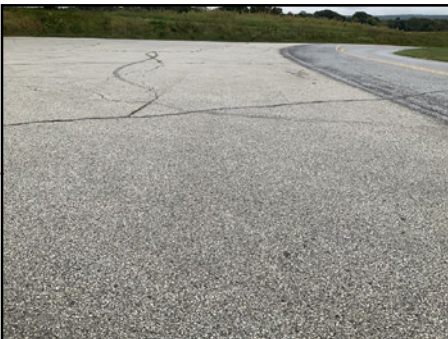
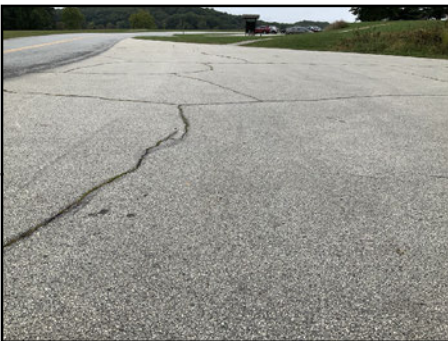
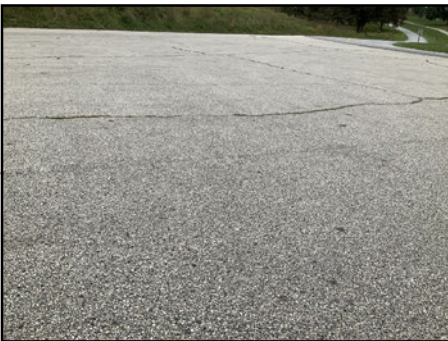
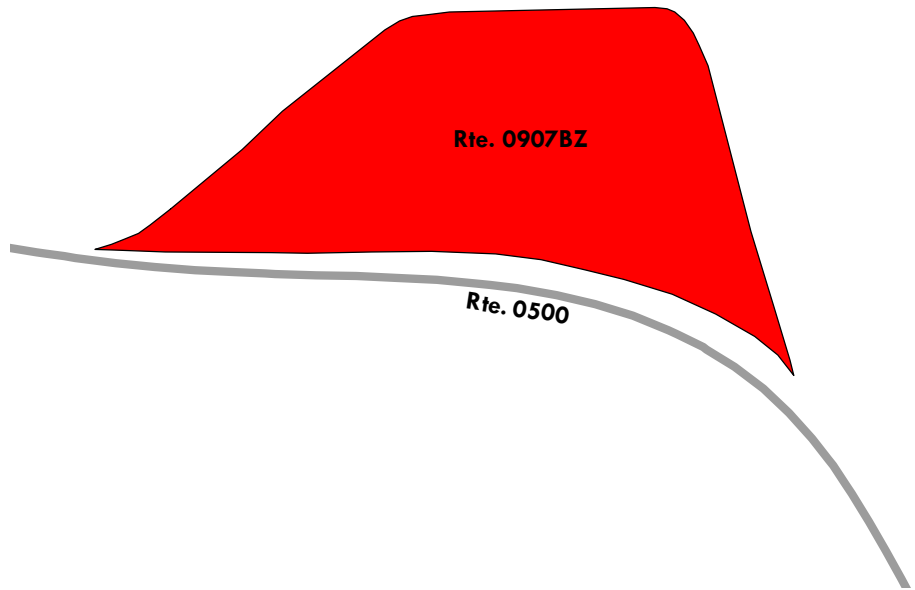
ROUTE 0907BZ: NATIONAL MEMORIAL ARCH PARKING B

Inspection Date	FMSS Number	User Access	Surface Type
9/27/2020	39874	PUBLIC	ASPHALT
Area (Sq. Ft.)	Lane Miles (11' Widths)	Curb Reveal (Inches)	Curb Recommendation
9,313	0.16	NOT APPLICABLE	NOT APPLICABLE
Curb Type		Curb & Gutter Type	
NO CURB		NO CURB AND GUTTER	
Pavement Recommendation		Condition Rating / PCR	
HEAVY 3R TREATMENTS		POOR / 53

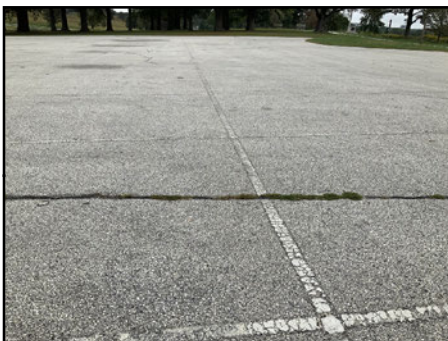
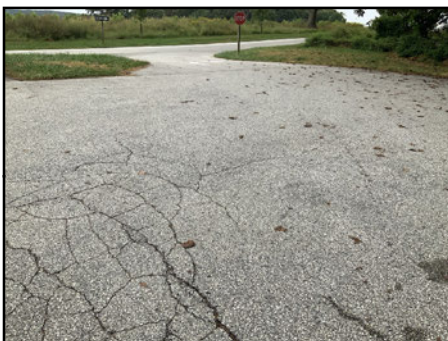
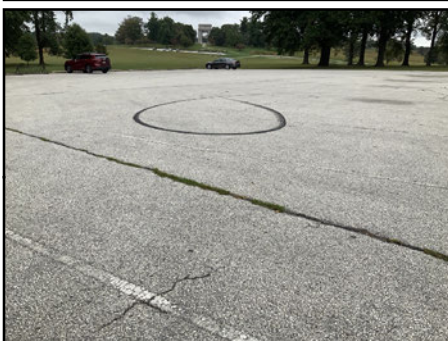
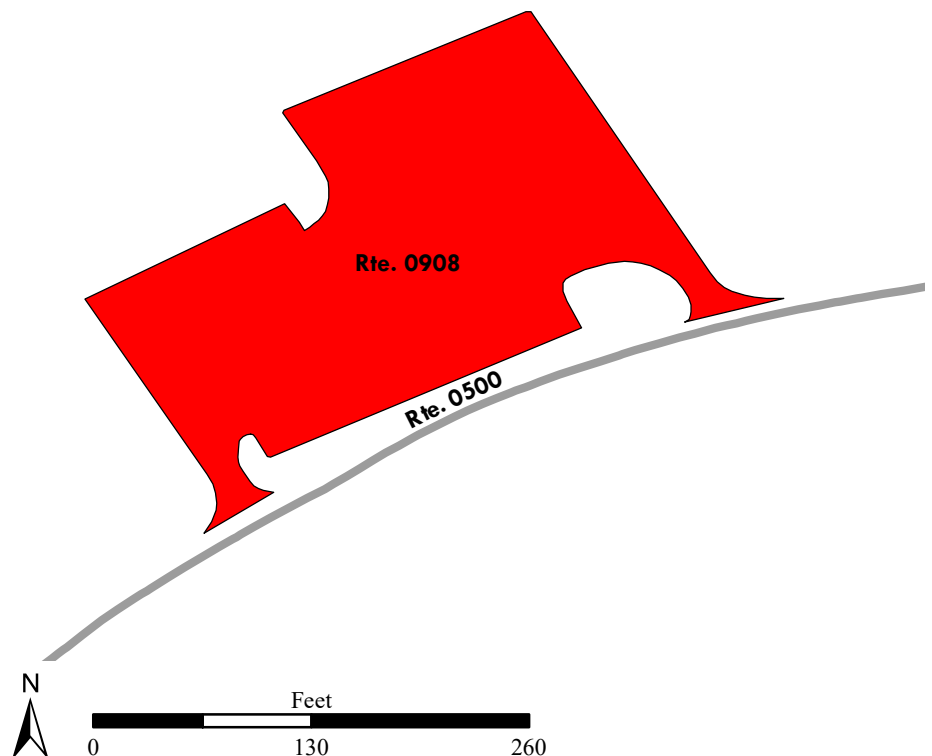
ROUTE 0908: WAYNES WOODS PARKING

Inspection Date	FMSS Number	User Access	Surface Type
9/27/2020	39852	PUBLIC	ASPHALT
Area (Sq. Ft.)	Lane Miles (11' Widths)	Curb Reveal (Inches)	Curb Recommendation
38,838	0.669	NOT APPLICABLE	NOT APPLICABLE
Curb Type		Curb & Gutter Type	
NO CURB		NO CURB AND GUTTER	
Pavement Recommendation		Condition Rating / PCR	
HEAVY 3R TREATMENTS		POOR / 53

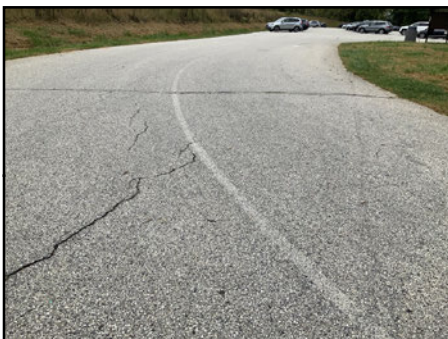
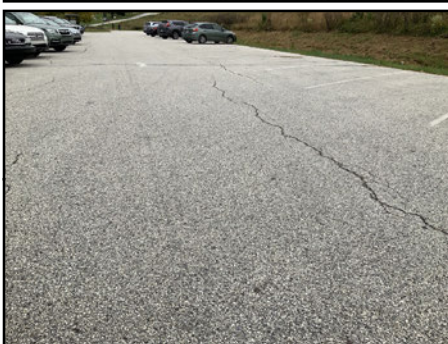
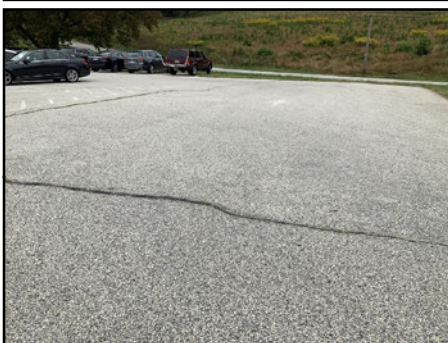
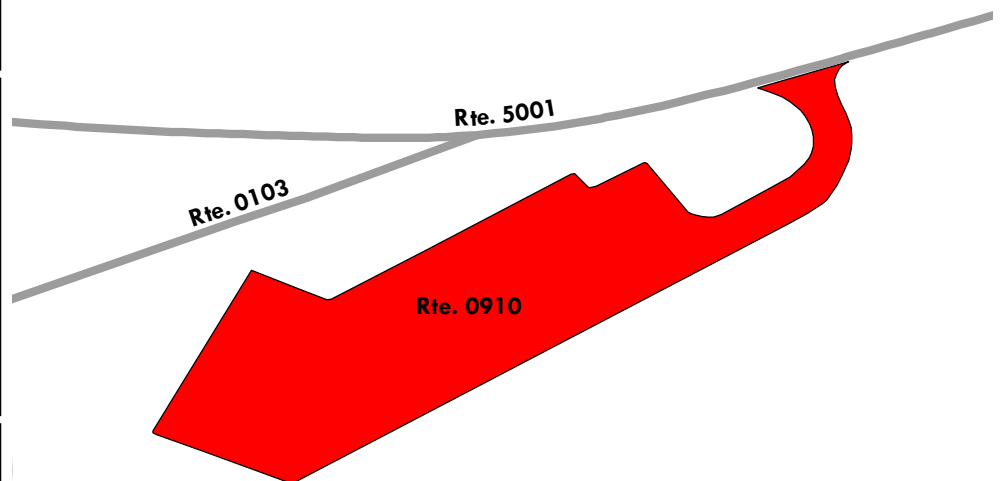
Inspection Date	FMSS Number	User Access	Surface Type
9/27/2020	39860	PUBLIC	ASPHALT
Area (Sq. Ft.)	Lane Miles (11' Widths)	Curb Reveal (Inches)	Curb Recommendation
45,686	0.787	NOT APPLICABLE	NOT APPLICABLE
Curb Type		Curb & Gutter Type	
NO CURB		NO CURB AND GUTTER	
Pavement Recommendation		Condition Rating / PCR	
HEAVY 3R TREATMENTS		POOR / 53

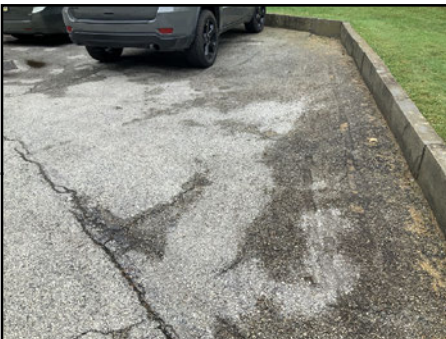
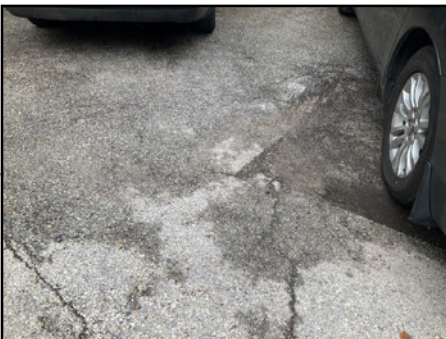
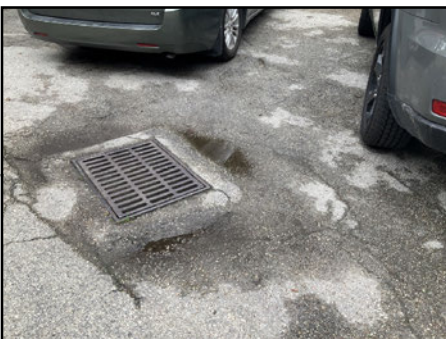
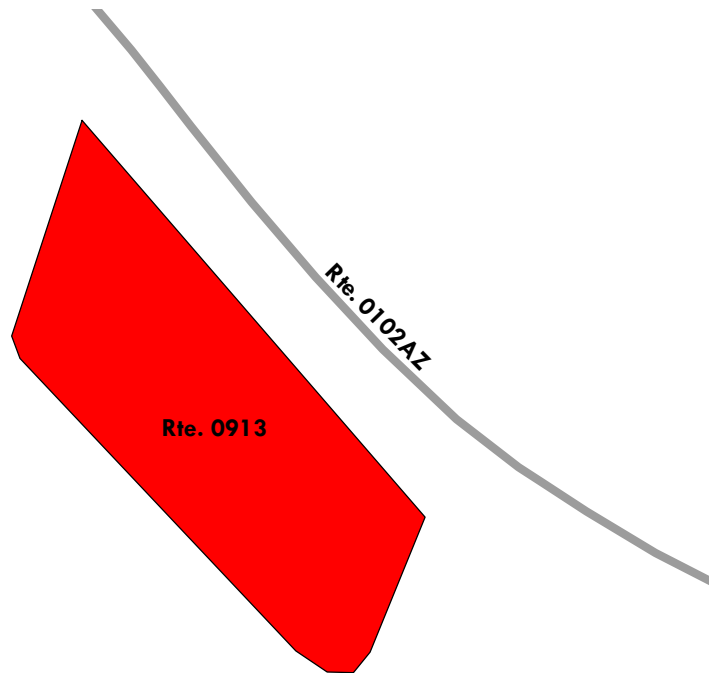
ROUTE 0913: PHILANDER KNOX HOUSE (MAXWELL'S QUARTERS) PARKING

Inspection Date	FMSS Number	User Access	Surface Type
9/27/2020	231533	PUBLIC	ASPHALT
Area (Sq. Ft.)	Lane Miles (11' Widths)	Curb Reveal (Inches)	Curb Recommendation
929	0.016	11	LIGHT REPAIR
Curb Type		Curb & Gutter Type	
CONCRETE		NO CURB AND GUTTER	
Pavement Recommendation		Condition Rating / PCR	
HEAVY 3R TREATMENTS		POOR / 53

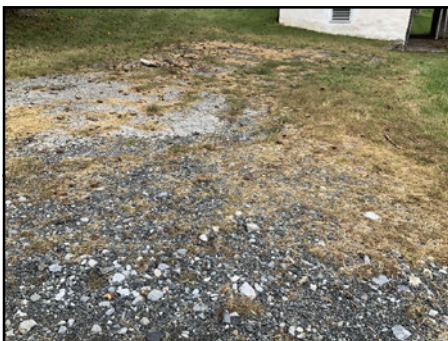
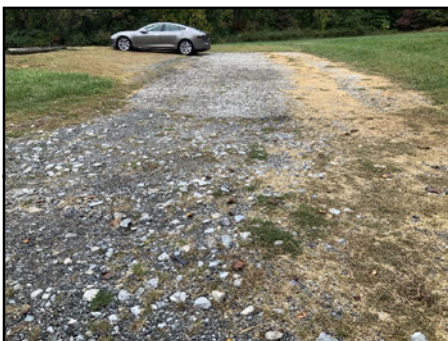
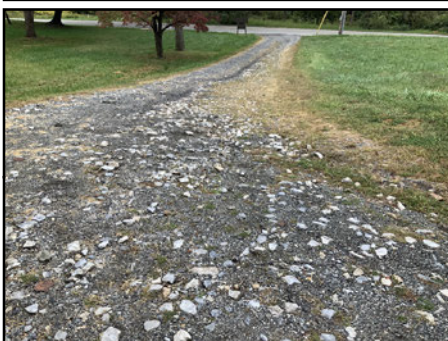
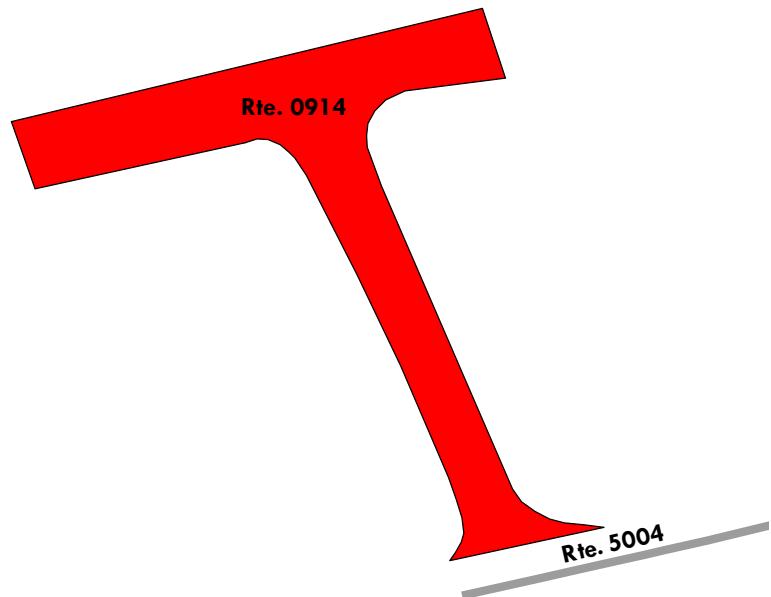
ROUTE 0914: LORD STIRLING'S QUARTERS PARKING

Inspection Date	FMSS Number	User Access	Surface Type
9/27/2020	104714	NONPUBLIC	ASPHALT
Area (Sq. Ft.)	Lane Miles (11' Widths)	Curb Reveal (Inches)	Curb Recommendation
4,148	0.071	NOT APPLICABLE	NOT APPLICABLE
Curb Type		Curb & Gutter Type	
NO CURB		NO CURB AND GUTTER	
Pavement Recommendation		Condition Rating / PCR	
RECONSTRUCTION		POOR / 0

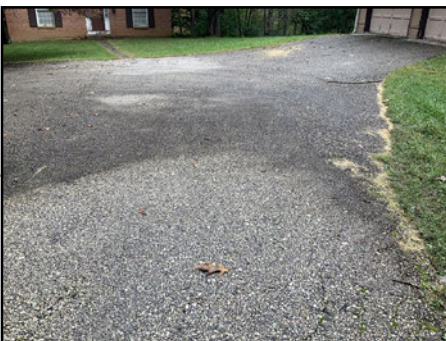
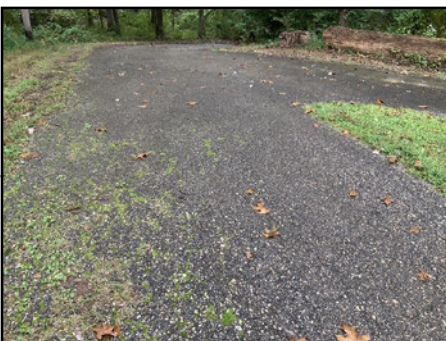
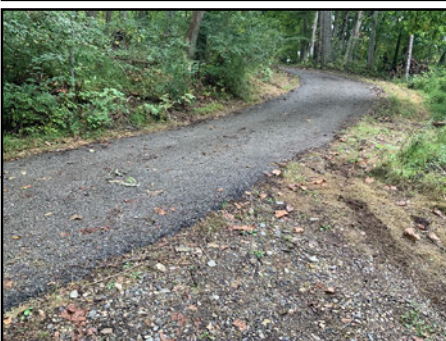
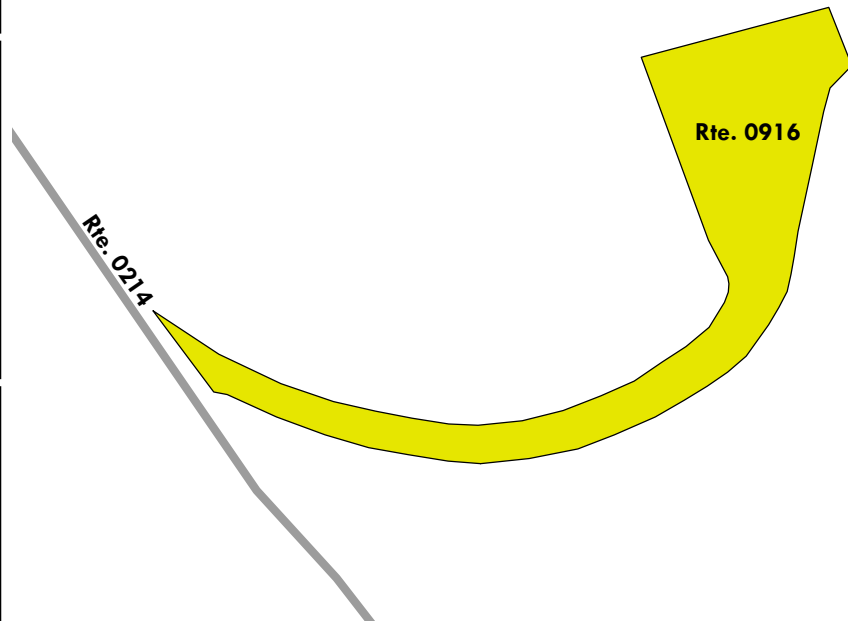
ROUTE 0916: WHITTLE HOUSE AND DRIVEWAY PARKING

Inspection Date	FMSS Number	User Access	Surface Type
9/27/2020	97348	NONPUBLIC	ASPHALT
Area (Sq. Ft.)	Lane Miles (11' Widths)	Curb Reveal (Inches)	Curb Recommendation
5,399	0.093	NOT APPLICABLE	NOT APPLICABLE
Curb Type		Curb & Gutter Type	
NO CURB		NO CURB AND GUTTER	
Pavement Recommendation		Condition Rating / PCR	
LIGHT 3R TREATMENTS		FAIR / 73

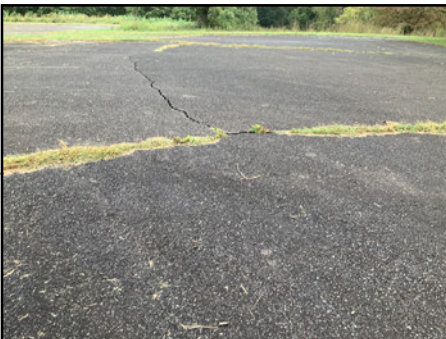
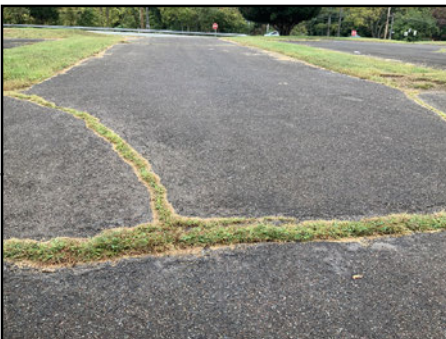
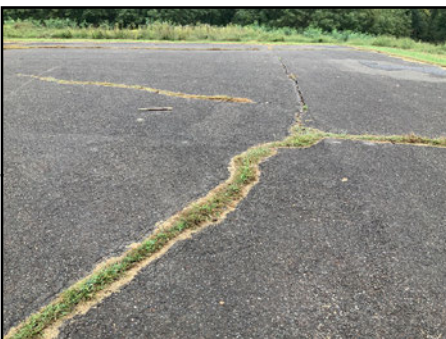
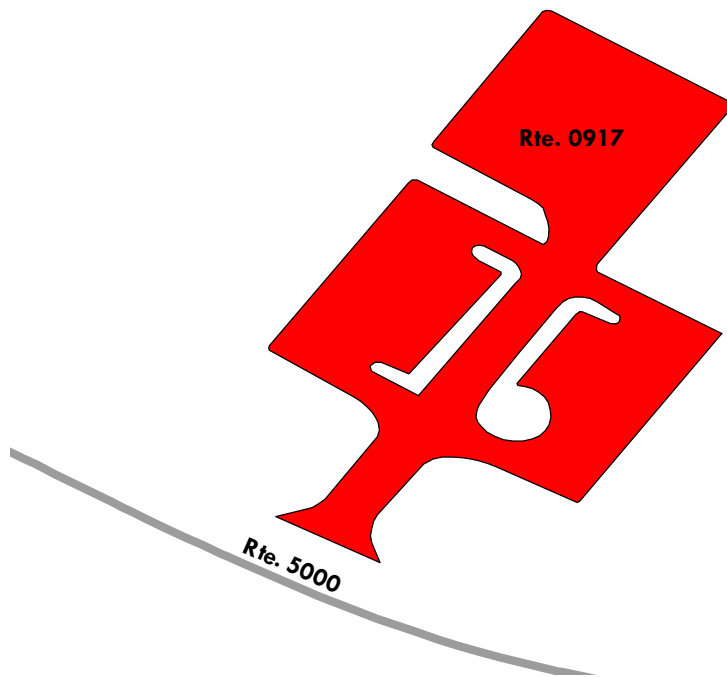
ROUTE 0917: STEUBEN MEMORIAL INFORMATION CENTER PARKING

Inspection Date	FMSS Number	User Access	Surface Type
9/27/2020	39863	PUBLIC	ASPHALT
Area (Sq. Ft.)	Lane Miles (11' Widths)	Curb Reveal (Inches)	Curb Recommendation
29,062	0.5	NOT APPLICABLE	NOT APPLICABLE
Curb Type		Curb & Gutter Type	
NO CURB		NO CURB AND GUTTER	
Pavement Recommendation		Condition Rating / PCR	
HEAVY 3R TREATMENTS		POOR / 53
