VAFO Cycle 6

Final Report

Road Inventory and Condition Assessment of Paved Routes Valley Forge National Historical Park

**Federal Highway Administration
Eastern Federal Lands Highway Division
Road Inventory Program (RIP)**

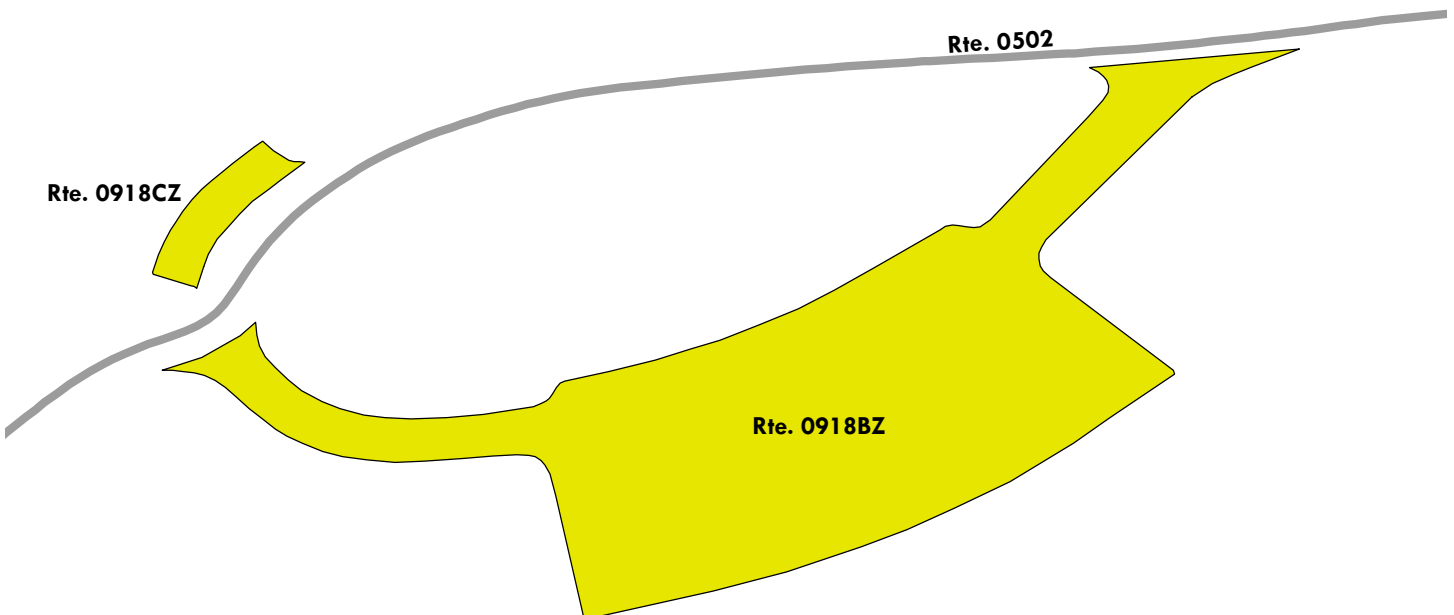
ROUTE 0918ZZ: WASHINGTON'S HEADQUARTERS PARKING AREAS

Inspection Date	FMSS Number	User Access	Surface Type
9/27/2020	95775	PUBLIC	ASPHALT
Area (Sq. Ft.)	Lane Miles (11' Widths)	Condition Rating / PCR	
30,372	0.523	SUMMARY / 74	
Route Condition Legend – Pavement Condition Rating (PCR)			
Poor (0 - 60)	Fair (61- 84)	Good (85 - 94)	Excellent (95 - 100)
Not Rated			
See Appendix for definitions and formulas

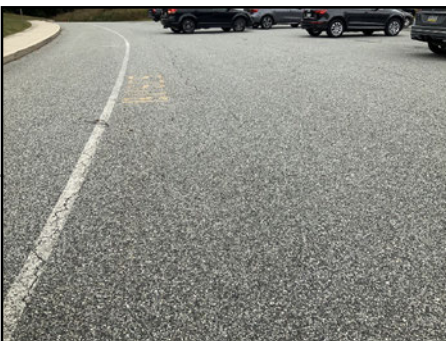
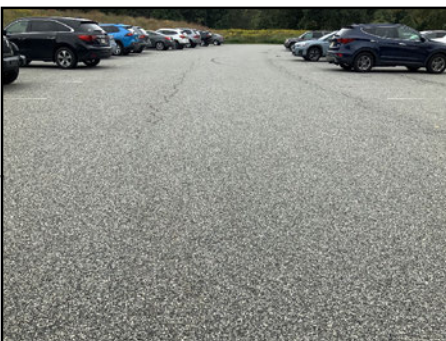
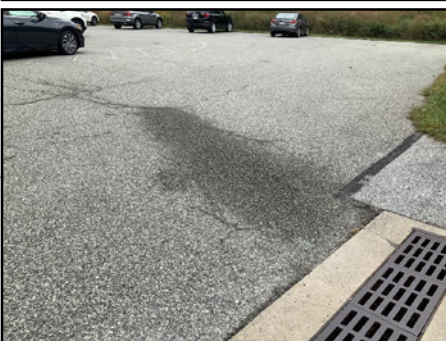
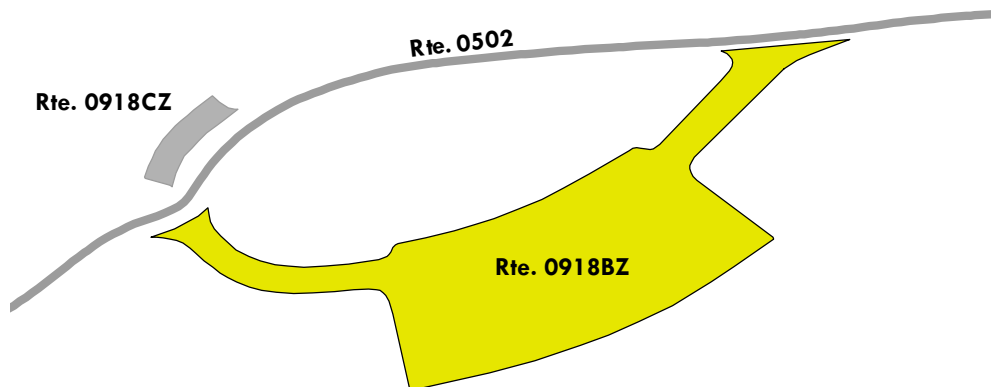
ROUTE 0918BZ: WASHINGTON'S HEADQUARTERS UPPER PARKING B

Inspection Date	FMSS Number	User Access	Surface Type
9/27/2020	95775	PUBLIC	ASPHALT
Area (Sq. Ft.)	Lane Miles (11' Widths)	Curb Reveal (Inches)	Curb Recommendation
29,094	0.501	6	DO NOTHING
Curb Type		Curb & Gutter Type	
CONCRETE		NO CURB AND GUTTER	
Pavement Recommendation		Condition Rating / PCR	
LIGHT 3R TREATMENTS		FAIR / 73

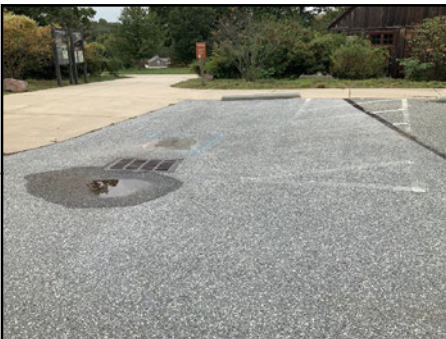
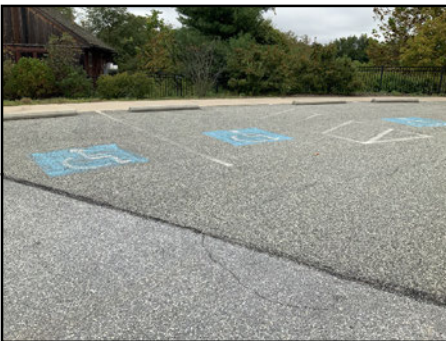
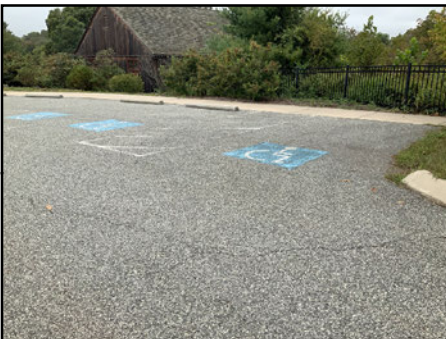
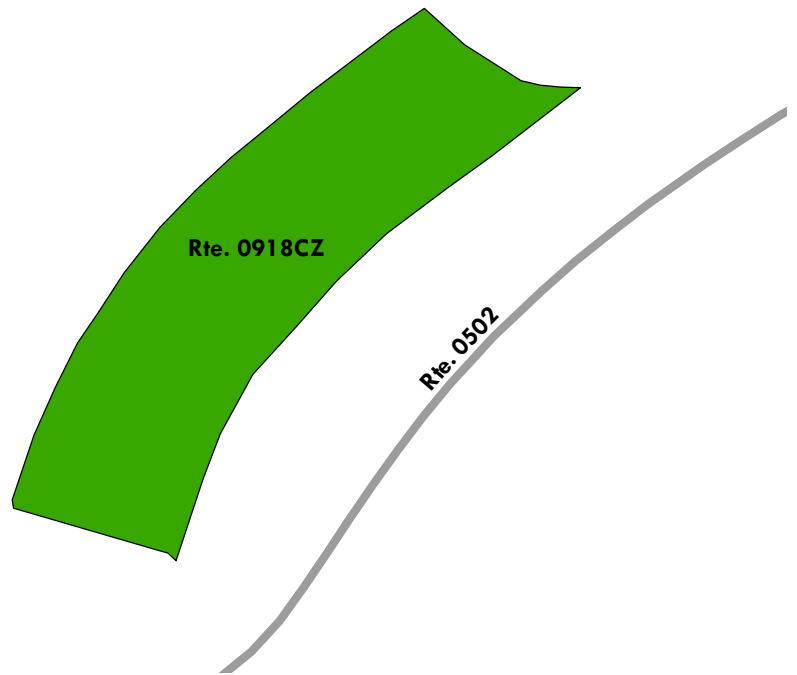
ROUTE 0918CZ: WASHINGTON'S HEADQUARTERS HANDICAP

Inspection Date	FMSS Number	User Access	Surface Type
9/27/2020	95775	PUBLIC	ASPHALT
Area (Sq. Ft.)	Lane Miles (11' Widths)	Curb Reveal (Inches)	Curb Recommendation
1,278	0.022	NOT APPLICABLE	NOT APPLICABLE
Curb Type		Curb & Gutter Type	
NO CURB		NO CURB AND GUTTER	
Pavement Recommendation		Condition Rating / PCR	
PREVENTIVE MAINTENANCE		GOOD / 90

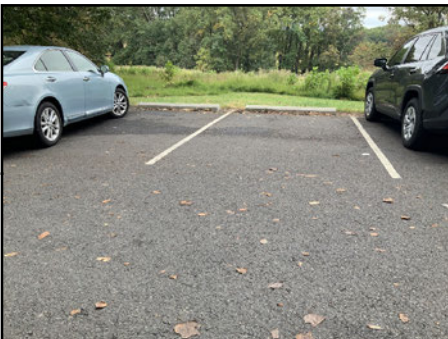
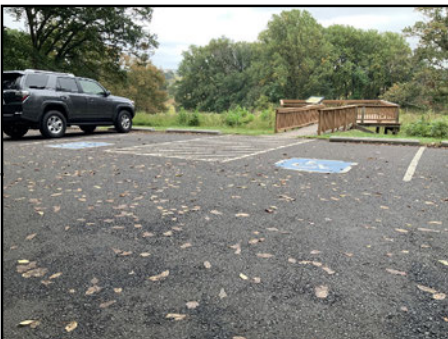
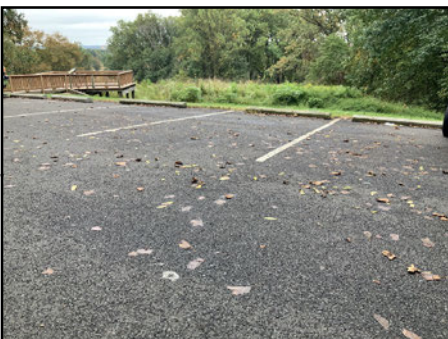
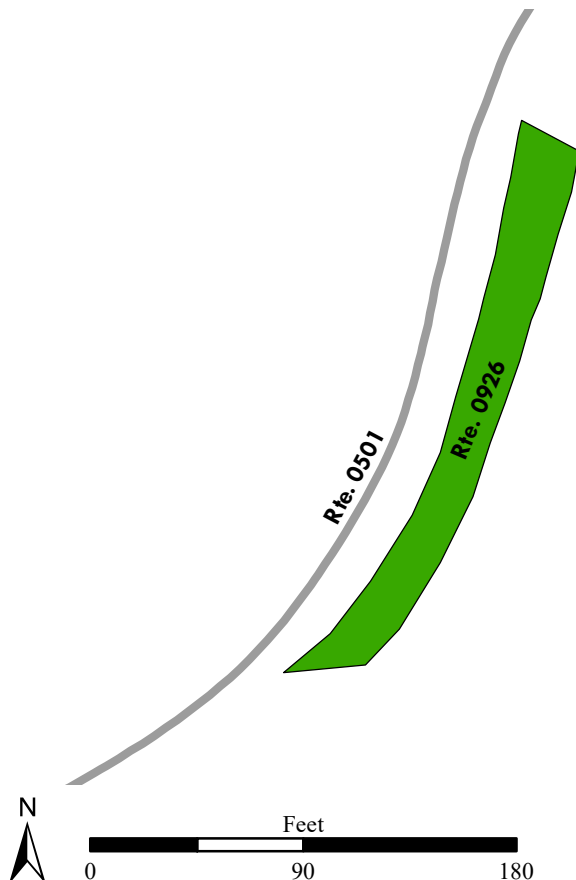
ROUTE 0926: REDOUBT 3 PARKING

Inspection Date	FMSS Number	User Access	Surface Type
9/27/2020	39872	PUBLIC	ASPHALT
Area (Sq. Ft.)	Lane Miles (11' Widths)	Curb Reveal (Inches)	Curb Recommendation
4,174	0.072	NOT APPLICABLE	NOT APPLICABLE
Curb Type		Curb & Gutter Type	
NO CURB		NO CURB AND GUTTER	
Pavement Recommendation		Condition Rating / PCR	
PREVENTIVE MAINTENANCE		GOOD / 90

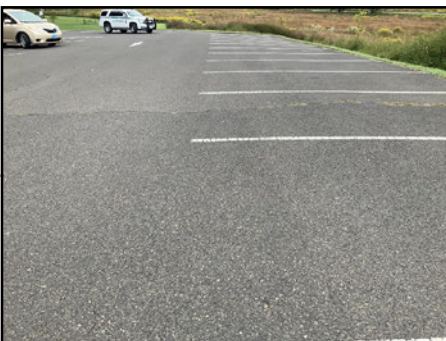
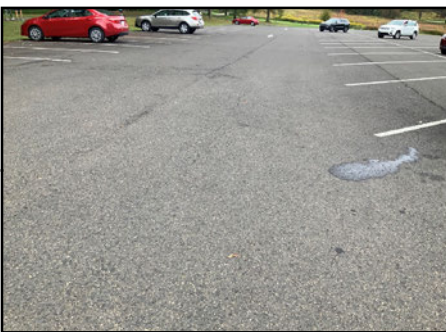
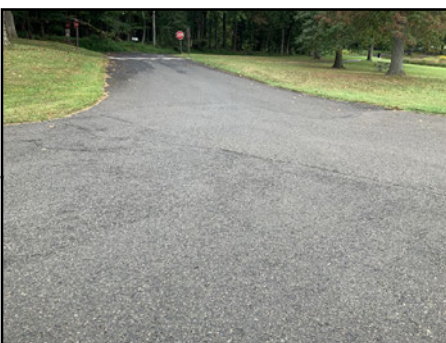
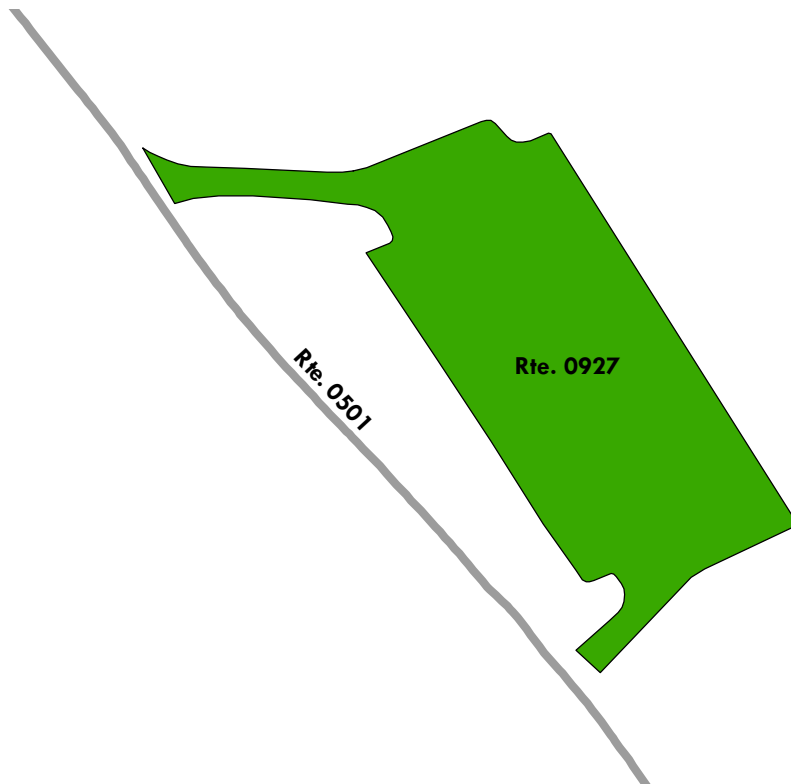
ROUTE 0927: ARTILLERY PARK PARKING

Inspection Date	FMSS Number	User Access	Surface Type
9/27/2020	39847	PUBLIC	ASPHALT
Area (Sq. Ft.)	Lane Miles (11' Widths)	Curb Reveal (Inches)	Curb Recommendation
40,701	0.701	NOT APPLICABLE	NOT APPLICABLE
Curb Type		Curb & Gutter Type	
NO CURB		NO CURB AND GUTTER	
Pavement Recommendation		Condition Rating / PCR	
PREVENTIVE MAINTENANCE		GOOD / 90

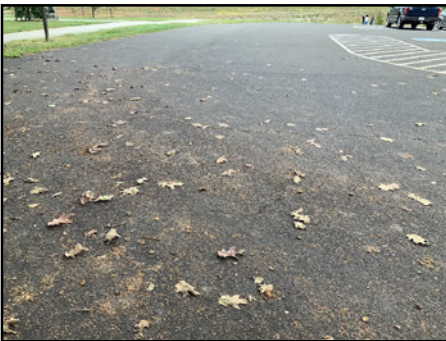
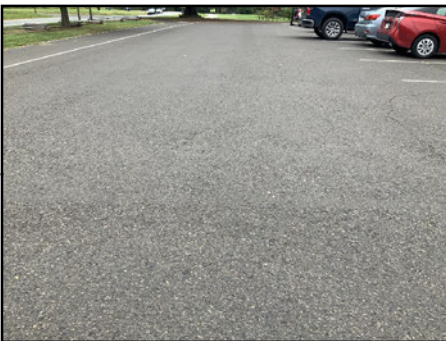
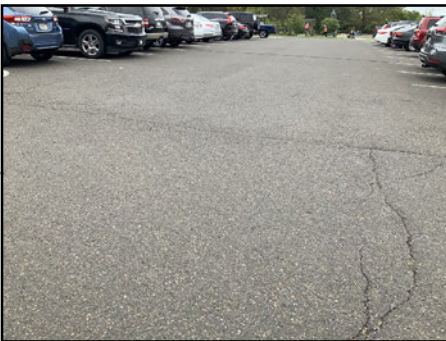
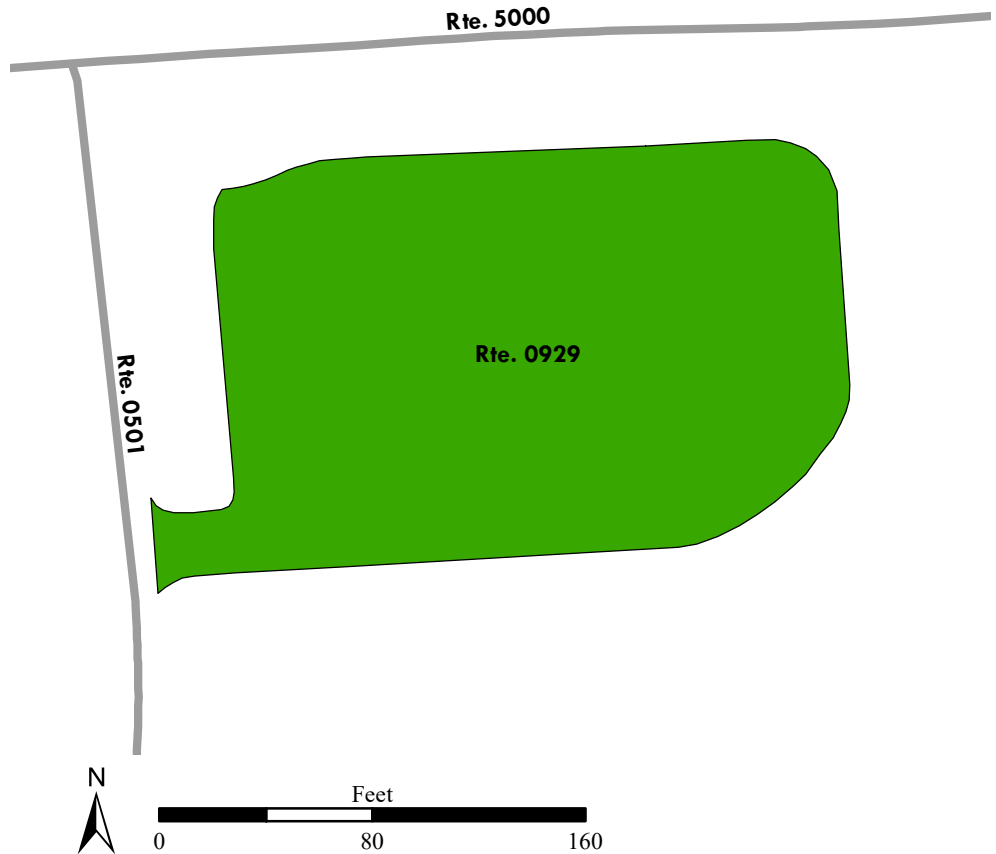
ROUTE 0930: VARNUM'S PICNIC AREA PARKING

Inspection Date	FMSS Number	User Access	Surface Type
9/27/2020	39858	PUBLIC	ASPHALT
Area (Sq. Ft.)	Lane Miles (11' Widths)	Curb Reveal (Inches)	Curb Recommendation
39,766	0.685	NOT APPLICABLE	NOT APPLICABLE
Curb Type		Curb & Gutter Type	
NO CURB		NO CURB AND GUTTER	
Pavement Recommendation		Condition Rating / PCR	
PREVENTIVE MAINTENANCE		GOOD / 90

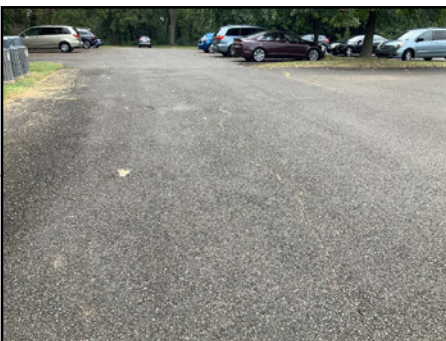
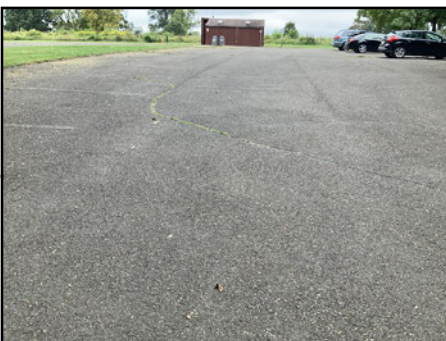
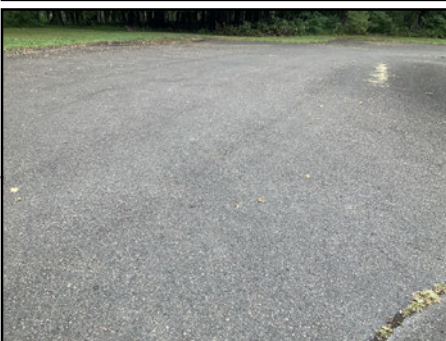
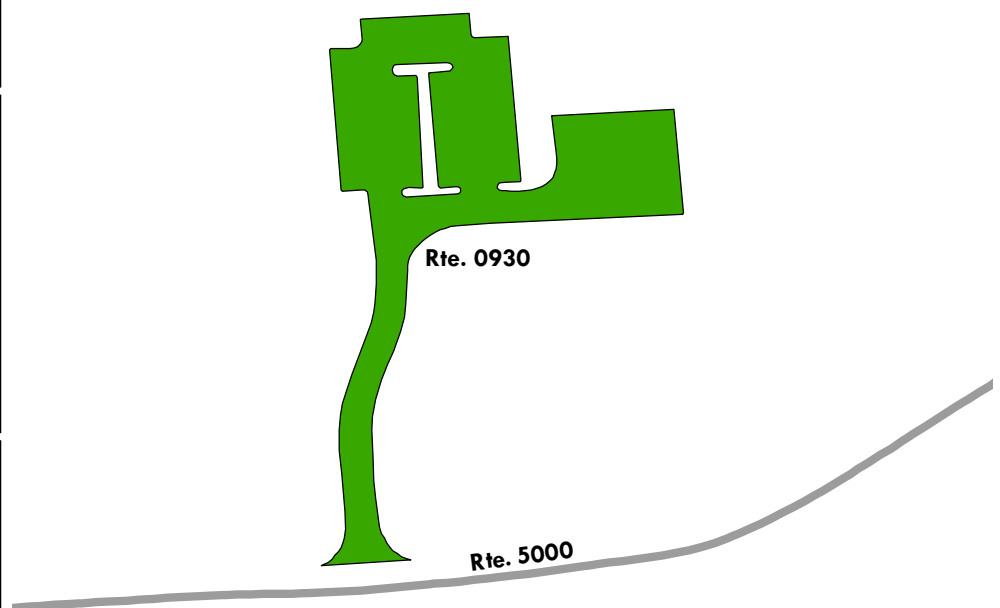
ROUTE 0931: MAURICE STEPHENS PARKING

Inspection Date	FMSS Number	User Access	Surface Type
9/27/2020	39862	PUBLIC	ASPHALT
Area (Sq. Ft.)	Lane Miles (11' Widths)	Curb Reveal (Inches)	Curb Recommendation
22,729	0.391	NOT APPLICABLE	NOT APPLICABLE
Curb Type		Curb & Gutter Type	
NO CURB		NO CURB AND GUTTER	
Pavement Recommendation		Condition Rating / PCR	
HEAVY 3R TREATMENTS		POOR / 53

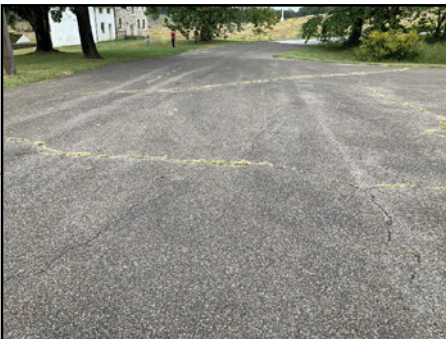
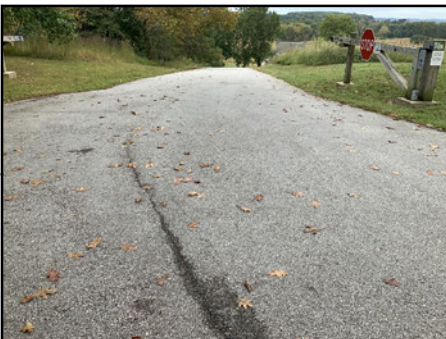
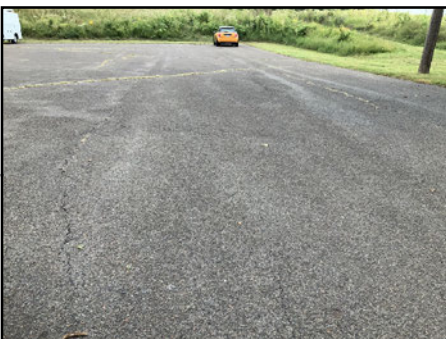
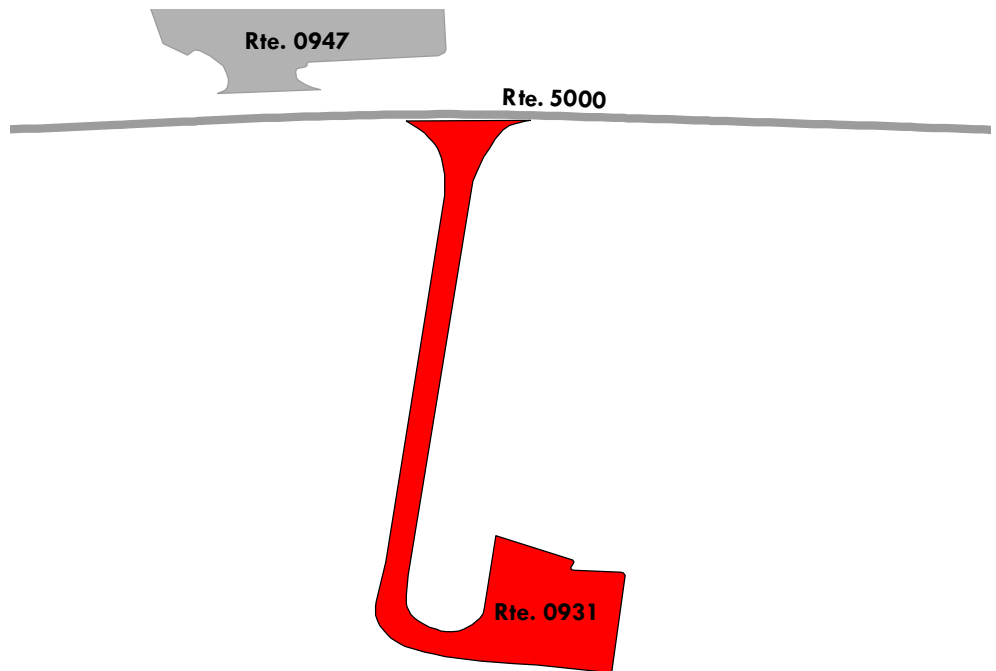
ROUTE 0932: MAINTENANCE AREA

Inspection Date	FMSS Number	User Access	Surface Type
9/27/2020	39876	NONPUBLIC	ASPHALT
Area (Sq. Ft.)	Lane Miles (11' Widths)	Curb Reveal (Inches)	Curb Recommendation
94,724	1.631	NOT APPLICABLE	NOT APPLICABLE
Curb Type		Curb & Gutter Type	
NO CURB		NO CURB AND GUTTER	
Pavement Recommendation		Condition Rating / PCR	
RECONSTRUCTION		POOR / 30

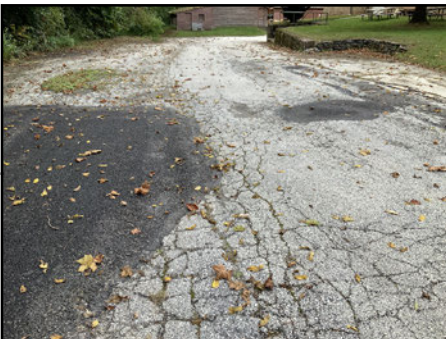
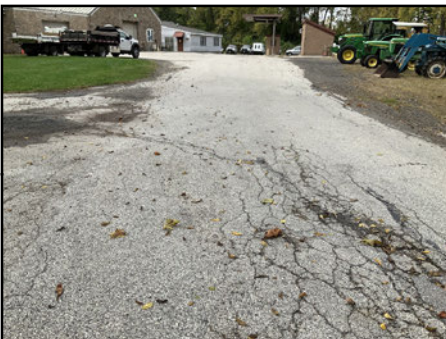
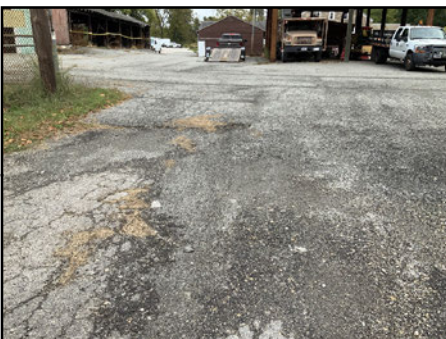
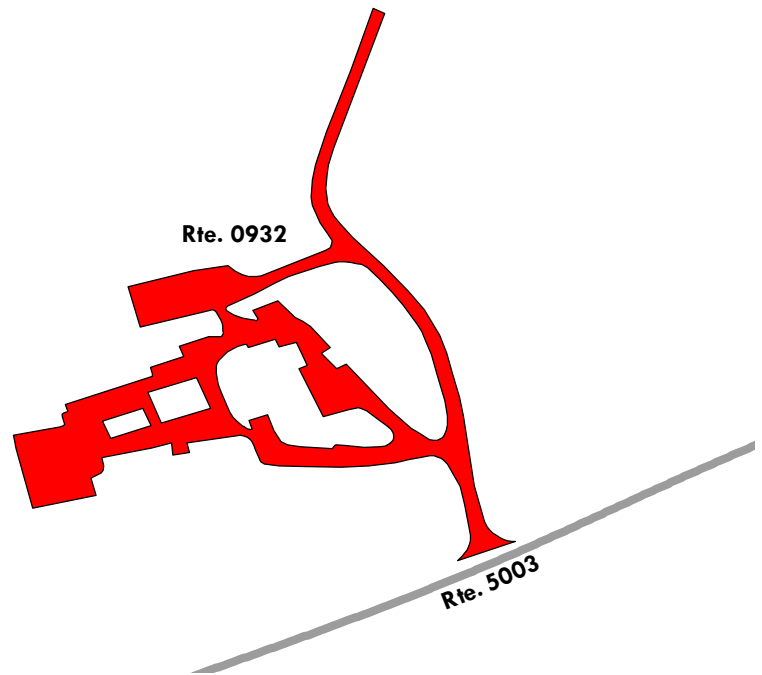
ROUTE 0933: KENNEDY-SUPPLEE MANSION PARKING

Inspection Date	FMSS Number	User Access	Surface Type
9/27/2020	104716	PUBLIC	ASPHALT
Area (Sq. Ft.)	Lane Miles (11' Widths)	Curb Reveal (Inches)	Curb Recommendation
52,360	0.902	NOT APPLICABLE	NOT APPLICABLE
Curb Type		Curb & Gutter Type	
NO CURB		NO CURB AND GUTTER	
Pavement Recommendation		Condition Rating / PCR	
RECONSTRUCTION		POOR / 30

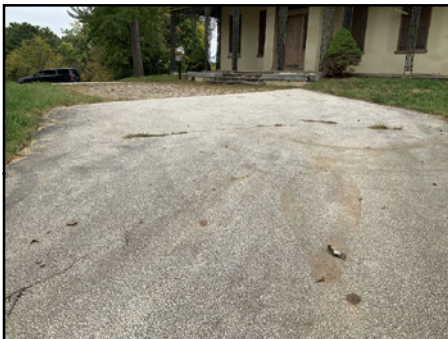
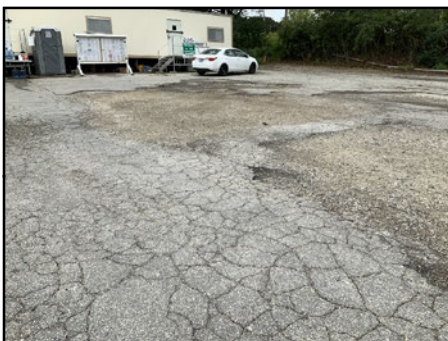
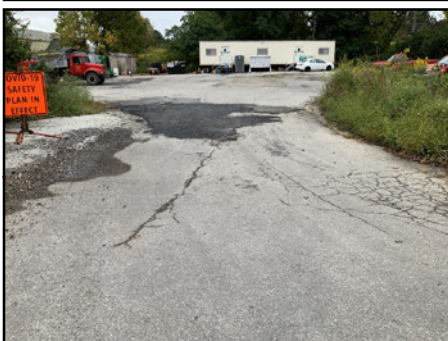
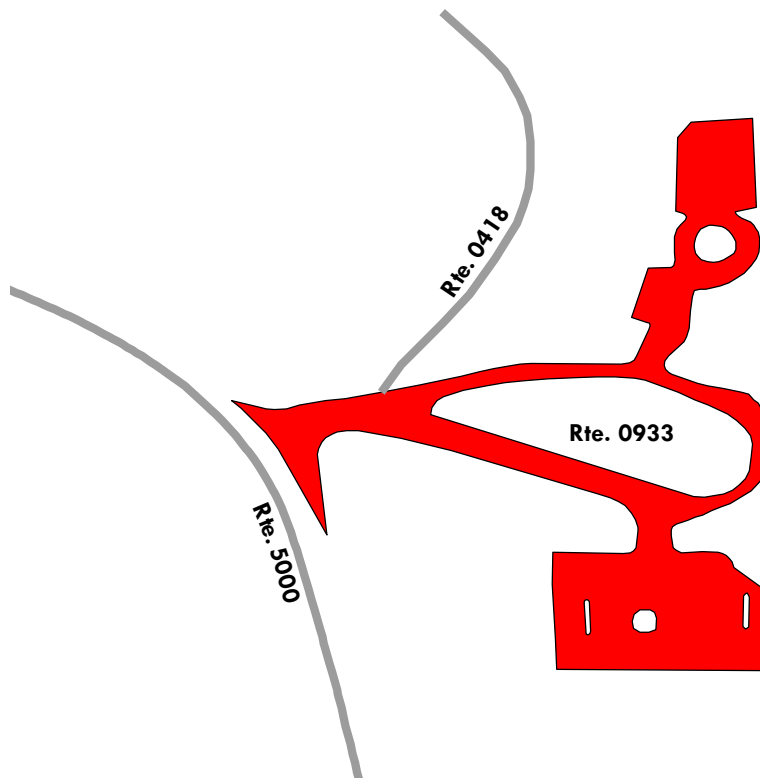
ROUTE 0934: PORT KENNEDY TRAIN STATION PARKING

Inspection Date	FMSS Number	User Access	Surface Type
9/27/2020	39870	PUBLIC	ASPHALT
Area (Sq. Ft.)	Lane Miles (11' Widths)	Curb Reveal (Inches)	Curb Recommendation
19,962	0.344	NOT APPLICABLE	NOT APPLICABLE
Curb Type		Curb & Gutter Type	
NO CURB		NO CURB AND GUTTER	
Pavement Recommendation		Condition Rating / PCR	
RECONSTRUCTION		POOR / 30

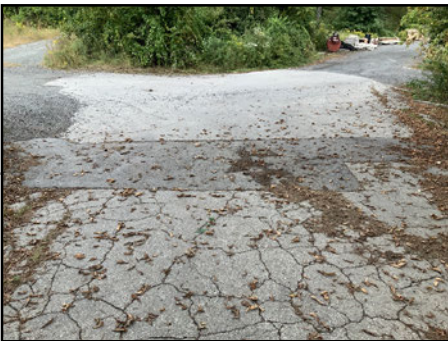
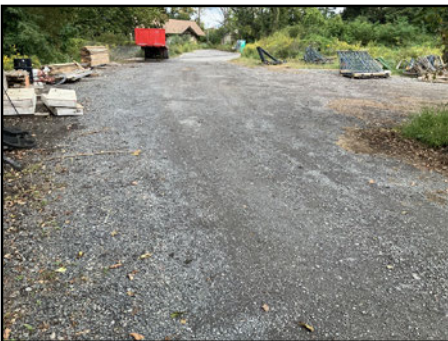
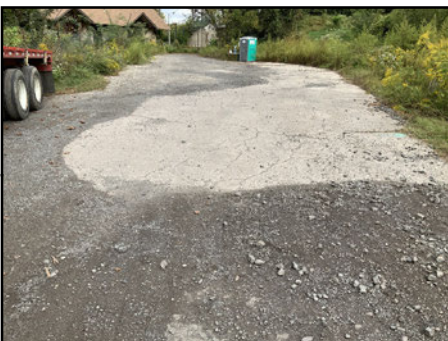
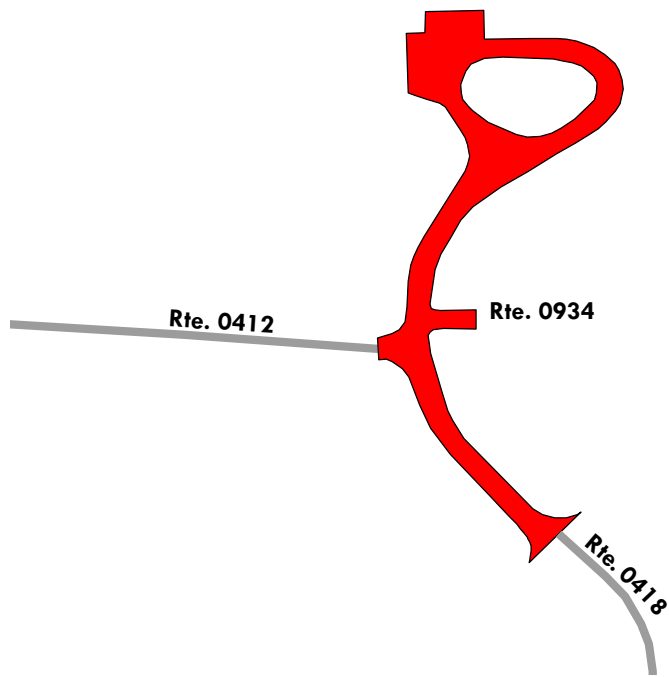
ROUTE 0935: BETZWOOD BOAT RAMP PARKING

Inspection Date	FMSS Number	User Access	Surface Type
9/27/2020	39855	PUBLIC	ASPHALT
Area (Sq. Ft.)	Lane Miles (11' Widths)	Curb Reveal (Inches)	Curb Recommendation
16,031	0.276	5	LIGHT REPAIR
Curb Type		Curb & Gutter Type	
CONCRETE		NO CURB AND GUTTER	
Pavement Recommendation		Condition Rating / PCR	
RECONSTRUCTION		POOR / 30

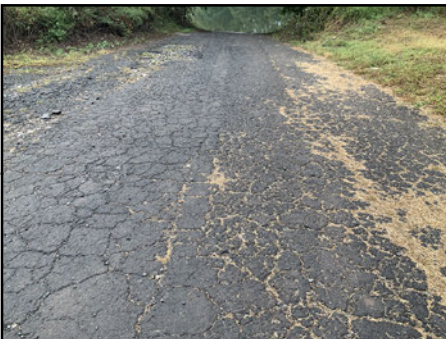
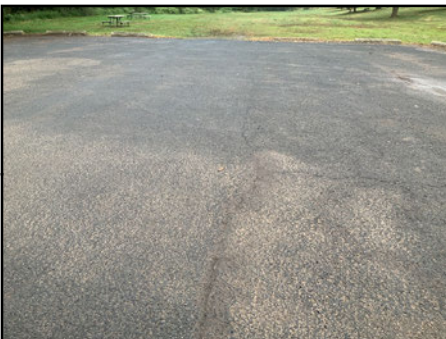
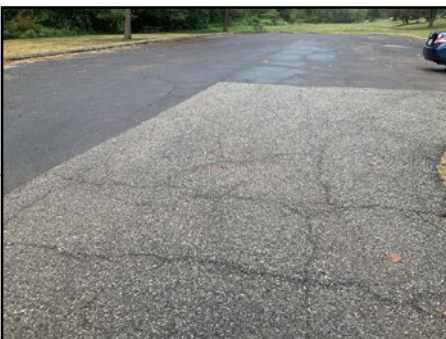
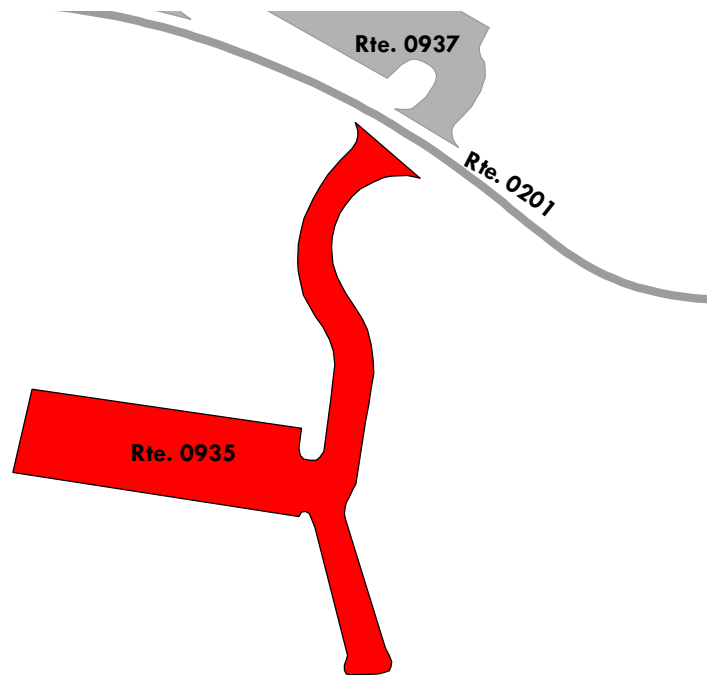
ROUTE 0937: BETZWOOD BIKE PATH PARKING

Inspection Date	FMSS Number	User Access	Surface Type
9/27/2020	104718	PUBLIC	ASPHALT
Area (Sq. Ft.)	Lane Miles (11' Widths)	Curb Reveal (Inches)	Curb Recommendation
9,756	0.168	5	MODERATE REPAIR
Curb Type		Curb & Gutter Type	
CONCRETE		NO CURB AND GUTTER	
Pavement Recommendation		Condition Rating / PCR	
HEAVY 3R TREATMENTS		POOR / 53

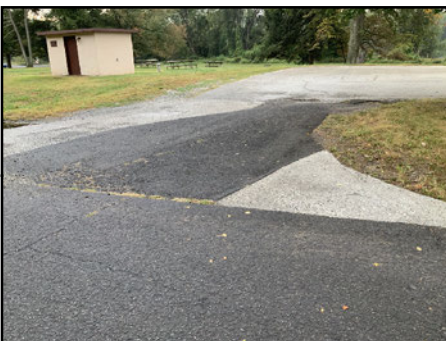
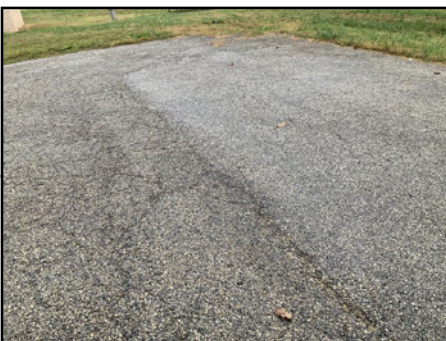
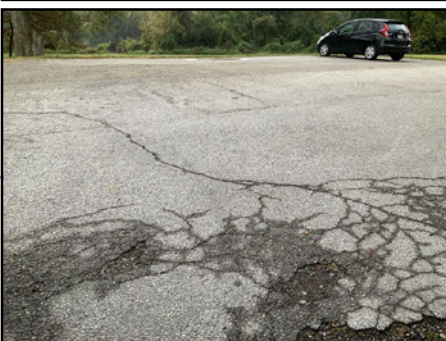
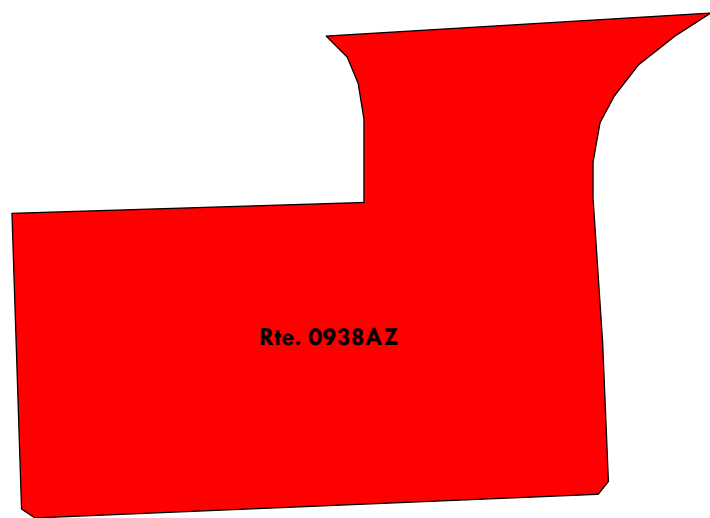
ROUTE 0938BZ: BETZWOOD PICNIC AREA PARKING B

Inspection Date	FMSS Number	User Access	Surface Type
9/27/2020	104719	PUBLIC	ASPHALT
Area (Sq. Ft.)	Lane Miles (11' Widths)	Curb Reveal (Inches)	Curb Recommendation
4,224	0.073	NOT APPLICABLE	NOT APPLICABLE
Curb Type		Curb & Gutter Type	
CONCRETE		NO CURB AND GUTTER	
Pavement Recommendation		Condition Rating / PCR	
RECONSTRUCTION		POOR / 30

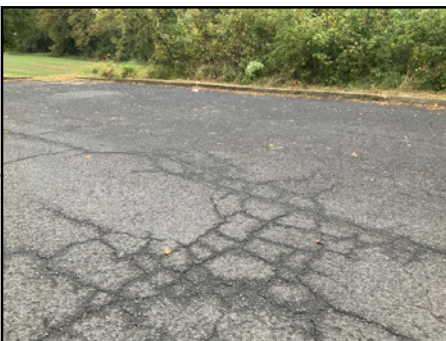
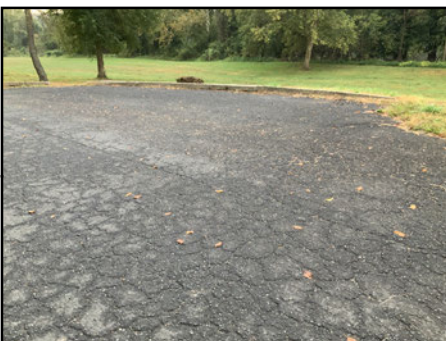
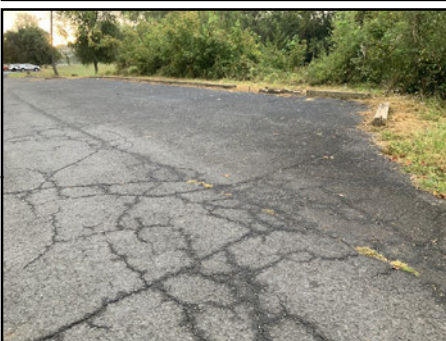
ROUTE 0938DZ: BETZWOOD PICNIC AREA PARKING D

Inspection Date	FMSS Number	User Access	Surface Type
9/27/2020	104719	PUBLIC	ASPHALT
Area (Sq. Ft.)	Lane Miles (11' Widths)	Curb Reveal (Inches)	Curb Recommendation
2,691	0.046	NOT APPLICABLE	NOT APPLICABLE
Curb Type		Curb & Gutter Type	
CONCRETE		NO CURB AND GUTTER	
Pavement Recommendation		Condition Rating / PCR	
RECONSTRUCTION		POOR / 30

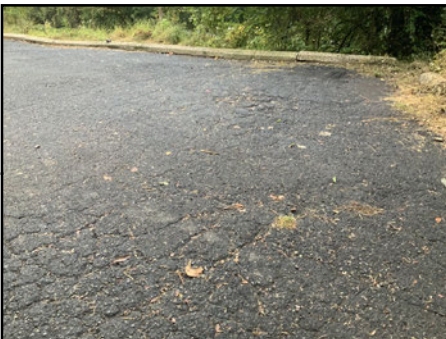
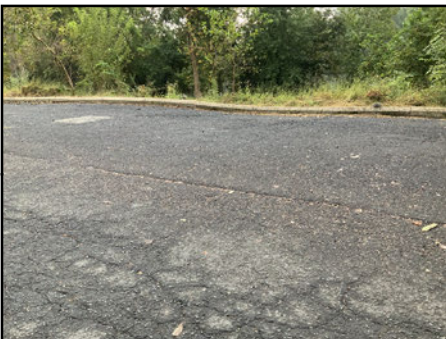
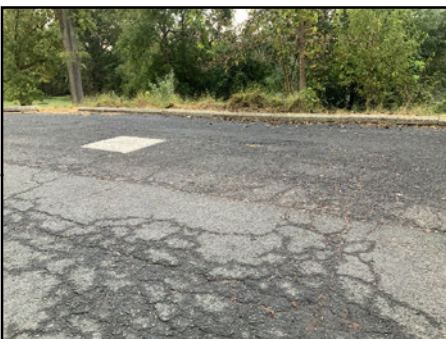
ROUTE 0939: LOUGHLIN HOUSE PARKING

Inspection Date	FMSS Number	User Access	Surface Type
9/27/2020	97349	NONPUBLIC	ASPHALT
Area (Sq. Ft.)	Lane Miles (11' Widths)	Curb Reveal (Inches)	Curb Recommendation
3,358	0.058	NOT APPLICABLE	NOT APPLICABLE
Curb Type		Curb & Gutter Type	
NO CURB		NO CURB AND GUTTER	
Pavement Recommendation		Condition Rating / PCR	
LIGHT 3R TREATMENTS		FAIR / 73

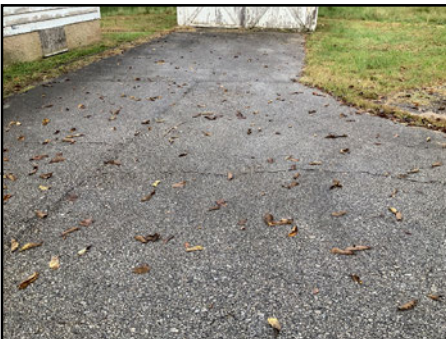
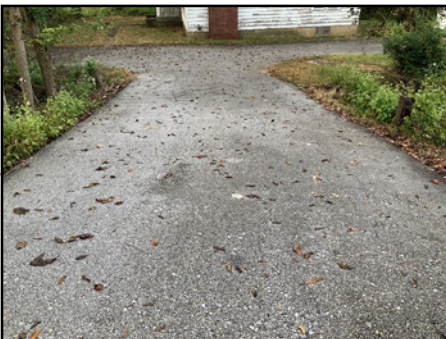
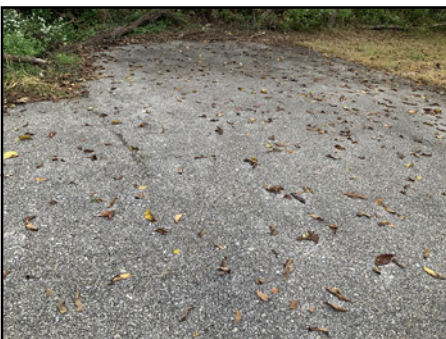
ROUTE 0940: RANGER STATION PARKING

Inspection Date	FMSS Number	User Access	Surface Type
9/27/2020	104721	PUBLIC	ASPHALT
Area (Sq. Ft.)	Lane Miles (11' Widths)	Curb Reveal (Inches)	Curb Recommendation
16,378	0.282	6	DO NOTHING
Curb Type		Curb & Gutter Type	
CONCRETE		NO CURB AND GUTTER	
Pavement Recommendation		Condition Rating / PCR	
LIGHT 3R TREATMENTS		FAIR / 73

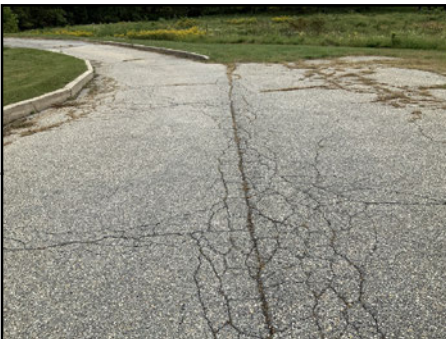
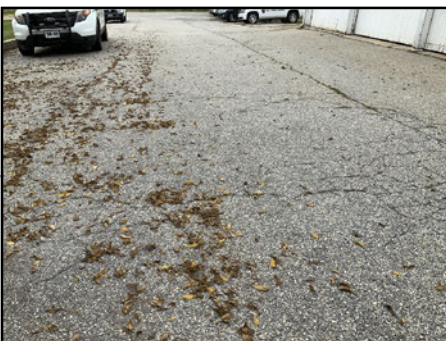
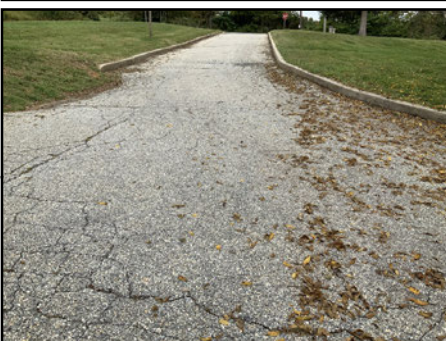
ROUTE 0948: POSA (ROGERS HOUSE) PARKING

Inspection Date	FMSS Number	User Access	Surface Type
9/27/2020	39868	PUBLIC	ASPHALT
Area (Sq. Ft.)	Lane Miles (11' Widths)	Curb Reveal (Inches)	Curb Recommendation
4,539	0.078	NOT APPLICABLE	NOT APPLICABLE
Curb Type		Curb & Gutter Type	
NO CURB		NO CURB AND GUTTER	
Pavement Recommendation		Condition Rating / PCR	
HEAVY 3R TREATMENTS		POOR / 53

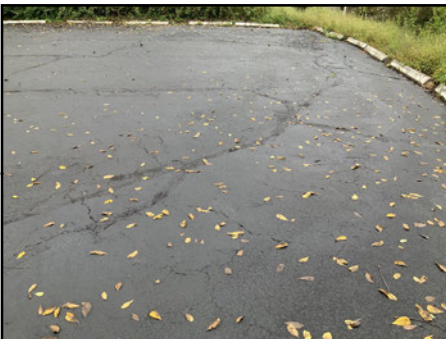
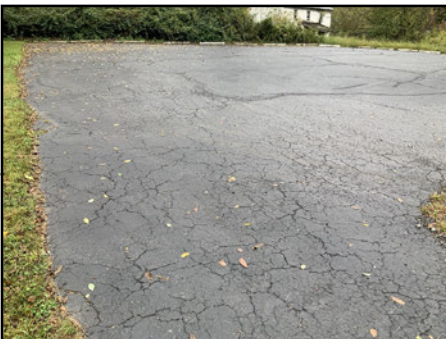
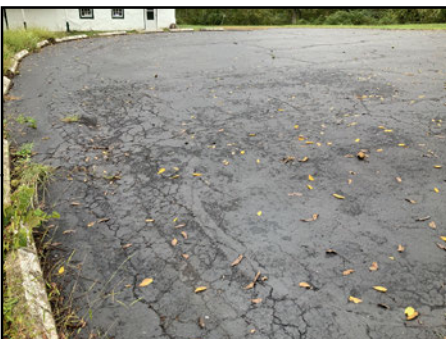
ROUTE 0947: CHAPEL PARKING

Inspection Date	FMSS Number	User Access	Surface Type
9/27/2020	39873	PUBLIC	ASPHALT
Area (Sq. Ft.)	Lane Miles (11' Widths)	Curb Reveal (Inches)	Curb Recommendation
48,877	0.842	4	LIGHT REPAIR
Curb Type		Curb & Gutter Type	
ASPHALT		NO CURB AND GUTTER	
Pavement Recommendation		Condition Rating / PCR	
RECONSTRUCTION		POOR / 30
