# VAMA Cycle 6

### Road Inventory and Condition Assessment of Paved Routes Vanderbilt Mansion National Historic Site

**Federal Highway Administration  
Eastern Federal Lands Highway Division  
Road Inventory Program (RIP)**

**Report Date: June 2021**

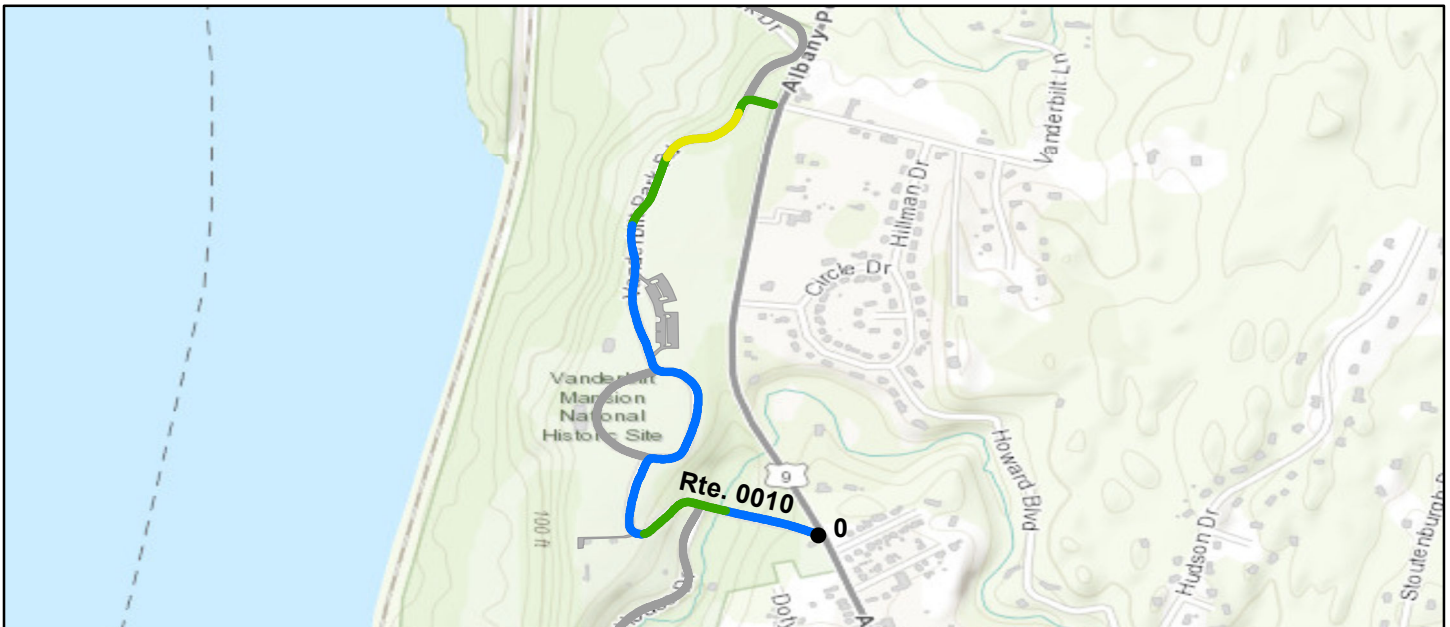
## ROUTE 0010: MAIN ENTRANCE ROAD

Route Condition Legend – Pavement Condition Rating (PCR)						
Poor (0 - 60)	Fair (61- 84)	Good (85 - 94)	Excellent (95 - 100)	Not Rated		
Colors on map represent condition scores at 0.10-mile intervals. See Appendix for definitions and formulas.						
<b>Inspection Date:</b> 10/20/2020	<b>Beginning Section MP</b>	0				
<b>Paved Length (Miles):</b> 0.95	<b>Section Length (MI)</b>	0.95				
<b>Surface Type:</b> ASPHALT	<b>Route Summary</b>					
<b>Roadway Condition Information</b>						
Pavement Condition Rating (PCR)	94	94				
Surface Condition Rating (SCR)	94	94				
Roughness Condition Index (RCI)	N/A	N/A				
<b>Distress Index Values</b>						
Structural Crack Index	94	94				
Alligator Crack Index	100	100				
Longitudinal Crack Index	94	94				
Transverse Cracking Index	99	99				
Patching Index	100	100				
Rutting Index	96	96				
International Roughness Index (IRI)	N/A	N/A				
<b>Lane &amp; Width Information</b>

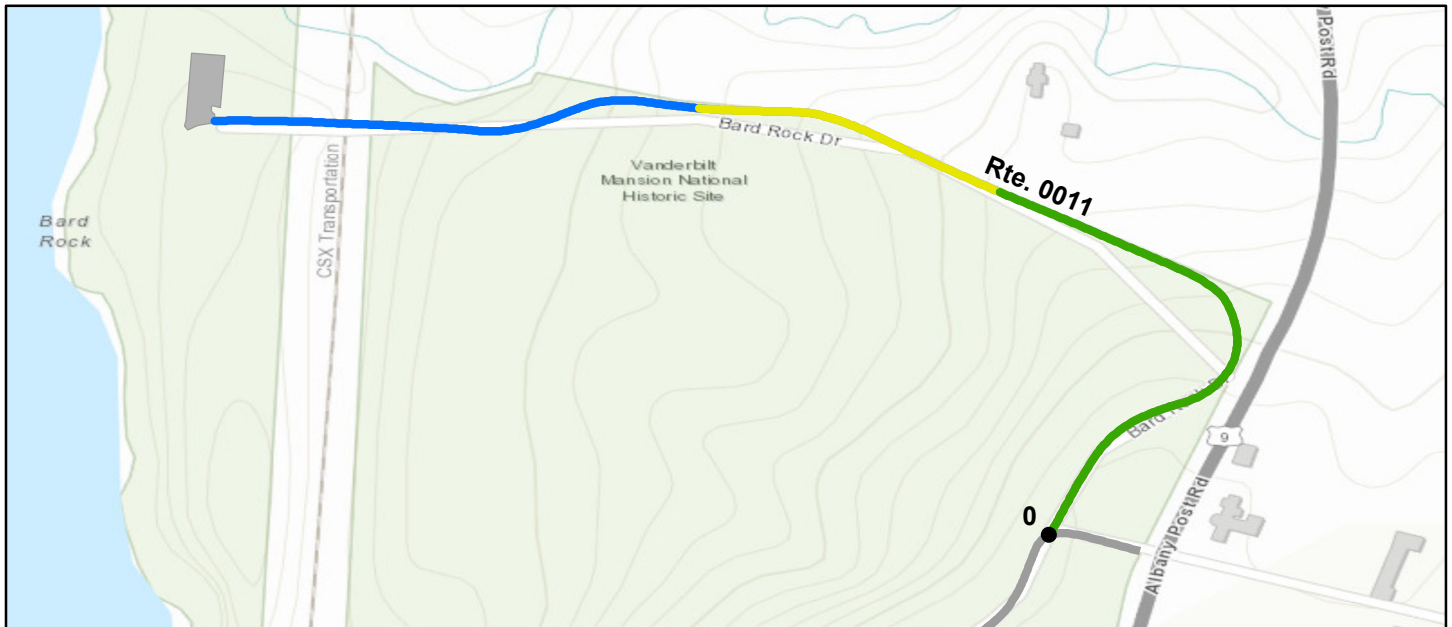
## ROUTE 0011: BARD ROCK ROAD

<b>Inspection Date:</b>	10/20/2020	<b>Beginning Section MP</b>	0				
<b>Paved Length (Miles):</b>	0.45	<b>Section Length (MI)</b>	0.45				
<b>Surface Type:</b>	ASPHALT	<b>Route Summary</b>					
<b>Roadway Condition Information</b>							
Pavement Condition Rating (PCR)	90	90					
Surface Condition Rating (SCR)	90	90					
Roughness Condition Index (RCI)	N/A	N/A					
<b>Distress Index Values</b>							
Structural Crack Index	90	90					
Alligator Crack Index	100	100					
Longitudinal Crack Index	90	90					
Transverse Cracking Index	98	98					
Patching Index	100	100					
Rutting Index	98	98					
International Roughness Index (IRI)	N/A	N/A					
<b>Lane &amp; Width Information</b>							
Number of Lanes	2	2					
Paved Width (ft)	17.3	17.3					
Lane Width (ft)	8.7	8.7

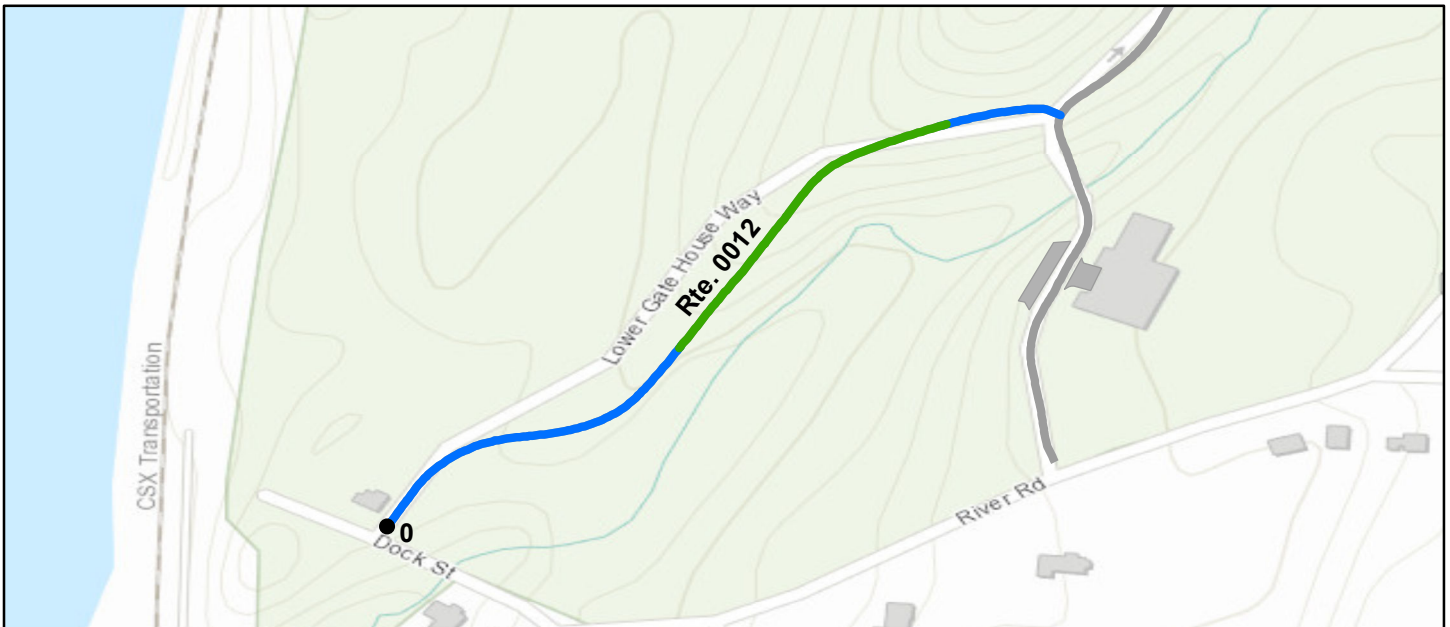
## ROUTE 0012: LOWER GATEHOUSE ROAD

Route Condition Legend – Pavement Condition Rating (PCR)						
Poor (0 - 60)	Fair (61- 84)	Good (85 - 94)	Excellent (95 - 100)	Not Rated		
Colors on map represent condition scores at 0.10-mile intervals. See Appendix for definitions and formulas.						
<b>Inspection Date:</b>	10/20/2020	<b>Beginning Section MP</b>	0			
<b>Paved Length (Miles):</b>	0.23	<b>Section Length (MI)</b>	0.23			
<b>Surface Type:</b>	ASPHALT	<b>Route Summary</b>				
<b>Roadway Condition Information</b>						
Pavement Condition Rating (PCR)	93	93				
Surface Condition Rating (SCR)	93	93				
Roughness Condition Index (RCI)	N/A	N/A				
<b>Distress Index Values</b>						
Structural Crack Index	93	93				
Alligator Crack Index	100	100				
Longitudinal Crack Index	93	93				
Transverse Cracking Index	99	99				
Patching Index	100	100				
Rutting Index	98	98				
International Roughness Index (IRI)	N/A	N/A				
<b>Lane &amp; Width Information</b>

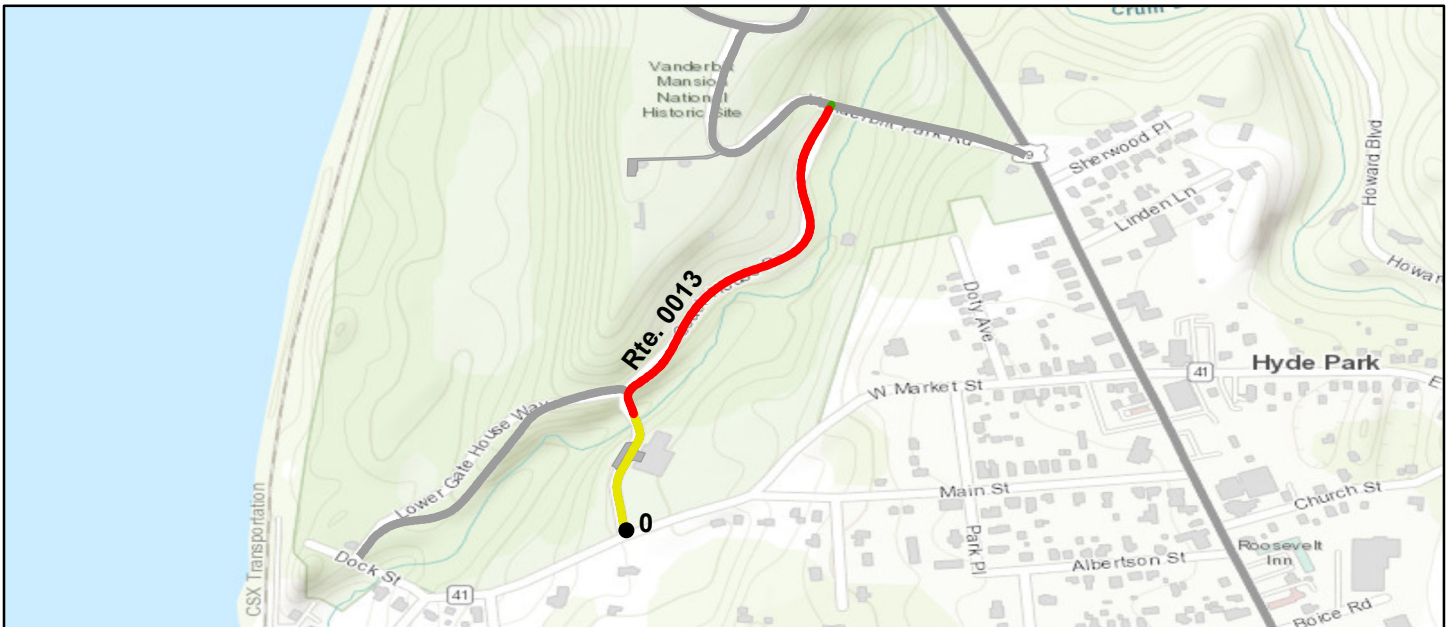
## ROUTE 0013: COACH HOUSE ROAD

<b>Inspection Date:</b>	10/20/2020	<b>Beginning Section MP</b>	0				
<b>Paved Length (Miles):</b>	0.4	<b>Section Length (MI)</b>	0.4				
<b>Surface Type:</b>	ASPHALT	<b>Route Summary</b>					
<b>Roadway Condition Information</b>							
Pavement Condition Rating (PCR)	50	50					
Surface Condition Rating (SCR)	50	50					
Roughness Condition Index (RCI)	N/A	N/A					
<b>Distress Index Values</b>							
Structural Crack Index	50	50					
Alligator Crack Index	100	100					
Longitudinal Crack Index	50	50					
Transverse Cracking Index	90	90					
Patching Index	100	100					
Rutting Index	97	97					
International Roughness Index (IRI)	N/A	N/A					
<b>Lane &amp; Width Information</b>							
Number of Lanes	2	2					
Paved Width (ft)	17	17					
Lane Width (ft)	8.5	8.5

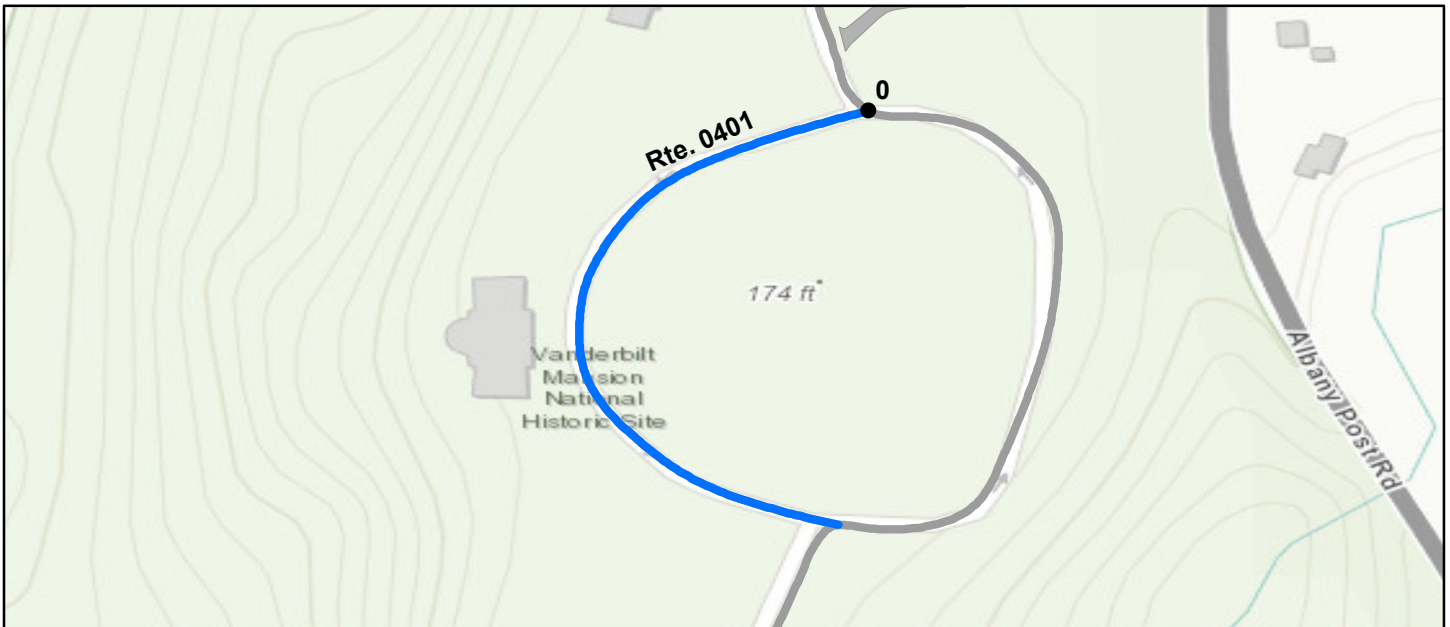
## ROUTE 0401: MANSION LOOP

Route Condition Legend – Pavement Condition Rating (PCR)						
Poor (0 - 60)		Fair (61- 84)		Good (85 - 94)		Excellent (95 - 100)
						Not Rated
Colors on map represent condition scores at 0.10-mile intervals. See Appendix for definitions and formulas.						
<b>Inspection Date:</b>	10/20/2020	<b>Beginning Section MP</b>	0			
<b>Paved Length (Miles):</b>	0.17	<b>Section Length (MI)</b>	0.17			
<b>Surface Type:</b>	ASPHALT	<b>Route Summary</b>				
<b>Roadway Condition Information</b>						
Pavement Condition Rating (PCR)		97	97			
Surface Condition Rating (SCR)		97	97			
Roughness Condition Index (RCI)		N/A	N/A			
<b>Distress Index Values</b>						
Structural Crack Index		97	97			
Alligator Crack Index		100	100			
Longitudinal Crack Index		97	97			
Transverse Cracking Index		97	97			
Patching Index		100	100			
Rutting Index		98	98			
International Roughness Index (IRI)		N/A	N/A			
<b>Lane &amp; Width Information</b>

Number of Lanes		2	2			
Paved Width (ft)		17.2	17.2			
Lane Width (ft)		8.6	8.6
