VIIS Cycle 6

Final Report

Road Inventory and Condition Assessment of Paved Routes Virgin Islands National Park

Report Date: February 2023

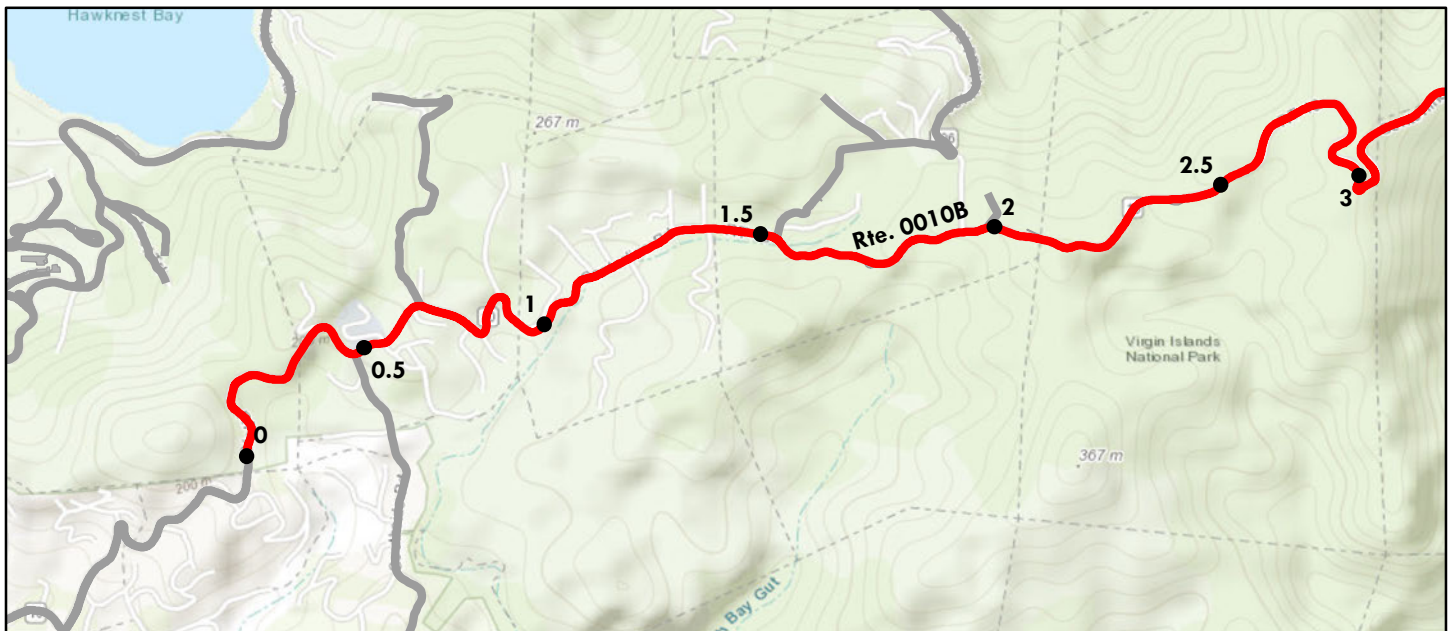
ROUTE 0010B: STATE HIGHWAY 10 (CENTER LINE ROAD)

Route Condition Legend – Pavement Condition Rating (PCR)						
Poor (0 - 60)	Fair (61- 84)	Good (85 - 94)	Excellent (95 - 100)	Not Rated		
See Appendix for definitions and formulas						
Inspection Date: 3/21/2022	Beginning Section MP	0.00	0.50	1.00	1.50	2.00
Paved Length (Miles): 5.93	Section Length (MI)	0.50	0.50	0.50	0.50	0.50
Surface Type: ASPHALT	Route Summary					
Roadway Condition Information						
Pavement Condition Rating (PCR)	49	53	53	53	53	30
Surface Condition Rating (SCR)	49	53	53	53	53	30
Roughness Condition Index (RCI)	N/A	N/A	N/A	N/A	N/A	N/A
Distress Index Values						
Structural Crack Index	N/A	N/A	N/A	N/A	N/A	N/A
Alligator Crack Index	49	53	53	53	53	30
Longitudinal Crack Index	67	73	73	73	73	73
Transverse Cracking Index	85	90	90	90	90	90
Patching Index	63	53	53	73	73	73
Rutting Index	73	73	73	73	73	73
International Roughness Index (IRI)	N/A	N/A	N/A	N/A	N/A	N/A
Lane & Width Information

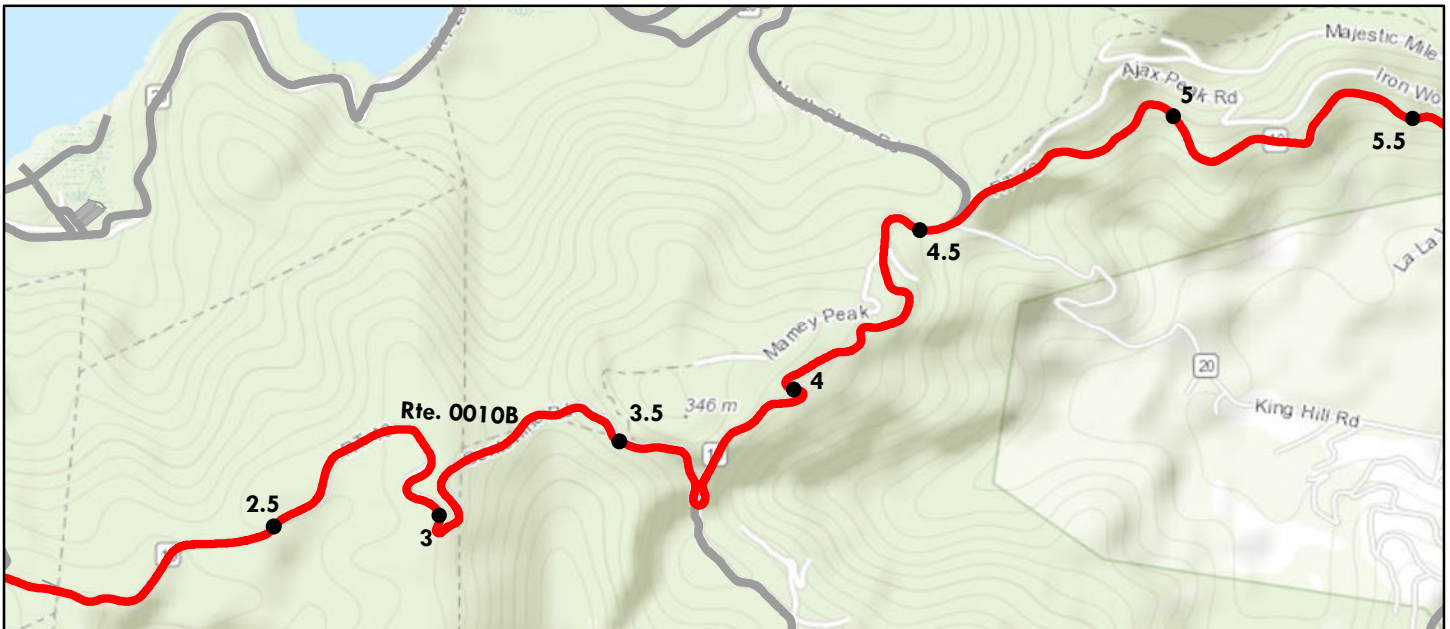
ROUTE 0010B: STATE HIGHWAY 10 (CENTER LINE ROAD)

Route Condition Legend – Pavement Condition Rating (PCR)						
Poor (0 - 60)	Fair (61- 84)	Good (85 - 94)	Excellent (95 - 100)	Not Rated		
See Appendix for definitions and formulas						
Inspection Date: 3/21/2022	Beginning Section MP	2.50	3.00	3.50	4.00	4.50
Paved Length (Miles): 5.93	Section Length (MI)	0.50	0.50	0.50	0.50	0.50
Surface Type: ASPHALT	Route Summary					
Roadway Condition Information						
Pavement Condition Rating (PCR)	49	30	53	53	53	53
Surface Condition Rating (SCR)	49	30	53	53	53	53
Roughness Condition Index (RCI)	N/A	N/A	N/A	N/A	N/A	N/A
Distress Index Values						
Structural Crack Index	N/A	N/A	N/A	N/A	N/A	N/A
Alligator Crack Index	49	30	53	53	53	53
Longitudinal Crack Index	67	73	73	73	53	53
Transverse Cracking Index	85	90	90	90	73	73
Patching Index	63	73	53	53	53	53
Rutting Index	73	73	73	73	73	73
International Roughness Index (IRI)	N/A	N/A	N/A	N/A	N/A	N/A
Lane & Width Information

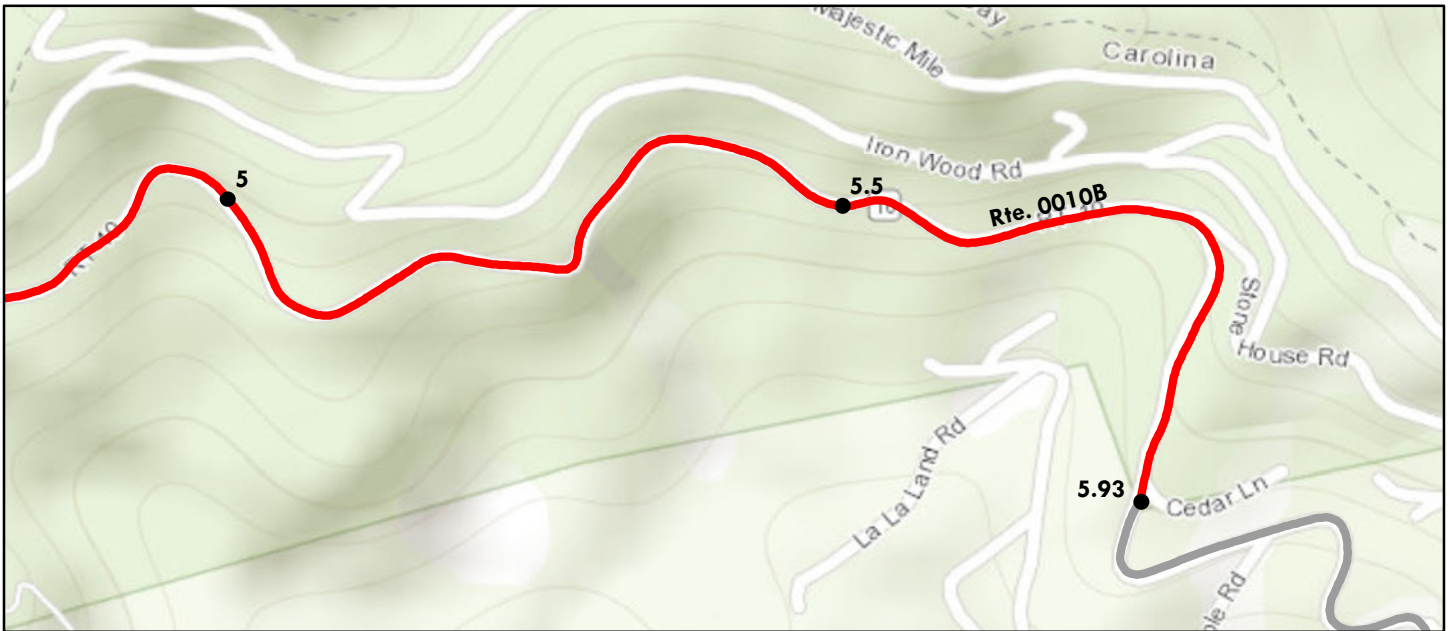
ROUTE 0010B: STATE HIGHWAY 10 (CENTER LINE ROAD)

Route Condition Legend – Pavement Condition Rating (PCR)						
Poor (0 - 60)	Fair (61- 84)	Good (85 - 94)	Excellent (95 - 100)	Not Rated		
See Appendix for definitions and formulas						
Inspection Date: 3/21/2022	Beginning Section MP	5.00	5.50			
Paved Length (Miles): 5.93	Section Length (MI)	0.50	0.43			
Surface Type: ASPHALT	Route Summary					
Roadway Condition Information						
Pavement Condition Rating (PCR)	49	53	53			
Surface Condition Rating (SCR)	49	53	53			
Roughness Condition Index (RCI)	N/A	N/A	N/A			
Distress Index Values						
Structural Crack Index	N/A	N/A	N/A			
Alligator Crack Index	49	53	53			
Longitudinal Crack Index	67	53	53			
Transverse Cracking Index	85	73	73			
Patching Index	63	73	73			
Rutting Index	73	73	73			
International Roughness Index (IRI)	N/A	N/A	N/A			
Lane & Width Information						
Number of Lanes	2	2	2			
Paved Width (ft)	21.5	21.1	21.1			
Lane Width (ft)	8.8	8.7	8.7

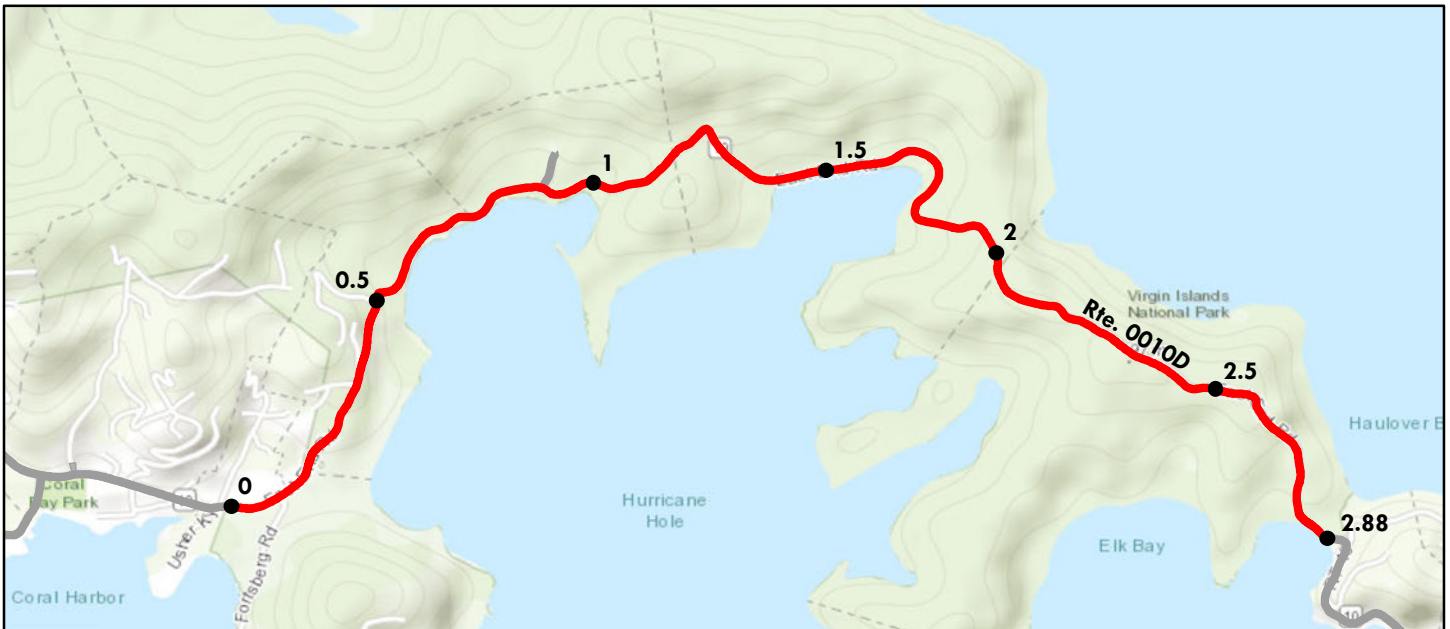
ROUTE 0010D: STATE HIGHWAY 10 (EAST END ROAD)

Route Condition Legend – Pavement Condition Rating (PCR)						
Poor (0 - 60)	Fair (61- 84)	Good (85 - 94)	Excellent (95 - 100)	Not Rated		
See Appendix for definitions and formulas						
Inspection Date: 3/22/2022	Beginning Section MP	0.00	0.50	1.00	1.50	2.00
Paved Length (Miles): 2.88	Section Length (MI)	0.50	0.50	0.50	0.50	0.50
Surface Type: ASPHALT	Route Summary					
Roadway Condition Information						
Pavement Condition Rating (PCR)	53	53	53	53	53	30
Surface Condition Rating (SCR)	53	53	53	53	53	30
Roughness Condition Index (RCI)	N/A	N/A	N/A	N/A	N/A	N/A
Distress Index Values						
Structural Crack Index	N/A	N/A	N/A	N/A	N/A	N/A
Alligator Crack Index	53	73	73	53	53	30
Longitudinal Crack Index	53	53	53	53	53	53
Transverse Cracking Index	79	73	73	90	90	73
Patching Index	60	73	73	53	53	53
Rutting Index	73	73	73	73	73	73
International Roughness Index (IRI)	N/A	N/A	N/A	N/A	N/A	N/A
Lane & Width Information

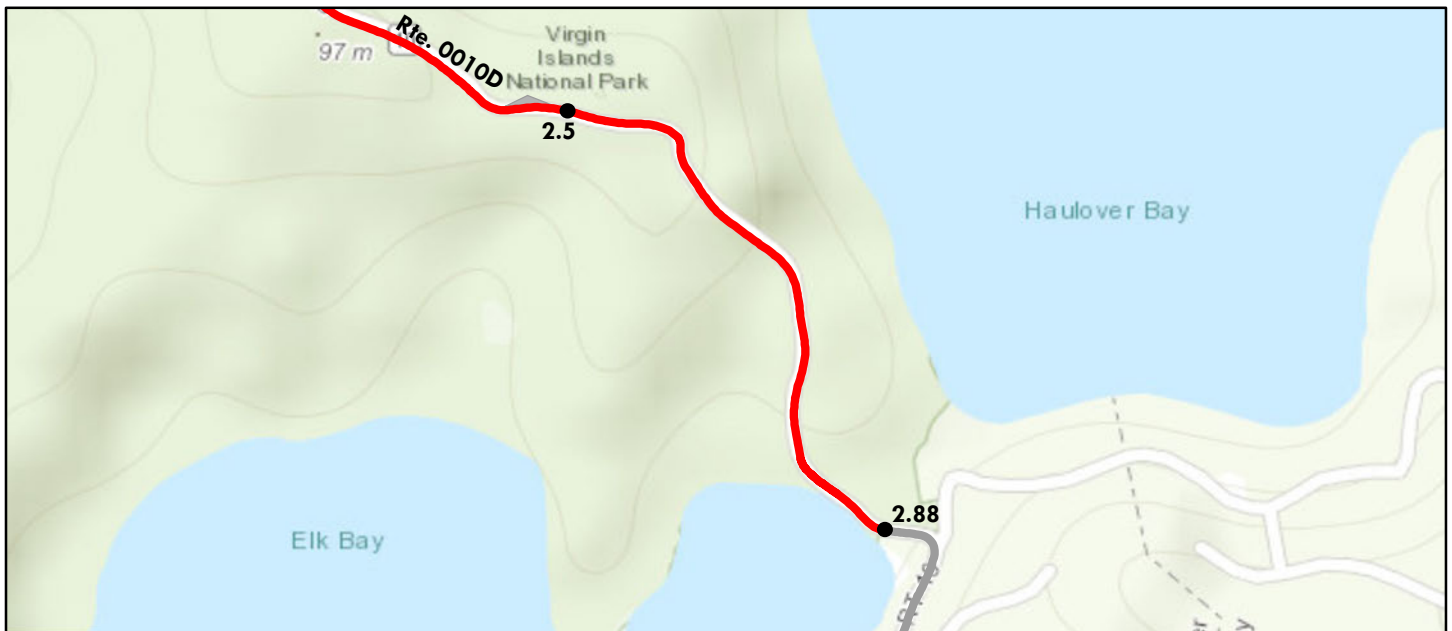
ROUTE 0010D: STATE HIGHWAY 10 (EAST END ROAD)

Route Condition Legend – Pavement Condition Rating (PCR)						
Poor (0 - 60)	Fair (61- 84)	Good (85 - 94)	Excellent (95 - 100)	Not Rated		
See Appendix for definitions and formulas						
Inspection Date:	3/22/2022	Beginning Section MP	2.50			
Paved Length (Miles):	2.88	Section Length (MI)	0.38			
Surface Type:	ASPHALT	Route Summary				
Roadway Condition Information						
Pavement Condition Rating (PCR)	53	30				
Surface Condition Rating (SCR)	53	30				
Roughness Condition Index (RCI)	N/A	N/A				
Distress Index Values						
Structural Crack Index	N/A	N/A				
Alligator Crack Index	53	30				
Longitudinal Crack Index	53	53				
Transverse Cracking Index	79	73				
Patching Index	60	53				
Rutting Index	73	73				
International Roughness Index (IRI)	N/A	N/A				
Lane & Width Information						
Number of Lanes	2	2				
Paved Width (ft)	21.3	20.9				
Lane Width (ft)	9.9	10.2

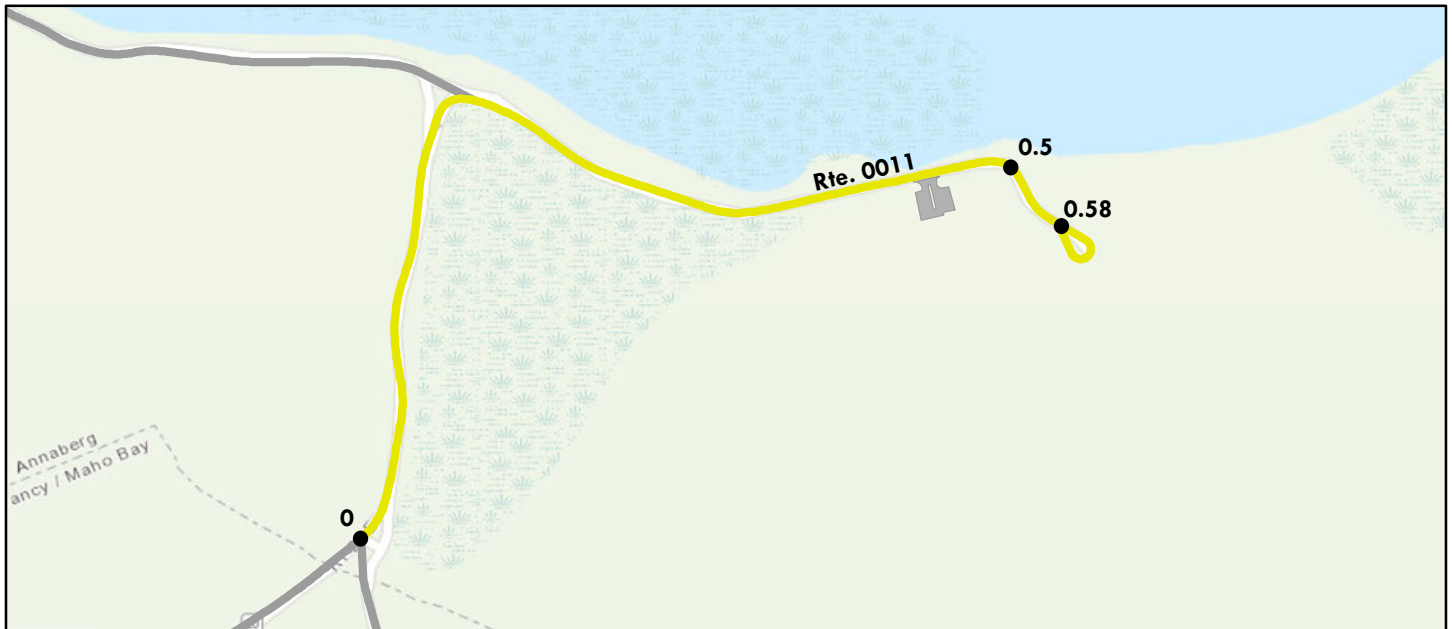
ROUTE 0011: ANNABERG ROAD

Route Condition Legend – Pavement Condition Rating (PCR)						
Poor (0 - 60)	Fair (61- 84)	Good (85 - 94)	Excellent (95 - 100)	Not Rated		
See Appendix for definitions and formulas						
Inspection Date: 3/23/2022	Beginning Section MP	0.00	0.50			
Paved Length (Miles): 0.58	Section Length (MI)	0.50	0.08			
Surface Type: ASPHALT	Route Summary					
Roadway Condition Information						
Pavement Condition Rating (PCR)	73	73	73			
Surface Condition Rating (SCR)	73	73	73			
Roughness Condition Index (RCI)	N/A	N/A	N/A			
Distress Index Values						
Structural Crack Index	N/A	N/A	N/A			
Alligator Crack Index	73	73	73			
Longitudinal Crack Index	90	90	90			
Transverse Cracking Index	90	90	90			
Patching Index	90	90	90			
Rutting Index	90	90	90			
International Roughness Index (IRI)	N/A	N/A	N/A			
Lane & Width Information						
Number of Lanes	2	2	2			
Paved Width (ft)	20.3	20.3	20.3			
Lane Width (ft)	8.9	8.9	8.9

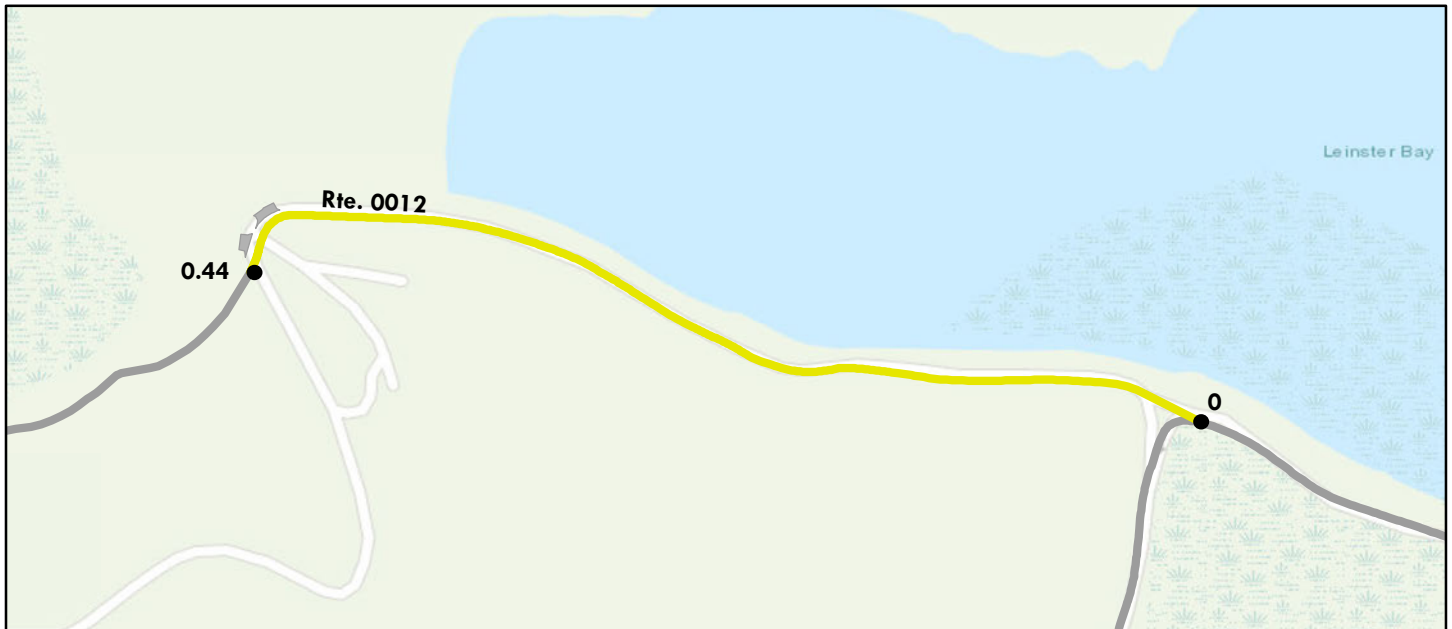
ROUTE 0012: MARY CREEK ROAD

Inspection Date:	3/23/2022	Beginning Section MP	0.00				
Paved Length (Miles):	0.44	Section Length (MI)	0.44				
Surface Type:	ASPHALT	Route Summary					
Roadway Condition Information							
Pavement Condition Rating (PCR)	73	73					
Surface Condition Rating (SCR)	73	73					
Roughness Condition Index (RCI)	N/A	N/A					
Distress Index Values							
Structural Crack Index	N/A	N/A					
Alligator Crack Index	73	73					
Longitudinal Crack Index	73	73					
Transverse Cracking Index	90	90					
Patching Index	90	90					
Rutting Index	90	90					
International Roughness Index (IRI)	N/A	N/A					
Lane & Width Information							
Number of Lanes	2	2					
Paved Width (ft)	19	19					
Lane Width (ft)	7.8	7.8

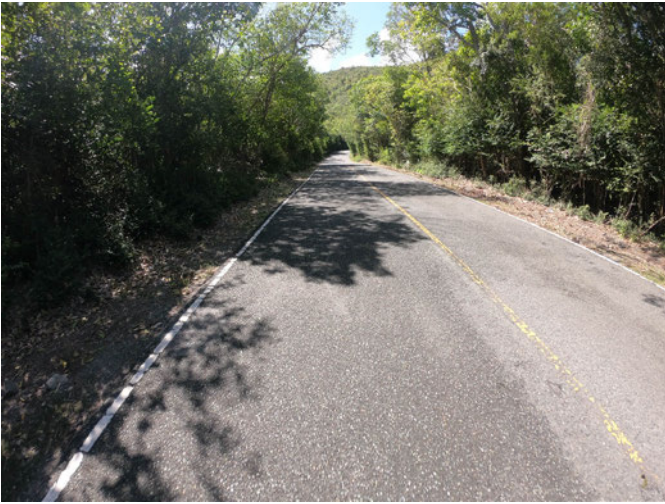
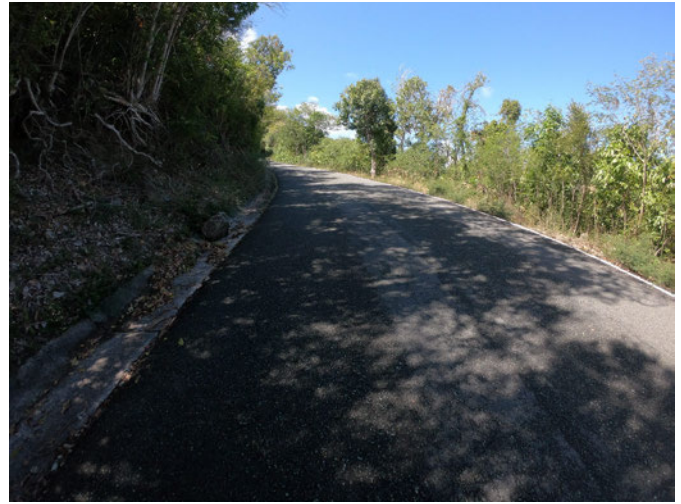
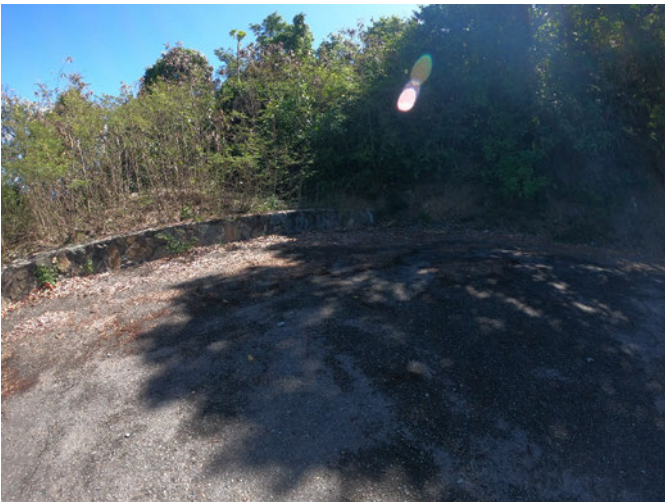
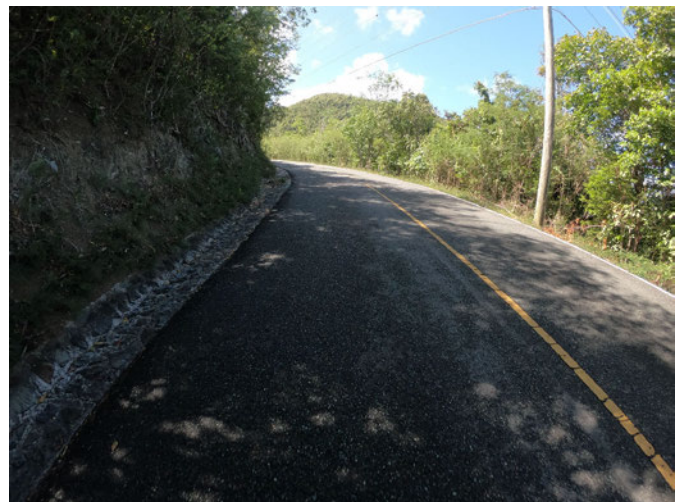
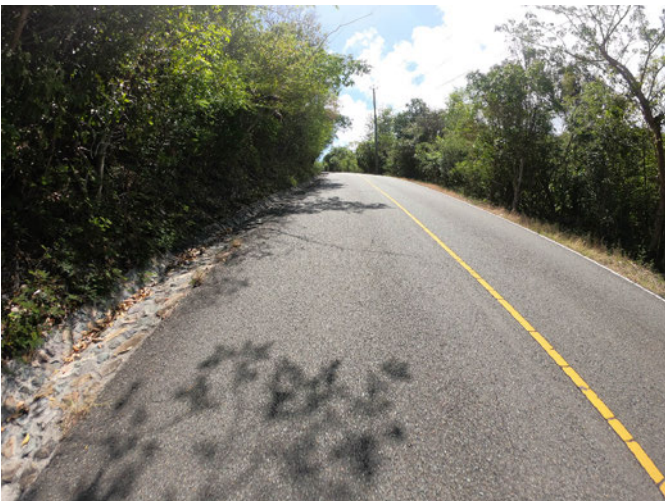
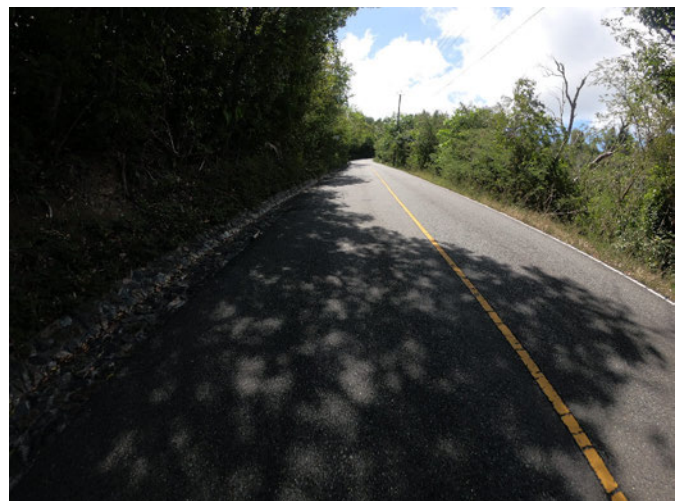
ROUTE 0020CZ: STATE HIGHWAY 20 / NORTH SHORE ROAD/ SECTION C

Inspection Date: 3/23/2022	Beginning Section MP	0.00	0.50			
Paved Length (Miles): 0.99	Section Length (MI)	0.50	0.49			
Surface Type: ASPHALT	Route Summary					
Roadway Condition Information						
Pavement Condition Rating (PCR)	73	73	73			
Surface Condition Rating (SCR)	73	73	73			
Roughness Condition Index (RCI)	N/A	N/A	N/A			
Distress Index Values						
Structural Crack Index	N/A	N/A	N/A			
Alligator Crack Index	73	73	73			
Longitudinal Crack Index	81	73	90			
Transverse Cracking Index	90	90	90			
Patching Index	90	90	90			
Rutting Index	90	90	90			
International Roughness Index (IRI)	N/A	N/A	N/A			
Lane & Width Information						
Number of Lanes	2	2	2			
Paved Width (ft)	19.9	19.9	19.9			
Lane Width (ft)	9.5	9.5	9.5

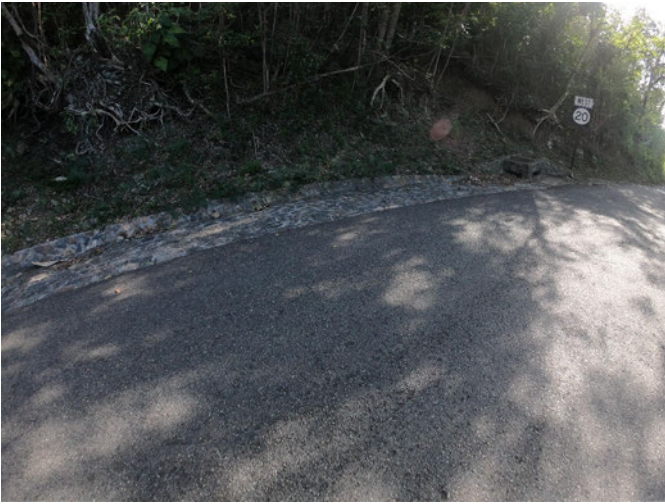
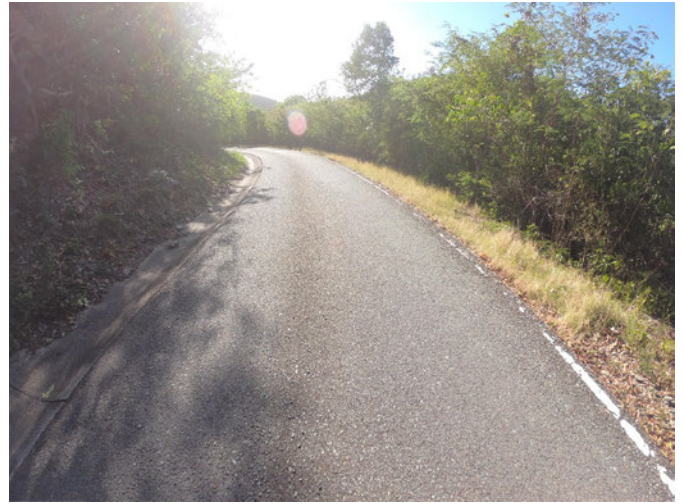
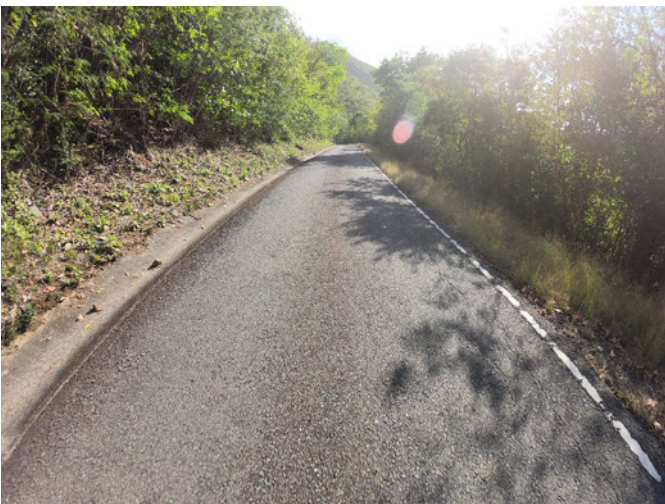
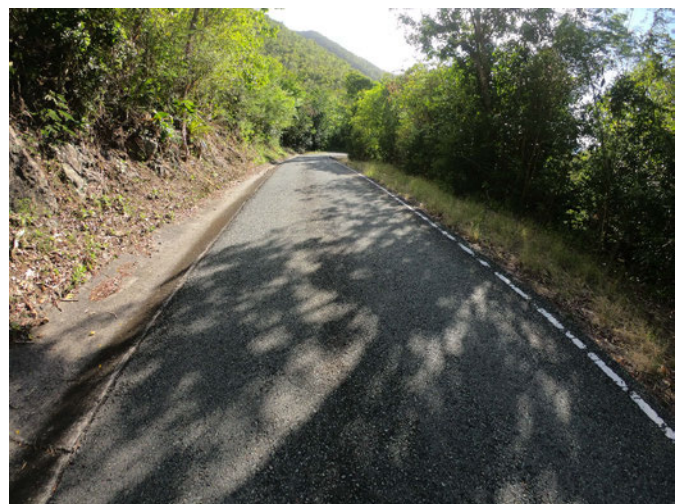
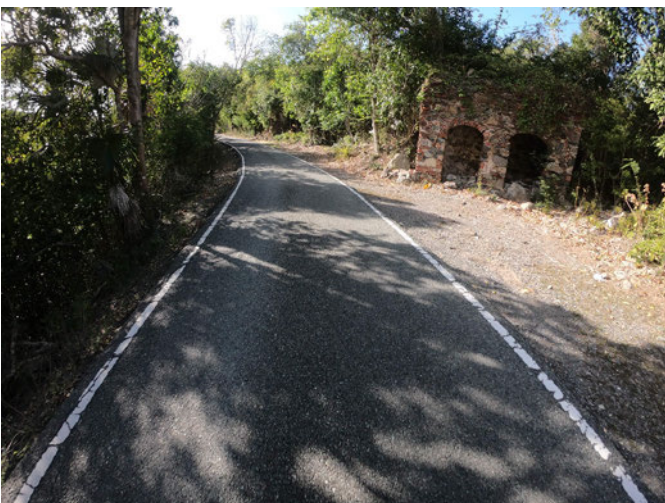
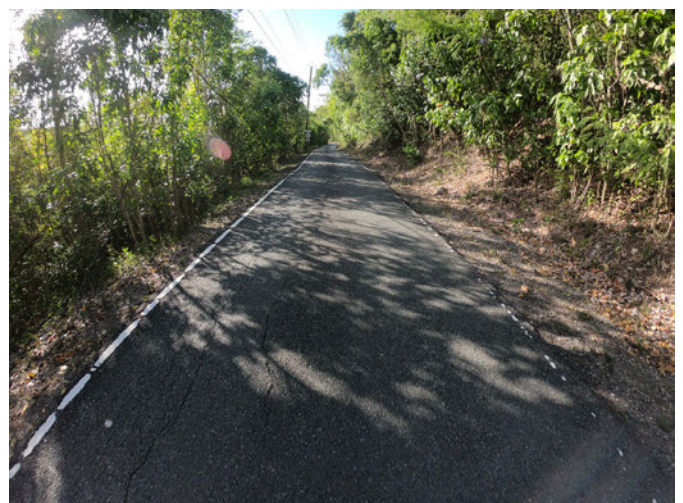
ROUTE 0020DZ: STATE HIGHWAY 20 / NORTH SHORE ONE-WAY ROAD WESTBOUND

Route Condition Legend – Pavement Condition Rating (PCR)						
Poor (0 - 60)	Fair (61- 84)	Good (85 - 94)	Excellent (95 - 100)	Not Rated		
See Appendix for definitions and formulas						
Inspection Date: 3/22/2022	Beginning Section MP	0.00				
Paved Length (Miles): 0.33	Section Length (MI)	0.33				
Surface Type: ASPHALT	Route Summary					
Roadway Condition Information						
Pavement Condition Rating (PCR)	73	73				
Surface Condition Rating (SCR)	73	73				
Roughness Condition Index (RCI)	N/A	N/A				
Distress Index Values						
Structural Crack Index	N/A	N/A				
Alligator Crack Index	73	73				
Longitudinal Crack Index	73	73				
Transverse Cracking Index	90	90				
Patching Index	97	97				
Rutting Index	73	73				
International Roughness Index (IRI)	N/A	N/A				
Lane & Width Information						
Number of Lanes	1	1				
Paved Width (ft)	10.3	10.3				
Lane Width (ft)	9.8	9.8

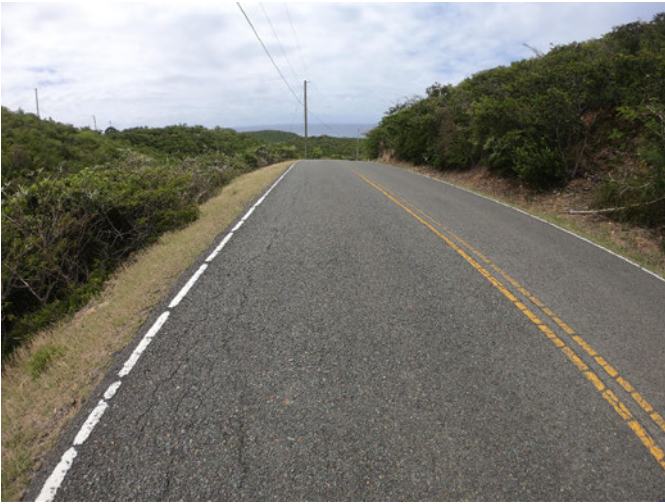
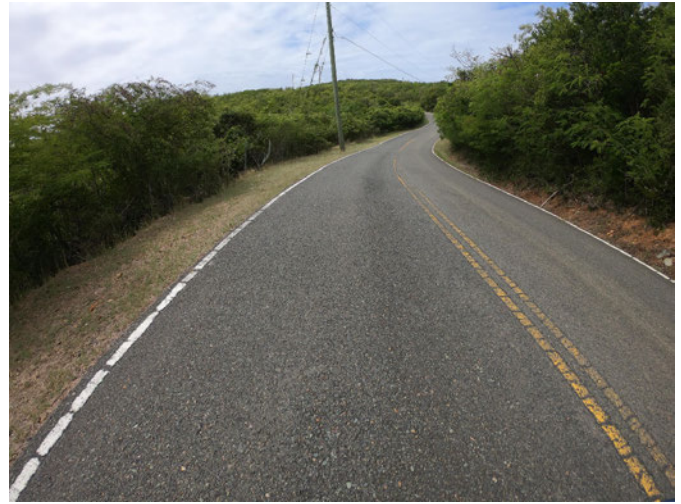
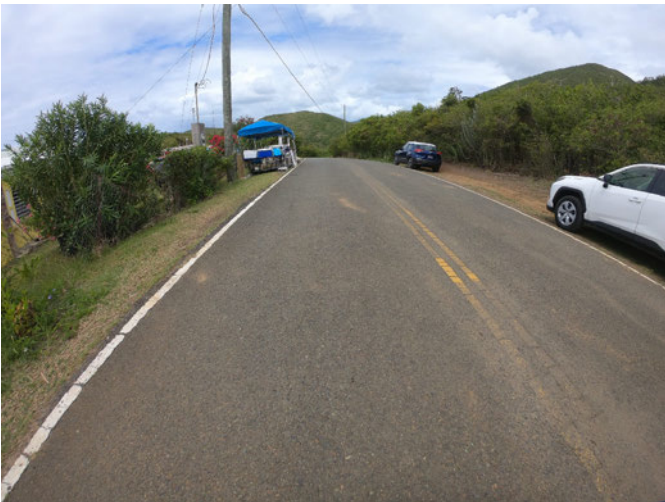
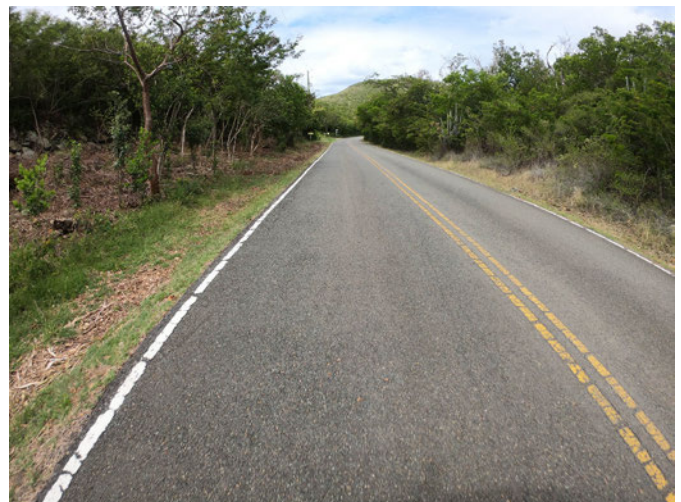
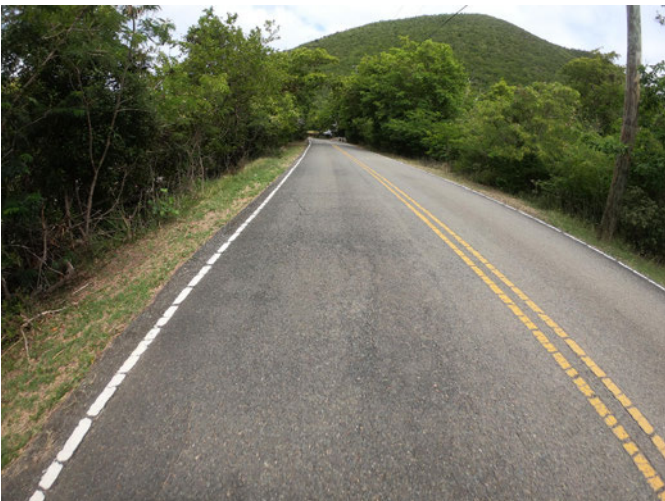
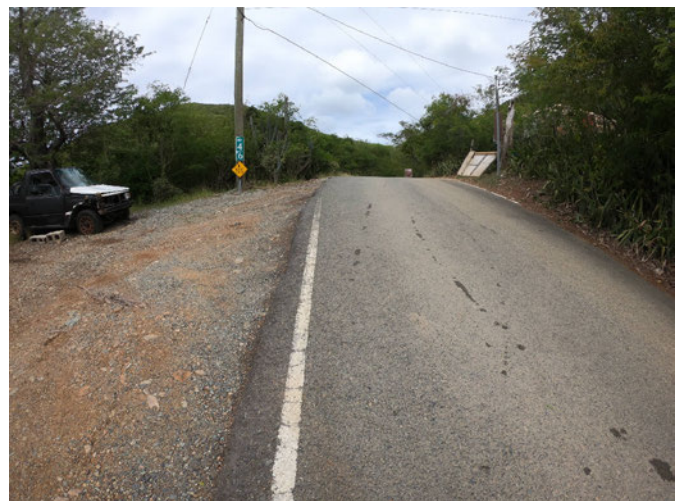
ROUTE 0100AZ: LAMESHUR ROAD A

Inspection Date:	3/22/2022	Beginning Section MP	0.00	0.50			
Paved Length (Miles):	0.75	Section Length (MI)	0.50	0.25			
Surface Type:	ASPHALT	Route Summary					
Roadway Condition Information							
Pavement Condition Rating (PCR)	73	73	73				
Surface Condition Rating (SCR)	73	73	73				
Roughness Condition Index (RCI)	N/A	N/A	N/A				
Distress Index Values							
Structural Crack Index	N/A	N/A	N/A				
Alligator Crack Index	79	73	90				
Longitudinal Crack Index	73	73	73				
Transverse Cracking Index	90	90	90				
Patching Index	81	73	97				
Rutting Index	90	90	90				
International Roughness Index (IRI)	N/A	N/A	N/A				
Lane & Width Information							
Number of Lanes	2	2	2				
Paved Width (ft)	21.5	21.5	21.5				
Lane Width (ft)	9	9	9

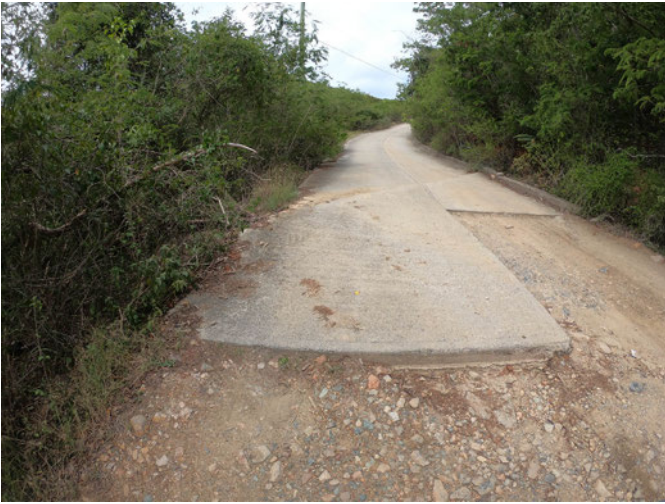
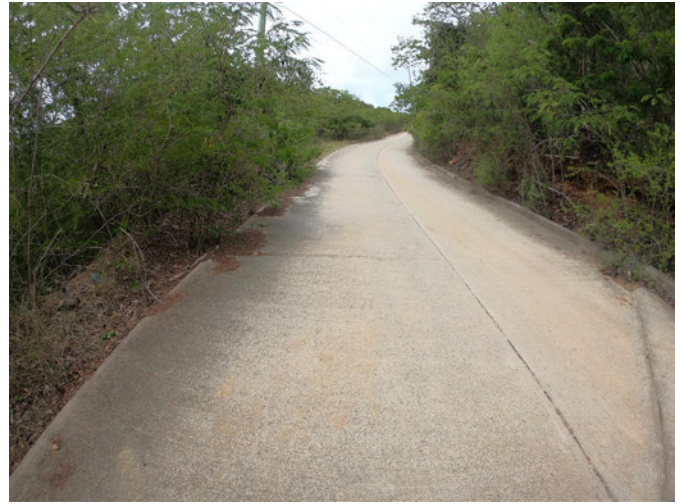
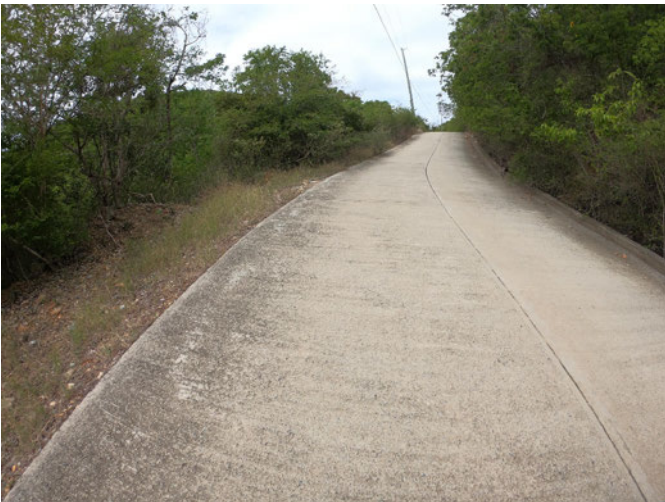
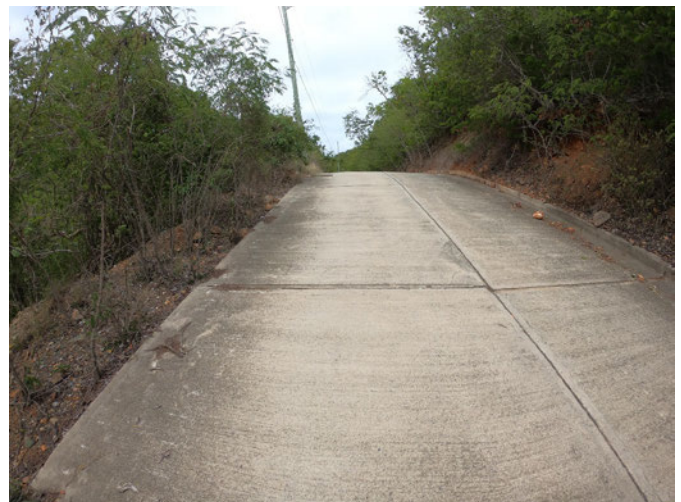
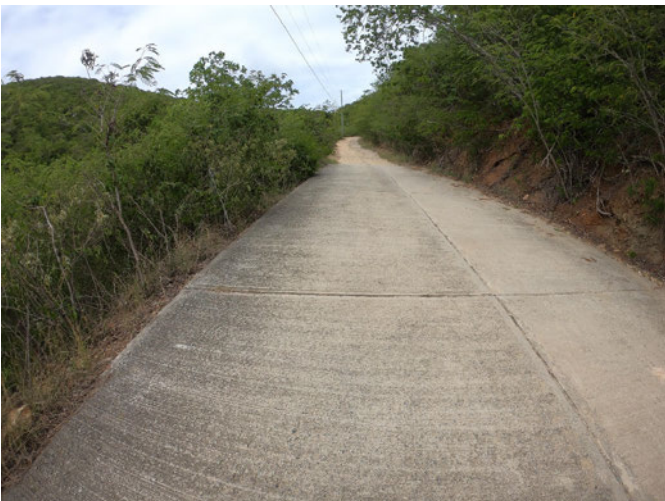
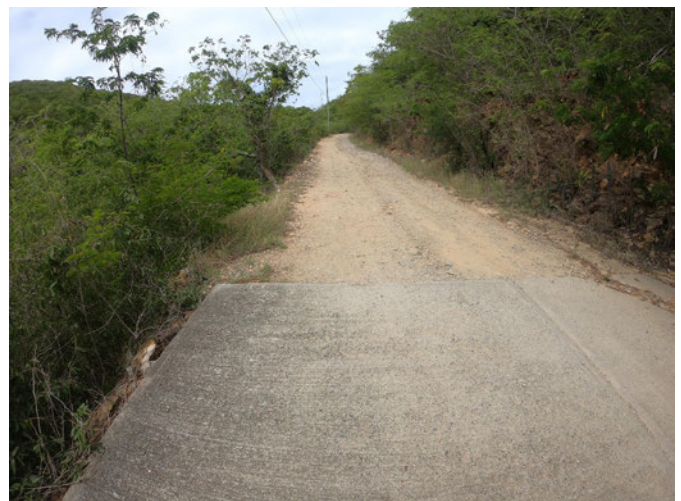
ROUTE 0100CZ: LAMESHUR ROAD C

Route Condition Legend – Pavement Condition Rating (PCR)						
Poor (0 - 60)	Fair (61- 84)	Good (85 - 94)	Excellent (95 - 100)	Not Rated		
See Appendix for definitions and formulas						
Inspection Date: 3/22/2022	Beginning Section MP	0.00				
Paved Length (Miles): 0.05	Section Length (MI)	0.05				
Surface Type: CONCRETE	Route Summary					
Roadway Condition Information						
Pavement Condition Rating (PCR)	53	53				
Surface Condition Rating (SCR)	53	53				
Roughness Condition Index (RCI)	N/A	N/A				
Distress Index Values						
Structural Crack Index	N/A	N/A				
Alligator Crack Index	N/A	N/A				
Longitudinal Crack Index	N/A	N/A				
Transverse Cracking Index	N/A	N/A				
Patching Index	N/A	N/A				
Rutting Index	N/A	N/A				
International Roughness Index (IRI)	N/A	N/A				
Lane & Width Information						
Number of Lanes	2	2				
Paved Width (ft)	17	17				
Lane Width (ft)	8.5	8.5

Concrete Distress Indices: Slab Cracking (90), Surface Delamination and Popouts (73), Joint Distress (53), Joint Faulting (73), Patches (90).

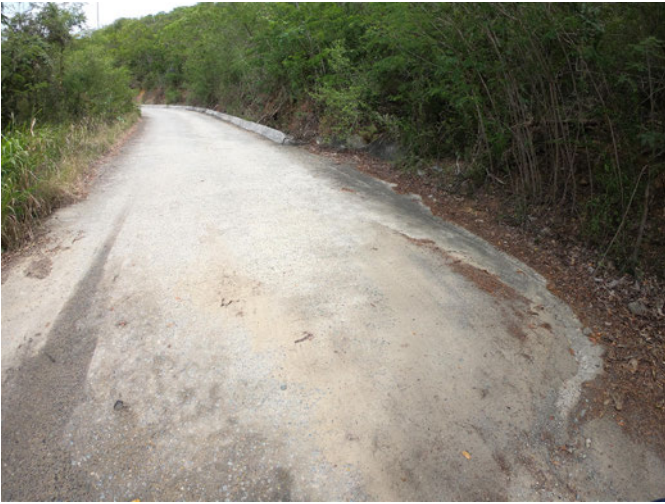
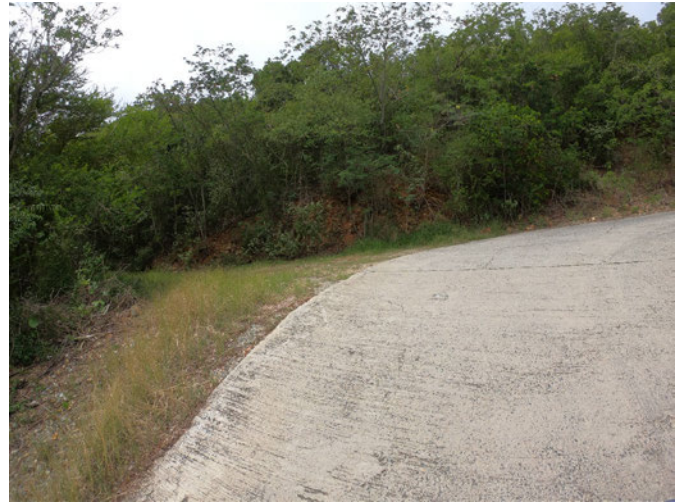
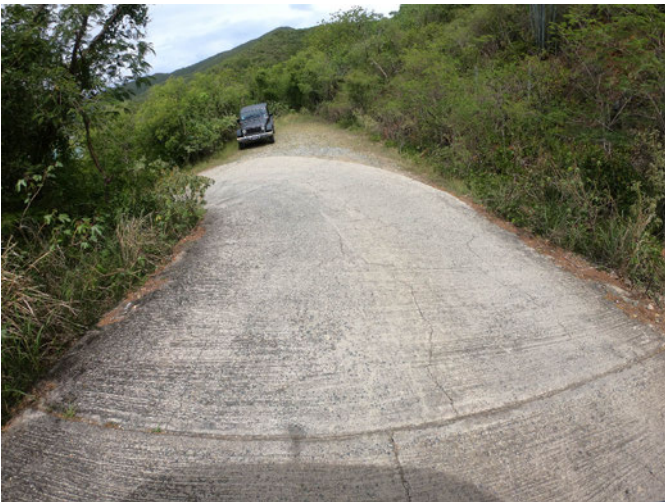
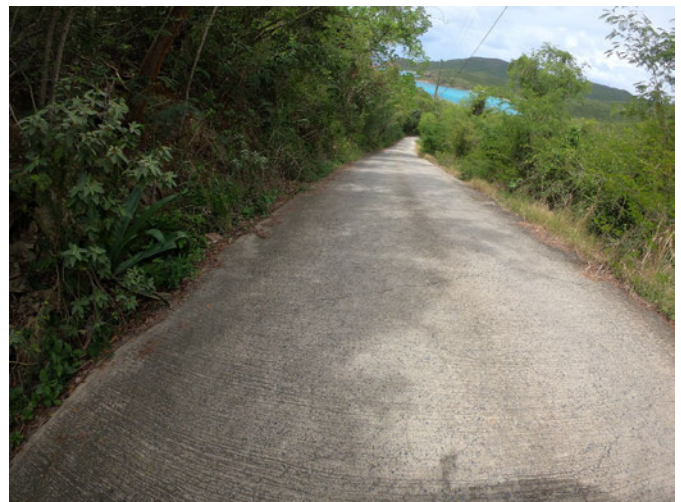
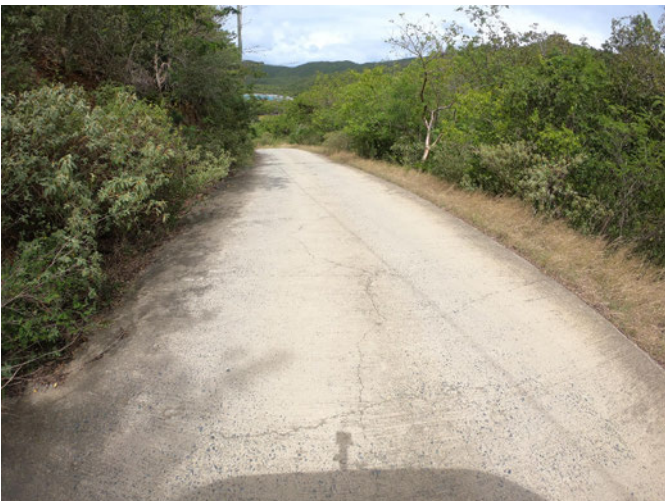
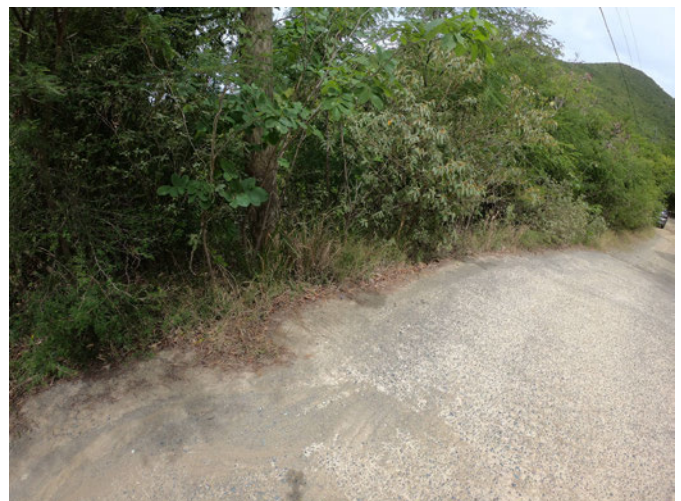
ROUTE 0100EZ: LAMESHUR ROAD E

Route Condition Legend – Pavement Condition Rating (PCR)						
Poor (0 - 60)	Fair (61- 84)	Good (85 - 94)	Excellent (95 - 100)	Not Rated		
See Appendix for definitions and formulas						
Inspection Date: 3/22/2022	Beginning Section MP	0.00				
Paved Length (Miles): 0.25	Section Length (MI)	0.25				
Surface Type: CONCRETE	Route Summary					
Roadway Condition Information						
Pavement Condition Rating (PCR)	30	30				
Surface Condition Rating (SCR)	30	30				
Roughness Condition Index (RCI)	N/A	N/A				
Distress Index Values						
Structural Crack Index	N/A	N/A				
Alligator Crack Index	N/A	N/A				
Longitudinal Crack Index	N/A	N/A				
Transverse Cracking Index	N/A	N/A				
Patching Index	N/A	N/A				
Rutting Index	N/A	N/A				
International Roughness Index (IRI)	N/A	N/A				
Lane & Width Information						
Number of Lanes	2	2				
Paved Width (ft)	14	14				
Lane Width (ft)	7	7

Concrete Distress Indices: Slab Cracking (30), Surface Delamination and Popouts (53), Joint Distress (30), Joint Faulting (73), Patches (90).

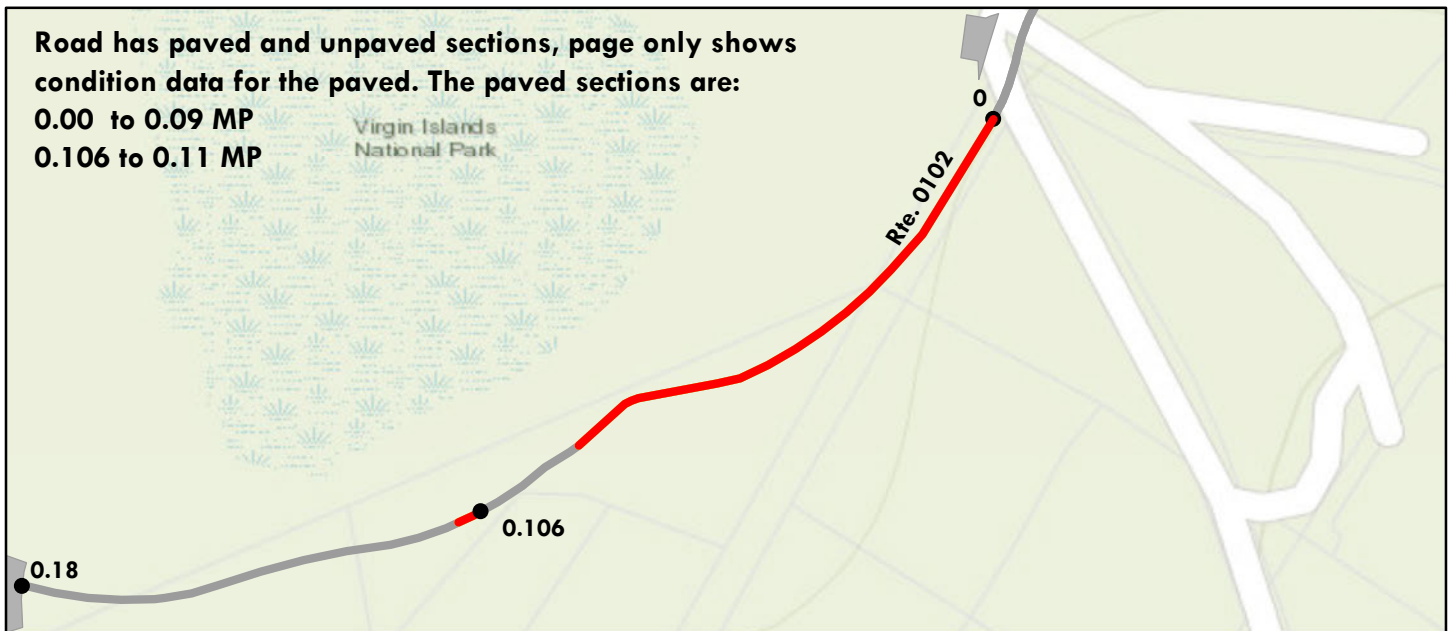
ROUTE 0102: FRANCIS BAY ACCESS

Route Condition Legend – Pavement Condition Rating (PCR)						
Poor (0 - 60)	Fair (61- 84)	Good (85 - 94)	Excellent (95 - 100)	Not Rated		
See Appendix for definitions and formulas						
Inspection Date:	3/23/2022	Beginning Section MP	0.00	0.106		
Paved Length (Miles):	0.09	Section Length (MI)	0.09	0.11		
Surface Type:	CONCRETE	Route Summary				
Roadway Condition Information						
Pavement Condition Rating (PCR)	53	53	53			
Surface Condition Rating (SCR)	53	53	53			
Roughness Condition Index (RCI)	N/A	N/A	N/A			
Distress Index Values						
Structural Crack Index	N/A	N/A	N/A			
Alligator Crack Index	N/A	N/A	N/A			
Longitudinal Crack Index	N/A	N/A	N/A			
Transverse Cracking Index	N/A	N/A	N/A			
Patching Index	N/A	N/A	N/A			
Rutting Index	N/A	N/A	N/A			
International Roughness Index (IRI)	N/A	N/A	N/A			
Lane & Width Information						
Number of Lanes	2	2	2			
Paved Width (ft)	14	14	14			
Lane Width (ft)	7	7	7

Concrete Distress Indices: Slab Cracking (90), Surface Delamination and Popouts (73), Joint Distress (53), Joint Faulting (73), Patches (90).

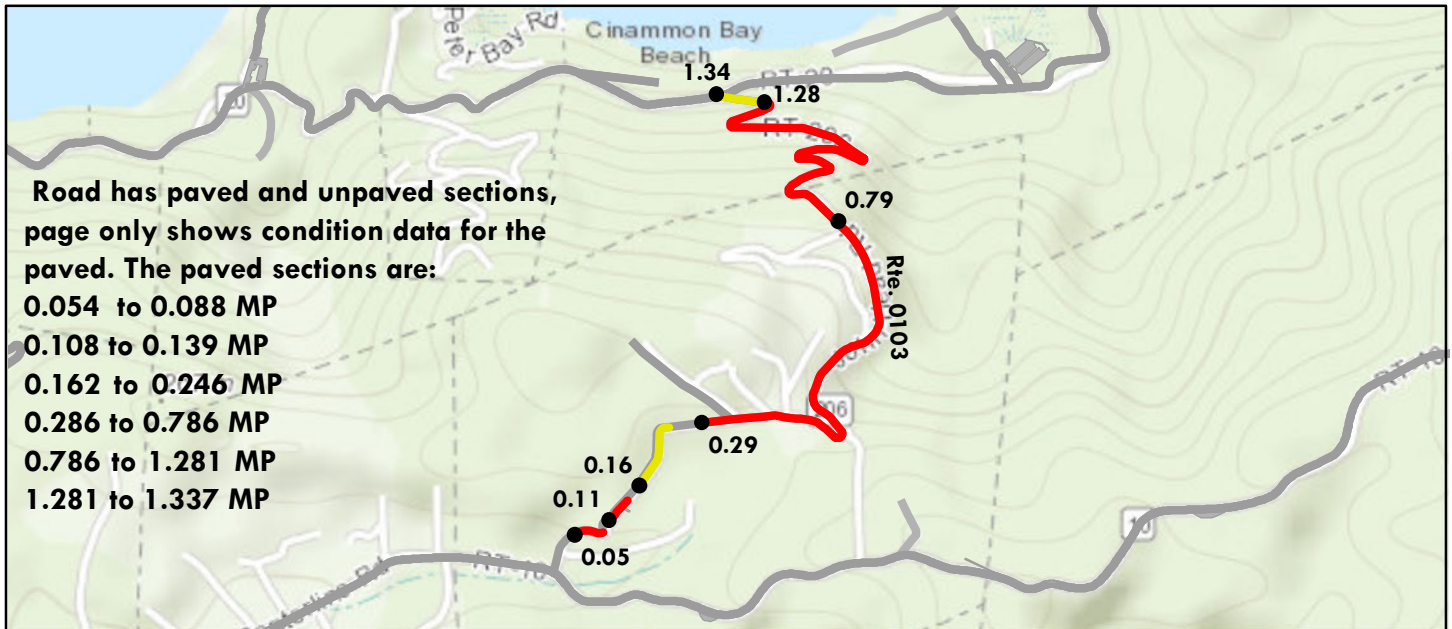
ROUTE 0103: STATE HIGHWAY 206 (JOHN HEAD ROAD) SECTION A

Inspection Date: 3/23/2022	Beginning Section MP	0.05	0.11	0.16	0.29	0.79
Paved Length (Miles): 1.20	Section Length (MI)	0.03	0.03	0.08	0.50	0.50
Surface Type: CONCRETE	Route Summary					
Roadway Condition Information						
Pavement Condition Rating (PCR)	45	30	30	73	53	30
Surface Condition Rating (SCR)	45	30	30	73	53	30
Roughness Condition Index (RCI)	N/A	N/A	N/A	N/A	N/A	N/A
Distress Index Values						
Structural Crack Index	N/A	N/A	N/A	N/A	N/A	N/A
Alligator Crack Index	73	N/A	N/A	N/A	N/A	N/A
Longitudinal Crack Index	90	N/A	N/A	N/A	N/A	N/A
Transverse Cracking Index	90	N/A	N/A	N/A	N/A	N/A
Patching Index	73	N/A	N/A	N/A	N/A	N/A
Rutting Index	97	N/A	N/A	N/A	N/A	N/A
International Roughness Index (IRI)	N/A	N/A	N/A	N/A	N/A	N/A
Lane & Width Information						
Number of Lanes	1	1	1	1	1	1
Paved Width (ft)	12	12	12	12	12.5	11.5
Lane Width (ft)	12	12	12	12	12.5	11.5
