VIIS Cycle 6

Final Report

Road Inventory and Condition Assessment of Paved Routes Virgin Islands National Park

Report Date: February 2023

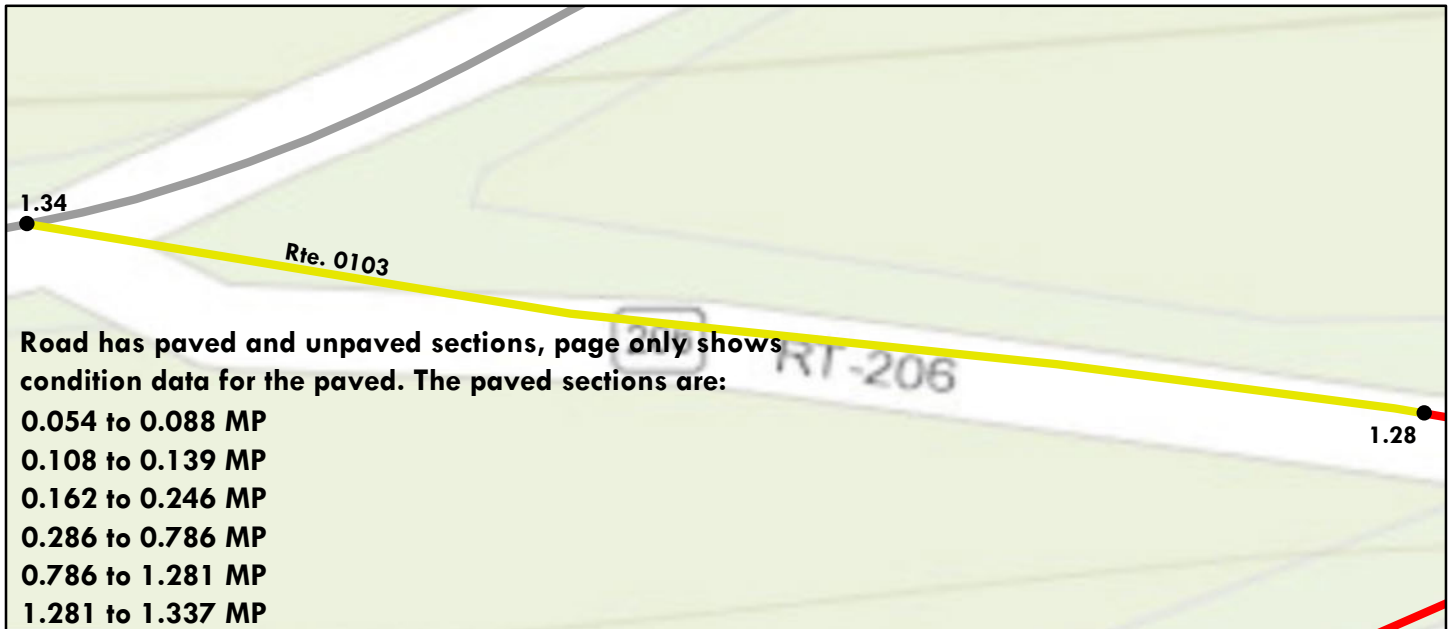
ROUTE 0103: STATE HIGHWAY 206 (JOHN HEAD ROAD) SECTION A

Route Condition Legend – Pavement Condition Rating (PCR)						
Poor (0 - 60)	Fair (61- 84)	Good (85 - 94)	Excellent (95 - 100)	Not Rated		
See Appendix for definitions and formulas						
Inspection Date: 3/23/2022	Beginning Section MP	1.28				
Paved Length (Miles): 1.20	Section Length (MI)	0.06				
Surface Type: CONCRETE	Route Summary					
Roadway Condition Information						
Pavement Condition Rating (PCR)	45	73				
Surface Condition Rating (SCR)	45	73				
Roughness Condition Index (RCI)	N/A	N/A				
Distress Index Values						
Structural Crack Index	N/A	N/A				
Alligator Crack Index	73	73				
Longitudinal Crack Index	90	90				
Transverse Cracking Index	90	90				
Patching Index	73	73				
Rutting Index	97	97				
International Roughness Index (IRI)	N/A	N/A				
Lane & Width Information						
Number of Lanes	1	1				
Paved Width (ft)	12	11				
Lane Width (ft)	12	11

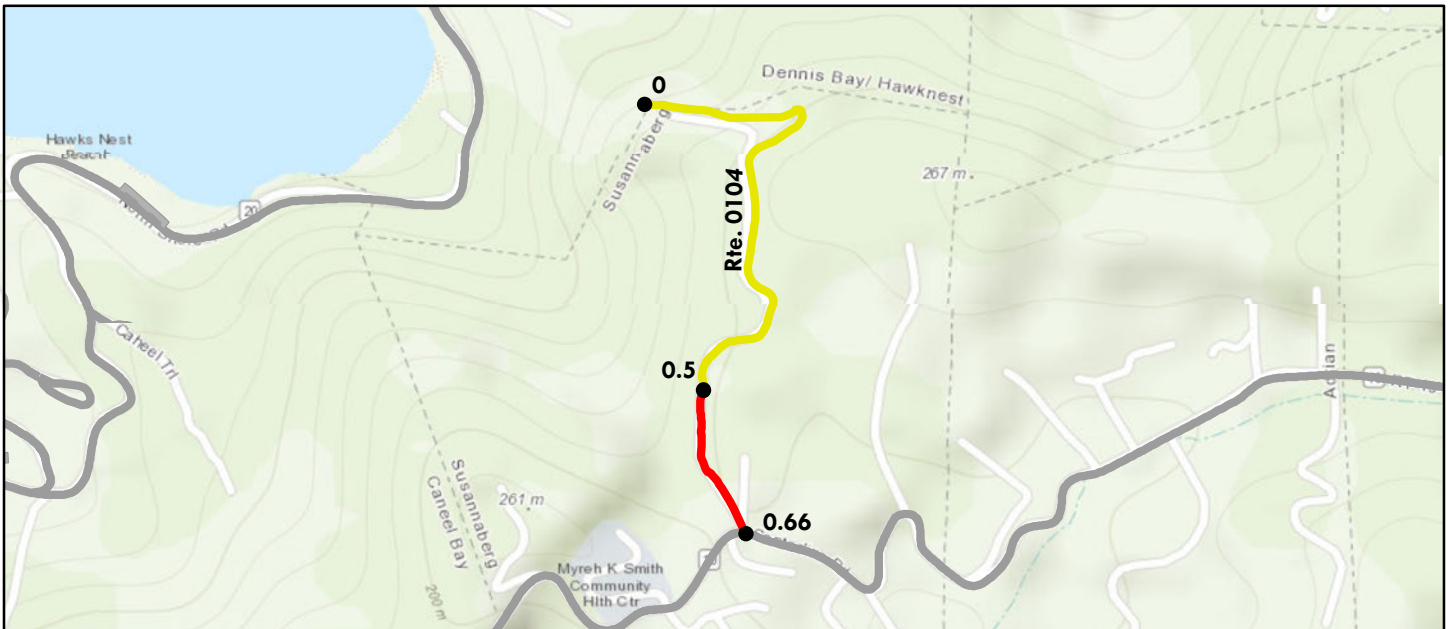
ROUTE 0104: STATE HIGHWAY 204 (SUSANNABERG ROAD)

Route Condition Legend – Pavement Condition Rating (PCR)						
Poor (0 - 60)	Fair (61- 84)	Good (85 - 94)	Excellent (95 - 100)	Not Rated		
See Appendix for definitions and formulas						
Inspection Date: 3/23/2022	Beginning Section MP	0.00	0.50			
Paved Length (Miles): 0.66	Section Length (MI)	0.50	0.16			
Surface Type: CONCRETE	Route Summary					
Roadway Condition Information						
Pavement Condition Rating (PCR)	63	73	30			
Surface Condition Rating (SCR)	63	73	30			
Roughness Condition Index (RCI)	N/A	N/A	N/A			
Distress Index Values						
Structural Crack Index	N/A	N/A	N/A			
Alligator Crack Index	N/A	N/A	N/A			
Longitudinal Crack Index	N/A	N/A	N/A			
Transverse Cracking Index	N/A	N/A	N/A			
Patching Index	N/A	N/A	N/A			
Rutting Index	N/A	N/A	N/A			
International Roughness Index (IRI)	N/A	N/A	N/A			
Lane & Width Information						
Number of Lanes	1	1	1			
Paved Width (ft)	10	10	10			
Lane Width (ft)	10	10	10

Note: Section between 0.130 MP to 0.168 MP (0.038 miles) is in poor condition (0). Section between 0.363 MP to 0.437 MP (0.074 miles) is in poor condition (30). Section between 0.572 MP to 0.623 MP (0.051 miles) is in poor condition; concrete is gone and looks unpaved.

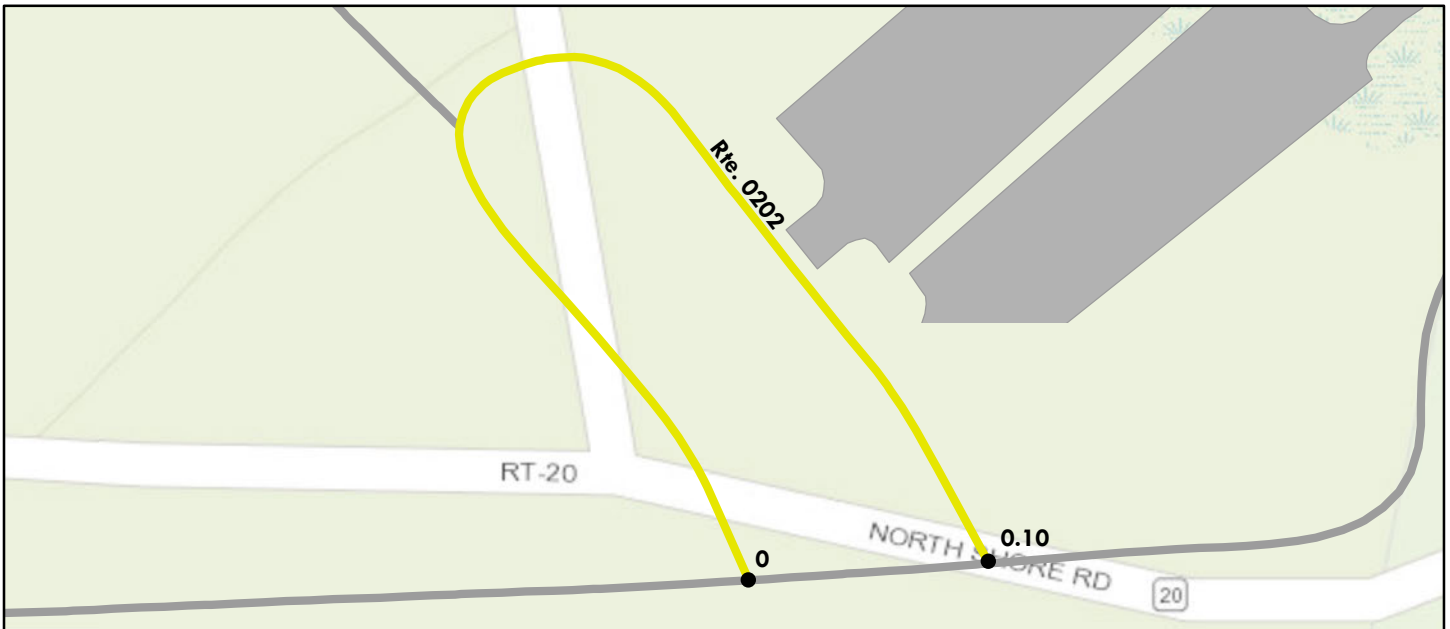
ROUTE 0202: CINNAMON BAY ROAD

Inspection Date: 3/23/2022	Beginning Section MP	0.00				
Paved Length (Miles): 0.10	Section Length (MI)	0.10				
Surface Type: ASPHALT	Route Summary					
Roadway Condition Information						
Pavement Condition Rating (PCR)	73	73				
Surface Condition Rating (SCR)	73	73				
Roughness Condition Index (RCI)	N/A	N/A				
Distress Index Values						
Structural Crack Index	N/A	N/A				
Alligator Crack Index	73	73				
Longitudinal Crack Index	90	90				
Transverse Cracking Index	90	90				
Patching Index	90	90				
Rutting Index	73	73				
International Roughness Index (IRI)	N/A	N/A				
Lane & Width Information						
Number of Lanes	1	1				
Paved Width (ft)	10.8	10.8				
Lane Width (ft)	10.8	10.8

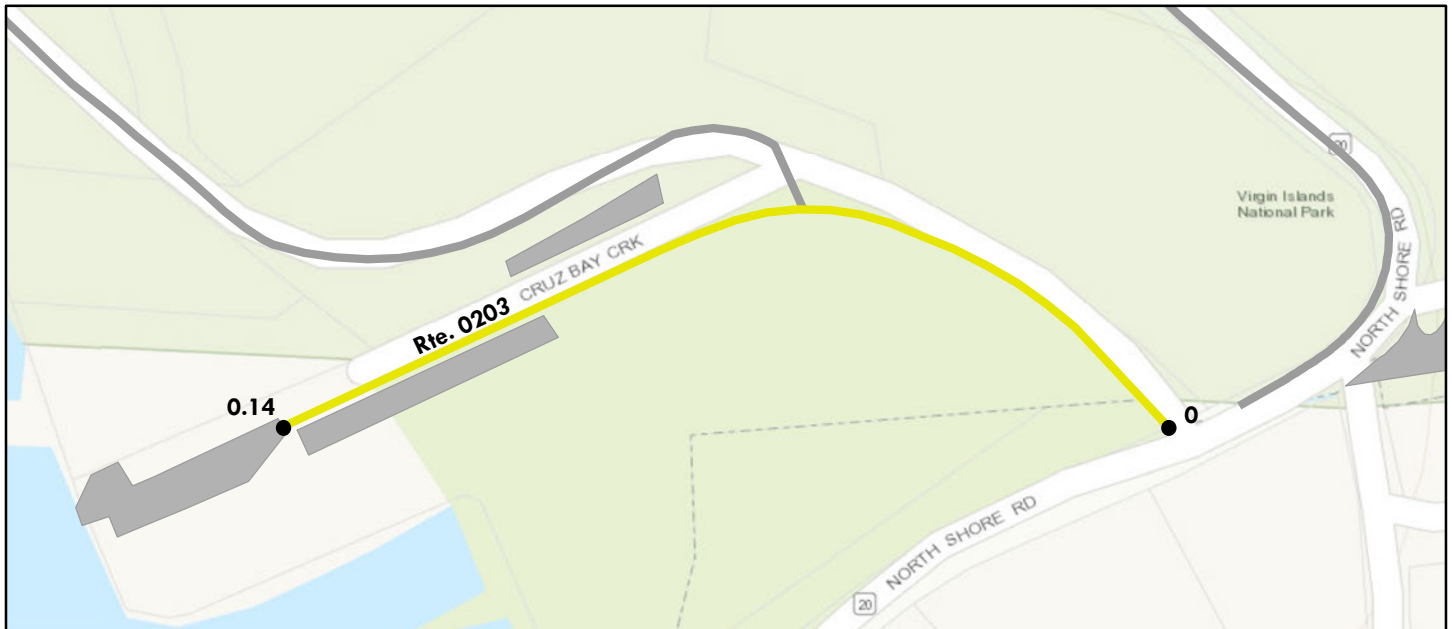
ROUTE 0203: CRUZ BAY VISITOR CENTER ROAD

Route Condition Legend – Pavement Condition Rating (PCR)						
Poor (0 - 60)	Fair (61- 84)	Good (85 - 94)	Excellent (95 - 100)	Not Rated		
See Appendix for definitions and formulas						
Inspection Date:	3/22/2022	Beginning Section MP	0.00			
Paved Length (Miles):	0.14	Section Length (MI)	0.14			
Surface Type:	ASPHALT	Route Summary				
Roadway Condition Information						
Pavement Condition Rating (PCR)	73	73				
Surface Condition Rating (SCR)	73	73				
Roughness Condition Index (RCI)	N/A	N/A				
Distress Index Values						
Structural Crack Index	N/A	N/A				
Alligator Crack Index	73	73				
Longitudinal Crack Index	90	90				
Transverse Cracking Index	90	90				
Patching Index	73	73				
Rutting Index	90	90				
International Roughness Index (IRI)	N/A	N/A				
Lane & Width Information						
Number of Lanes	2	2				
Paved Width (ft)	21.2	21.2				
Lane Width (ft)	10.6	10.6

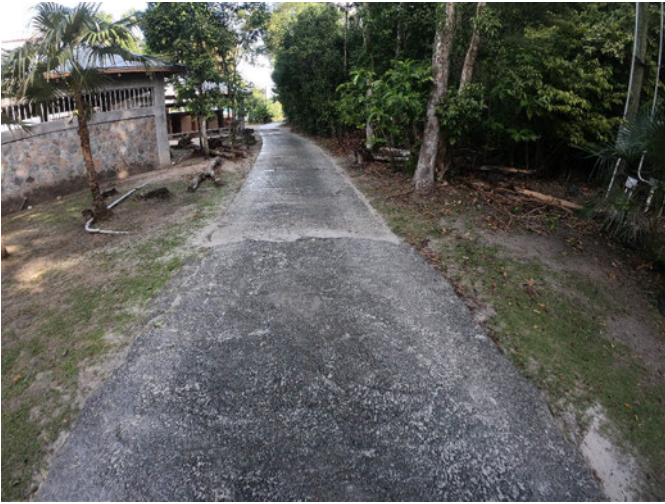
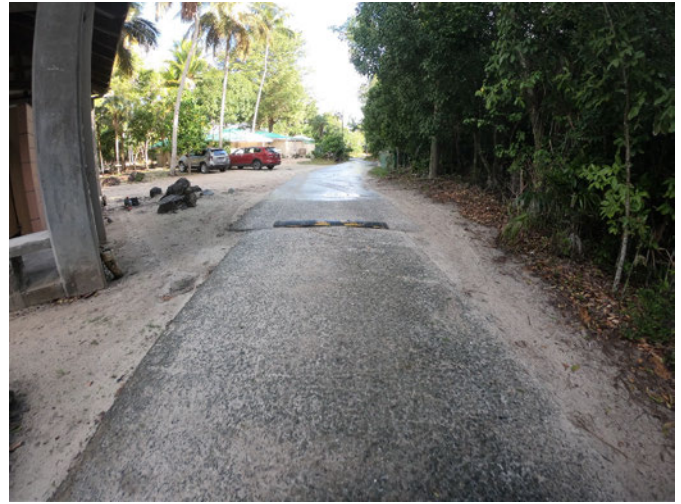
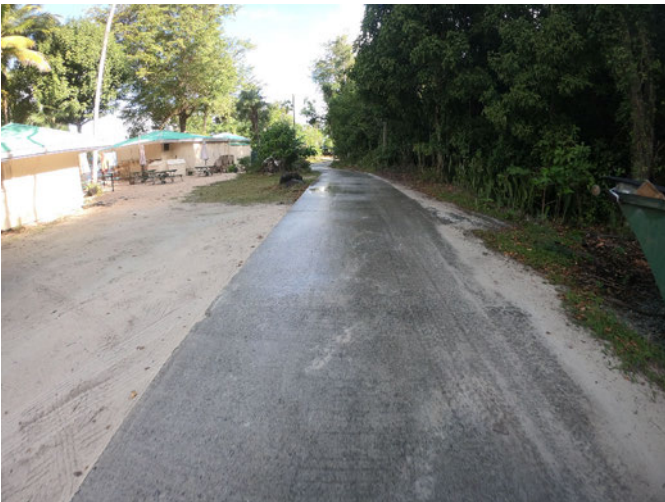
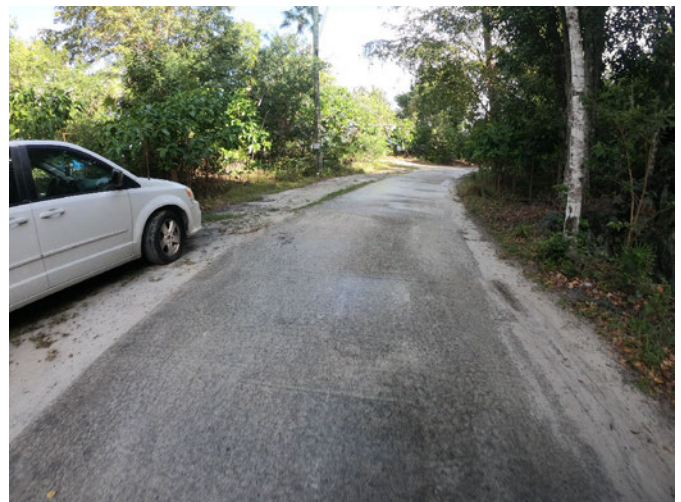
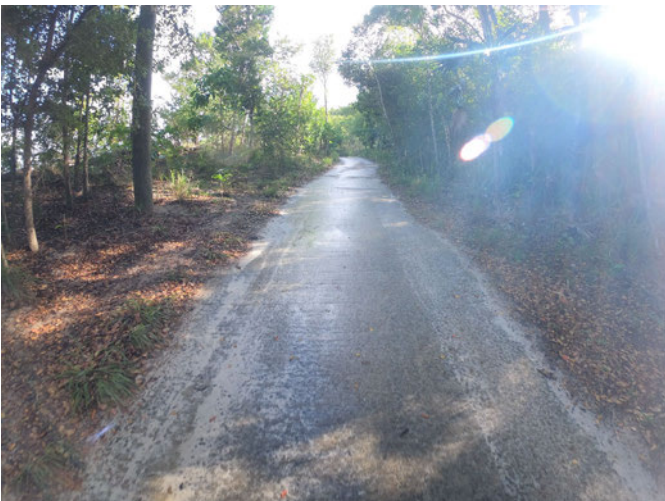
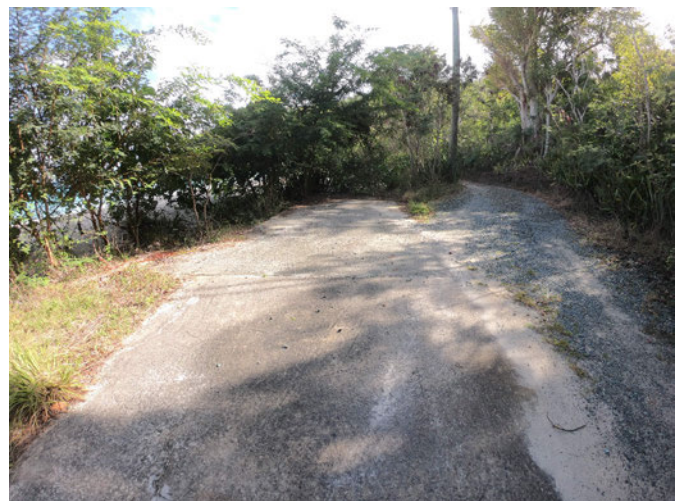
Concrete Distress Indices: Slab Cracking (97), Surface Delamination and Popouts (90), Joint Distress (97), Joint Faulting (90), Patches (97).

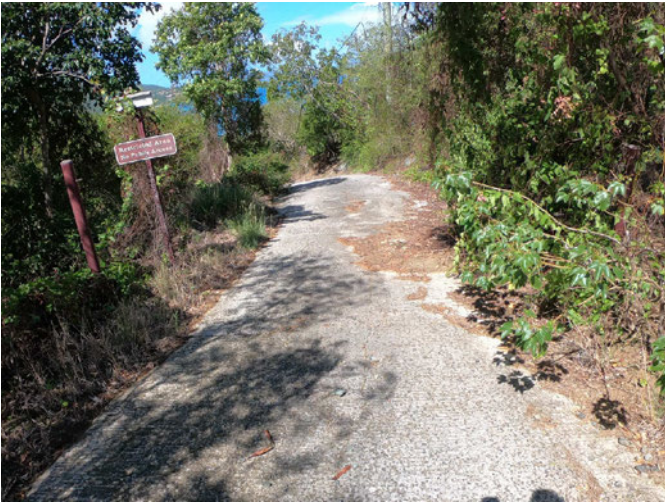
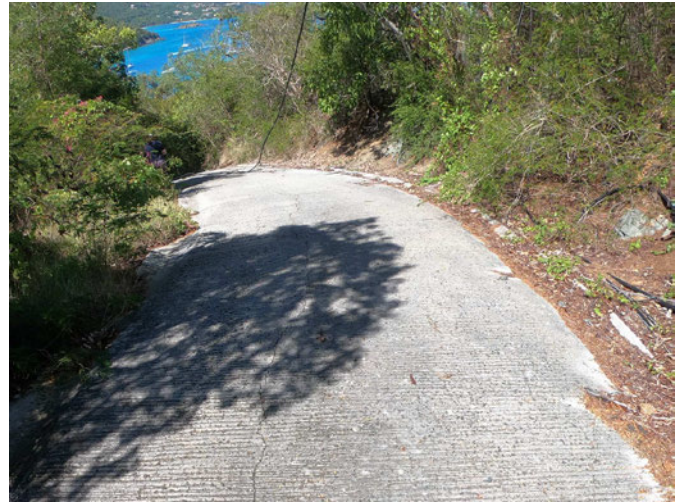
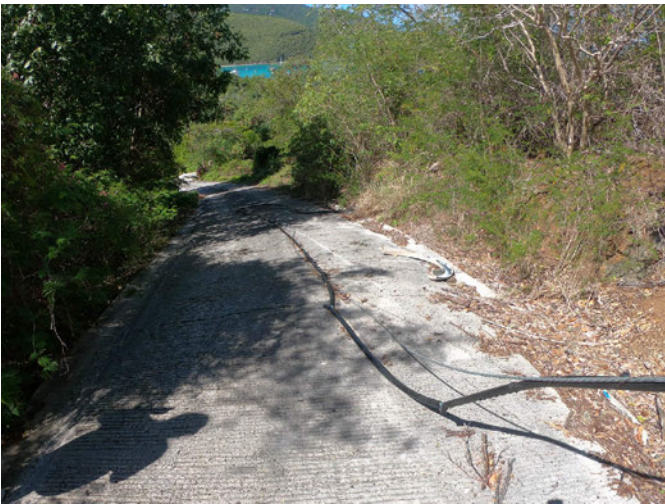
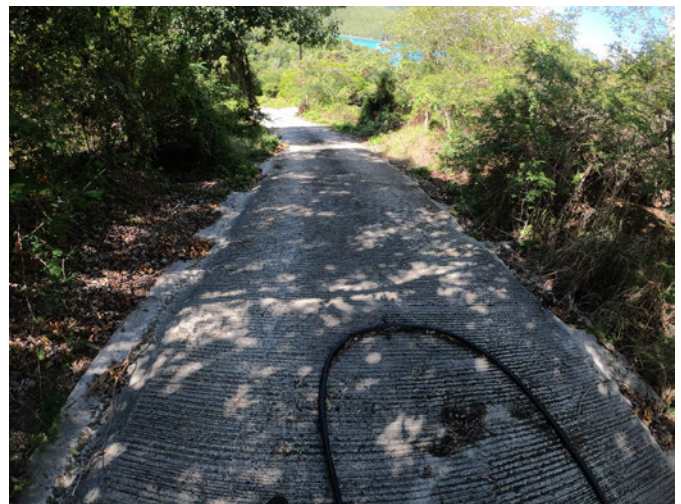
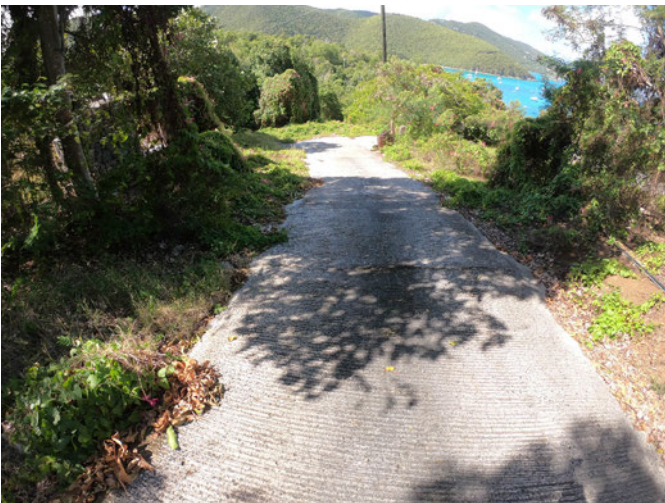
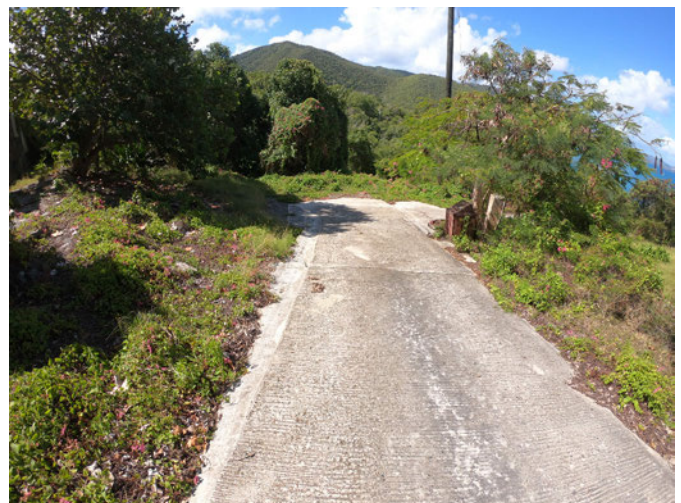
Concrete Distress Indices: Slab Cracking (30), Surface Delamination and Popouts (53), Joint Distress (73), Joint Faulting (73), Patches (90).

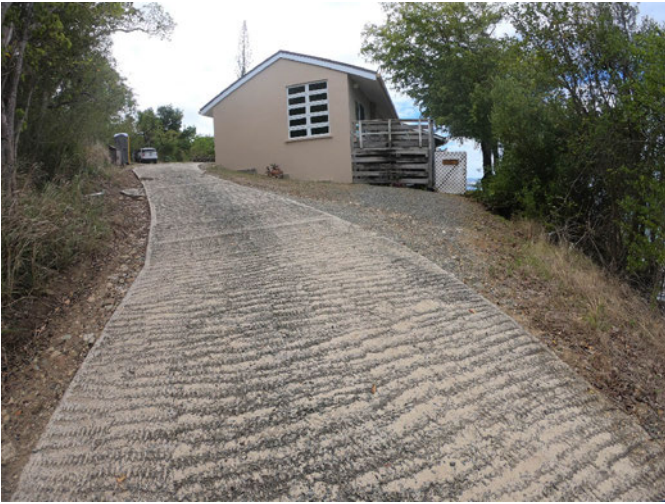
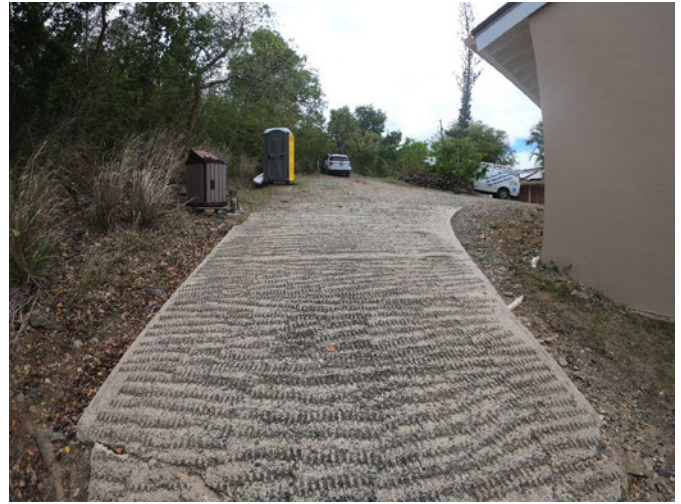
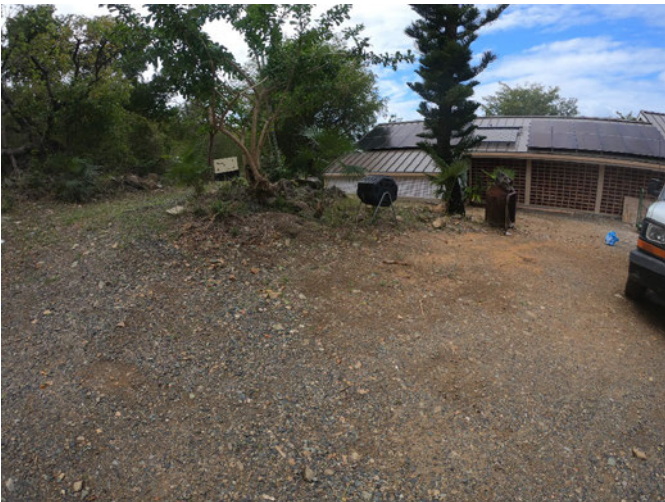
Concrete Distress Indices: Slab Cracking (53), Surface Delamination and Popouts (30), Joint Distress (73), Joint Faulting (73), Patches (90). Portion of the road is unpaved.

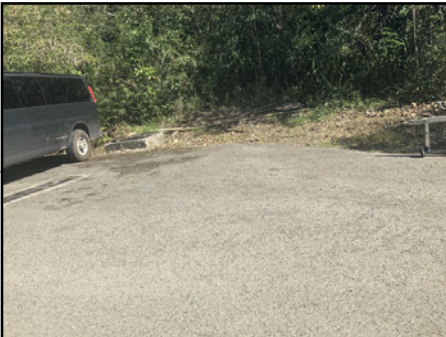
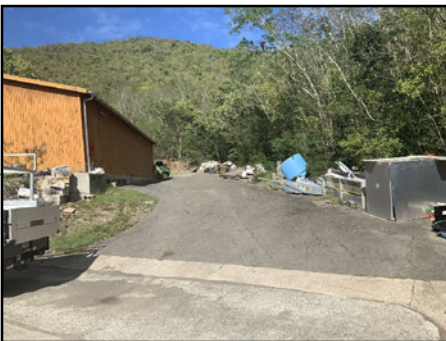
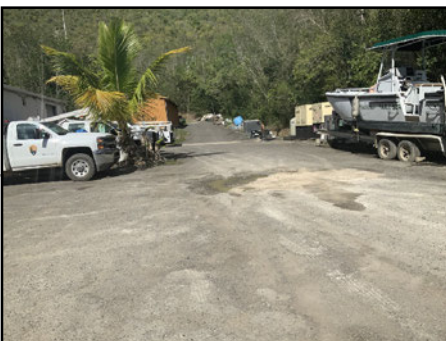
Inspection Date	FMSS Number	User Access	Surface Type
3/22/2022	35896	NONPUBLIC	ASPHALT
Area (Sq. Ft.)	Lane Miles (11' Widths)	Curb Reveal (Inches)	Curb Recommendation
25,434	0.438	NOT APPLICABLE	NOT APPLICABLE
Curb Type		Curb & Gutter Type	
NO CURB		NO CURB AND GUTTER	
Pavement Recommendation		Condition Rating / PCR	
RECONSTRUCTION		POOR / 30

Note: Parking area consists of multiple surface types: 2 parts Asphalt at 22,141 square feet; 2 parts Concrete at 3,293 square feet.

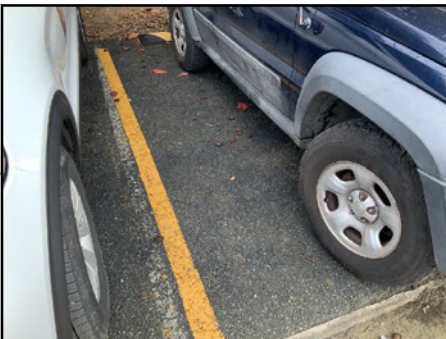
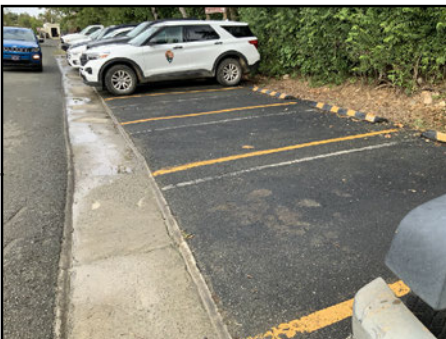
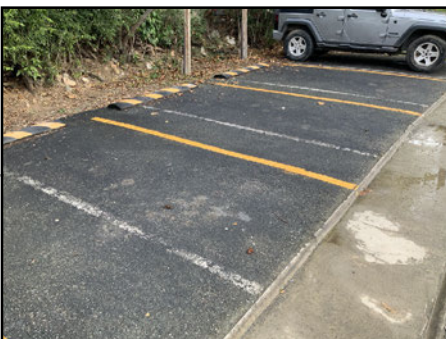
ROUTE 0901AZ: CRUZ BAY VISITOR CENTER A PARKING

Inspection Date	FMSS Number	User Access	Surface Type
3/22/2022	35890	NONPUBLIC	ASPHALT
Area (Sq. Ft.)	Lane Miles (11' Widths)	Curb Reveal (Inches)	Curb Recommendation
1,513	0.026	NOT APPLICABLE	NOT APPLICABLE
Curb Type		Curb & Gutter Type	
NO CURB		NO CURB AND GUTTER	
Pavement Recommendation		Condition Rating / PCR	
PREVENTIVE MAINTENANCE		GOOD / 90

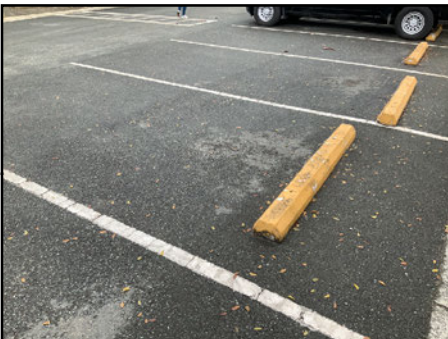
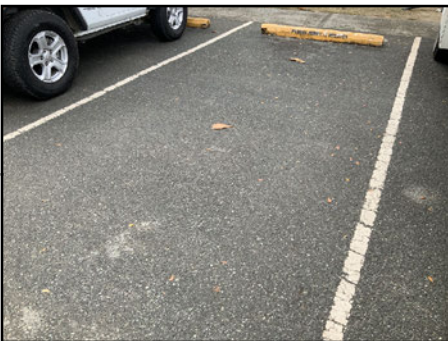
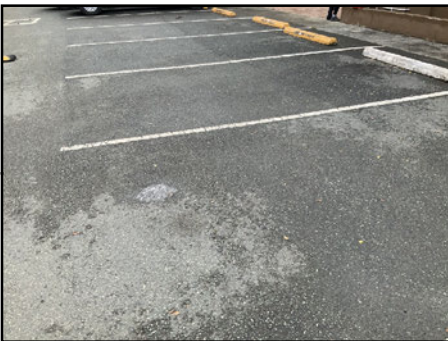
ROUTE 0901CZ: CRUZ BAY VISITOR CENTER C PARKING

Inspection Date	FMSS Number	User Access	Surface Type
3/22/2022	35890	NONPUBLIC	ASPHALT
Area (Sq. Ft.)	Lane Miles (11' Widths)	Curb Reveal (Inches)	Curb Recommendation
2,914	0.05	NOT APPLICABLE	NOT APPLICABLE
Curb Type		Curb & Gutter Type	
NO CURB		NO CURB AND GUTTER	
Pavement Recommendation		Condition Rating / PCR	
PREVENTIVE MAINTENANCE		GOOD / 90

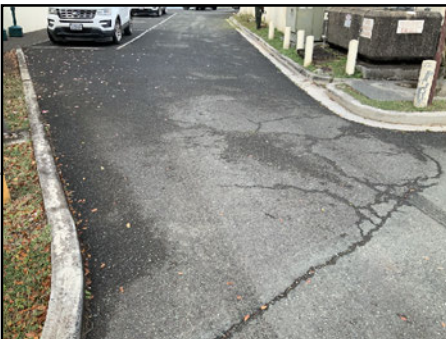
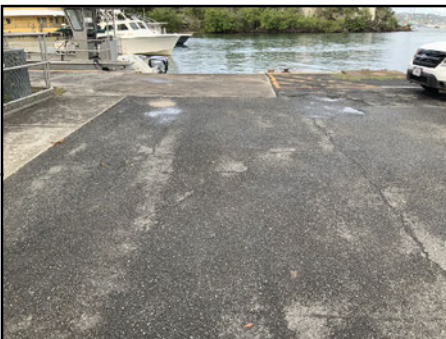
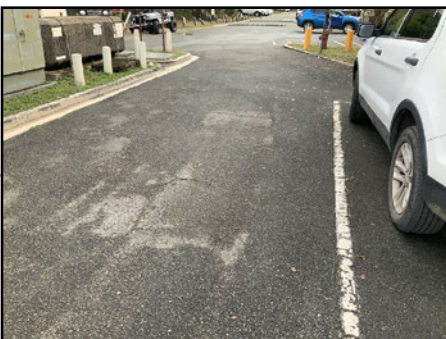
ROUTE 0901DZ: CRUZ BAY VISITOR CENTER D PARKING

Inspection Date	FMSS Number	User Access	Surface Type
3/22/2022	35890	NONPUBLIC	ASPHALT
Area (Sq. Ft.)	Lane Miles (11' Widths)	Curb Reveal (Inches)	Curb Recommendation
3,766	0.065	2	DO NOTHING
Curb Type		Curb & Gutter Type	
CONCRETE		NO CURB AND GUTTER	
Pavement Recommendation		Condition Rating / PCR	
LIGHT 3R TREATMENTS		FAIR / 73

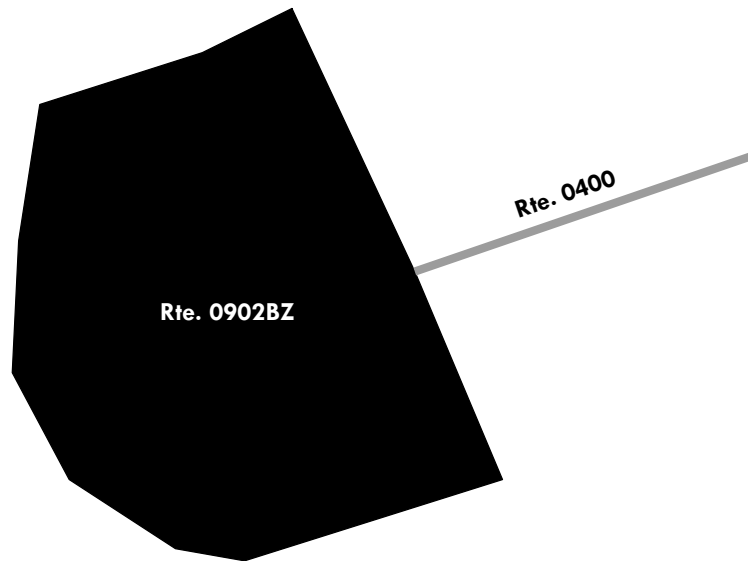
Inspection Date	FMSS Number	User Access	Surface Type
3/22/2022	33298	NONPUBLIC	ASPHALT
Area (Sq. Ft.)	Lane Miles (11' Widths)	Curb Reveal (Inches)	Curb Recommendation
815	0.014	NOT APPLICABLE	NOT APPLICABLE
Curb Type		Curb & Gutter Type	
NO CURB		NO CURB AND GUTTER	
Pavement Recommendation		Condition Rating / PCR	
NOT APPLICABLE		NOT RATED

Note: Parking area was covered with debris since the area is under Construction.

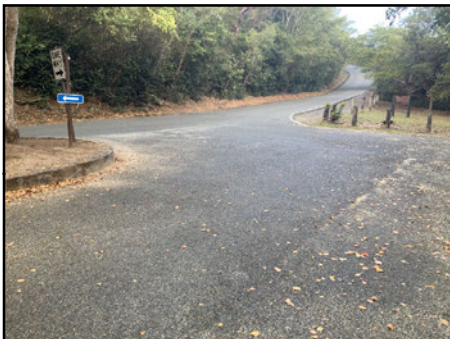
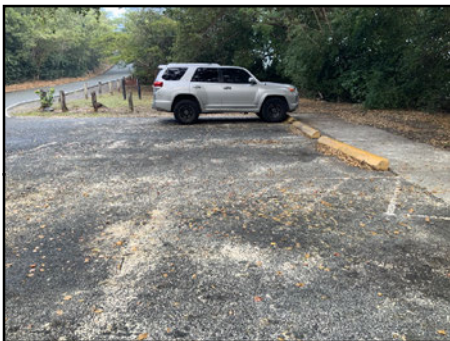
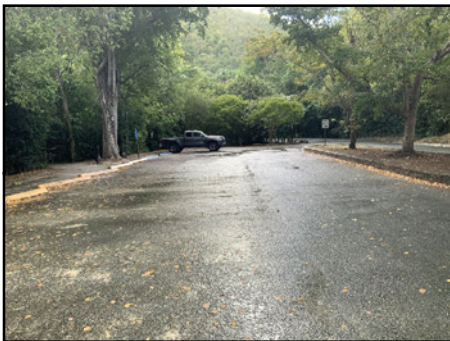
ROUTE 0903: HAWKSNEST BEACH PARKING

Inspection Date	FMSS Number	User Access	Surface Type
3/23/2022	33346	PUBLIC	ASPHALT
Area (Sq. Ft.)	Lane Miles (11' Widths)	Curb Reveal (Inches)	Curb Recommendation
11,167	0.192	9	DO NOTHING
Curb Type		Curb & Gutter Type	
STONE		NO CURB AND GUTTER	
Pavement Recommendation		Condition Rating / PCR	
LIGHT 3R TREATMENTS		FAIR / 73

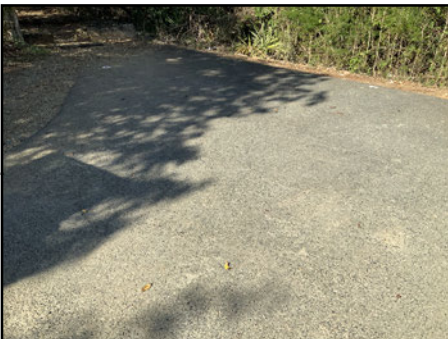
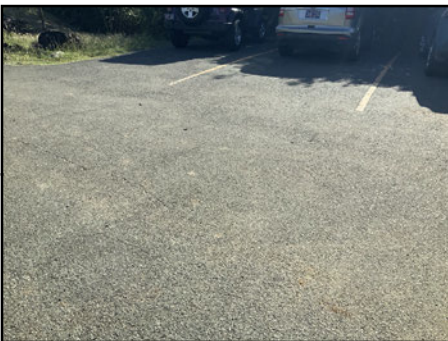
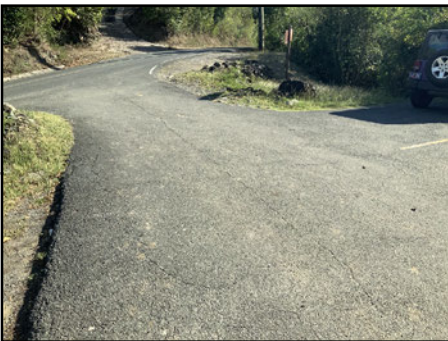
ROUTE 0904: PEACE HILL PARKING

Inspection Date	FMSS Number	User Access	Surface Type
3/22/2022	33496	PUBLIC	ASPHALT
Area (Sq. Ft.)	Lane Miles (11' Widths)	Curb Reveal (Inches)	Curb Recommendation
2,542	0.044	NOT APPLICABLE	NOT APPLICABLE
Curb Type		Curb & Gutter Type	
NO CURB		NO CURB AND GUTTER	
Pavement Recommendation		Condition Rating / PCR	
PREVENTIVE MAINTENANCE		GOOD / 90

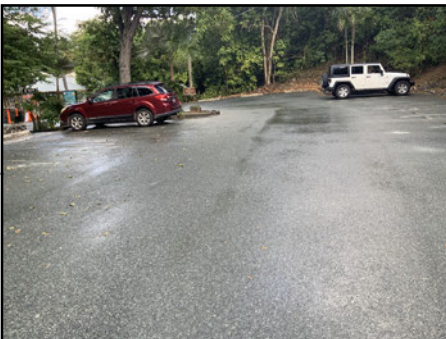
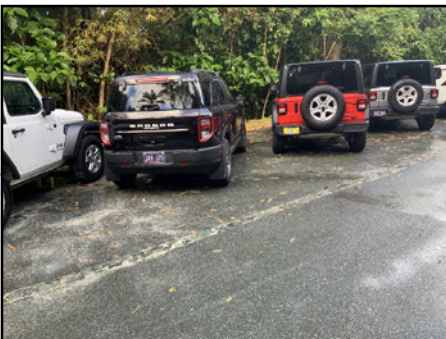
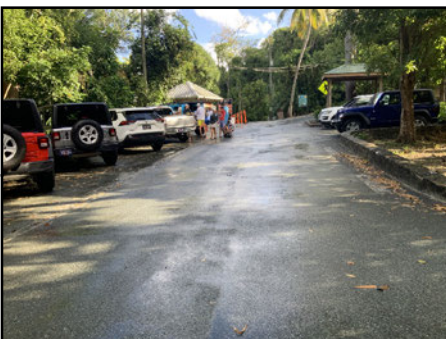
ROUTE 0905: TRUNK BAY PARKING

Inspection Date	FMSS Number	User Access	Surface Type
3/23/2022	33354	PUBLIC	ASPHALT
Area (Sq. Ft.)	Lane Miles (11' Widths)	Curb Reveal (Inches)	Curb Recommendation
14,562	0.251	8	LIGHT REPAIR
Curb Type		Curb & Gutter Type	
STONE		NO CURB AND GUTTER	
Pavement Recommendation		Condition Rating / PCR	
LIGHT 3R TREATMENTS		FAIR / 73

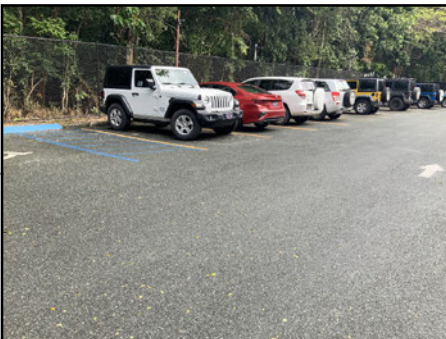
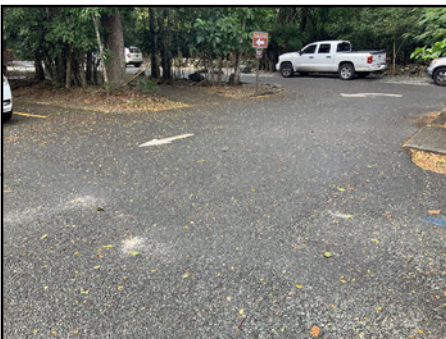
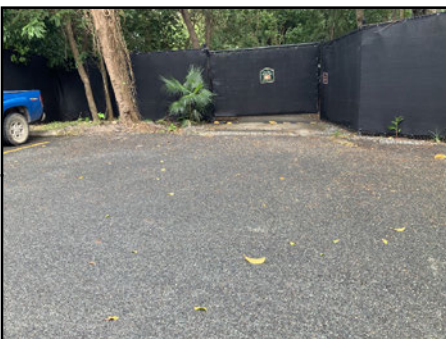
ROUTE 0906: CINNAMON BAY PARKING

Inspection Date	FMSS Number	User Access	Surface Type
3/23/2022	33529	PUBLIC	ASPHALT
Area (Sq. Ft.)	Lane Miles (11' Widths)	Curb Reveal (Inches)	Curb Recommendation
15,626	0.269	3	MODERATE REPAIR
Curb Type		Curb & Gutter Type	
STONE		NO CURB AND GUTTER	
Pavement Recommendation		Condition Rating / PCR	
PREVENTIVE MAINTENANCE		GOOD / 90

Note: Parking area consists of multiple surface types: 1 part Asphalt at 15,504 square feet; 1 part Concrete at 122 square feet.

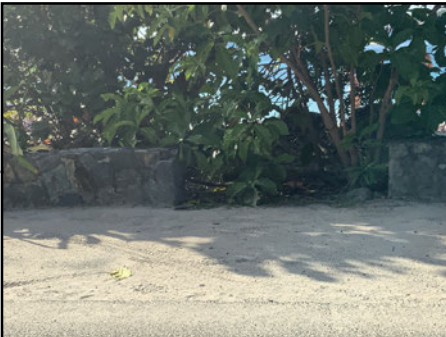
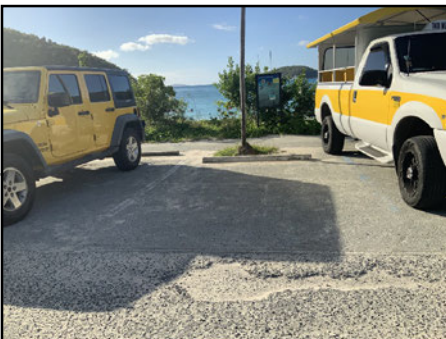
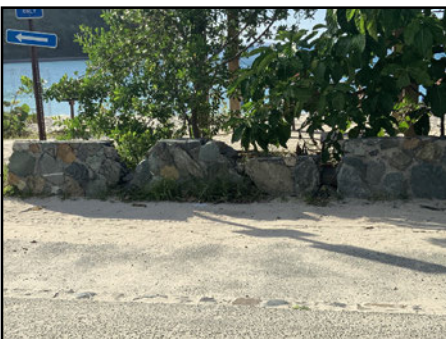
Inspection Date	FMSS Number	User Access	Surface Type
3/22/2022	33644	PUBLIC	ASPHALT
Area (Sq. Ft.)	Lane Miles (11' Widths)	Curb Reveal (Inches)	Curb Recommendation
2,663	0.046	8	DO NOTHING
Curb Type		Curb & Gutter Type	
STONE		NO CURB AND GUTTER	
Pavement Recommendation		Condition Rating / PCR	
NOT APPLICABLE		NOT RATED / -1

Note: Parking area was covered with sand. Parking area consists of multiple surface types: 1 part Asphalt at 1,622 square feet; 1 part Concrete at 1,041 square feet.

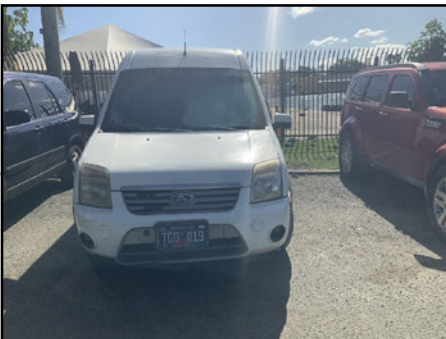
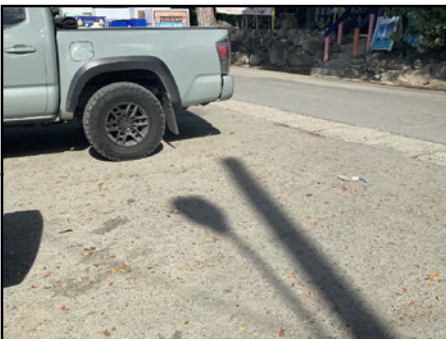
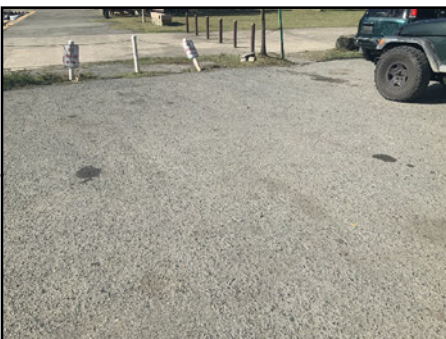
ROUTE 0910: CRUZ BAY VISITOR CENTER 15 MINUTE PARKING

Inspection Date	FMSS Number	User Access	Surface Type
3/22/2022	35877	PUBLIC	ASPHALT
Area (Sq. Ft.)	Lane Miles (11' Widths)	Curb Reveal (Inches)	Curb Recommendation
3,206	0.055	NOT APPLICABLE	NOT APPLICABLE
Curb Type		Curb & Gutter Type	
NO CURB		NO CURB AND GUTTER	
Pavement Recommendation		Condition Rating / PCR	
LIGHT 3R TREATMENTS		FAIR / 73

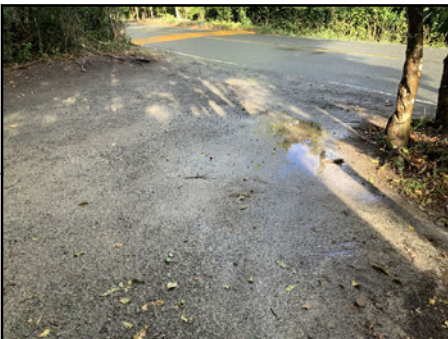
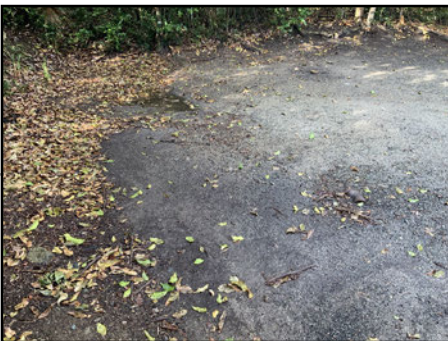
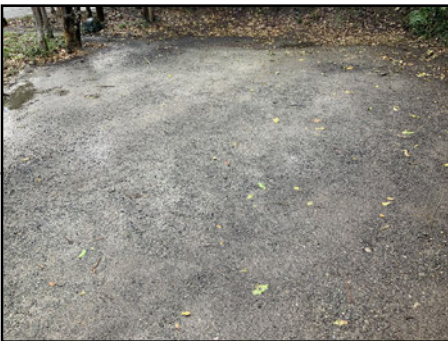
ROUTE 0911AZ: JUMBIE BEACH A PARKING

Inspection Date	FMSS Number	User Access	Surface Type
3/23/2022	33349	PUBLIC	ASPHALT
Area (Sq. Ft.)	Lane Miles (11' Widths)	Curb Reveal (Inches)	Curb Recommendation
532	0.009	NOT APPLICABLE	NOT APPLICABLE
Curb Type		Curb & Gutter Type	
NO CURB		NO CURB AND GUTTER	
Pavement Recommendation		Condition Rating / PCR	
RECONSTRUCTION		POOR / 0

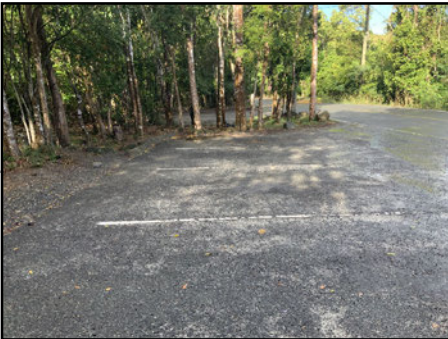
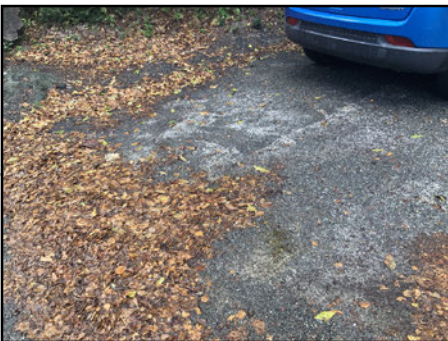
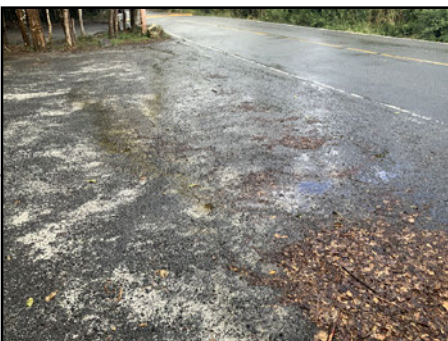
ROUTE 0911BZ: JUMBIE BEACH B PARKING

Inspection Date	FMSS Number	User Access	Surface Type
3/23/2022	33349	PUBLIC	ASPHALT
Area (Sq. Ft.)	Lane Miles (11' Widths)	Curb Reveal (Inches)	Curb Recommendation
1,375	0.024	NOT APPLICABLE	NOT APPLICABLE
Curb Type		Curb & Gutter Type	
NO CURB		NO CURB AND GUTTER	
Pavement Recommendation		Condition Rating / PCR	
LIGHT 3R TREATMENTS		FAIR / 73

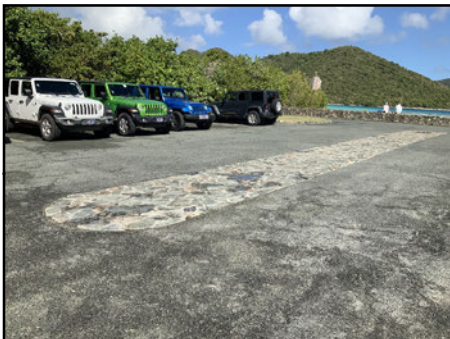
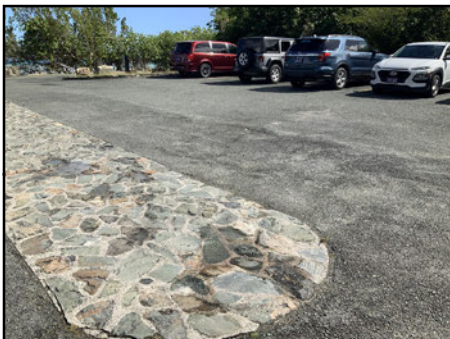
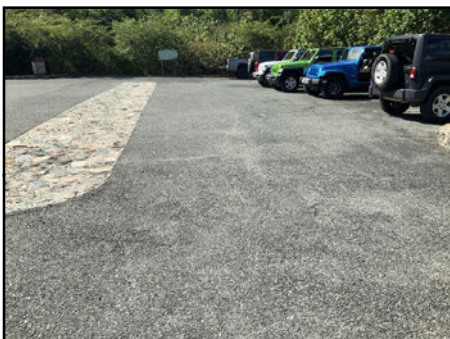
ROUTE 0912: ANNABERG SUGAR MILL PARKING

Inspection Date	FMSS Number	User Access	Surface Type
3/23/2022	34422	PUBLIC	ASPHALT
Area (Sq. Ft.)	Lane Miles (11' Widths)	Curb Reveal (Inches)	Curb Recommendation
6,736	0.116	6	DO NOTHING
Curb Type		Curb & Gutter Type	
STONE		NO CURB AND GUTTER	
Pavement Recommendation		Condition Rating / PCR	
LIGHT 3R TREATMENTS		FAIR / 73

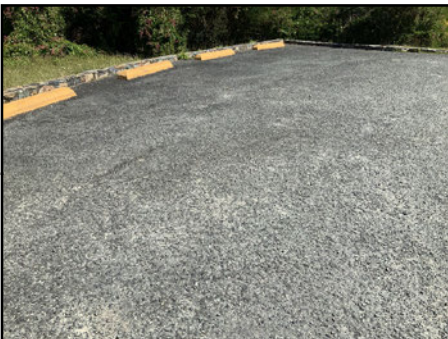
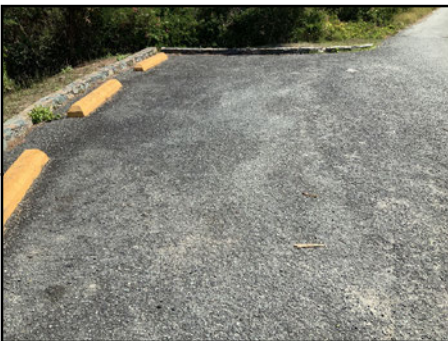
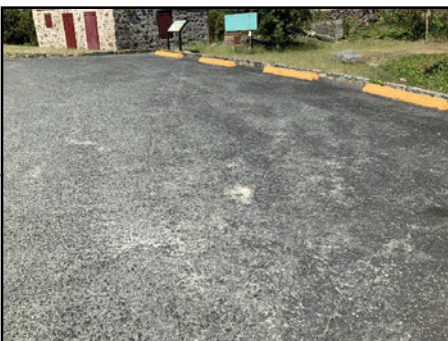
ROUTE 0913AZ: FRANCIS BAY TRAIL A PARKING

Inspection Date	FMSS Number	User Access	Surface Type
3/23/2022	34410	PUBLIC	ASPHALT
Area (Sq. Ft.)	Lane Miles (11' Widths)	Curb Reveal (Inches)	Curb Recommendation
1,088	0.019	6	DO NOTHING
Curb Type		Curb & Gutter Type	
STONE		NO CURB AND GUTTER	
Pavement Recommendation		Condition Rating / PCR	
HEAVY 3R TREATMENTS		POOR / 53

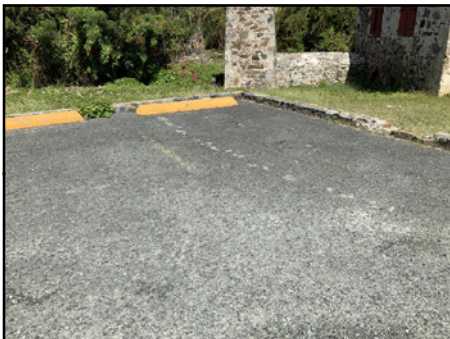
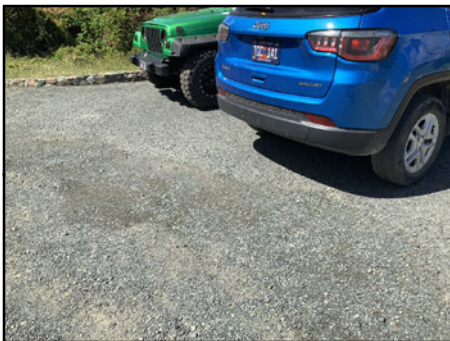
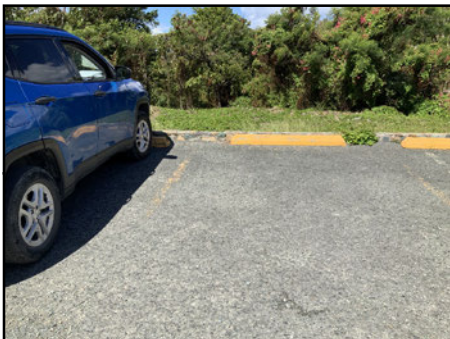
ROUTE 0913BZ: FRANCIS BAY TRAIL B PARKING

Inspection Date	FMSS Number	User Access	Surface Type
3/23/2022	34410	PUBLIC	ASPHALT
Area (Sq. Ft.)	Lane Miles (11' Widths)	Curb Reveal (Inches)	Curb Recommendation
897	0.015	6	DO NOTHING
Curb Type		Curb & Gutter Type	
STONE		NO CURB AND GUTTER	
Pavement Recommendation		Condition Rating / PCR	
LIGHT 3R TREATMENTS		FAIR / 73

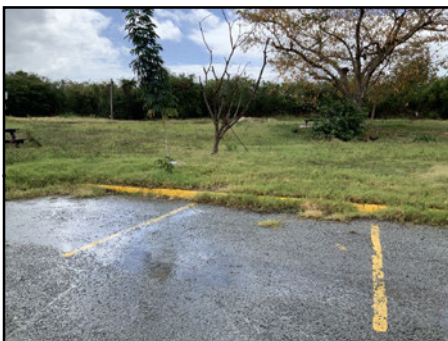
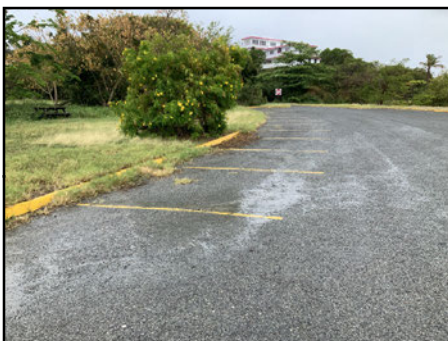
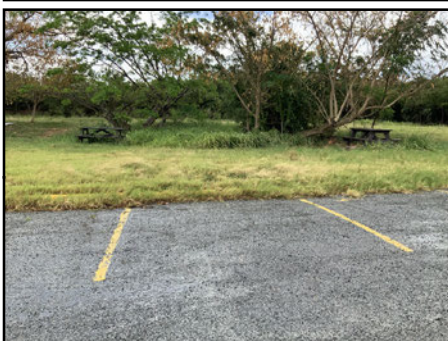
ROUTE 0914AZ: RED HOOK A PARKING

Inspection Date	FMSS Number	User Access	Surface Type
3/21/2022	35907	PUBLIC	ASPHALT
Area (Sq. Ft.)	Lane Miles (11' Widths)	Curb Reveal (Inches)	Curb Recommendation
2,751	0.047	6	DO NOTHING
Curb Type		Curb & Gutter Type	
CONCRETE		NO CURB AND GUTTER	
Pavement Recommendation		Condition Rating / PCR	
RECONSTRUCTION		POOR / 30

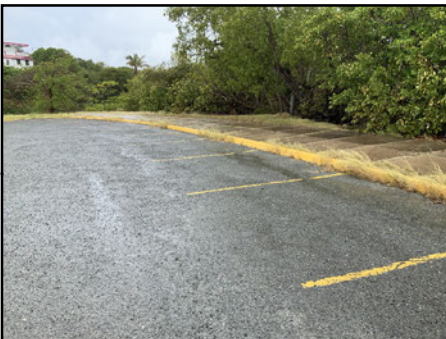
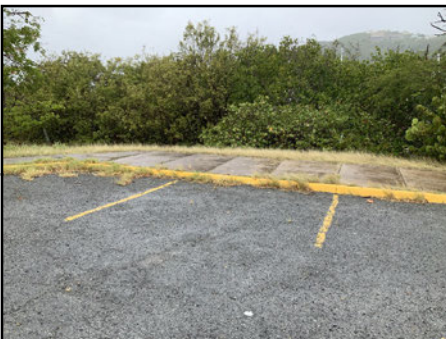
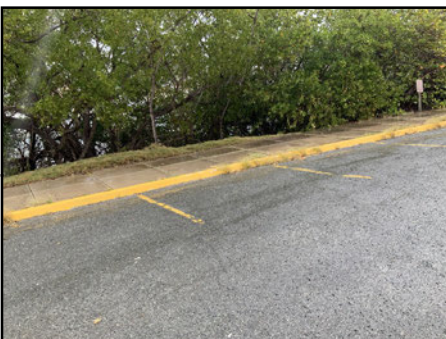
ROUTE 0914BZ: RED HOOK B PARKING

Inspection Date	FMSS Number	User Access	Surface Type
3/21/2022	35907	PUBLIC	ASPHALT
Area (Sq. Ft.)	Lane Miles (11' Widths)	Curb Reveal (Inches)	Curb Recommendation
2,764	0.048	5	DO NOTHING
Curb Type		Curb & Gutter Type	
CONCRETE		NO CURB AND GUTTER	
Pavement Recommendation		Condition Rating / PCR	
HEAVY 3R TREATMENTS		POOR / 53

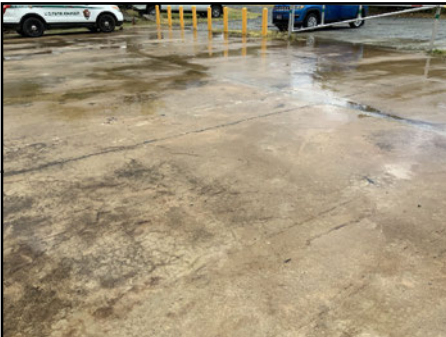
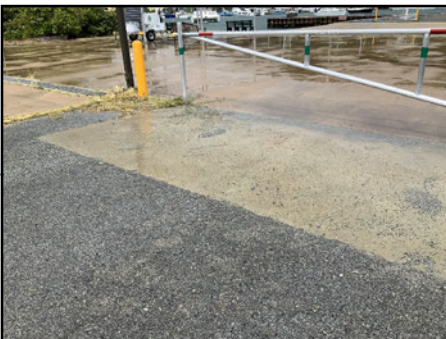
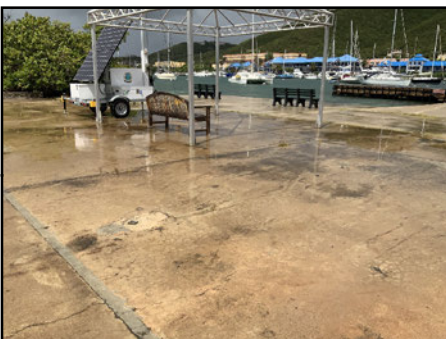
Note: Parking area covered with sand. Parking area consists of multiple surface types: 1 part Asphalt at 1,530 square feet; 1 part Concrete at 9,081 square feet.

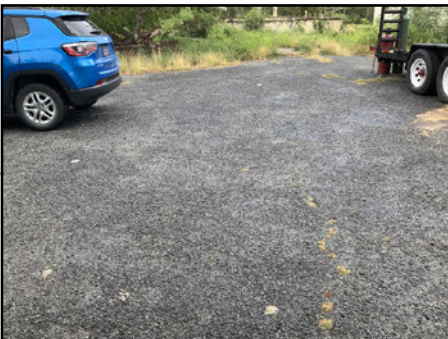
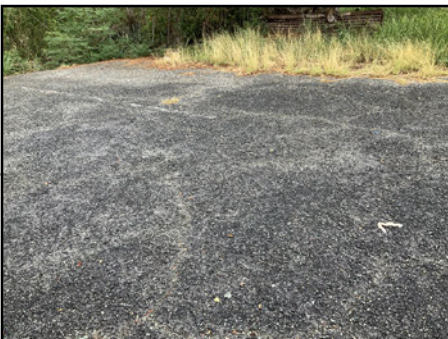
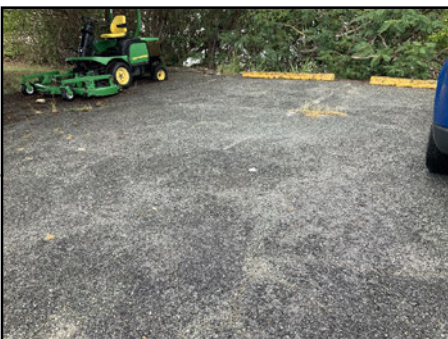
ROUTE 0914DZ: RED HOOK D PARKING

Inspection Date	FMSS Number	User Access	Surface Type
3/21/2022	35907	PUBLIC	ASPHALT
Area (Sq. Ft.)	Lane Miles (11' Widths)	Curb Reveal (Inches)	Curb Recommendation
1,424	0.025	NOT APPLICABLE	NOT APPLICABLE
Curb Type		Curb & Gutter Type	
NO CURB		NO CURB AND GUTTER	
Pavement Recommendation		Condition Rating / PCR	
RECONSTRUCTION		POOR / 30

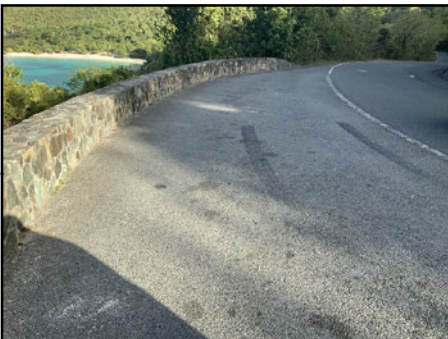
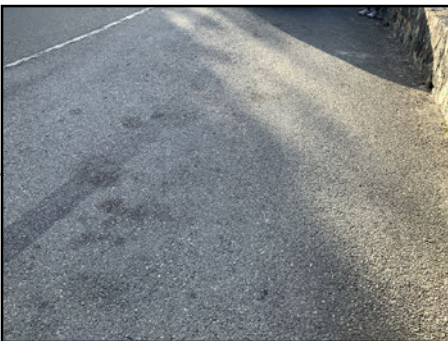
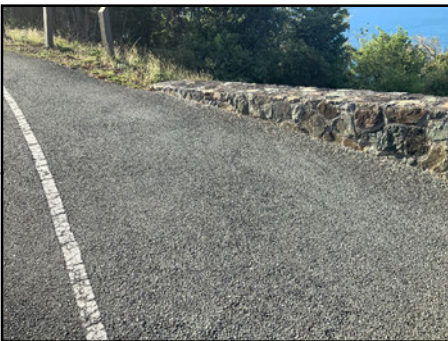
ROUTE 0925: MAHO BAY OVERLOOK

Inspection Date	FMSS Number	User Access	Surface Type
3/22/2022	N/A	PUBLIC	ASPHALT
Area (Sq. Ft.)	Lane Miles (11' Widths)	Curb Reveal (Inches)	Curb Recommendation
1,211	0.021	NOT APPLICABLE	NOT APPLICABLE
Curb Type		Curb & Gutter Type	
NO CURB		NO CURB AND GUTTER	
Pavement Recommendation		Condition Rating / PCR	
PREVENTIVE MAINTENANCE		GOOD / 90

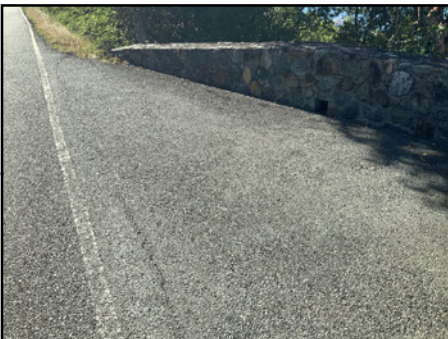
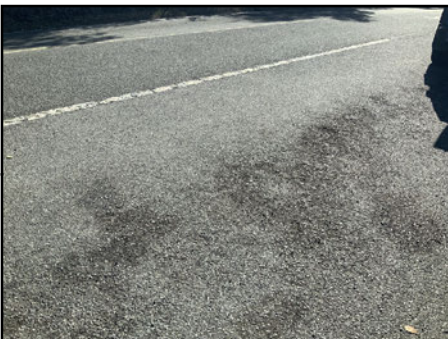
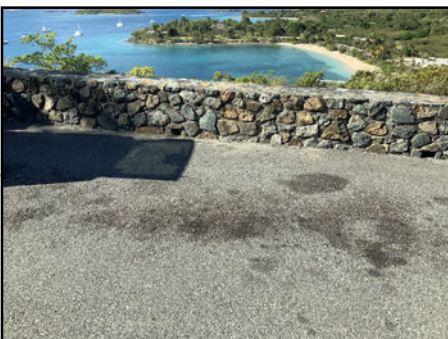
ROUTE 0927: CANEEL BAY OVERLOOK PARKING

Inspection Date	FMSS Number	User Access	Surface Type
3/22/2022	N/A	PUBLIC	ASPHALT
Area (Sq. Ft.)	Lane Miles (11' Widths)	Curb Reveal (Inches)	Curb Recommendation
1,033	0.018	NOT APPLICABLE	NOT APPLICABLE
Curb Type		Curb & Gutter Type	
NO CURB		NO CURB AND GUTTER	
Pavement Recommendation		Condition Rating / PCR	
PREVENTIVE MAINTENANCE		GOOD / 90

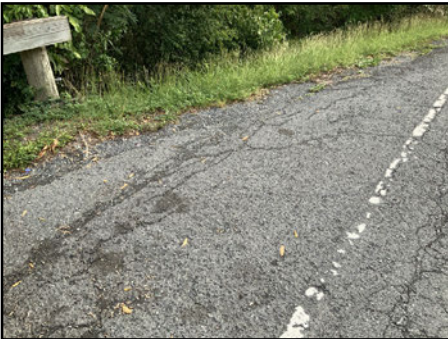
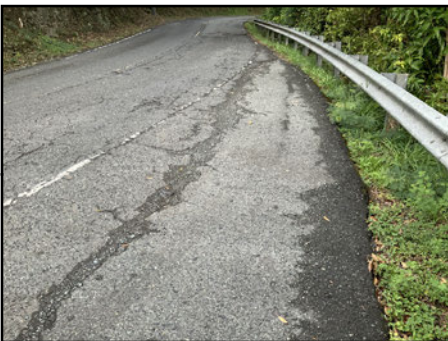
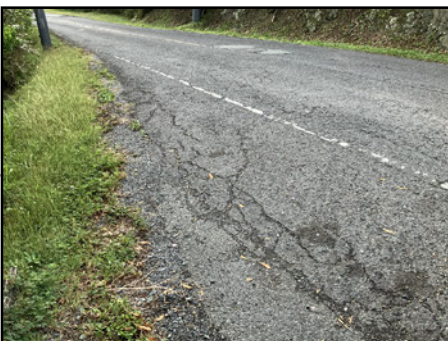
ROUTE 0934: CENTERLINE OVERLOOK

Inspection Date	FMSS Number	User Access	Surface Type
3/22/2022	N/A	PUBLIC	ASPHALT
Area (Sq. Ft.)	Lane Miles (11' Widths)	Curb Reveal (Inches)	Curb Recommendation
967	0.017	NOT APPLICABLE	NOT APPLICABLE
Curb Type		Curb & Gutter Type	
NO CURB		NO CURB AND GUTTER	
Pavement Recommendation		Condition Rating / PCR	
HEAVY 3R TREATMENTS		POOR / 53
