VIIS Cycle 6

Final Report

Road Inventory and Condition Assessment of Paved Routes Virgin Islands National Park

Report Date: February 2023

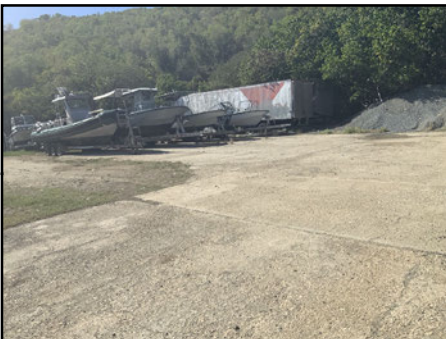
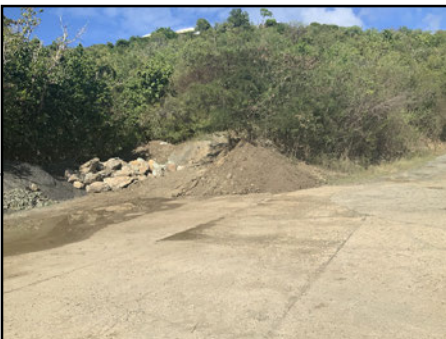
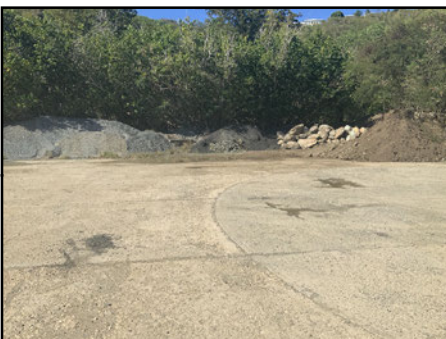
ROUTE 0946: CRUZ BAY BOAT PARKING

Inspection Date	FMSS Number	User Access	Surface Type
3/22/2022	N/A	PUBLIC	CONCRETE
Area (Sq. Ft.)	Lane Miles (11' Widths)	Curb Reveal (Inches)	Curb Recommendation
7,913	0.136	NOT APPLICABLE	NOT APPLICABLE
Curb Type		Curb & Gutter Type	
NO CURB		NO CURB AND GUTTER	
Pavement Recommendation		Condition Rating / PCR	
RECONSTRUCTION		POOR / 30

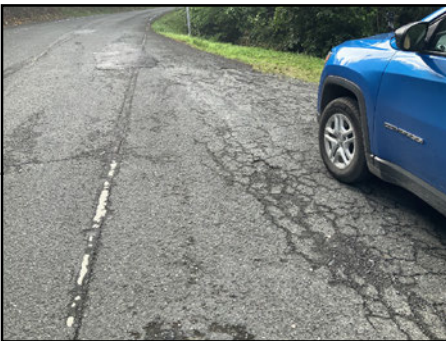
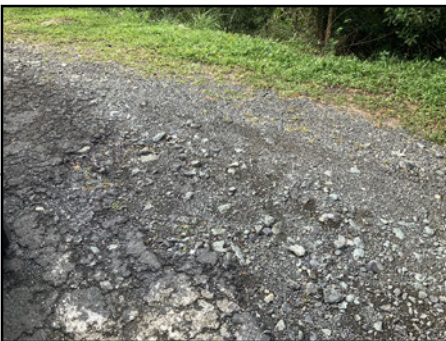
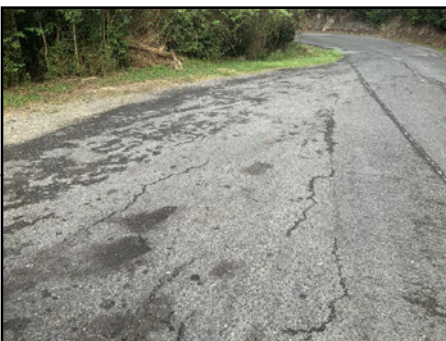
ROUTE 0963: CENTER LINE PARKING

Inspection Date	FMSS Number	User Access	Surface Type
3/22/2022	N/A	PUBLIC	ASPHALT
Area (Sq. Ft.)	Lane Miles (11' Widths)	Curb Reveal (Inches)	Curb Recommendation
1,733	0.03	NOT APPLICABLE	NOT APPLICABLE
Curb Type		Curb & Gutter Type	
NO CURB		NO CURB AND GUTTER	
Pavement Recommendation		Condition Rating / PCR	
RECONSTRUCTION		POOR / 30

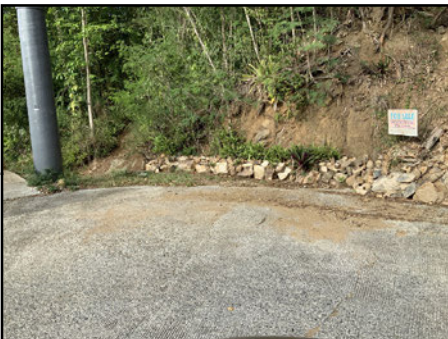
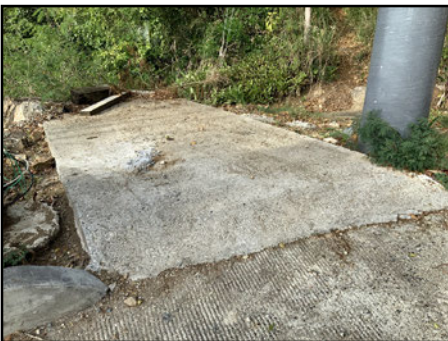
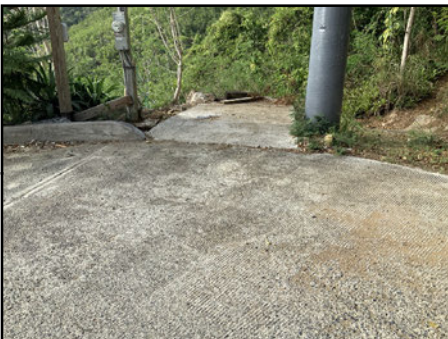
ROUTE 0965: GREAT SEIBAN TRAIL PARKING

Inspection Date	FMSS Number	User Access	Surface Type
3/21/2022	N/A	PUBLIC	CONCRETE
Area (Sq. Ft.)	Lane Miles (11' Widths)	Curb Reveal (Inches)	Curb Recommendation
149	0.003	6	DO NOTHING
Curb Type		Curb & Gutter Type	
CONCRETE		NO CURB AND GUTTER	
Pavement Recommendation		Condition Rating / PCR	
LIGHT 3R TREATMENTS		FAIR / 73

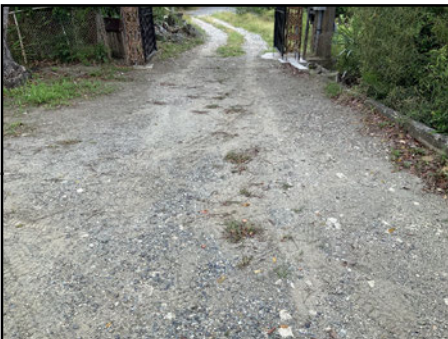
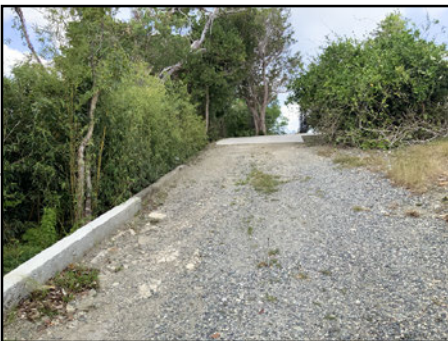
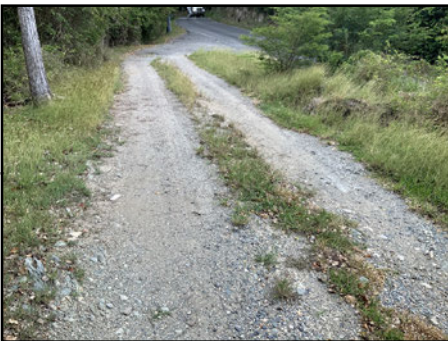
ROUTE 0967: MONTAQUE HOUSE DRIVEWAY

Inspection Date	FMSS Number	User Access	Surface Type
3/23/2022	35711	NONPUBLIC	ASPHALT
Area (Sq. Ft.)	Lane Miles (11' Widths)	Curb Reveal (Inches)	Curb Recommendation
1,285	0.022	5	DO NOTHING
Curb Type		Curb & Gutter Type	
CONCRETE		NOT APPLICABLE	
Pavement Recommendation		Condition Rating / PCR	
RECONSTRUCTION		POOR / 0
