VOYA Cycle 6

Final Report

Road Inventory and Condition Assessment of Paved Routes Voyageurs National Park

**Federal Highway Administration
Eastern Federal Lands Highway Division
Road Inventory Program (RIP)**

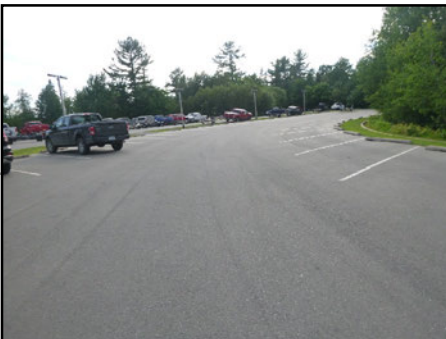
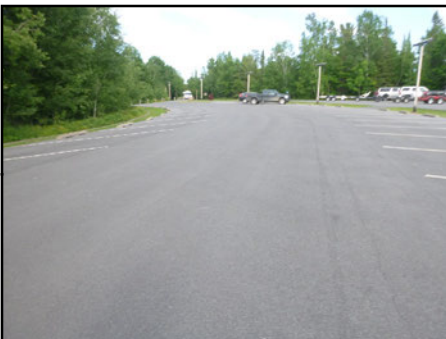
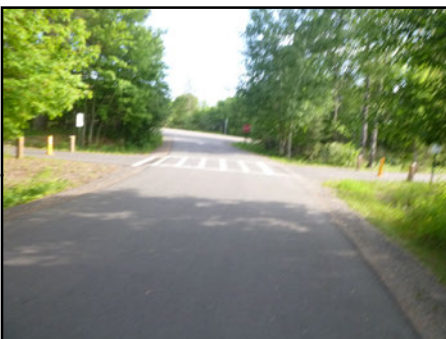
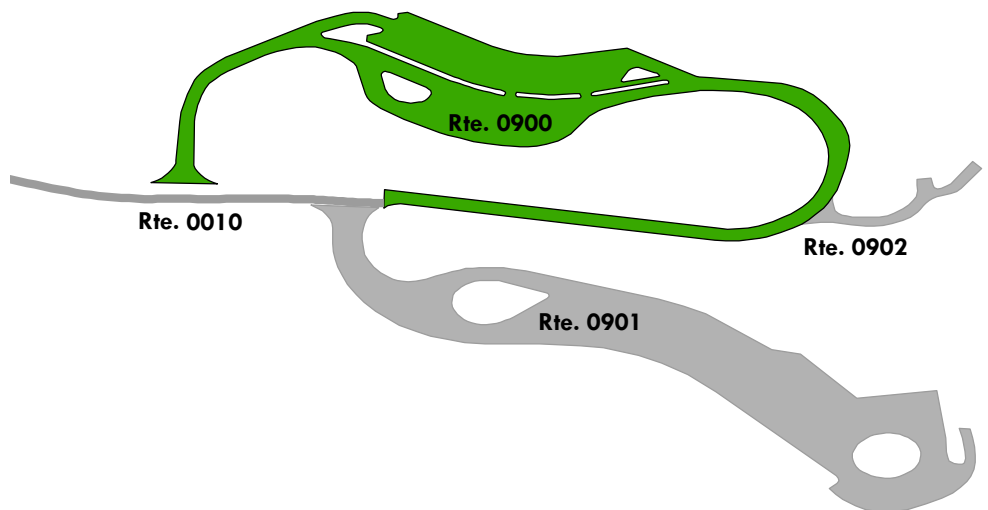
Inspection Date	FMSS Number	User Access	Surface Type
6/22/2019	37494	PUBLIC	ASPHALT
Area (Sq. Ft.)	Lane Miles (11' Widths)	Curb Reveal (Inches)	Curb Recommendation
57,788	0.995	NOT APPLICABLE	NOT APPLICABLE
Curb Type		Curb & Gutter Type	
NO CURB		NO CURB AND GUTTER	
Pavement Recommendation		Condition Rating / PCR	
PREVENTIVE MAINTENANCE		GOOD / 90

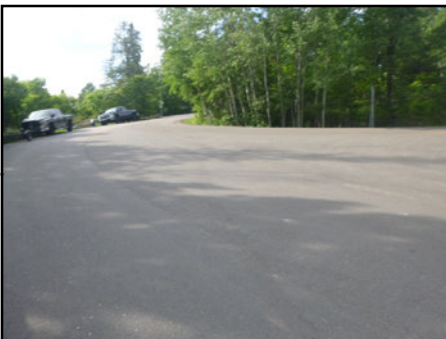
ROUTE 0901: RAINY LAKE BOAT LAUNCH PARKING

Inspection Date	FMSS Number	User Access	Surface Type
6/22/2019	51535	PUBLIC	ASPHALT
Area (Sq. Ft.)	Lane Miles (11' Widths)	Curb Reveal (Inches)	Curb Recommendation
65,720	1.132	2	DO NOTHING
Curb Type		Curb & Gutter Type	
WOOD		NO CURB AND GUTTER	
Pavement Recommendation		Condition Rating / PCR	
PREVENTIVE MAINTENANCE		GOOD / 90

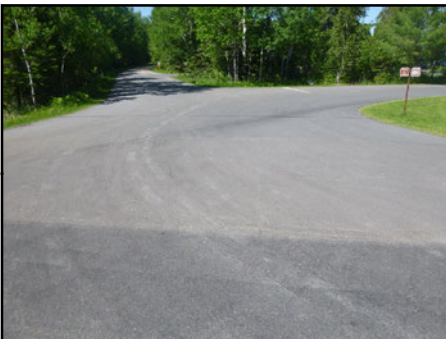
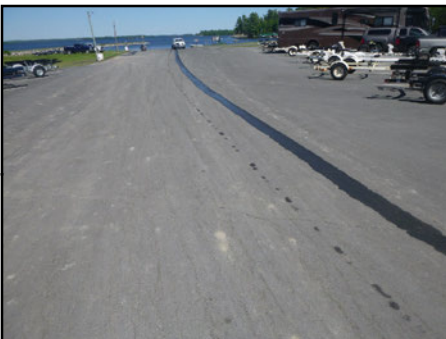
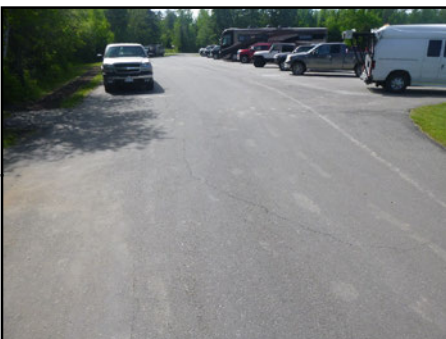
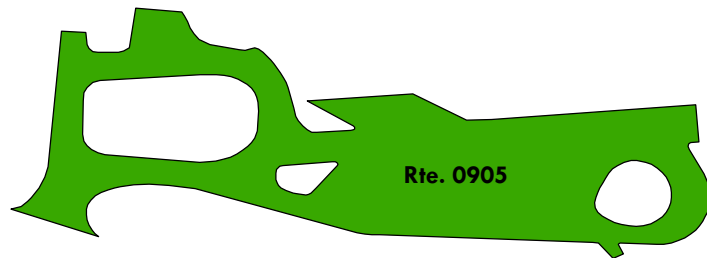
Inspection Date	FMSS Number	User Access	Surface Type
6/22/2019	37523	PUBLIC	ASPHALT
Area (Sq. Ft.)	Lane Miles (11' Widths)	Curb Reveal (Inches)	Curb Recommendation
55,359	0.953	NOT APPLICABLE	NOT APPLICABLE
Curb Type		Curb & Gutter Type	
NO CURB		NO CURB AND GUTTER	
Pavement Recommendation		Condition Rating / PCR	
PREVENTIVE MAINTENANCE		GOOD / 90

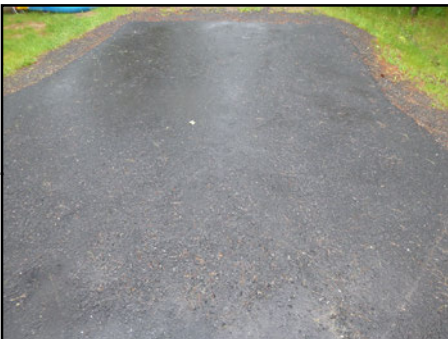
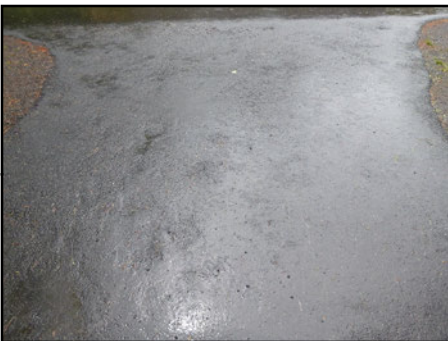
ROUTE 0910CZ: WHISPERING PINES HOUSING PARKING C

Inspection Date	FMSS Number	User Access	Surface Type
6/24/2019	37617	NONPUBLIC	ASPHALT
Area (Sq. Ft.)	Lane Miles (11' Widths)	Curb Reveal (Inches)	Curb Recommendation
248	0.004	NOT APPLICABLE	NOT APPLICABLE
Curb Type		Curb & Gutter Type	
NO CURB		NO CURB AND GUTTER	
Pavement Recommendation		Condition Rating / PCR	
PREVENTIVE MAINTENANCE		GOOD / 90

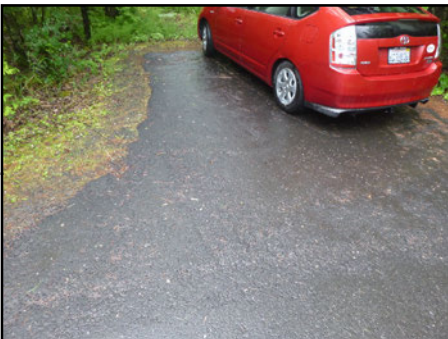
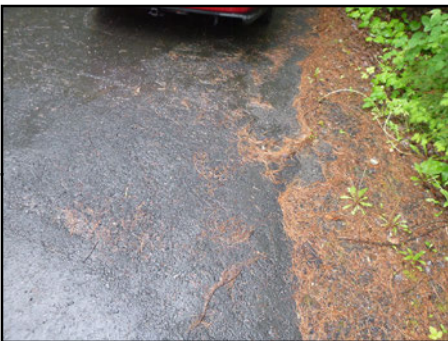
ROUTE 0910DZ: WHISPERING PINES HOUSING PARKING D

Inspection Date	FMSS Number	User Access	Surface Type
6/24/2019	37617	NONPUBLIC	ASPHALT
Area (Sq. Ft.)	Lane Miles (11' Widths)	Curb Reveal (Inches)	Curb Recommendation
376	0.006	NOT APPLICABLE	NOT APPLICABLE
Curb Type		Curb & Gutter Type	
NO CURB		NO CURB AND GUTTER	
Pavement Recommendation		Condition Rating / PCR	
PREVENTIVE MAINTENANCE		GOOD / 90

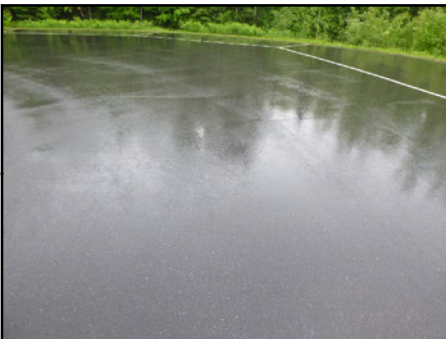
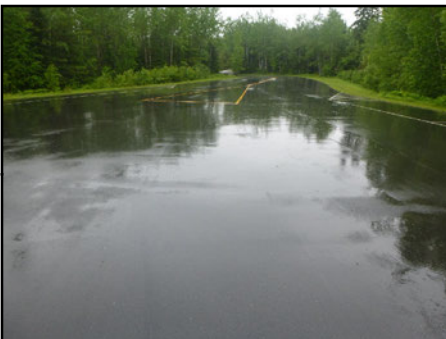
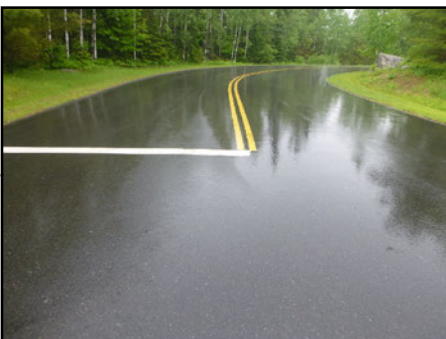
ROUTE 0911: FOREST OVERLOOK TRAIL PARKING

Inspection Date	FMSS Number	User Access	Surface Type
6/24/2019	37587	PUBLIC	ASPHALT
Area (Sq. Ft.)	Lane Miles (11' Widths)	Curb Reveal (Inches)	Curb Recommendation
27,195	0.468	NOT APPLICABLE	NOT APPLICABLE
Curb Type		Curb & Gutter Type	
NO CURB		NO CURB AND GUTTER	
Pavement Recommendation		Condition Rating / PCR	
PREVENTIVE MAINTENANCE		GOOD / 90

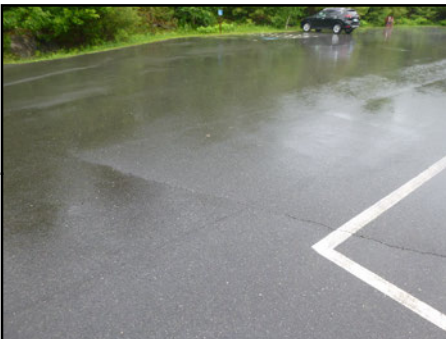
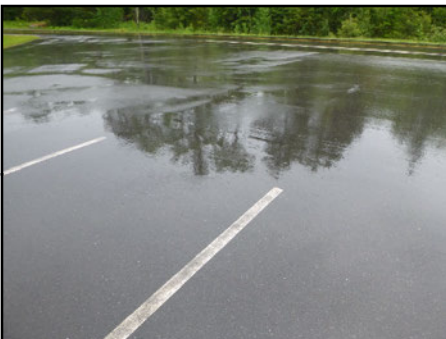
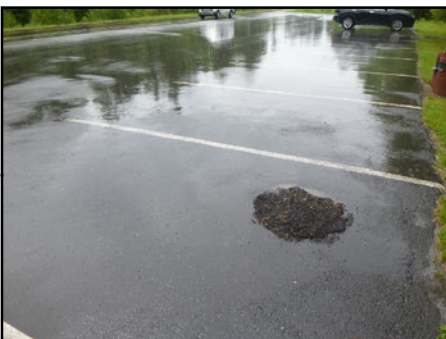
ROUTE 0912: KABETOGAMA LAKE OVERLOOK TRAIL PARKING

Inspection Date	FMSS Number	User Access	Surface Type
6/24/2019	37603	PUBLIC	ASPHALT
Area (Sq. Ft.)	Lane Miles (11' Widths)	Curb Reveal (Inches)	Curb Recommendation
11,454	0.197	NOT APPLICABLE	NOT APPLICABLE
Curb Type		Curb & Gutter Type	
NO CURB		NO CURB AND GUTTER	
Pavement Recommendation		Condition Rating / PCR	
PREVENTIVE MAINTENANCE		GOOD / 90

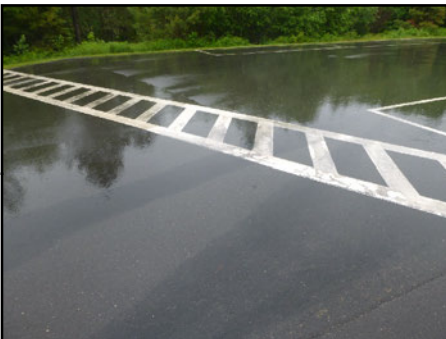
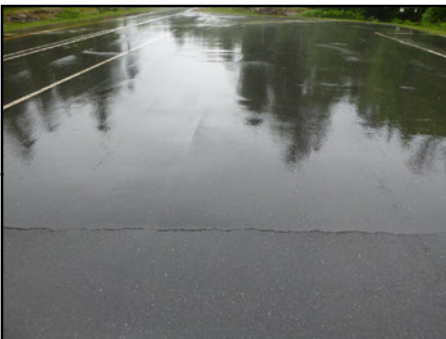
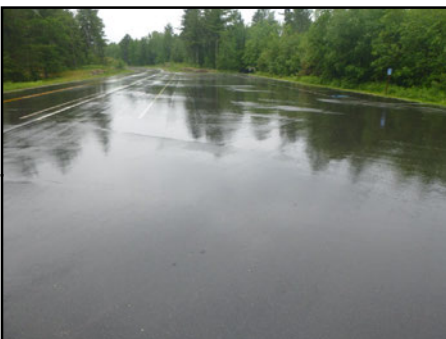
ROUTE 0913: BEAVER POND OVERLOOK PARKING

Inspection Date	FMSS Number	User Access	Surface Type
6/24/2019	37607	PUBLIC	ASPHALT
Area (Sq. Ft.)	Lane Miles (11' Widths)	Curb Reveal (Inches)	Curb Recommendation
10,024	0.173	NOT APPLICABLE	NOT APPLICABLE
Curb Type		Curb & Gutter Type	
NO CURB		NO CURB AND GUTTER	
Pavement Recommendation		Condition Rating / PCR	
PREVENTIVE MAINTENANCE		GOOD / 90

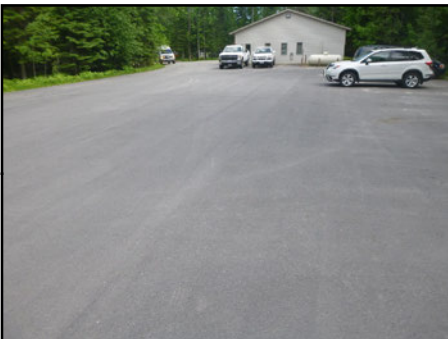
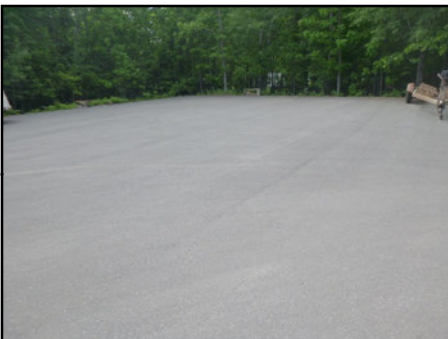
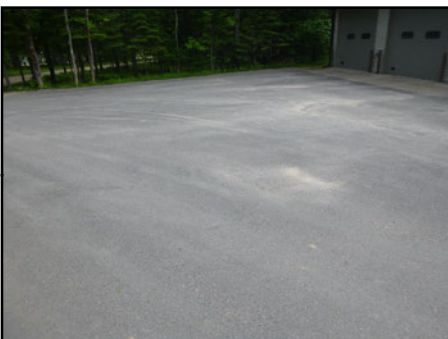
ROUTE 0918: KABETOGAMA OPERATIONS BUILDING PARKING

Inspection Date	FMSS Number	User Access	Surface Type
6/24/2019	87498	NONPUBLIC	ASPHALT
Area (Sq. Ft.)	Lane Miles (11' Widths)	Curb Reveal (Inches)	Curb Recommendation
16,450	0.283	NOT APPLICABLE	NOT APPLICABLE
Curb Type		Curb & Gutter Type	
NO CURB		NO CURB AND GUTTER	
Pavement Recommendation		Condition Rating / PCR	
PREVENTIVE MAINTENANCE		GOOD / 90
