WHHO Cycle 6

Final Report

Road Inventory and Condition Assessment of Paved Routes White House - President's Park

White House - President's Park in District of Columbia

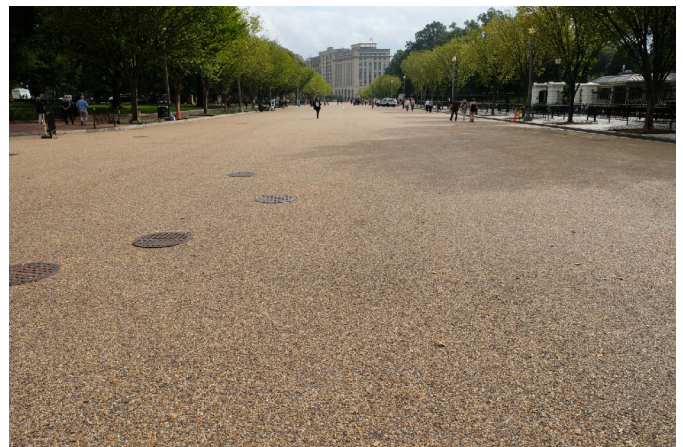
WHHO_0407_4852.JPG

Note: Middle section of exposed aggregate asphalt surface. Granite stone block sections on east and west end have some blocks with cracking (photo #3 on next page).

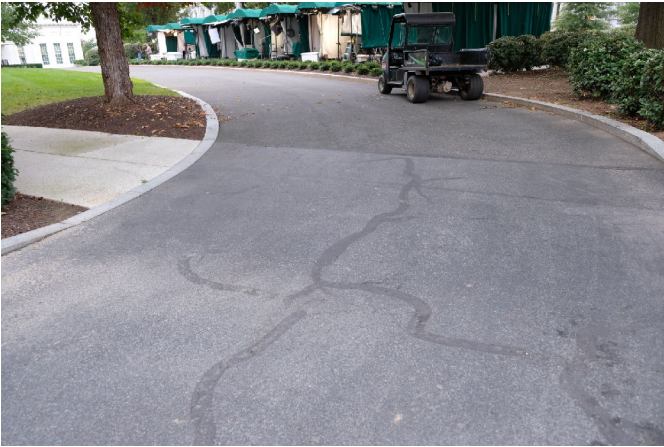
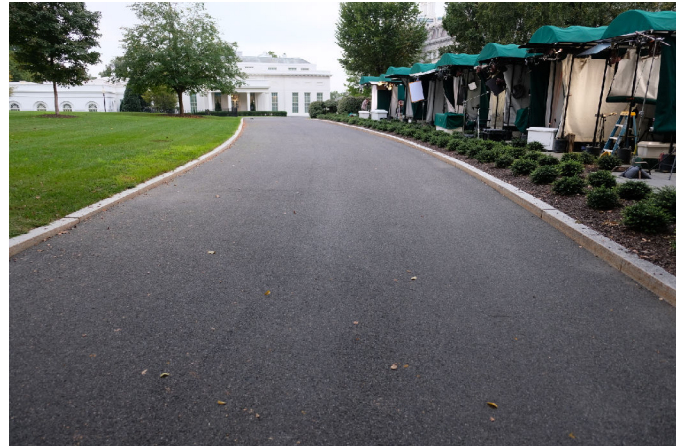
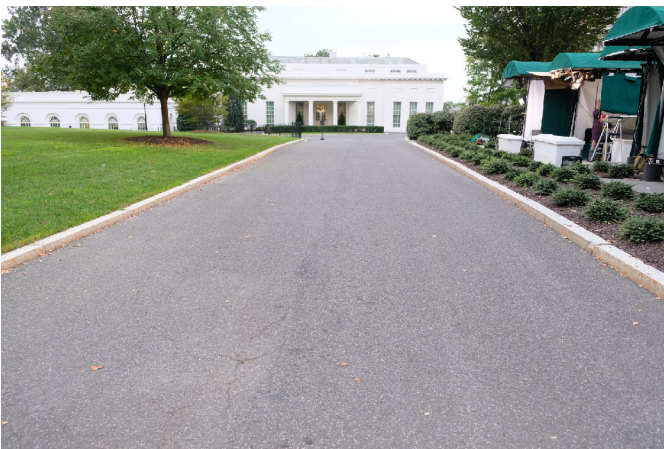
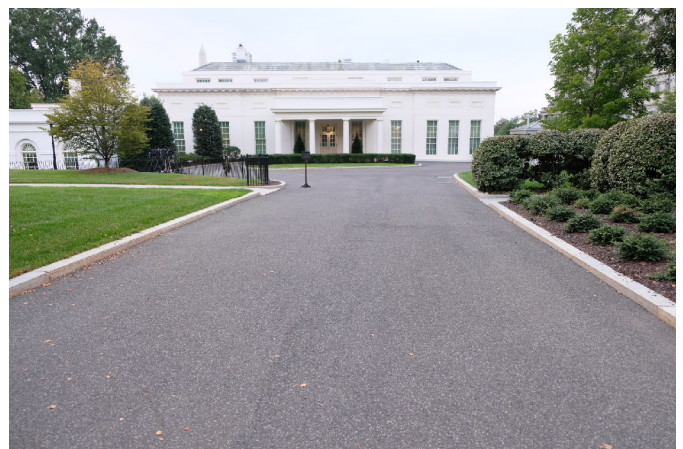
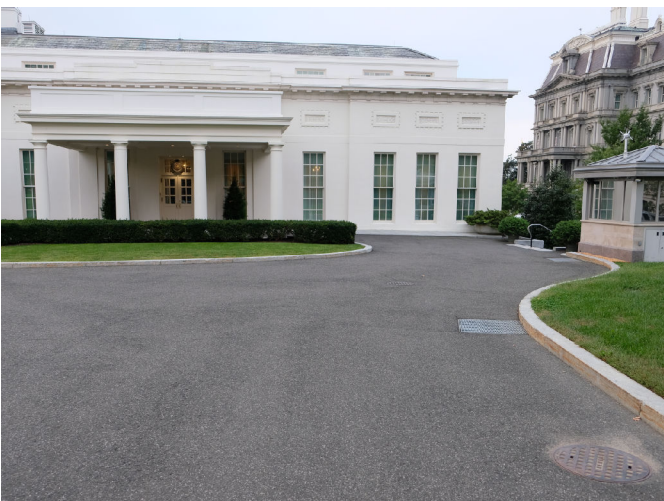
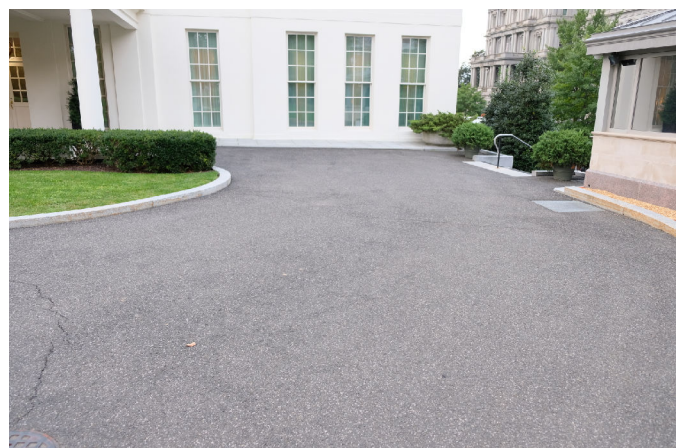
Inspection Date: 10/10/2018	Beginning Section MP	0.00				
Paved Length (Miles): 0.09	Section Length (MI)	0.09				
Surface Type: ASPHALT	Route Summary					
Roadway Condition Information						
Pavement Condition Rating (PCR)	90	90				
Surface Condition Rating (SCR)	90	90				
Roughness Condition Index (RCI)	N/A	N/A				
Distress Index Values						
Structural Crack Index	N/A	N/A				
Alligator Crack Index	97	97				
Longitudinal Crack Index	90	90				
Transverse Cracking Index	90	90				
Patching Index	97	97				
Rutting Index	97	97				
International Roughness Index (IRI)	N/A	N/A				
Lane & Width Information						
Number of Lanes	2	2				
Paved Width (ft)	22	22				
Lane Width (ft)	11	11

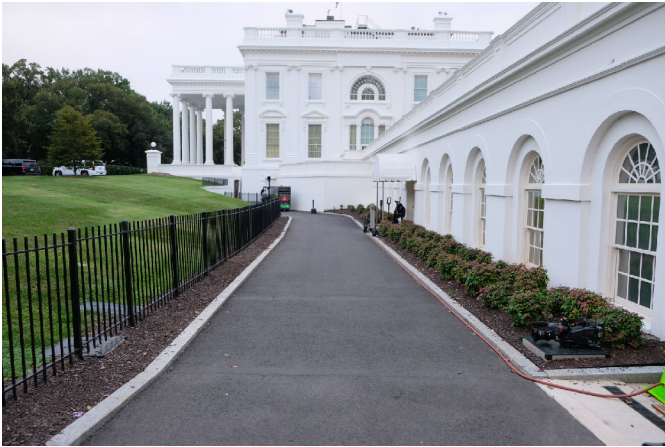
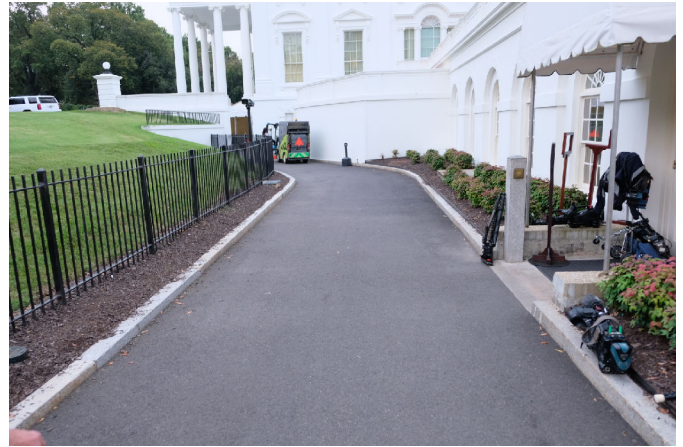
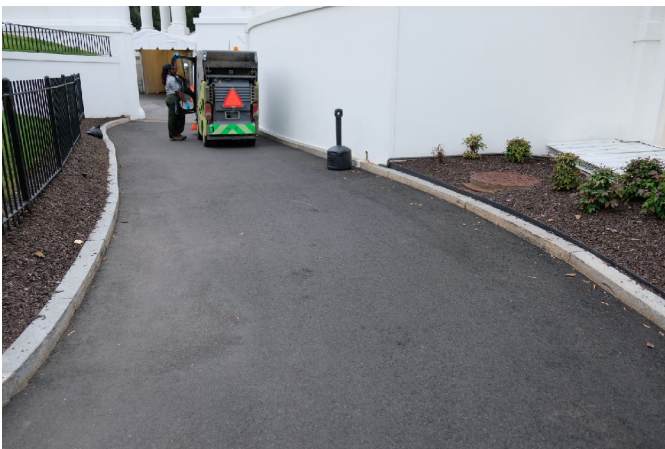
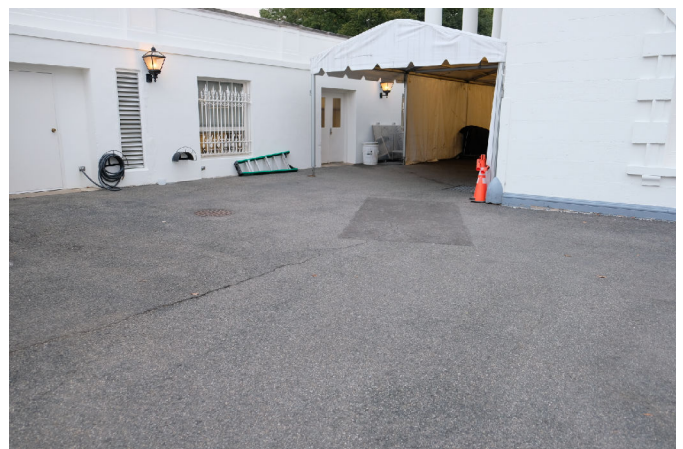
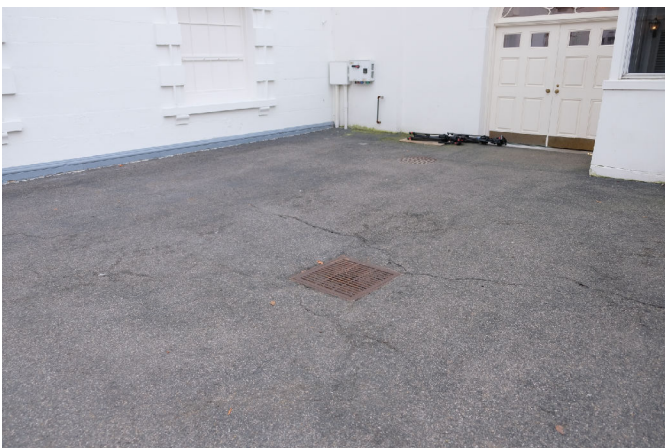
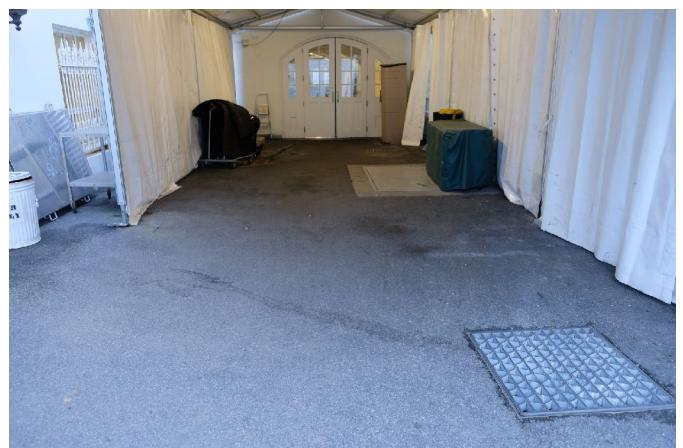
Route Condition Legend – Pavement Condition Rating (PCR)						
Poor (0 - 60)	Fair (61- 84)	Good (85 - 94)	Excellent (95 - 100)	Not Rated		
See Appendix for definitions and formulas						
Inspection Date: 10/10/2018	Beginning Section MP	0.00				
Paved Length (Miles): 0.06	Section Length (MI)	0.06				
Surface Type: ASPHALT	Route Summary					
Roadway Condition Information						
Pavement Condition Rating (PCR)	90	90				
Surface Condition Rating (SCR)	90	90				
Roughness Condition Index (RCI)	N/A	N/A				
Distress Index Values						
Structural Crack Index	N/A	N/A				
Alligator Crack Index	97	97				
Longitudinal Crack Index	97	97				
Transverse Cracking Index	90	90				
Patching Index	90	90				
Rutting Index	97	97				
International Roughness Index (IRI)	N/A	N/A				
Lane & Width Information						
Number of Lanes	1	1				
Paved Width (ft)	12.5	12.5				
Lane Width (ft)	12.5	12.5

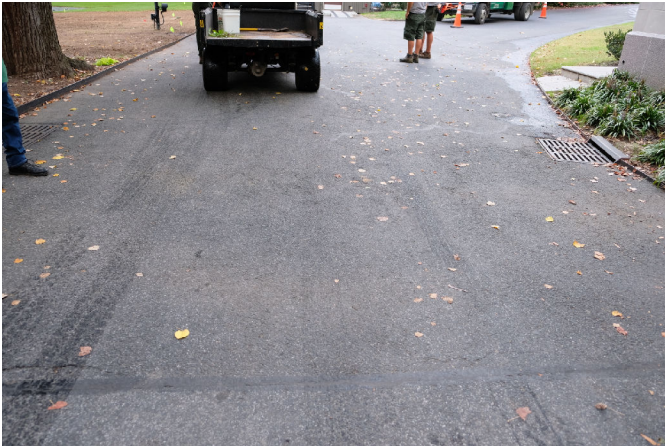
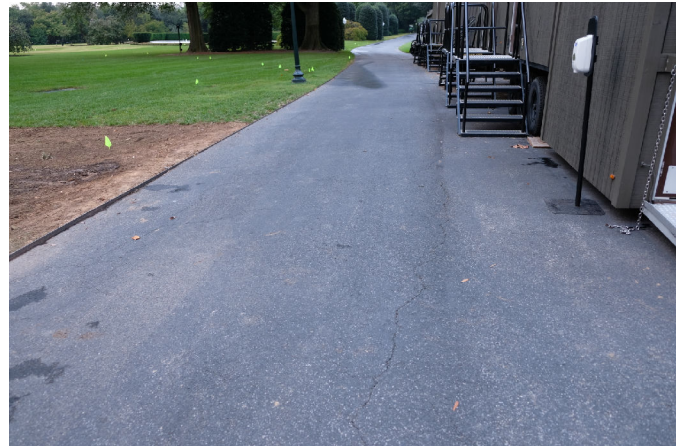
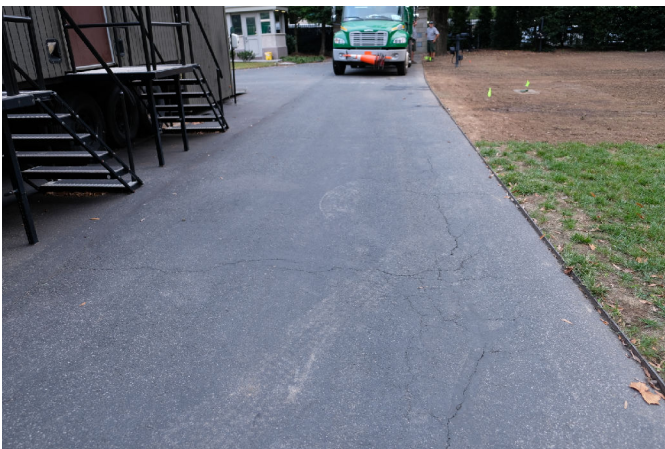
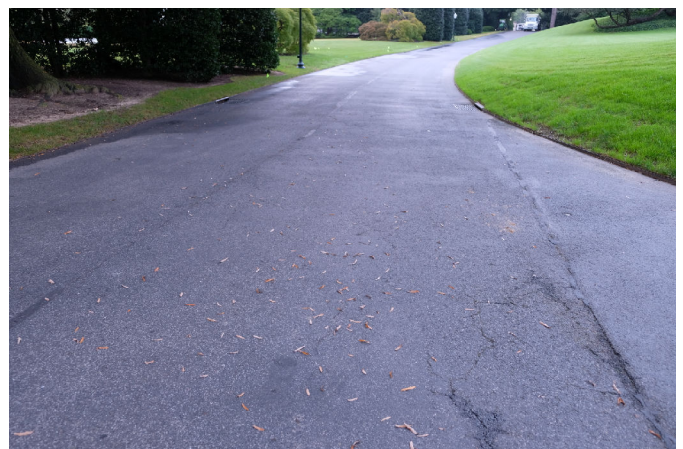
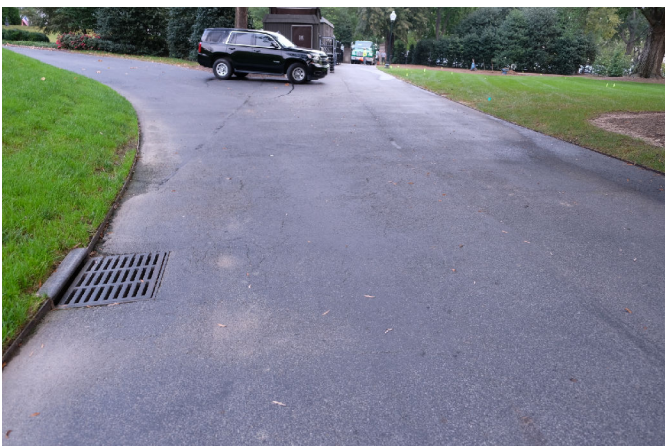
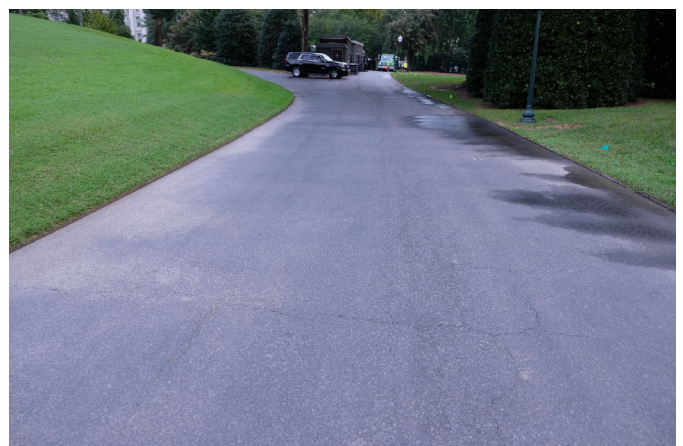
Inspection Date:	10/10/2018	Beginning Section MP	0.00				
Paved Length (Miles):	0.16	Section Length (MI)	0.16				
Surface Type:	ASPHALT	Route Summary					
Roadway Condition Information							
Pavement Condition Rating (PCR)		90	90				
Surface Condition Rating (SCR)		90	90				
Roughness Condition Index (RCI)		N/A	N/A				
Distress Index Values							
Structural Crack Index		N/A	N/A				
Alligator Crack Index		90	90				
Longitudinal Crack Index		90	90				
Transverse Cracking Index		90	90				
Patching Index		90	90				
Rutting Index		97	97				
International Roughness Index (IRI)		N/A	N/A				
Lane & Width Information							
Number of Lanes		2	2				
Paved Width (ft)		20	20				
Lane Width (ft)		10	10

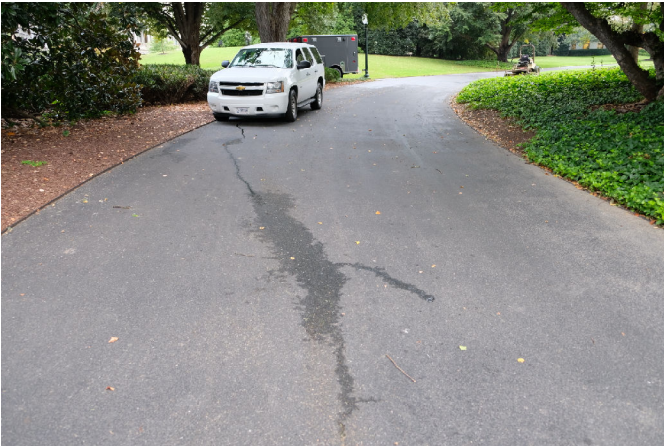
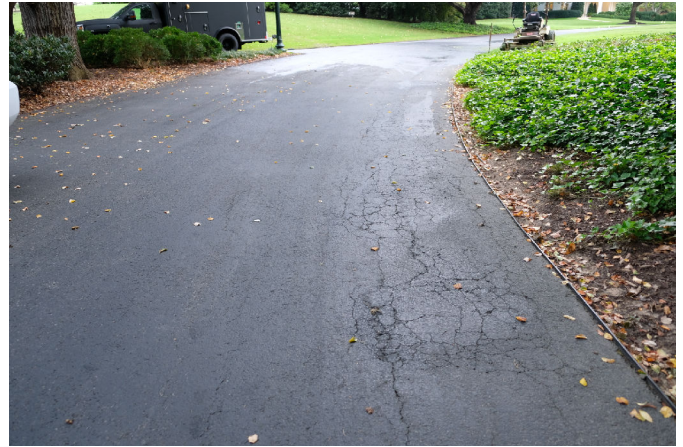
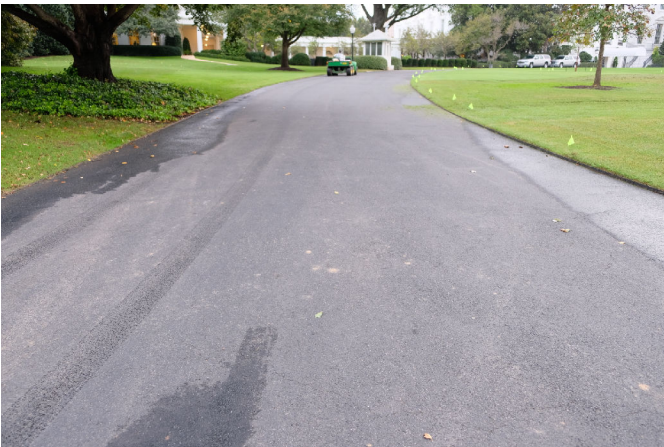
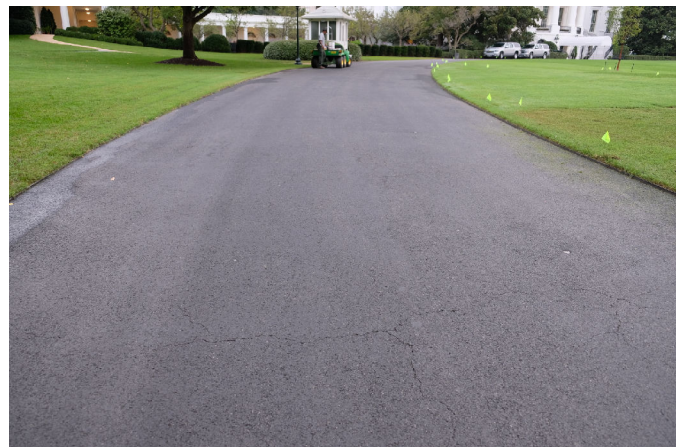
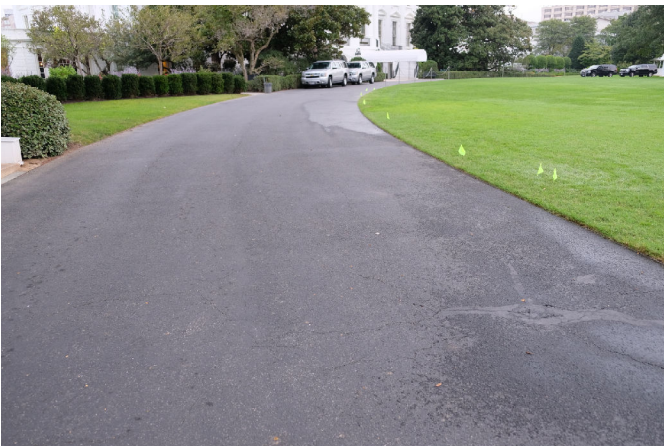
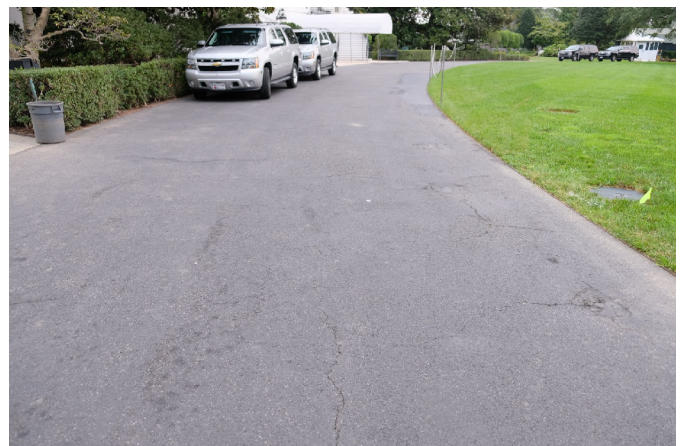
Inspection Date: 10/10/2018	Beginning Section MP	0.00				
Paved Length (Miles): 0.19	Section Length (MI)	0.19				
Surface Type: ASPHALT	Route Summary					
Roadway Condition Information						
Pavement Condition Rating (PCR)	73	73				
Surface Condition Rating (SCR)	73	73				
Roughness Condition Index (RCI)	N/A	N/A				
Distress Index Values						
Structural Crack Index	N/A	N/A				
Alligator Crack Index	73	73				
Longitudinal Crack Index	90	90				
Transverse Cracking Index	90	90				
Patching Index	90	90				
Rutting Index	90	90				
International Roughness Index (IRI)	N/A	N/A				
Lane & Width Information						
Number of Lanes	2	2				
Paved Width (ft)	20.3	20.3				
Lane Width (ft)	10.1	10.1

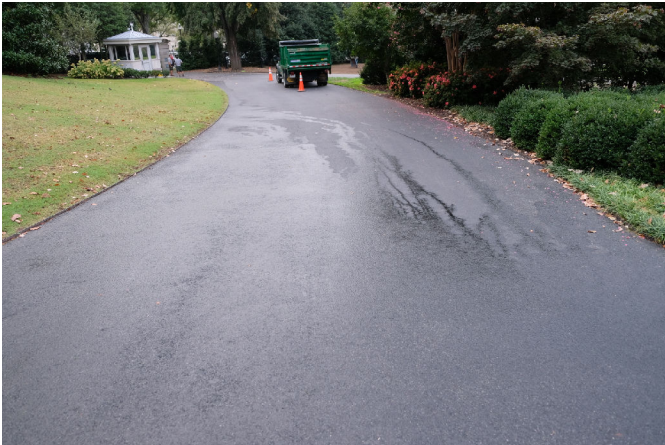
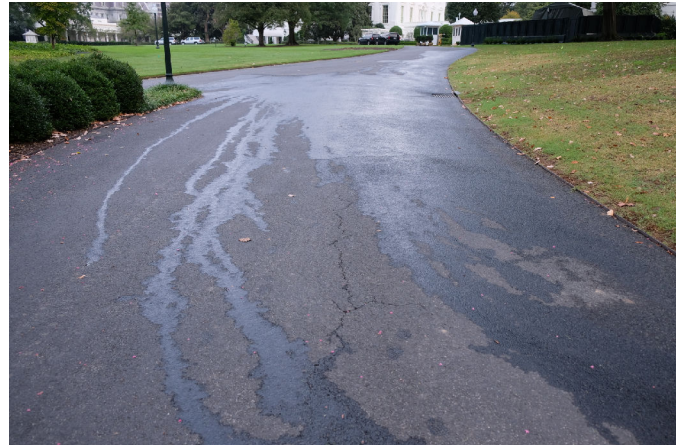
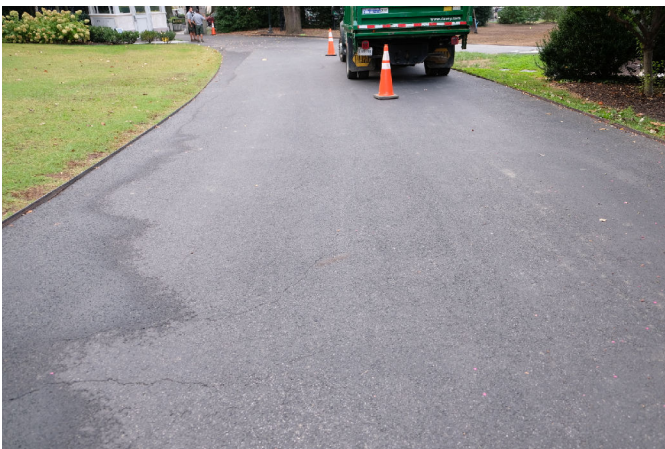
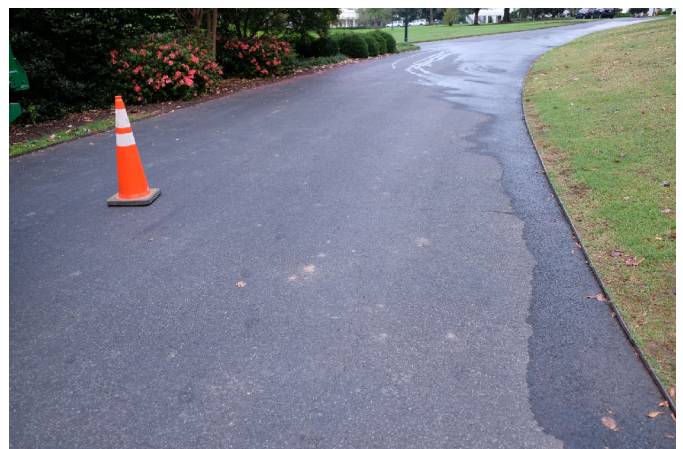
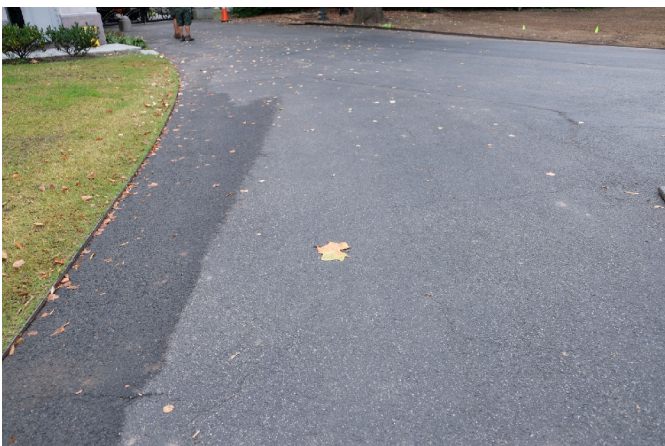
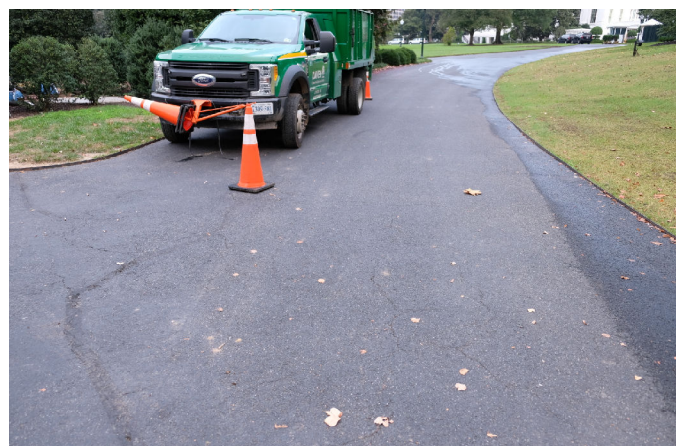
Route Condition Legend – Pavement Condition Rating (PCR)						
Poor (0 - 60)		Fair (61- 84)		Good (85 - 94)		Excellent (95 - 100)
Not Rated						
See Appendix for definitions and formulas						
Inspection Date:	10/10/2018	Beginning Section MP	0.00			
Paved Length (Miles):	0.04	Section Length (MI)	0.04			
Surface Type:	ASPHALT	Route Summary				
Roadway Condition Information						
Pavement Condition Rating (PCR)		90	90			
Surface Condition Rating (SCR)		90	90			
Roughness Condition Index (RCI)		N/A	N/A			
Distress Index Values						
Structural Crack Index		N/A	N/A			
Alligator Crack Index		97	97			
Longitudinal Crack Index		97	97			
Transverse Cracking Index		90	90			
Patching Index		97	97			
Rutting Index		97	97			
International Roughness Index (IRI)		N/A	N/A			
Lane & Width Information						
Number of Lanes		2	2			
Paved Width (ft)		19	19			
Lane Width (ft)		9.5	9.5

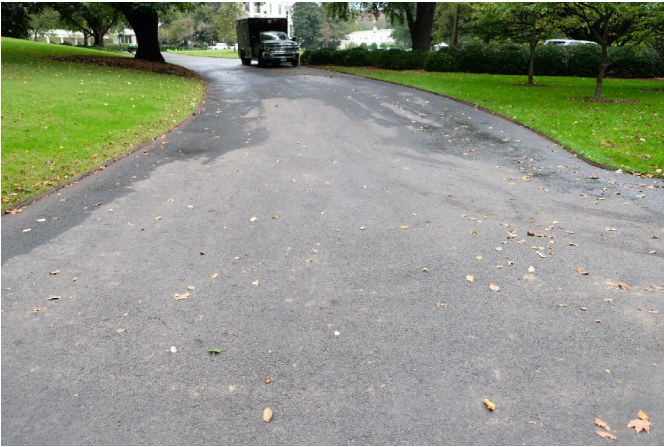
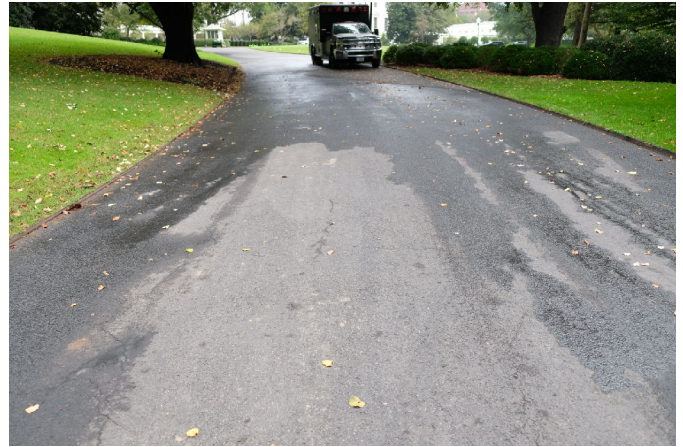
Route Condition Legend – Pavement Condition Rating (PCR)						
Poor (0 - 60)	Fair (61- 84)	Good (85 - 94)	Excellent (95 - 100)	Not Rated		
See Appendix for definitions and formulas						
Inspection Date: 10/10/2018	Beginning Section MP	0.00				
Paved Length (Miles): 0.04	Section Length (MI)	0.04				
Surface Type: ASPHALT	Route Summary					
Roadway Condition Information						
Pavement Condition Rating (PCR)	90	90				
Surface Condition Rating (SCR)	90	90				
Roughness Condition Index (RCI)	N/A	N/A				
Distress Index Values						
Structural Crack Index	N/A	N/A				
Alligator Crack Index	97	97				
Longitudinal Crack Index	97	97				
Transverse Cracking Index	90	90				
Patching Index	97	97				
Rutting Index	97	97				
International Roughness Index (IRI)	N/A	N/A				
Lane & Width Information						
Number of Lanes	2	2				
Paved Width (ft)	19	19				
Lane Width (ft)	9.5	9.5

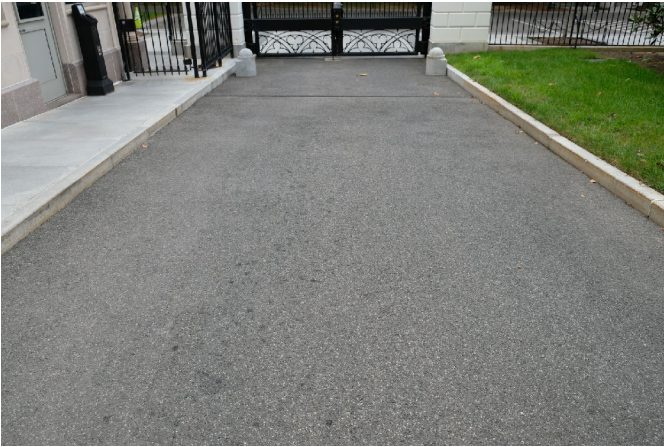
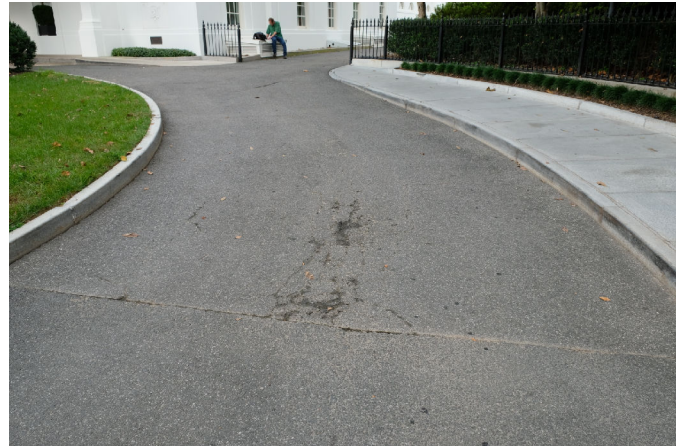
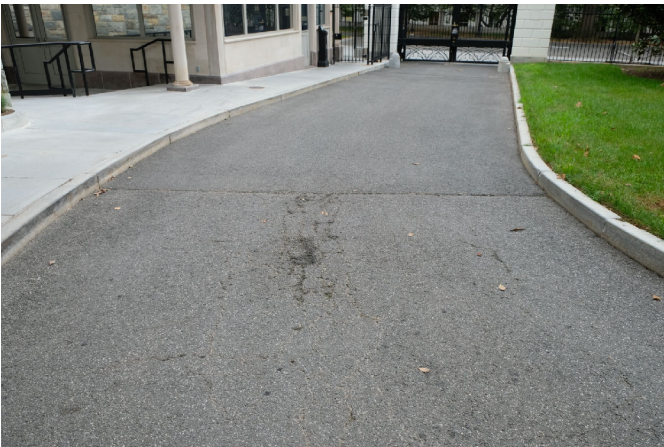
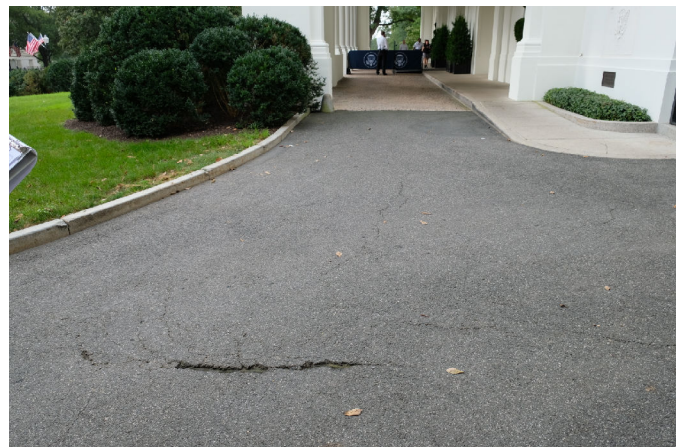
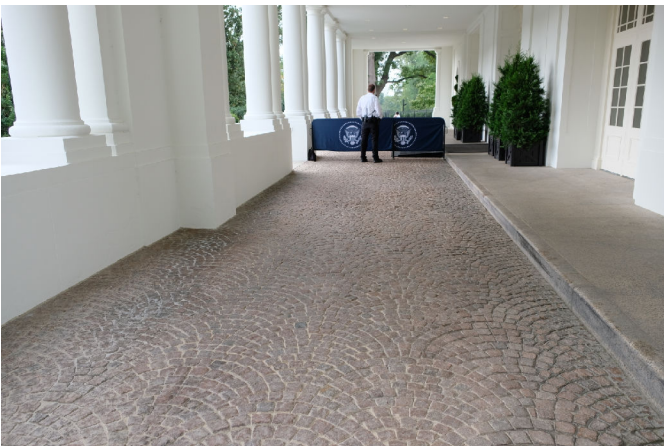
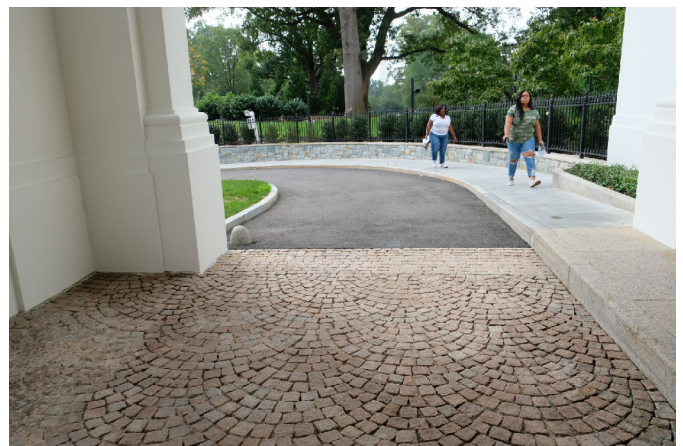
Note: Granite stone section in middle in very good condition.

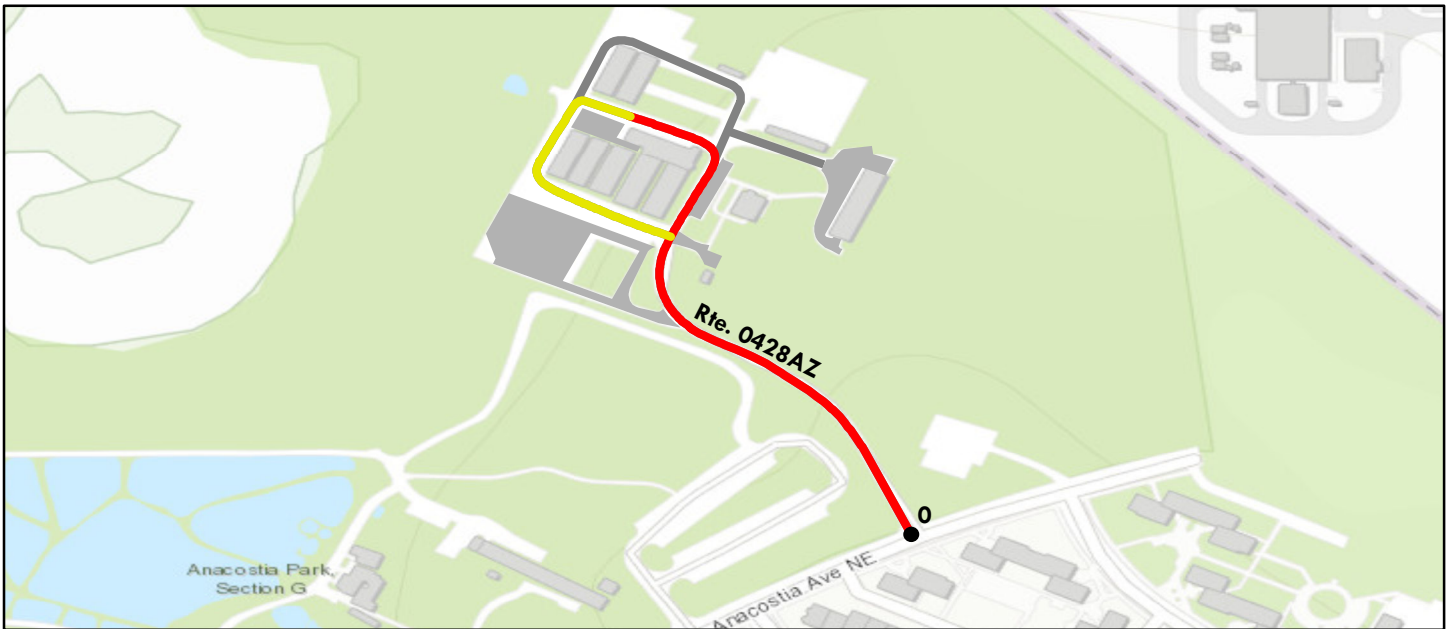
Inspection Date: 7/27/2018	Beginning Section MP	0				
Paved Length (Miles): 0.28	Section Length (MI)	0.28				
Surface Type: ASPHALT	Route Summary					
Roadway Condition Information						
Pavement Condition Rating (PCR)	17	17				
Surface Condition Rating (SCR)	17	17				
Roughness Condition Index (RCI)	N/A	N/A				
Distress Index Values						
Structural Crack Index	59	59				
Alligator Crack Index	97	97				
Longitudinal Crack Index	62	62				
Transverse Cracking Index	17	17				
Patching Index	99	99				
Rutting Index	88	88				
International Roughness Index (IRI)	N/A	N/A				
Lane & Width Information						
Number of Lanes	2	2				
Paved Width (ft)	17.1	17.1				
Lane Width (ft)	8.6	8.6

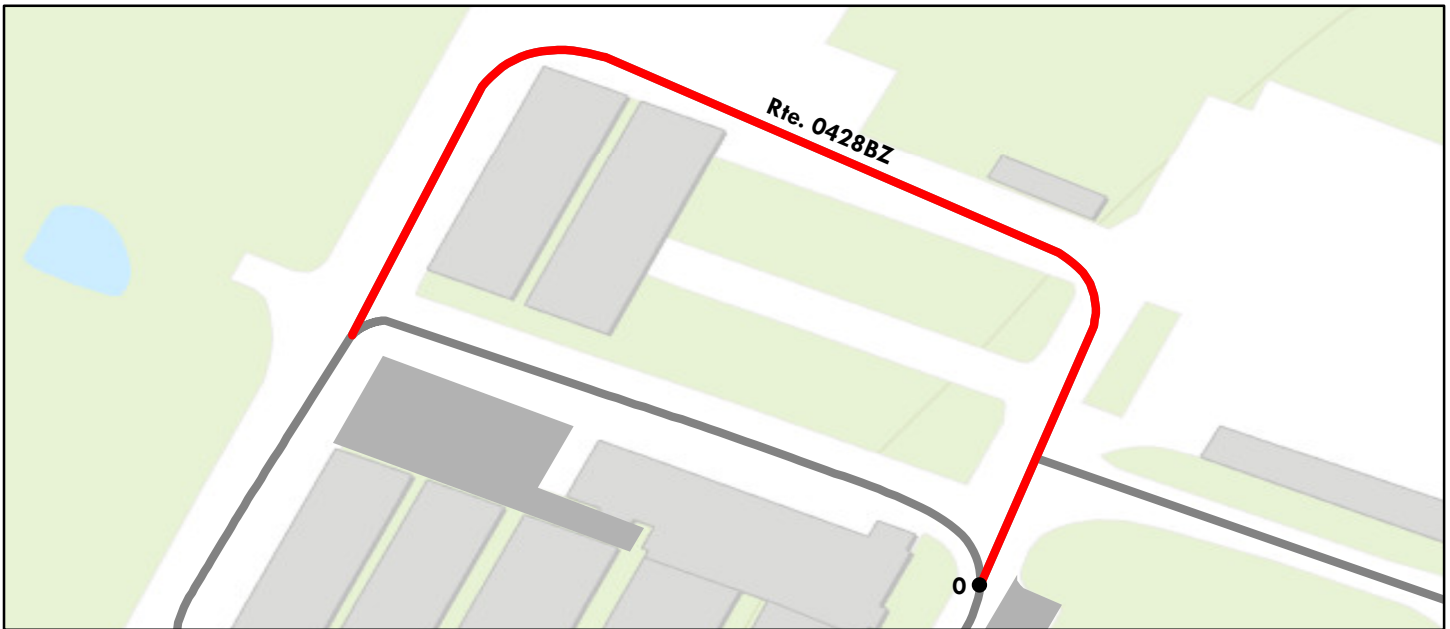
ROUTE 0428BZ: 110 - B

Inspection Date: 7/27/2018	Beginning Section MP	0				
Paved Length (Miles): 0.09	Section Length (MI)	0.09				
Surface Type: ASPHALT	Route Summary					
Roadway Condition Information						
Pavement Condition Rating (PCR)	54	54				
Surface Condition Rating (SCR)	54	54				
Roughness Condition Index (RCI)	N/A	N/A				
Distress Index Values						
Structural Crack Index	61	61				
Alligator Crack Index	91	91				
Longitudinal Crack Index	70	70				
Transverse Cracking Index	54	54				
Patching Index	100	100				
Rutting Index	94	94				
International Roughness Index (IRI)	N/A	N/A				
Lane & Width Information						
Number of Lanes	2	2				
Paved Width (ft)	23.3	23.3				
Lane Width (ft)	11.7	11.7

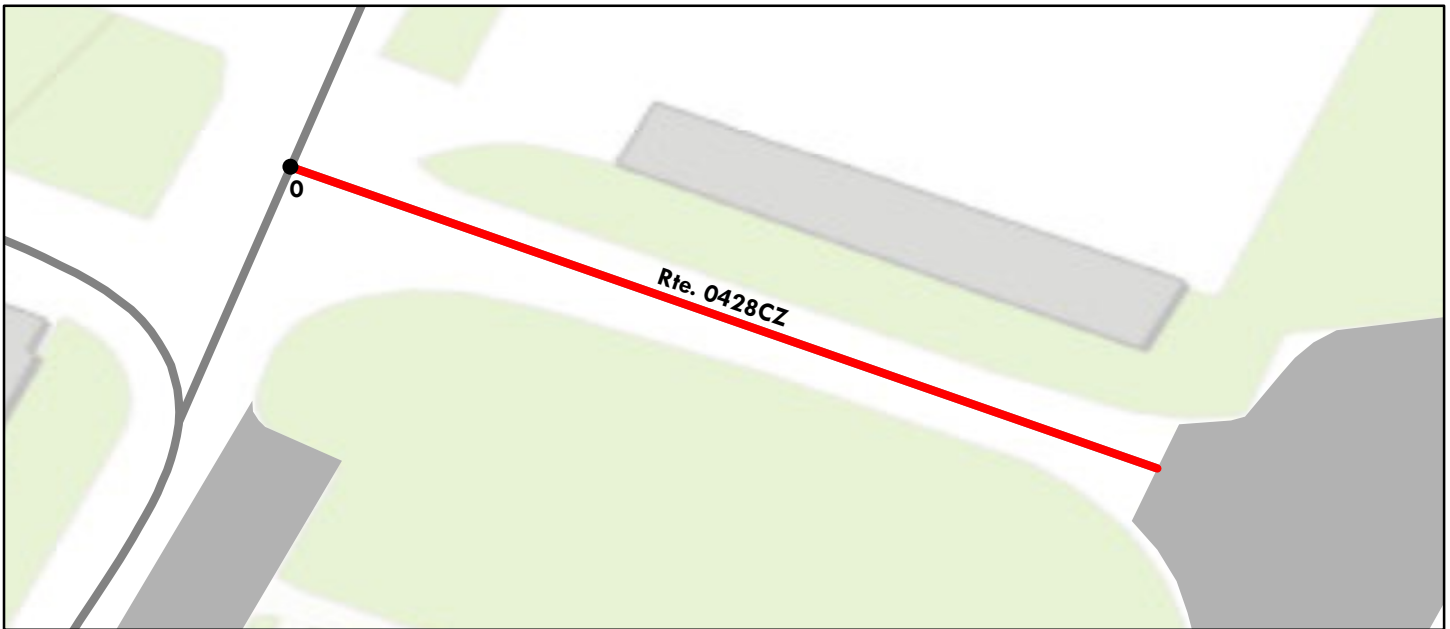
Inspection Date: 7/27/2018	Beginning Section MP	0				
Paved Length (Miles): 0.03	Section Length (MI)	0.03				
Surface Type: ASPHALT	Route Summary					
Roadway Condition Information						
Pavement Condition Rating (PCR)	57	57				
Surface Condition Rating (SCR)	57	57				
Roughness Condition Index (RCI)	N/A	N/A				
Distress Index Values						
Structural Crack Index	93	93				
Alligator Crack Index	100	100				
Longitudinal Crack Index	93	93				
Transverse Cracking Index	57	57				
Patching Index	100	100				
Rutting Index	98	98				
International Roughness Index (IRI)	N/A	N/A				
Lane & Width Information						
Number of Lanes	2	2				
Paved Width (ft)	14.8	14.8				
Lane Width (ft)	7.4	7.4

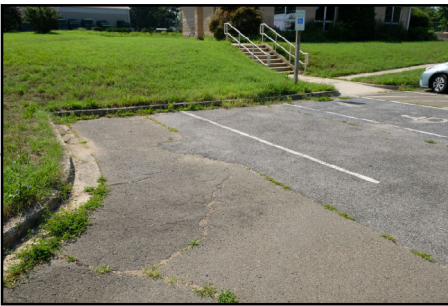
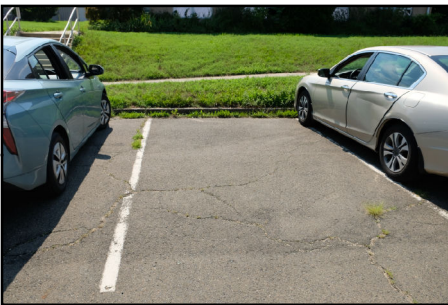
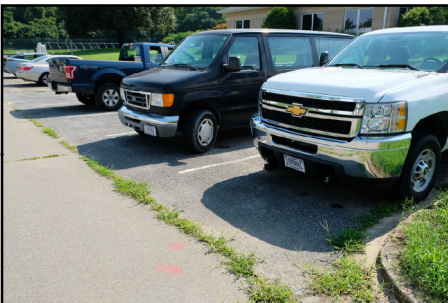
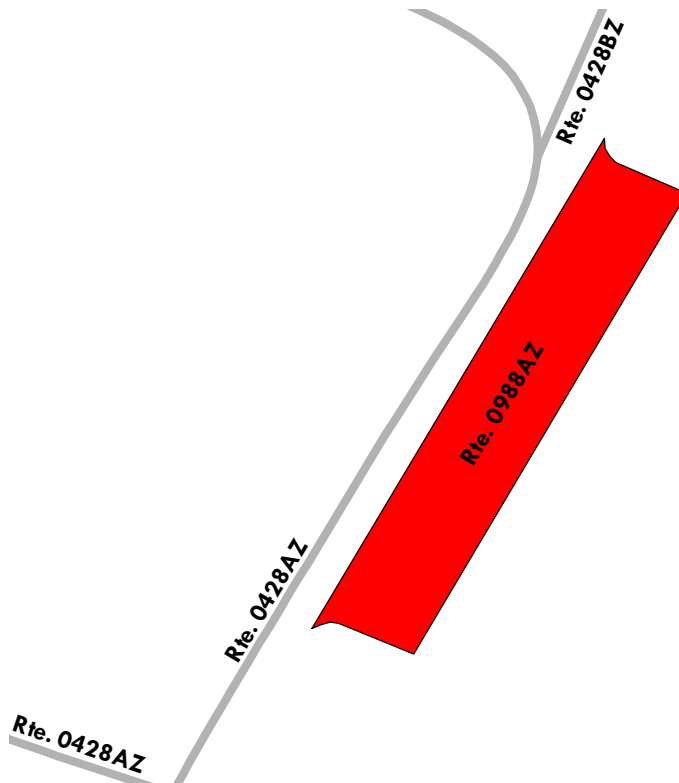
ROUTE 0988AZ: 115 - A

Inspection Date	FMSS Number	User Access	Surface Type
7/27/2018	241988	NONPUBLIC	ASPHALT
Area (Sq. Ft.)	Lane Miles (11' Widths)	Curb Reveal (Inches)	Curb Recommendation
2,348	0.04	NOT APPLICABLE	LIGHT REPAIR
Curb Type		Curb & Gutter Type	
NO CURB		CONCRETE	
Pavement Recommendation		Condition Rating / PCR	
HEAVY 3R TREATMENTS		POOR / 53

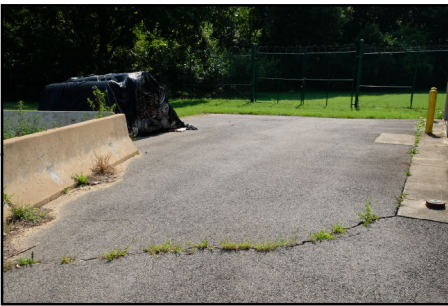
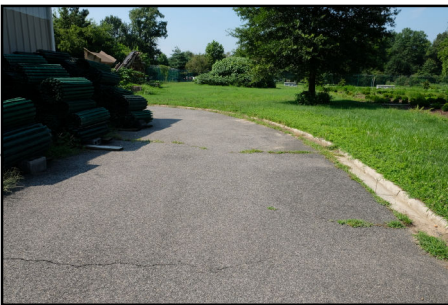
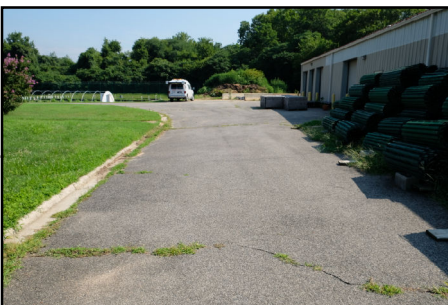
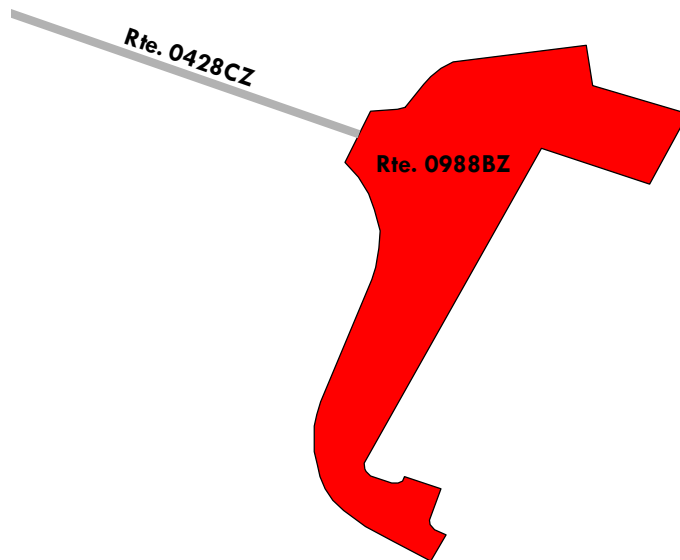
ROUTE 0988BZ: 115 - B

Inspection Date	FMSS Number	User Access	Surface Type
7/27/2018	241988	NONPUBLIC	ASPHALT
Area (Sq. Ft.)	Lane Miles (11' Widths)	Curb Reveal (Inches)	Curb Recommendation
8,469	0.146	NOT APPLICABLE	DO NOTHING
Curb Type		Curb & Gutter Type	
NO CURB		CONCRETE	
Pavement Recommendation		Condition Rating / PCR	
HEAVY 3R TREATMENTS		POOR / 53

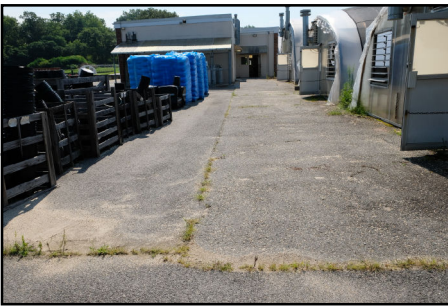
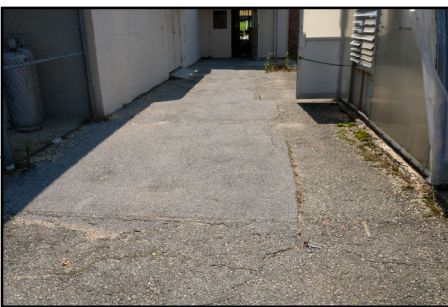
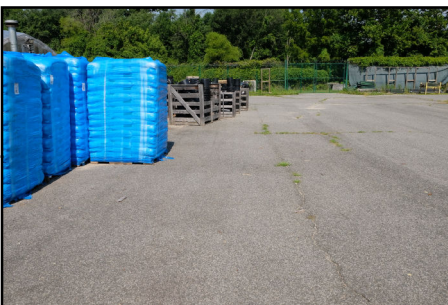
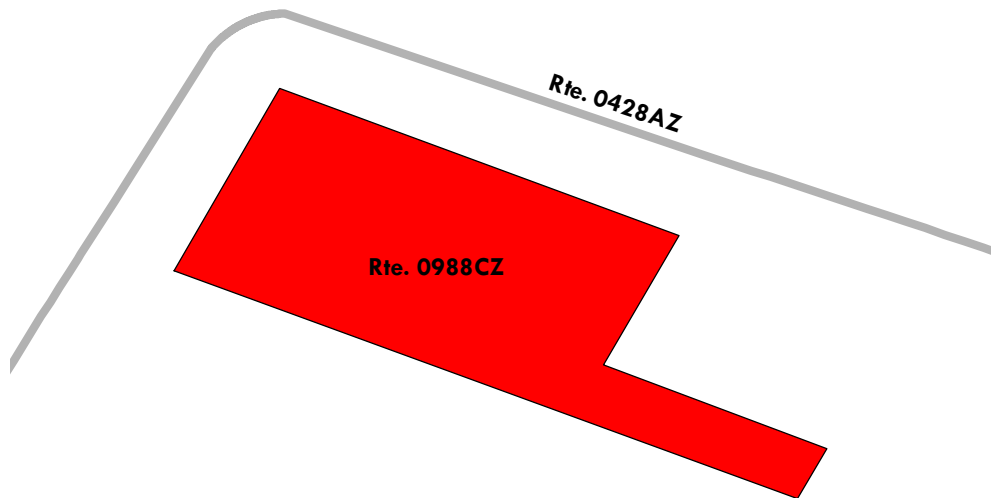
ROUTE 0988CZ: 115 - C

Inspection Date	FMISS Number	User Access	Surface Type
7/27/2018	241988	NONPUBLIC	ASPHALT
Area (Sq. Ft.)	Lane Miles (11' Widths)	Curb Reveal (Inches)	Curb Recommendation
3,396	0.058	NOT APPLICABLE	NOT APPLICABLE
Curb Type		Curb & Gutter Type	
NO CURB		NO CURB AND GUTTER	
Pavement Recommendation		Condition Rating / PCR	
HEAVY 3R TREATMENTS		POOR / 53

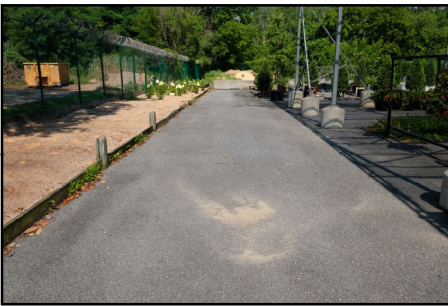
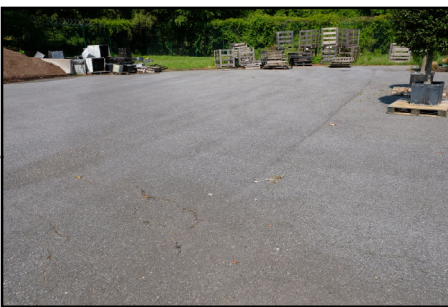
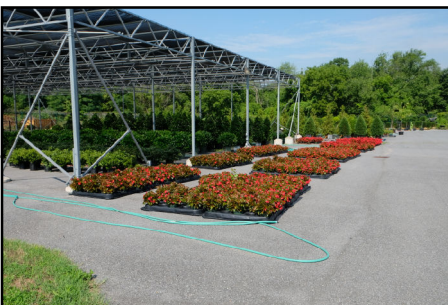
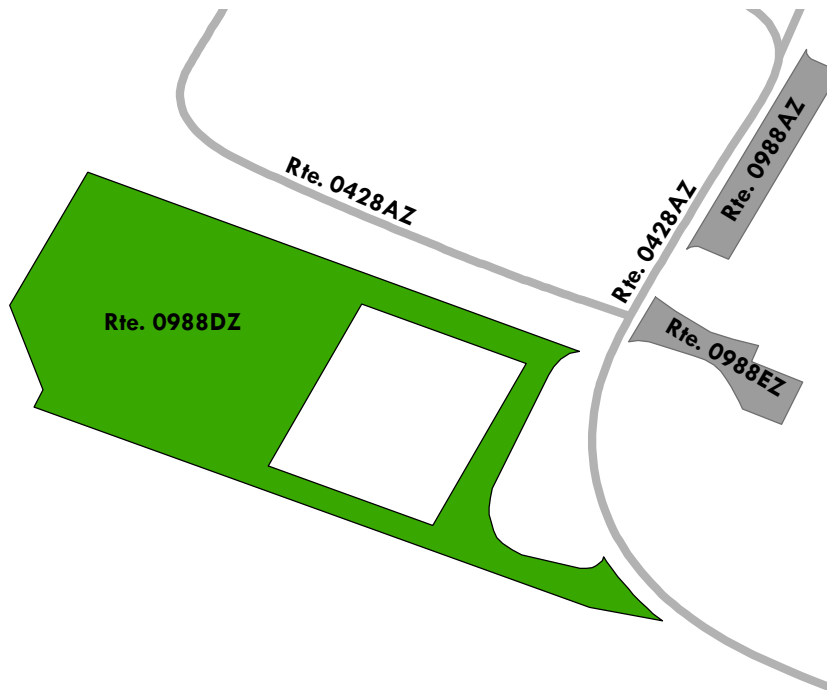
ROUTE 0988DZ: 115 - D

Inspection Date	FMISS Number	User Access	Surface Type
7/27/2018	241988	NONPUBLIC	ASPHALT
Area (Sq. Ft.)	Lane Miles (11' Widths)	Curb Reveal (Inches)	Curb Recommendation
24,674	0.425	NOT APPLICABLE	NOT APPLICABLE
Curb Type		Curb & Gutter Type	
NO CURB		NO CURB AND GUTTER	
Pavement Recommendation		Condition Rating / PCR	
PREVENTIVE MAINTENANCE		GOOD / 90

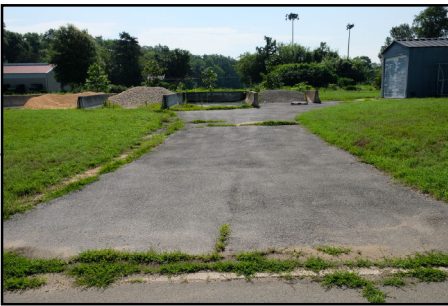
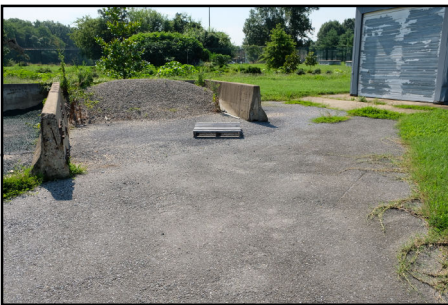
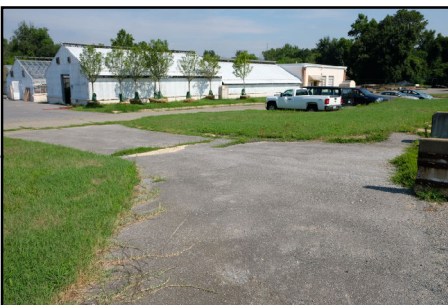
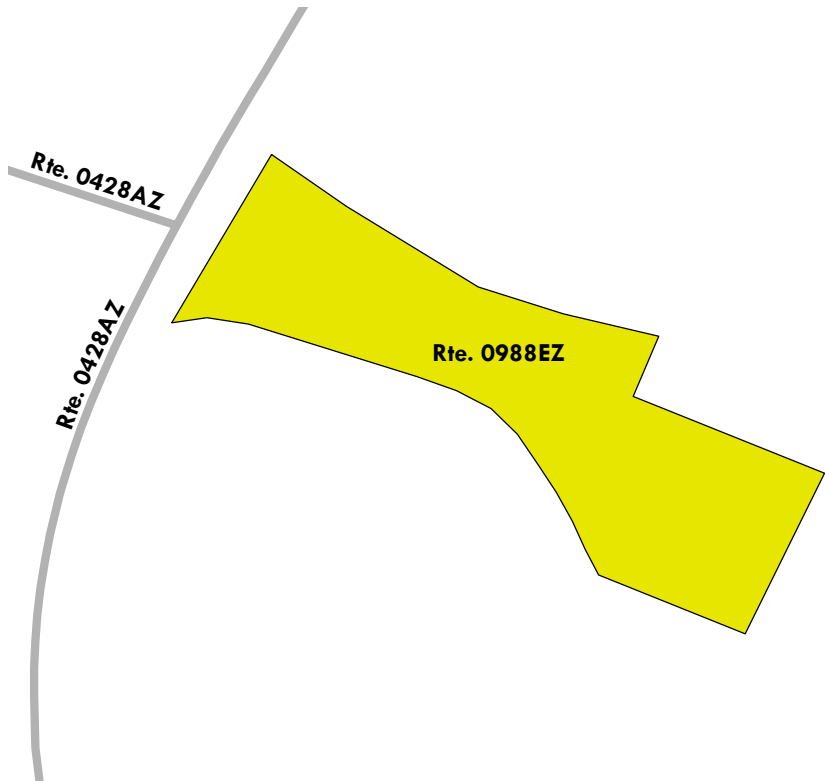
ROUTE 0988EZ: 115 - E

Inspection Date	FMISS Number	User Access	Surface Type
7/27/2018	241988	NONPUBLIC	ASPHALT
Area (Sq. Ft.)	Lane Miles (11' Widths)	Curb Reveal (Inches)	Curb Recommendation
1,806	0.031	NOT APPLICABLE	NOT APPLICABLE
Curb Type		Curb & Gutter Type	
NO CURB		NO CURB AND GUTTER	
Pavement Recommendation		Condition Rating / PCR	
LIGHT 3R TREATMENTS		FAIR / 73
