BAWA WIP Report

NPS Retaining Wall Inventory Program Baltimore - Washington Parkway National Capital

Federal Highway Administration
Eastern Federal Lands Highway Division
Road Inventory Program (RIP)

Data Collection Date: August 2007
Report Date: October 2015

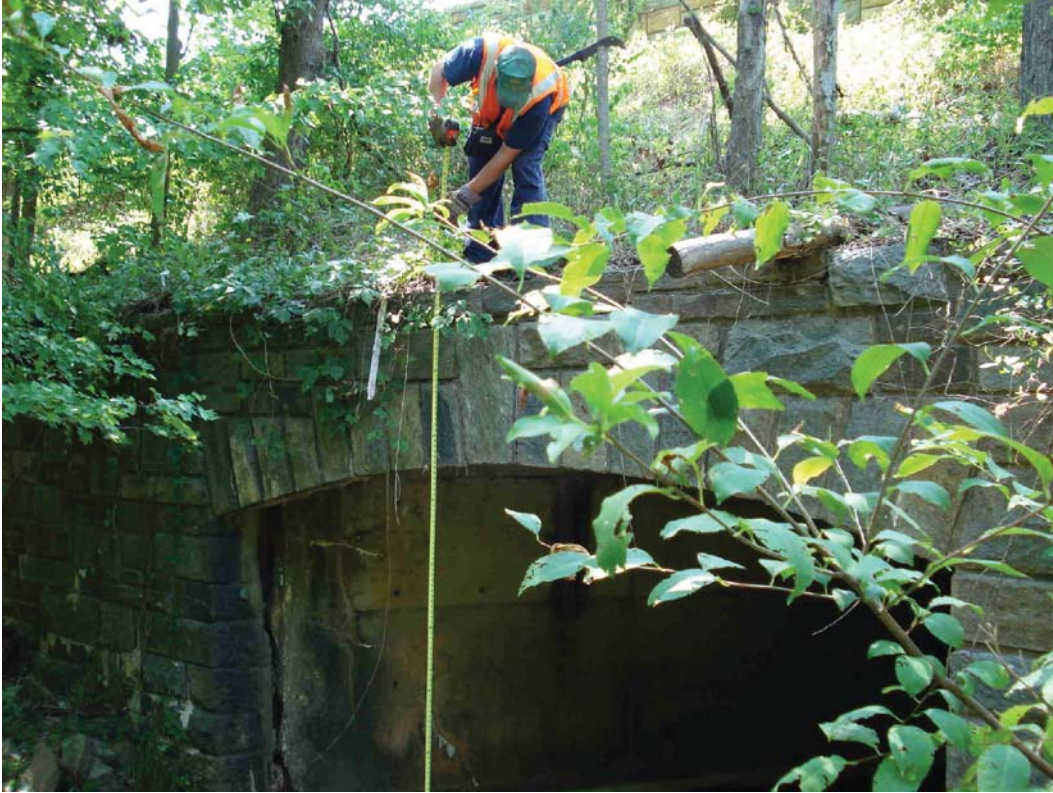
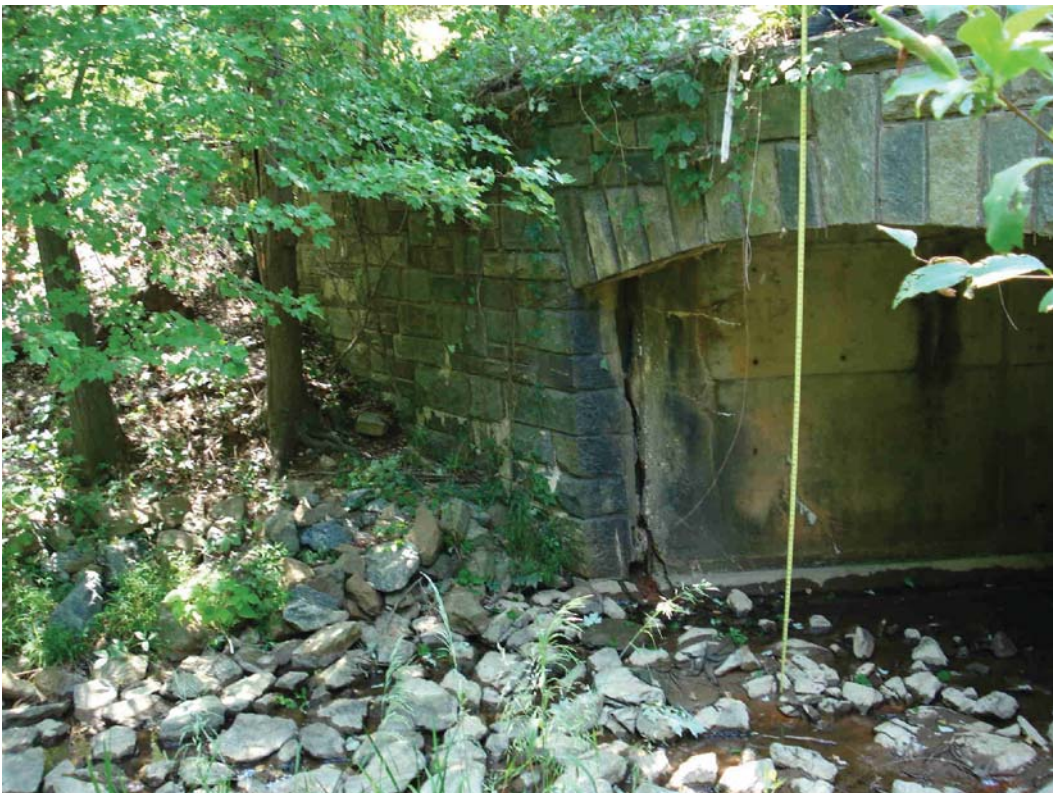
Wall ID:	BAWA-0001-10.000-R		
Route Name:	BALTIMORE-WASHINGTON PARKWAY (NB)		
Inspection Date:	August 14, 2007	Approximate Year Built:	1965
*Wall Rating:	71	Maintenance Action:	Repair Elements
Wall Description			
Wall Function:	Head Wall	Primary Wall Type:	Gravity - Mortared Stone
Surface Treatment:		Secondary Wall Type:	
Secondary Surface Treatment:		Architectural Facing:	
General Description:	Stone masonry headwall for 7.5 ft x 15 ft concrete box culvert constructed along right shoulder and along base of embankment supporting a high ADT roadway moderate consequence of failure		
Wall Measurements			
Wall Length (ft.):	60	Face Area (sq.):	376
Average Wall Height (ft.):	6	Face Angle (deg.):	90
Maximum Wall Height (ft.):	10	Vertical Offset (ft.):	-10
Assessed Elements			
Element (Weighting Factor)	Narrative		Condition Rating (0 - 10)
PERFORMANCE 8.00	Fair condition; wall has rotated forward about its base; moderate cracking and debonding of mortar at wall/culvert interface		6

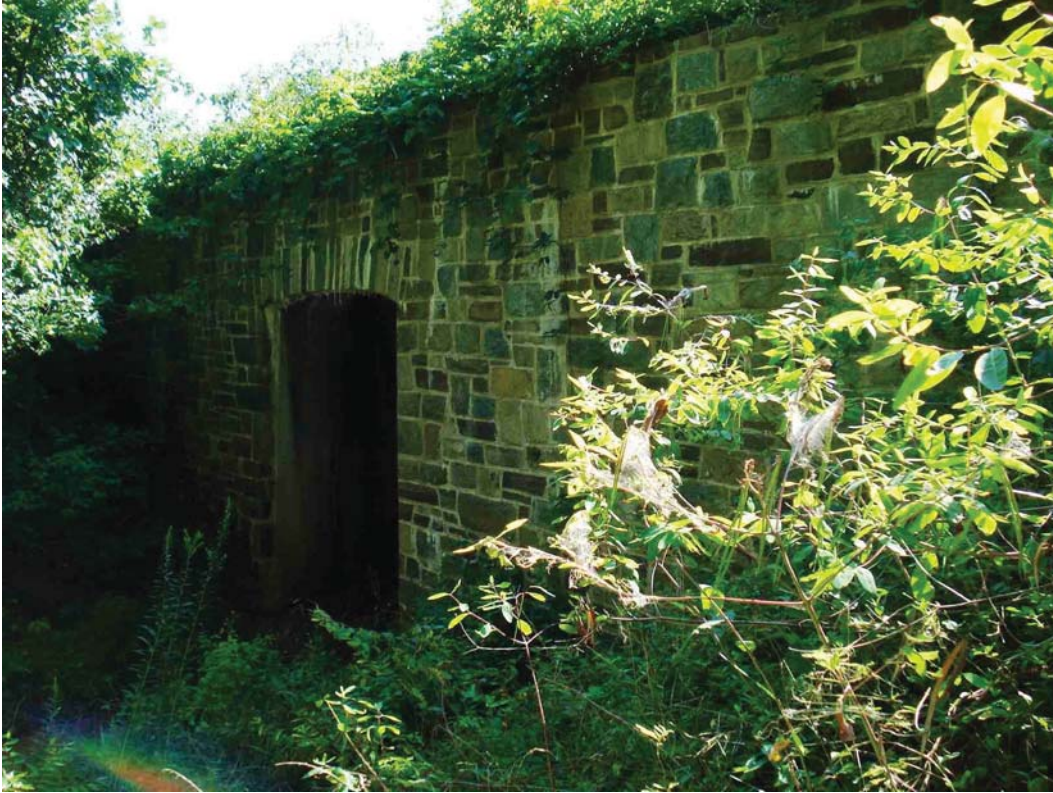
BAWA_0002_0.483_R_1.jpg

Wall ID:	BAWA-0002-0.483-R		
Route Name:	BALTIMORE-WASHINGTON PARKWAY (SB)		
Inspection Date:	August 14, 2007	Approximate Year Built:	1965
*Wall Rating:	90	Maintenance Action:	Maintenance
Wall Description			
Wall Function:	Head Wall	Primary Wall Type:	Gravity - Mortared Stone
Surface Treatment:		Secondary Wall Type:	
Secondary Surface Treatment:		Architectural Facing:	
General Description:	Stone masonry inlet headwall for 10 ft x 12 ft concrete box culvert constructed along right shoulder and directly supports a high ADT roadway high consequence of failure due to size and proximity to roadway		
Wall Measurements			
Wall Length (ft.):	81	Face Area (sq.):	396
Average Wall Height (ft.):	4	Face Angle (deg.):	90
Maximum Wall Height (ft.):	14	Vertical Offset (ft.):	0
Assessed Elements			
Element (Weighting Factor)	Narrative		Condition Rating (0 - 10)
PERFORMANCE 8.00	Good condition; evidence of possible leak from catch basin at along roadway; minor to moderate efflorescence inside culvert		8

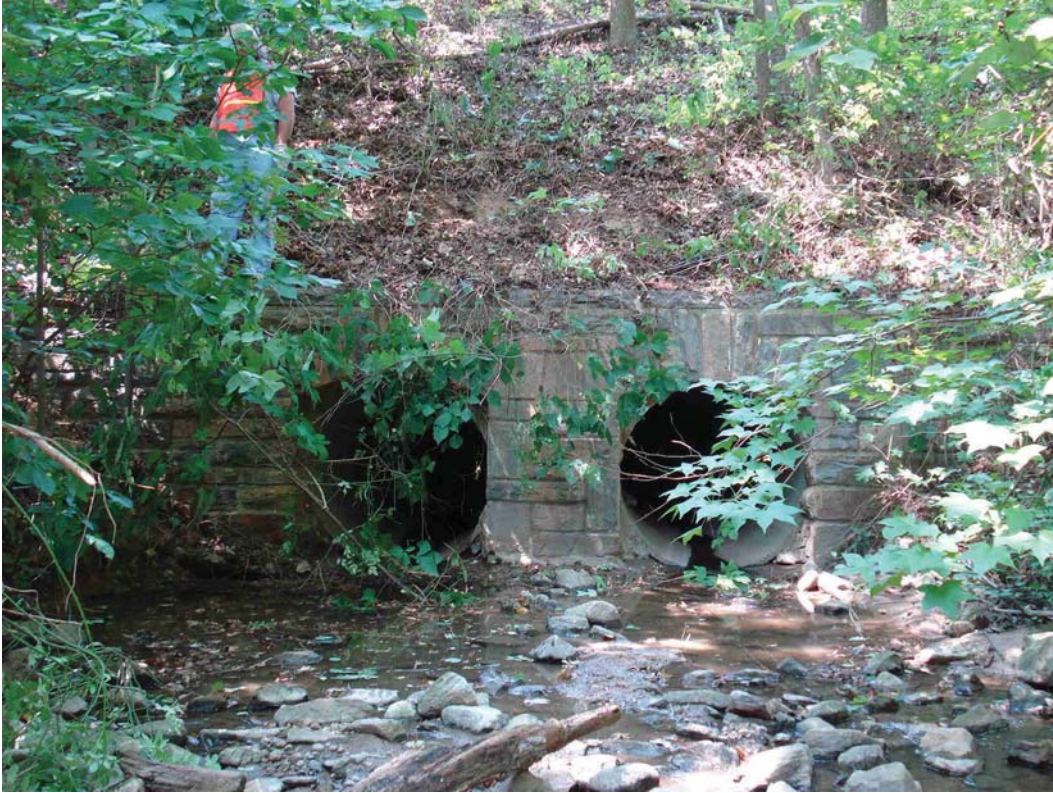
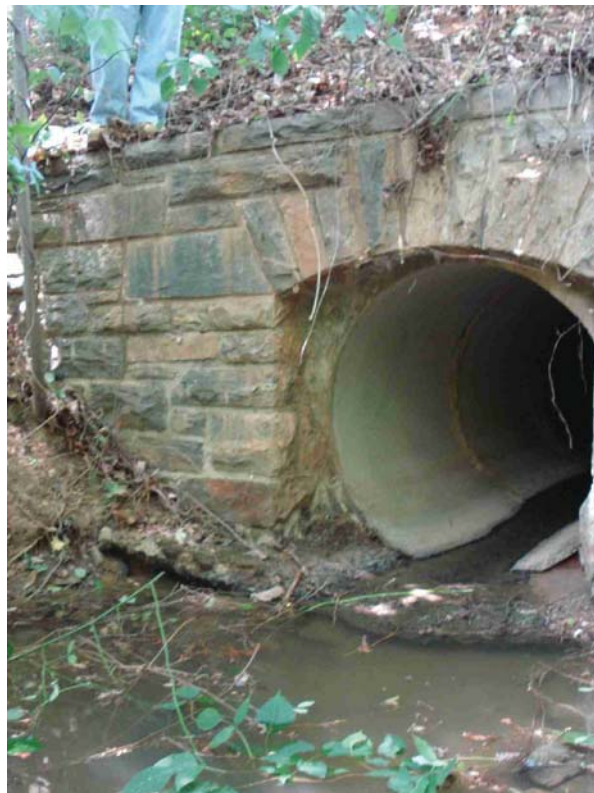
Wall ID:	BAWA-0002-4.066-L		
Route Name:	BALTIMORE-WASHINGTON PARKWAY (SB)		
Inspection Date:	August 14, 2007	Approximate Year Built:	1965
*Wall Rating:	81	Maintenance Action:	Maintenance
Wall Description			
Wall Function:	Head Wall	Primary Wall Type:	Gravity - Mortared Stone
Surface Treatment:		Secondary Wall Type:	
Secondary Surface Treatment:		Architectural Facing:	
General Description:	Stone masonry outlet headwall for two 48 in diameter concrete pipe culverts constructed along left shoulder and along base of a steep embankment supporting a high ADT roadway low consequence of failure		
Wall Measurements			
Wall Length (ft.):	26	Face Area (sq.):	90
Average Wall Height (ft.):	3	Face Angle (deg.):	90
Maximum Wall Height (ft.):	6	Vertical Offset (ft.):	-18
Assessed Elements			
Element (Weighting Factor)	Narrative	Condition Rating (0 - 10)	
PERFORMANCE 8.00	Good condition; scour hole at outlet is causing foundation undermining and threatens the long-term stability of wall	7

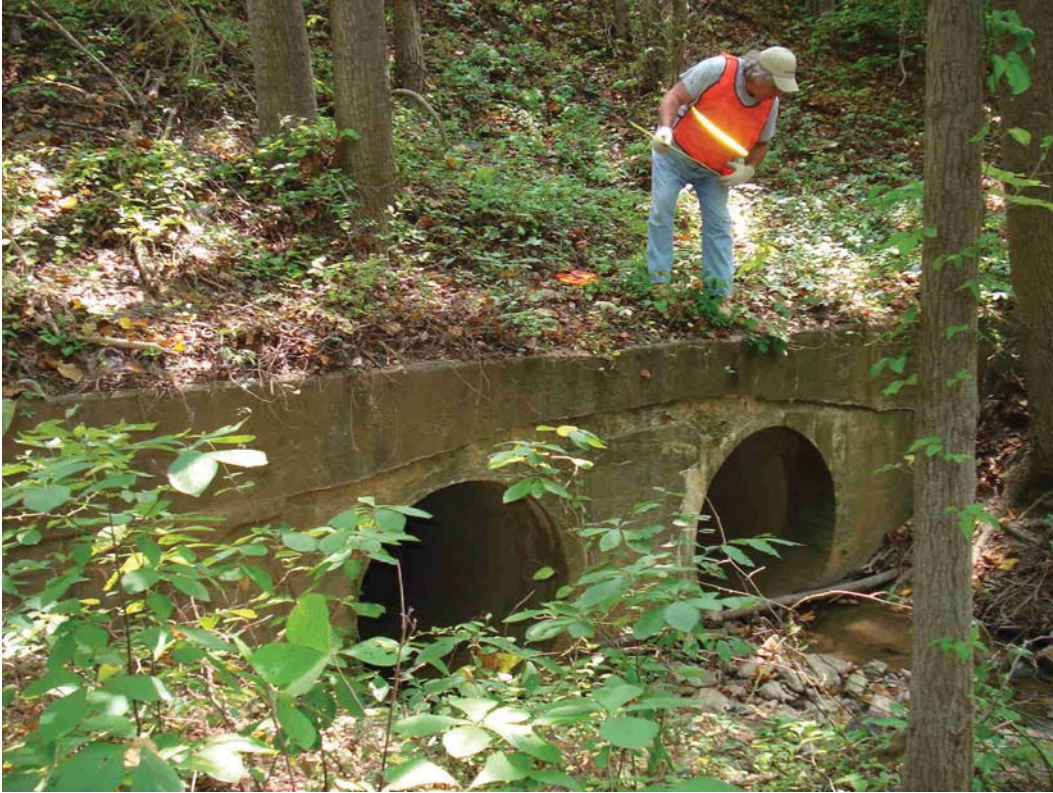
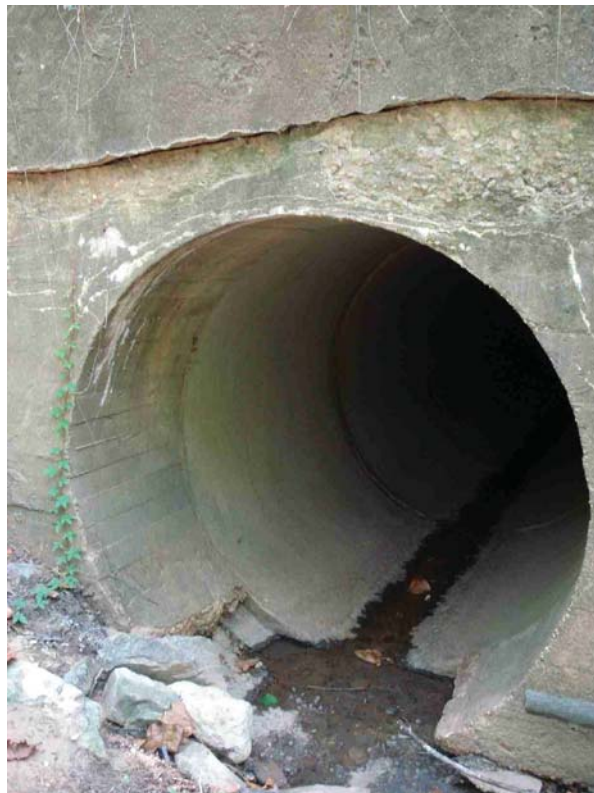
Wall ID:	BAWA-0002-4.066-R		
Route Name:	BALTIMORE-WASHINGTON PARKWAY (SB)		
Inspection Date:	August 14, 2007	Approximate Year Built:	1965
*Wall Rating:	76	Maintenance Action:	Repair Elements
Wall Description			
Wall Function:	Head Wall	Primary Wall Type:	Gravity - Mass Concrete
Surface Treatment:		Secondary Wall Type:	
Secondary Surface Treatment:		Architectural Facing:	
General Description:	Concrete inlet headwall for two 48 in diameter culverts constructed along right shoulder and along base of a steep embankment supporting a high ADT roadway low consequence of failure		
Wall Measurements			
Wall Length (ft.):	32	Face Area (sq.):	106
Average Wall Height (ft.):	3	Face Angle (deg.):	90
Maximum Wall Height (ft.):	6	Vertical Offset (ft.):	-17
Assessed Elements			
Element (Weighting Factor)	Narrative		Condition Rating (0 - 10)
PERFORMANCE 8.00	Fair to good condition; severe delamination with moderate spalling of concrete across face of wall; scour hole and medium diameter trees growing adjacent to wall and threatens the wall's long-term stability		6

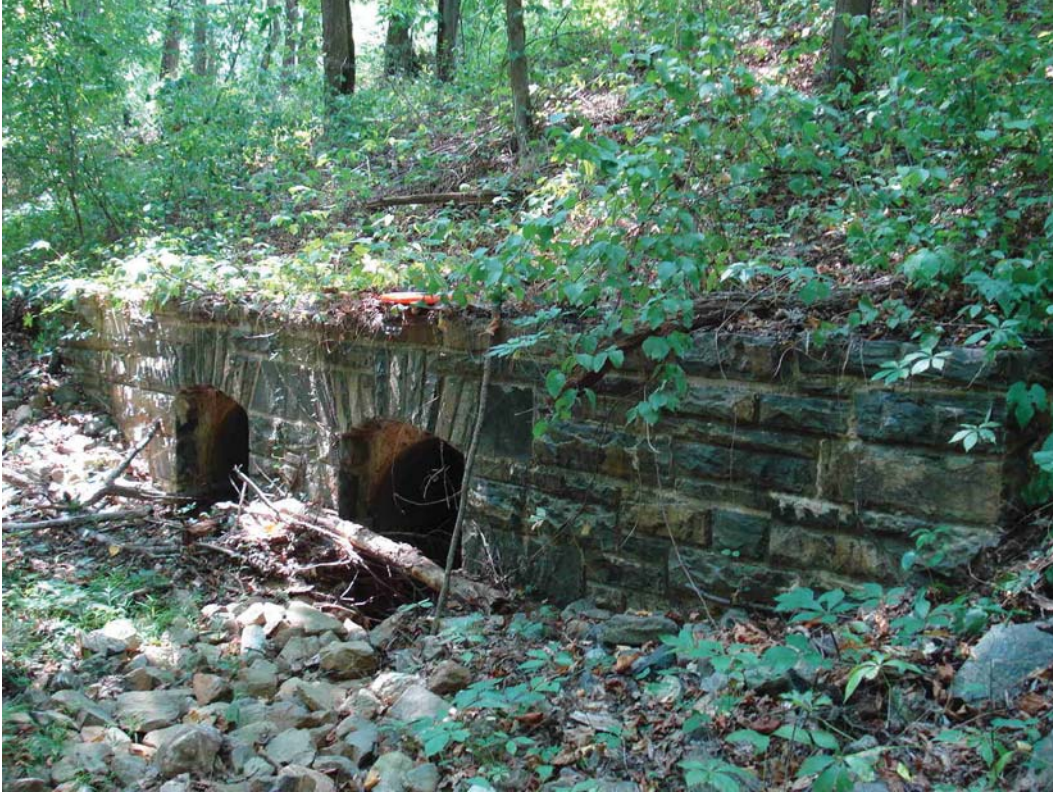
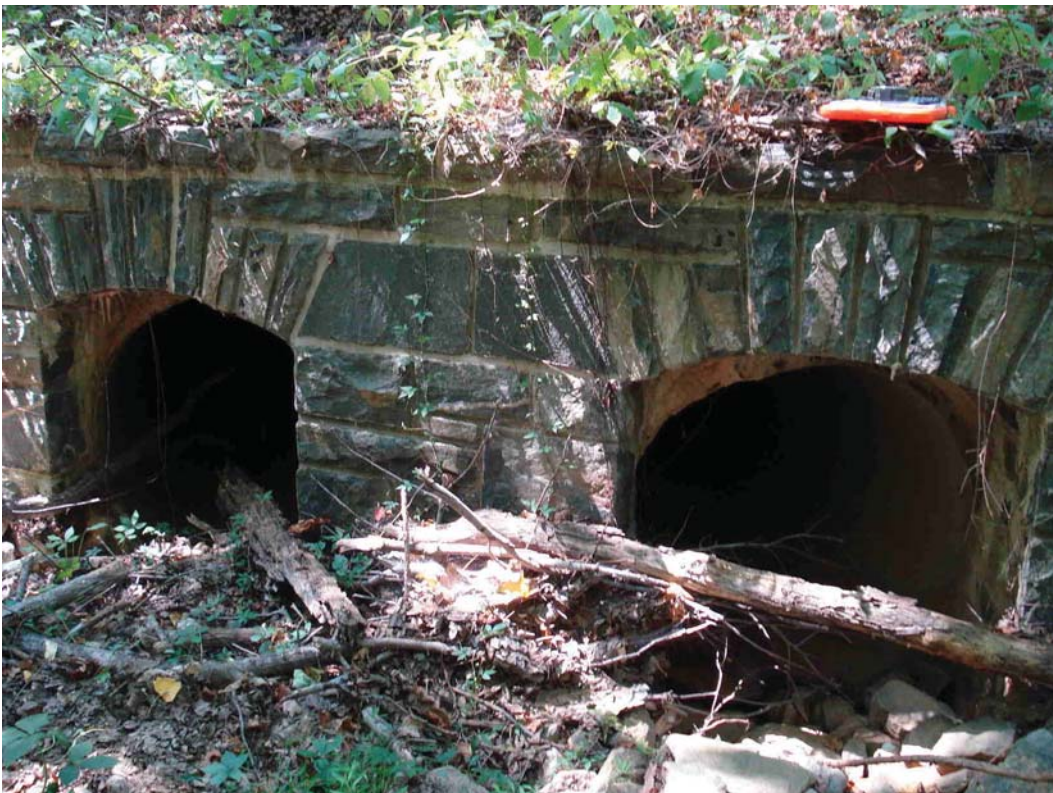
Wall ID:	BAWA-0002-4.781-L		
Route Name:	BALTIMORE-WASHINGTON PARKWAY (SB)		
Inspection Date:	August 14, 2007	Approximate Year Built:	1965
*Wall Rating:	86	Maintenance Action:	Maintenance
Wall Description			
Wall Function:	Head Wall	Primary Wall Type:	Gravity - Mortared Stone
Surface Treatment:		Secondary Wall Type:	
Secondary Surface Treatment:		Architectural Facing:	
General Description:	Stone masonry inlet headwall for two 48 in diameter concrete culverts constructed along left shoulder and along base of gently sloping embankment supporting a high ADT roadway low consequence of failure		
Wall Measurements			
Wall Length (ft.):	30	Face Area (sq.):	108
Average Wall Height (ft.):	3	Face Angle (deg.):	90
Maximum Wall Height (ft.):	6	Vertical Offset (ft.):	-7
Assessed Elements			
Element (Weighting Factor)	Narrative		Condition Rating (0 - 10)
PERFORMANCE 8.00	Good to excellent condition; debris in channel will impede the flow of water and promote water accumulation at inlet		8

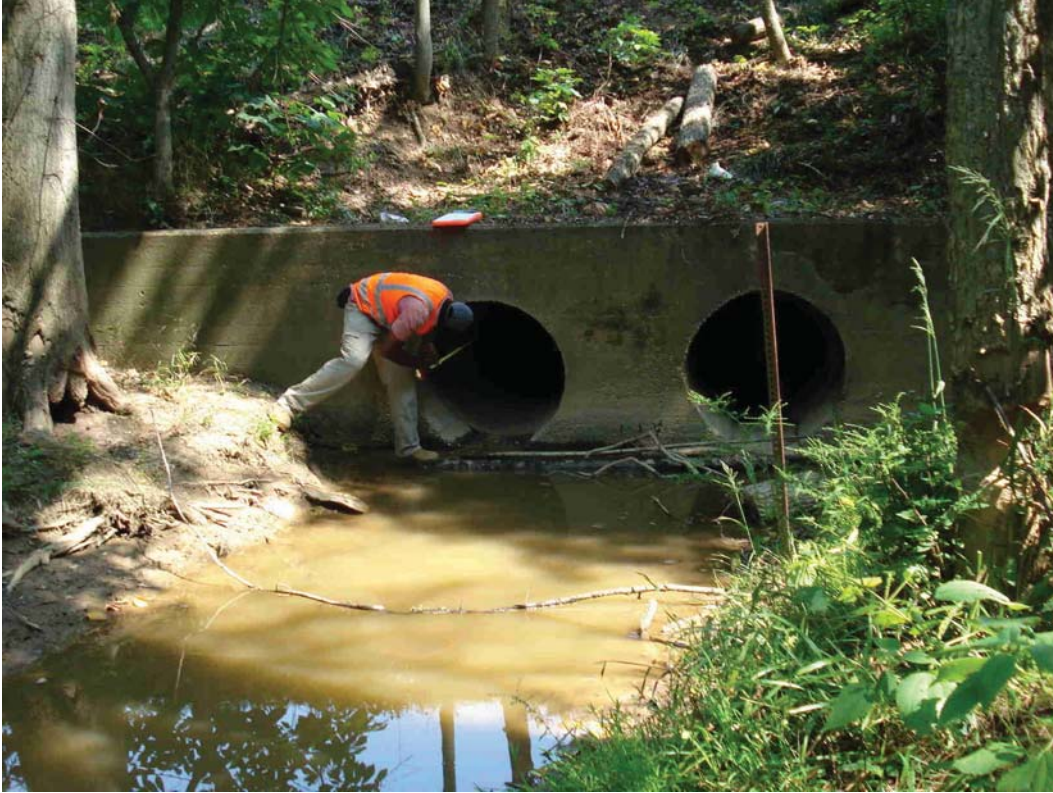
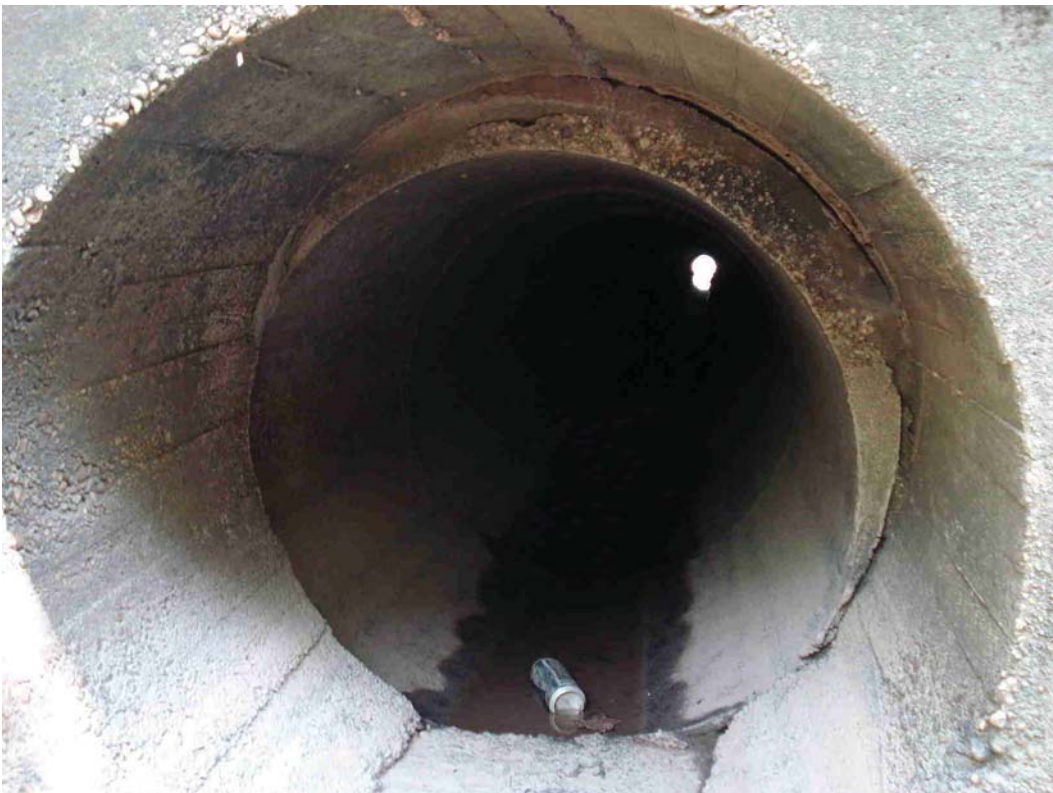
Wall ID:	BAWA-0002-6.441-R		
Route Name:	BALTIMORE-WASHINGTON PARKWAY (SB)		
Inspection Date:	August 14, 2007	Approximate Year Built:	1965
*Wall Rating:	60	Maintenance Action:	Repair Elements
Wall Description			
Wall Function:	Head Wall	Primary Wall Type:	Gravity - Mass Concrete
Surface Treatment:		Secondary Wall Type:	
Secondary Surface Treatment:		Architectural Facing:	
General Description:	Concrete inlet headwall for two 42 in diameter concrete pipe culverts constructed along right shoulder and along base of moderately sloping embankment supporting a high ADT roadway moderate consequence of failure		
Wall Measurements			
Wall Length (ft.):	28	Face Area (sq.):	112
Average Wall Height (ft.):	4	Face Angle (deg.):	90
Maximum Wall Height (ft.):	5	Vertical Offset (ft.):	-13
Assessed Elements			
Element (Weighting Factor)	Narrative		Condition Rating (0 - 10)
PERFORMANCE 8.00	Poor condition; ongoing erosion and undermining of foundation material; misaligned culvert end sections due to rotation of headwall		5

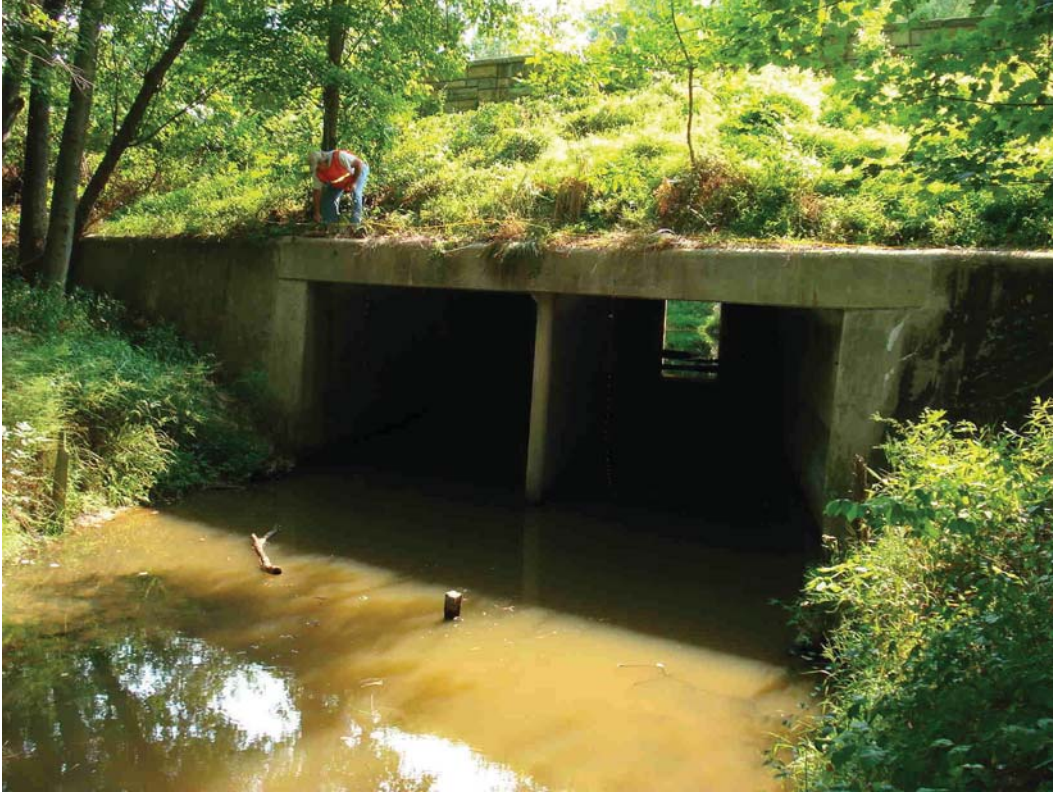
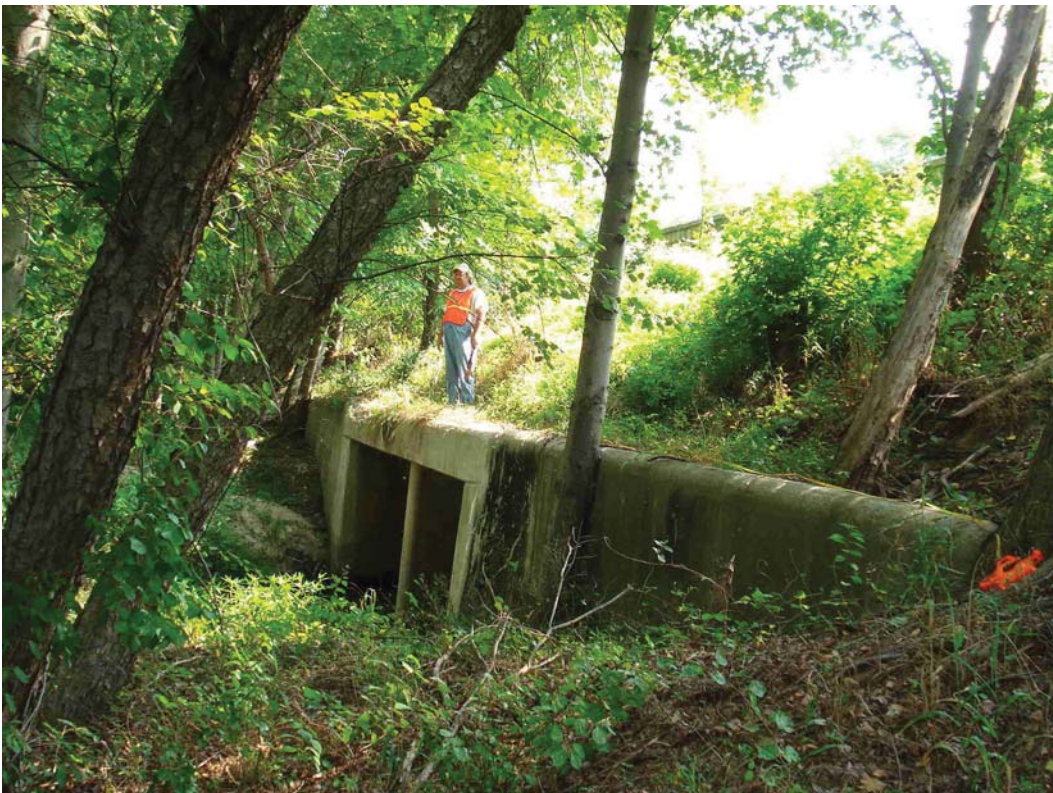
Wall ID:	BAWA-0002-9.761-R		
Route Name:	BALTIMORE-WASHINGTON PARKWAY (SB)		
Inspection Date:	August 15, 2007	Approximate Year Built:	1965
*Wall Rating:	79	Maintenance Action:	Maintenance
Wall Description			
Wall Function:	Head Wall	Primary Wall Type:	Gravity - Mass Concrete
Surface Treatment:		Secondary Wall Type:	
Secondary Surface Treatment:		Architectural Facing:	
General Description:	Concrete headwall for a 10 ft x 12 ft double box culvert constructed along right shoulder and along base of moderately sloping embankment supporting a high ADT roadway high consequence of failure		
Wall Measurements			
Wall Length (ft.):	68	Face Area (sq.):	248
Average Wall Height (ft.):	3	Face Angle (deg.):	90
Maximum Wall Height (ft.):	12	Vertical Offset (ft.):	-6
Assessed Elements			
Element (Weighting Factor)	Narrative		Condition Rating (0 - 10)
PERFORMANCE 8.00	Good condition; several 1/16 to 1/8 inch cracks along top of wall; several medium diameter trees growing adjacent to wall and threatens the wall's long-term stability		7

WALL FOUNDATION MATERIAL 8.00	No distress; no evidence of settlement, rotation, undermining or seepage		9
CONCRETE 8.00	Minor cracking, mostly along top of wall; cracks threaten the long-term stability of wall; minor efflorescence		7
DOWNSLOPE 0.50	Approximately 36-in. of standing water in the channel; poor down slope drainage; no observed distress		8
LATERAL SLOPE 0.50	No distress; no evidence of movement; no erosion		9
CULVERT 0.50	10 ft x 12 ft double box culvert; no observed distress		10
CURB/BERM/DITCH 0.50	No distress to concrete curb and gutter		10
ROAD/SIDEWALK/SHOULDER 0.50	No distress to roadway		10
TRAFFIC BARRIER/FENCE 0.50	No distress to stone guard wall with a stone veneer facing		10
Repair Recommendations			
Failure Consequence:	HIGH		
Recommendation Narrative:	Cut medium diameter trees, 8 trees (\$200/tree) = \$1,600, crack cleaning, routing and sealing, 30 lnft (\$5/lnft) = \$150.

Repair Cost:	\$1,750		
2007 cost estimate (ASTM Class D), preliminary for comparison to other repair costs only.

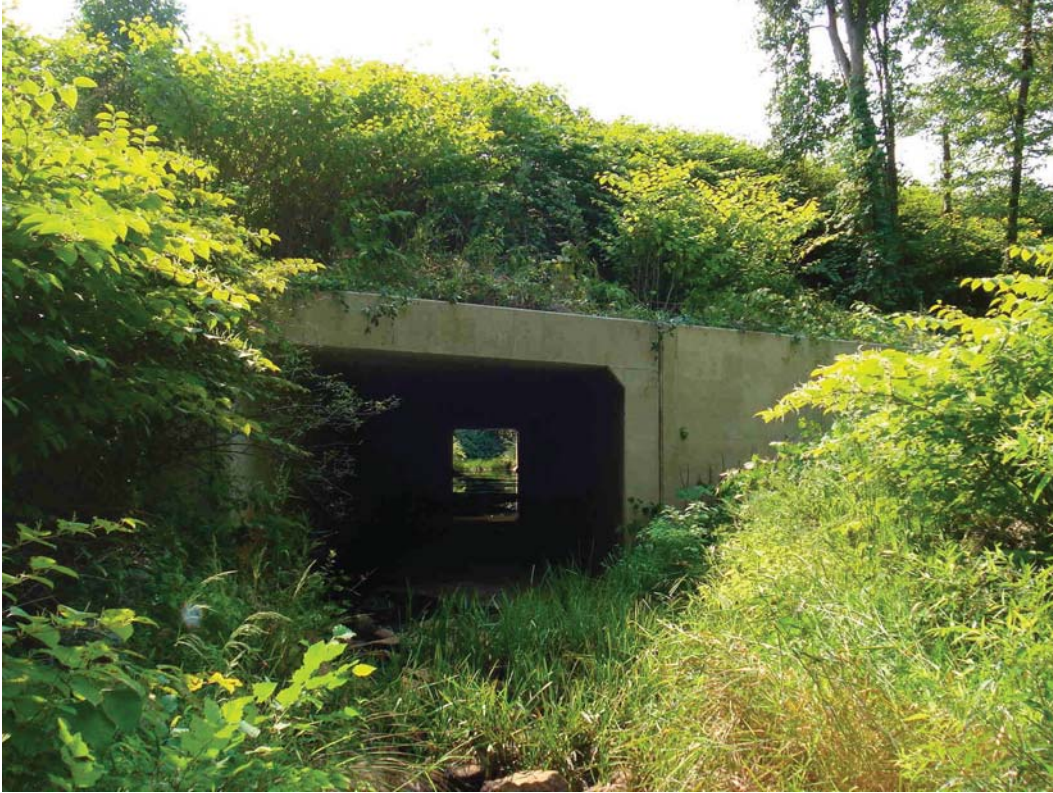
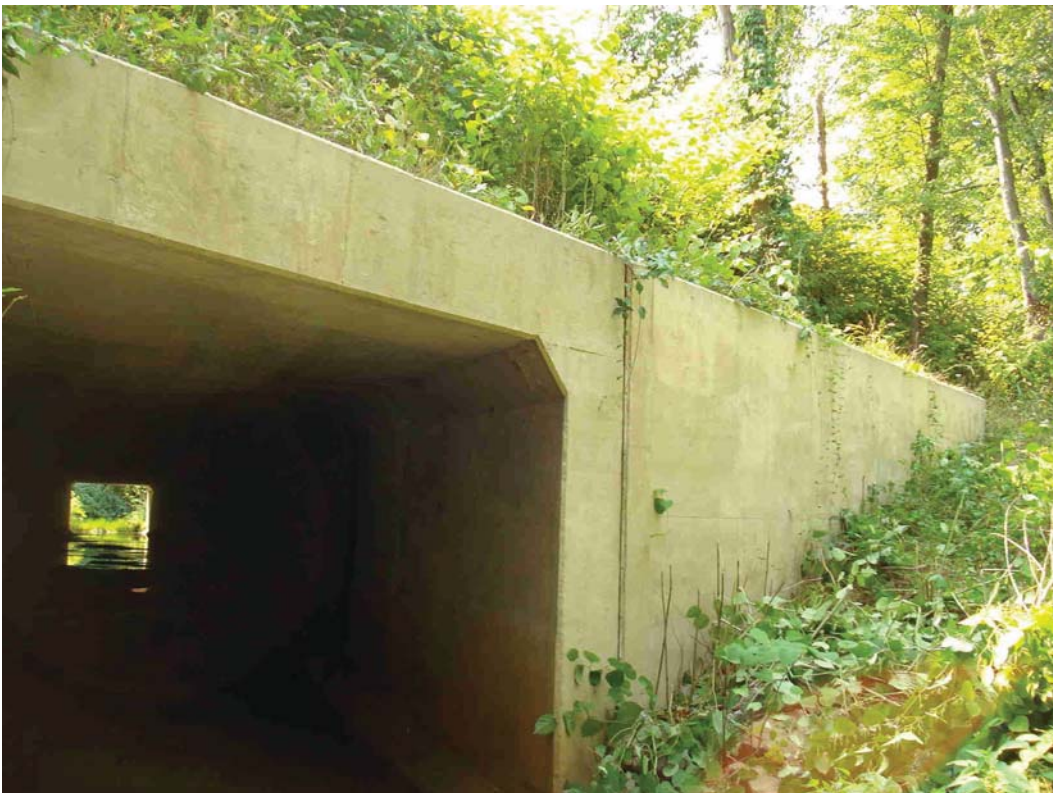
Wall ID:	BAWA-0002-9.902-R		
Route Name:	BALTIMORE-WASHINGTON PARKWAY (SB)		
Inspection Date:	August 15, 2007	Approximate Year Built:	1986
*Wall Rating:	97	Maintenance Action:	Maintenance
Wall Description			
Wall Function:	Head Wall	Primary Wall Type:	Gravity - Mass Concrete
Surface Treatment:		Secondary Wall Type:	
Secondary Surface Treatment:		Architectural Facing:	
General Description:	Concrete inlet headwall for a 9 ft x 17 ft concrete box culvert constructed along right shoulder and along base of gently sloping embankment supporting a high ADT roadway high consequence of failure		
Wall Measurements			
Wall Length (ft.):	75	Face Area (sq.):	407
Average Wall Height (ft.):	5	Face Angle (deg.):	90
Maximum Wall Height (ft.):	11	Vertical Offset (ft.):	-6
Assessed Elements			
Element (Weighting Factor)	Narrative		Condition Rating (0 - 10)
PERFORMANCE 8.00	Good to excellent condition; small vegetation has overgrown the wall; wall is functioning properly as intended		9

WALL FOUNDATION MATERIAL 8.00	No distress; no evidence of settlement, rotation, undermining or seepage		10
CONCRETE 8.00	No distress; relatively recent construction		10
VEGETATION 0.50	The wall is overgrown with vegetation		8
WALL DRAINS 0.50	No evidence of drainage-related distress		9
CULVERT 0.50	No observed distress to 9 ft x 12 ft concrete box culvert		10
CURB/BERM/DITCH 0.50	No distress to concrete curb and gutter		10
DOWNSLOPE 0.50	No distress to riprap-lined channel		10
LATERAL SLOPE 0.50	No distress; riprap erosion protection along lateral slope		10
Repair Recommendations			
Failure Consequence:	HIGH		
Recommendation Narrative:	Clear vegetation - 8 labor hrs (\$55/hr) = \$440		
Repair Cost:	\$440		
2007 cost estimate (ASTM Class D), preliminary for comparison to other repair costs only.

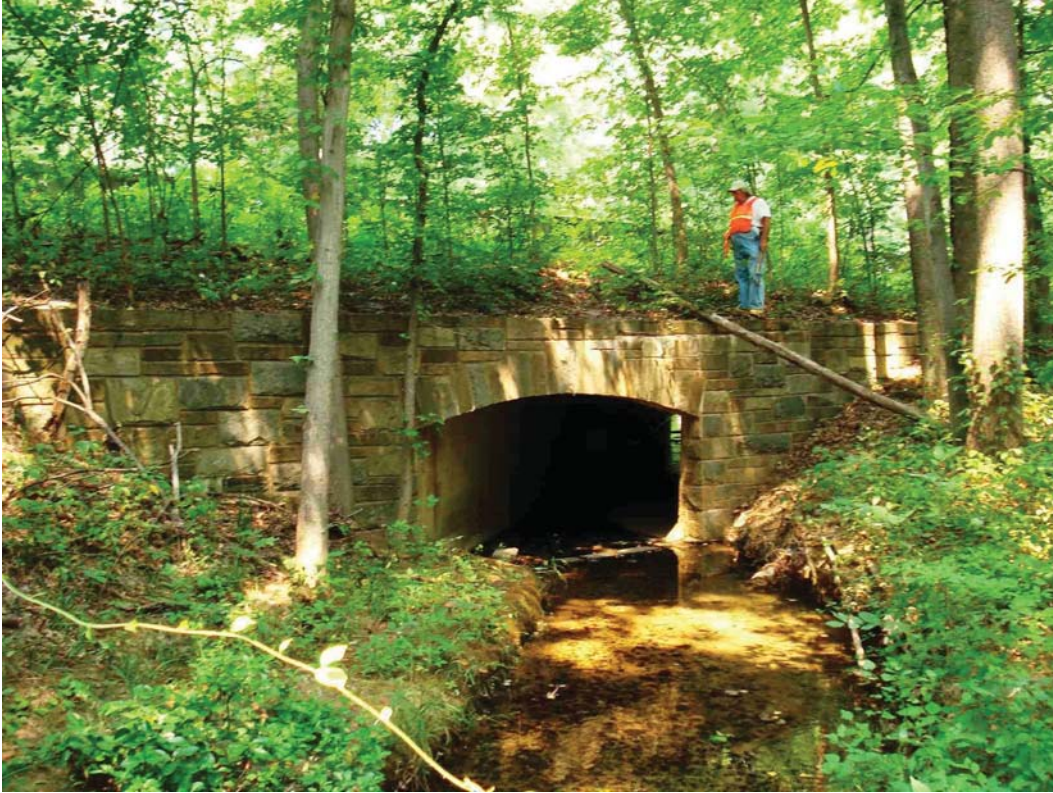
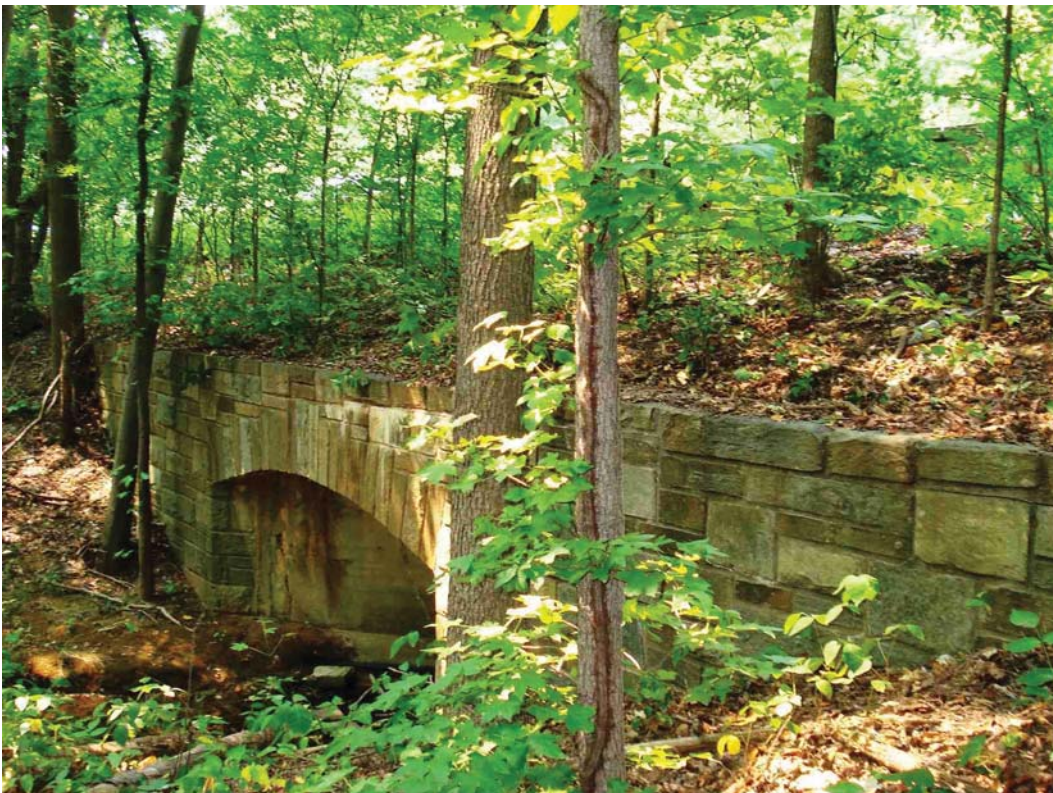
Wall ID:	BAWA-0002-11.015-L		
Route Name:	BALTIMORE-WASHINGTON PARKWAY (SB)		
Inspection Date:	August 15, 2007	Approximate Year Built:	1965
*Wall Rating:	87	Maintenance Action:	Maintenance
Wall Description			
Wall Function:	Head Wall	Primary Wall Type:	Gravity - Mortared Stone
Surface Treatment:		Secondary Wall Type:	
Secondary Surface Treatment:		Architectural Facing:	
General Description:	Stone masonry inlet headwall for a 6 ft x 14 ft concrete box culvert constructed along left shoulder of a high ADT roadway high consequence of failure due to size and proximity to roadway		
Wall Measurements			
Wall Length (ft.):	45	Face Area (sq.):	190
Average Wall Height (ft.):	4	Face Angle (deg.):	90
Maximum Wall Height (ft.):	8	Vertical Offset (ft.):	-3
Assessed Elements			
Element (Weighting Factor)	Narrative		Condition Rating (0 - 10)
PERFORMANCE 8.00	Good condition; spalling along wall/culvert interface; minor cracking of mortar		7

WALL FOUNDATION MATERIAL 8.00	No distress; no evidence of settlement, rotation, undermining or seepage		10
MORTAR 8.00	General age-related weathering; minor cracking along joints		8
STONE MASONRY 8.00	No distress to cut blocks		10
LATERAL SLOPE 0.50	No evidence of movement or erosion; medium diameter trees growing both ends of wall		8
CURB/BERM/DITCH 0.50	No distress to concrete curb and gutter		10
ROAD/SIDEWALK/SHOULDER 0.50	No distress to roadway or paved shoulder		10
TRAFFIC BARRIER/FENCE 0.50	No distress to concrete guard wall with stone veneer facing		10
UPSLOPE 0.50	No distress to relatively-flat, heavily-vegetated slope		10
Repair Recommendations			
Failure Consequence:	HIGH		
Recommendation Narrative:	Stone masonry repointing- 10 % of wall = 0.10(190.25 sqft)(\$75/sqft) = \$1,427, repoint interface = 26 ft (4/12) (\$75/sqft) = \$650. Cut medium diameter trees - 5 trees (\$200/tree) = \$1,000.

Repair Cost:	\$3,077		
2007 cost estimate (ASTM Class D), preliminary for comparison to other repair costs only.

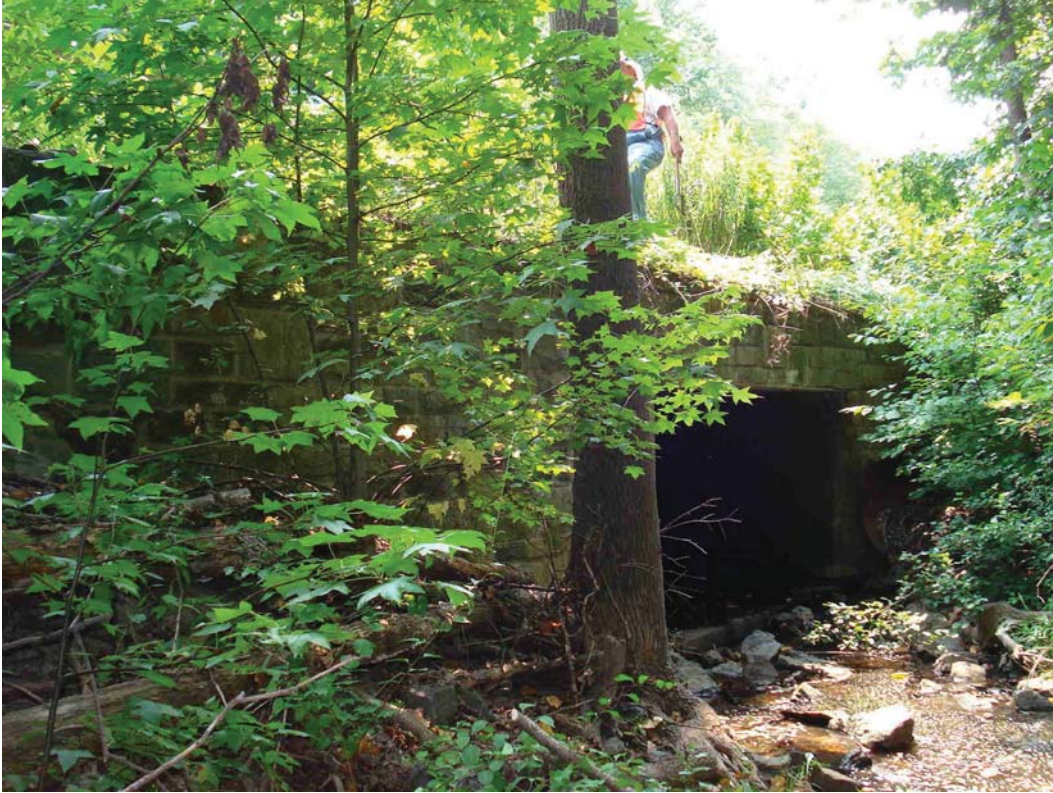
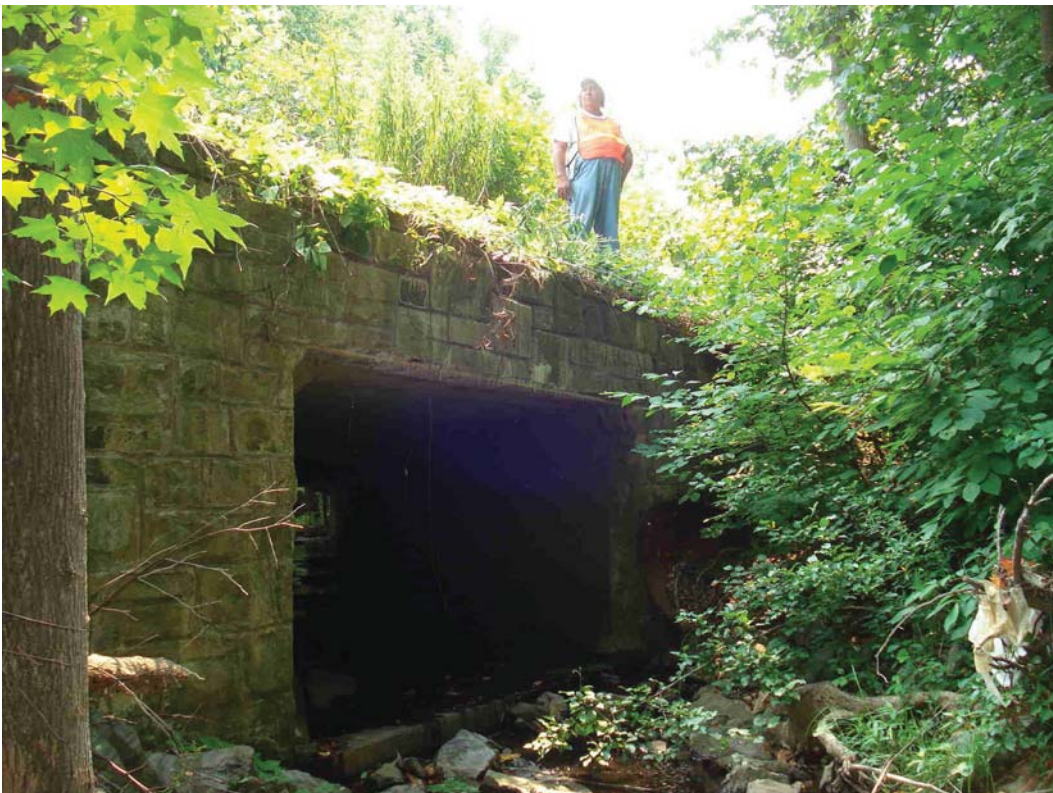
Wall ID:	BAWA-0002-11.033-R		
Route Name:	BALTIMORE-WASHINGTON PARKWAY (SB)		
Inspection Date:	August 15, 2007	Approximate Year Built:	1965
*Wall Rating:	90	Maintenance Action:	Maintenance
Wall Description			
Wall Function:	Head Wall	Primary Wall Type:	Gravity - Mortared Stone
Surface Treatment:		Secondary Wall Type:	
Secondary Surface Treatment:		Architectural Facing:	
General Description:	Stone masonry outlet headwall for a 6 ft x 14 ft concrete box culvert constructed along right shoulder of a high ADT roadway high consequence of failure due to size and proximity to roadway		
Wall Measurements			
Wall Length (ft.):	56	Face Area (sq.):	453
Average Wall Height (ft.):	8	Face Angle (deg.):	90
Maximum Wall Height (ft.):	9	Vertical Offset (ft.):	-4
Assessed Elements			
Element (Weighting Factor)	Narrative		Condition Rating (0 - 10)
PERFORMANCE 8.00	Good condition; minor cracking through mortar along the top of wall; minor erosion of lateral slope		8

WALL FOUNDATION MATERIAL 8.00	No distress; no evidence of settlement, rotation, undermining or seepage		10
MORTAR 8.00	General age-related weathering with minor cracking, mostly along the top of wall; evidence of recent repointing		8
STONE MASONRY 8.00	No distress to cut blocks		10
LATERAL SLOPE 0.50	Minor erosion along the north end of wall		8
CULVERT 0.50	No observed distress to 6 ft x 14 ft concrete box culvert		9
CURB/BERM/DITCH 0.50	No distress to concrete curb and gutter		10
DOWNSLOPE 0.50	No distress to riprap-lined channel; good drainage away from wall		10
ROAD/SIDEWALK/SHOULDER 0.50	No distress to roadway or paved shoulder		10
Repair Recommendations			
Failure Consequence:	HIGH		
Recommendation Narrative:	Cut large diameter trees - 2 trees (\$955/tree) = \$1,910		
Repair Cost:	\$1,910		
2007 cost estimate (ASTM Class D), preliminary for comparison to other repair costs only.

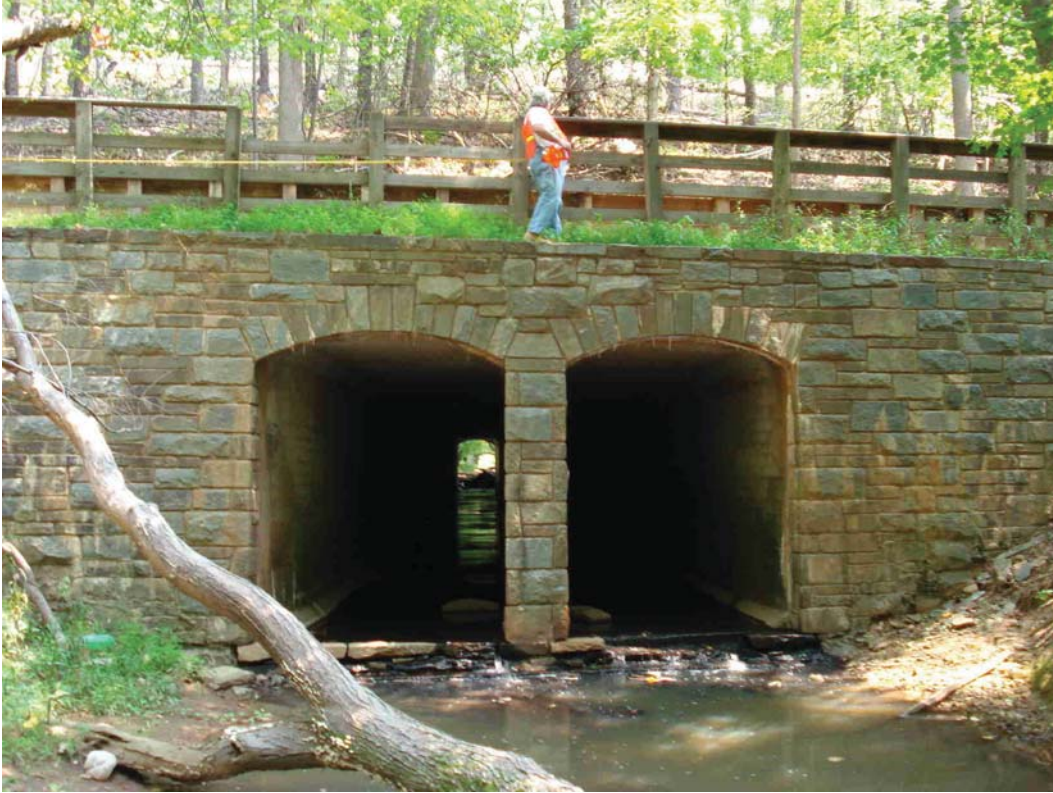
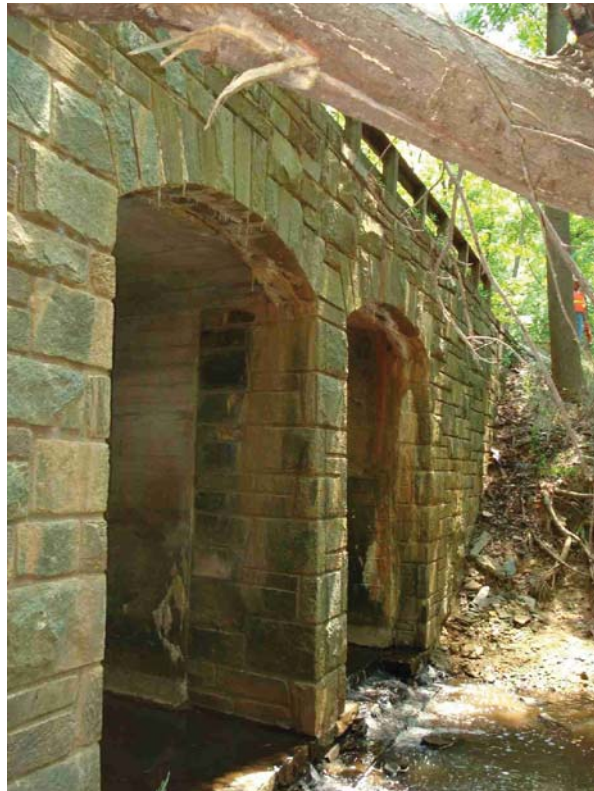
Wall ID:	BAWA-0002-12.920-R		
Route Name:	BALTIMORE-WASHINGTON PARKWAY (SB)		
Inspection Date:	August 15, 2007	Approximate Year Built:	1965
*Wall Rating:	74	Maintenance Action:	Maintenance
Wall Description			
Wall Function:	Head Wall	Primary Wall Type:	Gravity - Mortared Stone
Surface Treatment:		Secondary Wall Type:	
Secondary Surface Treatment:		Architectural Facing:	
General Description:	Stone masonry outlet headwall for two 8 ft x 10 ft concrete box culverts hiking trail across the top of headwall constructed along right shoulder and along base of steep embankment supporting a high ADT roadway		
Wall Measurements			
Wall Length (ft.):	70	Face Area (sq.):	521
Average Wall Height (ft.):	7	Face Angle (deg.):	90
Maximum Wall Height (ft.):	14	Vertical Offset (ft.):	-25
Assessed Elements			
Element (Weighting Factor)	Narrative	Condition Rating (0 - 10)	
PERFORMANCE 8.00	Good condition; minor cracking and spalling of mortar; moderate degradation of mortar below openings; large scour hole forming along face of wall	6

WALL FOUNDATION MATERIAL 8.00	Minor erosion at outlet; no evidence of settlement, rotation, undermining or seepage	7	
MORTAR 8.00	Minor cracking and spalling; moderate degradation below the outlets	7	
STONE MASONRY 8.00	No distress to cut blocks	9	
VEGETATION 0.50	Medium diameter trees growing within 3 ft of wall; trees not currently causing distress to wall, but do threaten the wall's long-term stability	8	
CULVERT 0.50	No observed distress to two 8 ft x 10 ft concrete box culverts	9	
LATERAL SLOPE 0.50	Medium diameter trees growing along both ends of wall; no evidence of movement; no erosion	9	
WALL DRAINS 0.50	No evidence of drainage-related distress	9	
CURB/BERM/DITCH 0.50	No distress to concrete curb and gutter	10	
Repair Recommendations			
Failure Consequence:	LOW		
Recommendation Narrative:	Cut trees - 3 medium diameter trees (\$200/tree) = \$600. Backfill scour hole - earthwork geotextile = 40 sqyd (\$5/sqyd) = \$200, placed riprap, Class 3 = 8.89 cuyd (\$200/cuyd) = \$1, 778. Clear debris - 6 labor hrs (\$55/hr) = \$330. Stone masonry

Repair Cost:	\$18,545		
2007 cost estimate (ASTM Class D), preliminary for comparison to other repair costs only.
