BAWA WIP Report

NPS Retaining Wall Inventory Program Baltimore - Washington Parkway National Capital

Federal Highway Administration
Eastern Federal Lands Highway Division
Road Inventory Program (RIP)

Data Collection Date: August 2007
Report Date: October 2015

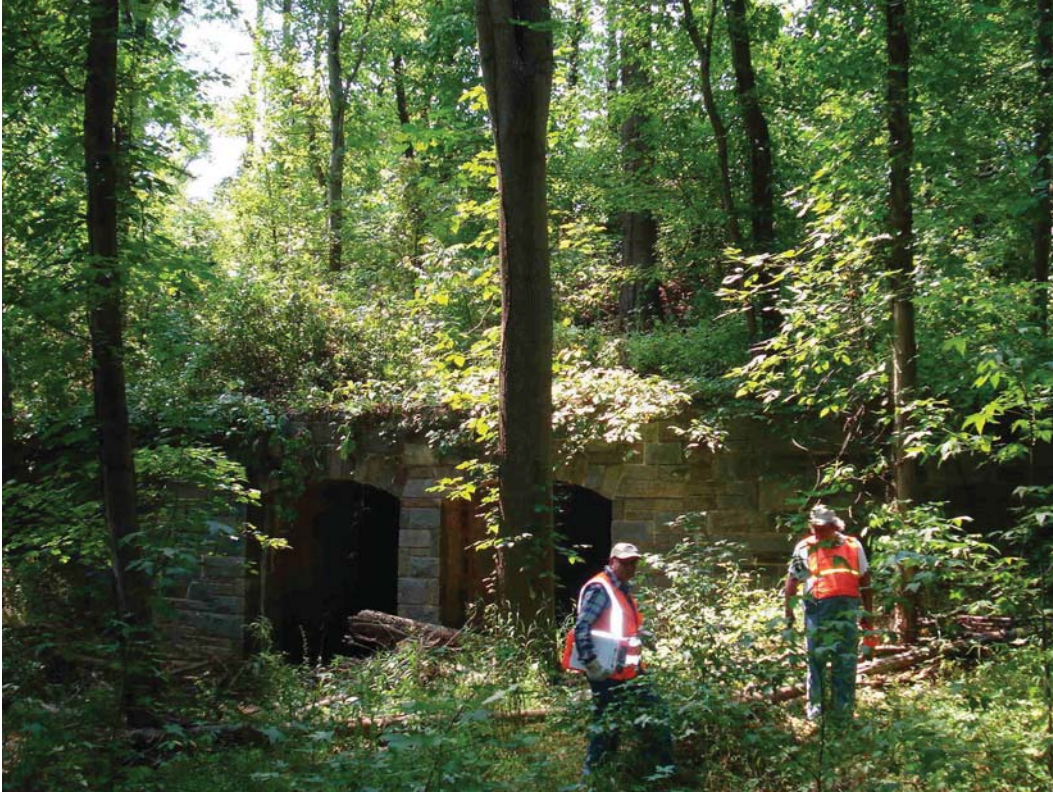
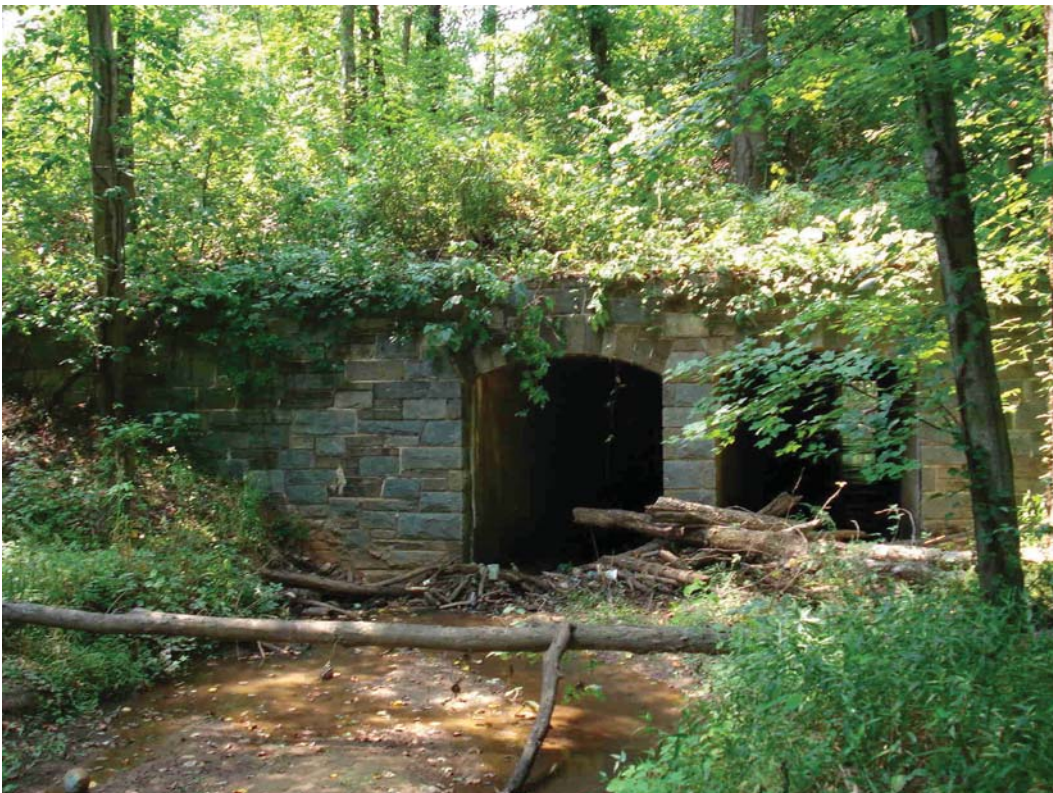
Wall ID:	BAWA-0002-12.926-L		
Route Name:	BALTIMORE-WASHINGTON PARKWAY (SB)		
Inspection Date:	August 15, 2007	Approximate Year Built:	1965
*Wall Rating:	80	Maintenance Action:	Repair Elements
Wall Description			
Wall Function:	Head Wall	Primary Wall Type:	Gravity - Mass Concrete
Surface Treatment:		Secondary Wall Type:	
Secondary Surface Treatment:		Architectural Facing:	Stone Veneer
General Description:	Concrete inlet headwall for two 8 ft x 10 ft concrete box culvert constructed along right shoulder and along base of steep slope supporting a high ADT roadway low consequence of failure due to distance from roadway		
Wall Measurements			
Wall Length (ft.):	70	Face Area (sq.):	590
Average Wall Height (ft.):	8	Face Angle (deg.):	90
Maximum Wall Height (ft.):	14	Vertical Offset (ft.):	-20
Assessed Elements			
Element (Weighting Factor)	Narrative		Condition Rating (0 - 10)
PERFORMANCE 8.00	Good condition; debris piled along face of wall is impeding flow and causing realignment of the channel; spalled concrete with exposed and moderately rusted rebar; peeling joint compound		7

WALL FOUNDATION MATERIAL 8.00	No distress; no evidence of settlement, rotation, undermining or seepage		9
CONCRETE 8.00	Minor hairline cracking observed along exposed ends of wall with minor efflorescence		8
MORTAR 8.00	General age-related weathering; minor cracking; minor debonding		8
ARCHITECTURAL FACING 0.50	Minor cracking or mortar with minor debonding; blocks are in excellent condition		9
LATERAL SLOPE 0.50	No distress; no evidence of movement; no erosion		9
ROAD/SIDEWALK/SHOULDER 0.50	No distress to roadway		10
TRAFFIC BARRIER/FENCE 0.50	No distress to concrete guard wall with a stone veneer facing		10
UPSLOPE 0.50	No distress to moderately-sloping, well-vegetated slope		10
Repair Recommendations			
Failure Consequence:	LOW		
Recommendation Narrative:	Concrete repair - 5 sqft (\$150/sqft) = \$750. Reseal Joint - 56 lnft (\$5/lnft) = \$280. Clear debris - 24 labor hrs (\$55/hr) = \$1,320. Cut trees - 4 trees (\$200/tree) = \$800.

Repair Cost:	\$3,150		
2007 cost estimate (ASTM Class D), preliminary for comparison to other repair costs only.

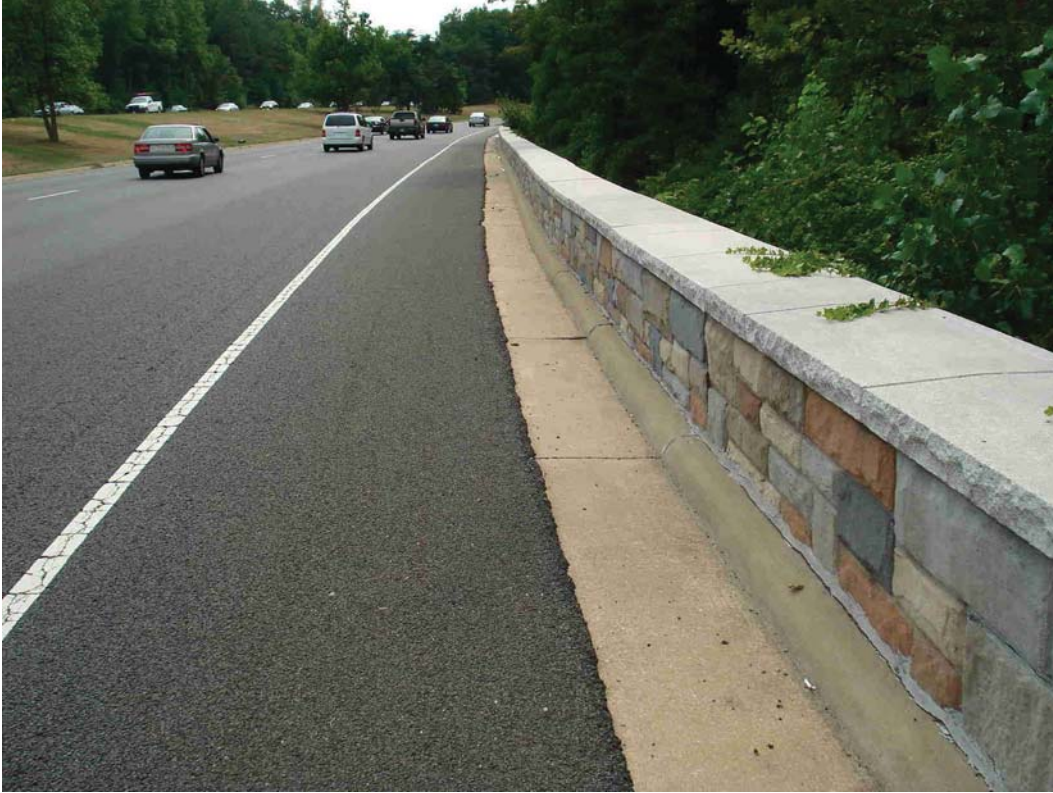
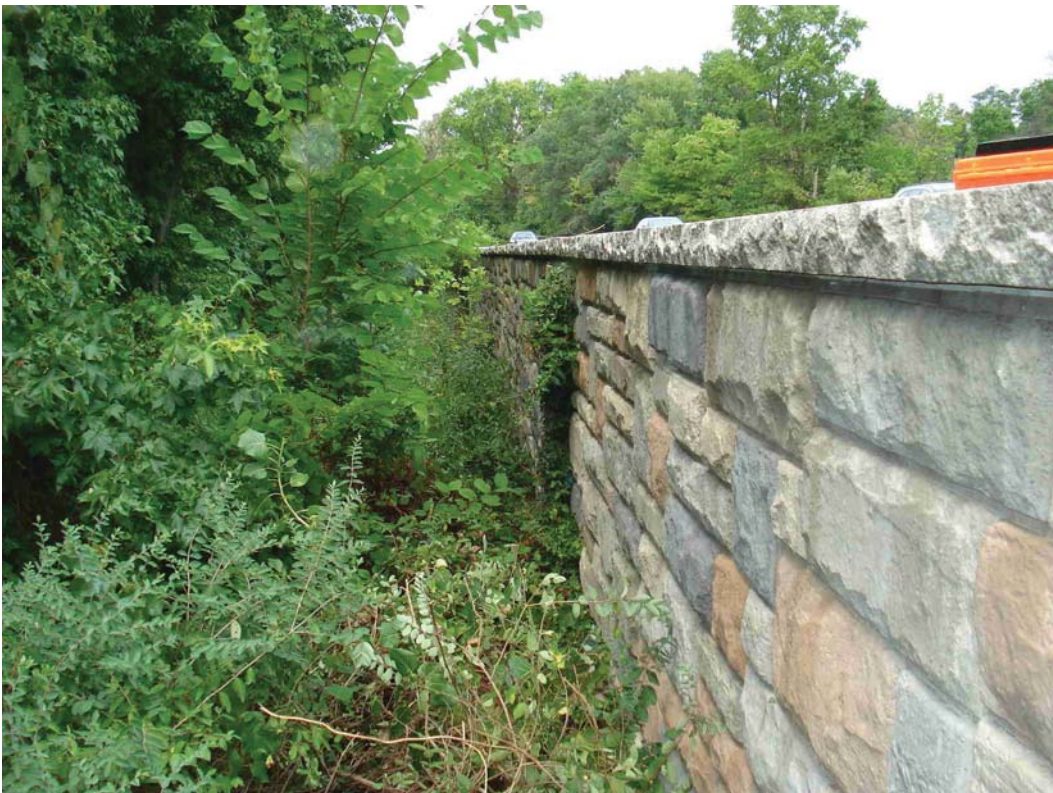
Wall ID:	BAWA-0002-15.109-R		
Route Name:	BALTIMORE-WASHINGTON PARKWAY (SB)		
Inspection Date:	August 16, 2007	Approximate Year Built:	1965
*Wall Rating:	95	Maintenance Action:	No Action
Wall Description			
Wall Function:	Fill Wall	Primary Wall Type:	Gravity - Mass Concrete
Surface Treatment:		Secondary Wall Type:	
Secondary Surface Treatment:		Architectural Facing:	Stone Veneer
General Description:	Concrete fill wall with an integral concrete guard wall stone veneer facing on both wall and guard wall constructed along right shoulder and directly supports a high ADT roadway high consequence of failure		
Wall Measurements			
Wall Length (ft.):	578	Face Area (sq.):	2312
Average Wall Height (ft.):	4	Face Angle (deg.):	90
Maximum Wall Height (ft.):	4	Vertical Offset (ft.):	0
Assessed Elements			
Element (Weighting Factor)	Narrative		Condition Rating (0 - 10)
PERFORMANCE 8.00	Good to excellent condition		9
WALL FOUNDATION MATERIAL 8.00	No distress; no evidence of settlement or rotation		10

OTHER PRIMARY ELEMENT 8.00	Partially exposed concrete footing; no observed distress		9
CONCRETE 8.00	Not able to observe; however no observed projection of distress to stone veneer facing		10
VEGETATION 0.50	Base of wall is overgrown with creeping vines; vegetation is not affecting nor threatens the performance of wall		9
WALL DRAINS 0.50	No visible drains; no evidence of drainage-related distress		9
ARCHITECTURAL FACING 0.50	No distress to stone veneer facing		10
CURB/BERM/DITCH 0.50	No distress to concrete curb and gutter		10
DOWNSLOPE 0.50	No distress to well-vegetated slope		10
Repair Recommendations			
Failure Consequence:	HIGH		
Recommendation Narrative:	None		
Repair Cost:	\$0		
2007 cost estimate (ASTM Class D), preliminary for comparison to other repair costs only.

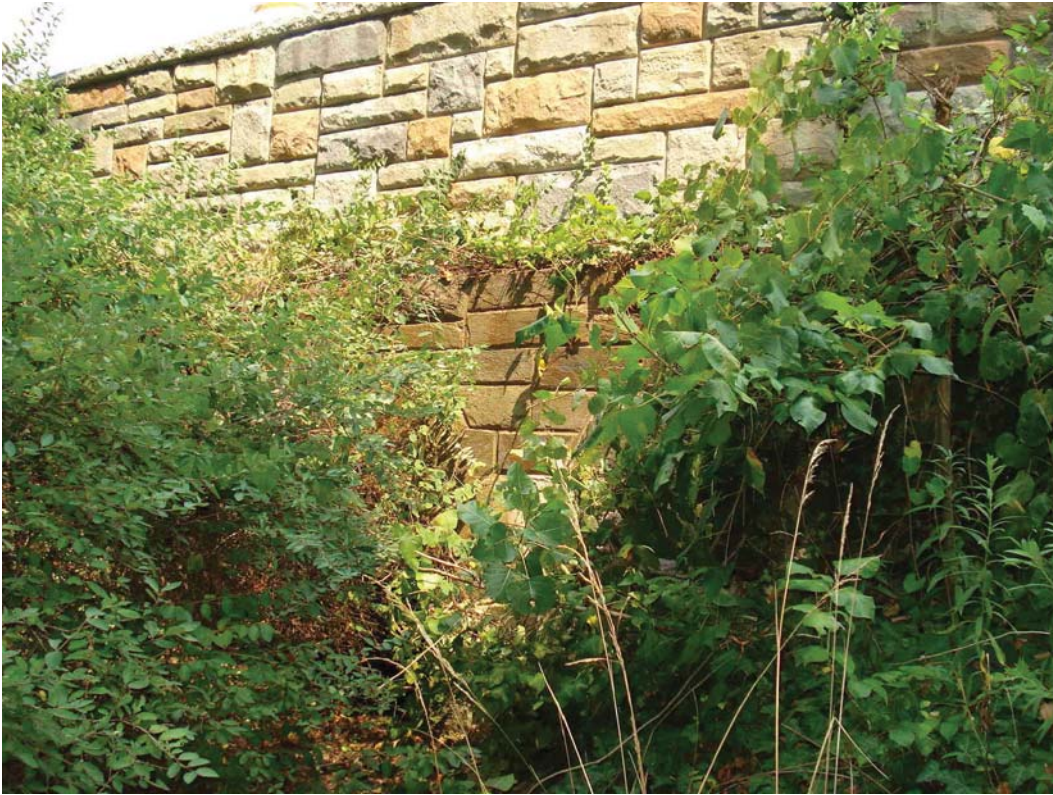
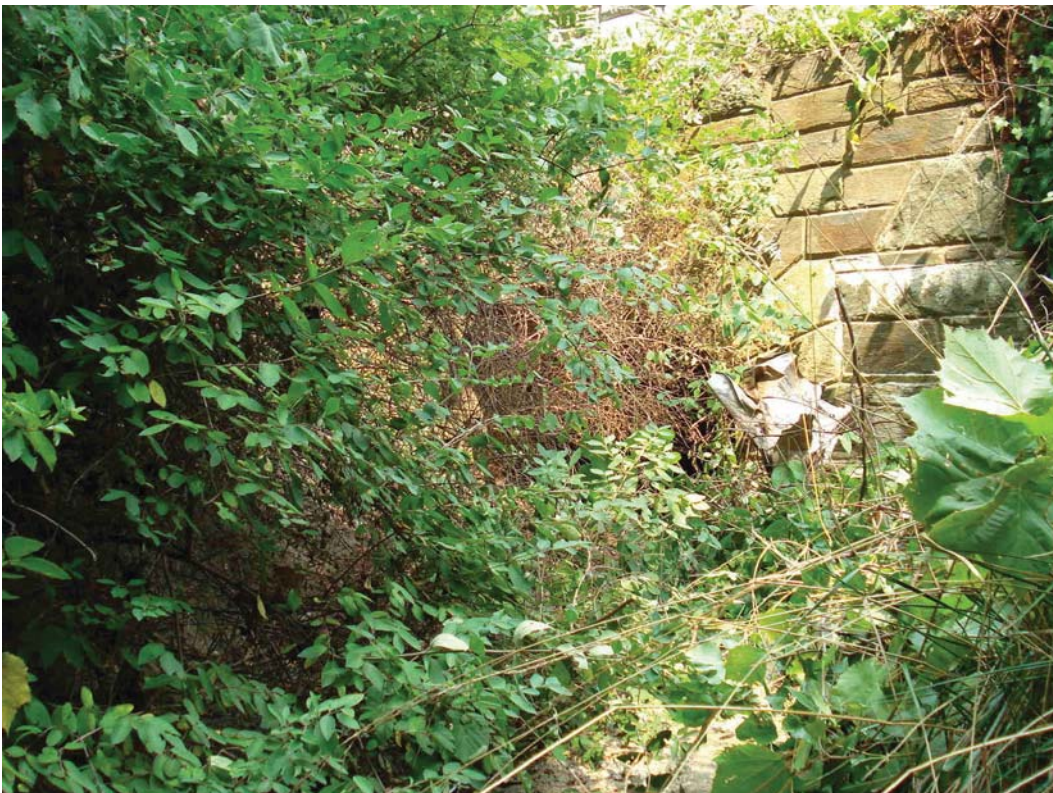
Wall ID:	BAWA-0002-15.154-R		
Route Name:	BALTIMORE-WASHINGTON PARKWAY (SB)		
Inspection Date:	August 15, 2007	Approximate Year Built:	1965
*Wall Rating:	88	Maintenance Action:	Maintenance
Wall Description			
Wall Function:	Head Wall	Primary Wall Type:	Gravity - Mortared Stone
Surface Treatment:		Secondary Wall Type:	
Secondary Surface Treatment:		Architectural Facing:	
General Description:	Stone masonry inlet headwall for a 4 ft x 6 ft concrete arch culvert constructed along right shoulder and along base of a fill wall supporting a high ADT roadway high consequence of failure		
Wall Measurements			
Wall Length (ft.):	30	Face Area (sq.):	91
Average Wall Height (ft.):	3	Face Angle (deg.):	90
Maximum Wall Height (ft.):	6	Vertical Offset (ft.):	-4
Assessed Elements			
Element (Weighting Factor)	Narrative		Condition Rating (0 - 10)
PERFORMANCE 8.00	Good condition; minor cracking of mortar; minor to moderate cracking of concrete apron; wall is overgrown with vegetation		8

WALL FOUNDATION MATERIAL 8.00	No distress; no evidence of settlement, rotation, undermining or seepage		10
MORTAR 8.00	General age-related weathering; minor cracking along joints		8
STONE MASONRY 8.00	No distress to cut blocks		9
DOWNSLOPE 0.50	A concrete apron extends from face of wall and down slope approximately 60 ft; minor to moderate cracking of apron; no distress to gently-sloping, well-vegetated slope		8
VEGETATION 0.50	Small brush and creeping vines have overgrown the wall; vegetation is not currently causing distress, but should be cut back from the wall face		8
CULVERT 0.50	No distress to 4 ft x 6 ft concrete arch culvert		9
CURB/BERM/DITCH 0.50	No distress to concrete curb and gutter		10
LATERAL SLOPE 0.50	No distress; no evidence of movement; no erosion		10
Repair Recommendations			
Failure Consequence:	HIGH		
Recommendation Narrative:	Clear vegetation - 6 labor hrs (\$55/hr) = \$330

Repair Cost:	\$330		
2007 cost estimate (ASTM Class D), preliminary for comparison to other repair costs only.

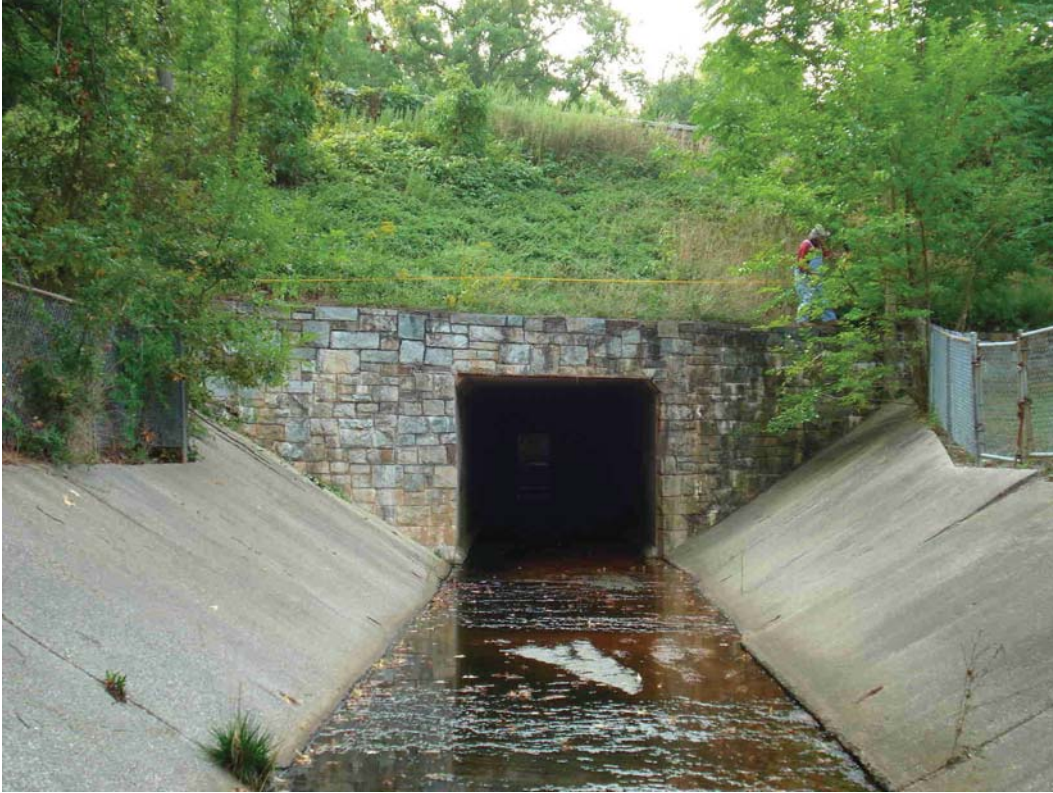
BAWA_0002_15.391_R_1.jpg

Wall ID:	BAWA-0002-15.391-R		
Route Name:	BALTIMORE-WASHINGTON PARKWAY (SB)		
Inspection Date:	August 16, 2007	Approximate Year Built:	1965
*Wall Rating:	88	Maintenance Action:	Repair Elements
Wall Description			
Wall Function:	Head Wall	Primary Wall Type:	Gravity - Mortared Stone
Surface Treatment:		Secondary Wall Type:	
Secondary Surface Treatment:		Architectural Facing:	
General Description:	Stone masonry outlet headwall for a 9 ft x 11 ft concrete box culvert constructed along right shoulder and at base of a steep embankment supporting a high ADT roadway moderate consequence of failure		
Wall Measurements			
Wall Length (ft.):	60	Face Area (sq.):	329
Average Wall Height (ft.):	5	Face Angle (deg.):	90
Maximum Wall Height (ft.):	12	Vertical Offset (ft.):	-10
Assessed Elements			
Element (Weighting Factor)	Narrative		Condition Rating (0 - 10)
PERFORMANCE 8.00	Good condition; moderate spalling of concrete inside culvert resulting in exposure and moderate rusting of rebar; distress does not pose significant risk to culvert or headwall, but should be repaired		8

WALL FOUNDATION MATERIAL 8.00	No distress; no evidence of settlement, rotation, undermining or seepage		10
MORTAR 8.00	Minor to moderate degradation of mortar; minor weeping		8
STONE MASONRY 8.00	No distress to cut blocks		9
CULVERT 0.50	9 ft x 11 ft concrete box culvert; some moderate spalling of concrete causing exposure and moderate rusting of rebar		8
VEGETATION 0.50	Small brush and one medium diameter trees growing immediately adjacent to wall		8
DOWNSLOPE 0.50	A concrete apron extends well down slope from the face of wall; some of the sidewall panels are misaligned and may promote water infiltration		9
CURB/BERM/DITCH 0.50	No distress to concrete curb and gutter		10
LATERAL SLOPE 0.50	No distress; no evidence of movement; no erosion		10
Repair Recommendations			
Failure Consequence:	MODERATE		
Recommendation Narrative:	Cut tree - 1 medium diameter tree (\$200/tree) = \$200. Concrete repair - 0.926 cuyd (\$150/cuyd) = \$139.

Repair Cost:	\$500		
2007 cost estimate (ASTM Class D), preliminary for comparison to other repair costs only.

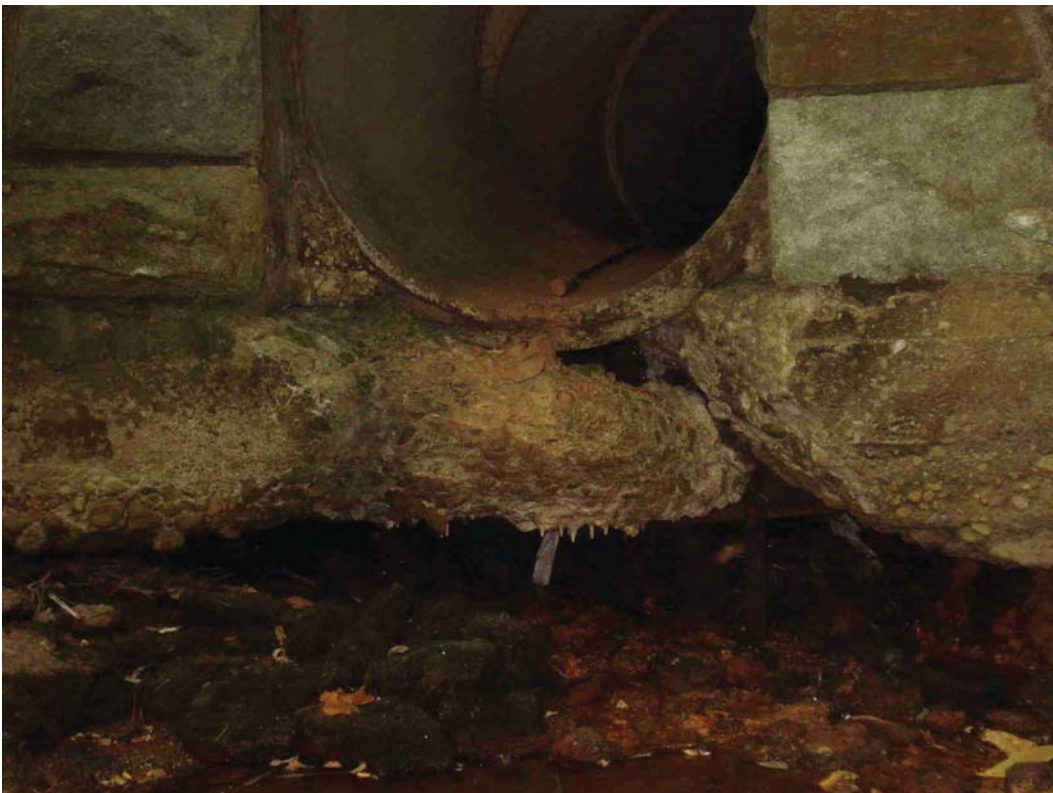
BAWA_0002_17.106_R_2.jpg

Wall ID:	BAWA-0002-17.106-R		
Route Name:	BALTIMORE-WASHINGTON PARKWAY (SB)		
Inspection Date:	August 16, 2007	Approximate Year Built:	1954
*Wall Rating:	43	Maintenance Action:	Repair Elements
Wall Description			
Wall Function:	Head Wall	Primary Wall Type:	Gravity - Mortared Stone
Surface Treatment:		Secondary Wall Type:	
Secondary Surface Treatment:		Architectural Facing:	
General Description:	Stone masonry outlet headwall for a 36 in diameter concrete pipe culvert constructed along right shoulder and along base of a steep embankment supporting a high ADT roadway low consequence of failure		
Wall Measurements			
Wall Length (ft.):	20	Face Area (sq.):	103
Average Wall Height (ft.):	5	Face Angle (deg.):	90
Maximum Wall Height (ft.):	6	Vertical Offset (ft.):	-13
Assessed Elements			
Element (Weighting Factor)	Narrative		Condition Rating (0 - 10)
PERFORMANCE 8.00	Critical condition; severely undermined foundation possibly due to the formation of a large diameter scour hole; footing is critically cracked through; movement of headwall has caused misalignment of the culvert; misaligned culverts discharge water into b		2

WALL FOUNDATION MATERIAL 8.00	Founded on a soil subgrade; foundation is critically eroded resulting in foundation undermining; there is a large void below the wall; wall has rotated forward approximately 4 to 6 inches		1
CONCRETE 8.00	Exposed 18-in. concrete footing with an approximate 2 to 3 inch wide crack below the culvert opening		3
MORTAR 8.00	Moderate degradation; moderate cracking with moderate spalling across approximately 30% of face		6
STONE MASONRY 8.00	No distress to cut blocks		9
DOWNSLOPE 1.00	There is a 15 ft diameter scour hole, approximately 30-in. deep at the outfall; ongoing scour of the foundation soil and lateral slope; debris in channel in impeding the flow of water away from wall		4
UPSLOPE 1.00	There is an approximate 2 ft. x 6 ft deep hole behind the headwall; hole appears to have resulted from the ongoing erosion of backfill material		4
CURB/BERM/DITCH 0.50	No distress to concrete curb and gutter		9

Wall ID:	BAWA-0002-17.106-R		
Route Name:	BALTIMORE-WASHINGTON PARKWAY (SB)		
Inspection Date:	August 16, 2007	Approximate Year Built:	1954
*Wall Rating:	43	Maintenance Action:	Repair Elements
Repair Recommendations			
Failure Consequence:	LOW		
Recommendation Narrative:	Remove/reset headwall - 1 HW (\$4,430 each) =\$4,430. Structure excavation - 1,111.11 cuyd (\$40/cuyd) = \$44,444. Remove/reset pipe culvert - 20 lnft (\$165/lnft) = \$3,300. Structural backfill - 1111.11 cuyd (\$60/cuyd) = \$66,667. Clear debris		
Repair Cost:	\$125,585		
2007 cost estimate (ASTM Class D), preliminary for comparison to other repair costs only.

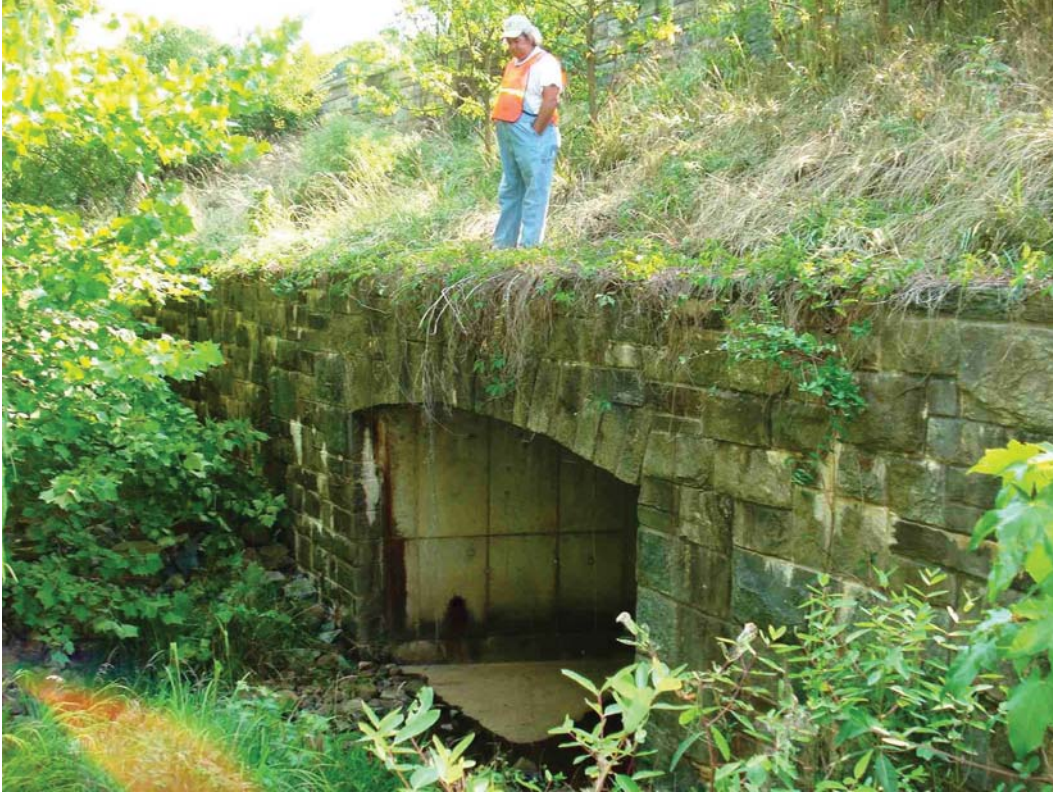
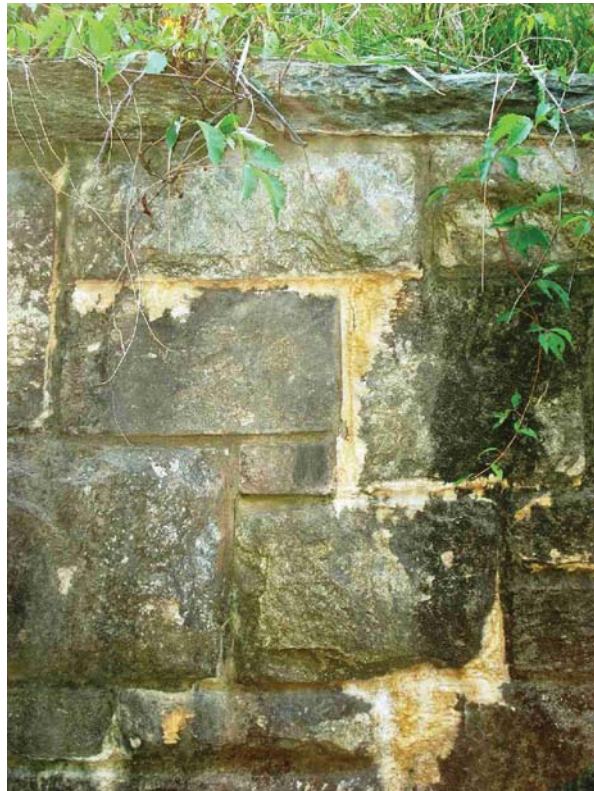
Wall ID:	BAWA-0506ZZ-0.010-R		
Route Name:	POWDER MILL ROAD RAMPS (MD ROUTE 212 INTERCHANGE)		
Inspection Date:	August 15, 2007	Approximate Year Built:	1965
*Wall Rating:	87	Maintenance Action:	No Action
Wall Description			
Wall Function:	Head Wall	Primary Wall Type:	Gravity - Mortared Stone
Surface Treatment:		Secondary Wall Type:	
Secondary Surface Treatment:		Architectural Facing:	
General Description:	Stone masonry inlet headwall for a 8 ft x 13 ft concrete box culvert constructed along right shoulder and along base of a gently sloping embankment supporting a high ADT roadway high consequence of failure		
Wall Measurements			
Wall Length (ft.):	60	Face Area (sq.):	368
Average Wall Height (ft.):	6	Face Angle (deg.):	90
Maximum Wall Height (ft.):	11	Vertical Offset (ft.):	-8
Assessed Elements			
Element (Weighting Factor)	Narrative		Condition Rating (0 - 10)
PERFORMANCE 8.00	Good condition; weeping of mortar as evidence by moderate efflorescence across face of wall		8

WALL FOUNDATION MATERIAL 8.00	No distress; no evidence of settlement, rotation, undermining or seepage		9
MORTAR 8.00	Moderate efflorescence across 30% of wall; minor cracking; minor debonding		8
WIRE/GEOSYNTHETIC FACING 8.00	Minor degradation of epoxy joint compound		8
STONE MASONRY 8.00	No distress to cut blocks		9
CONCRETE 8.00	No distress		10
LATERAL SLOPE 0.50	Minor erosion; general good condition		8
CULVERT 0.50	No observed distress to 8 ft x 13 ft concrete box culvert		9
DOWNSLOPE 0.50	No observed distress to riprap-lined channel		9
Repair Recommendations			
Failure Consequence:	LOW		
Recommendation Narrative:	None		
Repair Cost:	\$0		
2007 cost estimate (ASTM Class D), preliminary for comparison to other repair costs only.

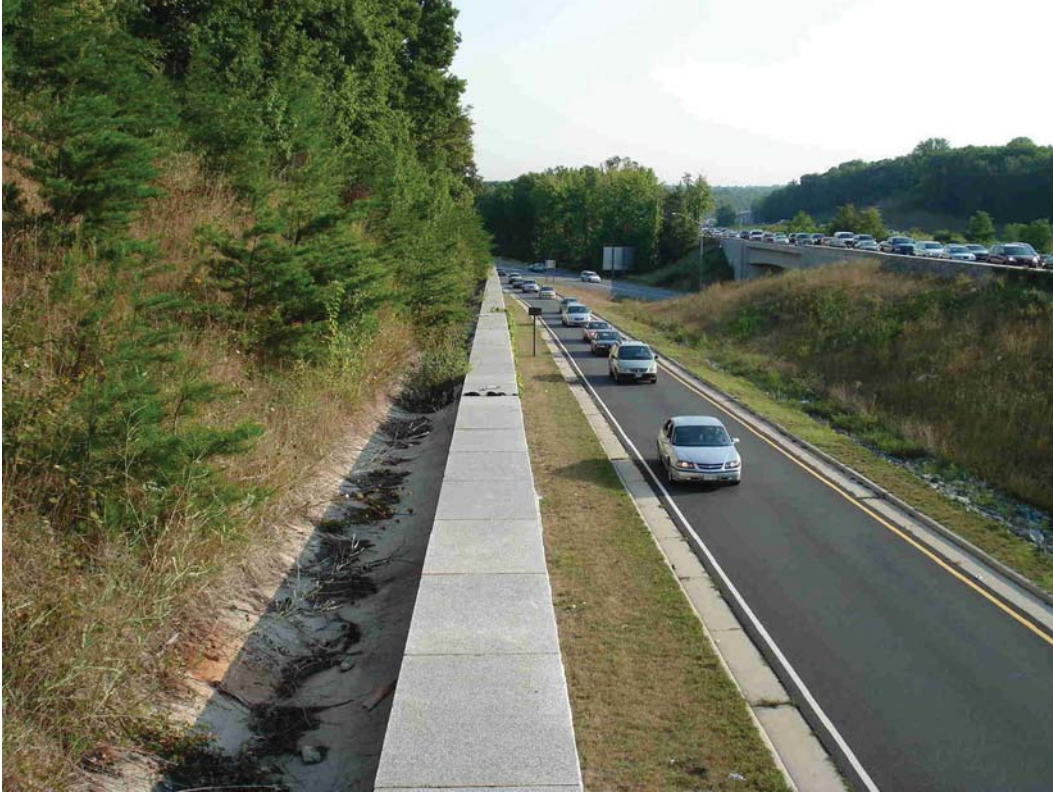
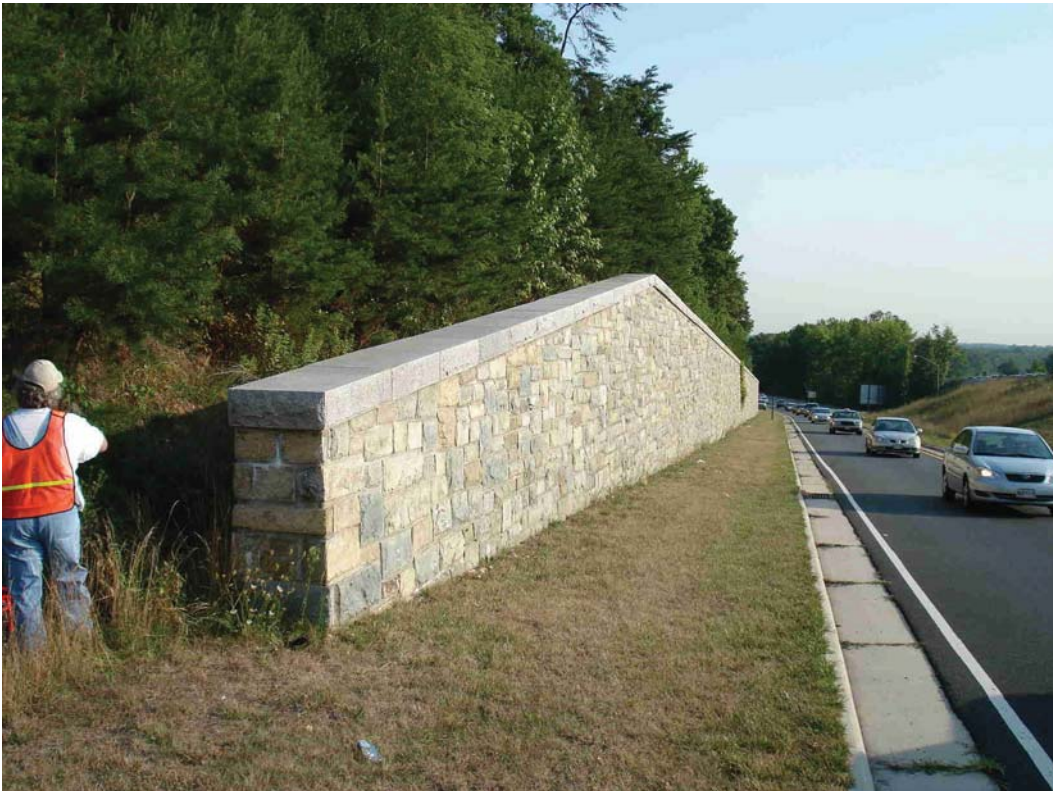
Wall ID:	BAWA-0507ZZ-0.075-R		
Route Name:	LAUREL-BOWIE ROAD RAMPS (MD ROUTE 197 INTERCHANGE)		
Inspection Date:	August 15, 2007	Approximate Year Built:	1986
*Wall Rating:	87	Maintenance Action:	Maintenance
Wall Description			
Wall Function:	Fill Wall	Primary Wall Type:	MSE - Precast Panel
Surface Treatment:		Secondary Wall Type:	
Secondary Surface Treatment:		Architectural Facing:	Stone Veneer
General Description:	MSE fill wall with a stone masonry facing constructed along right shoulder or ramp to the BW Parkway from eastbound Laurel Bowie Road supporting a relatively flat forested hill high consequence of failure		
Wall Measurements			
Wall Length (ft.):	690	Face Area (sq.):	8760
Average Wall Height (ft.):	12	Face Angle (deg.):	90
Maximum Wall Height (ft.):	14	Vertical Offset (ft.):	1
Assessed Elements			
Element (Weighting Factor)	Narrative		Condition Rating (0 - 10)
PERFORMANCE 8.00	Good condition; several small trees growing within 3 ft of the top of wall; cracked concrete ditch		7

WALL FOUNDATION MATERIAL 8.00	No evidence of settlement or rotation		10
WIRE/GEOSYNTHETIC FACING 8.00	Minor degradation of epoxy joint compound		8
CONCRETE 8.00	No distress		10
WALL DRAINS 0.50	No weepholes were observed along face of wall; likely water infiltration due to cracks in ditch along top of wall; evidence of weeping along base of wall		8
LATERAL SLOPE 0.50	No distress; no evidence of movement; no erosion		10
ROAD/SIDEWALK/SHOULDER 0.50	No distress to roadway or to relatively-flat grassy shoulder		10
UPSLOPE 0.50	No distress to gently-sloping, relatively flat and moderately-forested slope		10
CURB/BERM/DITCH 1.00	4 ft wide concrete ditch along top of wall; ditch has 1/8 to 1/4 inch cracks at several locations; cracks are promoting the infiltration of water behind the wall		7
Repair Recommendations			
Failure Consequence:	HIGH		
Recommendation Narrative:	Clear ditch - 24 labor hrs (\$55/hr) = \$1,320. Cut trees within 3 ft of wall - 12 trees (\$100/tree) = \$1,200. Repair cracks (30% of ditch) - 0.30(690 lnft)(\$5/lnft) = \$1,035. Repair joints - 14 lnft (\$60/lnft)(5 joints) = \$4,200.

Repair Cost:	\$7,755		
2007 cost estimate (ASTM Class D), preliminary for comparison to other repair costs only.
