BRCA WIP Report

NPS Retaining Wall Inventory Program Bryce Canyon National Park

Data Collection Date: April 2007
Report Date: October 2015

Bryce Canyon National Park in Utah

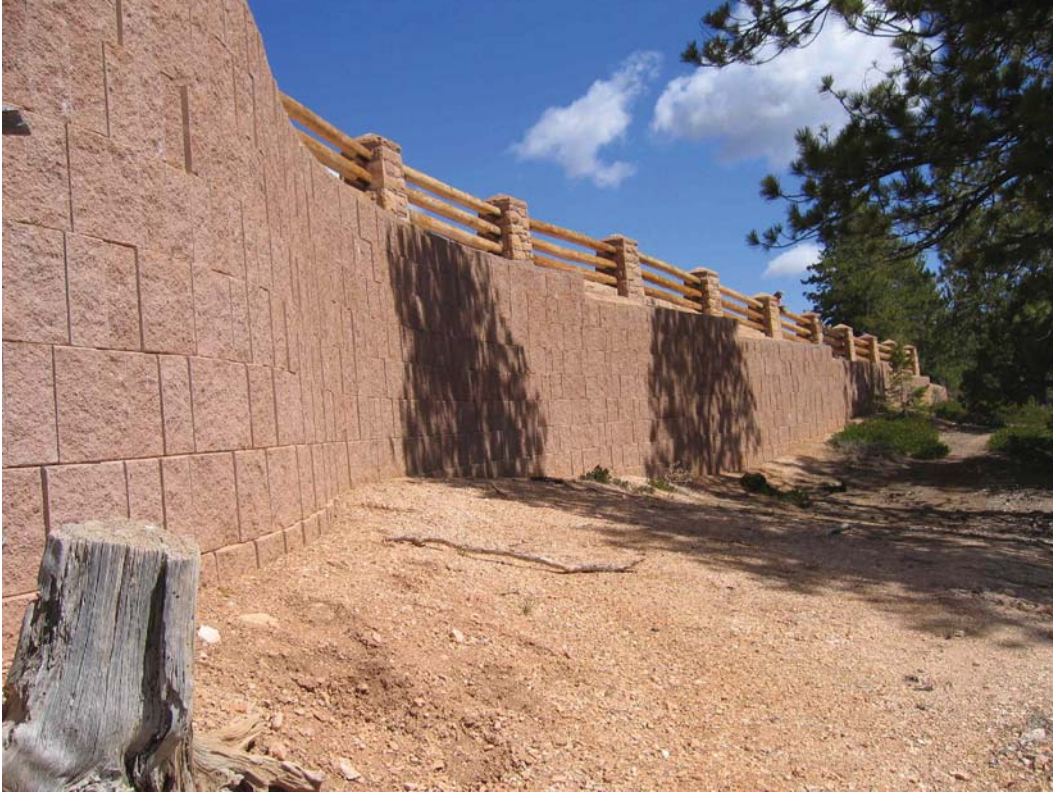
BRCA_0939_0.000_P1_1.jpg

Wall ID Inspection Date:	Wall Area (Sq. Ft.)	Wall Length (Ft.)	Wall Type	Wall Function	Overall Rating	Repair Cost
BRCA-0939-0.000-P1 4/17/2007	1645	251	MSE - Segmental Block	Fill Wall	96	\$0.00
