# COLM WIP Report

## NPS Retaining Wall Inventory Program Colorado National Monument

**Federal Lands Highway  
Road Inventory Program**

**Data Collection Date: May 2007  
Report Date: October 2015**

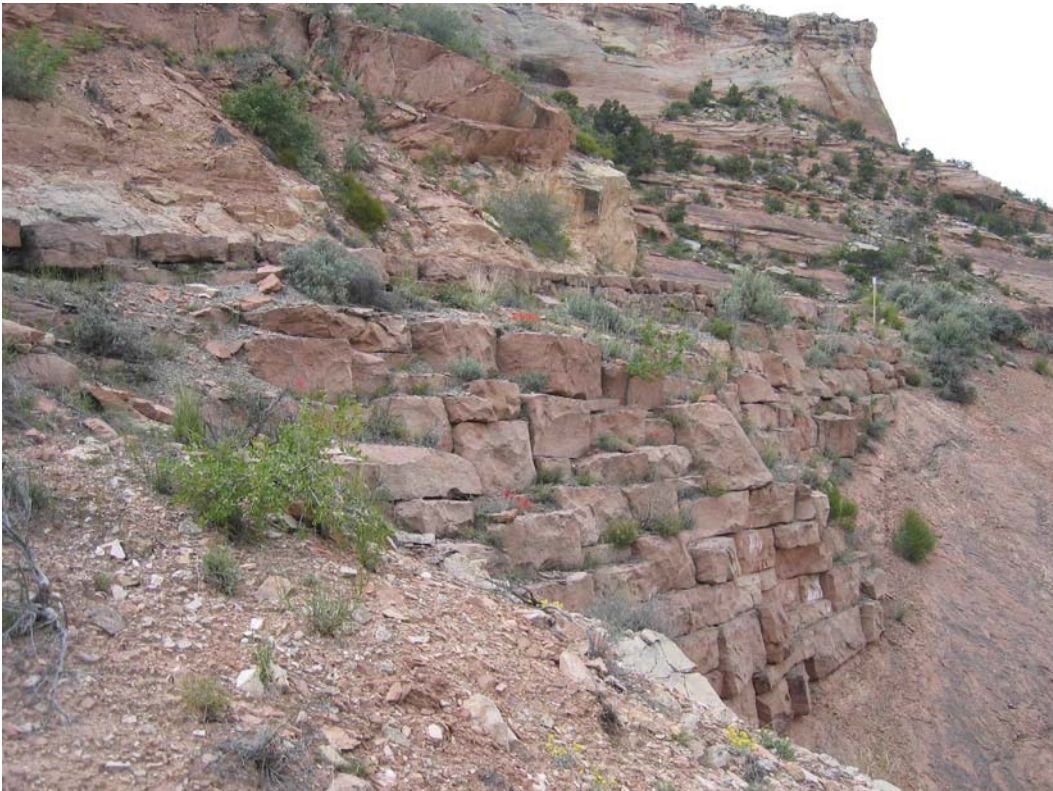
COLM\_0010\_0.840\_R\_2.jpg

<b>Element (Weighting Factor)</b>	<b>Narrative</b>	<b>Condition Rating (0 - 10)</b>
PERFORMANCE 8.00	No signs of global distresses. Functioning as intended.	8
WALL FOUNDATION MATERIAL 8.00	Foundation is hard, durable and stable sandstone, showing no signs of bearing distress.	9
PLACED STONE 8.00	See stone masonry.	8
STONE MASONRY 8.00	Dense, fresh cut sandstone blocks showing no signs of weathering, cracking, or similar distress. No blocks are missing or displaced.	8
ROAD/SIDEWALK/SHOULDER 0.50	No signs of distress, cracking, or settlement.	8
WALL DRAINS 0.50	No visible drains, but wall appears to be draining without problem - no signs of water staining, seepage, or soft ground.	8
LATERAL SLOPE 0.50	Lateral slopes are either exposed durable bedrock or well-vegetated, draining soil slopes showing no signs of erosion or slope distress.	9
TRAFFIC BARRIER/FENCE 1.00	Mortared stone guard wall with no significant signs of wall-related distress. Some minor mortar cracking, possibly due to wall settlement or weathering.	7

<b>Failure Consequence:</b>	HIGH
<b>Recommendation Narrative:</b>	None
<b>Repair Cost:</b>	\$0

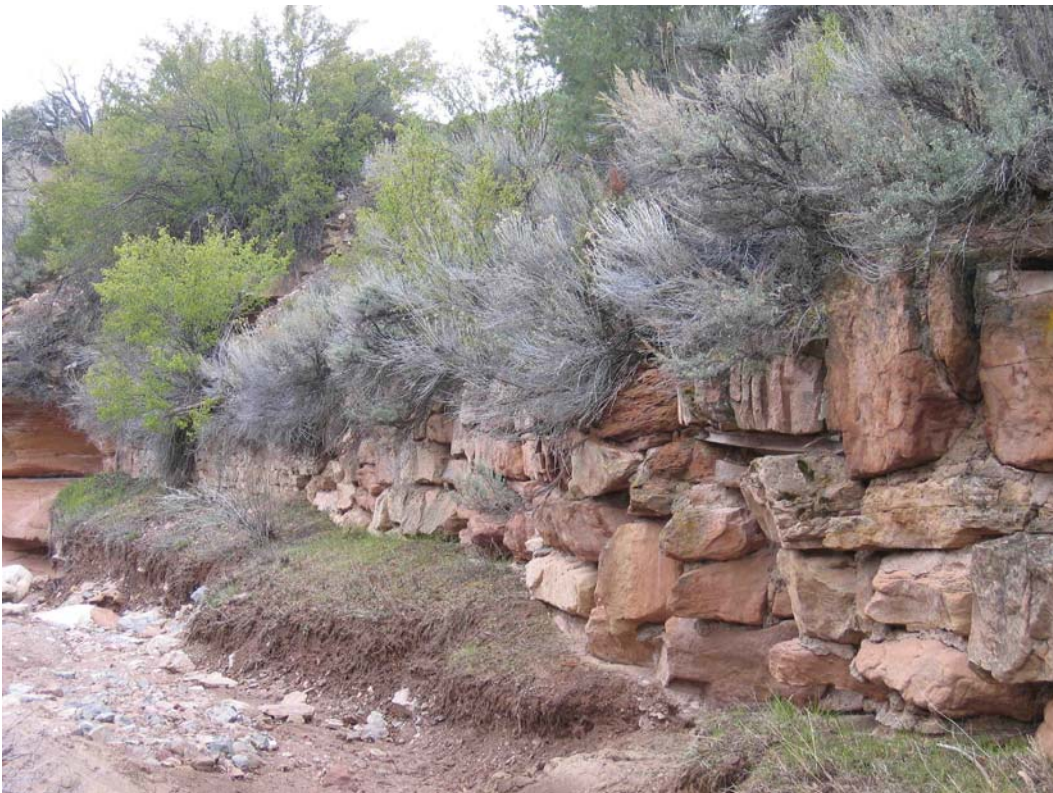
COLM\_0010\_11.627\_L\_2.jpg

<b>Element (Weighting Factor)</b>	<b>Narrative</b>	<b>Condition Rating (0 - 10)</b>
PERFORMANCE 8.00	Wall segments are performing according to design, no signs of movement.	8
WALL FOUNDATION MATERIAL 8.00	Soil over bedrock, intact, no signs of failure, sufficient to support structure.	8
MORTAR 8.00	In the end segments mortar is mostly intact with moderate to severe shrinkage, cracking. In center segment, mortar is severely shrinking with many gaps between blocks.	6
STONE MASONRY 8.00	Moderately weathered sandstone with large gaps and chinking in center segment. Wall appears to be remortared.	7
DOWNSLOPE 0.50	Drainage stream bottom, boulders, stable.	8
LATERAL SLOPE 0.50	Bedrock and fill materials no distress or failure, stable.	8
UPSLOPE 0.50	1:1 fill material soft with heavy vegetation, trees and sage bushes.	8
WALL DRAINS 0.50	No internal wall drains present. Self draining wall with minor seepage through wall face.	8

<b>Failure Consequence:</b>	HIGH
<b>Recommendation Narrative:</b>	None
<b>Repair Cost:</b>	\$0

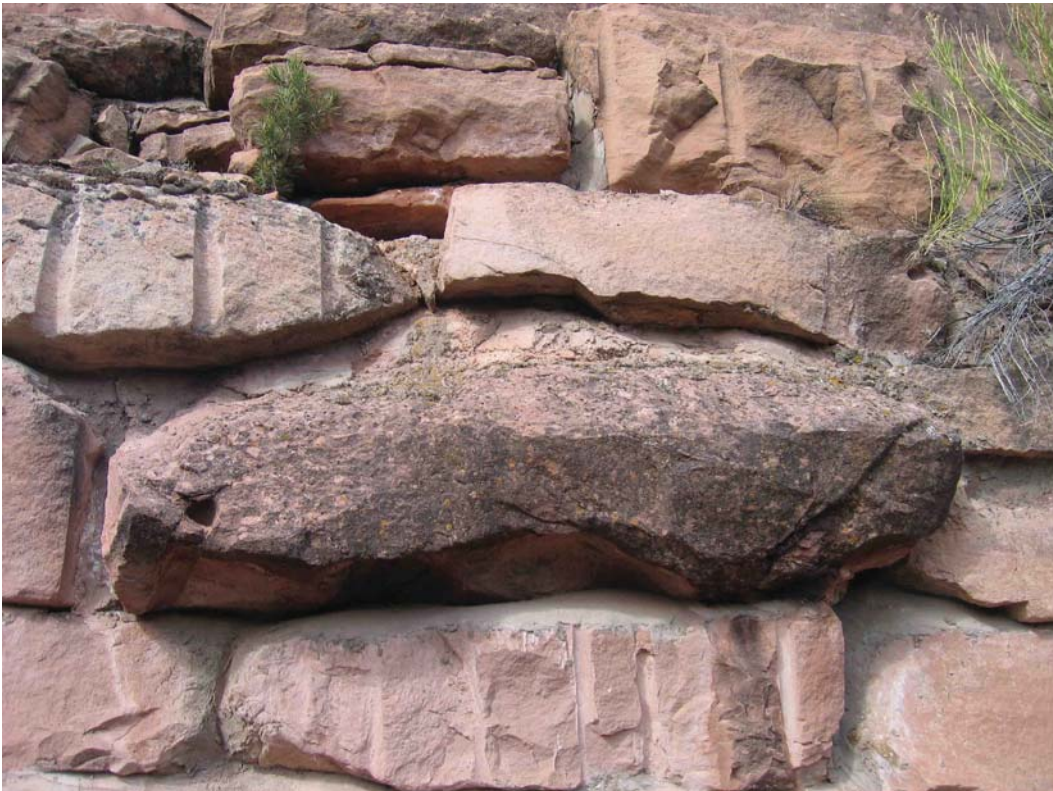
COLM\_0010\_12.563\_L\_2.jpg

<b>Wall Function:</b>	Fill Wall	<b>Primary Wall Type:</b>	Gravity - Mortared Stone
<b>Surface Treatment:</b>		<b>Secondary Wall Type:</b>	
<b>Secondary Surface Treatment:</b>		<b>Architectural Facing:</b>	
<b>General Description:</b>	Mortared masonry wall with guard wall, good condition.

<b>Element (Weighting Factor)</b>	<b>Narrative</b>	<b>Condition Rating (0 - 10)</b>
PERFORMANCE 8.00	Wall performing as designed, no signs of movement.	7
WALL FOUNDATION MATERIAL 8.00	Fill on sandstone bedrock, very steep cliff, signs of failure; adequate to support structure.	8
MORTAR 8.00	It appears to have been refreshed recently; moderate shrinkage.	7
STONE MASONRY 8.00	Moderately weathered sandstone large blocks; good condition.	7
DOWNSLOPE 0.50	1:1 fill over massive sandstone bedrock, well vegetated with trees and bushes.	8
LATERAL SLOPE 0.50	1:1 fill over massive sandstone bedrock, well vegetated with trees and bushes.	8
VEGETATION 0.50	Vegetation growing in wall face and along foundation toe. Recommend removing some trees from face area.	8
WALL DRAINS 0.50	No internal wall drains present. No signs of water seepage or water damage to wall.	8
ROAD/SIDEWALK/SHOULDER 0.50	Newly paved road, no evidence of cracking.	10

<b>Failure Consequence:</b>	HIGH
<b>Recommendation Narrative:</b>	Remove small trees / bushes from wall face and wall toe: estimate 8.00 man hours @ \$55.00 / hr. \$440.00
<b>Repair Cost:</b>	\$440
