# DEWA WIP Report

## NPS Retaining Wall Inventory Program Delaware Water Gap National Recreation Area

**Federal Lands Highway  
Road Inventory Program**

Data Collection Date: December 2007  
Report Date: October 2015

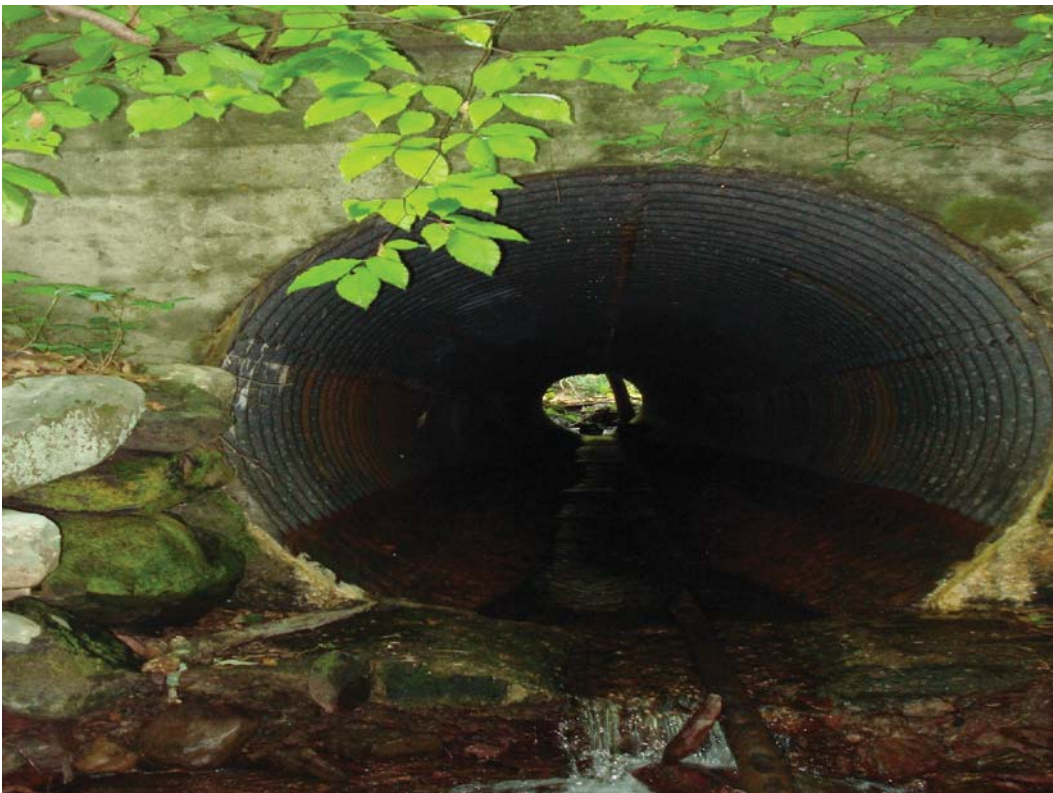
DEWA\_0010\_0.484\_L\_2.jpg

<b>Element (Weighting Factor)</b>	<b>Narrative</b>		<b>Condition Rating (0 - 10)</b>
PERFORMANCE 8.00	Good condition; 1/8-in. crack along top of wall; scour hole causing ongoing bank erosion and undermining of concrete apron; several medium to large diameter trees growing within 3 ft of wall		5
WALL FOUNDATION MATERIAL 8.00	No evidence of rotation, seepage or undermining; crack along top of wall suggests minor settlement along southern half of wall		8
CONCRETE 8.00	1/8-inch crack emanating from crown of culvert and extending up to top of wall; minor efflorescence around opening		8
WALL DRAINS 0.50	No evidence of drainage-related distress		9
LATERAL SLOPE 0.50	No distress; no evidence of movement; no erosion		10
ROAD/SIDEWALK/SHOULDER 0.50	No distress to pavement		10
TRAFFIC BARRIER/FENCE 0.50	No distress to relatively new steel-backed timber guard rail		10
UPSLOPE 0.50	No distress to moderate-to-steep heavily-vegetated slope		10

DOWNSLOPE 1.00	7-ft diameter x 0.5-ft deep scour hole adjacent to wall; scour hole is causing ongoing bank erosion		6
<b>Repair Recommendations</b>			
<b>Failure Consequence:</b>	MODERATE		
<b>Recommendation Narrative:</b>	Repair crack - 4.75 lft (\$5/lft) = \$23.75. Backfill scour hole - earthwork geotextile - (49sqft/9)(\$5/sqyd) = \$27.22. Placed riprap, class 3 - (24.5 cuft/27)(\$200/cuyd) = \$181.48 - 8 labor hrs (\$55/hr) = \$440. Reline 60-in. dia. cu		
<b>Repair Cost:</b>	\$39,902		
2007 cost estimate (ASTM Class D), preliminary for comparison to other repair costs only.

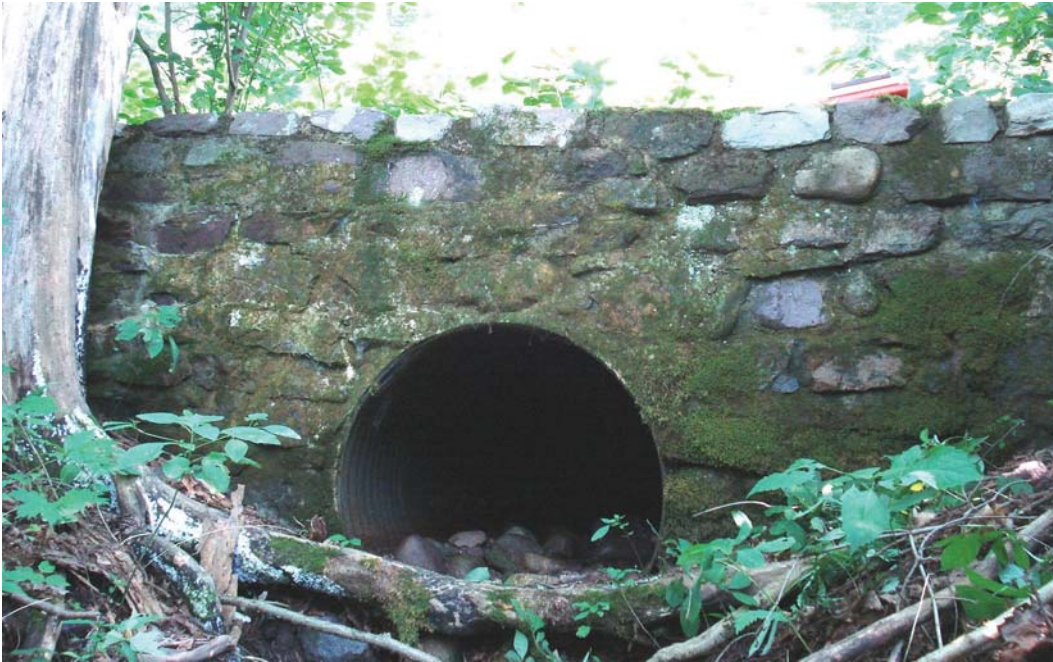
**DEWA\_0010\_1.890\_L\_1.jpg**

<b>Wall ID:</b>	DEWA-0010-1.890-L		
<b>Route Name:</b>	OLD MINE ROAD (SOUTH SECTION)		
<b>Inspection Date:</b>	August 02, 2007	<b>Approximate Year Built:</b>	Unknown
<b>*Wall Rating:</b>	87	<b>Maintenance Action:</b>	Maintenance
<b>Wall Description</b>			
<b>Wall Function:</b>	Head Wall	<b>Primary Wall Type:</b>	Gravity - Mortared Stone
<b>Surface Treatment:</b>		<b>Secondary Wall Type:</b>	
<b>Secondary Surface Treatment:</b>		<b>Architectural Facing:</b>	
<b>General Description:</b>	Stone masonry outlet headwall for a 36 in CMP culvert constructed along left shoulder of very low ADT roadway low consequence of failure		
<b>Wall Measurements</b>			
<b>Wall Length (ft.):</b>	12	<b>Face Area (sq.):</b>	46
<b>Average Wall Height (ft.):</b>	3	<b>Face Angle (deg.):</b>	90
<b>Maximum Wall Height (ft.):</b>	5	<b>Vertical Offset (ft.):</b>	0
<b>Assessed Elements</b>			
<b>Element (Weighting Factor)</b>	<b>Narrative</b>	<b>Condition Rating (0 - 10)</b>

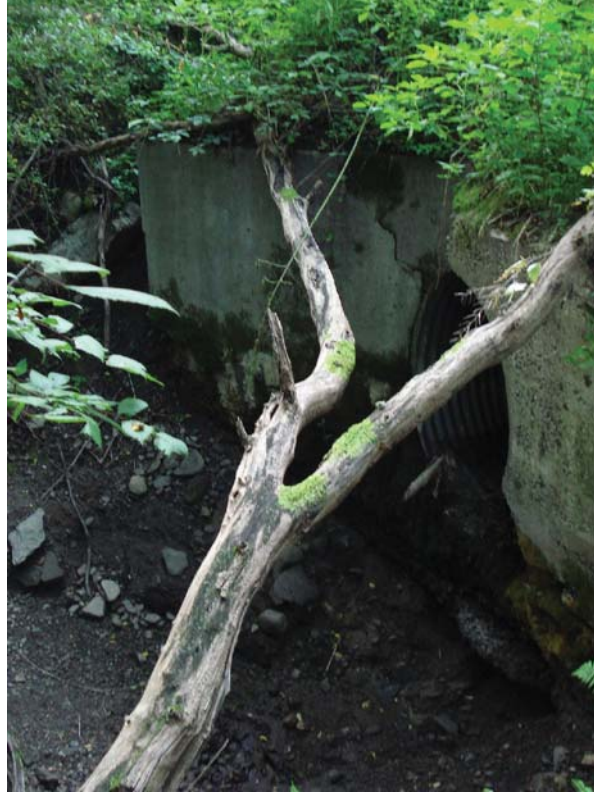
DEWA\_0010\_9.823\_L\_1.jpg

<b>Wall ID:</b>	DEWA-0010-9.823-L		
<b>Route Name:</b>	OLD MINE ROAD (SOUTH SECTION)		
<b>Inspection Date:</b>	August 02, 2007	<b>Approximate Year Built:</b>	Unknown
<b>*Wall Rating:</b>	25	<b>Maintenance Action:</b>	Replace Wall
<b>Wall Description</b>			
<b>Wall Function:</b>	Head Wall	<b>Primary Wall Type:</b>	Gravity - Mass Concrete
<b>Surface Treatment:</b>		<b>Secondary Wall Type:</b>	
<b>Secondary Surface Treatment:</b>		<b>Architectural Facing:</b>	
<b>General Description:</b>	Concrete outlet headwall for a 48 in diameter CMP culvert constructed along left shoulder and along base of moderate slope supporting a very low ADT roadway moderate consequence of failure wall is in critical condition		
<b>Wall Measurements</b>			
<b>Wall Length (ft.):</b>	16	<b>Face Area (sq.):</b>	79
<b>Average Wall Height (ft.):</b>	4	<b>Face Angle (deg.):</b>	90
<b>Maximum Wall Height (ft.):</b>	8	<b>Vertical Offset (ft.):</b>	-14

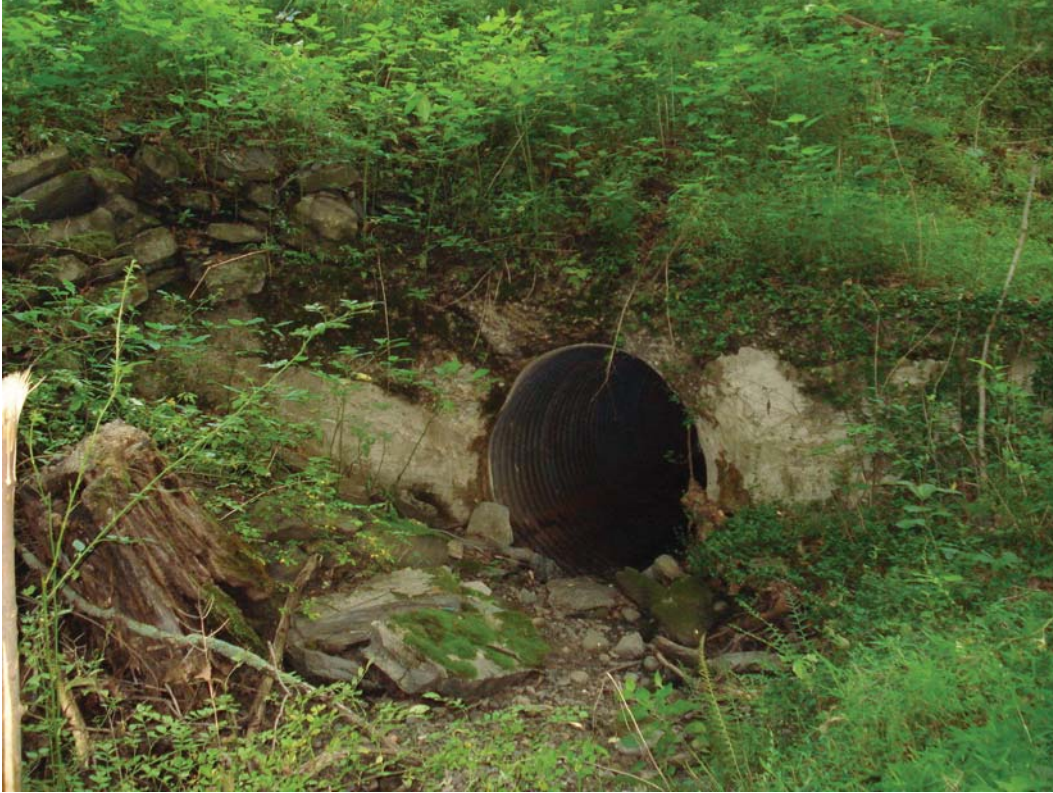
**DEWA\_0010\_9.823\_R\_1.jpg**

<b>Wall ID:</b>	DEWA-0010-9.823-R		
<b>Route Name:</b>	OLD MINE ROAD (SOUTH SECTION)		
<b>Inspection Date:</b>	August 03, 2007	<b>Approximate Year Built:</b>	Unknown
<b>*Wall Rating:</b>	57	<b>Maintenance Action:</b>	Replace Wall
<b>Wall Description</b>			
<b>Wall Function:</b>	Head Wall	<b>Primary Wall Type:</b>	Gravity - Mass Concrete
<b>Surface Treatment:</b>		<b>Secondary Wall Type:</b>	Gravity - Dry Stone
<b>Secondary Surface Treatment:</b>		<b>Architectural Facing:</b>	
<b>General Description:</b>	Concrete inlet headwall for a 48 in diameter CMP culvert constructed along right shoulder and along base of moderate slope supporting a very low ADT roadway low consequence of failure due to size and distance from roadway		
<b>Wall Measurements</b>			
<b>Wall Length (ft.):</b>	16	<b>Face Area (sq.):</b>	43
<b>Average Wall Height (ft.):</b>	2	<b>Face Angle (deg.):</b>	90
<b>Maximum Wall Height (ft.):</b>	6	<b>Vertical Offset (ft.):</b>	-11

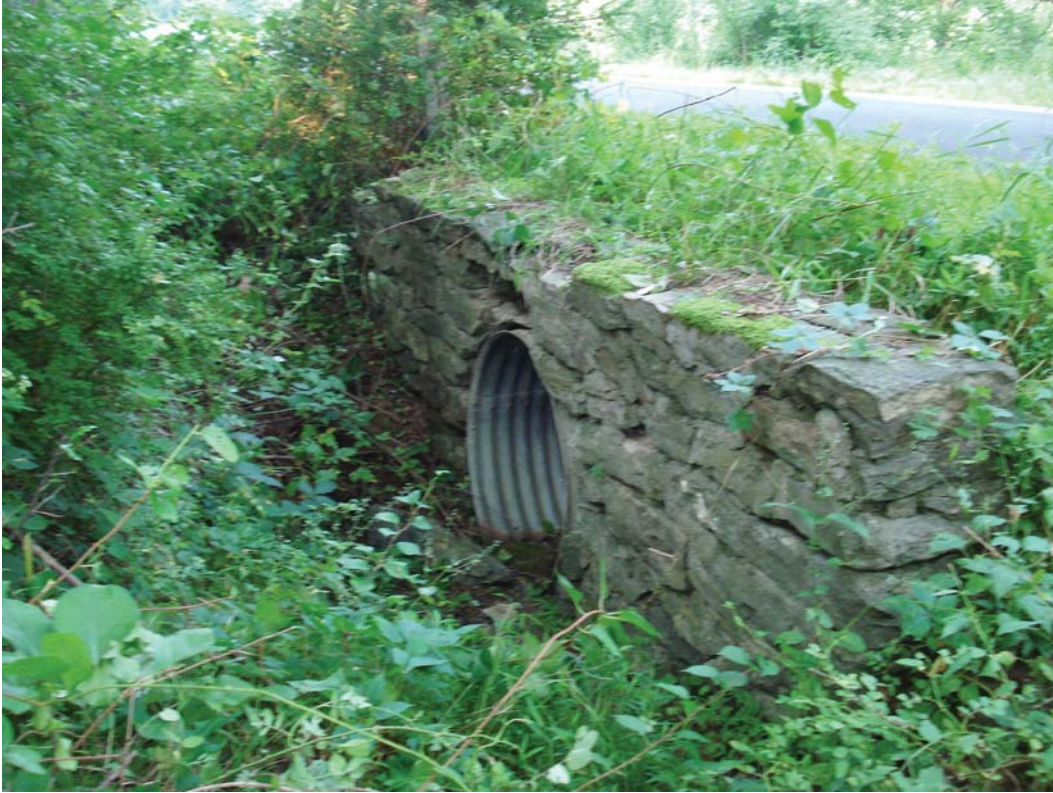
**DEWA\_0010\_10.525\_R\_1.jpg**

<b>Wall ID:</b>	DEWA-0010-10.525-R		
<b>Route Name:</b>	OLD MINE ROAD (SOUTH SECTION)		
<b>Inspection Date:</b>	August 03, 2007	<b>Approximate Year Built:</b>	Unknown
<b>*Wall Rating:</b>	64	<b>Maintenance Action:</b>	Repair Elements
<b>Wall Description</b>			
<b>Wall Function:</b>	Head Wall	<b>Primary Wall Type:</b>	Gravity - Mortared Stone
<b>Surface Treatment:</b>		<b>Secondary Wall Type:</b>	
<b>Secondary Surface Treatment:</b>		<b>Architectural Facing:</b>	
<b>General Description:</b>	Stone masonry inlet headwall for a 36 in diameter CMP culvert constructed along right shoulder of very low ADT roadway moderate consequence of failure due to proximity to roadway		
<b>Wall Measurements</b>			
<b>Wall Length (ft.):</b>	12	<b>Face Area (sq.):</b>	28
<b>Average Wall Height (ft.):</b>	2	<b>Face Angle (deg.):</b>	90
<b>Maximum Wall Height (ft.):</b>	4	<b>Vertical Offset (ft.):</b>	0
<b>Assessed Elements</b>

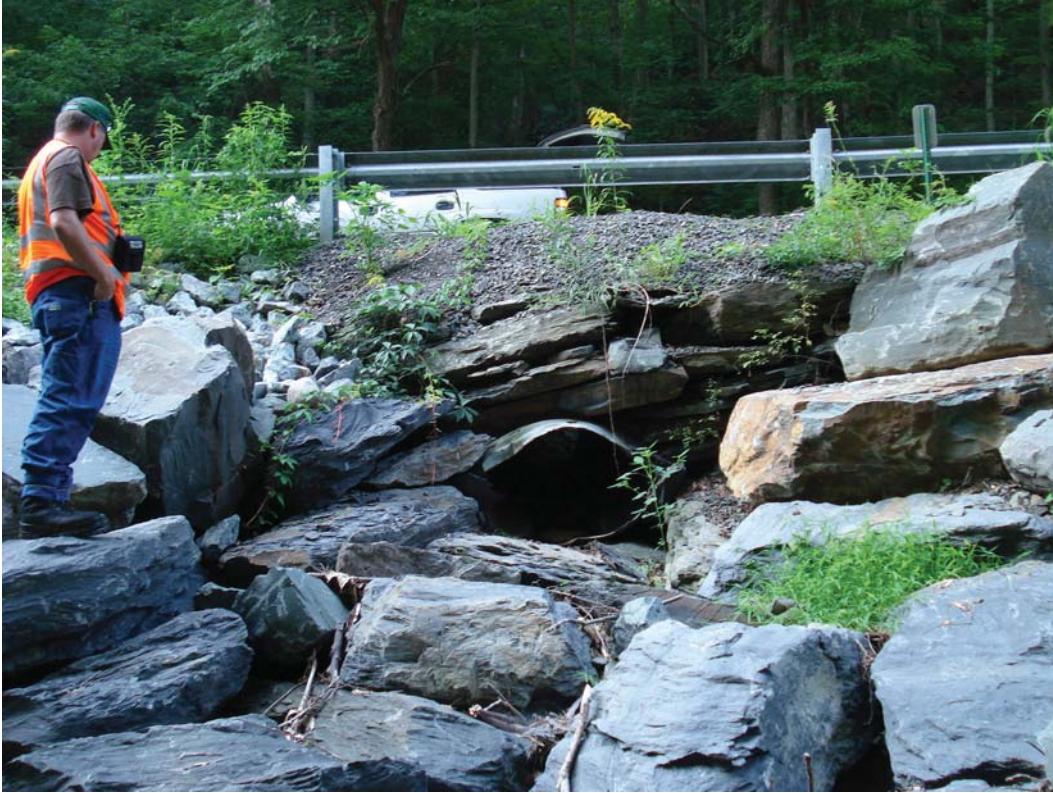
**DEWA\_0010\_13.190\_L\_1.jpg**

<b>Wall ID:</b>	DEWA-0010-13.190-L		
<b>Route Name:</b>	OLD MINE ROAD (SOUTH SECTION)		
<b>Inspection Date:</b>	August 03, 2007	<b>Approximate Year Built:</b>	Unknown
<b>*Wall Rating:</b>	93	<b>Maintenance Action:</b>	No Action
<b>Wall Description</b>			
<b>Wall Function:</b>	Head Wall	<b>Primary Wall Type:</b>	Gravity - Dry Stone
<b>Surface Treatment:</b>		<b>Secondary Wall Type:</b>	
<b>Secondary Surface Treatment:</b>		<b>Architectural Facing:</b>	
<b>General Description:</b>	Dry stacked stone inlet headwall for a 36 in diameter CMP culvert constructed along right shoulder and directly supports a low ADT roadway moderate consequence of failure as failure will directly affect the roadway		
<b>Wall Measurements</b>			
<b>Wall Length (ft.):</b>	12	<b>Face Area (sq.):</b>	38
<b>Average Wall Height (ft.):</b>	3	<b>Face Angle (deg.):</b>	90
<b>Maximum Wall Height (ft.):</b>	6	<b>Vertical Offset (ft.):</b>	0

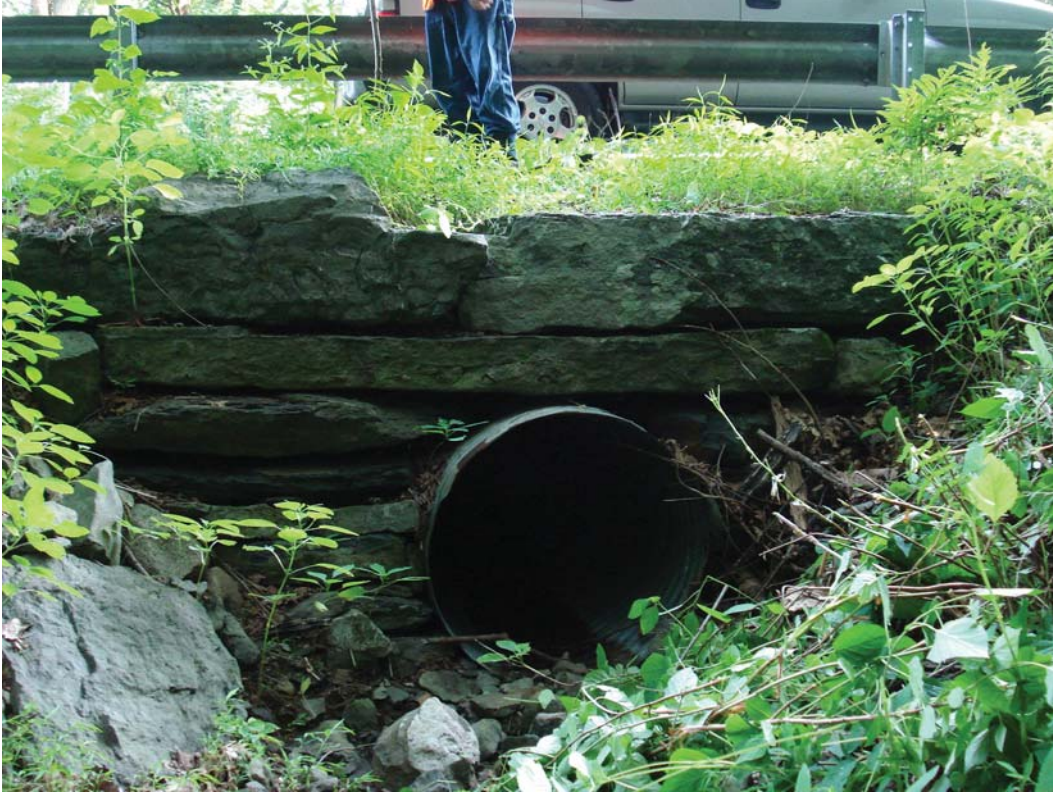
**DEWA\_0010\_13.190\_R\_1.jpg**

<b>Wall ID:</b>	DEWA-0010-13.190-R		
<b>Route Name:</b>	OLD MINE ROAD (SOUTH SECTION)		
<b>Inspection Date:</b>	August 03, 2007	<b>Approximate Year Built:</b>	Unknown
<b>*Wall Rating:</b>	87	<b>Maintenance Action:</b>	Maintenance
<b>Wall Description</b>			
<b>Wall Function:</b>	Head Wall	<b>Primary Wall Type:</b>	Gravity - Dry Stone
<b>Surface Treatment:</b>		<b>Secondary Wall Type:</b>	
<b>Secondary Surface Treatment:</b>		<b>Architectural Facing:</b>	
<b>General Description:</b>	Dry stacked stone outlet headwall for a 36 in diameter CMP culvert constructed along left shoulder and directly supports a low ADT roadway high consequence of failure due to size and proximity to roadway		
<b>Wall Measurements</b>			
<b>Wall Length (ft.):</b>	11	<b>Face Area (sq.):</b>	37
<b>Average Wall Height (ft.):</b>	3	<b>Face Angle (deg.):</b>	75
<b>Maximum Wall Height (ft.):</b>	5	<b>Vertical Offset (ft.):</b>	-2
<b>Assessed Elements</b>

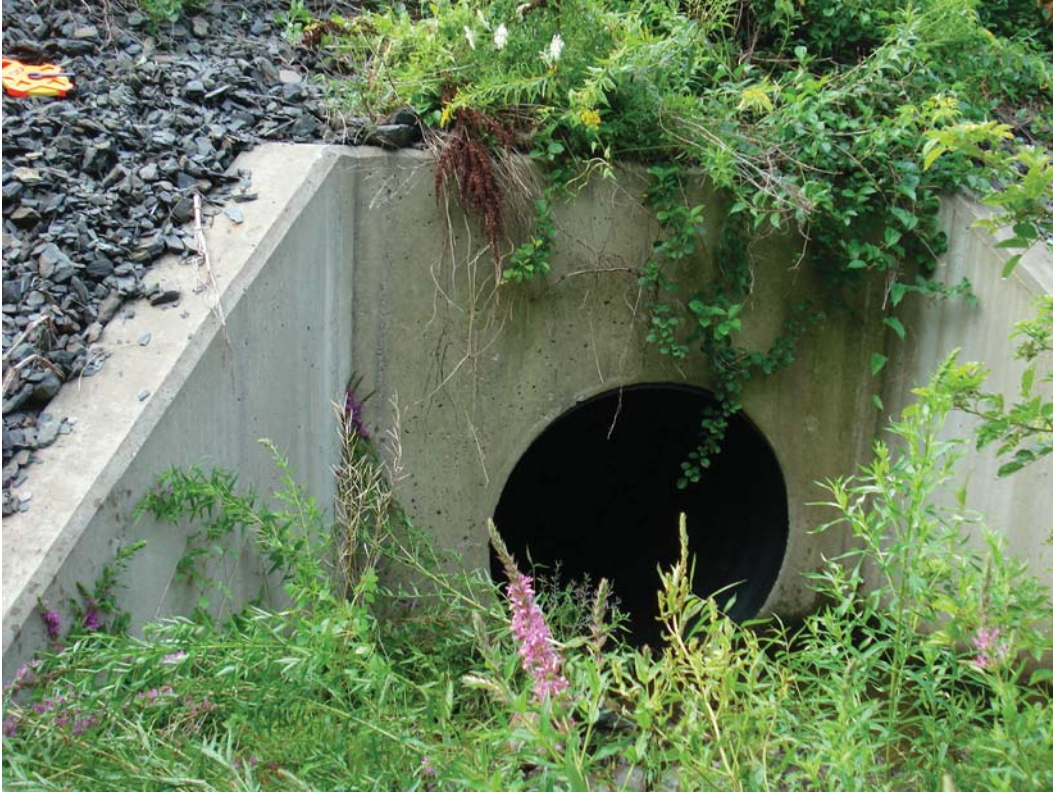
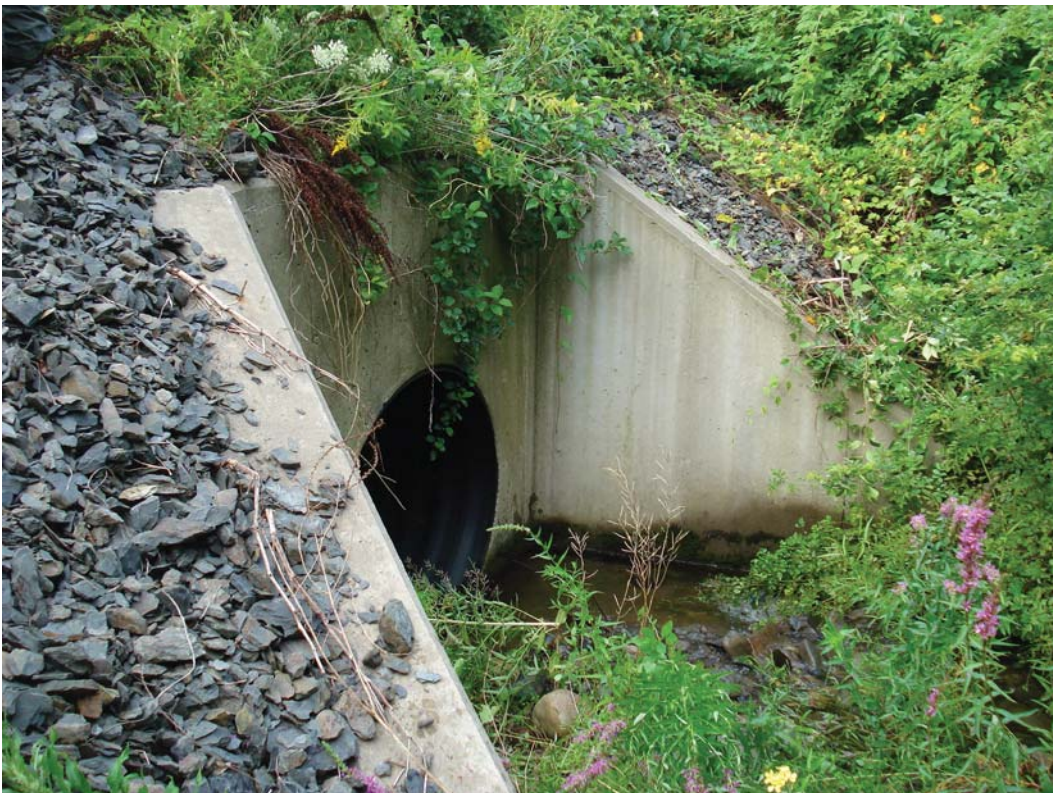
<b>Wall ID:</b>	DEWA-0014-3.985-L		
<b>Route Name:</b>	US ROUTE 209		
<b>Inspection Date:</b>	August 01, 2007	<b>Approximate Year Built:</b>	Unknown
<b>*Wall Rating:</b>	94	<b>Maintenance Action:</b>	No Action
<b>Wall Description</b>			
<b>Wall Function:</b>	Head Wall	<b>Primary Wall Type:</b>	Gravity - Mass Concrete
<b>Surface Treatment:</b>		<b>Secondary Wall Type:</b>	
<b>Secondary Surface Treatment:</b>		<b>Architectural Facing:</b>	
<b>General Description:</b>	Relatively new concrete inlet headwall for a 48 in diameter corrugated plastic pipe culvert constructed along left shoulder of a high ADT roadway high consequence of failure		
<b>Wall Measurements</b>			
<b>Wall Length (ft.):</b>	19	<b>Face Area (sq.):</b>	78
<b>Average Wall Height (ft.):</b>	4	<b>Face Angle (deg.):</b>	90
<b>Maximum Wall Height (ft.):</b>	7	<b>Vertical Offset (ft.):</b>	-9
<b>Assessed Elements</b>			
<b>Element (Weighting Factor)</b>	<b>Narrative</b>	<b>Condition Rating (0 - 10)</b>

PERFORMANCE 8.00	Excellent condition	9	
WALL FOUNDATION MATERIAL 8.00	No distress; no evidence of settlement, rotation, undermining or seepage	9	
CONCRETE 8.00	No distress to relatively new concrete headwall	10	
DOWNSLOPE 0.50	No distress to rip rap lined stream channel	9	
UPSLOPE 0.50	No distress to moderate slope; loose rip rap fill along face of slope	9	
CULVERT 0.50	No distress to 48-in. diameter corrugated plastic pipe	10	
LATERAL SLOPE 0.50	No distress; lateral slope is covered with loose-placed rip rap	10	
ROAD/SIDEWALK/SHOULDER 0.50	No distress to pavement	10	
TRAFFIC BARRIER/FENCE 0.50	No distress to steel guard rail	10	
<b>Repair Recommendations</b>			
<b>Failure Consequence:</b>	HIGH		
<b>Recommendation Narrative:</b>	None		
<b>Repair Cost:</b>	\$0		
2007 cost estimate (ASTM Class D), preliminary for comparison to other repair costs only.

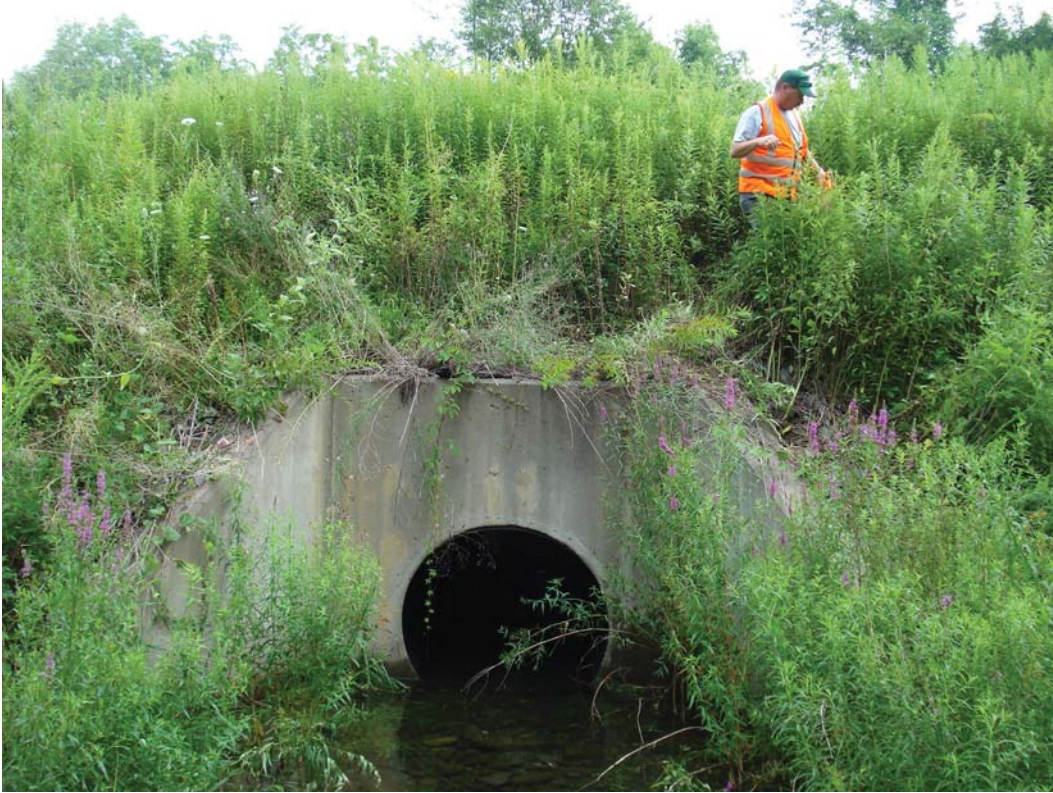
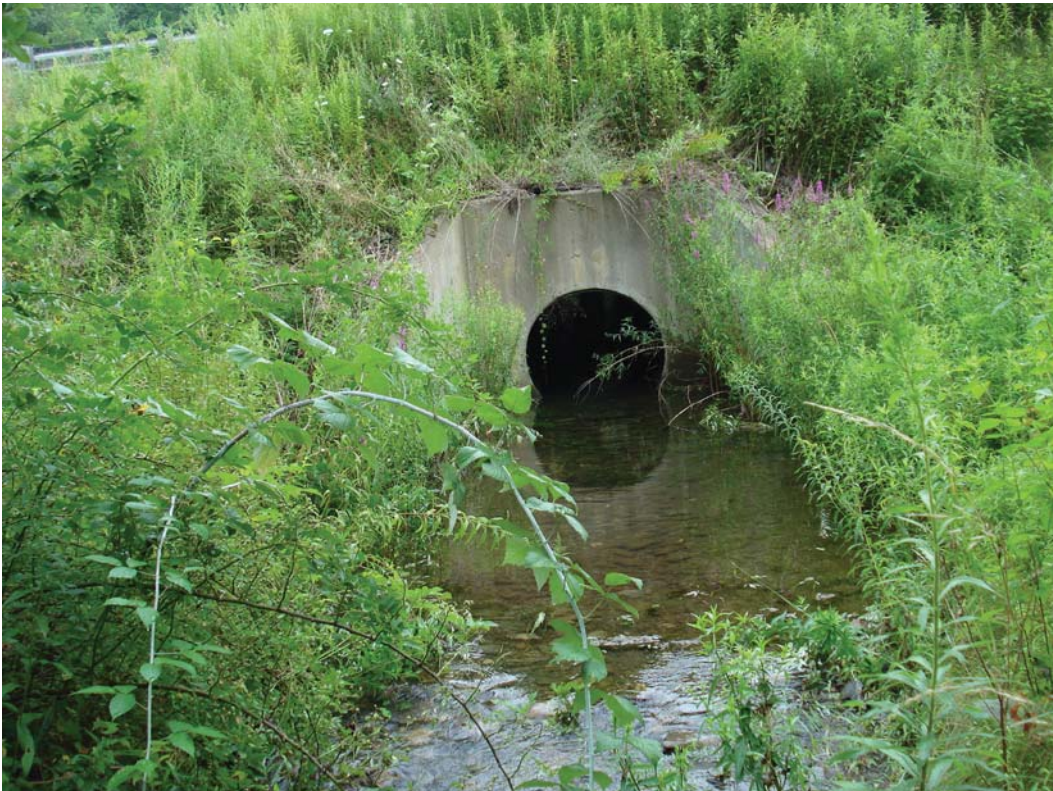
<b>Wall ID:</b>	DEWA-0014-3.986-R		
<b>Route Name:</b>	US ROUTE 209		
<b>Inspection Date:</b>	August 01, 2007	<b>Approximate Year Built:</b>	Unknown
<b>*Wall Rating:</b>	86	<b>Maintenance Action:</b>	Maintenance
<b>Wall Description</b>			
<b>Wall Function:</b>	Head Wall	<b>Primary Wall Type:</b>	Gravity - Mass Concrete
<b>Surface Treatment:</b>		<b>Secondary Wall Type:</b>	
<b>Secondary Surface Treatment:</b>		<b>Architectural Facing:</b>	
<b>General Description:</b>	Relatively new concrete outlet headwall for a 48 in diameter corrugated plastic pipe culvert constructed along right shoulder of high ADT roadway high consequence of failure		
<b>Wall Measurements</b>			
<b>Wall Length (ft.):</b>	19	<b>Face Area (sq.):</b>	92
<b>Average Wall Height (ft.):</b>	4	<b>Face Angle (deg.):</b>	90
<b>Maximum Wall Height (ft.):</b>	7	<b>Vertical Offset (ft.):</b>	-9
<b>Assessed Elements</b>			
<b>Element (Weighting Factor)</b>	<b>Narrative</b>		<b>Condition Rating (0 - 10)</b>

PERFORMANCE 8.00	Good condition; scour hole at outlet threatens the long-term stability of wall		7
WALL FOUNDATION MATERIAL 8.00	No distress; no evidence of settlement, rotation, undermining or seepage		9
CONCRETE 8.00	No distress to relatively new concrete headwall		10
UPSLOPE 0.50	No distress to moderate slope; loose rip rap fill along face of slope		9
VEGETATION 0.50	No distress		9
CULVERT 0.50	No distress to 48-in. diameter corrugated plastic pipe		10
ROAD/SIDEWALK/SHOULDER 0.50	No distress to pavement		10
TRAFFIC BARRIER/FENCE 0.50	No distress to steel guard rail		10
WALL DRAINS 0.50	No evidence of drainage-related distress		10
<b>Repair Recommendations</b>			
<b>Failure Consequence:</b>	HIGH		
<b>Recommendation Narrative:</b>	Clear channel - 16 labor hrs (\$55/hr) = \$880		
<b>Repair Cost:</b>	\$880		
2007 cost estimate (ASTM Class D), preliminary for comparison to other repair costs only.

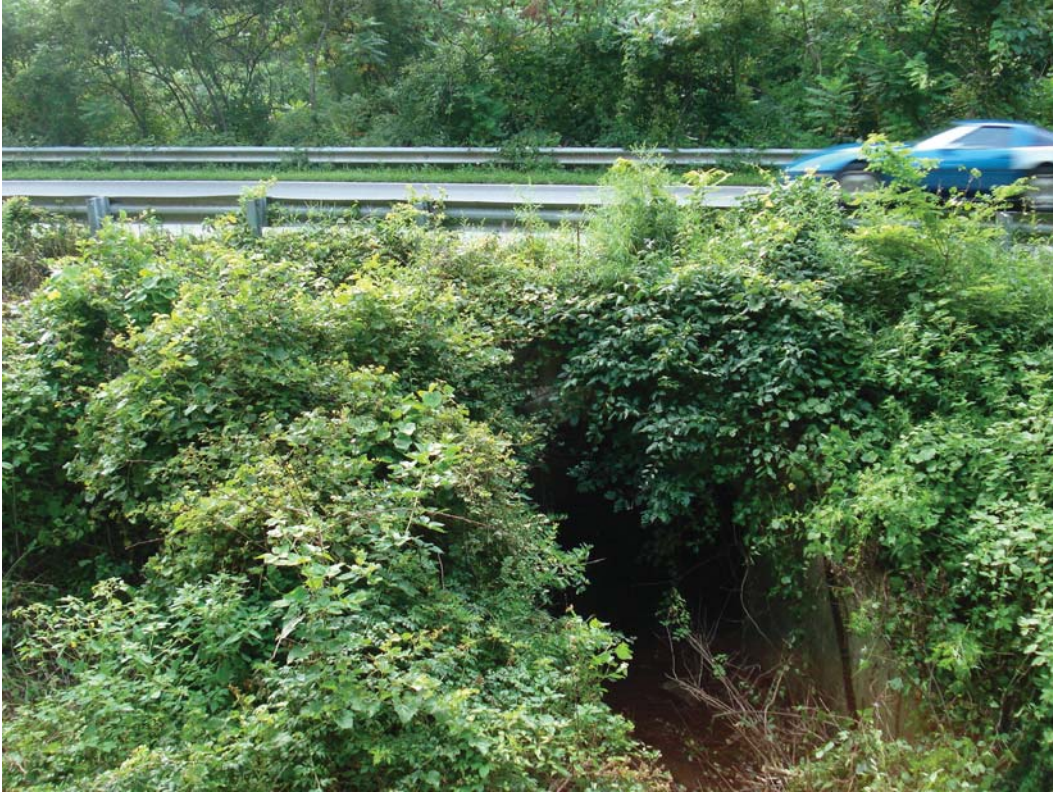
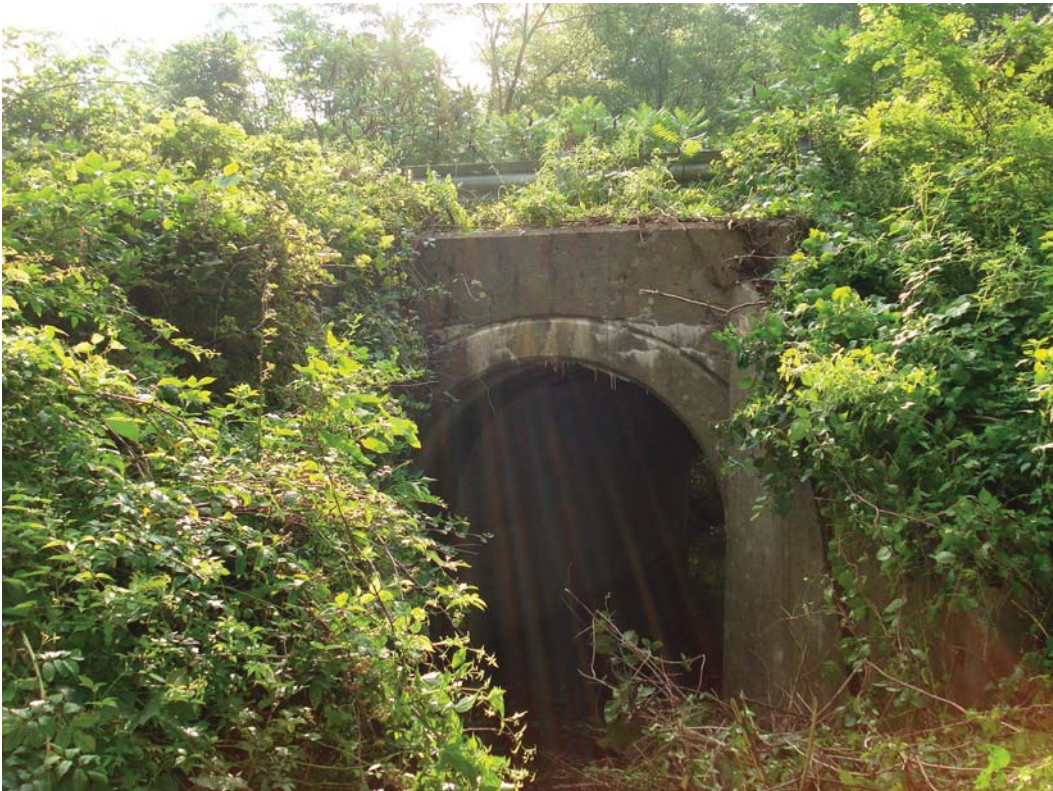
<b>Wall ID:</b>	DEWA-0014-8.400-L		
<b>Route Name:</b>	US ROUTE 209		
<b>Inspection Date:</b>	August 02, 2007	<b>Approximate Year Built:</b>	Unknown
<b>*Wall Rating:</b>	75	<b>Maintenance Action:</b>	Maintenance
<b>Wall Description</b>			
<b>Wall Function:</b>	Head Wall	<b>Primary Wall Type:</b>	Gravity - Mass Concrete
<b>Surface Treatment:</b>		<b>Secondary Wall Type:</b>	
<b>Secondary Surface Treatment:</b>		<b>Architectural Facing:</b>	
<b>General Description:</b>	Concrete inlet headwall for a 8 ft x 8.5 ft concrete arch culvert constructed along left shoulder of high ADT roadway high consequence of failure as structure directly supports roadway		
<b>Wall Measurements</b>			
<b>Wall Length (ft.):</b>	29	<b>Face Area (sq.):</b>	184
<b>Average Wall Height (ft.):</b>	6	<b>Face Angle (deg.):</b>	90
<b>Maximum Wall Height (ft.):</b>	12	<b>Vertical Offset (ft.):</b>	0
<b>Assessed Elements</b>			
<b>Element (Weighting Factor)</b>	<b>Narrative</b>		<b>Condition Rating (0 - 10)</b>

PERFORMANCE 8.00	Good condition; moderate efflorescence and several small cracks along face of wall; brush and vines have overgrown the wall		7
WALL FOUNDATION MATERIAL 8.00	No distress; no evidence of settlement, rotation, undermining or seepage		9
CONCRETE 8.00	1/8-in. cracks emanating from crown at opening up to the top of wall; minor spalling; moderate efflorescence at opening		6
CULVERT 0.50	No distress to 8 ft x 8.5 ft concrete arch culvert		9
DOWNSLOPE 0.50	No distress to stream channel; good drainage towards wall		9
LATERAL SLOPE 0.50	No distress; no evidence of movement; no erosion		9
ROAD/SIDEWALK/SHOULDER 0.50	No distress to pavement or relatively flat and narrow shoulder		9
TRAFFIC BARRIER/FENCE 0.50	No distress to steel guard rail; guard rail does not appear to meet current safety standards (too short)		9
VEGETATION 1.00	Wall is entirely covered with creeping vines and small vines along base of wall; brush is encroaching on the inlet		7

<b>Repair Recommendations</b>			
<b>Failure Consequence:</b>	HIGH		
<b>Recommendation Narrative:</b>	Clear vegetation - 16 labor hrs (\$55/hr) = \$880. Clean efflorescence - 8 labor hrs (\$55/hr) = \$440. Crack cleaning, routing & sealing - 20 lnft (\$10/lnft) = \$200.		
<b>Repair Cost:</b>	\$1,520		
2007 cost estimate (ASTM Class D), preliminary for comparison to other repair costs only.

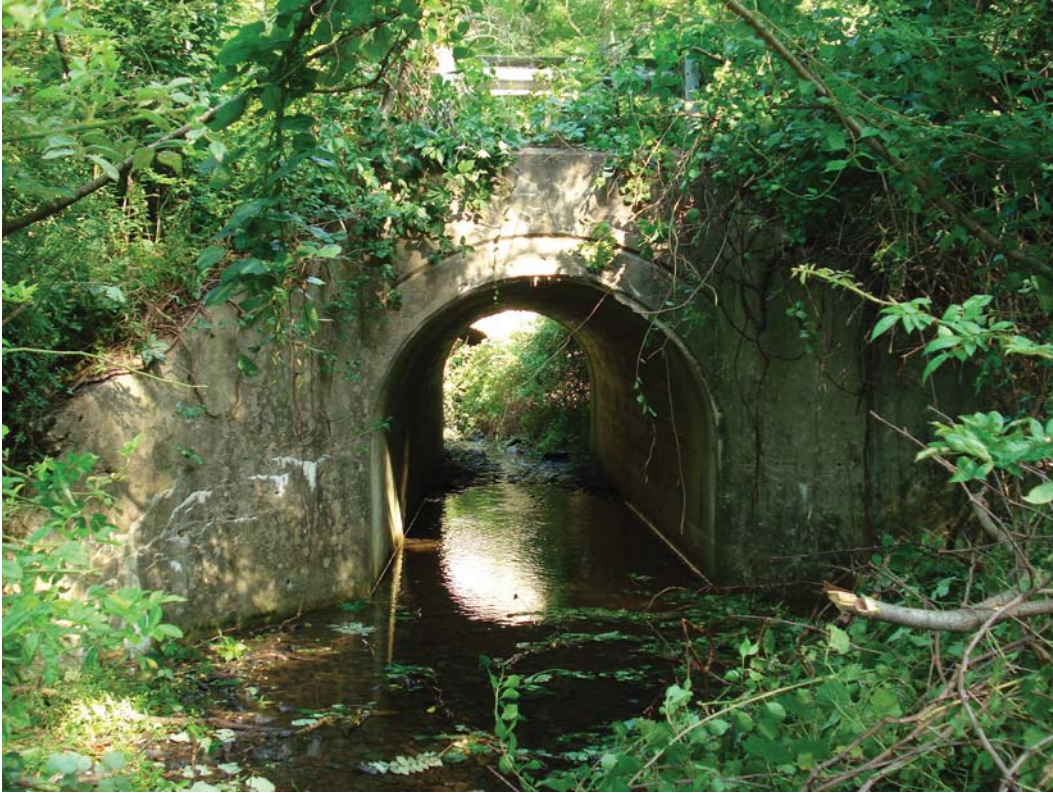
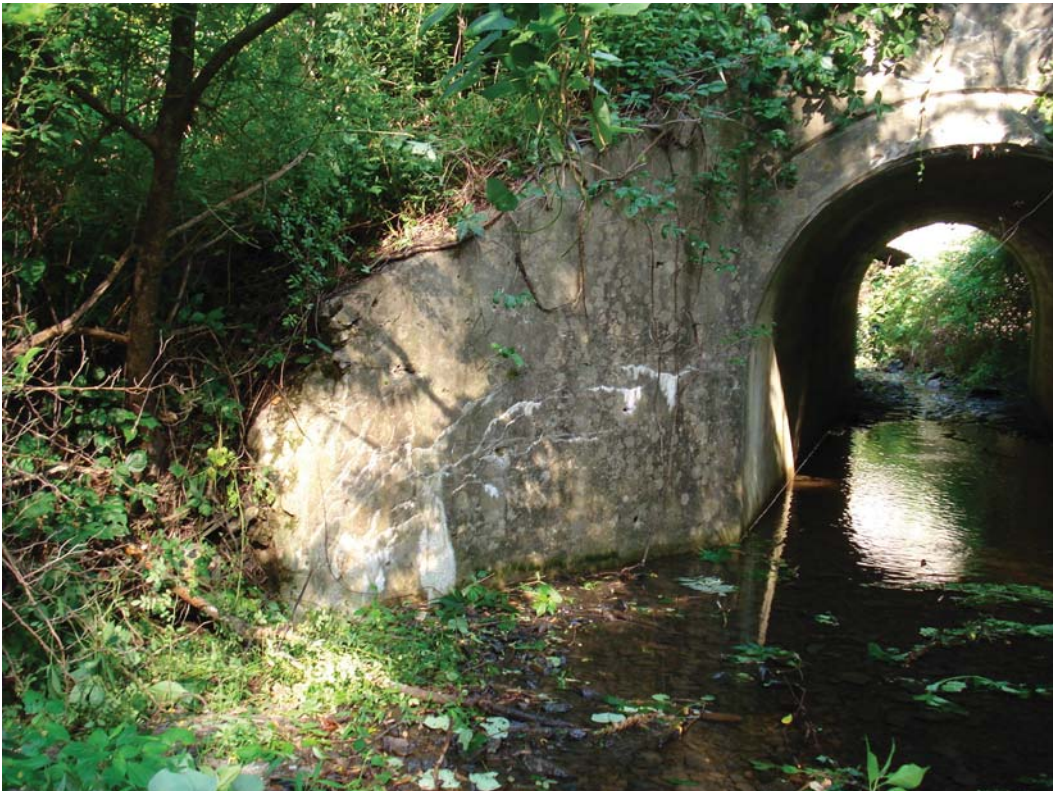
<b>Wall ID:</b>	DEWA-0014-8.400-R		
<b>Route Name:</b>	US ROUTE 209		
<b>Inspection Date:</b>	August 02, 2007	<b>Approximate Year Built:</b>	Unknown
<b>*Wall Rating:</b>	64	<b>Maintenance Action:</b>	Maintenance
<b>Wall Description</b>			
<b>Wall Function:</b>	Head Wall	<b>Primary Wall Type:</b>	Gravity - Mass Concrete
<b>Surface Treatment:</b>		<b>Secondary Wall Type:</b>	
<b>Secondary Surface Treatment:</b>		<b>Architectural Facing:</b>	
<b>General Description:</b>	Concrete outlet headwall for 8 ft x 8.5 ft concrete arch culvert constructed along right shoulder and directly supports a high ADT roadway high consequence of failure		
<b>Wall Measurements</b>			
<b>Wall Length (ft.):</b>	29	<b>Face Area (sq.):</b>	184
<b>Average Wall Height (ft.):</b>	6	<b>Face Angle (deg.):</b>	90
<b>Maximum Wall Height (ft.):</b>	12	<b>Vertical Offset (ft.):</b>	0
<b>Assessed Elements</b>			
<b>Element (Weighting Factor)</b>	<b>Narrative</b>		<b>Condition Rating (0 - 10)</b>

PERFORMANCE 8.00	Fair condition; many 1/8-in. to 1/4-in. cracks with minor to moderate spalling; moderate efflorescence along face of wall; poor drainage way from wall		5
WALL FOUNDATION MATERIAL 8.00	No distress; no evidence of settlement, rotation, undermining or seepage		9
CONCRETE 8.00	Minor to moderate delamination across wall; minor to moderate cracking with minor efflorescence; moderate cracking with spalled concrete at ends of both wingwalls		5
ROAD/SIDEWALK/SHOULDER 0.50	Minor transverse cracking of pavement; no distress to relatively narrow grassy shoulder		8
TRAFFIC BARRIER/FENCE 0.50	No distress to steel guard rail; guard rail does not appear to meet current safety standards (too short)		8
CULVERT 1.00	8 ft x 8.5 ft concrete arch culvert; several 1/8-in. to 1/4-in. cracks along face of wall; some cracks extend up to 6 ft inside culvert		5
LATERAL SLOPE 0.50	No distress; no evidence of movement; no erosion		10

WALL DRAINS 1.00	Evidence of freeze-thaw cracking along face of wall		6
DOWNSLOPE 1.00	Poor drainage away from wall due to accumulation of gravel downstream; no erosion of scouring of channel		7
<b>Repair Recommendations</b>			
<b>Failure Consequence:</b>	HIGH		
<b>Recommendation Narrative:</b>	Clear downstream channel - 8 labor hrs (\$55/hr) = \$440. Clear vegetation - 16 labor hrs (\$55/hr) = \$880. Clean efflorescence - 16 labor hrs (\$55/hr) = \$880, material cost = \$100. Crack cleaning, routing & sealing - 50 lft (\$10/lft) = \$50		
<b>Repair Cost:</b>	\$2,800		
2007 cost estimate (ASTM Class D), preliminary for comparison to other repair costs only.

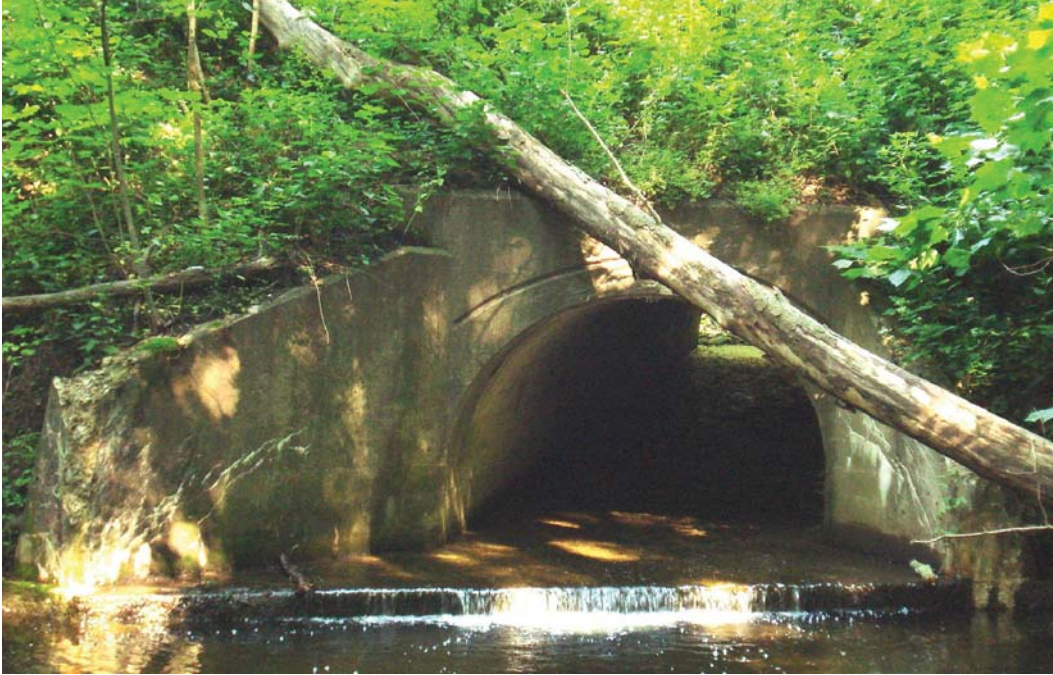
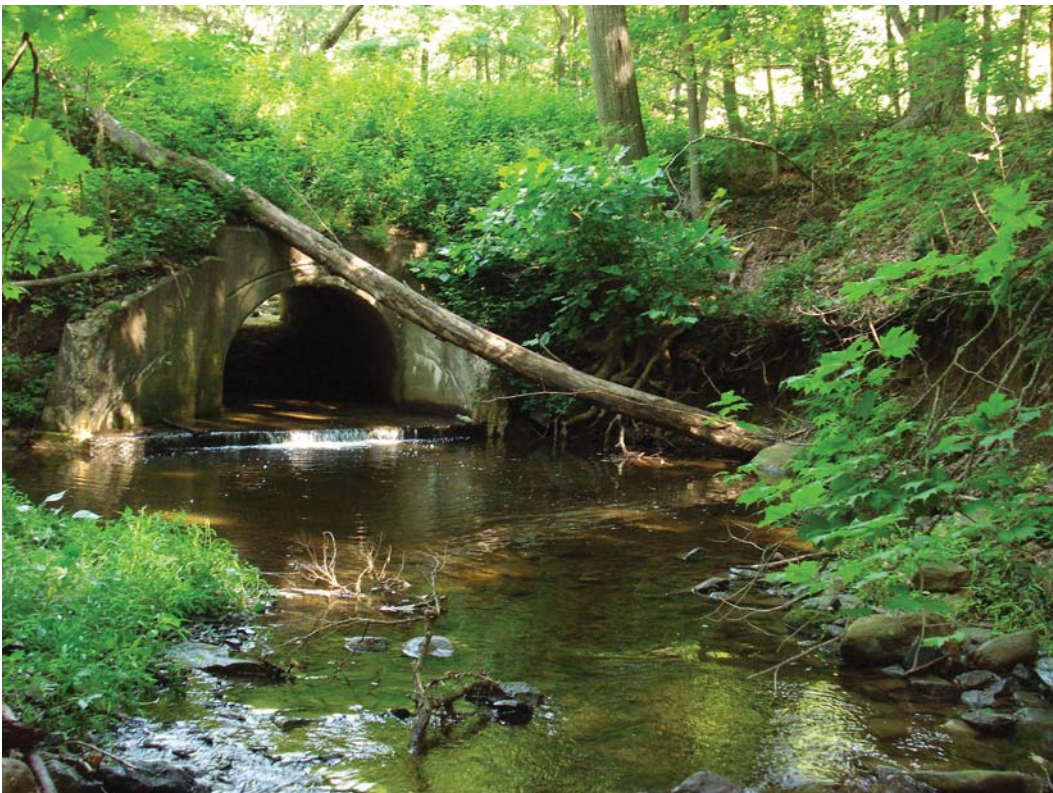
<b>Wall ID:</b>	DEWA-0014-9.096-R		
<b>Route Name:</b>	US ROUTE 209		
<b>Inspection Date:</b>	August 01, 2007	<b>Approximate Year Built:</b>	Unknown
<b>*Wall Rating:</b>	56	<b>Maintenance Action:</b>	Repair Elements
<b>Wall Description</b>			
<b>Wall Function:</b>	Head Wall	<b>Primary Wall Type:</b>	Gravity - Mass Concrete
<b>Surface Treatment:</b>		<b>Secondary Wall Type:</b>	
<b>Secondary Surface Treatment:</b>		<b>Architectural Facing:</b>	
<b>General Description:</b>	Concrete outlet headwall for an 11 ft x 6.67 ft concrete arch culvert constructed along right shoulder and along base of moderate slope supporting a high ADT roadway high consequence of failure		
<b>Wall Measurements</b>			
<b>Wall Length (ft.):</b>	27	<b>Face Area (sq.):</b>	187
<b>Average Wall Height (ft.):</b>	6	<b>Face Angle (deg.):</b>	90
<b>Maximum Wall Height (ft.):</b>	9	<b>Vertical Offset (ft.):</b>	-14
<b>Assessed Elements</b>

<b>Element (Weighting Factor)</b>	<b>Narrative</b>	<b>Condition Rating (0 - 10)</b>	
PERFORMANCE 8.00	Fair condition; moderate cracking and delamination along face of wall; severe ongoing scour and erosion of downslope and lateral slope	5	
WALL FOUNDATION MATERIAL 8.00	No distress; no evidence of settlement, rotation or seepage; moderate ongoing scour with up to 24-in. of the footing exposed	6	
CONCRETE 8.00	Minor cracking and delamination along wingwalls; minor spalling along ends of wingwalls (appears to be from equipment); moderate efflorescence along base of wall	5	
DOWNSLOPE 1.00	31 ft x 39 ft x 2 ft scour hole has formed at outlet and is eroding the foundation material and stream channel; scour hole threatens the near-term stability of wall	4	
LATERAL SLOPE 1.00	Severe ongoing erosion of bank resulting from scour hole; several undermined trees will topple into stream in the near term	4	
VEGETATION 0.50	Small brush and vegetation growing adjacent to wall, but not currently causing distress	8

CULVERT 0.50	No distress to 11 ft x 6.67 ft concrete arch culvert	9	
ROAD/SIDEWALK/SHOULDER 0.50	No distress to pavement	10	
TRAFFIC BARRIER/FENCE 0.50	No distress to steel guard rail	10	
<b>Repair Recommendations</b>			
<b>Failure Consequence:</b>	HIGH		
<b>Recommendation Narrative:</b>	Backfill scour hole - earthwork geotextile = 5.55 sqyd (\$5/sqyd) = \$27.78. Placed rip rap, Class 3 = 185 cuyd (\$200/cuyd) = \$37,037. Protect lateral slope - placed rip rap, Class 2 = 8.89 cuyd (\$220/cuyd) = \$1,955.56. Crack cleaning, routing		
<b>Repair Cost:</b>	\$40,200		
2007 cost estimate (ASTM Class D), preliminary for comparison to other repair costs only.

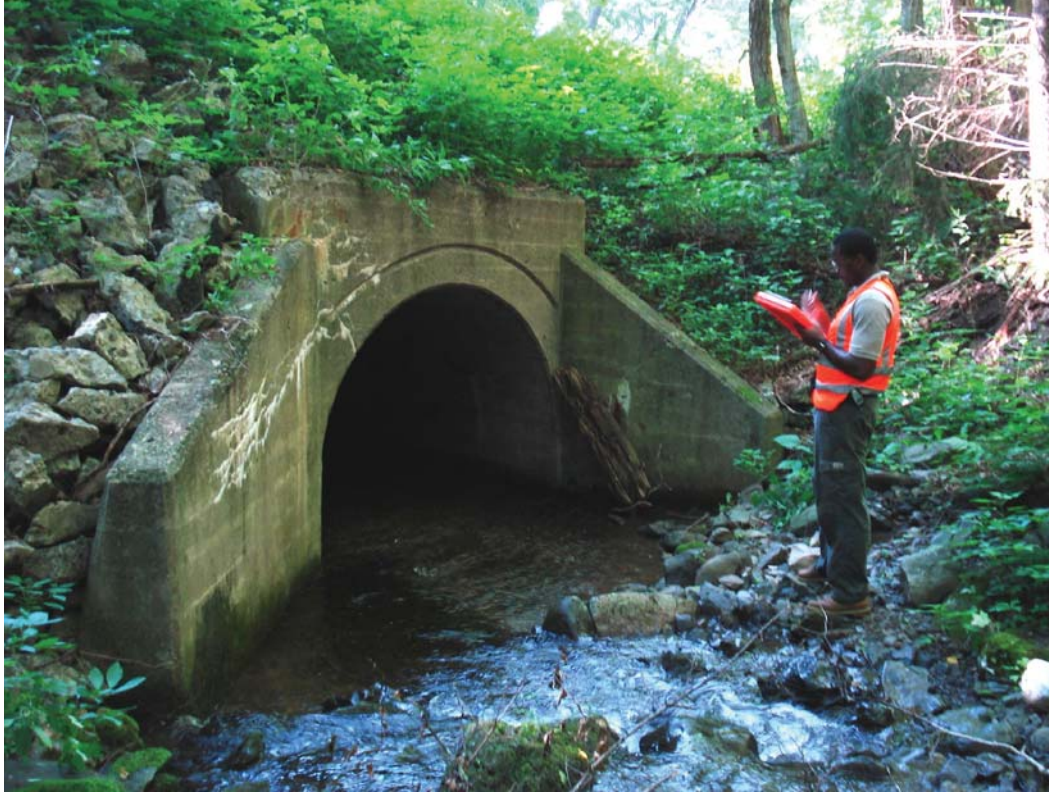
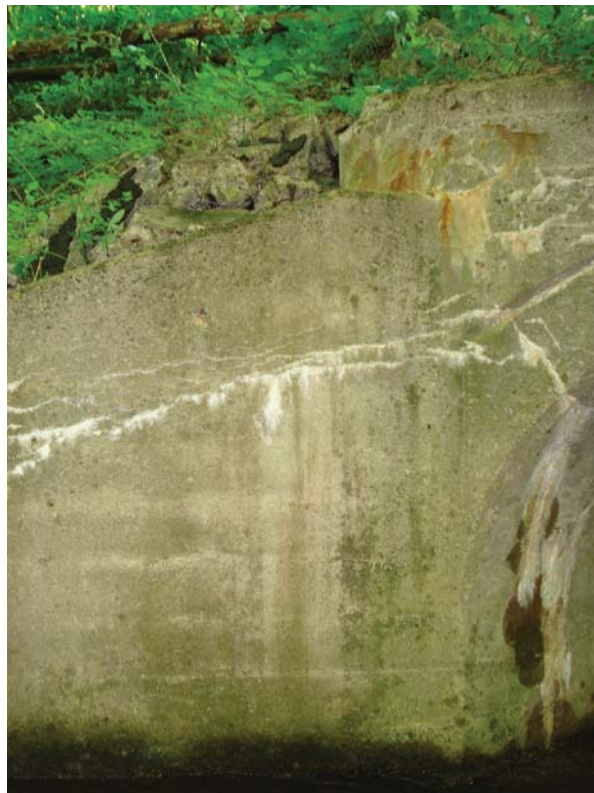
<b>Wall ID:</b>	DEWA-0014-9.098-L		
<b>Route Name:</b>	US ROUTE 209		
<b>Inspection Date:</b>	August 01, 2007	<b>Approximate Year Built:</b>	Unknown
<b>*Wall Rating:</b>	75	<b>Maintenance Action:</b>	Maintenance
<b>Wall Description</b>			
<b>Wall Function:</b>	Head Wall	<b>Primary Wall Type:</b>	Gravity - Mass Concrete
<b>Surface Treatment:</b>		<b>Secondary Wall Type:</b>	
<b>Secondary Surface Treatment:</b>		<b>Architectural Facing:</b>	
<b>General Description:</b>	Concrete inlet headwall for a 9.25 ft x 3.67 ft concrete arch culvert constructed along left shoulder and along base of moderate slope supporting a high ADT roadway high consequence of failure		
<b>Wall Measurements</b>			
<b>Wall Length (ft.):</b>	34	<b>Face Area (sq.):</b>	172
<b>Average Wall Height (ft.):</b>	5	<b>Face Angle (deg.):</b>	90
<b>Maximum Wall Height (ft.):</b>	8	<b>Vertical Offset (ft.):</b>	-11
<b>Assessed Elements</b>

<b>Element (Weighting Factor)</b>	<b>Narrative</b>		<b>Condition Rating (0 - 10)</b>
PERFORMANCE 8.00	Good condition; minor spalling of concrete resulting in exposure of rebar; exposed rebar is moderately rusted; moderate delamination; moderate erosion of lateral slope		7
WALL FOUNDATION MATERIAL 8.00	No distress; no evidence of settlement, rotation, undermining or seepage		9
CONCRETE 8.00	Minor to moderate delamination with minor spalling along face of wall; minor cracking; minor to moderate efflorescence		6
WALL DRAINS 0.50	Evidence of minor water infiltration		8
DOWNSLOPE 0.50	No distress to riprap -lined channel; a concrete apron extends out approximately 3 ft from the face of wall		9
ROAD/SIDEWALK/SHOULDER 0.50	No distress to pavement		9
TRAFFIC BARRIER/FENCE 0.50	Minor impact damage to steel guard rail		9
VEGETATION 0.50	Small brush growing adjacent to wall, but is not currently affecting wall performance		9

UPSLOPE 0.50	No distress to moderate, well-vegetated slope; some loosely placed pieces of concrete acting as slope protection		10
<b>Repair Recommendations</b>			
<b>Failure Consequence:</b>	HIGH		
<b>Recommendation Narrative:</b>	Crack cleaning, routing & sealing - 15 lnft (\$10/lnft) = \$150. Concrete repair - 3 sqft (\$150/sqft) = \$450. Placed riprap, Class 3 - 3 cuyd (\$200/cuyd) = \$600.		
<b>Repair Cost:</b>	\$1,200		
2007 cost estimate (ASTM Class D), preliminary for comparison to other repair costs only.
