# DEWA WIP Report

## NPS Retaining Wall Inventory Program Delaware Water Gap National Recreation Area

**Federal Lands Highway  
Road Inventory Program**

Data Collection Date: December 2007  
Report Date: October 2015

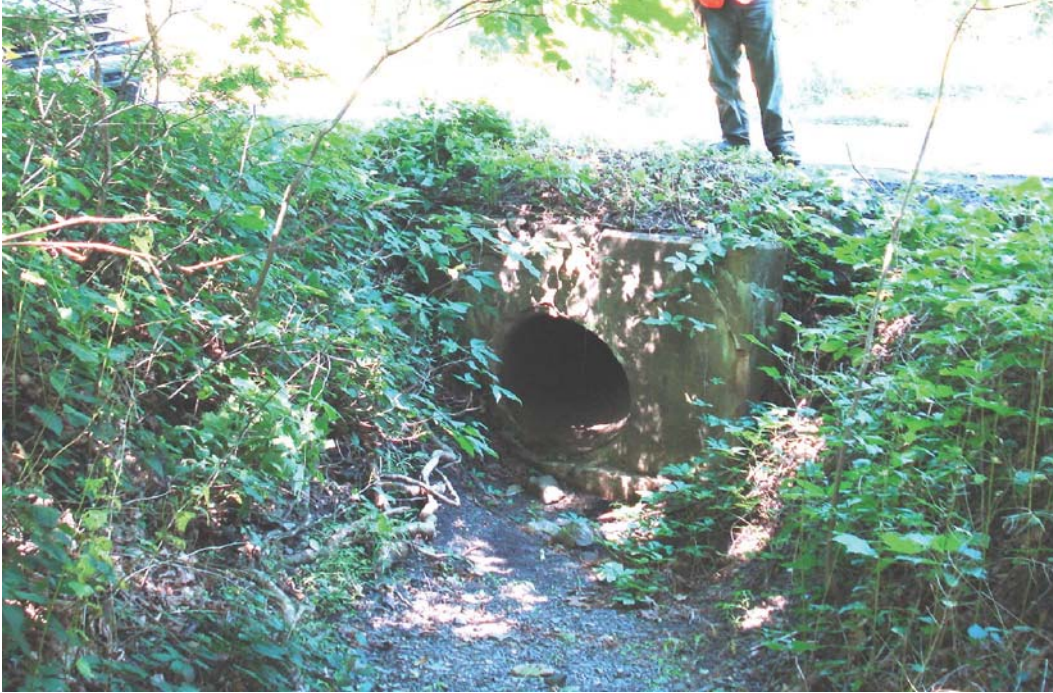
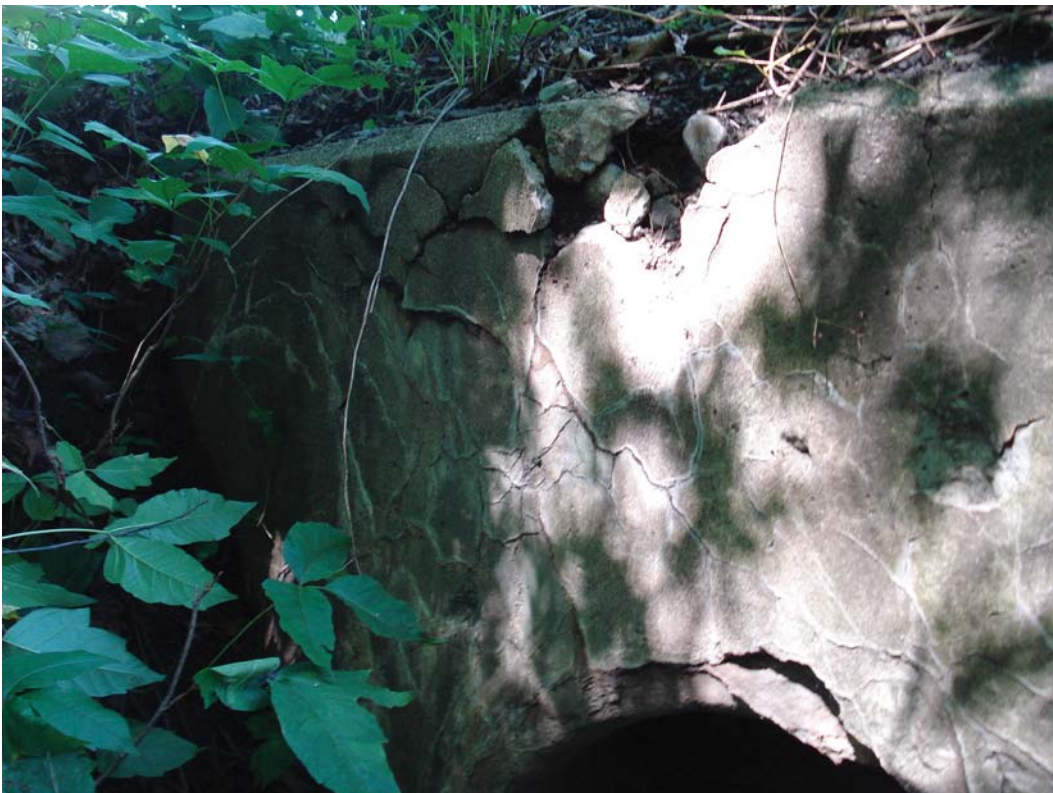
<b>Wall ID:</b>	DEWA-0014-9.795-R		
<b>Route Name:</b>	US ROUTE 209		
<b>Inspection Date:</b>	August 01, 2007	<b>Approximate Year Built:</b>	Unknown
<b>*Wall Rating:</b>	65	<b>Maintenance Action:</b>	Repair Elements
<b>Wall Description</b>			
<b>Wall Function:</b>	Head Wall	<b>Primary Wall Type:</b>	Gravity - Mass Concrete
<b>Surface Treatment:</b>		<b>Secondary Wall Type:</b>	
<b>Secondary Surface Treatment:</b>		<b>Architectural Facing:</b>	
<b>General Description:</b>	Concrete outlet headwall for a 30 in diameter concrete pipe culvert constructed along right shoulder of high ADT roadway high consequence of failure due to its proximity to roadway		
<b>Wall Measurements</b>			
<b>Wall Length (ft.):</b>	8	<b>Face Area (sq.):</b>	27
<b>Average Wall Height (ft.):</b>	3	<b>Face Angle (deg.):</b>	90
<b>Maximum Wall Height (ft.):</b>	4	<b>Vertical Offset (ft.):</b>	0
<b>Assessed Elements</b>			
<b>Element (Weighting Factor)</b>	<b>Narrative</b>	<b>Condition Rating (0 - 10)</b>

PERFORMANCE 8.00	Fair condition; moderate to severe delamination with moderate spalling; poor drainage away from wall; moderate erosion of lateral slope	6	
WALL FOUNDATION MATERIAL 8.00	No evidence of settlement, rotation, undermining or seepage	9	
CONCRETE 8.00	Moderate to severe delamination and spalling of concrete	4	
VEGETATION 0.50	No distress from small vegetation immediate to wall	8	
CULVERT 0.50	No distress to 30-in. diameter concrete pipe	9	
ROAD/SIDEWALK/SHOULDER 0.50	No distress to pavement or relatively narrow shoulder	9	
DOWNSLOPE 1.00	Accumulation of sediment downstream is promoting negative flow;	6	
LATERAL SLOPE 1.00	Moderate erosion along north end of wall (5 ft x 4 ft x 8-in.)	6	
WALL DRAINS 1.00	Evidence of minor weeping causing cracking and delamination	7	
<b>Repair Recommendations</b>			
<b>Failure Consequence:</b>	HIGH		
<b>Recommendation Narrative:</b>	Concrete repair (entire wall) - 26.67 sqft (\$150/sqft) = \$4,000.50. Backfill lateral slope - structural backfill = 0.49 cuyd (\$60) = \$29.63. Clear downstream channel - 16 labor hrs (\$55/hr) = \$880.

<b>Repair Cost:</b>	\$4,910		
2007 cost estimate (ASTM Class D), preliminary for comparison to other repair costs only.

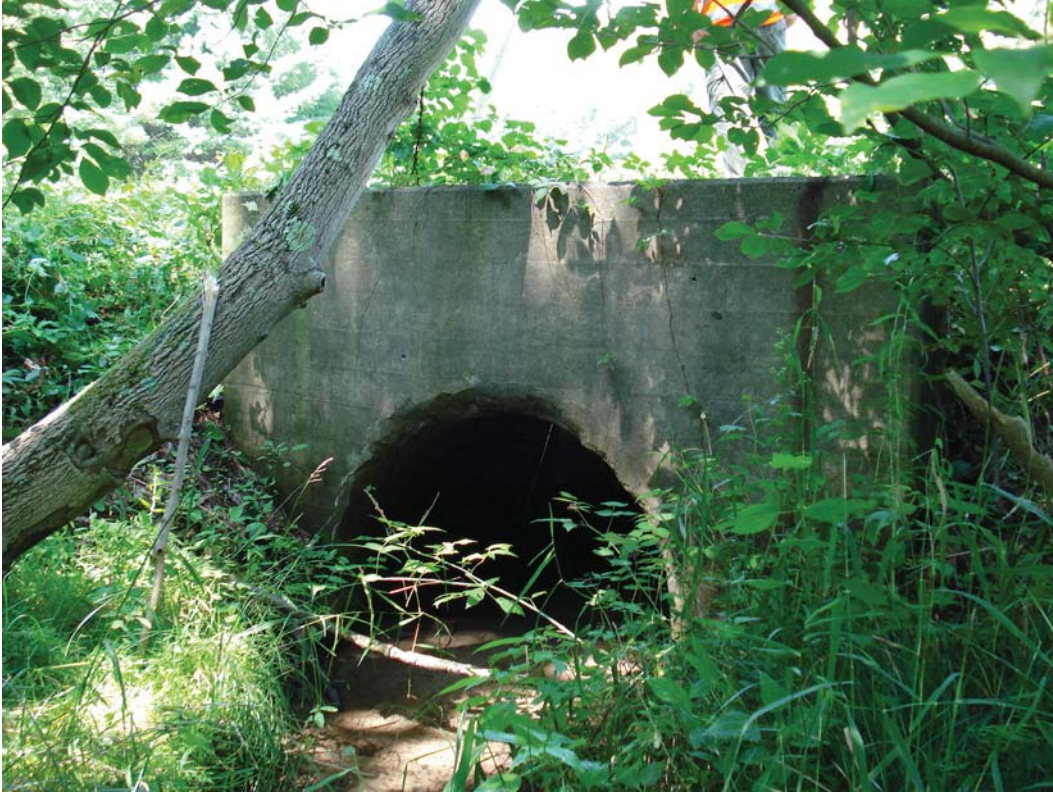
**DEWA\_0014\_11.515\_L\_1.jpg**

<b>Wall ID:</b>	DEWA-0014-11.515-L		
<b>Route Name:</b>	US ROUTE 209		
<b>Inspection Date:</b>	August 01, 2007	<b>Approximate Year Built:</b>	Unknown
<b>*Wall Rating:</b>	87	<b>Maintenance Action:</b>	Maintenance
<b>Wall Description</b>			
<b>Wall Function:</b>	Head Wall	<b>Primary Wall Type:</b>	Gravity - Mass Concrete
<b>Surface Treatment:</b>		<b>Secondary Wall Type:</b>	
<b>Secondary Surface Treatment:</b>		<b>Architectural Facing:</b>	
<b>General Description:</b>	Concrete outlet headwall for a 48 in diameter concrete pipe culvert constructed along right shoulder of high ADT roadway moderate consequence of failure		
<b>Wall Measurements</b>			
<b>Wall Length (ft.):</b>	9	<b>Face Area (sq.):</b>	19
<b>Average Wall Height (ft.):</b>	2	<b>Face Angle (deg.):</b>	90
<b>Maximum Wall Height (ft.):</b>	6	<b>Vertical Offset (ft.):</b>	-1
<b>Assessed Elements</b>			
<b>Element (Weighting Factor)</b>	<b>Narrative</b>	<b>Condition Rating (0 - 10)</b>

PERFORMANCE 8.00	Good condition; approximately 8-in. of sedimentation in invert; medium diameter tree threatens long-term stability of wall	8	
WALL FOUNDATION MATERIAL 8.00	No distress; no evidence of settlement, rotation, undermining or seepage	9	
CONCRETE 8.00	No distress; concrete is in good to excellent condition	9	
CULVERT 0.50	No distress to 48-in. diameter concrete pipe culvert; approximately 8-in. sedimentation along invert	8	
DOWNSLOPE 0.50	No distress to creek bed; good drainage way from wall; approximately 8-in. of sedimentation along invert	8	
VEGETATION 0.50	One medium diameter tree growing within 3 ft of wall, but is not currently affecting wall performance	8	
LATERAL SLOPE 0.50	No distress; no evidence of movement; no erosion	9	
ROAD/SIDEWALK/SHOULDER 0.50	Minor reflective cracking of pavement; no distress to shoulder	9	
WALL DRAINS 0.50	No evidence of drainage-related distress	10

<b>Repair Recommendations</b>			
<b>Failure Consequence:</b>	MODERATE		
<b>Recommendation Narrative:</b>	Clean culvert, in-place - 20 lnft (\$15/lnft) = \$300. Cut medium dia. Tree - 1 tree (\$200/tree) = \$200		
<b>Repair Cost:</b>	\$500		
2007 cost estimate (ASTM Class D), preliminary for comparison to other repair costs only.

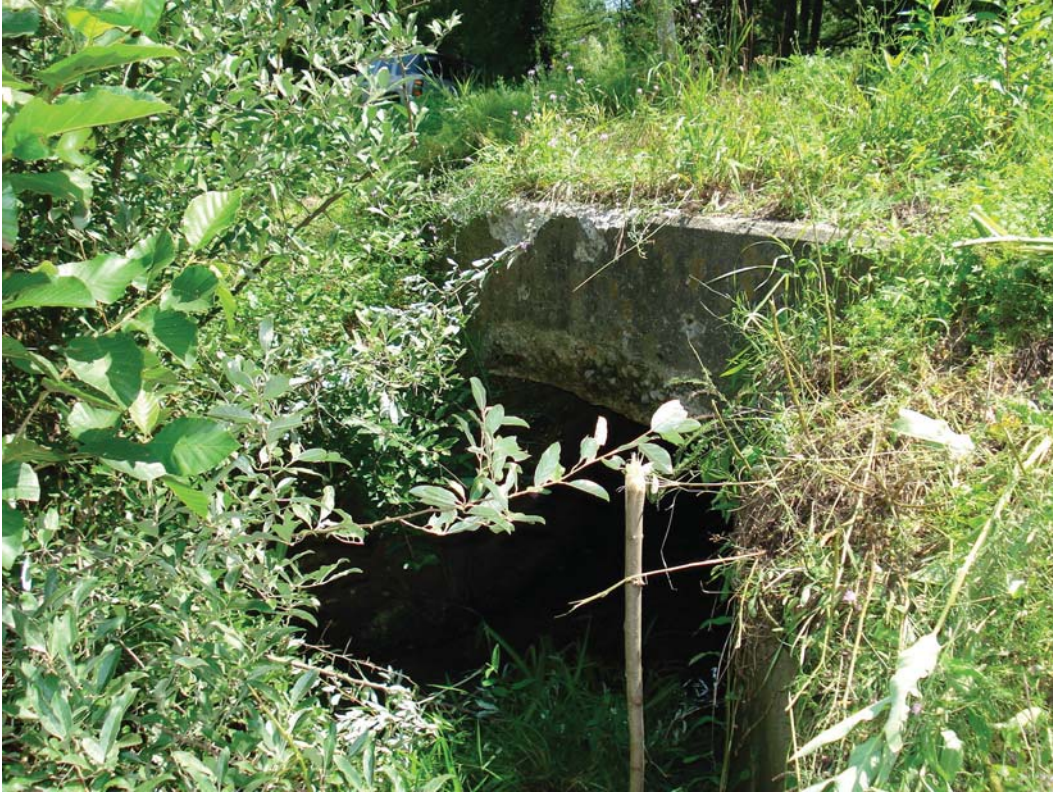
**DEWA\_0014\_11.515\_R\_1.jpg**

<b>Wall ID:</b>	DEWA-0014-11.515-R		
<b>Route Name:</b>	US ROUTE 209		
<b>Inspection Date:</b>	August 01, 2007	<b>Approximate Year Built:</b>	Unknown
<b>*Wall Rating:</b>	81	<b>Maintenance Action:</b>	Maintenance
<b>Wall Description</b>			
<b>Wall Function:</b>	Head Wall	<b>Primary Wall Type:</b>	Gravity - Mass Concrete
<b>Surface Treatment:</b>		<b>Secondary Wall Type:</b>	
<b>Secondary Surface Treatment:</b>		<b>Architectural Facing:</b>	
<b>General Description:</b>	Concrete inlet headwall for a 4.5 ft x 3.25 ft concrete box culvert constructed along left shoulder and directly supports a high ADT roadway high consequence of failure due to size and proximity to roadway		
<b>Wall Measurements</b>			
<b>Wall Length (ft.):</b>	20	<b>Face Area (sq.):</b>	58
<b>Average Wall Height (ft.):</b>	2	<b>Face Angle (deg.):</b>	90
<b>Maximum Wall Height (ft.):</b>	5	<b>Vertical Offset (ft.):</b>	0
<b>Assessed Elements</b>

<b>Element (Weighting Factor)</b>	<b>Narrative</b>	<b>Condition Rating (0 - 10)</b>	
PERFORMANCE 8.00	Good condition; moderate localized cracking and spalling of concrete	8	
WALL FOUNDATION MATERIAL 8.00	No distress; no evidence of settlement, rotation, undermining or seepage	9	
CONCRETE 8.00	Moderate cracking and spalling along crown of culvert	7	
DOWNSLOPE 0.50	Approximately 6-in. of sedimentation in channel; sedimentation extends out approximately 5 ft from face of wall	8	
CULVERT 0.50	No distress to 4.5 ft x 3.25 ft concrete arch culvert	9	
LATERAL SLOPE 0.50	No distress; no evidence of movement; no erosion	9	
VEGETATION 0.50	Small brush growing adjacent to wall, but is not currently affecting wall performance	9	
WALL DRAINS 0.50	No evidence of drainage-related distress	9	
ROAD/SIDEWALK/SHOULDER 0.50	No distress to pavement or relatively flat grassy shoulder	10	
<b>Repair Recommendations</b>

<b>Failure Consequence:</b>	HIGH		
<b>Recommendation Narrative:</b>	Concrete repair - 11.65 sqft (\$150/sqft) = \$4,368.75. Clear vegetation - 8 labor hrs (\$55/hr) = \$440. Clear sedimentation - 4 labor hrs (\$55/hr) = \$220.		
<b>Repair Cost:</b>	\$5,029		
2007 cost estimate (ASTM Class D), preliminary for comparison to other repair costs only.

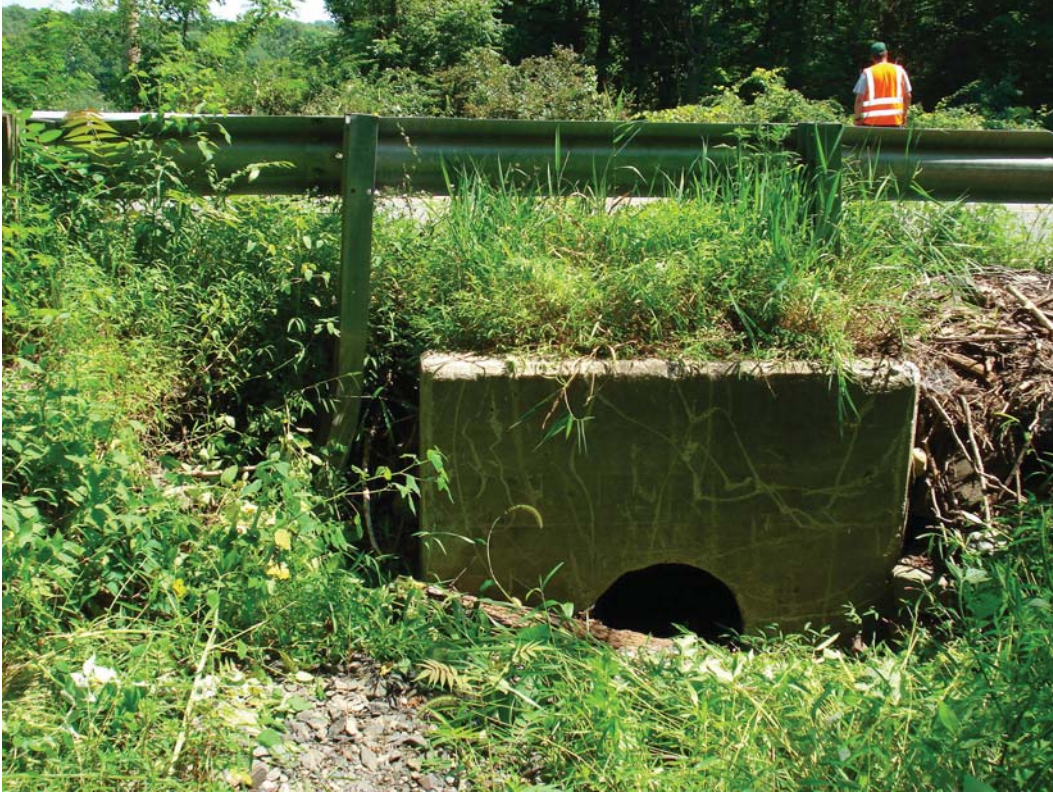
DEWA\_0014\_12.538\_L\_1.jpg

<b>Wall ID:</b>	DEWA-0014-12.538-L		
<b>Route Name:</b>	US ROUTE 209		
<b>Inspection Date:</b>	August 01, 2007	<b>Approximate Year Built:</b>	Unknown
<b>*Wall Rating:</b>	82	<b>Maintenance Action:</b>	Maintenance
<b>Wall Description</b>			
<b>Wall Function:</b>	Head Wall	<b>Primary Wall Type:</b>	Gravity - Mass Concrete
<b>Surface Treatment:</b>		<b>Secondary Wall Type:</b>	
<b>Secondary Surface Treatment:</b>		<b>Architectural Facing:</b>	
<b>General Description:</b>	Concrete inlet headwall for a 24 in diameter corrugated plastic pipe culvert constructed along left shoulder and is immediately adjacent to a high ADT roadway moderate consequence of failure due to its proximity to roadway		
<b>Wall Measurements</b>			
<b>Wall Length (ft.):</b>	6	<b>Face Area (sq.):</b>	22
<b>Average Wall Height (ft.):</b>	3	<b>Face Angle (deg.):</b>	90
<b>Maximum Wall Height (ft.):</b>	4	<b>Vertical Offset (ft.):</b>	0

<b>Assessed Elements</b>			
<b>Element (Weighting Factor)</b>	<b>Narrative</b>		<b>Condition Rating (0 - 10)</b>
PERFORMANCE 8.00	Good condition; severe erosion of lateral slope is encroaching on roadway		7
WALL FOUNDATION MATERIAL 8.00	No distress; no evidence of settlement, rotation, undermining or seepage		10
CONCRETE 8.00	Good condition; scratches along face are likely from earthwork equipment		8
VEGETATION 0.50	No distress; no significant vegetation in close proximity to wall		9
LATERAL SLOPE 1.00	Severe erosion along north end of wall is encroaching on roadway		5
ROAD/SIDEWALK/SHOULDER 0.50	No distress to pavement or relatively narrow grassy shoulder		10
WALL DRAINS 0.50	No evidence of drainage-related distress		10
CULVERT 1.00	24-in. diameter corrugated plastic pipe; approximately 12-in. of sedimentation along invert		7
DOWNSLOPE 1.00	Dry creek bed with substantial sedimentation		7
<b>Repair Recommendations</b>

<b>Failure Consequence:</b>	MODERATE		
<b>Recommendation Narrative:</b>	Clear debris - 16 labor hrs (\$55/hr) = \$880. Structural Backfill - 1.11 cuyd (\$60/cuyd) = \$66.70.		
<b>Repair Cost:</b>	\$947		
2007 cost estimate (ASTM Class D), preliminary for comparison to other repair costs only.

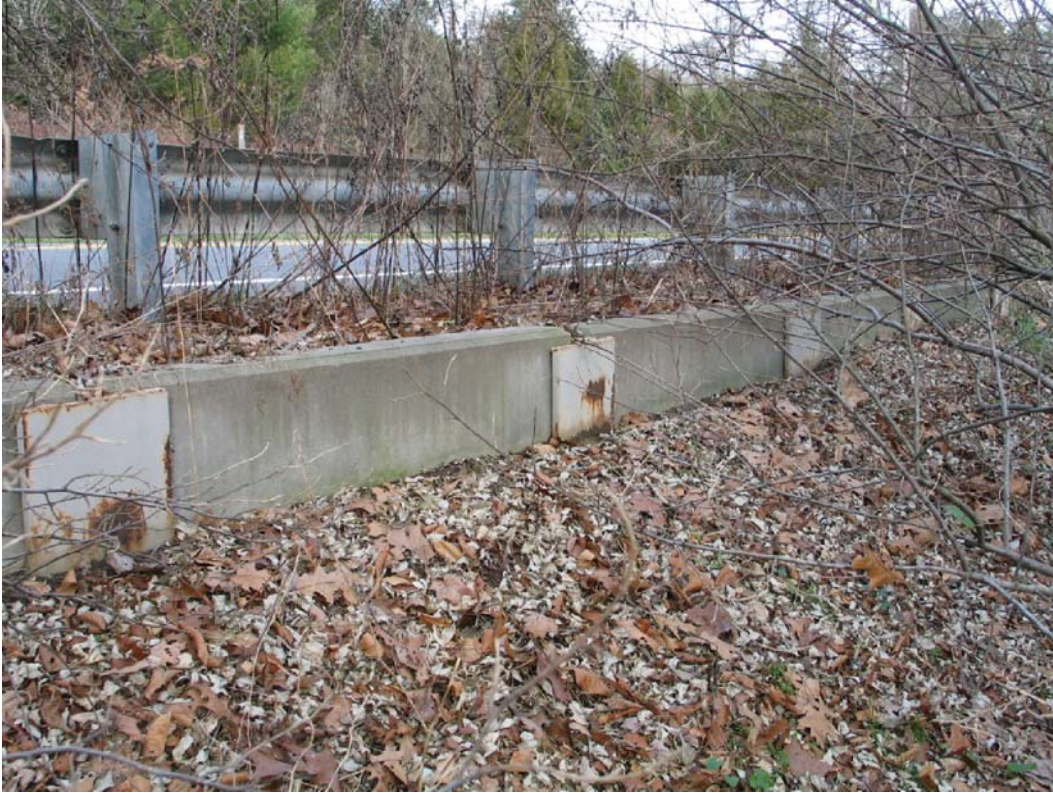
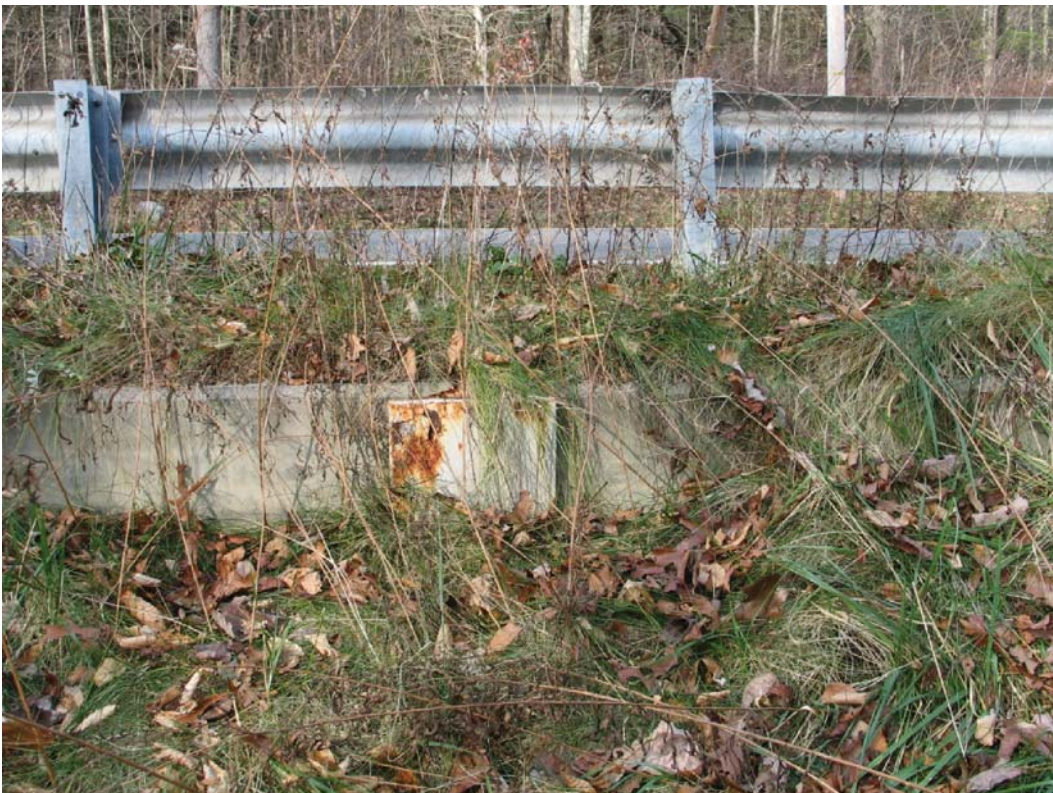
<b>Wall ID:</b>	DEWA-0014-15.027-R		
<b>Route Name:</b>	US ROUTE 209		
<b>Inspection Date:</b>	August 01, 2007	<b>Approximate Year Built:</b>	Unknown
<b>*Wall Rating:</b>	80	<b>Maintenance Action:</b>	Maintenance
<b>Wall Description</b>			
<b>Wall Function:</b>	Fill Wall	<b>Primary Wall Type:</b>	Cantilever - Soldier Pile
<b>Surface Treatment:</b>		<b>Secondary Wall Type:</b>	
<b>Secondary Surface Treatment:</b>		<b>Architectural Facing:</b>	
<b>General Description:</b>	Cantilevered soldier pile fill wall constructed along right shoulder and directly supports a high ADT roadway an average of 1.0 ft of wall is visible, but the wall is known to be embedded up to 40 ft		
<b>Wall Measurements</b>			
<b>Wall Length (ft.):</b>	270	<b>Face Area (sq.):</b>	270
<b>Average Wall Height (ft.):</b>	1	<b>Face Angle (deg.):</b>	90
<b>Maximum Wall Height (ft.):</b>	40	<b>Vertical Offset (ft.):</b>	-1
<b>Assessed Elements</b>

<b>Element (Weighting Factor)</b>	<b>Narrative</b>		<b>Condition Rating (0 - 10)</b>
PERFORMANCE 8.00	Good condition of wall; moderate spot rusting of soldier piles; severe ongoing down slope erosion threatens the long-term stability of wall		7
WALL FOUNDATION MATERIAL 8.00	No evidence of wall movement		9
PILES AND SHAFTS 8.00	Moderate spot rusting of painted H-pile members		7
LAGGING 8.00	No distress to visible concrete lagging		9
LATERAL SLOPE 0.50	No distress; no evidence of movement; no erosion		9
DOWNSLOPE 1.00	Severe ongoing erosion of moderate to steep slope; the ongoing erosion threatens the long-term stability of the wall		5
ROAD/SIDEWALK/SHOULDER 0.50	No distress to pavement or to relatively flat, grassy shoulder		10
TRAFFIC BARRIER/FENCE 0.50	No distress to relatively new steel guard rail		10
VEGETATION 0.50	No distress from vegetation; grass has overgrown the wall; no large vegetation in close proximity to wall		10

<b>Repair Recommendations</b>			
<b>Failure Consequence:</b>	HIGH		
<b>Recommendation Narrative:</b>	Clean & Repaint soldier piles - 16 labor hrs (\$55/hr) = \$880		
<b>Repair Cost:</b>	\$880		
2007 cost estimate (ASTM Class D), preliminary for comparison to other repair costs only.

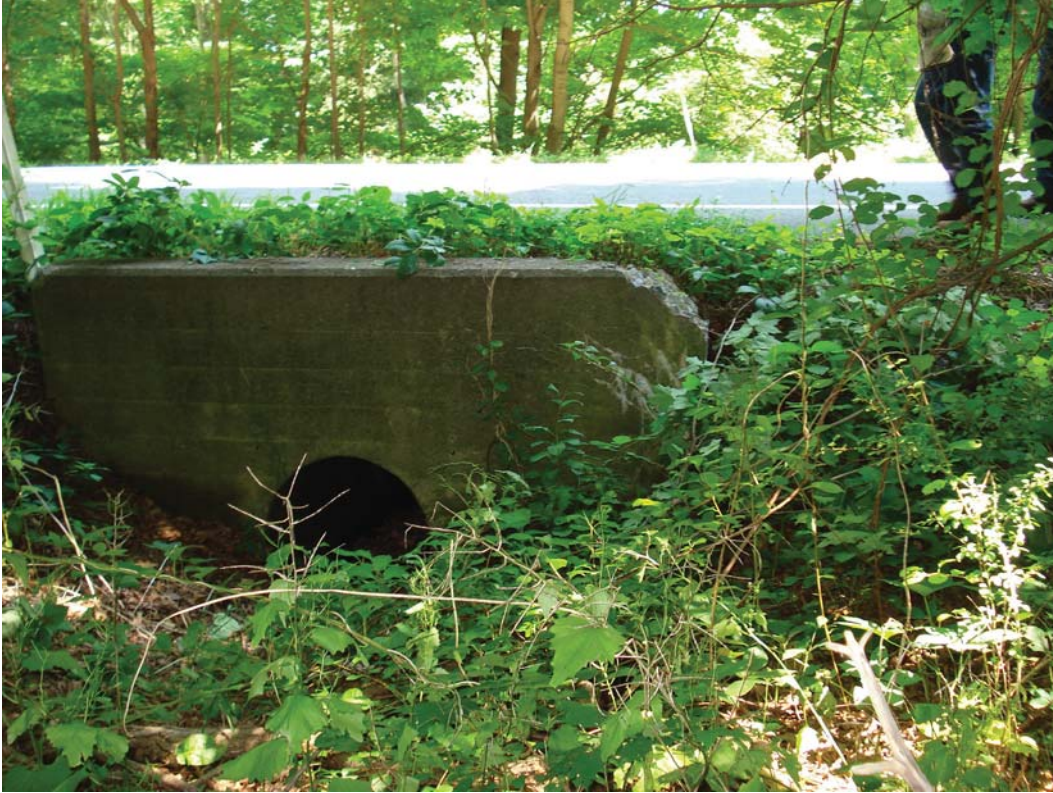
**DEWA\_0014\_15.323\_L\_1.jpg**

<b>Wall ID:</b>	DEWA-0014-15.323-L		
<b>Route Name:</b>	US ROUTE 209		
<b>Inspection Date:</b>	August 01, 2007	<b>Approximate Year Built:</b>	Unknown
<b>*Wall Rating:</b>	83	<b>Maintenance Action:</b>	Maintenance
<b>Wall Description</b>			
<b>Wall Function:</b>	Head Wall	<b>Primary Wall Type:</b>	Gravity - Mass Concrete
<b>Surface Treatment:</b>		<b>Secondary Wall Type:</b>	
<b>Secondary Surface Treatment:</b>		<b>Architectural Facing:</b>	
<b>General Description:</b>	Concrete inlet headwall for a 24 in diameter concrete pipe culvert constructed along left shoulder of a high ADT roadway moderate consequence of failure due to proximity to roadway		
<b>Wall Measurements</b>			
<b>Wall Length (ft.):</b>	8	<b>Face Area (sq.):</b>	20
<b>Average Wall Height (ft.):</b>	2	<b>Face Angle (deg.):</b>	90
<b>Maximum Wall Height (ft.):</b>	5	<b>Vertical Offset (ft.):</b>	0
<b>Assessed Elements</b>			
<b>Element (Weighting Factor)</b>	<b>Narrative</b>		<b>Condition Rating (0 - 10)</b>

PERFORMANCE 8.00	Good condition; minor cracking and spalling; leaf debris along channel and along invert of pipe		8
WALL FOUNDATION MATERIAL 8.00	No distress; no evidence of settlement, rotation, undermining or seepage		9
CONCRETE 8.00	Minor cracking and spalling along south end of wall; spalling is likely due to impact damage from earthwork equipment		8
DOWNSLOPE 0.50	No distress; leaf debris in channel may impede flow		8
VEGETATION 0.50	No distress from vegetation; no large vegetation in close proximity to wall		8
LATERAL SLOPE 0.50	No distress; no evidence of movement; no erosion		9
ROAD/SIDEWALK/SHOULDER 0.50	No distress to pavement or relatively narrow, paved shoulder		9
WALL DRAINS 0.50	No evidence of drainage-related distress		10
CULVERT 1.00	24-in. diameter concrete pipe; approximately 6-in. of leaf debris along invert		7
<b>Repair Recommendations</b>			
<b>Failure Consequence:</b>	MODERATE

<b>Recommendation Narrative:</b>	Clean culvert in-place - 12 lnft (\$15/lnft) = \$180. Clear channel - 4 labor hrs (\$55/hr) = \$220		
<b>Repair Cost:</b>	\$400		
2007 cost estimate (ASTM Class D), preliminary for comparison to other repair costs only.

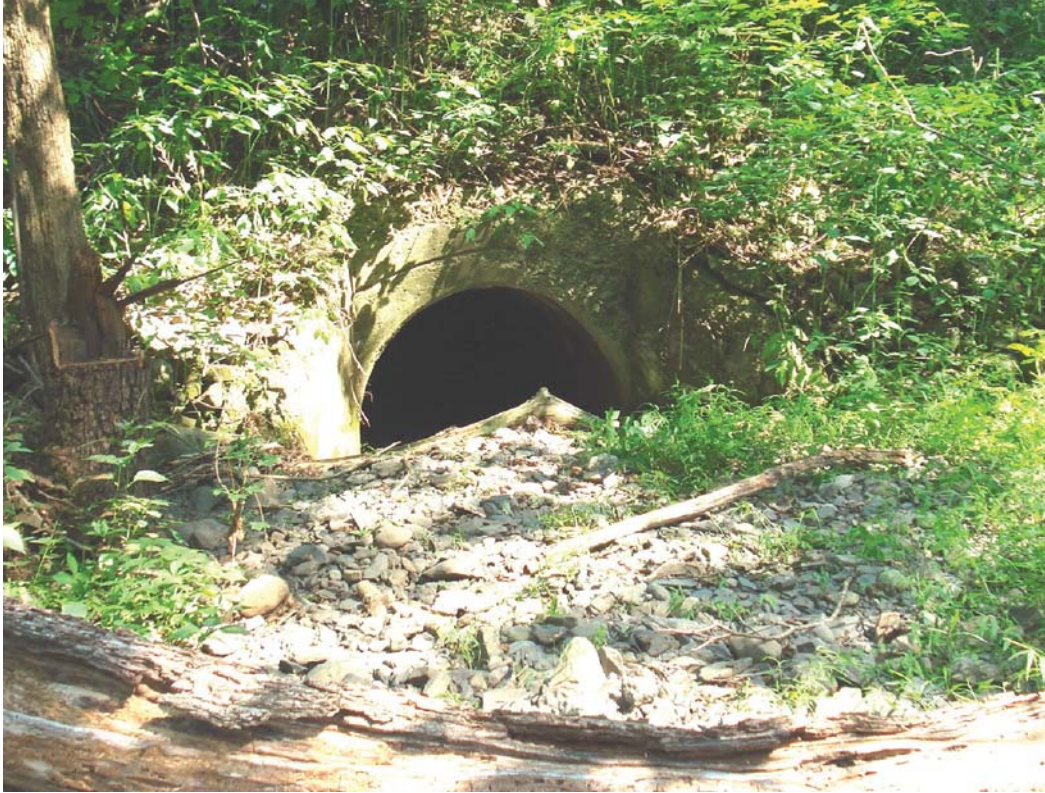
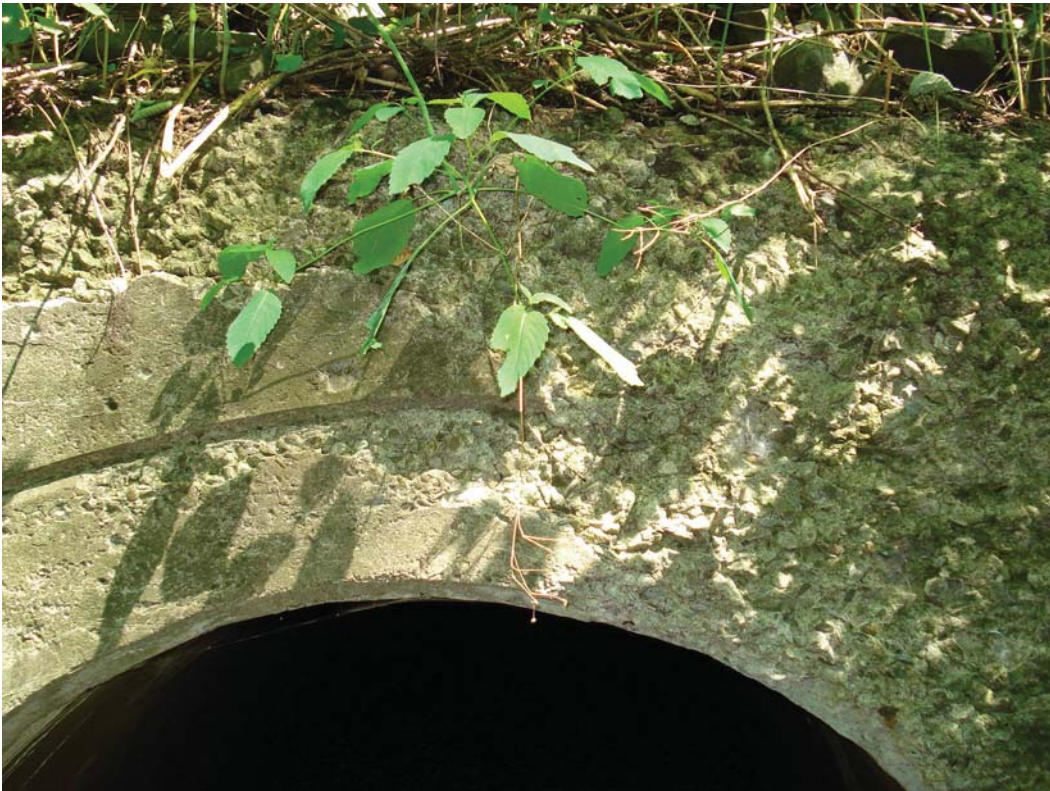
<b>Wall ID:</b>	DEWA-0014-15.557-L		
<b>Route Name:</b>	US ROUTE 209		
<b>Inspection Date:</b>	August 01, 2007	<b>Approximate Year Built:</b>	Unknown
<b>*Wall Rating:</b>	73	<b>Maintenance Action:</b>	Repair Elements
<b>Wall Description</b>			
<b>Wall Function:</b>	Head Wall	<b>Primary Wall Type:</b>	Gravity - Mass Concrete
<b>Surface Treatment:</b>		<b>Secondary Wall Type:</b>	
<b>Secondary Surface Treatment:</b>		<b>Architectural Facing:</b>	
<b>General Description:</b>	Concrete inlet headwall for a 6 ft x 3.75 ft concrete arch culvert constructed along left shoulder and along base of steep slope supporting a high ADT roadway moderate consequence of failure		
<b>Wall Measurements</b>			
<b>Wall Length (ft.):</b>	16	<b>Face Area (sq.):</b>	34
<b>Average Wall Height (ft.):</b>	2	<b>Face Angle (deg.):</b>	90
<b>Maximum Wall Height (ft.):</b>	6	<b>Vertical Offset (ft.):</b>	-17
<b>Assessed Elements</b>

<b>Element (Weighting Factor)</b>	<b>Narrative</b>		<b>Condition Rating (0 - 10)</b>
PERFORMANCE 8.00	Fair to good condition; severe delamination across face of wall; 6-in. of debris within the channel		7
WALL FOUNDATION MATERIAL 8.00	No distress; no evidence of settlement, rotation, undermining or seepage		9
CONCRETE 8.00	Severe delamination across face of wall		6
CULVERT 0.50	No distress to 6 ft x 3.75 ft concrete arch culvert		8
ROAD/SIDEWALK/SHOULDER 0.50	Minor fatigue cracking of pavement		8
TRAFFIC BARRIER/FENCE 1.00	Major impact damage to steel guard rail		4
LATERAL SLOPE 0.50	No distress; no evidence of movement; no erosion		9
UPSLOPE 0.50	No distress to steep, well-vegetated slope		9
WALL DRAINS 0.50	No evidence of drainage-related distress		9
<b>Repair Recommendations</b>			
<b>Failure Consequence:</b>	MODERATE		
<b>Recommendation Narrative:</b>	Concrete repair (25% of wall) - 8.46 sqft (\$150/sqft) = \$1,269.38. Clear debris - 32 labor hrs (\$55/hr) = \$1,760. Cut medium dia. Tree - 1 tree (\$200/tree) = \$200.

<b>Repair Cost:</b>	\$3,229		
2007 cost estimate (ASTM Class D), preliminary for comparison to other repair costs only.

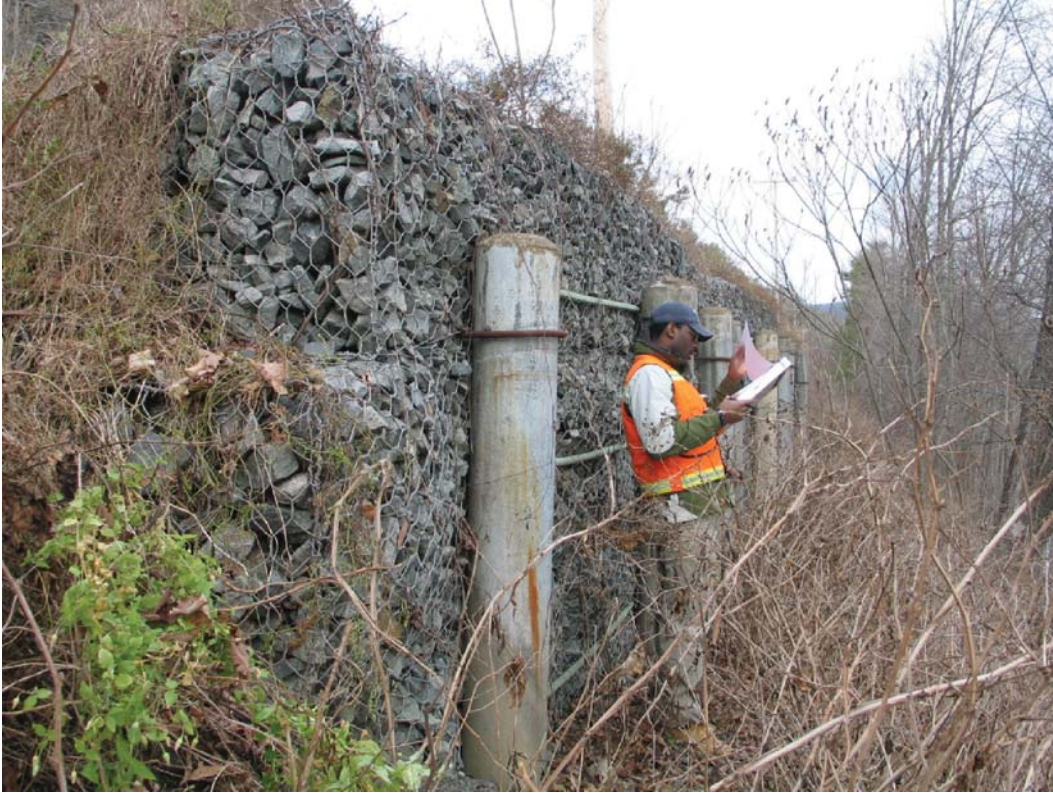
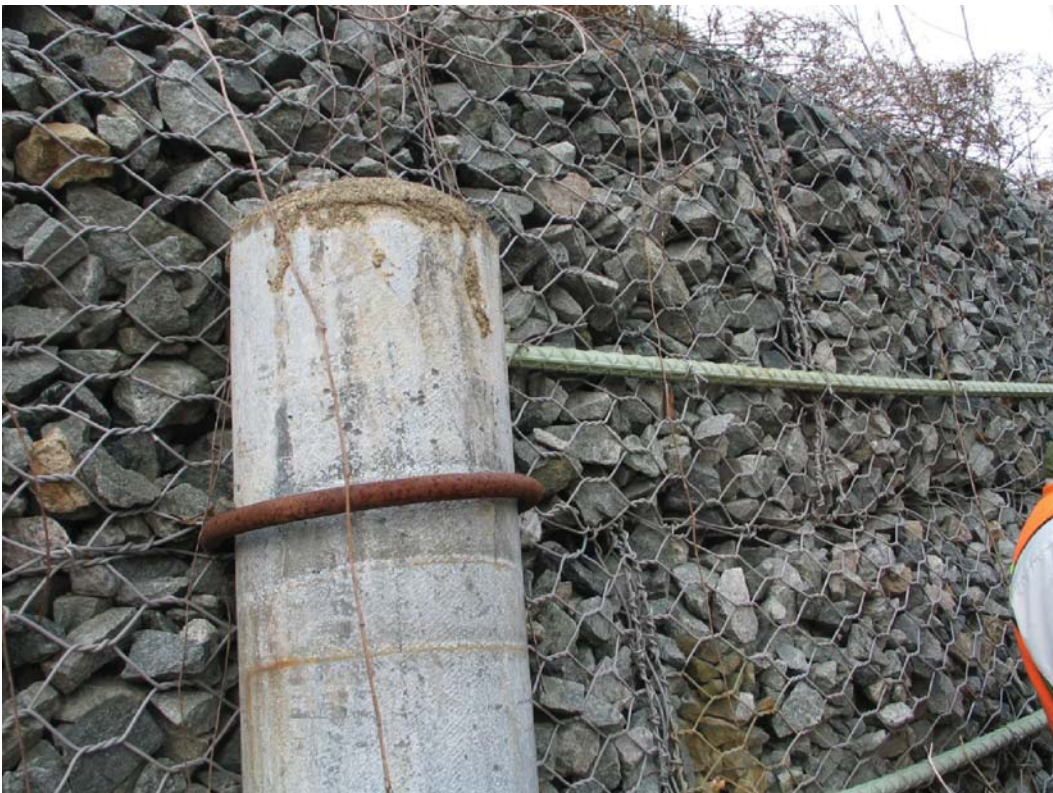
<b>Wall ID:</b>	DEWA-0014-17.088-R		
<b>Route Name:</b>	US ROUTE 209		
<b>Inspection Date:</b>	December 06, 2007	<b>Approximate Year Built:</b>	Unknown
<b>*Wall Rating:</b>	67	<b>Maintenance Action:</b>	Repair Elements
<b>Wall Description</b>			
<b>Wall Function:</b>	Fill Wall	<b>Primary Wall Type:</b>	Cantilever - Soldier Pile
<b>Surface Treatment:</b>		<b>Secondary Wall Type:</b>	Gravity - Gabion
<b>Secondary Surface Treatment:</b>		<b>Architectural Facing:</b>	
<b>General Description:</b>	Cantilevered FRP composite pile wall with gabion baskets acting as lagging constructed along right shoulder and directly supports a high ADT roadway high consequence of failure		
<b>Wall Measurements</b>			
<b>Wall Length (ft.):</b>	425	<b>Face Area (sq.):</b>	4675
<b>Average Wall Height (ft.):</b>	11	<b>Face Angle (deg.):</b>	90
<b>Maximum Wall Height (ft.):</b>	11	<b>Vertical Offset (ft.):</b>	-1
<b>Assessed Elements</b>

<b>Element (Weighting Factor)</b>	<b>Narrative</b>	<b>Condition Rating (0 - 10)</b>	
PERFORMANCE 8.00	Fair to good condition; moderate to severe damage to a number of piles; damage to piles threaten the near-term stability of wall; pile damage has translated into bulging of gabions	6	
WALL FOUNDATION MATERIAL 8.00	No distress; no evidence of settlement, rotation, undermining or settlement	9	
PILES AND SHAFTS 8.00	Moderate to severe cracking and spalling of fiber-reinforced polymer (FRP) composite piles; damage is to approximately 5 piles; moderate rusting of H-piles members where concrete has spalled; the top 2-ft of approximately 11 members are severely damaged	5	
CONCRETE 8.00	Concrete has spalled from piles where FRP encapsulation has been lost	6	
LAGGING 8.00	Minor localized bulging of gabion baskets; 3/4-in. gravel backfill	7	
ROAD/SIDEWALK/SHOULDER 0.50	Minor fatigue cracking along inboard wheel line; no distress to paved shoulder	8

TRAFFIC BARRIER/FENCE 0.50	Minor impact damage to steep guard rail	8	
VEGETATION 0.50	No distress; small brush has overgrown the wall; brush is not affecting wall performance, but should be cut back	8	
DOWNSLOPE 0.50	No distress to steep, well-vegetated slope; river along toes of slope	9	
<b>Repair Recommendations</b>			
<b>Failure Consequence:</b>	HIGH		
<b>Recommendation Narrative:</b>	Clear vegetation - 8 labor hrs (\$55/hr) = \$440. FRP pile repair - 55 lnft (\$250/lnft) = \$13,750		
<b>Repair Cost:</b>	\$14,190		
2007 cost estimate (ASTM Class D), preliminary for comparison to other repair costs only.

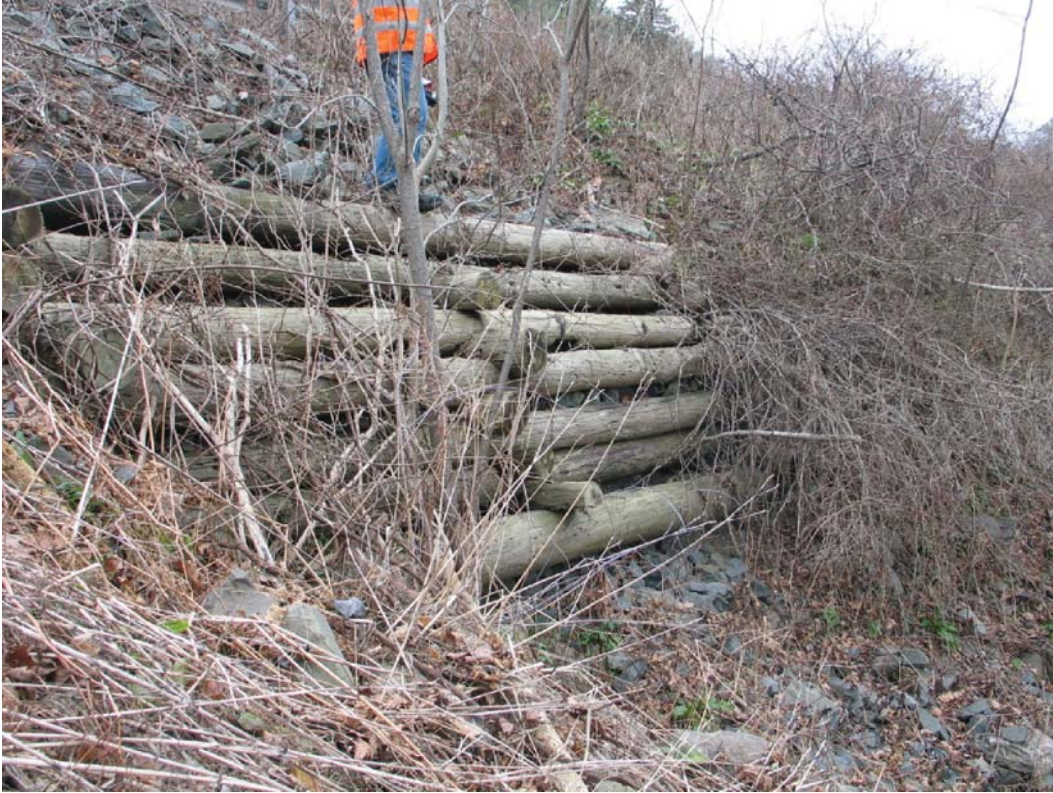
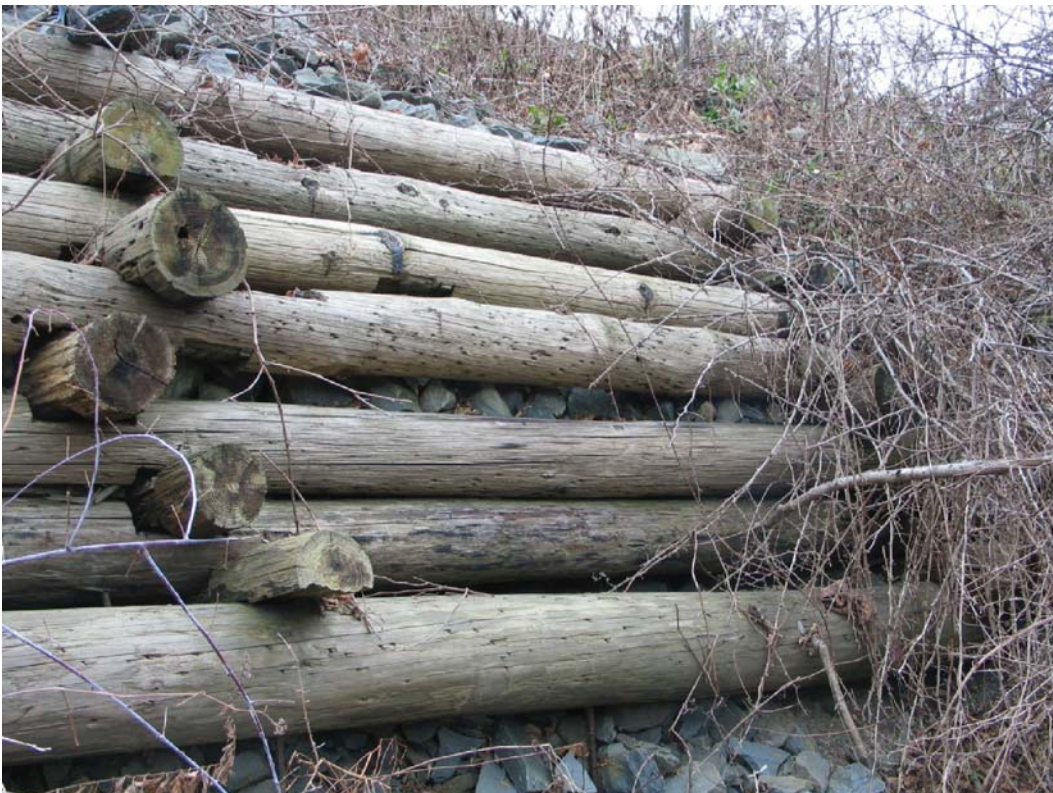
<b>Wall ID:</b>	DEWA-0014-17.276-R		
<b>Route Name:</b>	US ROUTE 209		
<b>Inspection Date:</b>	August 01, 2007	<b>Approximate Year Built:</b>	Unknown
<b>*Wall Rating:</b>	49	<b>Maintenance Action:</b>	Replace Wall
<b>Wall Description</b>			
<b>Wall Function:</b>	Fill Wall	<b>Primary Wall Type:</b>	Crib - Timber
<b>Surface Treatment:</b>		<b>Secondary Wall Type:</b>	
<b>Secondary Surface Treatment:</b>		<b>Architectural Facing:</b>	
<b>General Description:</b>	Timber crib wall with 3 in minus gravel backfill constructed along right shoulder of high ADT roadway wall is understood to be scheduled for removal in the near-term moderate consequence of failure		
<b>Wall Measurements</b>			
<b>Wall Length (ft.):</b>	20	<b>Face Area (sq.):</b>	140
<b>Average Wall Height (ft.):</b>	7	<b>Face Angle (deg.):</b>	80
<b>Maximum Wall Height (ft.):</b>	7	<b>Vertical Offset (ft.):</b>	-9
<b>Assessed Elements</b>			
<b>Element (Weighting Factor)</b>	<b>Narrative</b>		<b>Condition Rating (0 - 10)</b>

PERFORMANCE 8.00	Fair condition; severe deterioration of timber crib elements; ongoing minor erosion of foundation and lateral slope		5
WALL FOUNDATION MATERIAL 8.00	Founded on natural slope and loose riprap; minor and ongoing erosion of foundation material will cause wall to settle in the near-term		4
BIN OR CRIB 8.00	Moderate to severe decay of timber logs; logs are still functional but should be replaced		4
TRAFFIC BARRIER/FENCE 0.50	Minor impact damage to steel guard rail		8
UPSLOPE 0.50	No distress to steep slope; slope has loose riprap fill as slope protection		8
VEGETATION 0.50	Small brush growing along lateral slope, but is not causing distress to wall		9
WALL DRAINS 1.00	Wall is self-draining; evidence that drainage of water through wall is eroding foundation soils		6
DOWNSLOPE 1.00	Ongoing minor erosion		7
LATERAL SLOPE 1.00	Evidence of minor ongoing erosion		7
<b>Repair Recommendations</b>

<b>Failure Consequence:</b>	MODERATE		
<b>Recommendation Narrative:</b>	Replace timber crib wall - 140 sqft (4185/sqft) = \$25,900. Remove/replace w-beam guard rail - 100 lnft (\$15/lnft) = \$1,500. Rebuild lateral slope with unclassified borrow - 25 cuyd (\$35/cuyd) = \$875.		
<b>Repair Cost:</b>	\$28,275		
2007 cost estimate (ASTM Class D), preliminary for comparison to other repair costs only.

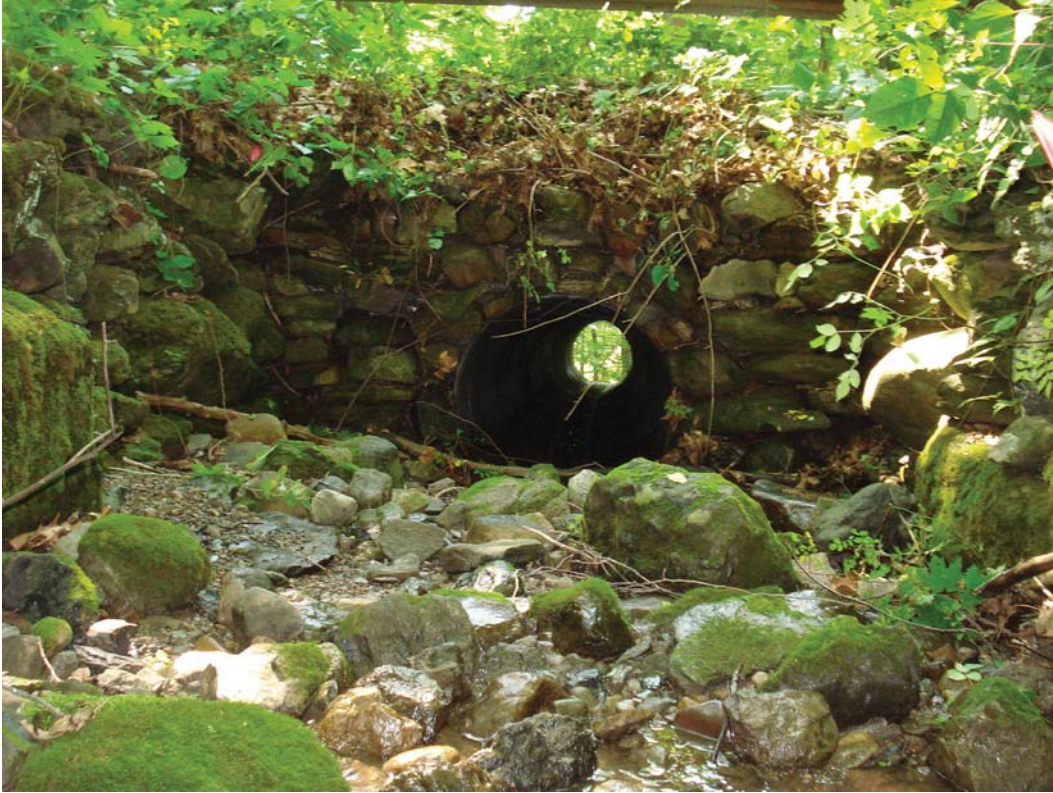
**DEWA\_0105\_1.075\_L\_1.jpg**

<b>Wall ID:</b>	DEWA-0105-1.075-L		
<b>Route Name:</b>	RIVER ROAD		
<b>Inspection Date:</b>	August 02, 2007	<b>Approximate Year Built:</b>	Unknown
<b>*Wall Rating:</b>	82	<b>Maintenance Action:</b>	No Action
<b>Wall Description</b>			
<b>Wall Function:</b>	Head Wall	<b>Primary Wall Type:</b>	Gravity - Dry Stone
<b>Surface Treatment:</b>		<b>Secondary Wall Type:</b>	
<b>Secondary Surface Treatment:</b>		<b>Architectural Facing:</b>	
<b>General Description:</b>	Dry stacked stone inlet headwall for a 36 in diameter CMP culvert constructed along left shoulder of a low ADT roadway moderate consequence of failure due to size and proximity to roadway		
<b>Wall Measurements</b>			
<b>Wall Length (ft.):</b>	28	<b>Face Area (sq.):</b>	122
<b>Average Wall Height (ft.):</b>	4	<b>Face Angle (deg.):</b>	90
<b>Maximum Wall Height (ft.):</b>	5	<b>Vertical Offset (ft.):</b>	-2
<b>Assessed Elements</b>			
<b>Element (Weighting Factor)</b>	<b>Narrative</b>		<b>Condition Rating (0 - 10)</b>

PERFORMANCE 8.00	Good condition; minor unraveling of wall; minor rusting along invert of culvert; 3 medium diameter trees growing in close proximity to wall		8
WALL FOUNDATION MATERIAL 8.00	No distress; no evidence of settlement, rotation, undermining or seepage		9
PLACED STONE 8.00	Generally in good condition; minor unraveling; no distress to blocks		7
CULVERT 0.50	36-in. diameter CMP with minor rusting along the invert		8
VEGETATION 0.50	Three medium diameter trees are growing adjacent to wall; trees not causing wall distress		8
WALL DRAINS 0.50	Wall is self-draining; no evidence of drainage-related distress		9
DOWNSLOPE 0.50	No distress to stream channel		10
LATERAL SLOPE 0.50	No distress; no evidence of movement; no distress		10
ROAD/SIDEWALK/SHOULDER 0.50	No distress to pavement or shoulder		10
<b>Repair Recommendations</b>			
<b>Failure Consequence:</b>	MODERATE		
<b>Recommendation Narrative:</b>	None

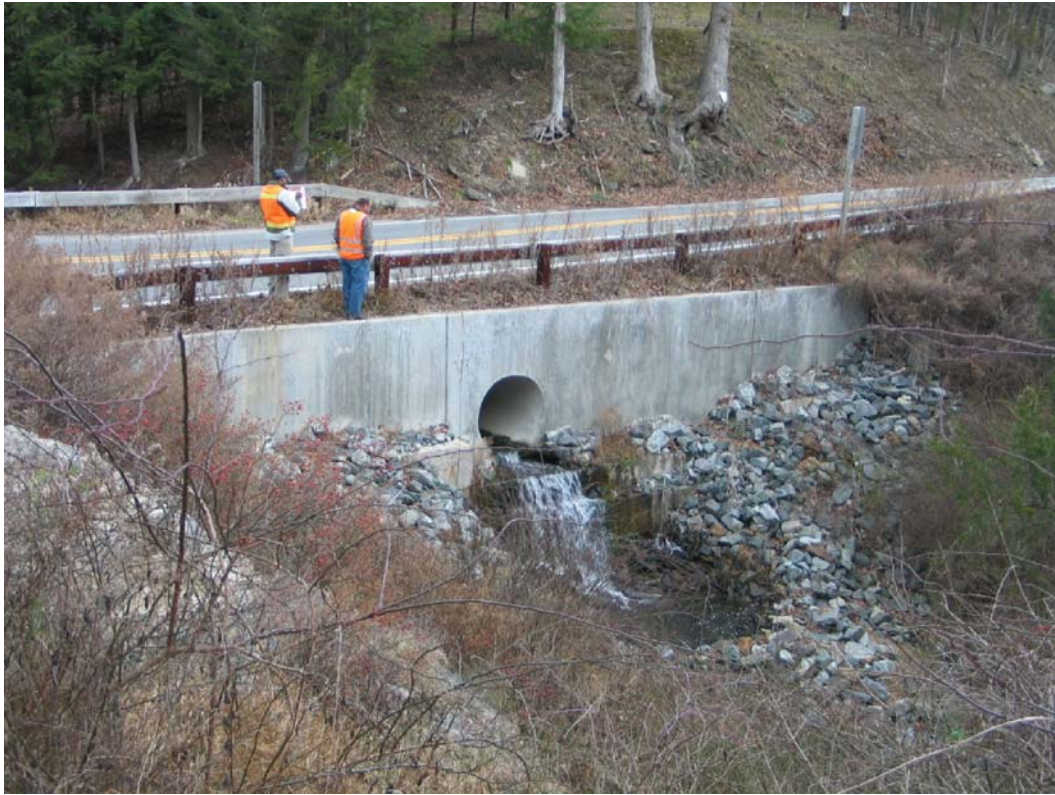
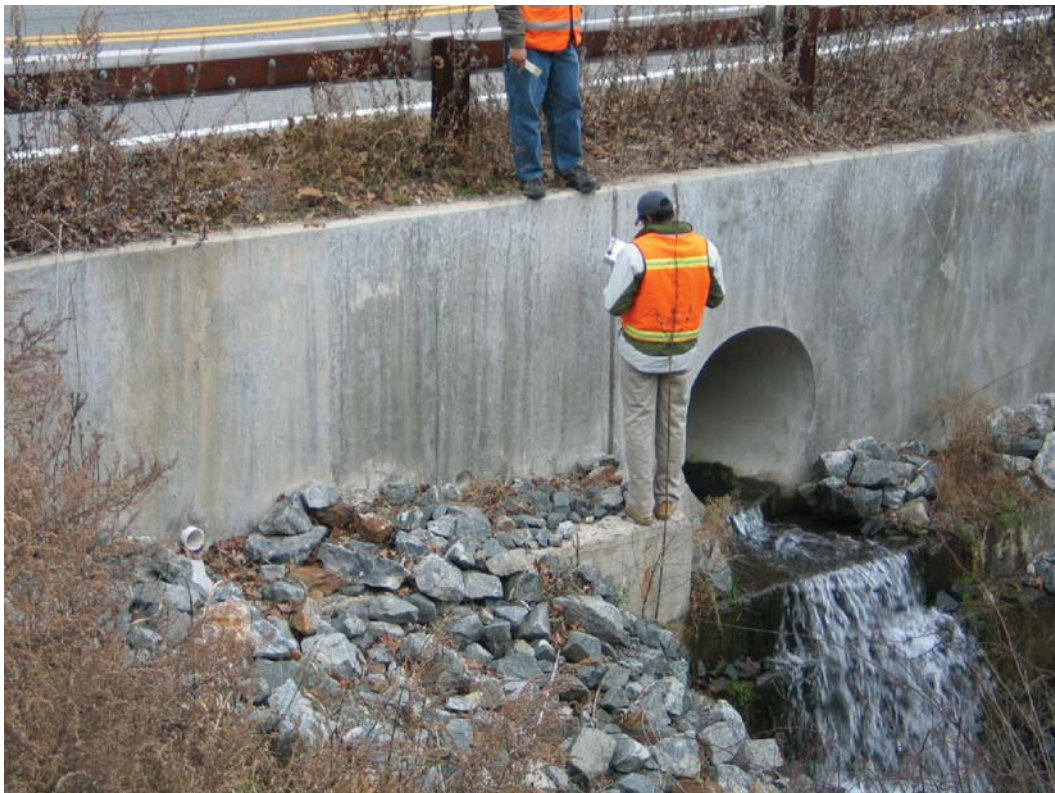
<b>Wall ID:</b>	DEWA-0113-1.714-R		
<b>Route Name:</b>	NPS ROUTE 615		
<b>Inspection Date:</b>	August 01, 2007	<b>Approximate Year Built:</b>	Unknown
<b>*Wall Rating:</b>	97	<b>Maintenance Action:</b>	No Action
<b>Wall Description</b>			
<b>Wall Function:</b>	Head Wall	<b>Primary Wall Type:</b>	Gravity - Mass Concrete
<b>Surface Treatment:</b>		<b>Secondary Wall Type:</b>	
<b>Secondary Surface Treatment:</b>		<b>Architectural Facing:</b>	
<b>General Description:</b>	Relatively new cast in-place concrete outlet headwall for a 48 in diameter concrete culvert constructed along inside curve and directly supports a very low ADT roadway high consequence of failure		
<b>Wall Measurements</b>			
<b>Wall Length (ft.):</b>	20	<b>Face Area (sq.):</b>	95
<b>Average Wall Height (ft.):</b>	4	<b>Face Angle (deg.):</b>	90
<b>Maximum Wall Height (ft.):</b>	6	<b>Vertical Offset (ft.):</b>	0
<b>Assessed Elements</b>			
<b>Element (Weighting Factor)</b>	<b>Narrative</b>		<b>Condition Rating (0 - 10)</b>

PERFORMANCE 8.00	Good to excellent condition		9
WALL FOUNDATION MATERIAL 8.00	No distress; no evidence of settlement, rotation, undermining or seepage		10
CONCRETE 8.00	No distress to relatively new concrete headwall		10
CULVERT 0.50	No distress to 48-in. diameter concrete pipe		9
DOWNSLOPE 0.50	No distress to riprap-lined channel		9
LATERAL SLOPE 0.50	No distress; no evidence of movement; no erosion		10
ROAD/SIDEWALK/SHOULDER 0.50	No distress to pavement		10
TRAFFIC BARRIER/FENCE 0.50	No distress to relatively new steel-backed timber guard rail		10
VEGETATION 0.50	No distress		10
<b>Repair Recommendations</b>			
<b>Failure Consequence:</b>	HIGH		
<b>Recommendation Narrative:</b>	None		
<b>Repair Cost:</b>	\$0		
2007 cost estimate (ASTM Class D), preliminary for comparison to other repair costs only.
