GATE WIP Report

NPS Retaining Wall Inventory Program Gateway National Recreation Area

Federal Highway Administration
Eastern Federal Lands Highway Division
Road Inventory Program (RIP)

Data Collection Date: October 2008
Report Date: November 2015

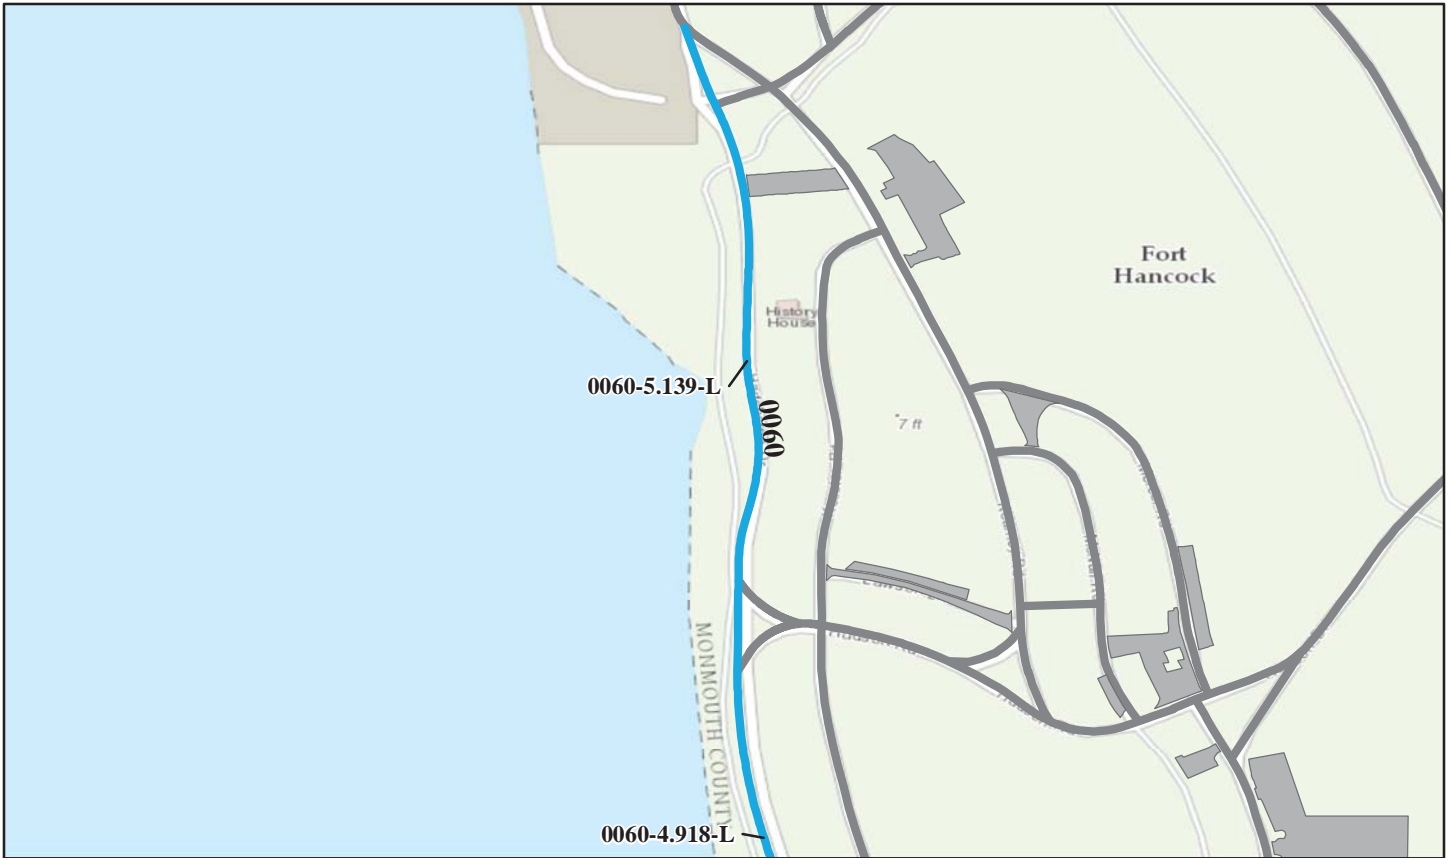
ROUTE 0060: HARTSHORNE DRIVE (NORTHBOUND)

Wall ID Inspection Date:	Wall Area (Sq. Ft.)	Wall Length (Ft.)	Wall Type	Wall Function	Overall Rating	Repair Cost
GATE-0060-4.918-L 10/8/2008	4,848	1,212	Gravity - Mass Concrete	Flood Wall	46	\$316,330.00
GATE-0060-5.139-L 10/8/2008	6,650	1,330	Other - Anchor Tieback Timber Pile	Flood Wall	37	\$86,000.00
