NPS Retaining Wall Inventory Program Glacier National Park

**Federal Lands Highway
Road Inventory Program**

**Federal Highway Administration
Eastern Federal Lands Highway Division
Road Inventory Program (RIP)**

**Data Collection Date: September 2007
Report Date: October 2015**

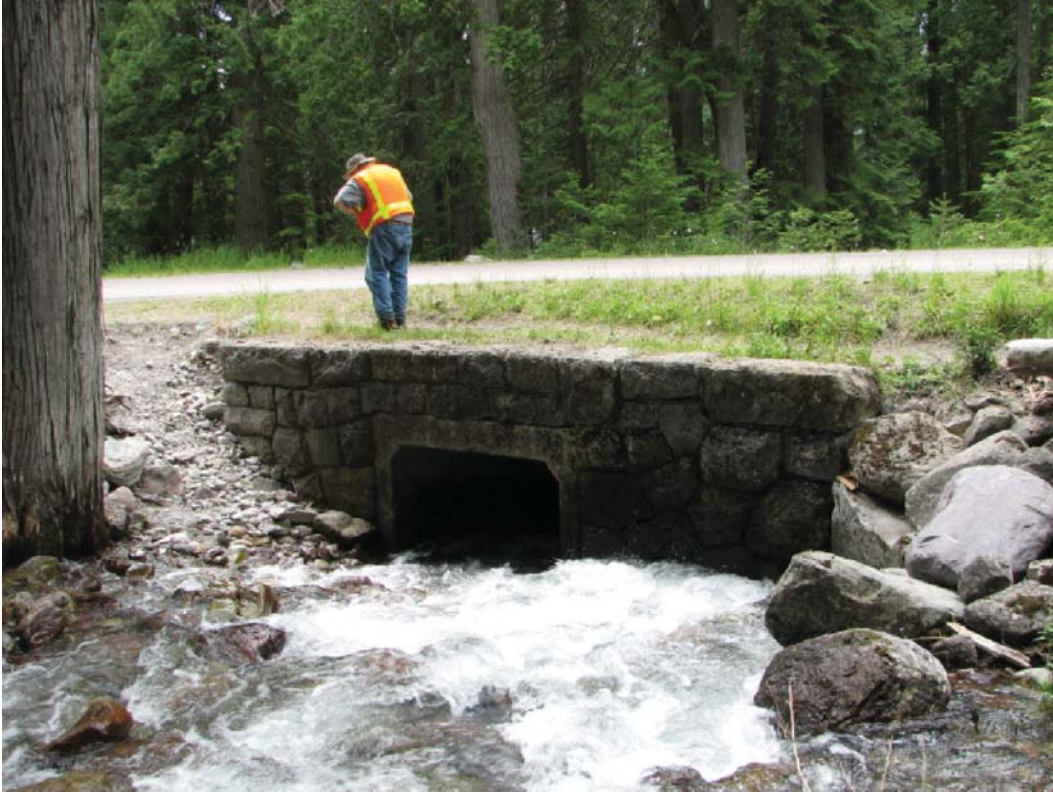
GLAC_0010W_10.230_R_1.jpg

Wall ID:	GLAC-0010W-10.230-R		
Route Name:	GOING TO THE SUN ROAD WEST		
Inspection Date:	July 08, 2007	Approximate Year Built:	Unknown
*Wall Rating:	78	Maintenance Action:	Maintenance
Wall Description			
Wall Function:	Head Wall	Primary Wall Type:	Gravity - Mortared Stone
Surface Treatment:		Secondary Wall Type:	
Secondary Surface Treatment:		Architectural Facing:	
General Description:	Inlet headwall for 4 ft x 6 ft box culvert still performing but mortar is degrading and lateral slopes are eroding. Culvert is grossly undersized for the current stream volume and should be replaced with a larger culvert.		
Wall Measurements			
Wall Length (ft.):	22	Face Area (sq.):	86
Average Wall Height (ft.):	3	Face Angle (deg.):	90
Maximum Wall Height (ft.):	6	Vertical Offset (ft.):	-2
Assessed Elements			
Element (Weighting Factor)	Narrative		Condition Rating (0 - 10)
PERFORMANCE 8.00	Overall the wall is performing well but needs maintenance to fill erosion channels in lateral slopes. Mortar is degrading but is still performing satisfactorily. This culvert is grossly undersized and need to be replaced with a larger one. At that time		8

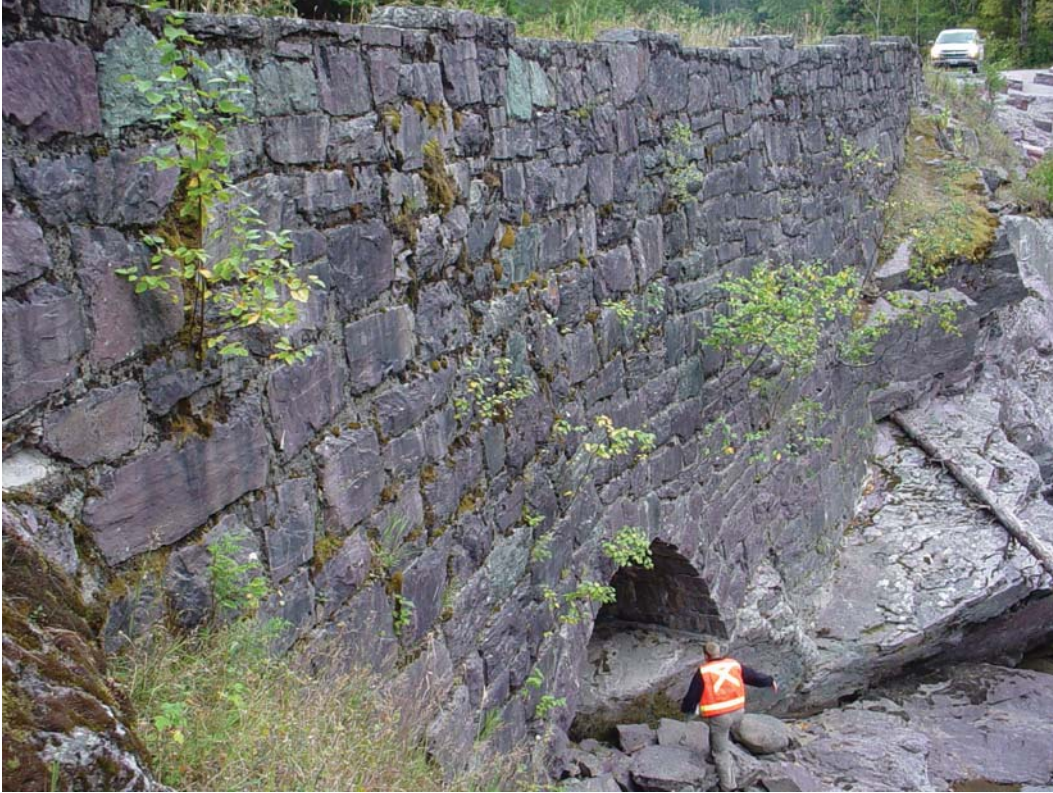
GLAC_0010W_17.340_L_1.jpg

Wall Function:	Fill Wall	Primary Wall Type:	Gravity - Mortared Stone
Surface Treatment:		Secondary Wall Type:	
Secondary Surface Treatment:		Architectural Facing:	
General Description:	Stone masonry wall still performing but has considerable mortar degradation. Possible vertical bulging displacement needs to be monitored.

Element (Weighting Factor)	Narrative	Condition Rating (0 - 10)
PERFORMANCE 8.00	Wall is still performing but needs mortar maintenance. Possible vertical bulging needs to be monitored.	7
WALL FOUNDATION MATERIAL 8.00	Either in place rock sloping toward the stream or sandy soil. No evidence of undermining or scour but toe is inundated and sand probably deposited during high water.	8
MORTAR 8.00	Mortar has considerable debonding over about 60 % of wall and deep spalling over about 30 %. Only about 10 % of the wall has good mortar.	5
STONE MASONRY 8.00	Mostly hard durable stones well interlocked with even grout lines. A few broken stones. Evidence of vertical bulging about 64 ft. from the start of the wall.	7
DOWNSLOPE 0.50	Bedrock sloping toward the stream. Toe is inundated during high water.	8
LATERAL SLOPE 0.50	Moderately sloping shallow bedrock on both sides.	8
WALL DRAINS 1.00	No drains installed. Some evidence of internal drainage distress with seepage stains at grout lines.	7

Failure Consequence:	MODERATE
Recommendation Narrative:	Repoint mortar for about 90 % of the wall area. Repoint mortar (0.90 x 695 sq. ft.) x \$75/sq.ft. = \$46,910
Repair Cost:	\$46,910

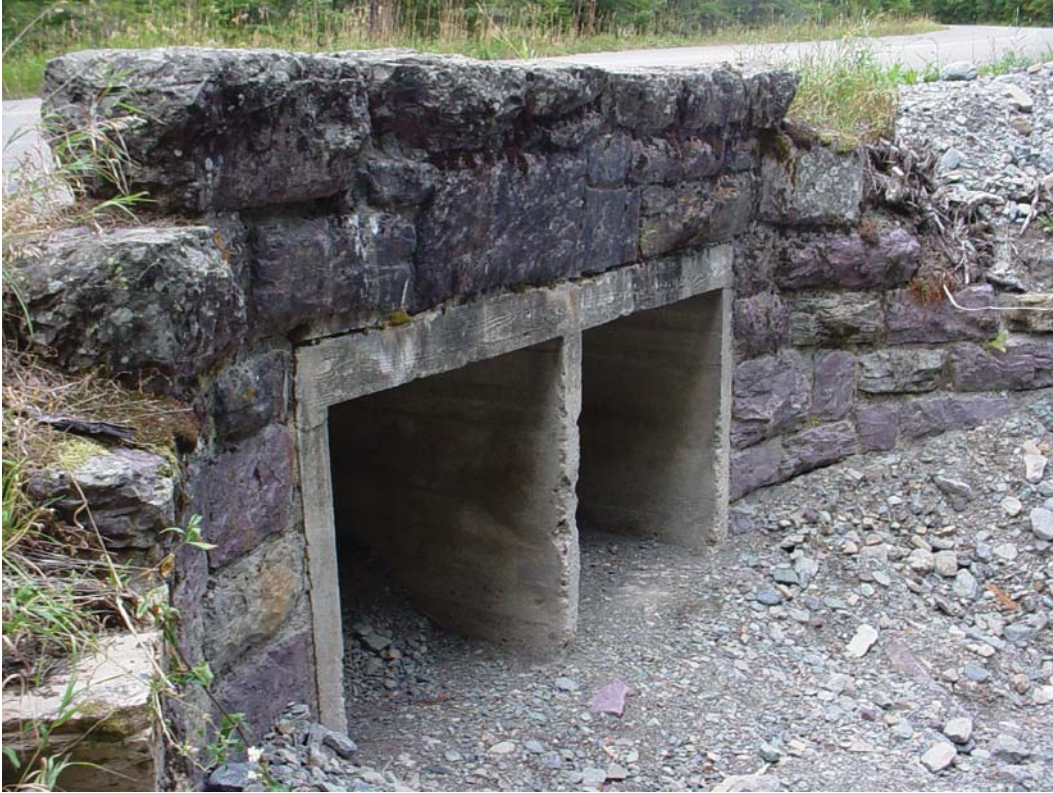
GLAC_0010W_18.748_R_1.jpg

Element (Weighting Factor)	Narrative	Condition Rating (0 - 10)
PERFORMANCE 8.00	Wall is still performing well but is in need of mortar maintenance and some stone resetting or replacement on its entire surface area. Possible settlement and batter displacement needs to be monitored.	6
WALL FOUNDATION MATERIAL 8.00	Stream channel is currently dry and recently cleared of debris. Evidence of settlement and batter distress possibly caused by earlier scour.	7
MORTAR 8.00	Major debonding for the entire wall including the guardwall above the culverts. Cracking, spalling and weathering is also moderate.	5
STONE MASONRY 8.00	Hard durable angular stones to 2 ft. max. Zones not well interlocked with joints to 3 in. Top stones are missing.	7
ROAD/SIDEWALK/SHOULDER 0.50	No evidence of pavement distress. Shoulder at end had been eroded and gully recently filled with rock.	8
LATERAL SLOPE 0.50	Gentle grassy fill slopes and brush and tree covered natural slopes.	9

WALL DRAINS 1.00	No drains installed. Some evidence of damage from runoff infiltration behind wall and seepage from grout lines below. Mortar missing and stones loose at these locations.	5
UPSLOPE 1.00	Stream channel had been filled with debris and recently cleaned. some evidence of wall settlement may have been caused by previous scour distress and undermining.	6

Failure Consequence:	LOW
Recommendation Narrative:	1. Replace or reset surface stones, use local stones. 2 Laborers x 12 hr. x \$55/hr. = \$1320. 2. Repoint mortar for stones above culverts and entire wall face area. Repoint mortar ((18 ft. x 1.5 ft.) + 135 sq. ft.) x \$75/sq.ft. = \$12,150. Total = \$13,470
Repair Cost:	\$13,470

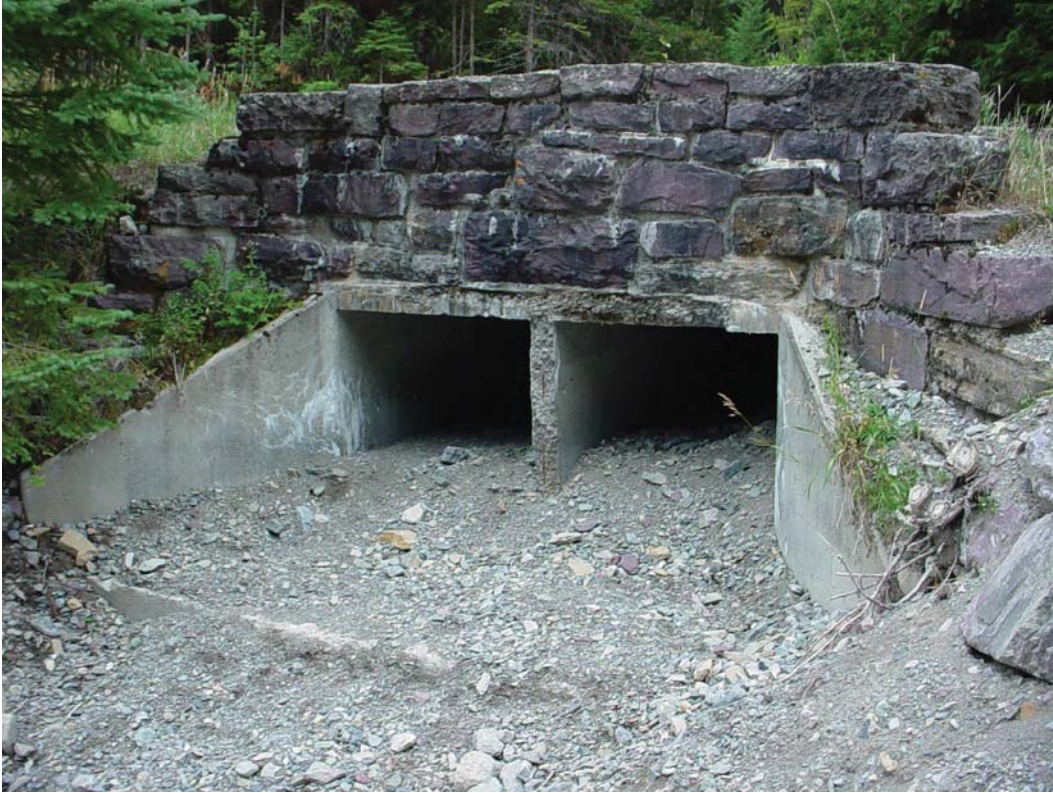
GLAC_0010W_18.750_L_1.jpg

Wall Function:	Head Wall	Primary Wall Type:	Gravity - Mortared Stone
Surface Treatment:		Secondary Wall Type:	
Secondary Surface Treatment:		Architectural Facing:	
General Description:	Stone masonry headwall at outlet of twin 5 ft x 5 ft box culverts. Performing well need to replace/reset a few stones at both the beginning and end of the wall. Monitor for settlement at the end.

Element (Weighting Factor)	Narrative	Condition Rating (0 - 10)
PERFORMANCE 8.00	Wall is performing well but needs to have stones replaced/reset at both ends of the wall. Settlement of the pavement at both ends of the wall needs to be monitored.	8
WALL FOUNDATION MATERIAL 8.00	Gravelly streambed. No scour distress.	9
STONE MASONRY 8.00	Hard durable angular stones, well interlocked. Stones are loose or missing at both ends of the wall.	7
MORTAR 8.00	Mortar is in good condition with only minor weathering, spalling and debonding degradation.	8
DOWNSLOPE 0.50	Gravelly streambed on gentle gradient. No scour distress noted.	8
LATERAL SLOPE 0.50	Gentle natural slopes, well vegetated. gravel overburden adjacent to each side.	8
WALL DRAINS 0.50	No drains installed. Some minor evidence of seepage from grout lines.	8
ROAD/SIDEWALK/SHOULDER 1.00	Pavement shows evidence of settlement of subgrade at both ends of the wall. Wall does not show any displacement and may not be affected.	6

CULVERT 1.00	Surface of concrete culverts is degrading and spalling, exposing rebar. Will eventually contribute to degradation of the adjacent wall.	7

Failure Consequence:	LOW
Recommendation Narrative:	Replace/reset stones at both ends of wall, use local stones. 2 Laborers x 4 hr. x \$55/hr. = \$440
Repair Cost:	\$440

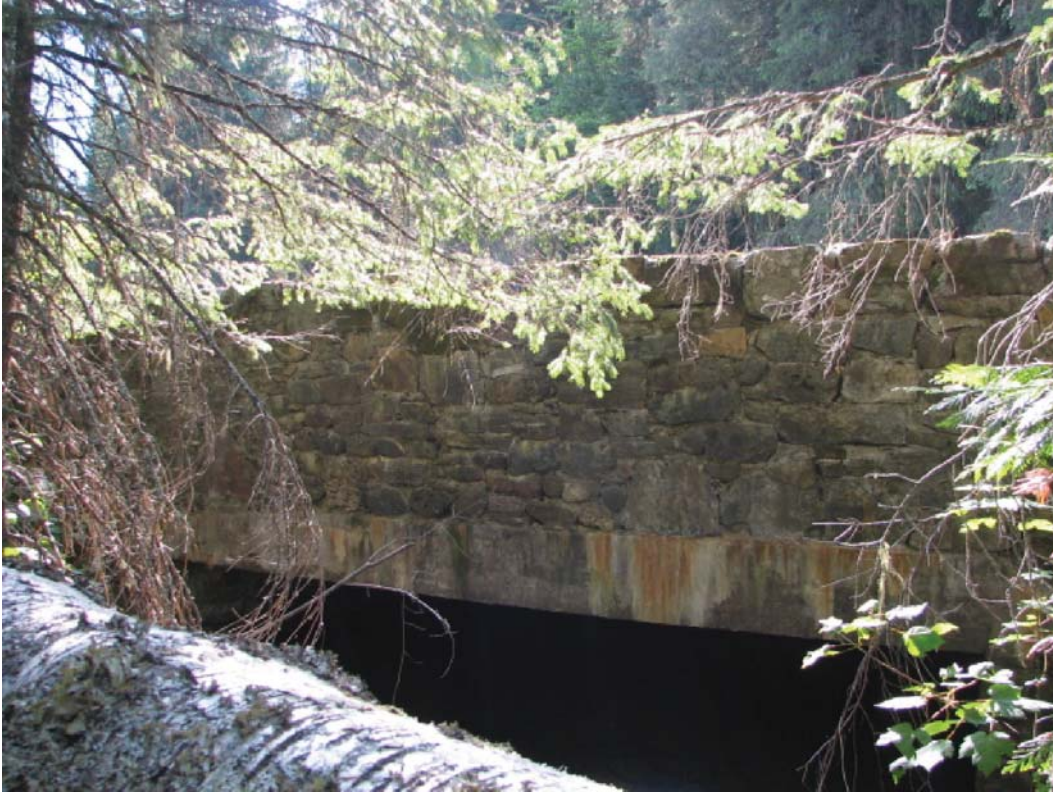
GLAC_0010W_19.590_L_1.jpg

Element (Weighting Factor)	Narrative	Condition Rating (0 - 10)
PERFORMANCE 8.00	Headwall is performing well but is need of mortar maintenance.	7
WALL FOUNDATION MATERIAL 8.00	Gravelly streambed, stable with no evidence of scour or undermining.	8
MORTAR 8.00	Mortar is missing, loose, or debonded on about 50 % of wall face.	5
STONE MASONRY 8.00	Hard durable angular to round stones to 1 ft. max. Poorly interlocked with uneven joint lines. Some stones are weathering and minor spalling. No batter or bulging distress noted.	7
DOWNSLOPE 0.50	Gravelly streambed. No evidence of scour distress. Flood debris scattered along stream banks.	8
LATERAL SLOPE 0.50	Gentle grassy fill slopes to tree covered flood plain.	9
ROAD/SIDEWALK/SHOULDER 0.50	No evidence of pavement, shoulder, or guardwall distress.	9
WALL DRAINS 1.00	No drains installed. Considerable evidence of seepage from grout lines probably contributing to mortar degradation..	6

Failure Consequence:	LOW
Recommendation Narrative:	Repoint and fill mortar voids for about 50 % of wall surface area. Repoint mortar (0.50 x ((31 ft. x 2 ft.) + 118 sq. ft.)) x \$75/sq.ft. = \$6750
Repair Cost:	\$6,750

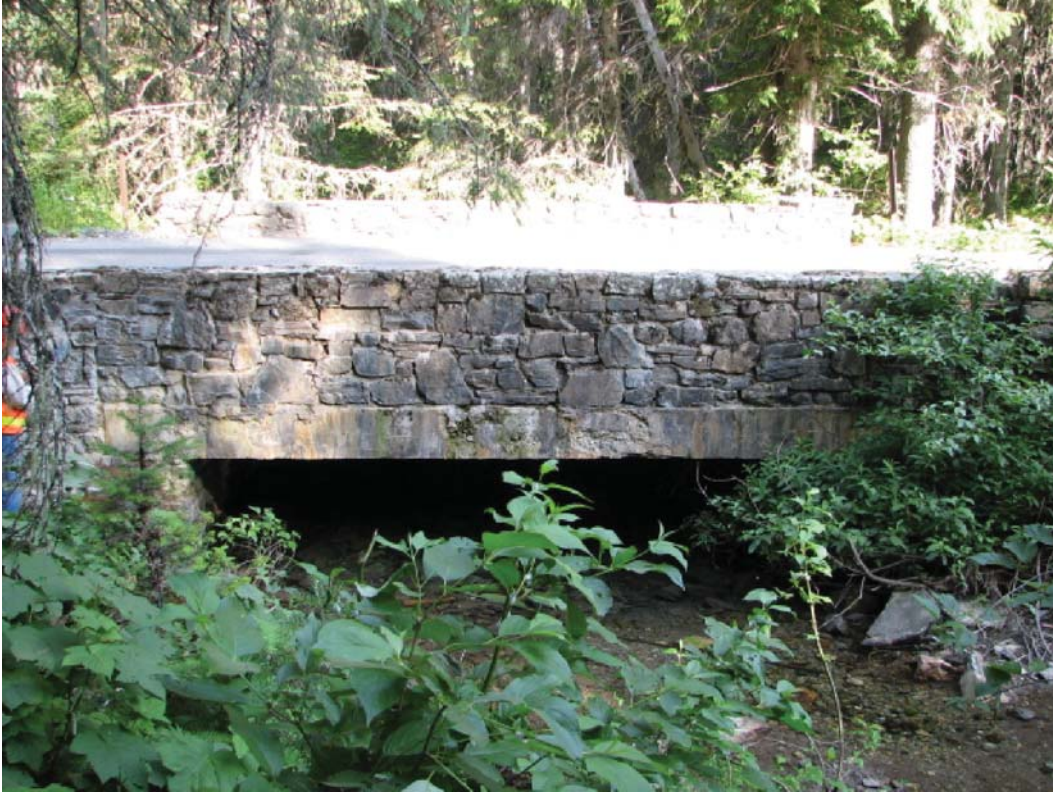
GLAC_0010W_19.590_R_1.jpg

Wall Function:	Fill Wall	Primary Wall Type:	Gravity - Mortared Stone
Surface Treatment:		Secondary Wall Type:	
Secondary Surface Treatment:		Architectural Facing:	
General Description:	Stone masonry headwall at inlet to 17 ft x 3 ft concrete bridge. Performing well. Stones are not as good quality as walls downstream and need to be monitored for degradation.

Element (Weighting Factor)	Narrative	Condition Rating (0 - 10)
PERFORMANCE 8.00	Wall is performing well. No maintenance necessary at this time. Monitor stone degradation and road rutting.	8
WALL FOUNDATION MATERIAL 8.00	Stable gravelly streambed. No evidence of scour distress or undermining.	9
MORTAR 8.00	Mortar is in good condition with less than 10 % of the area showing debonding and spalling distress.	8
STONE MASONRY 8.00	Mostly hard durable stones but range from angular to round. Poorly interlocked with uneven grout lines. No evidence of batter distress.	8
DOWNSLOPE 0.50	Gently sloping gravelly streambed. No evidence of scour distress.	8
LATERAL SLOPE 0.50	Gently sloping terrain.	9
ROAD/SIDEWALK/SHOULDER 1.00	Pavement is rutted at bridge location. No shoulder or guardwall distress noted.	6
WALL DRAINS 1.00	No drains installed. Some evidence of seepage at grout lines.	7

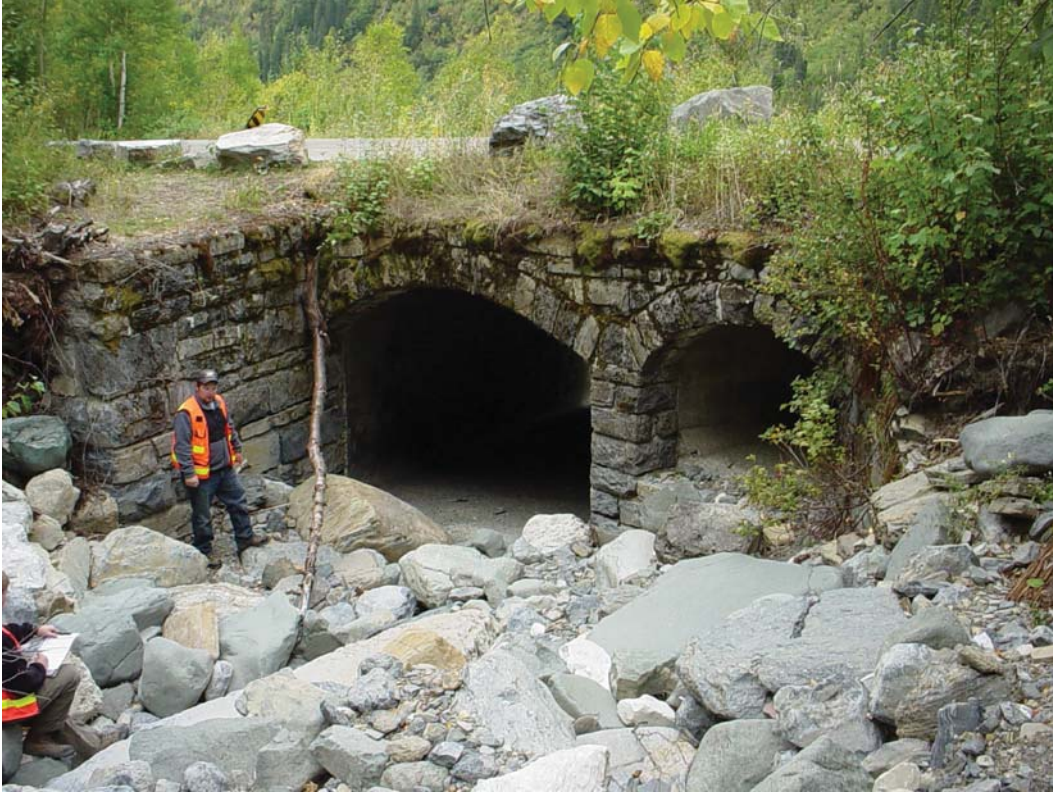
GLAC_0010W_22.354_R_1.jpg

Element (Weighting Factor)	Narrative	Condition Rating (0 - 10)
PERFORMANCE 8.00	As intended	7
WALL FOUNDATION MATERIAL 8.00	Coarse talus, firm, no distress	9
MORTAR 8.00	Minor debonding overall, total mortar loss in lower 4 feet of wall for 20% of wall, mortar loss at headwall/box culvert interface	6
STONE MASONRY 8.00	No distress	9
WALL DRAINS 0.50	None, no distress	9
CULVERT 1.00	Some cracking in concrete of 8'x9.5' box culvert; abrasion at concrete floor exposing steel reinforcement; roof cracks have been patched	7
DOWNSLOPE 1.00	Creek bed, boulder, some scour at inlet up to 1 foot deep	7
LATERAL SLOPE 1.00	Steep to vertical, some erosion from creek; bouldery, some erosion behind wing wall	7

Failure Consequence:	HIGH
Recommendation Narrative:	Repoint 20% of lower 4 feet of wall (40 sqft), patch culvert slab at inlet (1 cyd). Repoint: 40 sqft x \$75/sqft = \$3000. Concrete patch: 1 cyd x \$1500 = \$1,500. Total=\$4,500
Repair Cost:	\$4,500

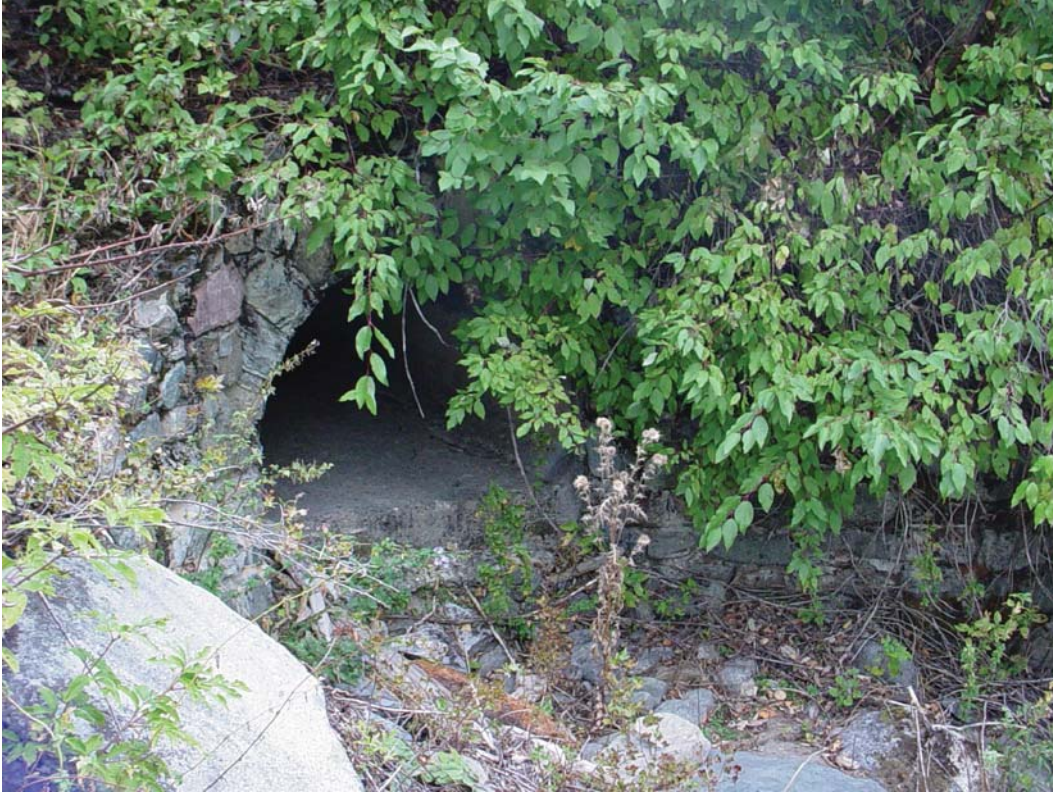
GLAC_0010W_22.360_L_1.jpg

Element (Weighting Factor)	Narrative	Condition Rating (0 - 10)
PERFORMANCE 8.00	No distress	7
WALL FOUNDATION MATERIAL 8.00	Soil, stable	7
MORTAR 8.00	Isolated cracking and debonding, some deterioration	6
STONE MASONRY 8.00	Smaller and medium sized stones, efflorescence staining, some weathering and fractures on stone	6
LATERAL SLOPE 0.50	Soil and vegetation, stable	8
WALL DRAINS 0.50	None	9
CULVERT 1.00	4'x6' cip box culvert, no distress	7
VEGETATION 1.00	Heavy vegetation growth over top of wall face	7

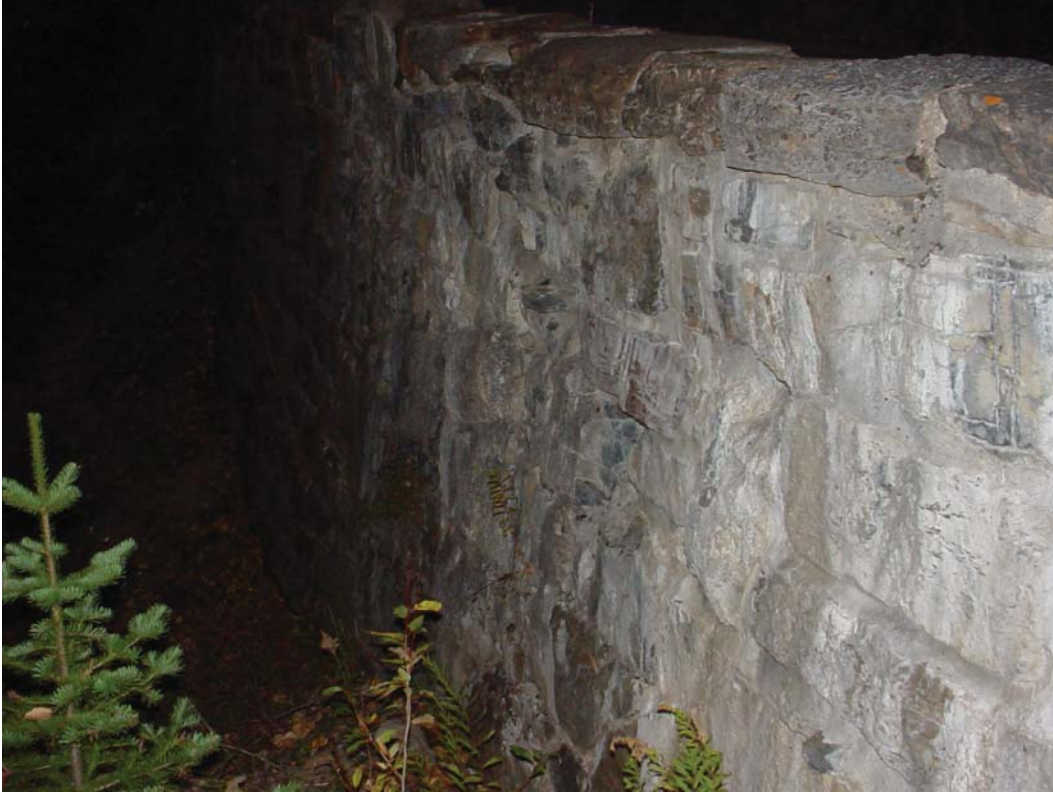
GLAC_0010W_25.102_R_1.jpg

Element (Weighting Factor)	Narrative	Condition Rating (0 - 10)
PERFORMANCE 8.00	As intended	9
WALL FOUNDATION MATERIAL 8.00	Bedrock, no distress	9
MORTAR 8.00	No distress, 40% repointed	9
STONE MASONRY 8.00	No distress	9
CULVERT 0.50	12" cmp cross drain culvert outlets beneath guardwall at end of wall, no distress	9
DOWNSLOPE 0.50	Bedrock, no distress	9
LATERAL SLOPE 0.50	Bedrock, no distress	9
TRAFFIC BARRIER/FENCE 0.50	No distress in guardwall	9
WALL DRAINS 0.50	None, no distress	9

Failure Consequence:	HIGH
Recommendation Narrative:	None
Repair Cost:	\$0

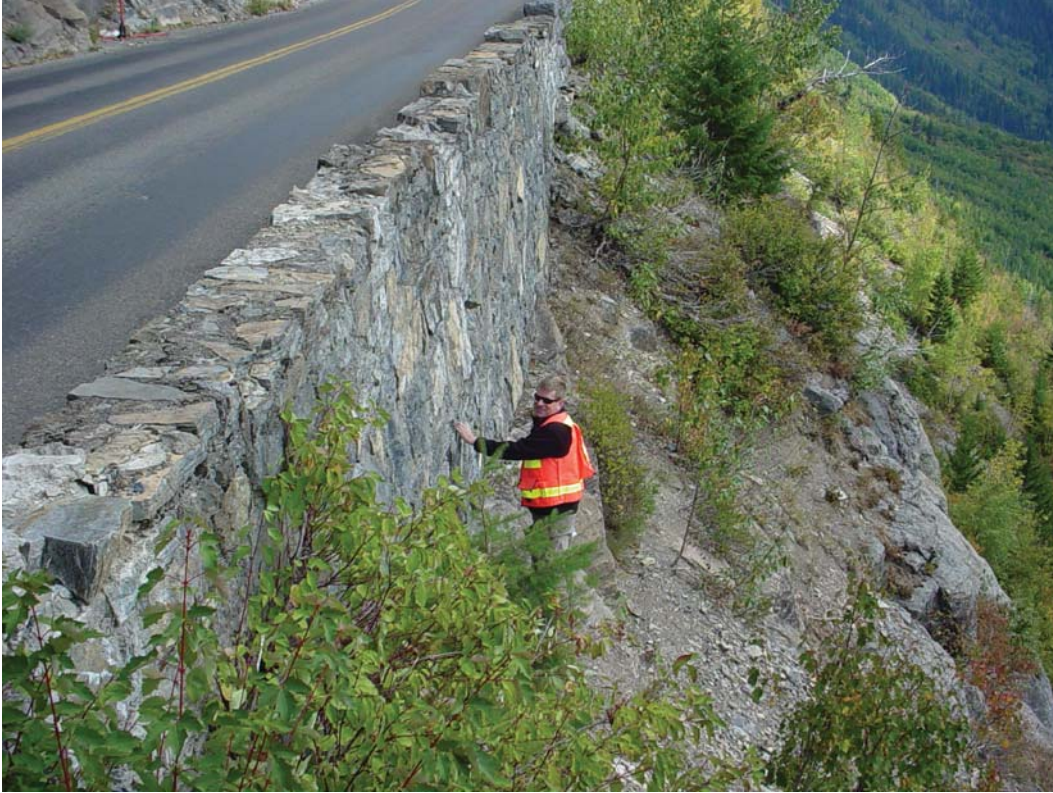
GLAC_0010W_25.388_R_1.jpg

Element (Weighting Factor)	Narrative	Condition Rating (0 - 10)
PERFORMANCE 8.00	As intended	8
WALL FOUNDATION MATERIAL 8.00	Bedrock, no distress	9
MORTAR 8.00	Mild debonding over 50% of wall	8
STONE MASONRY 8.00	No distress	9
ROAD/SIDEWALK/SHOULDER 0.50	Very minor cracking in overlay	8
CULVERT 0.50	18" cmp culvert outlets below wall, no distress	9
DOWNSLOPE 0.50	Steep bedrock cliff, no distress	9
LATERAL SLOPE 0.50	Steep bedrock cliff, no distress	9
WALL DRAINS 0.50	1 @ 3" drain tile outlets through face, no distress	9

Failure Consequence:	MODERATE
Recommendation Narrative:	None
Repair Cost:	\$0

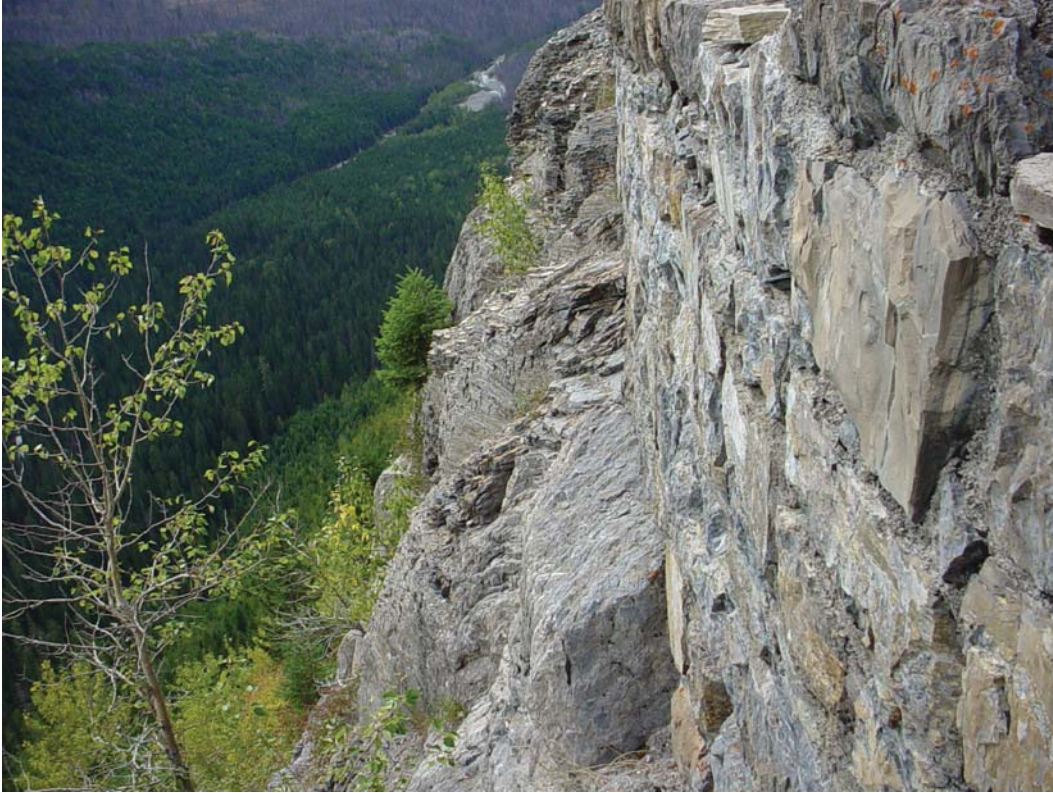
GLAC_0010W_25.420_R_1.jpg

Element (Weighting Factor)	Narrative	Condition Rating (0 - 10)
PERFORMANCE 8.00	As intended	8
WALL FOUNDATION MATERIAL 8.00	Bedrock, stable	8
MORTAR 8.00	No distress	8
STONE MASONRY 8.00	Regular, rectangular blocks, no distress	8
DOWNSLOPE 0.50	Bedrock, stable	8
LATERAL SLOPE 0.50	Bedrock, stable	8
WALL DRAINS 0.50	None	8

Failure Consequence:	MODERATE
Recommendation Narrative:	None
Repair Cost:	\$0

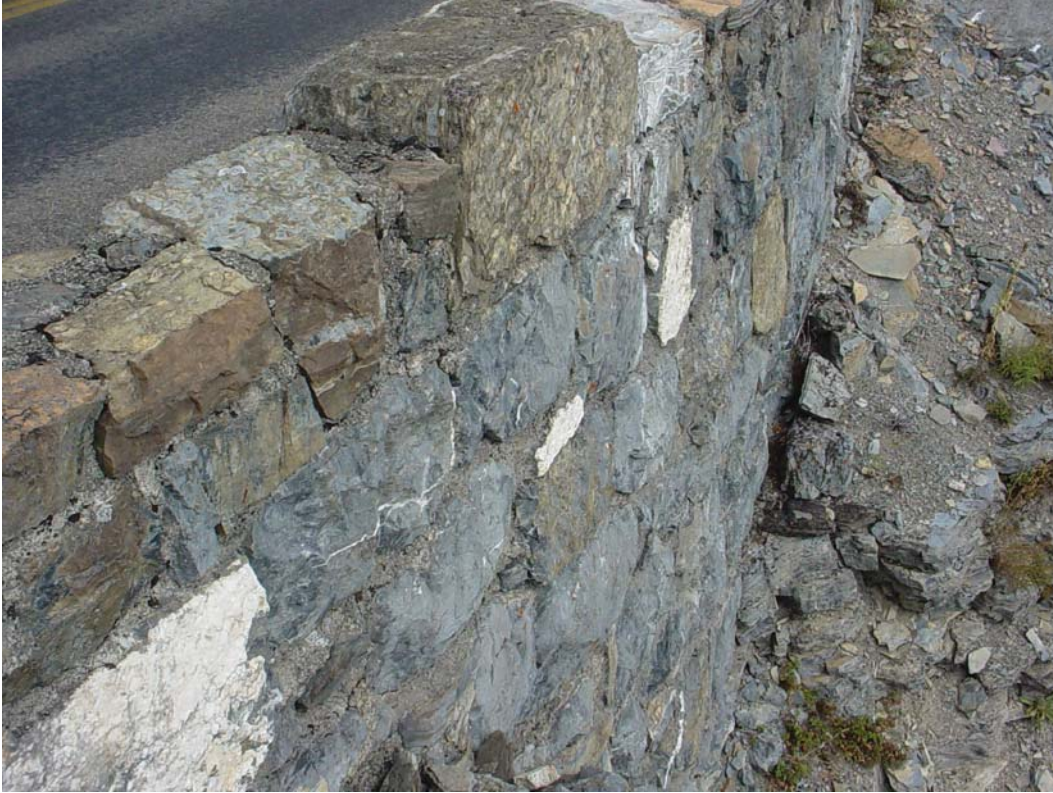
GLAC_0010W_25.425_R_1.jpg

Element (Weighting Factor)	Narrative	Condition Rating (0 - 10)
PERFORMANCE 8.00	As intended	8
WALL FOUNDATION MATERIAL 8.00	Bedrock, no distress	8
MORTAR 8.00	Isolated voids, otherwise no distress	7
STONE MASONRY 8.00	No distress	8
DOWNSLOPE 0.50	Very steep, stable	8
LATERAL SLOPE 0.50	Bedrock, steep	8
WALL DRAINS 0.50	None	8

Failure Consequence:	HIGH
Recommendation Narrative:	None
Repair Cost:	\$0

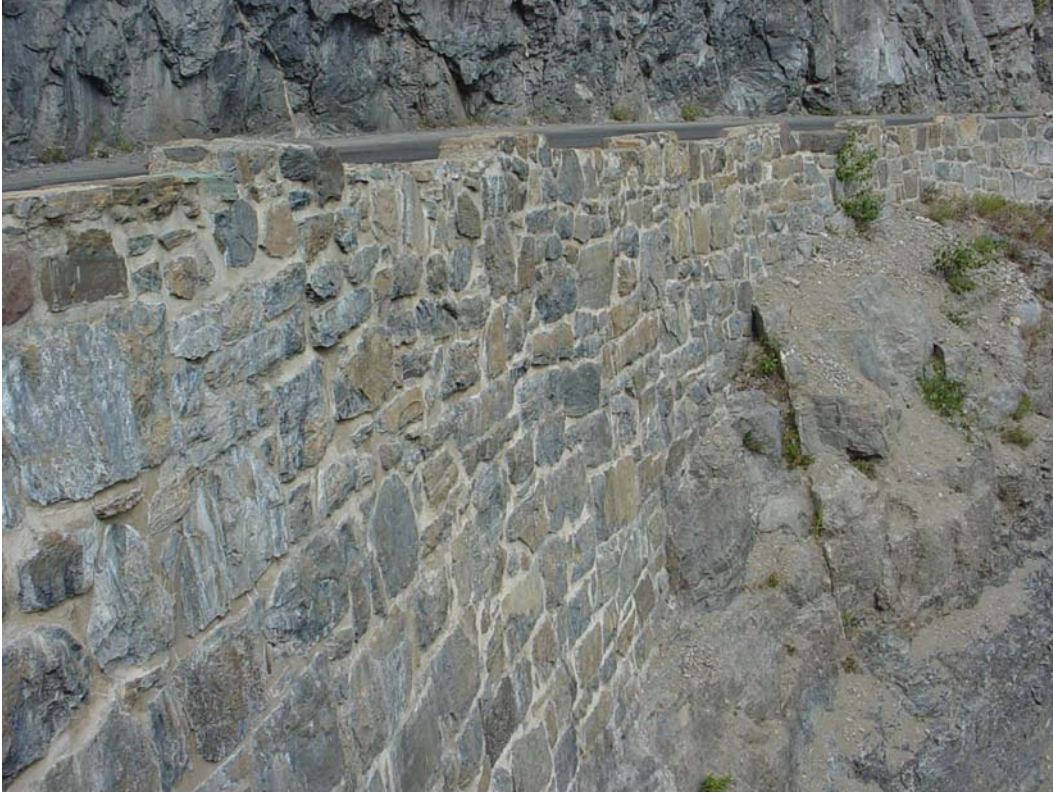
GLAC_0010W_25.437_R_1.jpg

Element (Weighting Factor)	Narrative	Condition Rating (0 - 10)
PERFORMANCE 8.00	Top 5-10 feet appear to be leaning slightly, road settled 2-3 inches at this location, recently repointed	8
WALL FOUNDATION MATERIAL 8.00	Bedrock, no distress	9
MORTAR 8.00	Recently repointed, no distress	9
STONE MASONRY 8.00	No distress	9
DOWNSLOPE 0.50	Bedrock cliff, no distress	9
LATERAL SLOPE 0.50	Bedrock, no distress	9
TRAFFIC BARRIER/FENCE 0.50	Recently repointed guardwall, no distress	9
WALL DRAINS 0.50	None, no distress	9
ROAD/SIDEWALK/SHOULDER 1.00	Lateral cracks along traffic lane and narrow asphalt shoulder; shoulder appears to have settled 2-3 inches	7

Failure Consequence:	HIGH
Recommendation Narrative:	None
Repair Cost:	\$0

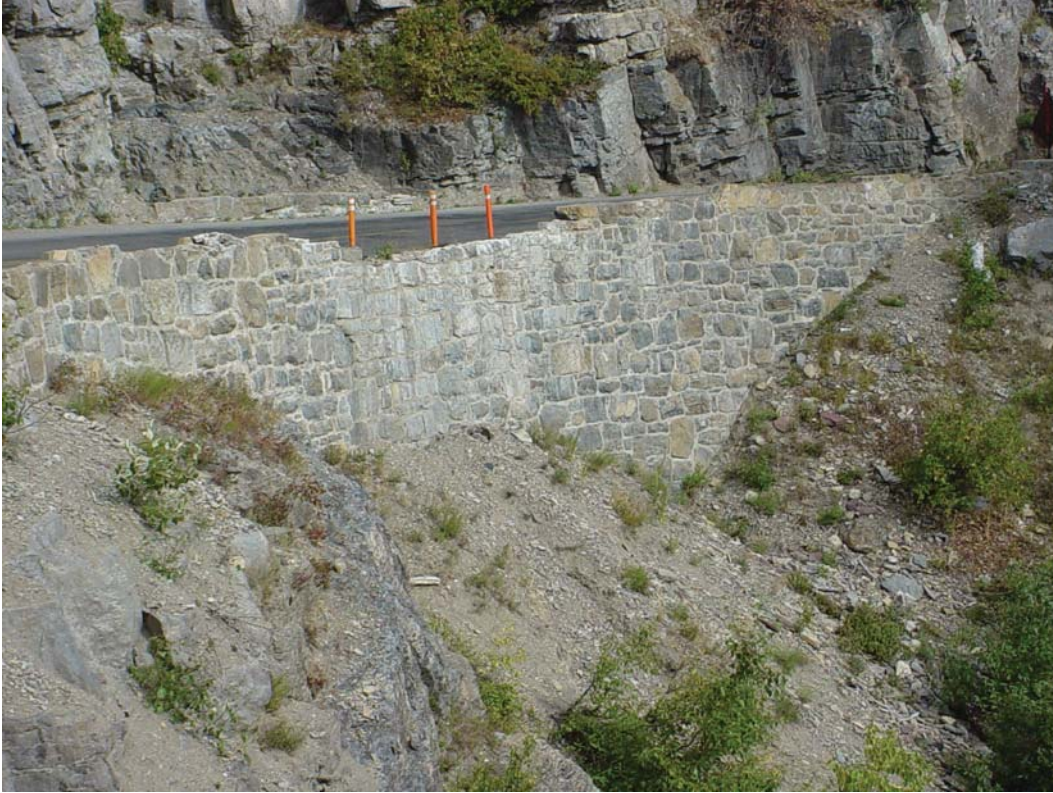
GLAC_0010W_25.453_R_1.jpg

Element (Weighting Factor)	Narrative	Condition Rating (0 - 10)
PERFORMANCE 8.00	Wall is functioning as intended	8
WALL FOUNDATION MATERIAL 8.00	Bedrock, soil, talus	8
STONE MASONRY 8.00	Large square and rectangular blocks, no distress	8
MORTAR 8.00	High quality, good workmanship	9
CULVERT 0.50	24" cmp in roadway embankment, small arch opening in stone masonry wall	8
LATERAL SLOPE 0.50	Bedrock and soil	8
ROAD/SIDEWALK/SHOULDER 1.00	40' length of guardwall destroyed as wall is in avalanche chute.	4
WALL DRAINS 0.50	2" clay pipe	8
DOWNSLOPE 1.00	Talus with erosion pockets	6

Failure Consequence:	HIGH
Recommendation Narrative:	Rebuild guardwall 40' - Candidate for avalanche resistant guardwall Barrier Replacement, stone masonry unreinforced - \$2900/lnft x 40lnft= \$116,000
Repair Cost:	\$116,000

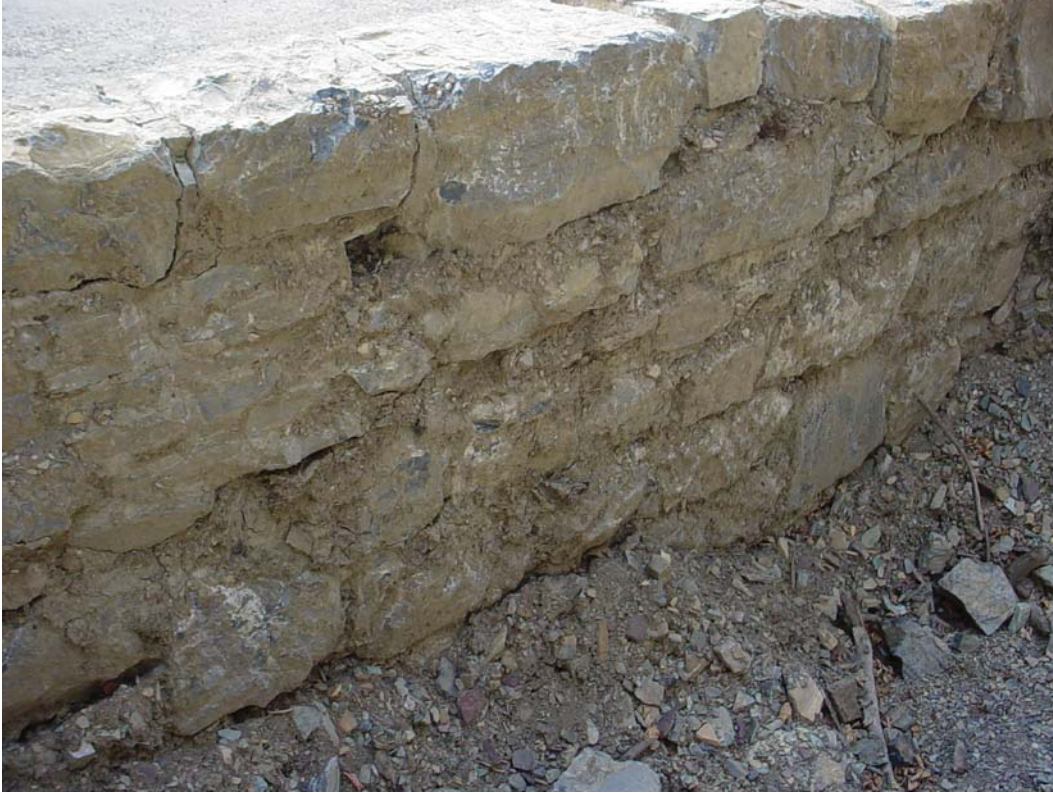
GLAC_0010W_25.465_L_1.jpg

Element (Weighting Factor)	Narrative	Condition Rating (0 - 10)
PERFORMANCE 8.00	Wall performing, culvert and basin need clean out	7
WALL FOUNDATION MATERIAL 8.00	Likely bedrock, no distress	9
MORTAR 8.00	Moderate debonding, mortar covered by dirt, some mortar loss	7
STONE MASONRY 8.00	No distress	9
LATERAL SLOPE 0.50	Bedrock, no distress	8
WALL DRAINS 0.50	None, no distress	9
TRAFFIC BARRIER/FENCE 1.00	Missing mortar, loose cap stones, missing 1-2 stones in guardwall	6
CULVERT 1.00	24" cmp culvert; completely buried by debris, likely filled/clogged	7
ROAD/SIDEWALK/SHOULDER 1.00	Cracked asphalt, impact damage	7

Failure Consequence:	MODERATE
Recommendation Narrative:	Repoint wall (80 sqft) and clean out culvert. Repoint: \$75/sqft x 80 sqft = \$6,000. Clean out basin and culvert = 2 man-days x \$350/day = \$700. Total=\$6,700
Repair Cost:	\$6,700

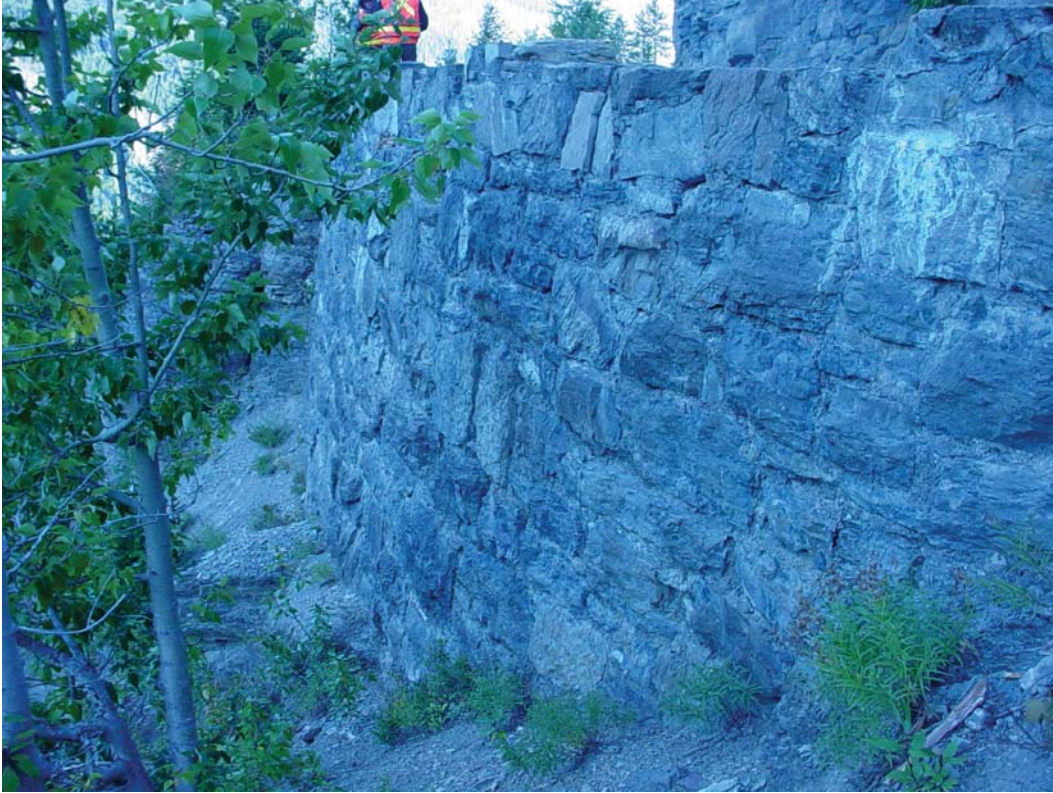
GLAC_0010W_25.680_R_1.jpg

Element (Weighting Factor)	Narrative	Condition Rating (0 - 10)
PERFORMANCE 8.00	As intended	8
WALL FOUNDATION MATERIAL 8.00	Bedrock, no distress	9
MORTAR 8.00	Minor debonding, very small voids over 2% of wall	7
STONE MASONRY 8.00	No distress	9
DOWNSLOPE 0.50	Thin loose talus over bedrock, no distress	9
LATERAL SLOPE 0.50	Bedrock, no distress	9
ROAD/SIDEWALK/SHOULDER 0.50	No distress in overlay	9
WALL DRAINS 0.50	1 @ 3" diameter drain tile outlets through face of wall near base, no distress	9

Failure Consequence:	HIGH
Recommendation Narrative:	None
Repair Cost:	\$0

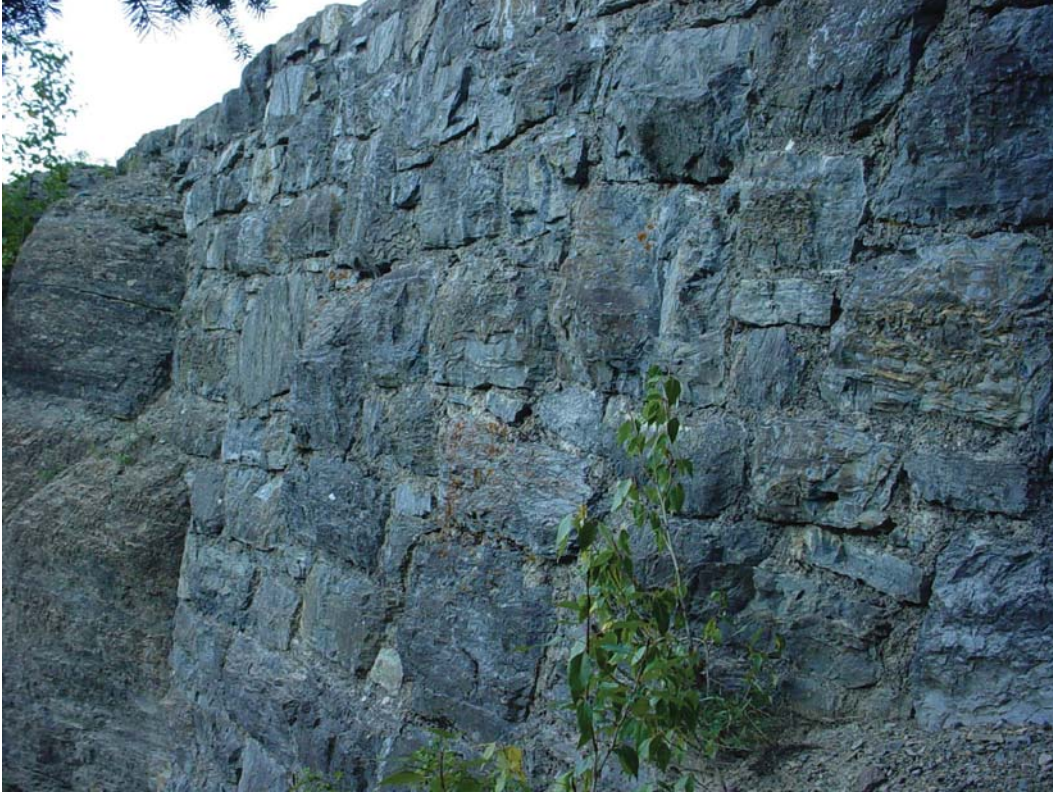
GLAC_0010W_25.707_R_1.jpg

Element (Weighting Factor)	Narrative	Condition Rating (0 - 10)
PERFORMANCE 8.00	As intended	8
WALL FOUNDATION MATERIAL 8.00	Soil and bedrock	8
MORTAR 8.00	50% of wall face mortar is debonded, separated from stones	6
STONE MASONRY 8.00	Large ashlar blocks, no distress	8
WALL DRAINS 0.50	None	8
DOWNSLOPE 1.00	Steep soil, talus, bedrock, no distress	7
LATERAL SLOPE 1.00	Soil, talus, bedrock, stable	7

Failure Consequence:	HIGH
Recommendation Narrative:	Repoint 50% of wall face (210 sqft) Repoint: 210 sqft x \$75/sqft = \$15,750 Total=\$15,750
Repair Cost:	\$15,750

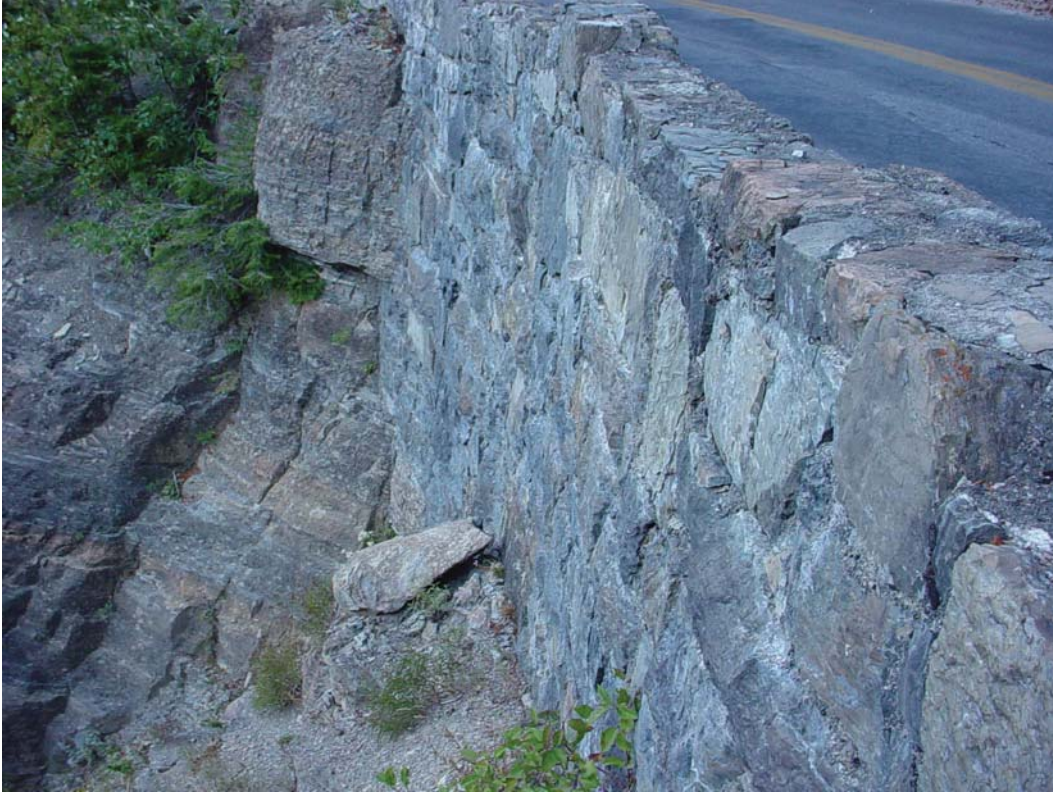
GLAC_0010W_25.725_R_1.jpg

Element (Weighting Factor)	Narrative	Condition Rating (0 - 10)
PERFORMANCE 8.00	Performing as intended with some deficiencies noted above	8
WALL FOUNDATION MATERIAL 8.00	Bedrock, no distress	9
MORTAR 8.00	25% of mortar is debonded, voids between stones where mortar is missing	7
STONE MASONRY 8.00	Slight weathering of stones, minor spalling of rocks	7
DOWNSLOPE 0.50	Very steep slope, no vegetation	8
LATERAL SLOPE 0.50	Beginning - bedrock, end - bedrock covered in soil	8
ROAD/SIDEWALK/SHOULDER 0.50	Road is in good condition, no distress	8
WALL DRAINS 0.50	No distress	9

Failure Consequence:	HIGH
Recommendation Narrative:	None
Repair Cost:	\$0

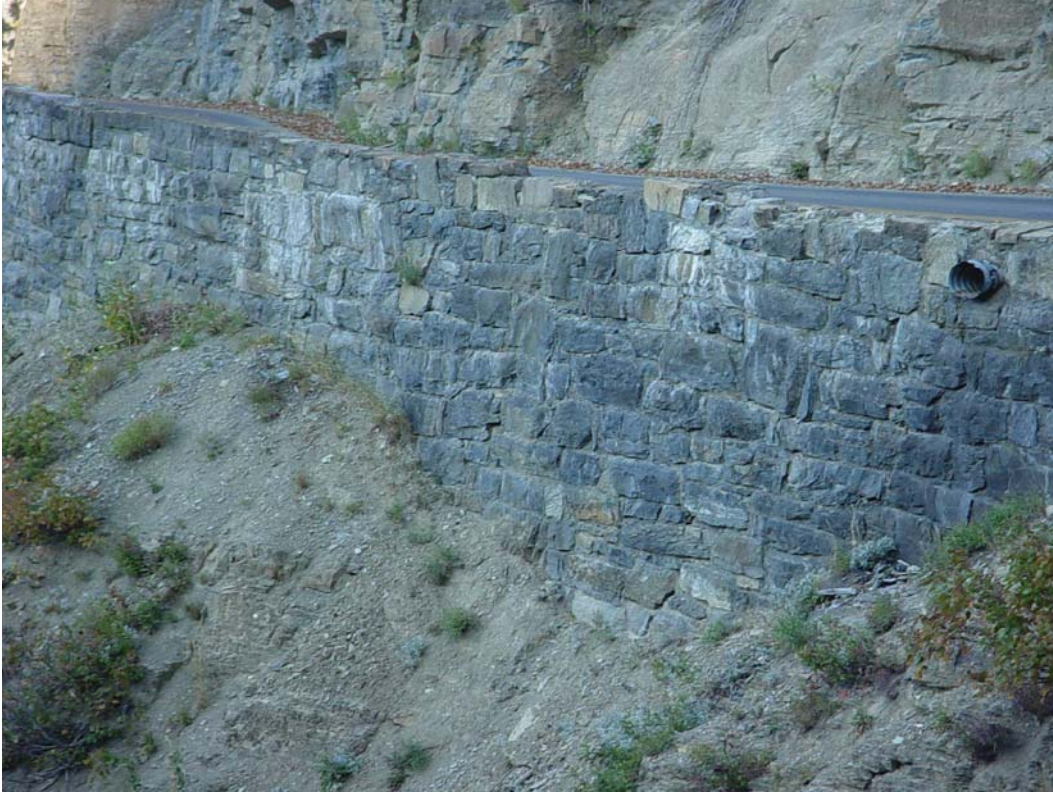
GLAC_0010W_25.737_R_1.jpg

Element (Weighting Factor)	Narrative	Condition Rating (0 - 10)
PERFORMANCE 8.00	As intended	8
WALL FOUNDATION MATERIAL 8.00	Soil, talus, bedrock, steep	7
MORTAR 8.00	Isolated debonding, cracking in mortar	7
STONE MASONRY 8.00	Large ashlar blocks, no distress	8
WALL DRAINS 0.50	None	8
TRAFFIC BARRIER/FENCE 1.00	Last 40' of guardwall shows impact damage, broken stones, cracked mortar	5
DOWNSLOPE 1.00	Talus, steep	7
LATERAL SLOPE 1.00	Talus, soil, bedrock, steep	7

Failure Consequence:	HIGH
Recommendation Narrative:	Repair 40' length of guardwall Barrier replacement, stone masonry unreinforced: \$2,900/lnft x 40 lnft = \$116,000 Total=\$116,000
Repair Cost:	\$116,000

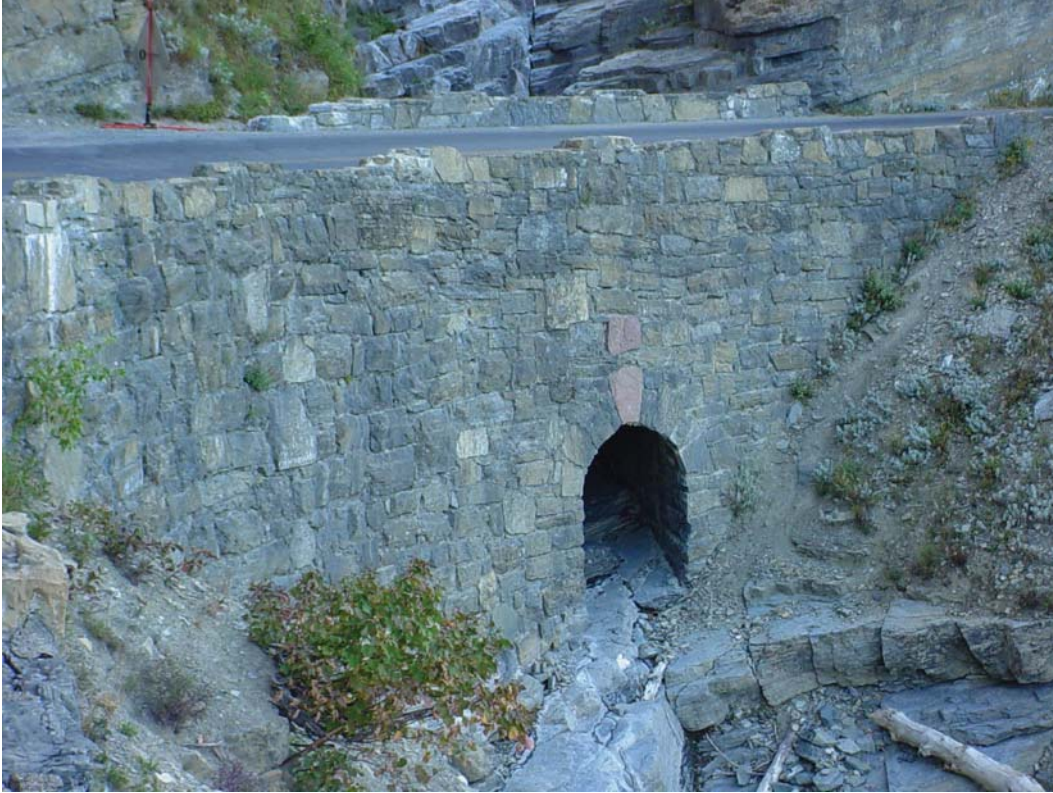
GLAC_0010W_25.760_R_1.jpg

Element (Weighting Factor)	Narrative	Condition Rating (0 - 10)
PERFORMANCE 8.00	Wall performing as intended	7
WALL FOUNDATION MATERIAL 8.00	Bedrock mostly, one 20' section may be built on coarse fill where a 5' section is being undermined slightly by creek erosion	8
MORTAR 8.00	Minor debonding over entire wall, moderate debonding over 40% of wall including severe debonding and small voids over 5%	7
STONE MASONRY 8.00	Minor spalling on 5% of stone blocks, not critical	8
CULVERT 0.50	7'x9' arched stone and mortar culvert; some efflorescence, debonding and mortar loss	8
DOWNSLOPE 0.50	Steep, bedrock and creek bed	8
LATERAL SLOPE 0.50	Bedrock at beginning, steep slope with soil and dry stack wall at end	8
WALL DRAINS 0.50	1 @ 3" diameter drain tile outlets through face, no distress. 1 @ 3" diameter drain tile outlets at base of wall	9
TRAFFIC BARRIER/FENCE 1.00	Severe guardwall damage (impact) at wall start and moderate impact damage along remaining length	6

Failure Consequence:	HIGH
Recommendation Narrative:	Repoint 40% of wall (550 sqft), patch minor undermining along toe (5' x 1'). Repoint: 550 sqft x \$75/sqft = \$41,250. Underpinning/stabilization: 5 sqft x \$200/sqft = \$1,000. Total = \$42,250
Repair Cost:	\$42,250
