NPS Retaining Wall Inventory Program Glacier National Park

**Federal Lands Highway
Road Inventory Program**

**Federal Highway Administration
Eastern Federal Lands Highway Division
Road Inventory Program (RIP)**

**Data Collection Date: September 2007
Report Date: October 2015**

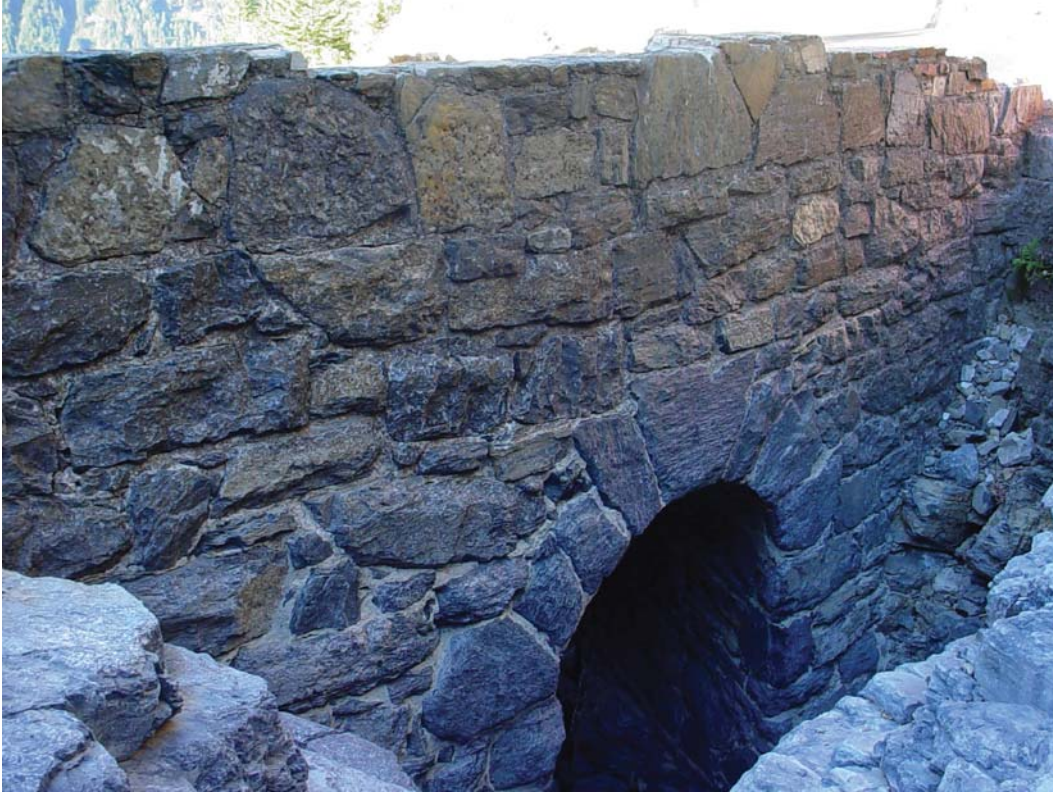
GLAC_0010W_25.778_L_1.jpg

Element (Weighting Factor)	Narrative	Condition Rating (0 - 10)
PERFORMANCE 8.00	As intended	8
WALL FOUNDATION MATERIAL 8.00	Bedrock	8
MORTAR 8.00	Widespread debonding of mortar in top 8' of headwall	6
STONE MASONRY 8.00	Large blocks, no distress	8
CULVERT 0.50	7' x 10' high stone masonry arch	8
LATERAL SLOPE 0.50	Bedrock, stable	8
UPSLOPE 0.50	Solid bedrock channel, very little debris flow	8
WALL DRAINS 0.50	None	9
TRAFFIC BARRIER/FENCE 1.00	First 15' of guardwall damaged by impact	6

Failure Consequence:	HIGH
Recommendation Narrative:	Repoint top 8' of wall (400 sqft), Rebuild 15' of guardwall. Repoint: 400 sqft x \$75/sqft = \$30,000. Barrier rebuild, stone masonry: 15 lnft x \$2900/lnft = \$43,500. Total=\$73,500
Repair Cost:	\$73,500

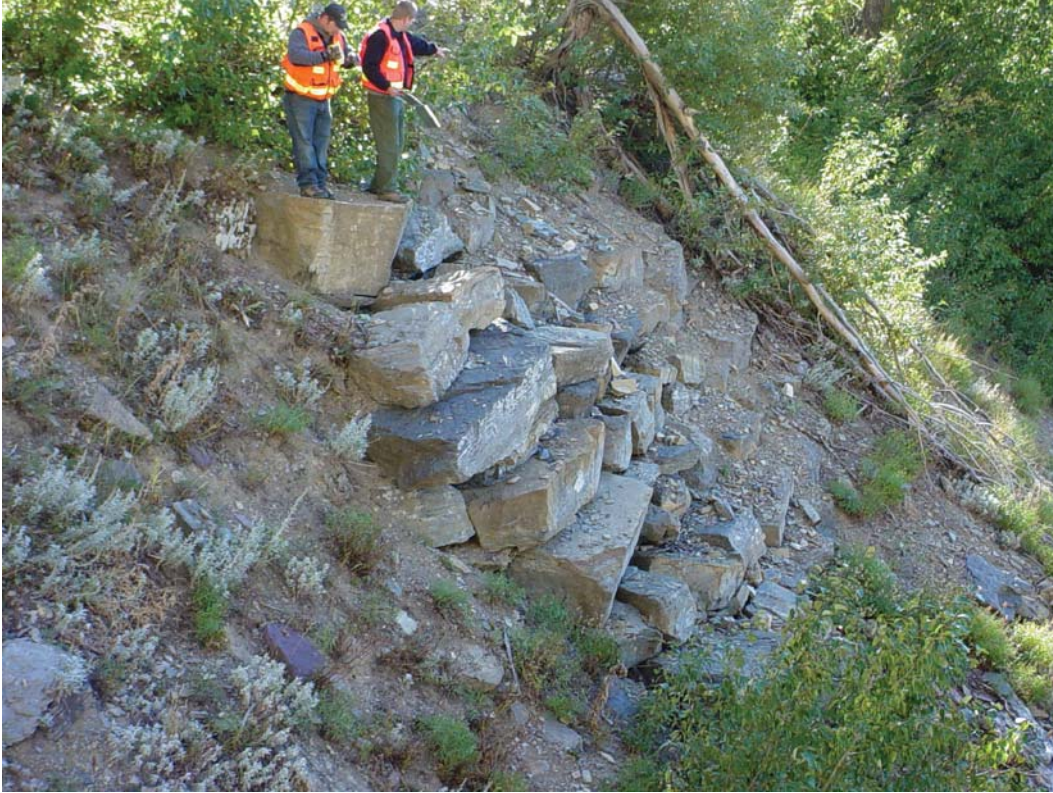
GLAC_0010W_25.788_R_1.jpg

Element (Weighting Factor)	Narrative	Condition Rating (0 - 10)
PERFORMANCE 8.00	As intended	8
WALL FOUNDATION MATERIAL 8.00	Coarse talus/fill, very minor creep	8
PLACED STONE 8.00	Large blocks, 1'-3' in diameter, no distress	9
DOWNSLOPE 0.50	Steep, loose, coarse talus/fill, minor raveling	8
LATERAL SLOPE 0.50	Steep, dense, coarse talus/fill, minor raveling	8
ROAD/SIDEWALK/SHOULDER 0.50	No distress	9
WALL DRAINS 0.50	None, no distress	9

Failure Consequence:	LOW
Recommendation Narrative:	None
Repair Cost:	\$0

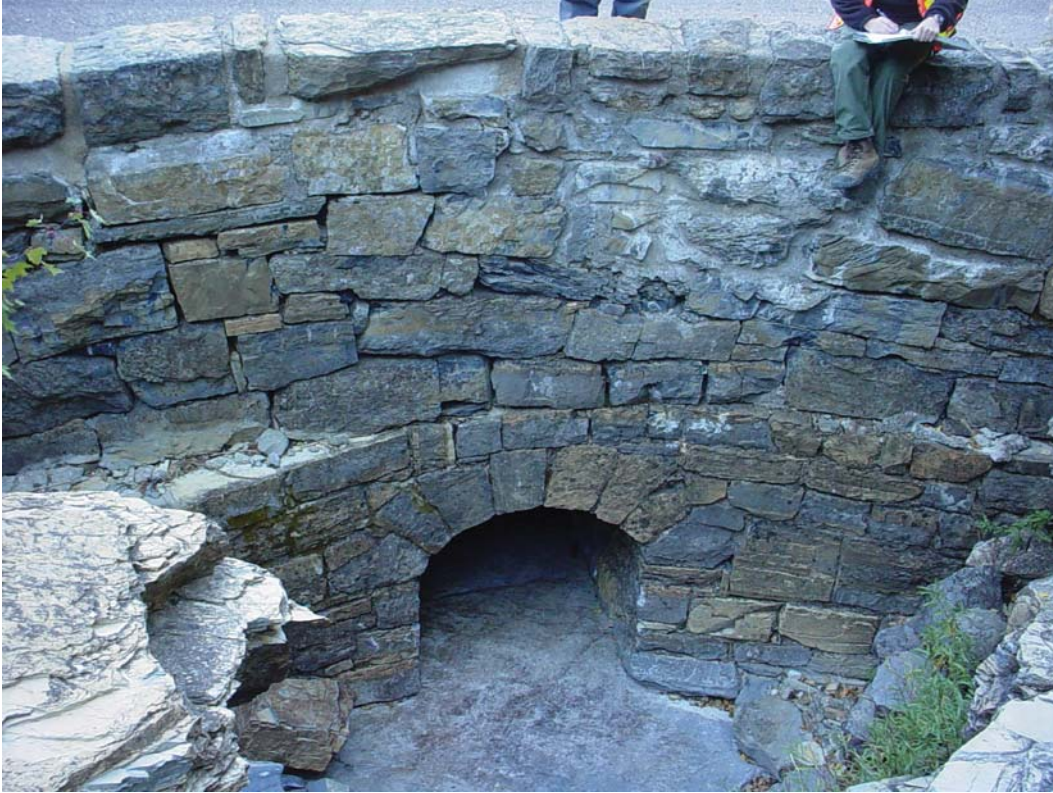
GLAC_0010W_25.960_L_1.jpg

Element (Weighting Factor)	Narrative	Condition Rating (0 - 10)
PERFORMANCE 8.00	As intended, monitor mortar	8
WALL FOUNDATION MATERIAL 8.00	Bedrock, no distress	9
MORTAR 8.00	Minor debonding over entire wall, moderate debonding and mortar loss over 20% of wall (scour)	7
PLACED STONE 8.00	Vertical cracks in dry laid blocks over 5% of wall	8
STONE MASONRY 8.00	No distress	9
CULVERT 0.50	4' diameter arched stone and mortar culvert, bedrock floor, minor debonding and efflorescence	8
CURB/BERM/DITCH 0.50	Ditch outlets at far end of headwall, no distress	9
DOWNSLOPE 0.50	Bedrock channel, no distress	9
LATERAL SLOPE 0.50	Bedrock, no distress	9

Failure Consequence:	MODERATE
Recommendation Narrative:	None
Repair Cost:	\$0

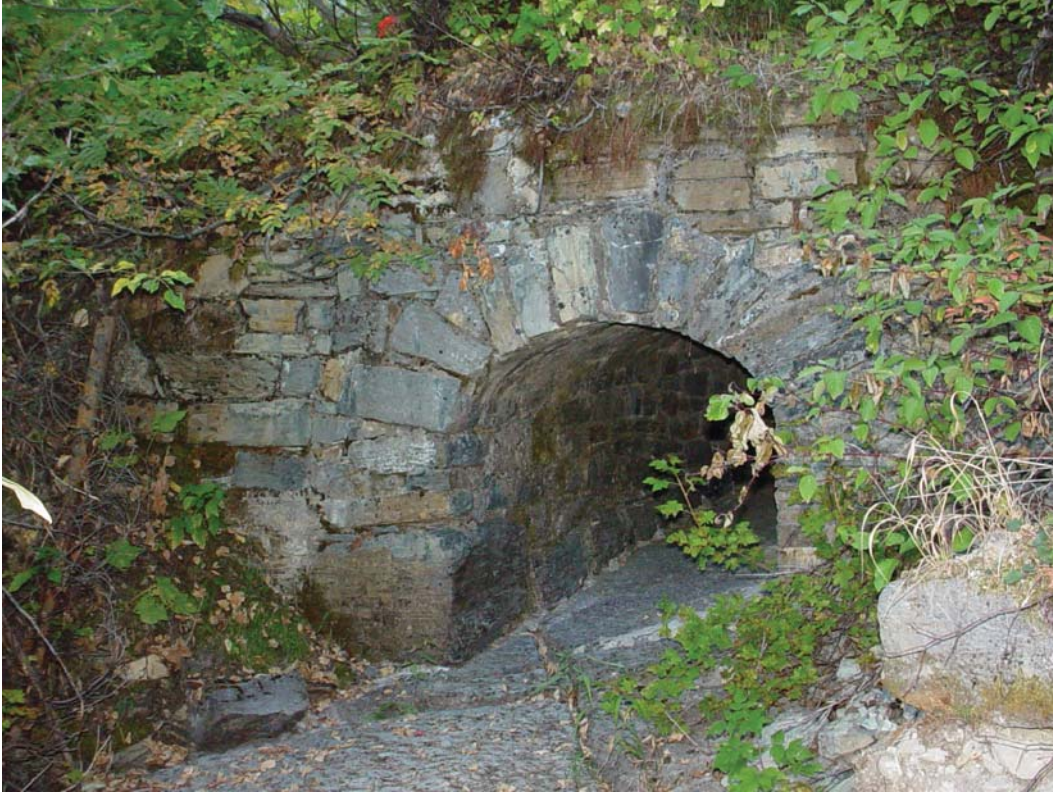
GLAC_0010W_25.961_R_1.jpg

Element (Weighting Factor)	Narrative	Condition Rating (0 - 10)
PERFORMANCE 8.00	As intended	8
WALL FOUNDATION MATERIAL 8.00	Soil, bedrock	8
MORTAR 8.00	Mortar cracked and debonded through 40% of wall face	7
STONE MASONRY 8.00	One stone missing, otherwise no distress	7
CULVERT 0.50	4' x 4' stone masonry culvert	8
DOWNSLOPE 0.50	Bedrock channel with soil side slopes, no distress	8
LATERAL SLOPE 0.50	Soil, stable	8
WALL DRAINS 0.50	None	8

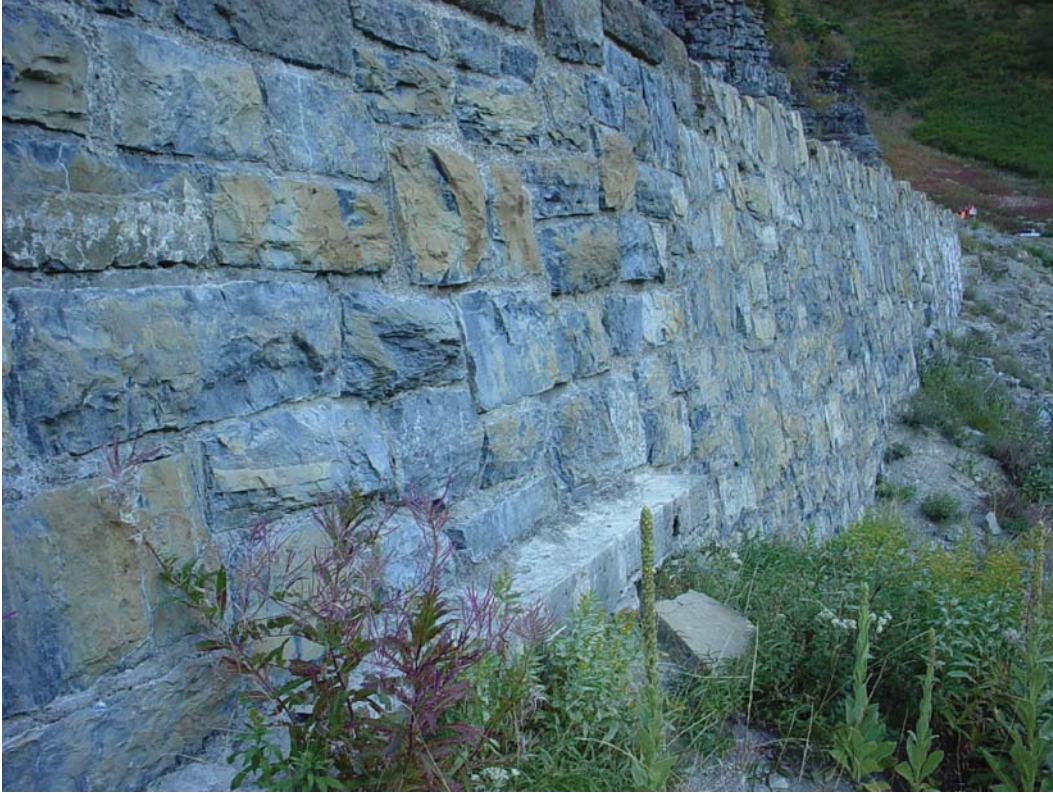
GLAC_0010W_28.806_R_1.jpg

Element (Weighting Factor)	Narrative	Condition Rating (0 - 10)
PERFORMANCE 8.00	Overall performing as intended; potential for localized failure near station 130	6
WALL FOUNDATION MATERIAL 8.00	Station 75 shows undermining; footing (or footing repair) exposed from station 0 to 55	6
STONE MASONRY 8.00	Localize loss of stone at station 130, adjacent to concrete pipe (4' x 4' loss), remainder of wall stones show minor cracking, weathering	5
MORTAR 8.00	Minor debonding, cracking in mortar	7
CULVERT 1.00	18" concrete pipe at station 130, 3' length is broken away from remainder	4
WALL DRAINS 0.50	2" drains near station 75	8
DOWNSLOPE 1.00	Soil, talus, erodible	7
LATERAL SLOPE 1.00	Soil, talus, minor vegetation	7
TRAFFIC BARRIER/FENCE 1.00	Stone masonry guardwall shows some tipping/rotation; first 65' of guardwall is newer, remainder shows crenellation stone loss in isolated areas	7

Failure Consequence:	HIGH
Recommendation Narrative:	Replace loss of wall stone adjacent to concrete pipe (16 sqft) Stone masonry replacement: 16 sqft x \$160/sqft = \$2,560 Total=\$2,560
Repair Cost:	\$2,560

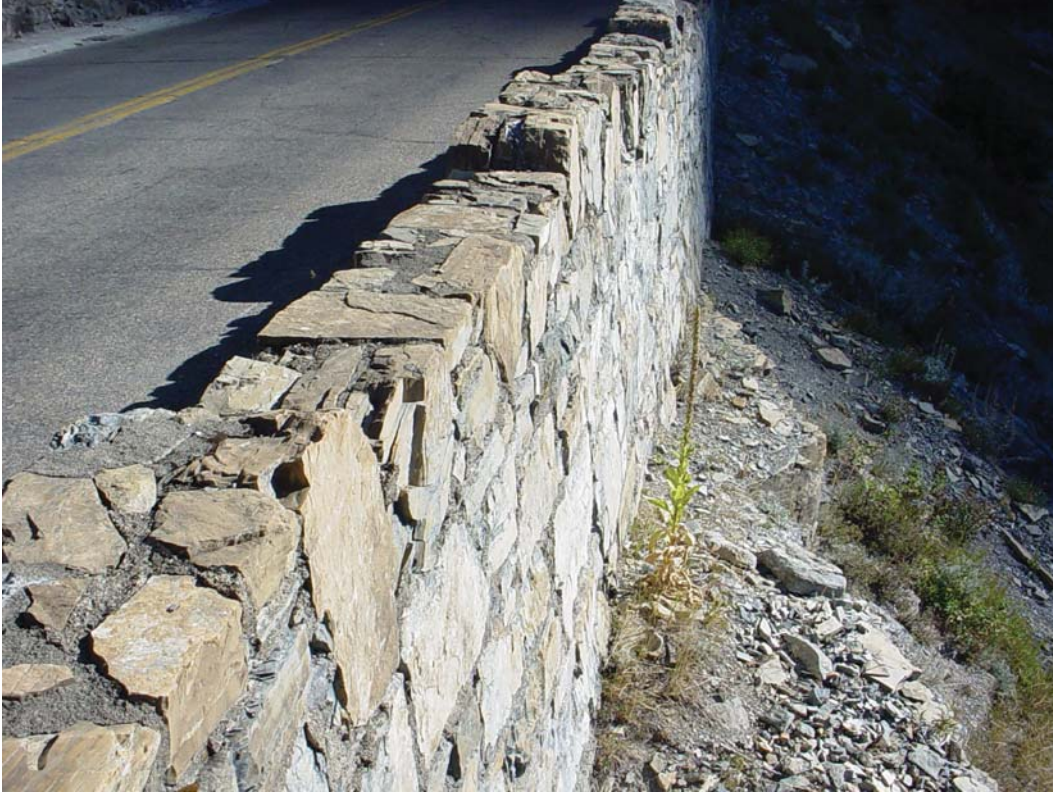
GLAC_0010W_28.852_R_1.jpg

Element (Weighting Factor)	Narrative	Condition Rating (0 - 10)
PERFORMANCE 8.00	As intended	8
WALL FOUNDATION MATERIAL 8.00	Likely shallow bedrock, no distress	9
MORTAR 8.00	Mild debonding	8
STONE MASONRY 8.00	No distress	9
CULVERT 0.50	24" cmp culvert outlets at base; partially filled with debris	8
DOWNSLOPE 0.50	Steep, talus and side cast fill, minor raveling	8
LATERAL SLOPE 0.50	Steep, talus and side cast fill, minor raveling	8
ROAD/SIDEWALK/SHOULDER 0.50	Minor cracking in roadway	8
WALL DRAINS 0.50	Possibly one drain outlet at base, no distress	9

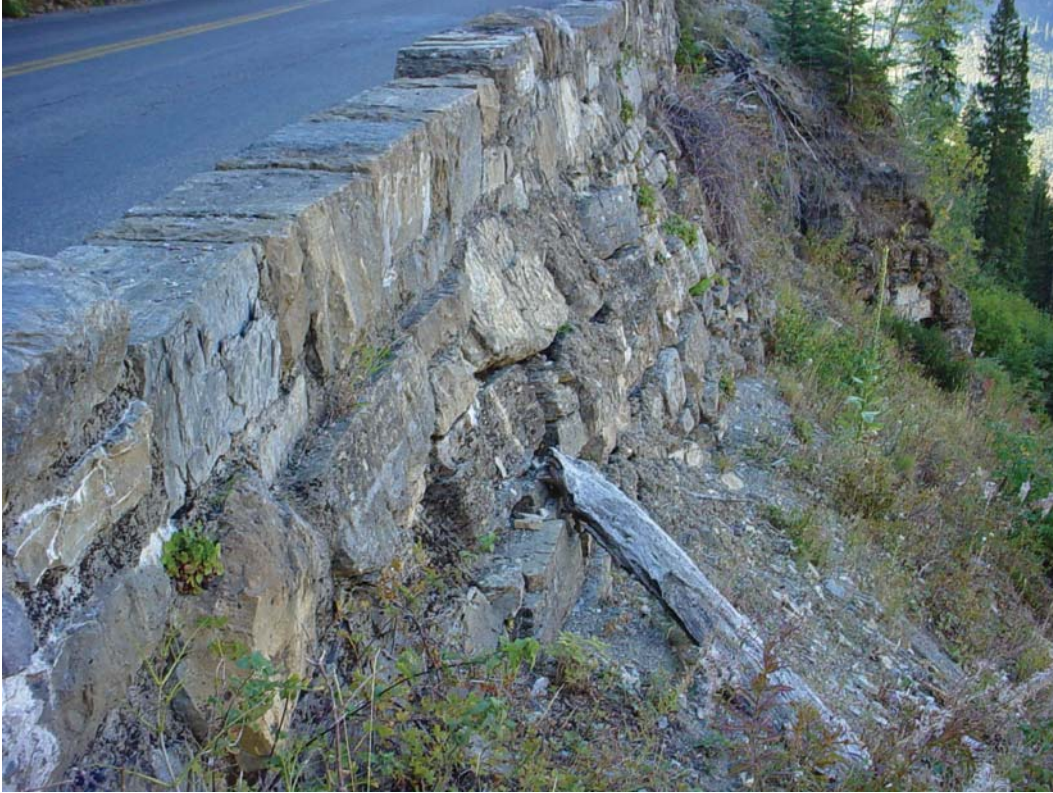
GLAC_0010W_29.160_R_1.jpg

Element (Weighting Factor)	Narrative	Condition Rating (0 - 10)
PERFORMANCE 8.00	Minor bulging of dry laid, no dislodged stones	7
WALL FOUNDATION MATERIAL 8.00	Soil and bedrock, no erosion	8
PLACED STONE 8.00	Dry stacked has vegetation growth, minor movement evident	6
MORTAR 8.00	No distress in stone masonry section	8
STONE MASONRY 8.00	Angular blocks, no distress	8
TRAFFIC BARRIER/FENCE 0.50	Stone masonry guardwall on top of dry laid and stone masonry wall.	8
WALL DRAINS 0.50	None	8
ROAD/SIDEWALK/SHOULDER 1.00	Roadway shows settlement, longitudinal cracks	6
DOWNSLOPE 1.00	Steep, bedrock and soil, stable	7

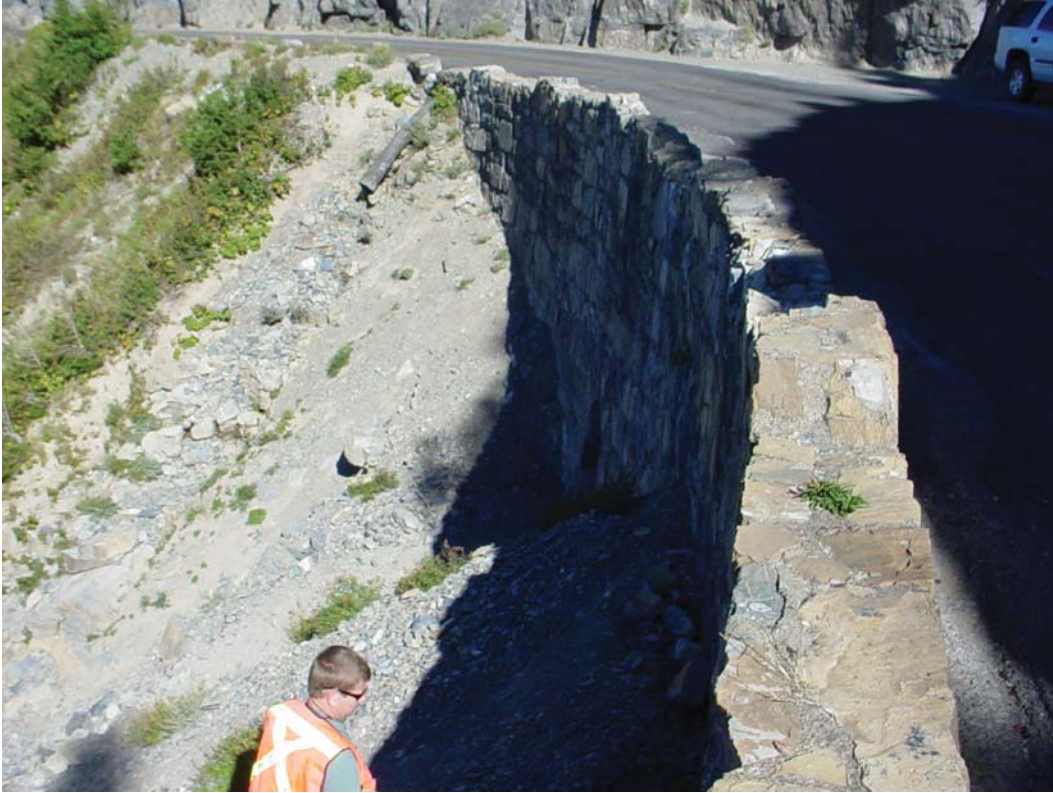
GLAC_0010W_29.553_R_1.jpg

Element (Weighting Factor)	Narrative	Condition Rating (0 - 10)
PERFORMANCE 8.00	Wall has impact damage to structure	6
WALL FOUNDATION MATERIAL 8.00	Likely bedrock, no distress	9
MORTAR 8.00	Mild to moderate debonding over 50% of wall and cracking through entire wall structure; likely due to avalanche impacts	6
STONE MASONRY 8.00	Minor cracking of blocks due to avalanche impact; blocks displaced by 1" - 4" along horizontal line 10 feet below top of wall	8
DOWNSLOPE 0.50	Steep, talus/colluvium/avalanche debris over shallow bedrock, minor raveling	8
LATERAL SLOPE 0.50	Steep, talus/colluvium/avalanche debris over shallow bedrock, minor raveling	8
WALL DRAINS 0.50	None, no distress	9
CURB/BERM/DITCH 1.00	Ditch outlets into 18" cmp at wall start, pipe has failed and first 8 feet of wall is settling and failing	6
ROAD/SIDEWALK/SHOULDER 1.00	Lateral cracking (up to 2" wide) and settling at shoulder up to 4"	6

Failure Consequence:	HIGH
Recommendation Narrative:	Replace top 10 feet of wall (1150 sqft) with avalanche resistant guardwall design, repair wall around culvert (20 sqft), repair 18" culvert. Replace stone masonry wall: 1150 sqft x \$160/sqft = \$184,000. Repair wall around culvert: 20 sqft x \$620/sqft = \$12,400.
Repair Cost:	\$200,000

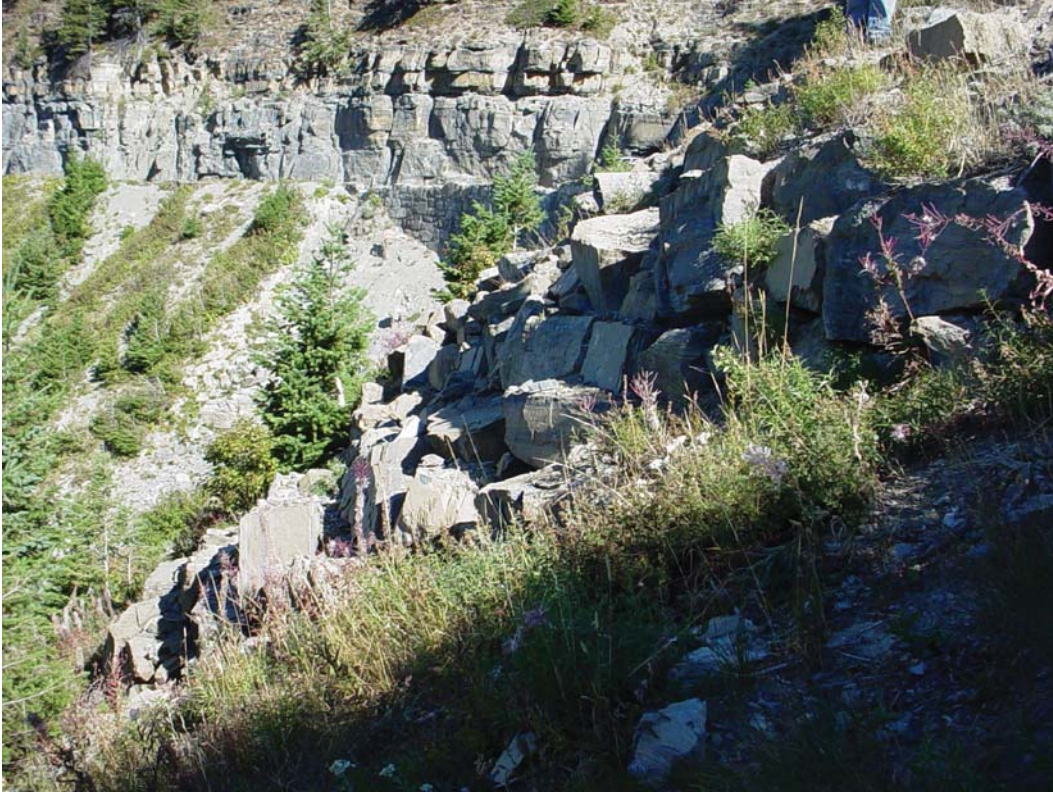
GLAC_0010W_29.587_R_1.jpg

Element (Weighting Factor)	Narrative	Condition Rating (0 - 10)
PERFORMANCE 8.00	As intended with minor voids	8
WALL FOUNDATION MATERIAL 8.00	Talus over shallow bedrock	8
PLACED STONE 8.00	Large semi-angular stones well interlocked with minimal voids	8
CULVERT 0.50	12" concrete culvert 10' from start, 4' below top of wall	8
DOWNSLOPE 0.50	Steep talus slope with vegetation	8
LATERAL SLOPE 0.50	Steep talus slope with vegetation	8
WALL DRAINS 0.50	No distress	9
ROAD/SIDEWALK/SHOULDER 1.00	Cracking along shoulder, settled up to 2"	6
TRAFFIC BARRIER/FENCE 1.00	Guardwall is displaced and has been moved approximately 7"	6

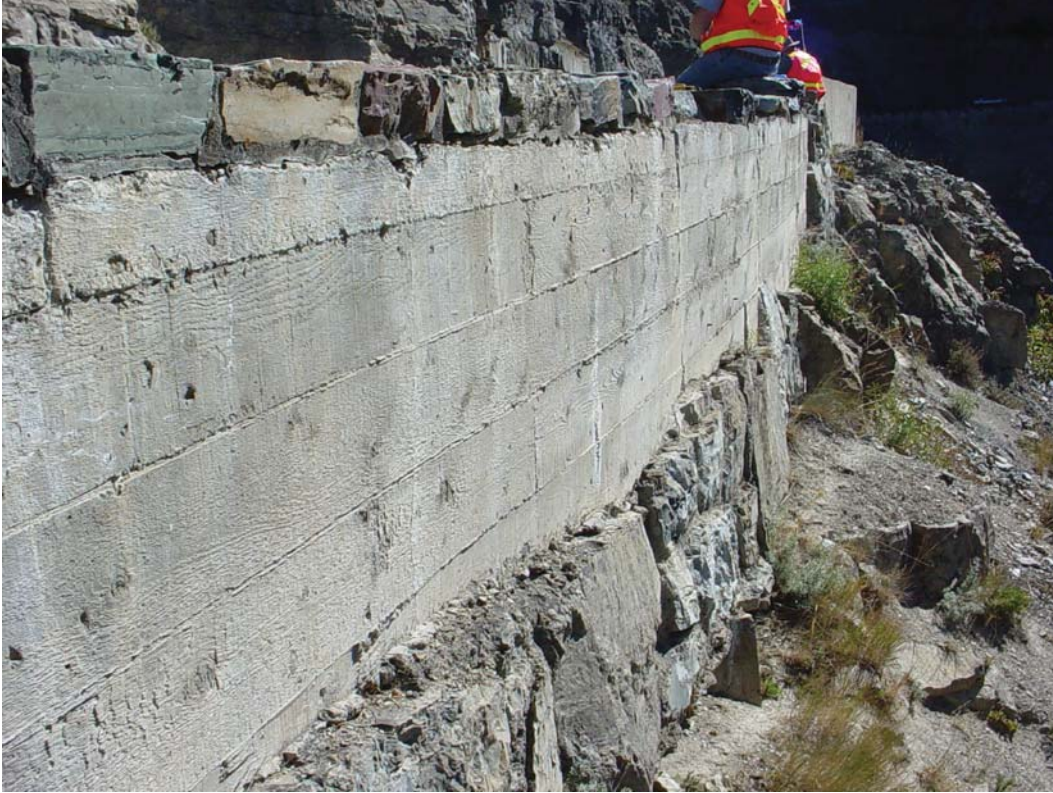
GLAC_0010W_29.782_R_1.jpg

Element (Weighting Factor)	Narrative	Condition Rating (0 - 10)
PERFORMANCE 8.00	As intended	8
WALL FOUNDATION MATERIAL 8.00	Stone masonry wall sitting on bedrock, approx 35% of stone masonry wall is undermined	7
MORTAR 8.00	Debonding of mortar and minor cracking	8
STONE MASONRY 8.00	Slight weathering	8
CONCRETE 8.00	No distress noted in concrete	9
DOWNSLOPE 0.50	Very steep, bedrock	8
LATERAL SLOPE 0.50	Very steep, bedrock	8
ROAD/SIDEWALK/SHOULDER 0.50	Avalanche resistant guard wall and roadway slab, minor cracking	8
WALL DRAINS 0.50	None noted, no distress	9

Failure Consequence:	MODERATE
Recommendation Narrative:	Repair foundation undermining, 15' length x 1' high Underpinning/stabilization: 15 sqft x \$200/sqft = \$3,000 Total=\$3,000
Repair Cost:	\$3,000

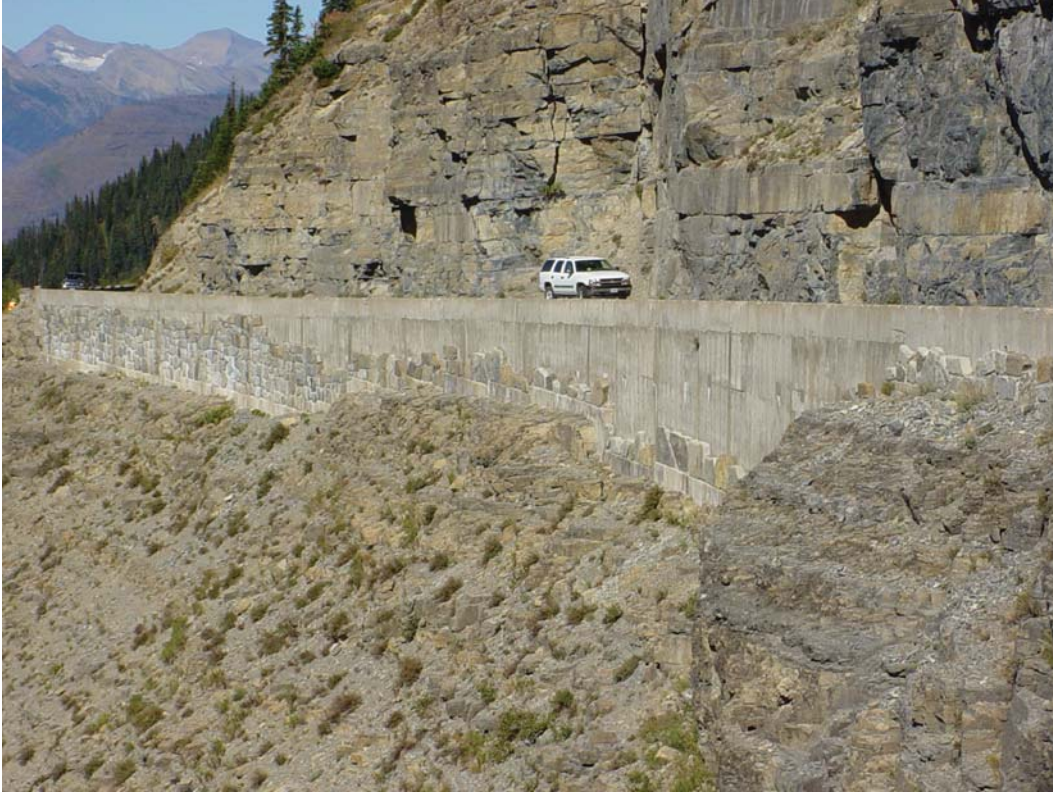
GLAC_0010W_29.798_R_1.jpg

Element (Weighting Factor)	Narrative	Condition Rating (0 - 10)
PERFORMANCE 8.00	As intended	8
WALL FOUNDATION MATERIAL 8.00	Bedrock, no distress	9
ANCHOR HEADS 8.00	Not visible, patched with concrete, minor efflorescence from patch	8
CONCRETE 8.00	Cast in place concrete, no distress, partially covered by stone facing	9
OTHER PRIMARY ELEMENT 8.00	Concrete footing at bottom 1-2' of wall, no distress	9
TRAFFIC BARRIER/FENCE 0.50	Concrete guardwall, no facing, minor impact damage	8
DOWNSLOPE 0.50	Bedrock cliffs, no distress	9
LATERAL SLOPE 0.50	Bedrock cliffs, no distress	9
WALL DRAINS 1.00	3" pvc wall drains spaced every 8 feet, minor to severe efflorescence has partially to completely blocked drains	6

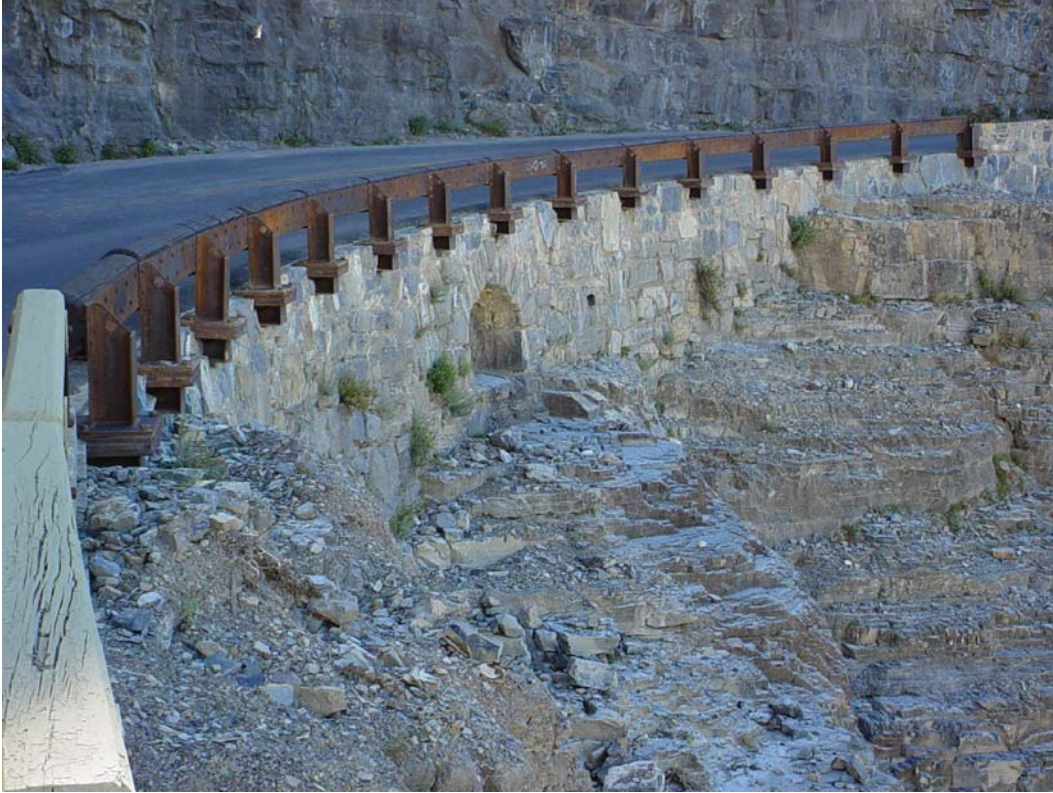
GLAC_0010W_29.887_R_1.jpg

Element (Weighting Factor)	Narrative	Condition Rating (0 - 10)
PERFORMANCE 8.00	As intended	8
WALL FOUNDATION MATERIAL 8.00	Bedrock, no distress	8
MORTAR 8.00	Minor cracking and debonding otherwise no distress	7
STONE MASONRY 8.00	Angular blocks, no distress	8
DOWNSLOPE 0.50	Bedrock cliff	8
LATERAL SLOPE 0.50	Bedrock cliff	8
WALL DRAINS 0.50	None	8
TRAFFIC BARRIER/FENCE 0.50	New removable guardwall installed	9

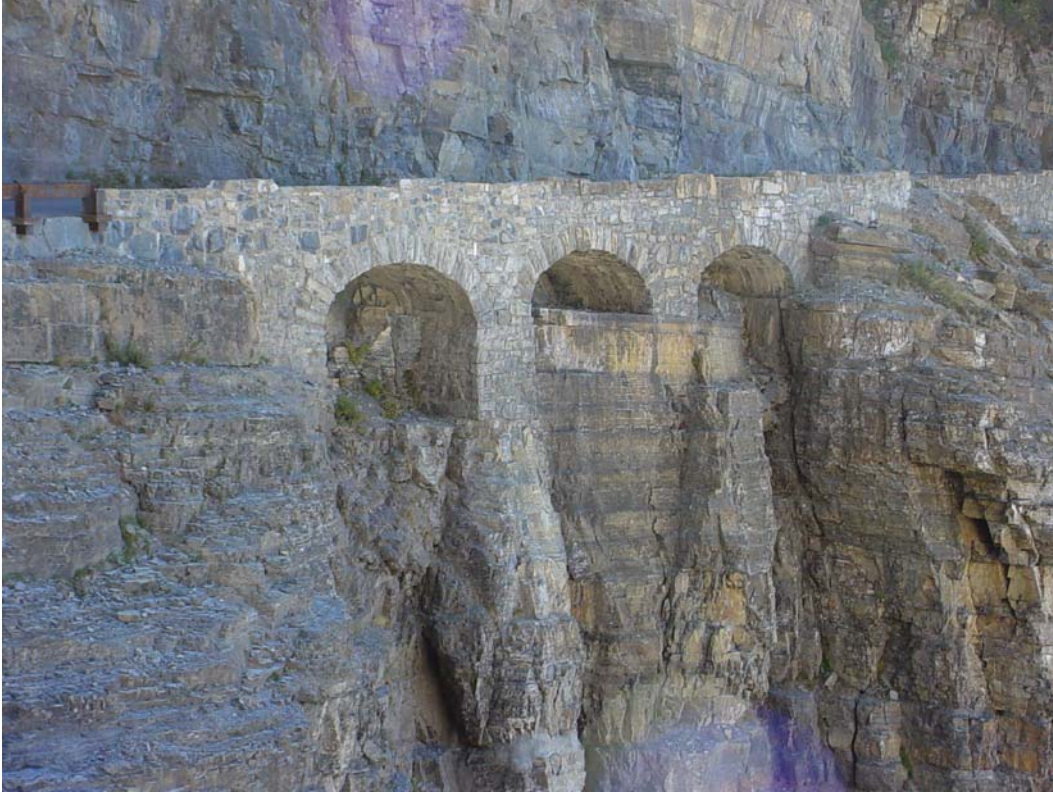
GLAC_0010W_29.900_R_1.jpg

Element (Weighting Factor)	Narrative	Condition Rating (0 - 10)
PERFORMANCE 8.00	As intended	8
WALL FOUNDATION MATERIAL 8.00	Bedrock, recently completed stabilization efforts	8
MORTAR 8.00	Isolated cracking and debonding otherwise no apparent distress	7
STONE MASONRY 8.00	Angular blocks with minor cracking, no apparent distress	7
DOWNSLOPE 0.50	Bedrock cliff	8
LATERAL SLOPE 0.50	Bedrock cliff	8
WALL DRAINS 0.50	None noted	8
TRAFFIC BARRIER/FENCE 1.00	Minor loss to stone guardwall	7

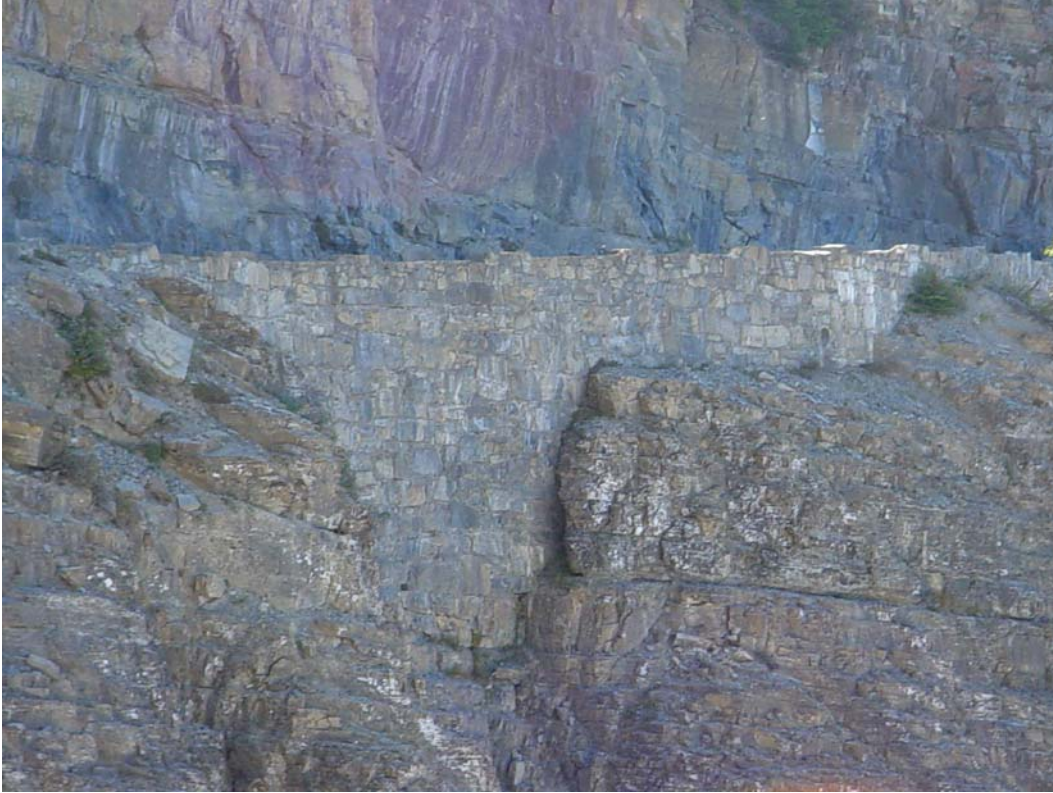
GLAC_0010W_29.925_R_1.jpg

Element (Weighting Factor)	Narrative	Condition Rating (0 - 10)
PERFORMANCE 8.00	As intended	8
WALL FOUNDATION MATERIAL 8.00	Bedrock, no distress	9
MORTAR 8.00	Poor access, 20% of wall has moderate debonding; 2% of wall with mortar loss	7
STONE MASONRY 8.00	Poor access, no distress	9
DOWNSLOPE 0.50	Bedrock, no distress	9
LATERAL SLOPE 0.50	Bedrock, no distress	9
WALL DRAINS 0.50	None, no distress	9
ROAD/SIDEWALK/SHOULDER 1.00	Up to 1/2" lateral cracks along paved shoulder, some settling at shoulder to 1"	7

Failure Consequence:	HIGH
Recommendation Narrative:	Repoint 20% of wall (240 sqft) Repoint: 240 sqft x \$75/sqft = 18,000 Total=\$18,000
Repair Cost:	\$18,000

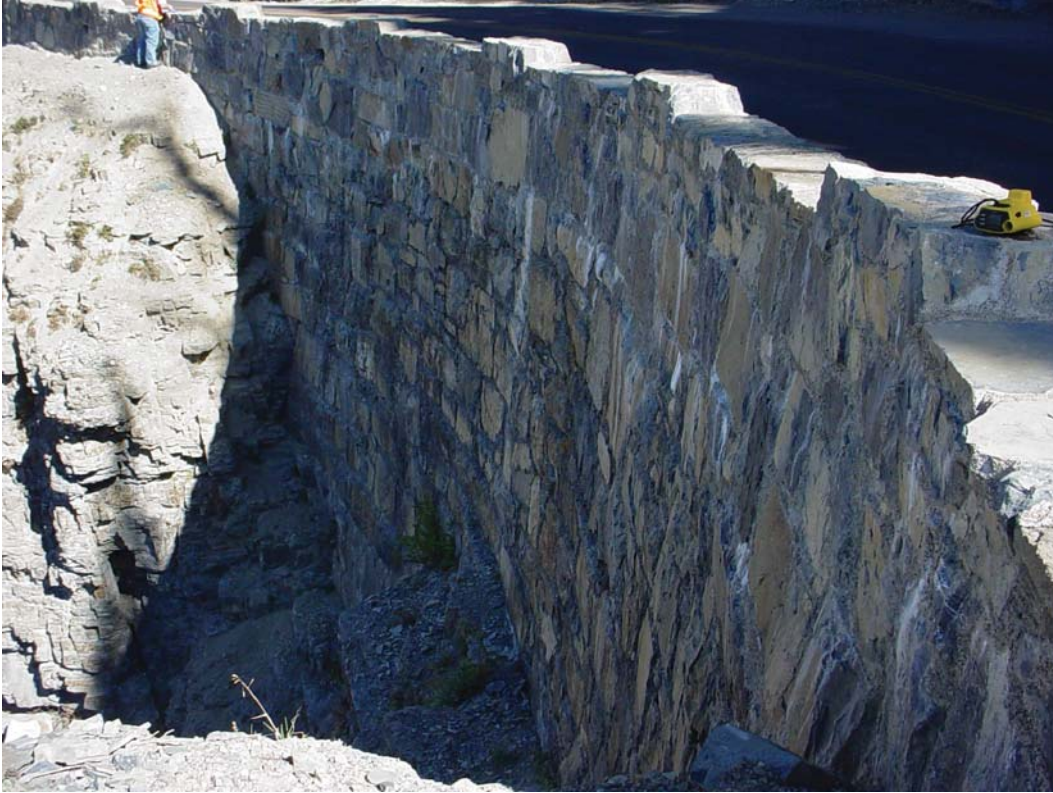
GLAC_0010W_29.959_R_1.jpg

Element (Weighting Factor)	Narrative	Condition Rating (0 - 10)
PERFORMANCE 8.00	As intended	8
WALL FOUNDATION MATERIAL 8.00	Bedrock	9
MORTAR 8.00	Moderate cracking of mortar, some mortar loss	7
STONE MASONRY 8.00	No distress noted	8
ROAD/SIDEWALK/SHOULDER 0.50	No distress noted	8
DOWNSLOPE 0.50	Bedrock	9
LATERAL SLOPE 0.50	Bedrock	9
WALL DRAINS 0.50	No distress noted	9

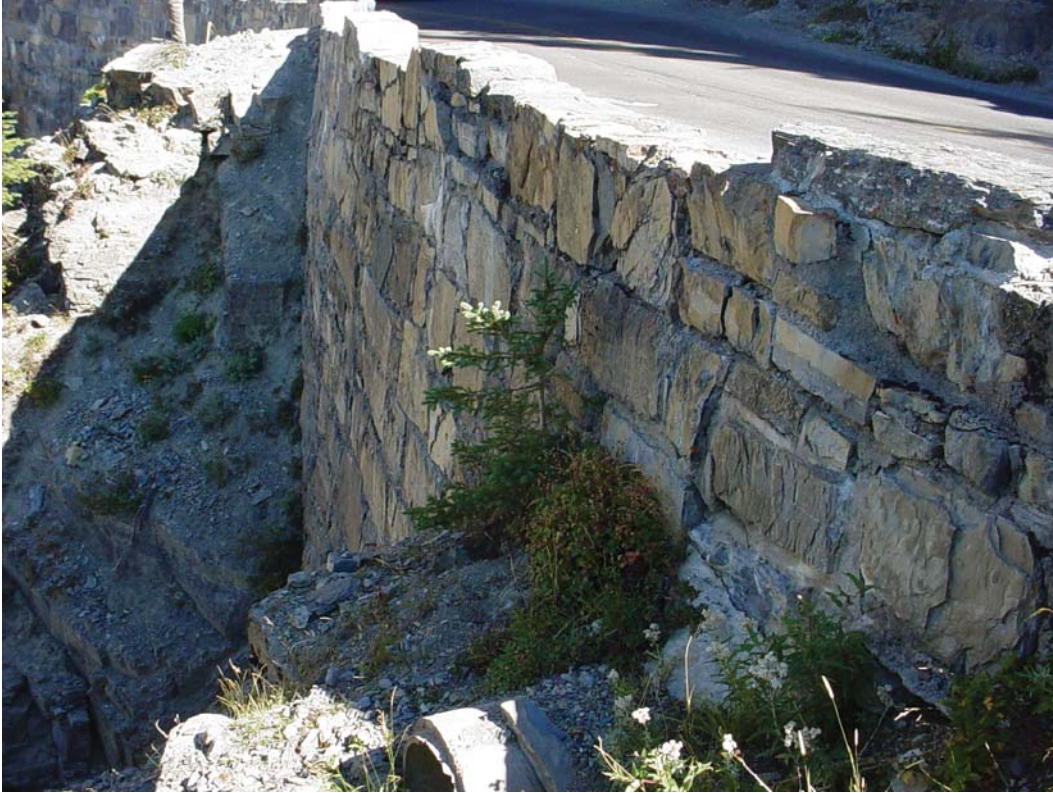
GLAC_0010W_29.976_R_1.jpg

Element (Weighting Factor)	Narrative	Condition Rating (0 - 10)
PERFORMANCE 8.00	As intended	8
WALL FOUNDATION MATERIAL 8.00	Bedrock	8
MORTAR 8.00	Cracking and debonding of mortar through 40% of wall face	6
STONE MASONRY 8.00	Large angular blocks with no distress	8
DOWNSLOPE 0.50	Bedrock, steep	8
LATERAL SLOPE 0.50	Bedrock and soil	8
WALL DRAINS 0.50	None	8
TRAFFIC BARRIER/FENCE 1.00	Cracking and broken stones in 20' length of stone guardwall	7
