GOGA WIP Report

NPS Retaining Wall Inventory Program Golden Gate National Recreation Area

**Federal Highway Administration
Eastern Federal Lands Highway Division
Road Inventory Program (RIP)**

**Data Collection Date: November 2007
Report Date: November 2015**

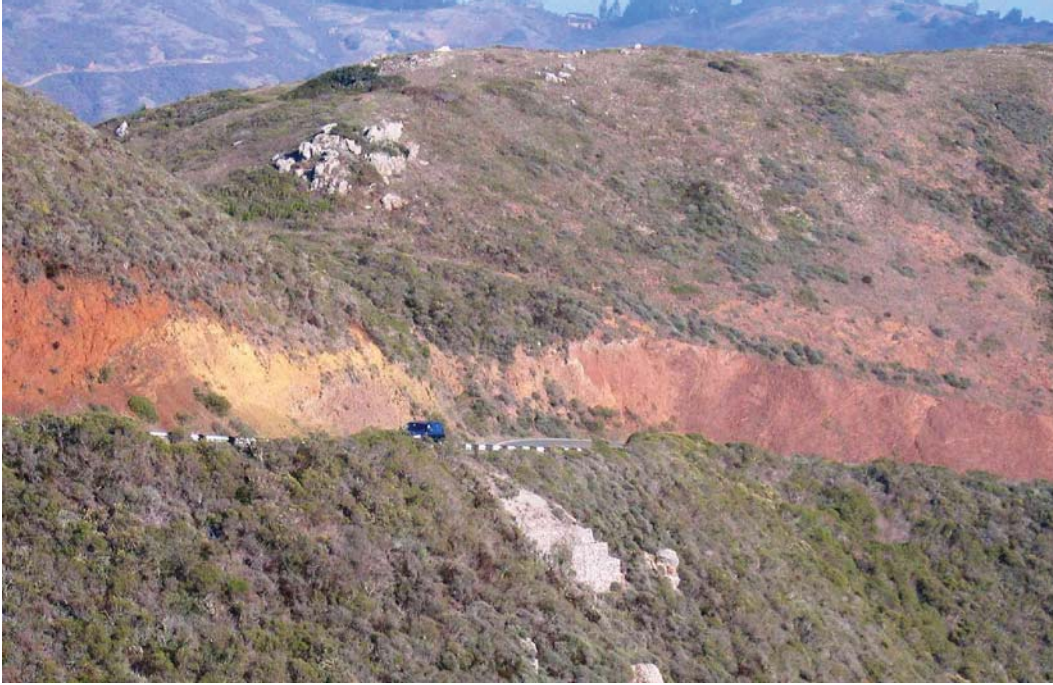
GOGA_0109ZZ_0.127_L_1.jpg

Wall ID:	GOGA-0109ZZ-0.127-L		
Route Name:	CONZELMAN ROAD		
Inspection Date:	November 09, 2007	Approximate Year Built:	Unknown
*Wall Rating:	77	Maintenance Action:	No Action

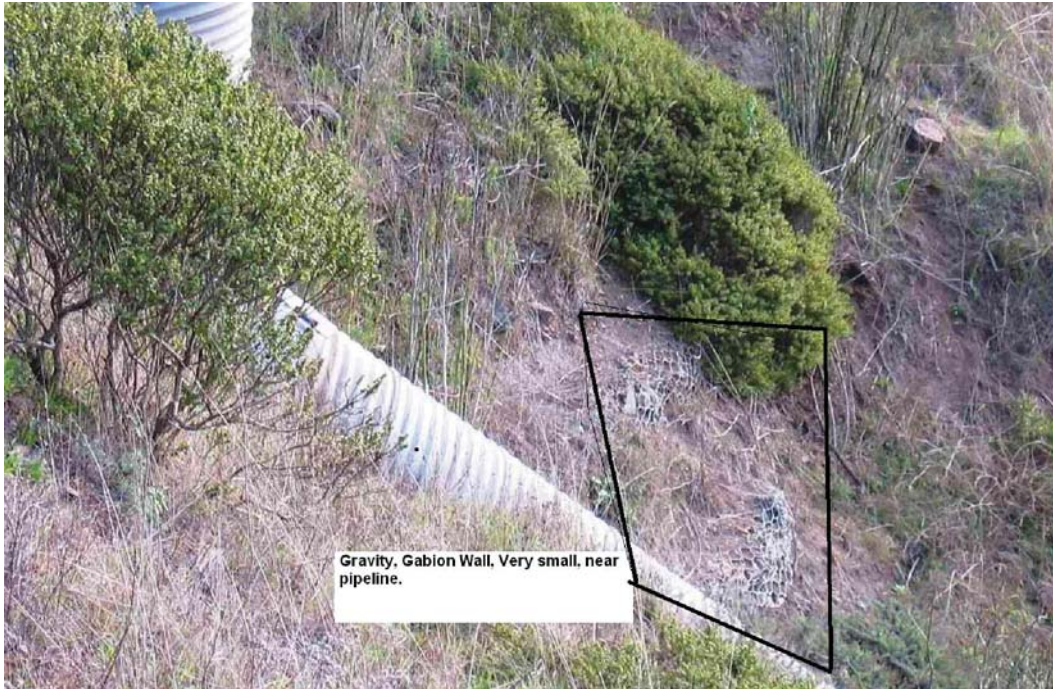
GOGA_0109ZZ_0.835_L_1.jpg

Wall Identification	Failure Consequence⁽¹⁾	Wall Rating⁽²⁾	Recommended Action⁽³⁾	2007 Repair Costs⁽⁴⁾
GOGA-0109ZZ-0.835-L	HIGH	10	REPLACE WALL	\$51,500
GOGA-0425-0.004-R	HIGH	36	REPLACE WALL	\$200,000
GOGA-0502B-0.120-L	LOW	43	NO ACTION	\$0

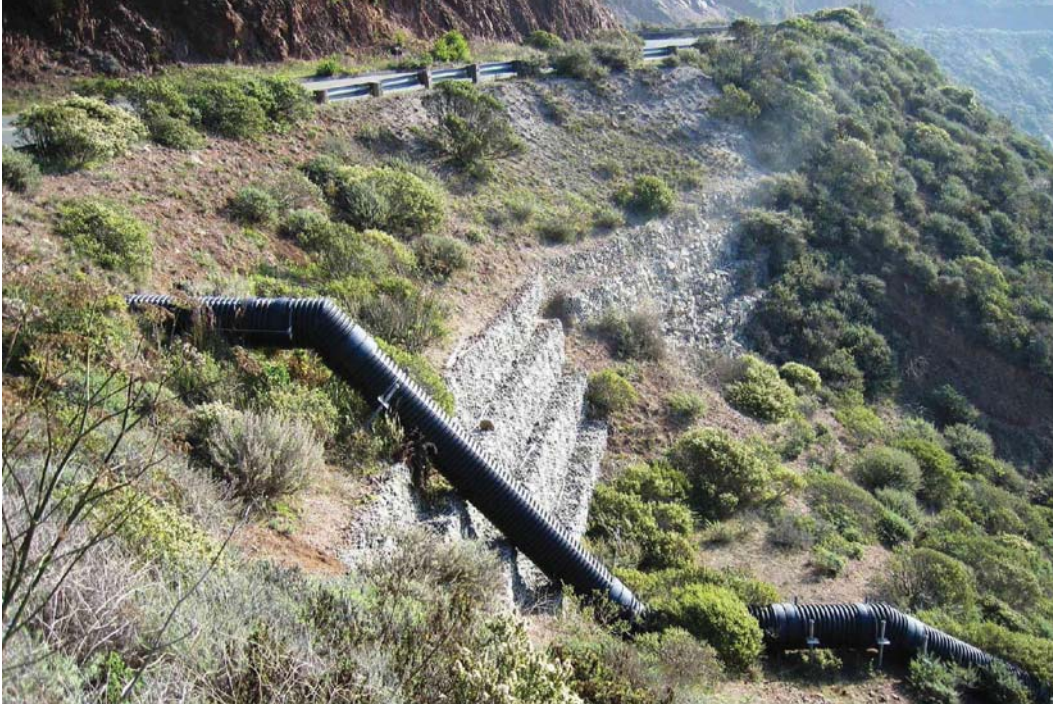
GOGA_0109ZZ_0.910_L_1.jpg

Wall ID:	GOGA-0109ZZ-0.910-L		
Route Name:	CONZELMAN ROAD		
Inspection Date:	November 09, 2007	Approximate Year Built:	Unknown
*Wall Rating:	90	Maintenance Action:	No Action

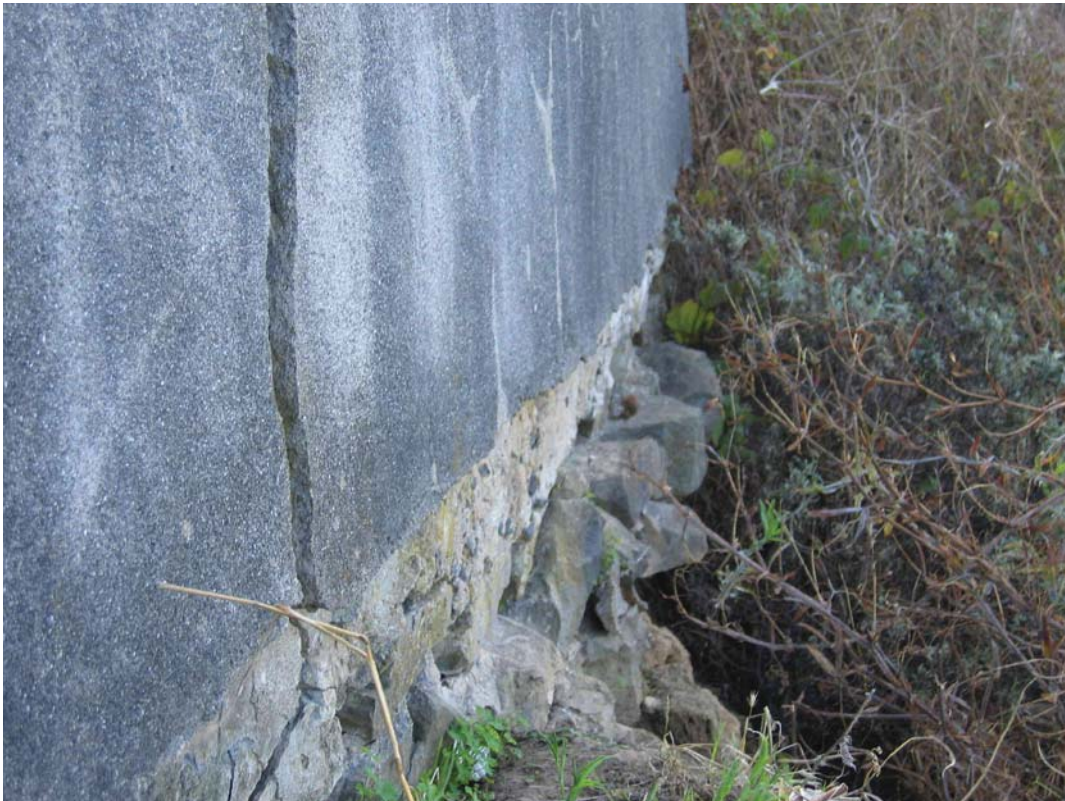
GOGA_0405_0.080_R_2.jpg

Element (Weighting Factor)	Narrative	Condition Rating (0 - 10)
PERFORMANCE 8.00	Wall is showing signs of bearing capacity failure either due to toe erosion or slope fatigue.	4
WALL FOUNDATION MATERIAL 8.00	Steep, highly eroded slope. Damaged section is settling, rotating out slightly.	4
MORTAR 8.00	Encased in concrete overlay. Missing in exposed areas requiring remortaring.	7
CONCRETE 8.00	Cracked concrete overlay, with minor spalling along toe of wall.	8
STONE MASONRY 8.00	Encased in concrete overlay. Exposed at wall toe. Needs to be mortared over, wall section is settling.	8
WALL DRAINS 0.50	Occasional wall drain, functioning properly.	8
DOWNSLOPE 1.00	Very steep slope onto bedrock. Highly eroded at some locations, undermining wall location.	5
ROAD/SIDEWALK/SHOULDER 1.00	Obvious signs of settlement, some minor patching has occurred. Needs more patching.	5
TRAFFIC BARRIER/FENCE 1.00	30" high concrete parapet. Severe cracks defining sections of wall that are settling with the slope.	5

Failure Consequence:	MODERATE
Recommendation Narrative:	Mortar patch the guardwall and wall face cracks. Mortar the exposed stone masonry at toe of wall. Underpin rotating wall section. Micropile underpinning - 500 sq.ft @ \$170/sf = \$85,000. Cementitious overlay - 100 sq ft @ \$65/sf = \$6,500. Roadway patch
Repair Cost:	\$107,500

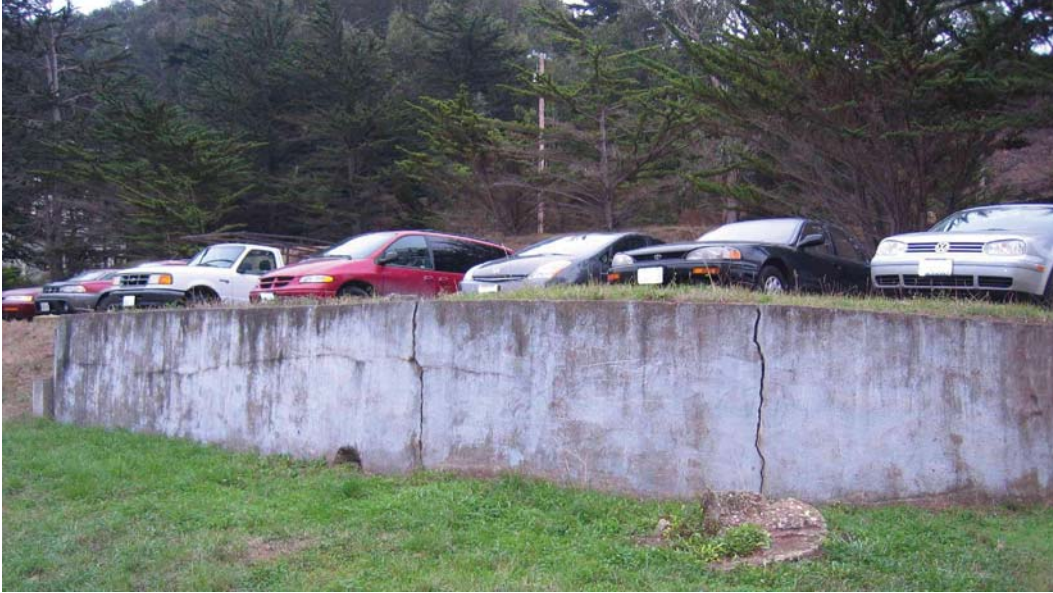
GOGA_0413_0.297_L_1.jpg

Element (Weighting Factor)	Narrative	Condition Rating (0 - 10)
PERFORMANCE 8.00	Good, no signs of failure or global distress.	8
WALL FOUNDATION MATERIAL 8.00	Fill soil with vegetation sufficient to support wall.	7
CONCRETE 8.00	Several longitudinal and transverse cracks, some extending from top to bottom of wall.	6
VEGETATION 0.50	No vegetation on the wall that affects wall stability.	8
WALL DRAINS 1.00	None, no signs of water-related distress.	6
DOWNSLOPE 1.00	Fill soil with grass, minor erosion.	7
LATERAL SLOPE 1.00	Fill soil with grass, minor erosion.	7
UPSLOPE 1.00	Flat parking area.	7

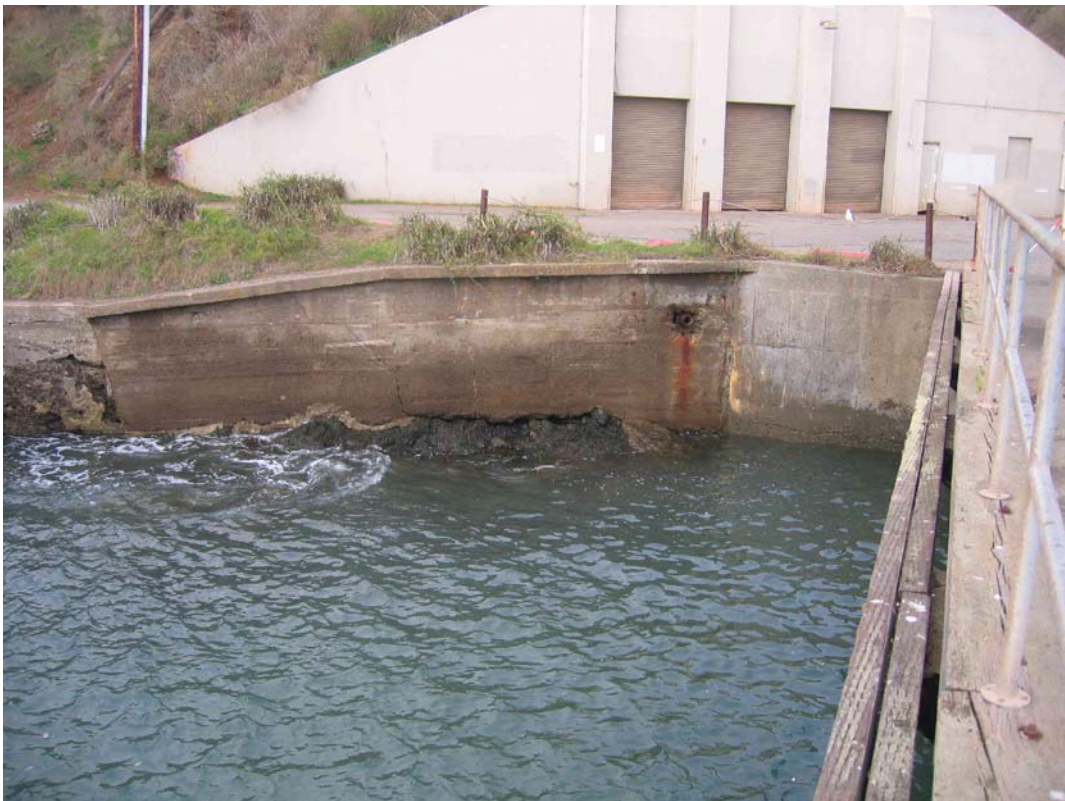
GOGA_0419_0.134_L_2.jpg

Element (Weighting Factor)	Narrative	Condition Rating (0 - 10)
PERFORMANCE 8.00	Good wall performance, but concrete is degrading caused by sea water and wave action. Some repairs have been done previously, but more are recommended.	7
WALL FOUNDATION MATERIAL 8.00	Foundation is below water in areas and sand and cobbles in part of the wall. Sufficient to support wall yet undermined but on bedrock.	5
CONCRETE 8.00	Concrete damaged, aggregate is exposed, loss of durability and strength. Also, chemical degradation.	7
UPSLOPE 0.50	Upslope consists of a paved road with a gravel sidewalk; stable condition.	8
TRAFFIC BARRIER/FENCE 1.00	Concrete barrier with cracking and degradation. Missing concrete in some segments.	6
CULVERT 1.00	A culvert is present and appears to be functioning properly.	7
LATERAL SLOPE 1.00	Piers on one side and large concrete blocks on the other.	7
ROAD/SIDEWALK/SHOULDER 1.00	No signs of roadway distress due to wall.	7

Failure Consequence:	HIGH
Recommendation Narrative:	Apply concrete patch along scoured toe of wall. Labor - 40 hours @ \$55/hr = \$2,200 Concrete, 2 cubic yards @ \$100/c.y. = \$200
Repair Cost:	\$2,400

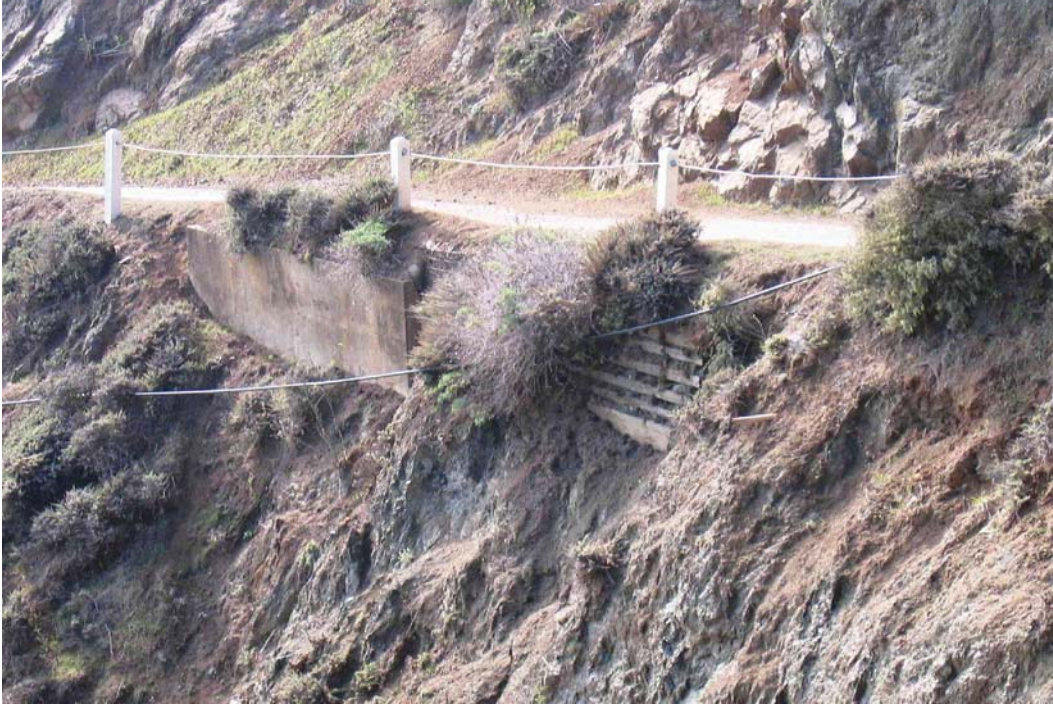
GOGA_0419_0.160_L_1.jpg

Element (Weighting Factor)	Narrative	Condition Rating (0 - 10)
PERFORMANCE 8.00	Fair due to foundation and slope erosion distress.	6
WALL FOUNDATION MATERIAL 8.00	Foundation under the MSE is eroded. Concrete area shows no distress.	7
WIRE/GEOSYNTHETIC FACING 8.00	Some corrosion, fabric intact.	7
CONCRETE 8.00	Looks good. Slightly weathered.	8
TRAFFIC BARRIER/FENCE 0.50	Pedestrian barrier fence. No signs of distress.	8
WALL DRAINS 0.50	None. No signs of distress.	8
DOWNSLOPE 1.00	Evidence of erosion underpinning the wall.	5
LATERAL SLOPE 1.00	Evidence of erosion cutting into wall ends.	6

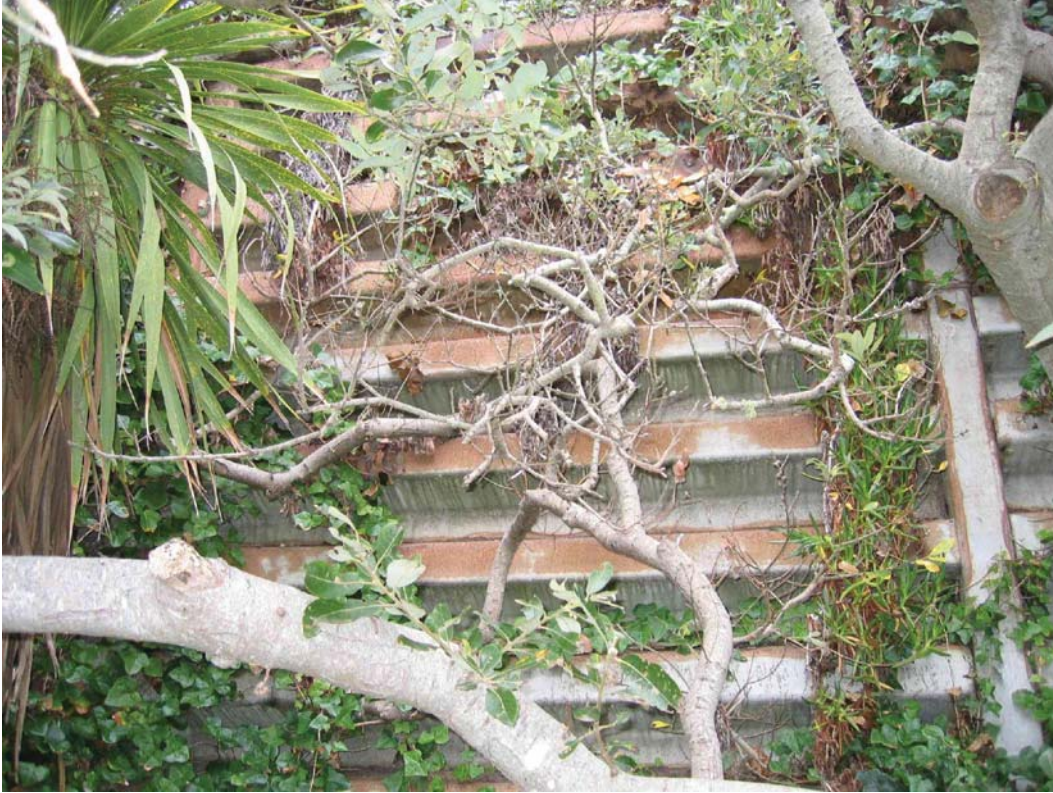
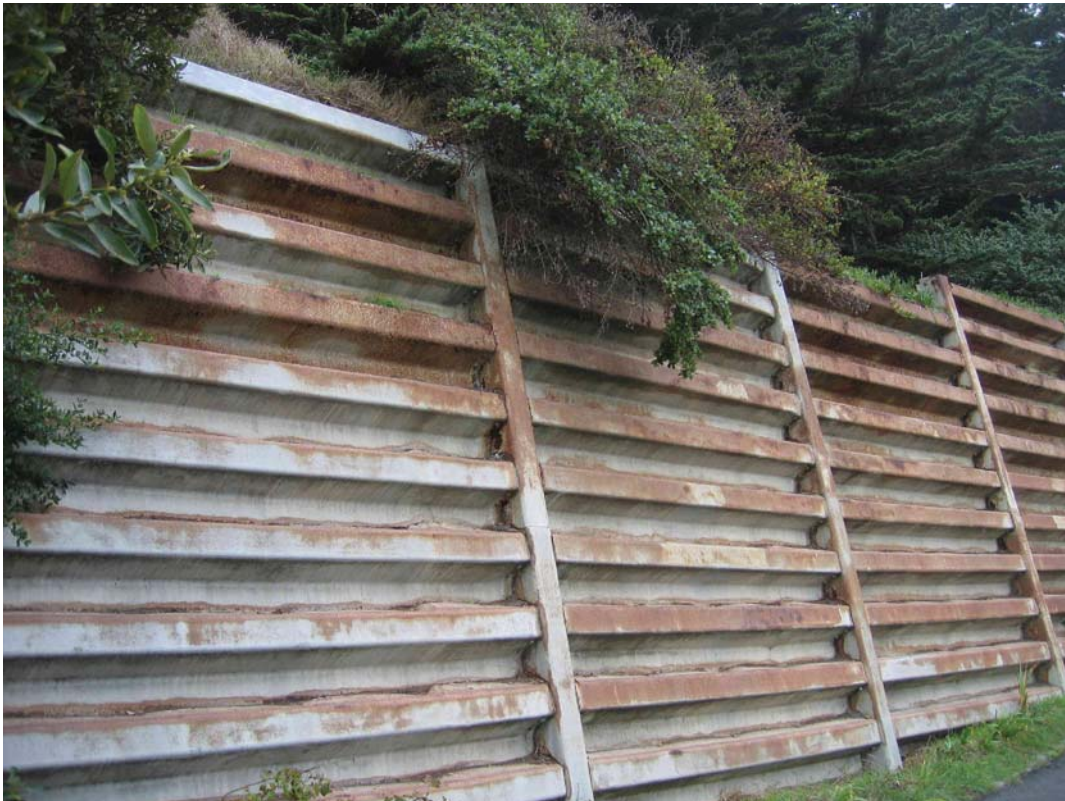
Wall ID:	GOGA-0907-0.000-P3		
Route Name:	CHINA BEACH PARKING LOT		
Inspection Date:	November 07, 2007	Approximate Year Built:	1965
*Wall Rating:	62	Maintenance Action:	Replace Wall

Wall Function:	Cut Wall	Primary Wall Type:	Bin - Metal
Surface Treatment:		Secondary Wall Type:	
Secondary Surface Treatment:		Architectural Facing:	
General Description:	Metal bin wall along beach access road. Highly corroded.

Element (Weighting Factor)	Narrative	Condition Rating (0 - 10)
PERFORMANCE 8.00	No signs of global distress, rotation, bulging or sliding. Face is highly corroded.	6
WALL FOUNDATION MATERIAL 8.00	Paved roadway. No signs of settlement or eroded foundation materials.	8
BIN OR CRIB 8.00	Highly corroded wall face. Some bin ribs deformed and/or rusted through <5%. Facing is stil functioning. Severe corrosion in some isolated locations.	4
LATERAL SLOPE 0.50	Well vegetated, stable slopes.	8
UPSLOPE 0.50	Heavily vegetated, moderately steep. No signs of slumping or erosion.	8
ROAD/SIDEWALK/SHOULDER 0.50	Paved roadway. No signs of wall-related distress. Excellent condition.	9
VEGETATION 1.00	Heavy vegetation possibly reinforcing one end of wall. Generally, no visible impact due to vegetation.	7
WALL DRAINS 1.00	No wall drains. Seepage is evident through the corroded wall face.	7

Failure Consequence:	HIGH
Recommendation Narrative:	Retrofit metal bin wall with soil nail wall. Investigate embedded bin metal quality and slope condition: Lump sum = \$30,000. Soil Nail wall: 1,900 sq.ft. @ \$110/s.f. = \$209,000. Misc. Labor: 300 hours @ \$55/hour = \$16,500. Heavy equipment: 80 hours @ \$200/hr
Repair Cost:	\$271,500

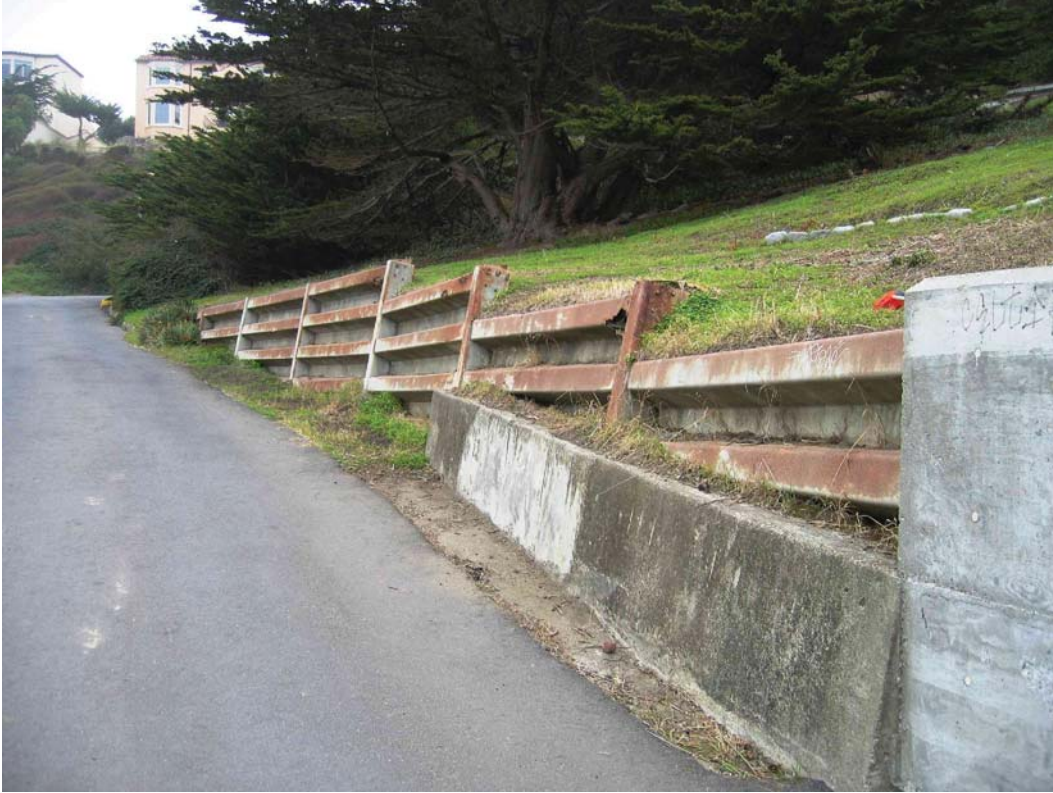
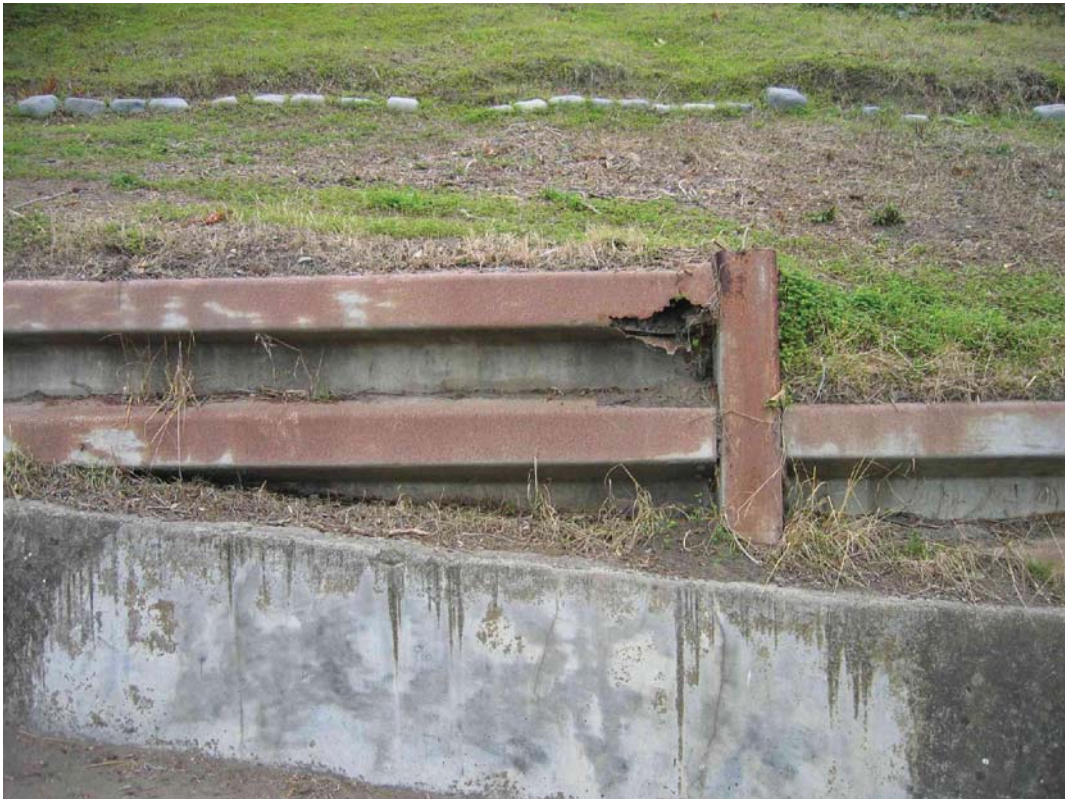
Wall ID:	GOGA-0907-0.000-P4		
Route Name:	CHINA BEACH PARKING LOT		
Inspection Date:	November 07, 2007	Approximate Year Built:	1965
*Wall Rating:	74	Maintenance Action:	No Action

Wall Function:	Cut Wall	Primary Wall Type:	Bin - Metal
Surface Treatment:		Secondary Wall Type:	Gravity - Mass Concrete
Secondary Surface Treatment:		Architectural Facing:	
General Description:	Highly corroded short bin wall on gentle slope. Wall could be removed with slope grading. Short gravity concrete wall underlying half of wall.

Element (Weighting Factor)	Narrative	Condition Rating (0 - 10)
PERFORMANCE 8.00	Good but facing is highly corroded. No signs of global distress.	7
WALL FOUNDATION MATERIAL 8.00	Soil foundation appears to provide good bearing. No distress.	9
BIN OR CRIB 8.00	Highly corroded metal facing. Broken in one location, but still retaining slope soil.	6
UPSLOPE 0.50	Very gentle upslope. Indications of settlement over the back of the bin. No signs of slope instability.	8
LATERAL SLOPE 0.50	Very gentle, modestly vegetated slopes showing no distress.	9
ROAD/SIDEWALK/SHOULDER 0.50	Roadway was recently paved but shows no wall-related distress.	9
WALL DRAINS 1.00	No wall drains. Seepage is evident through the corroded wall face.	7

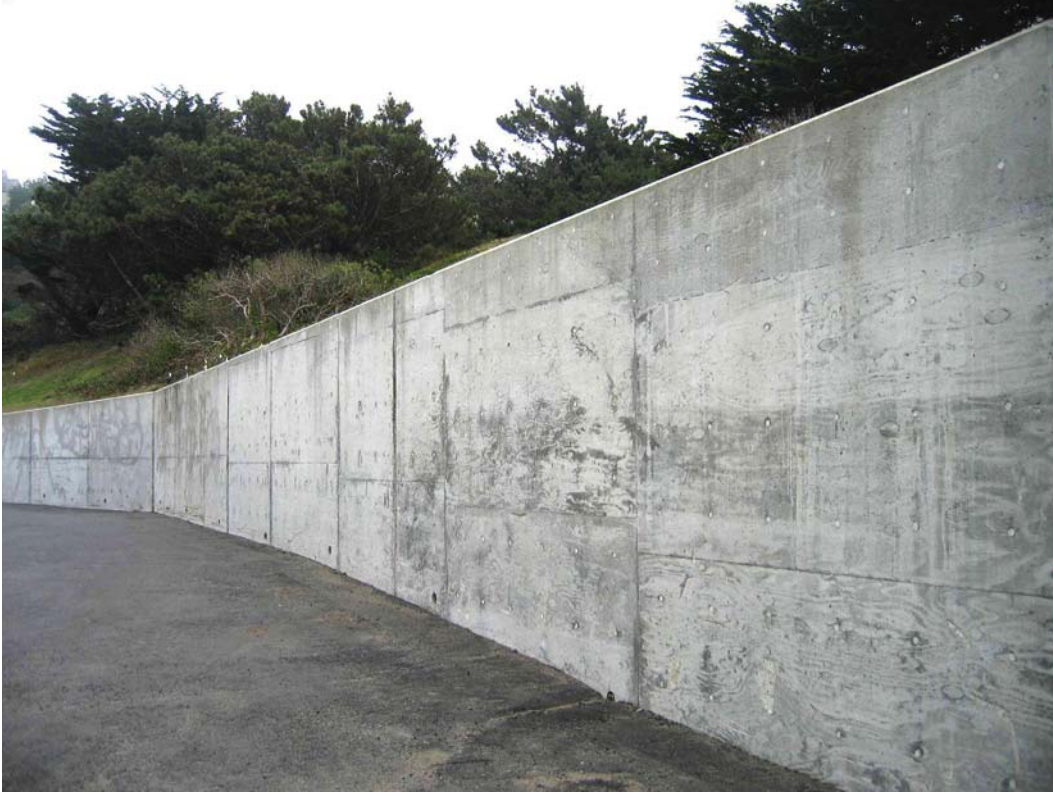
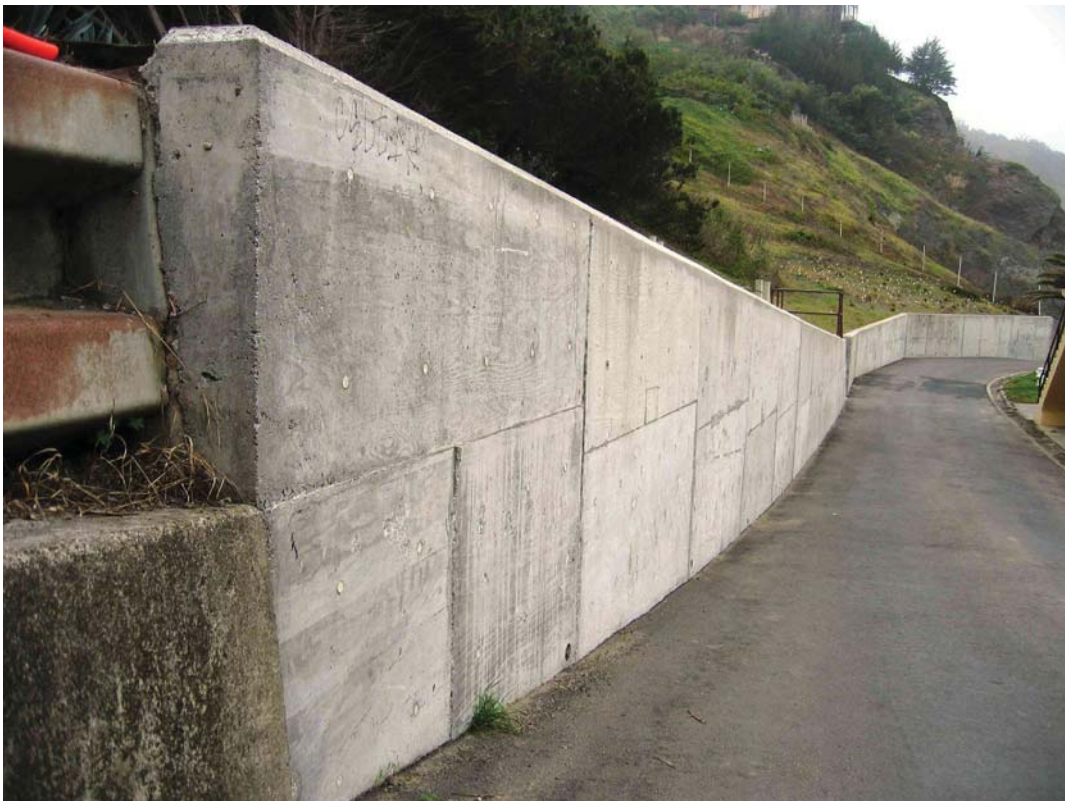
Wall ID:	GOGA-0907-0.000-P5		
Route Name:	CHINA BEACH PARKING LOT		
Inspection Date:	November 07, 2007	Approximate Year Built:	2004
*Wall Rating:	93	Maintenance Action:	No Action

Element (Weighting Factor)	Narrative	Condition Rating (0 - 10)
PERFORMANCE 8.00	New wall. Excellent condition. No distress.	9
WALL FOUNDATION MATERIAL 8.00	Asphalt roadway at wall toe indicates no settlement or eroded foundation materials.	9
CONCRETE 8.00	Hard, durable, fresh. No cracking or spalling.	10
LATERAL SLOPE 0.50	Stable lateral slopes showing no distress.	9
UPSLOPE 0.50	Gentle slope showing minor slumping. No significant erosion. Moderately vegetated.	9
ROAD/SIDEWALK/SHOULDER 0.50	Roadway recently paved. No signs of wall-related distress.	10
WALL DRAINS 0.50	Many toe drain pipes. All functioning very well. No seepage evident.	10

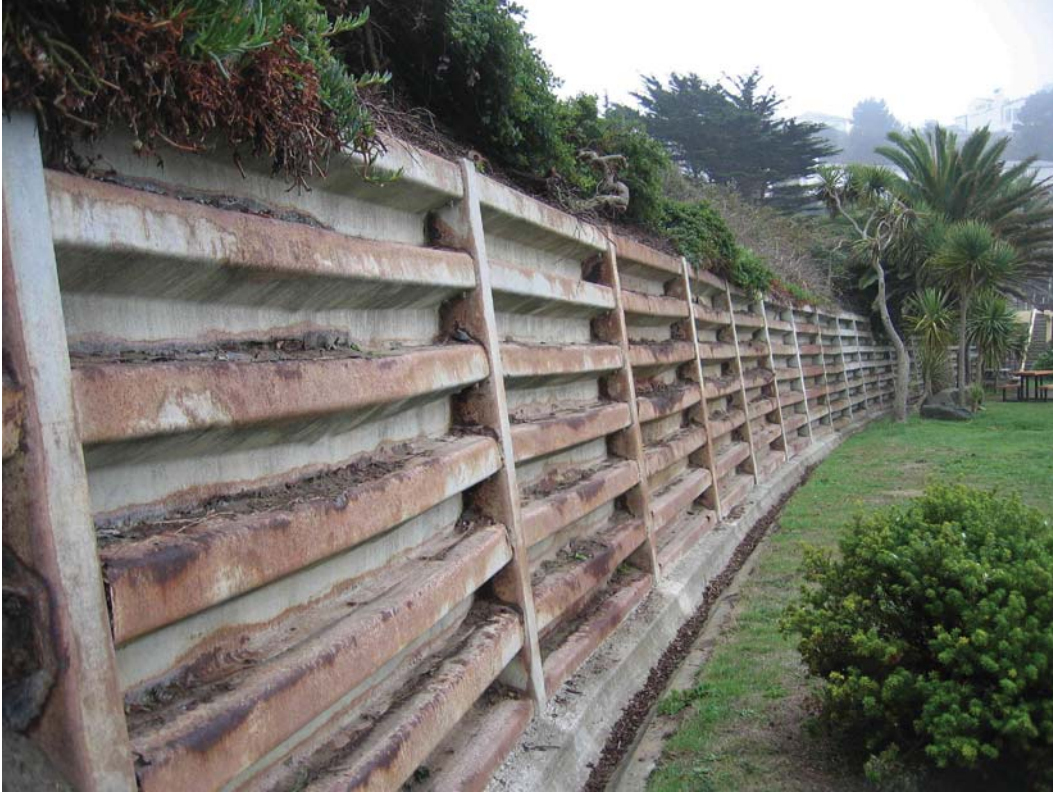
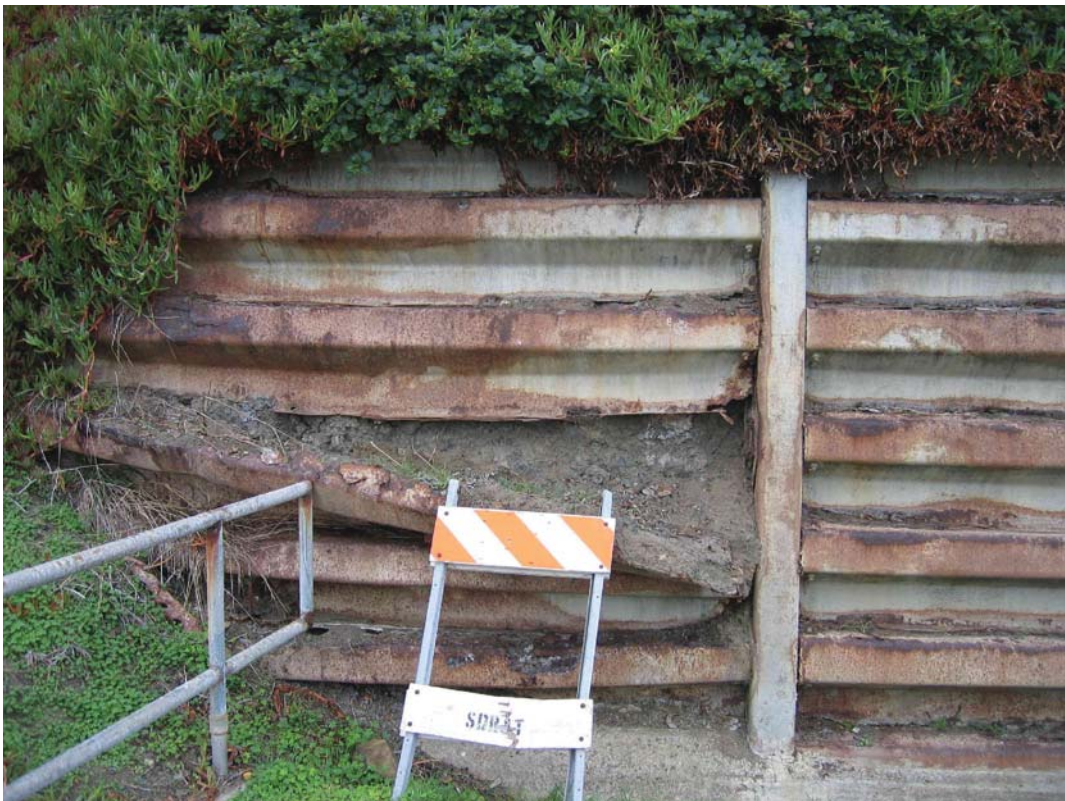
Wall ID:	GOGA-0907-0.000-P6		
Route Name:	CHINA BEACH PARKING LOT		
Inspection Date:	November 07, 2007	Approximate Year Built:	1965
*Wall Rating:	55	Maintenance Action:	Replace Wall

Wall Function:	Cut Wall	Primary Wall Type:	Bin - Metal
Surface Treatment:		Secondary Wall Type:	
Secondary Surface Treatment:		Architectural Facing:	
General Description:	Metal bin wall below beach access road. Highly corroded.

Element (Weighting Factor)	Narrative	Condition Rating (0 - 10)
PERFORMANCE 8.00	Wall facing is highly corroded and barely functioning to retain crib fill. No signs of global distress, rotation, bulging or sliding.	5
WALL FOUNDATION MATERIAL 8.00	No signs of settlement or foundation distress.	8
BIN OR CRIB 8.00	Metal crib facing is severely corroded, gill is migrating slowly through the face. Facing ribs are sagging in some sections. Unknown condition of embedded bin material.	3
DOWNSLOPE 0.50	Park greenbelt/beach building sidewalk. Flat. No signs of wall-related distress.	8
LATERAL SLOPE 1.00	Far end terminates at steep, coastal escarpment. End of wall is damaged due to erosion, possible slope movement.	4
UPSLOPE 0.50	Heavily vegetated. Appears stable with no signs of slumps or slides.	8
WALL DRAINS 1.00	No wall drains. Seepage is evident through the corroded wall face.	6
VEGETATION 1.00	Heavily vegetated along top of wall. Roots do not appear to be impacting wall.	7

Failure Consequence:	MODERATE
Recommendation Narrative:	Retrofit metal bin wall with soil nail wall. Investigate steel condition and slope condition in embedded section: Lump sum = \$40,000. Soil Nail wall - 1,830 sq.ft. @ \$110/s.f. = \$201,300. Misc. Labor - 300 hours @ \$55/hour = \$16,500. Heavy equipment - 40 hours
Repair Cost:	\$265,800

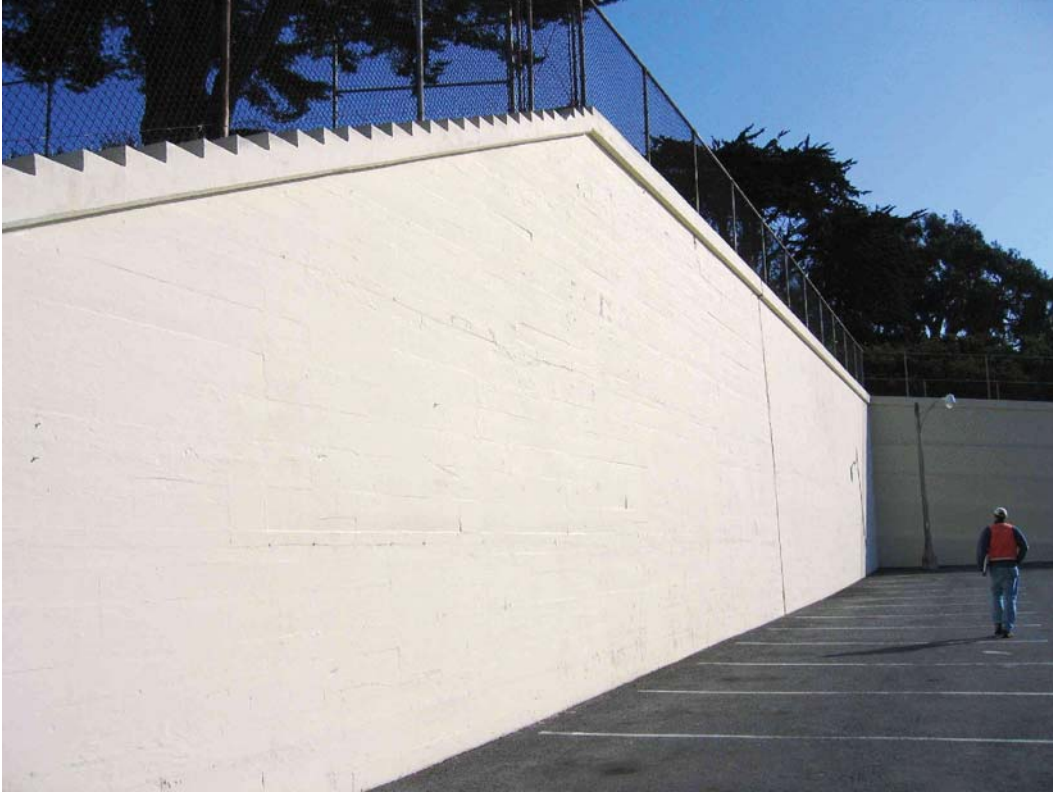
GOGA_0917_0.000_P1_1.jpg

Wall ID:	GOGA-0917-0.000-P1		
Route Name:	LOWER FORT MASON PARKING LOT		
Inspection Date:	November 06, 2007	Approximate Year Built:	1940
*Wall Rating:	93	Maintenance Action:	No Action

Element (Weighting Factor)	Narrative	Condition Rating (0 - 10)
PERFORMANCE 8.00	Excellent. Minor cracking. Minor deterioration at construction. No global distress.	9
WALL FOUNDATION MATERIAL 8.00	Asphalt parking to wall toe. No signs of settlement, heave, or water problems.	10
CONCRETE 8.00	Difficult to see due to fresh paint. Minor cracking. Patched. Sound, appears to be hard, durable concrete.	9
LATERAL SLOPE 0.50	Fort Mason tunnel portal to the right, grassy slope to the left. No signs of slumping or erosion.	9
TRAFFIC BARRIER/FENCE 0.50	Chain link fence at top of wall shows no signs of wall related distress.	9
UPSLOPE 0.50	Flat upslope with no signs of distress.	9
WALL DRAINS 0.50	No wall drains. No signs of seepage, staining.	9
ROAD/SIDEWALK/SHOULDER 0.50	No signs of distress in roadway at toe of wall.	10

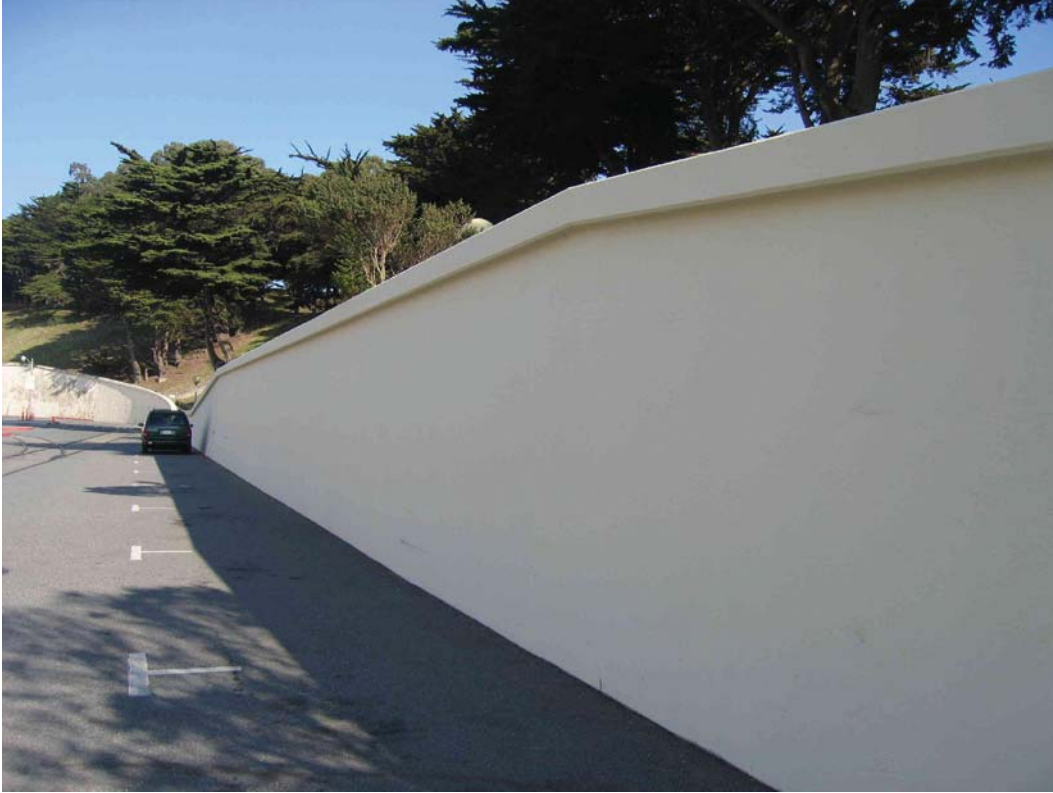
GOGA_0917_0.000_P2_1.jpg

Wall ID:	GOGA-0917-0.000-P2		
Route Name:	LOWER FORT MASON PARKING LOT		
Inspection Date:	November 06, 2007	Approximate Year Built:	1940
*Wall Rating:	87	Maintenance Action:	No Action

Element (Weighting Factor)	Narrative	Condition Rating (0 - 10)
PERFORMANCE 8.00	Very good, minor cracking but no signs of global distress.	9
WALL FOUNDATION MATERIAL 8.00	Parking lot. No signs of settlement or foundation distress.	9
CONCRETE 8.00	Painted CIP wall. No significant signs of distress, but fine cracking evident in some areas.	8
LATERAL SLOPE 0.50	Gentle grassy slopes with no signs of slumping, erosion, or water issues.	9
ROAD/SIDEWALK/SHOULDER 0.50	Roadway/parking below wall shows no distress.	9
UPSLOPE 0.50	Grassy, gentle slope showing minor erosion. Large trees have no impact on wall.	9
WALL DRAINS 0.50	No wall drains. No signs of water-related distress.	9

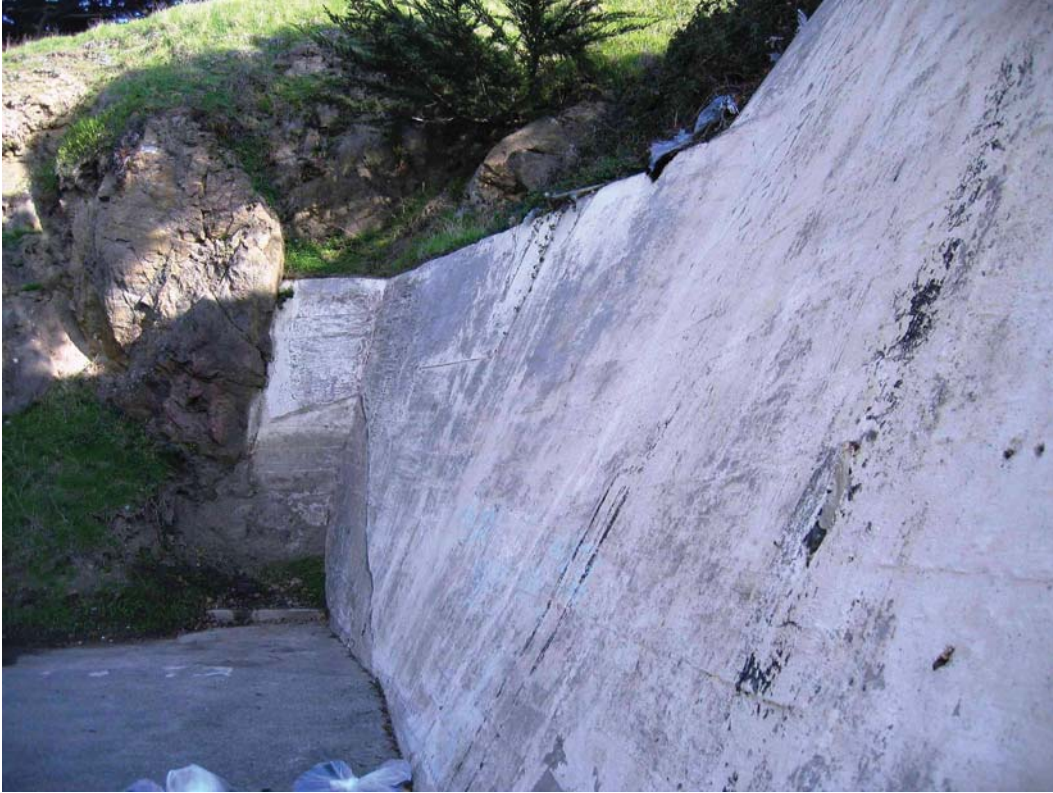
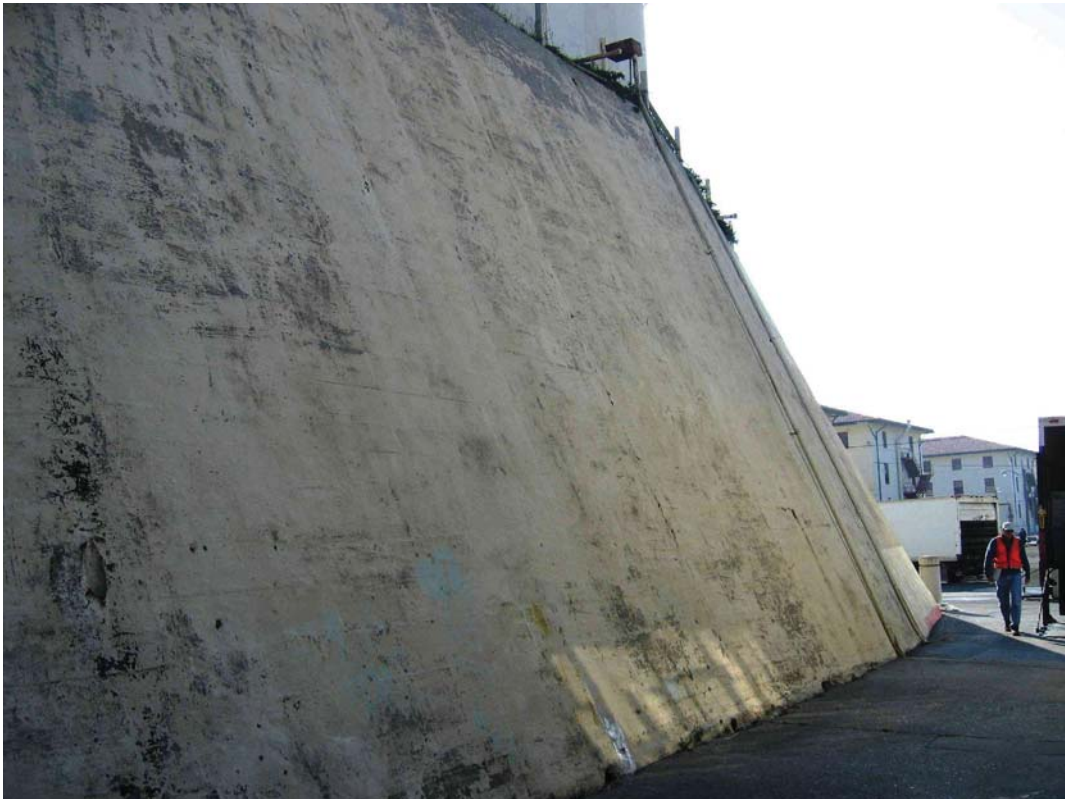
Wall ID:	GOGA-0917-0.000-P3		
Route Name:	LOWER FORT MASON PARKING LOT		
Inspection Date:	November 06, 2007	Approximate Year Built:	1940
*Wall Rating:	83	Maintenance Action:	No Action
