NPS Retaining Wall Inventory Program George Washington Memorial Parkway

**Federal Lands Highway
Road Inventory Program**

**Data Collection Date: December 2007
Report Date: October 2015**

George Washington Memorial Parkway in District of Columbia, Maryland, and Virginia

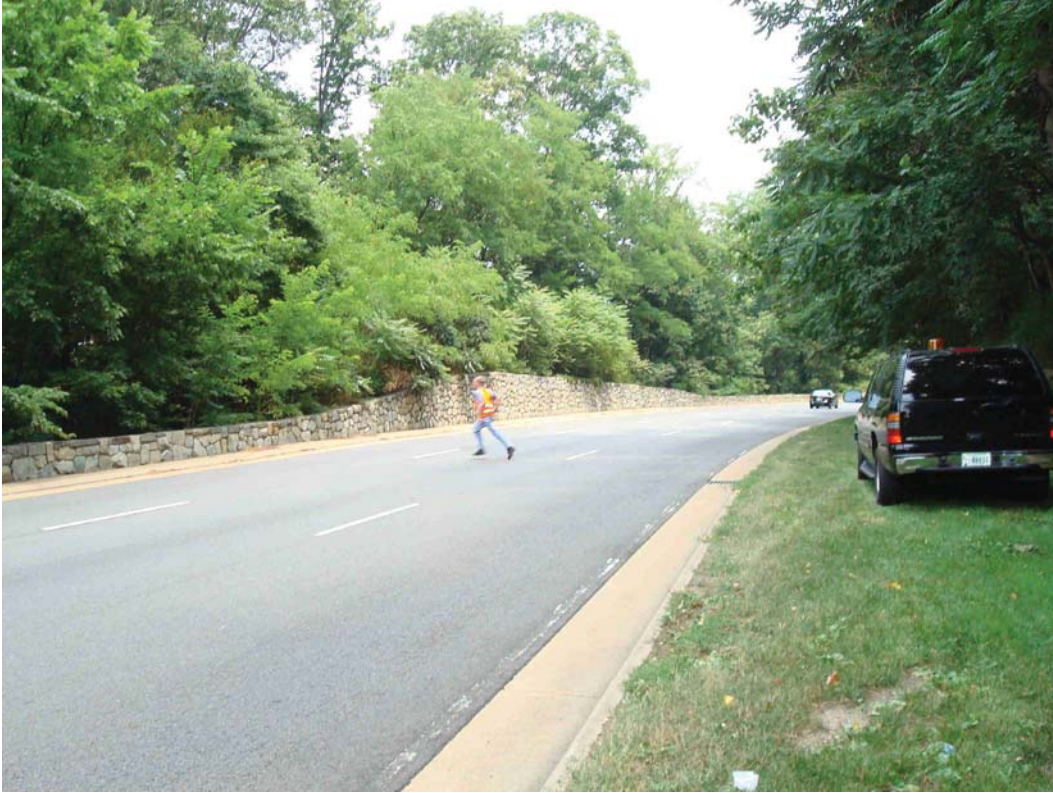
GWMP_0001_17.590_L_1.jpg

Wall ID:	GWMP-0001-17.590-L		
Route Name:	GWMP - SOUTHBOUND		
Inspection Date:	July 16, 2007	Approximate Year Built:	Unknown
*Wall Rating:	80	Maintenance Action:	No Action

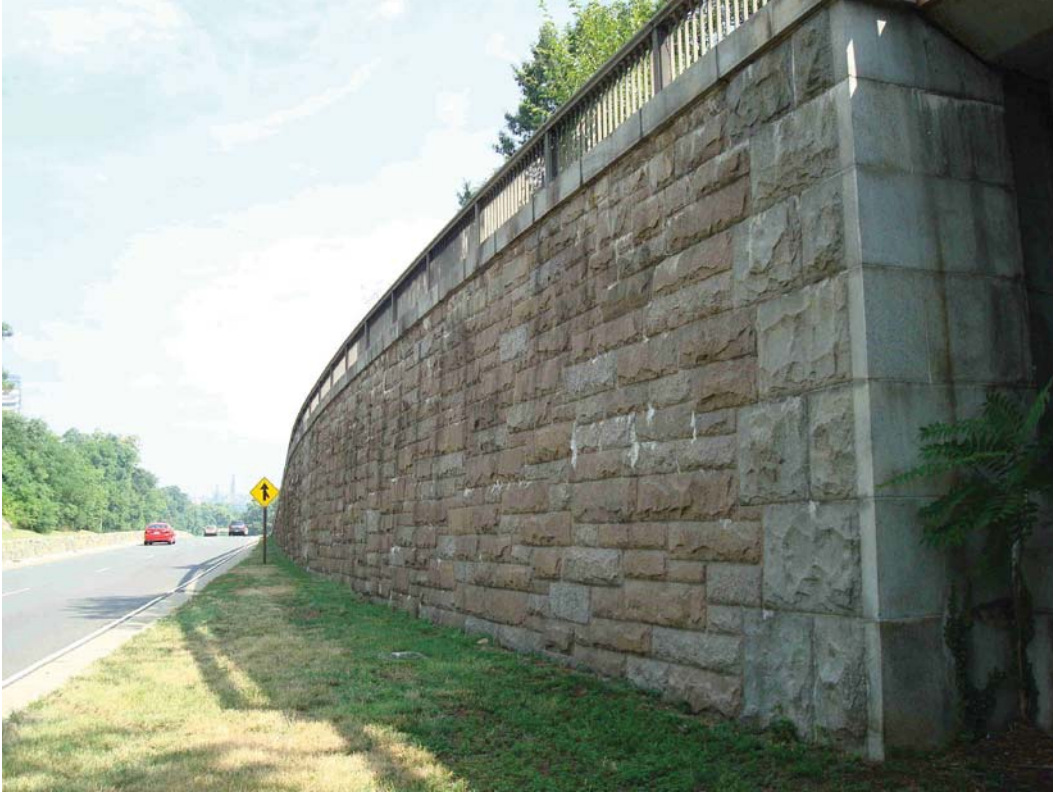
GWMP_0002_16.493_R_1.jpg

Wall ID:	GWMP-0002-16.493-R		
Route Name:	GWMP - NORTHBOUND		
Inspection Date:	July 11, 2007	Approximate Year Built:	Unknown
*Wall Rating:	81	Maintenance Action:	No Action

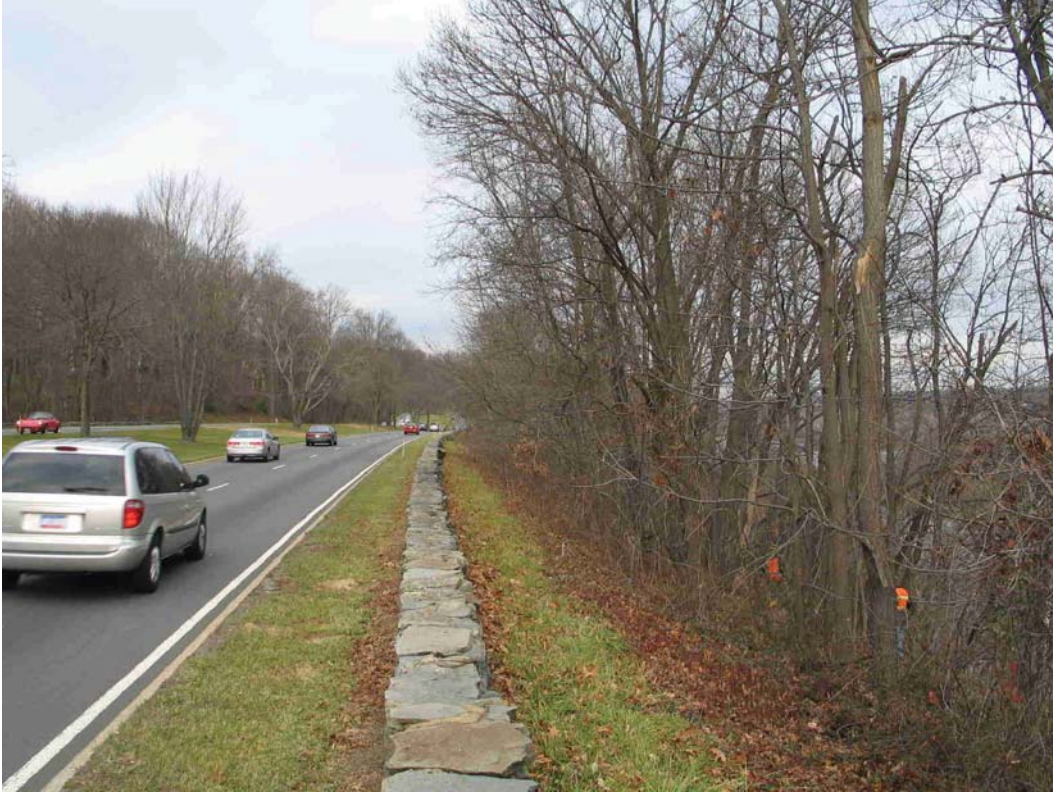
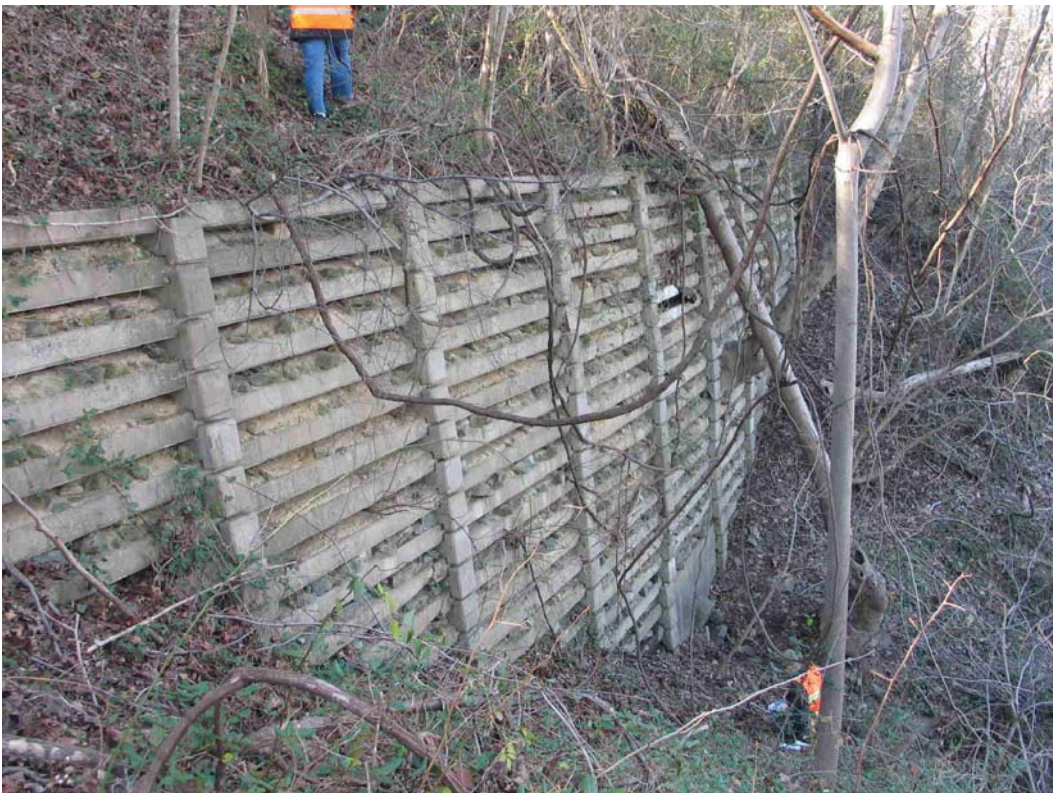
Element (Weighting Factor)	Narrative	Condition Rating (0 - 10)
PERFORMANCE 8.00	Needs repair or replacement, repair of bin elements, eroded areas, cut trees and reinforce wall	4
WALL FOUNDATION MATERIAL 8.00	No evidence of settlement below foundation	7
BIN OR CRIB 8.00	Wall bulging, likely caused by tree growth and erosion/infiltration at top. Losing fines through face of wall. No settlement at base.	4
CONCRETE 8.00	Several complete cracks of deadmen, exposed reinforcing steel	5
CULVERT 0.50	18" RCP in good condition	8
DOWNSLOPE 1.00	Erodable beyond the base. Mix of rock, boulders, silty material, severely eroded. Very steep slope/vertical at 15 ft. from toe.	4
VEGETATION 1.00	Lots of vegetation, 1 ft. diameter tree and stump growing through face	4
WALL DRAINS 1.00	Losing fines through face of wall, bulging wall	5
LATERAL SLOPE 1.00	Hole on south end near edge	6

Failure Consequence:	MODERATE
Recommendation Narrative:	None
Repair Cost:	\$0

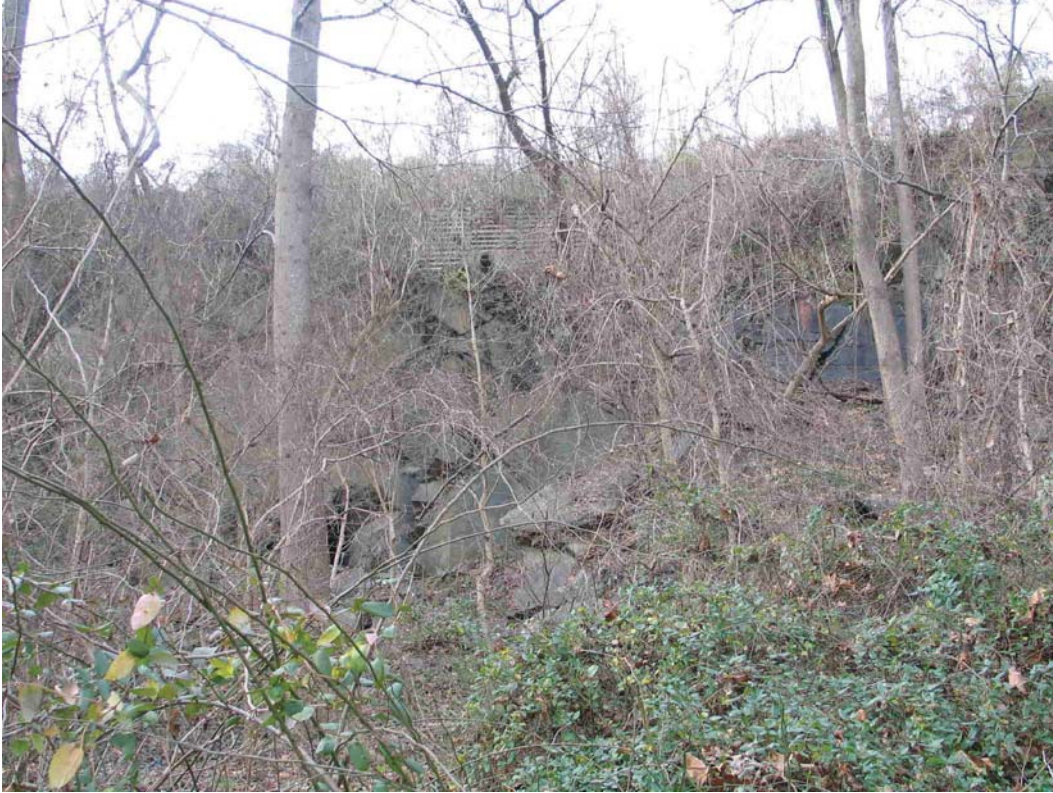
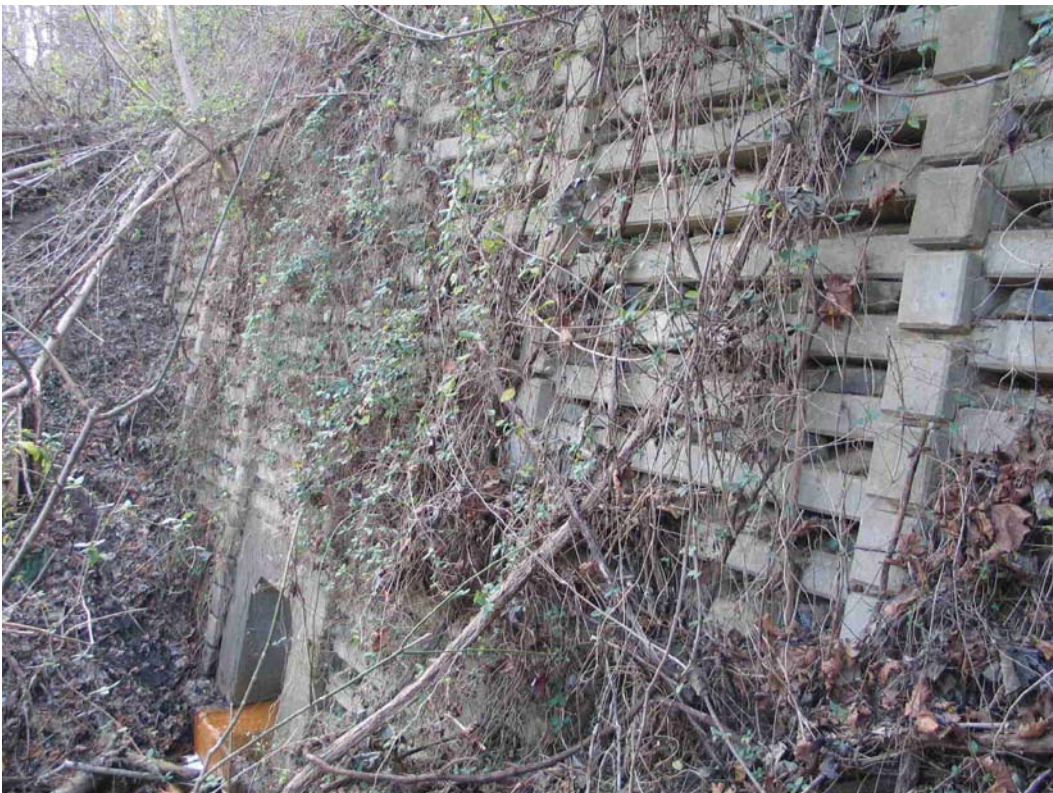
Element (Weighting Factor)	Narrative	Condition Rating (0 - 10)
PERFORMANCE 8.00	Mostly cosmetic issues	8
WALL FOUNDATION MATERIAL 8.00	Rock/partial soil, no settlement or erosion	8
CONCRETE 8.00	Good condition, some cracking, spalling, typical throughout wall	7
BIN OR CRIB 8.00	Overall Crib in good condition, best condition of the 5 crib walls	8
CULVERT 0.50	4' by 4' box, bottom center of wall	8
WALL DRAINS 0.50	Well drained through face	8
UPSLOPE 1.00	Steep	6
VEGETATION 1.00	Tree growing through face, vines throughout, not affecting performance	6
DOWNSLOPE 1.00	Rocky, steep	7

Failure Consequence:	MODERATE
Recommendation Narrative:	None
Repair Cost:	\$0

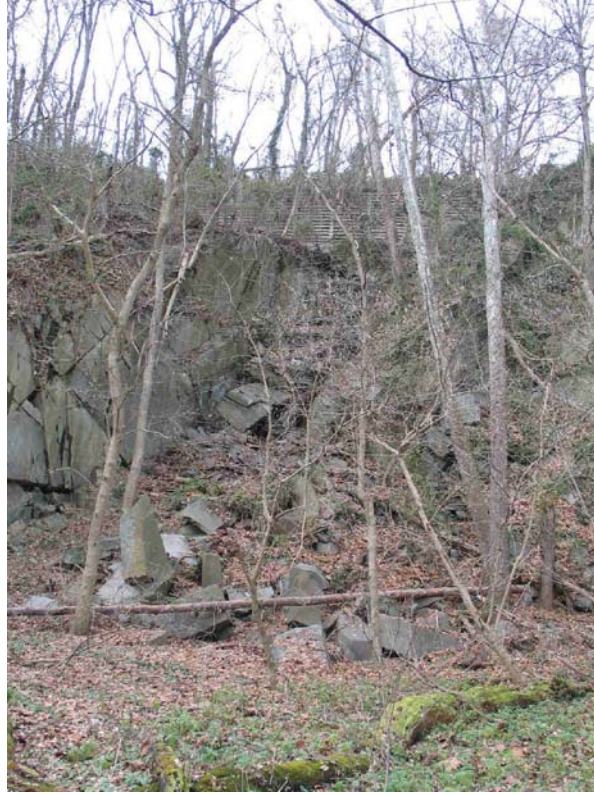
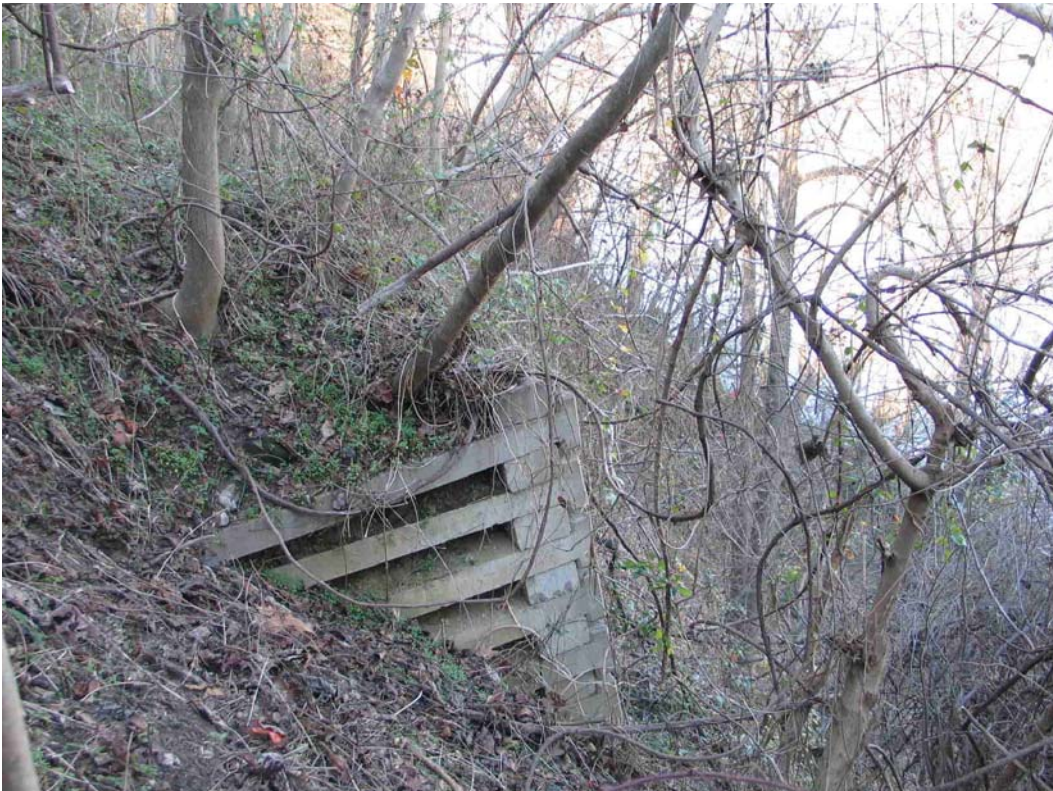
Element (Weighting Factor)	Narrative	Condition Rating (0 - 10)
PERFORMANCE 8.00	Crib foundation and culvert in good condition, needs concrete repair and vegetation removed. Note downslope severe.	6
WALL FOUNDATION MATERIAL 8.00	Rock foundation, short distance to vertical drop	7
CONCRETE 8.00	Few moderate cracks, 1 major vertical crack in header	6
BIN OR CRIB 8.00	Overall wall function not compromised, isolated elements under stress, small to moderate local bulges near trees	7
CULVERT 0.50	24" RCP through bottom center of wall	8
DOWNSLOPE 1.00	Rock ledge. Vertical drops of 20 to 30 ft. at distances of 5 to 15 ft. from toe of wall	5
VEGETATION 1.00	Trees growing through wall	5
LATERAL SLOPE 1.00	Steep	6
UPSLOPE 1.00	Steep, vegetated	6

Failure Consequence:	MODERATE
Recommendation Narrative:	None
Repair Cost:	\$0

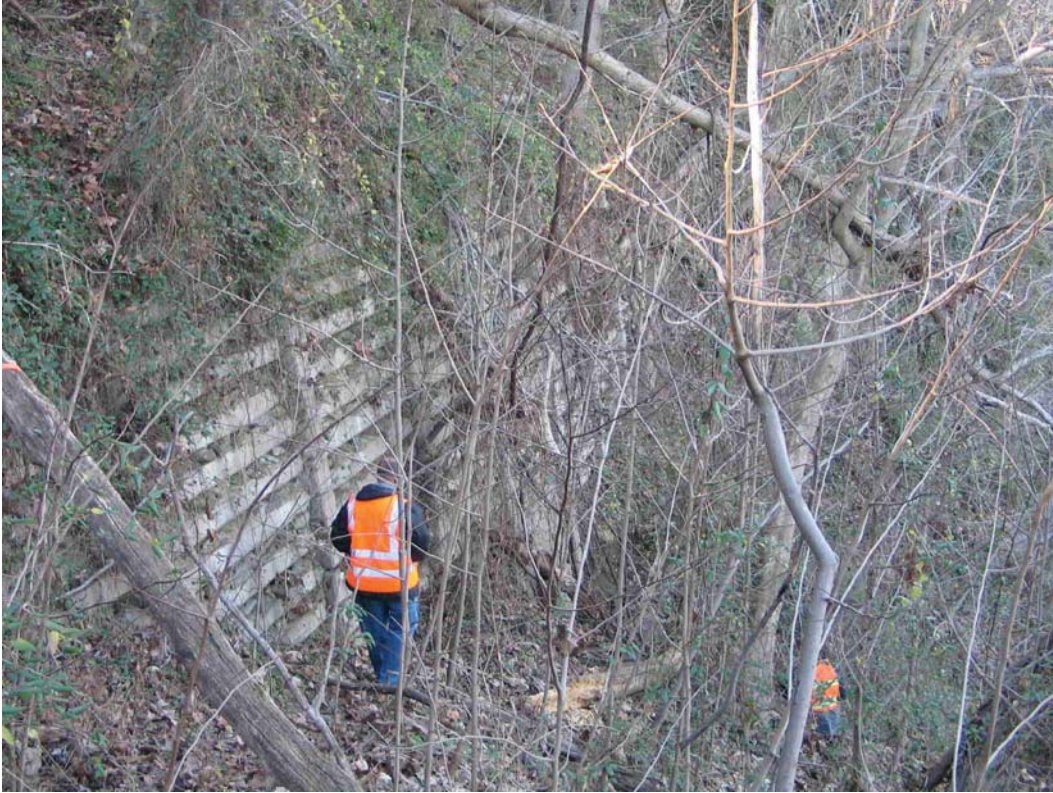
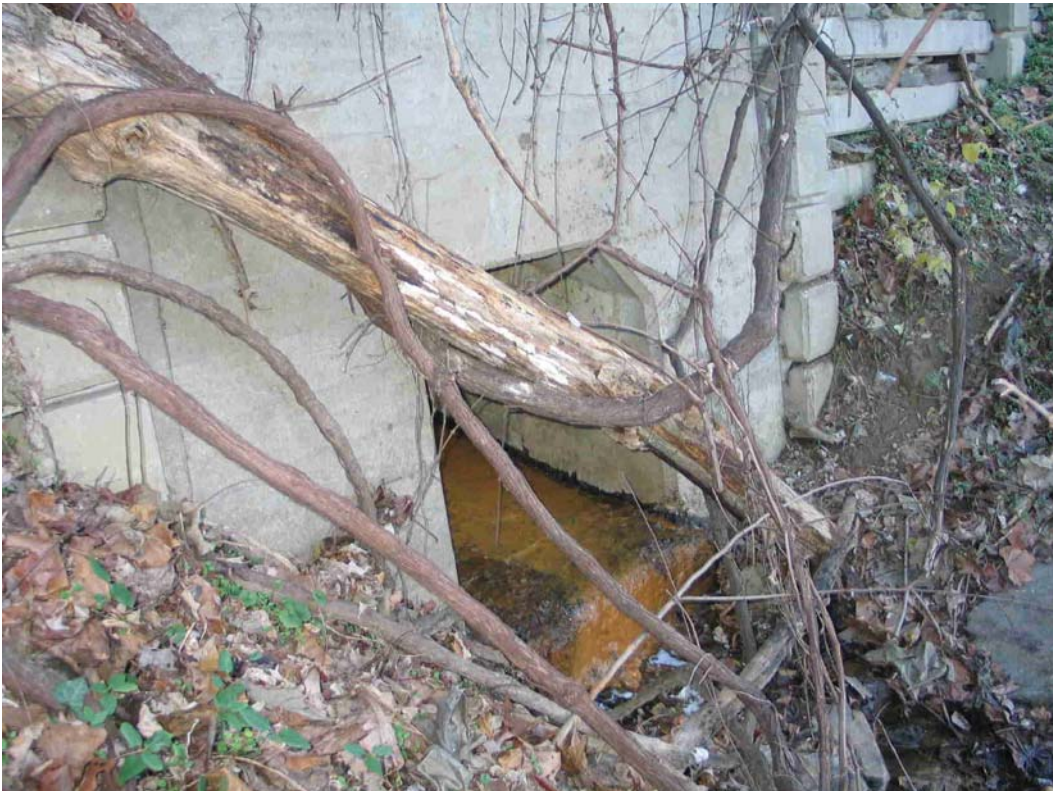
Element (Weighting Factor)	Narrative	Condition Rating (0 - 10)
PERFORMANCE 8.00	Needs repair of individual elements and trees cut, footings fully supported	6
WALL FOUNDATION MATERIAL 8.00	Three footings on south end visible. Three footings on north end visible and undermined/eroded.	5
CONCRETE 8.00	Exposed reinforcing steel, numerous cracks, some large	4
BIN OR CRIB 8.00	Numerous spalls, exposed reinforcing steel, trees growing through face. Overall wall function not compromised	6
CULVERT 0.50	3' by 3' box through bottom center of wall	8
VEGETATION 1.00	Significant tree growth throughout	4
DOWNSLOPE 1.00	Rock, severe slope	5
LATERAL SLOPE 1.00	Relatively mild, less severe than downslope	6
UPSLOPE 1.00	Steep, vegetated	6

Failure Consequence:	MODERATE
Recommendation Narrative:	None
Repair Cost:	\$0

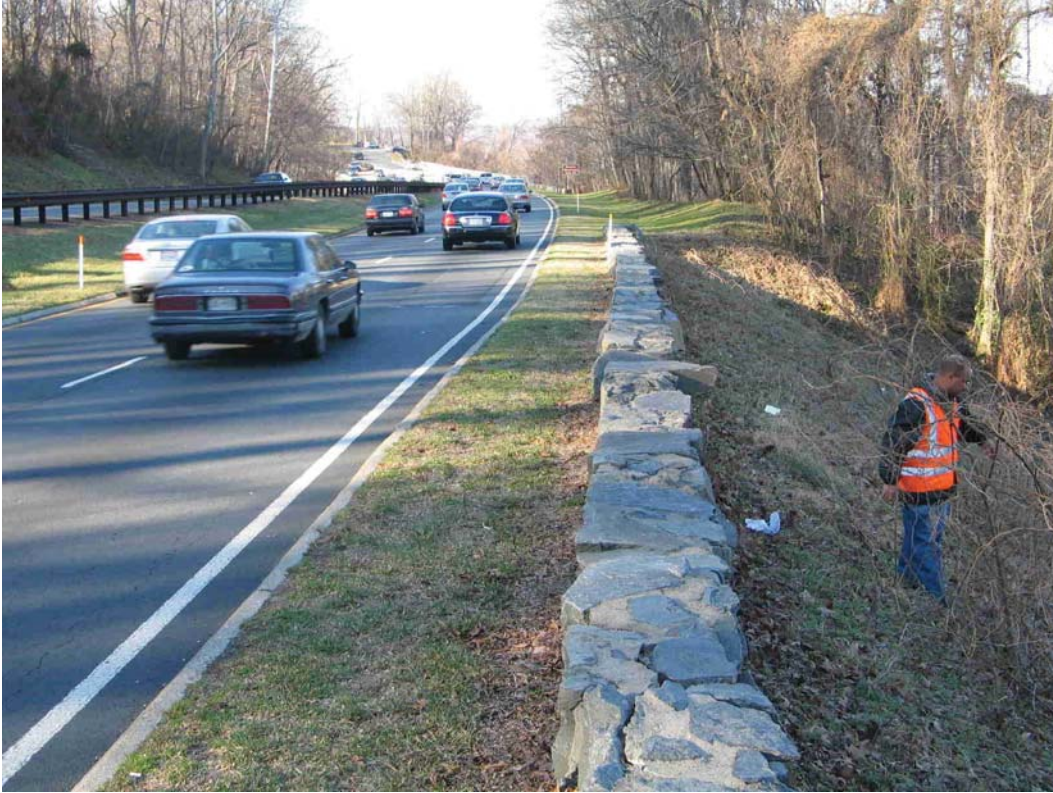
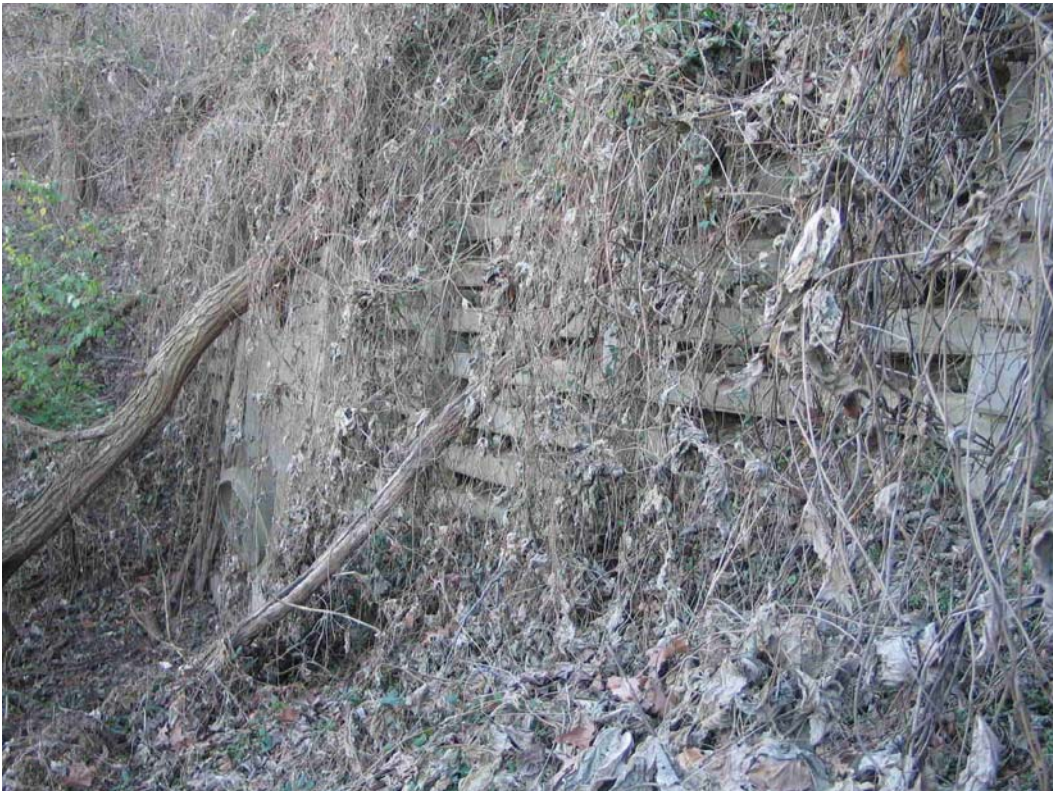
Element (Weighting Factor)	Narrative	Condition Rating (0 - 10)
PERFORMANCE 8.00	Headwall problems, undermined footings, culvert separation	5
WALL FOUNDATION MATERIAL 8.00	Footings undermined, culvert pipe separated and rotated	4
CONCRETE 8.00	Few major cracks, several minor cracks, headwall has 18" long major incipient spall	5
BIN OR CRIB 8.00	Headwall major crack, many cracks and some broken elements (spalls).	6
CULVERT 1.00	30" RCP through bottom center of wall, culvert 4' section, front face rotated down, 2.5" separation between pipes, 1.5" vertical gap Headwall 18" long incipient spall	4
VEGETATION 0.50	Vines present, no large trees	8
DOWNSLOPE 1.00	Steep drop	6
WALL DRAINS 1.00	Drains through face, drainage affected by separated culvert	6
LATERAL SLOPE 1.00	Less severe than downslope	7

Failure Consequence:	MODERATE
Recommendation Narrative:	None
Repair Cost:	\$0

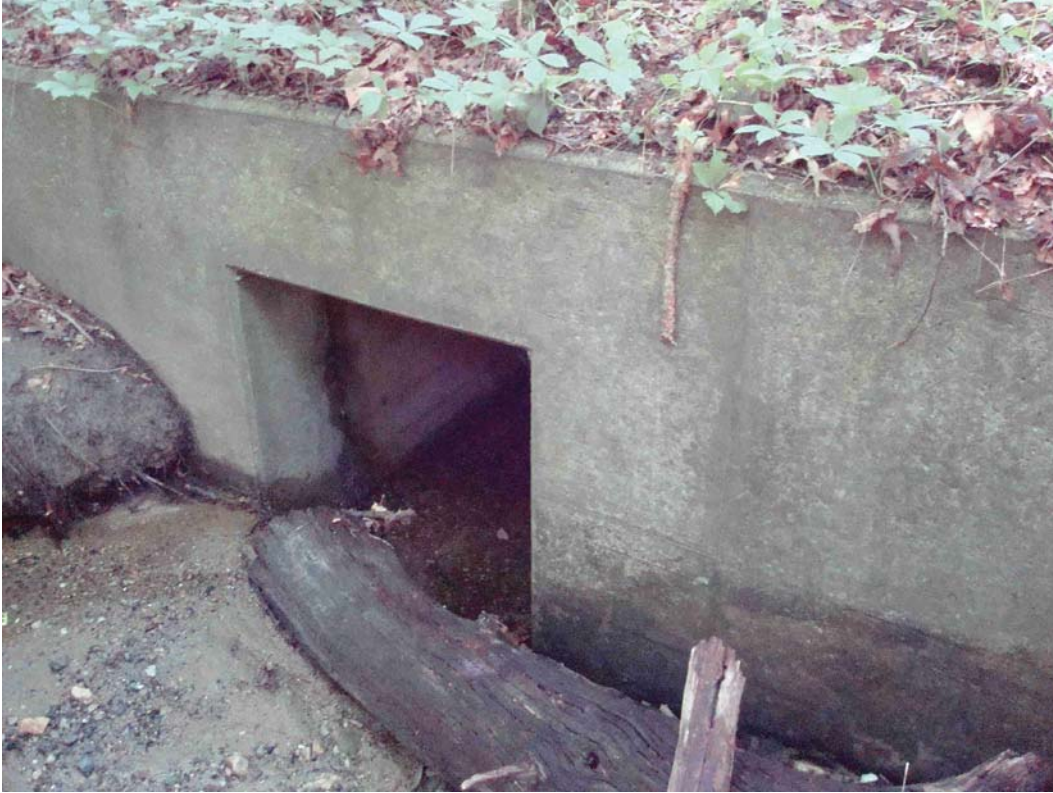
GWMP_0002_21.582_R_1.jpg

Element (Weighting Factor)	Narrative	Condition Rating (0 - 10)
PERFORMANCE 8.00	No global distress	7
WALL FOUNDATION MATERIAL 8.00	No evidence of settlement or erosion	7
CONCRETE 8.00	Sound and durable	7
DOWNSLOPE 0.50	Gradual slope	8
UPSLOPE 0.50	Gradual slope	8
LATERAL SLOPE 1.00	1H:1V	6
CULVERT 1.00	3'H by 3.2'W	7
WALL DRAINS 1.00	None visible	7

Failure Consequence:	LOW
Recommendation Narrative:	None
Repair Cost:	\$0

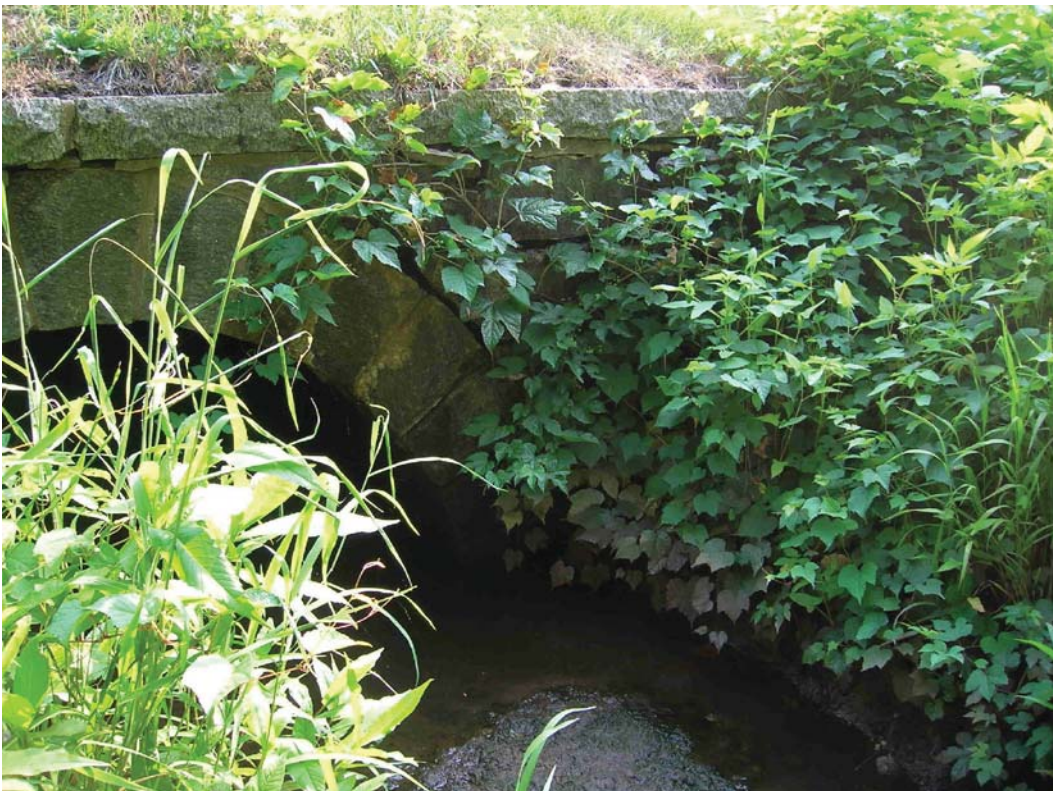
GWMP_0003ZZ_0.954_R_2.jpg

Element (Weighting Factor)	Narrative	Condition Rating (0 - 10)
PERFORMANCE 8.00	No evidence of global distress	7
WALL FOUNDATION MATERIAL 8.00	No evidence of settlement or erosion	7
MORTAR 8.00	Some cracks in mortar	6
STONE MASONRY 8.00	No fractures or degradation	7
DOWNSLOPE 0.50	Flat	8
LATERAL SLOPE 0.50	Flat	8
ROAD/SIDEWALK/SHOULDER 0.50	Grassed shoulder	8
WALL DRAINS 0.50	None visible	8
CULVERT 1.00	3'H by 6'W, appears OK condition, partially visible	6

Failure Consequence:	LOW
Recommendation Narrative:	Clear vegetation = 2 hrs * \$55/hr = \$110 Repoint mortar - 30 s.f. * \$75/s.f. = \$2,250
Repair Cost:	\$2,360

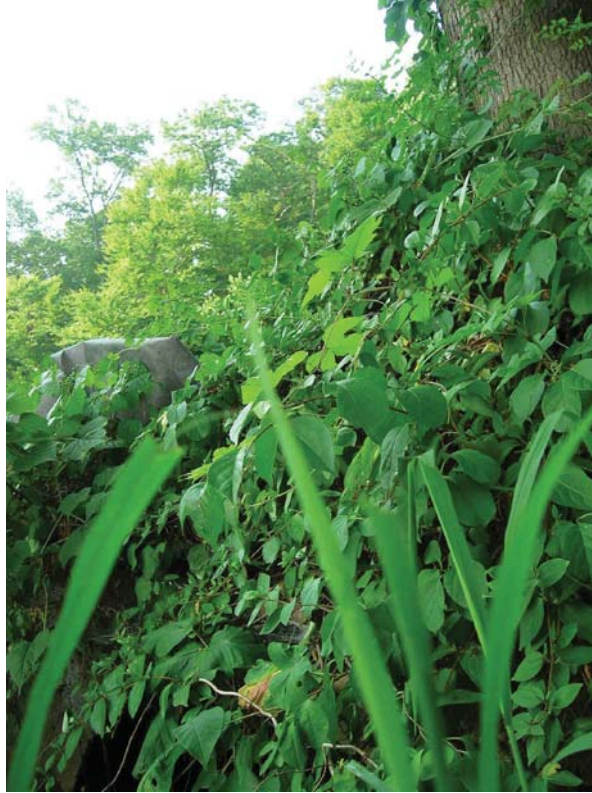
GWMP_0003ZZ_0.983_R_1.jpg

Element (Weighting Factor)	Narrative	Condition Rating (0 - 10)
PERFORMANCE 8.00	No evidence of global distress	7
WALL FOUNDATION MATERIAL 8.00	No evidence of settlement or erosion	7
MORTAR 8.00	Appears sound and durable, difficult to see with vines	7
STONE MASONRY 8.00	Appears no fractures or degradation, difficult to see with vines	7
DOWNSLOPE 0.50	Flat	8
LATERAL SLOPE 0.50	Flat	8
VEGETATION 1.00	Growing over face	6
UPSLOPE 1.00	3H:1V	7
WALL DRAINS 1.00	None visible	7

Failure Consequence:	LOW
Recommendation Narrative:	Clear vegetation - 2 hrs * \$55/hr = \$110
Repair Cost:	\$110

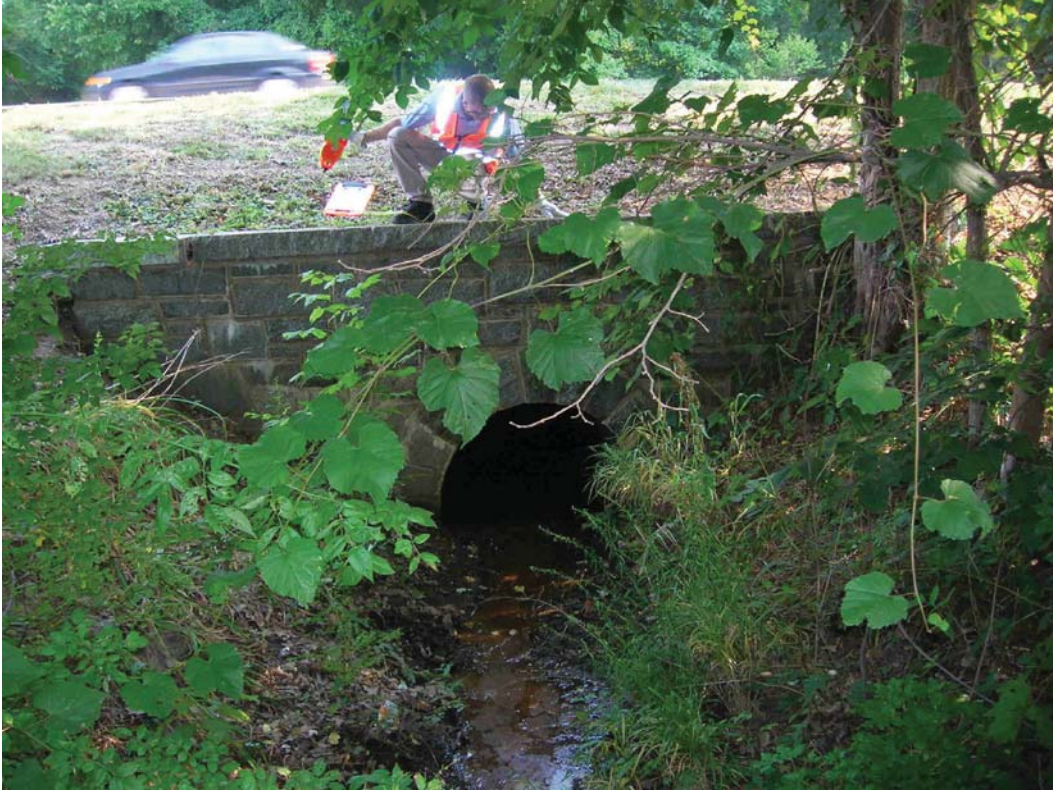
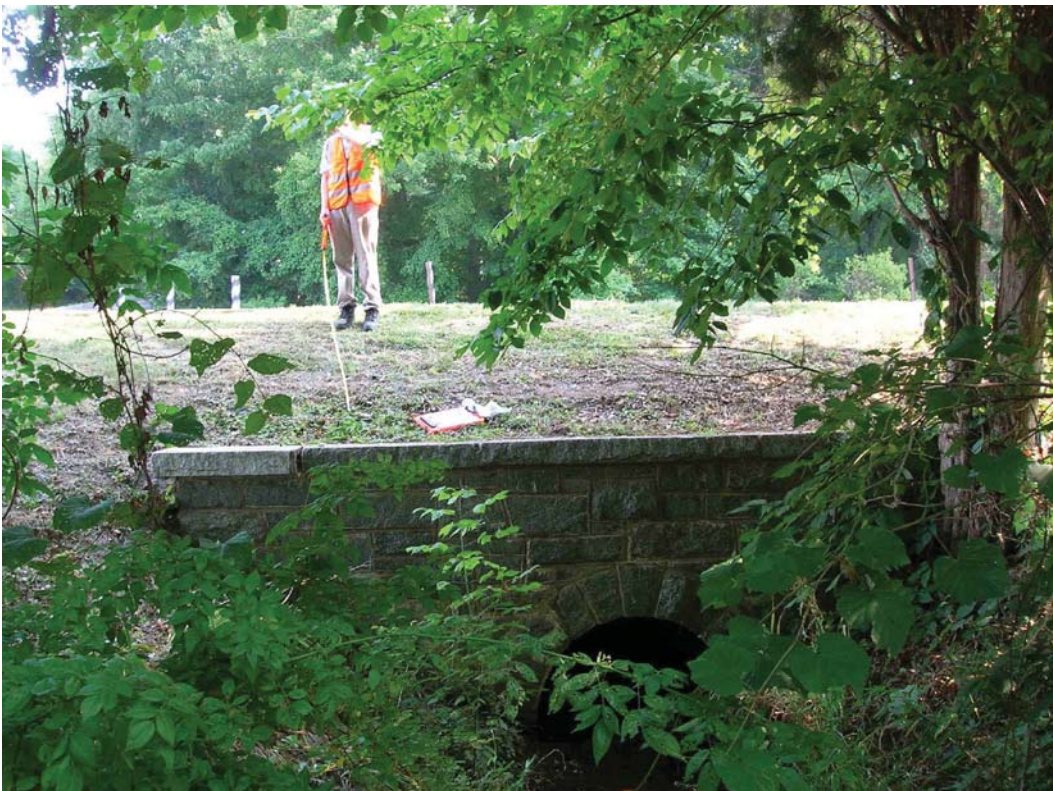
Element (Weighting Factor)	Narrative	Condition Rating (0 - 10)
PERFORMANCE 8.00	No global distress, but needs repair to local distress	7
WALL FOUNDATION MATERIAL 8.00	No evidence of settlement or erosion	7
MORTAR 8.00	Some efflorescence, missing/cracked mortar for capstones	6
STONE MASONRY 8.00	Capstone on top left is out of place, otherwise OK	6
DOWNSLOPE 0.50	Flat	8
LATERAL SLOPE 0.50	Flat	8
VEGETATION 1.00	Tree immediately next to right side of wall, potential future distress to wall	5
UPSLOPE 1.00	2H:1V, drains around wall, cause of offset capstone?	6
CULVERT 1.00	2.5' H by 3.5' W Appears to function well	7

Failure Consequence:	LOW
Recommendation Narrative:	Clear Tree - 1 tree * \$955/tree = \$955 Repoint/Reset capstone - 20 s.f. * \$75/s.f. = \$1,500
Repair Cost:	\$2,455

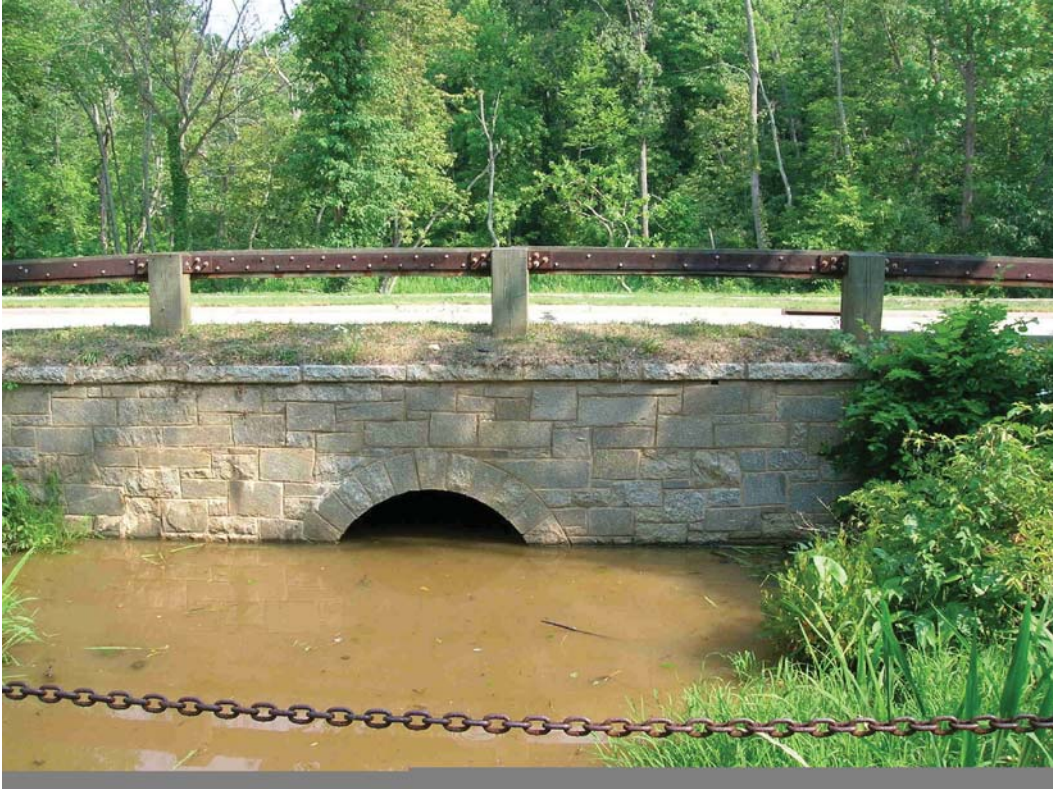
GWMP_0003ZZ_2.608_R_1.jpg

Element (Weighting Factor)	Narrative	Condition Rating (0 - 10)
PERFORMANCE 8.00	May be hydraulic/drainage issue - culvert may be too small for site	6
WALL FOUNDATION MATERIAL 8.00	No visible settlement or erosion	7
MORTAR 8.00	Loose mortar (6 l.f.) between capstones, but still in place Slight efflorescence	7
STONE MASONRY 8.00	No fractures or degradation	7
LATERAL SLOPE 0.50	Flat	8
WALL DRAINS 1.00	Eroding around corners, otherwise wall face OK High water could affect performance	5
DOWNSLOPE 1.00	Flat, water, swampy	6
CULVERT 1.00	5.5'W by 3'H High water	7
ROAD/SIDEWALK/SHOULDER 1.00	Grassed, mild slope	7

Failure Consequence:	MODERATE
Recommendation Narrative:	Repoint Mortar - 20 s.f. * \$75/s.f. = \$1,500 May need hydraulics evaluation
Repair Cost:	\$1,500

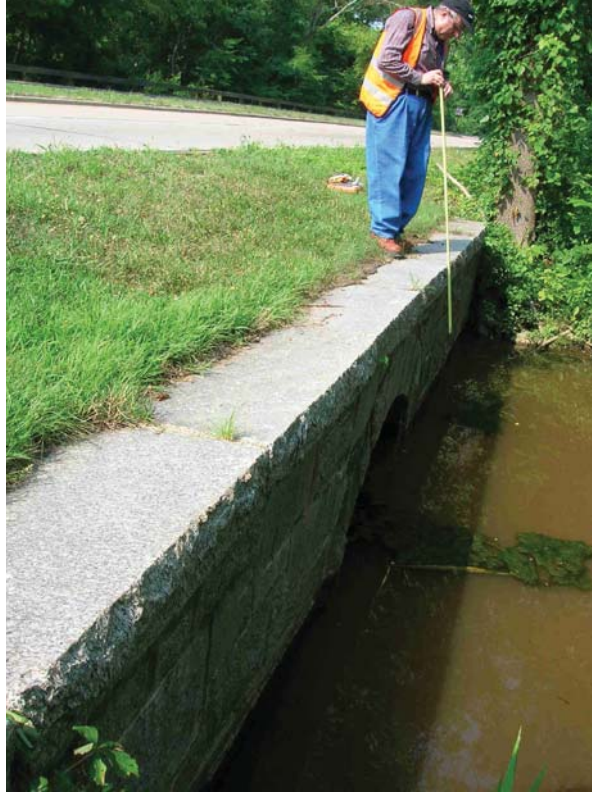
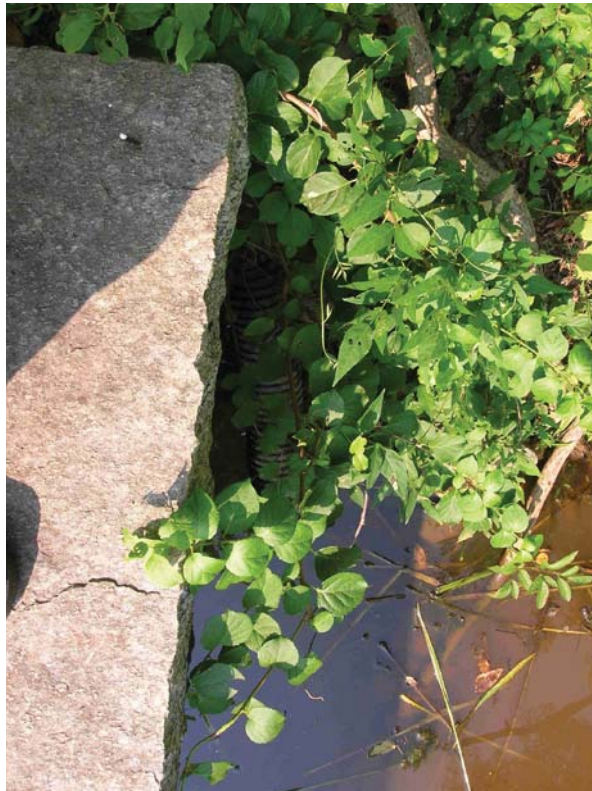
Element (Weighting Factor)	Narrative	Condition Rating (0 - 10)
PERFORMANCE 8.00	May be hydraulics/drainage issue - culvert may be too small for site	6
WALL FOUNDATION MATERIAL 8.00	No evidence of settlement	7
MORTAR 8.00	Mortar missing in capstones - approximately 4 linear feet. No stones displaced	6
STONE MASONRY 8.00	No fractures or deterioration	7
LATERAL SLOPE 0.50	Flat	8
WALL DRAINS 1.00	Drain pipe - corrugated black plastic pipe around southern end. Corner of headwall slightly eroded near pipe High water could affect performance	5
DOWNSLOPE 1.00	Flat, wet, swampy area	6
CULVERT 1.00	5.5' W by 3' H High water	7
ROAD/SIDEWALK/SHOULDER 1.00	Gradual slope, grassed	7

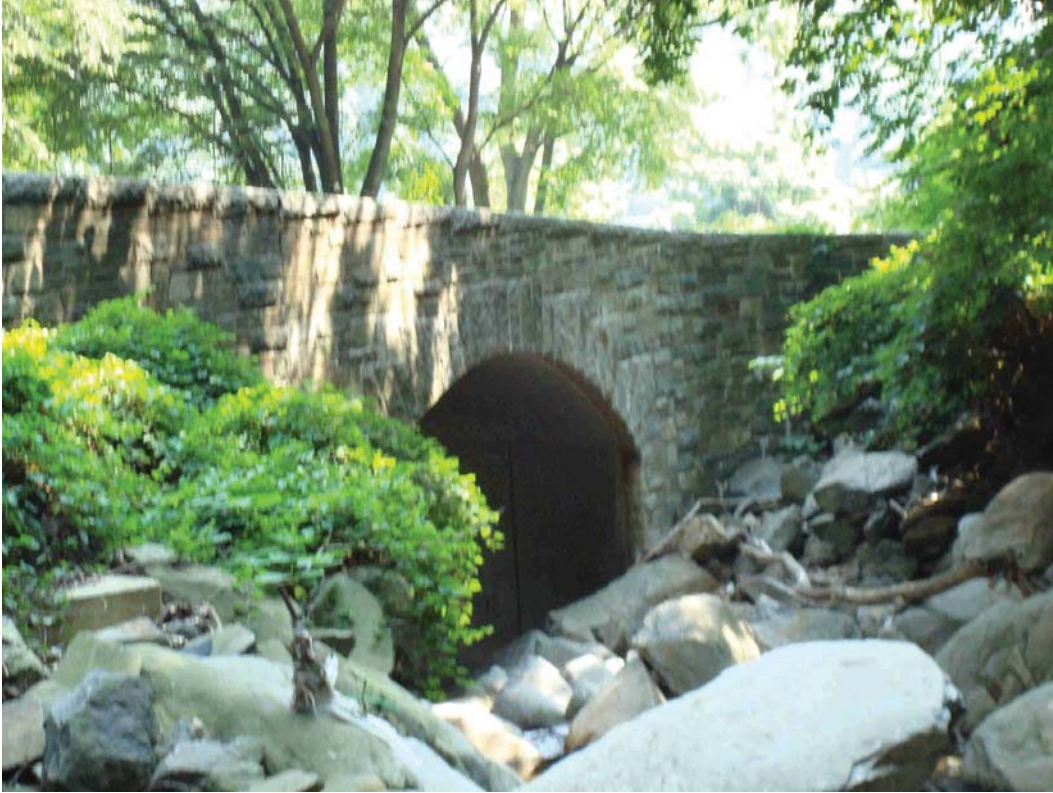
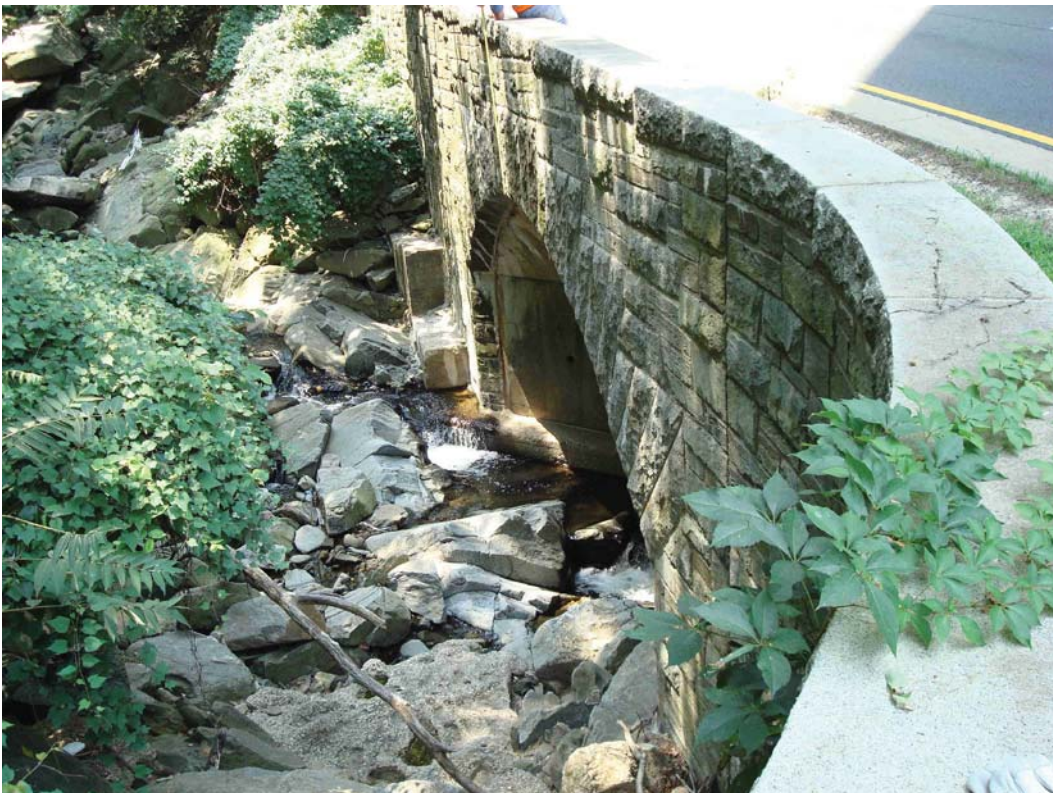
Wall ID:	GWMP-0005ZZ-0.157-L		
Route Name:	SPOUT RUN PARKWAY WESTBOUND AND RAMPS		
Inspection Date:	July 16, 2007	Approximate Year Built:	Unknown
*Wall Rating:	66	Maintenance Action:	No Action

Element (Weighting Factor)	Narrative	Condition Rating (0 - 10)
PERFORMANCE 8.00	No other signs of global distress, however, scour undermining a threat to future stability Work on scour to be done under GWMP 4(1),5(1)	6
WALL FOUNDATION MATERIAL 8.00	Severe scour inside culvert - see photo GWMP-0005B-0.157-L-3 - from project GWMP 4(1),5(1)	4
MORTAR 8.00	Sound, durable	8
STONE MASONRY 8.00	No fracturing or degradation	8
LATERAL SLOPE 0.50	Gentle slope	8
ROAD/SIDEWALK/SHOULDER 0.50	Flat, grassy	8
DOWNSLOPE 1.00	Gradual, streambed, high scour potential	6
CULVERT 1.00	15'H by 27"W, concrete arch	7
WALL DRAINS 1.00	Inside Culvert	7

Failure Consequence:	HIGH
Recommendation Narrative:	None
Repair Cost:	\$0

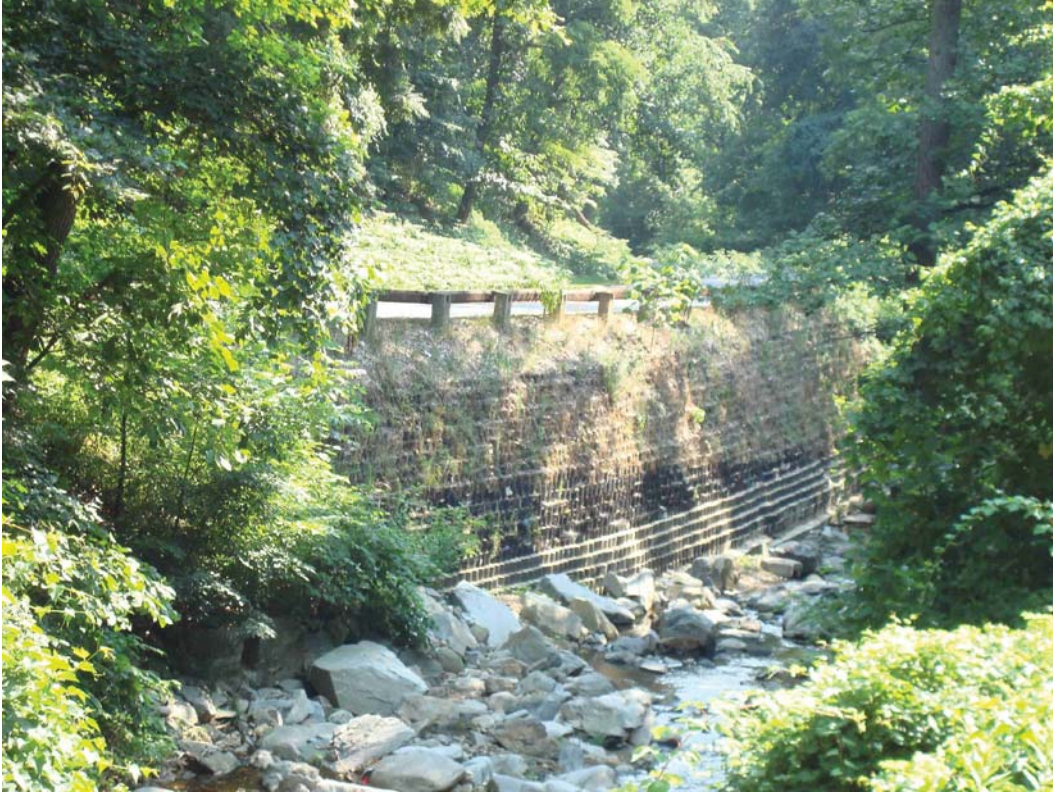
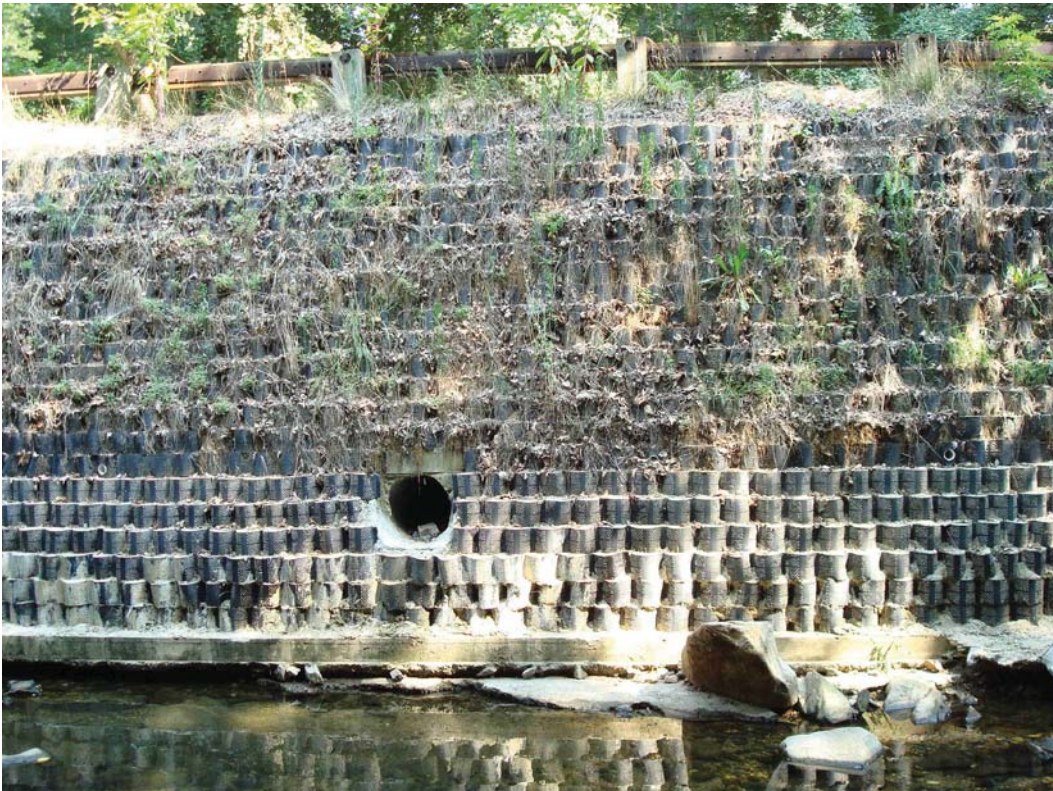
Wall ID:	GWMP-0005ZZ-0.379-L		
Route Name:	SPOUT RUN PARKWAY WESTBOUND AND RAMPS		
Inspection Date:	July 16, 2007	Approximate Year Built:	2004
*Wall Rating:	65	Maintenance Action:	Repair Elements

Element (Weighting Factor)	Narrative	Condition Rating (0 - 10)
PERFORMANCE 8.00	Undermining of foundation due to scour from high water. Need hydraulics input and repair or global stability threatened	6
WALL FOUNDATION MATERIAL 8.00	Undermining of concrete slab/footing in stream, from metal culvert for a length of 30 feet to the west. 1' vertical by 1'-2' deep	4
BIN OR CRIB 8.00	Cellular wall is in good condition, no evidence of cracks/breaks Newly constructed wall	9
CULVERT 0.50	30" corrugated metal pipe, not distress	8
LATERAL SLOPE 0.50	Gently sloping	8
VEGETATION 0.50	Vegetation on top face by design	9
WALL DRAINS 0.50	10' O-C at approximately 5' above footing	9
DOWNSLOPE 1.00	Flat streambed, extreme scour after 3 years	5
ROAD/SIDEWALK/SHOULDER 1.00	Flat shoulder	7

Failure Consequence:	HIGH
Recommendation Narrative:	Grout to stabilize foundation - 40 ft * 2 ft * \$110/s.f. = \$8,800 Mobilization - 12% EE = \$1,056 Difficult access - 20% = \$1,971
Repair Cost:	\$11,827
