NPS Retaining Wall Inventory Program George Washington Memorial Parkway

**Federal Lands Highway
Road Inventory Program**

**Data Collection Date: December 2007
Report Date: October 2015**

George Washington Memorial Parkway in District of Columbia, Maryland, and Virginia

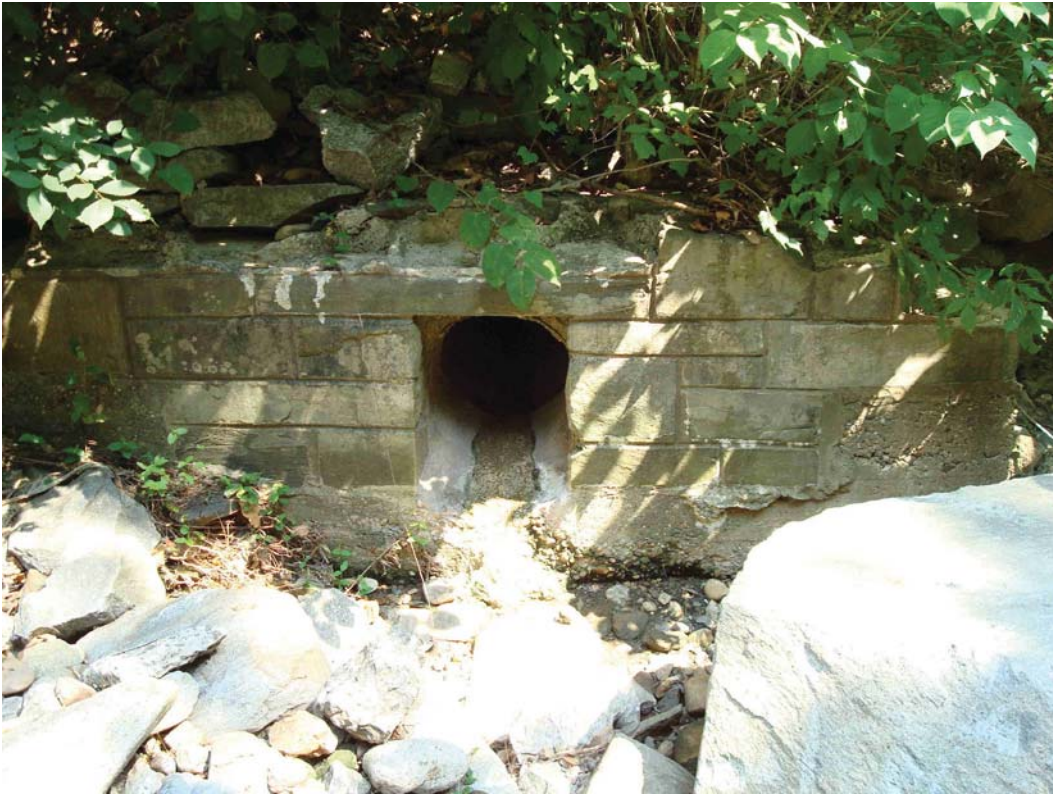
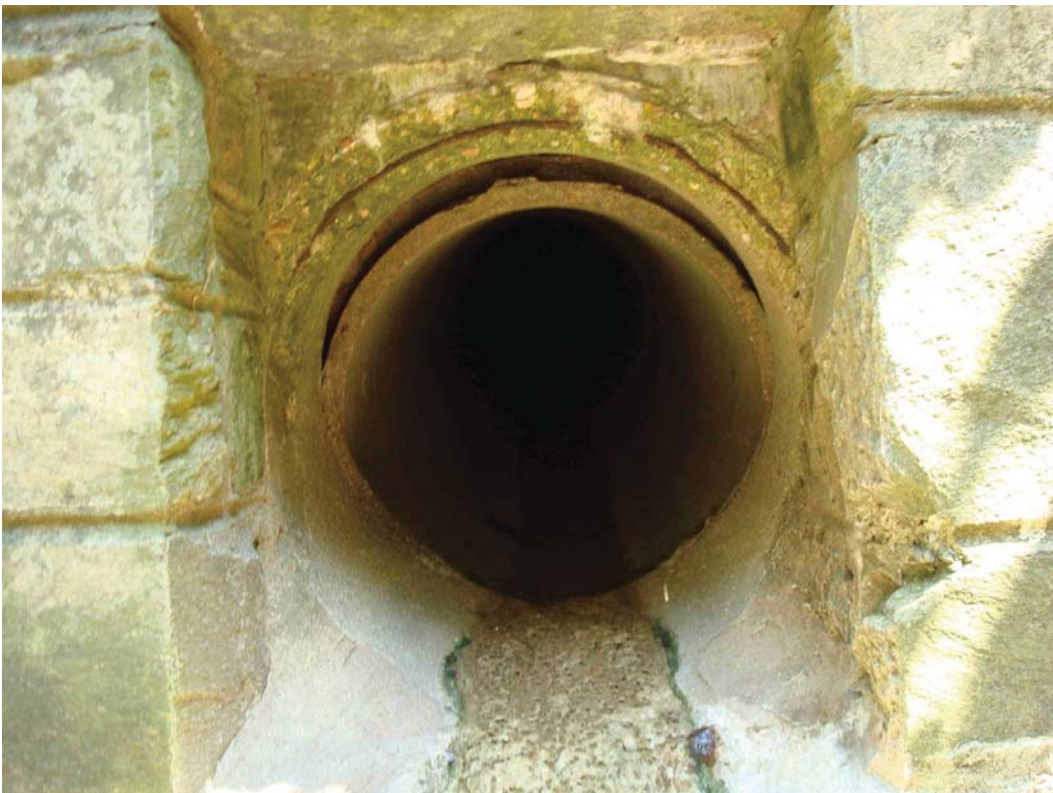
Wall ID:	GWMP-0005ZZ-0.380-L		
Route Name:	SPOUT RUN PARKWAY WESTBOUND AND RAMPS		
Inspection Date:	July 16, 2007	Approximate Year Built:	Unknown
*Wall Rating:	54	Maintenance Action:	Replace Wall

Element (Weighting Factor)	Narrative	Condition Rating (0 - 10)
PERFORMANCE 8.00	Wall needs to be replaced	4
WALL FOUNDATION MATERIAL 8.00	Head wall pushed forward and down, rotated	5
STONE MASONRY 8.00	Missing most of the cap pieces, otherwise stone in good condition	5
MORTAR 8.00	Sound and durable, aged and discolored	7
CULVERT 1.00	20" diameter circular concrete pipe. Interior has dropped 2", 1" horizontal gap at the bottom of pipe	4
LATERAL SLOPE 0.50	Flat	8
UPSLOPE 1.00	1H:1V	6
VEGETATION 1.00	Moderate vegetation above wall	6
DOWNSLOPE 1.00	Flat/gentle/stream, but susceptible to scour	7

Failure Consequence:	MODERATE
Recommendation Narrative:	Remove/reset Stone Masonry - 2 cy * \$3,195/cy = \$6,390
Repair Cost:	\$6,390

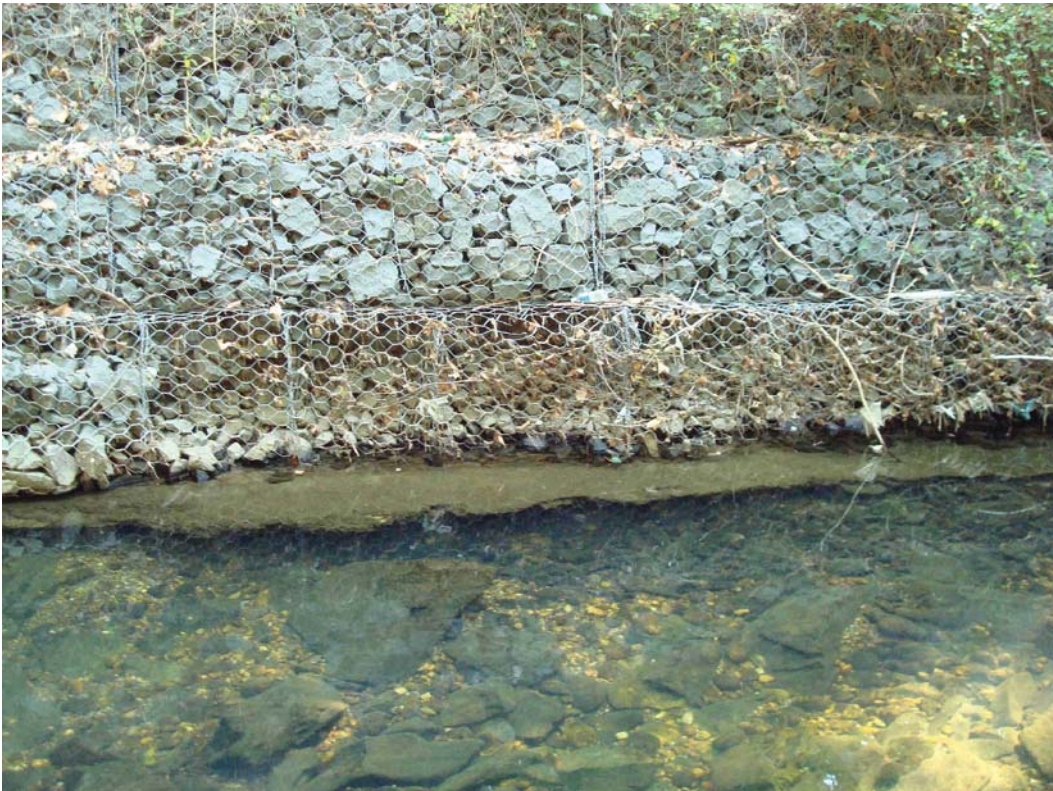
GWMP_0005ZZ_0.446_L_2.jpg

Wall ID:	GWMP-0005ZZ-0.446-L		
Route Name:	SPOUT RUN PARKWAY WESTBOUND AND RAMPS		
Inspection Date:	July 16, 2007	Approximate Year Built:	1980
*Wall Rating:	44	Maintenance Action:	Replace Wall
Wall Description			
Wall Function:	Fill Wall	Primary Wall Type:	Gravity - Gabion
Surface Treatment:		Secondary Wall Type:	
Secondary Surface Treatment:		Architectural Facing:	
General Description:	Gabion wall similar to what was replaced previously at mile 0.381 (replaced with geocell wall)		
Wall Measurements			
Wall Length (ft.):	35	Face Area (sq.):	350
Average Wall Height (ft.):	10	Face Angle (deg.):	79
Maximum Wall Height (ft.):	10	Vertical Offset (ft.):	-2
Assessed Elements			
Element (Weighting Factor)	Narrative		Condition Rating (0 - 10)
PERFORMANCE 8.00	Needs replacement - local gabion basket failures beginning to affect global stability		3
WALL FOUNDATION MATERIAL 8.00	Lean concrete footing/working pad, undermined/scoured 6" to 1' vertical, 1' - 2' deep, for most or all of length of wall		3

WIRE/GEOSYNTHETIC FACING 8.00	4 tiers, bottom tier rusted out in 8 of 13 baskets, rocks fallen out of those cells. Based on EFLHD knowledge of project, wall only 1 gabion basket deep - not adequate retaining structure in this condition		3
MORTAR 8.00	Frequent loose mortar for uppermost stones (not capstones). Several loose stones - significant repointing needed entire length of wall at top tier of stones to prevent further loss of stones and deterioration of wall below the top surface.		4
STONE MASONRY 8.00	Stone in good condition, not deteriorated. One stone imminent to fall into EB roadway, this and two other stones removed. This rated under "Mortar" because stone in good condition, mortar is the problem.		8
DOWNSLOPE 0.50	Flat		8
UPSLOPE 0.50	Flat		8
WALL DRAINS 0.50	Self-draining		8
LATERAL SLOPE 1.00	Gentle, but eroded on east end from scour at high water		6

Failure Consequence:	MODERATE
Recommendation Narrative:	Remove gabion wall - 350 s.f. * \$50/s.f. = \$17,500 Geocell/concrete wall - 400 s.f. * \$250/s.f. = \$100,000
Repair Cost:	\$117,500

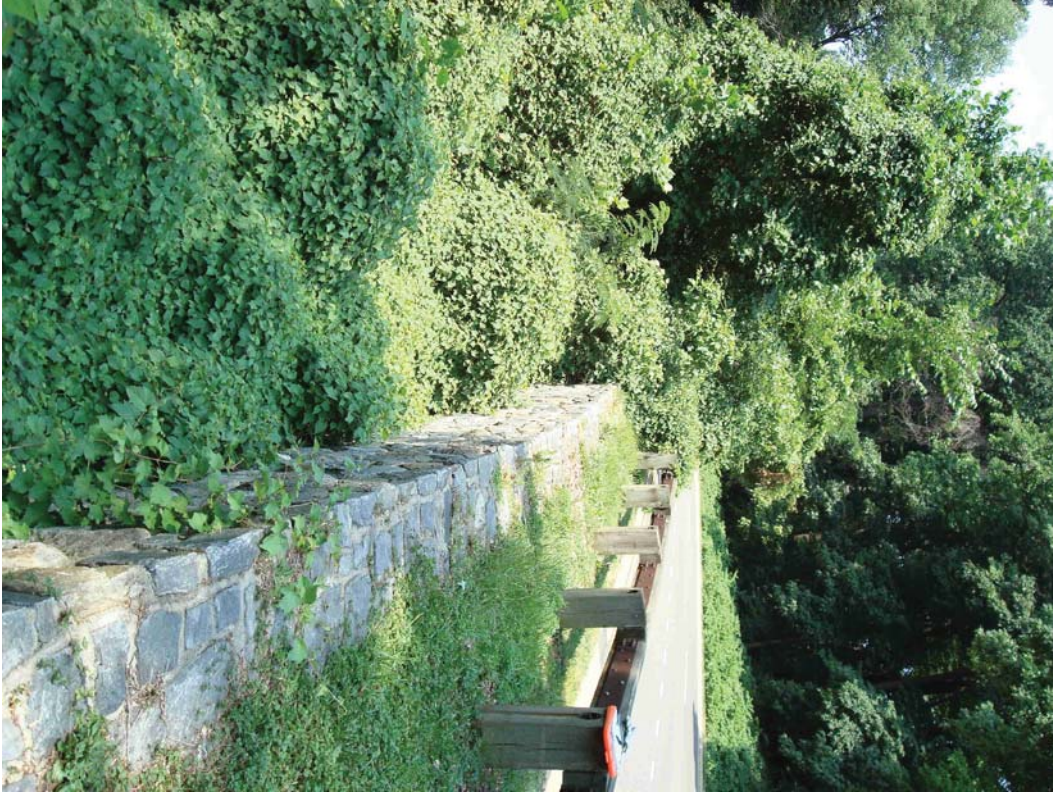
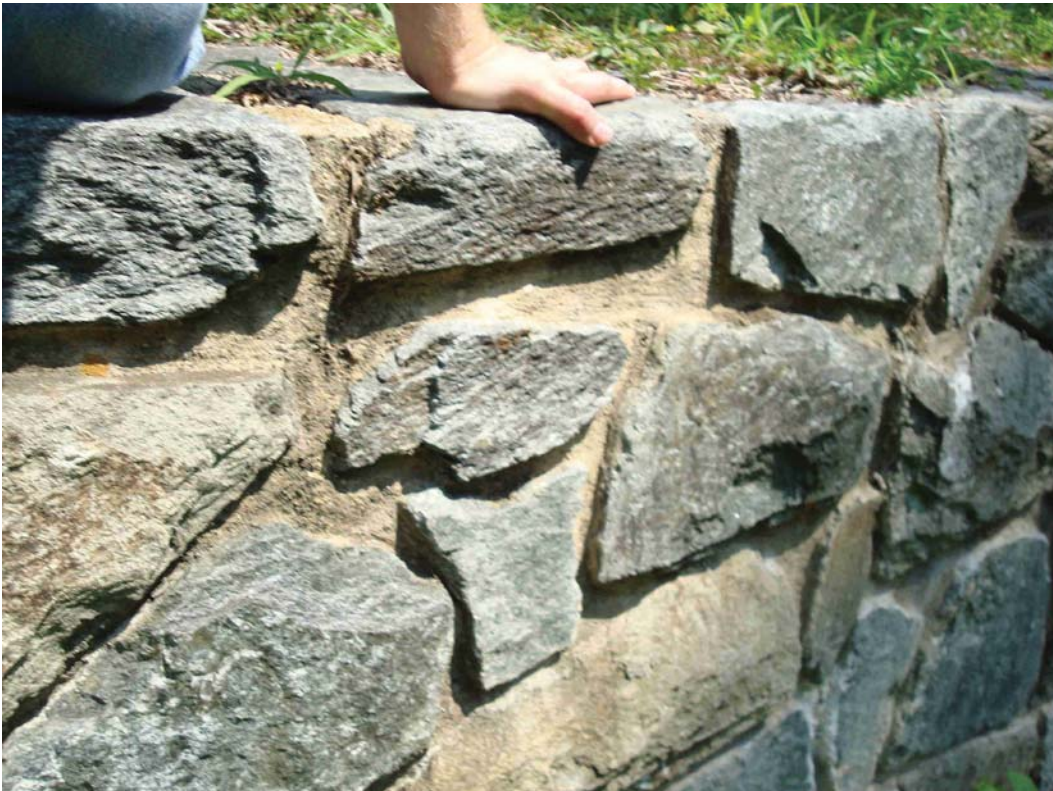
Wall ID:	GWMP-0005ZZ-0.510-L		
Route Name:	SPOUT RUN PARKWAY WESTBOUND AND RAMPS		
Inspection Date:	July 16, 2007	Approximate Year Built:	Unknown
*Wall Rating:	79	Maintenance Action:	No Action

Element (Weighting Factor)	Narrative	Condition Rating (0 - 10)
PERFORMANCE 8.00	No global distresses or evidence of repair	8
WALL FOUNDATION MATERIAL 8.00	No evidence of settlement or erosion	8
MORTAR 8.00	Sound, durable, aged and discolored	8
STONE MASONRY 8.00	No fractures or degradation	8
LATERAL SLOPE 0.50	Flat	8
ROAD/SIDEWALK/SHOULDER 0.50	Grassed, flat	8
DOWNSLOPE 1.00	3H:1V	7
WALL DRAINS 1.00	No drains visible, appears well-drained	7

Failure Consequence:	MODERATE
Recommendation Narrative:	None
Repair Cost:	\$0

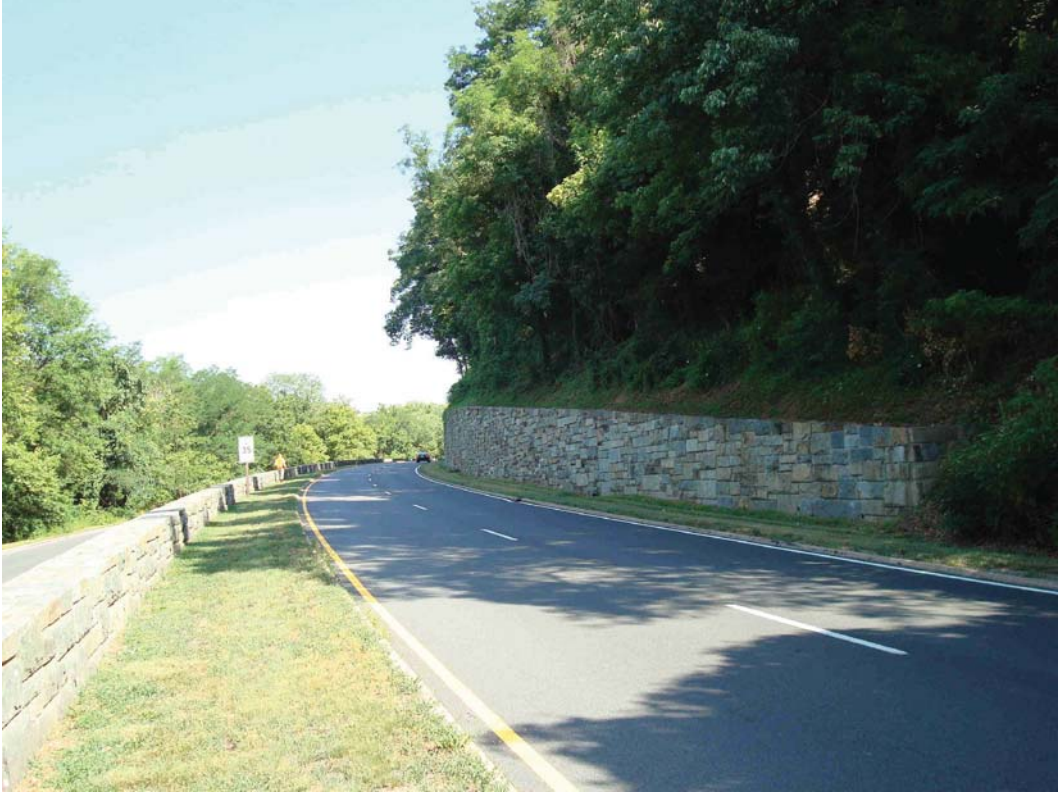
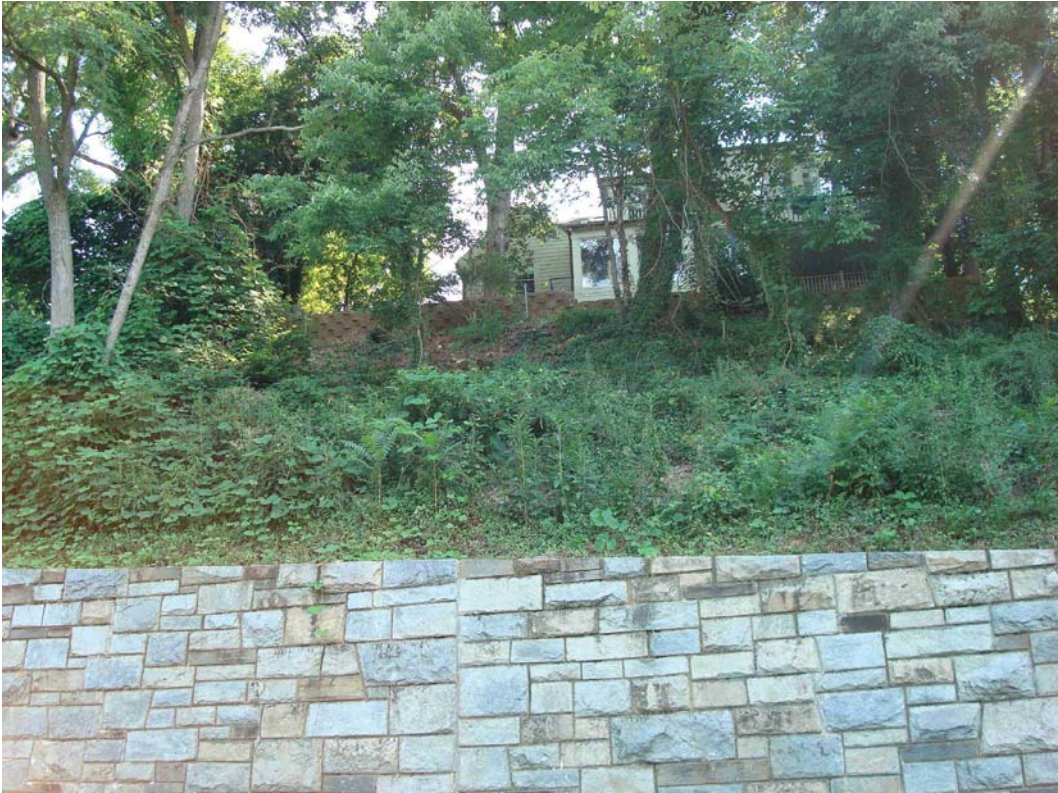
Wall ID:	GWMP-0006-0.844-R		
Route Name:	WB (OUTBOUND) CLARA BARTON MEMORIAL PARKWAY		
Inspection Date:	July 17, 2007	Approximate Year Built:	Unknown
*Wall Rating:	74	Maintenance Action:	Maintenance

Element (Weighting Factor)	Narrative	Condition Rating (0 - 10)
PERFORMANCE 8.00	Good condition, minor separation of mortar, needs weep holes cleaned out	7
WALL FOUNDATION MATERIAL 8.00	No settlement or erosion of foundation materials	8
MORTAR 8.00	Limited minor separation from stone	7
STONE MASONRY 8.00	Very good condition, no spalls	8
ROAD/SIDEWALK/SHOULDER 0.50	Grassed shoulder	8
WALL DRAINS 1.00	Weep holes approximately 10 ft. on center. Some reportedly covered/filled with leaves/grass from mowing.	6
LATERAL SLOPE 1.00	Gradual	7
UPSLOPE 1.00	Recent tree cutting performed at top of wall. Slope is approximately 2H:1V, homes at top of slope, chain link fence is 15 ft. up slope from top of wall.	7

Failure Consequence:	MODERATE
Recommendation Narrative:	Clean out weep holes - 30 hours * \$55/hr
Repair Cost:	\$1,650

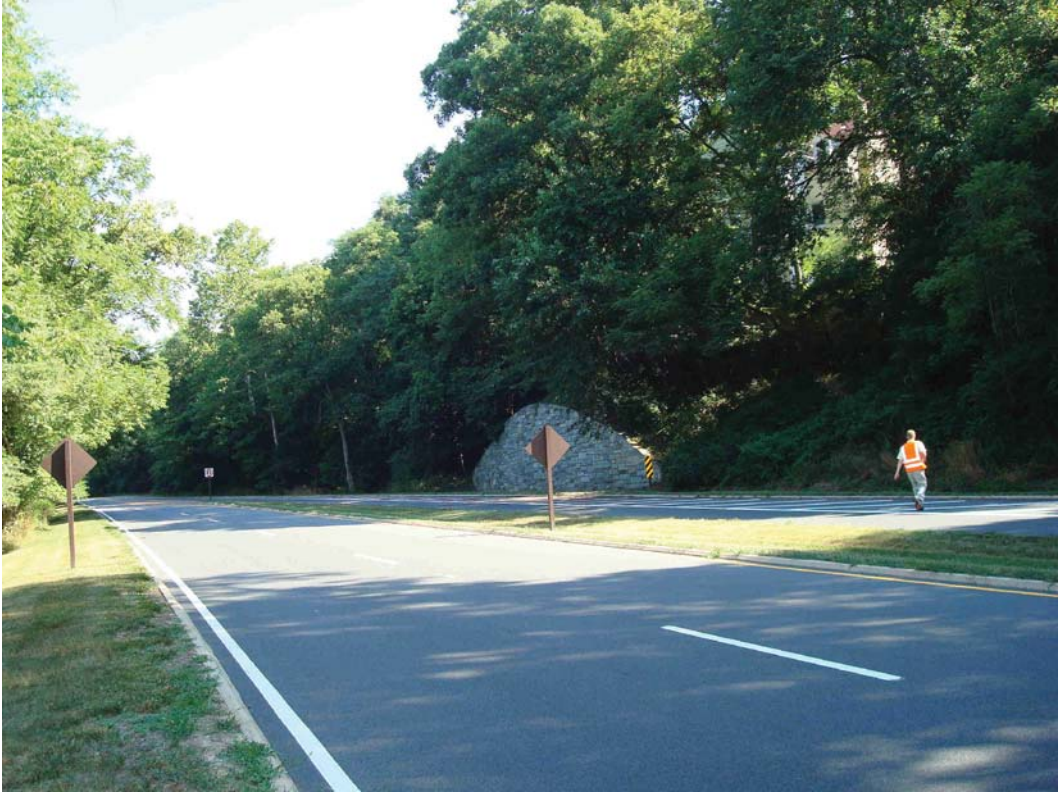
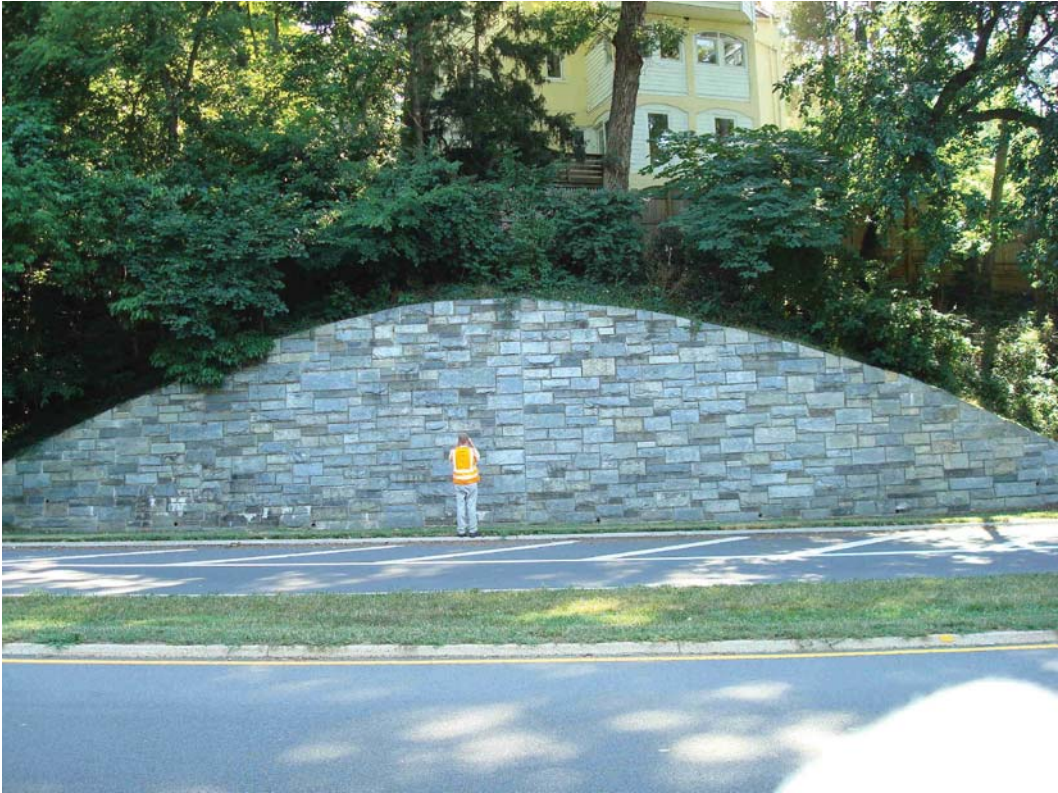
Wall ID:	GWMP-0006-1.310-R		
Route Name:	WB (OUTBOUND) CLARA BARTON MEMORIAL PARKWAY		
Inspection Date:	July 17, 2007	Approximate Year Built:	Unknown
*Wall Rating:	80	Maintenance Action:	No Action

Element (Weighting Factor)	Narrative	Condition Rating (0 - 10)
PERFORMANCE 8.00	Overall good performance	8
WALL FOUNDATION MATERIAL 8.00	No evidence of settlement or erosion	8
MORTAR 8.00	Slight efflorescence, darkened, good condition	8
STONE MASONRY 8.00	Sound and durable	8
DOWNSLOPE 0.50	Flat	8
LATERAL SLOPE 0.50	Gradual	8
WALL DRAINS 0.50	Drains 10' on center	8
UPSLOPE 1.00	Flat 10', then 2H:1V, Private wood log retaining wall at East end above wall, 28' horizontally from wall face	7

Failure Consequence:	MODERATE
Recommendation Narrative:	None
Repair Cost:	\$0

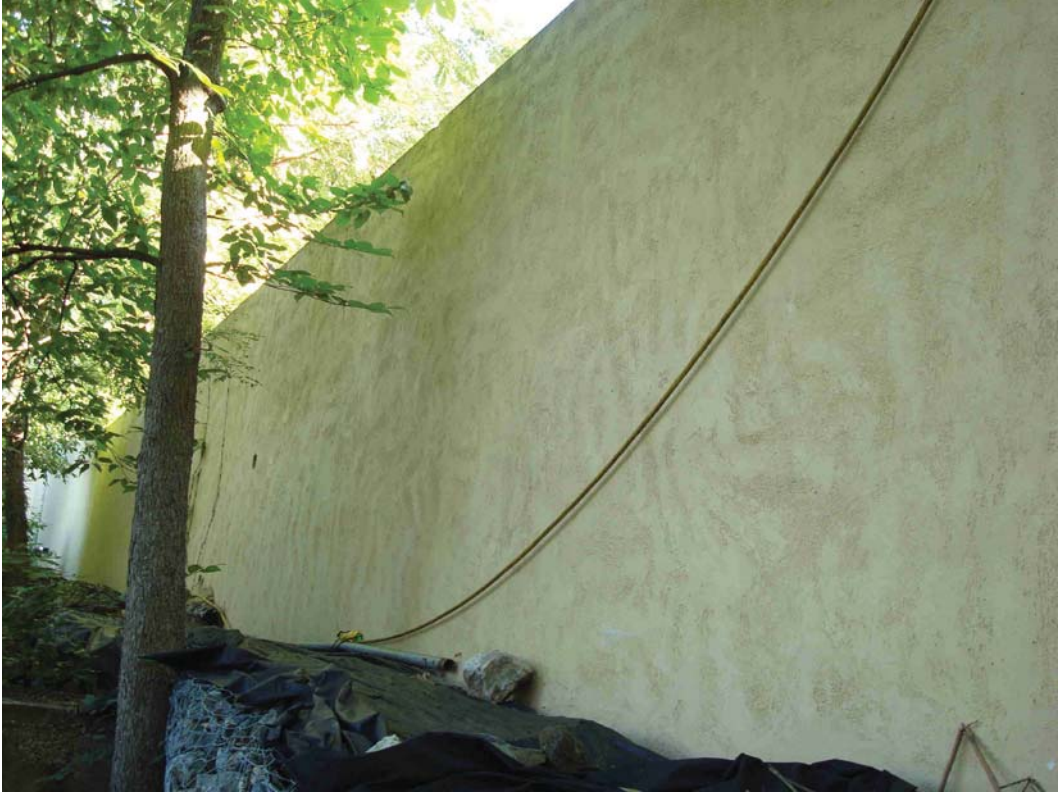
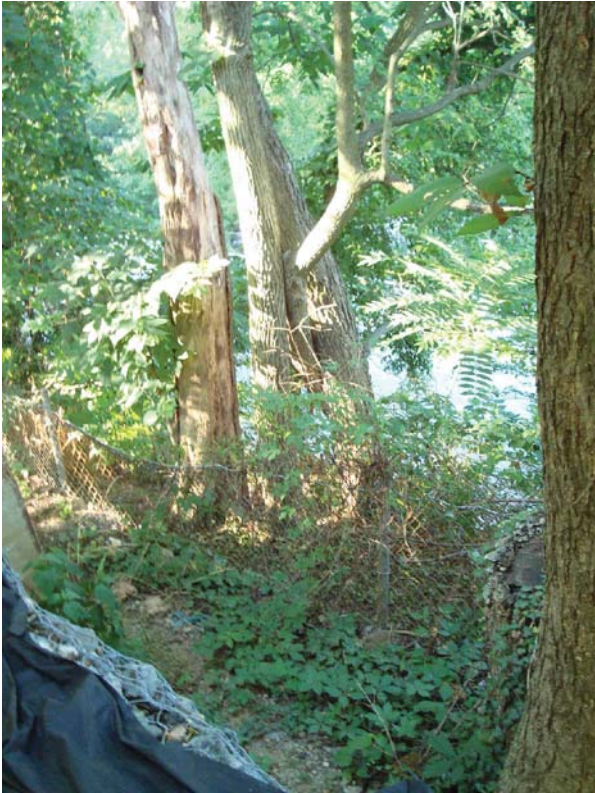
Wall ID:	GWMP-0006-2.876-R		
Route Name:	WB (OUTBOUND) CLARA BARTON MEMORIAL PARKWAY		
Inspection Date:	July 16, 2007	Approximate Year Built:	Unknown
*Wall Rating:	63	Maintenance Action:	Repair Elements

Element (Weighting Factor)	Narrative	Condition Rating (0 - 10)
PERFORMANCE 8.00	Overall performing well, but roof drainage is undermining gabion basket. Threatens gabion element function and hazard to traffic below if there was a failure.	5
WALL FOUNDATION MATERIAL 8.00	Undermining/erosion of gabions at one location. Lack of treatment threatens element function. Likely caused by roof drainage directly to foundation soils.	4
CONCRETE 8.00	Yellow-painted retaining wall connected to building foundation. Concrete durable, no sign of spalling.	8
WIRE/GEOSYNTHETIC FACING 8.00	Gabion baskets in good condition, no degradation, but foundation undermining a section of wall (see Wall Foundation Material)	8
DOWNSLOPE 1.00	Flat 10 ft. horizontally, then 1H:1V for 20 ft. horizontally - severe slope to Clara Barton Parkway WB	6
CULVERT 1.00	12" black corrugated pipe through base of wall	7
LATERAL SLOPE 1.00	Flat to gradual	7

Failure Consequence:	MODERATE
Recommendation Narrative:	Gabion underpinning/stabilization, maintain a minimum 2 ft. of cover below ground nearest ground surface - 150 s.f. * \$110/s.f. = \$16,500. Mob 12% EE = \$1,980. Difficult access - add 20% - = \$3,696. Consider redirecting drainage to a more protected area.
Repair Cost:	\$22,176

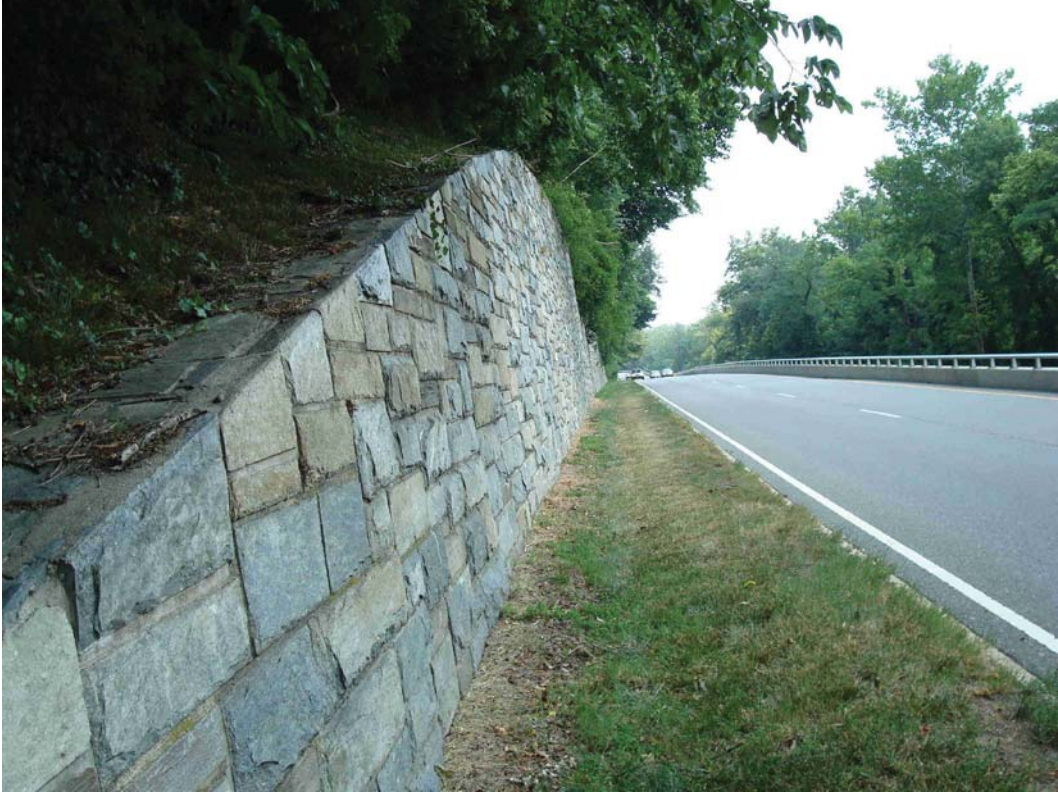
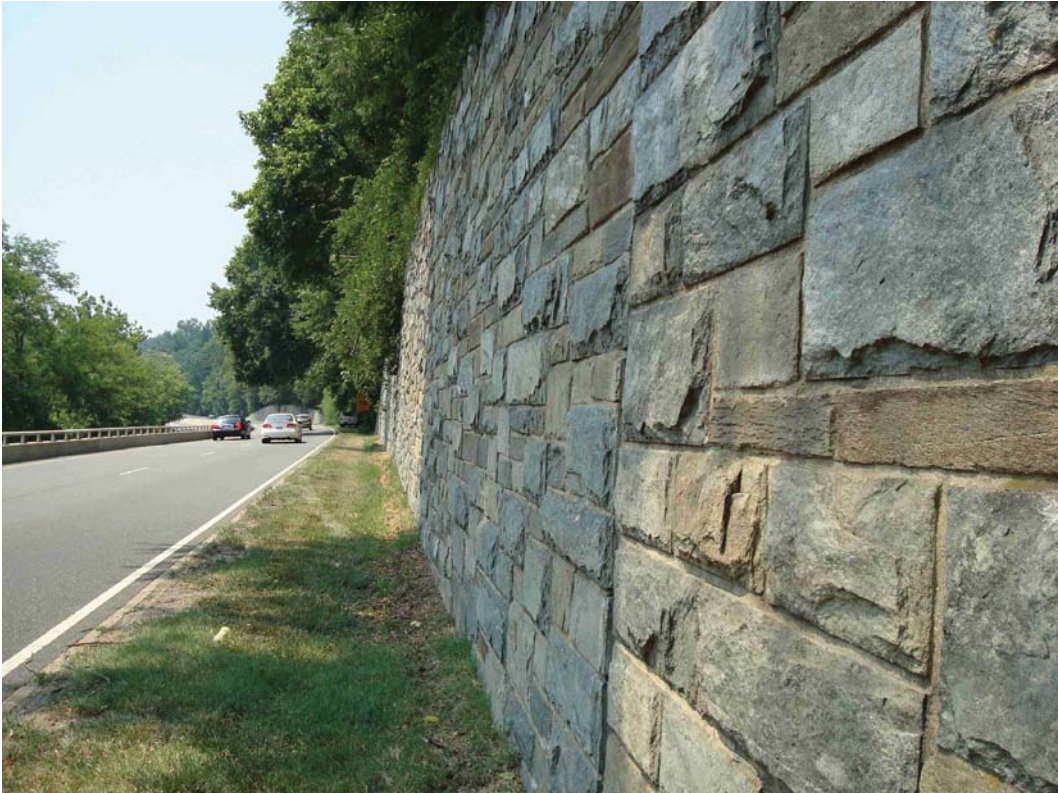
Wall ID:	GWMP-0006-3.160-R		
Route Name:	WB (OUTBOUND) CLARA BARTON MEMORIAL PARKWAY		
Inspection Date:	July 09, 2007	Approximate Year Built:	Unknown
*Wall Rating:	84	Maintenance Action:	Maintenance

Element (Weighting Factor)	Narrative	Condition Rating (0 - 10)
PERFORMANCE 8.00	Overall good performance, need to clean drains	8
WALL FOUNDATION MATERIAL 8.00	No evidence of settlement or erosion	9
MORTAR 8.00	minor efflorescence, minor light moss	8
STONE MASONRY 8.00	Good condition, no degradation	9
LATERAL SLOPE 0.50	Slight slope	8
WALL DRAINS 0.50	Not visible, reportedly filled in/buried	8
DOWNSLOPE 1.00	Divided highway, elevation drop of 15'	7
UPSLOPE 1.00	3H:1V	7

Failure Consequence:	MODERATE
Recommendation Narrative:	Clean weep holes - 20 hours * \$55/hr
Repair Cost:	\$1,100

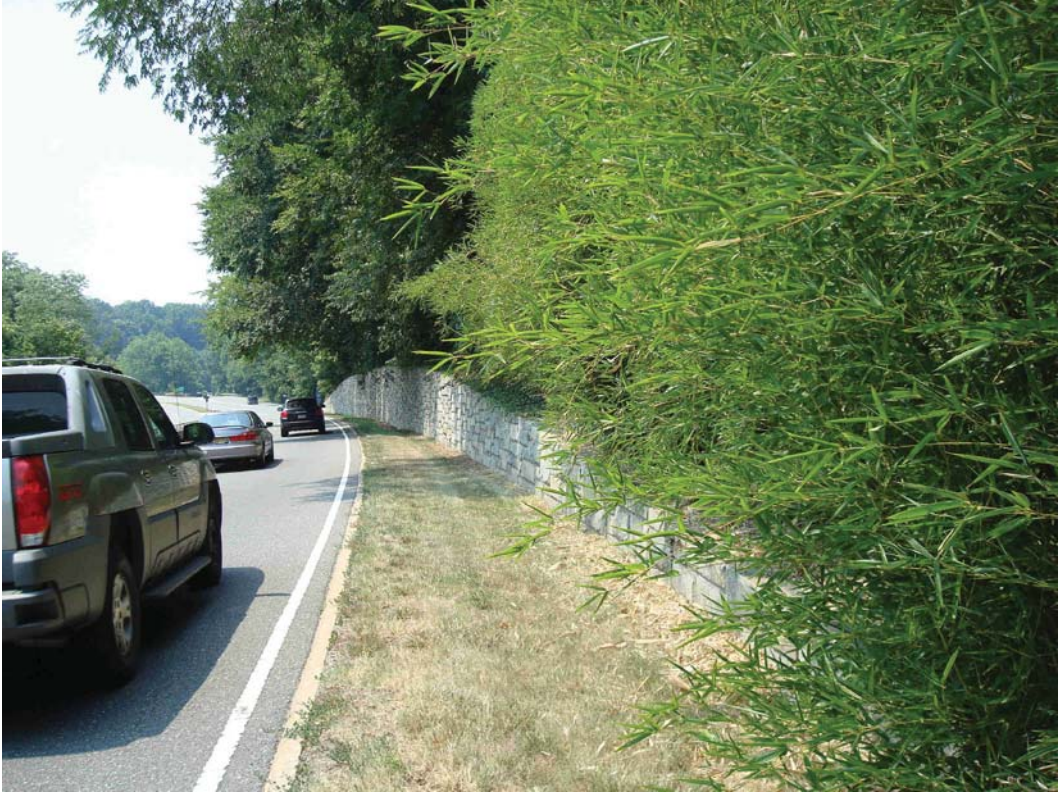
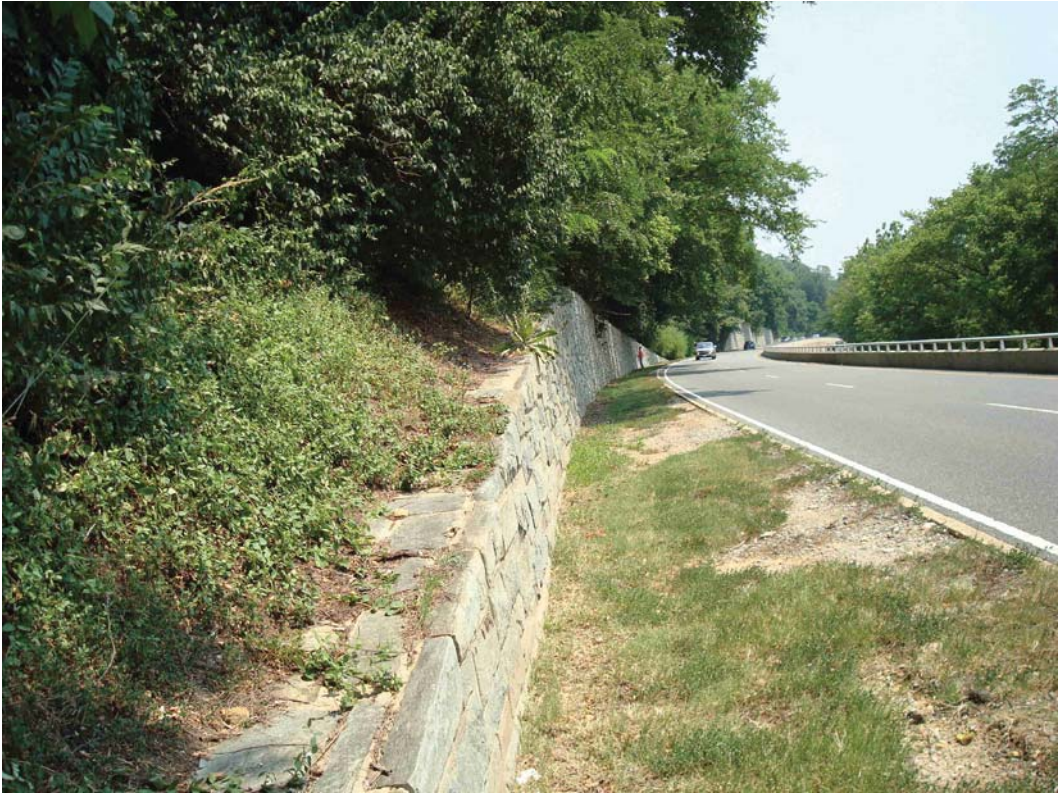
Wall ID:	GWMP-0006-3.284-R		
Route Name:	WB (OUTBOUND) CLARA BARTON MEMORIAL PARKWAY		
Inspection Date:	July 09, 2007	Approximate Year Built:	Unknown
*Wall Rating:	81	Maintenance Action:	Maintenance

Failure Consequence:	MODERATE
Recommendation Narrative:	Clean weep holes - 20 hrs * \$55/hr
Repair Cost:	\$1,100

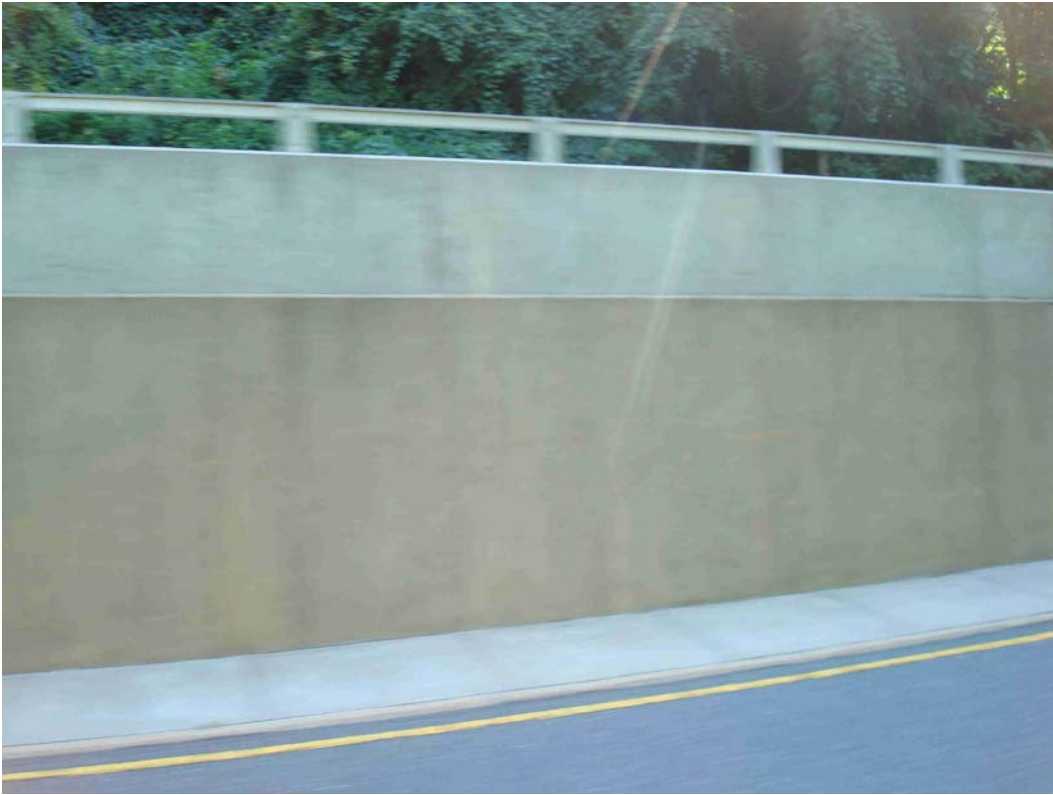
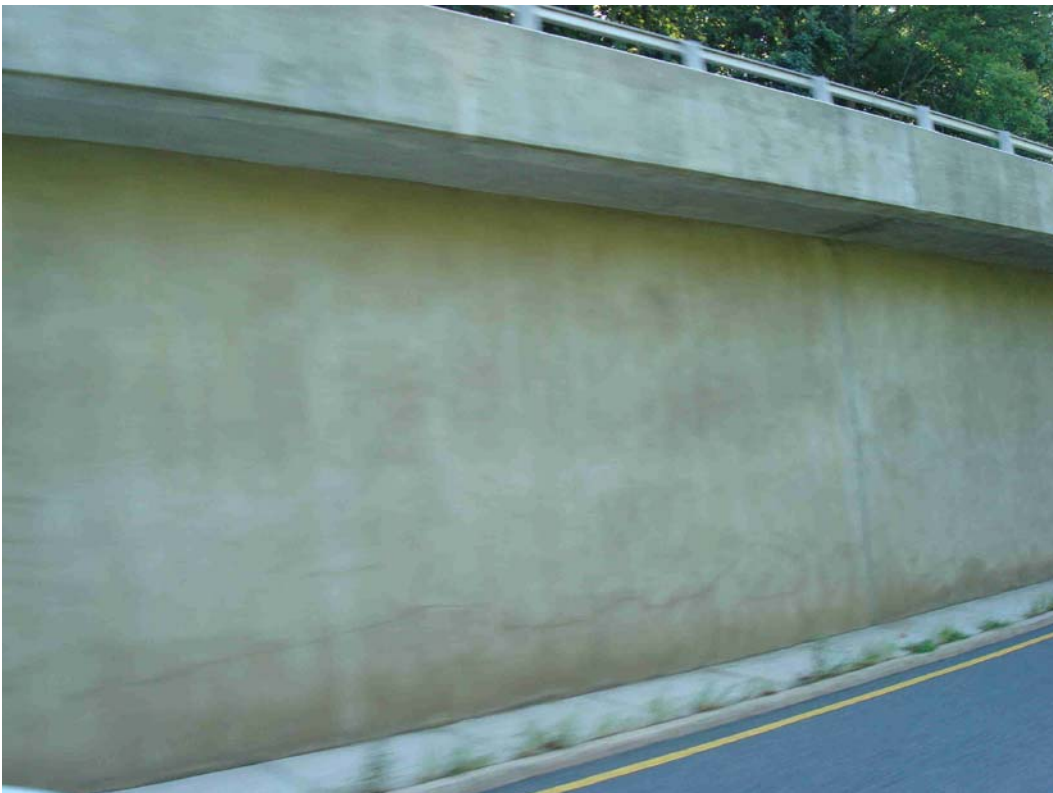
Wall ID:	GWMP-0007-3.542-L		
Route Name:	EB (INBOUND) CLARA BARTON MEMORIAL PARKWAY		
Inspection Date:	July 17, 2007	Approximate Year Built:	1960
*Wall Rating:	79	Maintenance Action:	No Action

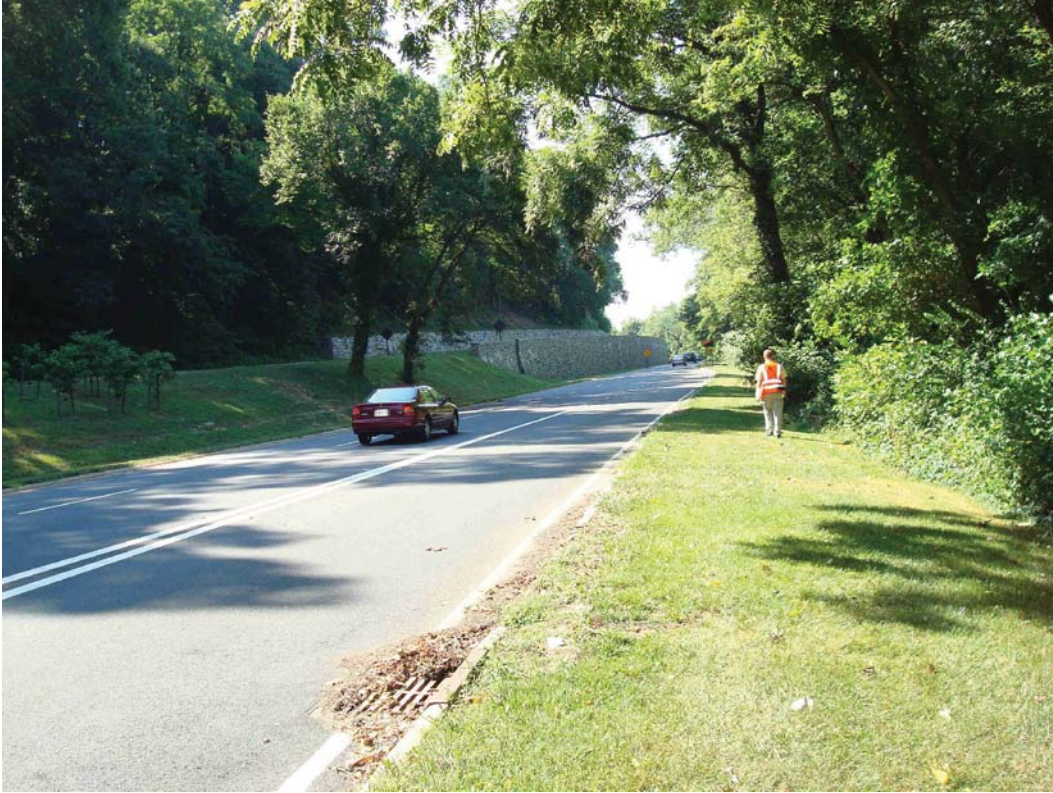
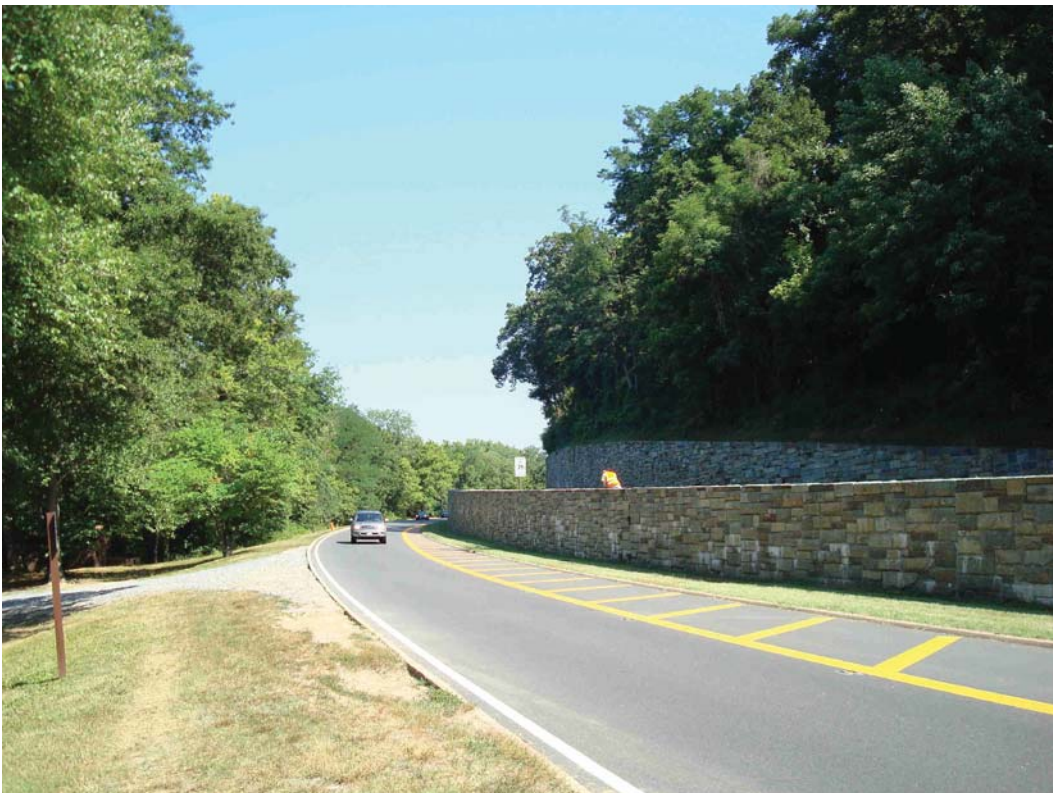
Wall ID:	GWMP-0007-5.819-L		
Route Name:	EB (INBOUND) CLARA BARTON MEMORIAL PARKWAY		
Inspection Date:	July 17, 2007	Approximate Year Built:	Unknown
*Wall Rating:	68	Maintenance Action:	Repair Elements

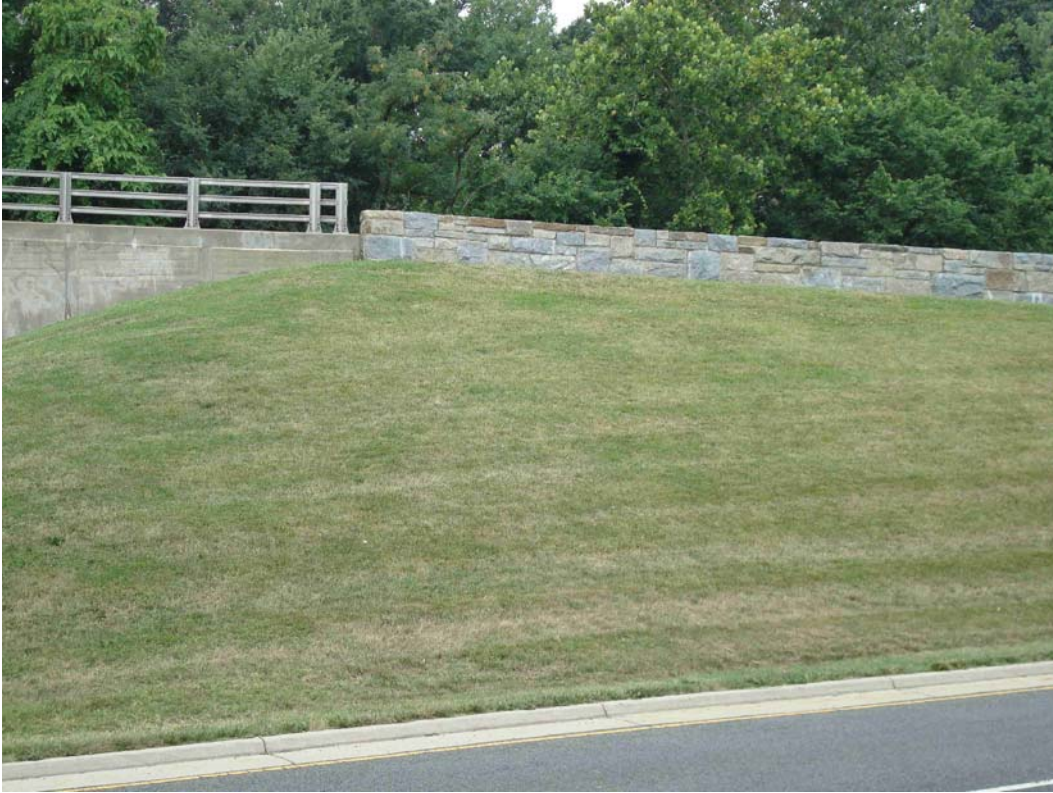
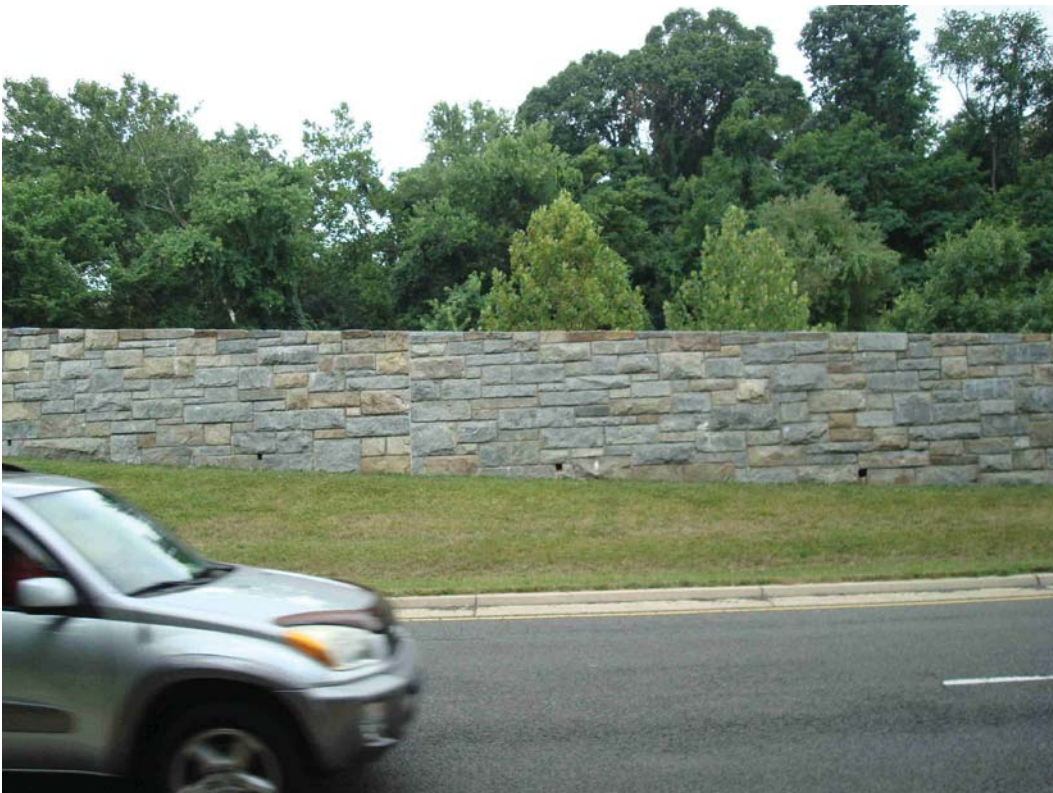
Wall ID:	GWMP-0509B-0.147-R		
Route Name:	ROSSLYN CIRCLE RAMP TO NB GWMP		
Inspection Date:	July 11, 2007	Approximate Year Built:	Unknown
*Wall Rating:	79	Maintenance Action:	No Action

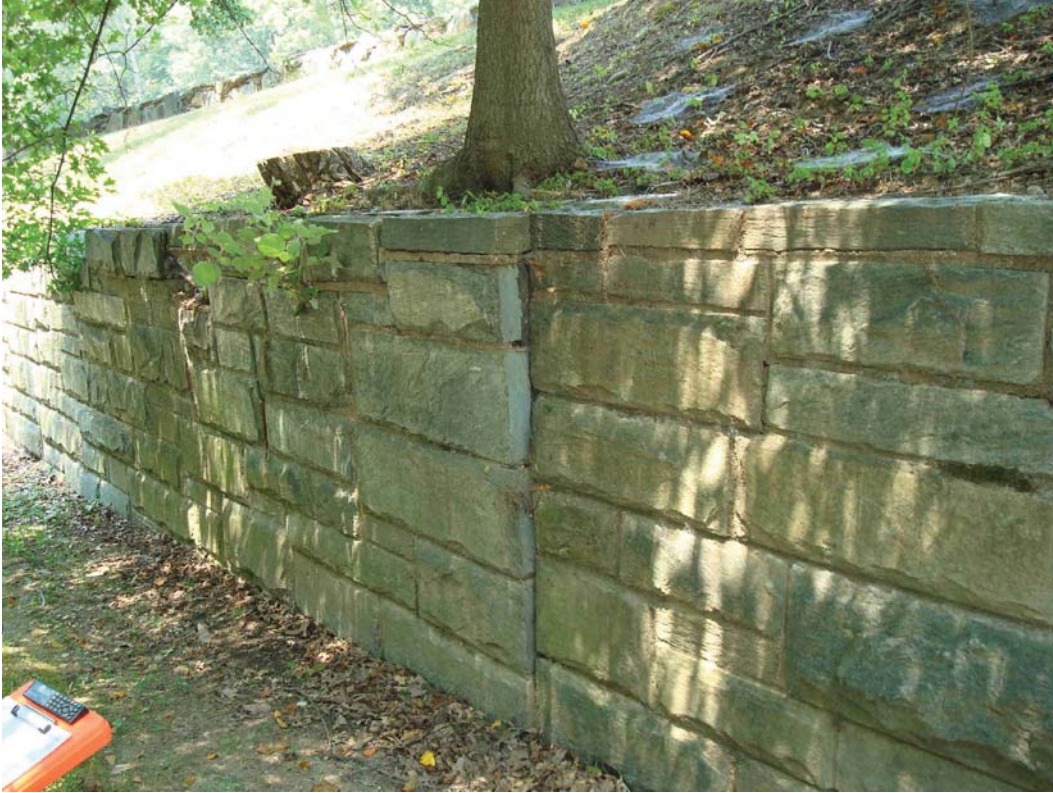
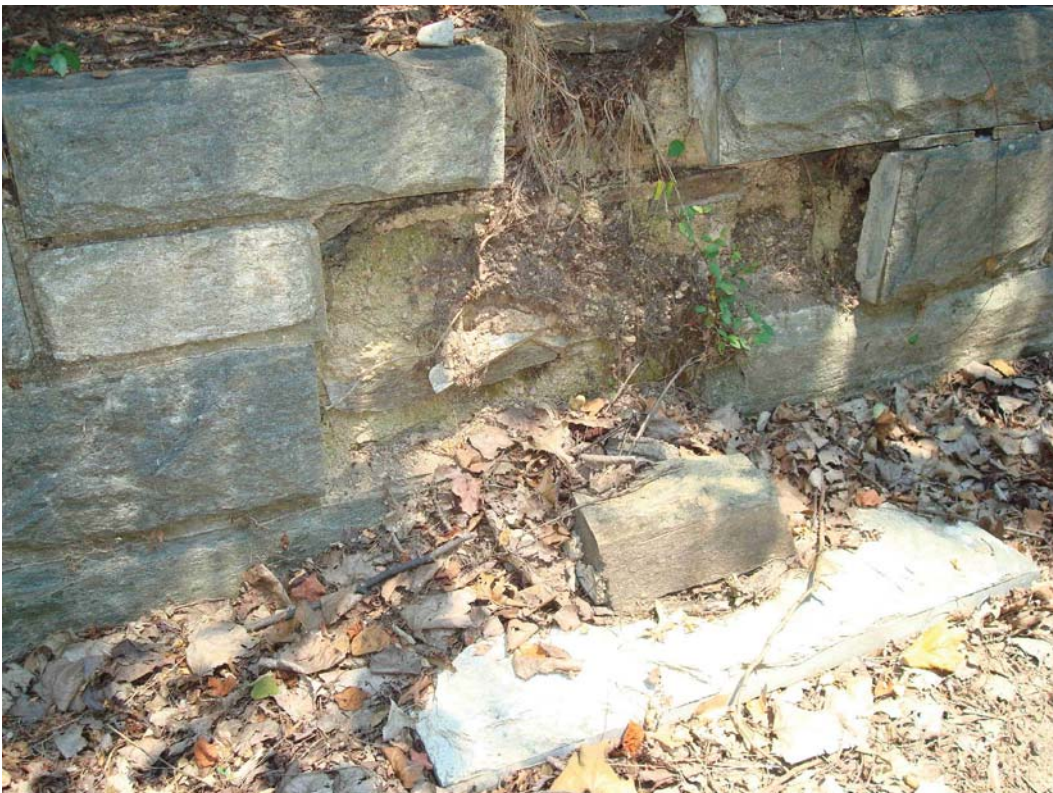
Wall ID:	GWMP-0513AZZ-0.032-R		
Route Name:	EB CLARA BARTON PARKWAY RAMPS AND SPUR AT CARDEROCK AND NAVAL RESEARCH CENTER		
Inspection Date:	July 09, 2007	Approximate Year Built:	Unknown
*Wall Rating:	58	Maintenance Action:	Replace Elements

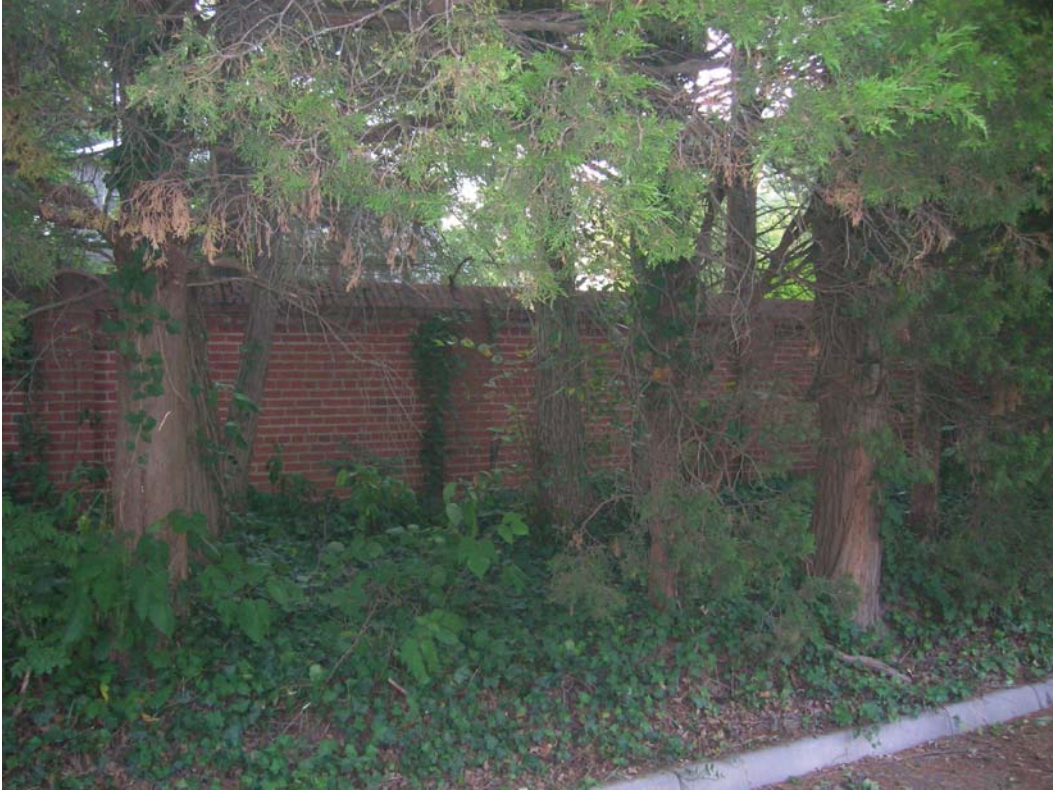
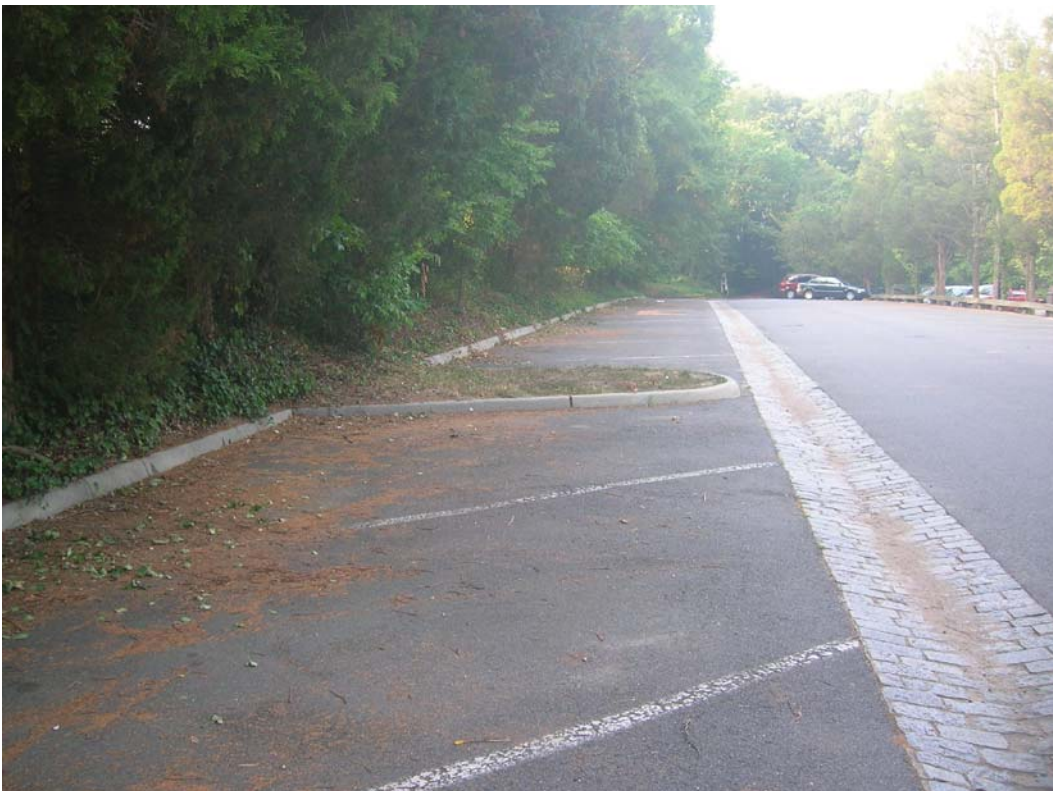
Wall ID:	GWMP-0917-0.000-P1		
Route Name:	MOUNT VERNON PARKING EAST LOT		
Inspection Date:	July 10, 2007	Approximate Year Built:	Unknown
*Wall Rating:	72	Maintenance Action:	No Action
