NPS Retaining Wall Inventory Program George Washington Memorial Parkway

**Federal Lands Highway
Road Inventory Program**

**Data Collection Date: December 2007
Report Date: October 2015**

George Washington Memorial Parkway in District of Columbia, Maryland, and Virginia

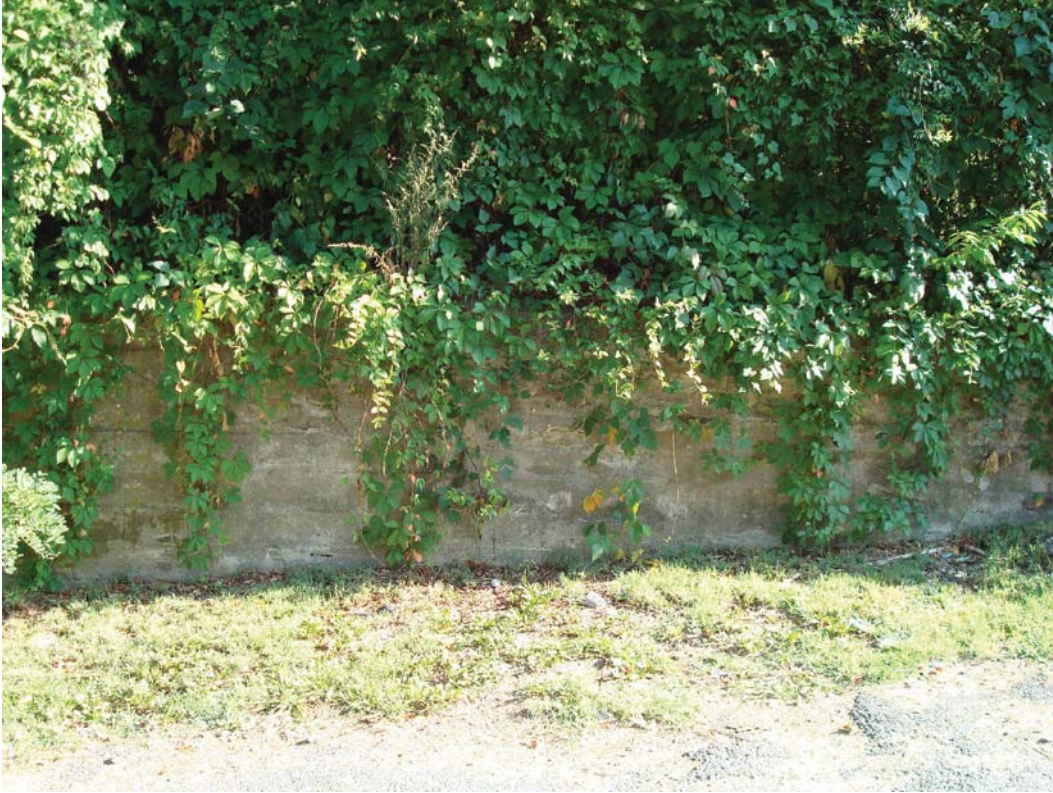
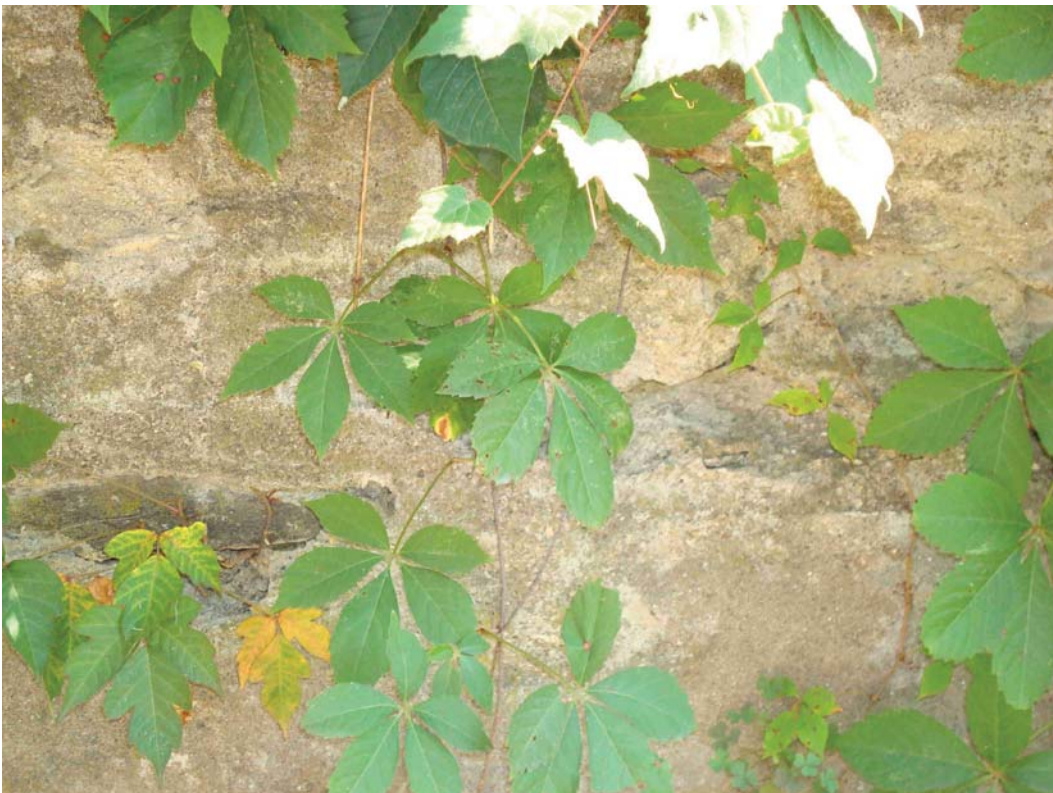
Wall ID:	GWMP-0933-0.000-P1		
Route Name:	GLEN ECHO SERVICE AREA		
Inspection Date:	July 17, 2007	Approximate Year Built:	Unknown
*Wall Rating:	68	Maintenance Action:	Repair Elements

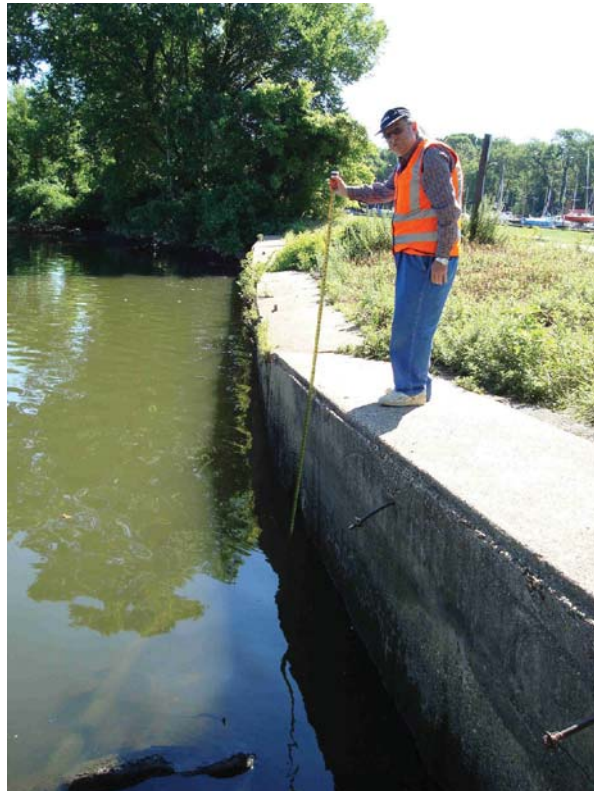
GWMP_0936ZZ_0.000_P1_2.jpg

Wall ID:	GWMP-0936ZZ-0.000-P1		
Route Name:	WASHINGTON MARINA PARKING AREAS		
Inspection Date:	July 12, 2007	Approximate Year Built:	Unknown
*Wall Rating:	48	Maintenance Action:	Replace Wall
