HALE WIP Report

NPS Retaining Wall Inventory Program Haleakala National Park

Federal Highway Administration
Eastern Federal Lands Highway Division
Road Inventory Program (RIP)

Data Collection Date: July 2007
Report Date: October 2015

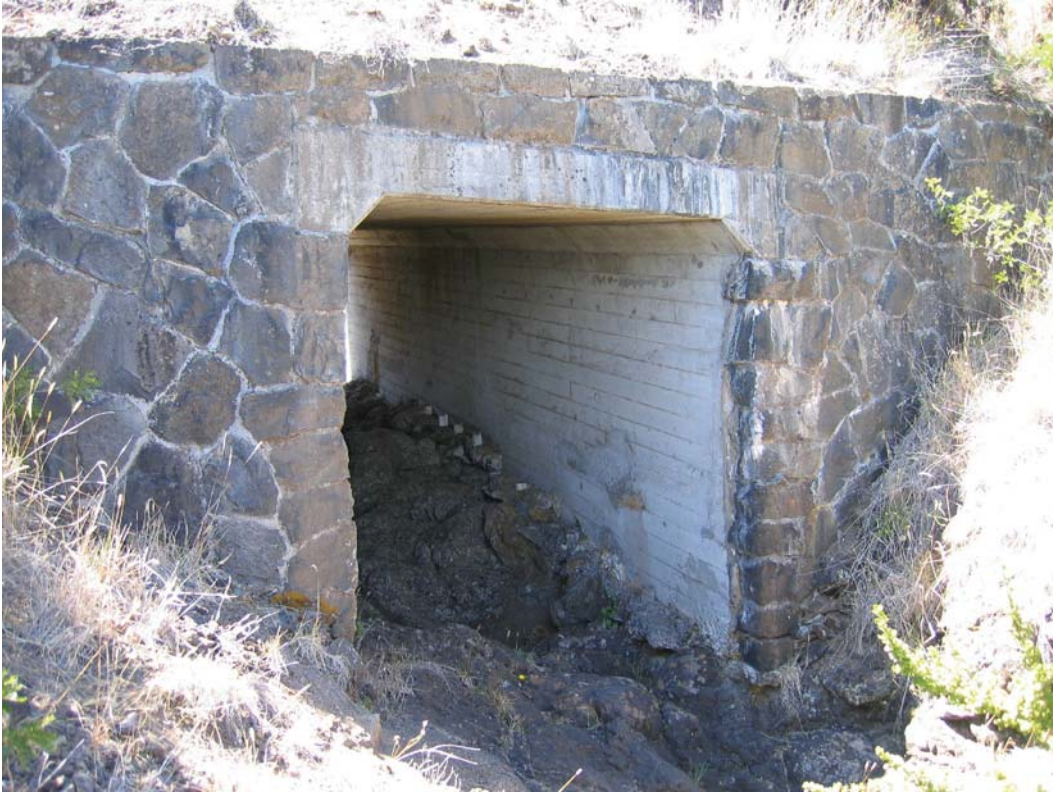
HALE_0010_2.947_R_1.jpg

Wall ID:	HALE-0010-2.947-R		
Route Name:	HALEAKALA PARK ROAD		
Inspection Date:	July 10, 2007	Approximate Year Built:	1934
*Wall Rating:	79	Maintenance Action:	No Action

Element (Weighting Factor)	Narrative	Condition Rating (0 - 10)
PERFORMANCE 8.00	Performing well and good overall stability.	8
WALL FOUNDATION MATERIAL 8.00	Rocks and soil sufficient to support wall, no signs of settlement.	8
MORTAR 8.00	Minor cracking and shrinkage in the upper layers.	8
STONE MASONRY 8.00	Good condition. No elements missing, no signs of settlement or bulging.	8
CULVERT 1.00	2' CMP in good condition.	7
DOWNSLOPE 1.00	Heavily vegetated; minor scour/erosion.	7
LATERAL SLOPE 1.00	Very steep 1:1, well vegetated with bushes.	7
UPSLOPE 1.00	Slope protection riprap placed for 1:1 slope; good condition.	7
WALL DRAINS 1.00	No drainage related distress.	7

Failure Consequence:	HIGH
Recommendation Narrative:	None
Repair Cost:	\$0

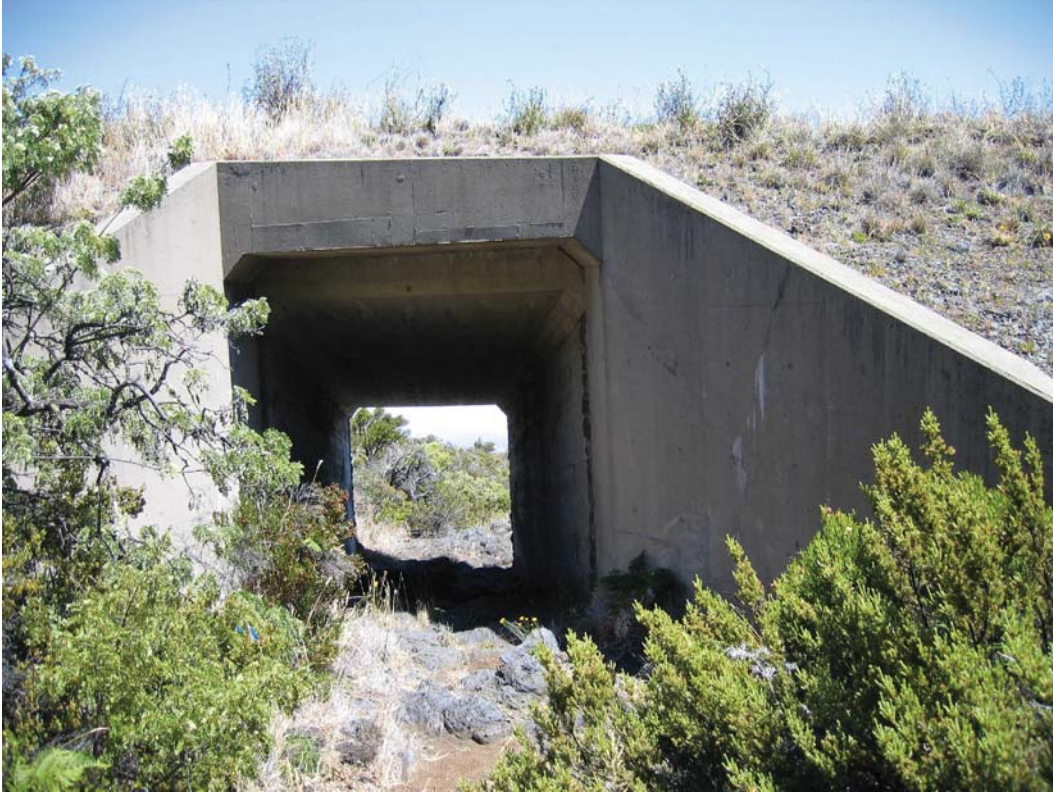
HALE_0010_2.991_L_1.jpg

Wall ID:	HALE-0010-2.991-L		
Route Name:	HALEAKALA PARK ROAD		
Inspection Date:	July 10, 2007	Approximate Year Built:	1934
*Wall Rating:	76	Maintenance Action:	No Action

Element (Weighting Factor)	Narrative	Condition Rating (0 - 10)
PERFORMANCE 8.00	Newly installed wall, no settlement, good overall stability.	8
WALL FOUNDATION MATERIAL 8.00	Bedrock sufficient to support wall.	8
CONCRETE 8.00	Concrete is sound and durable; minor cracking and fatigue. No spalling, no water seepage.	7
DOWNSLOPE 0.50	Bedrock, stable, no signs of erosion.	8
UPSLOPE 0.50	Stable soil/gravel fill with boulders.	8
CULVERT 1.00	10' x 10' CIP culvert in good condition.	7
LATERAL SLOPE 1.00	Compacted, stable soil, no signs of erosion, a few bushes.	7
VEGETATION 1.00	No vegetation impacts on the wall.	7
WALL DRAINS 1.00	No drainage related distress.	7

Failure Consequence:	HIGH
Recommendation Narrative:	None
Repair Cost:	\$0

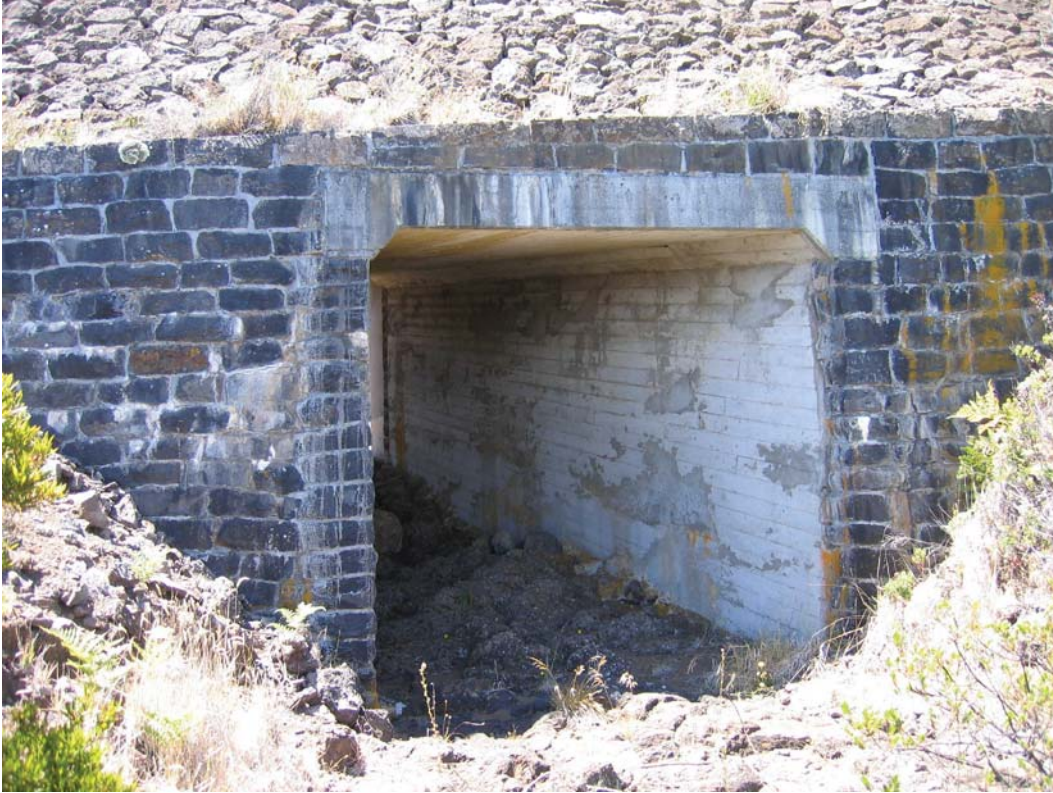
HALE_0010_2.991_R_1.jpg

Wall ID:	HALE-0010-2.991-R		
Route Name:	HALEAKALA PARK ROAD		
Inspection Date:	July 10, 2007	Approximate Year Built:	1934
*Wall Rating:	79	Maintenance Action:	No Action

Element (Weighting Factor)	Narrative	Condition Rating (0 - 10)
PERFORMANCE 8.00	Performing well and good overall stability.	8
WALL FOUNDATION MATERIAL 8.00	Rocks and soil sufficient to support wall, no signs of settlement.	8
MORTAR 8.00	New mortar recently added.	8
STONE MASONRY 8.00	Good condition. No elements missing, no signs of settlement or bulging.	8
CULVERT 1.00	2' CMP in good condition.	7
DOWNSLOPE 1.00	Heavily vegetated; minor scour/erosion.	7
LATERAL SLOPE 1.00	Very steep 1:1, well vegetated with bushes.	7
UPSLOPE 1.00	Slope protection riprap placed for 1:1 slope; good condition.	7
WALL DRAINS 1.00	No drainage related distress.	7

Failure Consequence:	HIGH
Recommendation Narrative:	None
Repair Cost:	\$0

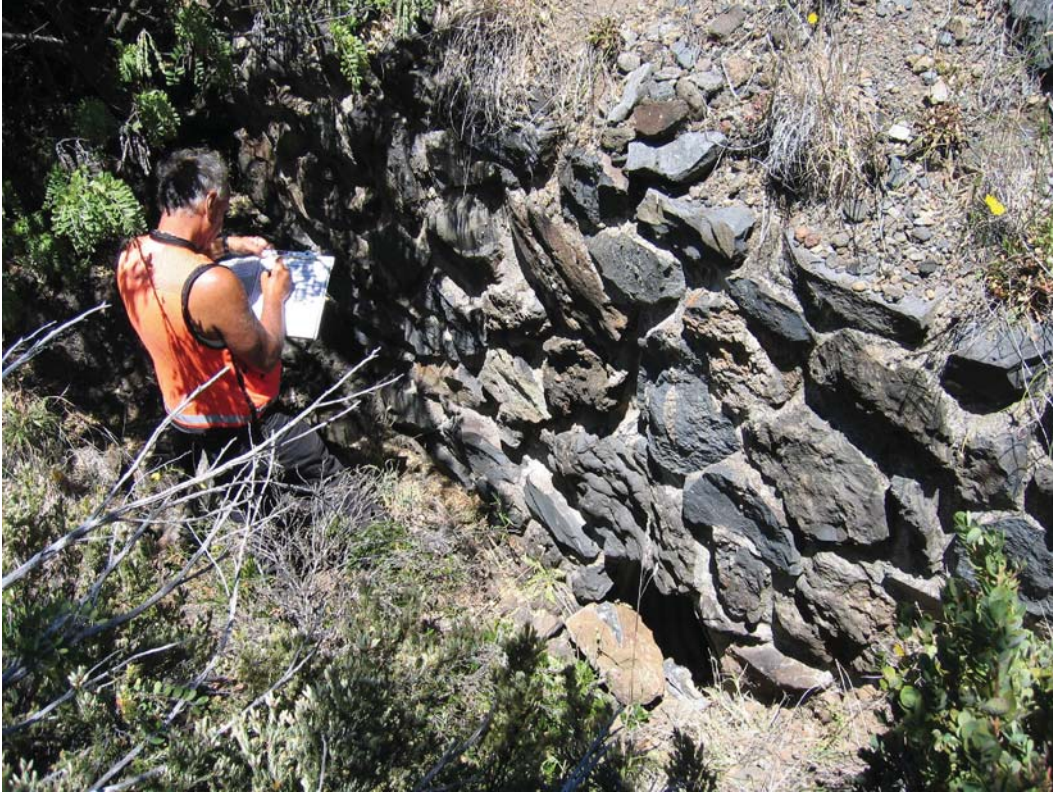
HALE_0010_3.342_L_1.jpg

Wall ID:	HALE-0010-3.342-L		
Route Name:	HALEAKALA PARK ROAD		
Inspection Date:	July 10, 2007	Approximate Year Built:	1934
*Wall Rating:	72	Maintenance Action:	No Action

Element (Weighting Factor)	Narrative	Condition Rating (0 - 10)
PERFORMANCE 8.00	Performing as designed, no signs of distress, good global stability.	7
WALL FOUNDATION MATERIAL 8.00	Bedrock with boulders, sufficient to support wall.	8
MORTAR 8.00	Good condition, intact, no shrinkage or cracking.	7
STONE MASONRY 8.00	Good condition, strong, no weathering or cracking; no movement or bulging.	7
WALL DRAINS 0.50	No drainage related distress.	8
CULVERT 1.00	2' CMP in good condition.	7
DOWNSLOPE 1.00	Bedrock, strong and competent.	7
LATERAL SLOPE 1.00	Bedrock/soil with heavy vegetation.	7
UPSLOPE 1.00	Boulders imbedded in 1.5:1 slope; no signs of movement or failure.	7

Failure Consequence:	MODERATE
Recommendation Narrative:	None
Repair Cost:	\$0

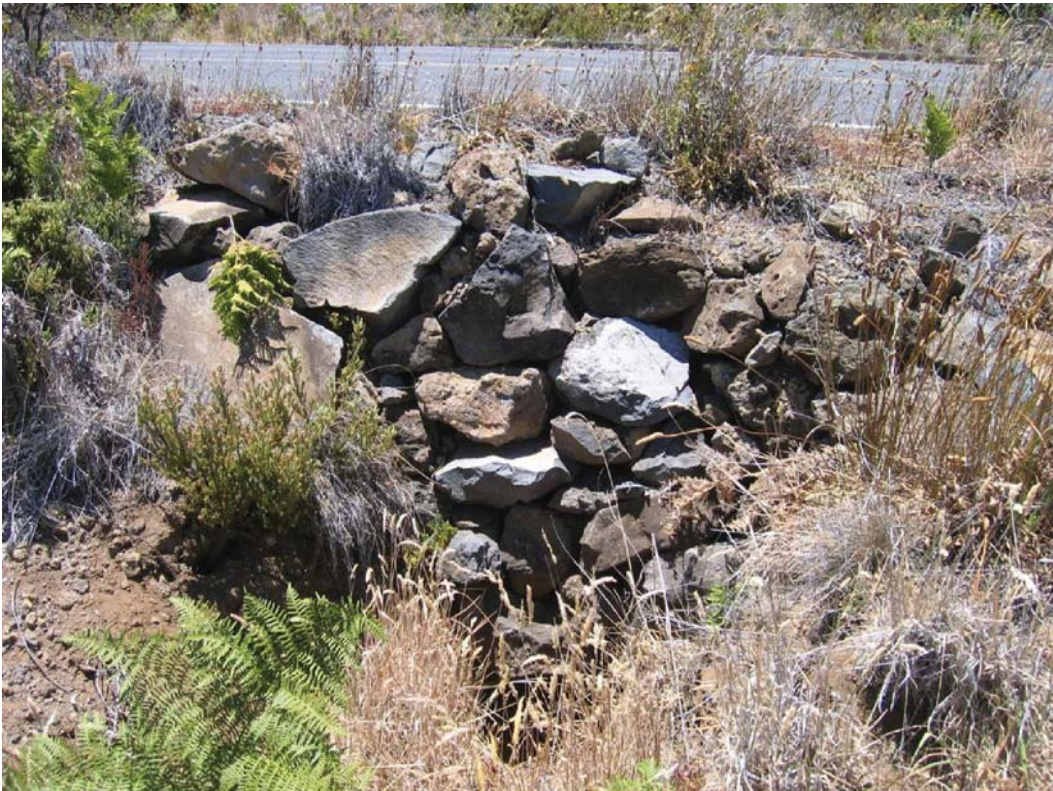
HALE_0010_3.692_L_2.jpg

Wall Function:	Head Wall	Primary Wall Type:	Gravity - Dry Stone
Surface Treatment:		Secondary Wall Type:	
Secondary Surface Treatment:		Architectural Facing:	
General Description:	Dry stack stone headwall in good condition.

Element (Weighting Factor)	Narrative	Condition Rating (0 - 10)
PERFORMANCE 8.00	Poorly constructed wall, but is stable and shows no signs of global distress.	7
WALL FOUNDATION MATERIAL 8.00	Soil and rocks.	8
PLACED STONE 8.00	Poorly stacked stones with some gaps. Stones are strong, durable.	7
ROAD/SIDEWALK/SHOULDER 0.50	No signs of wall-related distress to roadway.	8
WALL DRAINS 0.50	Free draining wall, no drainage related distress.	8
DOWNSLOPE 1.00	Channel erosion evident, but not affecting toe of wall.	7
LATERAL SLOPE 1.00	No significant erosion on minor slope.	7

Failure Consequence:	MODERATE
Recommendation Narrative:	None
Repair Cost:	\$0

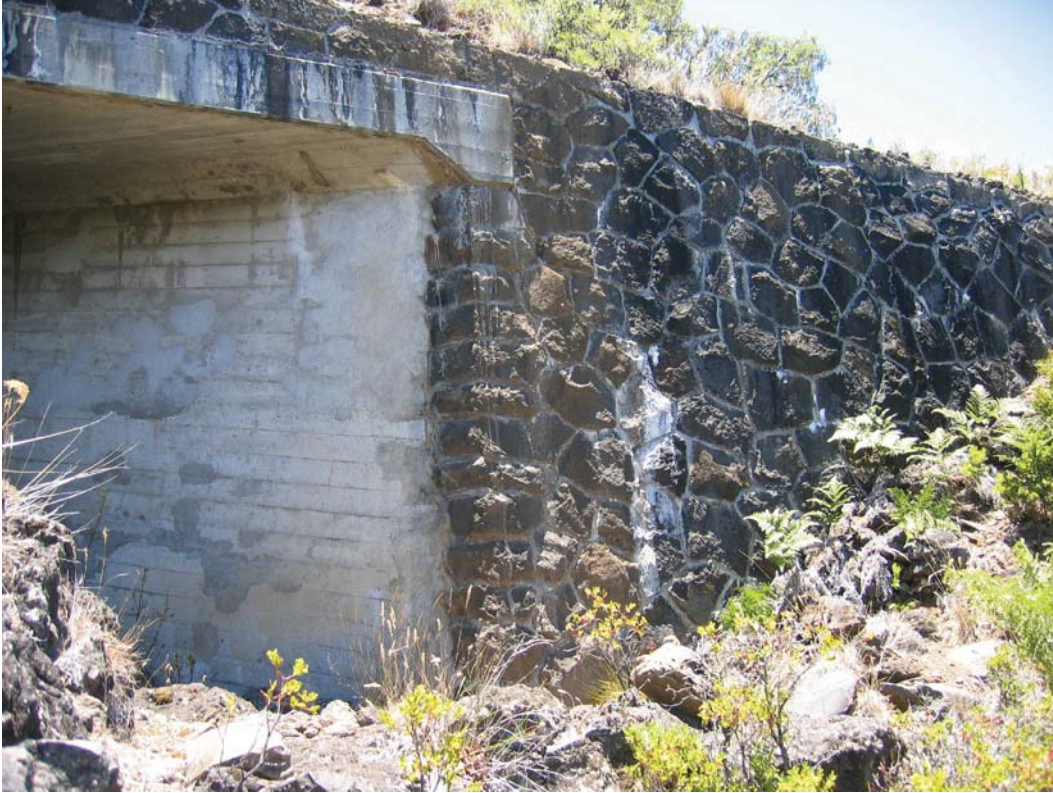
HALE_0010_3.777_L_1.jpg

Wall Function:	Head Wall	Primary Wall Type:	Gravity - Mortared Stone
Surface Treatment:		Secondary Wall Type:	
Secondary Surface Treatment:		Architectural Facing:	
General Description:	Mortared stone headwall with 10 ft x 12 ft box culvert in good condition.

Element (Weighting Factor)	Narrative	Condition Rating (0 - 10)
PERFORMANCE 8.00	Good overall performance with no signs of settlement or rotation. No evidence of prior repairs.	7
WALL FOUNDATION MATERIAL 8.00	Rock, boulders, and competent soil sufficient to support wall. No signs of scour.	7
MORTAR 8.00	Durable and sound, no signs of shrinkage or cracking; no water seepage; no missing mortar. Good condition.	7
STONE MASONRY 8.00	All stones are intact, no signs of weathering, erosion, or cracking. No signs of bulging or settlement.	7
CULVERT 1.00	2' CMP in good condition. Culvert clear with no debris.	7
DOWNSLOPE 1.00	Rock/soil compacted; no signs of erosion or scour.	7
LATERAL SLOPE 1.00	Stable slope with boulders, brush, and gravel. No signs of erosion or scour.	7
UPSLOPE 1.00	Rock/soil compacted; some vegetation. No concerns.	7
VEGETATION 1.00	No vegetation related impacts to wall stability.	7

Failure Consequence:	HIGH
Recommendation Narrative:	None
Repair Cost:	\$0

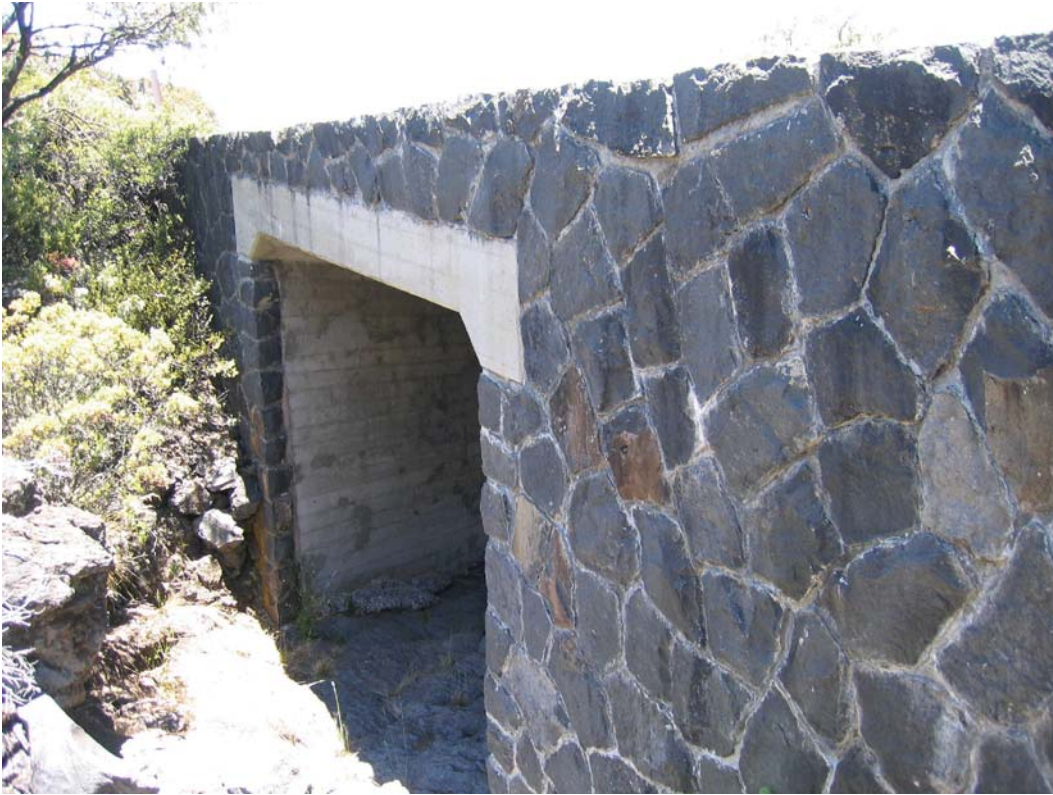
HALE_0010_3.785_R_1.jpg

Wall Function:	Head Wall	Primary Wall Type:	Gravity - Mortared Stone
Surface Treatment:		Secondary Wall Type:	
Secondary Surface Treatment:		Architectural Facing:	
General Description:	Mortared stone headwall with 10 ft x 12 ft box culvert in good condition.

Element (Weighting Factor)	Narrative	Condition Rating (0 - 10)
PERFORMANCE 8.00	Good overall performance with no signs of settlement or rotation. No evidence of prior repairs.	7
WALL FOUNDATION MATERIAL 8.00	Rock, boulders, and competent soil sufficient to support wall. No signs of scour.	7
STONE MASONRY 8.00	All stones are intact, no signs of weathering, erosion, or cracking. No signs of bulging or settlement.	7
MORTAR 8.00	Some mortar has been added recently.	8
CULVERT 1.00	2' CMP in good condition. Culvert clear with no debris.	7
DOWNSLOPE 1.00	Rock/soil compacted; no signs of erosion or scour.	7
LATERAL SLOPE 1.00	Stable slope with boulders, brush, and gravel. No signs of erosion or scour.	7
UPSLOPE 1.00	Rock/soil compacted; some vegetation. No concerns.	7
VEGETATION 1.00	No vegetation related impacts to wall stability.	7

Failure Consequence:	HIGH
Recommendation Narrative:	None
Repair Cost:	\$0

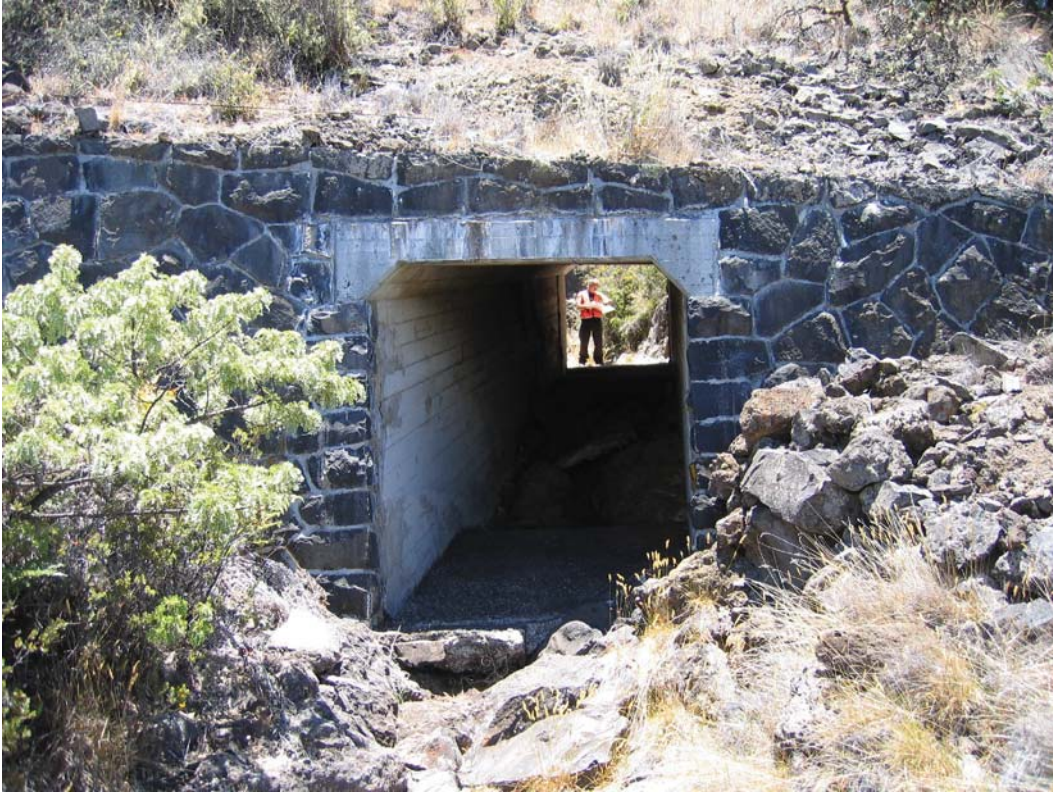
HALE_0010_3.858_L_1.jpg

Wall Function:	Head Wall	Primary Wall Type:	Gravity - Mortared Stone
Surface Treatment:		Secondary Wall Type:	
Secondary Surface Treatment:		Architectural Facing:	
General Description:	Mortared stone headwall with a 6 ft x6 ft box culvert in good condition.

Element (Weighting Factor)	Narrative	Condition Rating (0 - 10)
PERFORMANCE 8.00	Good overall performance with no signs of settlement or rotation. No evidence of prior repairs.	7
WALL FOUNDATION MATERIAL 8.00	Rock, boulders, and competent soil sufficient to support wall. No signs of scour.	7
MORTAR 8.00	Durable and sound, no signs of shrinkage or cracking; no water seepage; no missing mortar. Good condition.	7
STONE MASONRY 8.00	All stones are intact, no signs of weathering, erosion, or cracking. No signs of bulging or settlement.	7
CULVERT 1.00	2' CMP in good condition. Culvert clear with no debris.	7
DOWNSLOPE 1.00	Rock/soil compacted; no signs of erosion or scour.	7
LATERAL SLOPE 1.00	Stable slope with boulders, brush, and gravel. No signs of erosion or scour.	7
UPSLOPE 1.00	Rock/soil compacted; some vegetation. No concerns.	7
VEGETATION 1.00	No vegetation related impacts to wall stability.	7

Failure Consequence:	HIGH
Recommendation Narrative:	None
Repair Cost:	\$0

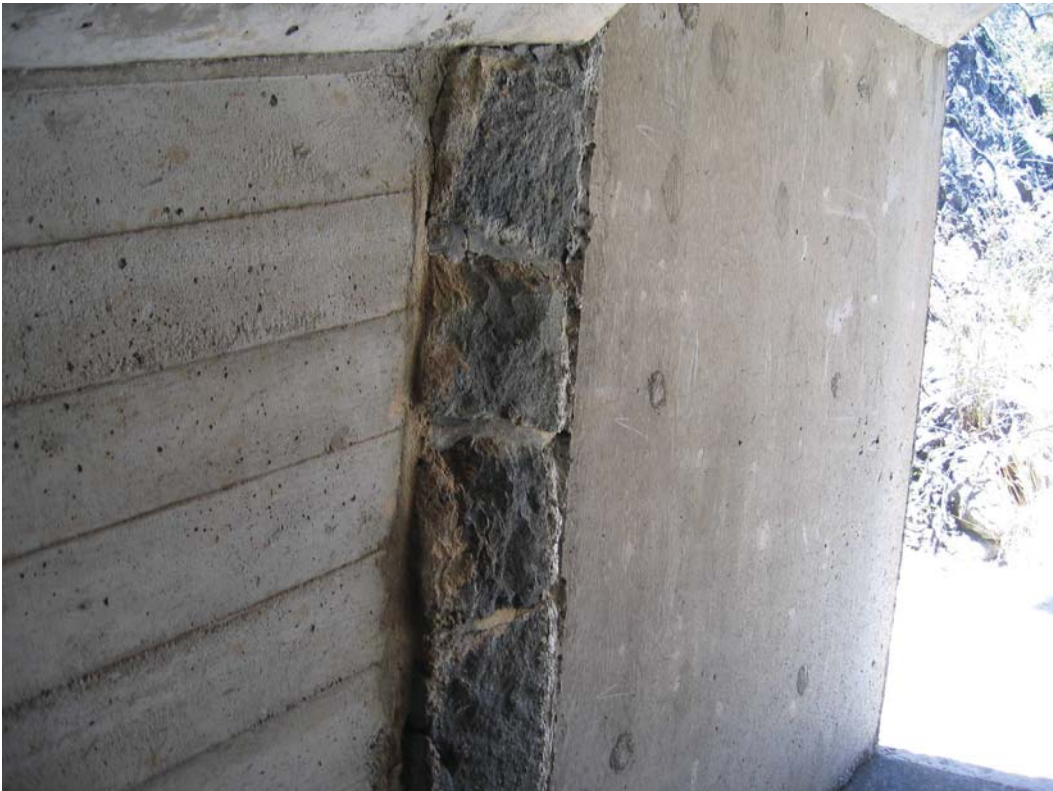
HALE_0010_3.859_R_2.jpg

Element (Weighting Factor)	Narrative	Condition Rating (0 - 10)
PERFORMANCE 8.00	Performing well and good overall stability.	8
WALL FOUNDATION MATERIAL 8.00	Concrete over bedrock.	8
CONCRETE 8.00	Good condition, no signs of cracking.	8
CULVERT 1.00	6'x6' box culvert in excellent condition.	7
DOWNSLOPE 1.00	Heavily vegetated; minor scour/erosion.	7
LATERAL SLOPE 1.00	Very steep 1:1, well vegetated with bushes.	7
UPSLOPE 1.00	Slope protection riprap placed for 1:1 slope; good condition.	7
WALL DRAINS 1.00	No drainage related distress.	7

Failure Consequence:	HIGH
Recommendation Narrative:	None
Repair Cost:	\$0

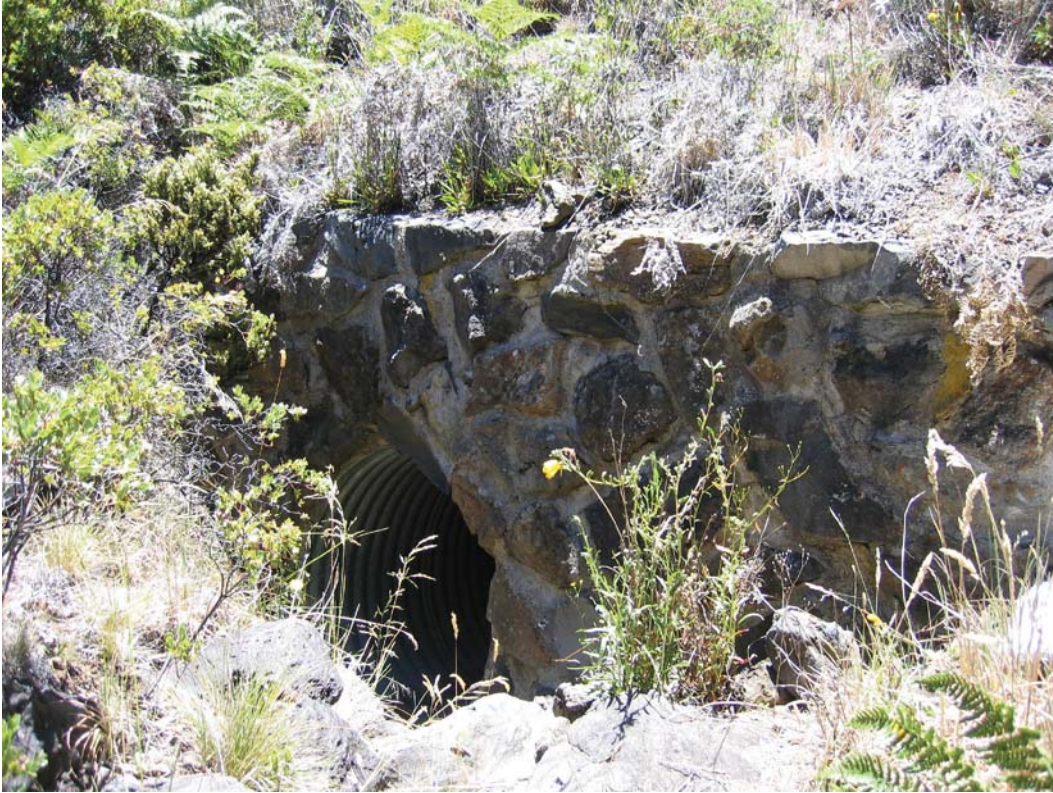
HALE_0010_4.096_R_1.jpg

Wall Function:	Head Wall	Primary Wall Type:	Gravity - Mortared Stone
Surface Treatment:		Secondary Wall Type:	
Secondary Surface Treatment:		Architectural Facing:	
General Description:	Mortared stone headwall with 3 ft CMP in good condition.

Element (Weighting Factor)	Narrative	Condition Rating (0 - 10)
PERFORMANCE 8.00	Good overall performance with no signs of settlement or rotation. No evidence of prior repairs.	7
WALL FOUNDATION MATERIAL 8.00	Rock, boulders, and competent soil sufficient to support wall. No signs of scour.	7
MORTAR 8.00	Durable and sound, no signs of shrinkage or cracking; no water seepage; no missing mortar. Good condition.	7
STONE MASONRY 8.00	All stones are intact, no signs of weathering, erosion, or cracking. No signs of bulging or settlement.	7
CULVERT 1.00	3' CMP in good condition. Culvert clear with no debris.	7
DOWNSLOPE 1.00	Rock/soil compacted; no signs of erosion or scour.	7
LATERAL SLOPE 1.00	Stable slope with boulders, brush, and gravel. No signs of erosion or scour.	7
UPSLOPE 1.00	Rock/soil compacted; some vegetation. No concerns.	7
VEGETATION 1.00	No vegetation related impacts to wall stability.	7

Failure Consequence:	HIGH
Recommendation Narrative:	None
Repair Cost:	\$0

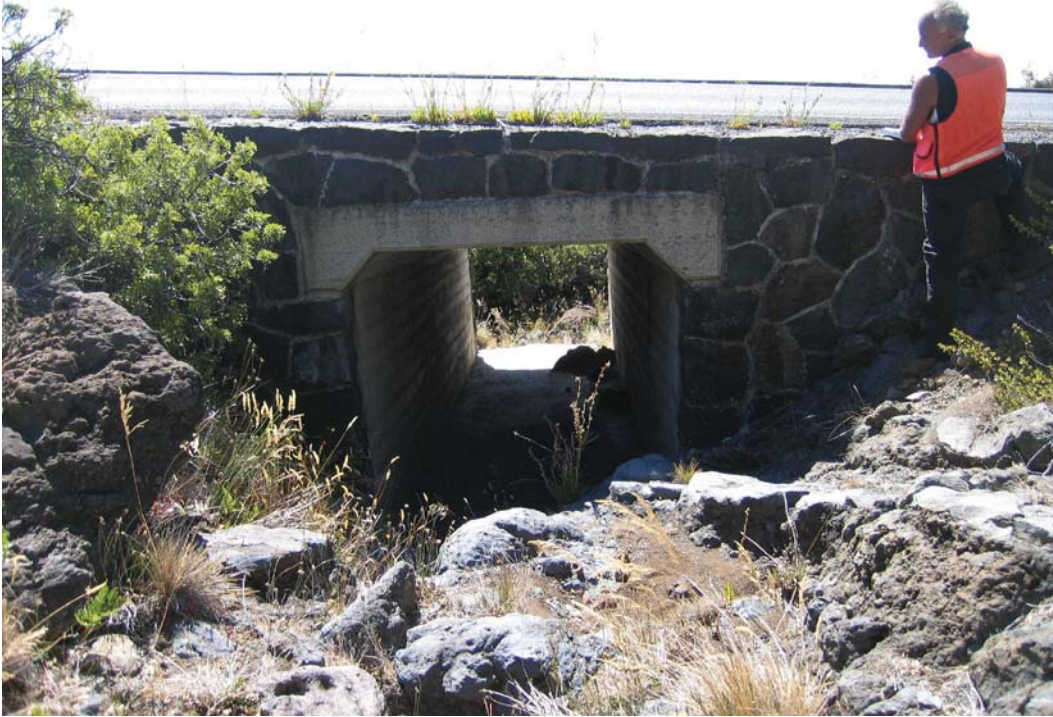
HALE_0010_5.727_L_1.jpg

Wall ID:	HALE-0010-5.727-L		
Route Name:	HALEAKALA PARK ROAD		
Inspection Date:	July 10, 2007	Approximate Year Built:	1934
*Wall Rating:	64	Maintenance Action:	Repair Elements

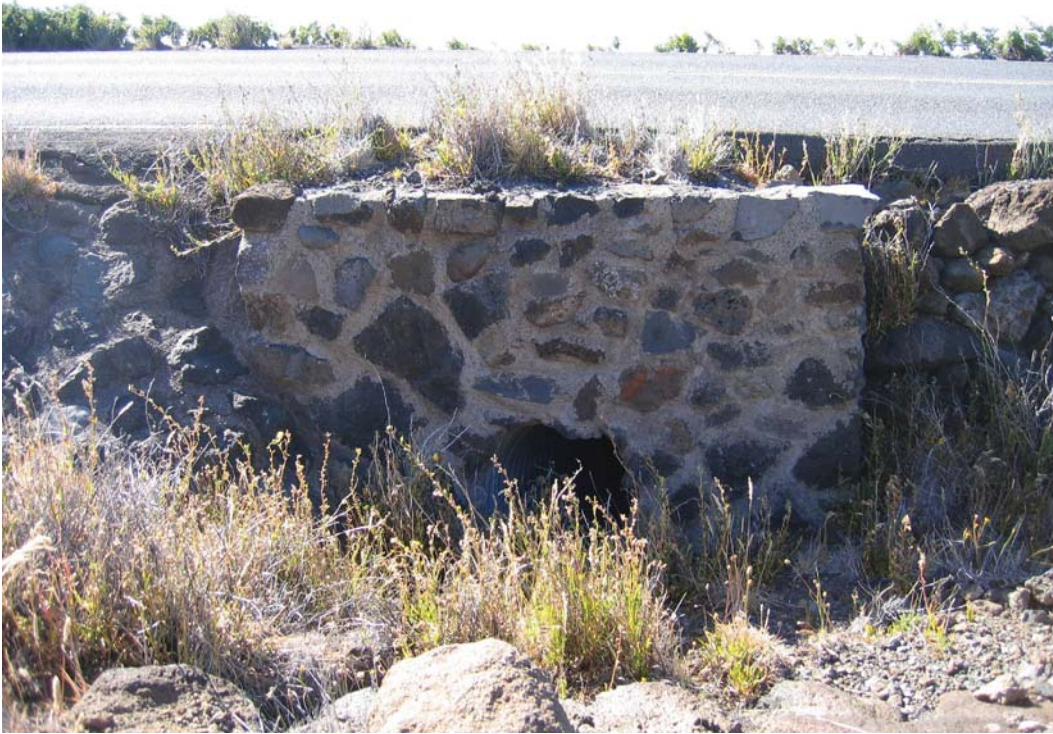
HALE_0010_5.915_L_1.jpg

Wall Function:	Head Wall	Primary Wall Type:	Gravity - Mortared Stone
Surface Treatment:		Secondary Wall Type:	
Secondary Surface Treatment:		Architectural Facing:	
General Description:	Mortared stone headwall in good condition.

Element (Weighting Factor)	Narrative	Condition Rating (0 - 10)
PERFORMANCE 8.00	Good overall performance with no signs of settlement or rotation.	8
WALL FOUNDATION MATERIAL 8.00	Solid, stable rock, sufficient for wall stability.	8
MORTAR 8.00	Minor distress with some cracking near top of wall.	8
STONE MASONRY 8.00	All stones are intact, no signs of weathering, erosion, or cracking. No signs of bulging or settlement.	8
LATERAL SLOPE 0.50	Bedrock and grouted riprap on one side, dry stack riprap on other side.	8
VEGETATION 0.50	No vegetation related impacts to wall stability.	8
WALL DRAINS 0.50	No wall drains visible; no drainage related distress.	8
UPSLOPE 1.00	Loose gravel with vegetation.	6
DOWNSLOPE 1.00	Rock/soil compacted; no signs of erosion or scour.	7

Failure Consequence:	MODERATE
Recommendation Narrative:	None
Repair Cost:	\$0

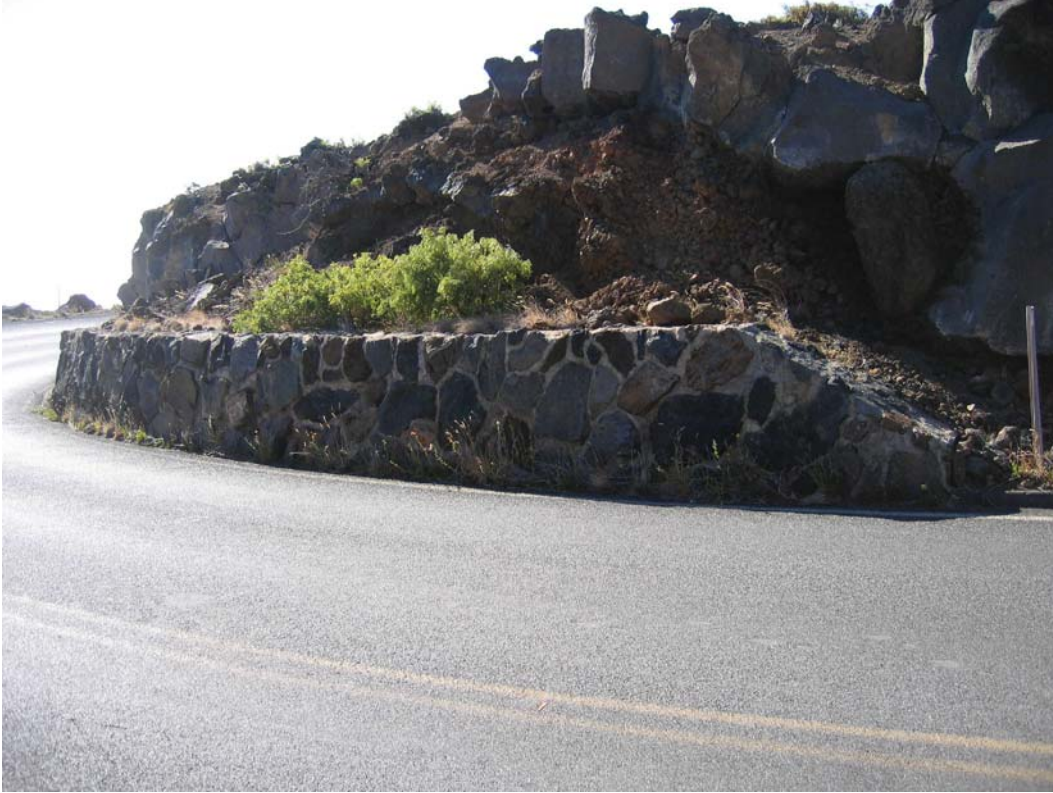
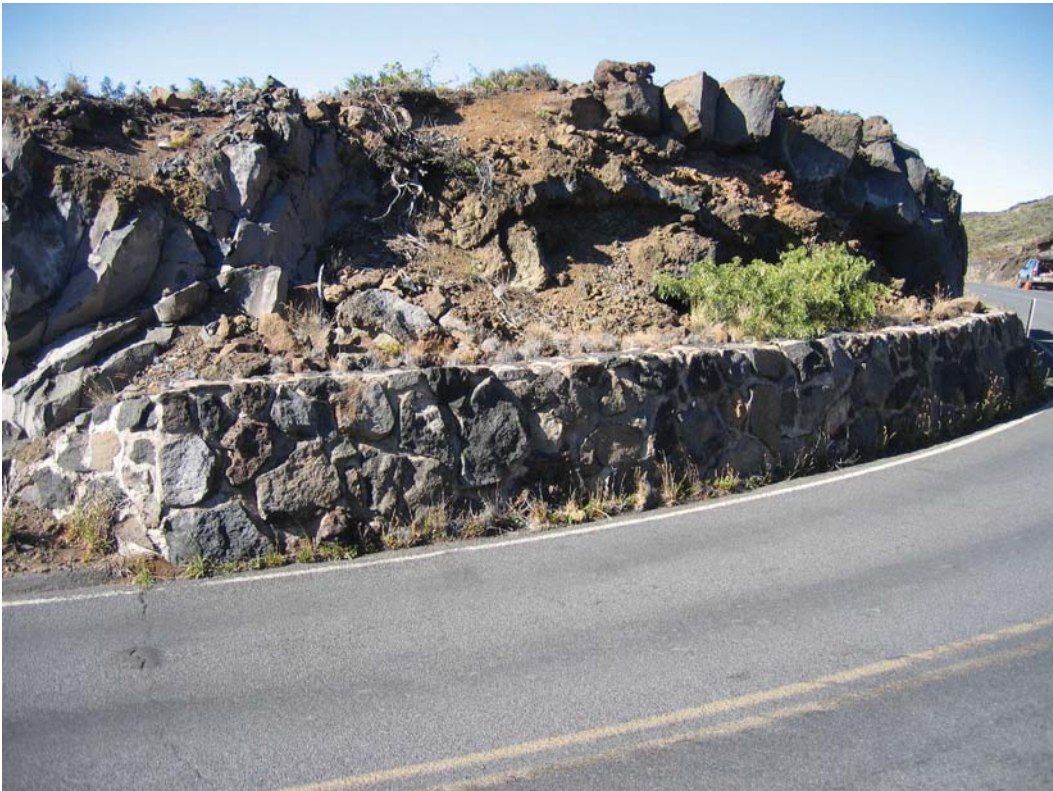
Wall Function:	Cut Wall	Primary Wall Type:	Gravity - Mortared Stone
Surface Treatment:		Secondary Wall Type:	
Secondary Surface Treatment:		Architectural Facing:	
General Description:	Mortared stone masonry cutwall in good condition.

Element (Weighting Factor)	Narrative	Condition Rating (0 - 10)
PERFORMANCE 8.00	Good overall performance with no signs of movement or global instability.	8
WALL FOUNDATION MATERIAL 8.00	Pavement; no signs of settlement, cracking or in roadway.	9
MORTAR 8.00	Minor shrinkage and cracking.	7
STONE MASONRY 8.00	No signs of cracking or weathering.	8
UPSLOPE 0.50	Steep bedrock with loose lava rocks.	8
VEGETATION 0.50	No vegetation related impacts to wall stability.	8
WALL DRAINS 0.50	PVC pipe appears to be draining the wall very well.	8
DOWNSLOPE 0.50	Pavement, no signs of failure, erosion, or other distress.	9
LATERAL SLOPE 0.50	Bedrock, no signs of failure, erosion, or other distress.	9

Failure Consequence:	MODERATE
Recommendation Narrative:	None
Repair Cost:	\$0

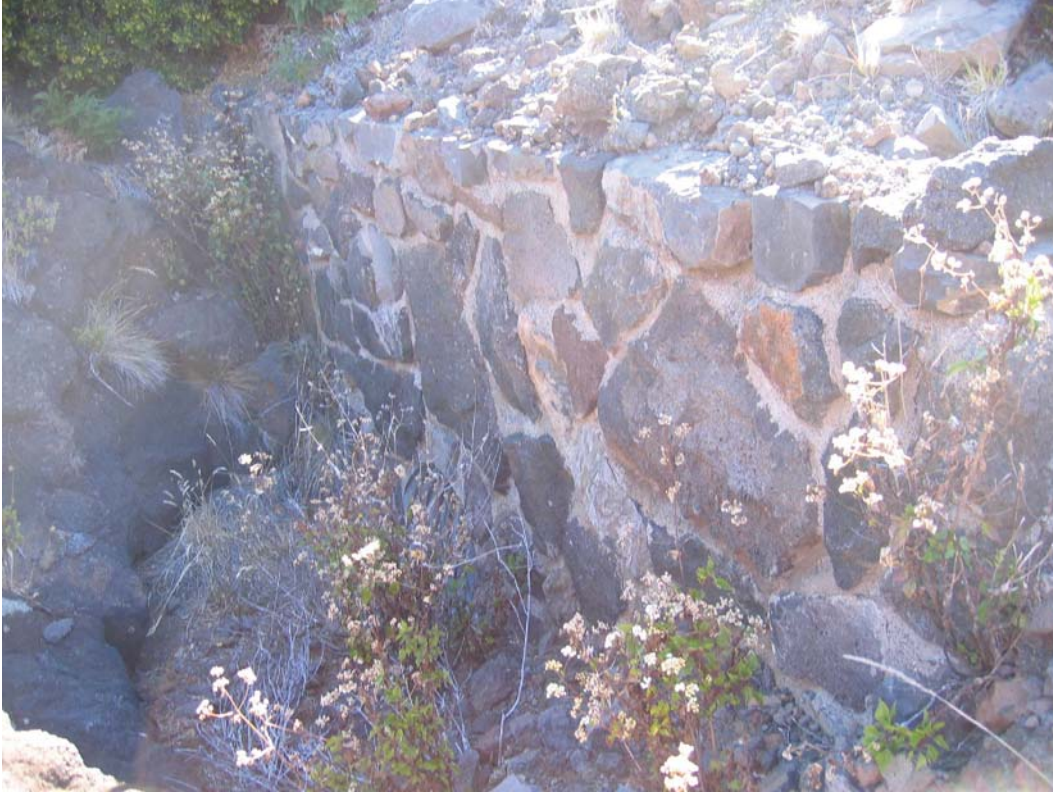
HALE_0010_6.206_R_1.jpg

Wall Function:	Head Wall	Primary Wall Type:	Gravity - Mortared Stone
Surface Treatment:		Secondary Wall Type:	
Secondary Surface Treatment:		Architectural Facing:	
General Description:	Mortared stone headwall in good condition.

Element (Weighting Factor)	Narrative	Condition Rating (0 - 10)
PERFORMANCE 8.00	Good overall performance with no signs of movement or global instability.	8
WALL FOUNDATION MATERIAL 8.00	Solid, stable bedrock, sufficient for wall stability.	7
MORTAR 8.00	Durable and sound, no signs of shrinkage or cracking; no water seepage; no missing mortar. Good condition.	7
STONE MASONRY 8.00	All stones are intact, no signs of weathering, erosion, or cracking. No signs of bulging or settlement.	7
UPSLOPE 1.00	Loose gravel fill with boulders and cobbles; no vegetation.	6
CULVERT 1.00	2' CMP in good condition.	7
DOWNSLOPE 1.00	Bedrock, no signs of slope failure.	7
LATERAL SLOPE 1.00	Loose gravel on one side and bedrock on downhill side. No signs of failure.	7
VEGETATION 1.00	No vegetation related impacts to wall stability.	7

Failure Consequence:	MODERATE
Recommendation Narrative:	None
Repair Cost:	\$0

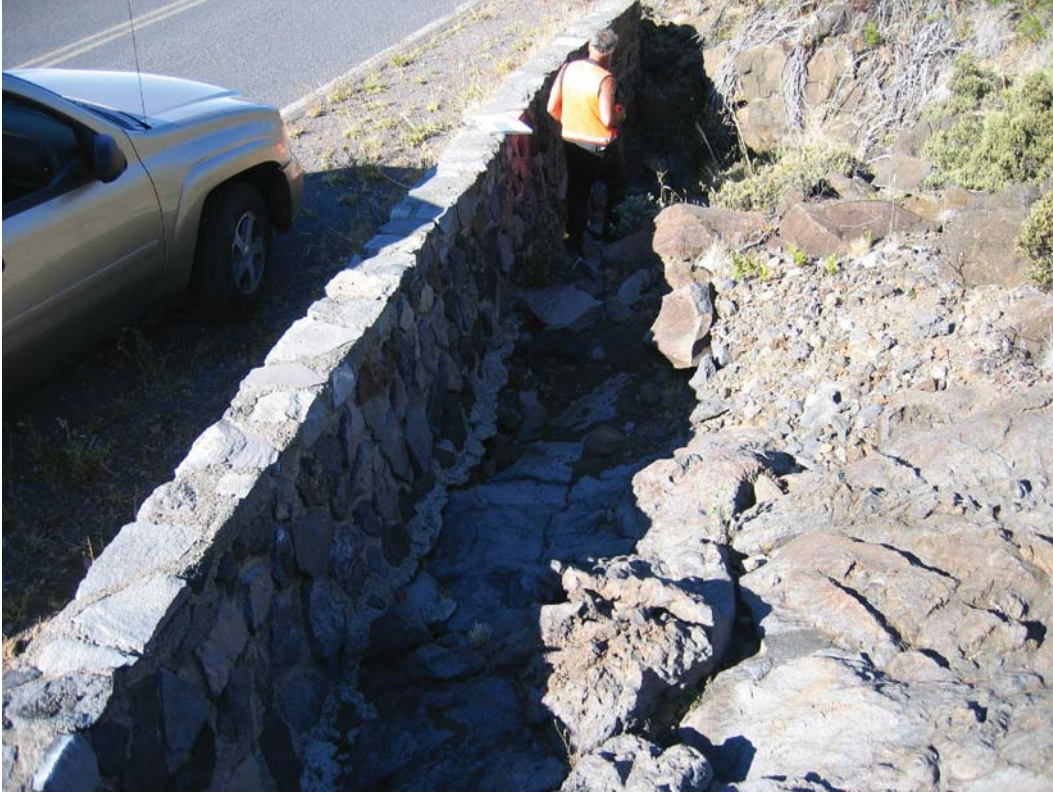
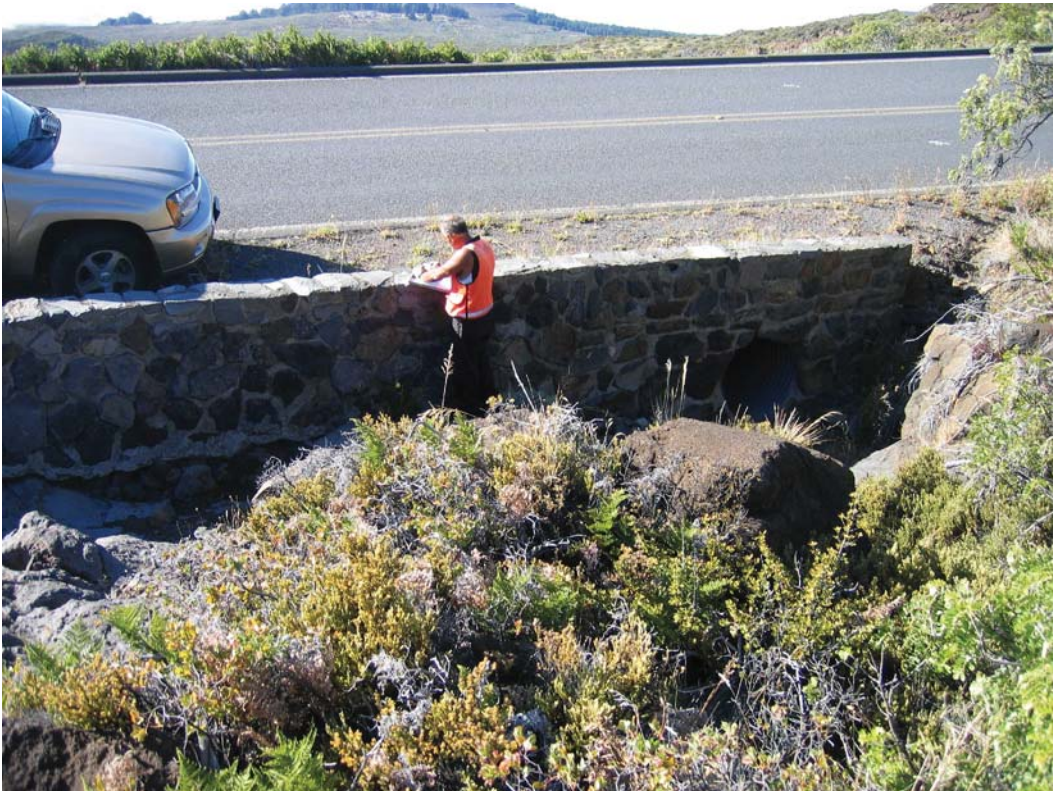
Wall Function:	Head Wall	Primary Wall Type:	Gravity - Mortared Stone
Surface Treatment:		Secondary Wall Type:	
Secondary Surface Treatment:		Architectural Facing:	
General Description:	Mortared stone headwall, wingwall on one side, in good condition.

Element (Weighting Factor)	Narrative	Condition Rating (0 - 10)
PERFORMANCE 8.00	Good overall performance with no signs of settlement or global instability.	7
WALL FOUNDATION MATERIAL 8.00	Bedrock at foundation with some undercutting, but no effect on wall stability.	7
MORTAR 8.00	Moderate shrinkage and cracking.	6
STONE MASONRY 8.00	Durable stones, no signs of weathering, erosion, or cracking.	7
CULVERT 0.50	3' CMP in good condition.	8
DOWNSLOPE 0.50	Bedrock, no signs of slope failure, erosion, or other distress.	8
LATERAL SLOPE 0.50	Bedrock, 6:1 slope on one side, steeper 1:1 slope on other side.	8
UPSLOPE 1.00	Loose gravel, no vegetation.	6
WALL DRAINS 1.00	No wall drains visible; no drainage related distress.	7

Failure Consequence:	HIGH
Recommendation Narrative:	None
Repair Cost:	\$0

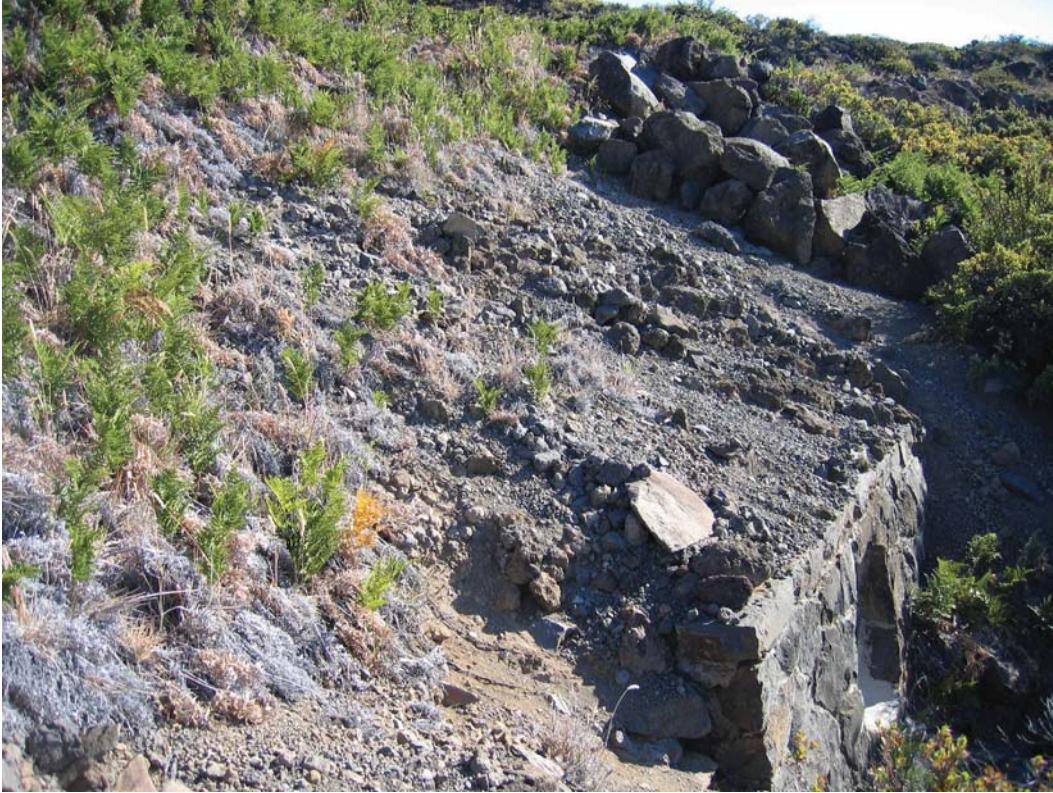
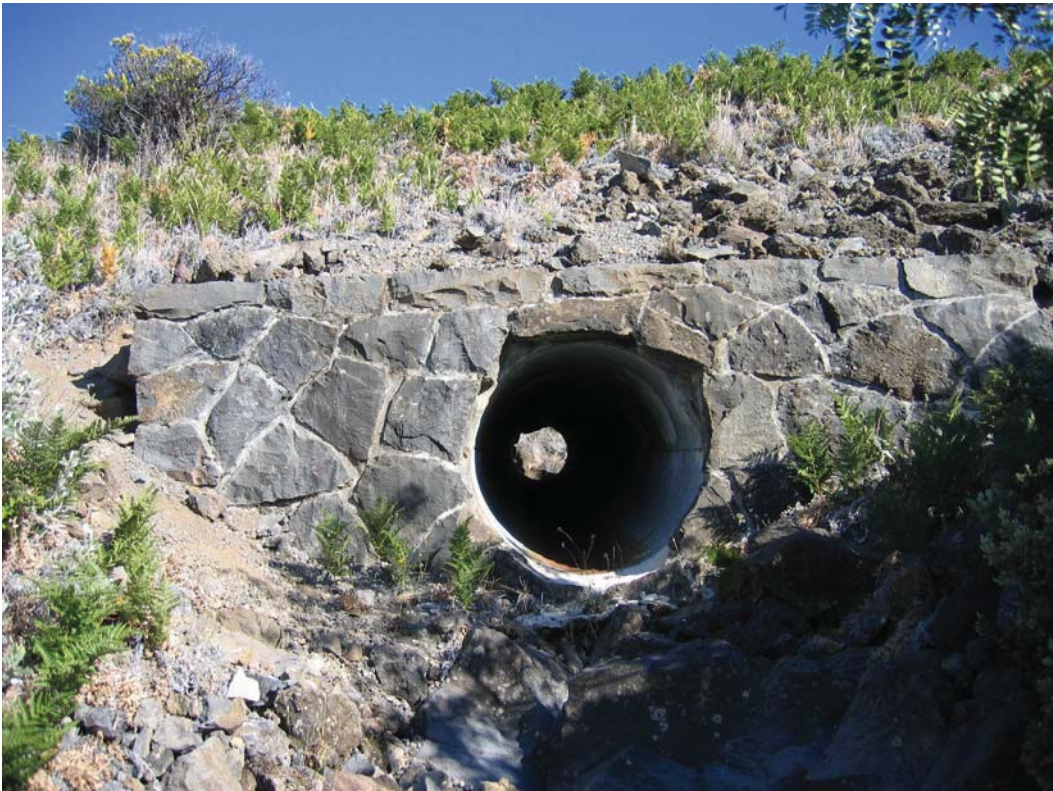
Wall Function:	Head Wall	Primary Wall Type:	Gravity - Mortared Stone
Surface Treatment:		Secondary Wall Type:	
Secondary Surface Treatment:		Architectural Facing:	
General Description:	Mortared stone headwall in good condition, with 2 ft CMP.

Element (Weighting Factor)	Narrative	Condition Rating (0 - 10)
PERFORMANCE 8.00	Good overall performance with no signs of movement or global instability.	8
WALL FOUNDATION MATERIAL 8.00	Solid, stable rock, sufficient for wall stability.	8
MORTAR 8.00	Durable and sound, no signs of shrinkage or cracking; no water seepage; no missing mortar. Good condition.	8
STONE MASONRY 8.00	All stones are intact, no signs of weathering, erosion, or cracking. No signs of bulging or settlement.	8
CULVERT 0.50	2' CMP in good condition; free of debris.	8
DOWNSLOPE 0.50	Rock/soil compacted; some vegetation. No concerns.	8
LATERAL SLOPE 0.50	Rock/soil compacted; no signs of erosion or scour.	8
WALL DRAINS 0.50	No wall drains visible; no drainage related distress.	8
UPSLOPE 1.00	Loose gravel and cobbles.	6

Failure Consequence:	MODERATE
Recommendation Narrative:	None
Repair Cost:	\$0

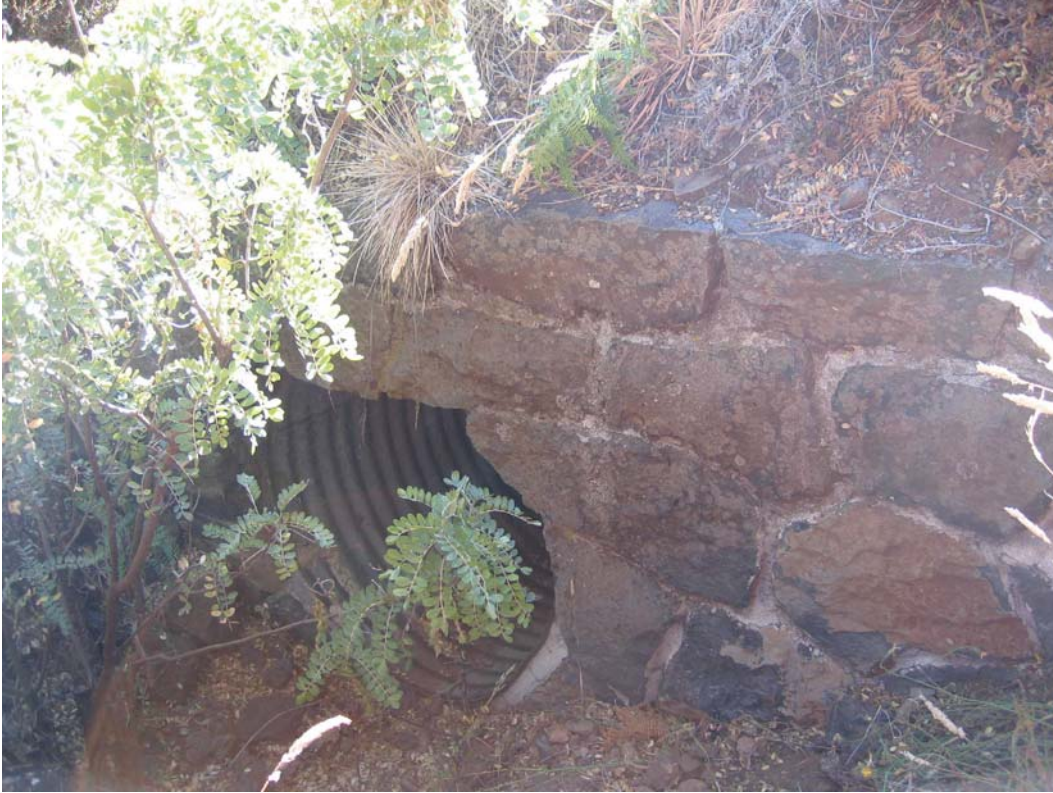
HALE_0010_6.451_R_1.jpg

Wall Function:	Head Wall	Primary Wall Type:	Gravity - Mortared Stone
Surface Treatment:		Secondary Wall Type:	
Secondary Surface Treatment:		Architectural Facing:	
General Description:	Mortared stone headwall in good condition with 3 ft CMP.

Element (Weighting Factor)	Narrative	Condition Rating (0 - 10)
PERFORMANCE 8.00	Good overall performance with no signs of movement or global instability.	7
WALL FOUNDATION MATERIAL 8.00	Foundation is sufficient to support the wall, but tree roots may affect the foundation at some time.	6
MORTAR 8.00	Durable and sound, no signs of shrinkage or cracking; no missing mortar. Good condition.	7
STONE MASONRY 8.00	All stones are intact, no signs of weathering, erosion, or cracking.	7
VEGETATION 1.00	Large tree in front of the culvert poses a problem. Need removal.	5
UPSLOPE 1.00	Loose gravel, no vegetation.	6
CULVERT 1.00	3' CMP in good condition.	7
DOWNSLOPE 1.00	Rock/soil compacted. No concerns.	7
LATERAL SLOPE 1.00	Rock and compacted soil. No signs of failure, no issues.	7

Failure Consequence:	HIGH
Recommendation Narrative:	Remove large tree from culvert inlet: 2 hours of labor @ \$55.00 per hour = \$110.00
Repair Cost:	\$110
