HALE WIP Report

NPS Retaining Wall Inventory Program Haleakala National Park

Federal Highway Administration
Eastern Federal Lands Highway Division
Road Inventory Program (RIP)

Data Collection Date: July 2007
Report Date: October 2015

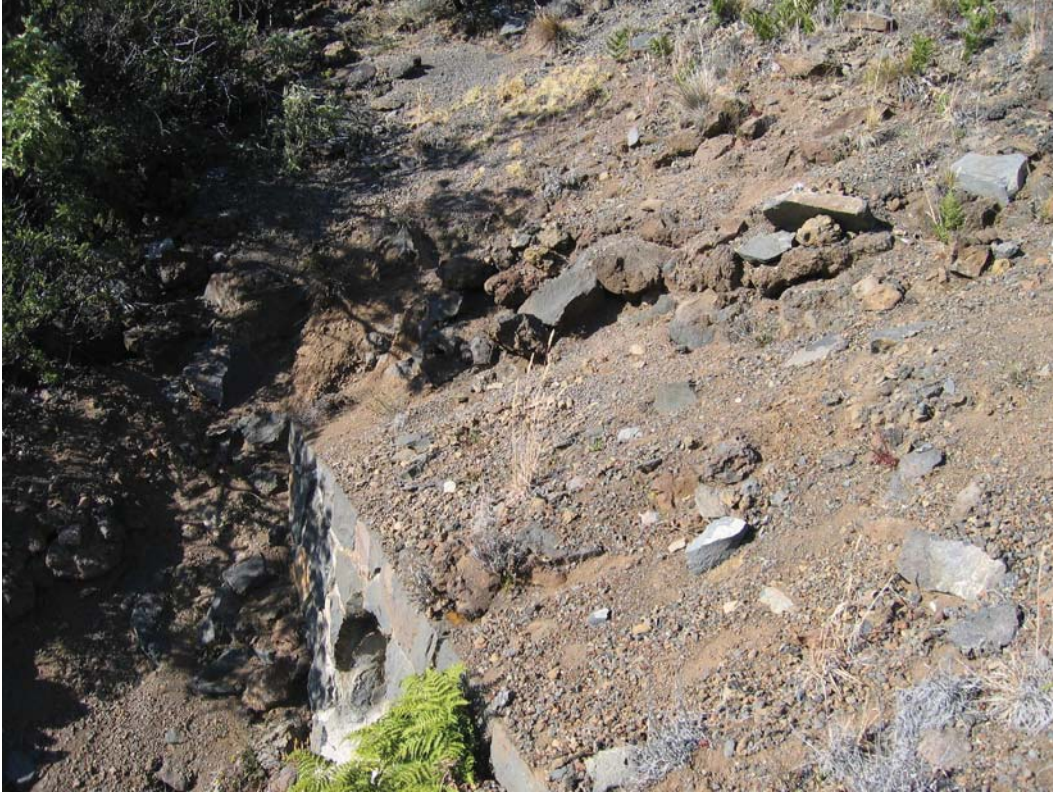
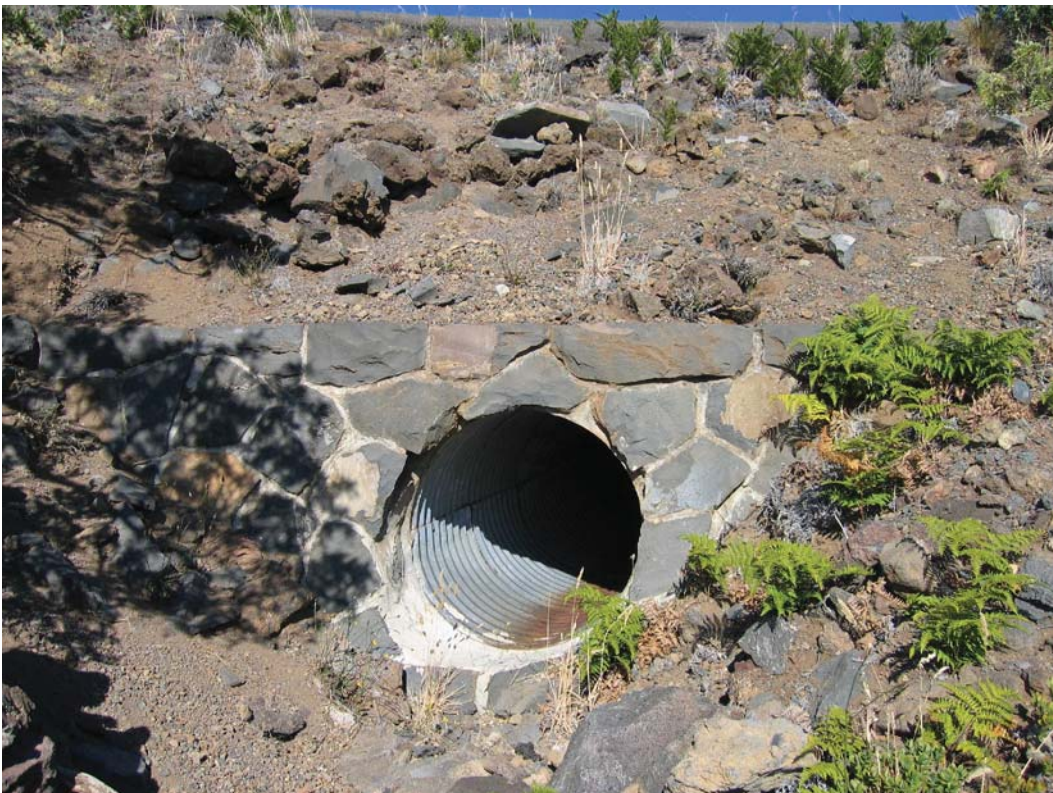
Wall Function:	Head Wall	Primary Wall Type:	Gravity - Mortared Stone
Surface Treatment:		Secondary Wall Type:	
Secondary Surface Treatment:		Architectural Facing:	
General Description:	Mortared stone headwall in good condition with 3 ft CMP.

Element (Weighting Factor)	Narrative	Condition Rating (0 - 10)
PERFORMANCE 8.00	Good overall performance with no signs of movement or global instability.	7
WALL FOUNDATION MATERIAL 8.00	Solid, stable rock, sufficient for wall stability.	7
MORTAR 8.00	Durable and sound, no signs of shrinkage or cracking; no missing mortar. Good condition.	7
STONE MASONRY 8.00	All stones are intact, no signs of weathering, erosion, or cracking. No signs of bulging or settlement.	7
CULVERT 1.00	3' CMP in good condition.	7
DOWNSLOPE 1.00	Rock/soil compacted; no signs of erosion or scour.	7
LATERAL SLOPE 1.00	Compacted soil, stable, no concerns.	7
UPSLOPE 1.00	Rock/soil compacted, stable, no concerns.	7
VEGETATION 1.00	No vegetation related impacts to wall stability.	7

Failure Consequence:	MODERATE
Recommendation Narrative:	None
Repair Cost:	\$0

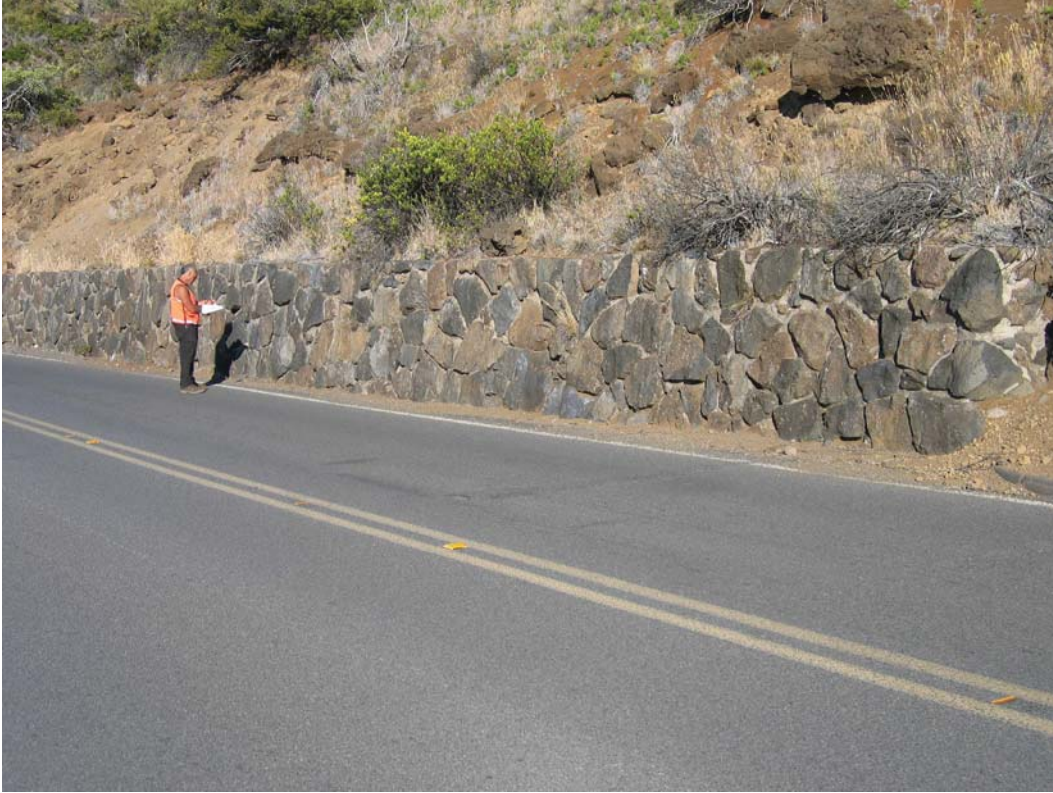
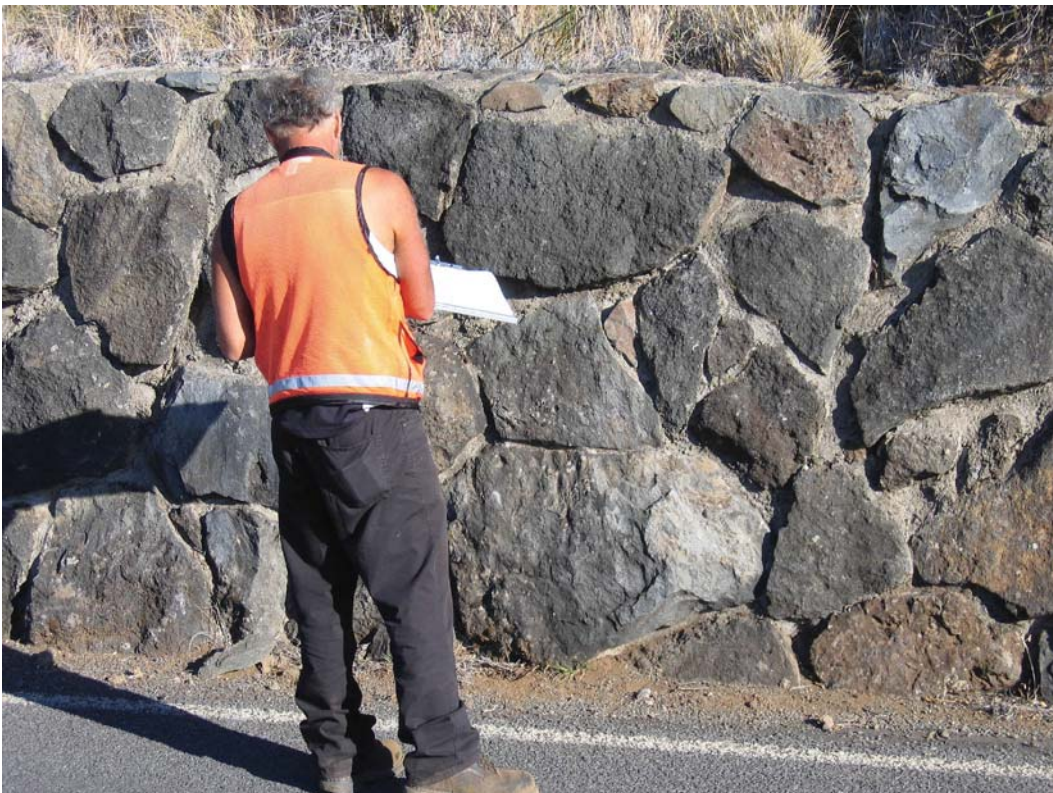
Wall Function:	Cut Wall	Primary Wall Type:	Gravity - Mortared Stone
Surface Treatment:		Secondary Wall Type:	
Secondary Surface Treatment:		Architectural Facing:	
General Description:	Mortared stone cut wall for slope protection, good condition.

Element (Weighting Factor)	Narrative	Condition Rating (0 - 10)
PERFORMANCE 8.00	Good overall performance with no signs of movement or global instability.	8
WALL FOUNDATION MATERIAL 8.00	Wall is set on pavement, no signs of settlement in roadway.	9
MORTAR 8.00	Minor shrinkage and cracking.	7
STONE MASONRY 8.00	All stones are intact, no signs of weathering or cracking. No signs of bulging or settlement.	8
UPSLOPE 0.50	Compacted soil with boulders and vegetation, no issues.	8
VEGETATION 0.50	No vegetation related impacts to wall stability.	8
WALL DRAINS 0.50	PVC pipe is draining the wall well.	8
DOWNSLOPE 0.50	Pavement, no wall related distress.	9
LATERAL SLOPE 0.50	Compacted soil with boulders, vegetation, no signs of failure or erosion.	9

Failure Consequence:	HIGH
Recommendation Narrative:	None
Repair Cost:	\$0

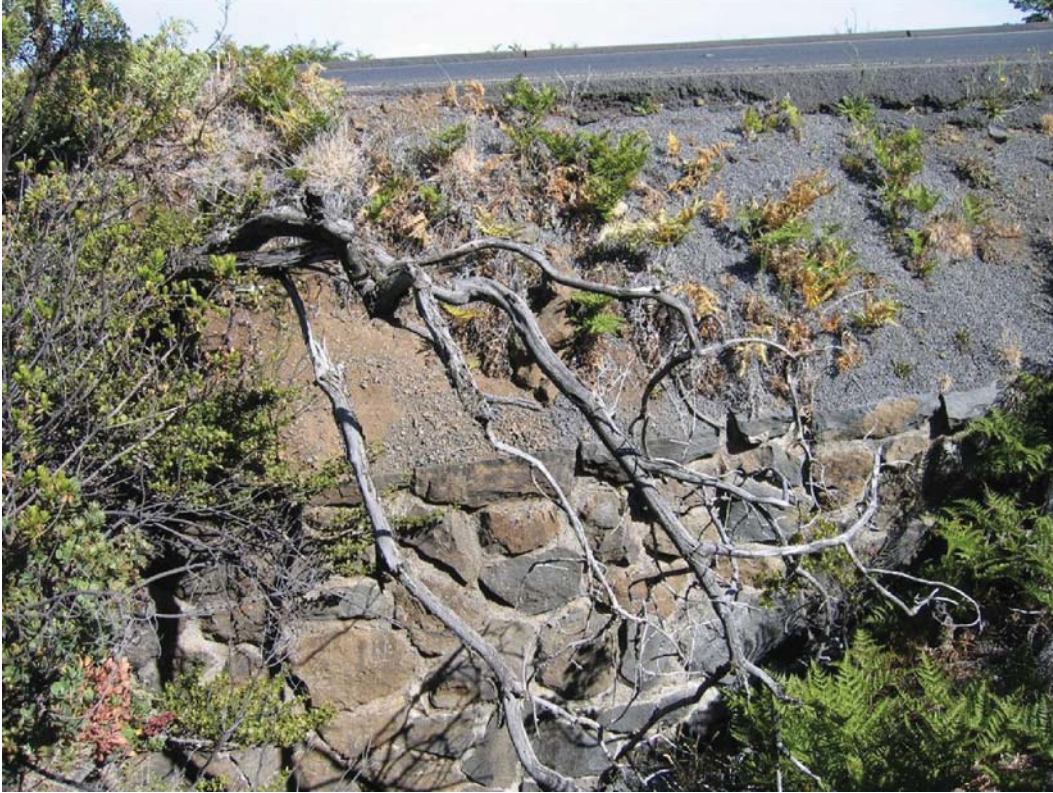
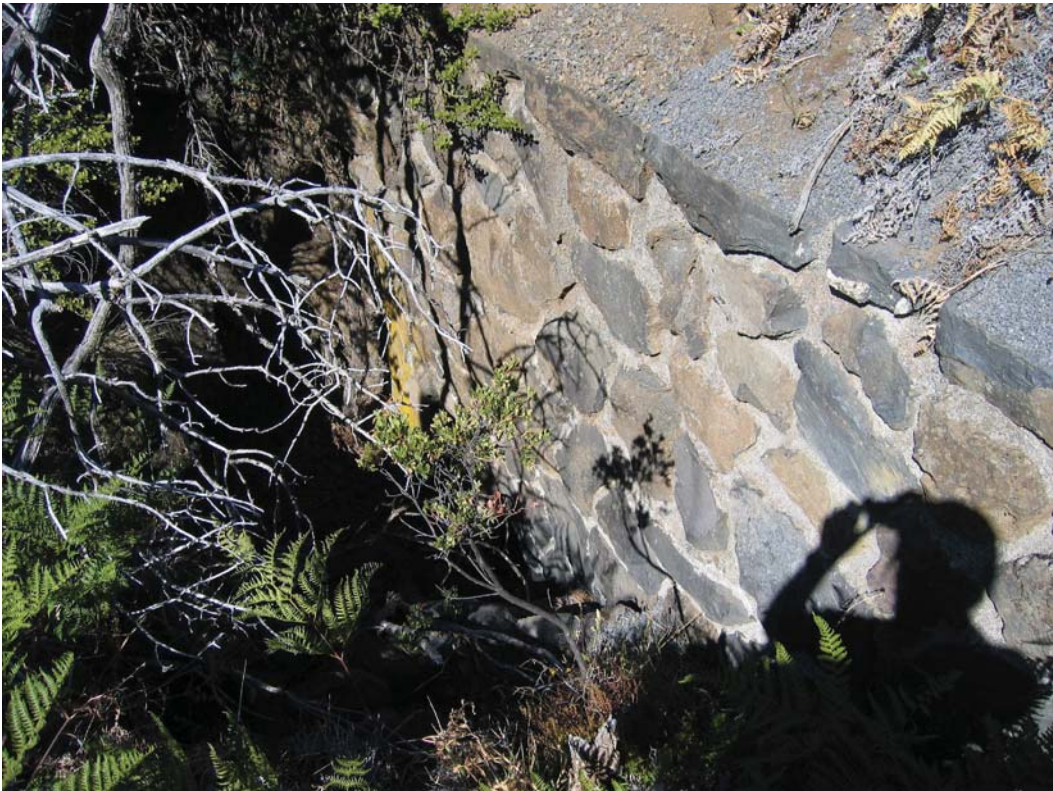
Wall Function:	Head Wall	Primary Wall Type:	Gravity - Mortared Stone
Surface Treatment:		Secondary Wall Type:	
Secondary Surface Treatment:		Architectural Facing:	
General Description:	Mortared stone headwall in good condition with 3 ft CMP.

Element (Weighting Factor)	Narrative	Condition Rating (0 - 10)
PERFORMANCE 8.00	Good overall performance with no signs of movement or global instability.	8
WALL FOUNDATION MATERIAL 8.00	Solid, stable bedrock, sufficient for wall stability.	8
MORTAR 8.00	Durable and sound, no signs of shrinkage or cracking; no missing mortar. Good condition.	8
STONE MASONRY 8.00	All stones are intact, no signs of weathering, erosion, or cracking. No signs of bulging or settlement.	8
CULVERT 0.50	3' CMP in good condition.	8
DOWNSLOPE 0.50	Bedrock, no signs of slope failure or distress.	8
LATERAL SLOPE 0.50	Bedrock on both sides, no signs of slope failure or distress.	8
VEGETATION 0.50	No vegetation related impacts to wall stability.	8
WALL DRAINS 0.50	No wall drains visible; no drainage related distress.	8

Failure Consequence:	HIGH
Recommendation Narrative:	Remove dead tree from upslope: 2 hours of labor @ \$55.00 per hour = \$110.00
Repair Cost:	\$110

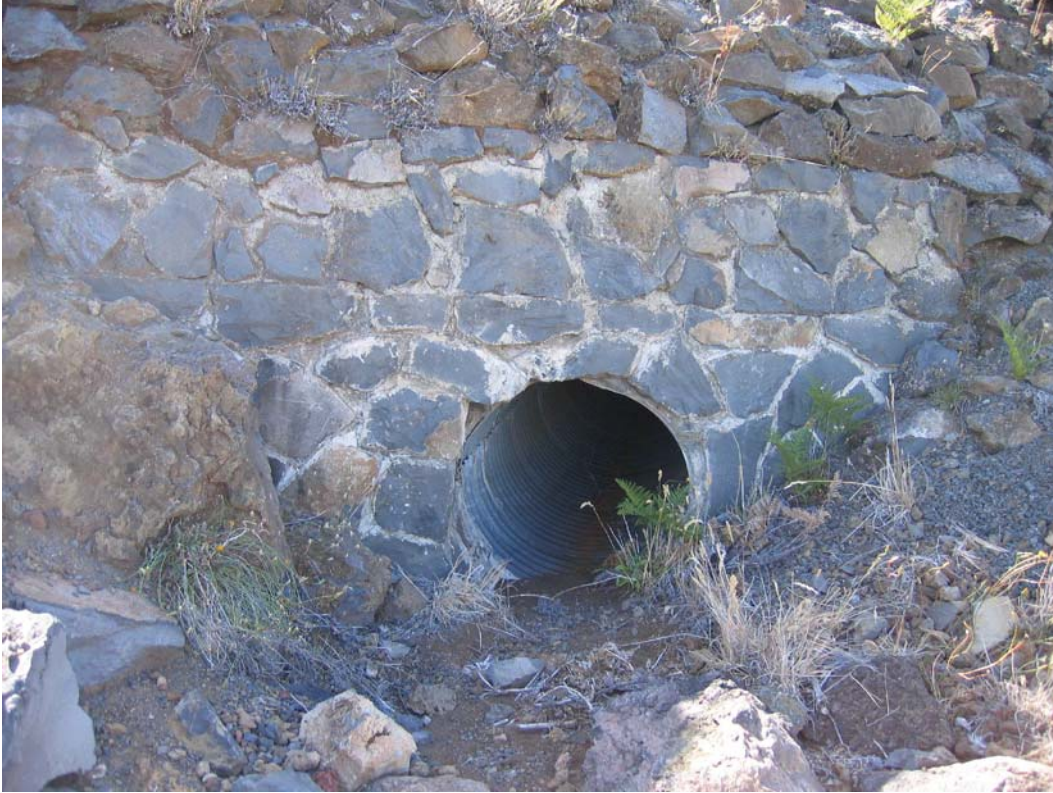
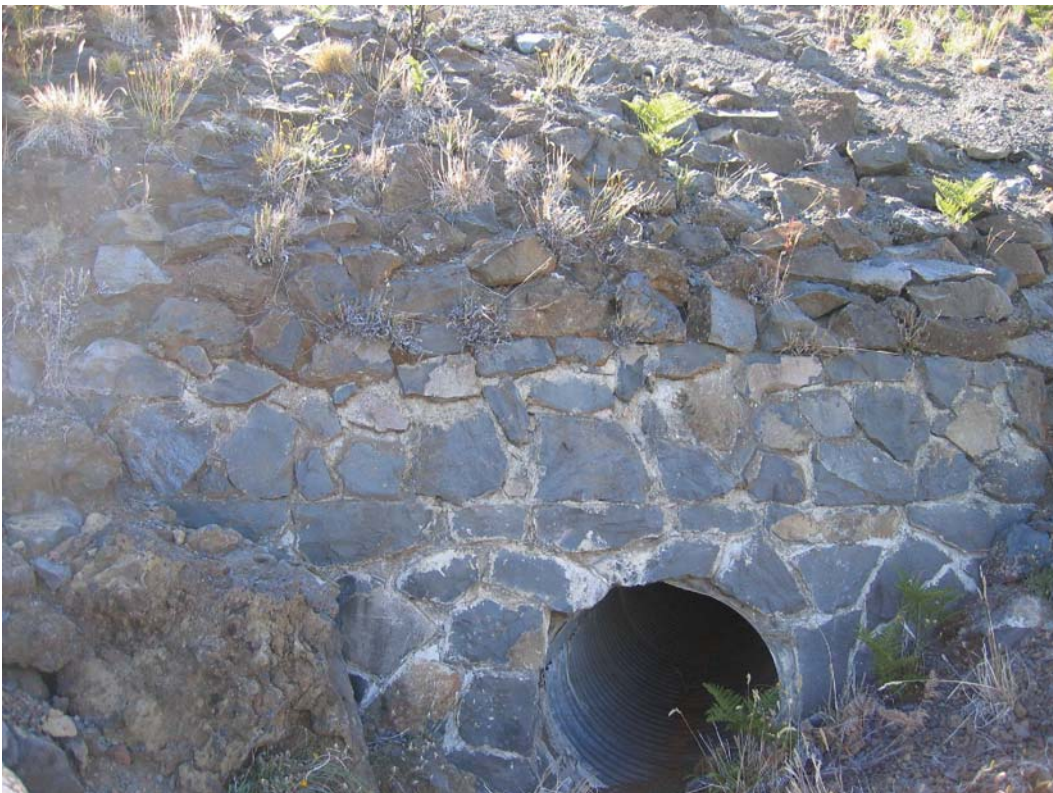
Wall ID:	HALE-0010-6.546-L		
Route Name:	HALEAKALA PARK ROAD		
Inspection Date:	July 11, 2007	Approximate Year Built:	Unknown
*Wall Rating:	72	Maintenance Action:	No Action

Failure Consequence:	LOW
Recommendation Narrative:	None
Repair Cost:	\$0

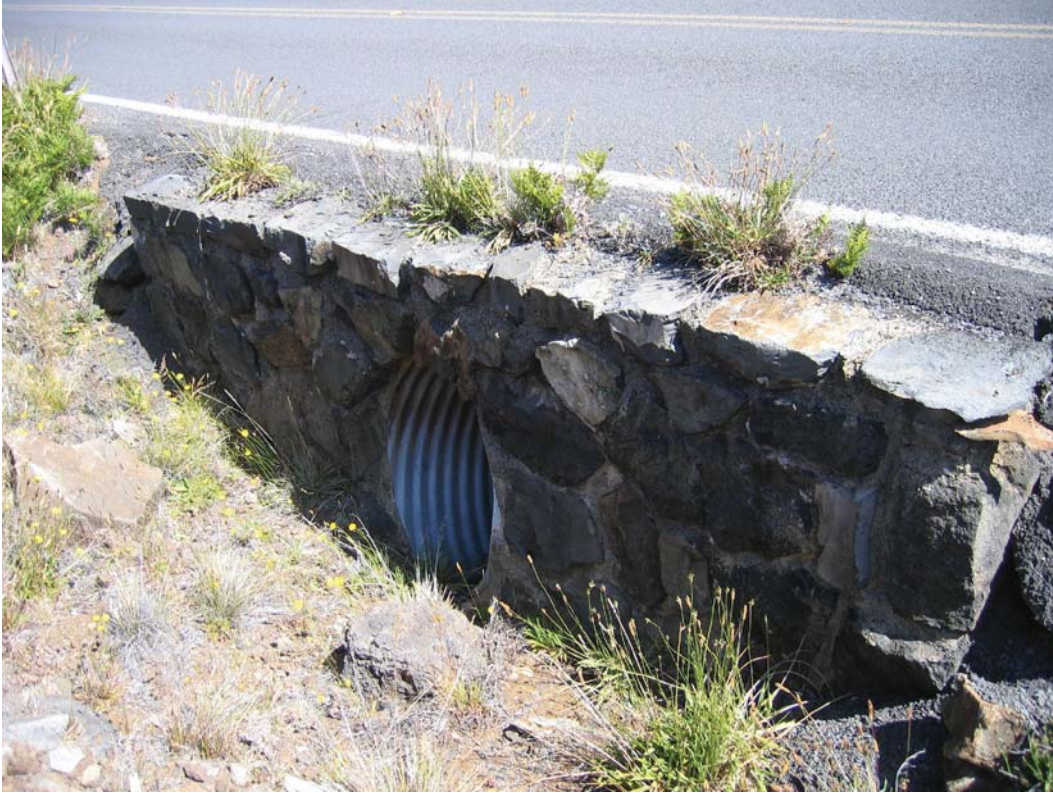
HALE_0010_7.182_R_1.jpg

Wall ID:	HALE-0010-7.182-R		
Route Name:	HALEAKALA PARK ROAD		
Inspection Date:	July 11, 2007	Approximate Year Built:	1934
*Wall Rating:	73	Maintenance Action:	No Action

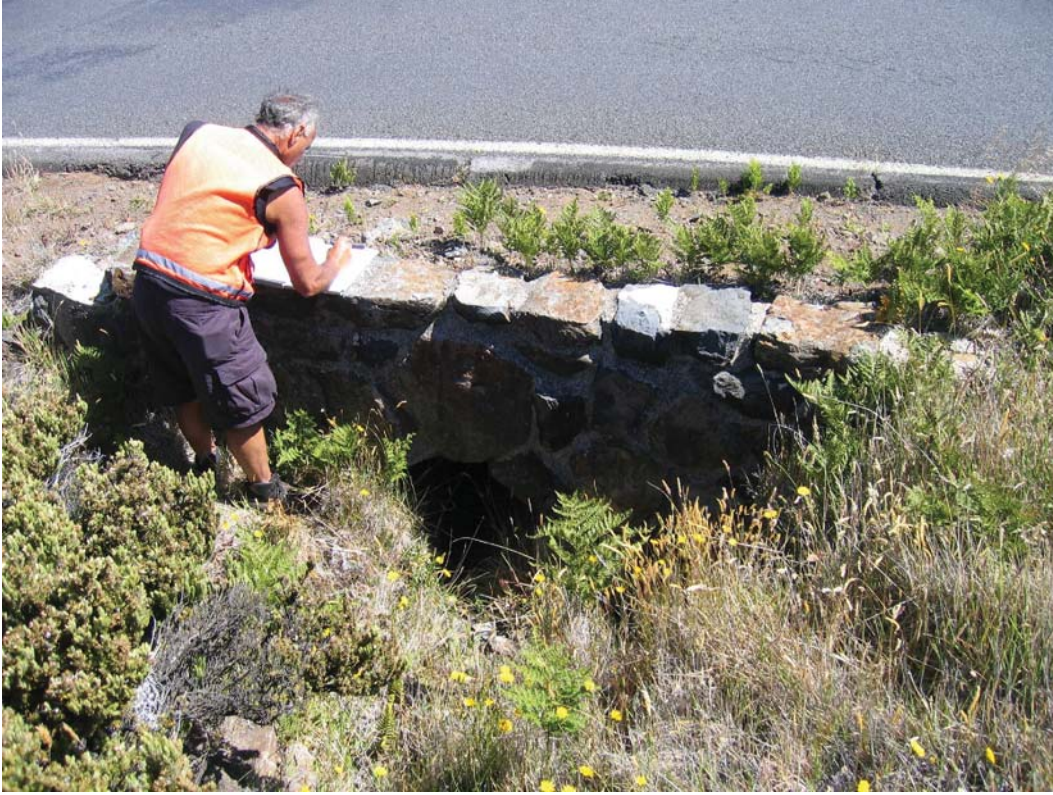
HALE_0010_7.320_R_1.jpg

Wall ID:	HALE-0010-7.320-R		
Route Name:	HALEAKALA PARK ROAD		
Inspection Date:	July 11, 2007	Approximate Year Built:	1934
*Wall Rating:	59	Maintenance Action:	Maintenance

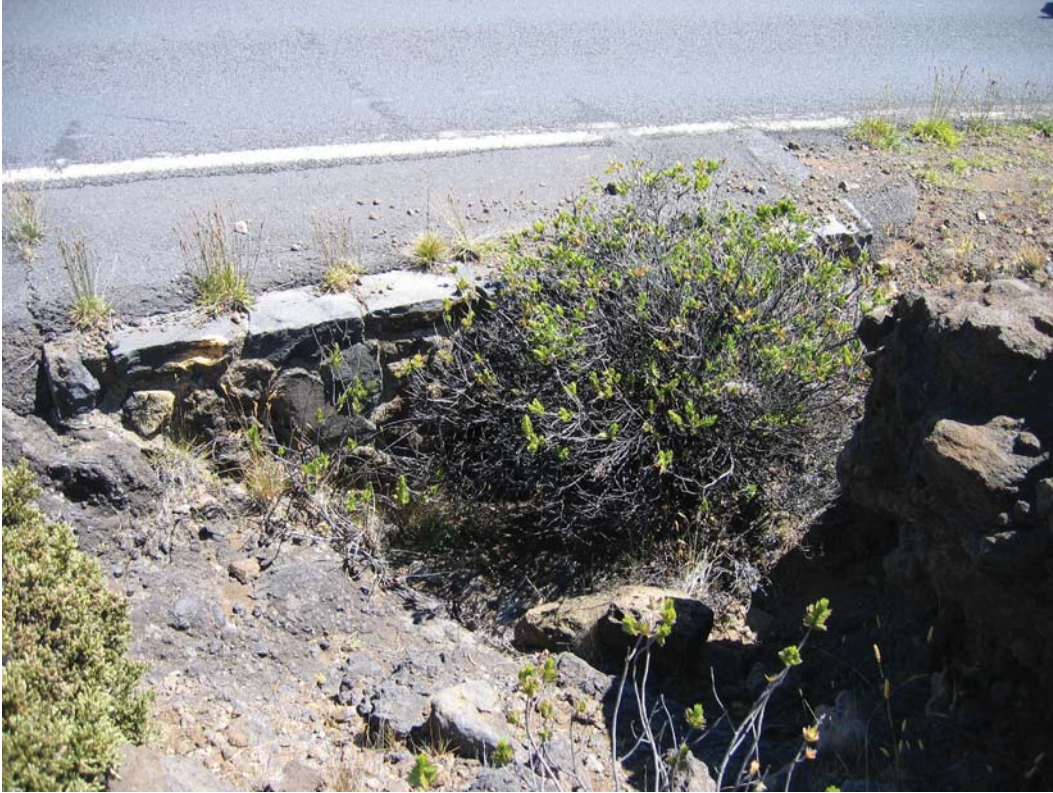
HALE_0010_7.766_L_1.jpg

Wall ID:	HALE-0010-7.766-L		
Route Name:	HALEAKALA PARK ROAD		
Inspection Date:	July 11, 2007	Approximate Year Built:	1934
*Wall Rating:	70	Maintenance Action:	Maintenance

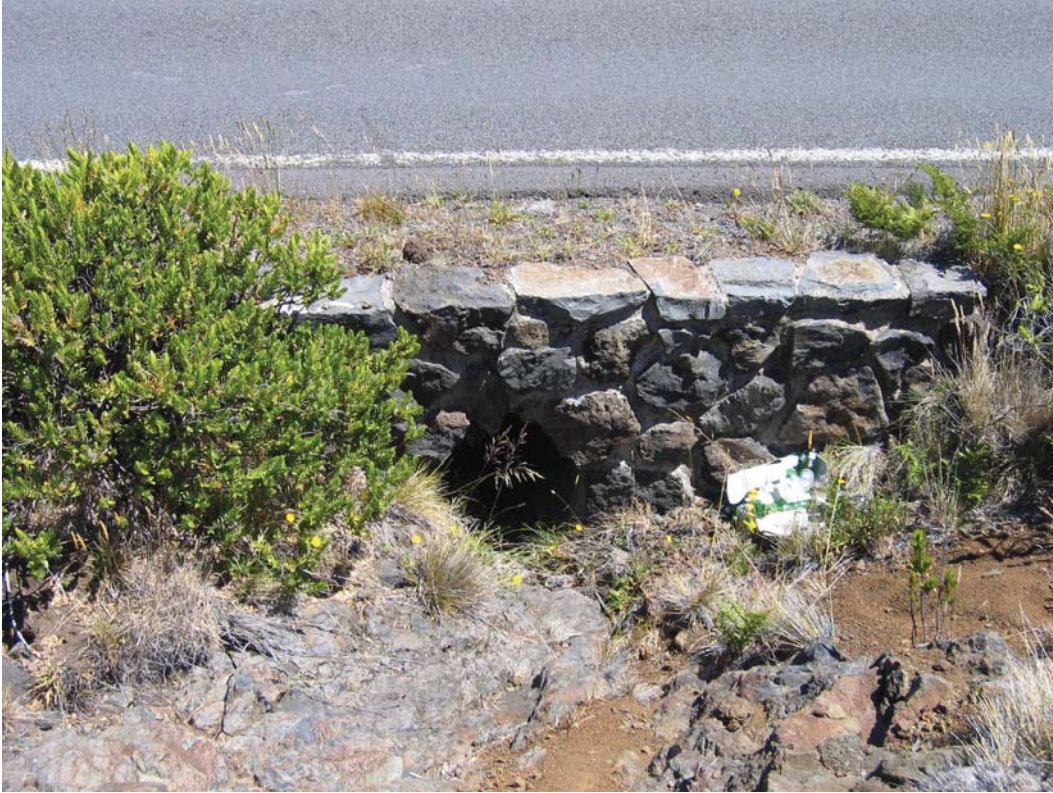
HALE_0010_7.819_L_1.jpg

Wall ID:	HALE-0010-7.819-L		
Route Name:	HALEAKALA PARK ROAD		
Inspection Date:	July 11, 2007	Approximate Year Built:	1934
*Wall Rating:	70	Maintenance Action:	No Action

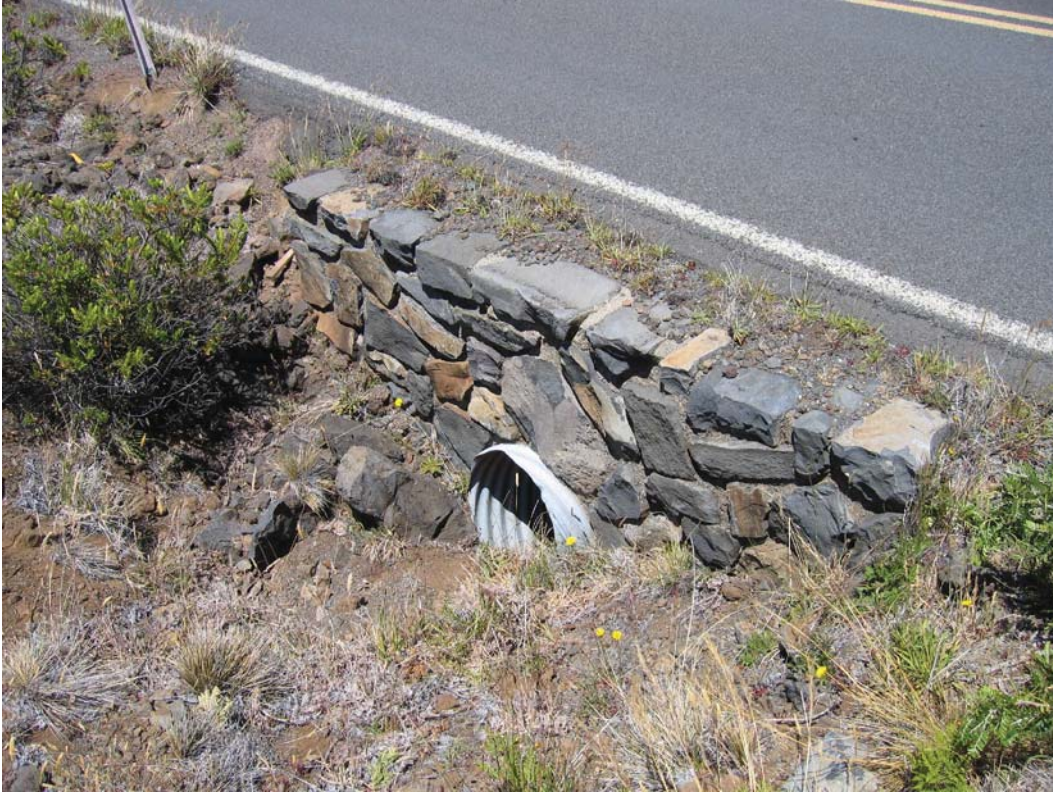
HALE_0010_7.928_L_1.jpg

Wall ID:	HALE-0010-7.928-L		
Route Name:	HALEAKALA PARK ROAD		
Inspection Date:	July 11, 2007	Approximate Year Built:	1934
*Wall Rating:	75	Maintenance Action:	No Action

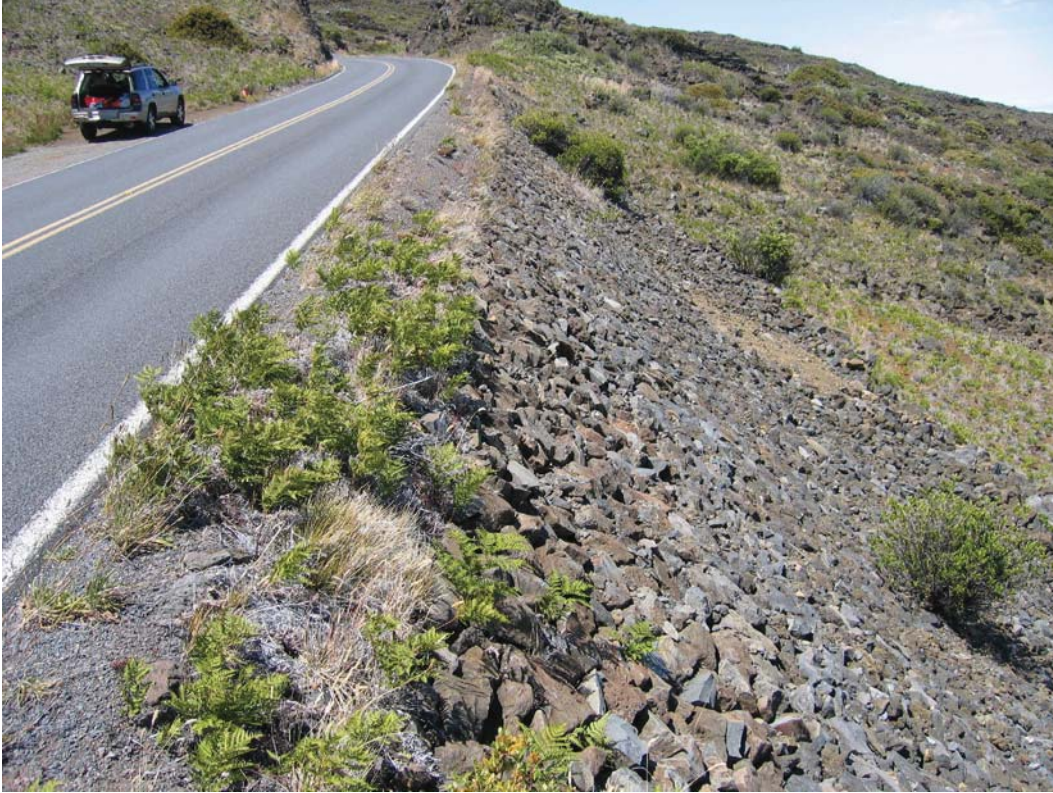
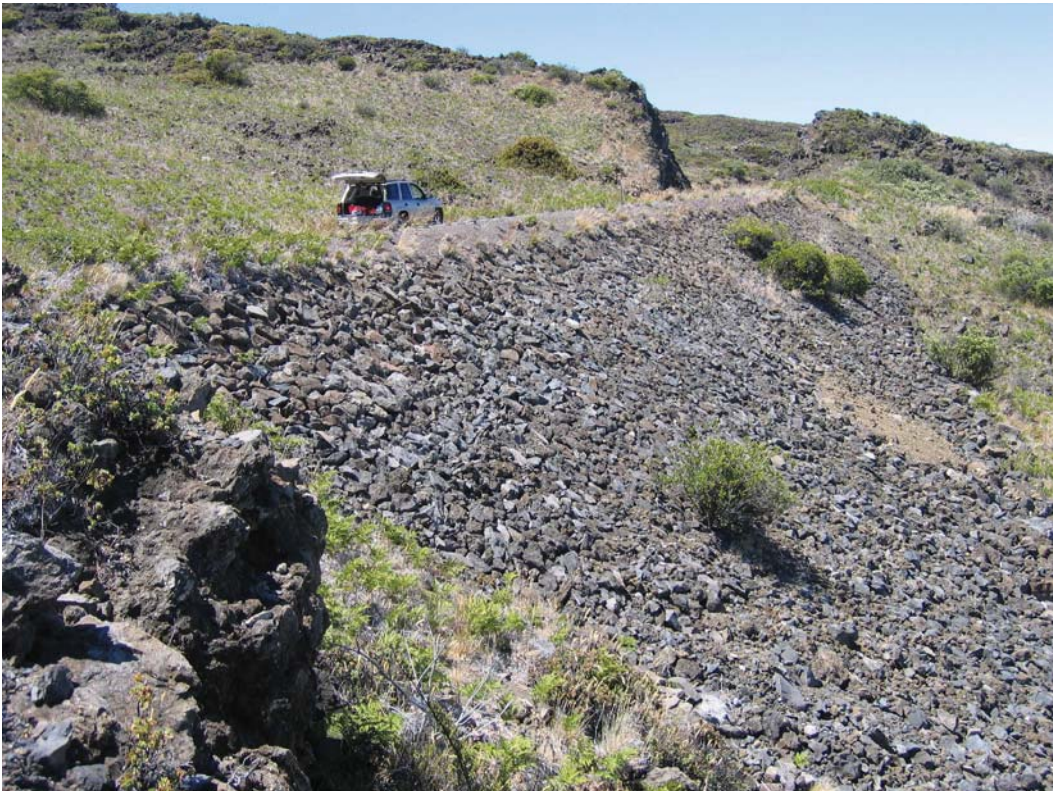
Wall ID:	HALE-0010-7.970-R		
Route Name:	HALEAKALA PARK ROAD		
Inspection Date:	July 11, 2007	Approximate Year Built:	Unknown
*Wall Rating:	76	Maintenance Action:	No Action

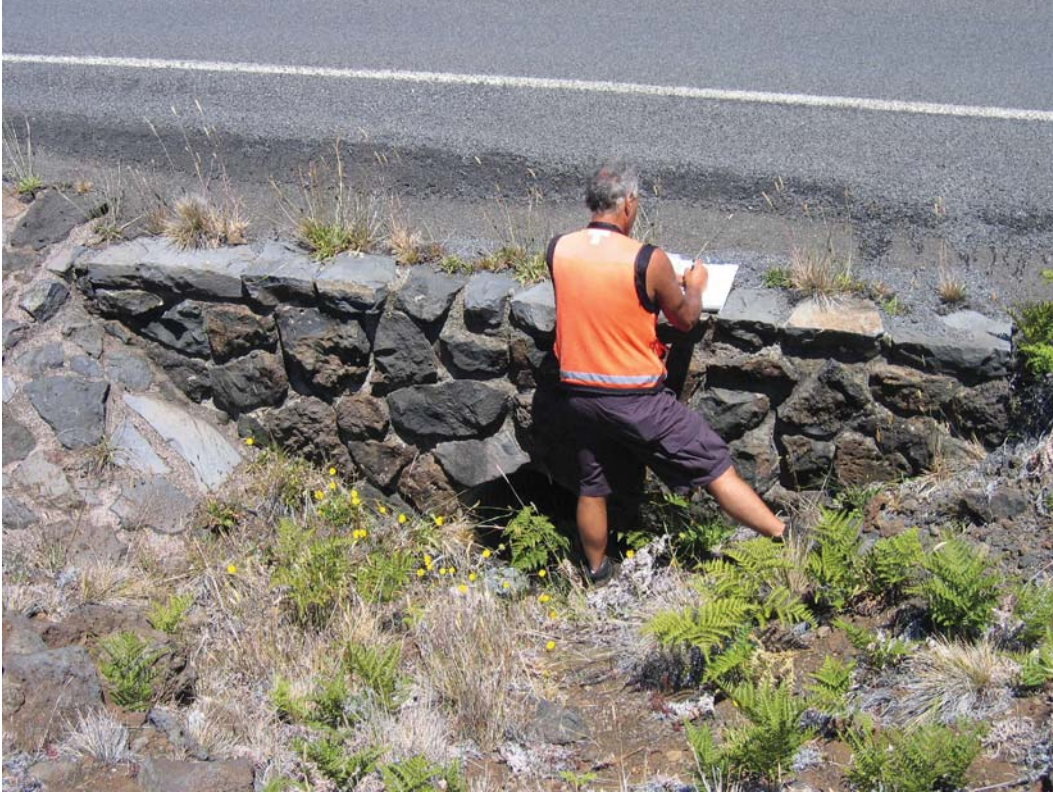
HALE_0010_7.997_L_1.jpg

Wall ID:	HALE-0010-7.997-L		
Route Name:	HALEAKALA PARK ROAD		
Inspection Date:	July 11, 2007	Approximate Year Built:	1934
*Wall Rating:	70	Maintenance Action:	No Action

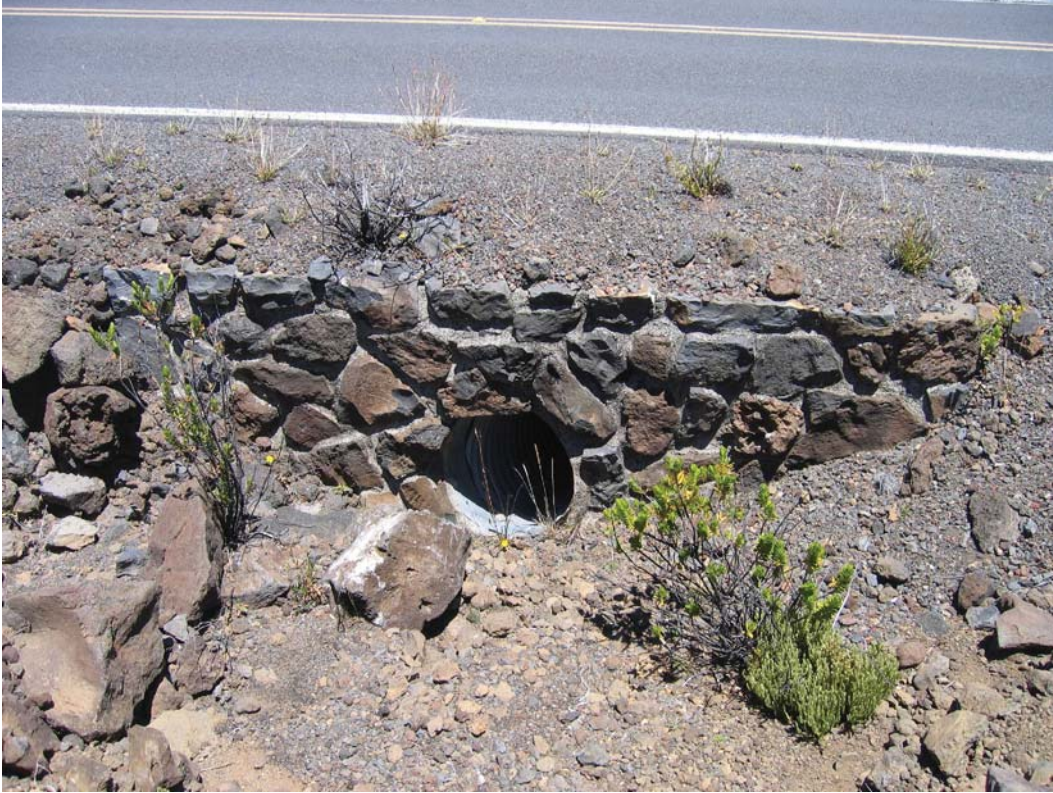
HALE_0010_8.322_L_1.jpg

Wall ID:	HALE-0010-8.322-L		
Route Name:	HALEAKALA PARK ROAD		
Inspection Date:	July 11, 2007	Approximate Year Built:	1934
*Wall Rating:	75	Maintenance Action:	No Action

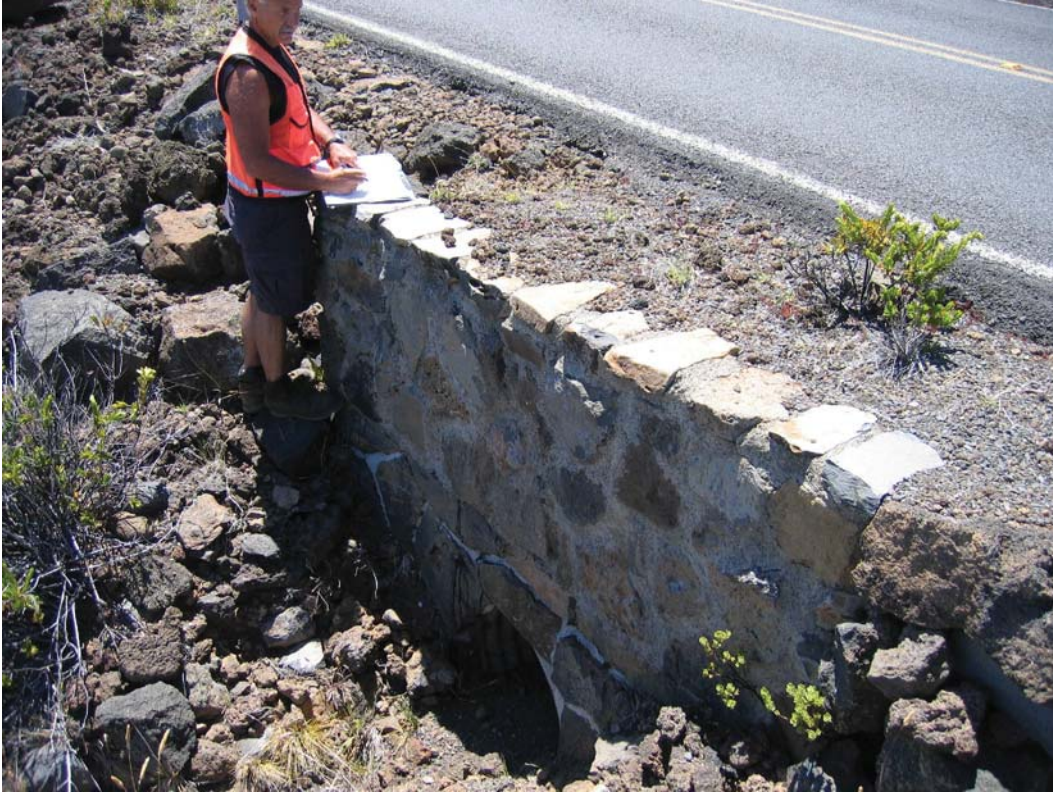
HALE_0010_8.560_L_1.jpg

Wall ID:	HALE-0010-8.560-L		
Route Name:	HALEAKALA PARK ROAD		
Inspection Date:	July 11, 2007	Approximate Year Built:	1934
*Wall Rating:	75	Maintenance Action:	No Action

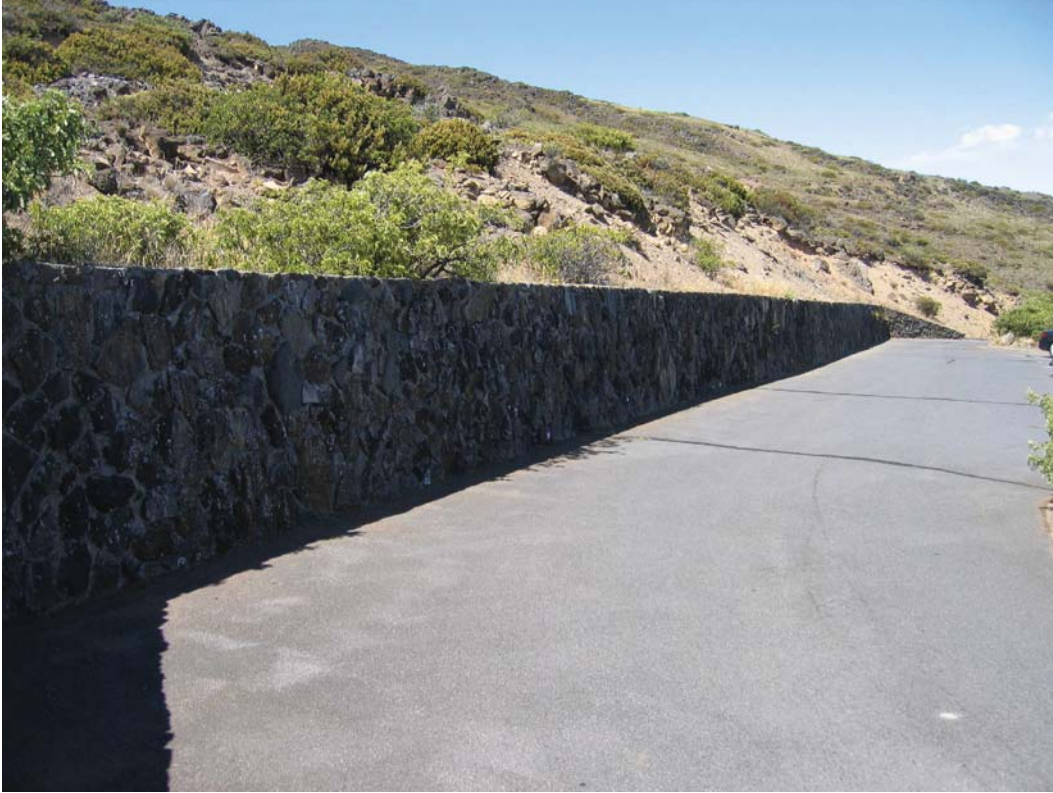
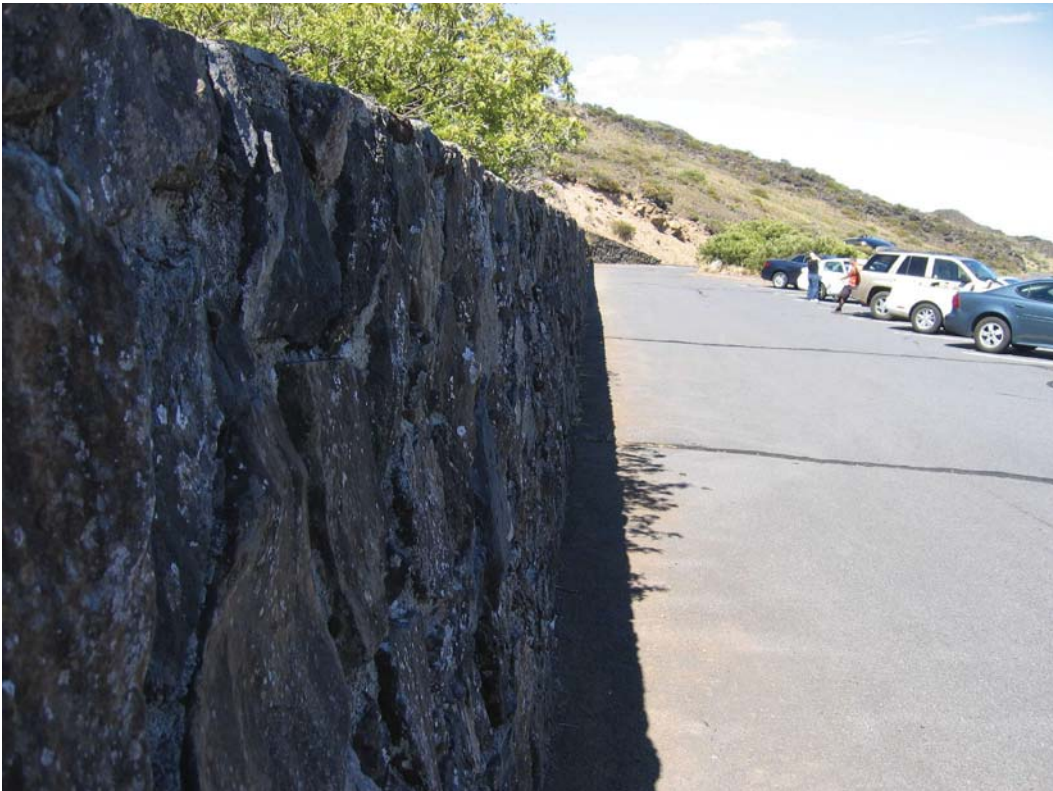
Wall ID:	HALE-0902-0.000-P1		
Route Name:	LELEIWI OVERLOOK PARKING		
Inspection Date:	July 11, 2007	Approximate Year Built:	1934
*Wall Rating:	77	Maintenance Action:	No Action

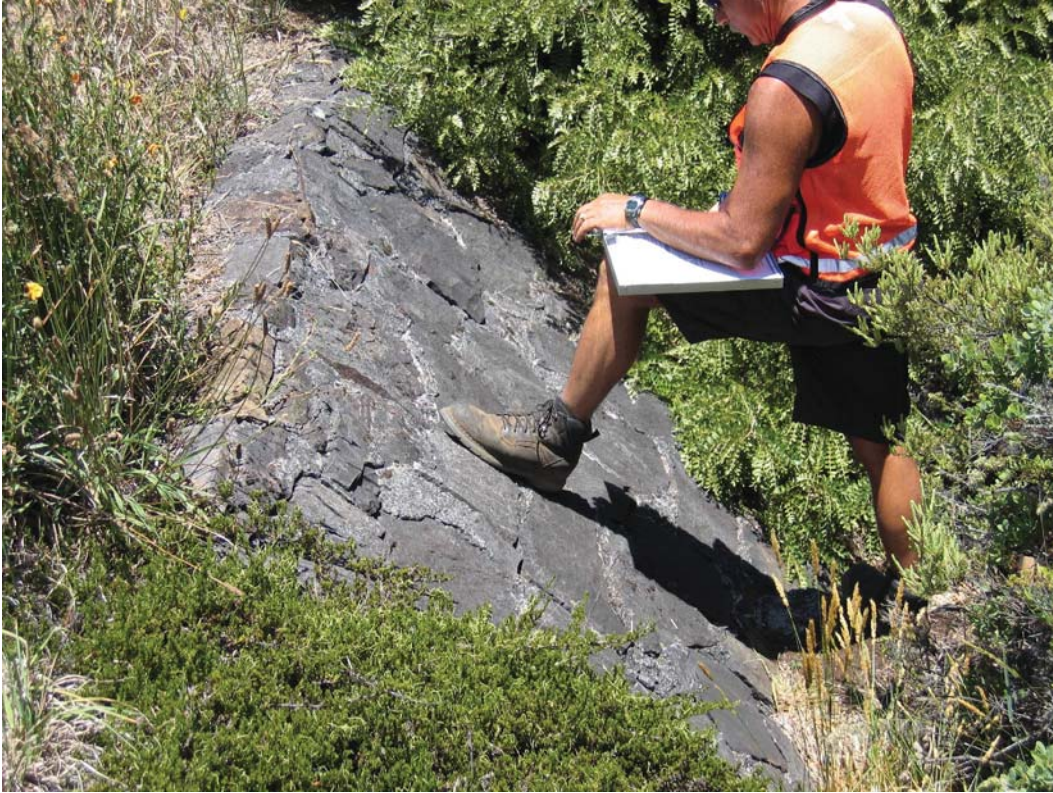
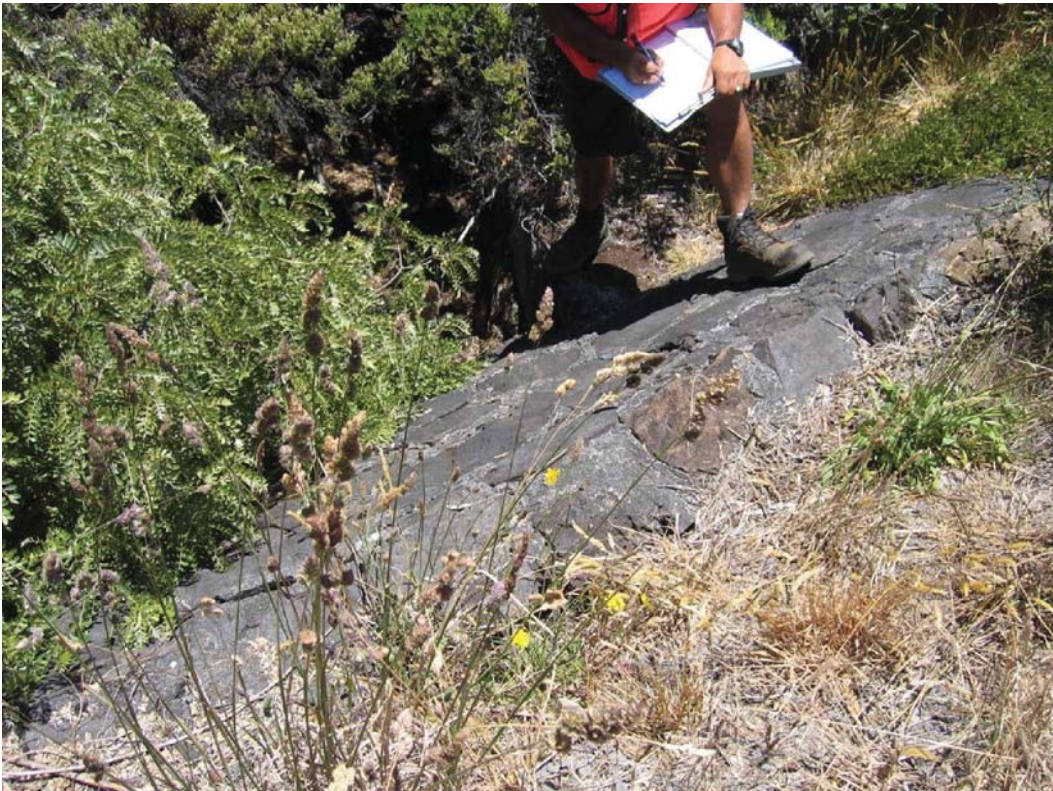
Wall ID:	HALE-0906ZZ-0.000-P1		
Route Name:	HOSMER GROVE CAMPGROUND PARKING AREAS		
Inspection Date:	July 11, 2007	Approximate Year Built:	1934
*Wall Rating:	66	Maintenance Action:	Maintenance

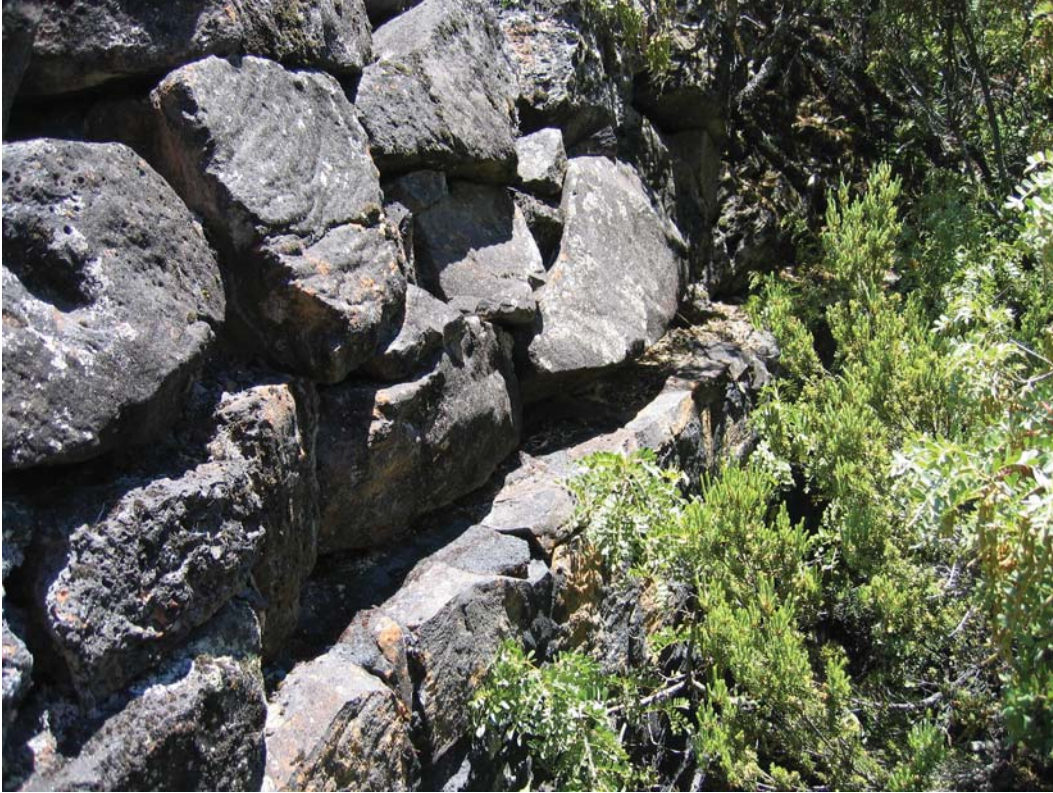
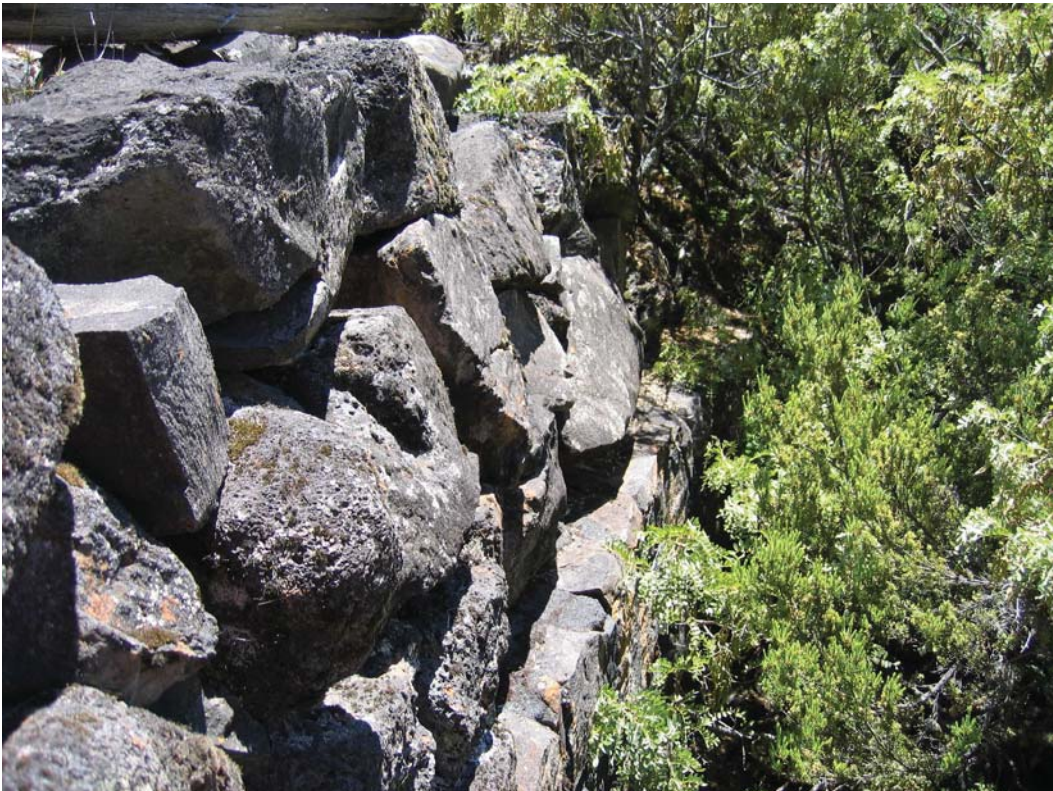
Wall ID:	HALE-0906ZZ-0.000-P2		
Route Name:	HOSMER GROVE CAMPGROUND PARKING AREAS		
Inspection Date:	July 11, 2007	Approximate Year Built:	1934
*Wall Rating:	57	Maintenance Action:	Maintenance
