# HOSP WIP Report

## NPS Retaining Wall Inventory Program Hot Springs National Park

Data Collection Date: April 2007  
Report Date: October 2015

# Hot Springs National Park in Arkansas

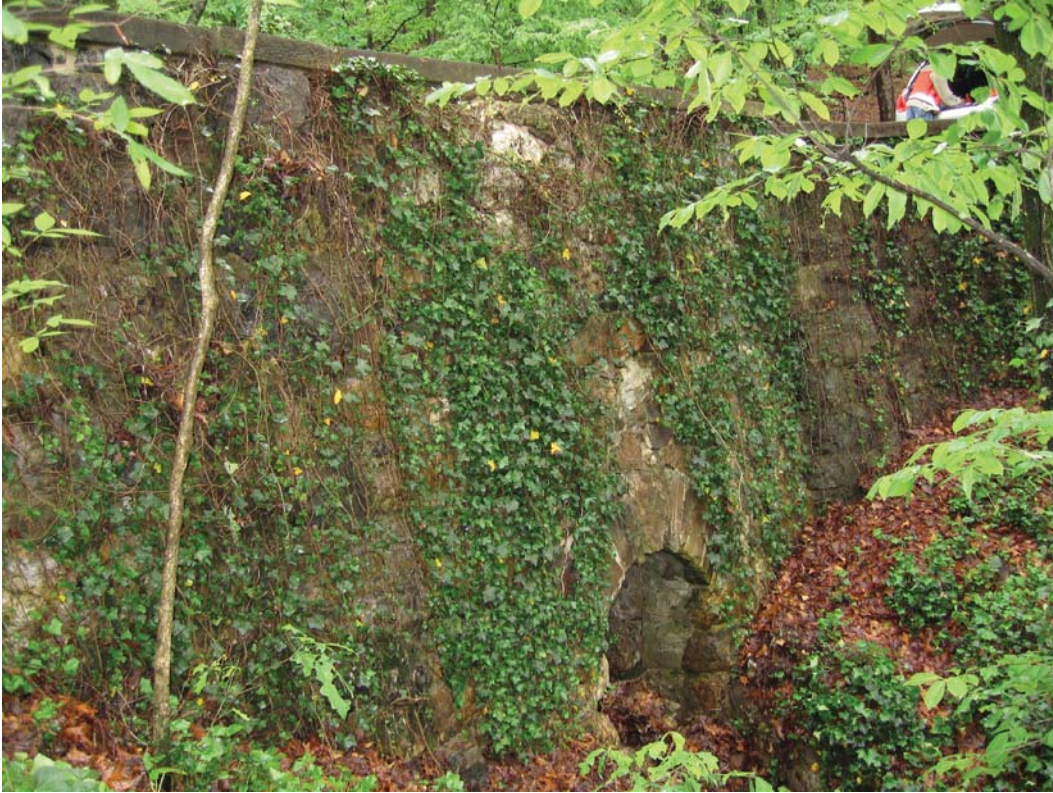
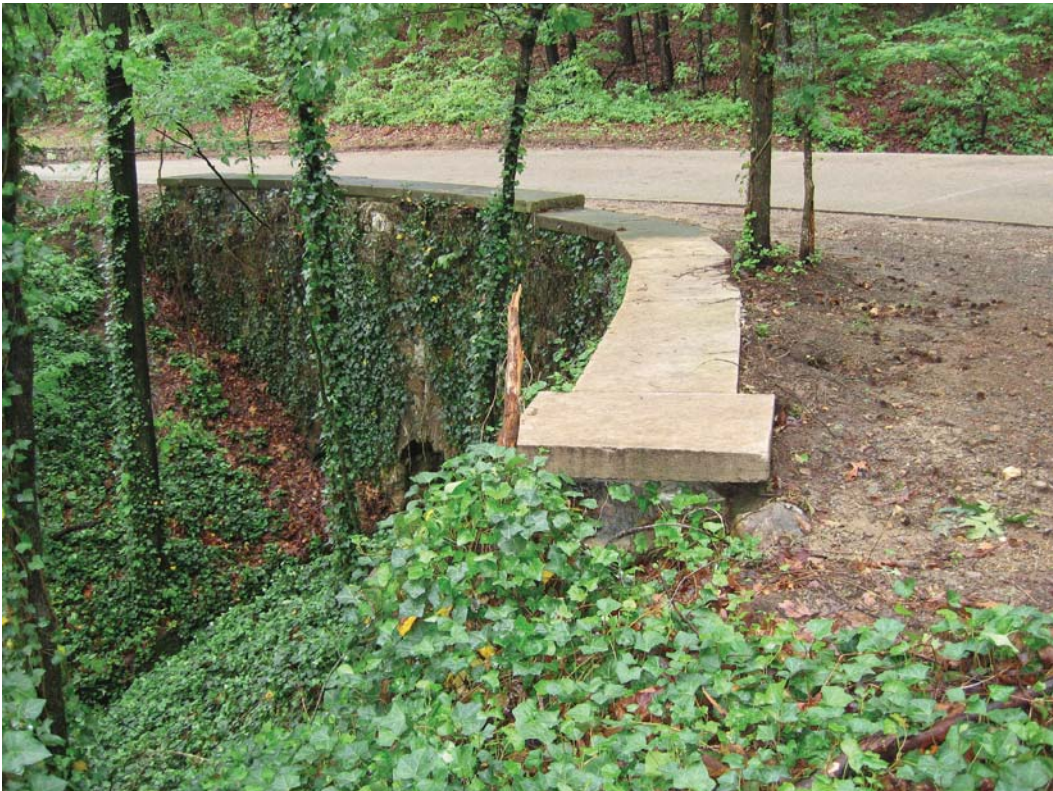
<b>Wall ID:</b>	HOSP-0010-0.205-R		
<b>Route Name:</b>	HOT SPRINGS MOUNTAIN DRIVE		
<b>Inspection Date:</b>	April 25, 2007	<b>Approximate Year Built:</b>	1911
<b>*Wall Rating:</b>	82	<b>Maintenance Action:</b>	No Action

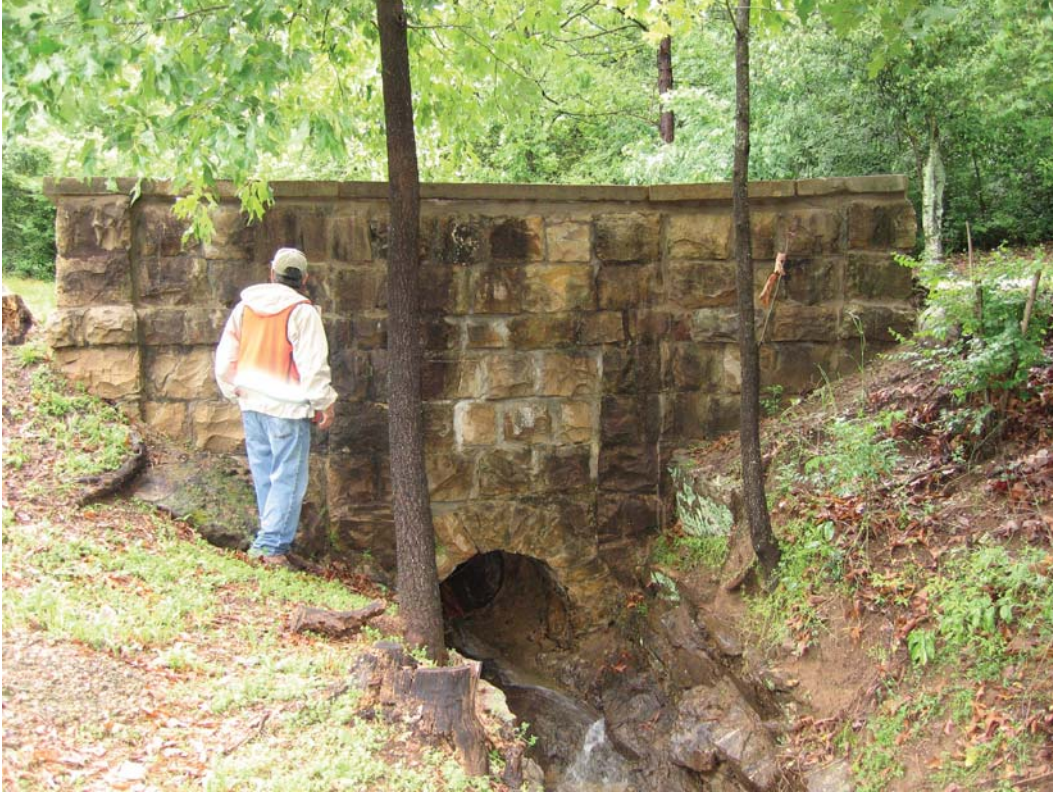
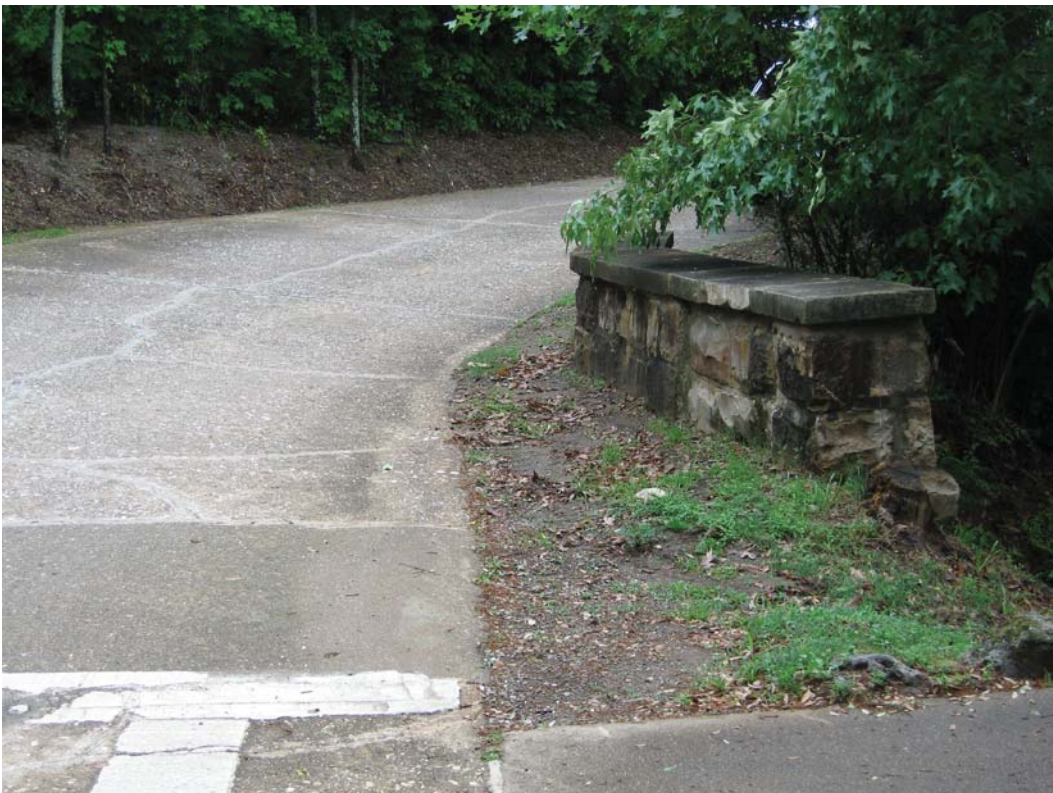
<b>Wall ID:</b>	HOSP-0010-0.396-R		
<b>Route Name:</b>	HOT SPRINGS MOUNTAIN DRIVE		
<b>Inspection Date:</b>	April 25, 2007	<b>Approximate Year Built:</b>	1911
<b>*Wall Rating:</b>	83	<b>Maintenance Action:</b>	No Action

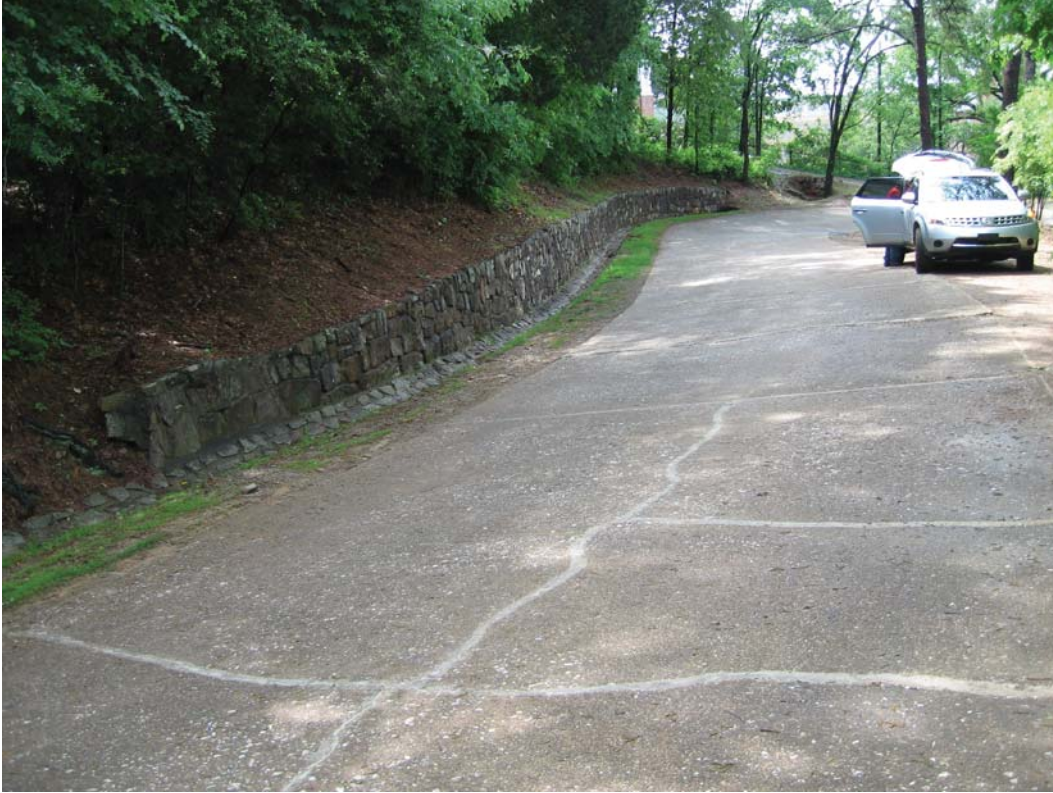
**HOSP\_0010\_0.488\_R\_1.jpg**

<b>Wall ID:</b>	HOSP-0010-0.488-R		
<b>Route Name:</b>	HOT SPRINGS MOUNTAIN DRIVE		
<b>Inspection Date:</b>	April 25, 2007	<b>Approximate Year Built:</b>	1911
<b>*Wall Rating:</b>	89	<b>Maintenance Action:</b>	No Action

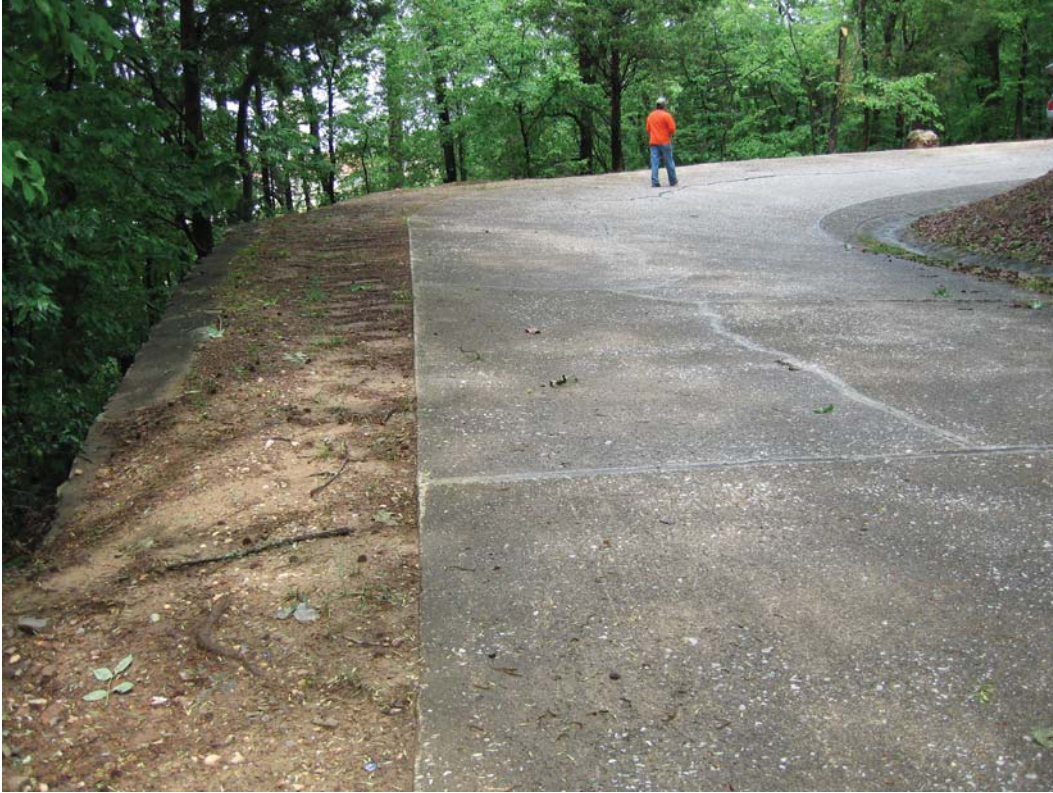
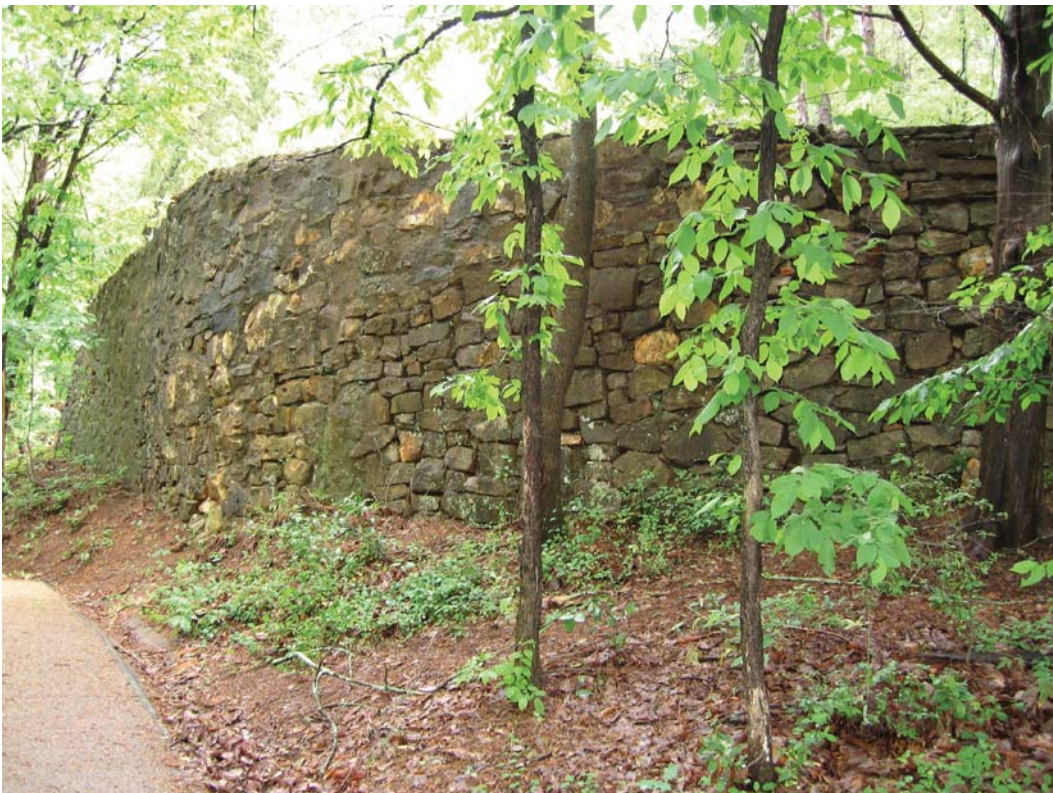
<b>Wall ID:</b>	HOSP-0010-0.589-L		
<b>Route Name:</b>	HOT SPRINGS MOUNTAIN DRIVE		
<b>Inspection Date:</b>	April 25, 2007	<b>Approximate Year Built:</b>	1911
<b>*Wall Rating:</b>	72	<b>Maintenance Action:</b>	No Action

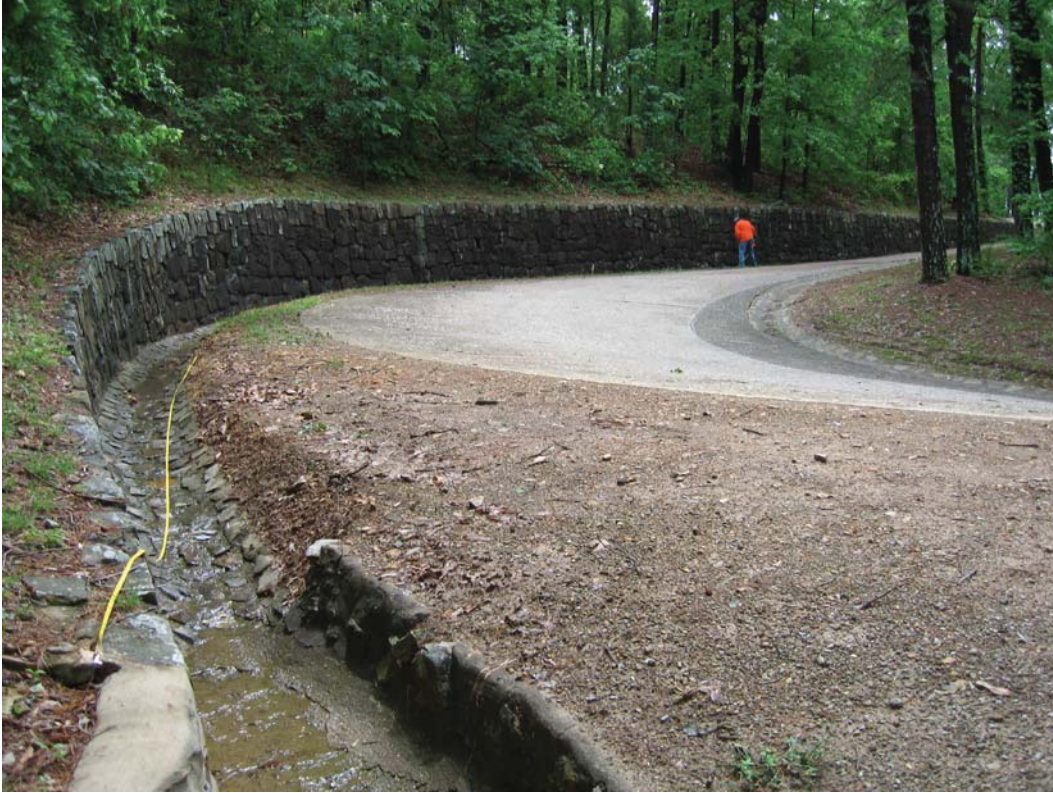
**HOSP\_0010\_0.812\_L\_1.jpg**

<b>Wall ID:</b>	HOSP-0010-0.812-L		
<b>Route Name:</b>	HOT SPRINGS MOUNTAIN DRIVE		
<b>Inspection Date:</b>	April 25, 2007	<b>Approximate Year Built:</b>	1911
<b>*Wall Rating:</b>	78	<b>Maintenance Action:</b>	No Action

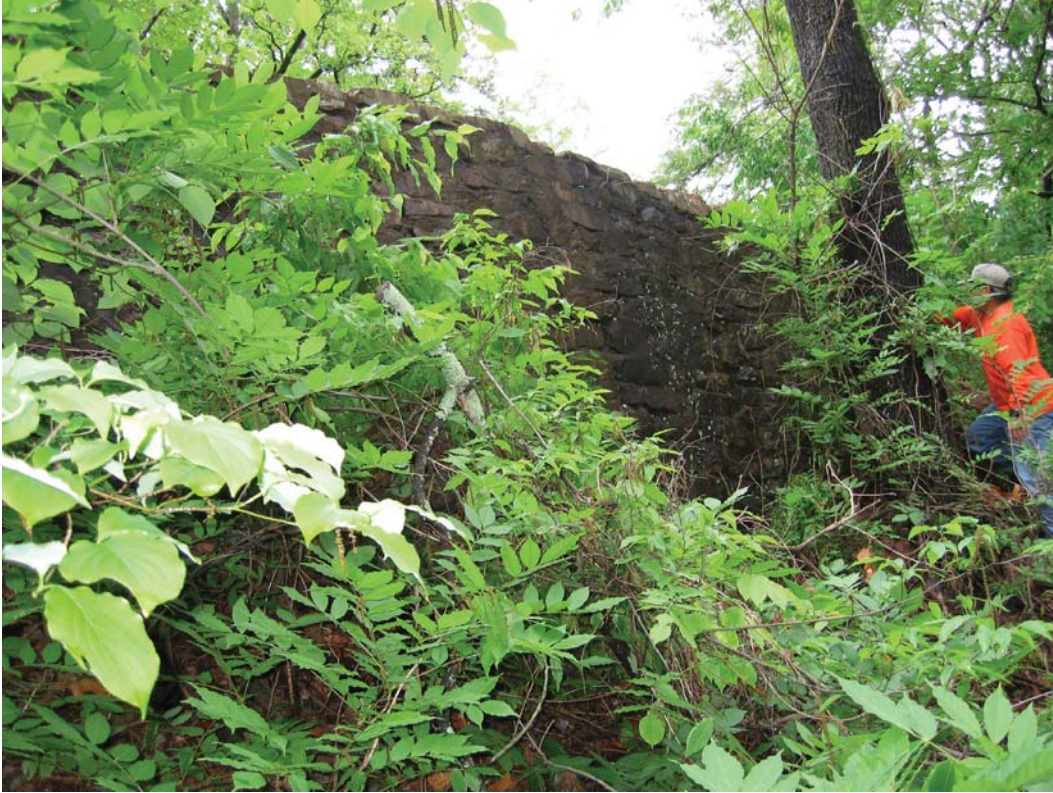
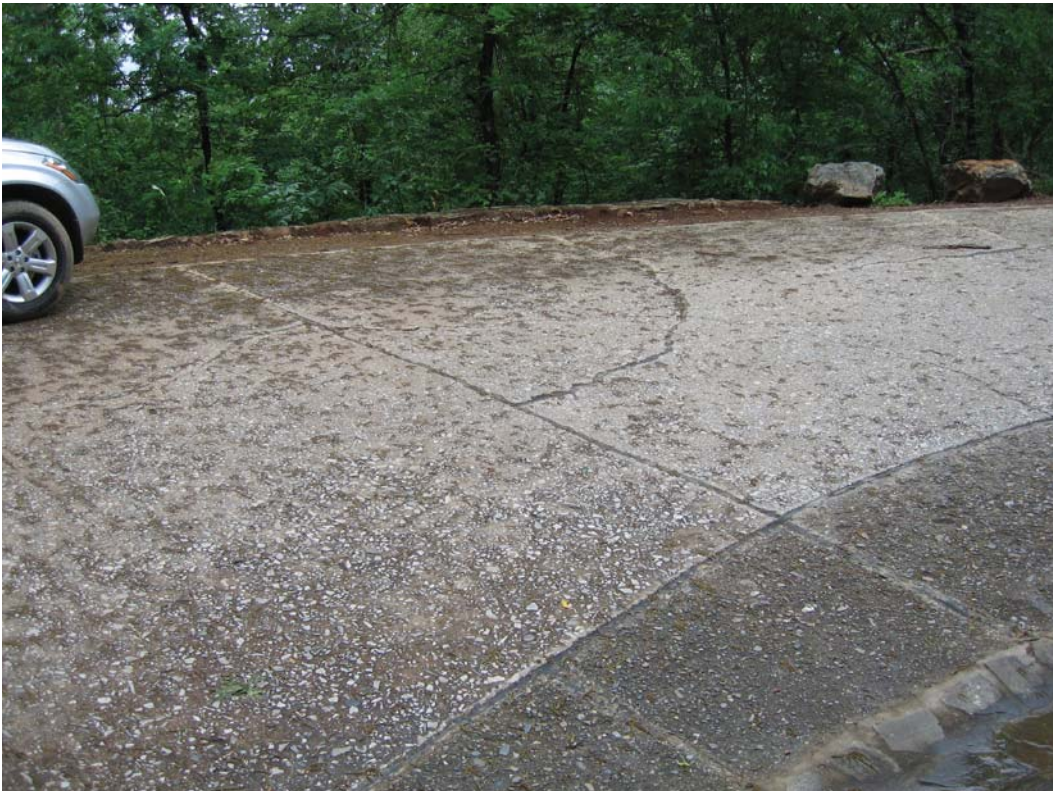
<b>Wall ID:</b>	HOSP-0010-1.008-L		
<b>Route Name:</b>	HOT SPRINGS MOUNTAIN DRIVE		
<b>Inspection Date:</b>	April 25, 2007	<b>Approximate Year Built:</b>	1911
<b>*Wall Rating:</b>	74	<b>Maintenance Action:</b>	No Action

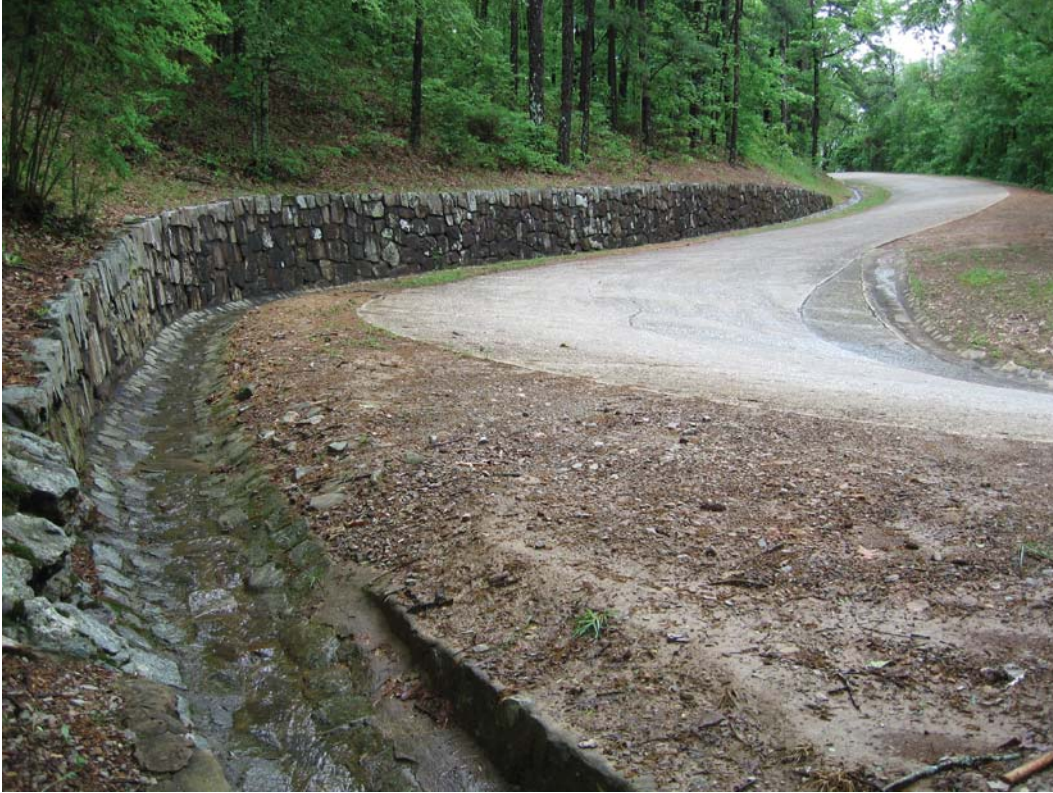
**HOSP\_0010\_1.015\_L\_1.jpg**

<b>Wall ID:</b>	HOSP-0010-1.015-L		
<b>Route Name:</b>	HOT SPRINGS MOUNTAIN DRIVE		
<b>Inspection Date:</b>	April 25, 2007	<b>Approximate Year Built:</b>	1911
<b>*Wall Rating:</b>	85	<b>Maintenance Action:</b>	No Action

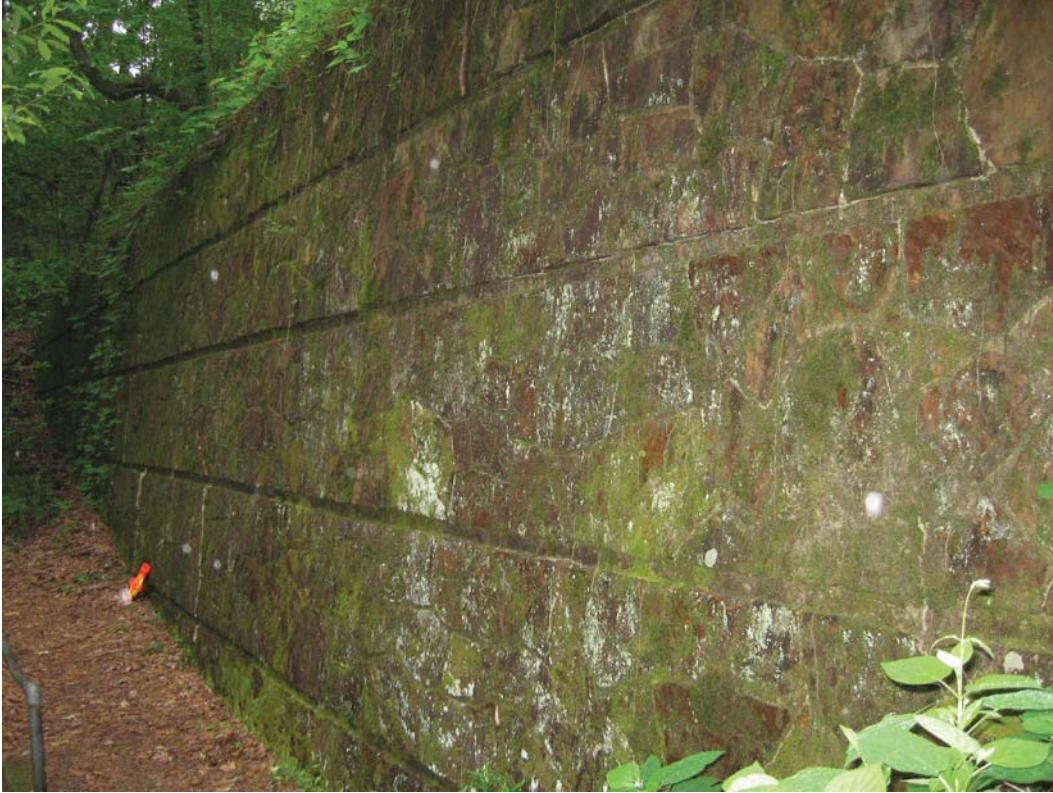
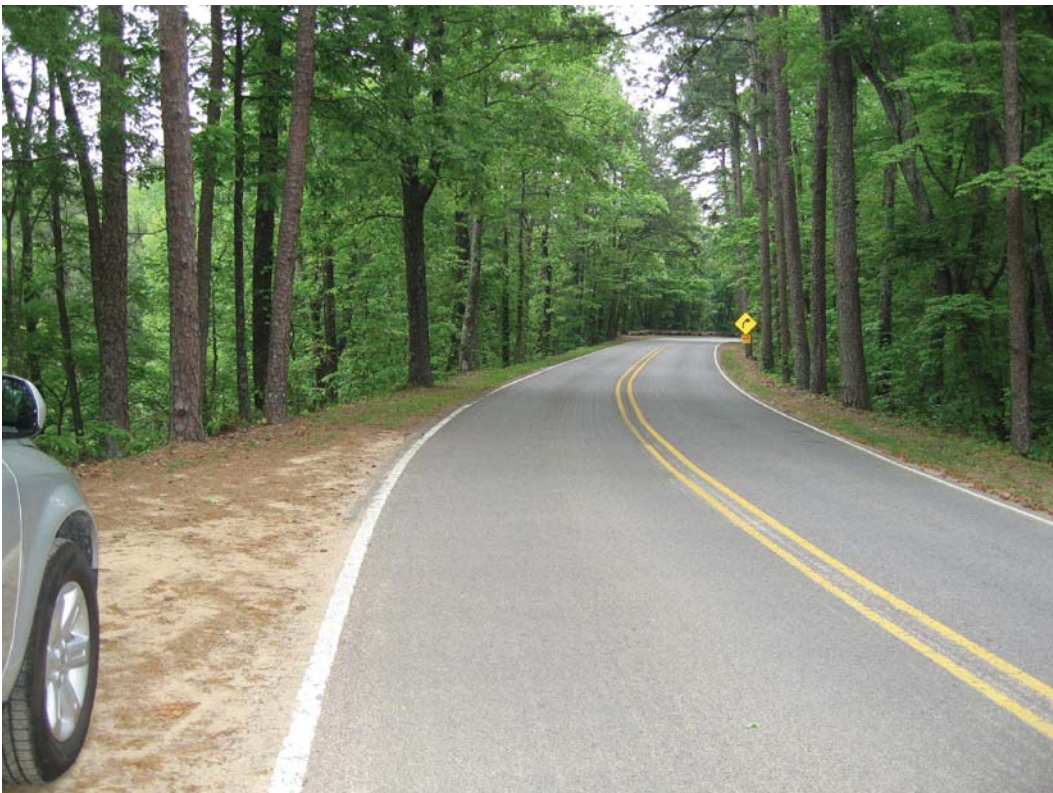
<b>Wall ID:</b>	HOSP-0011-1.088-L		
<b>Route Name:</b>	WEST MOUNTAIN DRIVE		
<b>Inspection Date:</b>	April 24, 2007	<b>Approximate Year Built:</b>	1950
<b>*Wall Rating:</b>	88	<b>Maintenance Action:</b>	No Action

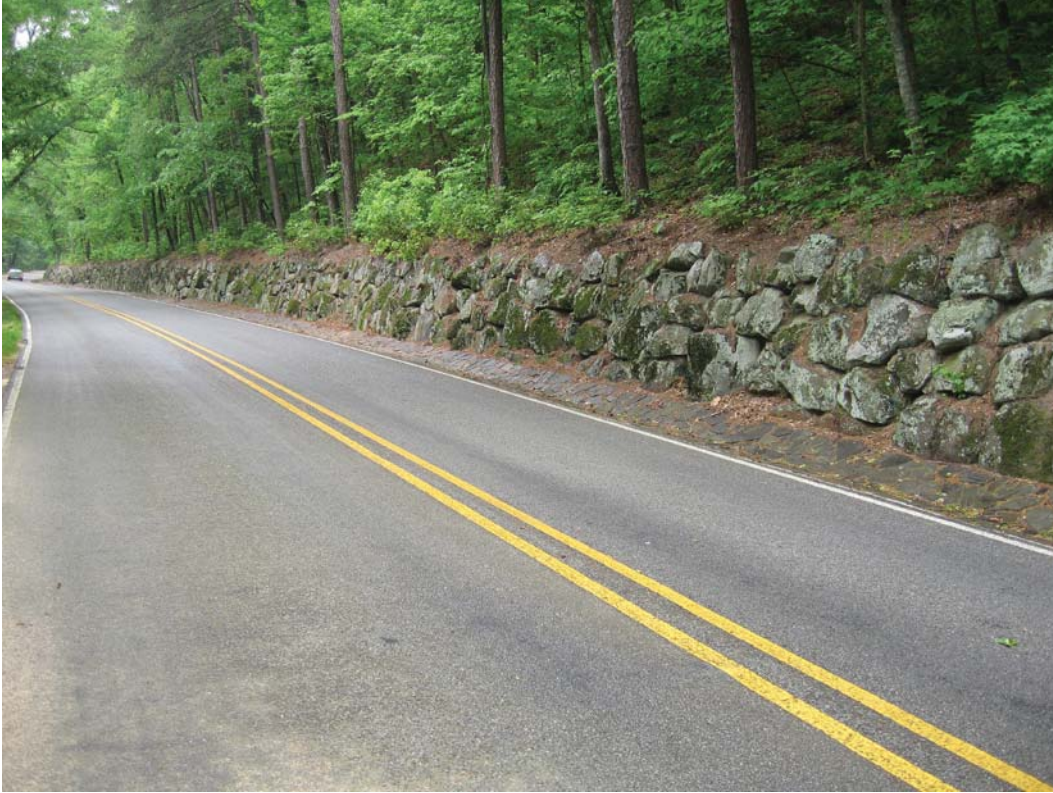
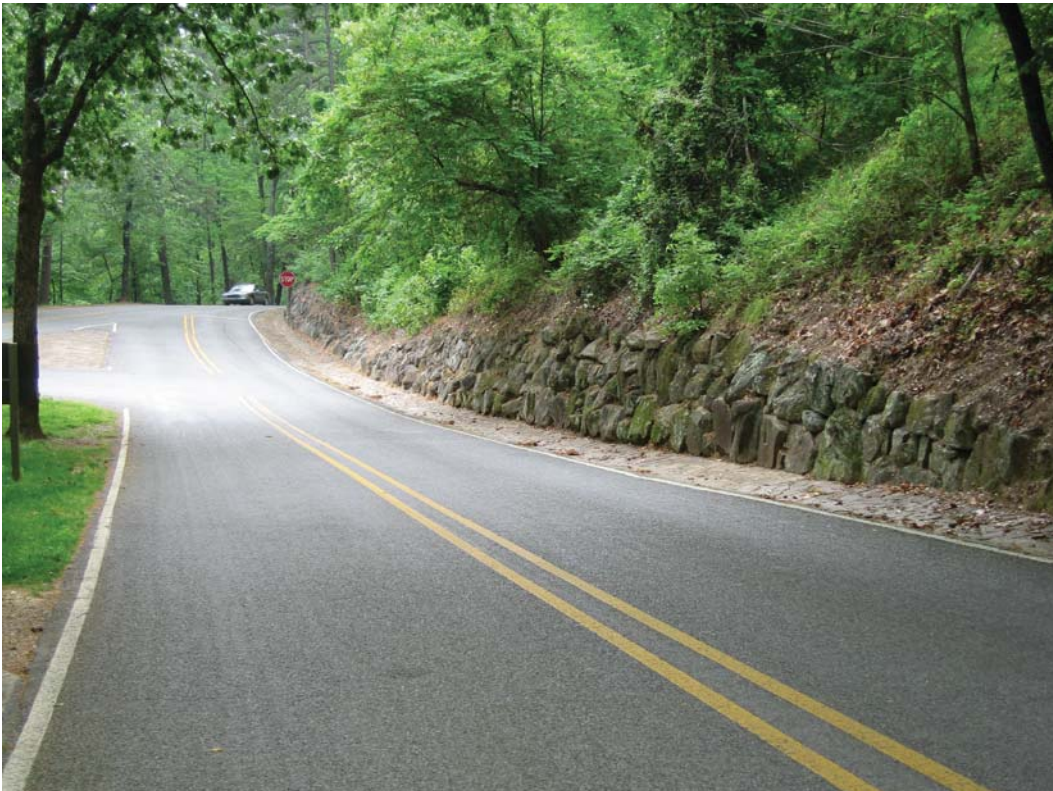
<b>Wall ID:</b>	HOSP-0011-1.290-R		
<b>Route Name:</b>	WEST MOUNTAIN DRIVE		
<b>Inspection Date:</b>	April 24, 2007	<b>Approximate Year Built:</b>	1935
<b>*Wall Rating:</b>	84	<b>Maintenance Action:</b>	No Action

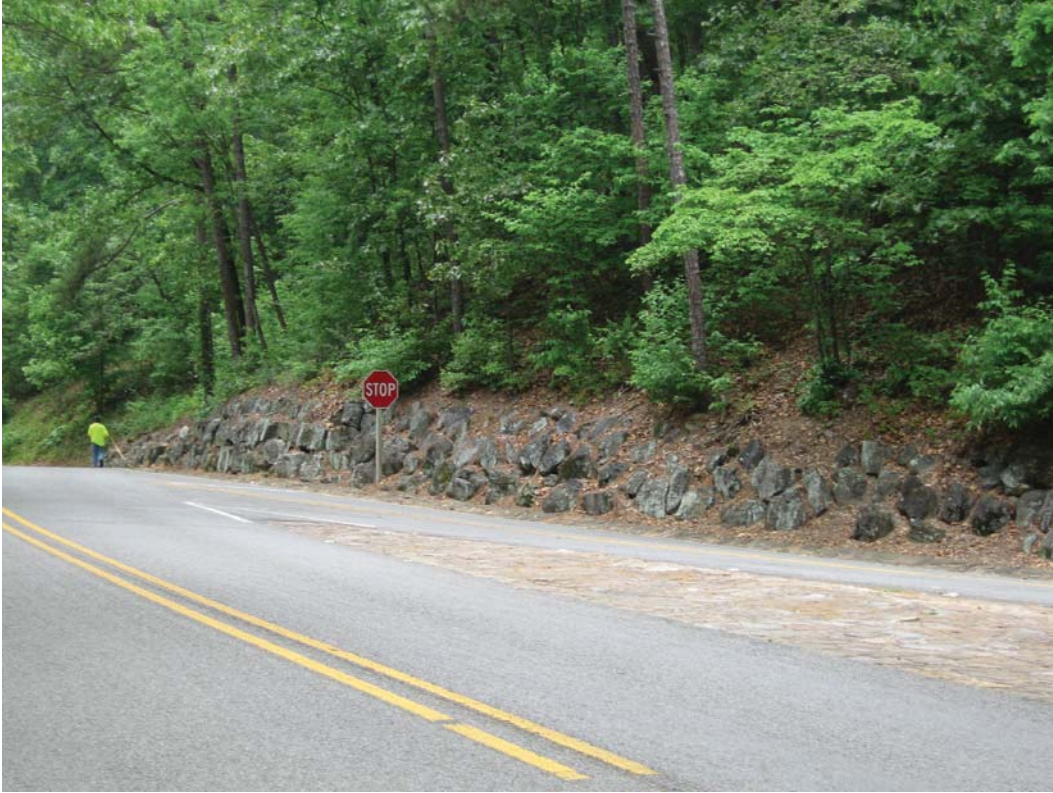
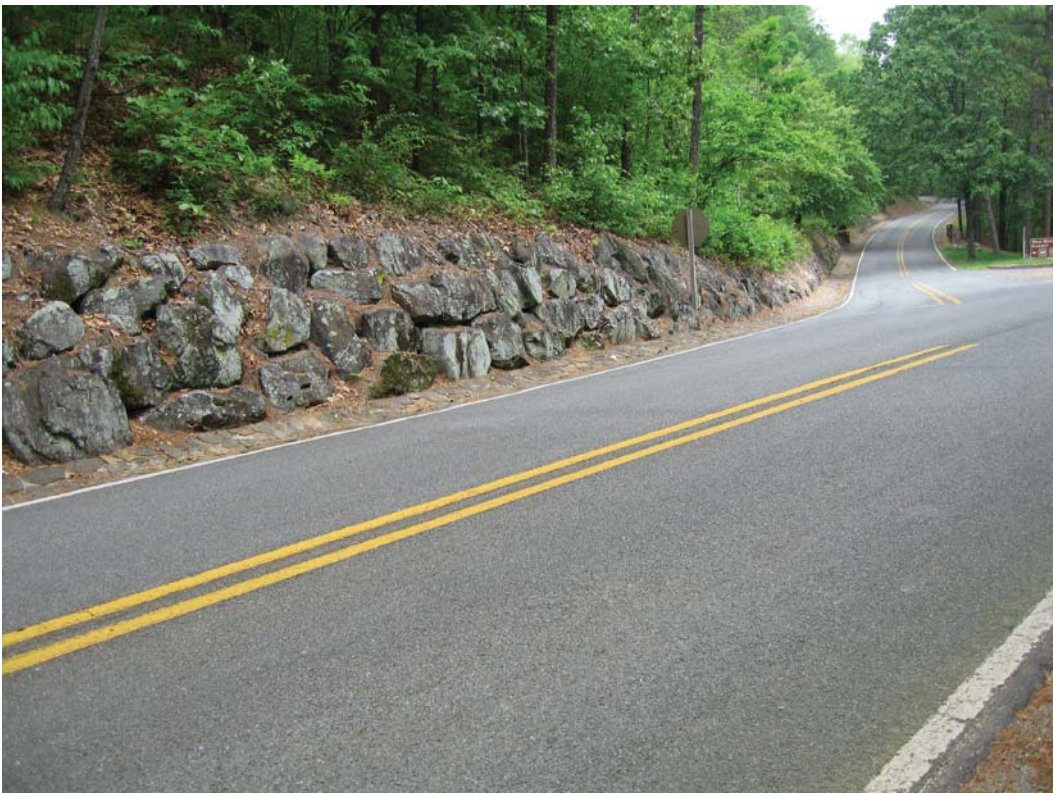
<b>Wall ID:</b>	HOSP-0011-1.687-R		
<b>Route Name:</b>	WEST MOUNTAIN DRIVE		
<b>Inspection Date:</b>	April 24, 2007	<b>Approximate Year Built:</b>	1935
<b>*Wall Rating:</b>	80	<b>Maintenance Action:</b>	No Action

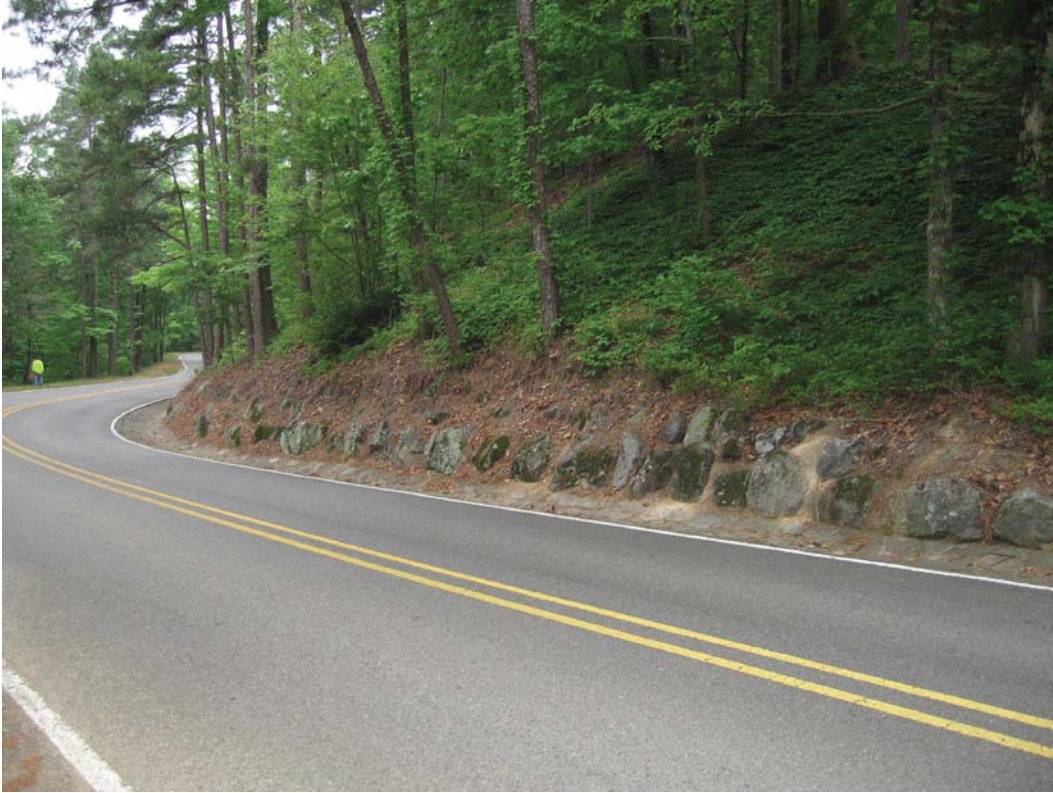
HOSP\_0011\_1.780\_R\_1.jpg

<b>Wall ID:</b>	HOSP-0011-1.780-R		
<b>Route Name:</b>	WEST MOUNTAIN DRIVE		
<b>Inspection Date:</b>	April 24, 2007	<b>Approximate Year Built:</b>	1935
<b>*Wall Rating:</b>	83	<b>Maintenance Action:</b>	No Action

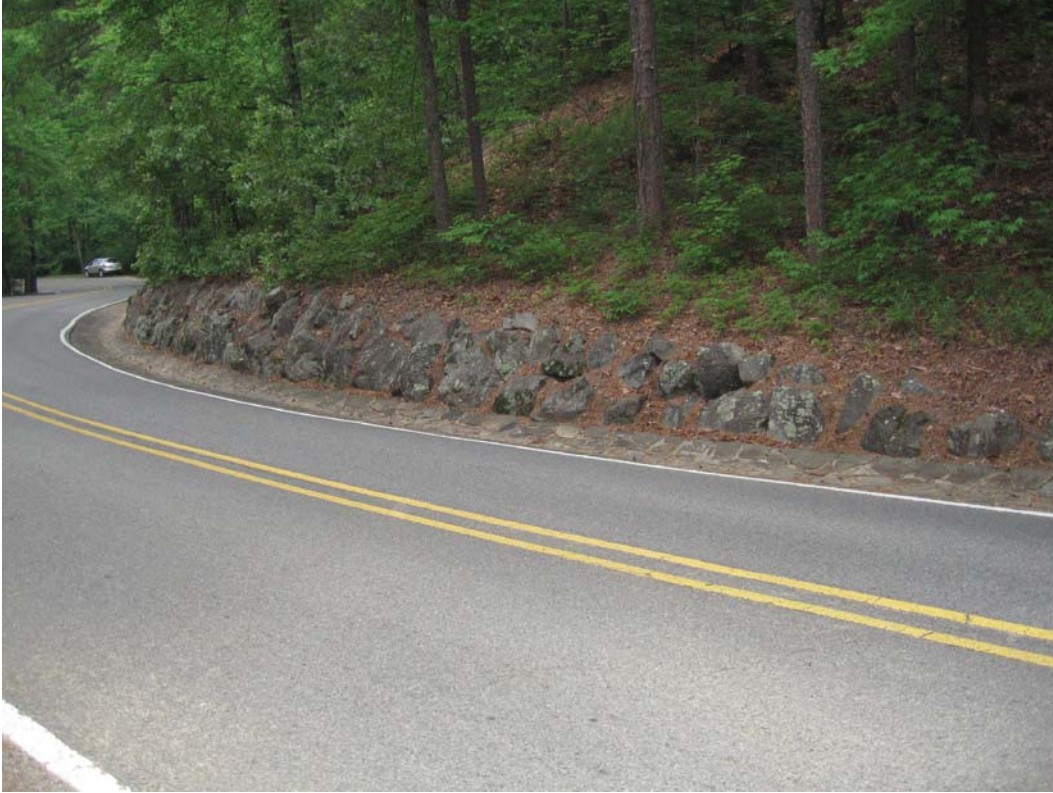
HOSP\_0011\_1.935\_R\_1.jpg

<b>Wall ID:</b>	HOSP-0011-1.935-R		
<b>Route Name:</b>	WEST MOUNTAIN DRIVE		
<b>Inspection Date:</b>	April 24, 2007	<b>Approximate Year Built:</b>	1935
<b>*Wall Rating:</b>	84	<b>Maintenance Action:</b>	No Action

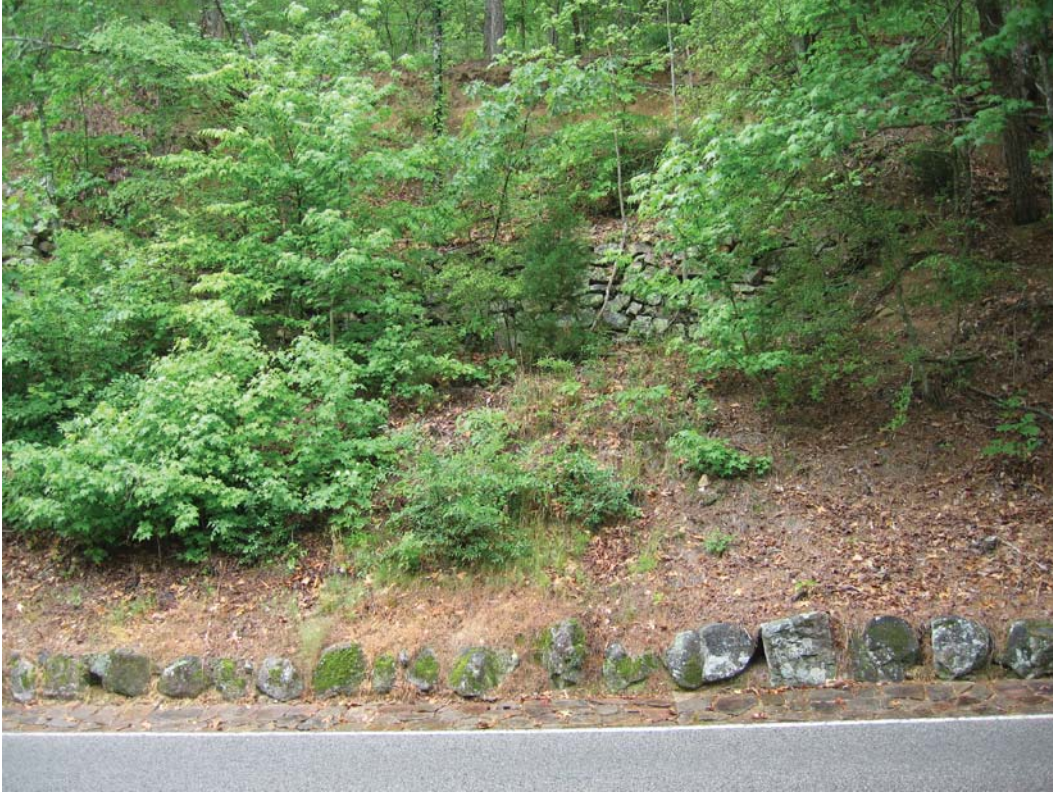
HOSP\_0101\_0.068\_L\_1.jpg

<b>Element (Weighting Factor)</b>	<b>Narrative</b>	<b>Condition Rating (0 - 10)</b>
PERFORMANCE 8.00	Good to fair condition, should monitor slump are for erosion that could impact the wall and roadway below	7
WALL FOUNDATION MATERIAL 8.00	Lower tier - no distress observed Upper tier- foundation on loose, uncompacted soil, but no distress observed, functioning as intended	6
PLACED STONE 8.00	Lower tier- large rocks probably built with roadway, good condition Upper tier- placed secondarily with smaller rock, not as good construction, no weathering, occasional voids, loose at the top, occasional missing stones, good performance overall	7
CURB/BERM/DITCH 0.50	Ditch - occasional small missing pieces, fractured mortar, performing as intended	8
LATERAL SLOPE 0.50	1.5H:1V slope, steep but no signs of additional slumping	8
ROAD/SIDEWALK/SHOULDER 0.50	Road - no distress from wall observed	9
WALL DRAINS 0.50	None observed, no indication of wall distress or erosion from water-related issues	9

<b>Failure Consequence:</b>	LOW
<b>Recommendation Narrative:</b>	None
<b>Repair Cost:</b>	\$0

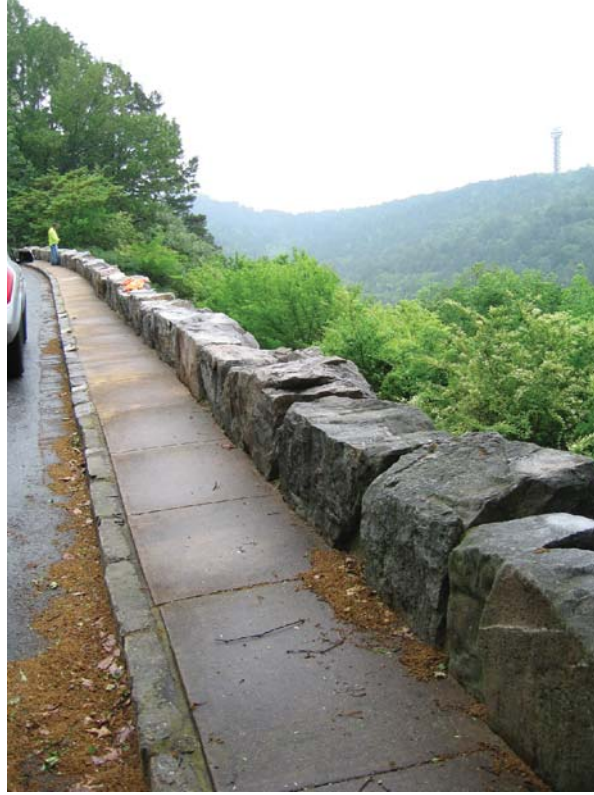
HOSP\_0101\_0.348\_R\_1.jpg

<b>Element (Weighting Factor)</b>	<b>Narrative</b>	<b>Condition Rating (0 - 10)</b>
PERFORMANCE 8.00	Good condition, no significant signs of distress, performing as intended	8
WALL FOUNDATION MATERIAL 8.00	Good condition, no visible slumping or distress, on berm with landscaped grassy face	9
MORTAR 8.00	Cracked and spalling in places, local raveling, coarse concrete mix	7
PLACED STONE 8.00	Good condition, minor weathering, none missing, no cracking or spalling	8
LATERAL SLOPE 0.50	1.5H:1V to 2H:1V grass transitions to natural vegetation, no signs of distress	8
ROAD/SIDEWALK/SHOULDER 0.50	Sidewalk at top in good condition, no cracking or spalling, minor unlevel locations, functioning as intended	8
TRAFFIC BARRIER/FENCE 0.50	Guardwall at top of wall, added as secondary wall (mortared), performing as intended	8
DOWNSLOPE 0.50	Man-made berm 1.5H:1V landscaped grassy (well-established), no signs of distress	9

WALL DRAINS 0.50	No distress observed due to drainage issues	9

<b>Failure Consequence:</b>	LOW
<b>Recommendation Narrative:</b>	None
<b>Repair Cost:</b>	\$0

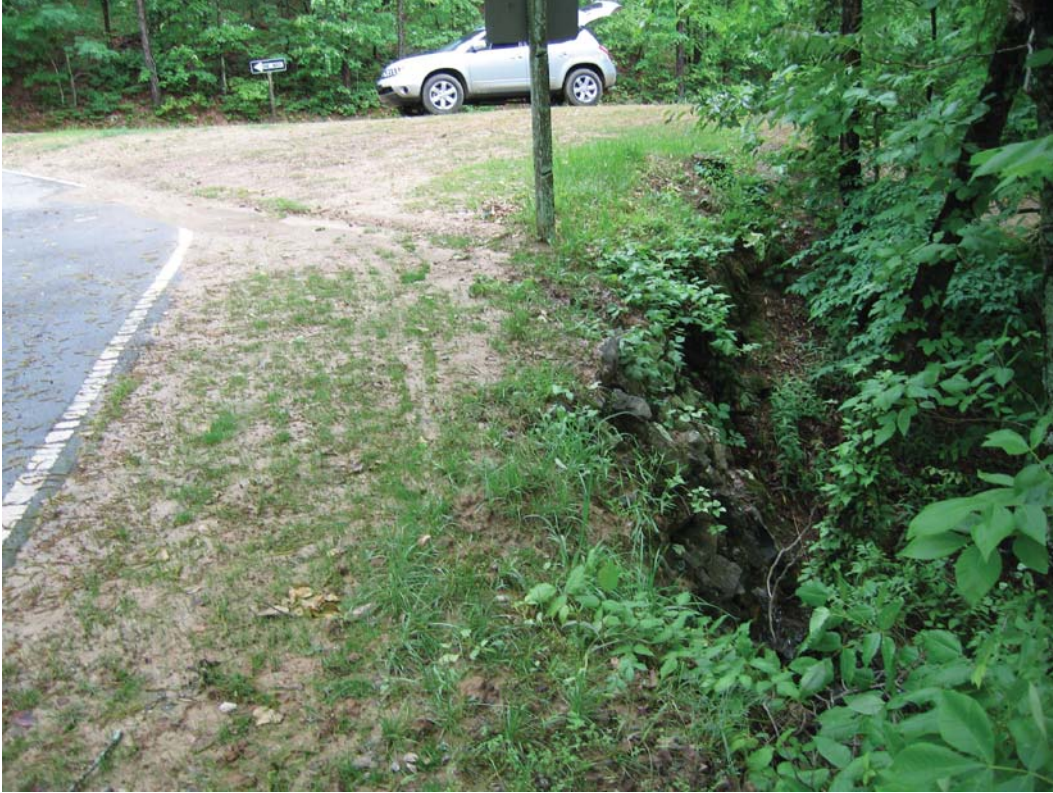
HOSP\_0201\_0.517\_R\_1.jpg

<b>Element (Weighting Factor)</b>	<b>Narrative</b>	<b>Condition Rating (0 - 10)</b>
PERFORMANCE 8.00	Good condition. Minor loose rock and minor erosion at sides.	7
WALL FOUNDATION MATERIAL 8.00	Good condition, no indication of settlement or movement.	8
PLACED STONE 8.00	Good, sound, durable rock. Occasional loose rock with minor movement out of face.	7
DOWNSLOPE 0.50	Trail immediately below. Good condition.	8
VEGETATION 0.50	Minor. May slightly help stability. Minor brush. No adverse affect of vegetation.	8
WALL DRAINS 0.50	None observed. Drainage and water not impacting wall performance.	9
LATERAL SLOPE 1.00	Minor erosion at both ends. No vegetation. Minor creep.	6
CULVERT 1.00	18" clay pipe at base of wall. Broken end but functioning good.	7
ROAD/SIDEWALK/SHOULDER 1.00	Road. Occasional transverse cracks, not impacting road. Loose, soft shoulder.	7

<b>Failure Consequence:</b>	LOW
<b>Recommendation Narrative:</b>	None
<b>Repair Cost:</b>	\$0

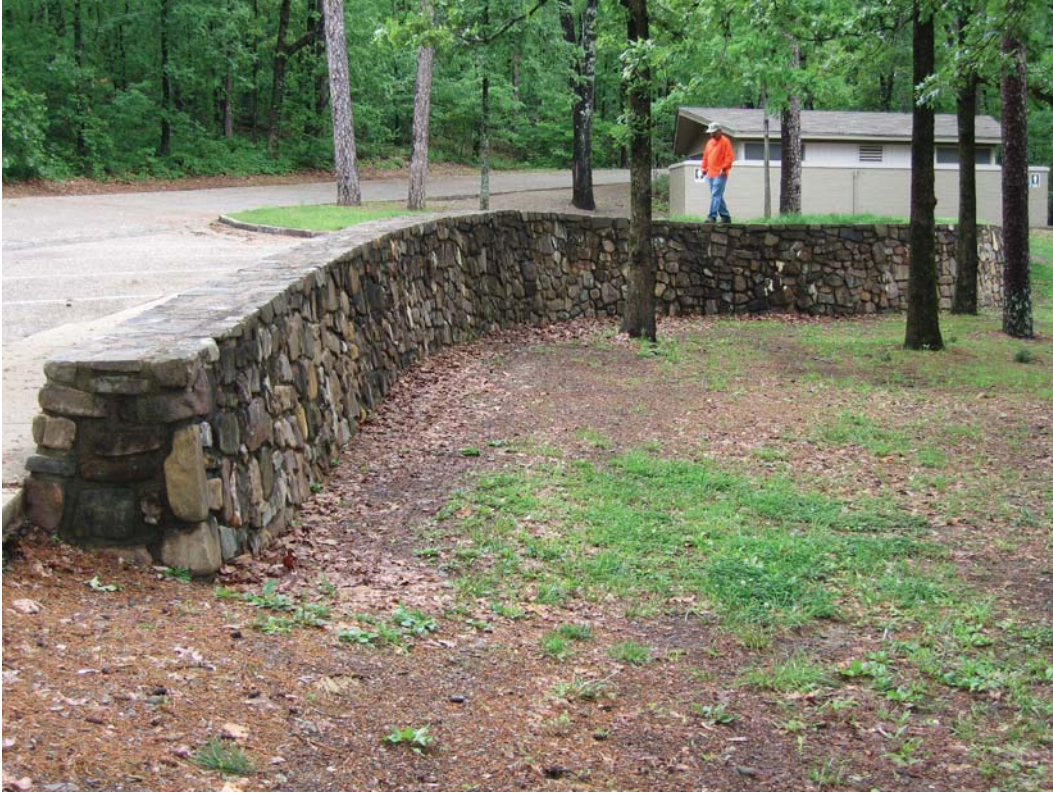
HOSP\_0901C\_0.000\_P1\_1.jpg

<b>Element (Weighting Factor)</b>	<b>Narrative</b>	<b>Condition Rating (0 - 10)</b>
PERFORMANCE 8.00	Very good, performing as intended.	9
WALL FOUNDATION MATERIAL 8.00	Good condition, no signs of distress. Good soil base.	9
MORTAR 8.00	Good condition, minor cracking (1/8").	9
PLACED STONE 8.00	Sound, durable rock, none missing.	9
LATERAL SLOPE 0.50	Flat at one end and gentle slope at the other. No observed erosion.	9
WALL DRAINS 0.50	None observed. Drainage and water not impacting wall performance. None observed. No signs of drainage related issues.	9
DOWNSLOPE 0.50	Relatively flat with grass.	10
ROAD/SIDEWALK/SHOULDER 1.00	Sidewalk. Minor displacement (vertically) possibly due to wall. Not affecting wall performance.	7

<b>Failure Consequence:</b>	LOW
<b>Recommendation Narrative:</b>	None
<b>Repair Cost:</b>	\$0

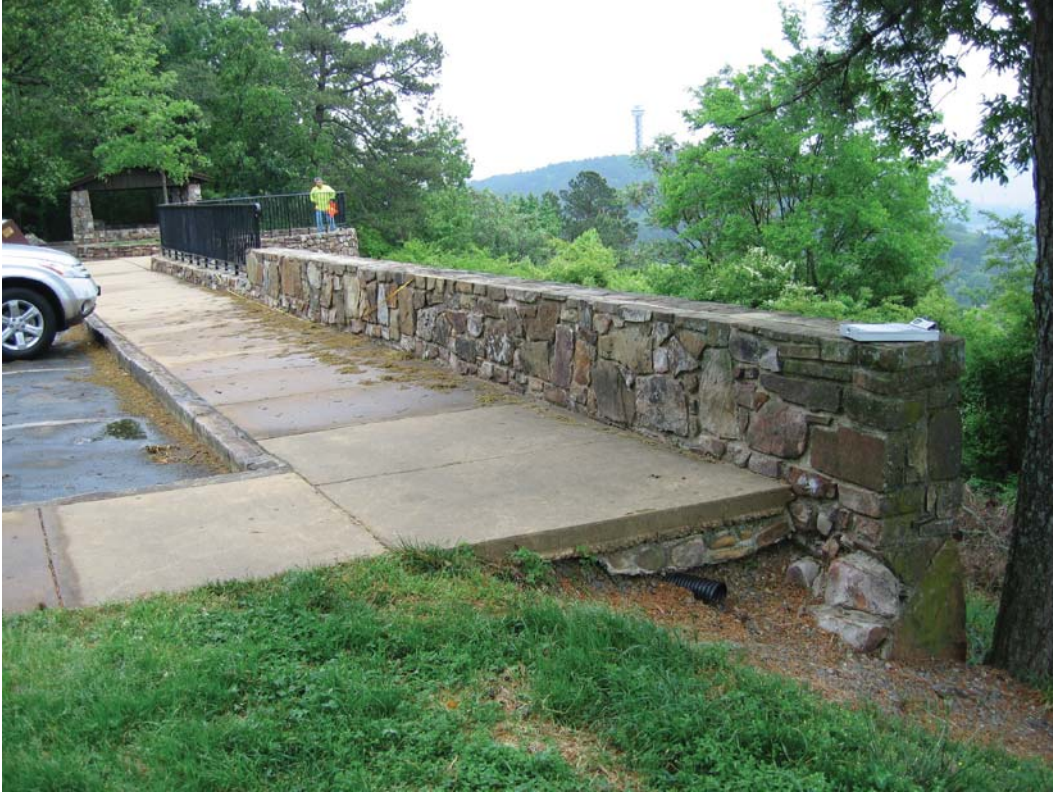
**HOSP\_0905\_0.000\_P1\_1.jpg**

<b>Element (Weighting Factor)</b>	<b>Narrative</b>	<b>Condition Rating (0 - 10)</b>
PERFORMANCE 8.00	Good, performing as intended. No missing elements.	9
WALL FOUNDATION MATERIAL 8.00	Good condition, no erosion, slumping, or displacement on footing, good ground.	9
MORTAR 8.00	Good condition, minor cracking, minor separation with new patching.	8
PLACED STONE 8.00	Minor weathering, no cracking or missing pieces.	9
LATERAL SLOPE 0.50	2.5:1 to 2:1 slope. No erosion observed.	8
ROAD/SIDEWALK/SHOULDER 0.50	Sidewalk in good condition, minor cracking or spalling, minor changes in elevation.	8
TRAFFIC BARRIER/FENCE 0.50	No distress observed related to poor drainage. No scour.	8
DOWNSLOPE 0.50	3:1 gentle slope, grassy.	9
WALL DRAINS 0.50	6" PVC partially buried but functioning. No distress observed related to poor drainage. No scour.	9

<b>Failure Consequence:</b>	LOW
<b>Recommendation Narrative:</b>	None
<b>Repair Cost:</b>	\$0
