MEVE WIP Report

NPS Retaining Wall Inventory Program Mesa Verde National Park

**Federal Highway Administration
Eastern Federal Lands Highway Division
Road Inventory Program (RIP)**

**Data Collection Date: December 2006
Report Date: October 2015**

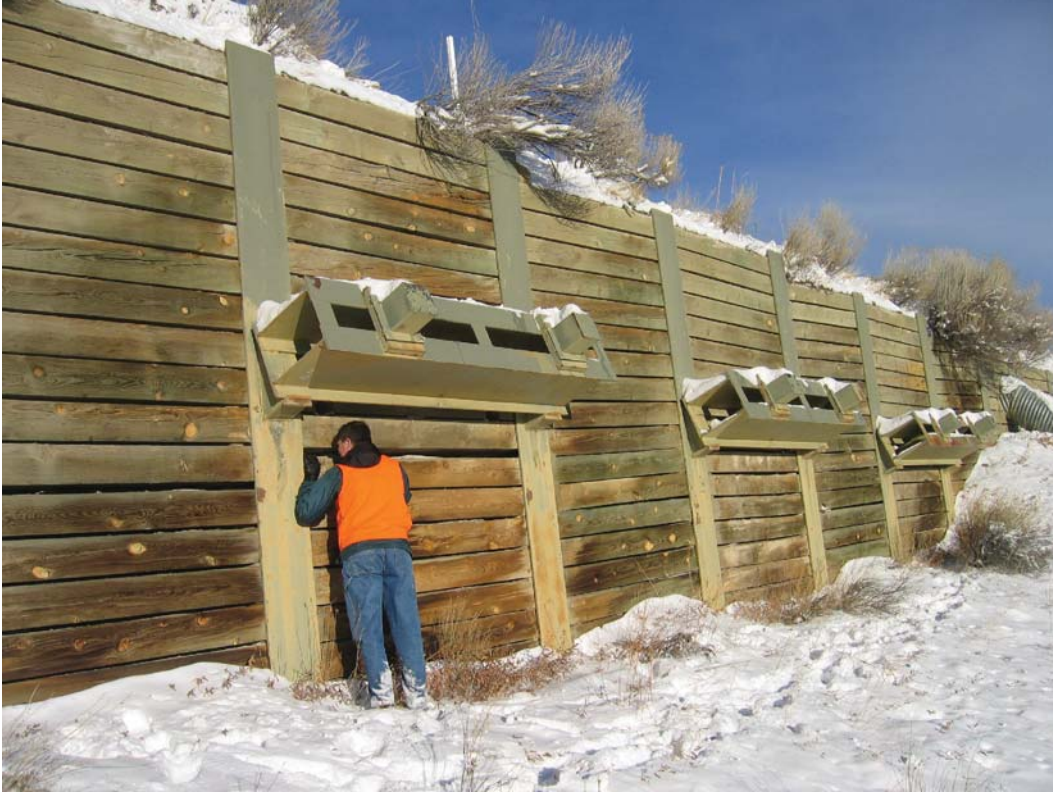
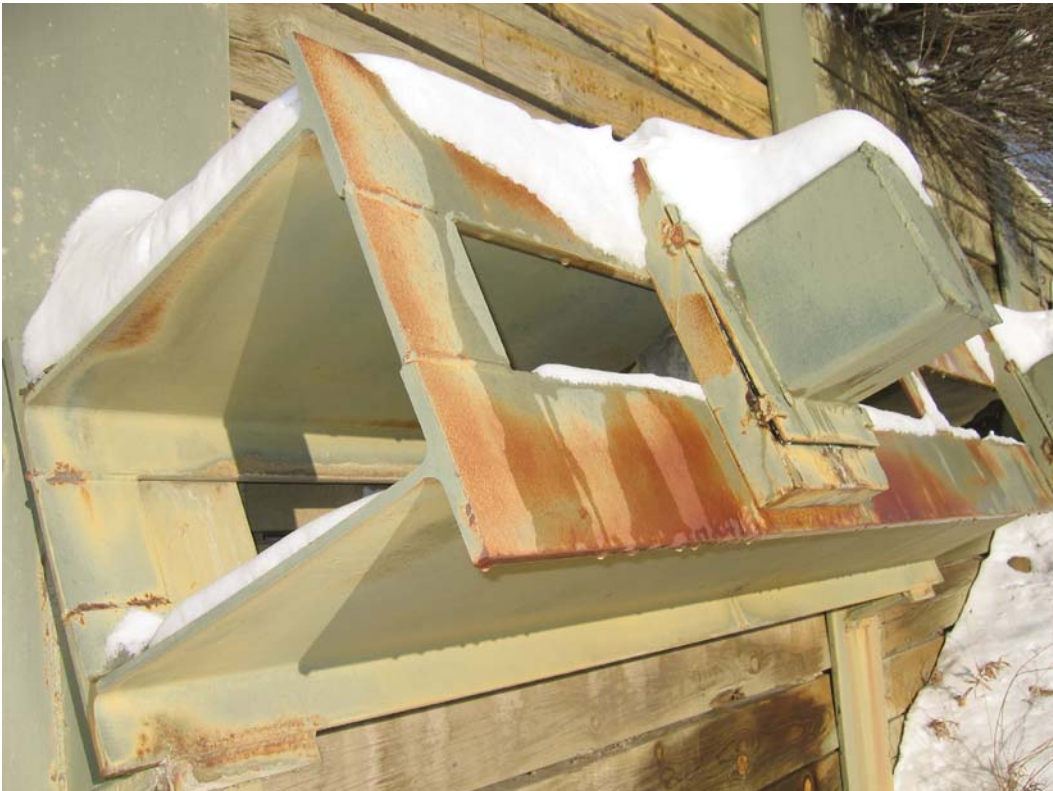
MEVE_0010_2.649_L_1.jpg

Element (Weighting Factor)	Narrative	Condition Rating (0 - 10)
PERFORMANCE 8.00	Good condition with need of minor repairs, functioning as intended	8
ANCHOR HEADS 8.00	Minor surficial corrosion, minor cracking, isolated areas of paint missing	8
LAGGING 8.00	Isolated minor timber deformation (at 2 locations), not impacting the function	8
PILES AND SHAFTS 8.00	Minor surficial corrosion, minor cracking, isolated areas of paint missing	8
ROAD/SIDEWALK/SHOULDER 0.50	Road has minor cracking in outbound lane parallel to slope	8
CULVERT 0.50	No issues or obvious signs of distress, appears to function properly	9
DOWNSLOPE 0.50	Approximately 5-ft wide bench before moderate slope, no signs of significant erosion, minor vegetation, low visibility due to snow cover	9
LATERAL SLOPE 0.50	No signs of significant erosion, minor vegetation, low visibility due to snow cover	9
TRAFFIC BARRIER/FENCE 0.50	Guardrail shows no signs of distress	9

Failure Consequence:	MODERATE
Recommendation Narrative:	Surface treatment (painting) of walers: 400ft ² painting walers @ \$1/ft ² = \$400. 20 hrs labor @ \$55/hr=\$1100, TOTAL=\$1500
Repair Cost:	\$1,500

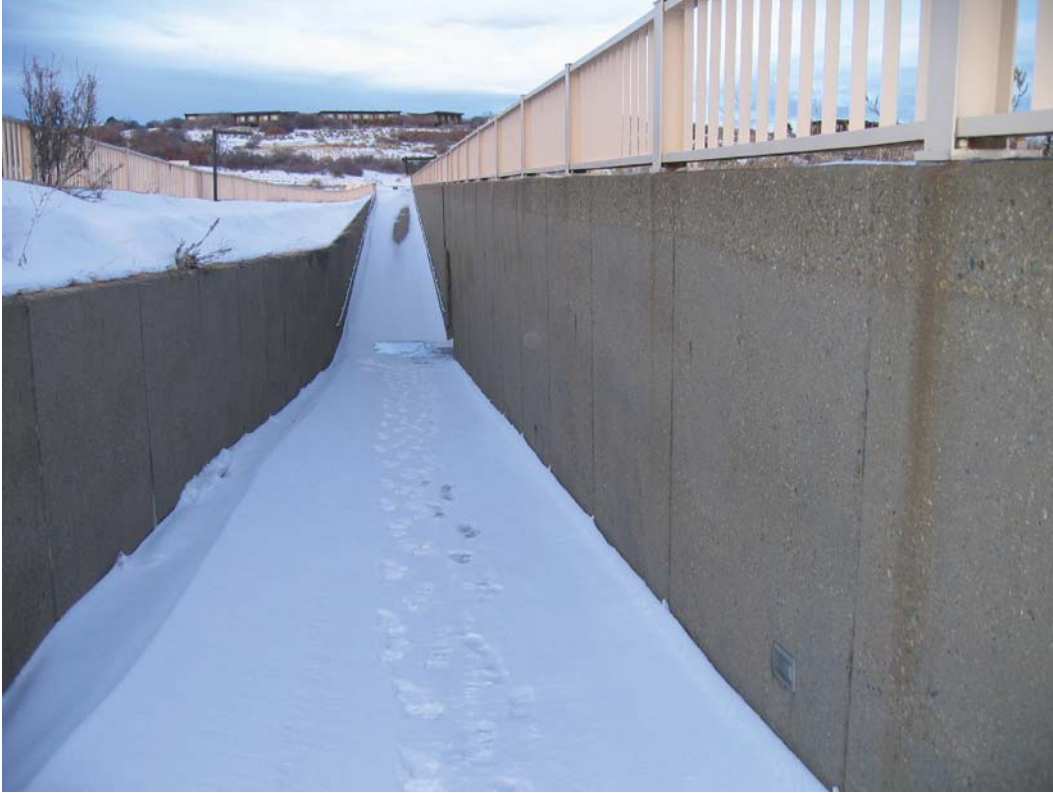
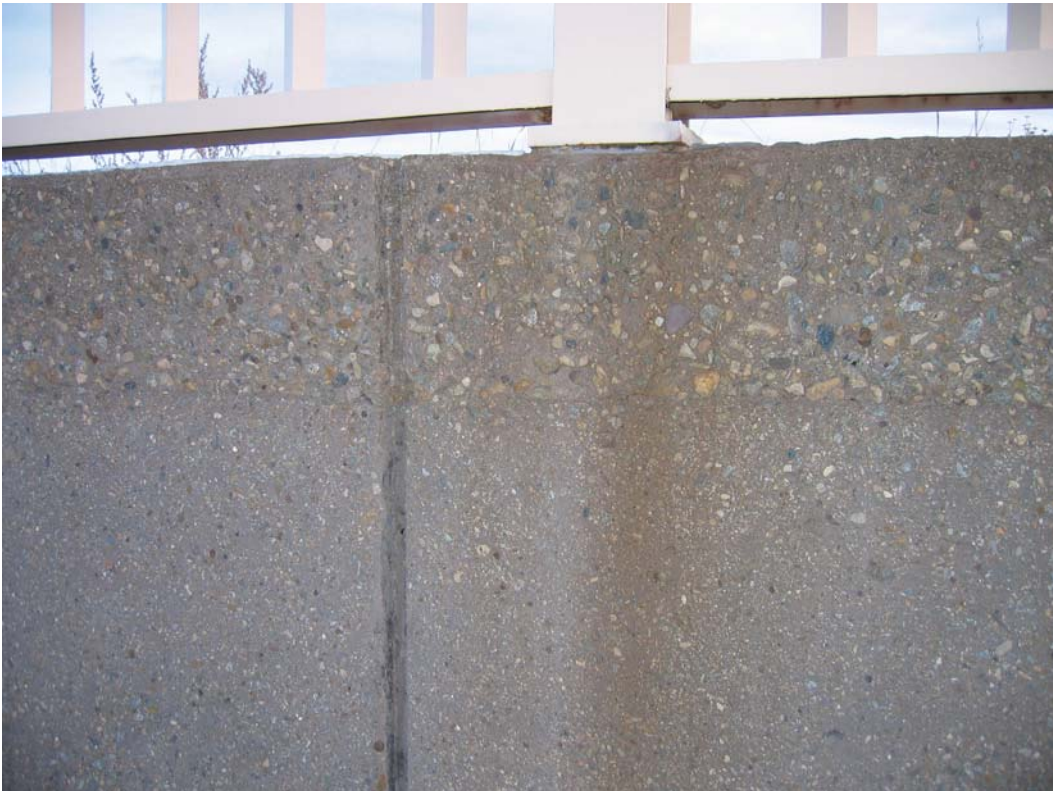
Wall ID:	MEVE-0010-14.883-R		
Route Name:	ENTRANCE ROAD		
Inspection Date:	December 12, 2006	Approximate Year Built:	1970
*Wall Rating:	85	Maintenance Action:	No Action

Element (Weighting Factor)	Narrative	Condition Rating (0 - 10)
PERFORMANCE 8.00	Good, minor cracking and spalling may need routine maintenance, functioning as intended	9
WALL FOUNDATION MATERIAL 8.00	No signs of distress, limited visibility due to snow cover	9
CONCRETE 8.00	Minor longitudinal cracking outside construction joints, minor spalling at tunnel, approximately 2 inch offset at top of wall at tunnel joint, function not impacted, recommend routine maintenance at spalling areas near tunnel (may continue to deteriorate)	8
TRAFFIC BARRIER/FENCE 0.50	Metal rail at top, no signs of distress due to retaining wall	9
UPSLOPE 0.50	Flat, no observed distress, limited visibility due to snow cover	9

Failure Consequence:	LOW
Recommendation Narrative:	None
Repair Cost:	\$0

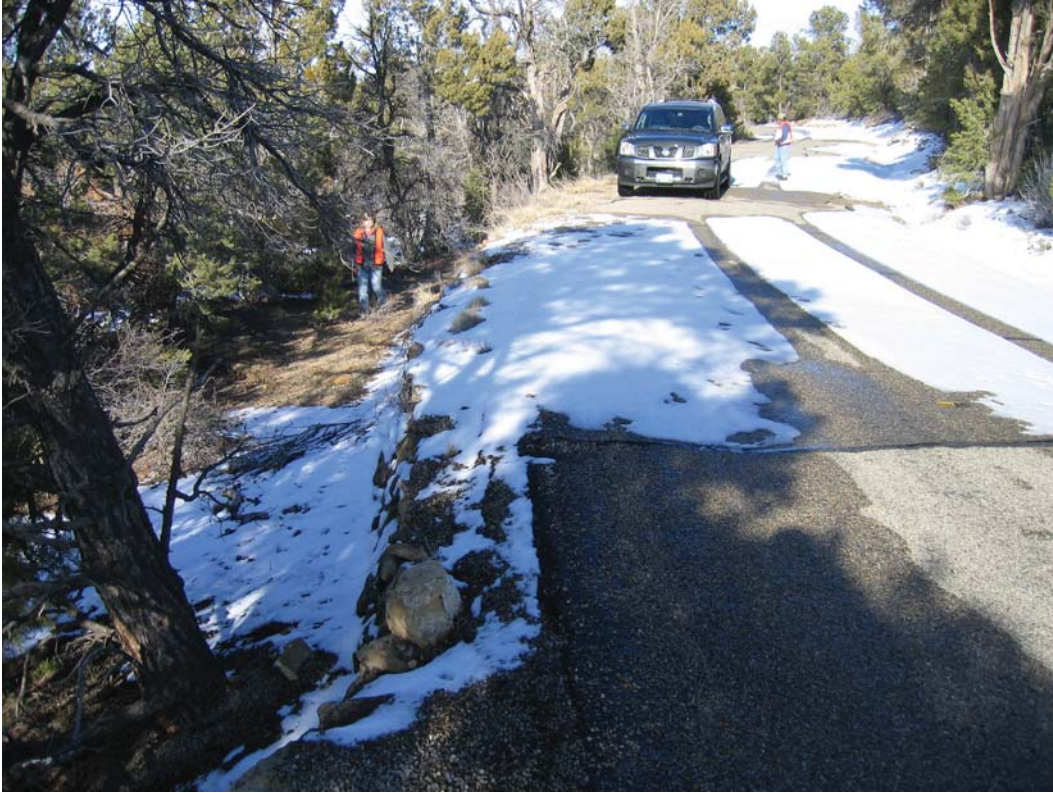
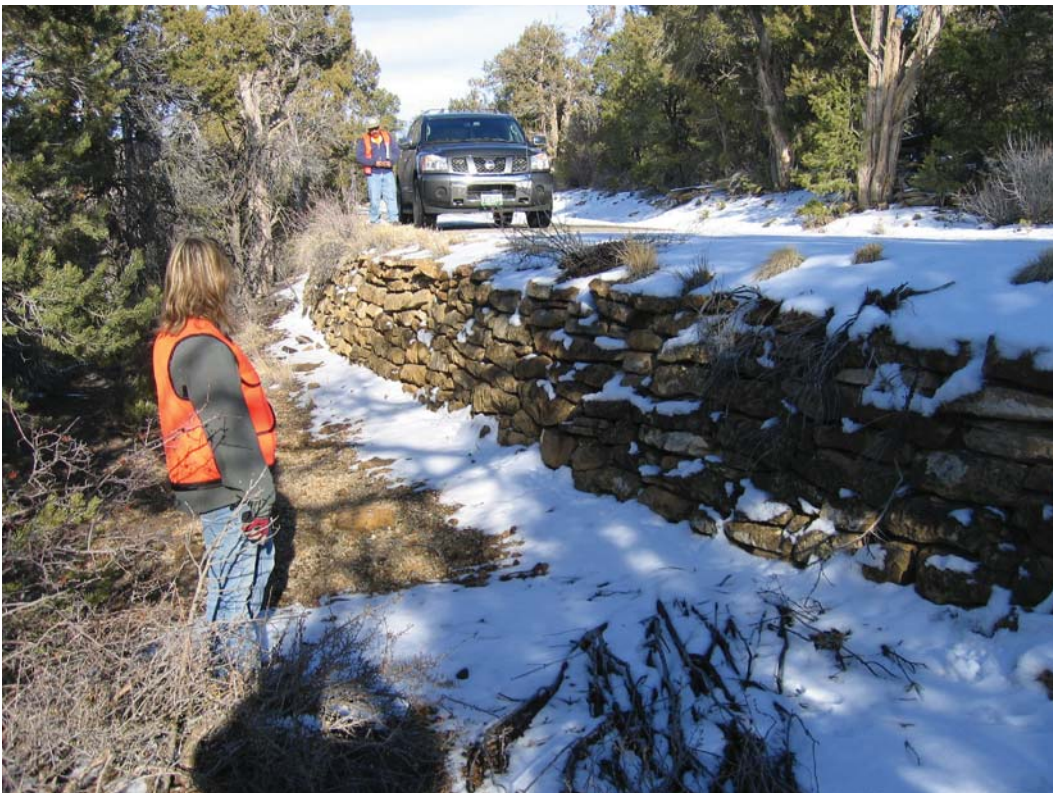
Wall ID:	MEVE-0100-1.553-R		
Route Name:	BALCONY HOUSE / CLIFF PALACE ROAD		
Inspection Date:	December 13, 2006	Approximate Year Built:	1923
*Wall Rating:	83	Maintenance Action:	No Action

Element (Weighting Factor)	Narrative	Condition Rating (0 - 10)
PERFORMANCE 8.00	Overall good shape, no significant or noticeable distress	8
WALL FOUNDATION MATERIAL 8.00	Shallow soil to bedrock	9
PLACED STONE 8.00	Slight to moderately weathered sandstone, good condition	8
DOWNSLOPE 0.50	Gentle slope, shallow bedrock	8
LATERAL SLOPE 0.50	No signs of distress	8
ROAD/SIDEWALK/SHOULDER 0.50	Road no distress due to wall, recent chipseal	8
VEGETATION 1.00	Some vegetation along caprock	7

Failure Consequence:	MODERATE
Recommendation Narrative:	None
Repair Cost:	\$0

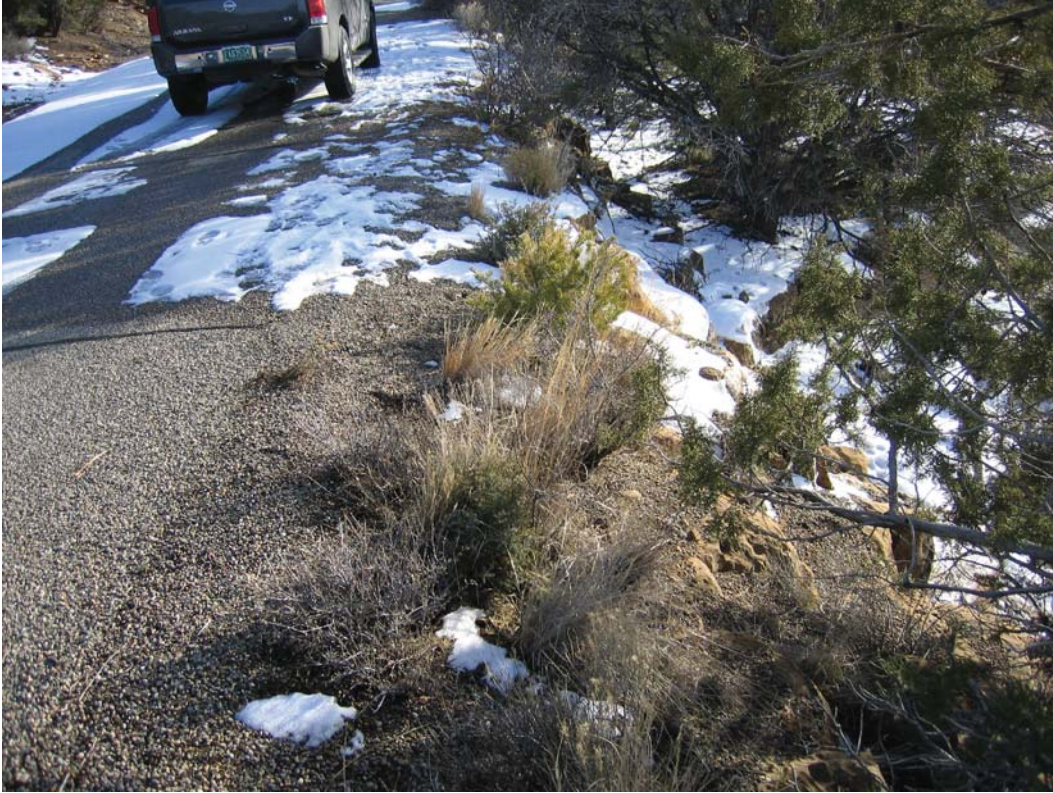
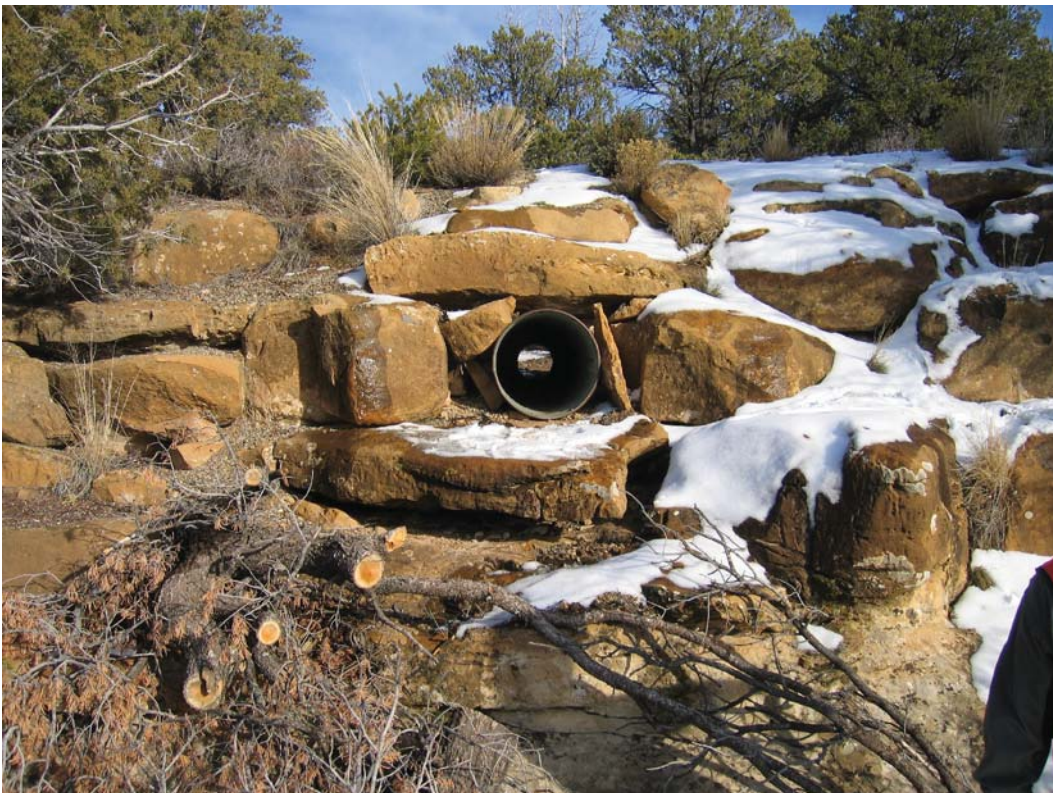
Wall ID:	MEVE-0100-2.173-R		
Route Name:	BALCONY HOUSE / CLIFF PALACE ROAD		
Inspection Date:	December 13, 2006	Approximate Year Built:	1923
*Wall Rating:	83	Maintenance Action:	No Action

Element (Weighting Factor)	Narrative	Condition Rating (0 - 10)
PERFORMANCE 8.00	Functioning good, no distress	8
WALL FOUNDATION MATERIAL 8.00	Bedrock at toe	9
PLACED STONE 8.00	Large Block sandstone, moderately durable	8
LATERAL SLOPE 0.50	No signs of distress	8
VEGETATION 0.50	Very minor, not affecting wall	8
CULVERT 0.50	18-inch CMP, functioning very well	9
DOWNSLOPE 0.50	Bedrock immediately below toe	9

Failure Consequence:	MODERATE
Recommendation Narrative:	None
Repair Cost:	\$0

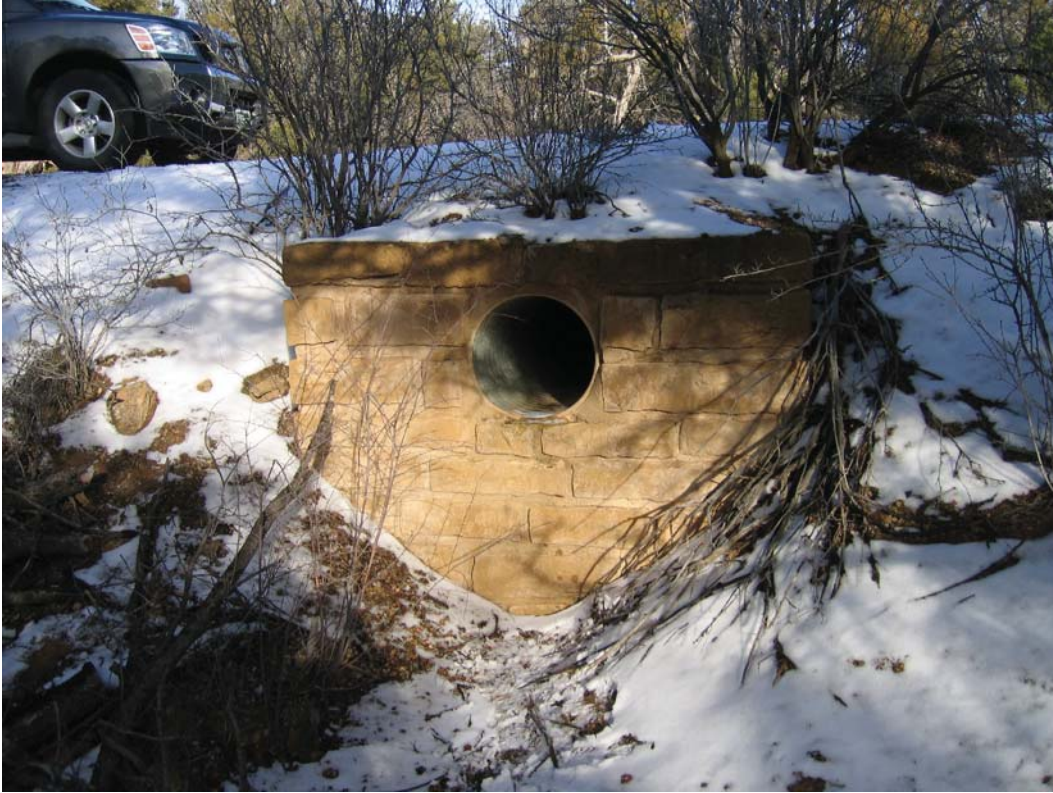
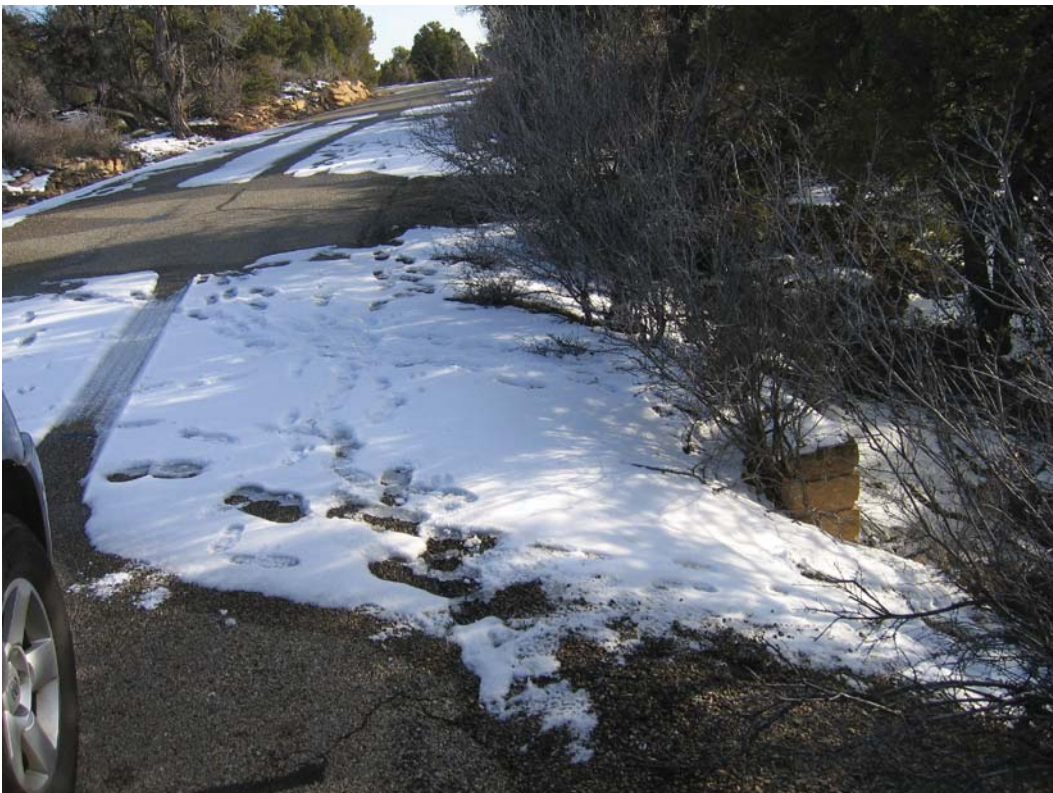
Wall ID:	MEVE-0100-2.217-R		
Route Name:	BALCONY HOUSE / CLIFF PALACE ROAD		
Inspection Date:	December 13, 2006	Approximate Year Built:	1940
*Wall Rating:	89	Maintenance Action:	Maintenance

Element (Weighting Factor)	Narrative	Condition Rating (0 - 10)
PERFORMANCE 8.00	Excellent condition with no signs of distress	9
WALL FOUNDATION MATERIAL 8.00	Thin stable soil over shallow bedrock	9
STONE MASONRY 8.00	Slightly weathered cut sandstone, mortar in very good shape, no cracks or weathering	9
DOWNSLOPE 0.50	Gentle, shallow bedrock, no signs of distress or erosion	9
LATERAL SLOPE 0.50	No signs of distress or erosion	9
CULVERT 0.50	CMP in excellent shape	10
VEGETATION 1.00	Some shrubbery growing over the tops, needs removal	6

Failure Consequence:	MODERATE
Recommendation Narrative:	<\$500
Repair Cost:	\$400

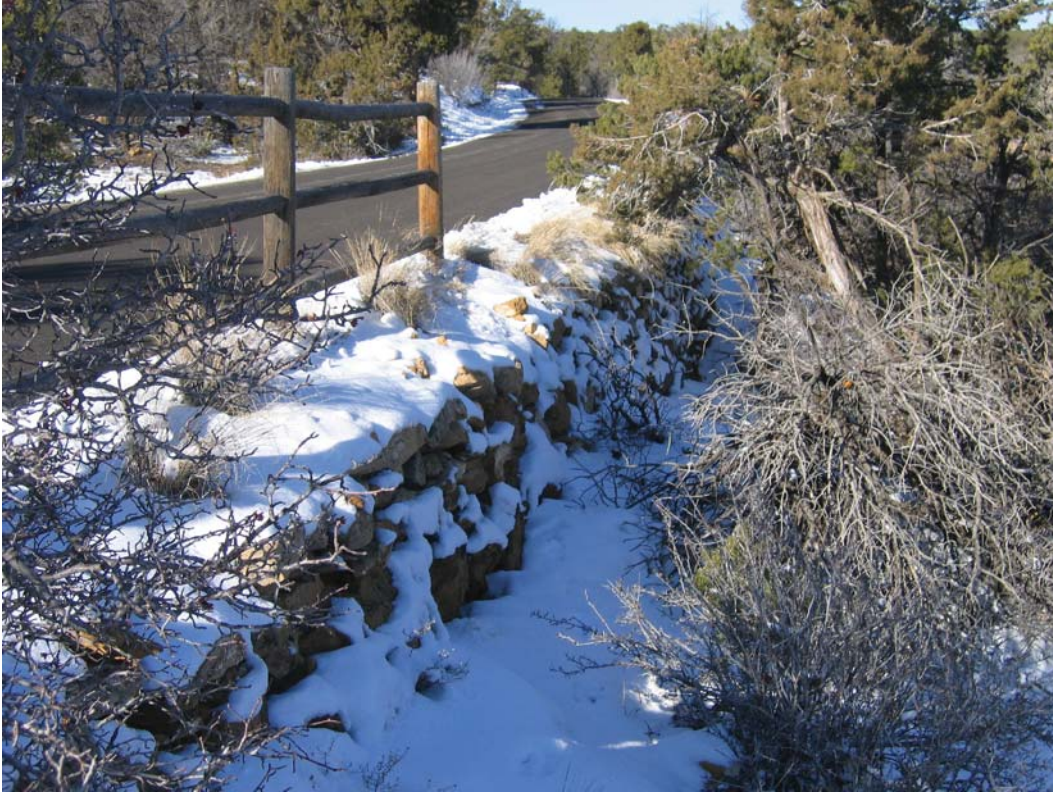
MEVE_0101_3.100_R_1.jpg

Wall ID:	MEVE-0101-3.100-R		
Route Name:	MESA TOP ROAD		
Inspection Date:	December 13, 2006	Approximate Year Built:	1923
*Wall Rating:	87	Maintenance Action:	No Action

Element (Weighting Factor)	Narrative	Condition Rating (0 - 10)
PERFORMANCE 8.00	Good, no visible distress, functioning as intended	9
WALL FOUNDATION MATERIAL 8.00	Bedrock shallow, no signs of deformation, limited visibility due to snow cover	9
PLACED STONE 8.00	Native sandstone, crudely constructed, performing as intended	8
CULVERT 0.50	Open, no distress	9
DOWNSLOPE 0.50	41 ft long 1-2 ft high dry stacked wall below existing wall functioning fine	9
ROAD/SIDEWALK/SHOULDER 0.50	Road no pavement distress	9

Failure Consequence:	MODERATE
Recommendation Narrative:	None
Repair Cost:	\$0

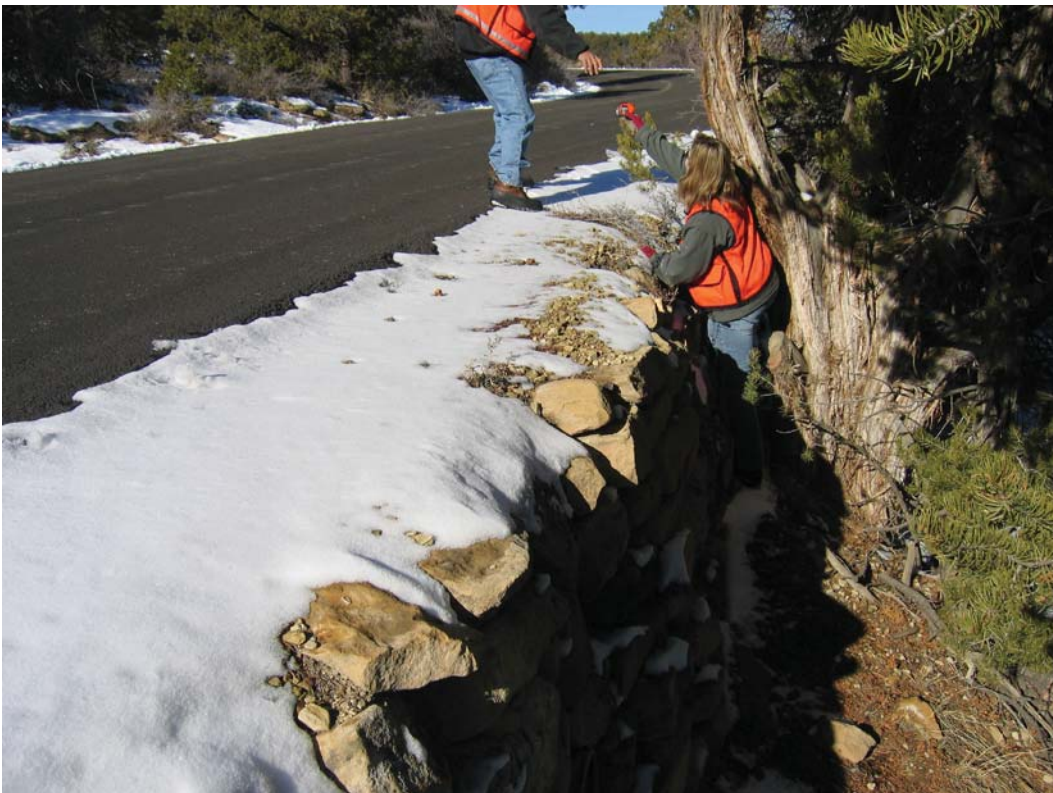
MEVE_0101_3.243_R_2.jpg

Wall ID:	MEVE-0101-3.243-R		
Route Name:	MESA TOP ROAD		
Inspection Date:	December 13, 2006	Approximate Year Built:	1923
*Wall Rating:	90	Maintenance Action:	No Action

Element (Weighting Factor)	Narrative	Condition Rating (0 - 10)
PERFORMANCE 8.00	Performing well, no distress	9
WALL FOUNDATION MATERIAL 8.00	On shallow bedrock	9
PLACED STONE 8.00	Sound durable sandstone, no cracking	9
DOWNSLOPE 0.50	Gentle slope, shallow bedrock	9
LATERAL SLOPE 0.50	No sign of impact or distress	9
ROAD/SIDEWALK/SHOULDER 0.50	No pavement distress due to wall, minor transverse crack	9

Failure Consequence:	MODERATE
Recommendation Narrative:	None
Repair Cost:	\$0

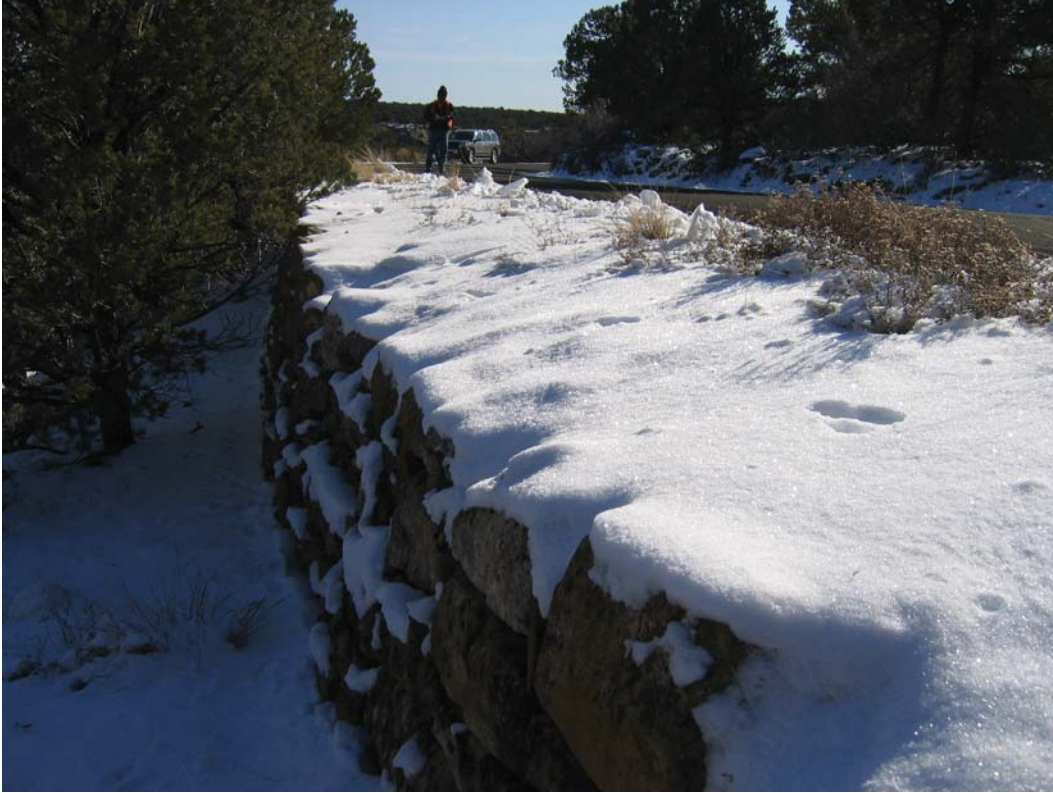
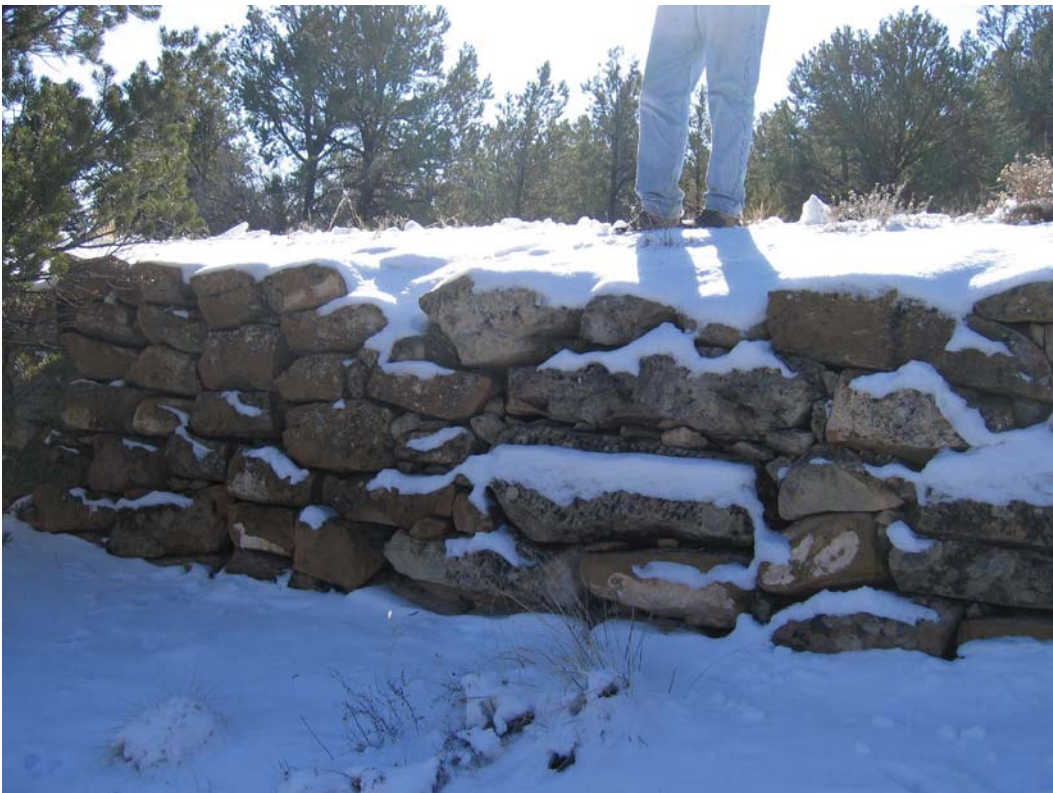
Wall ID:	MEVE-0101-3.265-R		
Route Name:	MESA TOP ROAD		
Inspection Date:	December 13, 2006	Approximate Year Built:	1940
*Wall Rating:	90	Maintenance Action:	No Action

Element (Weighting Factor)	Narrative	Condition Rating (0 - 10)
PERFORMANCE 8.00	Performing as intended, no signs of distress	9
WALL FOUNDATION MATERIAL 8.00	Shallow bedrock, no distress	9
PLACED STONE 8.00	Sound rock, no cracks or spalling	9
DOWNSLOPE 0.50	Gentle slope, shallow bedrock	9
LATERAL SLOPE 0.50	No signs of distress	9
ROAD/SIDEWALK/SHOULDER 0.50	No roadway distress due to wall, minor transverse crack	9

Failure Consequence:	MODERATE
Recommendation Narrative:	None
Repair Cost:	\$0

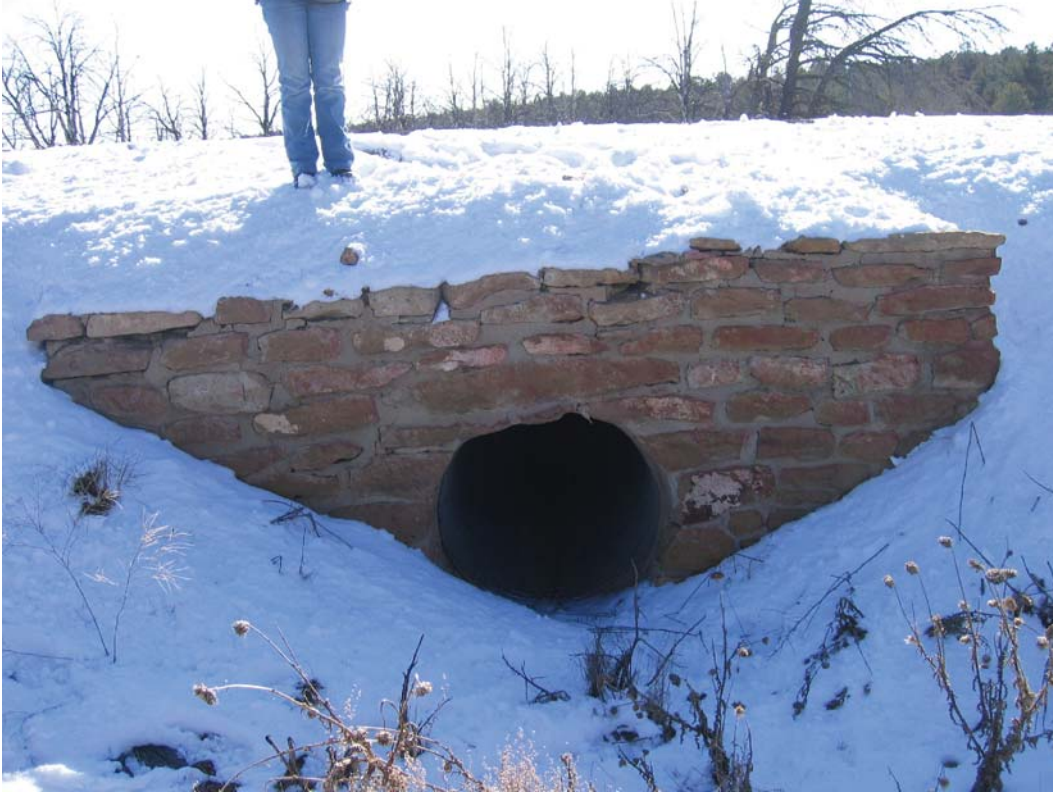
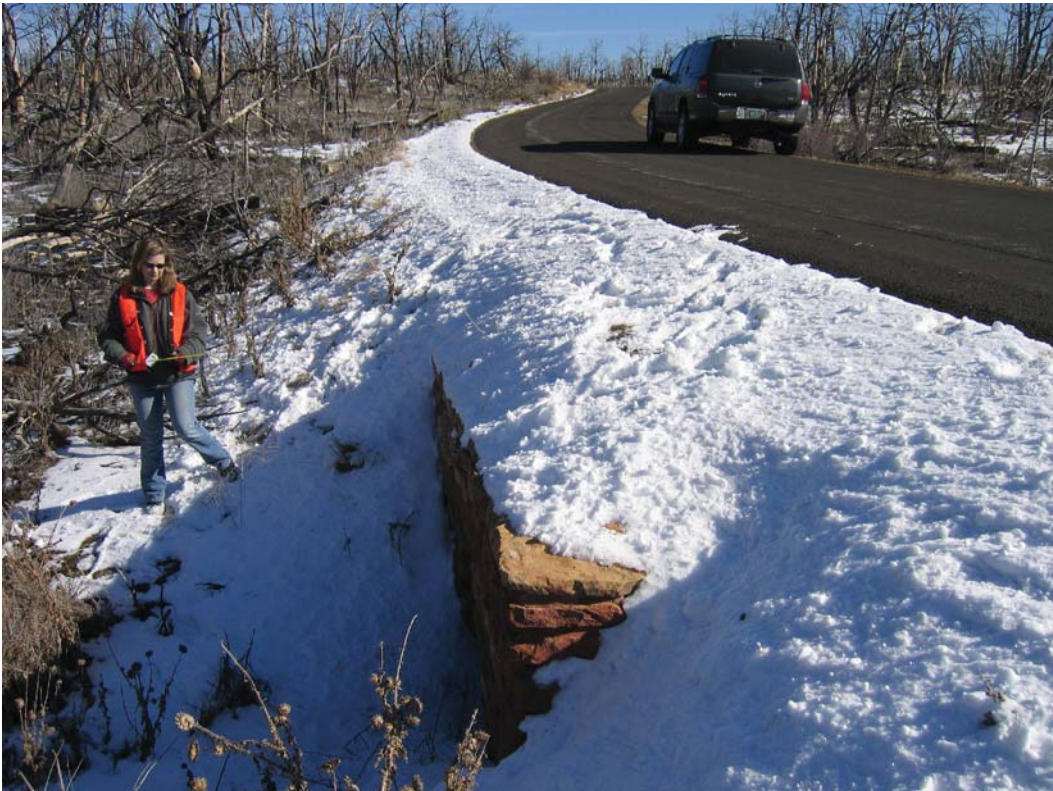
Wall ID:	MEVE-0101-3.516-L		
Route Name:	MESA TOP ROAD		
Inspection Date:	December 13, 2006	Approximate Year Built:	1923
*Wall Rating:	80	Maintenance Action:	Maintenance

Element (Weighting Factor)	Narrative	Condition Rating (0 - 10)
PERFORMANCE 8.00	Good, no signs of distress	8
WALL FOUNDATION MATERIAL 8.00	No signs of distress, limited visibility due to snow cover	8
STONE MASONRY 8.00	Cracked mortar, low to moderate	7
PLACED STONE 8.00	Sound sandstone	9
ROAD/SIDEWALK/SHOULDER 0.50	Road, no significant distress, minor transverse cracks from culvert	8
CULVERT 0.50	36inch CMP, good shape, functioning as intended	9

Failure Consequence:	LOW
Recommendation Narrative:	<\$500
Repair Cost:	\$400

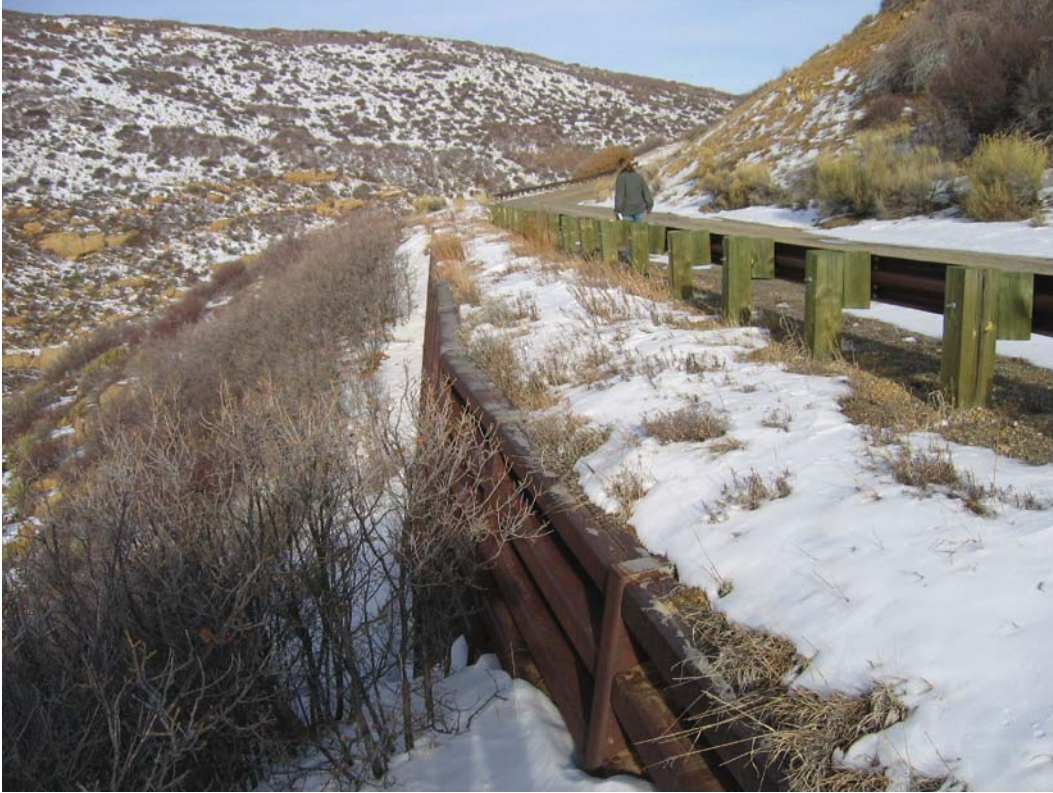
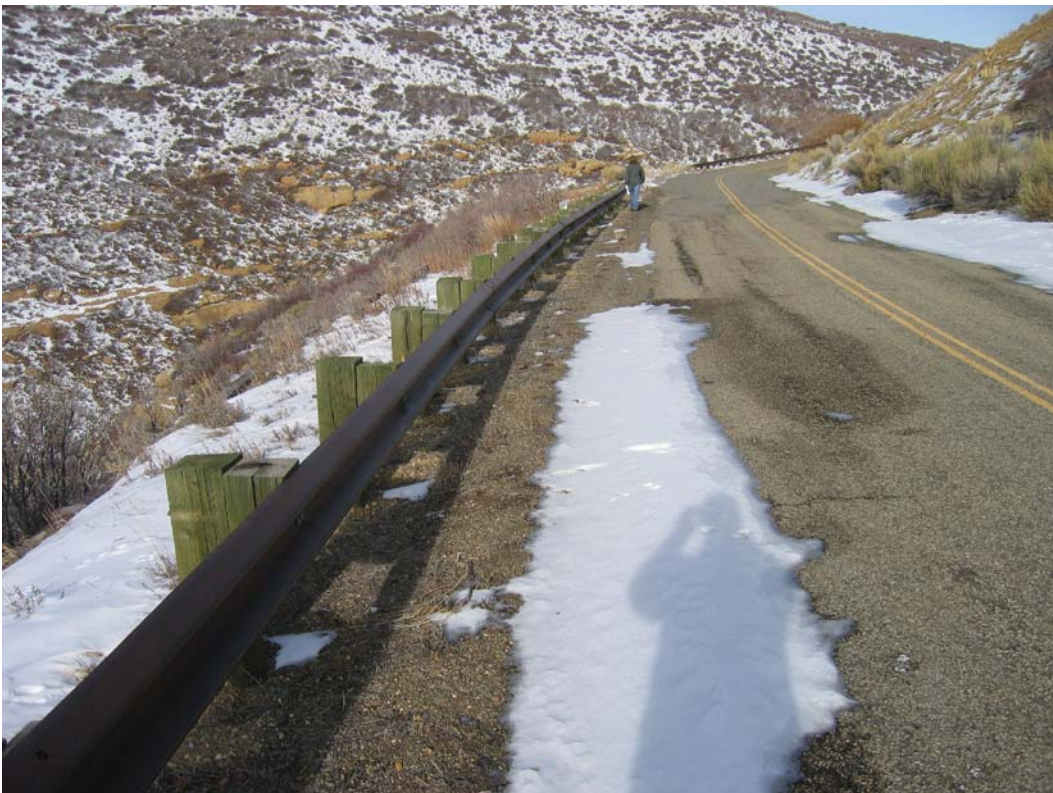
Wall ID:	MEVE-0200-6.753-L		
Route Name:	WETHERILL MESA ROAD		
Inspection Date:	December 14, 2006	Approximate Year Built:	1970
*Wall Rating:	84	Maintenance Action:	No Action

Element (Weighting Factor)	Narrative	Condition Rating (0 - 10)
PERFORMANCE 8.00	Good, functioning as intended, minor maintenance	8
WALL FOUNDATION MATERIAL 8.00	No signs of settlement or bulging, likely shallow bedrock foundation, well vegetated, limited visibility due to snow cover	9
BIN OR CRIB 8.00	minor corrosion with minor holes and deterioration of surface facing panels throughout; functioning as intended, no corrosion of bolts	8
DOWNSLOPE 0.50	No bench, moderate to steep slope with small trees and stable vegetation, no indication of settlement, limited visibility due to snow cover	9
LATERAL SLOPE 0.50	Moderate to steep slope with vegetation, no impact on retaining wall	9
ROAD/SIDEWALK/SHOULDER 0.50	Road minor cracking, no distress or settlement associated with retaining wall	9
TRAFFIC BARRIER/FENCE 0.50	Guardrail no distress associated with retaining wall	9
VEGETATION 0.50	Minor grass at top of retaining wall	9

Failure Consequence:	MODERATE
Recommendation Narrative:	None
Repair Cost:	\$0

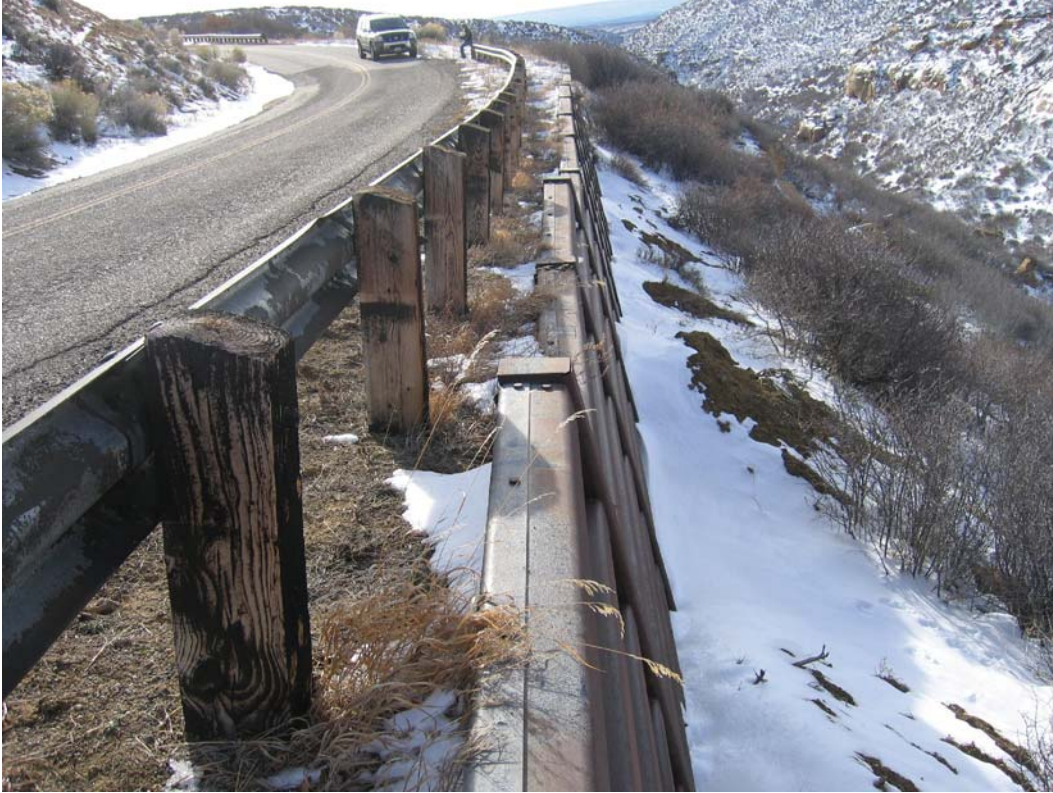
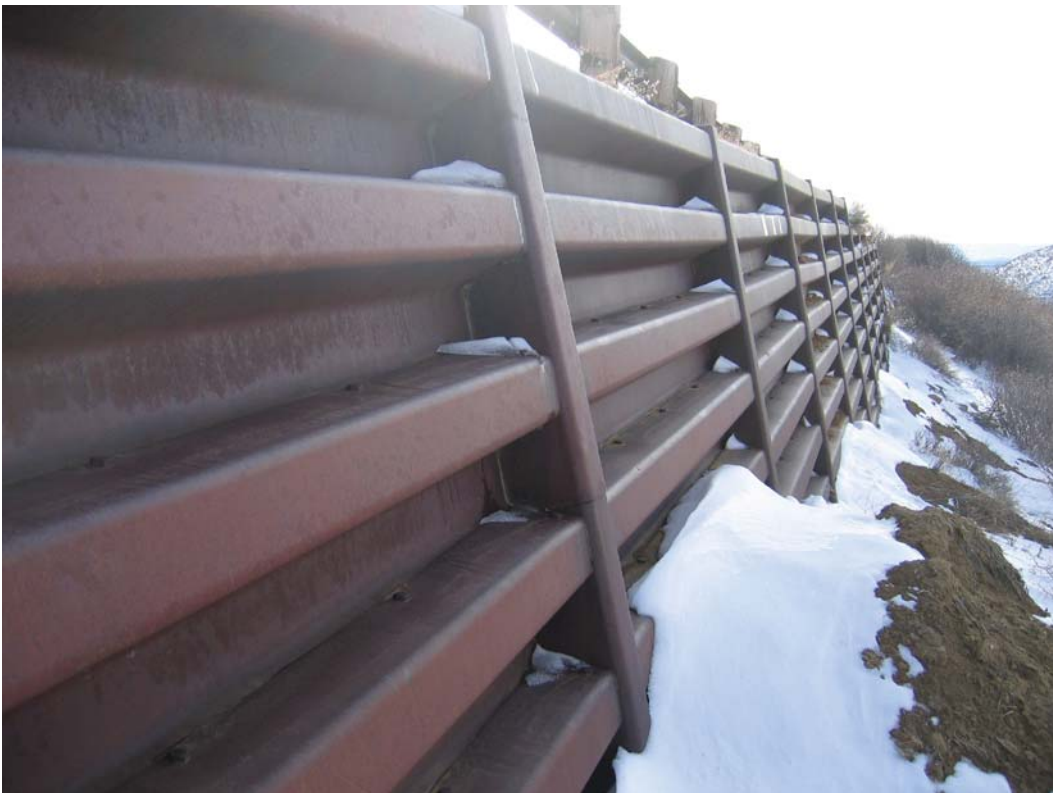
Wall ID:	MEVE-0200-6.803-L		
Route Name:	WETHERILL MESA ROAD		
Inspection Date:	December 14, 2006	Approximate Year Built:	1970
*Wall Rating:	84	Maintenance Action:	No Action

Element (Weighting Factor)	Narrative	Condition Rating (0 - 10)
PERFORMANCE 8.00	Good, functioning as intended, minor maintenance and monitoring	8
WALL FOUNDATION MATERIAL 8.00	No significant settlement or bulging, likely shallow bedrock, well vegetated, low visibility due to snow cover	9
BIN OR CRIB 8.00	Minor corrosion with minor holes and deterioration of surface facing panels, functioning as intended, no significant corrosion of bolts	8
DOWNSLOPE 0.50	No bench, moderate to steep slope with small trees	9
LATERAL SLOPE 0.50	Moderate to steep slope with moderate vegetation, no impact on retaining wall	9
ROAD/SIDEWALK/SHOULDER 0.50	Road minor cracking, no distress or settlement associated with retaining wall	9
TRAFFIC BARRIER/FENCE 0.50	Guardrail no distress associated with retaining wall	9
VEGETATION 0.50	Minor grass and small brush in retaining wall, no impact on function	9

Failure Consequence:	MODERATE
Recommendation Narrative:	None
Repair Cost:	\$0

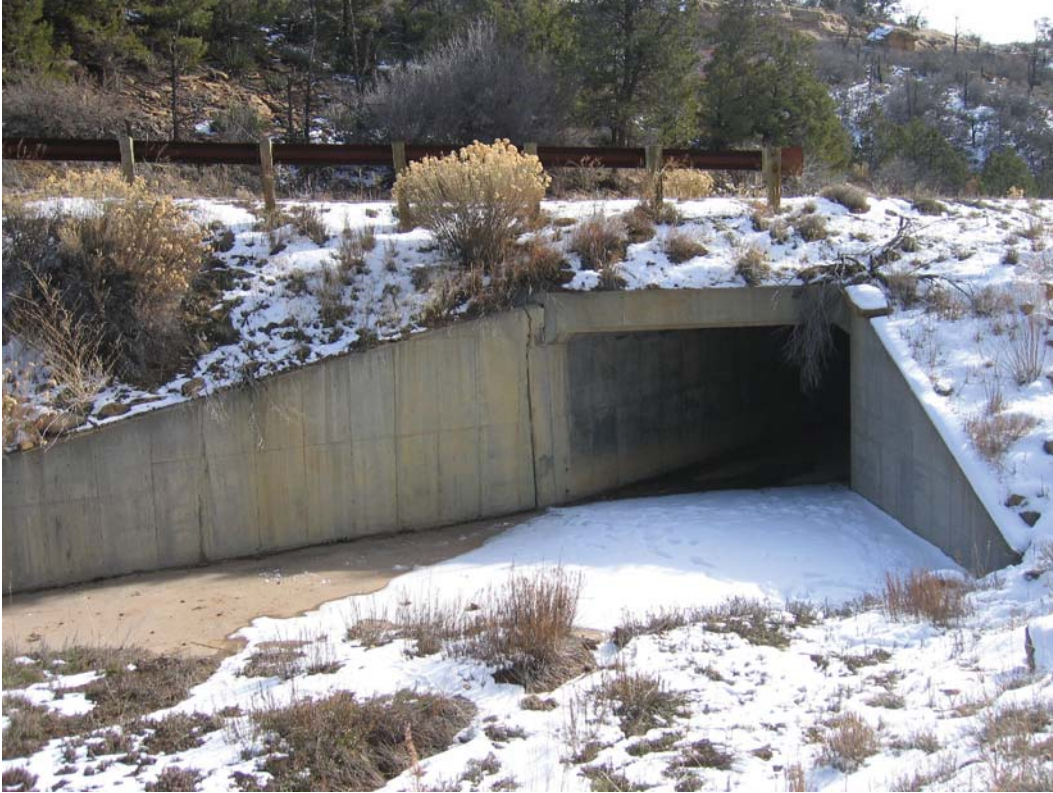
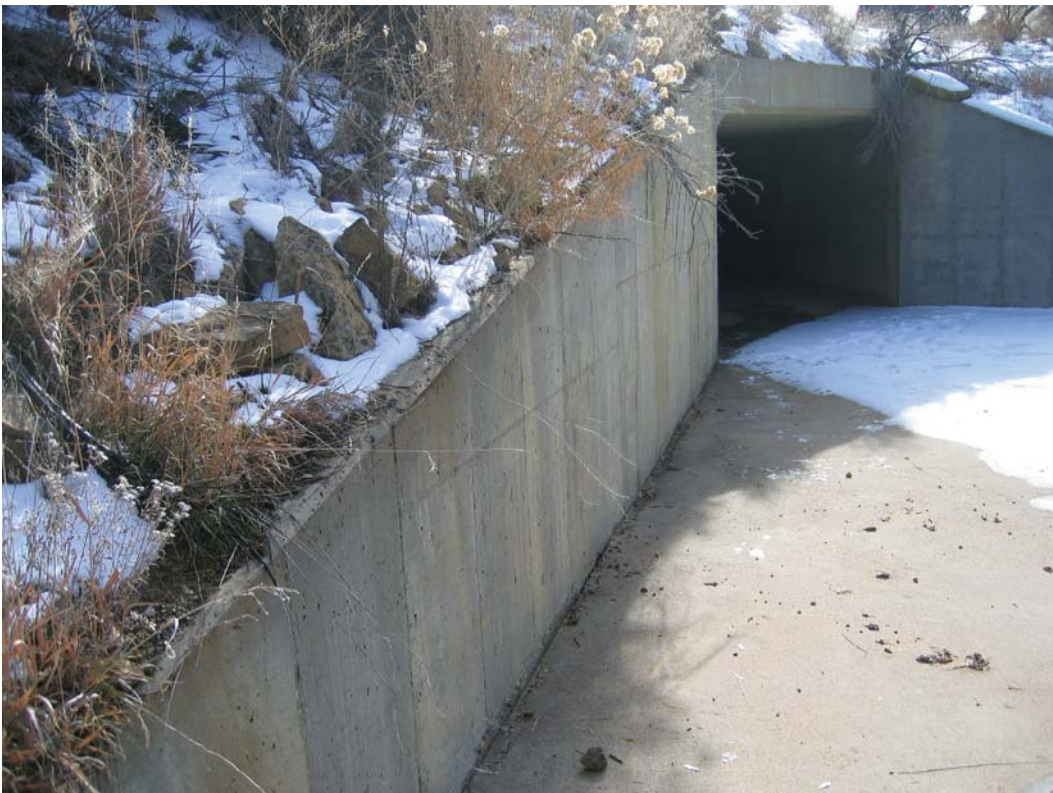
Wall ID:	MEVE-0200-11.290-R		
Route Name:	WETHERILL MESA ROAD		
Inspection Date:	December 14, 2006	Approximate Year Built:	1923
*Wall Rating:	90	Maintenance Action:	No Action

Element (Weighting Factor)	Narrative	Condition Rating (0 - 10)
PERFORMANCE 8.00	Good, functioning as intended	9
WALL FOUNDATION MATERIAL 8.00	Shallow bedrock at stream channel, minor settlement indicated by cracking at contact, no cracking in base slab, no cracking in box	9
CONCRETE 8.00	Low to moderate cracking at construction joints, minor oxidation on face, functioning as intended, minor spalling	9
VEGETATION 0.50	Minor brush and grass at toe of retaining wall, which may push out the wall, minor impact	8
CULVERT 0.50	No cracks in CBC 10ftx11ft, functioning as intended	9
LATERAL SLOPE 0.50	Low to moderate slopes, no impact	9
ROAD/SIDEWALK/SHOULDER 0.50	Road minor cracking, no impact from retaining wall	9
TRAFFIC BARRIER/FENCE 0.50	Guardrail no indication of movement from retaining wall	9
UPSLOPE 0.50	Moderate slope with large rocks, vegetated with brush and grass	9

Failure Consequence:	MODERATE
Recommendation Narrative:	None
Repair Cost:	\$0

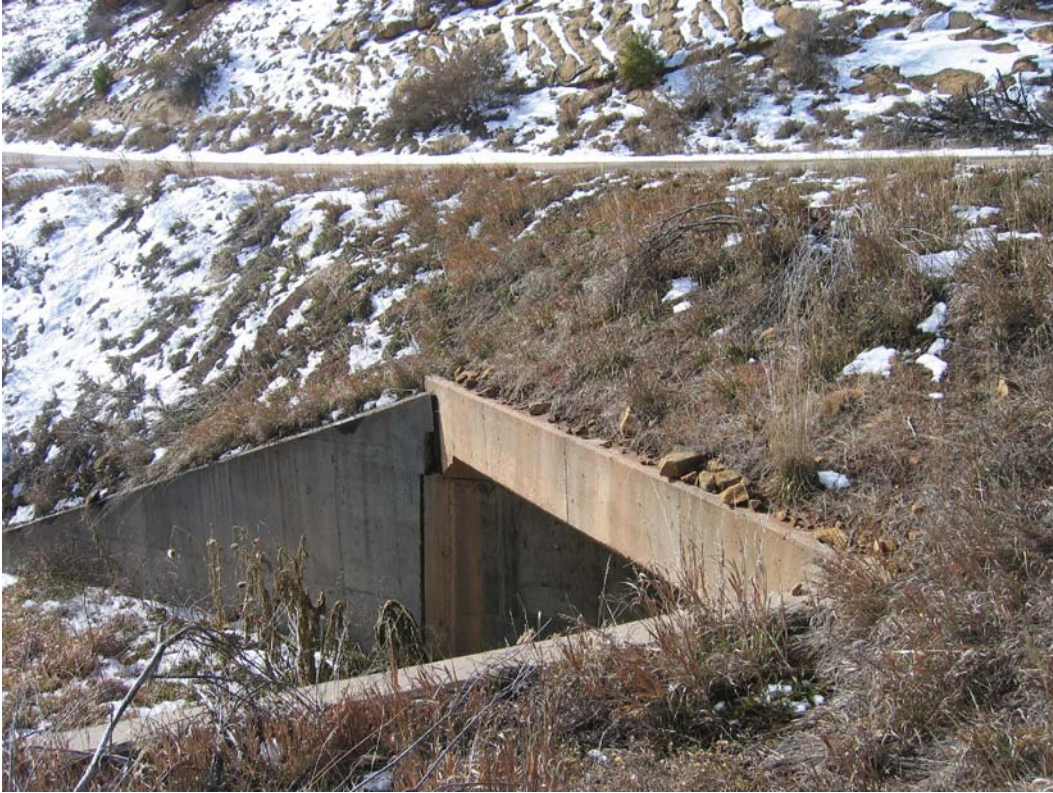
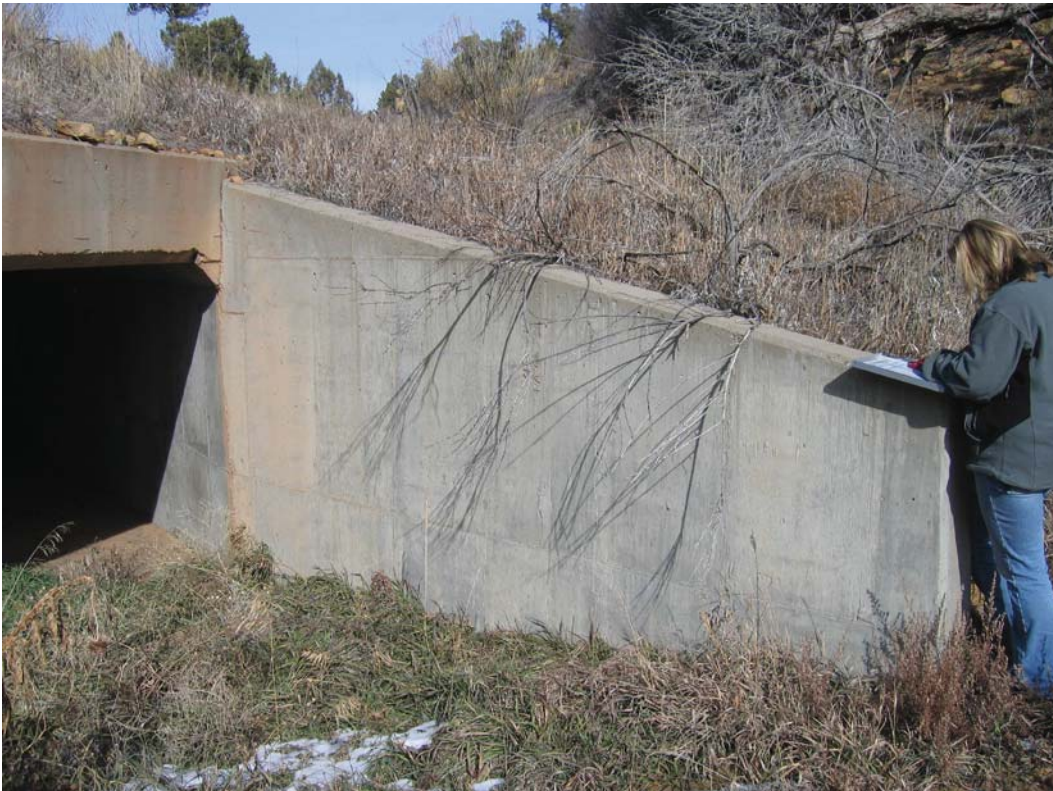
Wall ID:	MEVE-0200-11.309-L		
Route Name:	WETHERILL MESA ROAD		
Inspection Date:	December 14, 2006	Approximate Year Built:	1923
*Wall Rating:	89	Maintenance Action:	No Action
