MEVE WIP Report

NPS Retaining Wall Inventory Program Mesa Verde National Park

**Federal Highway Administration
Eastern Federal Lands Highway Division
Road Inventory Program (RIP)**

**Data Collection Date: December 2006
Report Date: October 2015**

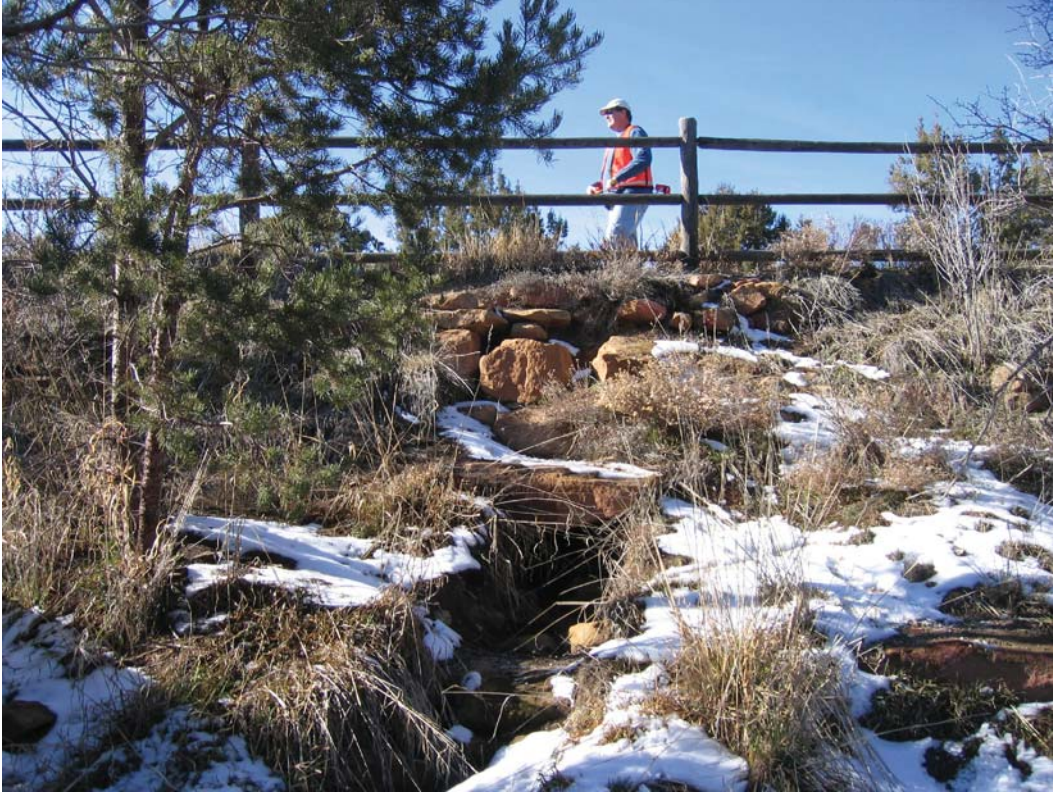
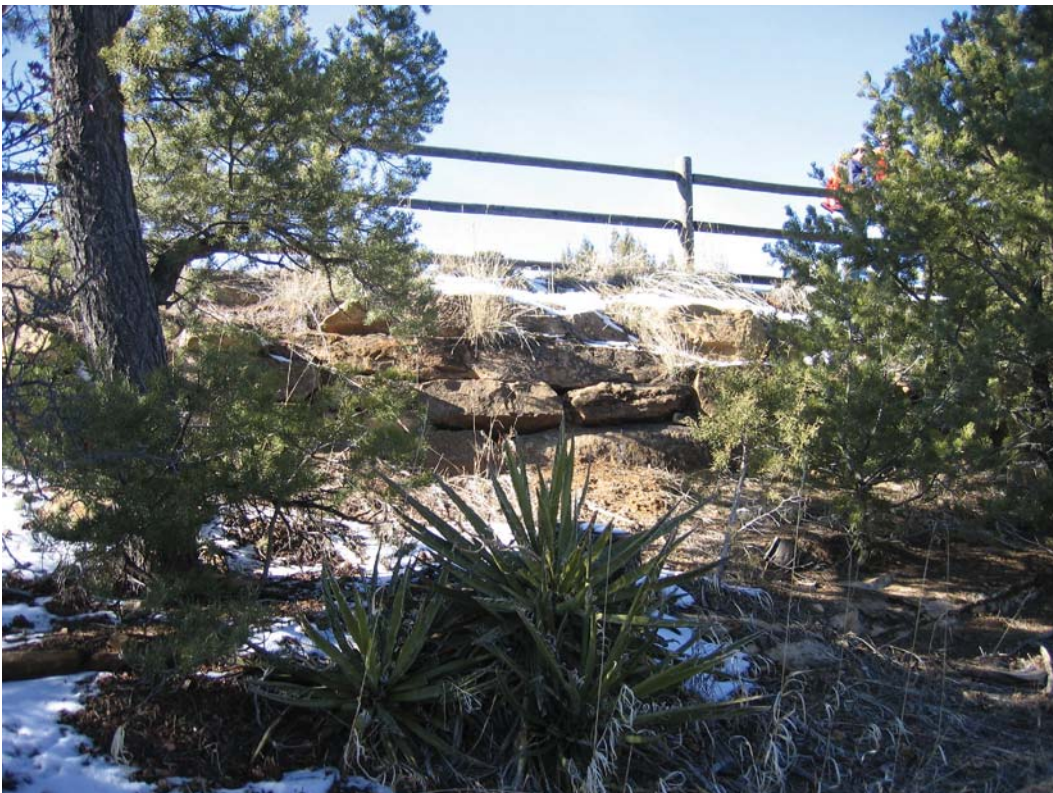
Wall ID:	MEVE-0209-0.812-R		
Route Name:	HEADQUARTERS LOOP ROAD		
Inspection Date:	December 13, 2006	Approximate Year Built:	1923
*Wall Rating:	79	Maintenance Action:	No Action

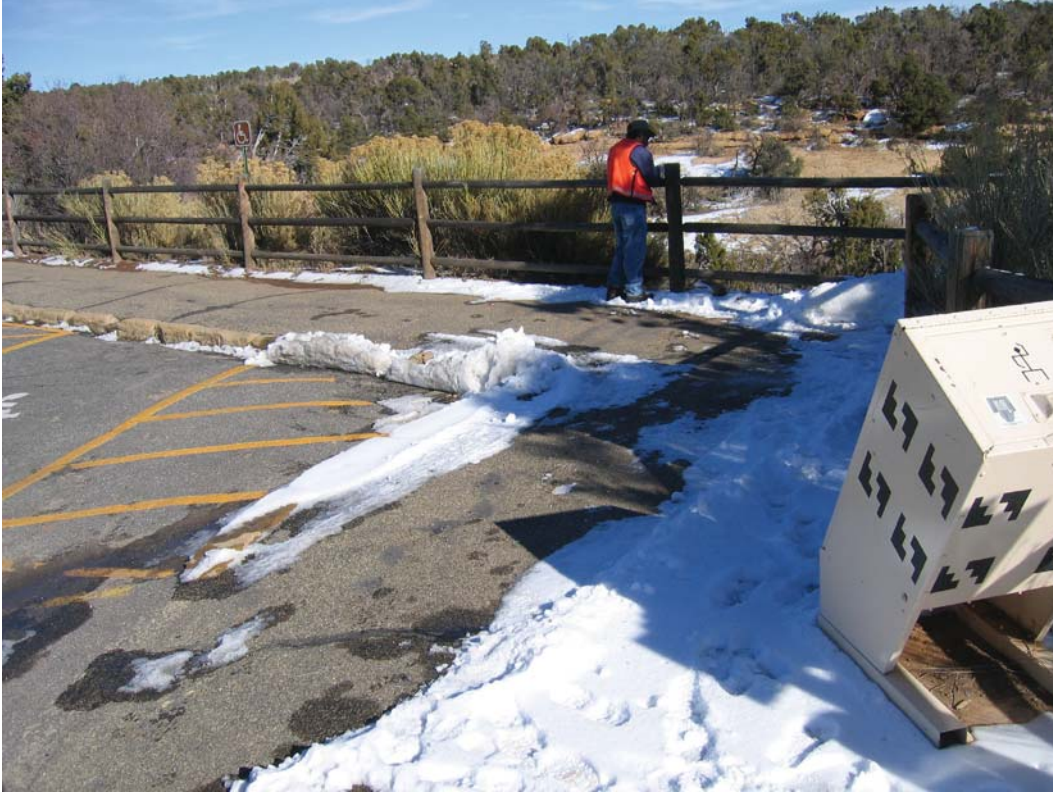
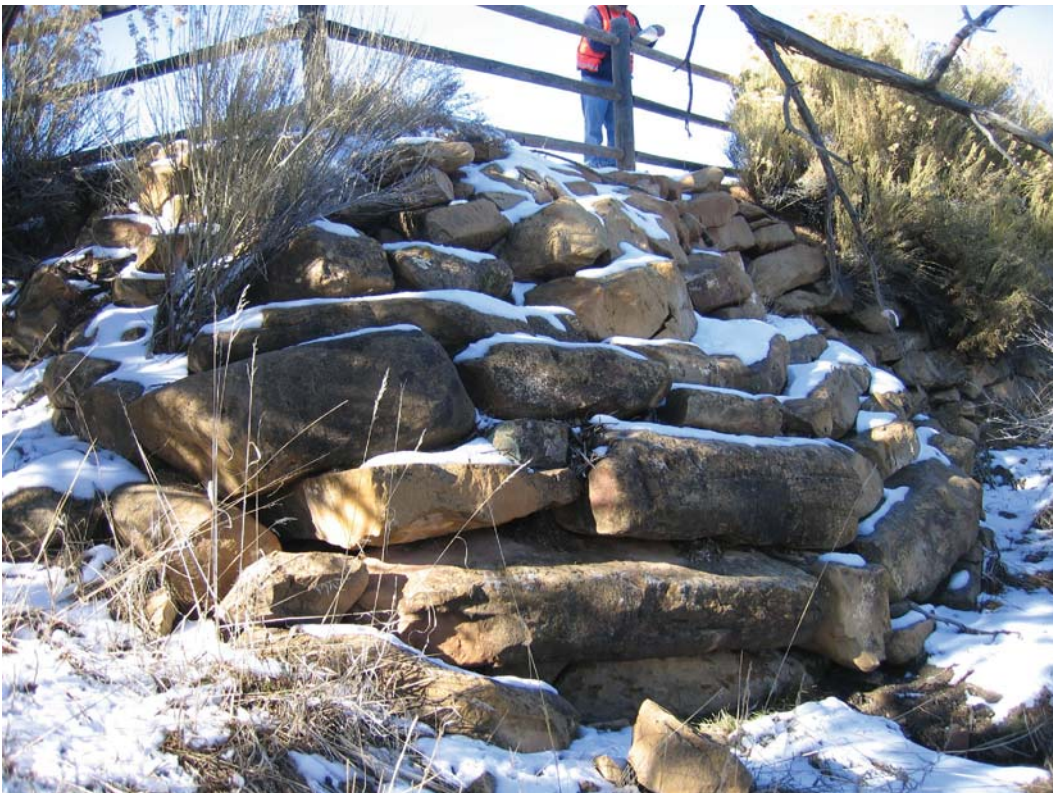
Wall ID:	MEVE-0209-0.855-R		
Route Name:	HEADQUARTERS LOOP ROAD		
Inspection Date:	December 13, 2006	Approximate Year Built:	1923
*Wall Rating:	76	Maintenance Action:	No Action

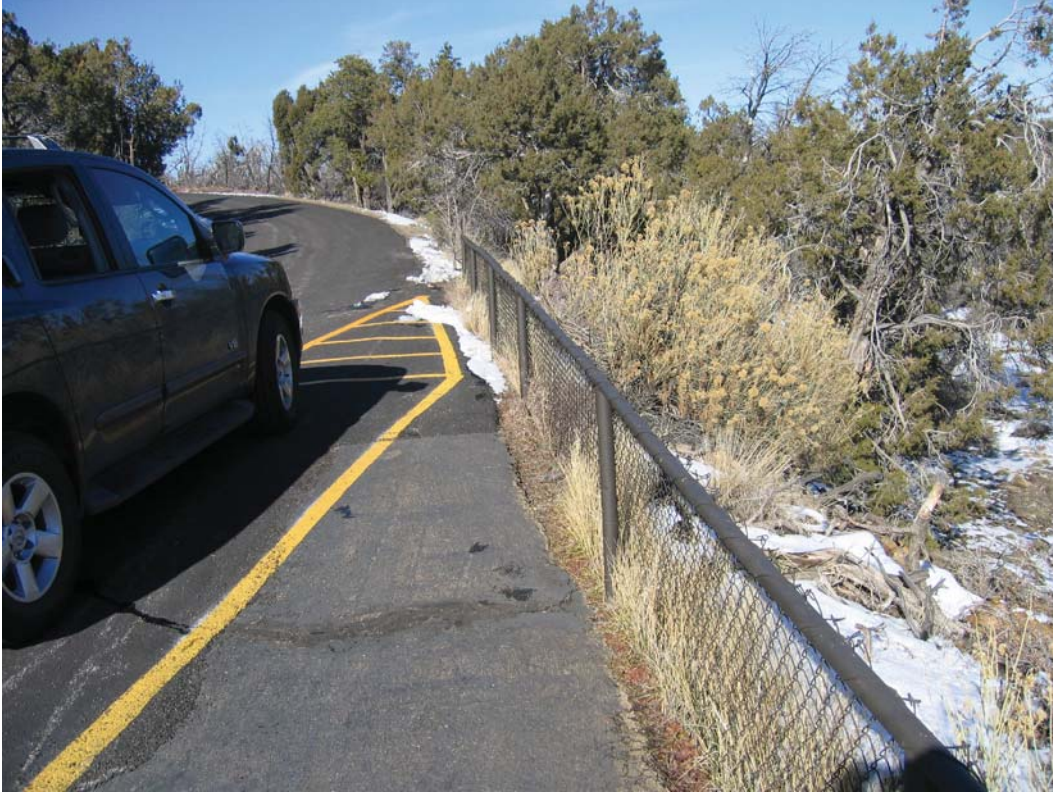
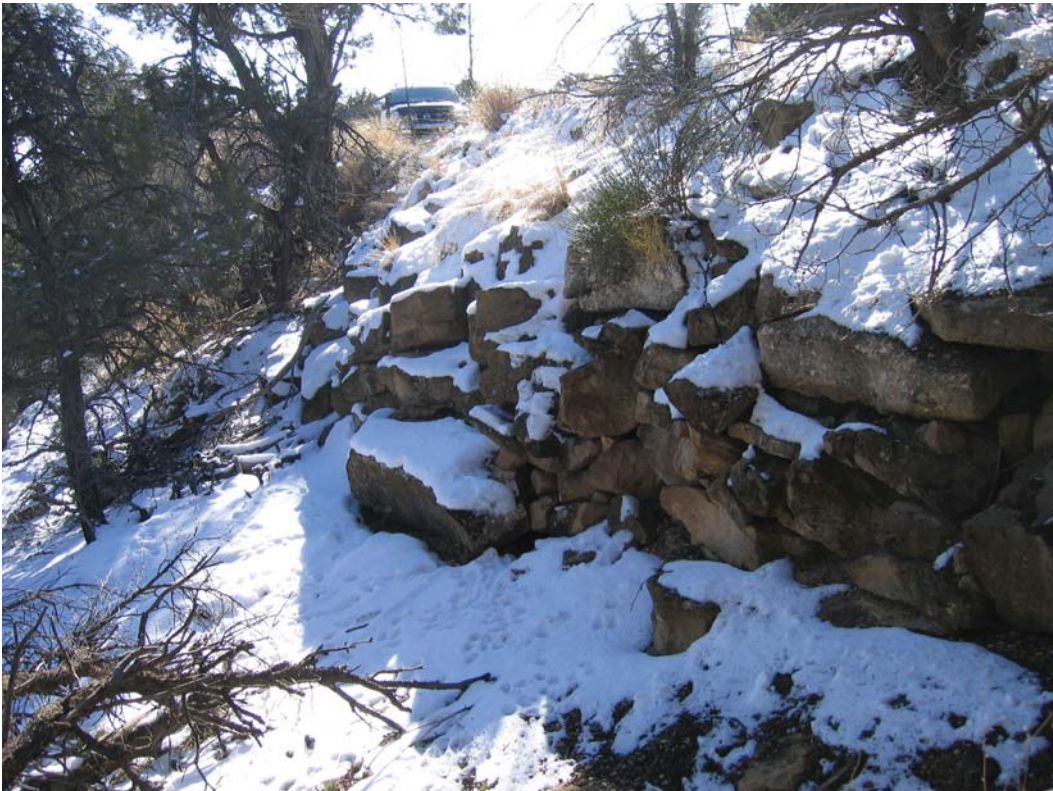
Wall ID:	MEVE-0211-0.308-R		
Route Name:	SUN TEMPLE ROAD		
Inspection Date:	December 13, 2006	Approximate Year Built:	1940
*Wall Rating:	83	Maintenance Action:	No Action

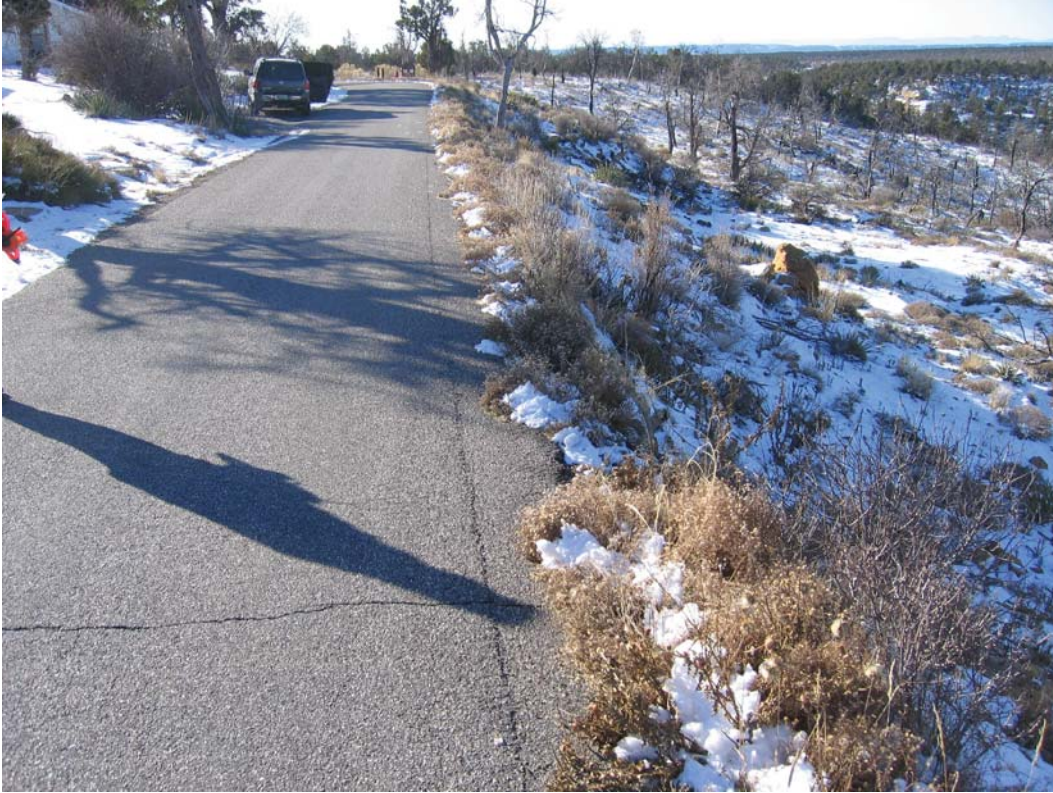
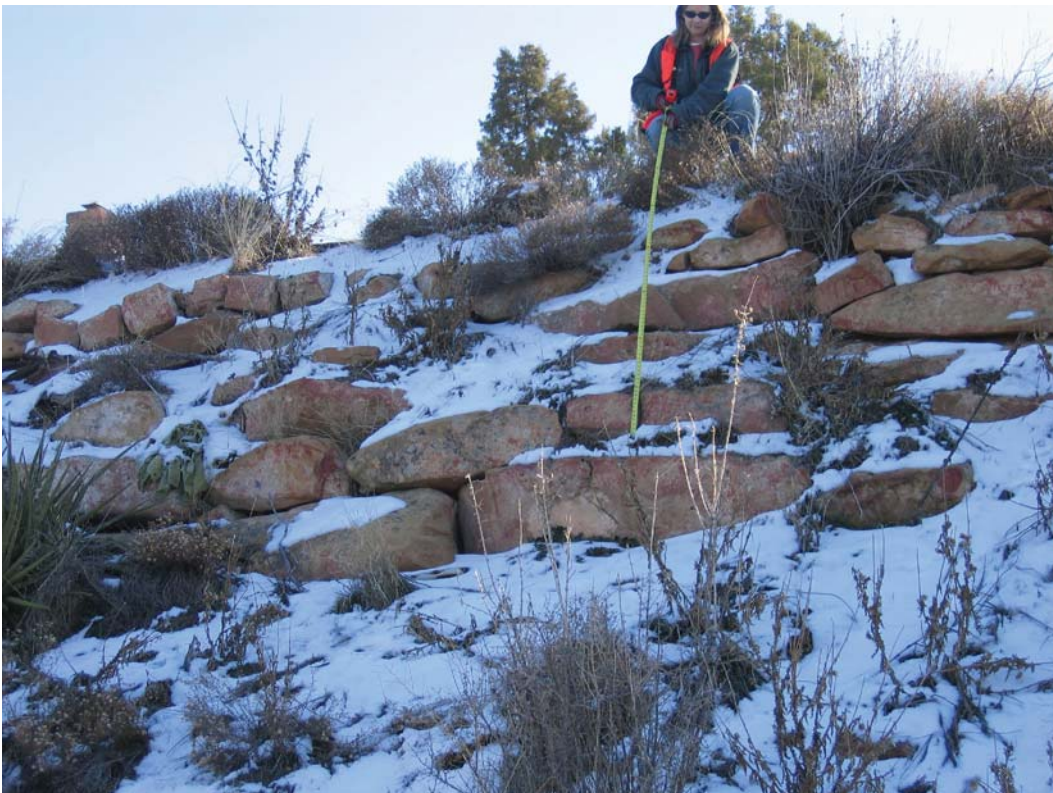
Wall ID:	MEVE-0415-0.157-R		
Route Name:	WHITE HOUSE RESIDENCE ROAD		
Inspection Date:	December 13, 2006	Approximate Year Built:	1923
*Wall Rating:	77	Maintenance Action:	No Action

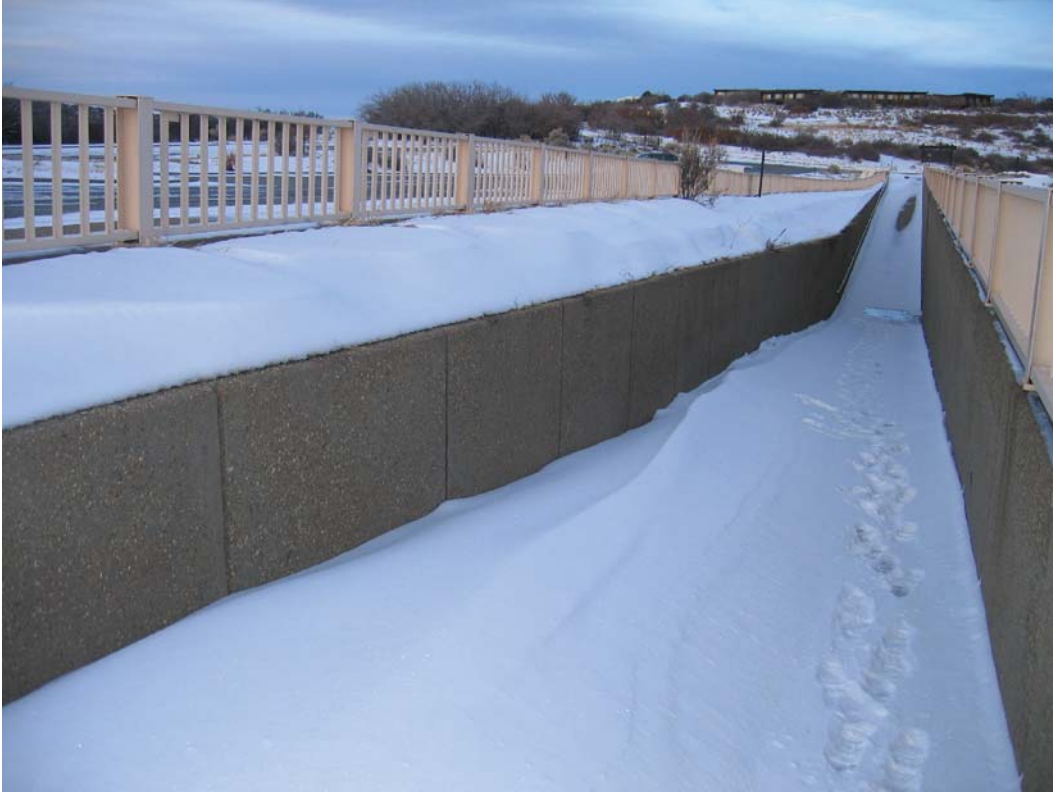
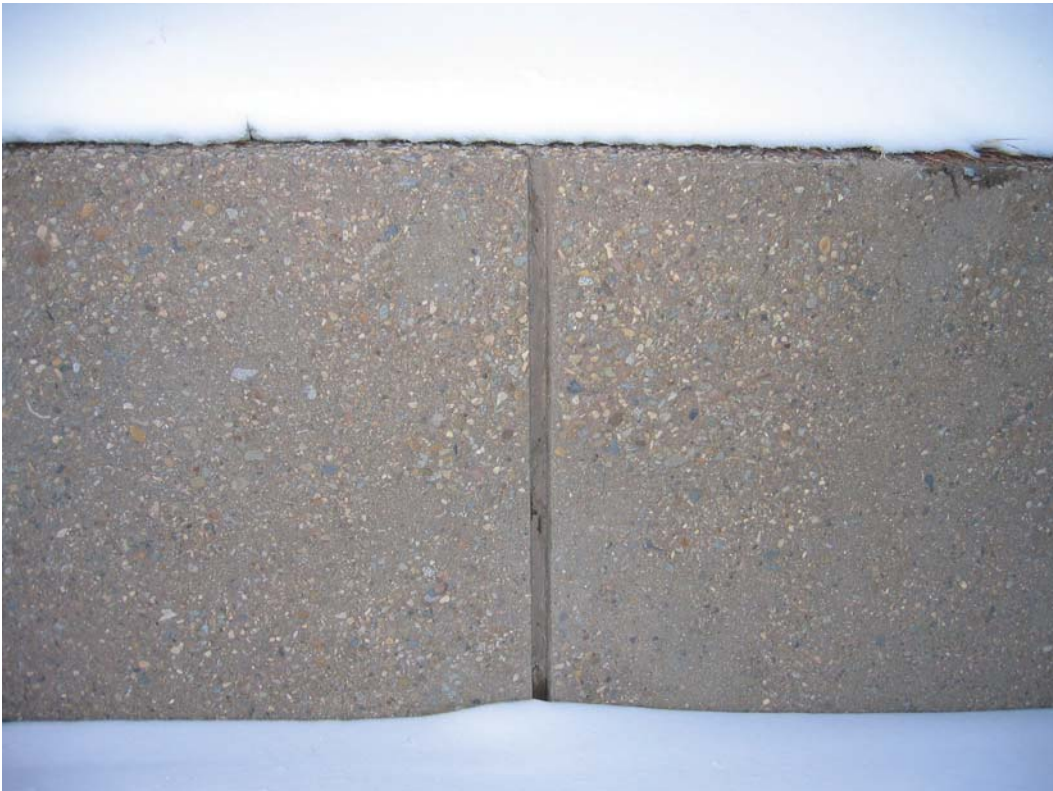
Wall ID:	MEVE-0918-0.000-P1		
Route Name:	VISITOR CENTER PARKING		
Inspection Date:	December 12, 2006	Approximate Year Built:	1970
*Wall Rating:	90	Maintenance Action:	No Action

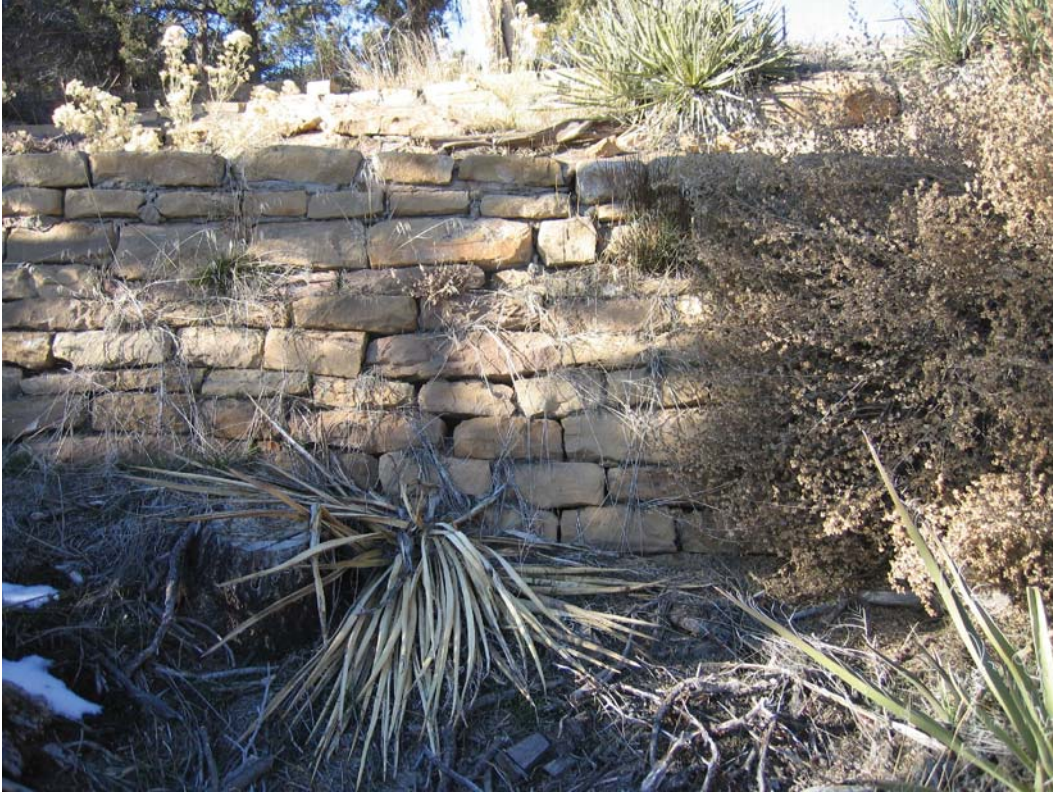
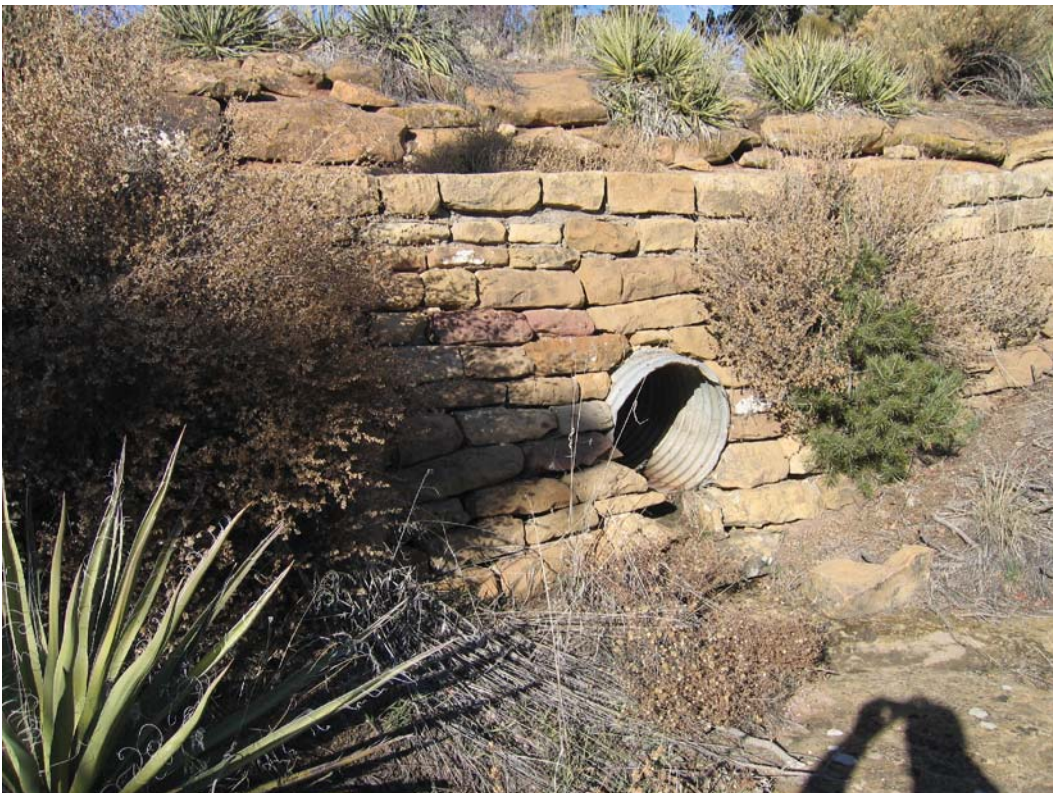
Wall ID:	MEVE-0925-0.000-P1		
Route Name:	SIDE HEADQUARTERS AND POST OFFICE PARKING		
Inspection Date:	December 13, 2006	Approximate Year Built:	1923
*Wall Rating:	82	Maintenance Action:	No Action

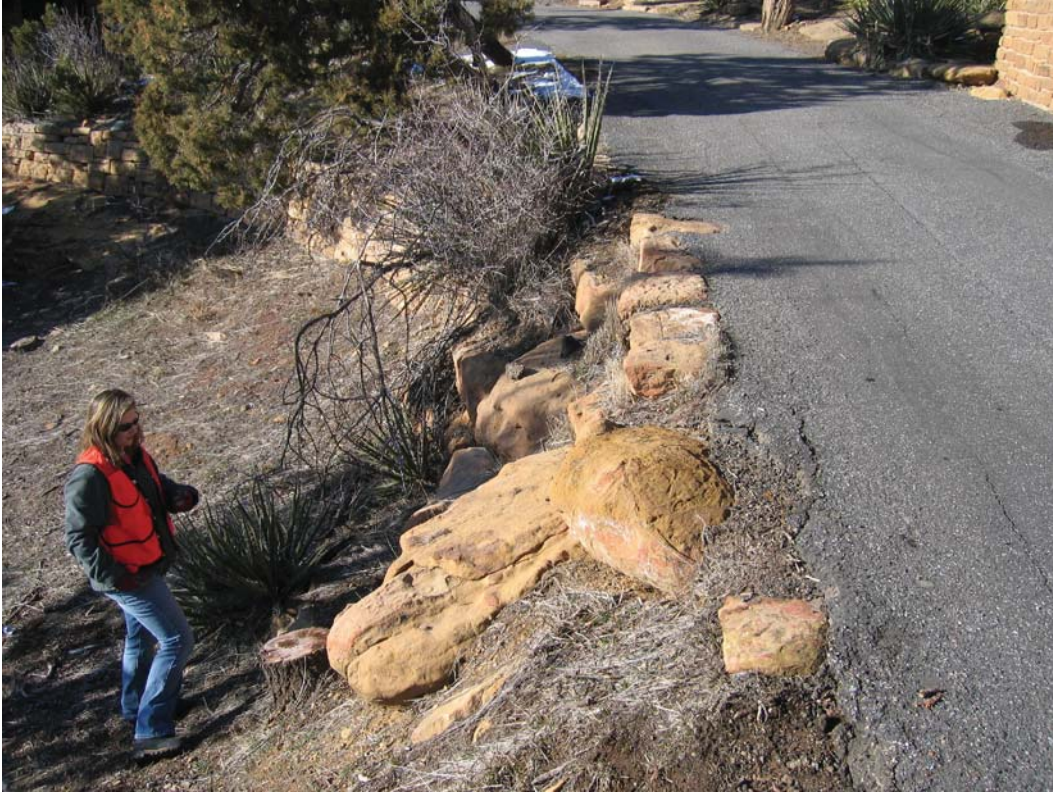
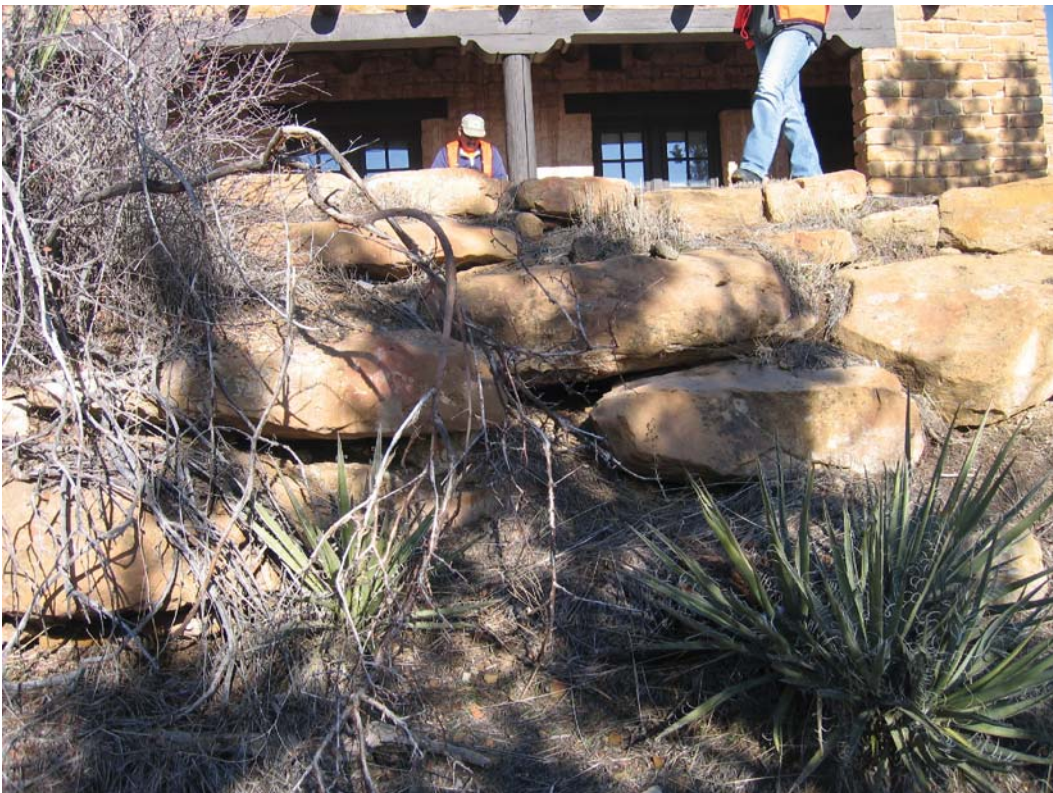
Wall ID:	MEVE-0925-0.000-P2		
Route Name:	SIDE HEADQUARTERS AND POST OFFICE PARKING		
Inspection Date:	December 13, 2006	Approximate Year Built:	1923
*Wall Rating:	79	Maintenance Action:	No Action
