NERI WIP Report

NPS Retaining Wall Inventory Program New River Gorge National River

Data Collection Date: October 2008
Report Date: November 2015

New River Gorge National River in West Virginia

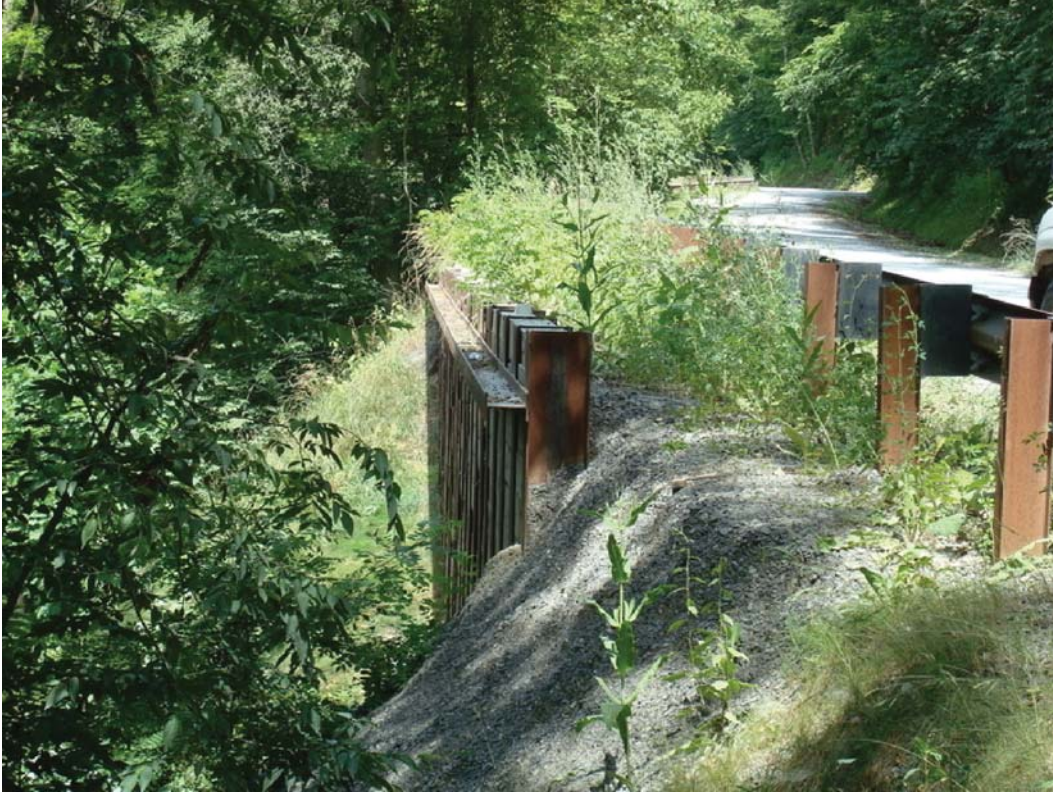
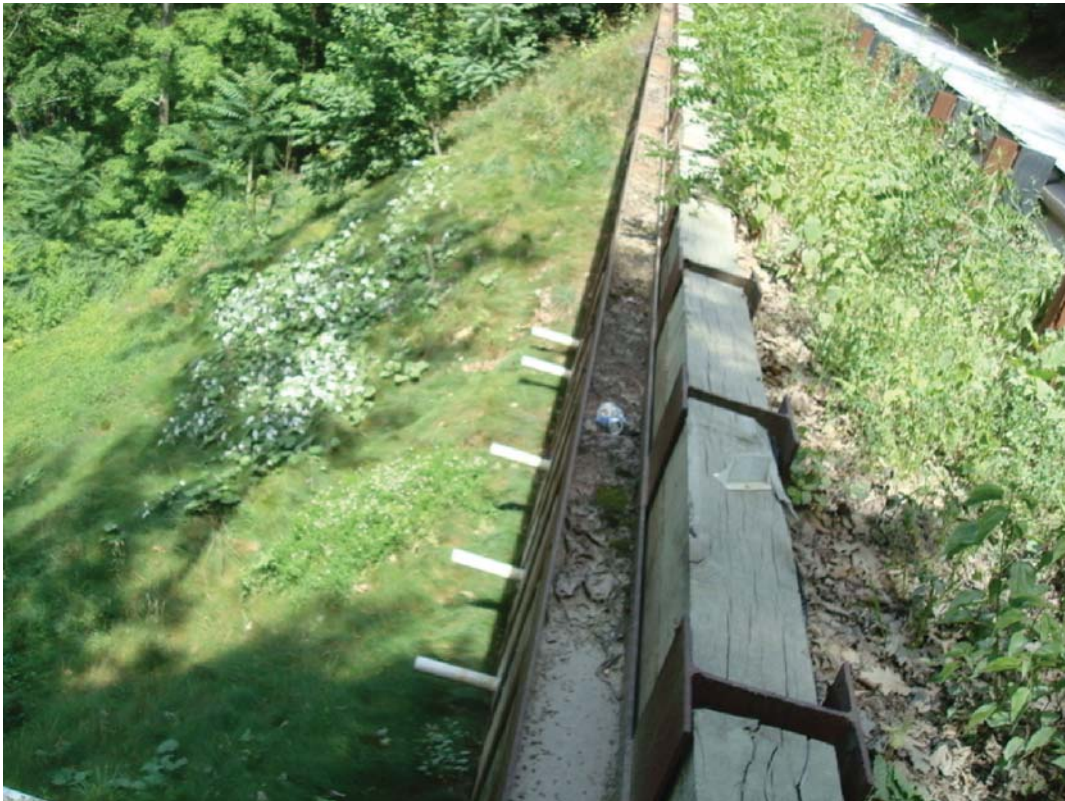
NERI_0117_0.712_L_1.JPG

Wall ID:	NERI-0117-.712-L		
Route Name:	GLADE CREEK ROAD		
Inspection Date:	June 25, 2008	Approximate Year Built:	2005
*Wall Rating:	89	Maintenance Action:	No Action

Element (Weighting Factor)	Narrative	Condition Rating (0 - 10)
PERFORMANCE 8.00	In good conditions.	9
WALL FOUNDATION MATERIAL 8.00	Shafts socket into shale bedrock about 7 ft.	9
LAGGING 8.00	9" thick timber lagging in good conditions.	9
PILES AND SHAFTS 8.00	H Pile installed into drilled concrete shafts in good conditions.	9
CULVERT 0.50	4 in diameter PVC pipes.	8
LATERAL SLOPE 0.50	Mild slope vegetation.	8
VEGETATION 0.50	Vegetation and trees.	8
ROAD/SIDEWALK/SHOULDER 0.50	Vegetated, narrow shoulder.	9
TRAFFIC BARRIER/FENCE 0.50	Steel guardrail; in good condition.	9

Failure Consequence:	HIGH
Recommendation Narrative:	None
Repair Cost:	\$0

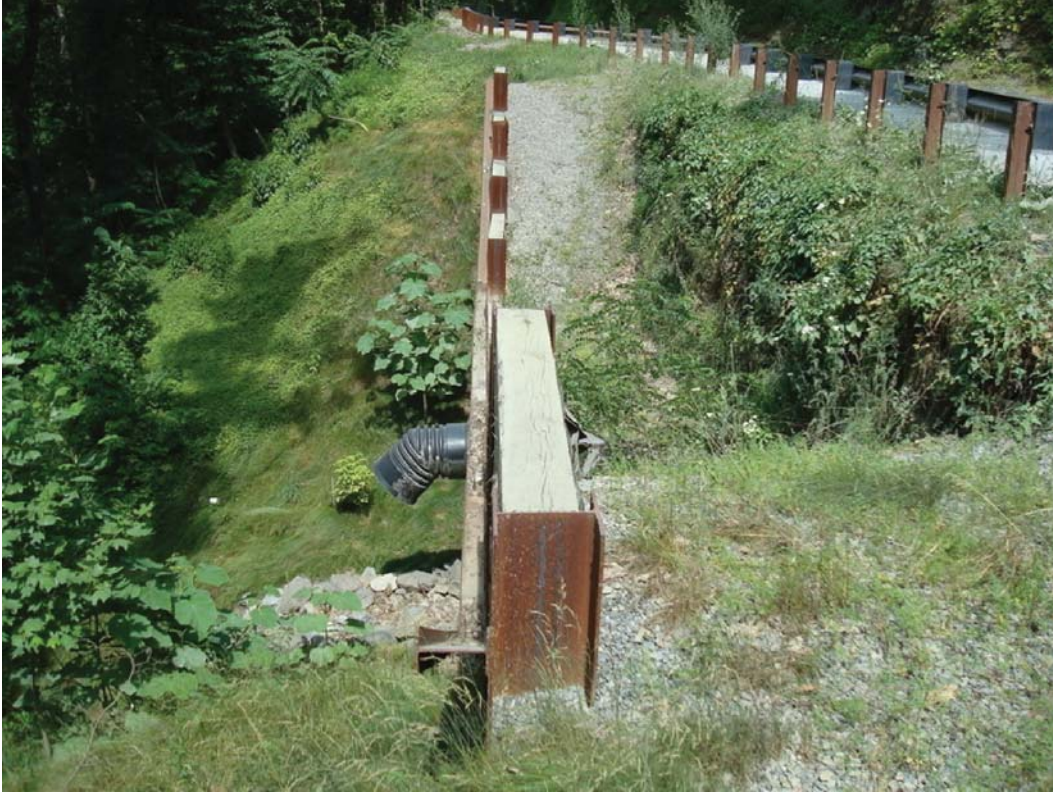
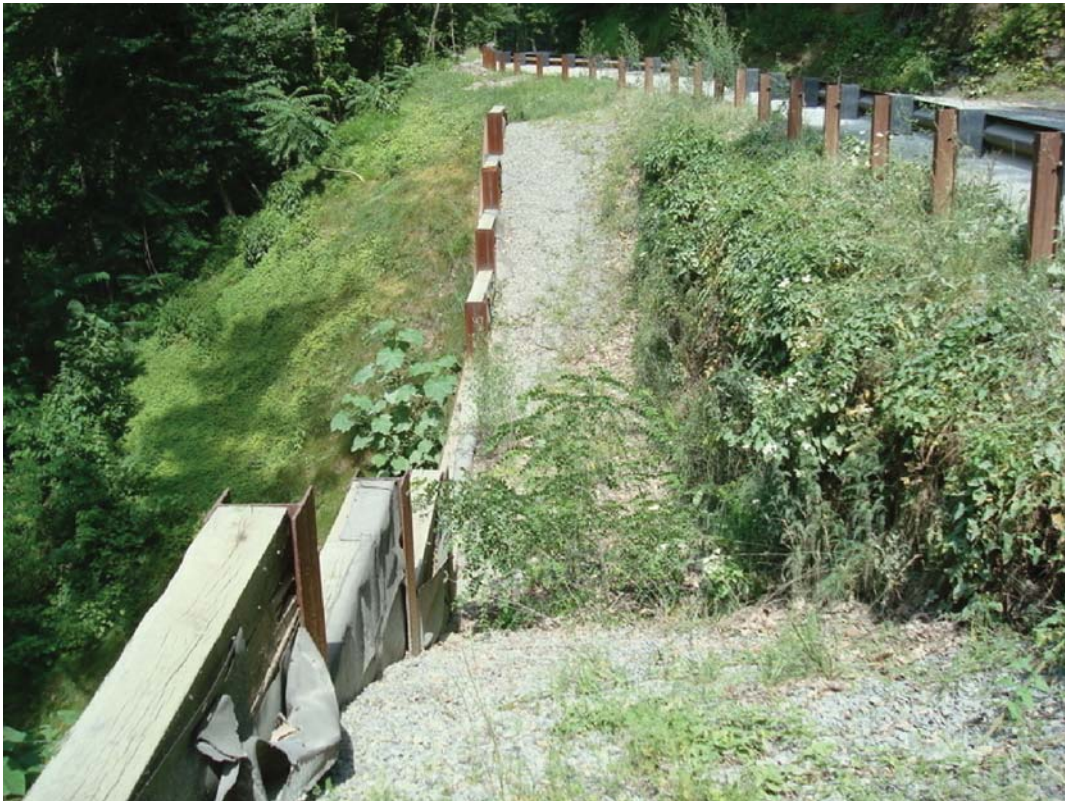
NERI_0117_0.794_L_1.JPG

Wall ID:	NERI-0117-.794-L		
Route Name:	GLADE CREEK ROAD		
Inspection Date:	June 25, 2008	Approximate Year Built:	2005
*Wall Rating:	86	Maintenance Action:	No Action

Element (Weighting Factor)	Narrative	Condition Rating (0 - 10)
PERFORMANCE 8.00	Good condition.	7
WALL FOUNDATION MATERIAL 8.00	Socketed into bedrock formation.	9
LAGGING 8.00	9" thick timber lagging in good conditions.	9
PILES AND SHAFTS 8.00	Concrete shafts socketed into bedrock with steel H piles in good conditions.	9
WIRE/GEOSYNTHETIC FACING 8.00	Geogrid reinforced wire baskets (biaxial).	9
CULVERT 0.50	36" diameter pipe culvert through wall.	9
DOWNSLOPE 0.50	Very steep slope, vegetated.	9
LATERAL SLOPE 0.50	Mild slope, vegetated.	9
ROAD/SIDEWALK/SHOULDER 0.50	Vegetated and narrow stone shoulder.	9

Failure Consequence:	HIGH
Recommendation Narrative:	None
Repair Cost:	\$0

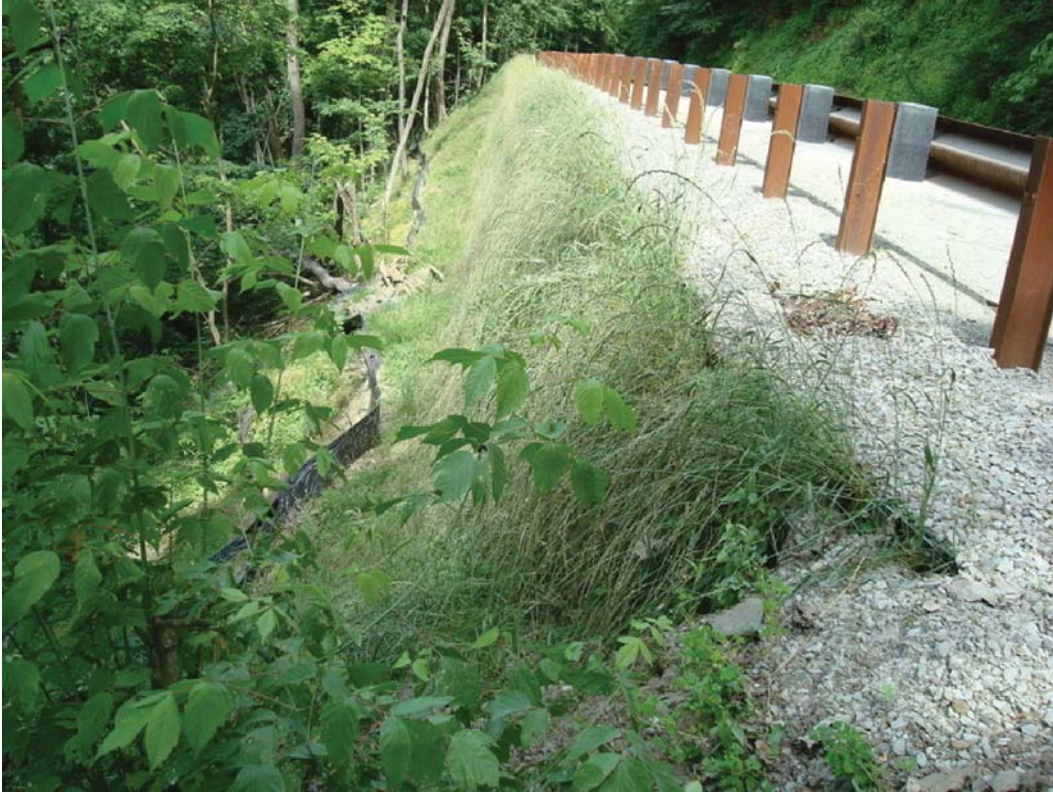
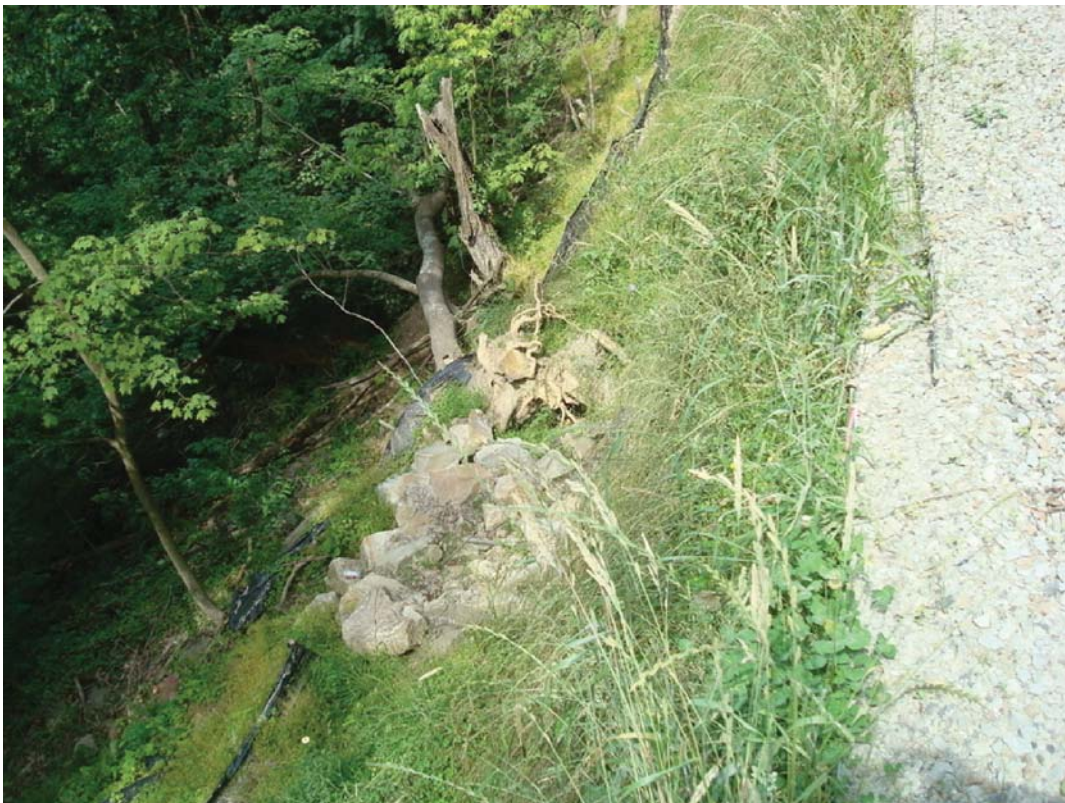
NERI_0117_0.828_L_1.JPG

Wall ID:	NERI-0117-828-L		
Route Name:	GLADE CREEK ROAD		
Inspection Date:	June 25, 2008	Approximate Year Built:	2006
*Wall Rating:	89	Maintenance Action:	No Action

Wall Function:	Fill Wall	Primary Wall Type:	MSE - Welded Wire Face
Surface Treatment:		Secondary Wall Type:	
Secondary Surface Treatment:		Architectural Facing:	
General Description:	Geogrid reinforced wire basket wall with vegetated face for embankment slope slide repair.

Element (Weighting Factor)	Narrative	Condition Rating (0 - 10)
PERFORMANCE 8.00	Good condition - new wall.	9
WALL FOUNDATION MATERIAL 8.00	dense soil or weathered to jointed rock.	9
WIRE/GEOSYNTHETIC FACING 8.00	Good condition, no settlement.	9
CULVERT 0.50	24" diameter pipe culvert through wall.	8
DOWNSLOPE 0.50	Very steep slope, vegetated and trees.	8
LATERAL SLOPE 0.50	Mild slope, vegetated and trees.	8
VEGETATION 0.50	Heavily vegetated and wooded.	8
ROAD/SIDEWALK/SHOULDER 0.50	Narrow aggregate shoulder.	9
TRAFFIC BARRIER/FENCE 0.50	Steel guardrail.	9

Failure Consequence:	HIGH
Recommendation Narrative:	None
Repair Cost:	\$0

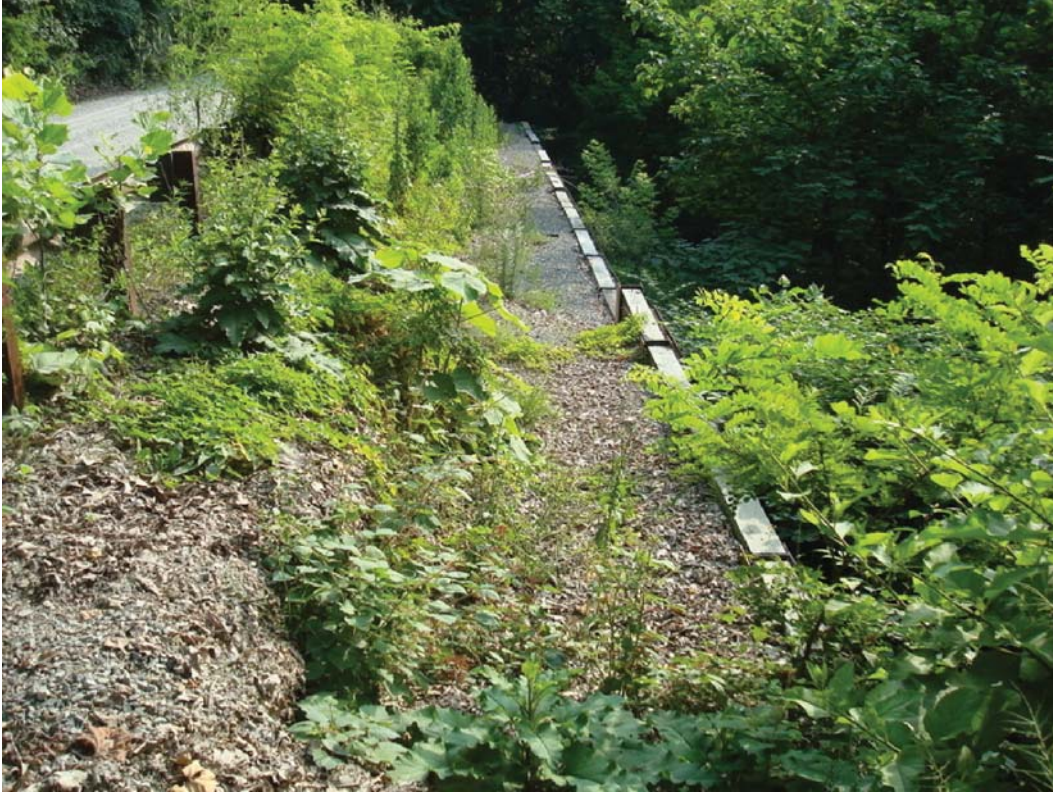
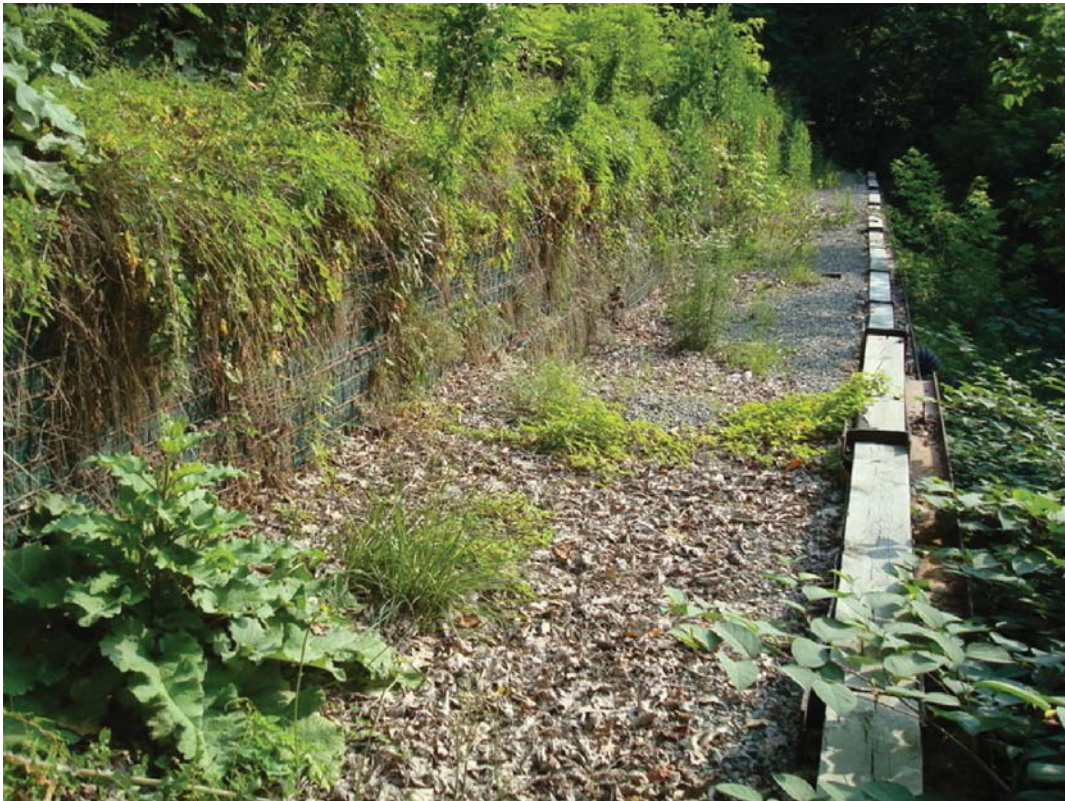
NERI_0117_1.283_L_1.JPG

Wall ID:	NERI-0117-1.283-L		
Route Name:	GLADE CREEK ROAD		
Inspection Date:	June 26, 2008	Approximate Year Built:	2006
*Wall Rating:	89	Maintenance Action:	No Action

Element (Weighting Factor)	Narrative	Condition Rating (0 - 10)
PERFORMANCE 8.00	Wall in good conditions.	9
WALL FOUNDATION MATERIAL 8.00	Shafts socketed 7ft into bedrock in good conditions.	9
LAGGING 8.00	Timber lagging in good conditions.	9
PILES AND SHAFTS 8.00	H Piles in concrete drilled shafts are in good conditions.	9
WIRE/GEOSYNTHETIC FACING 8.00	Biaxial geogrid and wire baskets are in good conditions.	9
LATERAL SLOPE 0.50	Mild slope heavily wooded and vegetated.	8
VEGETATION 0.50	Heavily vegetated and wooded.	8
CULVERT 0.50	36" pipe culvert through wall in good conditions.	9
ROAD/SIDEWALK/SHOULDER 0.50	Aggregate surface road in good conditions.	9

Failure Consequence:	HIGH
Recommendation Narrative:	None
Repair Cost:	\$0

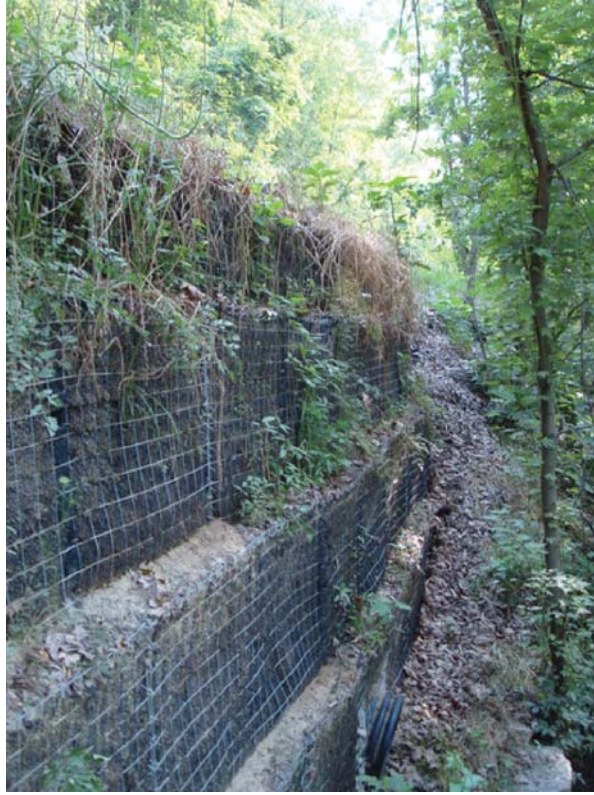
NERI_0117_1.702_L_1.JPG

Wall ID:	NERI-0117-1.702-L		
Route Name:	GLADE CREEK ROAD		
Inspection Date:	June 26, 2008	Approximate Year Built:	2002
*Wall Rating:	83	Maintenance Action:	No Action

Element (Weighting Factor)	Narrative	Condition Rating (0 - 10)
PERFORMANCE 8.00	Good condition; wall should be monitored to see if bulging/buckling persists.	9
WALL FOUNDATION MATERIAL 8.00	Good condition, no settlement or distressed cracks.	8
WIRE/GEOSYNTHETIC FACING 8.00	Good condition.	8
DOWNSLOPE 0.50	Good condition; steep, lightly forested slope.	8
LATERAL SLOPE 0.50	Minor erosion at both ends of the wall.	8
ROAD/SIDEWALK/SHOULDER 0.50	Good condition, good drainage to ditch along back edge of road.	8
WALL DRAINS 0.50	No evidence of internal drainage distress; sheet flow across face of wall contributing to distress.	8
CULVERT 0.50	18" diameter CPP culvert, good condition.	9

Failure Consequence:	HIGH
Recommendation Narrative:	None
Repair Cost:	\$0

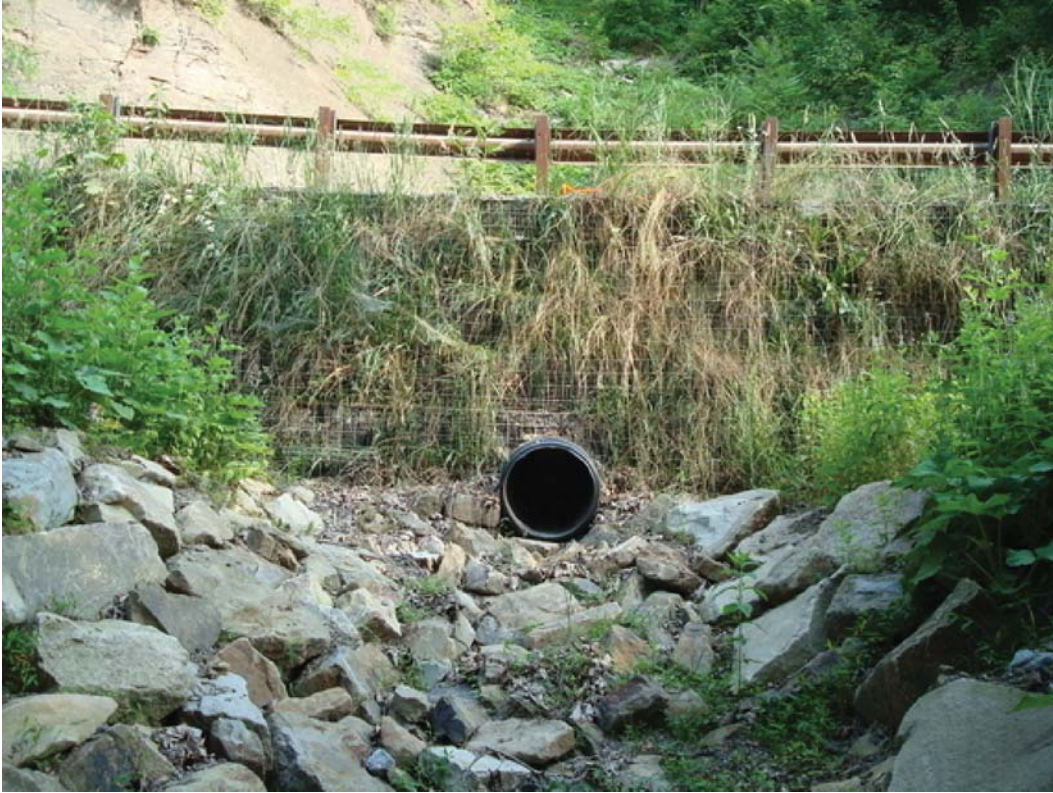
NERI_0117_1.713_L_1.JPG

Wall ID:	NERI-0117-1.713-L		
Route Name:	GLADE CREEK ROAD		
Inspection Date:	June 28, 2008	Approximate Year Built:	2007
*Wall Rating:	81	Maintenance Action:	No Action

Wall Function:	Fill Wall	Primary Wall Type:	MSE - Geosynthetic Wrapped Face
Surface Treatment:		Secondary Wall Type:	
Secondary Surface Treatment:		Architectural Facing:	
General Description:	MSE Wall with welded wire basket face directly supports the left shoulder of roadway low consequence of failure.

Element (Weighting Factor)	Narrative	Condition Rating (0 - 10)
PERFORMANCE 8.00	Good to excellent condition.	8
WALL FOUNDATION MATERIAL 8.00	On soil, no settlement cracks.	8
WIRE/GEOSYNTHETIC FACING 8.00	Good condition, no corrosion.	8
ROAD/SIDEWALK/SHOULDER 0.50	Gravel roadway; good condition; no observed distress.	8
TRAFFIC BARRIER/FENCE 0.50	Guardrail; in good condition.	8
UPSLOPE 0.50	Very steep.	8
WALL DRAINS 0.50	Self drainage.	8
CULVERT 0.50	24" diameter CPP at base of wall, good conditions with no observed distress.	9
DOWNSLOPE 0.50	No observed distress, riprap erosion protection at outlet of culvert.	9

Failure Consequence:	HIGH
Recommendation Narrative:	None
Repair Cost:	\$0

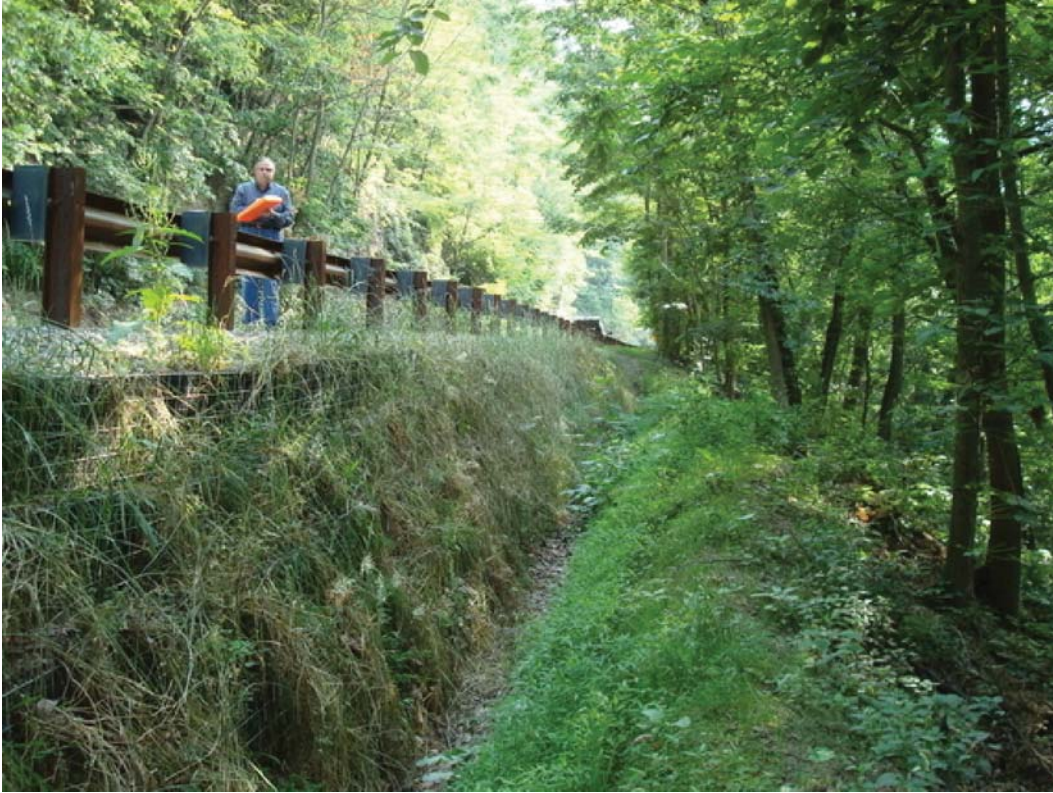
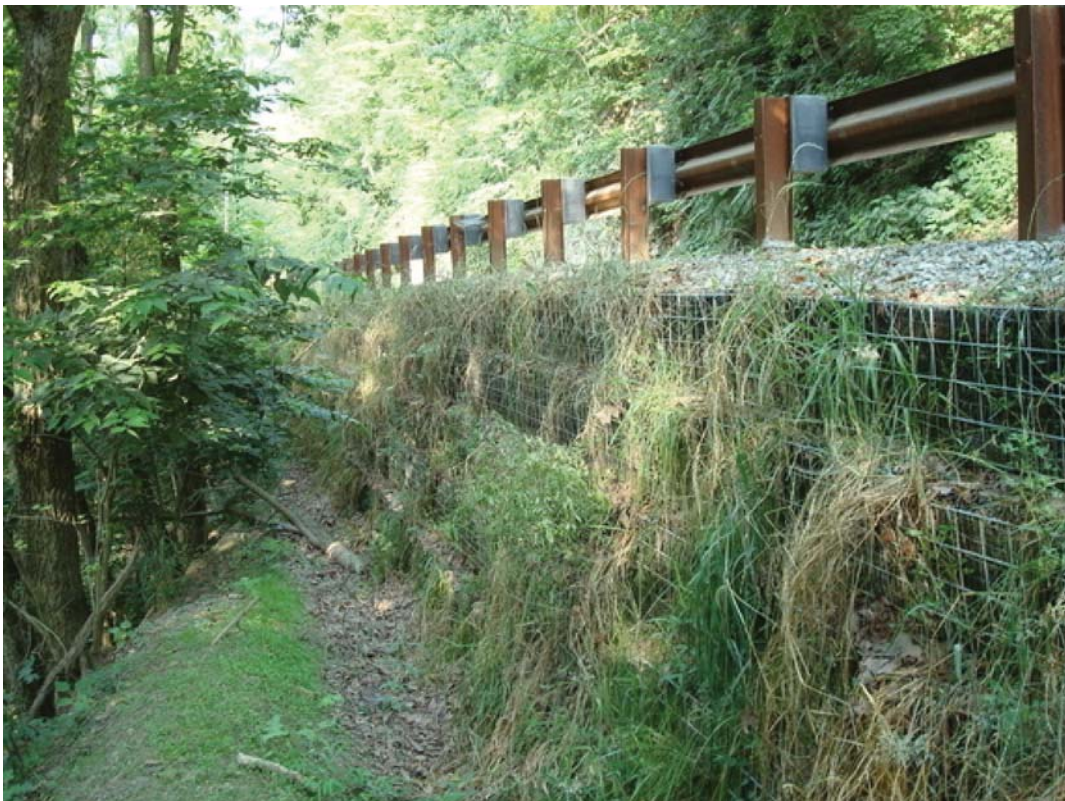
NERI_0117_1.752_L_1.JPG

Wall ID:	NERI-0117-1.752-L		
Route Name:	GLADE CREEK ROAD		
Inspection Date:	June 26, 2008	Approximate Year Built:	Unknown
*Wall Rating:	79	Maintenance Action:	No Action

Element (Weighting Factor)	Narrative	Condition Rating (0 - 10)
PERFORMANCE 8.00	Good condition.	8
WALL FOUNDATION MATERIAL 8.00	On soil, no settlement or distressed cracks.	8
WIRE/GEOSYNTHETIC FACING 8.00	Good condition, grass growing, minor buckling in the wirebasket.	8
CULVERT 0.50	15" diameter CPP.	8
ROAD/SIDEWALK/SHOULDER 0.50	Gravel road.	8
TRAFFIC BARRIER/FENCE 0.50	Guardrail; in good condition.	8
WALL DRAINS 0.50	Self draining.	9
DOWNSLOPE 1.00	Very steep, heavily wooded, no distressed vegetation.	7
LATERAL SLOPE 1.00	Very steep, heavily wooded.	7

Failure Consequence:	HIGH
Recommendation Narrative:	None
Repair Cost:	\$0

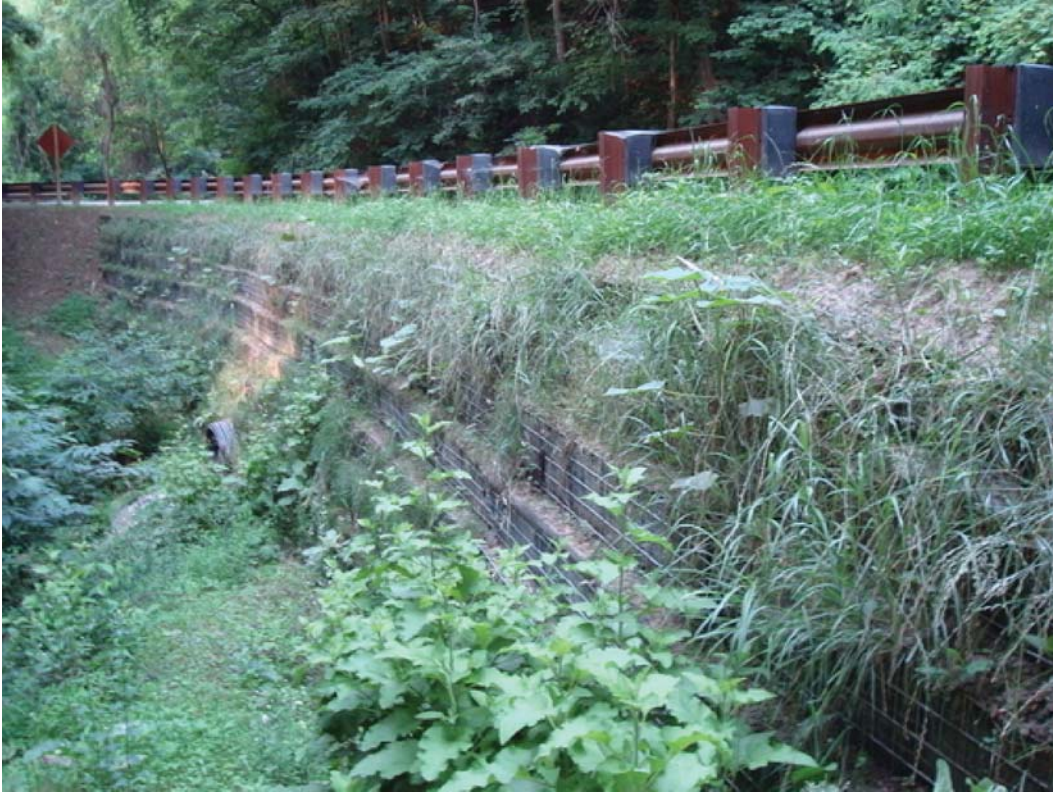
NERI_0117_2.392_L_1.JPG

Wall ID:	NERI-0117-2.392-L		
Route Name:	GLADE CREEK ROAD		
Inspection Date:	June 26, 2008	Approximate Year Built:	2007
*Wall Rating:	82	Maintenance Action:	No Action

Element (Weighting Factor)	Narrative	Condition Rating (0 - 10)
PERFORMANCE 8.00	Good condition.	8
WALL FOUNDATION MATERIAL 8.00	On soil, no settlement or distressed cracks.	8
WIRE/GEOSYNTHETIC FACING 8.00	Good condition, vegetation at the face of the wall.	9
CULVERT 0.50	30" diameter CPP, good conditions.	9
ROAD/SIDEWALK/SHOULDER 0.50	Gravel Road.	9
TRAFFIC BARRIER/FENCE 0.50	Gravel road.	9
WALL DRAINS 0.50	Self drainage, no problem related with drainage.	9
DOWNSLOPE 1.00	Very steep, heavily wooded.	7
LATERAL SLOPE 1.00	Very steep, heavily wooded.	7

Failure Consequence:	HIGH
Recommendation Narrative:	None
Repair Cost:	\$0

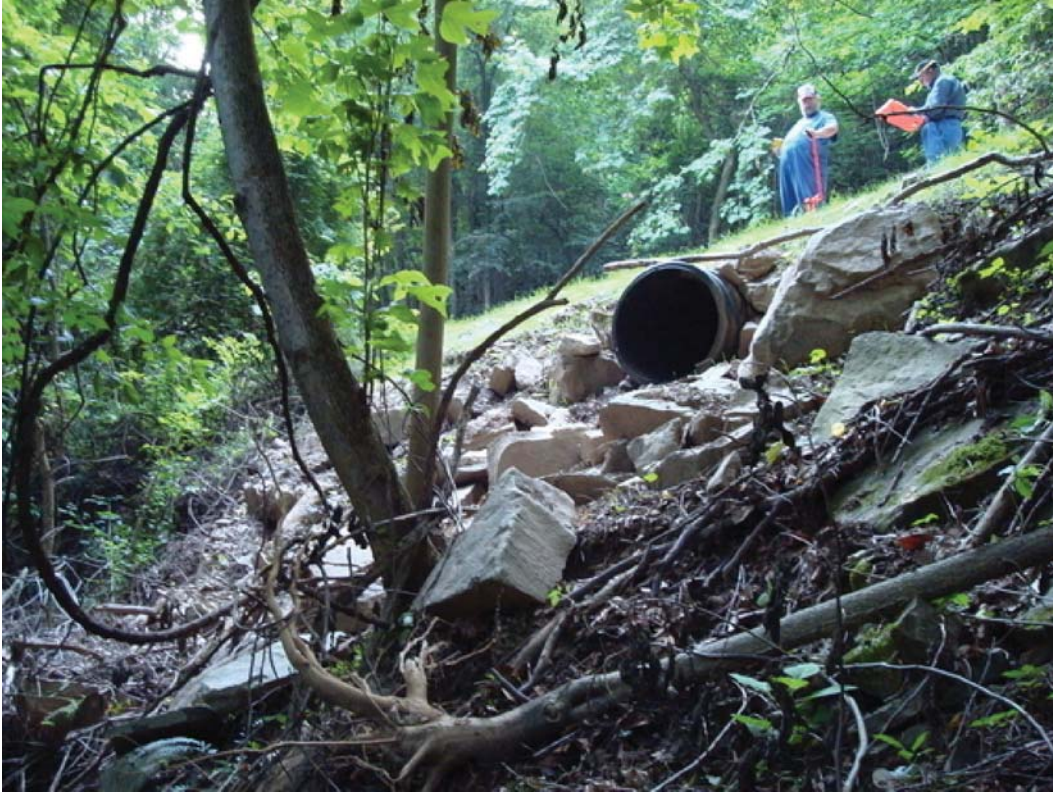
NERI_0117_3.596_L_1.JPG

Wall ID:	NERI-0117-3.596-L		
Route Name:	GLADE CREEK ROAD		
Inspection Date:	June 26, 2008	Approximate Year Built:	Unknown
*Wall Rating:	84	Maintenance Action:	No Action

Element (Weighting Factor)	Narrative	Condition Rating (0 - 10)
PERFORMANCE 8.00	Good conditions.	9
CULVERT 0.50	30" diameter PCC.	8
ROAD/SIDEWALK/SHOULDER 0.50	Gravel road.	8
DOWNSLOPE 1.00	Very steep, heavily wooded.	7
LATERAL SLOPE 1.00	Very steep, heavily wooded.	7
UPSLOPE 1.00	Gravel road, very steep, heavily wooded.	7

Failure Consequence:	LOW
Recommendation Narrative:	None
Repair Cost:	\$0
