OLYM WIP Report

NPS Retaining Wall Inventory Program Olympic National Park

**Federal Highway Administration
Eastern Federal Lands Highway Division
Road Inventory Program (RIP)**

**Data Collection Date: July 2007
Report Date: October 2015**

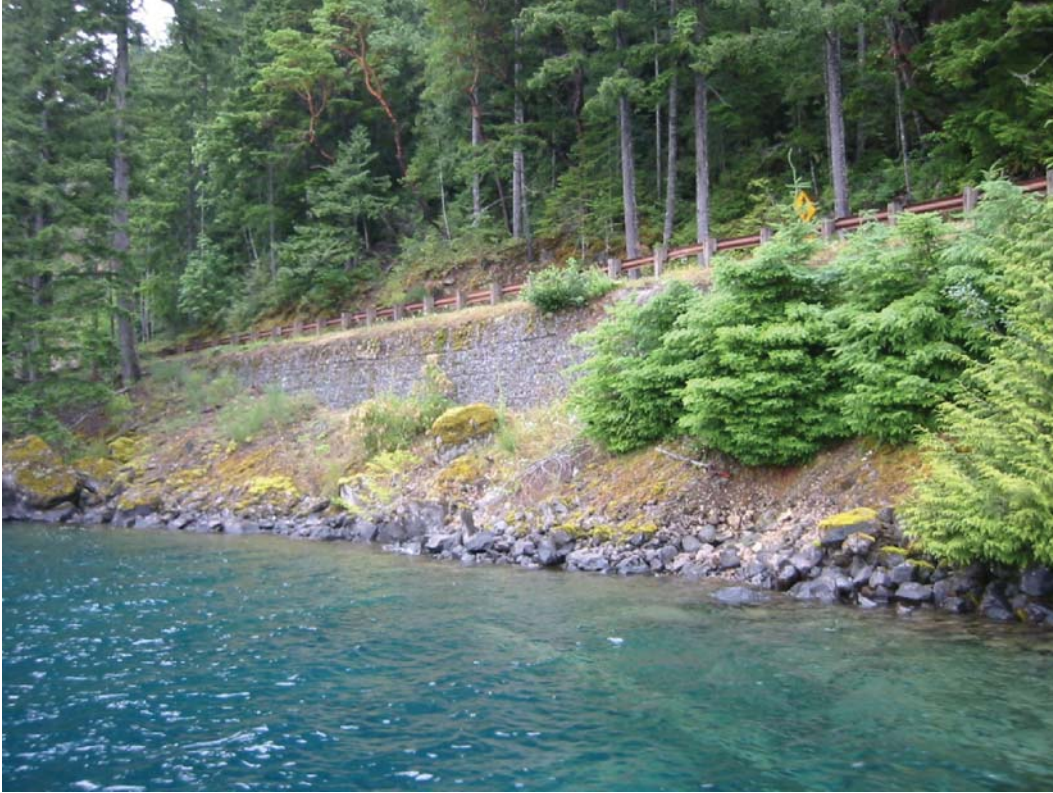
OLYM_0011_2.805_R_1.jpg

Wall ID:	OLYM-0011-2.805-R		
Route Name:	LAKE CRESCENT HIGHWAY (US 101)		
Inspection Date:	July 23, 2007	Approximate Year Built:	1984
*Wall Rating:	90	Maintenance Action:	No Action

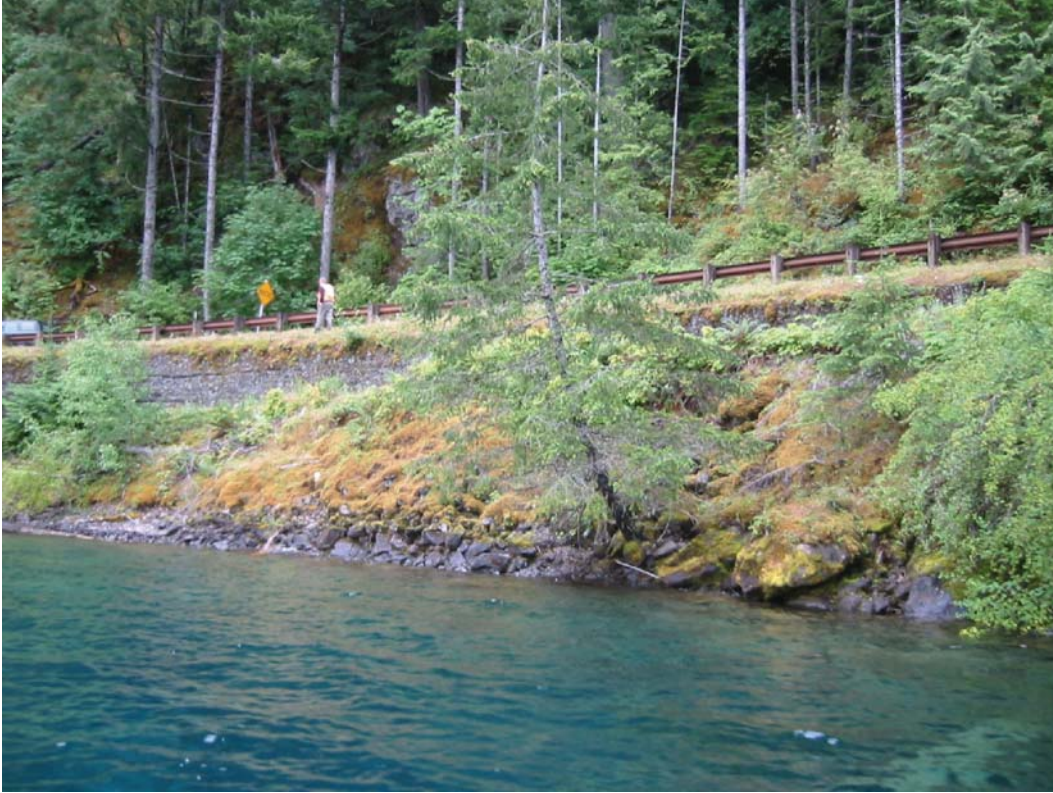
OLYM_0011_2.915_R_1.jpg

Wall ID:	OLYM-0011-2.915-R		
Route Name:	LAKE CRESCENT HIGHWAY (US 101)		
Inspection Date:	July 23, 2007	Approximate Year Built:	1984
*Wall Rating:	91	Maintenance Action:	No Action

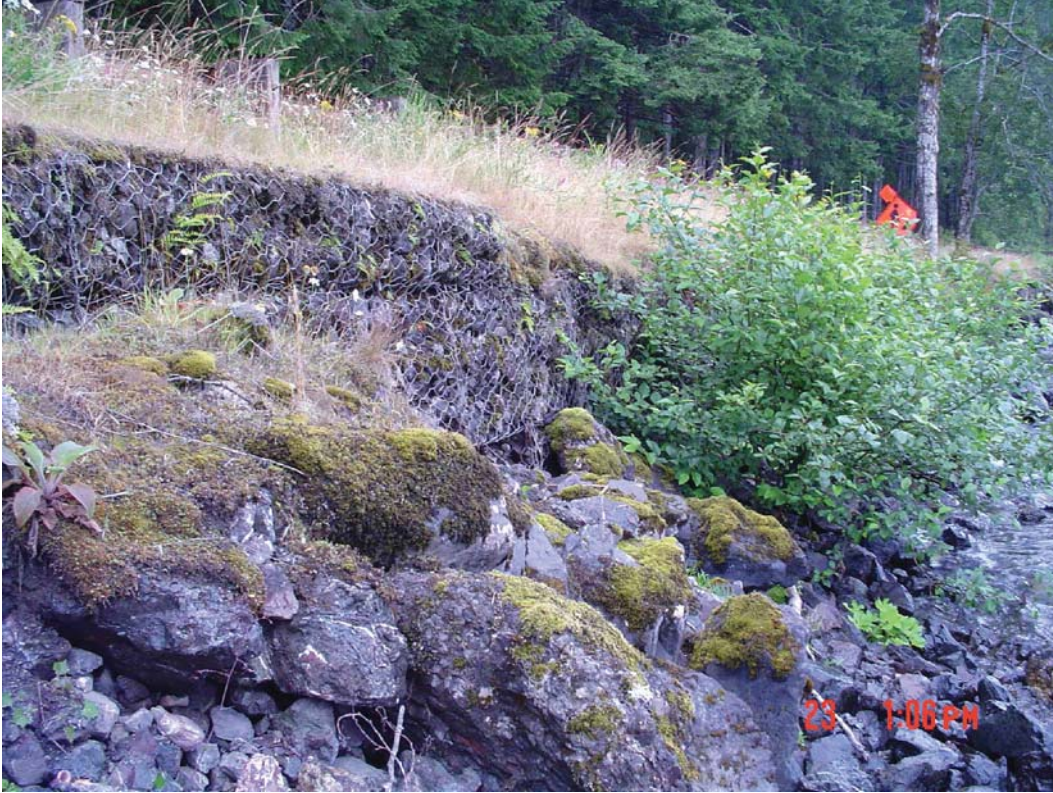
OLYM_0011_5.277_R_1.jpg

Wall ID:	OLYM-0011-5.277-R		
Route Name:	LAKE CRESCENT HIGHWAY (US 101)		
Inspection Date:	July 23, 2007	Approximate Year Built:	Unknown
*Wall Rating:	81	Maintenance Action:	No Action

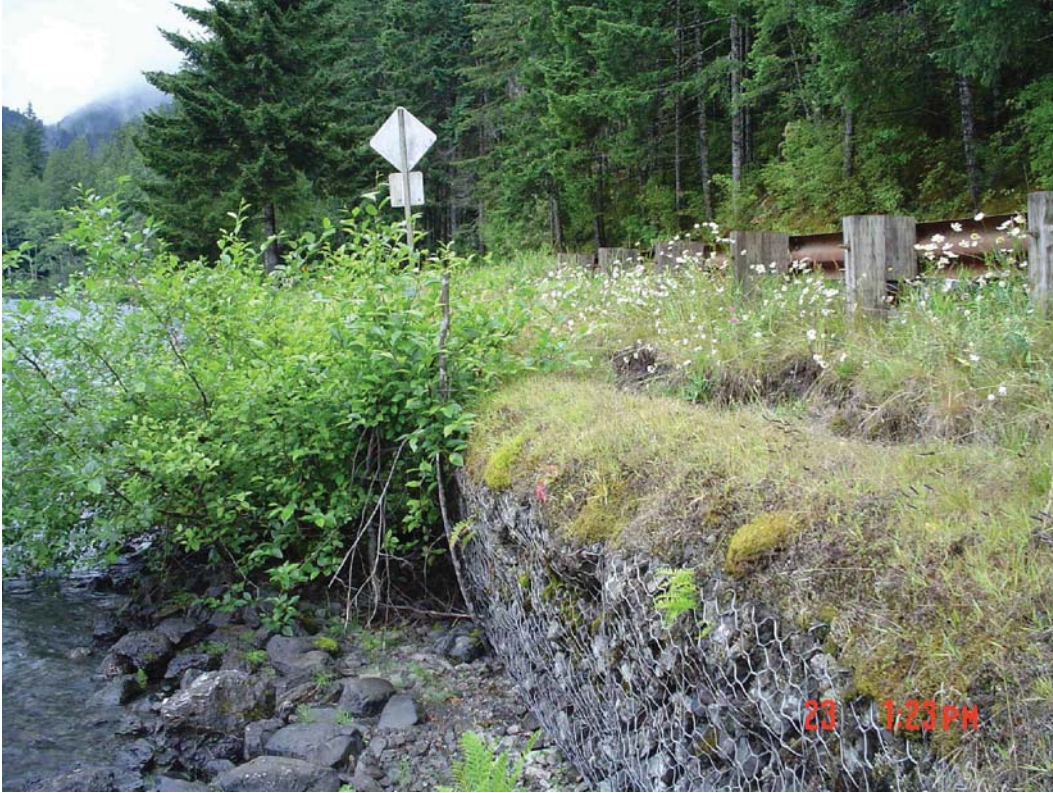
OLYM_0011_5.406_R_1.jpg

Wall ID:	OLYM-0011-5.406-R		
Route Name:	LAKE CRESCENT HIGHWAY (US 101)		
Inspection Date:	July 23, 2007	Approximate Year Built:	Unknown
*Wall Rating:	58	Maintenance Action:	Repair Elements

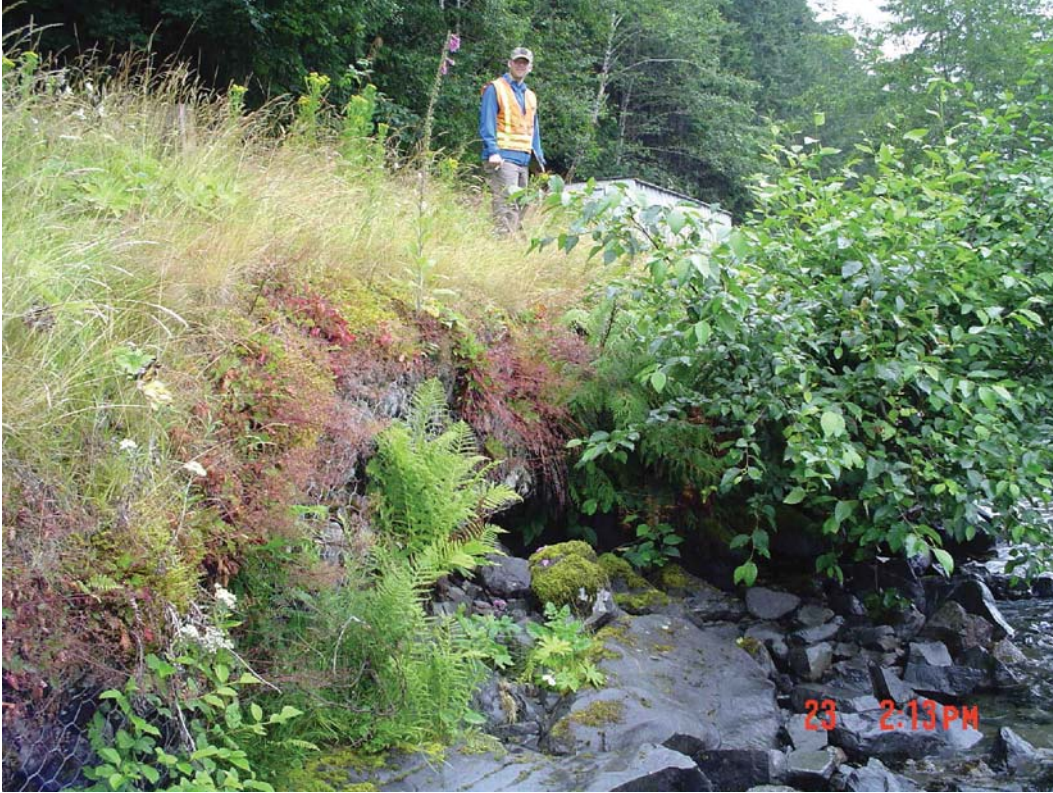
OLYM_0011_5.570_R_1.jpg

Wall ID:	OLYM-0011-5.570-R		
Route Name:	LAKE CRESCENT HIGHWAY (US 101)		
Inspection Date:	July 23, 2007	Approximate Year Built:	Unknown
*Wall Rating:	54	Maintenance Action:	Repair Elements

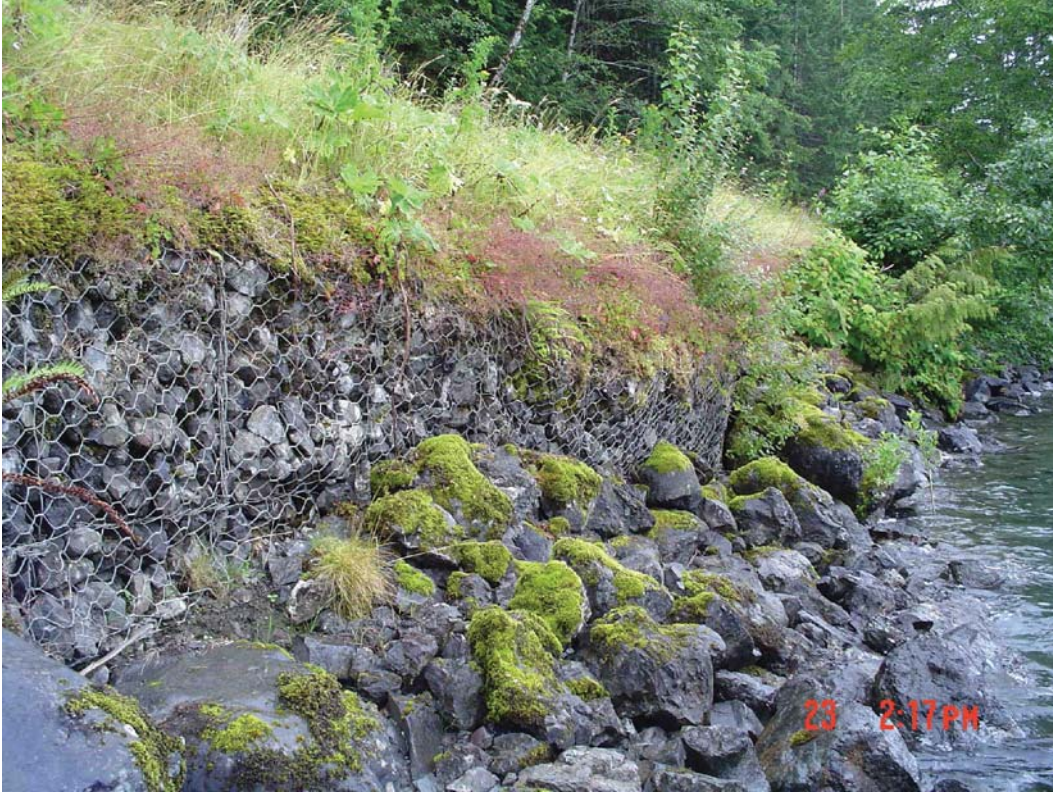
OLYM_0011_5.582_R_1.jpg

Wall ID:	OLYM-0011-5.582-R		
Route Name:	LAKE CRESCENT HIGHWAY (US 101)		
Inspection Date:	July 23, 2007	Approximate Year Built:	Unknown
*Wall Rating:	80	Maintenance Action:	No Action

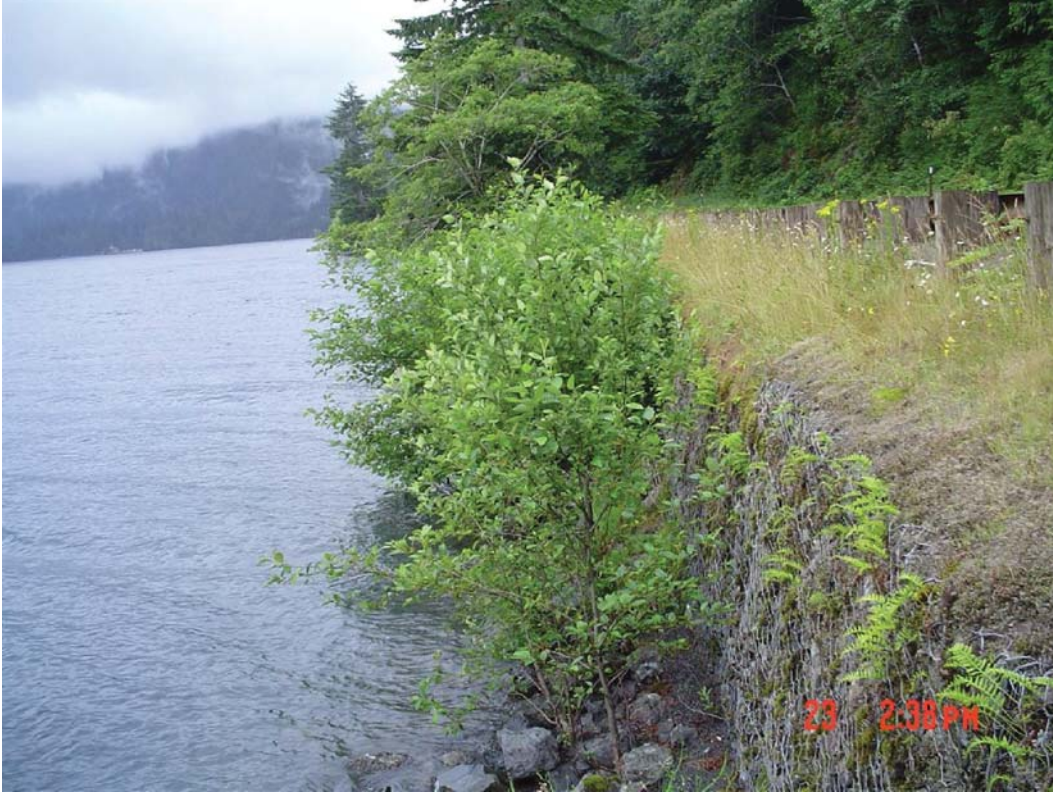
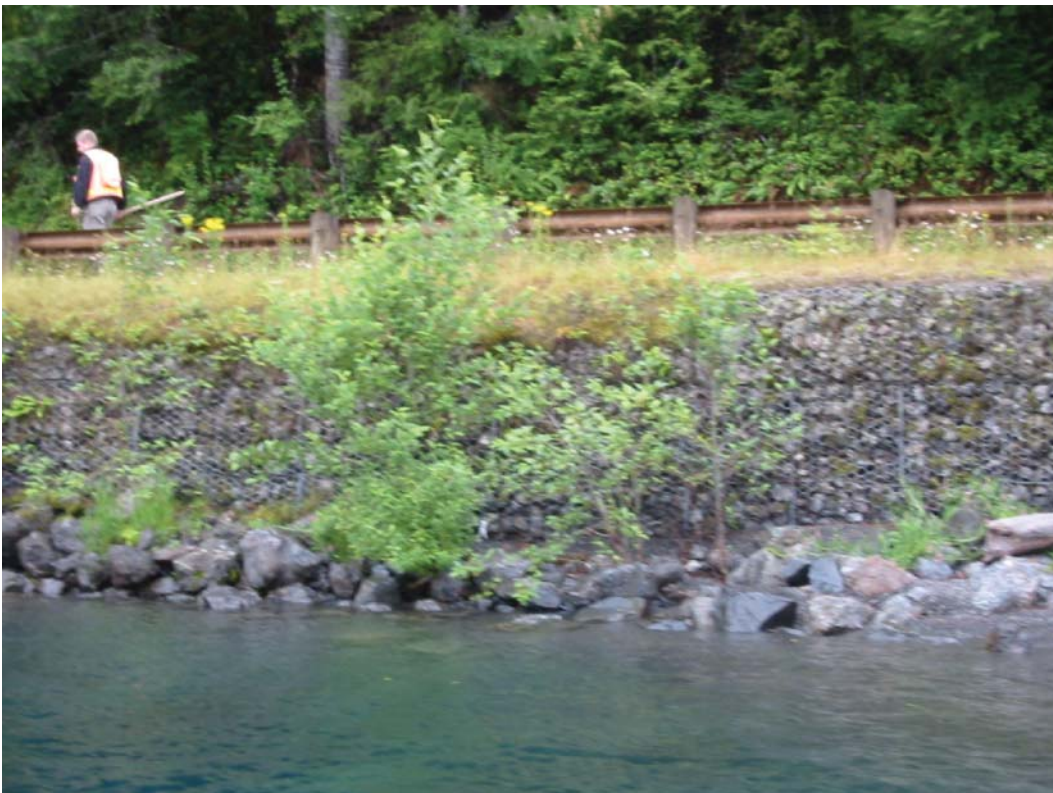
Wall ID:	OLYM-0011-5.636-R		
Route Name:	LAKE CRESCENT HIGHWAY (US 101)		
Inspection Date:	July 23, 2007	Approximate Year Built:	Unknown
*Wall Rating:	83	Maintenance Action:	No Action

Element (Weighting Factor)	Narrative	Condition Rating (0 - 10)
PERFORMANCE 8.00	Good - wall performing as intended	8
WALL FOUNDATION MATERIAL 8.00	Firm beach deposits and rip rap	9
WIRE/GEOSYNTHETIC FACING 8.00	Wire is in good shape, minor bulging, irregular rock degradation	8
DOWNSLOPE 0.50	Beach deposit and rip rap, appears stable	8
LATERAL SLOPE 0.50	Rip rap and heavy vegetation	8
ROAD/SIDEWALK/SHOULDER 0.50	Road- no distress noted shoulder- no distress, well vegetated	9
WALL DRAINS 0.50	No distress noted	9

Failure Consequence:	HIGH
Recommendation Narrative:	None
Repair Cost:	\$0

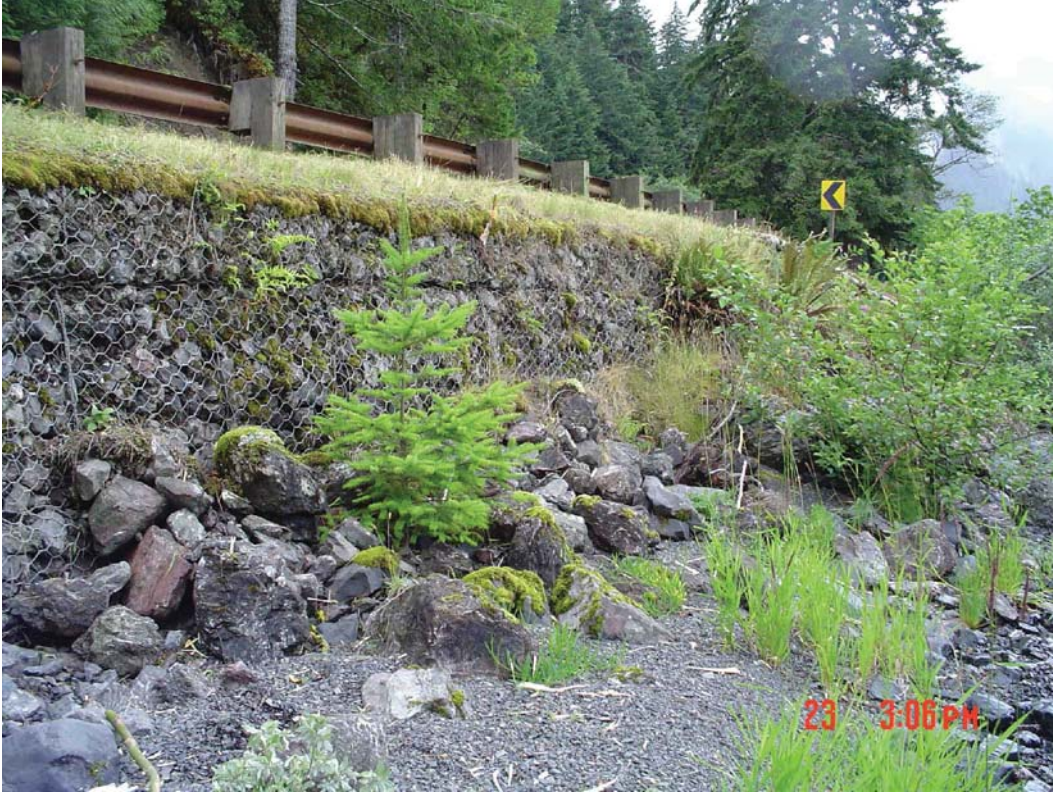
OLYM_0011_5.914_R_1.jpg

Wall ID:	OLYM-0011-5.914-R		
Route Name:	LAKE CRESCENT HIGHWAY (US 101)		
Inspection Date:	July 23, 2007	Approximate Year Built:	Unknown
*Wall Rating:	81	Maintenance Action:	No Action

Wall Function:	Fill Wall	Primary Wall Type:	Gravity - Gabion
Surface Treatment:		Secondary Wall Type:	
Secondary Surface Treatment:		Architectural Facing:	
General Description:	Gabion wall along lake, in generally good condition

Element (Weighting Factor)	Narrative	Condition Rating (0 - 10)
PERFORMANCE 8.00	Good - wall performing as intended	8
WALL FOUNDATION MATERIAL 8.00	Rip rap and gravel beach deposits	9
WIRE/GEOSYNTHETIC FACING 8.00	Some irregularity to face, 10% rock degradation	7
LATERAL SLOPE 0.50	Heavily vegetated, rip rap	8
DOWNSLOPE 0.50	Beach gravel and rip rap, stable	9
ROAD/SIDEWALK/SHOULDER 0.50	Road- no distress noted shoulder- grass covered no distress noted	9
WALL DRAINS 0.50	No distress noted	9

Failure Consequence:	HIGH
Recommendation Narrative:	None
Repair Cost:	\$0

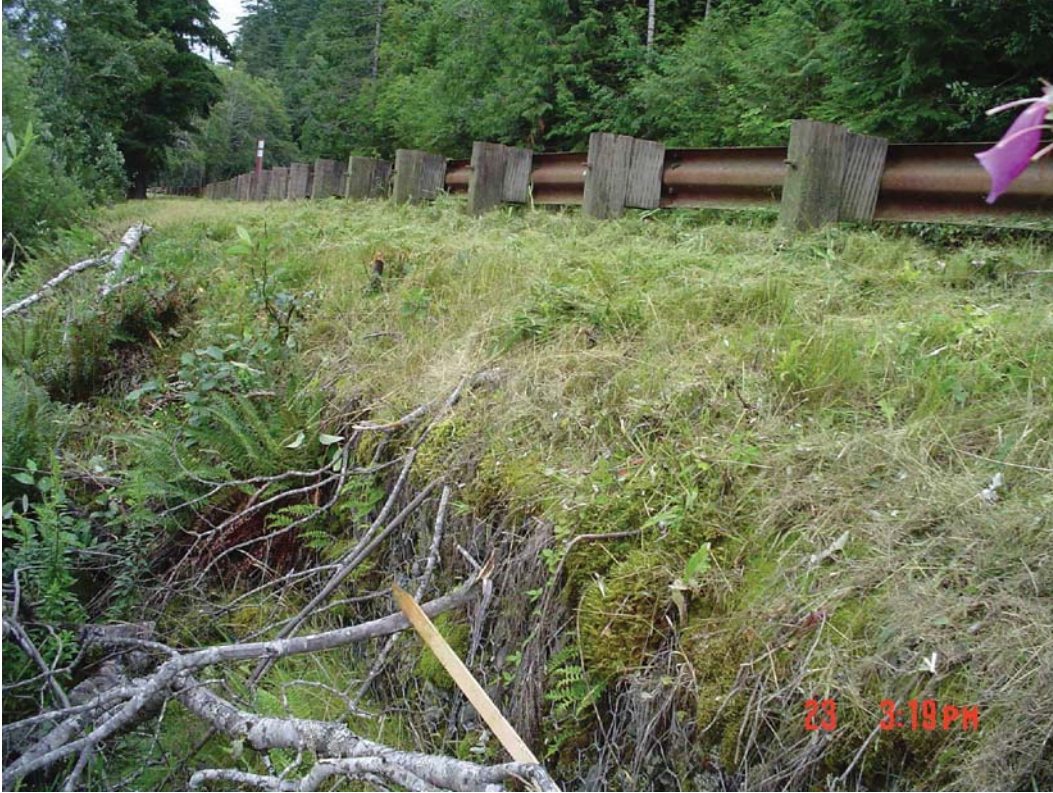
OLYM_0011_5.927_R_1.jpg

Wall ID:	OLYM-0011-5.927-R		
Route Name:	LAKE CRESCENT HIGHWAY (US 101)		
Inspection Date:	July 23, 2007	Approximate Year Built:	Unknown
*Wall Rating:	84	Maintenance Action:	No Action

Element (Weighting Factor)	Narrative	Condition Rating (0 - 10)
PERFORMANCE 8.00	Excellent - wall performing as intended	8
WALL FOUNDATION MATERIAL 8.00	Rip rap material, no apparent distress	9
WIRE/GEOSYNTHETIC FACING 8.00	Galvanized wire in good condition, some degrading of rock	8
DOWNSLOPE 0.50	Rip rap material that appears stable	9
LATERAL SLOPE 0.50	Heavily vegetated embankment, appears stable	9
ROAD/SIDEWALK/SHOULDER 0.50	Road- no distress noted shoulder- grass covered, no distress	9
WALL DRAINS 0.50	No distress noted	9

Failure Consequence:	HIGH
Recommendation Narrative:	None
Repair Cost:	\$0

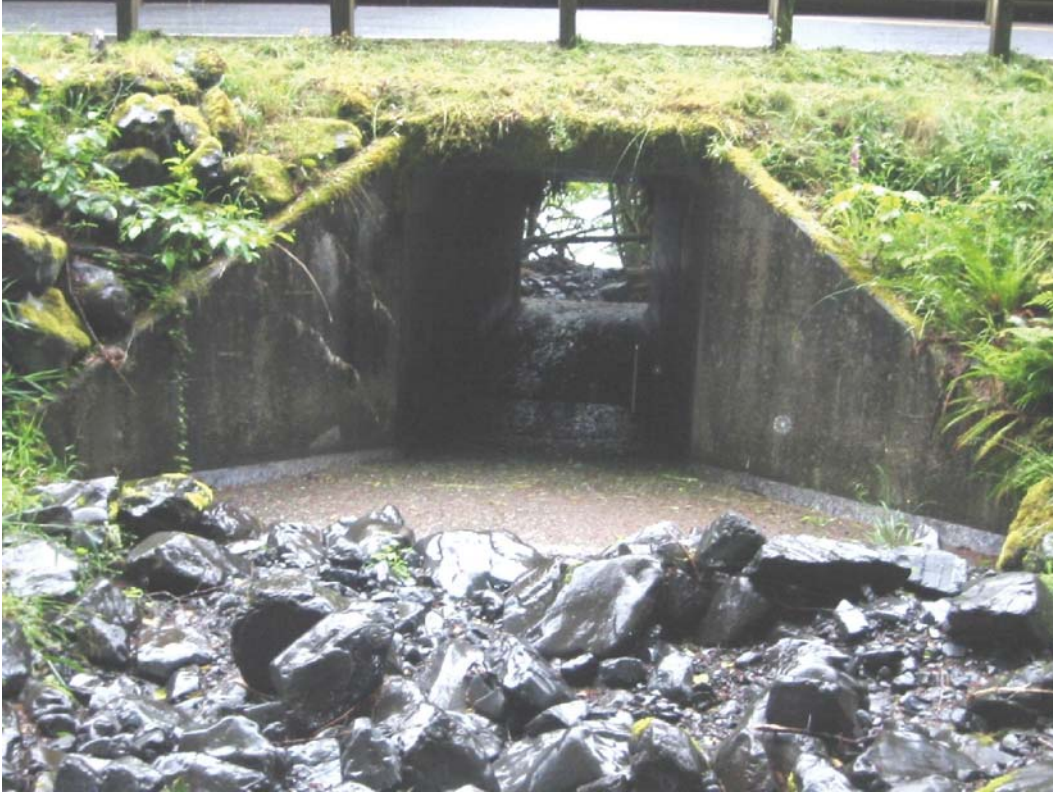
OLYM_0011_6.587_L_1.jpg

Wall ID:	OLYM-0011-6.587-L		
Route Name:	LAKE CRESCENT HIGHWAY (US 101)		
Inspection Date:	July 19, 2007	Approximate Year Built:	Unknown
*Wall Rating:	90	Maintenance Action:	No Action

Element (Weighting Factor)	Narrative	Condition Rating (0 - 10)
PERFORMANCE 8.00	Good - Minor distress in left wing	9
WALL FOUNDATION MATERIAL 8.00	Alluvium (streambed)	10
CONCRETE 8.00	2 cracks w/ leaching	8
DOWNSLOPE 0.50	Streambed uphill 30% gradient	8
LATERAL SLOPE 0.50	Vegetated w/ riprap behind left wing	8
ROAD/SIDEWALK/SHOULDER 0.50	No distress	10
UPSLOPE 0.50	No distress	10
WALL DRAINS 0.50	No distress	10

Failure Consequence:	MODERATE
Recommendation Narrative:	None
Repair Cost:	\$0

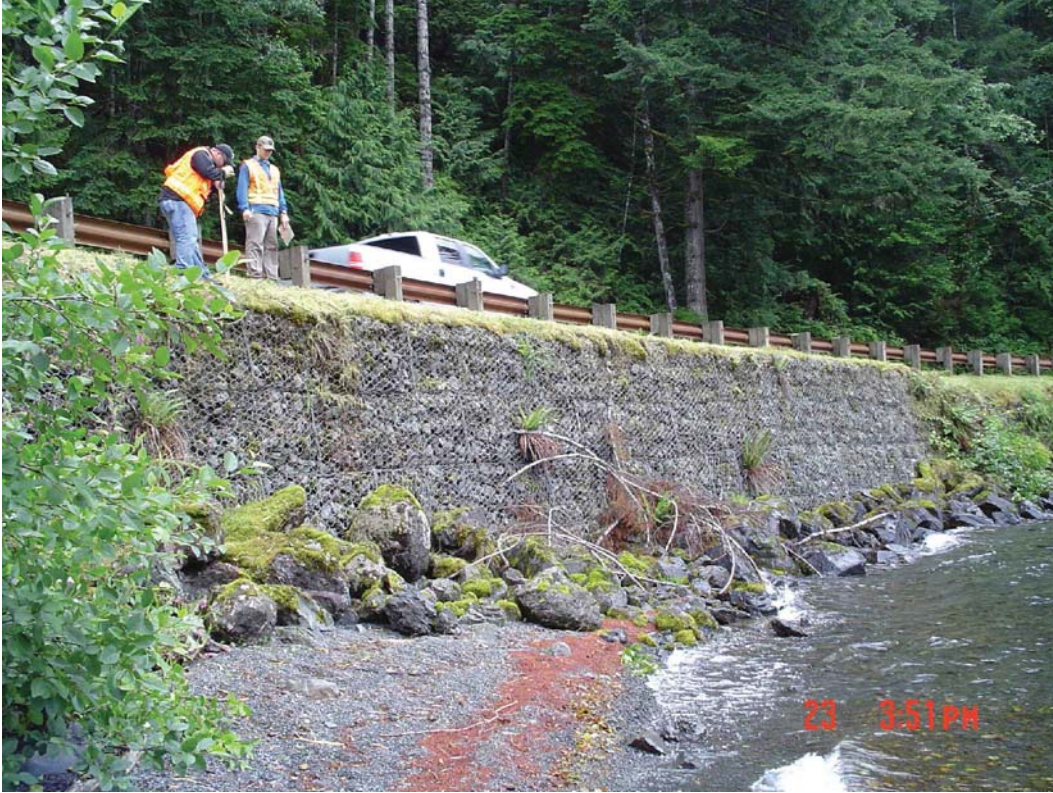
OLYM_0011_6.890_R_1.jpg

Wall ID:	OLYM-0011-6.890-R		
Route Name:	LAKE CRESCENT HIGHWAY (US 101)		
Inspection Date:	July 23, 2007	Approximate Year Built:	Unknown
*Wall Rating:	81	Maintenance Action:	No Action

Element (Weighting Factor)	Narrative	Condition Rating (0 - 10)
PERFORMANCE 8.00	Excellent, wall performing as intended	8
WALL FOUNDATION MATERIAL 8.00	Solid riprap material, no distress noted	9
WIRE/GEOSYNTHETIC FACING 8.00	Galvanized wire some bulging and irregular face	7
LATERAL SLOPE 0.50	Riprap embankment fill, good condition	8
DOWNSLOPE 0.50	Riprap and beach ravel appears stable	9
ROAD/SIDEWALK/SHOULDER 0.50	No distress in road or shoulder	9
WALL DRAINS 0.50	No distress noted	9

Failure Consequence:	HIGH
Recommendation Narrative:	None
Repair Cost:	\$0

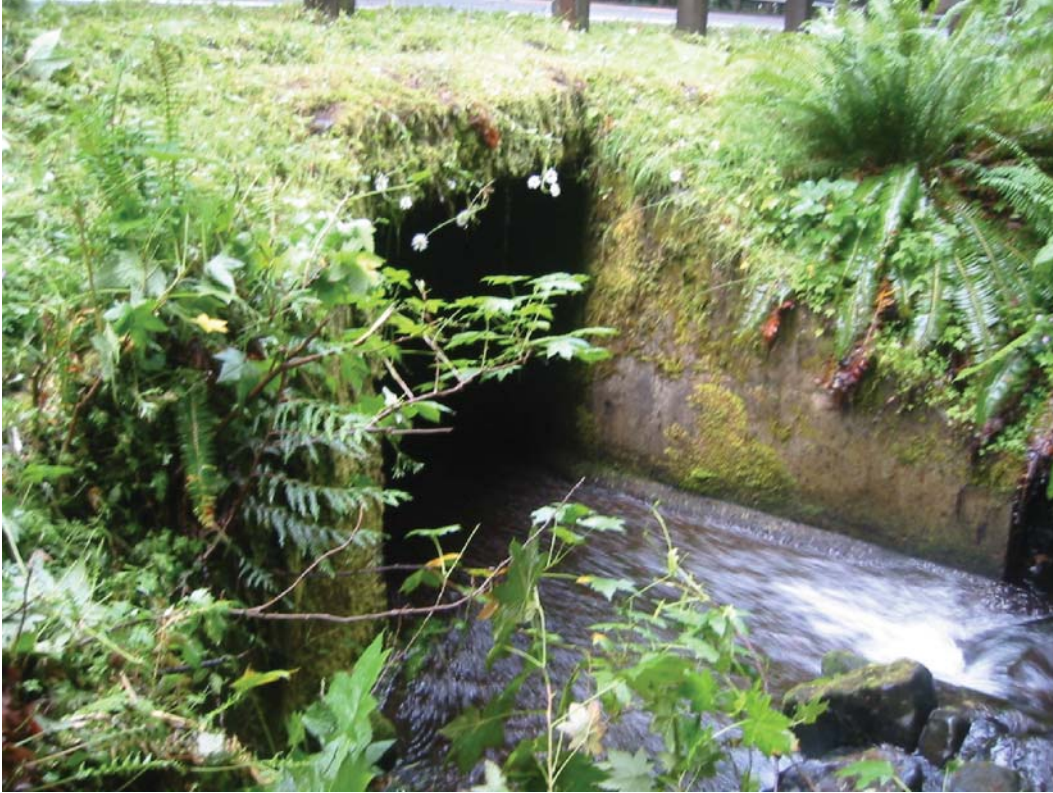
OLYM_0011_7.613_L_1.jpg

Element (Weighting Factor)	Narrative	Condition Rating (0 - 10)
PERFORMANCE 8.00	Good - wall performing as intended	9
WALL FOUNDATION MATERIAL 8.00	Alluvium	9
CONCRETE 8.00	No distress	10
CULVERT 0.50	No distress	9
WALL DRAINS 0.50	No distress	9
ROAD/SIDEWALK/SHOULDER 0.50	No distress	10
UPSLOPE 0.50	Vegetated, stable	10
LATERAL SLOPE 1.00	Erosion on left side, but stabilized by logs	7

Failure Consequence:	MODERATE
Recommendation Narrative:	None
Repair Cost:	\$0

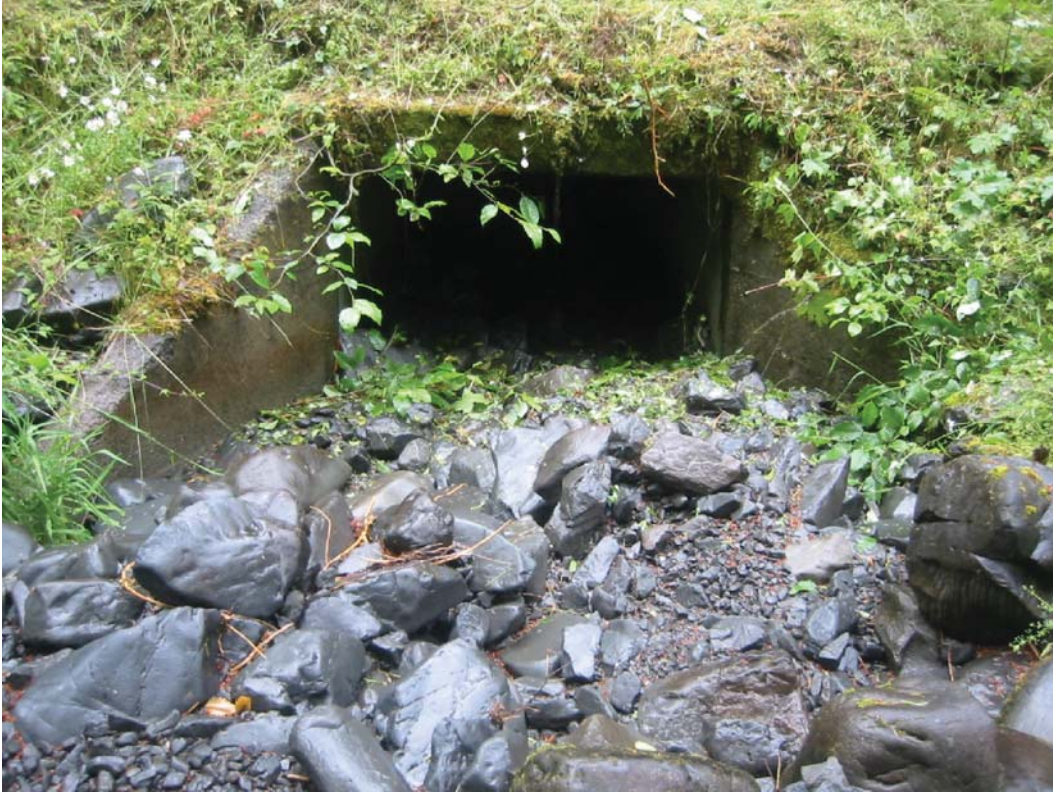
OLYM_0011_8.067_R_1.jpg

Element (Weighting Factor)	Narrative	Condition Rating (0 - 10)
PERFORMANCE 8.00	Good, but needs clean out	8
WALL FOUNDATION MATERIAL 8.00	Streambed and rock	8
CONCRETE 8.00	No distress	9
DOWNSLOPE 0.50	Streambed material, seasonally high flow, massive erosion downstream	8
LATERAL SLOPE 0.50	Vegetated, stable	9
ROAD/SIDEWALK/SHOULDER 0.50	Minor erosion, not wall related	9
UPSLOPE 0.50	1:1, vegetated	9
WALL DRAINS 0.50	None, no distress	9
CULVERT 1.00	Filled w/ 2'-3' of debris	7

Failure Consequence:	MODERATE
Recommendation Narrative:	Clean out rock debris from inlet, outlet and internal box section. 4 man crew x 4 hours @ \$55.00/hr = \$880. Backhoe 4 hrs @ \$150/hr = \$600. Dump truck 4 hrs @ \$120 = \$480. Bobcat 4 hrs @ 120 = \$480
Repair Cost:	\$2,500

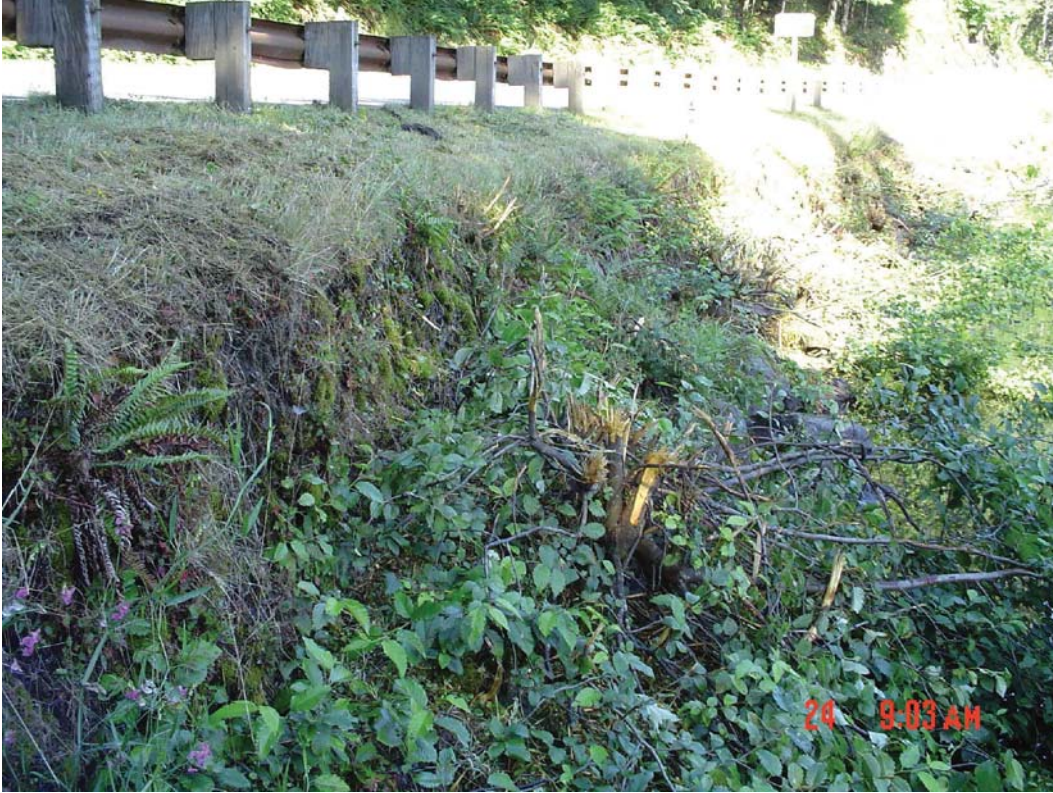
OLYM_0011_8.233_R_1.jpg

Wall ID:	OLYM-0011-8.233-R		
Route Name:	LAKE CRESCENT HIGHWAY (US 101)		
Inspection Date:	July 24, 2007	Approximate Year Built:	Unknown
*Wall Rating:	80	Maintenance Action:	No Action

Element (Weighting Factor)	Narrative	Condition Rating (0 - 10)
PERFORMANCE 8.00	Excellent - wall performing as intended	8
WALL FOUNDATION MATERIAL 8.00	Riprap material seems firm and stable	8
WIRE/GEOSYNTHETIC FACING 8.00	Galvanized wire in good condition, some face distortion, mild rock degradation, overall in good condition	8
DOWNSLOPE 0.50	Sub angular, stable, well interlocked riprap	8
LATERAL SLOPE 0.50	Riprap embankment fill, minor ravelling	8
ROAD/SIDEWALK/SHOULDER 0.50	No distress in road or shoulder	9
WALL DRAINS 0.50	No distress noted	9

Failure Consequence:	HIGH
Recommendation Narrative:	None
Repair Cost:	\$0

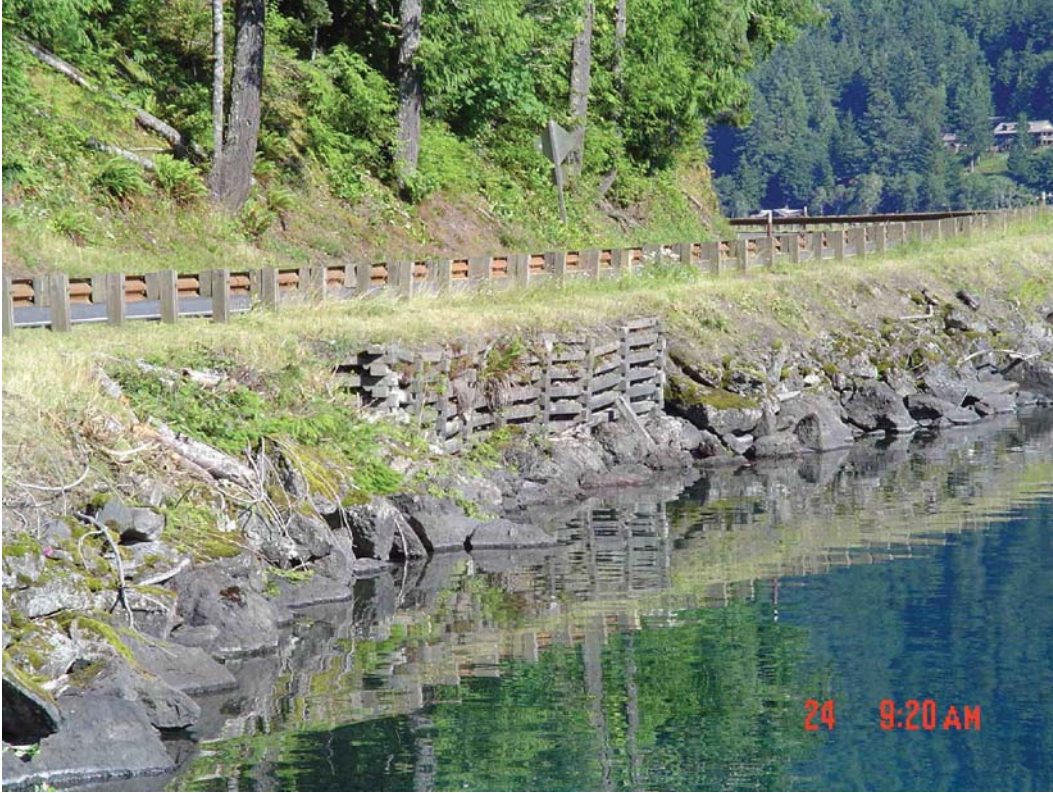
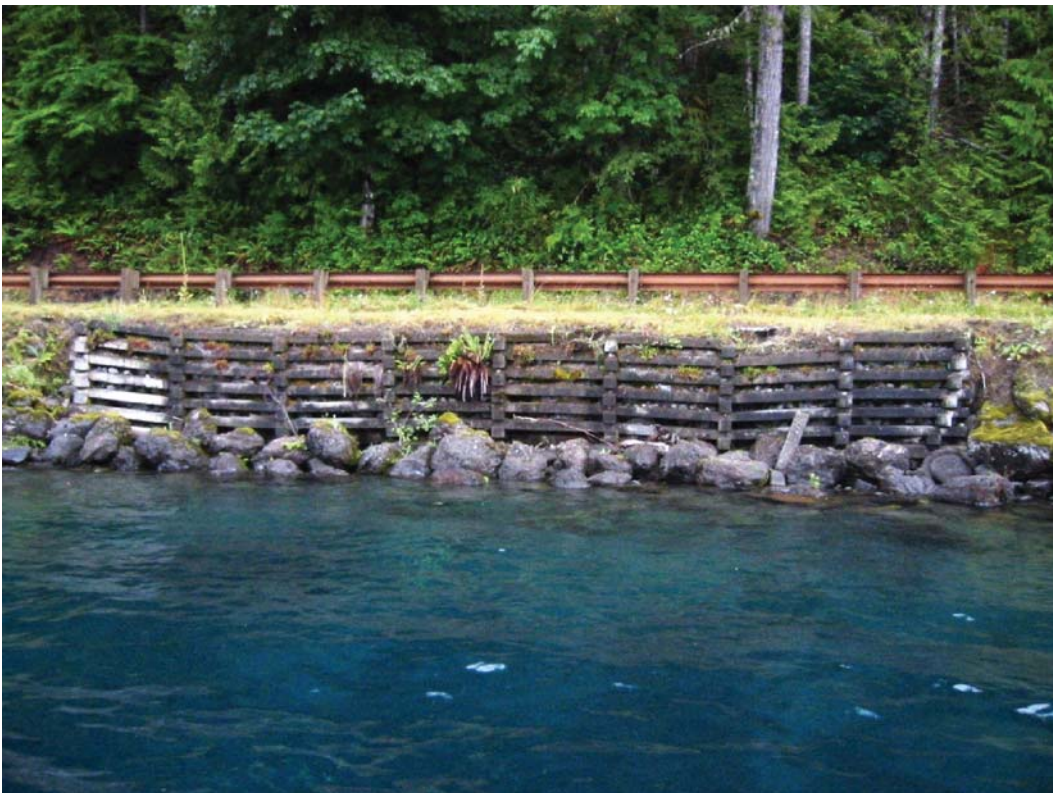
Wall ID:	OLYM-0011-8.449-R		
Route Name:	LAKE CRESCENT HIGHWAY (US 101)		
Inspection Date:	July 24, 2007	Approximate Year Built:	Unknown
*Wall Rating:	71	Maintenance Action:	No Action

Element (Weighting Factor)	Narrative	Condition Rating (0 - 10)
PERFORMANCE 8.00	Good - mild leaning, some missing elements	7
WALL FOUNDATION MATERIAL 8.00	Sub angular riprap, minor settling, likely from wave action	7
BIN OR CRIB 8.00	Components have minor chips, no cracking, lost 9 elements at base	7
DOWNSLOPE 0.50	Riprap toe at lake edge, minor wave erosion	8
LATERAL SLOPE 0.50	Minor erosion	8
ROAD/SIDEWALK/SHOULDER 0.50	Minor surface irregularities, and holes, in shoulder no distress in road	8
WALL DRAINS 0.50	No distress noted	9

Failure Consequence:	HIGH
Recommendation Narrative:	None
Repair Cost:	\$0

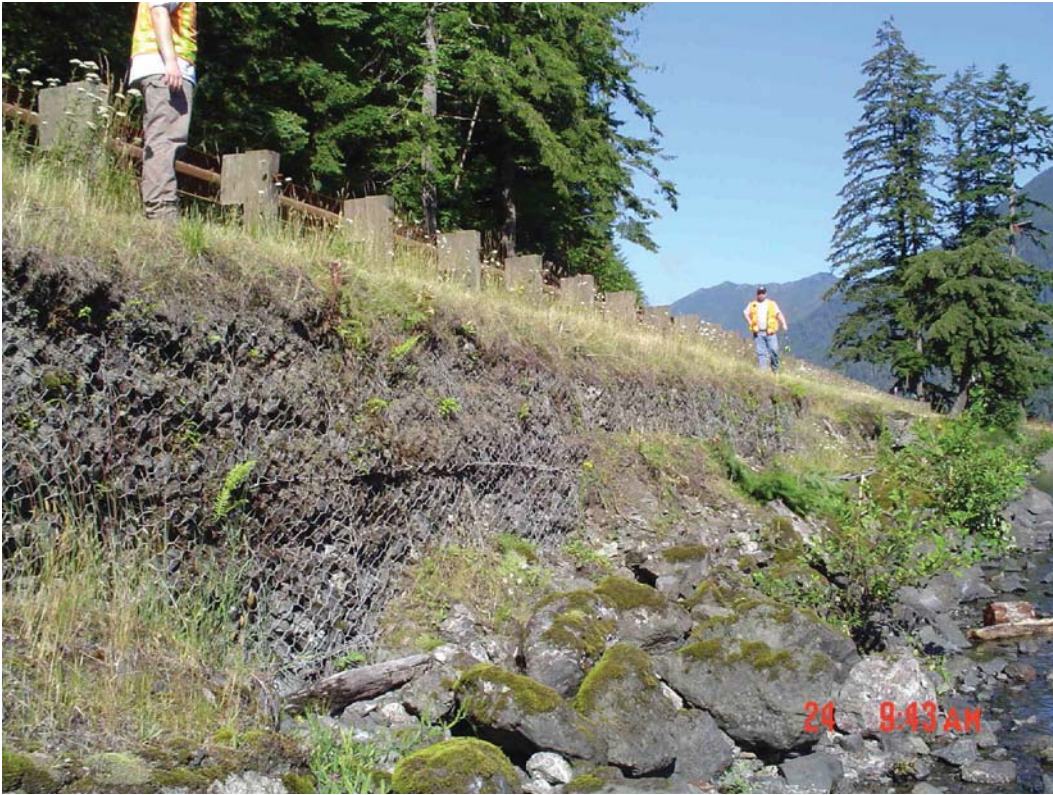
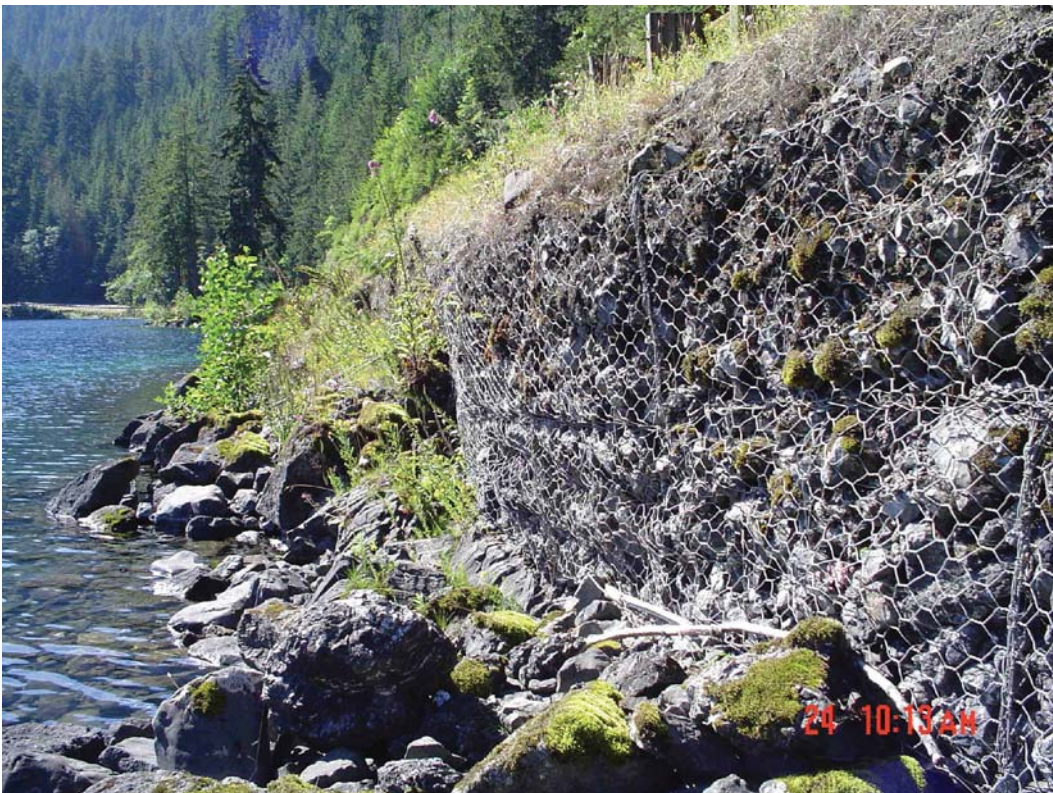
Wall ID:	OLYM-0011-8.492-R		
Route Name:	LAKE CRESCENT HIGHWAY (US 101)		
Inspection Date:	July 24, 2007	Approximate Year Built:	Unknown
*Wall Rating:	71	Maintenance Action:	Repair Elements

Element (Weighting Factor)	Narrative	Condition Rating (0 - 10)
PERFORMANCE 8.00	Good - half of wall is settling and leaning due to undermining by wave action	6
WALL FOUNDATION MATERIAL 8.00	Riprap and bedrock, first 126' of wall is undermined by wave action	6
BIN OR CRIB 8.00	Minor settling and minor lean, wire has minor rusting at base of wall	8
WIRE/GEOSYNTHETIC FACING 8.00	Galvanized wire, no distress noted	8
LATERAL SLOPE 0.50	Riprap, no distress noted, minor creep/ravelling	8
CULVERT 0.50	18" culvert outlets through wall, no distress noted	9
WALL DRAINS 0.50	No distress noted	9
DOWNSLOPE 1.00	Riprap over bedrock at lake edge, steep wave erosion	7
ROAD/SIDEWALK/SHOULDER 1.00	Shoulder has voids for 30ft	7

Failure Consequence:	HIGH
Recommendation Narrative:	Place riprap along wall (class 6 riprap). Riprap- 190cuyd @ \$120.00cuyd = \$22,800. Excavator- 16hrs @ \$150.00hr = \$2,400. 3 dumptrucks - 48 hrs @ \$120.00hr = \$5760.00. 2 laborers - 32hrs @ \$55.00hr = \$1,760.00. Traffic control= 3% of ee = \$1,000.00
Repair Cost:	\$33,720

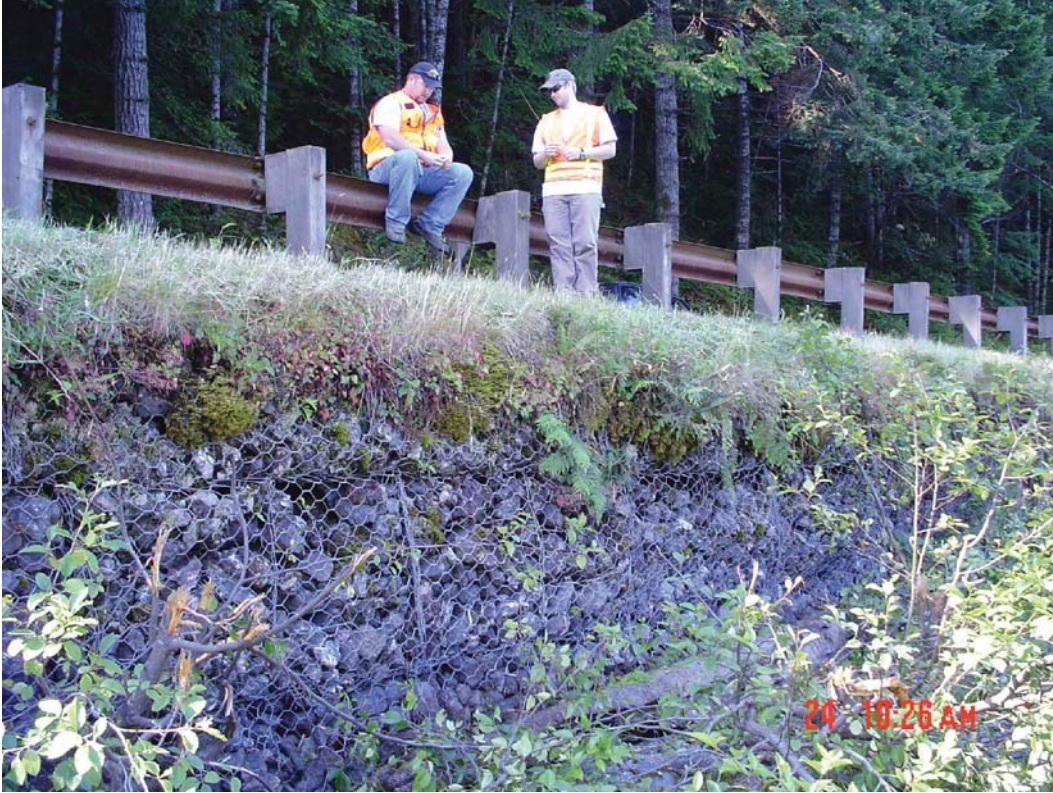
OLYM_0011_8.690_R_1.jpg

Wall ID:	OLYM-0011-8.690-R		
Route Name:	LAKE CRESCENT HIGHWAY (US 101)		
Inspection Date:	July 24, 2007	Approximate Year Built:	Unknown
*Wall Rating:	67	Maintenance Action:	Repair Elements

Wall Function:	Fill Wall	Primary Wall Type:	Gravity - Gabion
Surface Treatment:		Secondary Wall Type:	
Secondary Surface Treatment:		Architectural Facing:	
General Description:	Gabion fill wall along lake shore, minor to moderate undermining caused by wave action

Element (Weighting Factor)	Narrative	Condition Rating (0 - 10)
PERFORMANCE 8.00	Good - wall performing as intended, first 50' of wall needs to be repaired	6
WALL FOUNDATION MATERIAL 8.00	Undermining of wall due to wave action, foundation is shallow bedrock	7
WIRE/GEOSYNTHETIC FACING 8.00	Wire has no distress, baskets are sagging, 20% of rock is degrading, first 50 ft of wall is leaning out to 100%	7
WALL DRAINS 0.50	No distress noted	9
ROAD/SIDEWALK/SHOULDER 1.00	Shoulder has a minor irregular surface, first 50' has had a void filled with soil and rock by maintenance, road is new, no distress noted	6
DOWNSLOPE 1.00	Bedrock ledge along lake edge, wave erosion	7
LATERAL SLOPE 1.00	Riprap, minor raveling	7

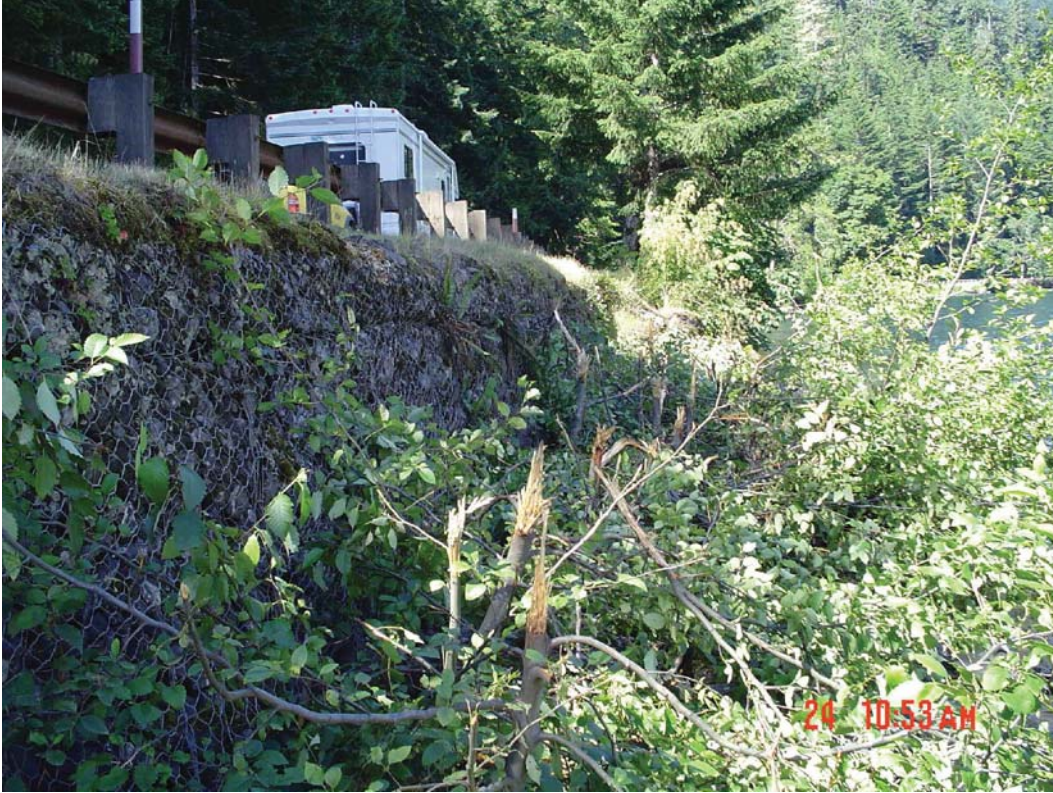
OLYM_0011_8.766_R_1.jpg

Wall ID:	OLYM-0011-8.766-R		
Route Name:	LAKE CRESCENT HIGHWAY (US 101)		
Inspection Date:	July 24, 2007	Approximate Year Built:	Unknown
*Wall Rating:	84	Maintenance Action:	No Action

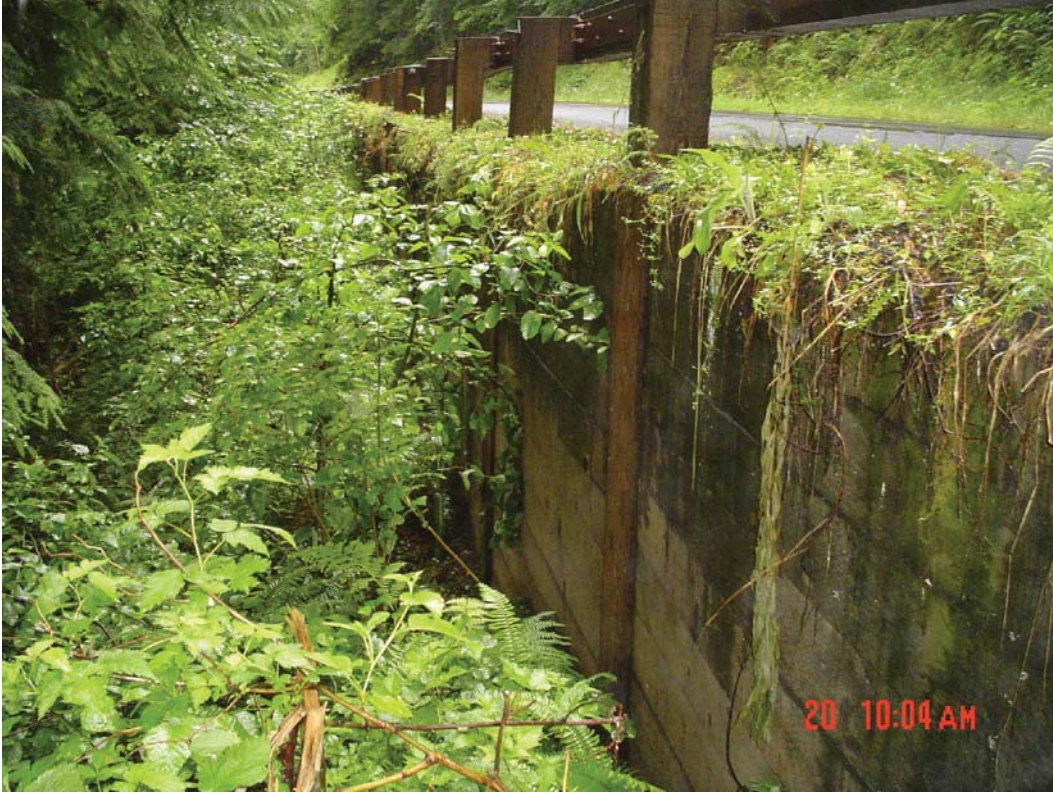
OLYM_0103_7.892_R_1.jpg

Wall ID:	OLYM-0103-7.892-R		
Route Name:	SOL DUC VALLEY ROAD		
Inspection Date:	July 20, 2007	Approximate Year Built:	Unknown
*Wall Rating:	80	Maintenance Action:	No Action

Wall Function:	Fill Wall	Primary Wall Type:	Cantilever - Soldier Pile
Surface Treatment:		Secondary Wall Type:	
Secondary Surface Treatment:		Architectural Facing:	
General Description:	Long soldier pile wall with wood lagging, many areas of pavement have been overlaid, has been repaired in 2003, no distress in overlays

Element (Weighting Factor)	Narrative	Condition Rating (0 - 10)
PERFORMANCE 8.00	Good - wall is performing as intended, possible future maintenance of lagging	8
WALL FOUNDATION MATERIAL 8.00	Firm fill soil, no distress noted	9
LAGGING 8.00	50% of lumber is bowed, wood lagging has gaps up to 14" @ base, minor weathering of wood	7
PILES AND SHAFTS 8.00	Minor pitting and weathering of surface	8
CULVERT 0.50	Two 24" cmp, some debris and rocks in culvert	8
LATERAL SLOPE 0.50	Steep heavily forested slope, minor creep of embankment fill	8
ROAD/SIDEWALK/SHOULDER 0.50	Many areas where pavement was overlaid, no distress noted	9
WALL DRAINS 0.50	One drain pipe observed, no distress noted	9
DOWNSLOPE 1.00	Steep forested vegetated slope, possible creep	7

Failure Consequence:	HIGH
Recommendation Narrative:	None
Repair Cost:	\$0

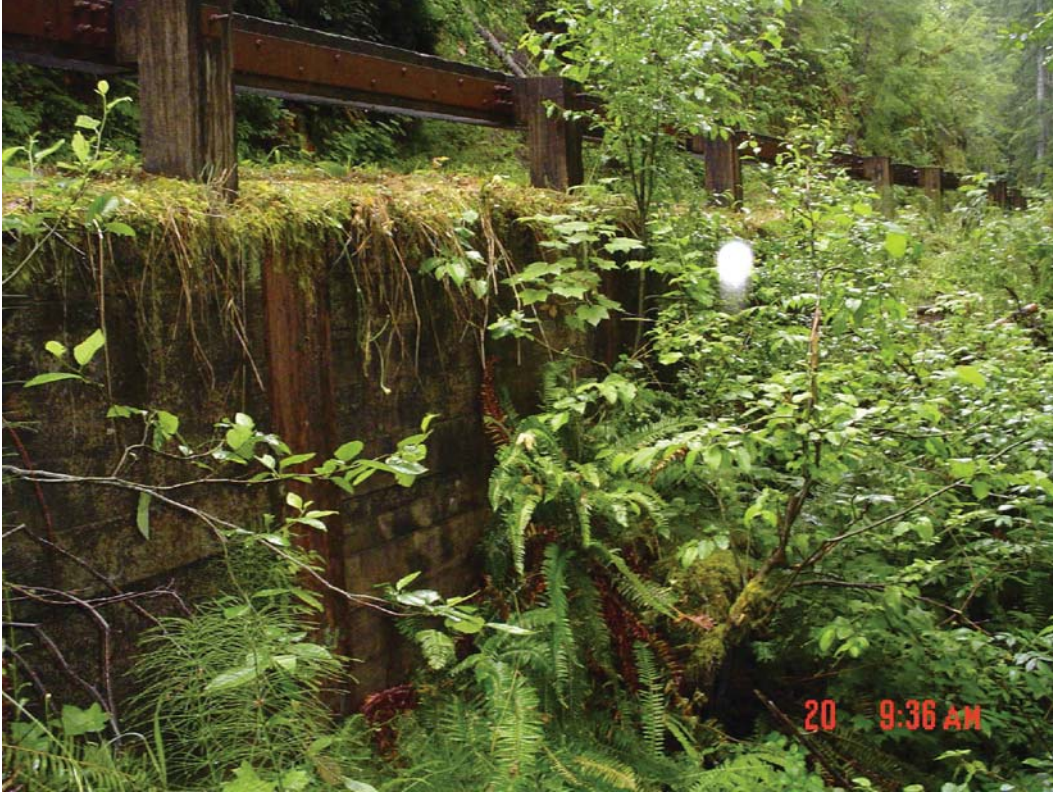
OLYM_0103_8.049_R_1.jpg

Wall ID:	OLYM-0103-8.049-R		
Route Name:	SOL DUC VALLEY ROAD		
Inspection Date:	July 20, 2007	Approximate Year Built:	Unknown
*Wall Rating:	80	Maintenance Action:	No Action

Element (Weighting Factor)	Narrative	Condition Rating (0 - 10)
PERFORMANCE 8.00	Good - wall performing as intended	8
WALL FOUNDATION MATERIAL 8.00	Firm soil, no distress	9
LAGGING 8.00	Minor weathering, 30% show minor bowing	7
PILES AND SHAFTS 8.00	Minor oxidation and pitting	8
CULVERT 0.50	24" cmp, no distress noted	9
ROAD/SIDEWALK/SHOULDER 0.50	No distress noted, recent overlay	9
WALL DRAINS 0.50	No distress noted	9
DOWNSLOPE 1.00	Steep wooded slope, minor creep in fill	7
LATERAL SLOPE 1.00	Steep wooded slope, shallow creep in fill	7

Failure Consequence:	HIGH
Recommendation Narrative:	None
Repair Cost:	\$0
