OLYM WIP Report

NPS Retaining Wall Inventory Program Olympic National Park

**Federal Highway Administration
Eastern Federal Lands Highway Division
Road Inventory Program (RIP)**

**Data Collection Date: July 2007
Report Date: October 2015**

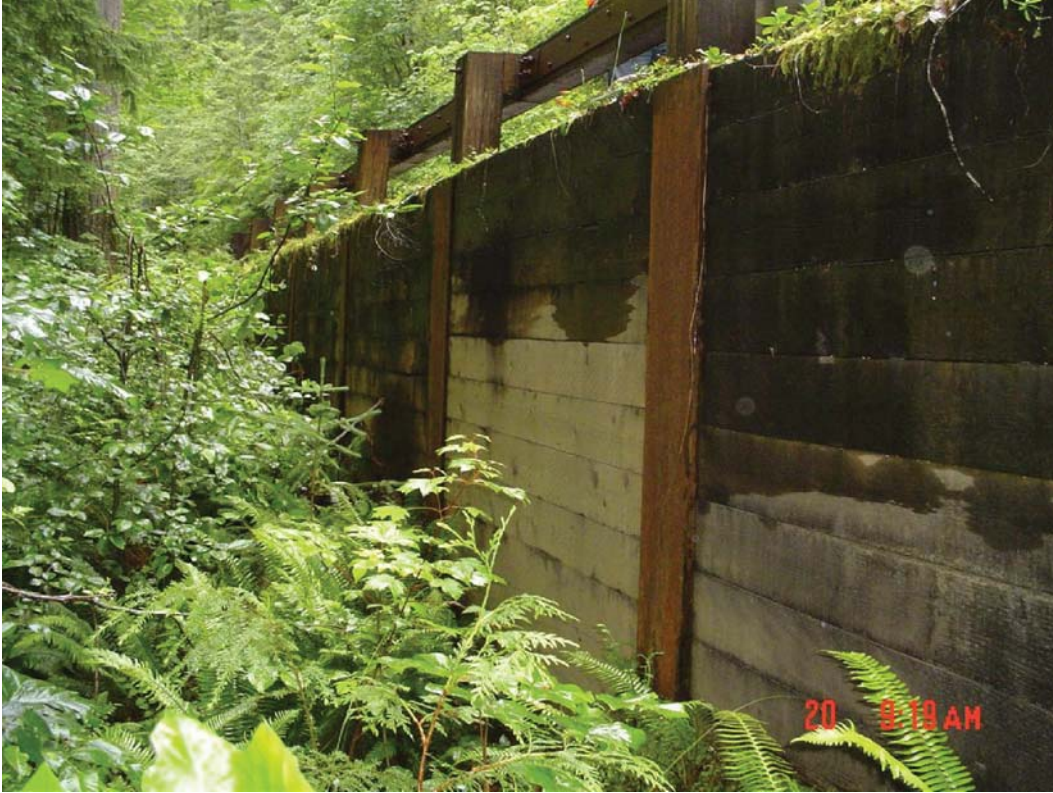
OLYM_0103_8.074_R_1.jpg

Wall ID:	OLYM-0103-8.074-R		
Route Name:	SOL DUC VALLEY ROAD		
Inspection Date:	July 20, 2007	Approximate Year Built:	Unknown
*Wall Rating:	80	Maintenance Action:	No Action

Element (Weighting Factor)	Narrative	Condition Rating (0 - 10)
PERFORMANCE 8.00	Good - performing as intended	8
WALL FOUNDATION MATERIAL 8.00	Firm soil , no undermining	9
LAGGING 8.00	40% of timber is bowed	7
PILES AND SHAFTS 8.00	Minor surface pitting and weathering	8
LATERAL SLOPE 0.50	Heavily forested, no distress noted	8
ROAD/SIDEWALK/SHOULDER 0.50	Pavement overlay, no distress noted	9
WALL DRAINS 0.50	No internal wall drain distress noted	9
DOWNSLOPE 1.00	Heavily vegetated, possible creep	7

Failure Consequence:	HIGH
Recommendation Narrative:	None
Repair Cost:	\$0

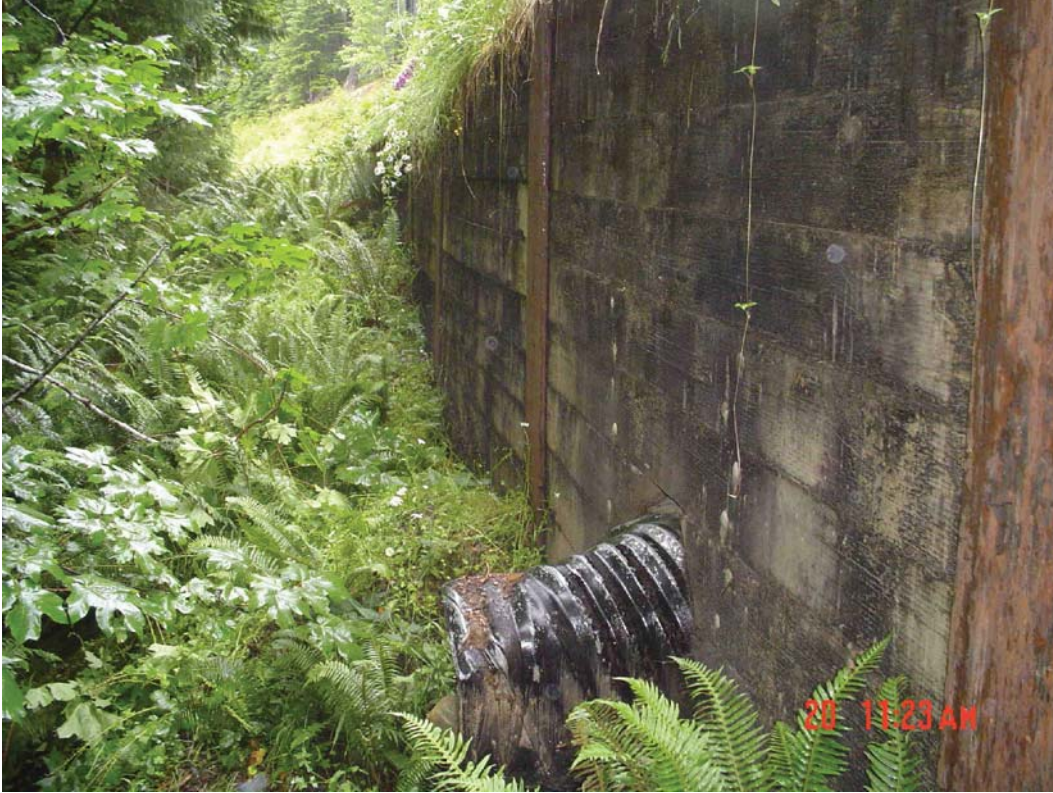
OLYM_0103_8.503_R_1.jpg

Wall ID:	OLYM-0103-8.503-R		
Route Name:	SOL DUC VALLEY ROAD		
Inspection Date:	July 20, 2007	Approximate Year Built:	Unknown
*Wall Rating:	77	Maintenance Action:	Maintenance

Element (Weighting Factor)	Narrative	Condition Rating (0 - 10)
PERFORMANCE 8.00	Good - wall performing as designed, needs minor maintenance	7
WALL FOUNDATION MATERIAL 8.00	Firm fill material, no distress noted	9
LAGGING 8.00	Mild weathering of wood, seperation 1"--2" of timbers over 1% of total wall, 1 top timber displaced, vegetation covering 30% of wall	7
PILES AND SHAFTS 8.00	Mild oxidation and pitting of steel	8
WALL DRAINS 0.50	No distress noted	9
CULVERT 1.00	Dented at outlet, small boulders lodged in pipe	6
DOWNSLOPE 1.00	Steep wooded slope with mild creep	7
LATERAL SLOPE 1.00	Steep wooded slope with mild creep	7
ROAD/SIDEWALK/SHOULDER 1.00	Cracked and patched roadway, no distress in overlay	7

Failure Consequence:	HIGH
Recommendation Narrative:	Clean out culvert and repair top lagging - 2 laborers @ \$55.00 hr x 8 hrs = \$440.00. Good access at end of wall
Repair Cost:	\$440

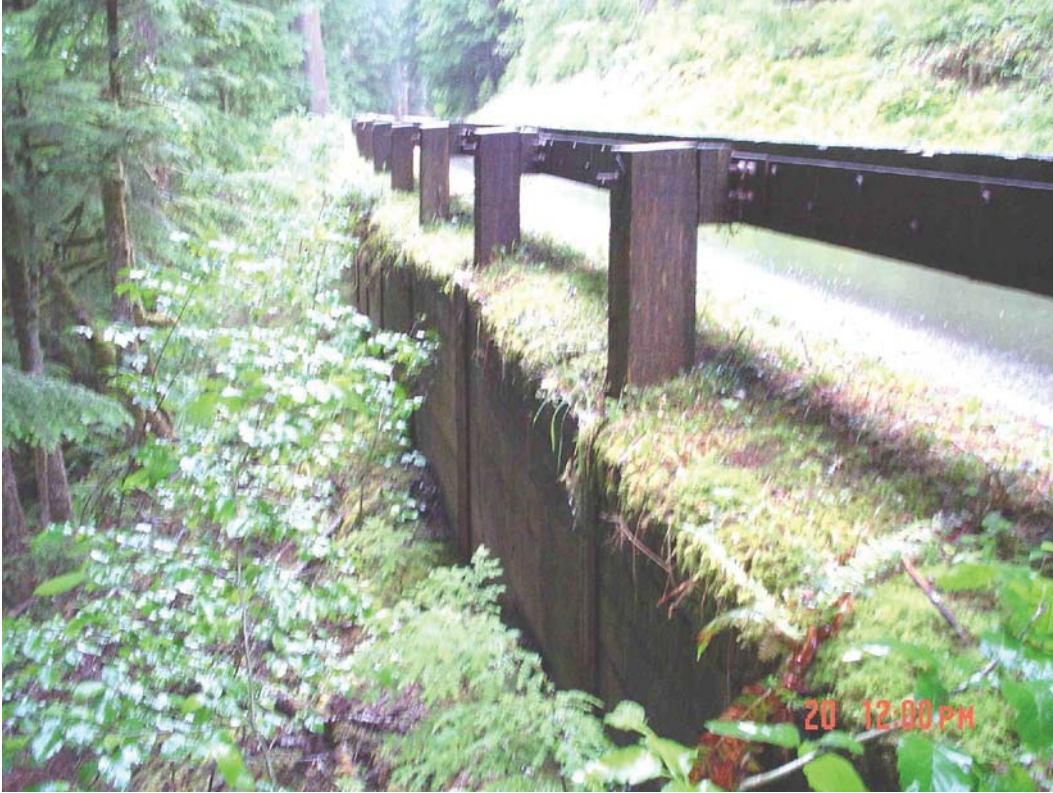
OLYM_0103_9.203_R_1.jpg

Wall ID:	OLYM-0103-9.203-R		
Route Name:	SOL DUC VALLEY ROAD		
Inspection Date:	July 20, 2007	Approximate Year Built:	Unknown
*Wall Rating:	79	Maintenance Action:	Maintenance

Element (Weighting Factor)	Narrative	Condition Rating (0 - 10)
PERFORMANCE 8.00	Good - wall performing as intended,	7
WALL FOUNDATION MATERIAL 8.00	Firm soil, no distress noted	9
LAGGING 8.00	Bowed and gaps between boards up to 2 inches, mild weathering of timbers	8
PILES AND SHAFTS 8.00	Minor pitting and weathering of steel	8
DOWNSLOPE 0.50	Heavily vegetated/forested slope, some possible slope creep	8
LATERAL SLOPE 0.50	Forested slope, possible creep of slope	8
WALL DRAINS 0.50	No internal distress noted	9
CULVERT 1.00	24" cmp not flowing, possible plug	6
ROAD/SIDEWALK/SHOULDER 1.00	Distress in pavement, multiple areas with overlays, no distress in overlays	7

Failure Consequence:	HIGH
Recommendation Narrative:	Clean out culvert: 2 LABORERS @ \$55.00/HR x 4 HRS = \$440.00. 2 LABORERS @ \$55.00/HR X 8 HRS prep and seal cracks = \$ 880.00. SEAL CRACKS EST. 300 FT @ \$5.00/FT
Repair Cost:	\$3,320

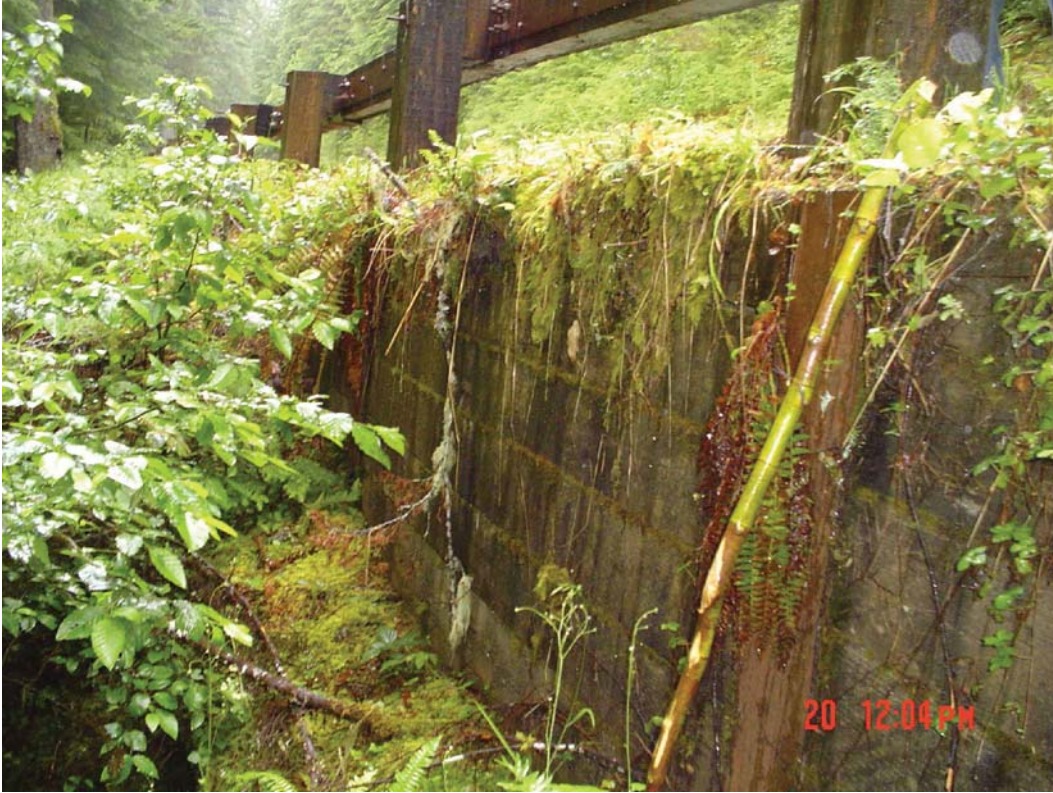
OLYM_0103_9.307_R_1.jpg

Wall ID:	OLYM-0103-9.307-R		
Route Name:	SOL DUC VALLEY ROAD		
Inspection Date:	July 20, 2007	Approximate Year Built:	Unknown
*Wall Rating:	80	Maintenance Action:	Maintenance

Element (Weighting Factor)	Narrative	Condition Rating (0 - 10)
PERFORMANCE 8.00	Good - wall performing as intended	8
WALL FOUNDATION MATERIAL 8.00	Firm fill material	9
LAGGING 8.00	Pressure treated wood lagging, minor weathering, upper 3 ft of wall is bowed	7
PILES AND SHAFTS 8.00	Minor surface piting and weathering of steel	8
DOWNSLOPE 0.50	Steep forested slope with possible creep	8
LATERAL SLOPE 0.50	Heavily vegetated slope with minor creep of embankment fill	8
ROAD/SIDEWALK/SHOULDER 0.50	Recent overlays, no distress noted	9
WALL DRAINS 0.50	No internal distress noted	9
CULVERT 1.00	24" corrugated metal pipe, possible plug	7

Failure Consequence:	HIGH
Recommendation Narrative:	Clean out culvert - 2 laborers @ \$55.00 hr x 8 hrs = \$440.00. Good access
Repair Cost:	\$440

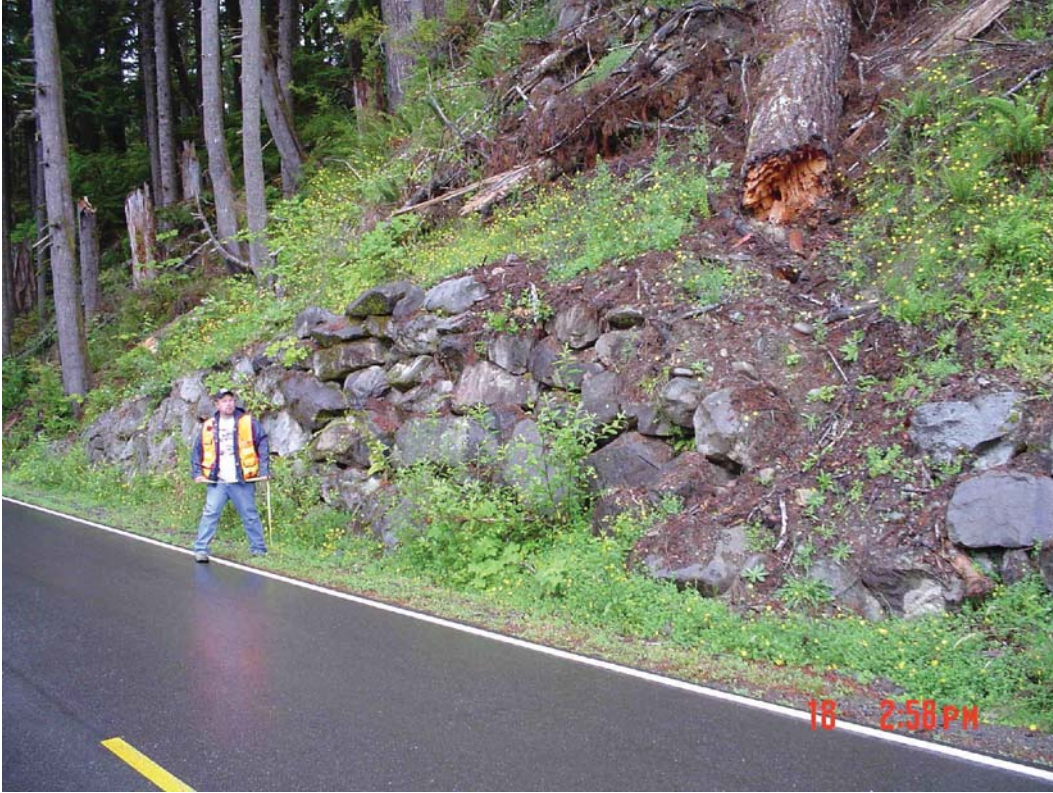
OLYM_0107_1.586_L_1.jpg

Wall ID:	OLYM-0107-1.586-L		
Route Name:	HOH ROAD		
Inspection Date:	July 18, 2007	Approximate Year Built:	Unknown
*Wall Rating:	80	Maintenance Action:	Repair Elements

Wall Function:	Cut Wall	Primary Wall Type:	Gravity - Dry Stone
Surface Treatment:		Secondary Wall Type:	
Secondary Surface Treatment:		Architectural Facing:	
General Description:	Rockery wall on cut side, rockery damaged by tree fall

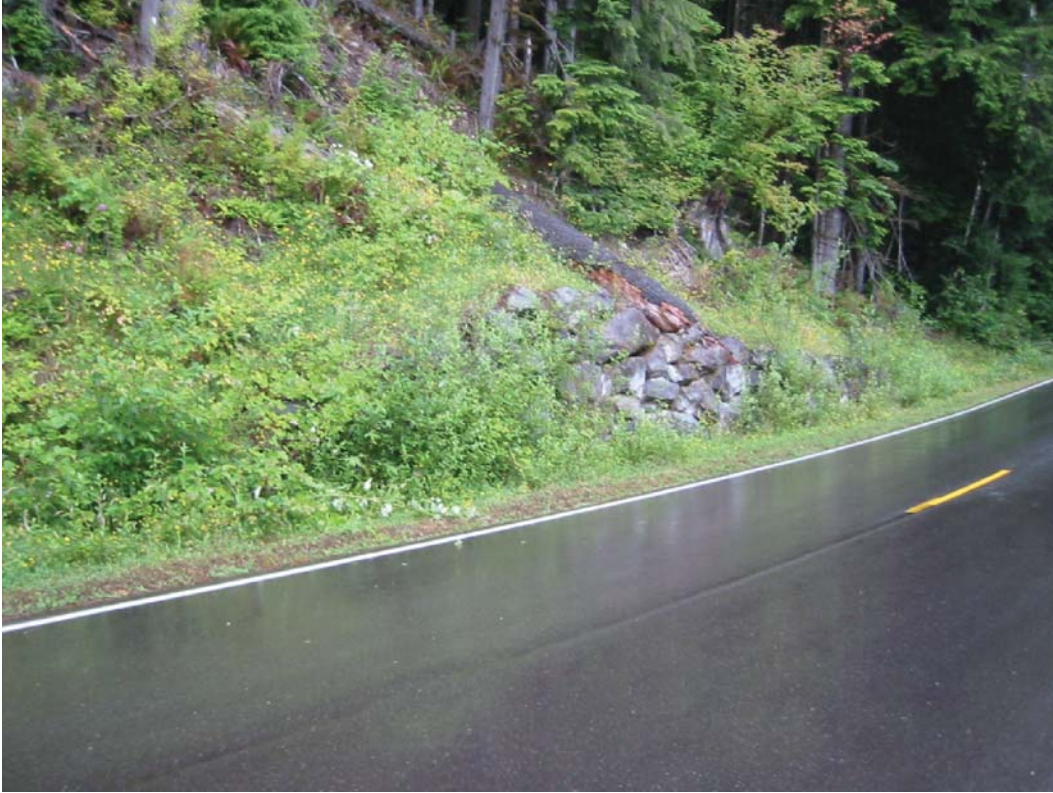
OLYM_0107_1.616_L_1.jpg

Wall ID:	OLYM-0107-1.616-L		
Route Name:	HOH ROAD		
Inspection Date:	July 18, 2007	Approximate Year Built:	2002
*Wall Rating:	88	Maintenance Action:	No Action

Failure Consequence:	MODERATE
Recommendation Narrative:	None
Repair Cost:	\$0
