NPS Retaining Wall Inventory Program Rocky Mountain National Park

**Federal Lands Highway
Road Inventory Program**

**Federal Highway Administration
Eastern Federal Lands Highway Division
Road Inventory Program (RIP)**

**Data Collection Date: September 2007
Report Date: October 2015**

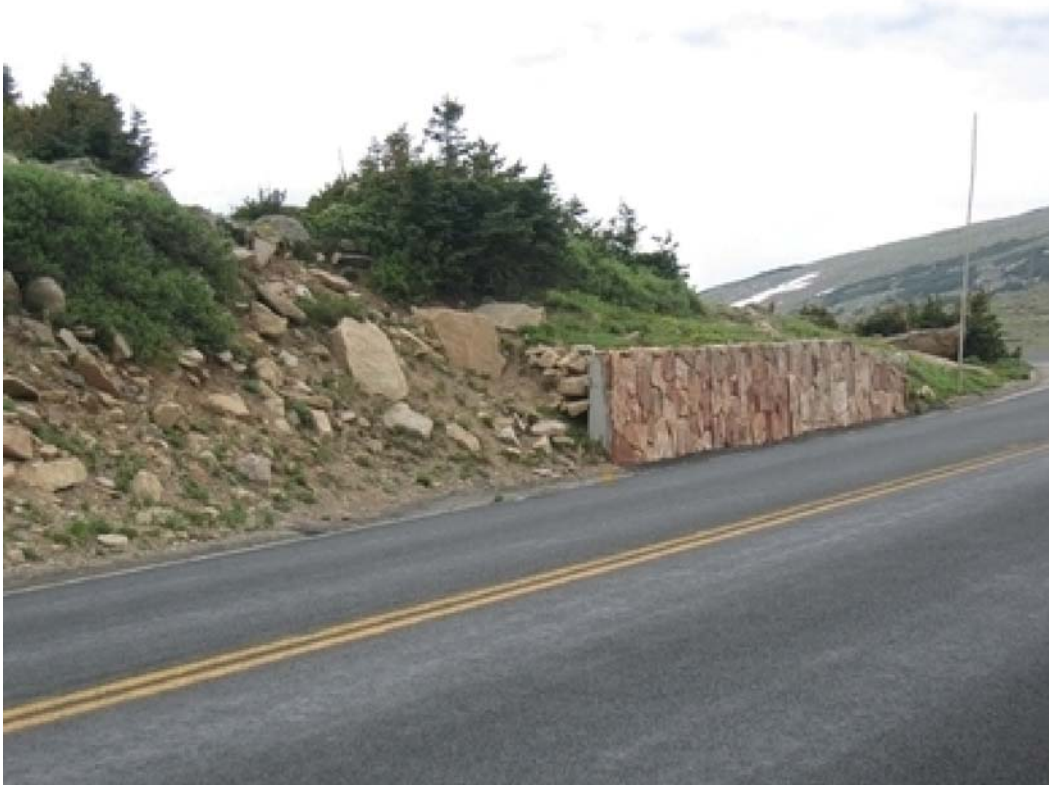
ROMO_0010_14.080_L_1.jpg

Element (Weighting Factor)	Narrative	Condition Rating (0 - 10)
PERFORMANCE 8.00	Good, performing as intended.	8
WALL FOUNDATION MATERIAL 8.00	On footing, no sign of settlement.	8
CONCRETE 8.00	Rebar exposed at wall start.	7
STONE MASONRY 8.00	Missing stone veneer at wall start.	7
MORTAR 8.00	Recently built, no spalling, very minor cracks.	8
LATERAL SLOPE 0.50	Ties into soil/rock mix, 1.5:1 no sign of erosion.	8
UPSLOPE 0.50	Gentle, well vegetated, no sign of erosion.	8
WALL DRAINS 0.50	None observed. No water related problems.	8

Failure Consequence:	LOW
Recommendation Narrative:	Replace 3 sq. ft. of stone veneer and mortar:: 3 sq. ft. @ \$75 s.f. = \$225
Repair Cost:	\$225

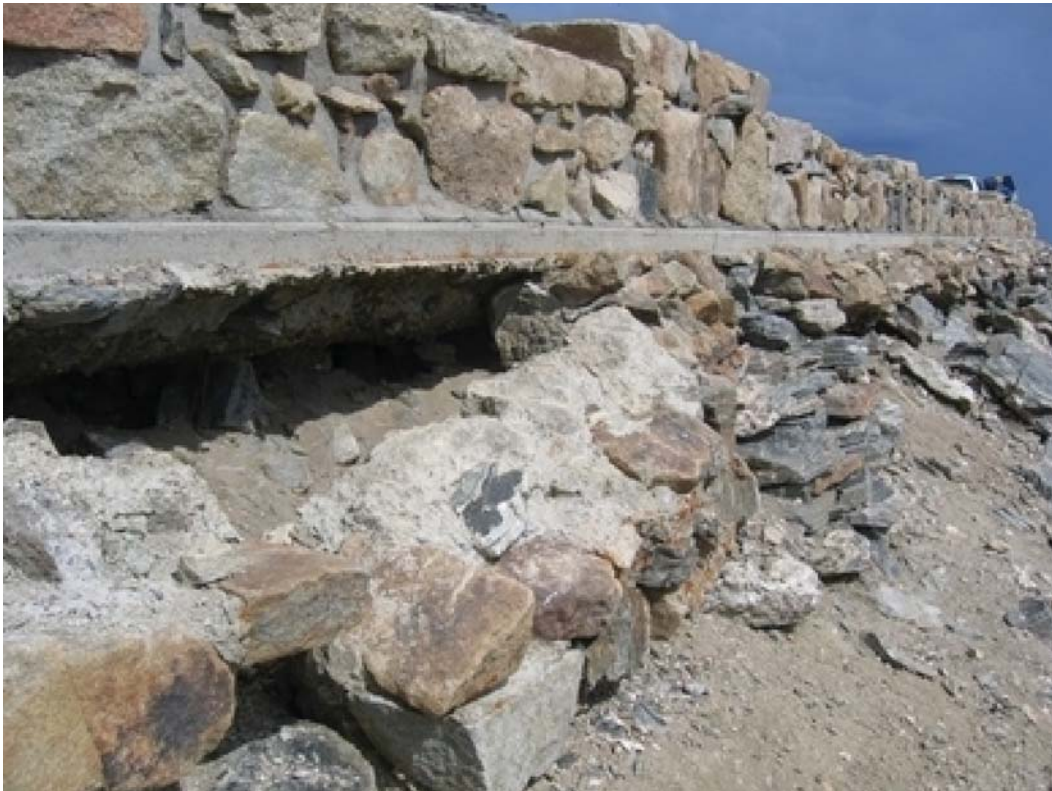
ROMO_0010_17.206_L_2.jpg

Element (Weighting Factor)	Narrative	Condition Rating (0 - 10)
PERFORMANCE 8.00	Poor, severe undermining of foundation, parking lot and guardwall still intact.	4
WALL FOUNDATION MATERIAL 8.00	Rock and erodible soil mix, undermined in places.	2
MORTAR 8.00	Cracking, separation, failing at several locations.	4
STONE MASONRY 8.00	Several pieces have broke off.	5
PLACED STONE 8.00	Durable rock, slightly weathered.	6
DOWNSLOPE 1.00	Loose erodible soil and boulders, 1.5:1 slope, undermined in many locations.	4
LATERAL SLOPE 1.00	Ties into soil and rock fragments, some erosion.	6
WALL DRAINS 1.00	None visible.	6

Failure Consequence:	LOW
Recommendation Narrative:	TBD - Wall repairs are being planned under a current construction project.
Repair Cost:	\$20,000

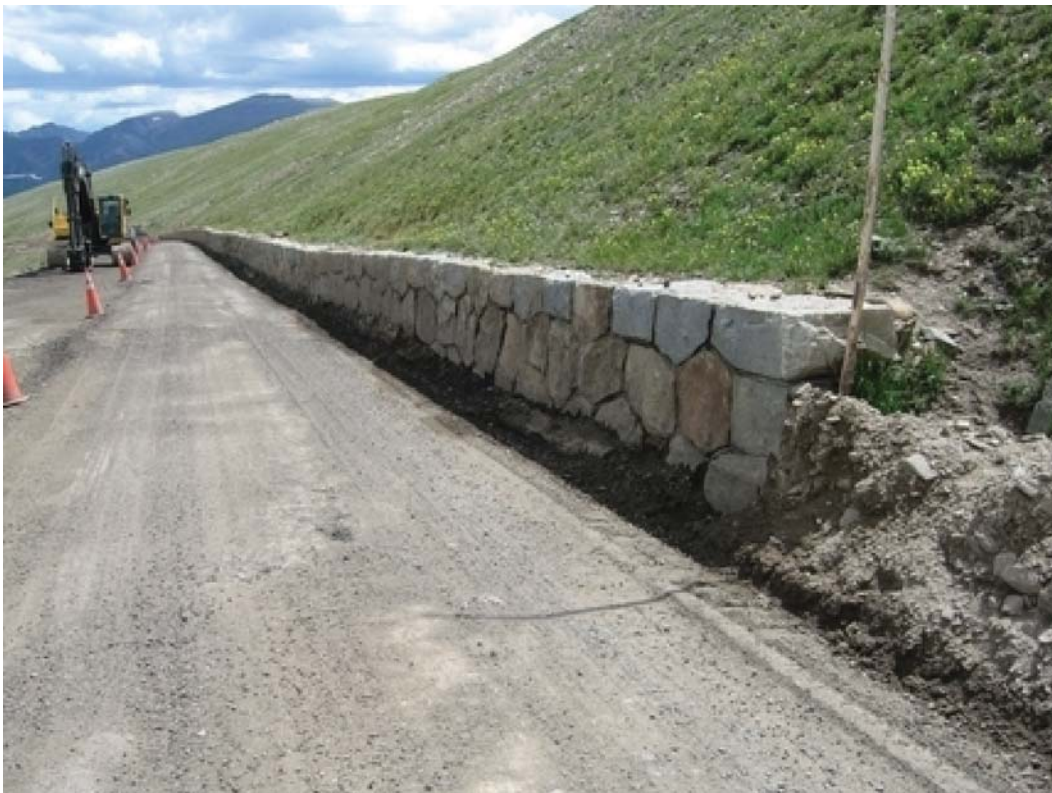
ROMO_0010_20.690_R_2.jpg

Element (Weighting Factor)	Narrative	Condition Rating (0 - 10)
PERFORMANCE 8.00	Good condition, wall performing as intended.	8
WALL FOUNDATION MATERIAL 8.00	Founded on road, no signs of distress or settlement.	8
MORTAR 8.00	Some cracking and spalling, up to 1/4-inch gaps.	7
CONCRETE 8.00	Not visible, no signs of distress.	8
STONE MASONRY 8.00	Hard curable rock, minor weathering.	9
WALL DRAINS 0.50	None observed, no water-related problems with wall.	8
LATERAL SLOPE 1.00	1.5H:1V slope with minor surface erosion, not impacting wall performance.	6
UPSLOPE 1.00	Minor sloughing, some voids behind wall that are backfilled with boulders.	7

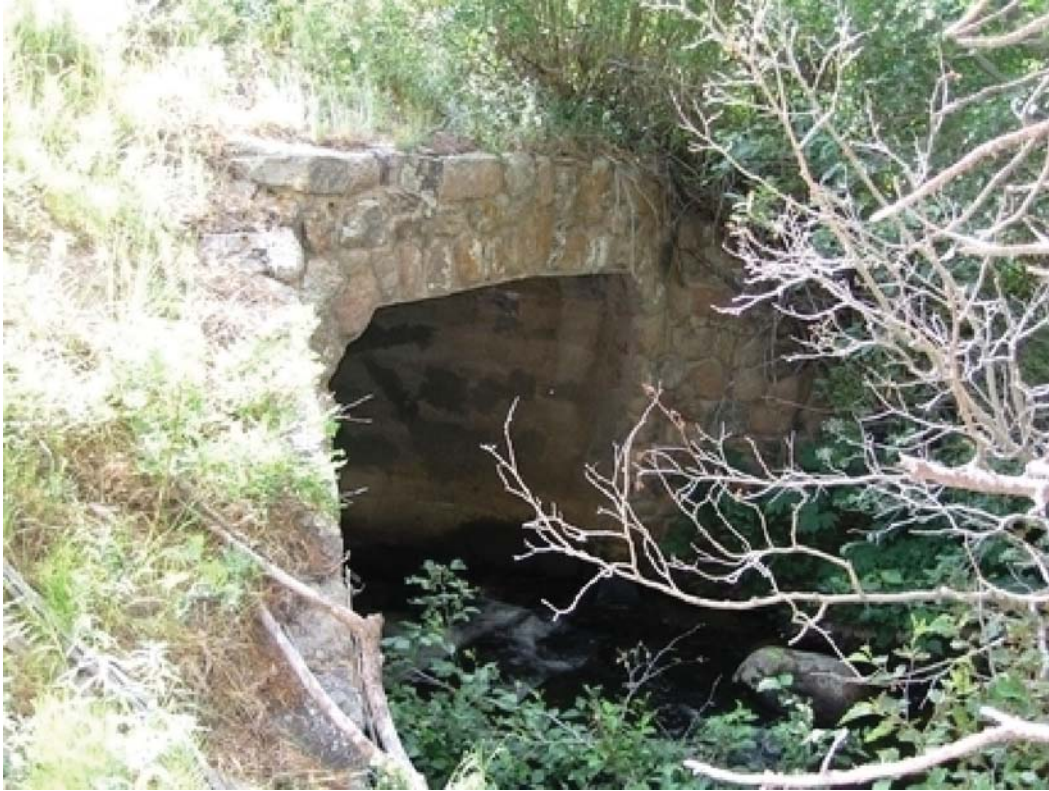
ROMO_0012_3.625_L_1.jpg

Wall ID:	ROMO-0012-3.625-L		
Route Name:	BEAR LAKE ROAD		
Inspection Date:	July 24, 2007	Approximate Year Built:	Unknown
*Wall Rating:	81	Maintenance Action:	No Action

Element (Weighting Factor)	Narrative	Condition Rating (0 - 10)
PERFORMANCE 8.00	Good condition and performing as intended.	9
WALL FOUNDATION MATERIAL 8.00	No sign of settlement or distress. Alluvium stream channel bed.	8
CONCRETE 8.00	No sign of distress	8
CULVERT 0.50	10 ft x 8 ft concrete box culvert with continuous water flow. Minor oxidation and patching. Culvert is performing as intended.	8
ARCHITECTURAL FACING 0.50	Minor cracking (less than 1/8 inch) and minor spalling (less than 1/4"). Minor oxidation, no erosion, or cracking in granite stone.	9
UPSLOPE 0.50	1V:2H slope with minor vegetation and one tree. No sign of distress.	9
WALL DRAINS 0.50	None observed.	9
LATERAL SLOPE 1.00	Minor surface erosion and not impacting the structure.	7
ROAD/SIDEWALK/SHOULDER 1.00	Roadway has minor transverse cracking above culvert and reflected in roadway. Shoulder has minor surface erosion.	7

Failure Consequence:	MODERATE
Recommendation Narrative:	None
Repair Cost:	\$0

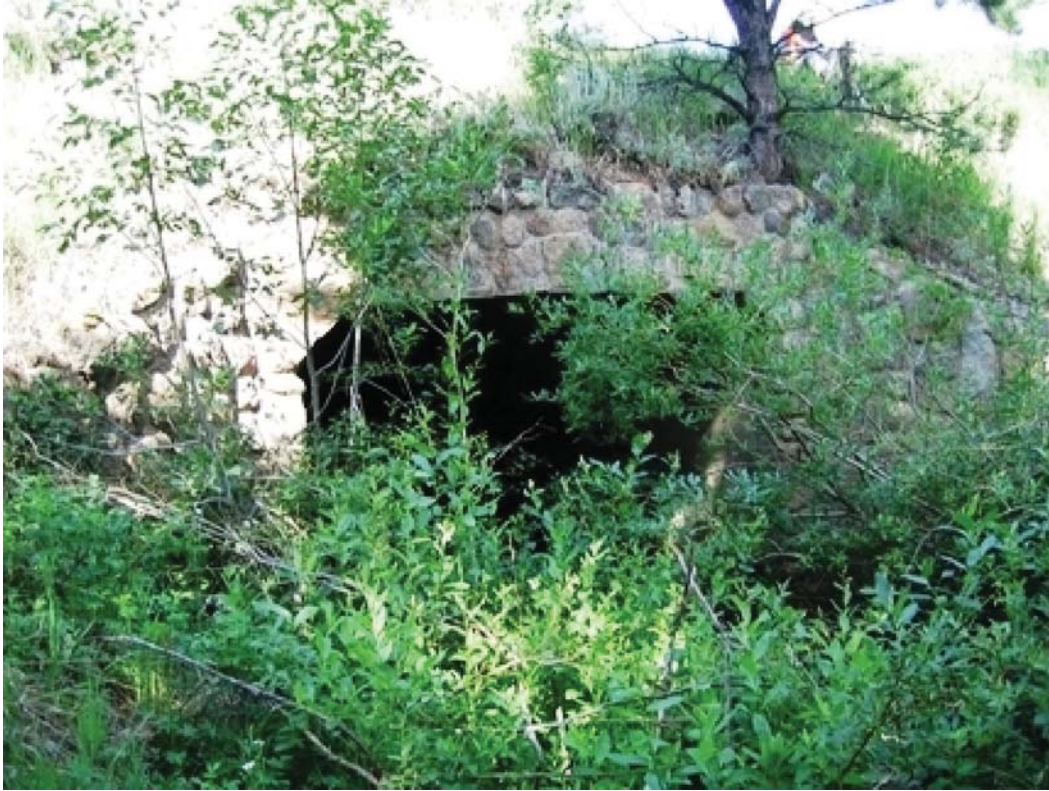
ROMO_0012_3.625_R_1.jpg

Wall ID:	ROMO-0012-3.625-R		
Route Name:	BEAR LAKE ROAD		
Inspection Date:	July 24, 2007	Approximate Year Built:	Unknown
*Wall Rating:	81	Maintenance Action:	No Action

Element (Weighting Factor)	Narrative	Condition Rating (0 - 10)
PERFORMANCE 8.00	Good condition and performing as intended.	9
WALL FOUNDATION MATERIAL 8.00	No sign of settlement or distress. Alluvium stream channel bed.	8
CONCRETE 8.00	No distress observed.	8
CULVERT 0.50	10 ft x 8 ft concrete box culvert with continuous water flow. Minor oxidation and patching but performing as intended.	8
UPSLOPE 0.50	1V:1.5H slope the minor vegetation and one tree. No sign of distress and not impacting wall.	8
ARCHITECTURAL FACING 0.50	Minor cracking (less than 1/8") and spalling (less than 1/4") in the mortar. Minor oxidation, no erosion or cracking in granite stones. Good condition and functioning as intended.	9
WALL DRAINS 0.50	None observed	9
LATERAL SLOPE 1.00	Minor surface erosion and not impacting structure.	7
ROAD/SIDEWALK/SHOULDER 1.00	Roadway has minor transverse cracking above culvert reflected in roadway. Shoulder has minor surface erosion in shoulder.	7

Failure Consequence:	MODERATE
Recommendation Narrative:	None
Repair Cost:	\$0

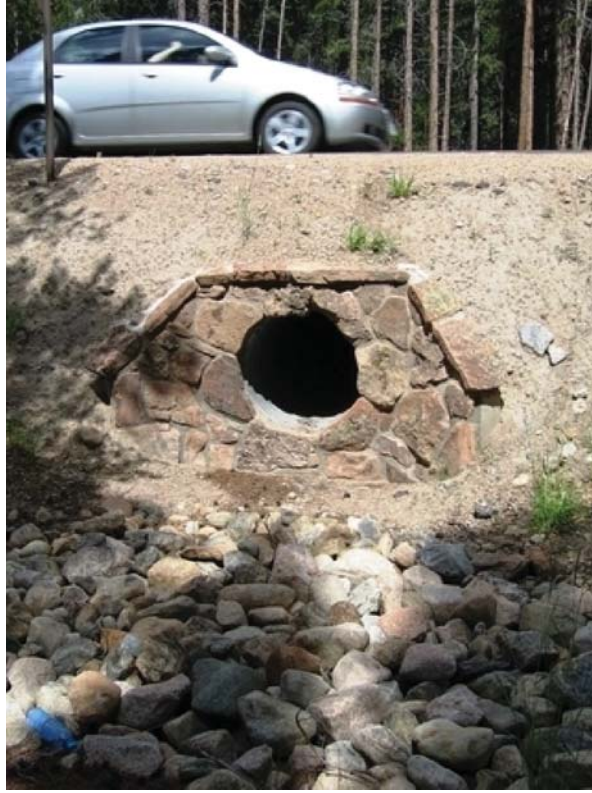
ROMO_0012_5.530_L_1.jpg

Wall ID:	ROMO-0012-5.530-L		
Route Name:	BEAR LAKE ROAD		
Inspection Date:	July 24, 2007	Approximate Year Built:	2004
*Wall Rating:	90	Maintenance Action:	No Action

Element (Weighting Factor)	Narrative	Condition Rating (0 - 10)
PERFORMANCE 8.00	Good to excellent condition. Performing as intended but minor surface erosion on lateral slope.	10
WALL FOUNDATION MATERIAL 8.00	Riprap apron and no sign of distress.	9
CONCRETE 8.00	No distress observed. Good to excellent condition.	9
ARCHITECTURAL FACING 0.50	No cracking or spalling in mortar. Minor oxidation and no cracks in stone masonry.	9
CULVERT 0.50	2.5 ft CMP culvert and performing as intended.	9
WALL DRAINS 0.50	None observed.	9
ROAD/SIDEWALK/SHOULDER 0.50	Roadway has no sign of distress. Shoulder has no sign of distress.	10
LATERAL SLOPE 1.00	1V:1.5H slope with moderate surface erosion with rills.	7
UPSLOPE 1.00	1V:2H slope with minor erosion and minor vegetation.	7

Failure Consequence:	MODERATE
Recommendation Narrative:	None
Repair Cost:	\$0

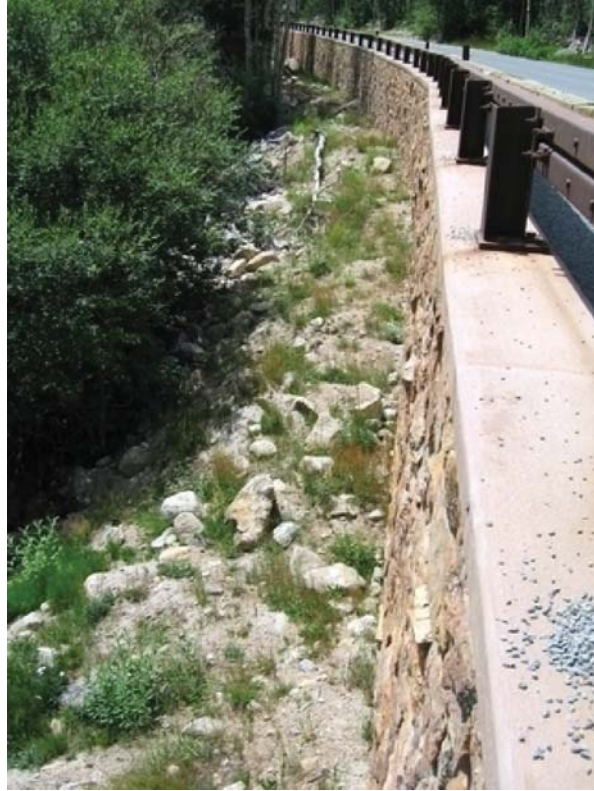
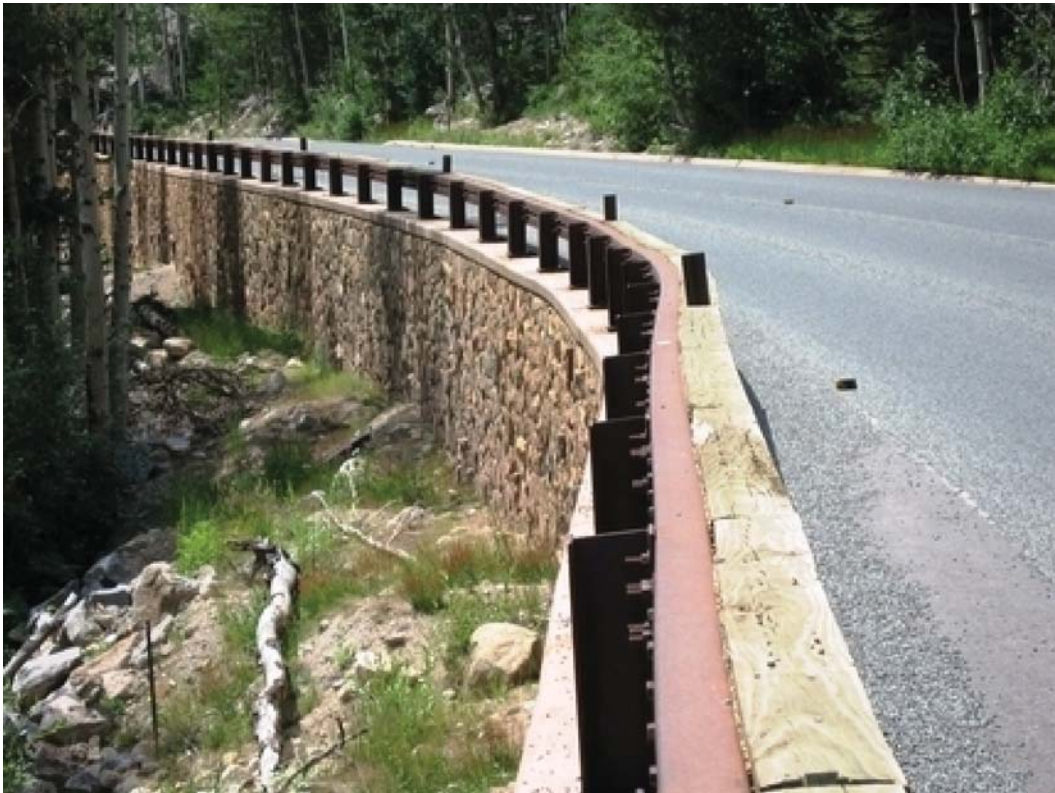
Wall ID:	ROMO-0012-7.383-L		
Route Name:	BEAR LAKE ROAD		
Inspection Date:	July 24, 2007	Approximate Year Built:	2004
*Wall Rating:	95	Maintenance Action:	No Action

Element (Weighting Factor)	Narrative	Condition Rating (0 - 10)
PERFORMANCE 8.00	Good to excellent performance except with minor surface erosion at the end of wall (lateral slope).	10
WALL FOUNDATION MATERIAL 8.00	Gravel and sand backfill with moderate vegetation. 4 ft wide bench with relative flat slope. No sign of distress, settlement, or erosion.	10
CONCRETE 8.00	No sign of distress observed. Concrete covered with stone veneer.	10
CURB/BERM/DITCH 0.50	Curb in good condition with minor cracking and one major crack and spalling at a wall joint on curb back face.	8
LATERAL SLOPE 0.50	Minor surface erosion with 1V:1.5H slope (end of walls)	8
DOWNSLOPE 0.50	Heavy vegetation and relatively flat (1V:2H) slope. No sign of instability	9
ARCHITECTURAL FACING 0.50	Mortar has minor cracking but good condition. Stone has minor oxidation but good condition.	10
TRAFFIC BARRIER/FENCE 0.50	No sign of distress. Two tube steel backed timber rail and in good condition.	10

Failure Consequence:	MODERATE
Recommendation Narrative:	None
Repair Cost:	\$0

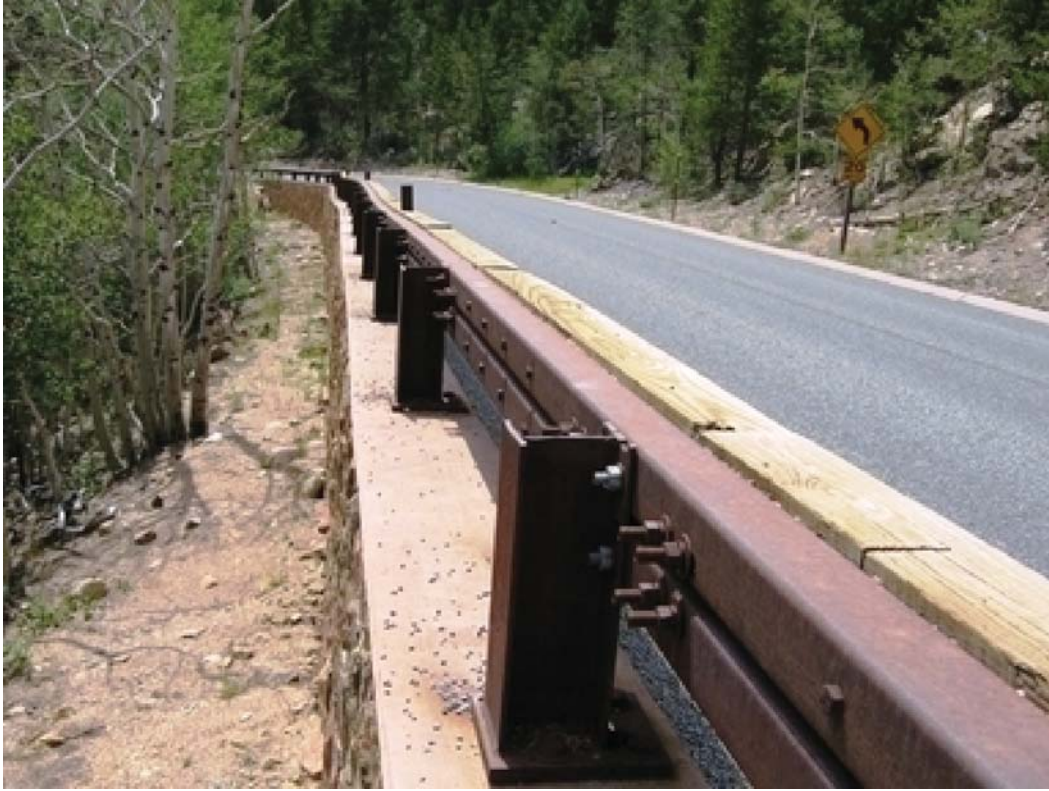
ROMO_0012_8.564_R_1.jpg

Wall ID:	ROMO-0012-8.564-R		
Route Name:	BEAR LAKE ROAD		
Inspection Date:	July 24, 2007	Approximate Year Built:	2004
*Wall Rating:	93	Maintenance Action:	No Action

Element (Weighting Factor)	Narrative	Condition Rating (0 - 10)
PERFORMANCE 8.00	Good to excellent condition with minor surface erosion on lateral slopes.	10
WALL FOUNDATION MATERIAL 8.00	Sand and gravel material. 1.5H:1V slope with 3 to 4 ft bench with good foundation material. Cover maintained on toe of wall.	9
CONCRETE 8.00	No distress observed. Concrete covered by stone veneer.	10
CULVERT 0.50	Three 24 inch CMP culvert. One culvert has minor undermining around it.	8
LATERAL SLOPE 0.50	1.5H:1V slope with minor surface erosion on both ends.	8
DOWNSLOPE 0.50	2H:1V slope and bench. Not impacting wall performance.	9
ARCHITECTURAL FACING 0.50	Minor cracking in mortar and minor oxidation on the stone. Good performance and functioning at intended.	10
CURB/BERM/DITCH 0.50	Minor cracking in curb. Overall, good condition.	10
TRAFFIC BARRIER/FENCE 0.50	Two tube steel backed timber guardrail in good condition. No signs of distress or displacement.	10

Failure Consequence:	MODERATE
Recommendation Narrative:	None
Repair Cost:	\$0

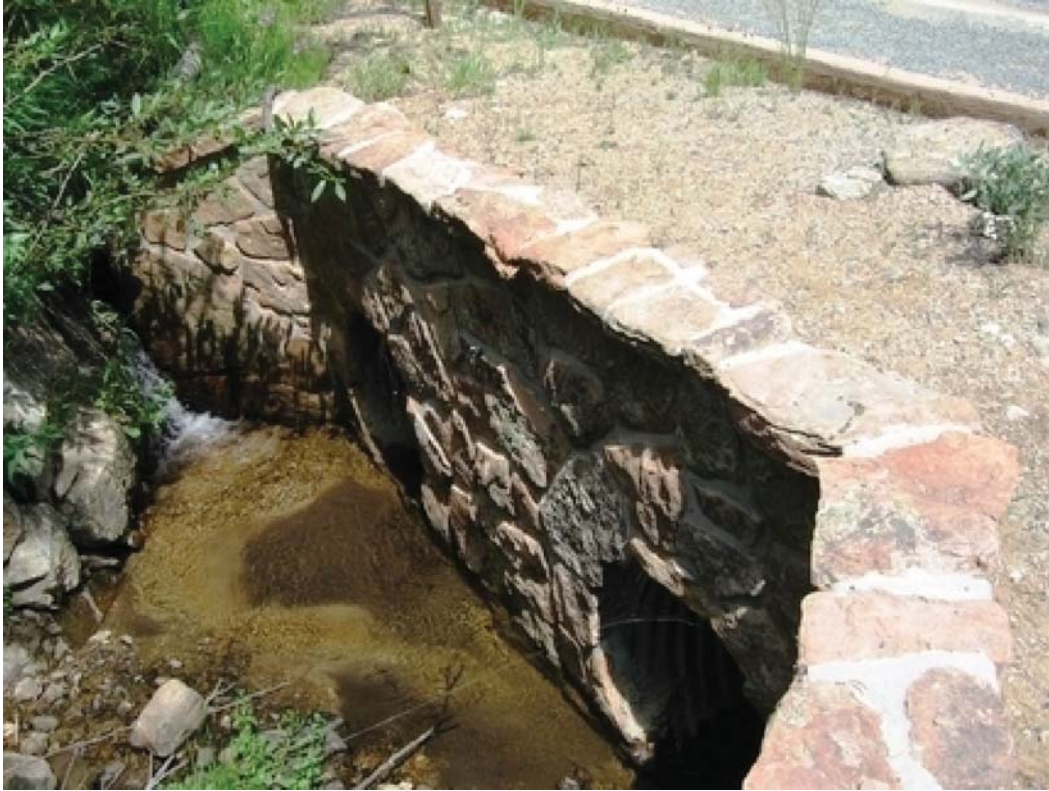
ROMO_0012_8.594_L_1.jpg

Wall ID:	ROMO-0012-8.594-L		
Route Name:	BEAR LAKE ROAD		
Inspection Date:	July 24, 2007	Approximate Year Built:	2004
*Wall Rating:	94	Maintenance Action:	No Action

Element (Weighting Factor)	Narrative	Condition Rating (0 - 10)
PERFORMANCE 8.00	Good to excellent condition and performing as intended.	10
WALL FOUNDATION MATERIAL 8.00	Alluvial stream channel material. No signs of settlement or distress.	10
CONCRETE 8.00	No signs of distress observed. Concrete covered by stone veneer.	9
LATERAL SLOPE 0.50	Minor surface erosion but no sign of distress. Not impacting wall.	9
UPSLOPE 0.50	Stream channel with boulders. Not impacting wall.	9
ARCHITECTURAL FACING 0.50	Minor cracking in mortar and minor oxidation/staining on stone. Functioning as intended.	10
ROAD/SIDEWALK/SHOULDER 0.50	No crack or distress in roadway.	10
WALL DRAINS 0.50	Two 30 inch CMP culvert at base of stream and side drainage. Functioning as intended.	10
CULVERT 0.50	Two 30 inch CMP culvert at base. Functioning as intended.	10

Failure Consequence:	MODERATE
Recommendation Narrative:	None
Repair Cost:	\$0

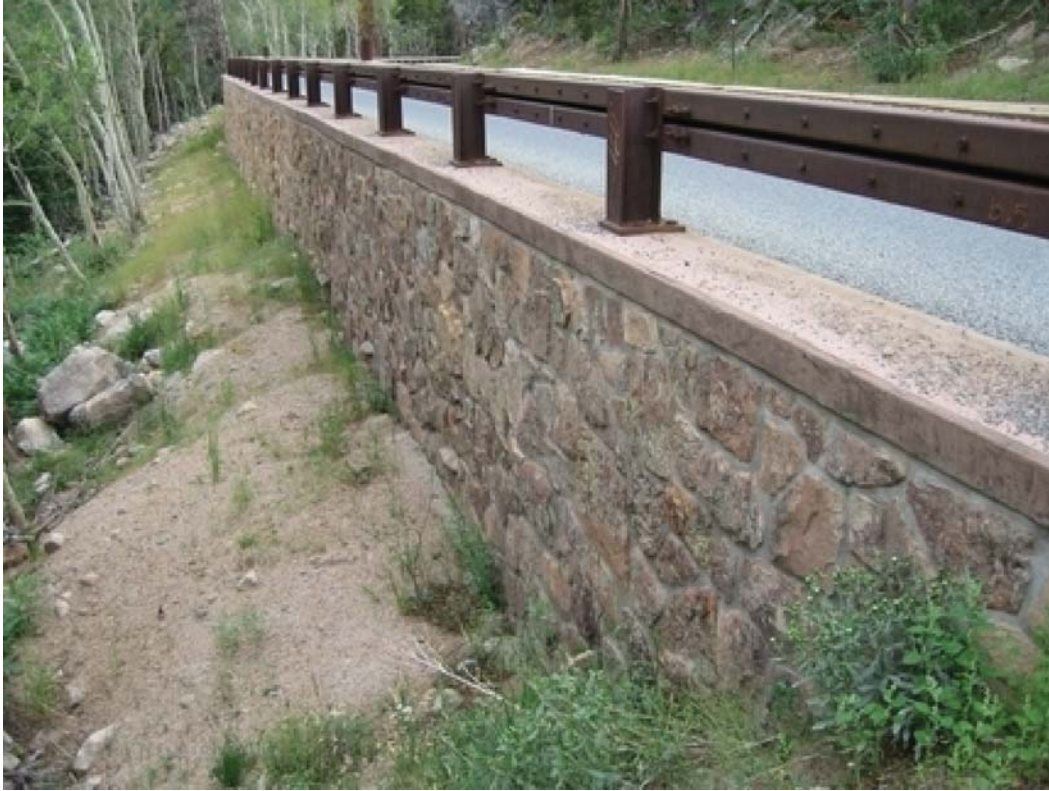
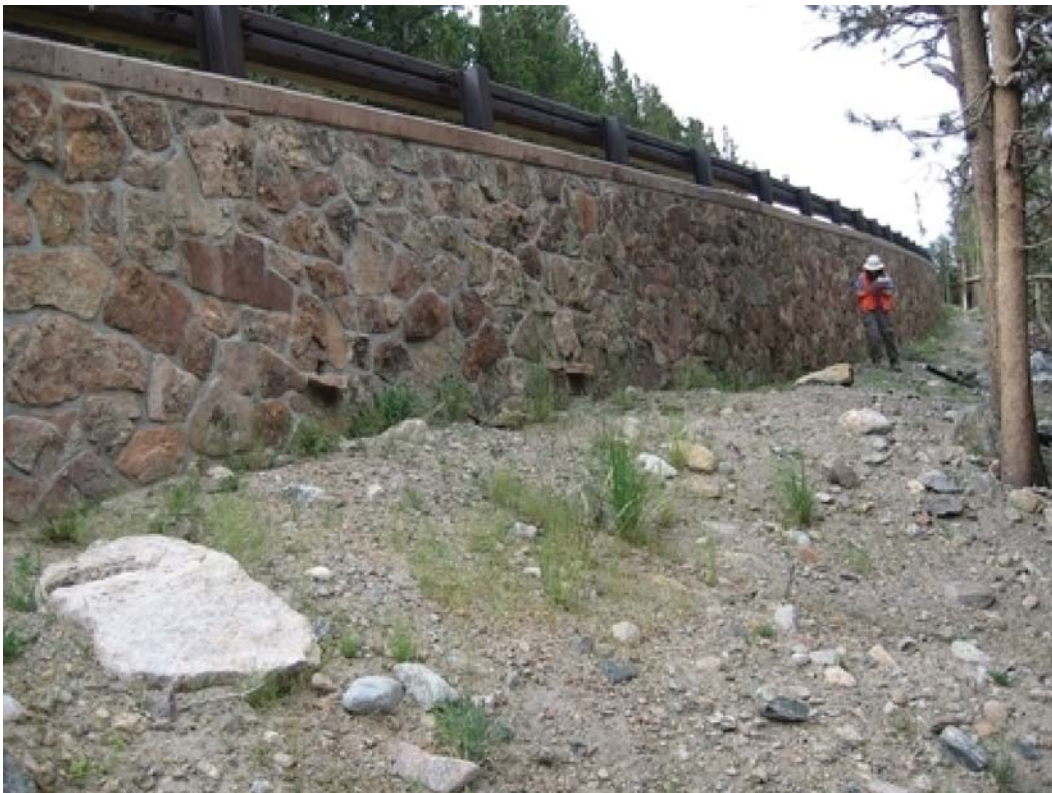
Wall ID:	ROMO-0012-8.728-R		
Route Name:	BEAR LAKE ROAD		
Inspection Date:	July 24, 2007	Approximate Year Built:	2004
*Wall Rating:	95	Maintenance Action:	No Action

Element (Weighting Factor)	Narrative	Condition Rating (0 - 10)
PERFORMANCE 8.00	Good to excellent wall performance with minor surfaced erosion on lateral slope.	10
WALL FOUNDATION MATERIAL 8.00	Good foundation material that consist of sand and gravel with 3 ft to 4 ft bench. No exposed wall toe and not impacting wall.	10
CONCRETE 8.00	No sign of distress observed. Concrete covered by stone veneer.	10
ARCHITECTURAL FACING 0.50	Minor cracking in the mortar. Minor oxidation in the stone. Good condition and functioning as intended.	9
LATERAL SLOPE 0.50	1.5H:1V stable slope with minor surface erosion and not impacting wall.	9
CULVERT 0.50	One 24 inch CMP culvert. Culvert has good cover and good performance.	10
CURB/BERM/DITCH 0.50	Curb has minor cracking and no sign of distress.	10
DOWNSLOPE 0.50	1.5H:1V stable slope with trees and vegetation.	10
TRAFFIC BARRIER/FENCE 0.50	Two tube steel backed timber rail in good condition. No distress from wall displacement.	10

Failure Consequence:	MODERATE
Recommendation Narrative:	None
Repair Cost:	\$0

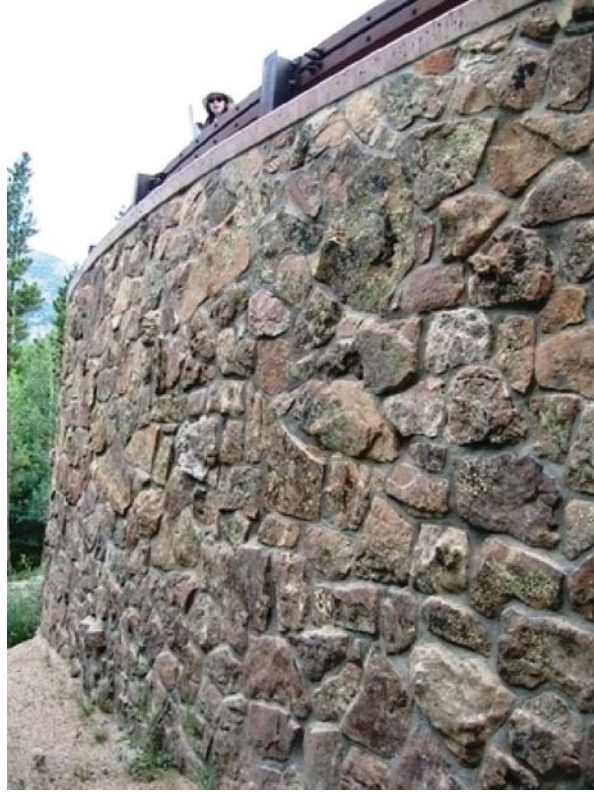
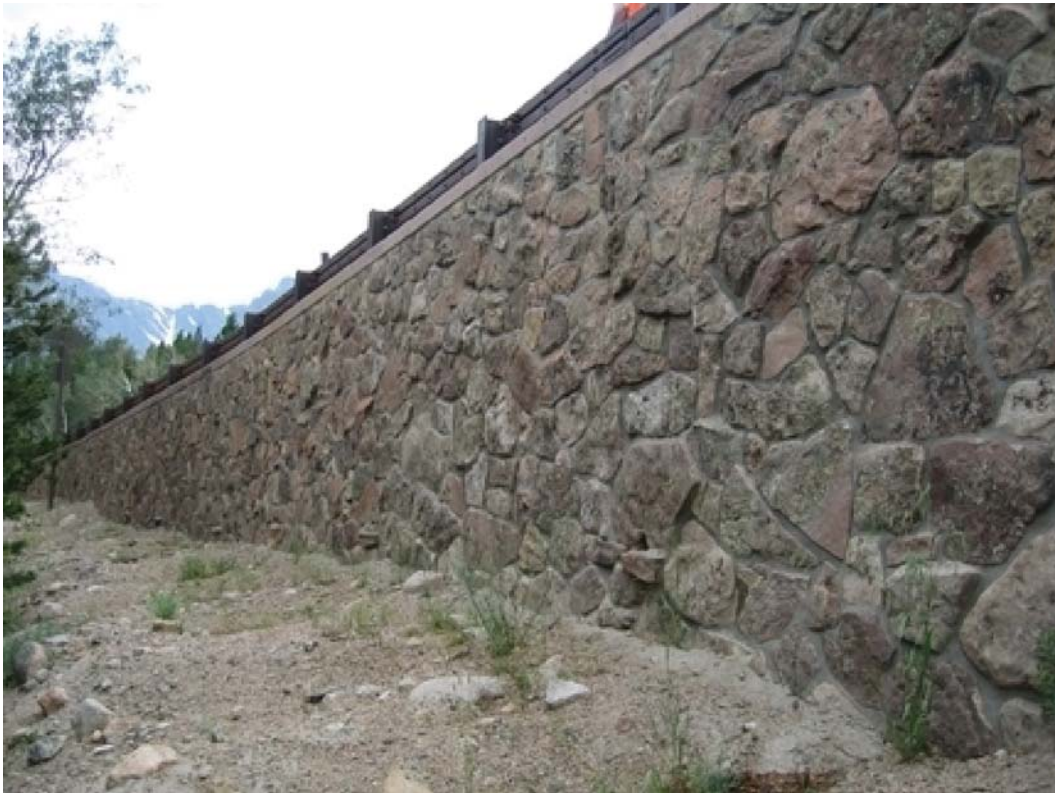
Wall ID:	ROMO-0012-8.838-R		
Route Name:	BEAR LAKE ROAD		
Inspection Date:	July 24, 2007	Approximate Year Built:	2004
*Wall Rating:	92	Maintenance Action:	No Action

Element (Weighting Factor)	Narrative	Condition Rating (0 - 10)
PERFORMANCE 8.00	Good to excellent condition. Minor wall cracking perhaps related to surface water drainage issues.	9
WALL FOUNDATION MATERIAL 8.00	Sand, gravel and alluvial materials. Good foundation and no indication of settlement or displacement. Wall toe exposed at step about 2 to 3 inches and sign of corrosion.	10
CONCRETE 8.00	Minor hairline cracking at facing veneer and may indicate minor wall movement beneath. Movement is not visible due to facing.	9
CURB/BERM/DITCH 0.50	Curb has a moderate crack (1/4 inch) at edge of traffic lane. May be possible surface water issue.	8
ARCHITECTURAL FACING 0.50	Minor vertical cracking in line with curb joint.	9
CULVERT 0.50	One 24 inch CMP culvert and functioning as intended.	9
LATERAL SLOPE 0.50	Begin wall has minor surface erosion at roadway edge and end wall has gradual slope (3H:1V). No impact on wall performance.	9

Failure Consequence:	MODERATE
Recommendation Narrative:	None
Repair Cost:	\$0

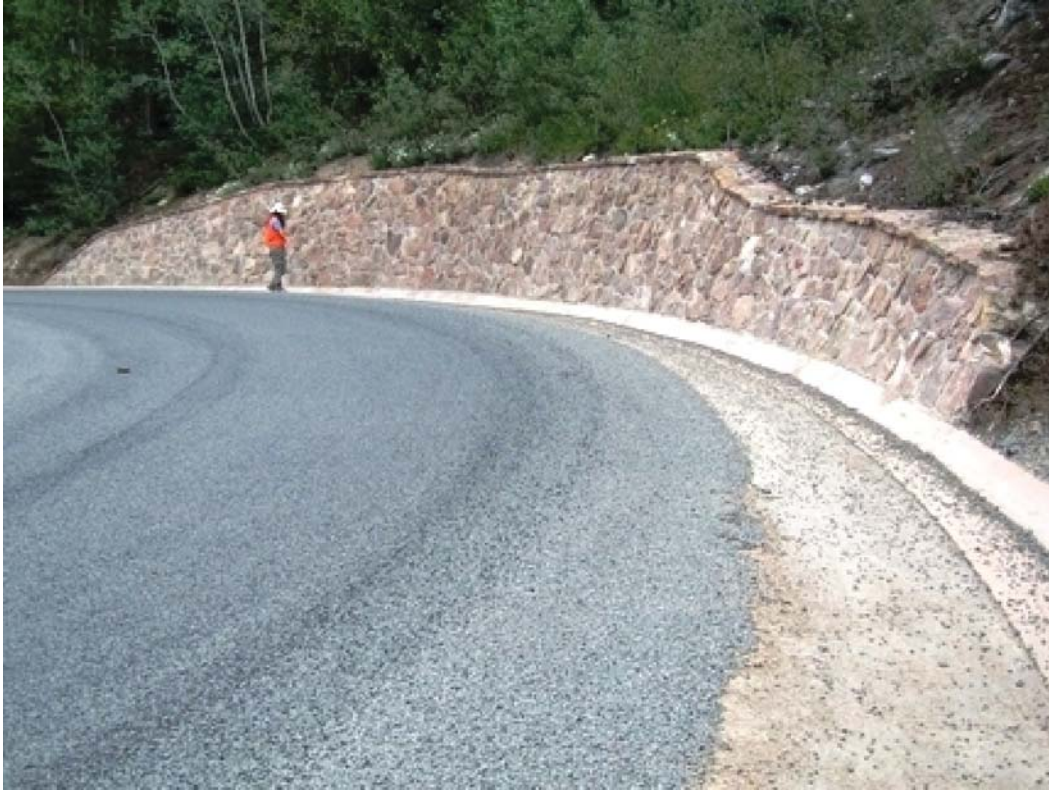
ROMO_0012_8.896_R_1.jpg

Wall ID:	ROMO-0012-8.896-R		
Route Name:	BEAR LAKE ROAD		
Inspection Date:	July 24, 2007	Approximate Year Built:	2004
*Wall Rating:	90	Maintenance Action:	No Action

Element (Weighting Factor)	Narrative	Condition Rating (0 - 10)
PERFORMANCE 8.00	Good to excellent condition with minor surface erosion on lateral surface.	9
WALL FOUNDATION MATERIAL 8.00	Covered with roadway and curb. No indication of distress.	9
SHOTCRETE 8.00	No indication of distress. Covered with stone veneer.	9
LATERAL SLOPE 0.50	Minor surface erosion and impacting wall performance.	8
CURB/BERM/DITCH 0.50	Curb has minor cracking and staining.	9
UPSLOPE 0.50	Stable (1.5H:1V) slope with trees and shrubs.	9
WALL DRAINS 0.50	No weep holes, horizontal drains, and underdrains outlet below wall observed. No signs of distress from drainage.	9
ARCHITECTURAL FACING 0.50	Minor cracking in mortar and iron staining. Performing as designed.	10
ROAD/SIDEWALK/SHOULDER 0.50	Roadway has no sign of distress or cracking.	10

Failure Consequence:	MODERATE
Recommendation Narrative:	None
Repair Cost:	\$0

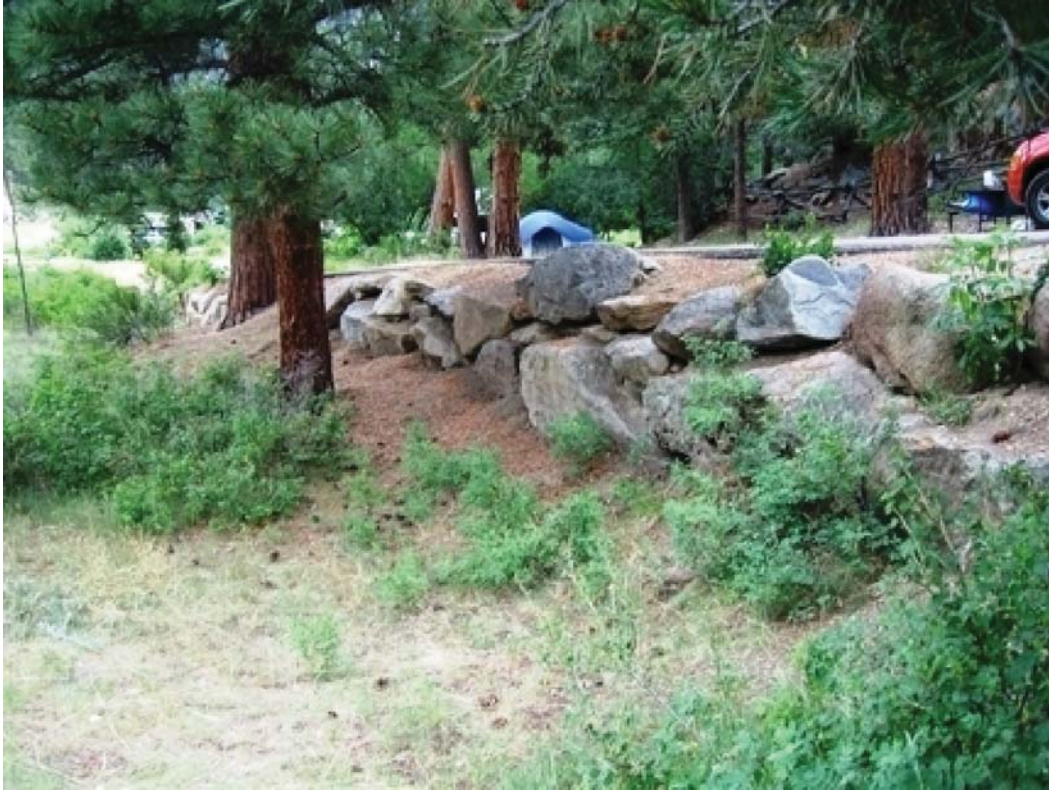
ROMO_0204ZZ_0.134_L_1.jpg

Wall ID:	ROMO-0204ZZ-0.134-L		
Route Name:	ASPENGLLEN CAMPGROUND ROADS		
Inspection Date:	July 23, 2007	Approximate Year Built:	Unknown
*Wall Rating:	76	Maintenance Action:	No Action

Element (Weighting Factor)	Narrative	Condition Rating (0 - 10)
PERFORMANCE 8.00	Good overall, minor surface drainage issues with minor erosion or upstation lateral slope and top of shoulder.	8
WALL FOUNDATION MATERIAL 8.00	Sandy material at relatively low slope of about 5H:1V, no signs of settlement.	8
PLACED STONE 8.00	Granite boulders, low iron staining due to minor erosion, good condition.	7
VEGETATION 0.50	Minor brush at top of wall and grass throughout, but not impacting wall stability.	8
WALL DRAINS 0.50	None observed, no water-related issued impacting wall.	8
DOWNSLOPE 0.50	Minor slope, relatively flat, minor surface erosion.	9
LATERAL SLOPE 1.00	Wall start slope has minor surface erosion due to surface water drainage from road.	6
ROAD/SIDEWALK/SHOULDER 1.00	No distress in road. Minor ravelling in the shoulder due to surface drainage.	7

Failure Consequence:	LOW
Recommendation Narrative:	None
Repair Cost:	\$0

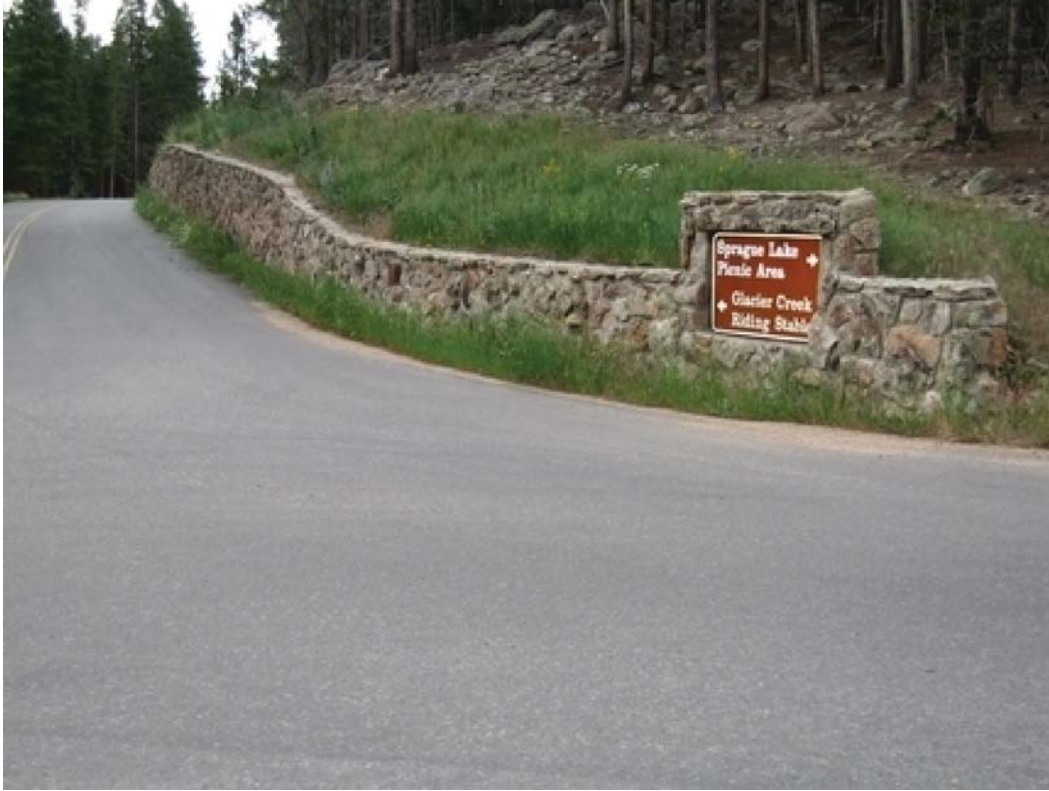
ROMO_0219_0.000_L_1.jpg

Wall ID:	ROMO-0219-0.000-L		
Route Name:	GLACIER CREEK RIDING STABLE ROAD		
Inspection Date:	July 24, 2007	Approximate Year Built:	Unknown
*Wall Rating:	87	Maintenance Action:	No Action

Element (Weighting Factor)	Narrative	Condition Rating (0 - 10)
PERFORMANCE 8.00	Good performance and performing as intended.	9
WALL FOUNDATION MATERIAL 8.00	Moderate vegetated flat ditch with minor undermining. No sign of distress.	8
CONCRETE 8.00	No sign of distress observed. Concrete covered by stone facing.	9
ARCHITECTURAL FACING 0.50	Minor cracking in mortar and minor spalling (isolated area) in the stone.	9
LATERAL SLOPE 0.50	Minor surface erosion and in overall good condition.	9
UPSLOPE 0.50	5H:1V stable slope with vegetation.	9
WALL DRAINS 0.50	No observed drains. No sign of drainage distress.	9
ROAD/SIDEWALK/SHOULDER 0.50	Roadway has no cracking and in good condition. Shoulder has no sign of distress and in good condition.	10

Failure Consequence:	LOW
Recommendation Narrative:	None
Repair Cost:	\$0

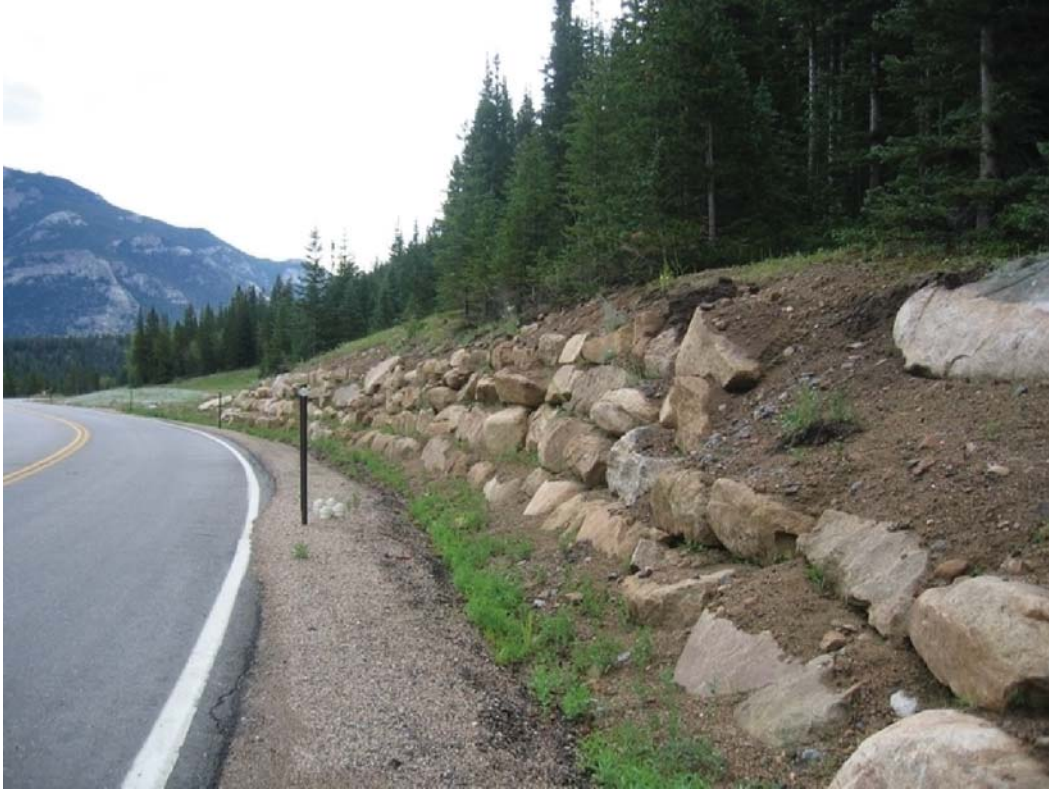
ROMO_0220_0.202_L_1.jpg

Wall ID:	ROMO-0220-0.202-L		
Route Name:	HIDDEN VALLEY ACCESS ROAD		
Inspection Date:	July 26, 2007	Approximate Year Built:	2004
*Wall Rating:	83	Maintenance Action:	No Action

Element (Weighting Factor)	Narrative	Condition Rating (0 - 10)
PERFORMANCE 8.00	Good condition, performing as intended.	8
WALL FOUNDATION MATERIAL 8.00	Founded on soil, no signs of settlement.	8
PLACED STONE 8.00	Large blocky granite, slightly weathered.	9
UPSLOPE 0.50	Very gentle, well vegetated, no signs of erosion.	8
VEGETATION 0.50	Some grass and wildflowers, not impacting wall performance.	8
WALL DRAINS 0.50	None observed, no water-related issues impacting wall.	8
LATERAL SLOPE 1.00	About 3H:1V at wall start with very minor sloughing. About 2.5H:1V at wall end, no erosion.	7

Failure Consequence:	MODERATE
Recommendation Narrative:	None
Repair Cost:	\$0

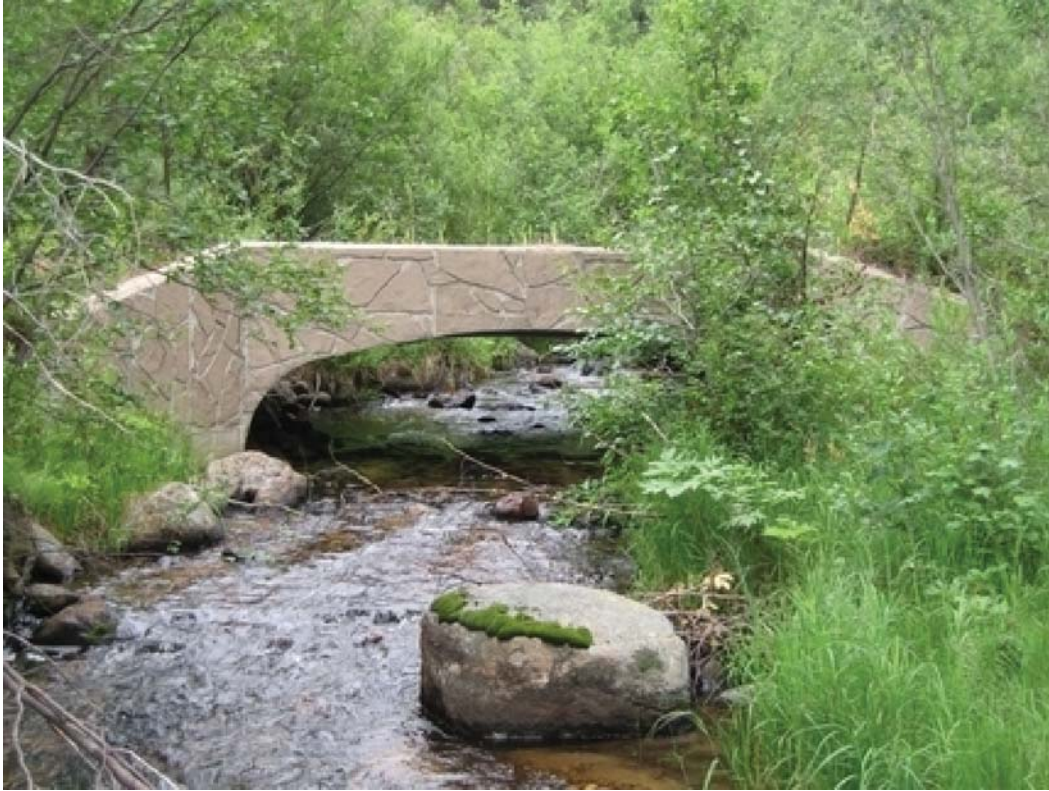
ROMO_0413_0.066_L_1.jpg

Wall ID:	ROMO-0413-0.066-L		
Route Name:	MILL CREEK RESIDENCE ROAD		
Inspection Date:	July 26, 2007	Approximate Year Built:	Unknown
*Wall Rating:	90	Maintenance Action:	No Action

Element (Weighting Factor)	Narrative	Condition Rating (0 - 10)
PERFORMANCE 8.00	Good performance and performing as intended.	9
WALL FOUNDATION MATERIAL 8.00	Boulder and granular material. Good foundation with free flowing river above it.	9
CONCRETE 8.00	No sign of distress observed. Minor cracking on formliner face.	9
ROAD/SIDEWALK/SHOULDER 0.50	Shoulder has minor depression behind wall but no impacting wall.	8
ARCHITECTURAL FACING 0.50	Formliner (Rock pattern with brown stain). Good condition with minor spalling.	9
CULVERT 0.50	Arch CMP 16 ft W x 4 ft H in 50 ft in length. Minor oxidation but performing as intended.	9
DOWNSLOPE 0.50	Stream channel with boulders. Moderate slope with moderate vegetation. No sign of surface erosion.	9
LATERAL SLOPE 0.50	Boulder riprap and relatively flat slope. Not impacting wall.	9
WALL DRAINS 0.50	None needed. No water issues.	9

Failure Consequence:	LOW
Recommendation Narrative:	None
Repair Cost:	\$0

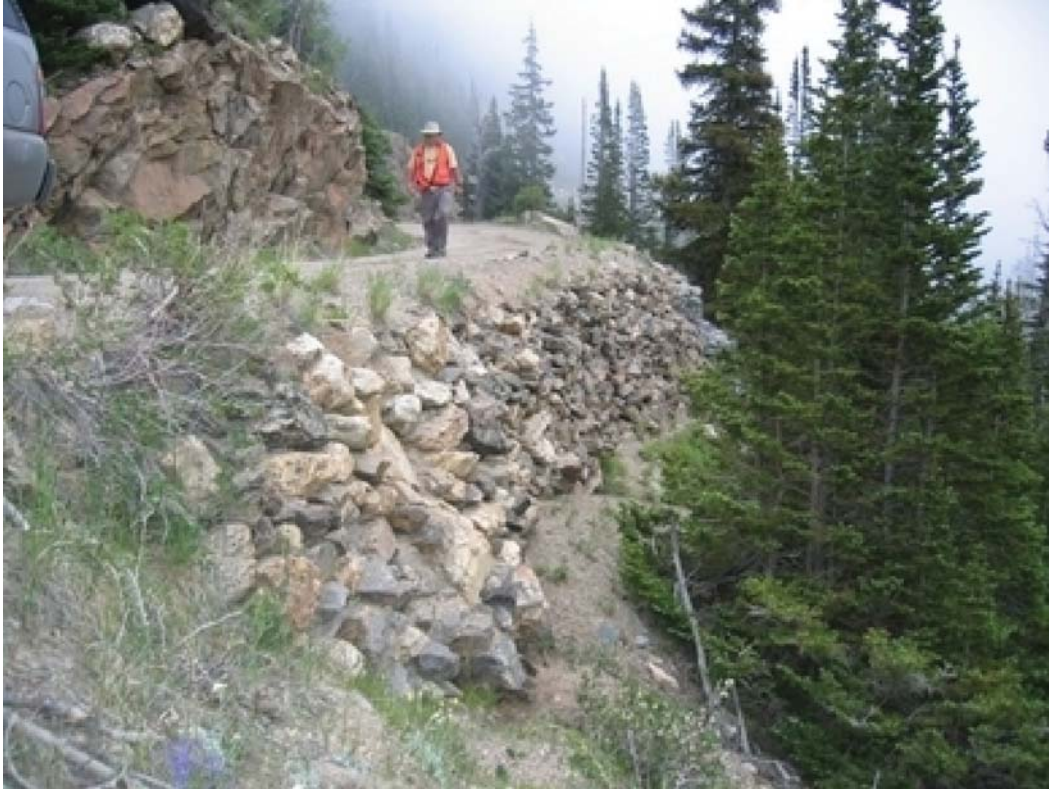
ROMO_0500_4.400_L_1.jpg

Element (Weighting Factor)	Narrative	Condition Rating (0 - 10)
PERFORMANCE 8.00	Fair to good, wall performing as intended.	6
WALL FOUNDATION MATERIAL 8.00	Shallow bedrock, no sign of settlement.	7
WIRE/GEOSYNTHETIC FACING 8.00	gabion basket shows some sagging, no corrosion.	6
PLACED STONE 8.00	Moderately weathered, loose rock.	7
LATERAL SLOPE 1.00	Loose soil/rock mix, some erosion.	5
DOWNSLOPE 1.00	Loose soil/rock mix and bedrock, very minor erosion.	6
WALL DRAINS 1.00	None present. No sign of water related problems.	7

Failure Consequence:	MODERATE
Recommendation Narrative:	None
Repair Cost:	\$0

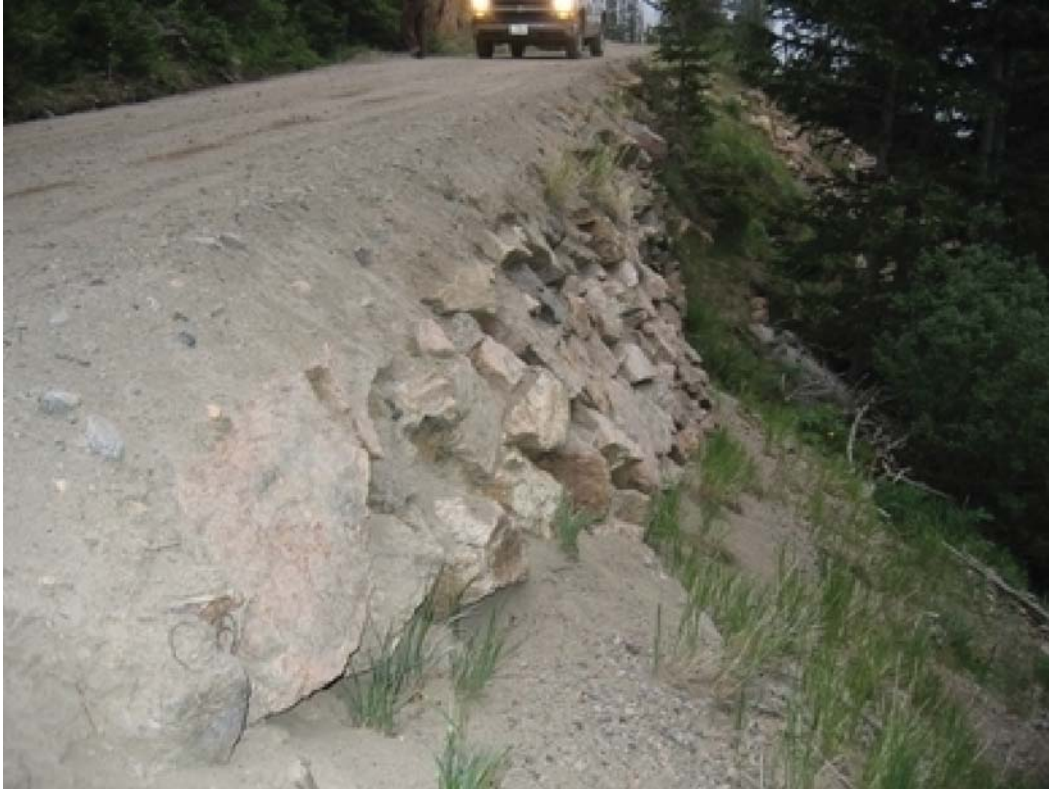
ROMO_0500_4.450_L_1.jpg

Element (Weighting Factor)	Narrative	Condition Rating (0 - 10)
PERFORMANCE 8.00	Good, wall performing as intended.	7
WALL FOUNDATION MATERIAL 8.00	Founded on gravelly soil, no settlement.	7
PLACED STONE 8.00	Slightly weathered, some loose rock.	7
CULVERT 1.00	24" CMP moderate corrosion, partially plugged but not affecting wall performance.	5
ROAD/SIDEWALK/SHOULDER 1.00	Shoulder has some erosion present.	5
LATERAL SLOPE 1.00	Loose soil/rock mix, some erosion.	6
VEGETATION 1.00	Some grass but not affecting wall performance.	7
WALL DRAINS 1.00	None present. No sign of water related problems.	7

Failure Consequence:	MODERATE
Recommendation Narrative:	None
Repair Cost:	\$0

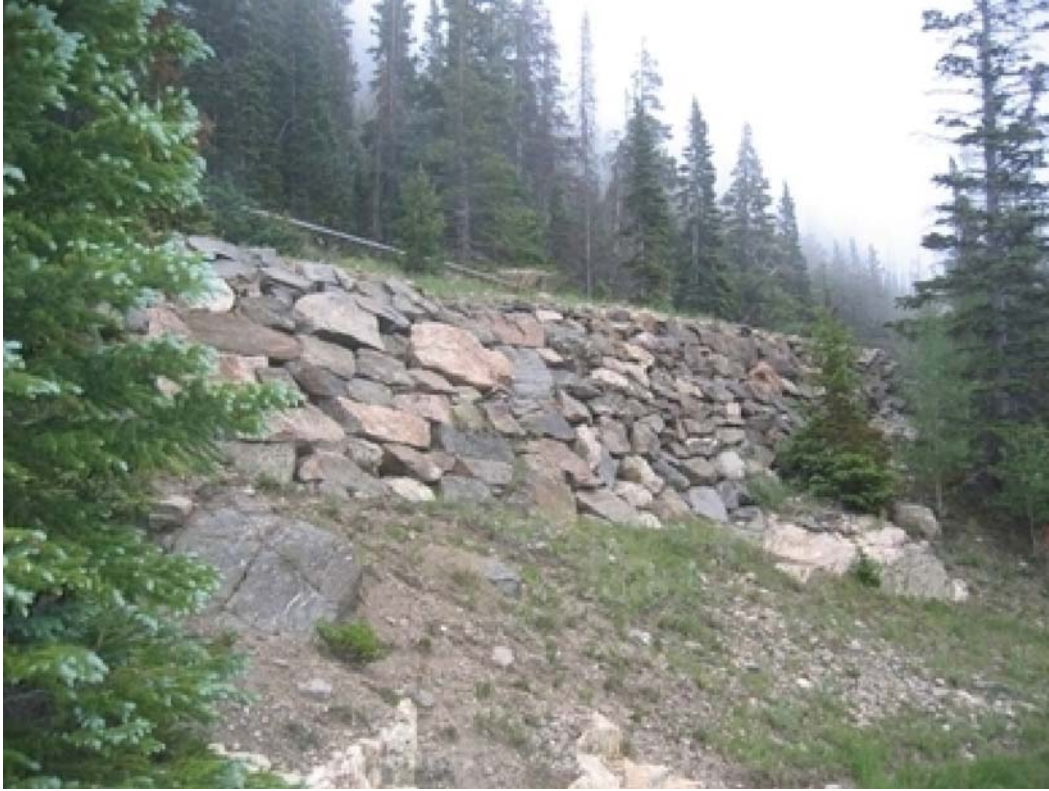
ROMO_0500_4.550_R_1.jpg

Element (Weighting Factor)	Narrative	Condition Rating (0 - 10)
PERFORMANCE 8.00	Good, wall performing as intended.	8
WALL FOUNDATION MATERIAL 8.00	Founded on bedrock and soil, no settlement.	8
PLACED STONE 8.00	Hard durable boulders, large to medium size.	8
DOWNSLOPE 0.50	Vegetated soil slope with large boulders.	8
LATERAL SLOPE 0.50	Bedrock at start and end.	8
WALL DRAINS 0.50	None present. No sign of water related problems.	8

Failure Consequence:	MODERATE
Recommendation Narrative:	None
Repair Cost:	\$0
