NPS Retaining Wall Inventory Program Rocky Mountain National Park

**Federal Lands Highway
Road Inventory Program**

**Federal Highway Administration
Eastern Federal Lands Highway Division
Road Inventory Program (RIP)**

**Data Collection Date: September 2007
Report Date: October 2015**

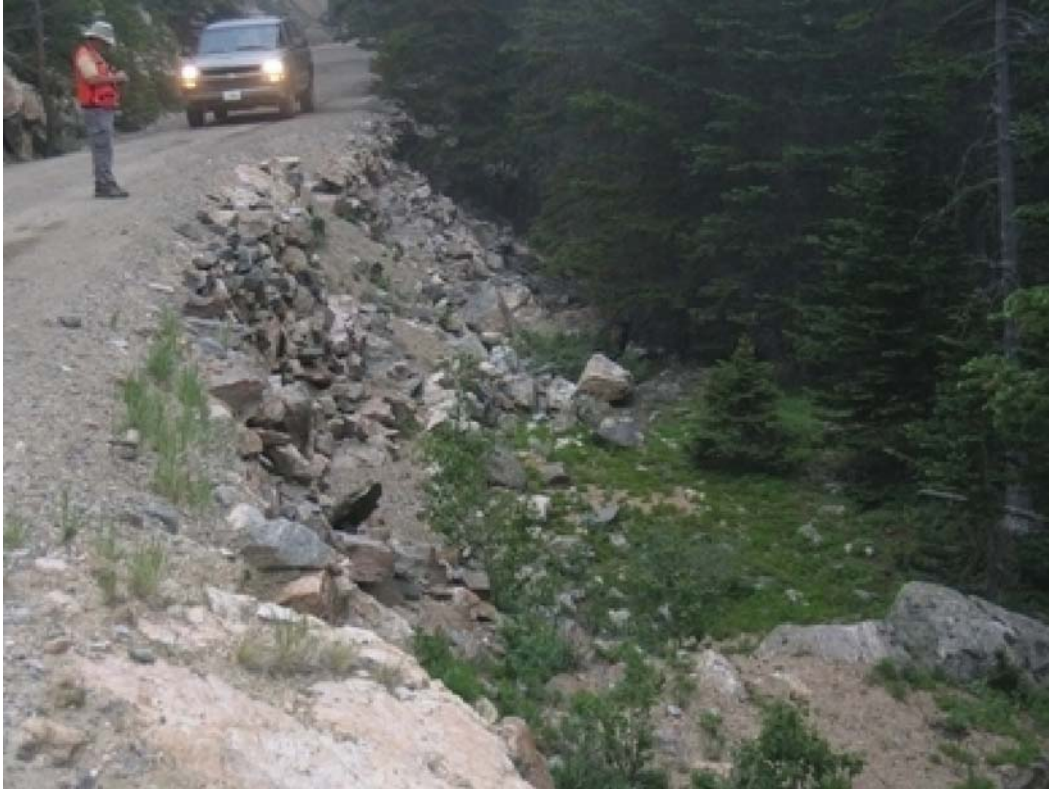
ROMO_0500_4.600_L_1.jpg

Element (Weighting Factor)	Narrative	Condition Rating (0 - 10)
PERFORMANCE 8.00	Fair to good , wall performing as intended.	7
WALL FOUNDATION MATERIAL 8.00	Soil/rock mix, no sign of settlement.	7
PLACED STONE 8.00	Moderately weathered, loose rock.	7
WIRE/GEOSYNTHETIC FACING 8.00	gabion basket shows some sagging, no corrosion.	7
DOWNSLOPE 1.00	Loose soil/rock, some erosion, very steep.	5
LATERAL SLOPE 1.00	Loose soil/rock, some erosion.	5
WALL DRAINS 1.00	None present. No sign of water related problems.	7

Failure Consequence:	MODERATE
Recommendation Narrative:	None
Repair Cost:	\$0

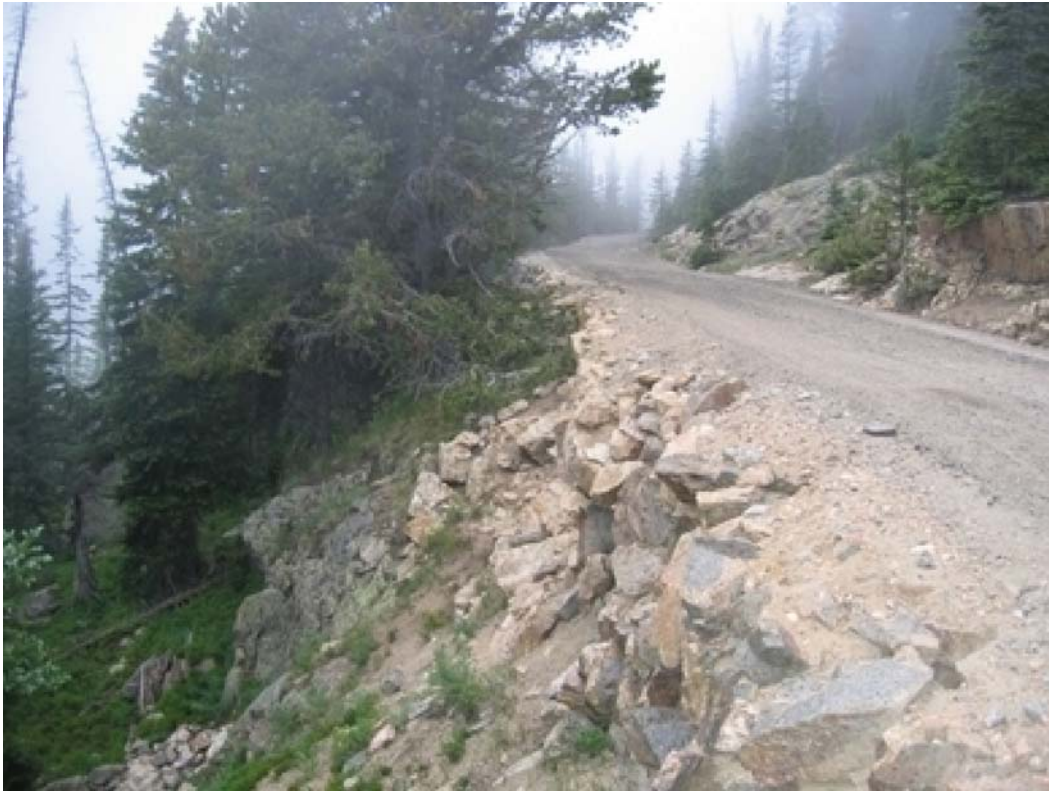
ROMO_0500_4.750_L_1.jpg

Element (Weighting Factor)	Narrative	Condition Rating (0 - 10)
PERFORMANCE 8.00	Fair, performing as intended.	6
WALL FOUNDATION MATERIAL 8.00	Founded on soil/rock mix, no sign of settlement.	7
PLACED STONE 8.00	Moderately weathered, many loose and missing pieces.	5
ROAD/SIDEWALK/SHOULDER 1.00	Shoulder loose, sloughing, some erosion.	5
LATERAL SLOPE 1.00	Loose soil/rock mix, minor erosion at wall start. Ties into bedrock at wall end.	6
DOWNSLOPE 1.00	Gentle, 3:1 slope, no sign of erosion.	7
WALL DRAINS 1.00	None observed. No water related problems.	7

Failure Consequence:	MODERATE
Recommendation Narrative:	None
Repair Cost:	\$0

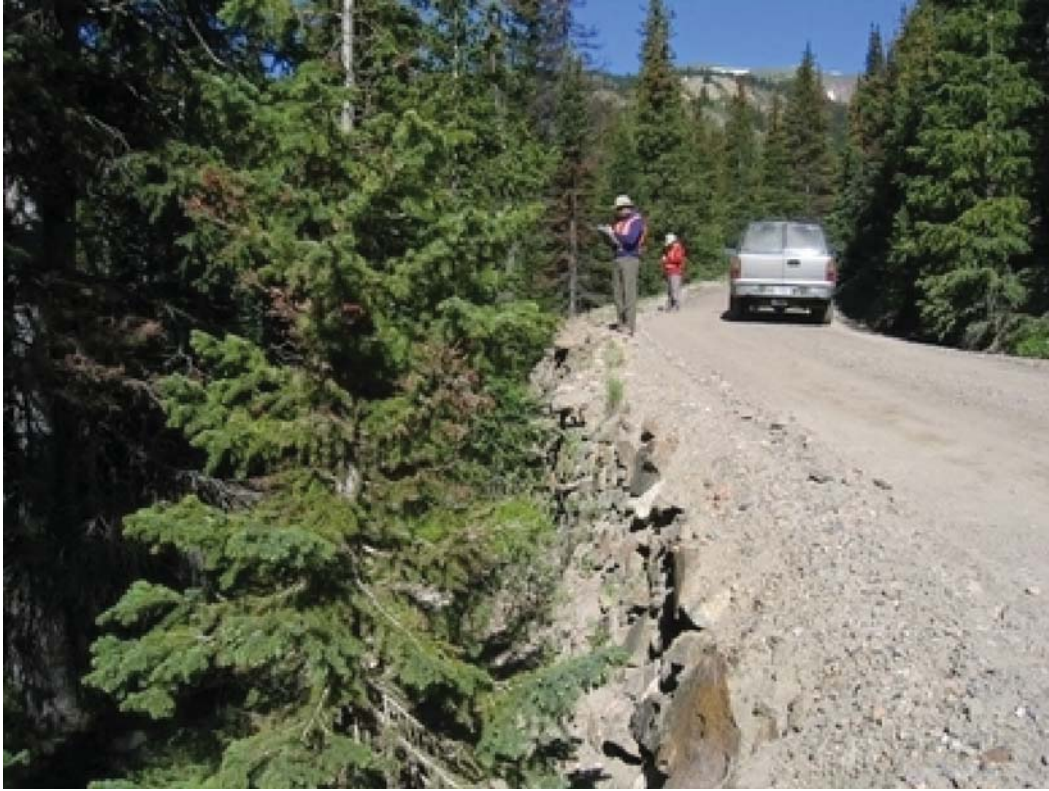
ROMO_0500_4.800_L_1.jpg

Wall ID:	ROMO-0500-4.800-L		
Route Name:	OLD FALL RIVER ROAD		
Inspection Date:	June 26, 2007	Approximate Year Built:	1925
*Wall Rating:	67	Maintenance Action:	No Action
Wall Description			
Wall Function:	Fill Wall	Primary Wall Type:	Gravity - Dry Stone
Surface Treatment:		Secondary Wall Type:	
Secondary Surface Treatment:		Architectural Facing:	
General Description:	Dry stacked fill wall		
Wall Measurements			
Wall Length (ft.):	132	Face Area (sq.):	600
Average Wall Height (ft.):	4	Face Angle (deg.):	77
Maximum Wall Height (ft.):	6	Vertical Offset (ft.):	0
Assessed Elements			
Element (Weighting Factor)	Narrative		Condition Rating (0 - 10)
PERFORMANCE 8.00	Good, performing as intended.		7
WALL FOUNDATION MATERIAL 8.00	Founded on bedrock and soil, no sign of settlement.		7
PLACED STONE 8.00	Slightly weathered, medium to large boulders, some loose pieces.		6
ROAD/SIDEWALK/SHOULDER 1.00	Shoulder has minor erosion.		6

DOWNSLOPE 1.00	Soil and bedrock with trees and vegetation. No signs of erosion.		7
LATERAL SLOPE 1.00	Soil and bedrock. No signs of erosion.		7
WALL DRAINS 1.00	None observed. No water related problems.		7
Repair Recommendations			
Failure Consequence:	MODERATE		
Recommendation Narrative:	None		
Repair Cost:	\$0		
2007 cost estimate (ASTM Class D), preliminary for comparison to other repair costs only.

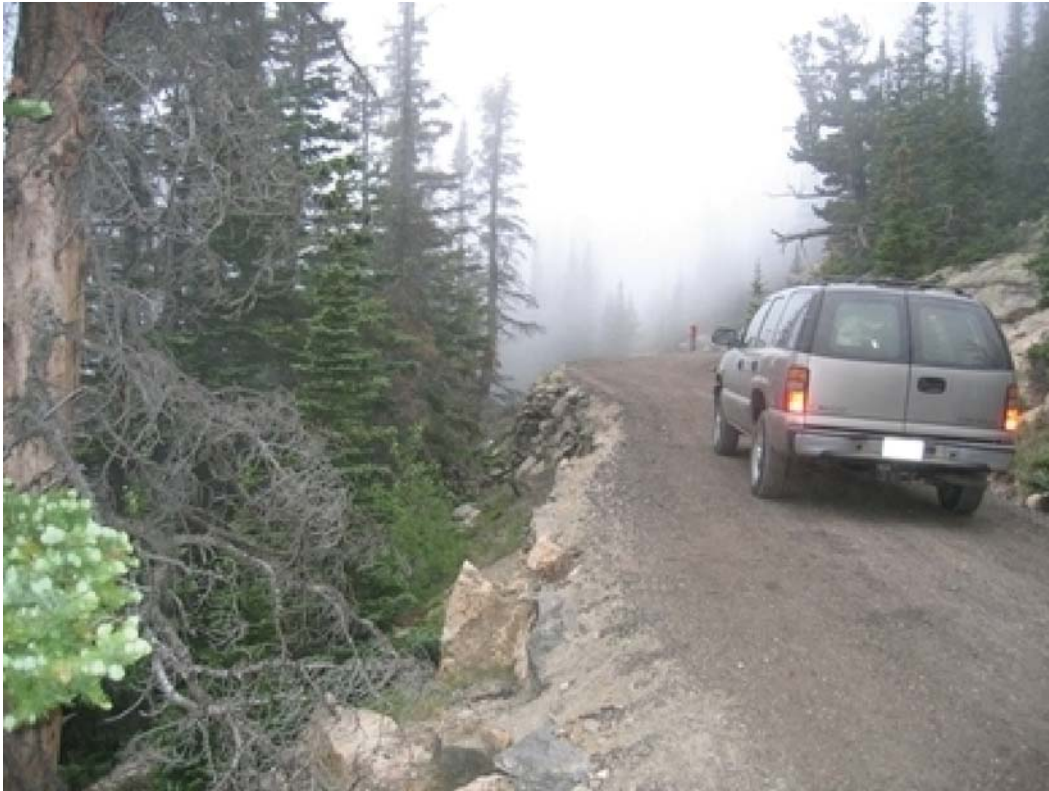
ROMO_0500_4.900_L_1.jpg

Element (Weighting Factor)	Narrative	Condition Rating (0 - 10)
PERFORMANCE 8.00	Fair to good, performing as intended.	6
WALL FOUNDATION MATERIAL 8.00	Founded on soil/rock mix and shallow bedrock no sign of settlement.	7
PLACED STONE 8.00	Moderately weathered, loose pieces.	7
DOWNSLOPE 1.00	Steep in places, minor erosion.	5
ROAD/SIDEWALK/SHOULDER 1.00	Shoulder loose and raveling.	5
LATERAL SLOPE 1.00	Loose soil/rock mix, minor erosion.	6
WALL DRAINS 1.00	None observed. No water related problems.	7

Failure Consequence:	MODERATE
Recommendation Narrative:	None
Repair Cost:	\$0

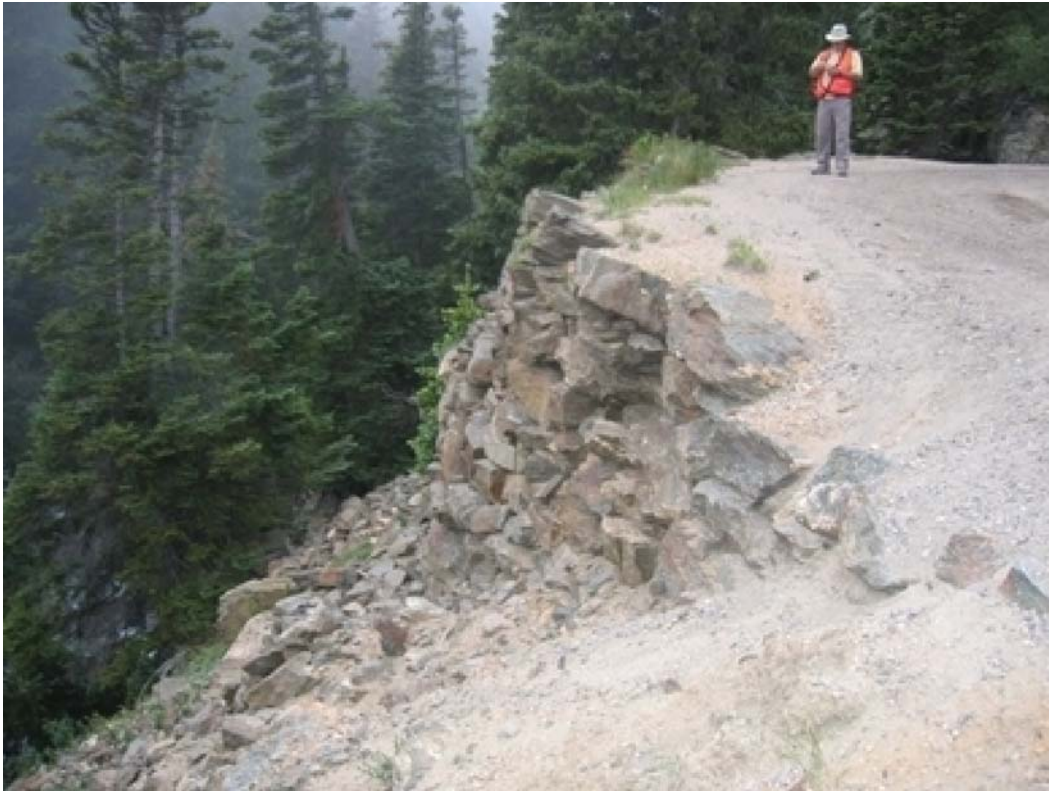
ROMO_0500_4.950_L_1.jpg

Element (Weighting Factor)	Narrative	Condition Rating (0 - 10)
PERFORMANCE 8.00	Good, performing as intended.	7
WALL FOUNDATION MATERIAL 8.00	Founded on shallow bedrock, no sign of settlement.	8
PLACED STONE 8.00	Hard durable rock, slightly weathered, some loose pieces.	7
ROAD/SIDEWALK/SHOULDER 1.00	Shoulder soft, raveling, minor erosion.	5
DOWNSLOPE 1.00	Shallow bedrock, creek below not affecting wall performance.	7
LATERAL SLOPE 1.00	Ties into soil over shallow bedrock at wall start. Ties into bedrock at wall end. No sign of erosion.	7
WALL DRAINS 1.00	None observed. No water related problems.	7

Failure Consequence:	MODERATE
Recommendation Narrative:	None
Repair Cost:	\$0

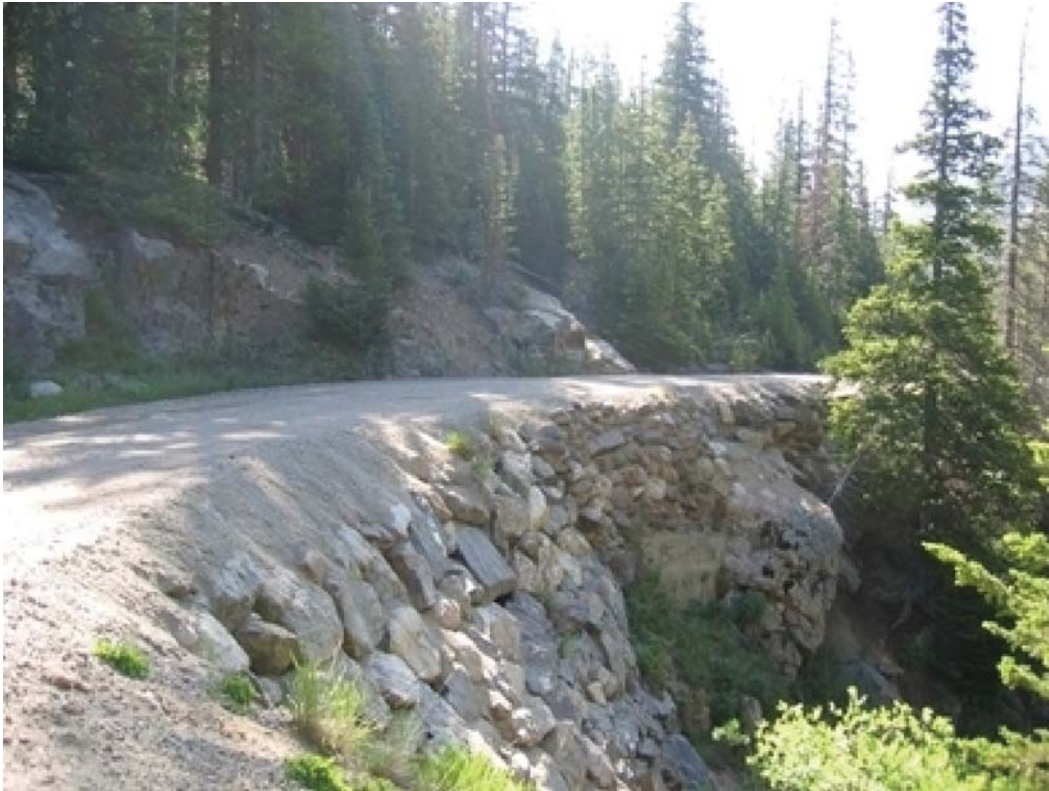
ROMO_0500_5.400_L_1.jpg

Element (Weighting Factor)	Narrative	Condition Rating (0 - 10)
PERFORMANCE 8.00	Good, performing as intended.	7
WALL FOUNDATION MATERIAL 8.00	Founded on soil/rock mix, no sign of settlement.	7
PLACED STONE 8.00	Slightly weathered, few loose pieces.	7
LATERAL SLOPE 1.00	Ties into soil at wall start. Ties into soil/rock mix. Moderate erosion.	5
CULVERT 1.00	18" CMP, minor corrosion, not affecting wall performance.	7
DOWNSLOPE 1.00	Well vegetated, grass, trees. No sign of erosion.	7
WALL DRAINS 1.00	None observed. No water related problems.	7

Failure Consequence:	MODERATE
Recommendation Narrative:	None
Repair Cost:	\$0

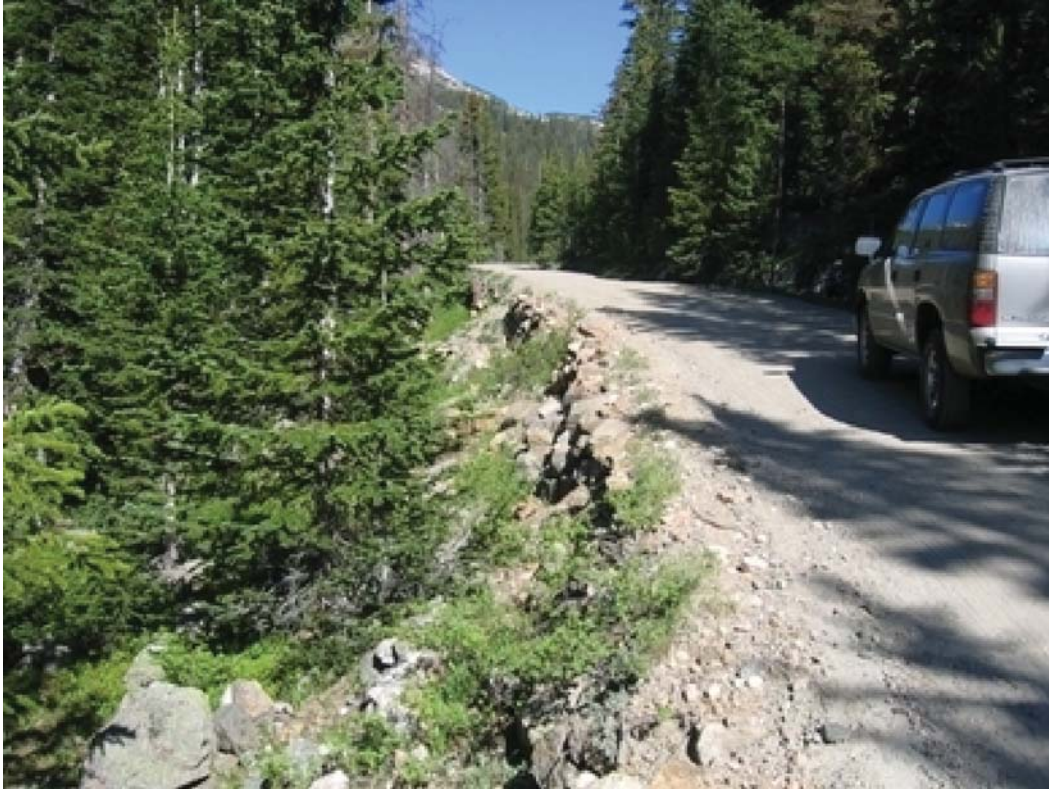
ROMO_0500_5.600_L_1.jpg

Element (Weighting Factor)	Narrative	Condition Rating (0 - 10)
PERFORMANCE 8.00	Fair to good, performing as intended.	7
WALL FOUNDATION MATERIAL 8.00	Founded on soil, no sign of settlement.	7
PLACED STONE 8.00	Moderately weathered, many loose pieces, crudely built.	5
ROAD/SIDEWALK/SHOULDER 1.00	Shoulder some raveling, some erosion.	5
LATERAL SLOPE 1.00	Ties into soil, minor erosion..	6
CULVERT 1.00	18" CMP, partially plugged, not affecting wall performance.	7
DOWNSLOPE 1.00	Gentle, well vegetated, no sign of erosion.	7
WALL DRAINS 1.00	None observed. No water related problems.	7

Failure Consequence:	MODERATE
Recommendation Narrative:	None
Repair Cost:	\$0

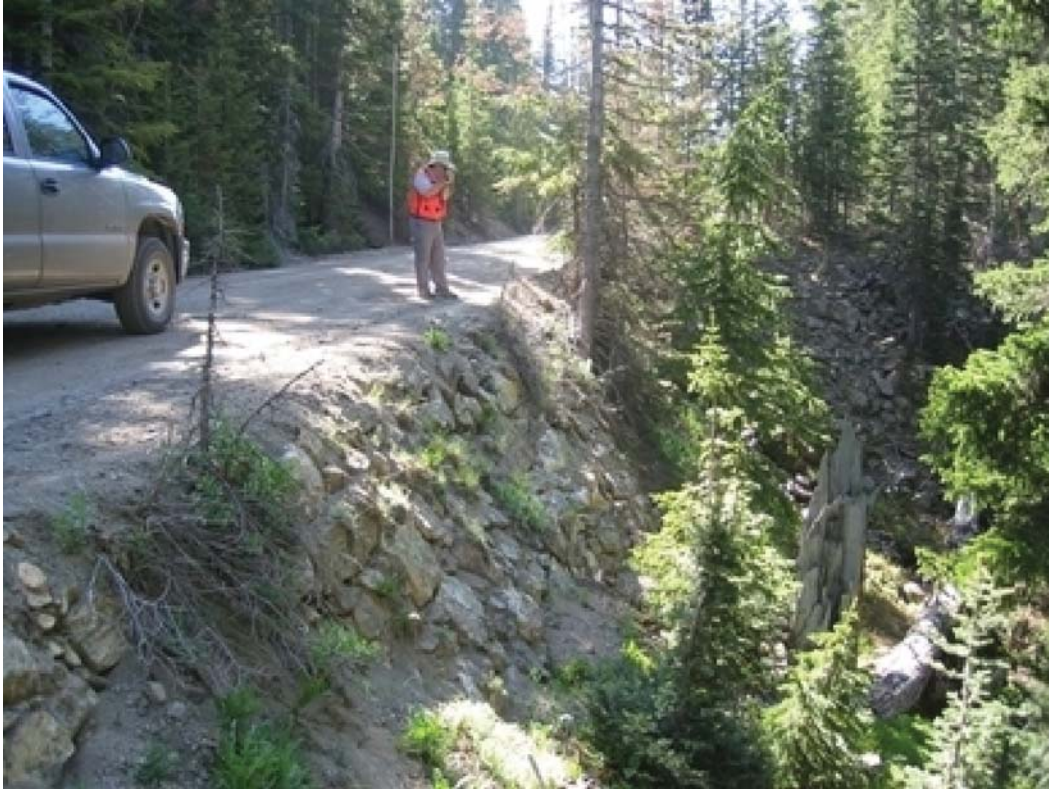
ROMO_0500_6.000_R_1.jpg

Element (Weighting Factor)	Narrative	Condition Rating (0 - 10)
PERFORMANCE 8.00	Fair to good, performing as intended.	6
WALL FOUNDATION MATERIAL 8.00	Founded on soil. No sign of settlement.	7
PLACED STONE 8.00	Moderately weathered, loose pieces.	7
ROAD/SIDEWALK/SHOULDER 1.00	Shoulder moderate erosion.	5
CULVERT 1.00	Two 18" CMP. One abandoned. Partially plugged, minor corrosion, not affecting wall performance.	6
DOWNSLOPE 1.00	Moderate slope, grass, trees, minor erosion.	6
LATERAL SLOPE 1.00	Soil/rock mix, minor erosion.	6
WALL DRAINS 1.00	None observed. No water related problems.	7

Failure Consequence:	MODERATE
Recommendation Narrative:	None
Repair Cost:	\$0

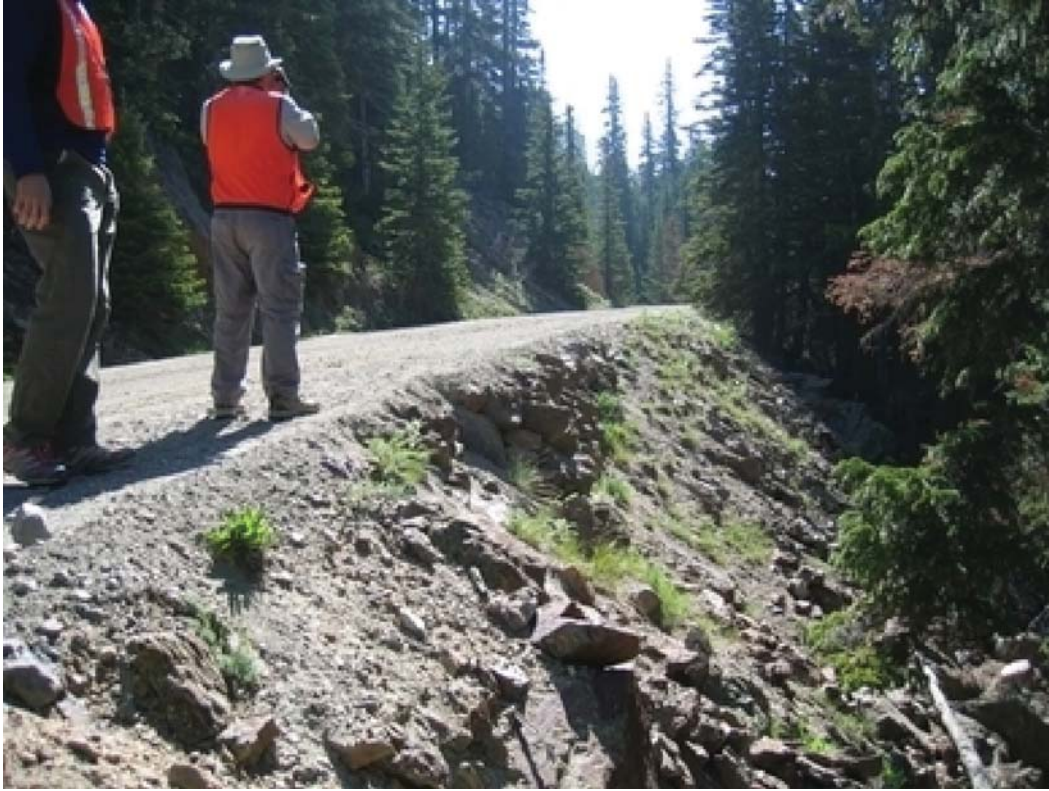
ROMO_0500_6.300_R_1.jpg

Element (Weighting Factor)	Narrative	Condition Rating (0 - 10)
PERFORMANCE 8.00	Fair to good, performing as intended.	6
WALL FOUNDATION MATERIAL 8.00	Founded on rock fill, no sign of settlement.	7
PLACED STONE 8.00	Moderately weathered, loose pieces.	6
ROAD/SIDEWALK/SHOULDER 1.00	Soft shoulder, raveling, some erosion.	4
LATERAL SLOPE 1.00	Ties into rock fill at both ends, very minor erosion.	6
DOWNSLOPE 1.00	Boulders, no sign of erosion.	7
WALL DRAINS 1.00	None observed. No water related problems.	7

Failure Consequence:	MODERATE
Recommendation Narrative:	None
Repair Cost:	\$0

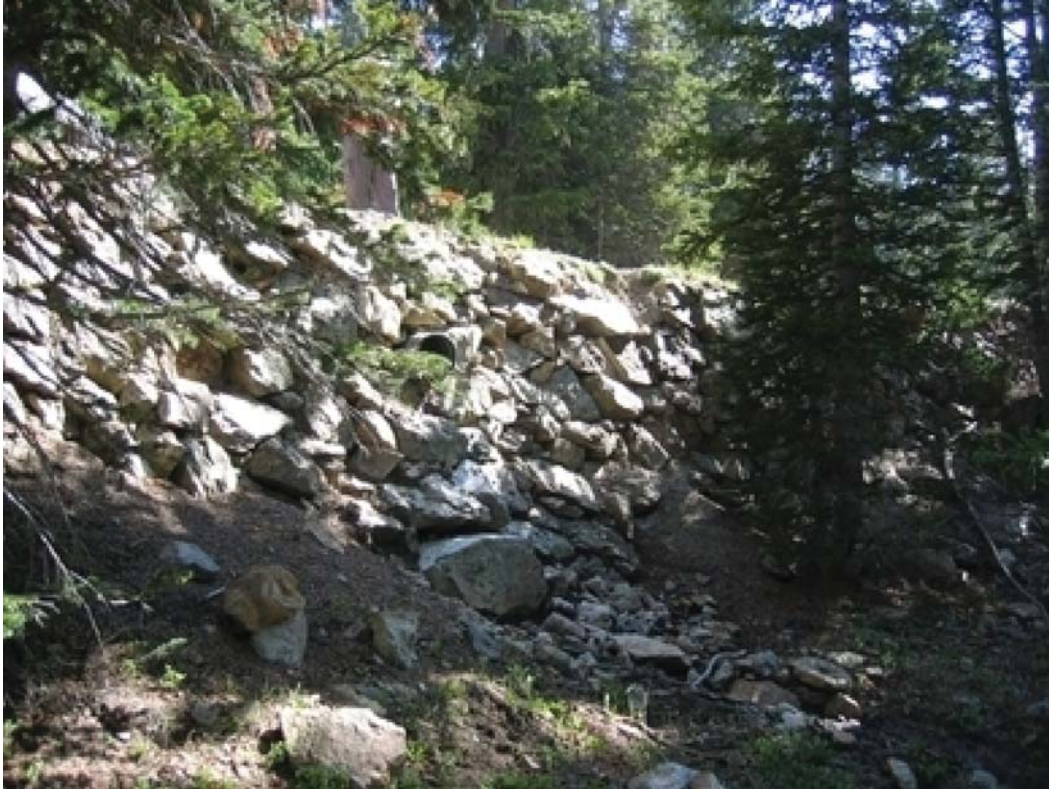
ROMO_0500_6.500_R_1.jpg

Element (Weighting Factor)	Narrative	Condition Rating (0 - 10)
PERFORMANCE 8.00	Good, performing as intended.	7
WALL FOUNDATION MATERIAL 8.00	Founded on soil/rock mix, no sign of settlement.	7
PLACED STONE 8.00	Moderately weathered, large and durable loose placed rock.	7
ROAD/SIDEWALK/SHOULDER 1.00	Some shoulder erosion at wall start.	6
CULVERT 1.00	18" CMP, minor corrosion, not affecting wall performance.	7
DOWNSLOPE 1.00	Soil/rock mix, no sign of erosion.	7
LATERAL SLOPE 1.00	Soil/rock mix at start and end, minor erosion at wall start.	7
WALL DRAINS 1.00	None observed. No water related problems.	7

Failure Consequence:	MODERATE
Recommendation Narrative:	None
Repair Cost:	\$0
