SHEN WIP Report

NPS Retaining Wall Inventory Program Shenandoah National Park

Federal Highway Administration
Eastern Federal Lands Highway Division
Road Inventory Program (RIP)

Data Collection Date: May 2007
Report Date: October 2015

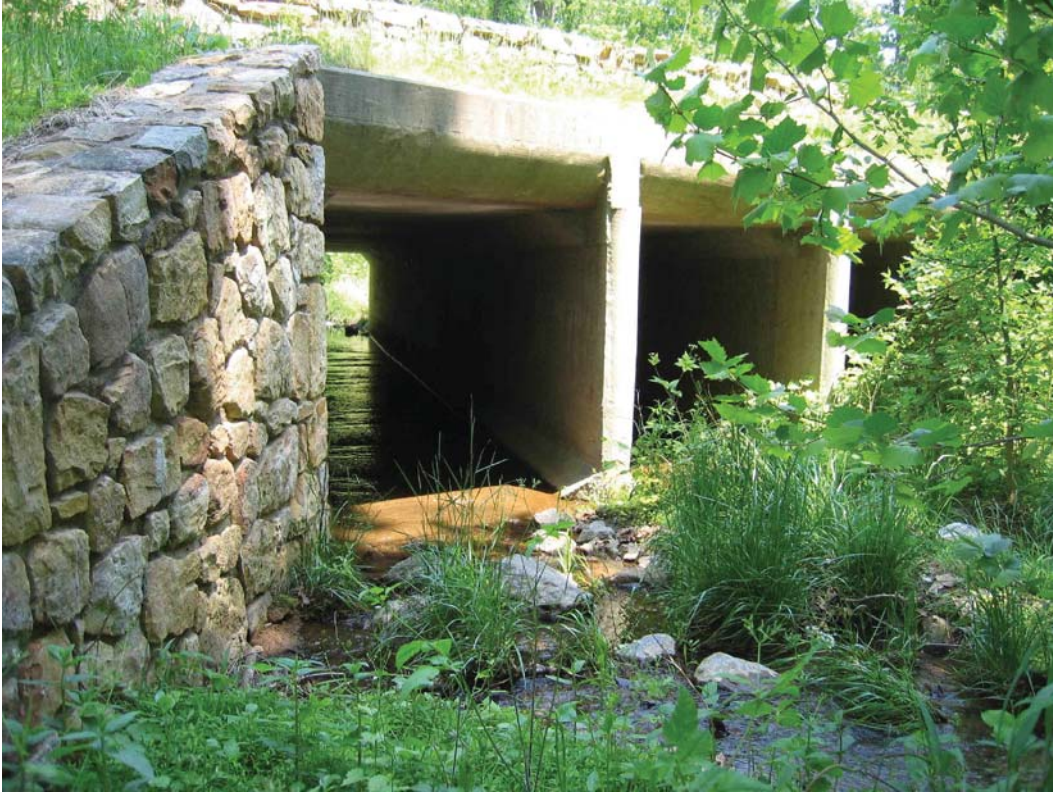
SHEN_0010A_0.188_R_1.jpg

Element (Weighting Factor)	Narrative	Condition Rating (0 - 10)
PERFORMANCE 8.00	Walls are performing as designed and constructed, showing no signs of global distress, settlement or displacement.	9
WALL FOUNDATION MATERIAL 8.00	Saturated soils and cobbles showing no signs of scour or other distress.	8
CONCRETE 8.00	Generally fresh, unweathered concrete showing no significant signs of cracking or other distress.	8
MORTAR 8.00	Unweathered, no signs of cracking, durable, and in-place.	8
STONE MASONRY 8.00	Minor weathering, no cracking or spalling, no missing blocks, well-cut blocks.	8
CULVERT 0.50	Functioning as designed, showing no signs of seepage or cracking within or about the box or wingwalls.	8
CURB/BERM/DITCH 0.50	Concrete curb shows no signs of wall-related distress.	8
DOWNSLOPE 0.50	Downslope is the drainage bottom, which shows no signs of significant channel erosion or other types of distress.	8

Failure Consequence:	MODERATE
Recommendation Narrative:	None
Repair Cost:	\$0

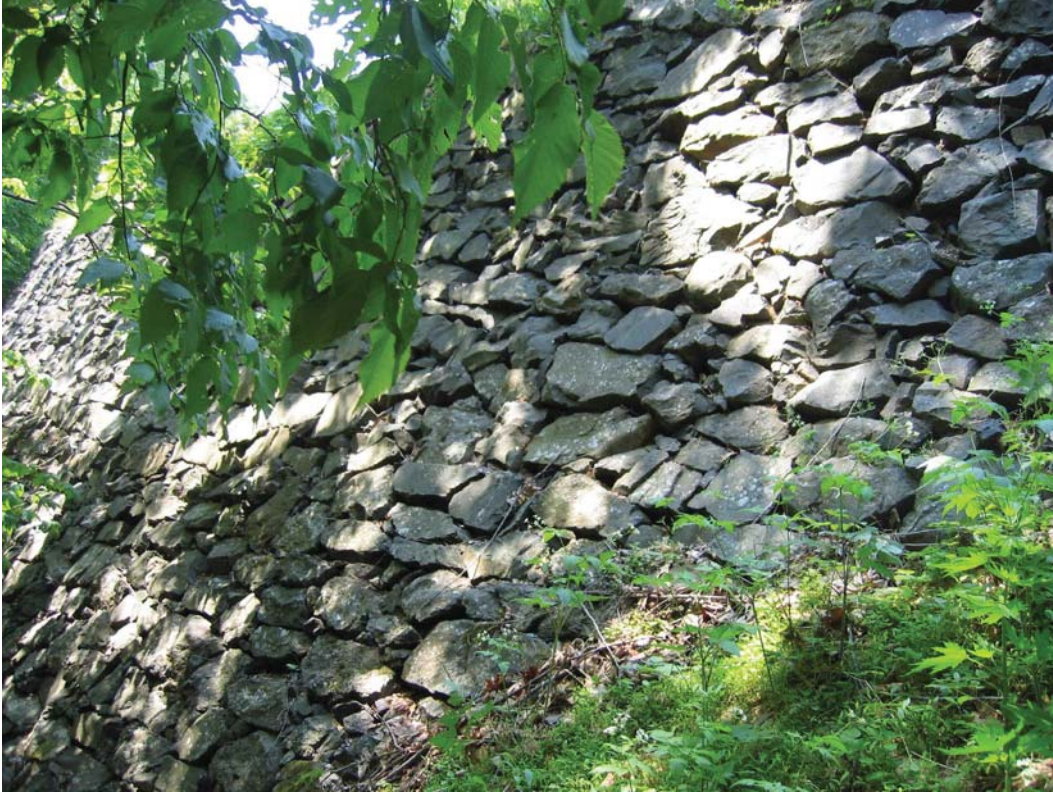
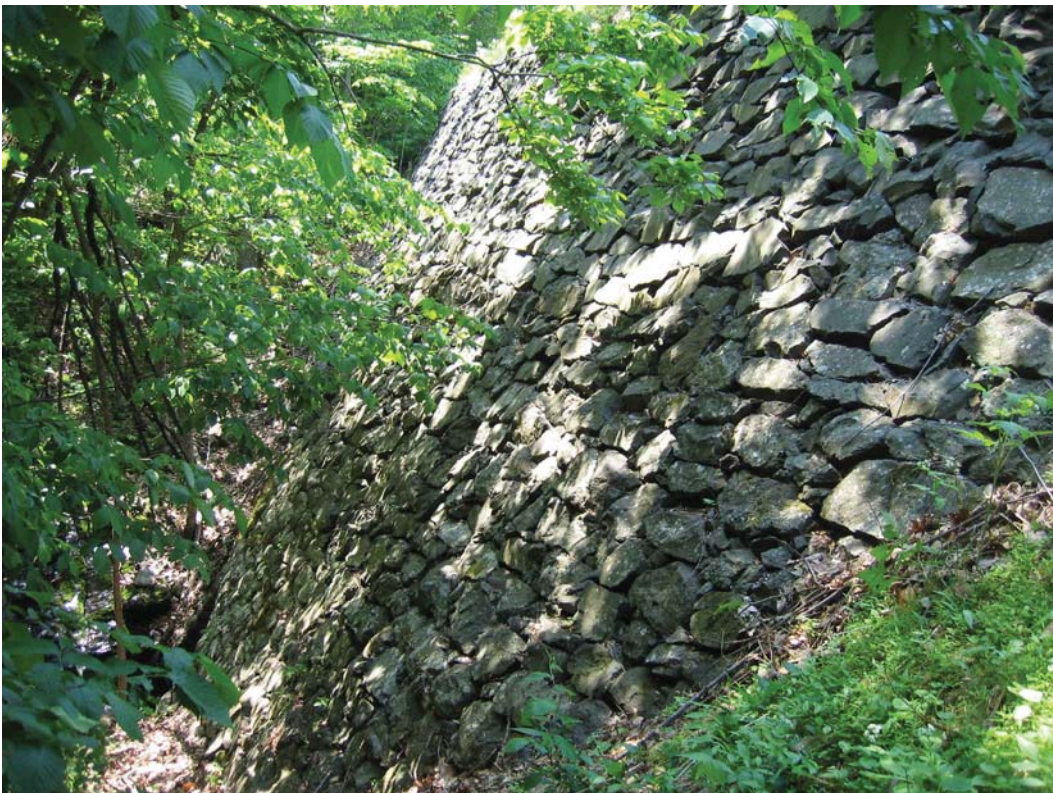
SHEN_0010A_1.536_L_1.jpg

Element (Weighting Factor)	Narrative	Condition Rating (0 - 10)
PERFORMANCE 8.00	Rough stone work and unknown retained soil conditions has resulted in minor bulging at isolated locations. Unknown if bulging is due to water/earth loads or due to slippage within placed rough-cut stone face. No signs of global failures, or of signifi	7
WALL FOUNDATION MATERIAL 8.00	Some bedrock visible in the immediate drainage at the wall toe. No signs of foundation-related wall distress. Difficult to see foundation material due to ground cover.	8
MORTAR 8.00	Minor mortar in lower few courses near box inlet. Weathered, separated from rock in places, missing in some places.	6
STONE MASONRY 8.00	Very rough-cut dry-laid rock showing minor weathering. No chinking is evident, with some slippage of facing rock (possible bulging of the face). Rock is generally angular and well interlocked.	7
CULVERT 0.50	Concrete box integrated into wall face is functioning as designed and constructed, showing no signs of significant distress, seepage, or displacement.	8

Failure Consequence:	HIGH
Recommendation Narrative:	None
Repair Cost:	\$0

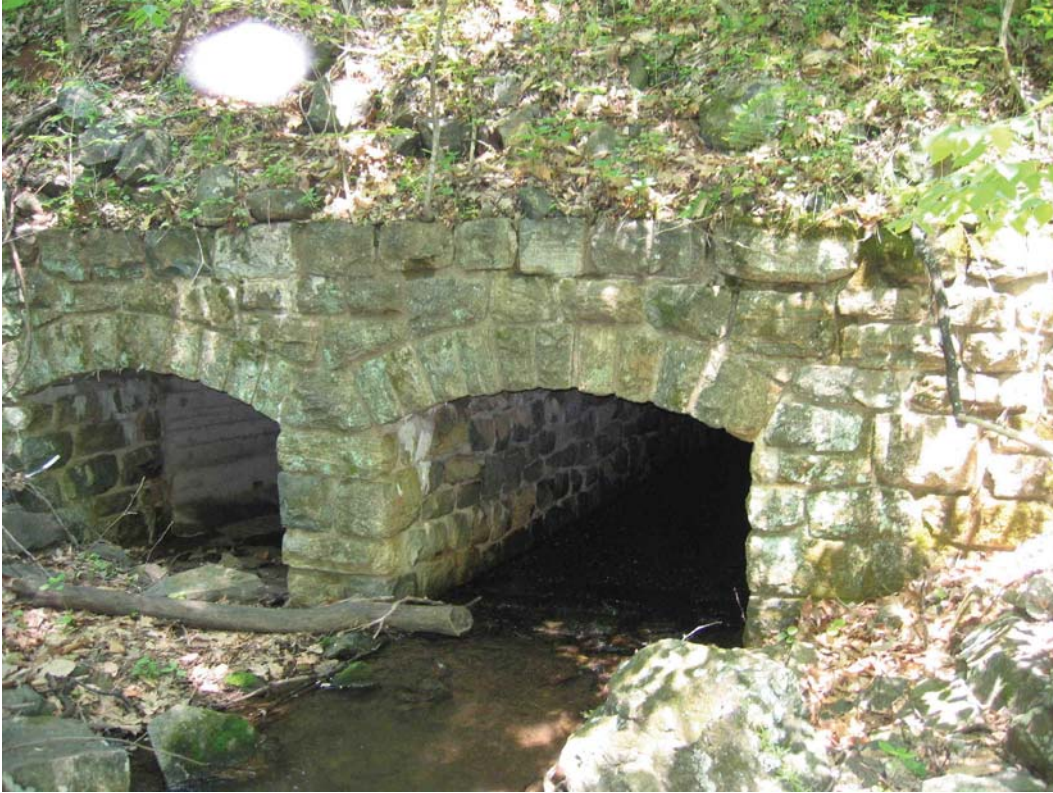
SHEN_0010A_1.854_L_1.jpg

Element (Weighting Factor)	Narrative	Condition Rating (0 - 10)
PERFORMANCE 8.00	Minor weathering of elements, but no global distresses, settlement, or displacement of the wingwalls or headwall structure.	8
WALL FOUNDATION MATERIAL 8.00	Saturated coarse aggregates and cobbles/boulders. Very stable foundation with no signs of scour or settlement.	8
MORTAR 8.00	Sound, durable, intact, with minor weathering. No signs of significant cracking.	7
STONE MASONRY 8.00	Sound, durable, with minor weathering. No cracked or missing blocks.	8
CULVERT 0.50	Culvert shows no signs of seepage in or around the box. Stone work within the box is intact and shows no signs of significant distress.	8
LATERAL SLOPE 0.50	Well-vegetated side slopes. Very stable.	8
TRAFFIC BARRIER/FENCE 0.50	Mortared stone masonry guardwall with no signs of wall-related distress.	8
DOWNSLOPE 0.50	Drainage bottom shows no signs of significant erosion or scour.	9

Failure Consequence:	MODERATE
Recommendation Narrative:	None
Repair Cost:	\$0

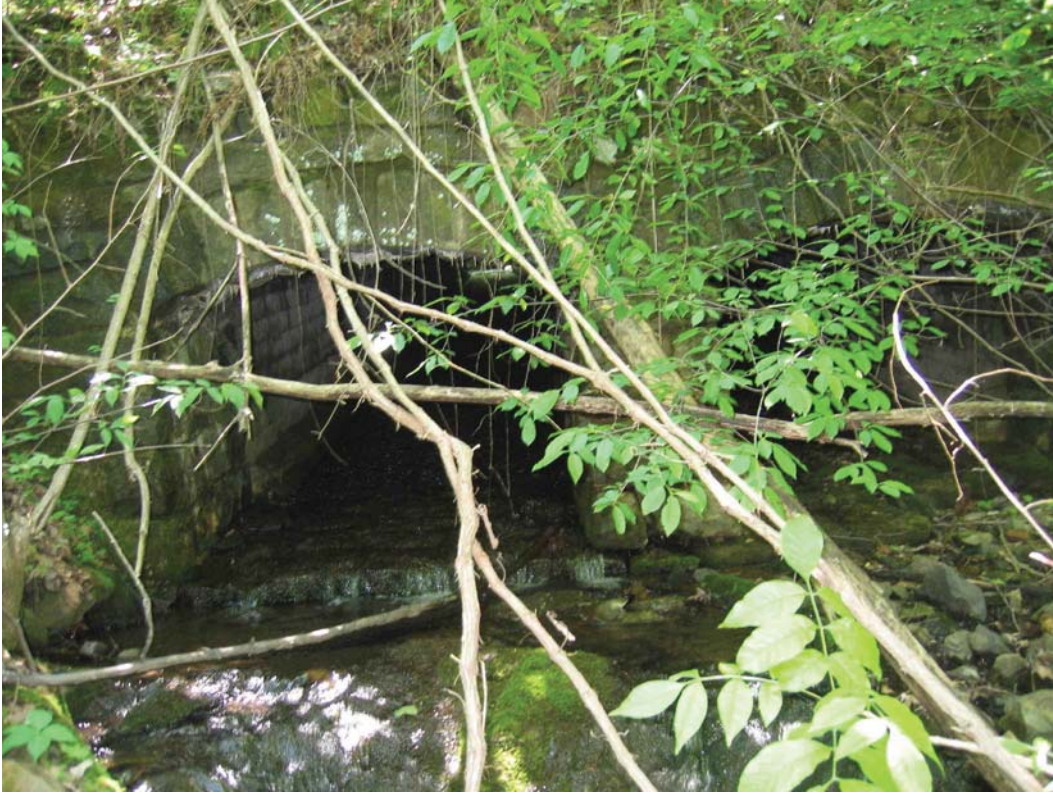
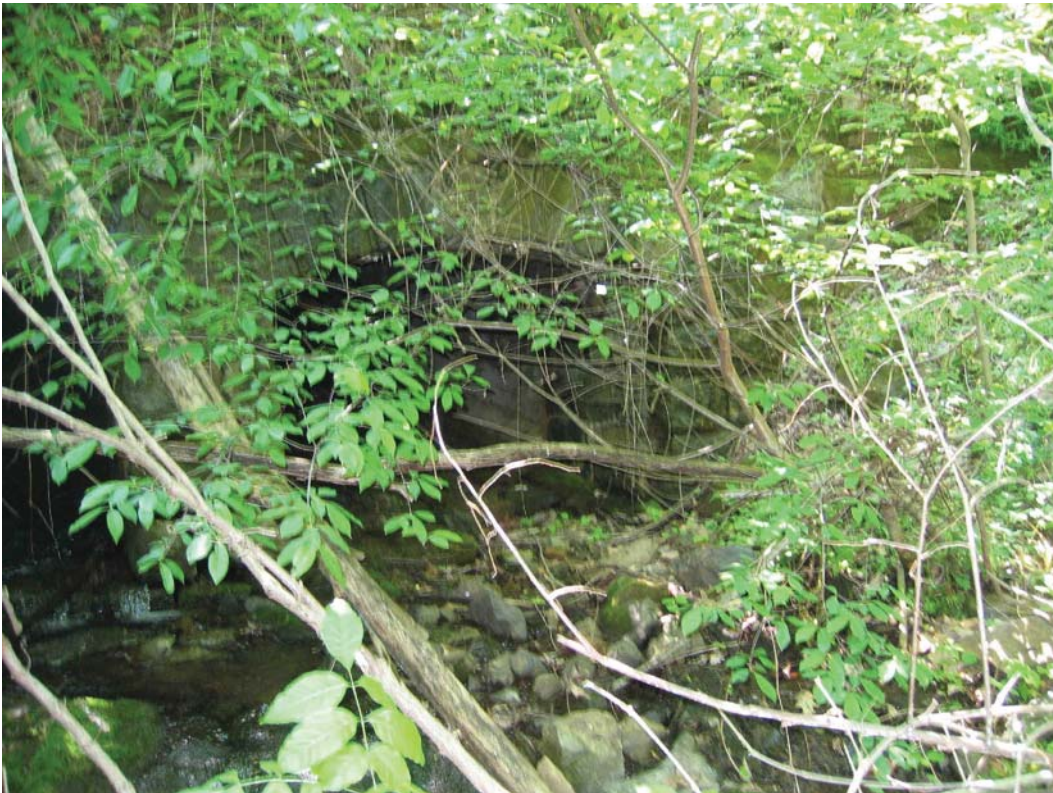
SHEN_0010A_1.857_R_1.jpg

Element (Weighting Factor)	Narrative	Condition Rating (0 - 10)
PERFORMANCE 8.00	Headwall/wingwalls are functioning as intended, showing signs of weathering and minor seepage distress to some elements. No signs of global distress, displacement or significant settlement of the structure.	8
WALL FOUNDATION MATERIAL 8.00	Saturated coarse aggregates and cobbles/boulders. Very stable foundation with no signs of scour or settlement.	8
MORTAR 8.00	Sound, durable, intact, with minor weathering. No signs of significant cracking.	7
STONE MASONRY 8.00	Sound, durable, with minor weathering. No cracked or missing blocks.	8
LATERAL SLOPE 0.50	Well-vegetated side slopes. Very stable.	8
TRAFFIC BARRIER/FENCE 0.50	Mortared stone masonry guardwall with no signs of wall-related distress.	8
UPSLOPE 0.50	Well-vegetated fill slope, very stable with no signs of bulging or sloughing.	8
DOWNSLOPE 0.50	Drainage bottom shows no signs of significant erosion or scour.	9

Failure Consequence:	MODERATE
Recommendation Narrative:	None
Repair Cost:	\$0

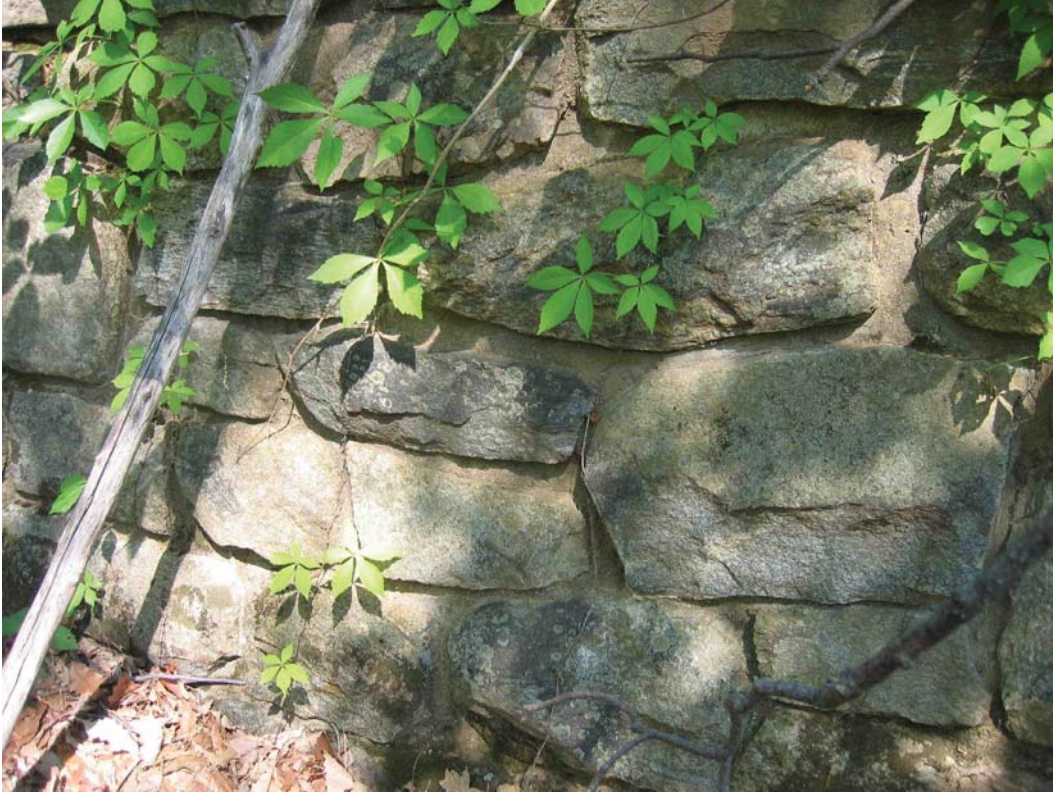
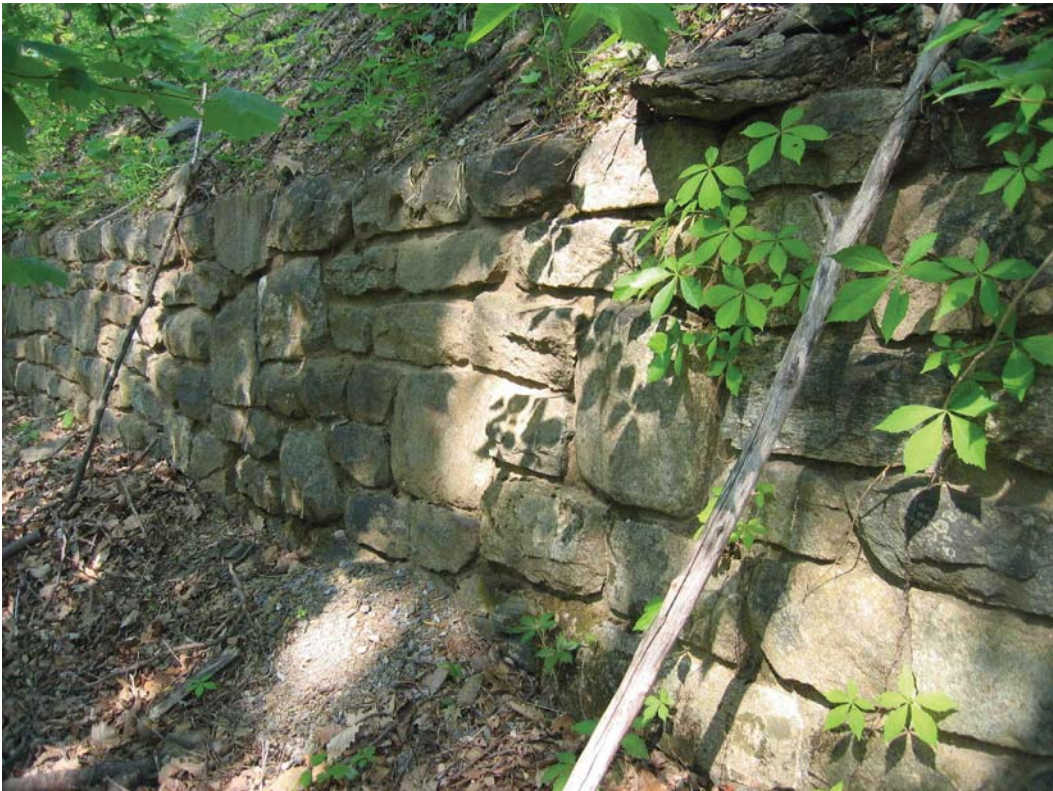
SHEN_0010A_8.386_L_1.jpg

Element (Weighting Factor)	Narrative	Condition Rating (0 - 10)
PERFORMANCE 8.00	Minor weathering of elements, but no global distresses, settlement, or displacement of the wall evident. Trees, shrubs and possibly buried wall sections should be cleared to better inspect and preserve wall performance.	7
WALL FOUNDATION MATERIAL 8.00	Rock fill with no signs of erosion, bulging or other distress.	8
MORTAR 8.00	Sound, durable, intact, with minor weathering. No signs of significant cracking.	7
STONE MASONRY 8.00	Sound, durable, with minor weathering. No cracked or missing blocks, though some sections of the wall are obscured by slide debris from top slope.	7
DOWNSLOPE 0.50	Well-vegetated fill slope, with signs of rock fill present. Very stable with no signs of bulging or sloughing.	8
LATERAL SLOPE 0.50	Well-vegetated fill slope, with signs of rock fill present. Very stable with no signs of bulging or sloughing.	8

TRAFFIC BARRIER/FENCE 0.50	Mortared stone masonry guardwall with no signs of wall-related distress.	8
ROAD/SIDEWALK/SHOULDER 0.50	Excellent condition with no signs of wall-related distress.	9
VEGETATION 1.00	Small trees and brush above and below the wall, with some minor impacting the wall. Brush and tress should be removed to prevent further impacts.	5

Failure Consequence:	MODERATE
Recommendation Narrative:	Clear small trees and brush from around top and toe of wall. Clear buried wall sections only if damage is observed once brush is removed. 40 hrs @ \$50/hr = \$2,000
Repair Cost:	\$2,000

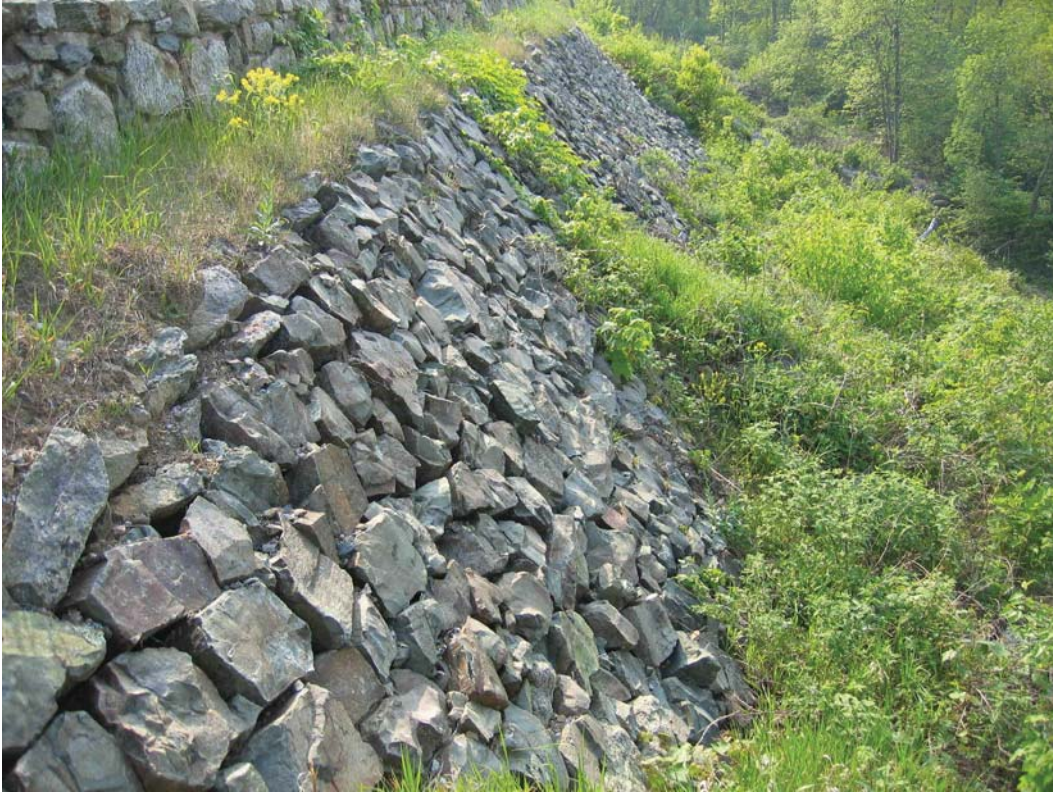
SHEN_0010A_10.878_L_1.jpg

Element (Weighting Factor)	Narrative	Condition Rating (0 - 10)
PERFORMANCE 8.00	No signs of global distress or significant slippage of rocks in the wall face. Performing as intended.	8
WALL FOUNDATION MATERIAL 8.00	Very stable rock fill foundation with no signs of bulging or settlement.	9
STONE MASONRY 8.00	Well-placed, chinked dry-laid rough-masoned stone. Relatively fresh, angular stone with minor weathering. No missing blocks evident.	8
DOWNSLOPE 0.50	Well-vegetated fill slope, with signs of rock fill present. Very stable with no signs of bulging or sloughing.	8
LATERAL SLOPE 0.50	Well-vegetated fill slope, with signs of rock fill present. Very stable with no signs of bulging or sloughing.	8
WALL DRAINS 0.50	No drains visible. Wall is free-draining, with no signs of water-related distress.	8
ROAD/SIDEWALK/SHOULDER 0.50	Excellent condition with no signs of wall-related distress.	9
TRAFFIC BARRIER/FENCE 0.50	Mortared stone masonry guardwall with no signs of wall-related distress.	9

Failure Consequence:	MODERATE
Recommendation Narrative:	None
Repair Cost:	\$0

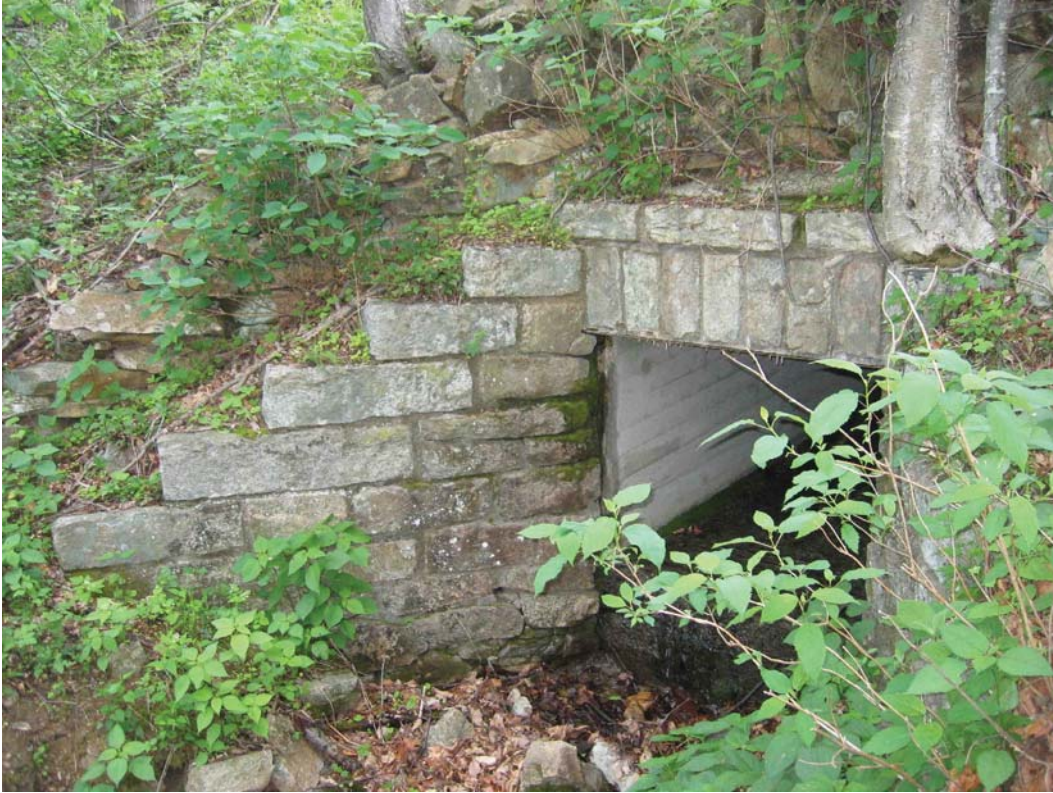
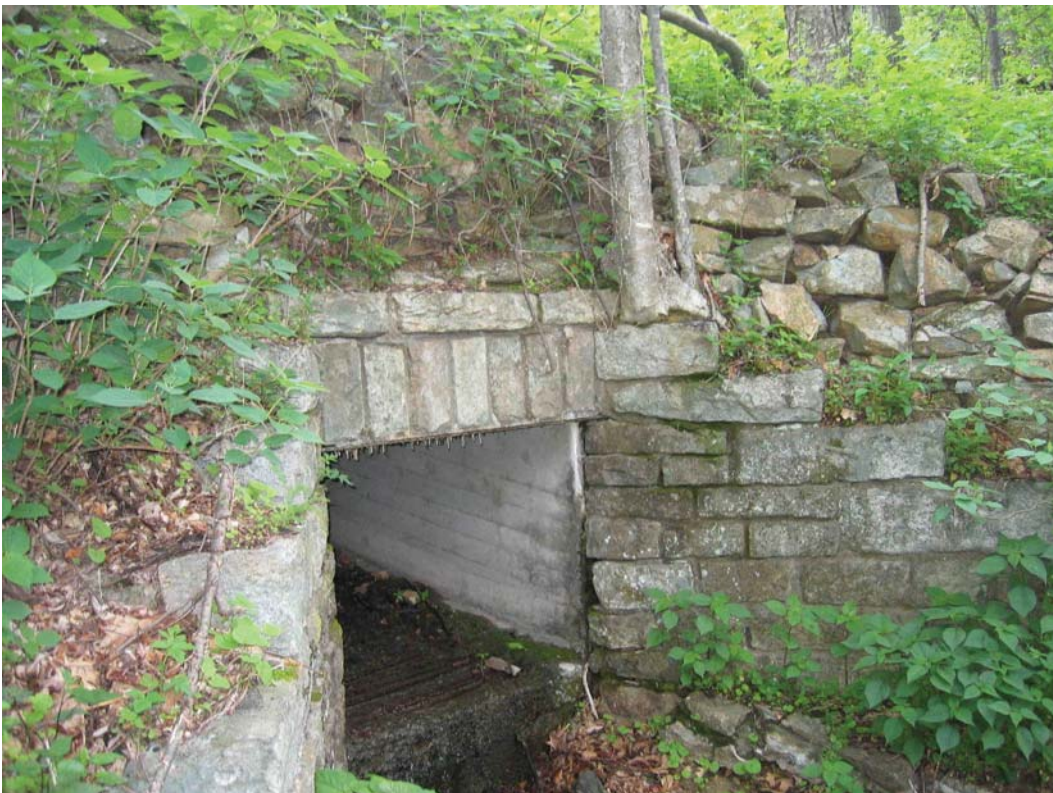
SHEN_0010A_12.012_L_1.jpg

Element (Weighting Factor)	Narrative	Condition Rating (0 - 10)
PERFORMANCE 8.00	Minor weathering of elements, but no global distresses, settlement, or displacement of the wingwalls or headwall structure.	8
WALL FOUNDATION MATERIAL 8.00	Coarse aggregates and cobbles/boulders. Very stable foundation with no signs of scour or settlement.	8
MORTAR 8.00	Sound, durable, intact, with minor weathering. No signs of significant cracking.	7
STONE MASONRY 8.00	Sound, durable, with minor weathering. No cracked or missing blocks.	8
CULVERT 0.50	Culvert shows no signs of seepage in or around the box. Stone work within the box is intact and shows no signs of significant distress.	8
DOWNSLOPE 0.50	Drainage bottom shows no signs of significant erosion or scour.	8
LATERAL SLOPE 0.50	Well-vegetated side slopes. Very stable.	8
ROAD/SIDEWALK/SHOULDER 0.50	Excellent condition with no signs of wall-related distress.	8
TRAFFIC BARRIER/FENCE 0.50	Mortared stone masonry guardwall with no signs of wall-related distress.	8

Failure Consequence:	LOW
Recommendation Narrative:	None
Repair Cost:	\$0

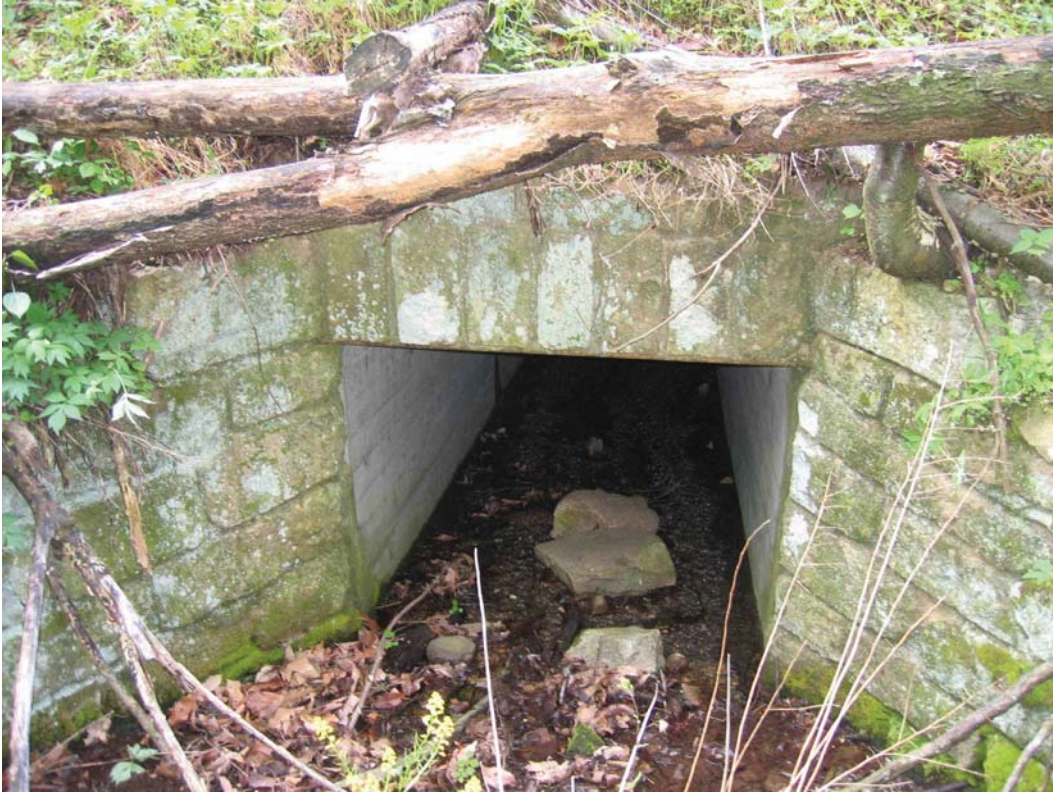
SHEN_0010A_12.012_R_1.jpg

Element (Weighting Factor)	Narrative	Condition Rating (0 - 10)
PERFORMANCE 8.00	Wall is showing no global signs of distress, but preventive maintenance is required to mitigate scour and vegetation problems.	6
WALL FOUNDATION MATERIAL 8.00	Coarse aggregates and cobbles/boulders. Very stable foundation with no signs of scour or settlement. Needs drainage fill to prevent scour of foundation in future.	7
MORTAR 8.00	Sound, durable, intact, with minor weathering. No signs of significant cracking.	7
PLACED STONE 8.00	Loosely placed, hard, angular rock. No chinking, but no missing blocks evident.	7
STONE MASONRY 8.00	Sound, durable, with minor weathering. No cracked or missing blocks.	8
CULVERT 0.50	Culvert shows no signs of seepage in or around the box. Stone work within the box is intact and shows no signs of significant distress.	8
DOWNSLOPE 1.00	Down-cutting in drainage below walls is scouring in front of the culvert. Rock fill needs to be added to the culvert to mitigate future scour problems.	4

Failure Consequence:	MODERATE
Recommendation Narrative:	Remove small trees from top of wall and place riprap for scour protection. Remove small trees: 4 hrs @ \$50/hr = \$200. Fill culvert drainage apron with riprap: 8 hrs @ \$50/hr = \$400. Total = \$600
Repair Cost:	\$600

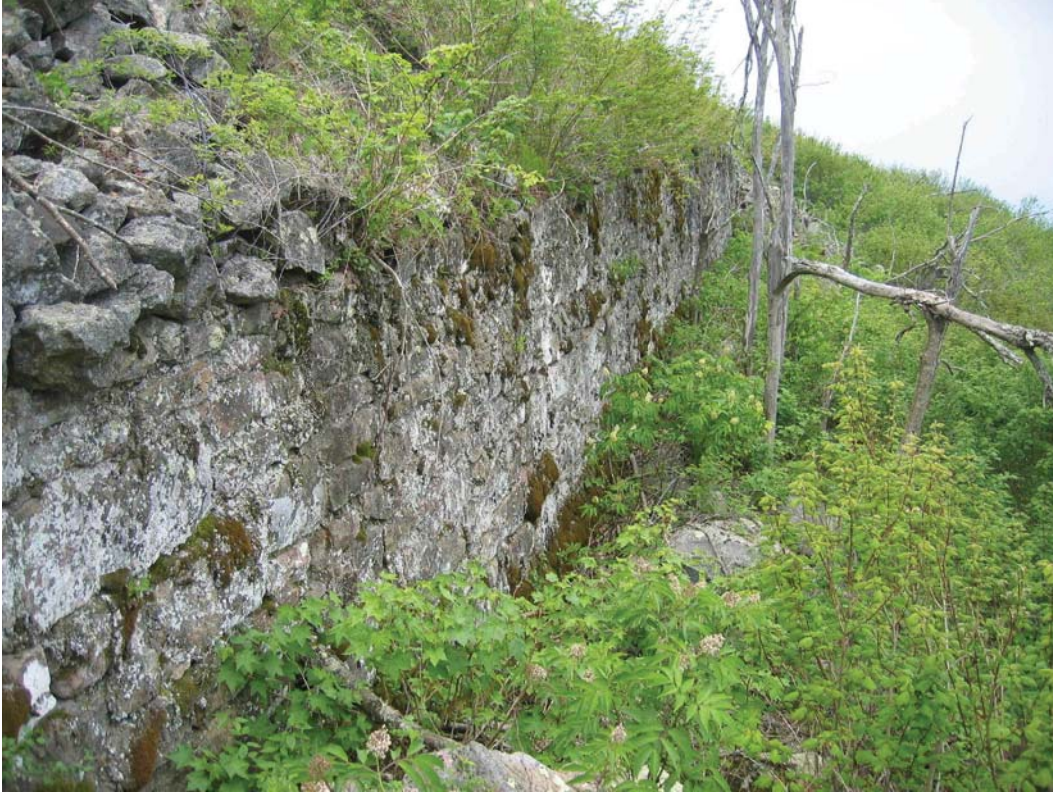
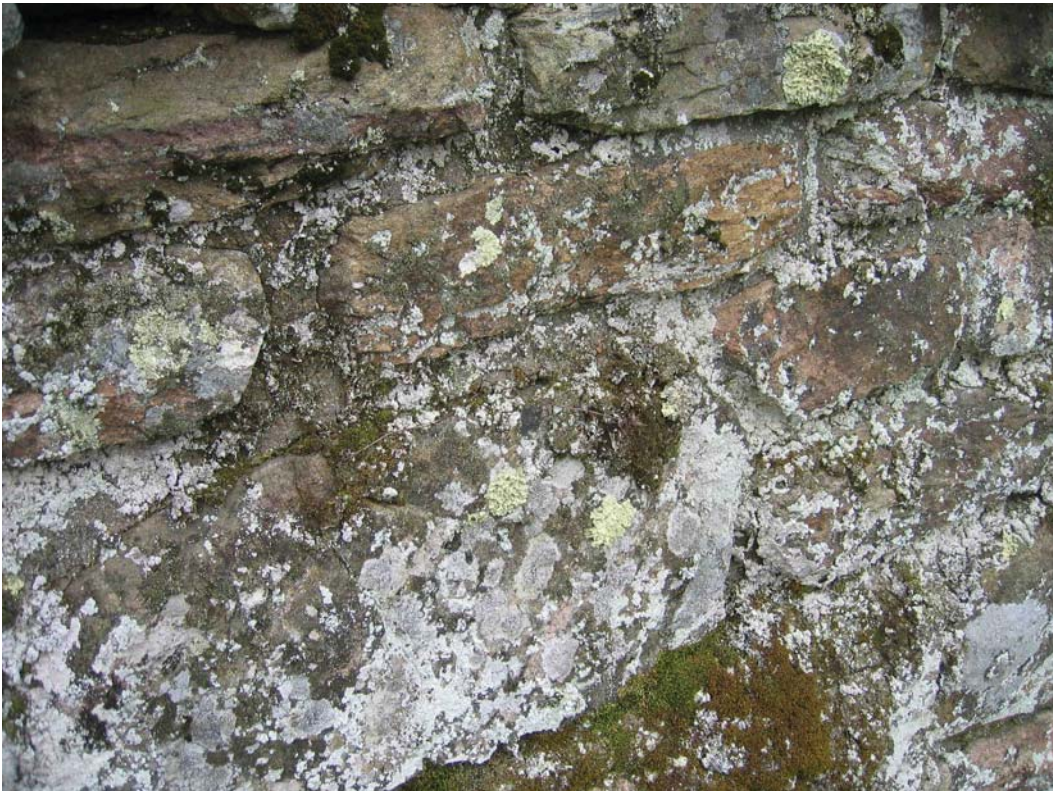
SHEN_0010A_21.093_R_1.jpg

Element (Weighting Factor)	Narrative	Condition Rating (0 - 10)
PERFORMANCE 8.00	No global distress observed, including significant settlement or wall displacement. Brush needs to be cleared and the end of the walls further inspected for ravel.	7
WALL FOUNDATION MATERIAL 8.00	Large boulder fill from the overlying road cut. Very stable with no signs of distress.	9
MORTAR 8.00	Moderately weathered, subject to isolated seepage in areas where mortar has separated from stone (moss evident at these locations). Mortar is generally present and intact, and hard.	7
STONE MASONRY 8.00	Hard, durable, unbroken or cracked blocks subject to surface weathering.	7
DOWNSLOPE 0.50	Large boulder fill - very stable.	8
LATERAL SLOPE 0.50	Lightly-vegetated fill slope, with substantial rock fill present. Very stable with no signs of bulging or sloughing.	8
TRAFFIC BARRIER/FENCE 0.50	Mortared stone masonry guardwall with no signs of wall-related distress.	8

Failure Consequence:	HIGH
Recommendation Narrative:	Remove brush and small trees from top of wall and inspect for additional wall damage. 30 hrs @ \$50/hr = \$1,500
Repair Cost:	\$1,500

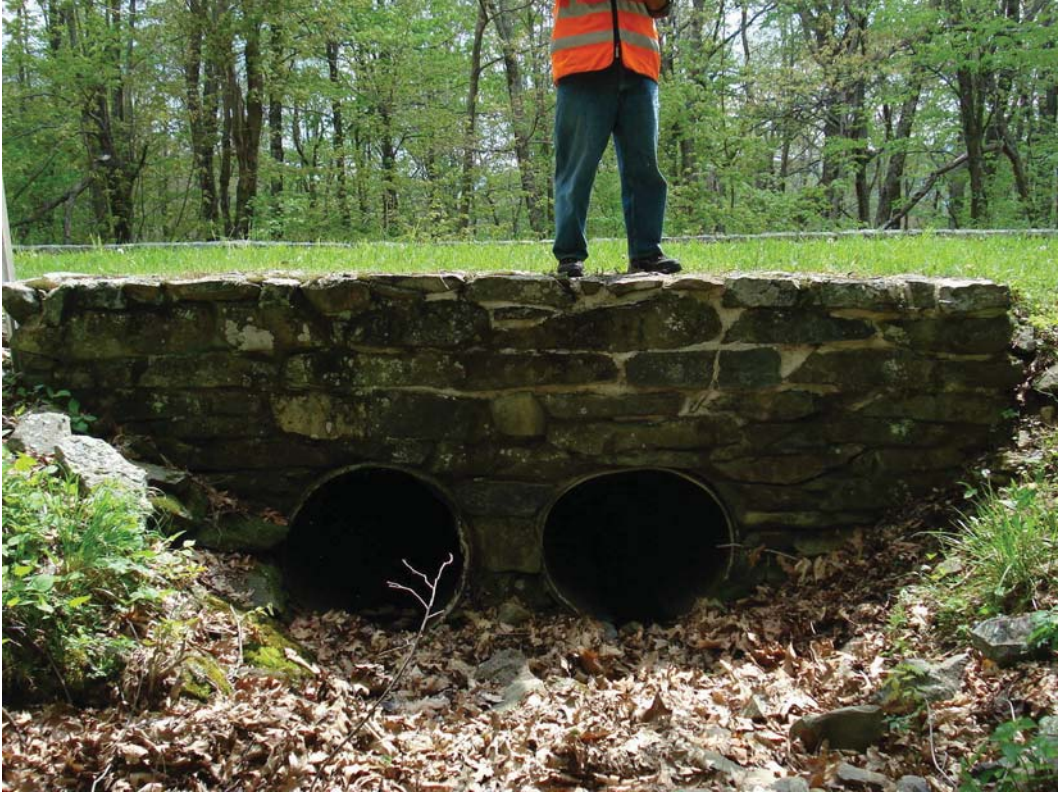
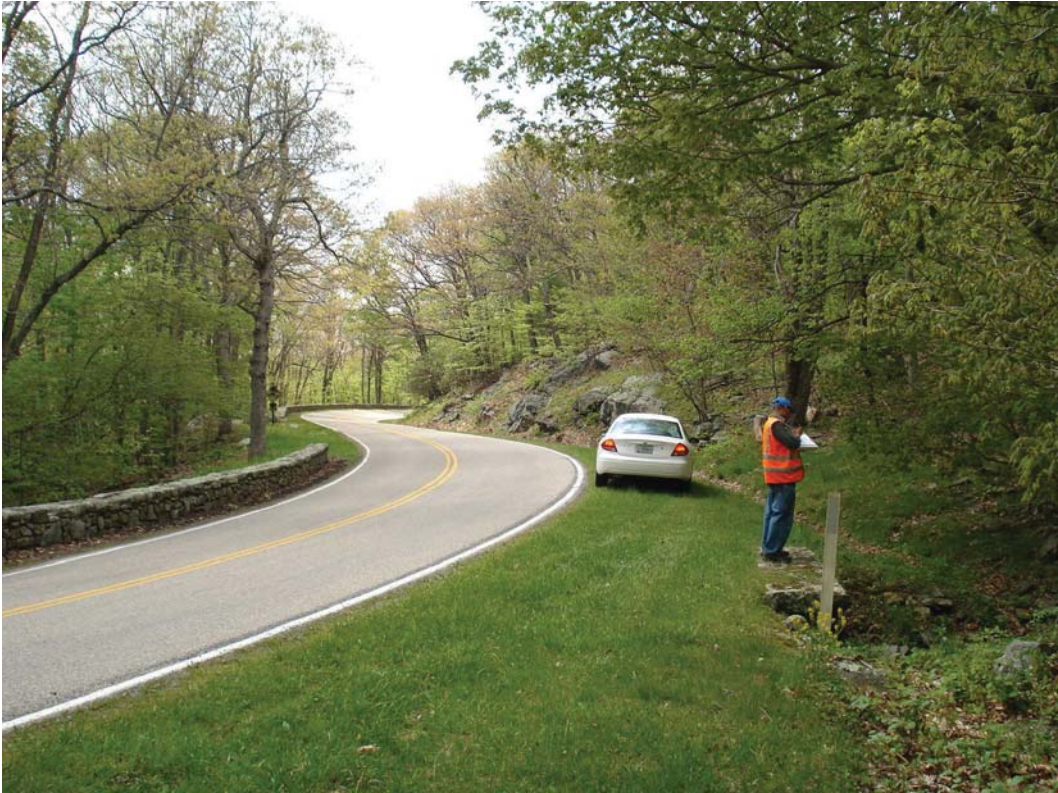
Wall ID:	SHEN-0010B-47.782-R		
Route Name:	SKYLINE DRIVE (CENTRAL)		
Inspection Date:	May 17, 2007	Approximate Year Built:	Unknown
*Wall Rating:	80	Maintenance Action:	No Action

Element (Weighting Factor)	Narrative	Condition Rating (0 - 10)
PERFORMANCE 8.00	Good to excellent performance of headwall; no evidence of movement or distress	8
WALL FOUNDATION MATERIAL 8.00	Wall founded on firm soil; no evidence of settlement or rotation	8
MORTAR 8.00	Generally good condition; shows sign of normal seasonal weathering; evidence of previous repointing along top of wall	8
STONE MASONRY 8.00	Stone blocks are in good condition; no sign of distress	8
CULVERT 0.50	Culvert appears to be in good conditions; leaves at/in the outlet impeding the flow of water should be removed	8
ROAD/SIDEWALK/SHOULDER 0.50	Asphalt pavement in good condition with minor cracking along outward wheel line (typical along the Drive); vegetated shoulder with no evidence of distress	8
UPSLOPE 0.50	Riprap erosion protection along the slope; no evidence of ongoing erosion	8
WALL DRAINS 0.50	Generally good drainage around wall; evidence of ongoing erosion of lateral slope at edges of HW	8

CURB/BERM/DITCH 0.50	Paved ditches graded to drain to the culverts are in good condition	9

Failure Consequence:	LOW
Recommendation Narrative:	None
Repair Cost:	\$0

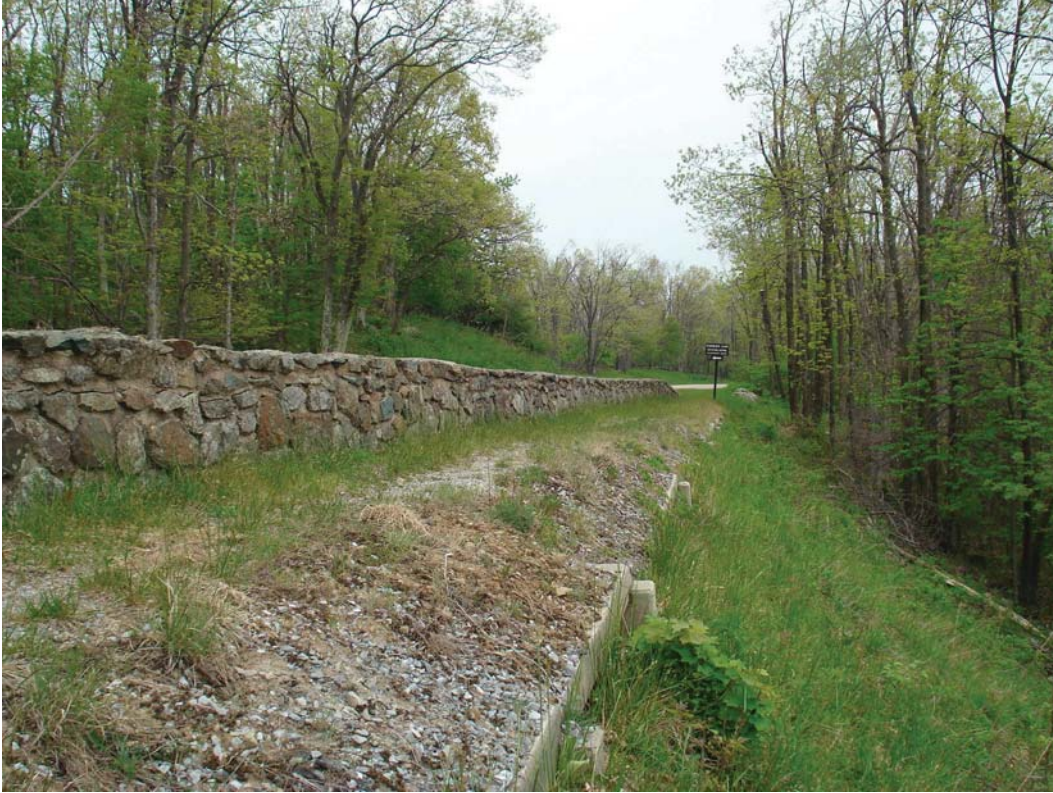
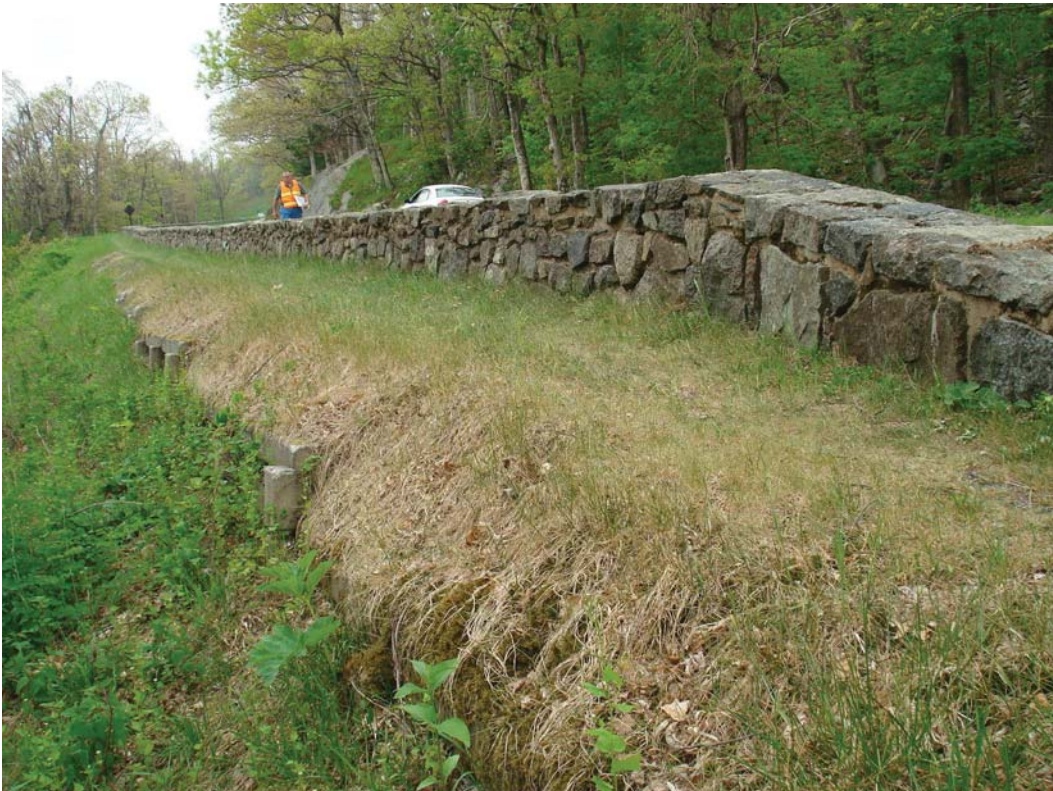
Wall ID:	SHEN-0010B-49.919-L		
Route Name:	SKYLINE DRIVE (CENTRAL)		
Inspection Date:	May 16, 2007	Approximate Year Built:	Unknown
*Wall Rating:	81	Maintenance Action:	No Action

Element (Weighting Factor)	Narrative	Condition Rating (0 - 10)
PERFORMANCE 8.00	Good to excellent performance of wall/headwall; no evidence of movement or distress	8
WALL FOUNDATION MATERIAL 8.00	Wall founded on soil and blast rock fill; no evidence of wall settlement or rotation	8
BIN OR CRIB 8.00	Concrete cribs appear to be in good condition; no evidence of distress	8
DOWNSLOPE 0.50	Moderate to steep slope (1(h):1(v)); steeper in sections; no evidence of slope movement or distress	8
ROAD/SIDEWALK/SHOULDER 0.50	Asphalt pavement in good condition with minor cracking along outward wheel line (typical along the Drive); vegetated shoulder with no evidence of distress	8
WALL DRAINS 0.50	Wall is self-draining; no observed drainage-related issues	8
LATERAL SLOPE 0.50	Ends of the wall are embedded into the slope; slope is in good condition with no sign of distress	9
TRAFFIC BARRIER/FENCE 0.50	GM guard wall at top of slope above wall; no observed distress	9

Failure Consequence:	HIGH
Recommendation Narrative:	None
Repair Cost:	\$0

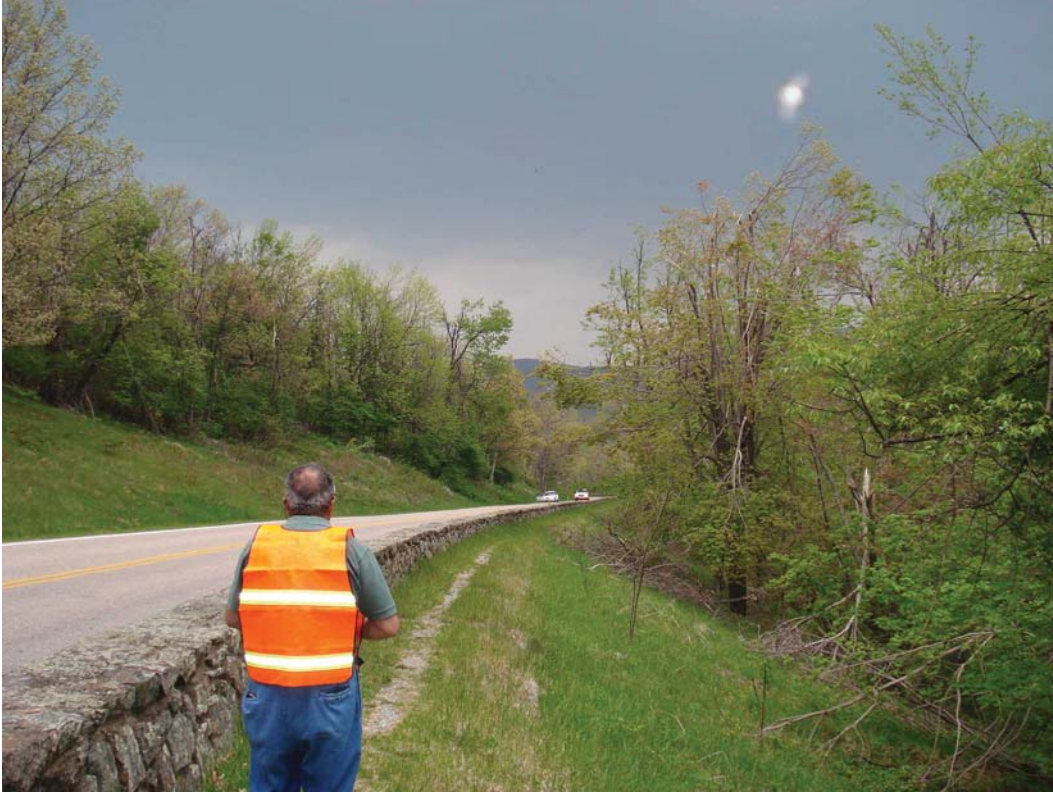
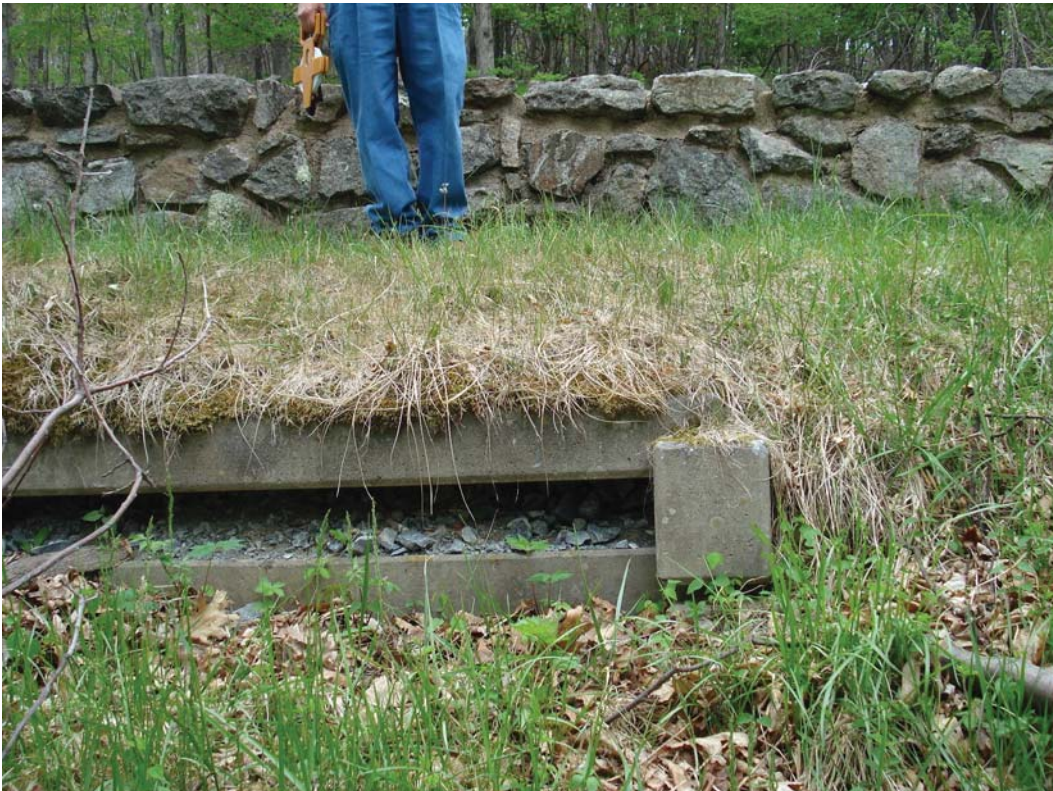
Wall ID:	SHEN-0010B-49.976-L		
Route Name:	SKYLINE DRIVE (CENTRAL)		
Inspection Date:	May 16, 2007	Approximate Year Built:	Unknown
*Wall Rating:	84	Maintenance Action:	No Action

Element (Weighting Factor)	Narrative	Condition Rating (0 - 10)
PERFORMANCE 8.00	Good to excellent performance of wall/headwall; no evidence of movement or distress	9
WALL FOUNDATION MATERIAL 8.00	Wall founded on firm soil; no evidence of settlement or rotation	8
BIN OR CRIB 8.00	Concrete cribs appear to be in good condition; no evidence of distress	8
WALL DRAINS 0.50	Wall is self-draining; no observed drainage-related issues	8
DOWNSLOPE 0.50	Moderate to steep slope (1(h):1(v)); steeper in sections; no evidence of slope movement or distress	9
LATERAL SLOPE 0.50	Ends of the wall are embedded into the slope; slope is in good condition with no sign of distress	9
ROAD/SIDEWALK/SHOULDER 0.50	Asphalt pavement in good condition with minor cracking along outward wheel line (typical along the Drive); vegetated shoulder with no evidence of distress	9
TRAFFIC BARRIER/FENCE 0.50	GM guard wall at top of slope above wall; no observed distress	9

Failure Consequence:	MODERATE
Recommendation Narrative:	None
Repair Cost:	\$0

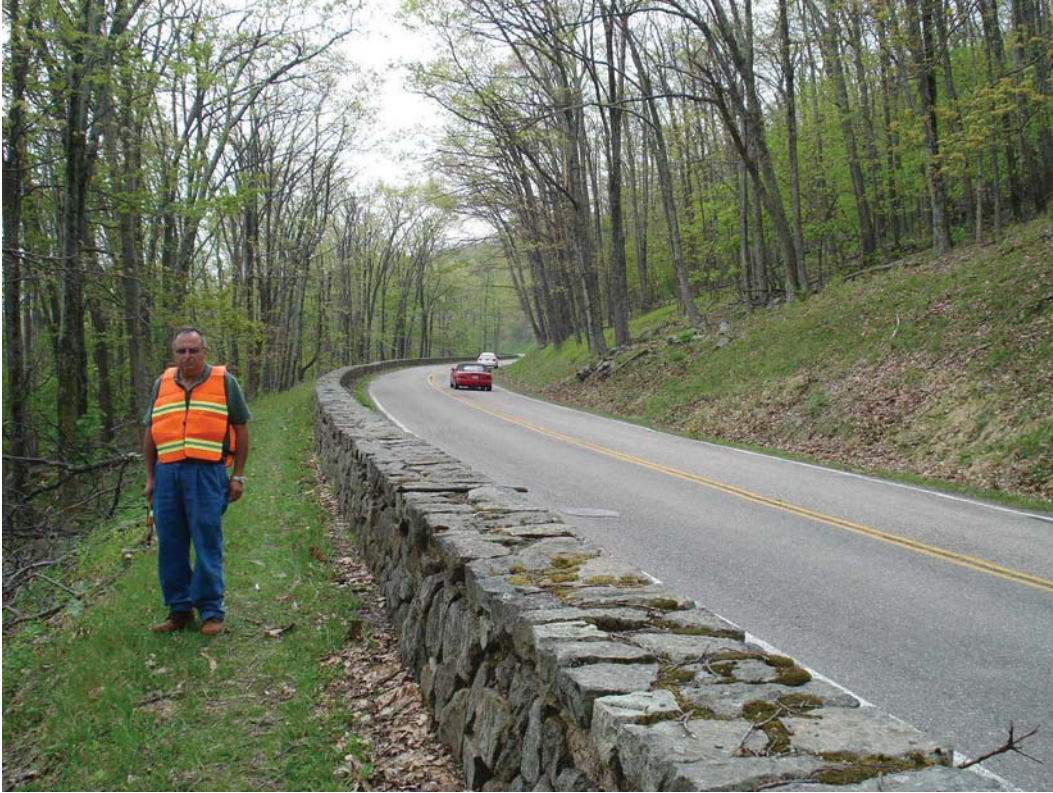
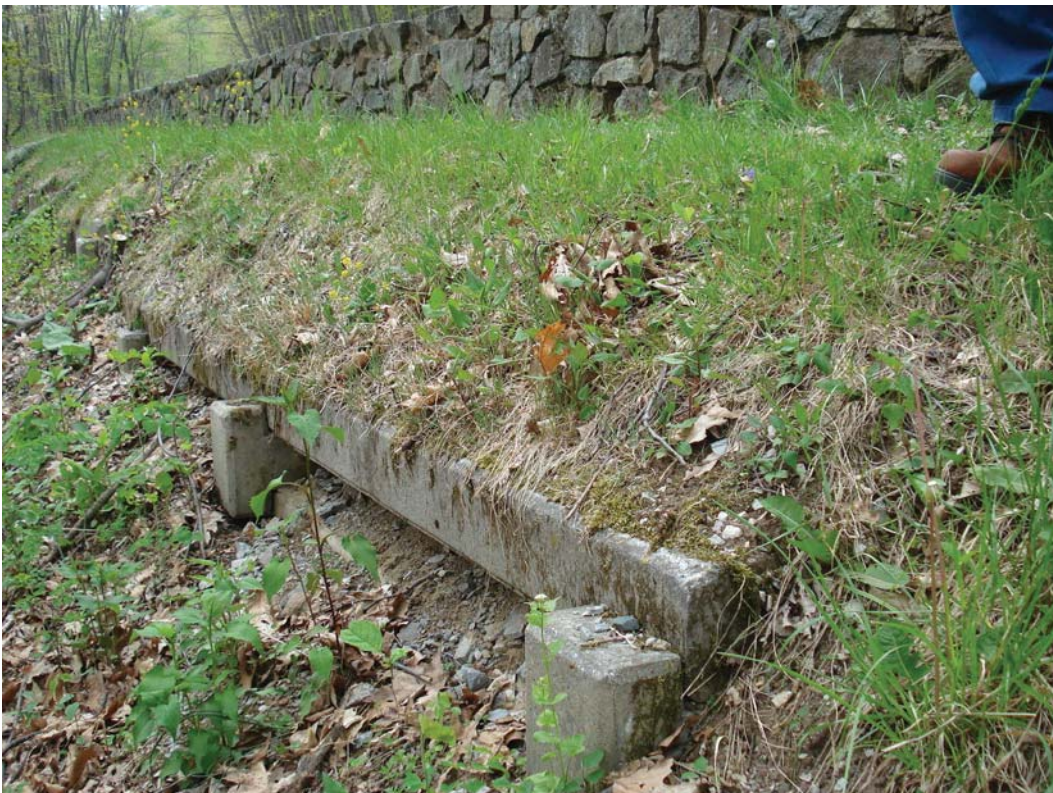
Wall ID:	SHEN-0010B-50.038-L		
Route Name:	SKYLINE DRIVE (CENTRAL)		
Inspection Date:	May 16, 2007	Approximate Year Built:	Unknown
*Wall Rating:	84	Maintenance Action:	No Action

Element (Weighting Factor)	Narrative	Condition Rating (0 - 10)
PERFORMANCE 8.00	Good to excellent performance of wall/headwall; no evidence of movement or distress	9
WALL FOUNDATION MATERIAL 8.00	Wall founded on firm soil; no evidence of settlement or rotation	8
BIN OR CRIB 8.00	Concrete cribs appear to be in good condition; no evidence of distress	8
DOWNSLOPE 0.50	Moderate to steep slope (1(h):1(v)); no evidence of slope movement or distress	8
WALL DRAINS 0.50	Wall is self-draining; no observed drainage-related issues	8
LATERAL SLOPE 0.50	No evidence of erosion or distress	9
ROAD/SIDEWALK/SHOULDER 0.50	Asphalt pavement in good condition with minor cracking along outward wheel line (typical along the Drive); vegetated shoulder with no evidence of distress	9
TRAFFIC BARRIER/FENCE 0.50	GM guard wall at top of slope above wall; no observed distress	9
UPSLOPE 0.50	Vegetated slope; relatively level; no evidence of slope movement	9

Failure Consequence:	HIGH
Recommendation Narrative:	None
Repair Cost:	\$0
