SHEN WIP Report

NPS Retaining Wall Inventory Program Shenandoah National Park

Federal Highway Administration
Eastern Federal Lands Highway Division
Road Inventory Program (RIP)

Data Collection Date: May 2007
Report Date: October 2015

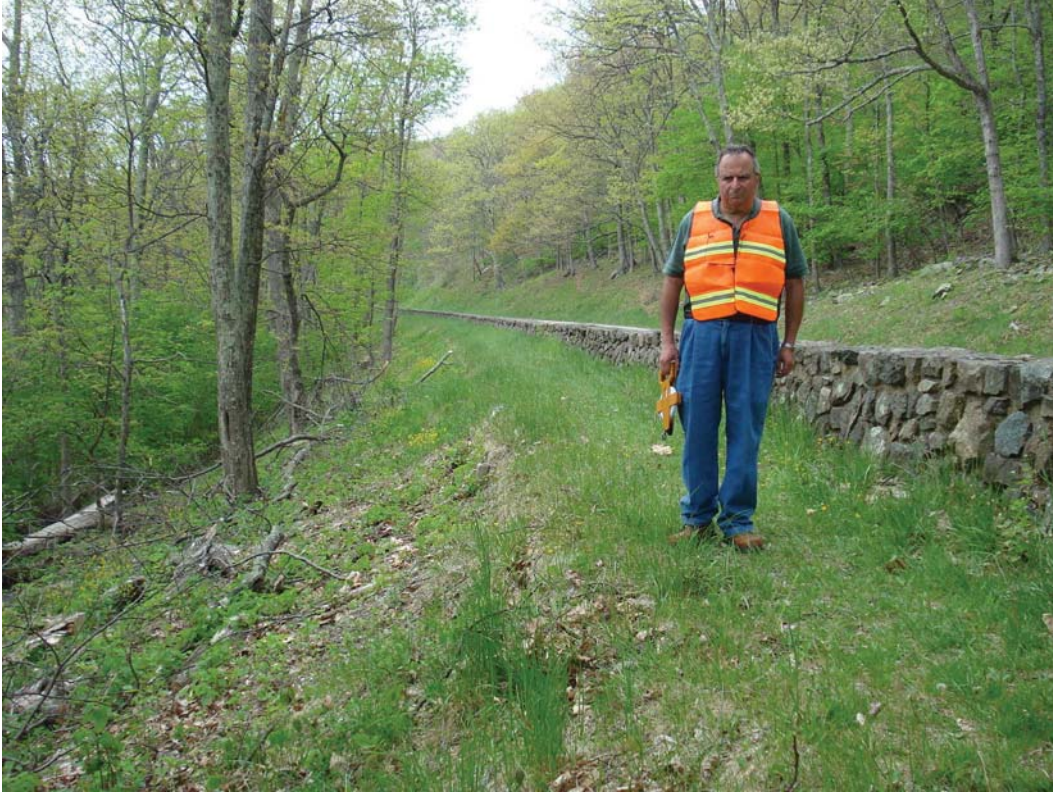
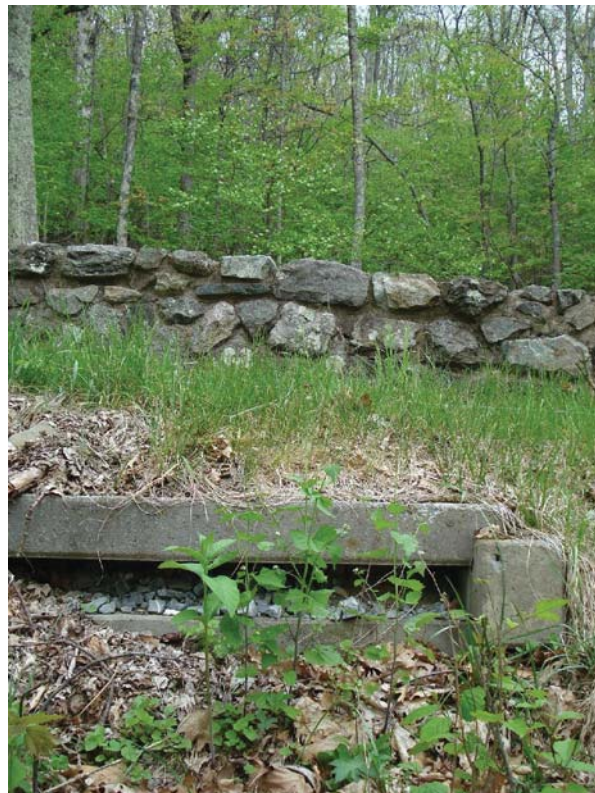
Wall ID:	SHEN-0010B-50.199-L		
Route Name:	SKYLINE DRIVE (CENTRAL)		
Inspection Date:	May 16, 2007	Approximate Year Built:	Unknown
*Wall Rating:	81	Maintenance Action:	No Action

Element (Weighting Factor)	Narrative	Condition Rating (0 - 10)
PERFORMANCE 8.00	Good to excellent wall performance; no observed movement or distress	8
WALL FOUNDATION MATERIAL 8.00	Wall founded on firm soil; no evidence of settlement or rotation	8
BIN OR CRIB 8.00	Concrete cribs appear to be in good condition; no evidence of distress	8
DOWNSLOPE 0.50	Steep slope (1(h):1(v); steeper in sections; no evidence of slope movement or distress	8
ROAD/SIDEWALK/SHOULDER 0.50	Asphalt pavement in good condition with minor cracking along outward wheel line (typical along the Drive); vegetated shoulder with no evidence of distress	8
UPSLOPE 0.50	Vegetated slope; level to steep; no evidence of slope movement	8
WALL DRAINS 0.50	Wall is self-draining; no observed drainage-related issues	8
CULVERT 0.50	24-in. diameter corrugated metal culvert through wall (approx. MP49.88) shows no evidence of distress; 18-in. diameter corrugated metal culvert through wall (approx. MP50.01) - no evidence of distress	9

Failure Consequence:	HIGH
Recommendation Narrative:	None
Repair Cost:	\$0

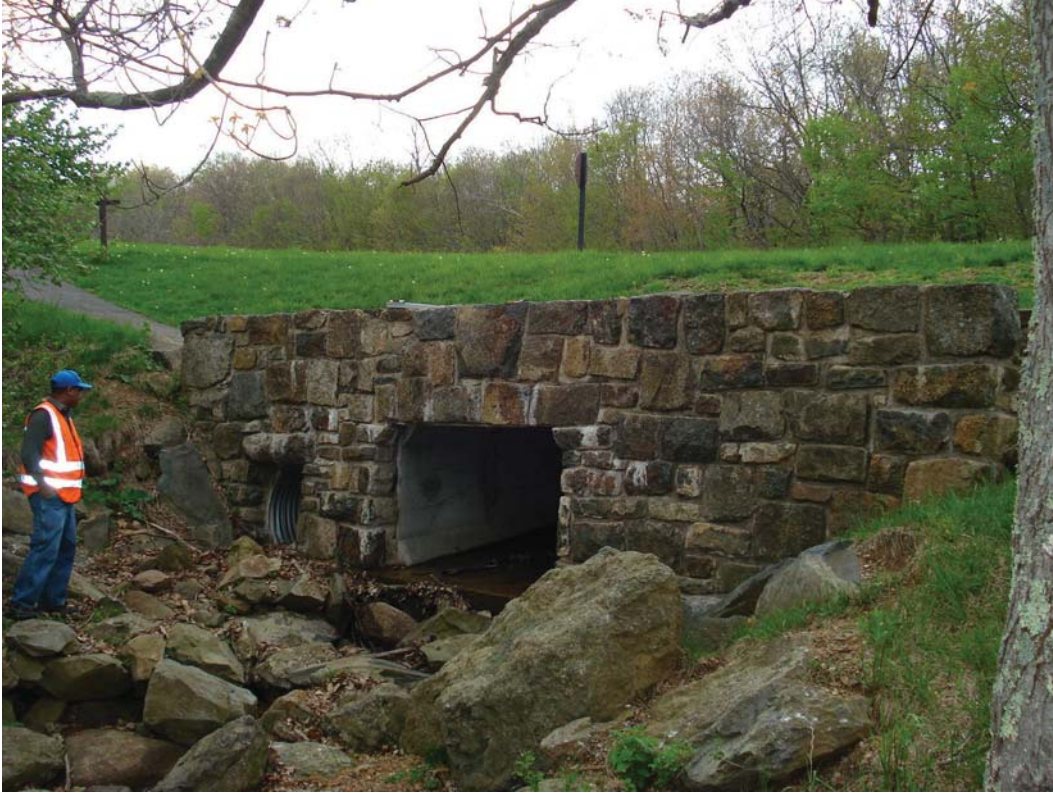
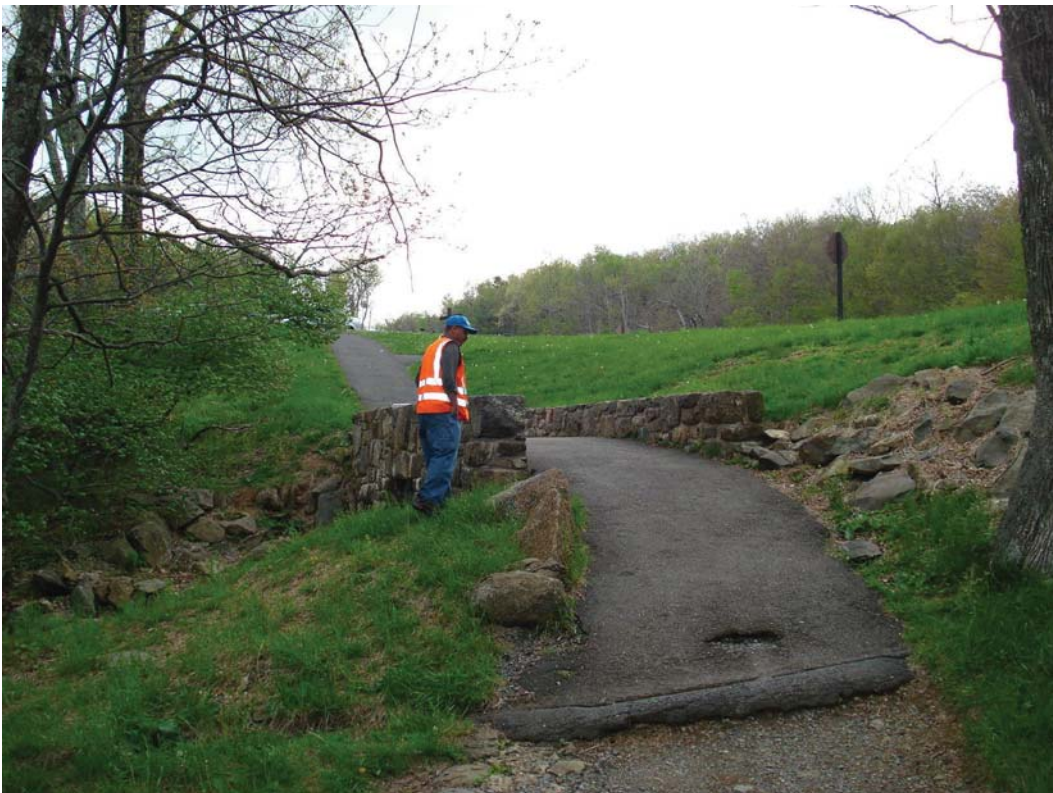
Wall ID:	SHEN-0010B-50.929-L		
Route Name:	SKYLINE DRIVE (CENTRAL)		
Inspection Date:	May 17, 2007	Approximate Year Built:	Unknown
*Wall Rating:	80	Maintenance Action:	No Action

Element (Weighting Factor)	Narrative	Condition Rating (0 - 10)
PERFORMANCE 8.00	Good to excellent performance; No observed movement or distress	8
WALL FOUNDATION MATERIAL 8.00	Wall founded on concrete footing on firm soil; no evidence of settlement or rotation	8
MORTAR 8.00	Generally good condition; shows sign of normal seasonal weathering	8
STONE MASONRY 8.00	Stone blocks are in good condition; no sign of distress	8
CULVERT 0.50	Culvert appears to be in good conditions; minor rusting of metal culvert invert; evidence of buckling within the metal culvert	8
DOWNSLOPE 0.50	Adequate riprap outlet protection; no evidence of ongoing erosion	8
LATERAL SLOPE 0.50	Good condition; no evidence of erosion	8
ROAD/SIDEWALK/SHOULDER 0.50	Skyline Dr. within influence of HW; asphalt pavement with minor cracking along outward wheel line (typical along the Drive); vegetated shoulder with no evidence of distress; asphalt trail on top of wall in good condition	8

Failure Consequence:	MODERATE
Recommendation Narrative:	None
Repair Cost:	\$0

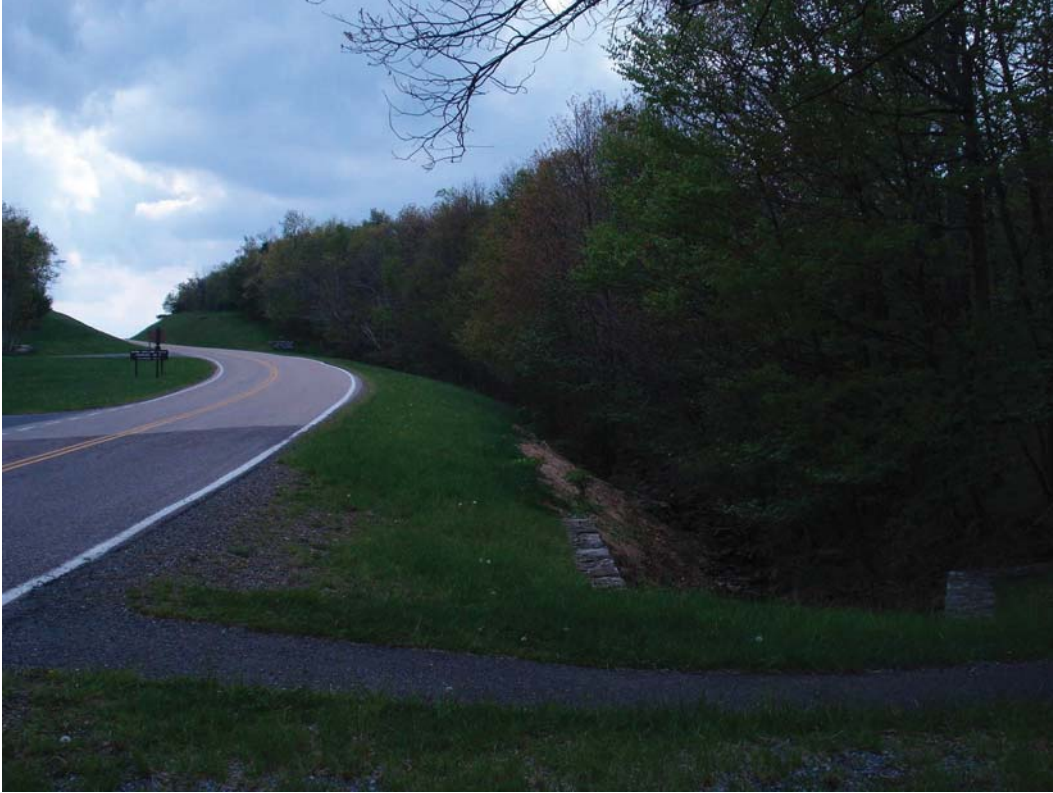
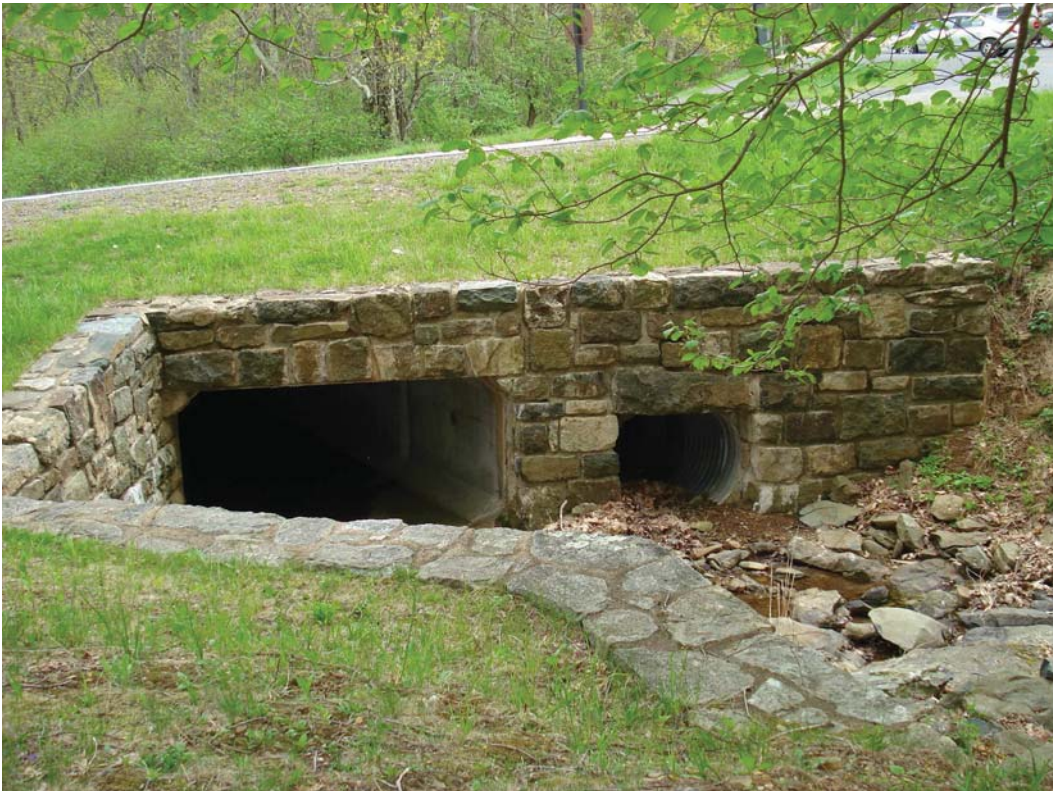
Wall ID:	SHEN-0010B-50.932-R		
Route Name:	SKYLINE DRIVE (CENTRAL)		
Inspection Date:	May 17, 2007	Approximate Year Built:	Unknown
*Wall Rating:	80	Maintenance Action:	No Action

Element (Weighting Factor)	Narrative	Condition Rating (0 - 10)
PERFORMANCE 8.00	Good to excellent performance of the headwall; no evidence of wall movement or distress	8
WALL FOUNDATION MATERIAL 8.00	Wall founded on firm soil; no evidence of settlement or rotation	8
MORTAR 8.00	Generally good condition; shows sign of normal seasonal weathering	8
STONE MASONRY 8.00	Stone blocks are in good condition; no sign of distress	8
CULVERT 0.50	Culvert appears to be in good conditions; minor rusting along invert of metal culvert; leaves at opening of metal culvert impeding flow of water	8
ROAD/SIDEWALK/SHOULDER 0.50	Asphalt pavement with minor cracking along outward wheel line (typical along the Drive); vegetated shoulder with no evidence of distress	8
UPSLOPE 0.50	Riprap outlet protection along slope leading to culverts; no evidence of ongoing erosion	8
VEGETATION 0.50	No large vegetation immediate to wall	9

Failure Consequence:	MODERATE
Recommendation Narrative:	None
Repair Cost:	\$0

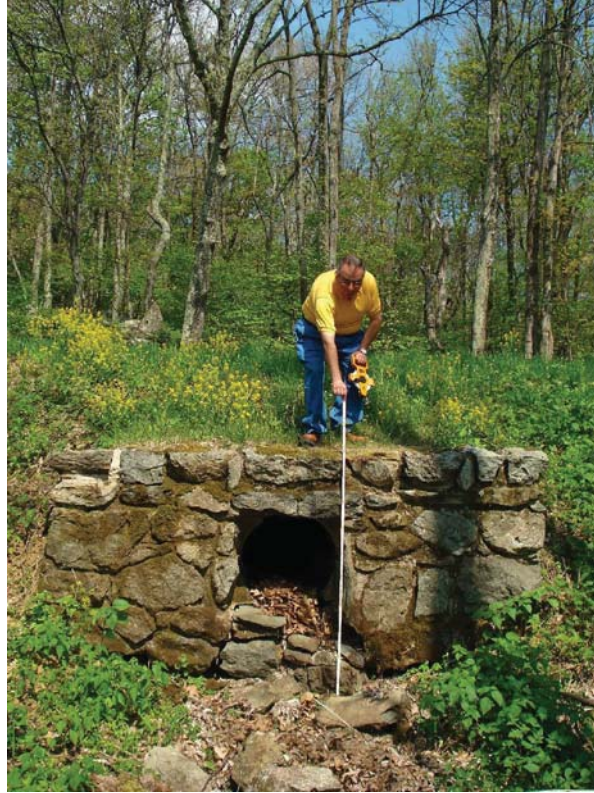
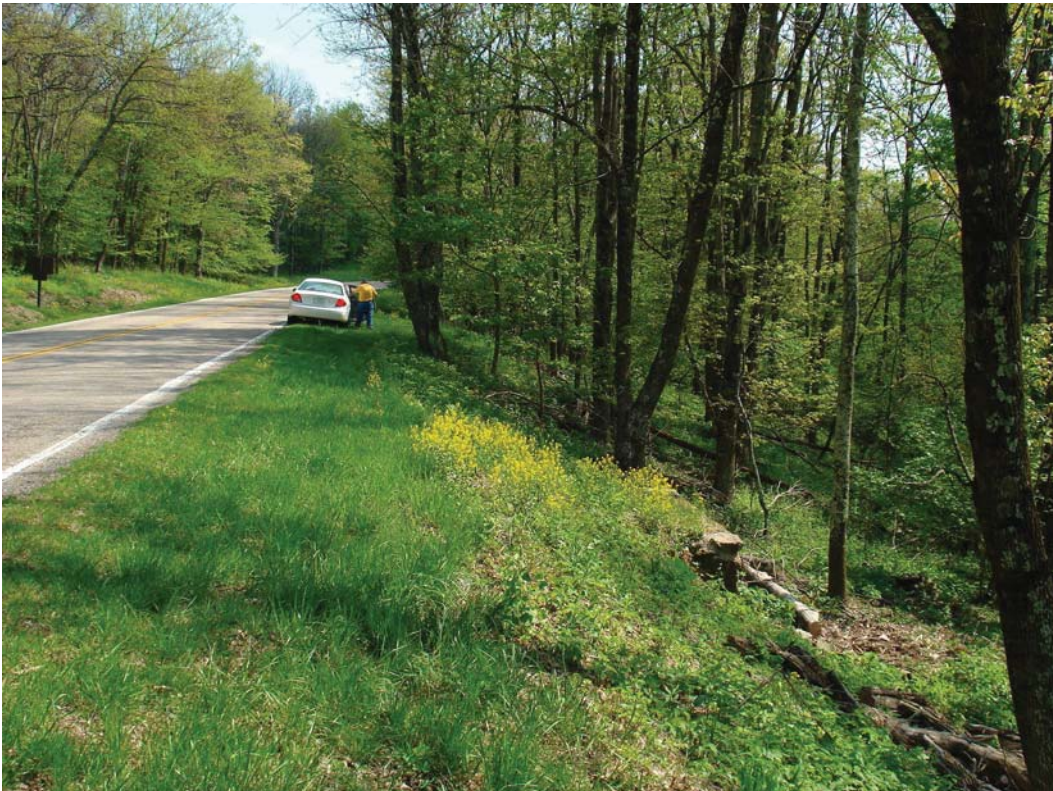
Wall ID:	SHEN-0010B-53.615-R		
Route Name:	SKYLINE DRIVE (CENTRAL)		
Inspection Date:	May 15, 2007	Approximate Year Built:	Unknown
*Wall Rating:	71	Maintenance Action:	Repair Elements

Element (Weighting Factor)	Narrative	Condition Rating (0 - 10)
PERFORMANCE 8.00	Good condition; some minor repair required to reset loose blocks below the culvert	7
WALL FOUNDATION MATERIAL 8.00	Wall founded on firm soil; no evidence of settlement or rotation	8
STONE MASONRY 8.00	Blocks are generally in good condition; no sign of distress; loose blocks below the culvert opening need to be replaced	6
MORTAR 8.00	Generally good condition; shows sign of normal seasonal weathering; evidence of recent repointing along southern end; badly deteriorated and missing mortar below culvert opening has resulted in loose blocks	7
CULVERT 0.50	Culvert appears to be in good conditions; leaves at/in the outlet impeding the flow of water should be removed	8
DOWNSLOPE 0.50	Adequate riprap outlet protection; no evidence of ongoing erosion	8
LATERAL SLOPE 0.50	Evidence of minor ongoing erosion along the edges of the HW	8

ROAD/SIDEWALK/SHOULDER 0.50	Asphalt pavement with minor cracking along outward wheel line (typical along the Drive); vegetated shoulder with no evidence of distress	8
UPSLOPE 0.50	Vegetated slope; no evidence of slope movement	8

Failure Consequence:	LOW
Recommendation Narrative:	(1) Remove/reset stone masonry = \$620/sqft (3.0 sf) = \$1860, (2) General Labor = \$55/hr (20 cuyd) = \$1100. Total = \$3,000
Repair Cost:	\$3,000

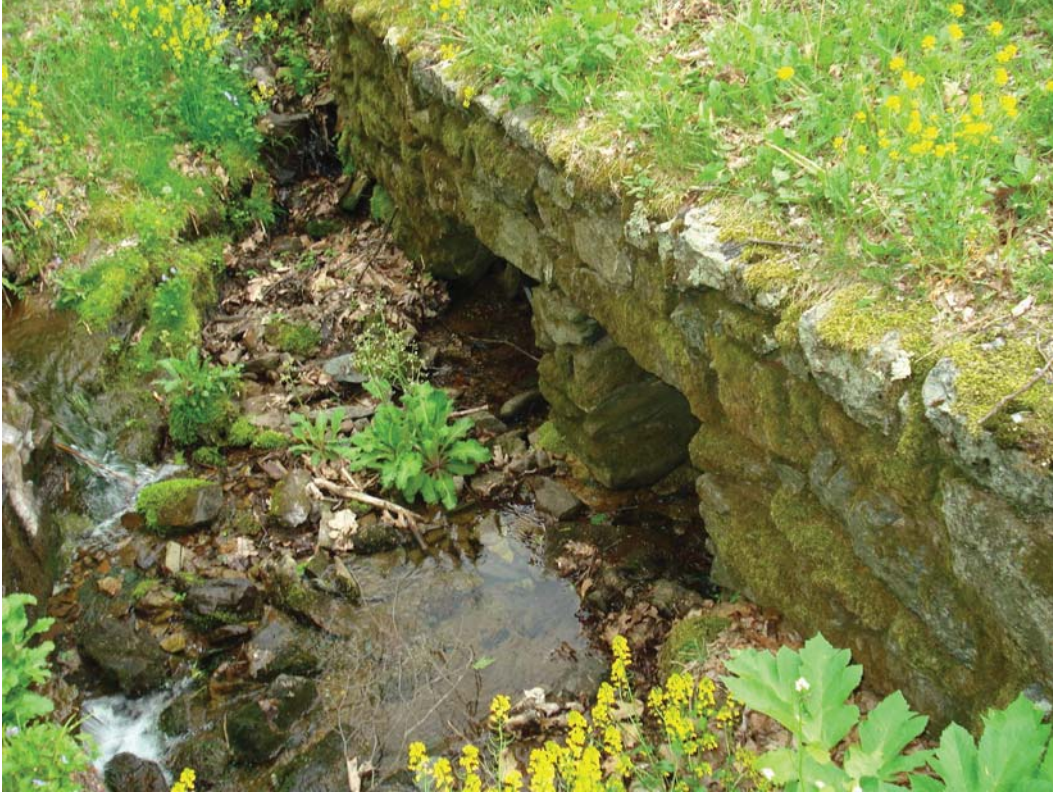
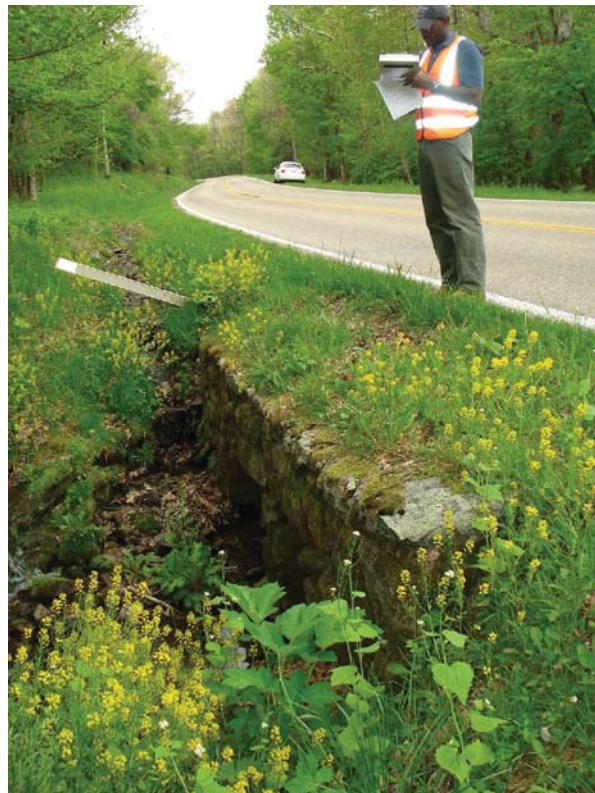
Wall ID:	SHEN-0010B-53.622-L		
Route Name:	SKYLINE DRIVE (CENTRAL)		
Inspection Date:	May 17, 2007	Approximate Year Built:	Unknown
*Wall Rating:	65	Maintenance Action:	Repair Elements

ROAD/SIDEWALK/SHOULDER 0.50	Asphalt pavement in good condition; vegetated should with no evidence of slope movement	8

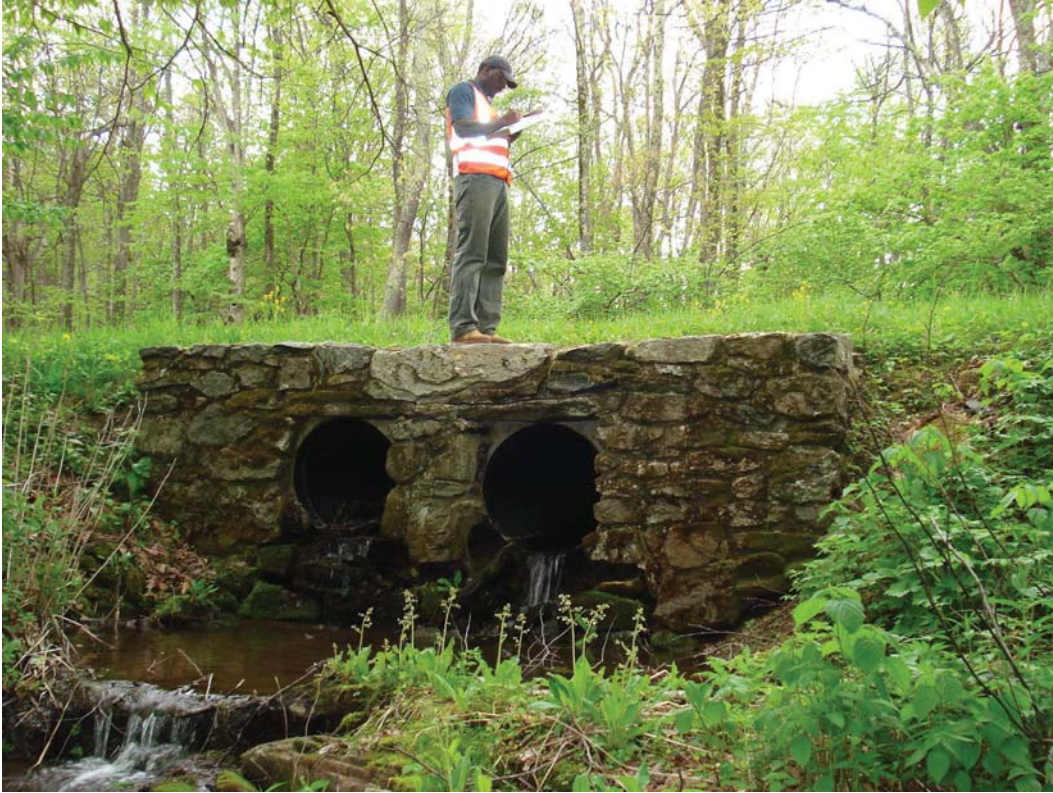
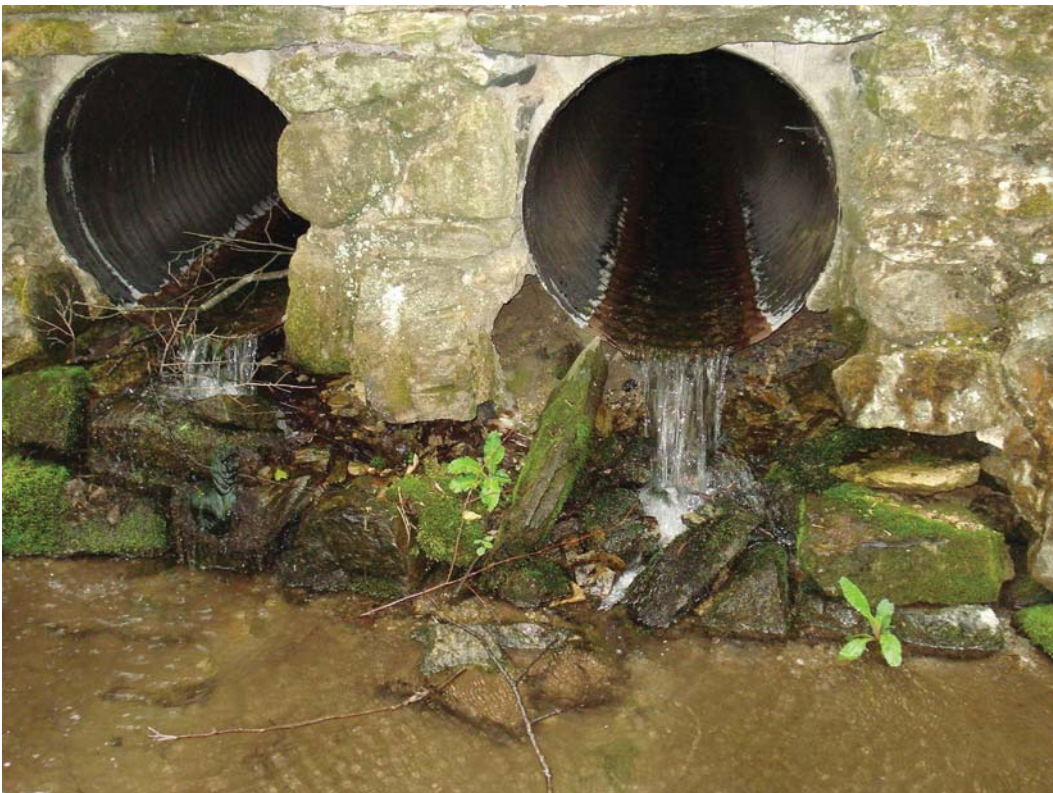
Wall ID:	SHEN-0010B-53.622-R		
Route Name:	SKYLINE DRIVE (CENTRAL)		
Inspection Date:	May 17, 2007	Approximate Year Built:	Unknown
*Wall Rating:	64	Maintenance Action:	Repair Elements

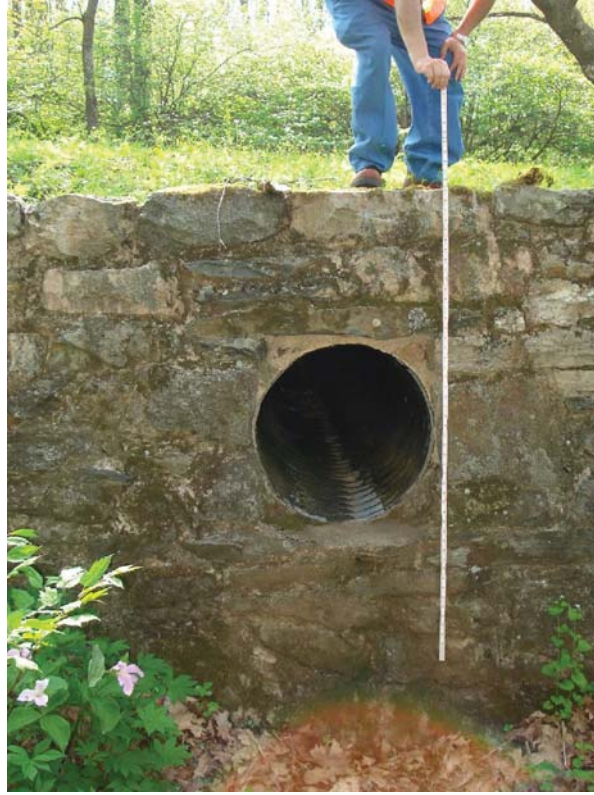
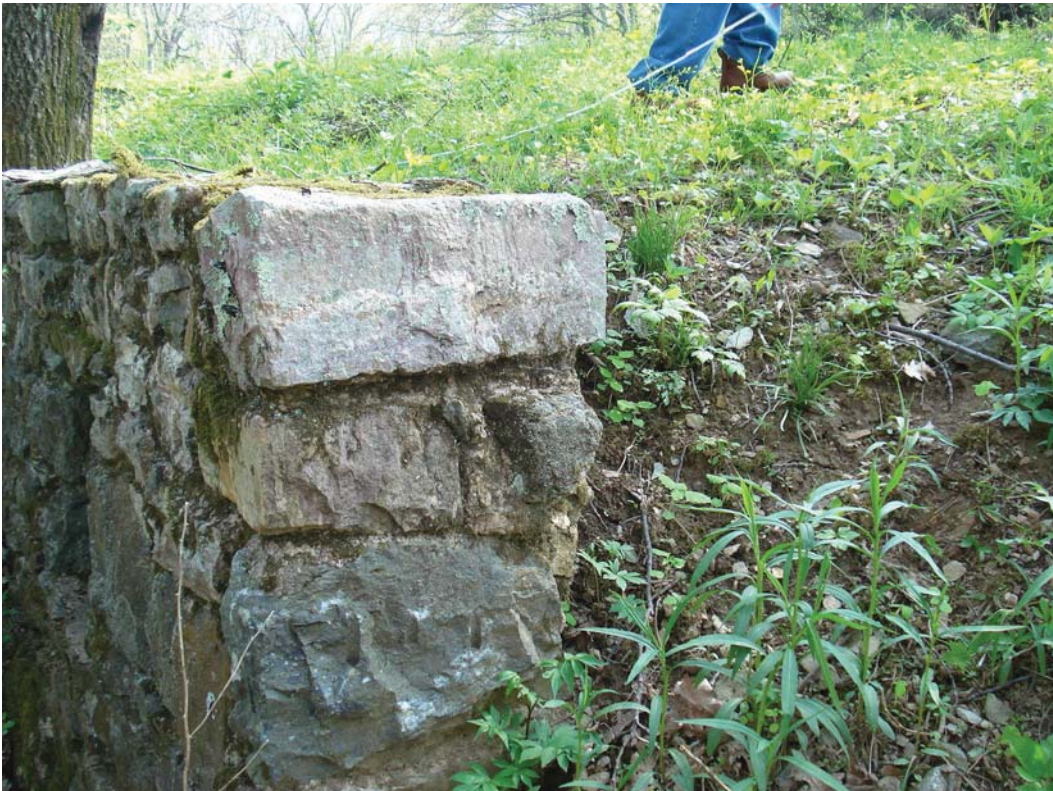
Wall ID:	SHEN-0010B-60.435-L		
Route Name:	SKYLINE DRIVE (CENTRAL)		
Inspection Date:	May 15, 2007	Approximate Year Built:	Unknown
*Wall Rating:	79	Maintenance Action:	No Action

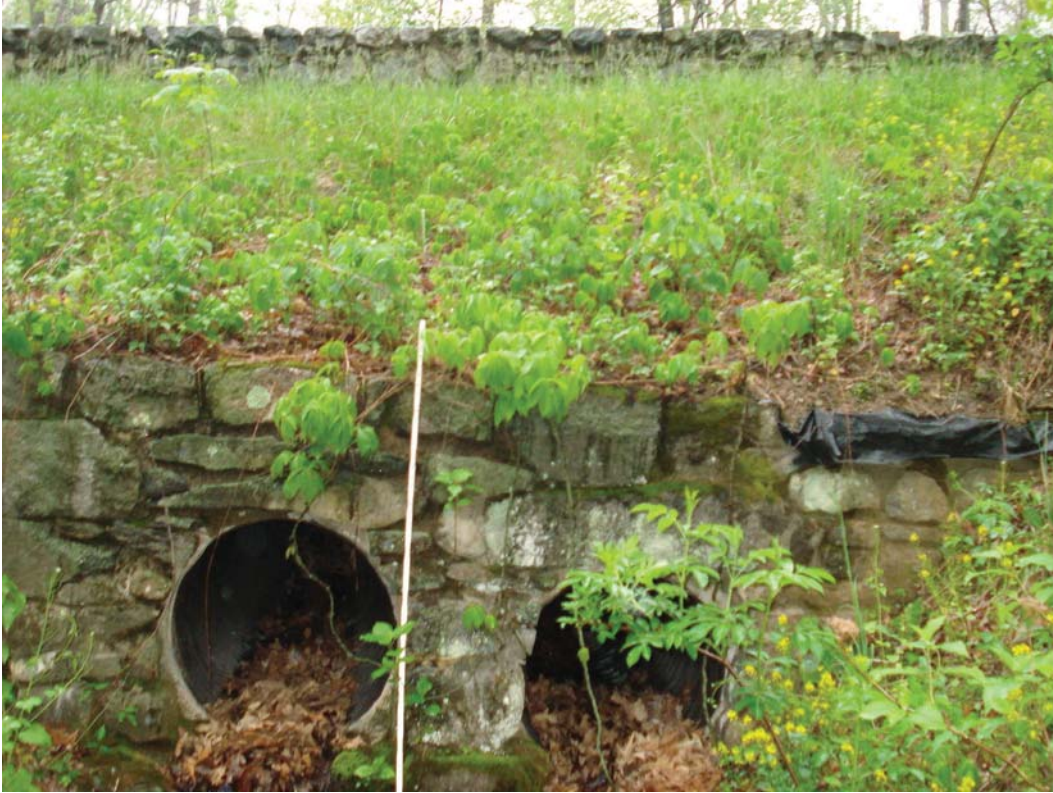
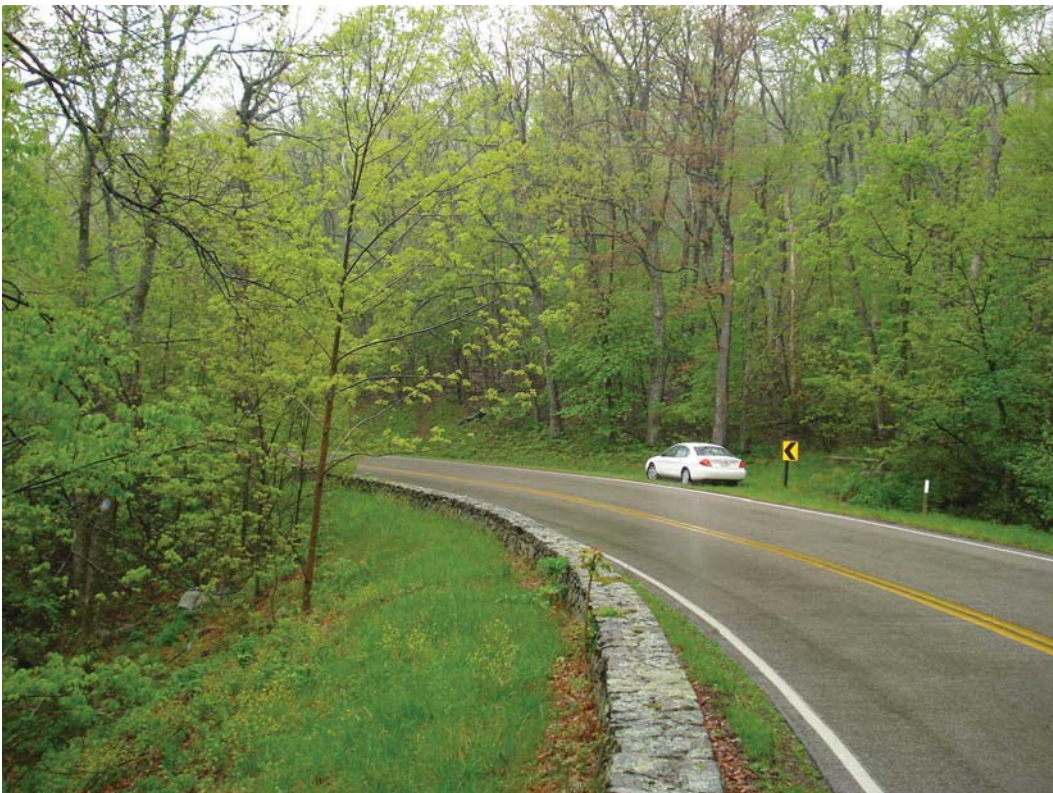
Wall ID:	SHEN-0010B-62.609-L		
Route Name:	SKYLINE DRIVE (CENTRAL)		
Inspection Date:	May 18, 2007	Approximate Year Built:	Unknown
*Wall Rating:	69	Maintenance Action:	No Action

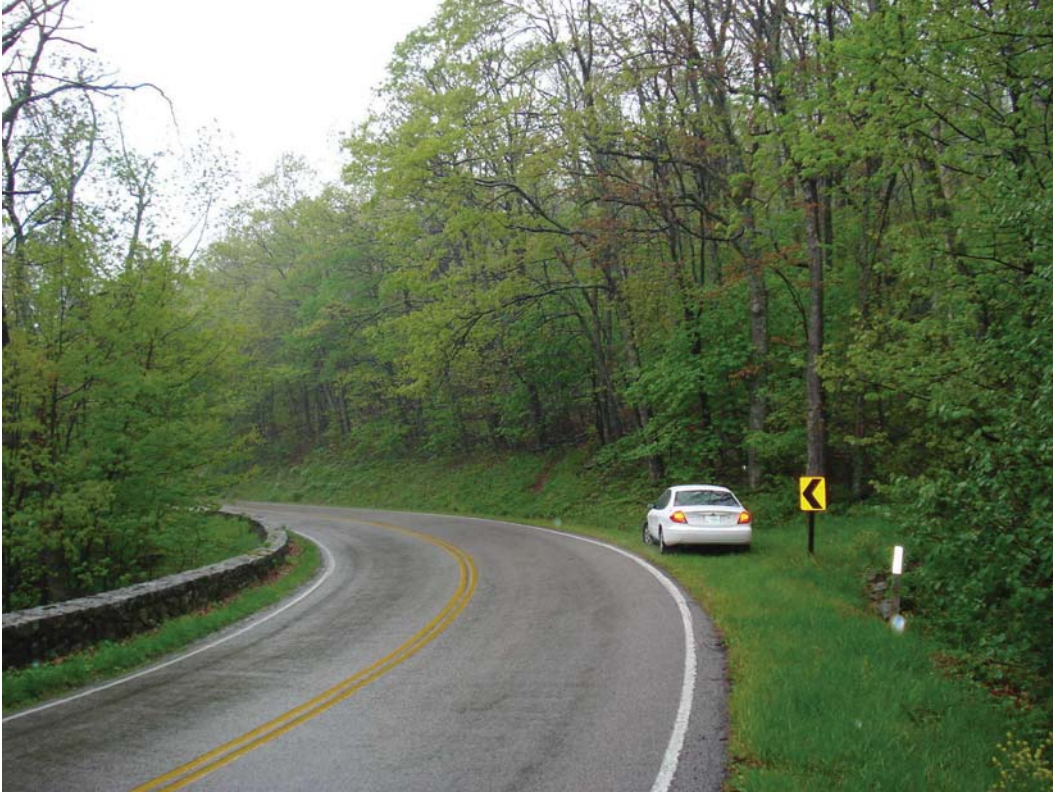
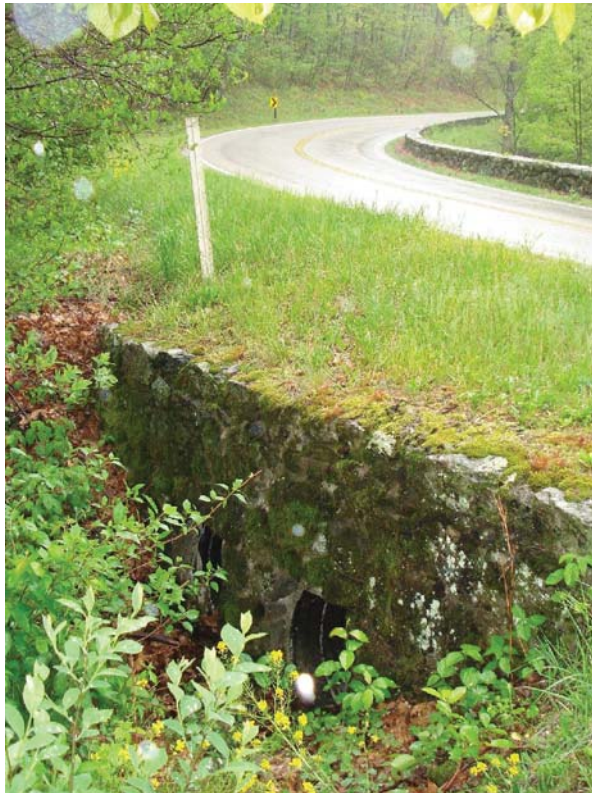
Wall ID:	SHEN-0010B-62.609-R		
Route Name:	SKYLINE DRIVE (CENTRAL)		
Inspection Date:	May 18, 2007	Approximate Year Built:	Unknown
*Wall Rating:	80	Maintenance Action:	No Action

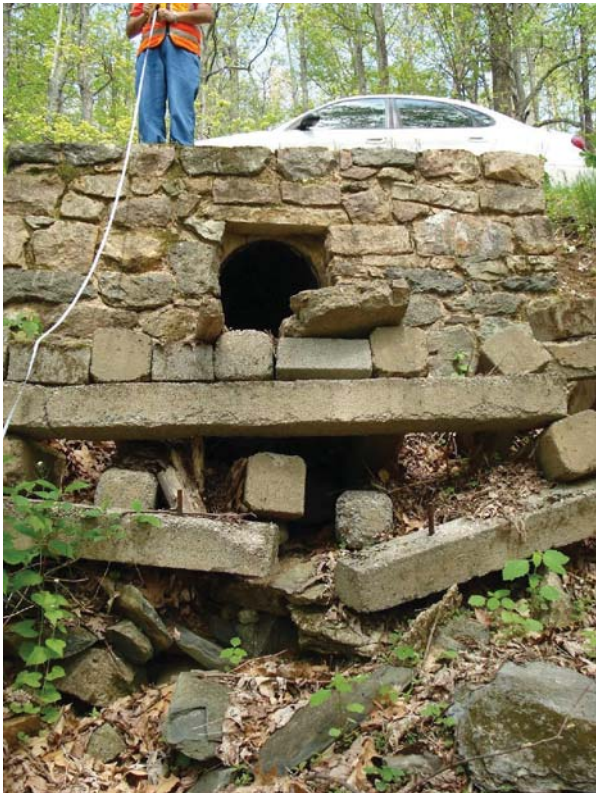
SHEN_0010B_62.820_L_2.jpg

Wall ID:	SHEN-0010B-62.820-L		
Route Name:	SKYLINE DRIVE (CENTRAL)		
Inspection Date:	May 17, 2007	Approximate Year Built:	Unknown
*Wall Rating:	47	Maintenance Action:	Repair Elements

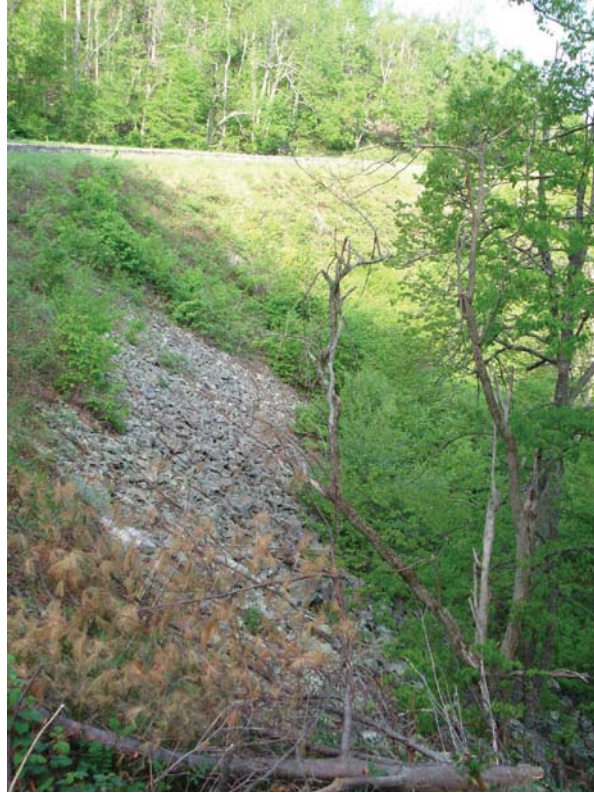
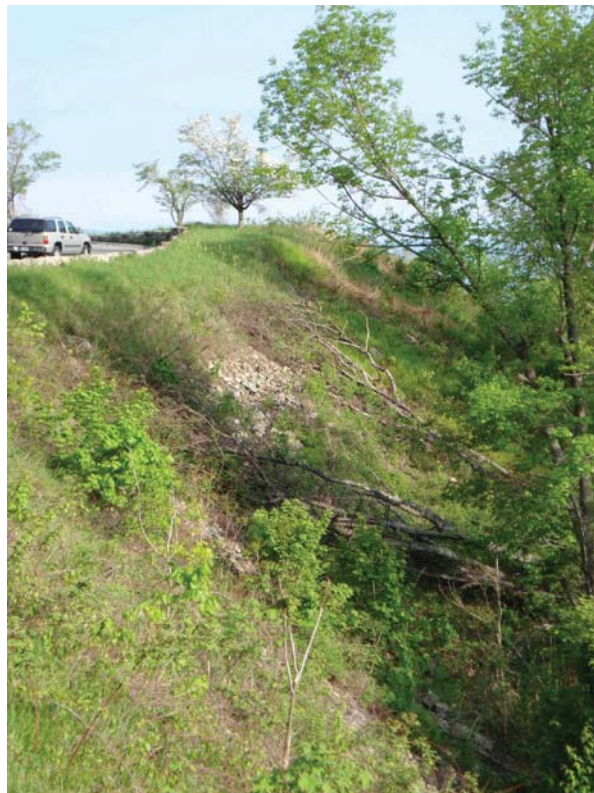
Wall ID:	SHEN-0010C-67.347-L		
Route Name:	SKYLINE DRIVE (SOUTH)		
Inspection Date:	May 17, 2007	Approximate Year Built:	1931
*Wall Rating:	64	Maintenance Action:	No Action

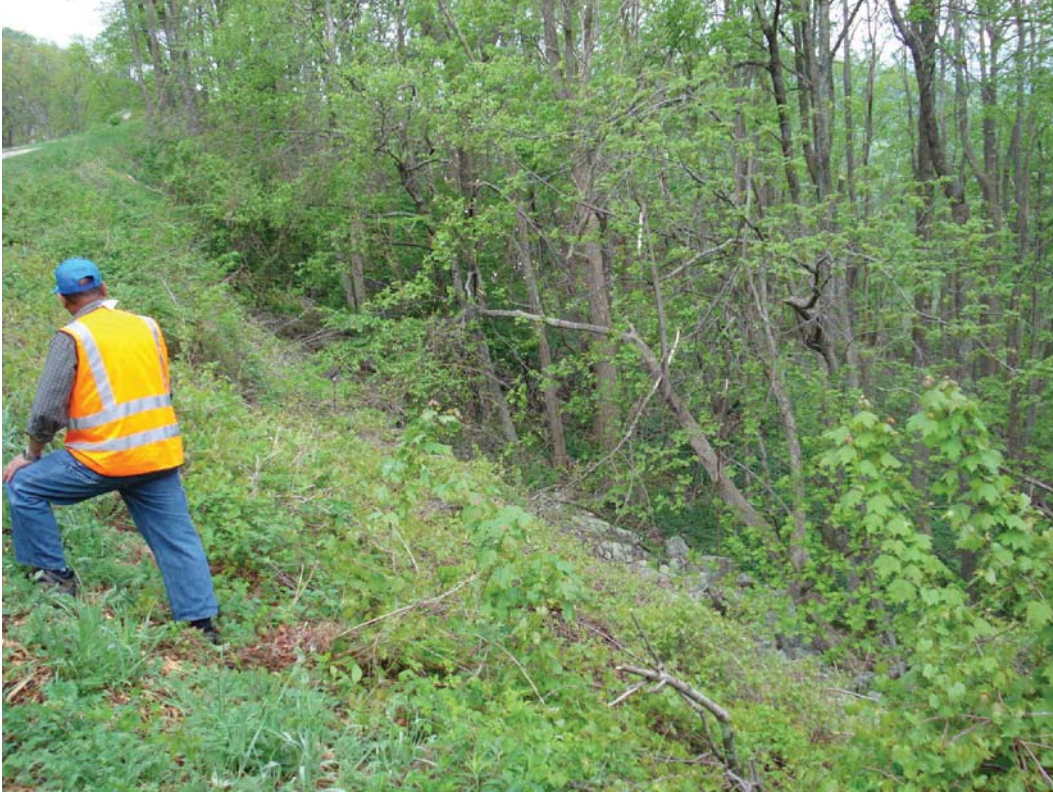
SHEN_0010C_67.546_R_1.jpg

Wall ID:	SHEN-0010C-67.546-R		
Route Name:	SKYLINE DRIVE (SOUTH)		
Inspection Date:	May 17, 2007	Approximate Year Built:	1931
*Wall Rating:	64	Maintenance Action:	No Action

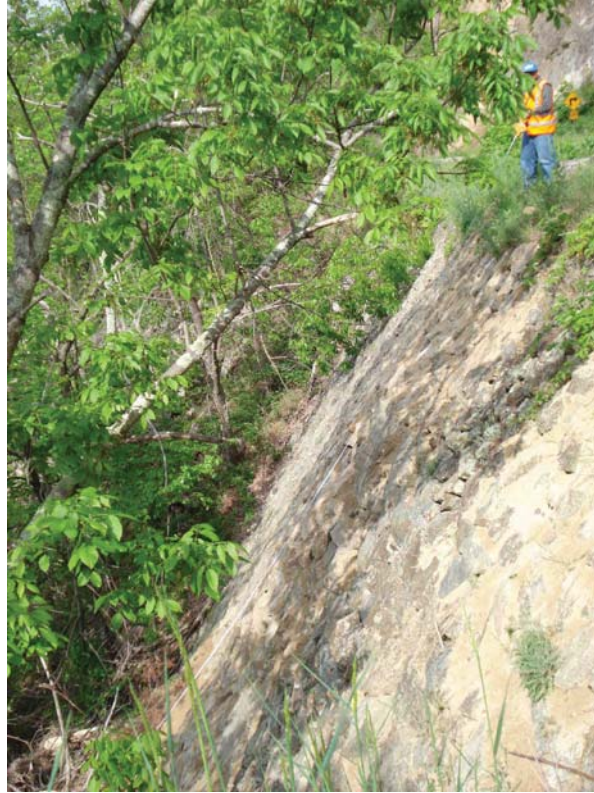
SHEN_0010C_69.390_L_1.jpg

Wall ID:	SHEN-0010C-69.390-L		
Route Name:	SKYLINE DRIVE (SOUTH)		
Inspection Date:	May 17, 2007	Approximate Year Built:	1931
*Wall Rating:	70	Maintenance Action:	No Action

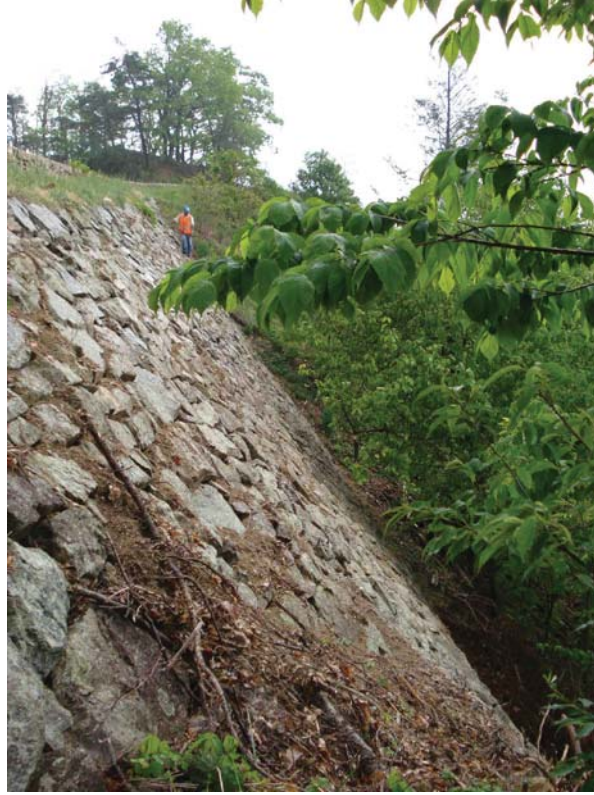
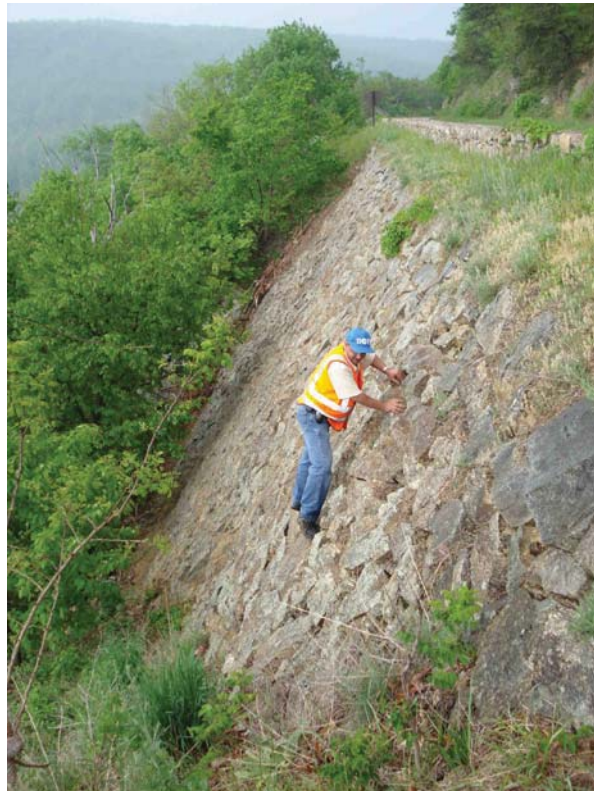
Wall ID:	SHEN-0010C-69.548-L		
Route Name:	SKYLINE DRIVE (SOUTH)		
Inspection Date:	May 17, 2007	Approximate Year Built:	1931
*Wall Rating:	80	Maintenance Action:	No Action

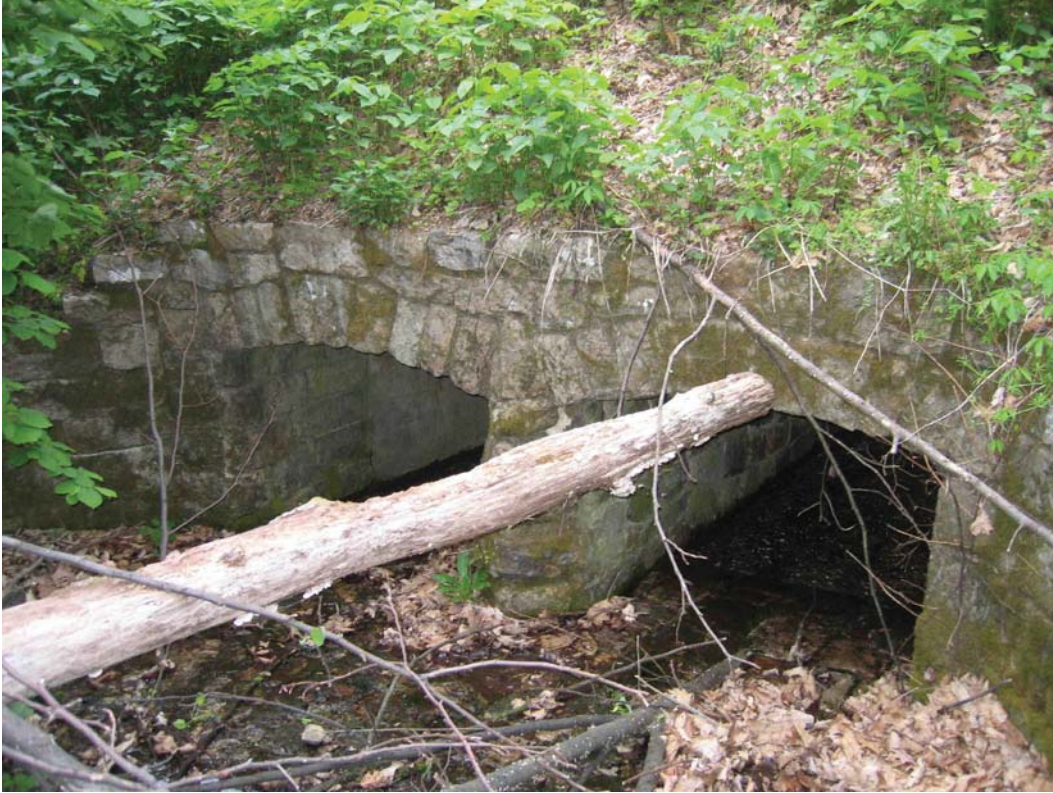
SHEN_0010C_71.967_L_1.jpg

Wall ID:	SHEN-0010C-71.967-L		
Route Name:	SKYLINE DRIVE (SOUTH)		
Inspection Date:	May 17, 2007	Approximate Year Built:	1937
*Wall Rating:	79	Maintenance Action:	No Action

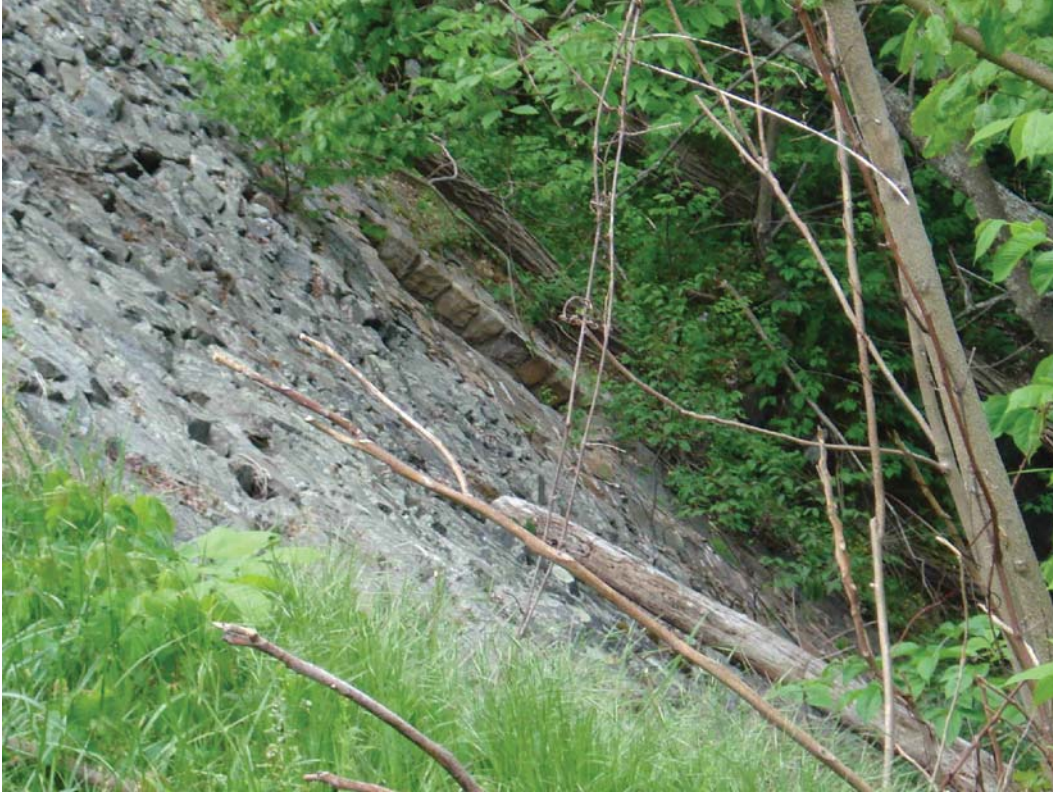
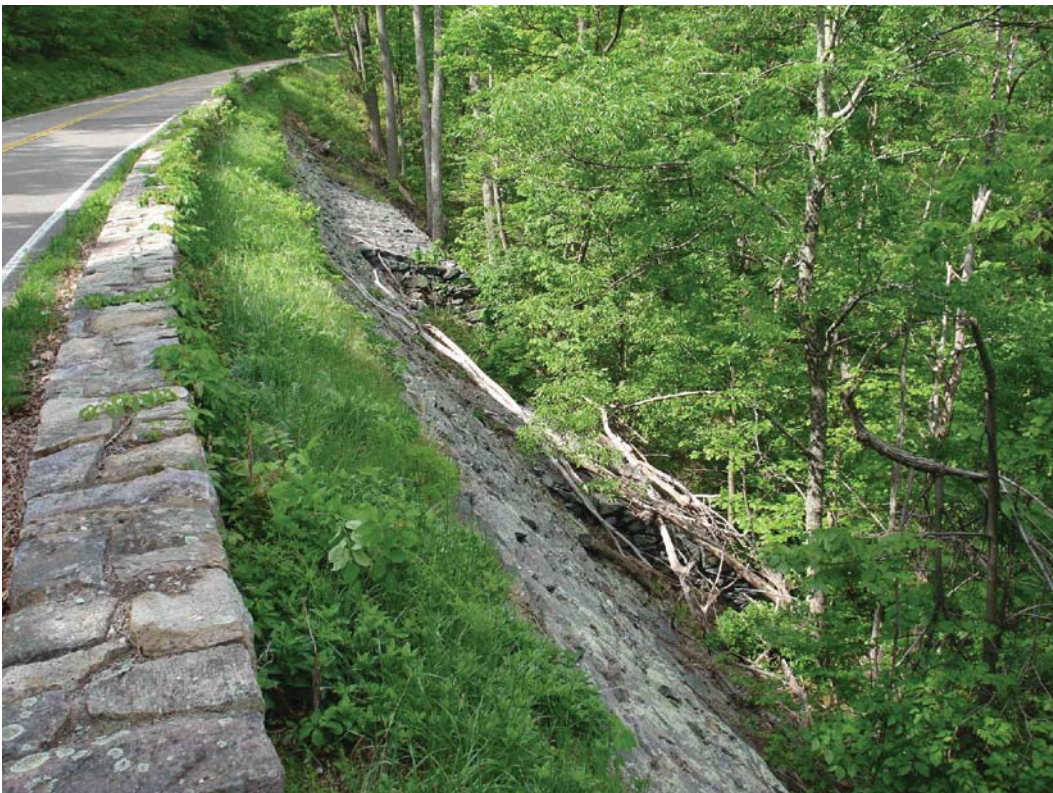
Wall ID:	SHEN-0010C-72.725-R		
Route Name:	SKYLINE DRIVE (SOUTH)		
Inspection Date:	May 17, 2007	Approximate Year Built:	1931
*Wall Rating:	75	Maintenance Action:	No Action

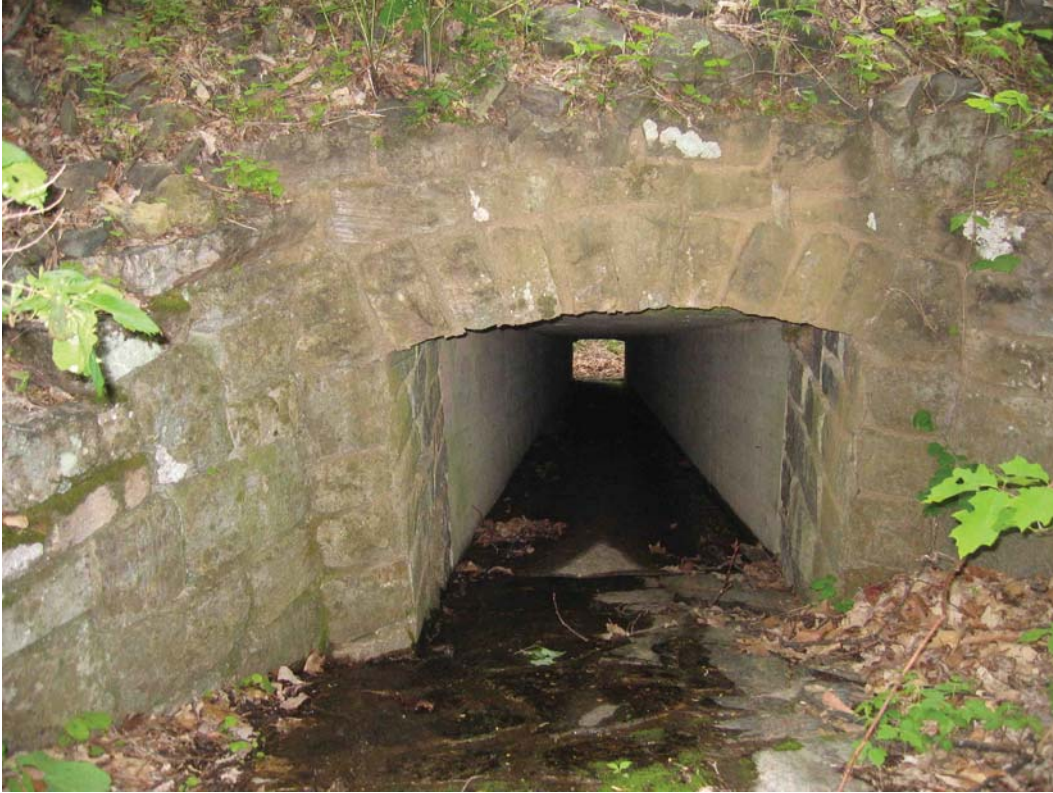
SHEN_0010C_72.930_L_1.jpg

Wall ID:	SHEN-0010C-72.930-L		
Route Name:	SKYLINE DRIVE (SOUTH)		
Inspection Date:	May 17, 2007	Approximate Year Built:	1937
*Wall Rating:	80	Maintenance Action:	No Action
