SHEN WIP Report

NPS Retaining Wall Inventory Program Shenandoah National Park

Federal Highway Administration
Eastern Federal Lands Highway Division
Road Inventory Program (RIP)

Data Collection Date: May 2007
Report Date: October 2015

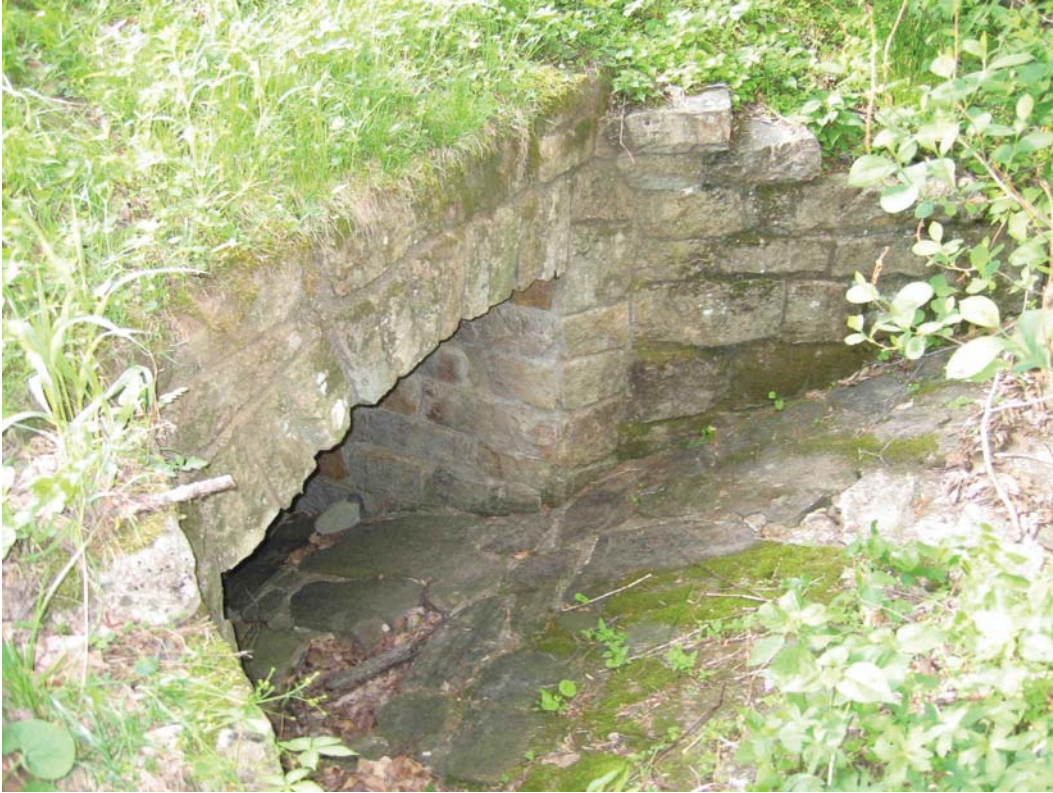
SHEN_0010C_73.067_L_1.jpg

Wall ID:	SHEN-0010C-73.067-L		
Route Name:	SKYLINE DRIVE (SOUTH)		
Inspection Date:	May 17, 2007	Approximate Year Built:	1937
*Wall Rating:	80	Maintenance Action:	No Action

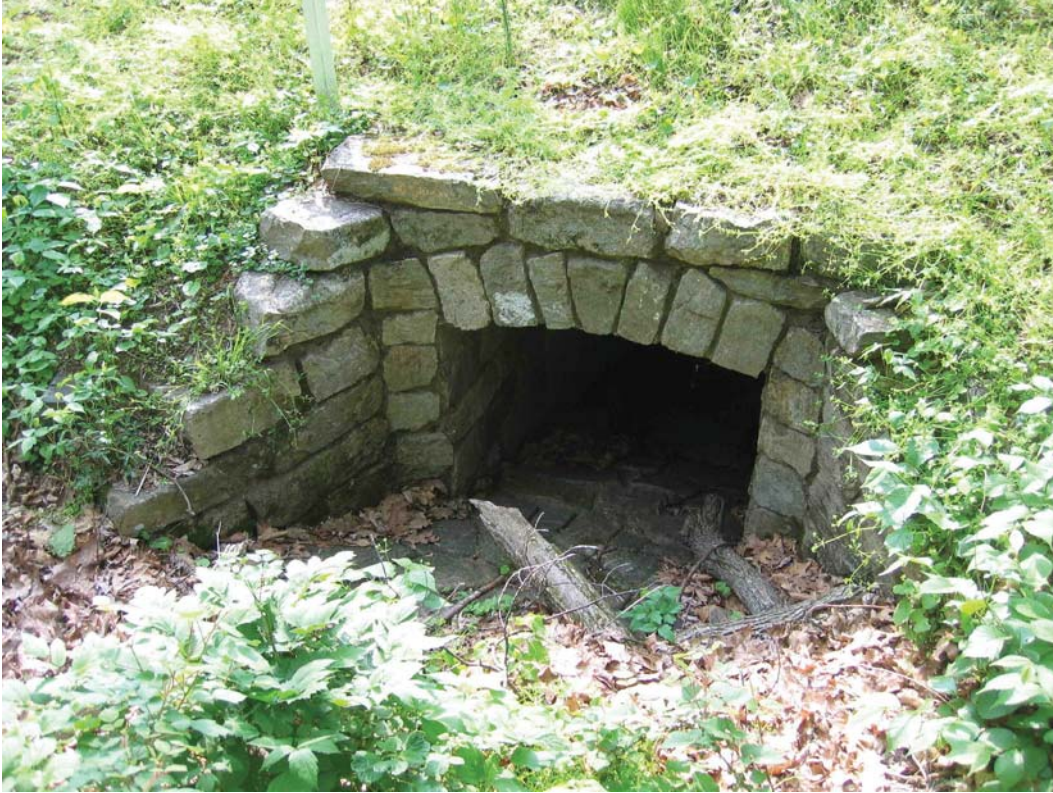
SHEN_0010C_73.400_L_1.jpg

Wall ID:	SHEN-0010C-73.400-L		
Route Name:	SKYLINE DRIVE (SOUTH)		
Inspection Date:	May 17, 2007	Approximate Year Built:	1937
*Wall Rating:	80	Maintenance Action:	No Action

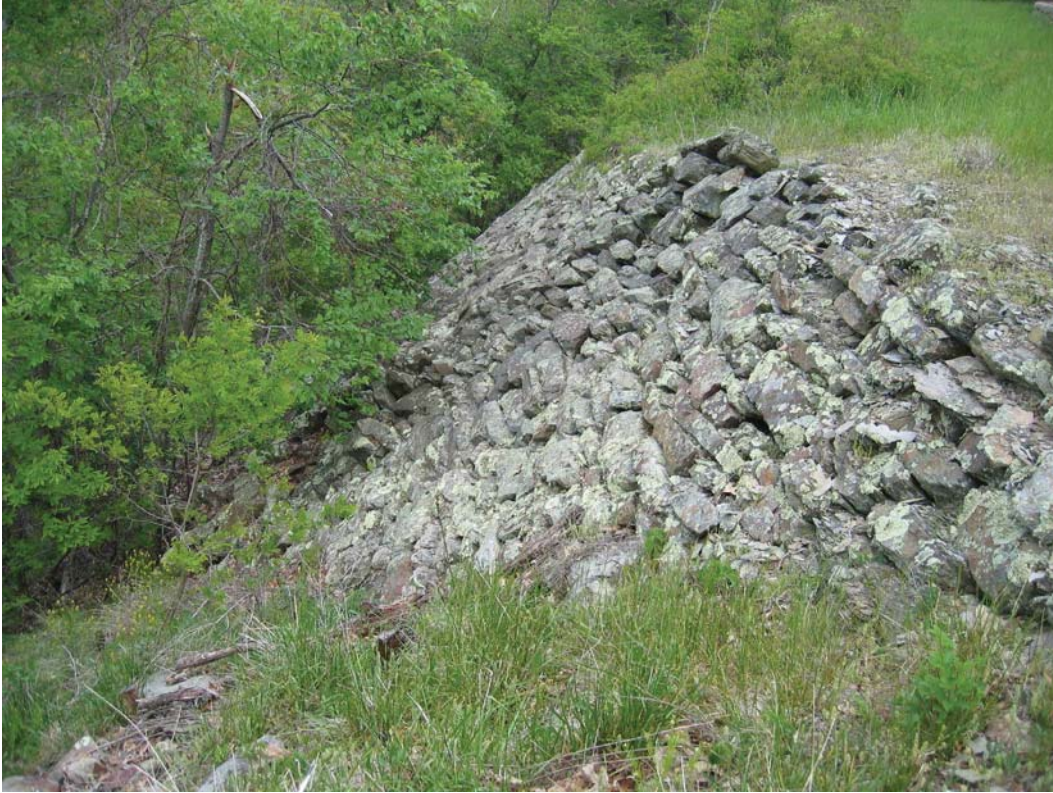
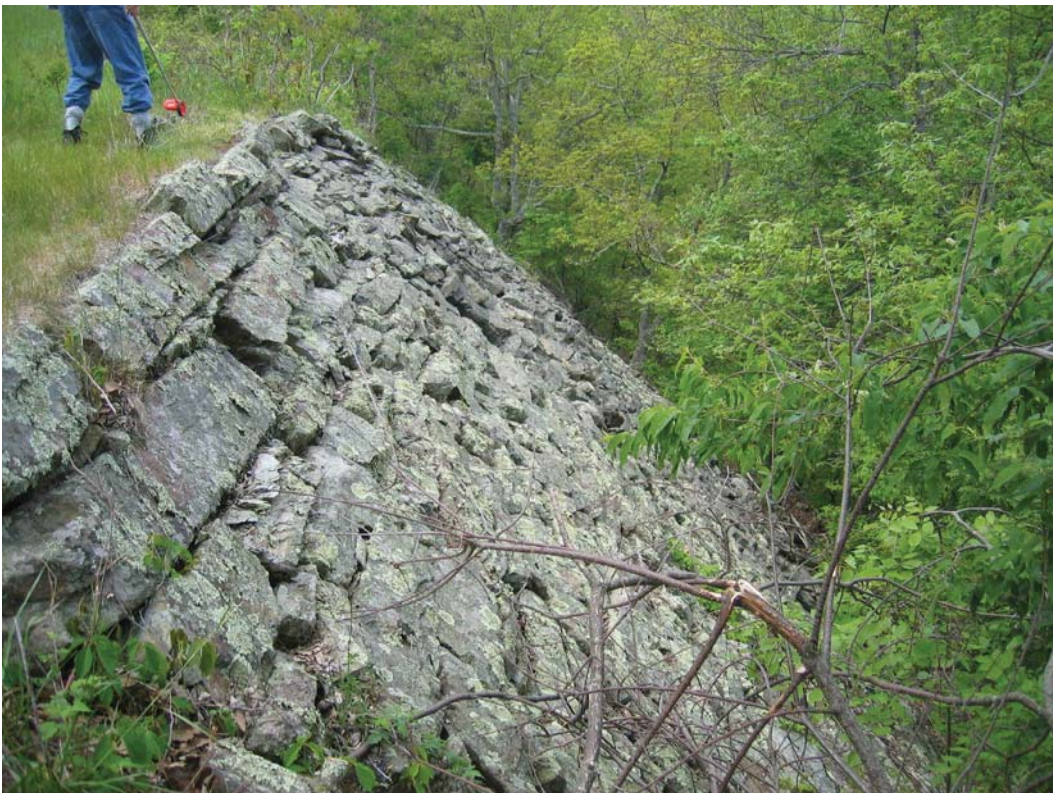
Element (Weighting Factor)	Narrative	Condition Rating (0 - 10)
PERFORMANCE 8.00	Minor bulging in wall face may be due to slippage between facing rocks, or due to the apparent slump at the top of the wall - not severe. Small sinkhole at one end of slump suggests fines are migrating through the face (could not find evidence at wall to	5
WALL FOUNDATION MATERIAL 8.00	Coarse aggregates and cobbles/boulders (Rock fill?) as well as some bedrock outcrop. Very stable foundation with no signs of scour or settlement.	8
STONE MASONRY 8.00	Well-placed, chinked dry-laid stone. Relatively fresh, angular stone with minor weathering. No missing blocks evident.	8
DOWNSLOPE 0.50	Downslope is stable, showing no signs of slumping or significant erosion.	8
LATERAL SLOPE 0.50	Well-vegetated side slopes. Very stable.	8
ROAD/SIDEWALK/SHOULDER 0.50	Excellent condition with no signs of wall-related distress.	8
TRAFFIC BARRIER/FENCE 0.50	Mortared stone masonry guardwall with no signs of wall-related distress.	8

Failure Consequence:	HIGH
Recommendation Narrative:	Regrade top slope and re-establish drainage away from top of wall. Labor: 100 hrs @ \$50/hr = \$5000. Equipment Time: 20 hrs excavator/backhoe @ \$150/hr = \$3000. Fill (unclassified borrow): 80 yds @ \$35/yd = \$2800. Total: \$10,800
Repair Cost:	\$10,800

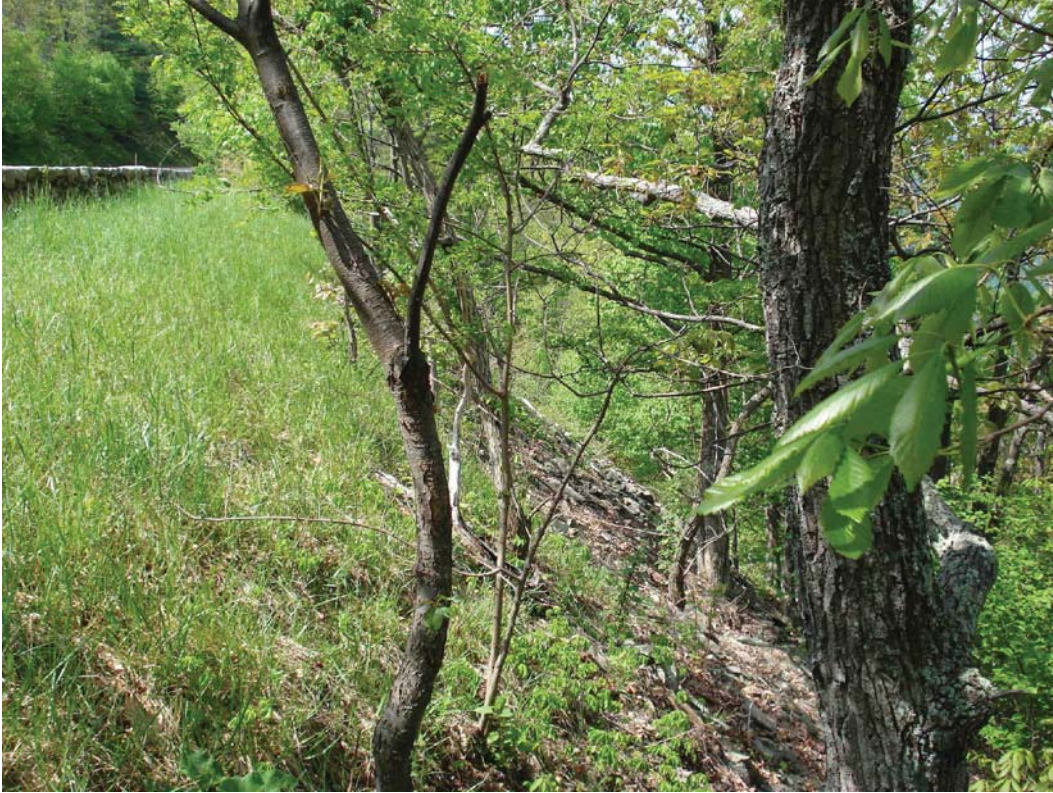
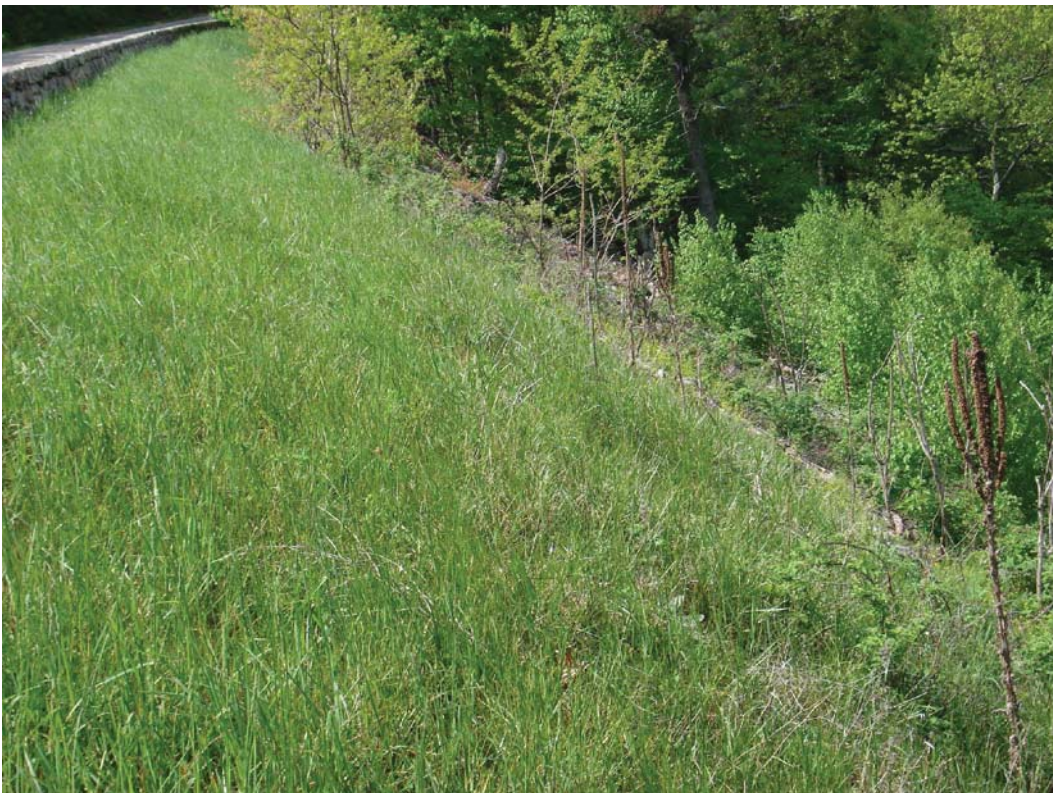
Element (Weighting Factor)	Narrative	Condition Rating (0 - 10)
PERFORMANCE 8.00	Somewhat deteriorated	6
WALL FOUNDATION MATERIAL 8.00	No settlement or erosion	7
PLACED STONE 8.00	Rubble, deteriorated, overgrown, mixed or covered with soil	6
LATERAL SLOPE 0.50	Mild	8
WALL DRAINS 1.00	None	7

Failure Consequence:	MODERATE
Recommendation Narrative:	None
Repair Cost:	\$0

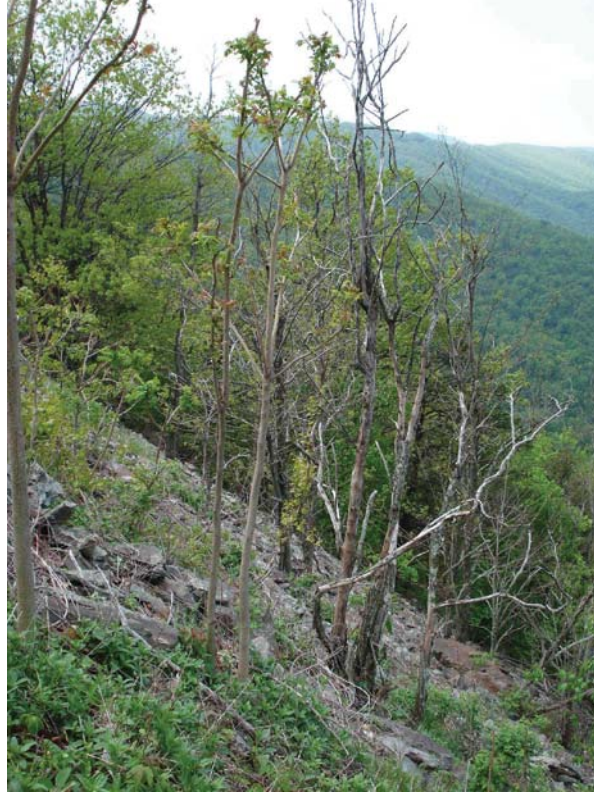
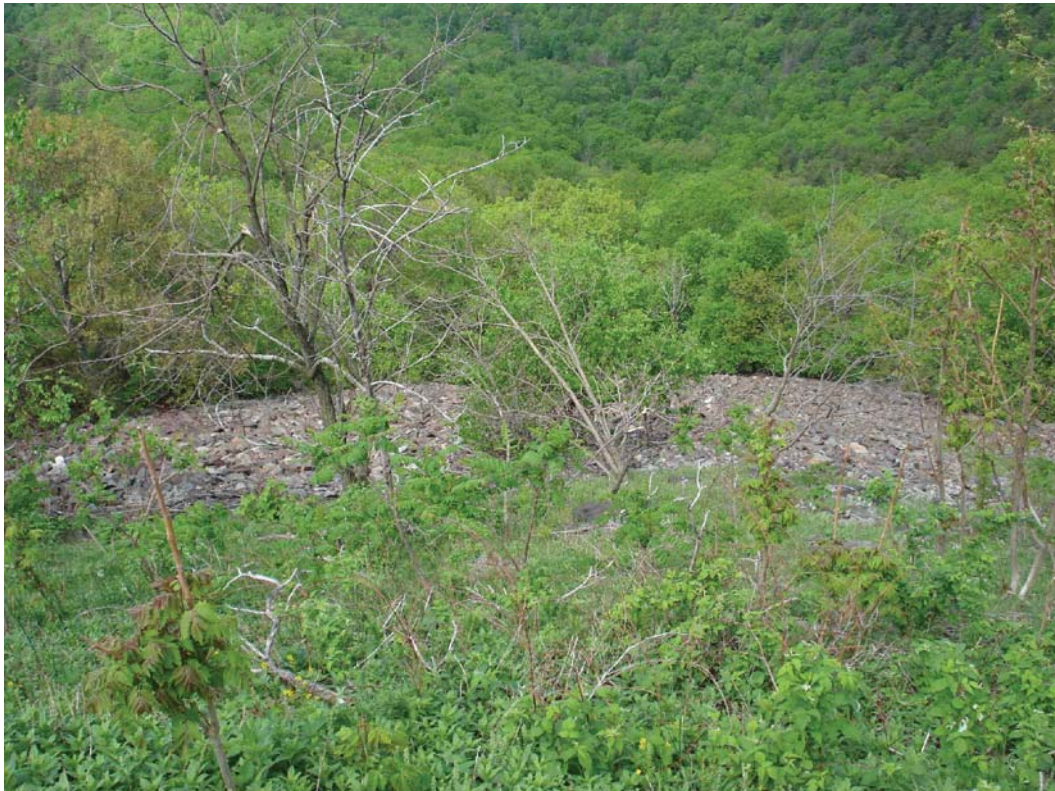
Element (Weighting Factor)	Narrative	Condition Rating (0 - 10)
PERFORMANCE 8.00	Somewhat deteriorated	6
WALL FOUNDATION MATERIAL 8.00	No settlement or erosion	7
PLACED STONE 8.00	Rubble, deteriorated, overgrown, mixed or covered with soil	6
LATERAL SLOPE 0.50	Mild	8
WALL DRAINS 1.00	none	7

Failure Consequence:	MODERATE
Recommendation Narrative:	None
Repair Cost:	\$0

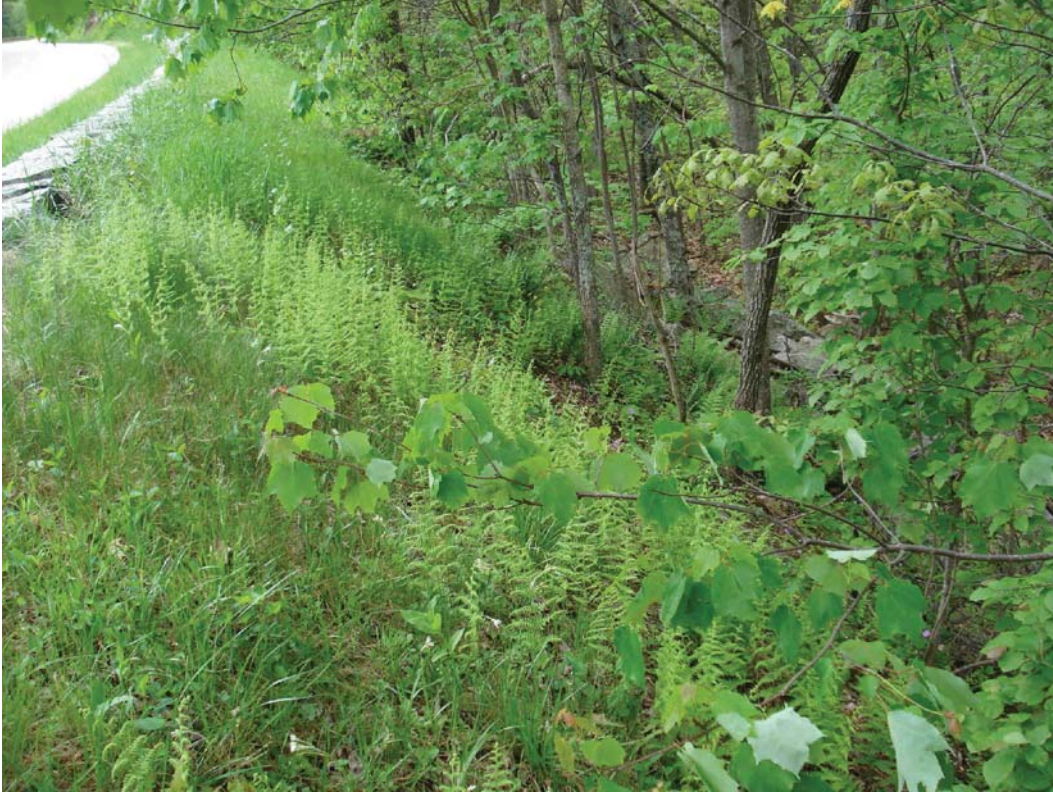
SHEN_0010C_79.292_R_1.jpg

Element (Weighting Factor)	Narrative	Condition Rating (0 - 10)
PERFORMANCE 8.00	Somewhat deteriorated	6
WALL FOUNDATION MATERIAL 8.00	No settlement or erosion	7
PLACED STONE 8.00	Rubble, deteriorated, overgrown, mixed or covered with soil	6
LATERAL SLOPE 0.50	Mild	8
WALL DRAINS 1.00	None	7

Failure Consequence:	MODERATE
Recommendation Narrative:	None
Repair Cost:	\$0

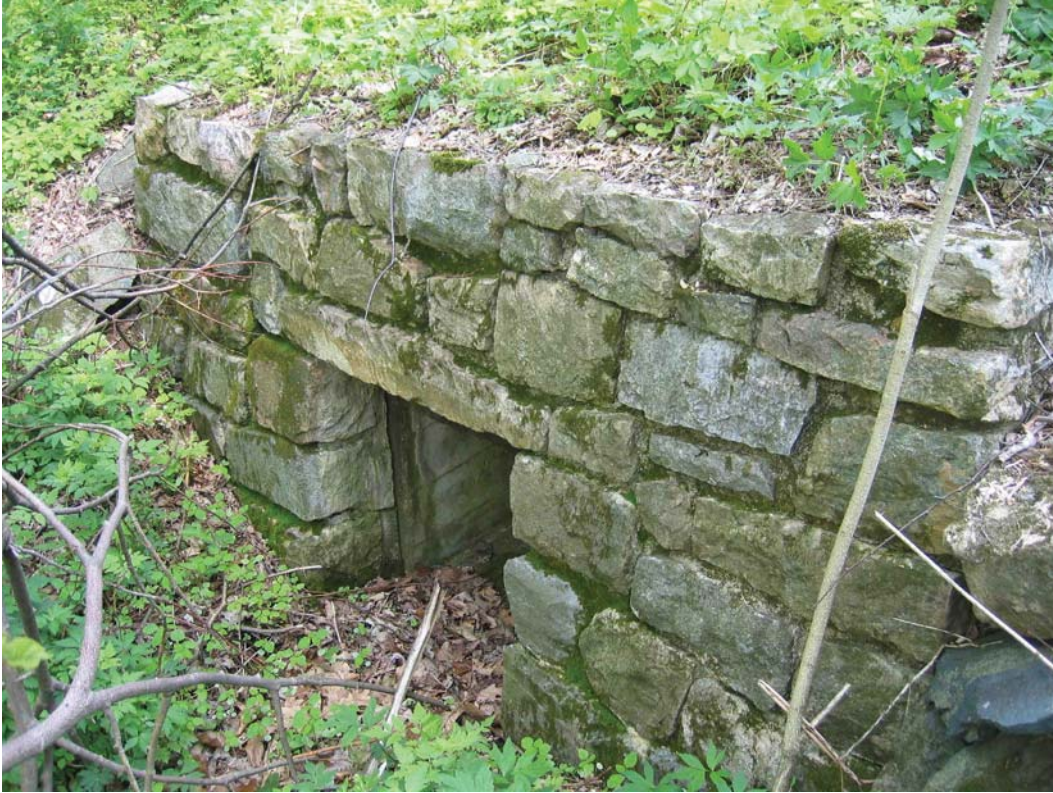
SHEN_0010C_80.464_R_1.jpg

Element (Weighting Factor)	Narrative	Condition Rating (0 - 10)
PERFORMANCE 8.00	Minor weathering of elements, but no global distresses, settlement, or displacement of the wingwalls or headwall structure.	7
WALL FOUNDATION MATERIAL 8.00	Coarse aggregates and cobbles/boulders. Very stable foundation with no signs of scour or settlement. (Difficult to see.)	8
MORTAR 8.00	Sound, durable, intact, with minor weathering. No signs of significant cracking.	8
STONE MASONRY 8.00	Sound, durable, with minor weathering. No cracked or missing blocks.	8
CULVERT 0.50	Culvert shows no signs of seepage in or around the box. Stone work within the box is intact and shows no signs of significant distress.	8
DOWNSLOPE 0.50	Drainage bottom shows no signs of significant erosion or scour.	8
LATERAL SLOPE 0.50	Well-vegetated fill slope, with signs of rock fill present. Very stable with no signs of bulging or sloughing.	8
ROAD/SIDEWALK/SHOULDER 0.50	Excellent condition with no signs of wall-related distress.	8

Failure Consequence:	LOW
Recommendation Narrative:	None
Repair Cost:	\$0

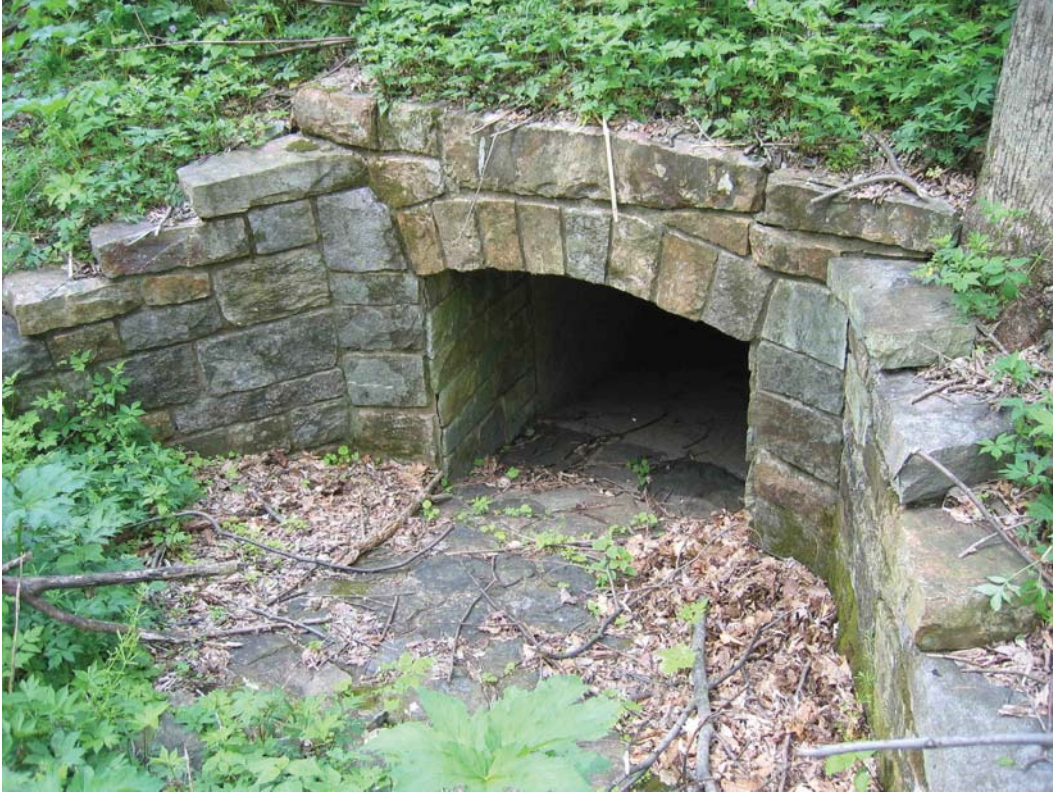
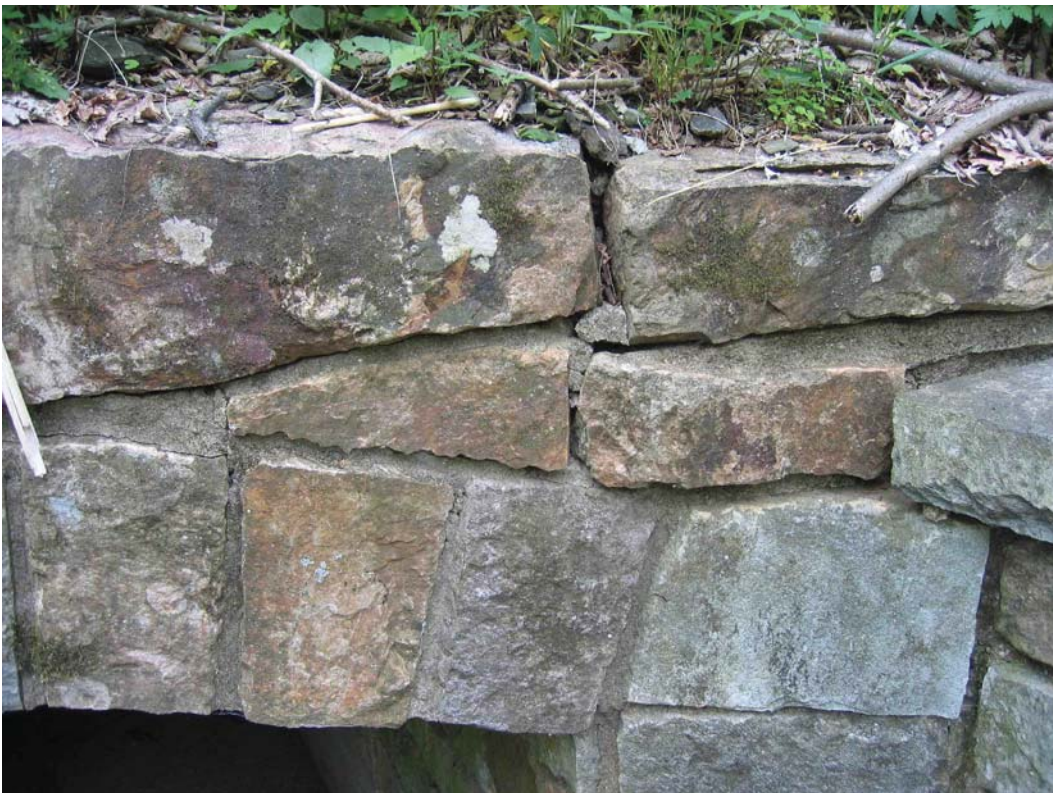
Element (Weighting Factor)	Narrative	Condition Rating (0 - 10)
PERFORMANCE 8.00	Minor weathering of elements, but no global distresses, settlement, or displacement of the wingwalls or headwall structure.	7
WALL FOUNDATION MATERIAL 8.00	Mortared rock drainage path. No signs of foundation settlement.	8
MORTAR 8.00	Sound, durable, intact, with minor weathering. Minor signs of significant cracking, with some missing mortar at the top of the headwall (top course).	7
STONE MASONRY 8.00	Sound, durable, with minor weathering. No cracked or missing blocks.	8
DOWNSLOPE 0.50	Drainage bottom shows no signs of significant erosion or scour.	8
LATERAL SLOPE 0.50	Well-vegetated fill slope, with signs of rock fill present. Very stable with no signs of bulging or sloughing.	8
ROAD/SIDEWALK/SHOULDER 0.50	Excellent condition with no signs of wall-related distress.	8
UPSLOPE 0.50	Well-vegetated fill slope, with signs of rock fill present. Very stable with no signs of bulging or sloughing.	8

Failure Consequence:	LOW
Recommendation Narrative:	Remortar loose headwall blocks. Labor: 2 hrs @ \$50/hr = \$100. Concrete Quik-Patch: Lump Sum = \$20. Total = \$120
Repair Cost:	\$120

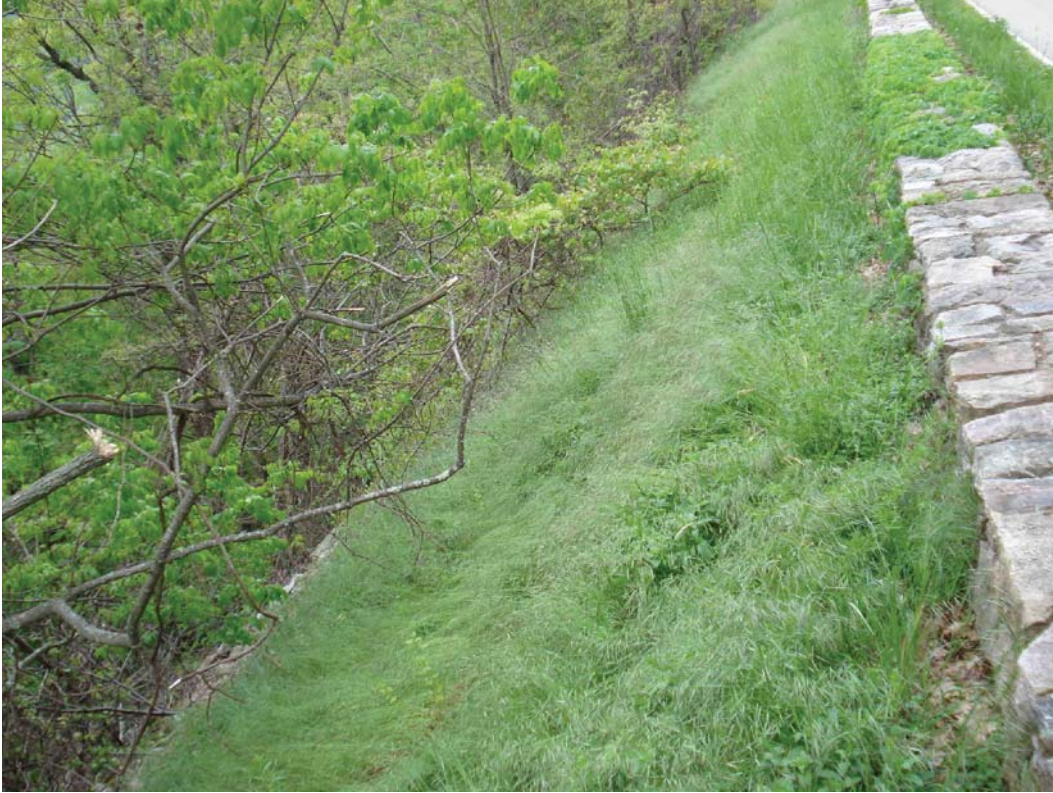
SHEN_0010C_82.478_L_1.jpg

Element (Weighting Factor)	Narrative	Condition Rating (0 - 10)
PERFORMANCE 8.00	Somewhat deteriorated	6
WALL FOUNDATION MATERIAL 8.00	No settlement or erosion	7
PLACED STONE 8.00	Rubble, deteriorated, overgrown, mixed or covered with soil	6
LATERAL SLOPE 0.50	Mild	8
WALL DRAINS 1.00	None	7

Failure Consequence:	MODERATE
Recommendation Narrative:	None
Repair Cost:	\$0

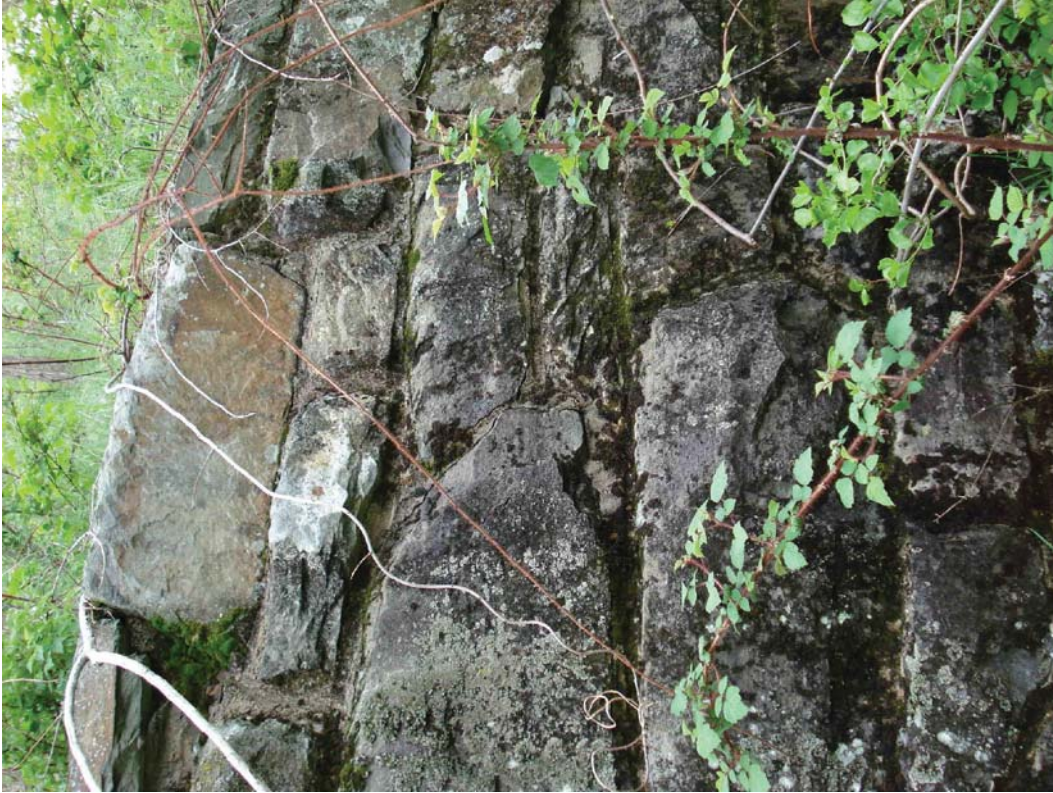
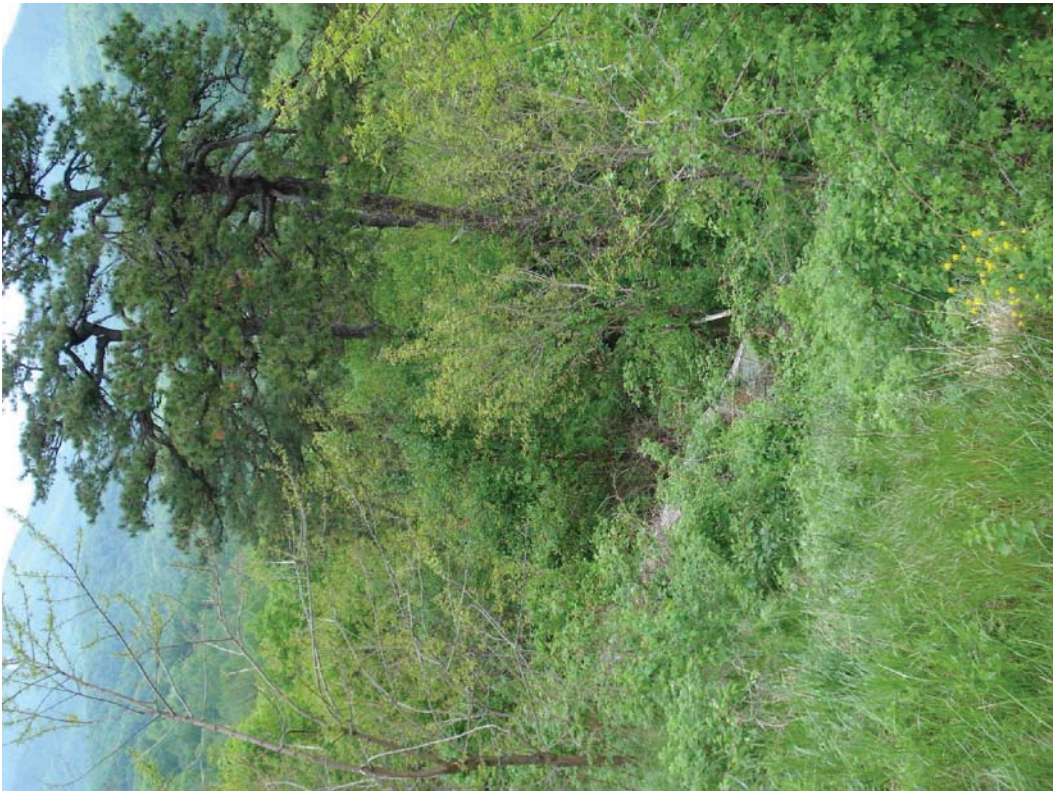
Element (Weighting Factor)	Narrative	Condition Rating (0 - 10)
PERFORMANCE 8.00	Performing well	7
WALL FOUNDATION MATERIAL 8.00	Soil	8
MORTAR 8.00	Missing mortar in a few locations	6
STONE MASONRY 8.00	Good condition, stones are 3' +/- rectangular blocks	7
ROAD/SIDEWALK/SHOULDER 0.50	Road in good condition, vegetated shoulder	8
WALL DRAINS 0.50	Self-draining	8
VEGETATION 1.00	Heavily vegetated at wall	6
DOWNSLOPE 1.00	Moderate downslope	7
LATERAL SLOPE 1.00	Gently sloping	7

Failure Consequence:	MODERATE
Recommendation Narrative:	None
Repair Cost:	\$0

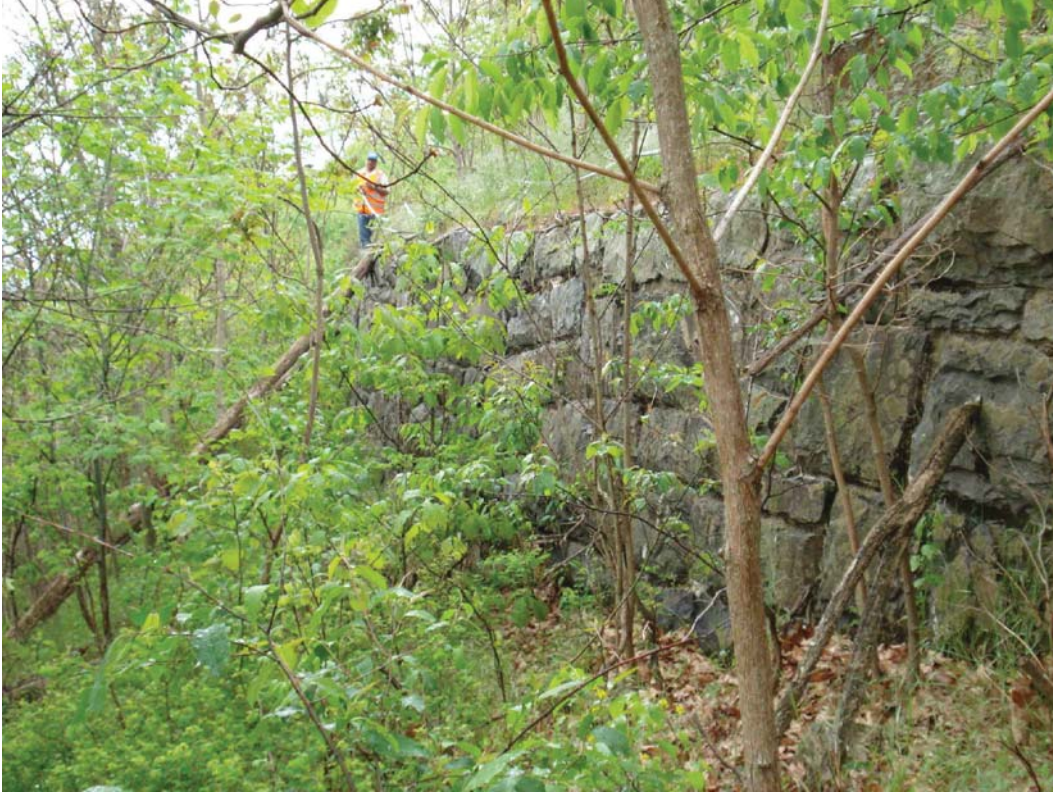
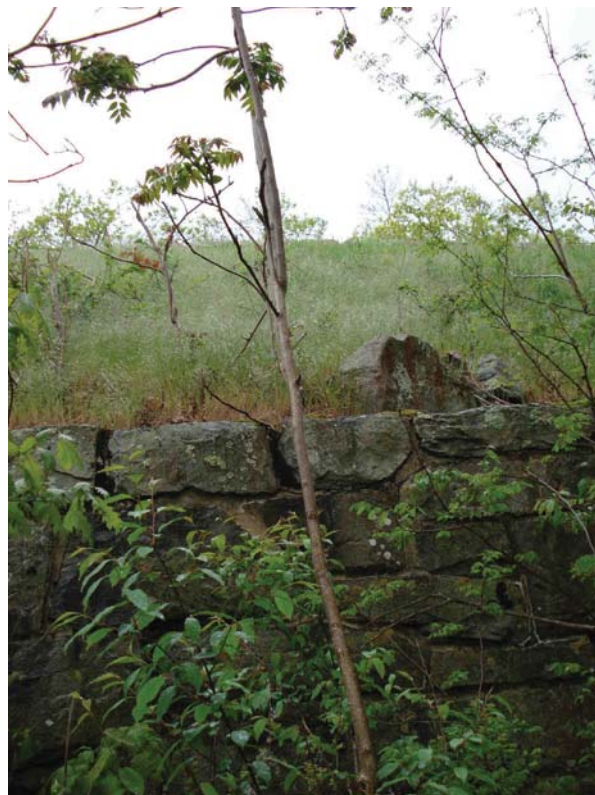
Element (Weighting Factor)	Narrative	Condition Rating (0 - 10)
PERFORMANCE 8.00	Good condition	8
WALL FOUNDATION MATERIAL 8.00	Good - no settlement/erosion	8
MORTAR 8.00	Fair to good, few losses	8
STONE MASONRY 8.00	Good - no loss of stone	8
LATERAL SLOPE 0.50	Moderate	8
ROAD/SIDEWALK/SHOULDER 0.50	Vegetated shoulder	8
UPSLOPE 0.50	Steep, vegetated, rock fill (good condition)	8
VEGETATION 0.50	Vegetated slopes for stability	8
WALL DRAINS 0.50	No drainage problems	8

Failure Consequence:	MODERATE
Recommendation Narrative:	None
Repair Cost:	\$0

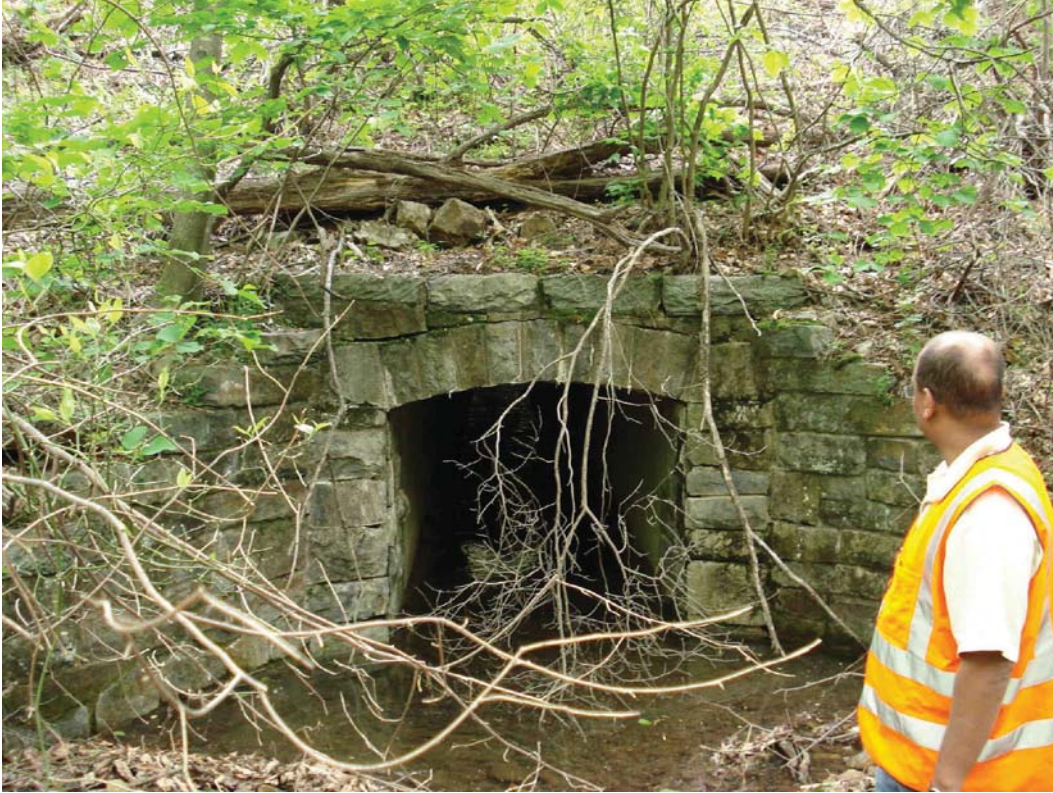
SHEN_0010C_87.348_L_1.jpg

Element (Weighting Factor)	Narrative	Condition Rating (0 - 10)
PERFORMANCE 8.00	Good condition	8
WALL FOUNDATION MATERIAL 8.00	Fair to good, minor scour	7
MORTAR 8.00	Fair to good, mortar loss around culvert opening	7
STONE MASONRY 8.00	Good - no loss	8
DOWNSLOPE 0.50	Gentle slope	8
LATERAL SLOPE 0.50	Moderate	8
ROAD/SIDEWALK/SHOULDER 0.50	Grassed shoulder	8
WALL DRAINS 0.50	None - no drainage problems	8
CULVERT 1.00	Culvert functioning well	7

Failure Consequence:	MODERATE
Recommendation Narrative:	None
Repair Cost:	\$0

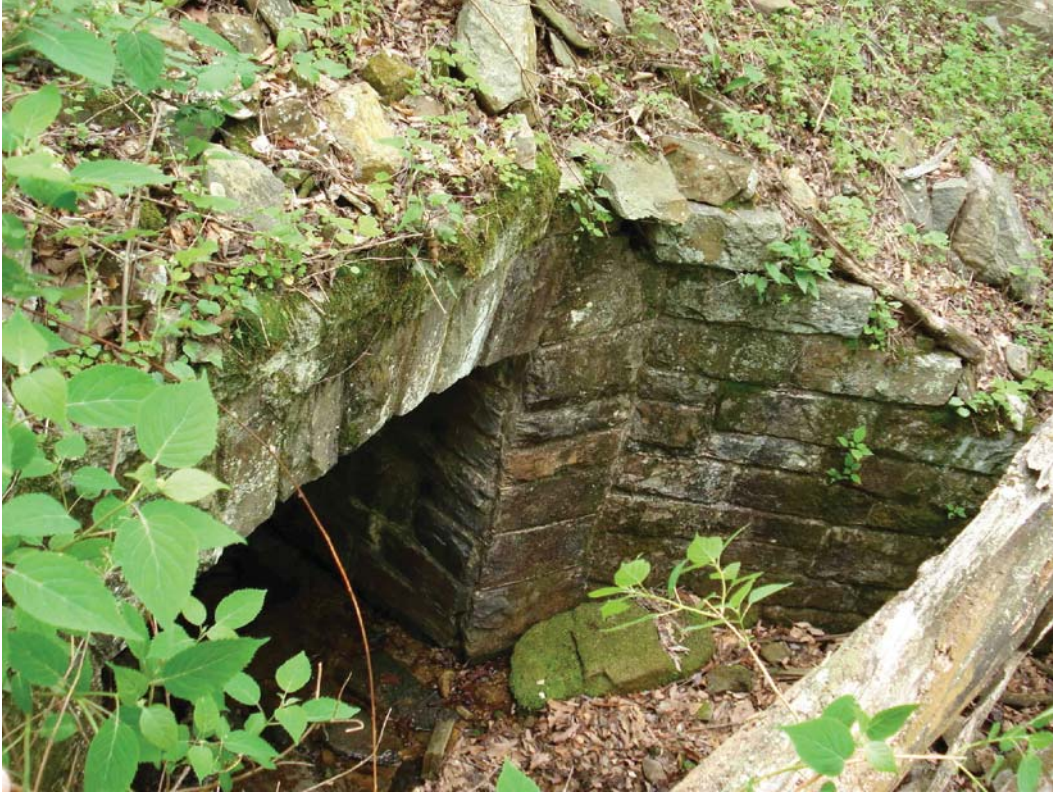
SHEN_0010C_87.348_R_1.jpg

Element (Weighting Factor)	Narrative	Condition Rating (0 - 10)
PERFORMANCE 8.00	Good condition	8
WALL FOUNDATION MATERIAL 8.00	Good - no settlement or erosion	8
MORTAR 8.00	Good - no loss	8
STONE MASONRY 8.00	Good - no loss or cracks	8
DOWNSLOPE 0.50	Very gentle slope	8
LATERAL SLOPE 0.50	Steep	8
ROAD/SIDEWALK/SHOULDER 0.50	Grassed shoulder	8
UPSLOPE 0.50	Steep	8
WALL DRAINS 0.50	None observed, no drainage problems	8

Failure Consequence:	MODERATE
Recommendation Narrative:	None
Repair Cost:	\$0

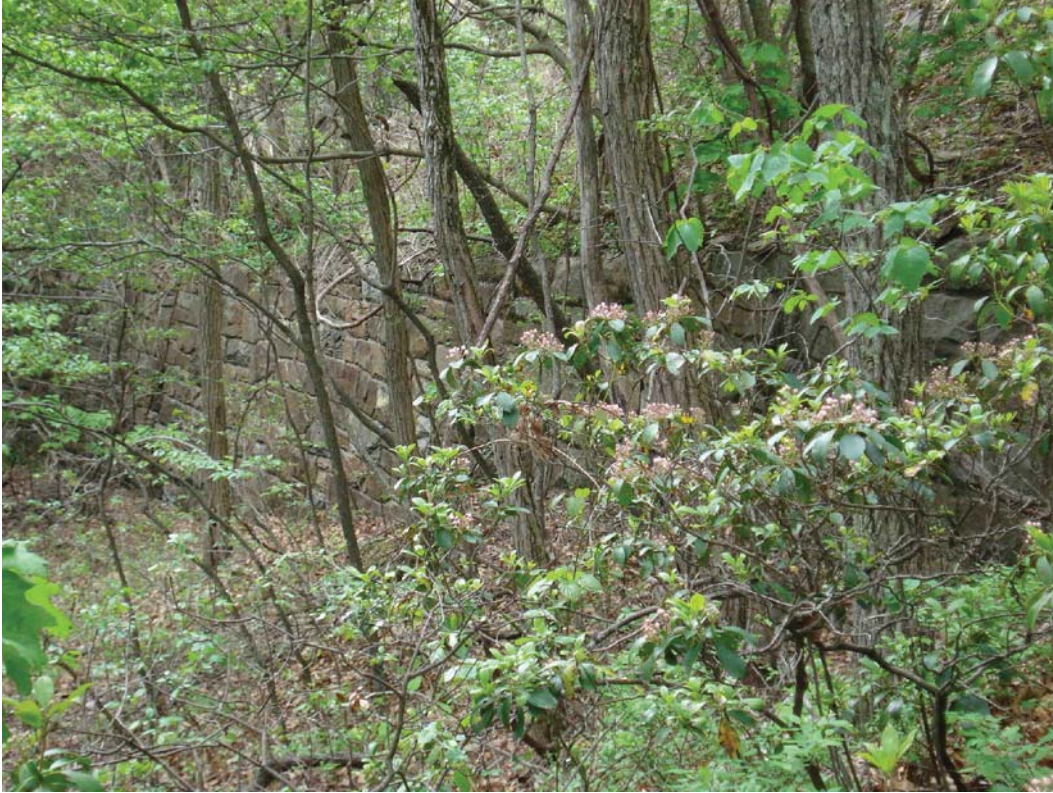
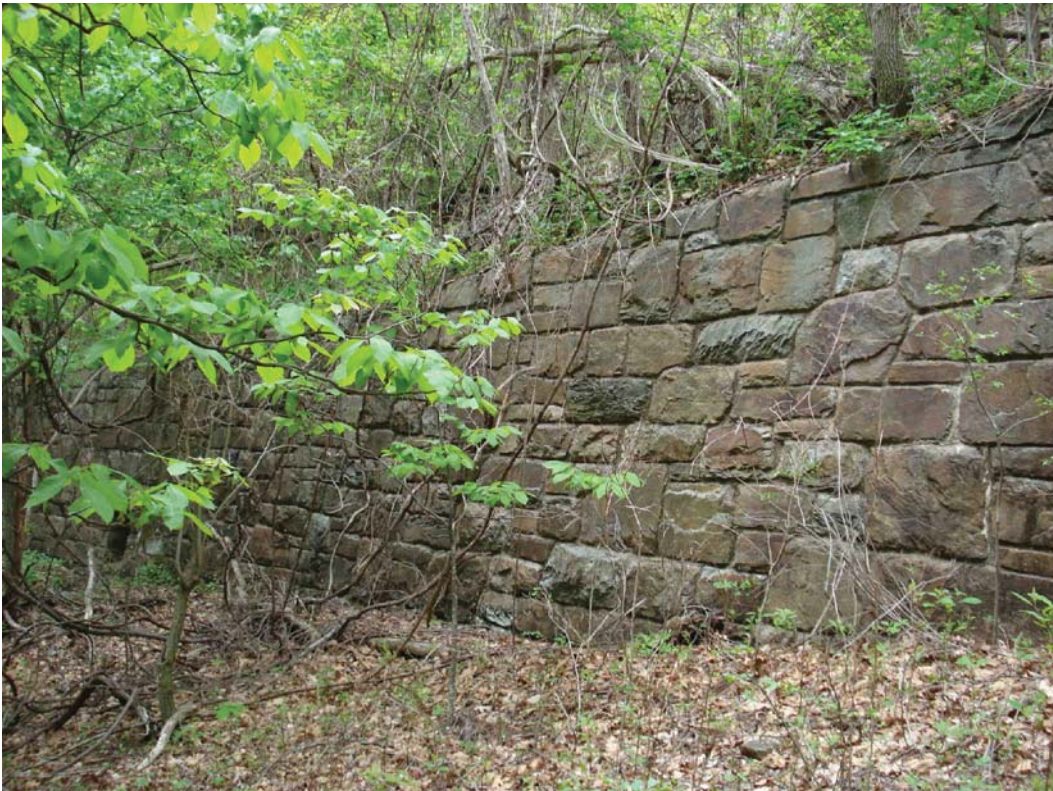
Element (Weighting Factor)	Narrative	Condition Rating (0 - 10)
PERFORMANCE 8.00	Good condition	7
WALL FOUNDATION MATERIAL 8.00	No settlement or erosion	7
MORTAR 8.00	Good condition	7
STONE MASONRY 8.00	No loss of stone	8
DOWNSLOPE 0.50	Moderate slope	8
LATERAL SLOPE 0.50	Gentle slope	8
ROAD/SIDEWALK/SHOULDER 0.50	Grassed shoulder	8
VEGETATION 0.50	Not much vegetation on the wall	8
WALL DRAINS 0.50	Self-draining	8

Failure Consequence:	MODERATE
Recommendation Narrative:	None
Repair Cost:	\$0

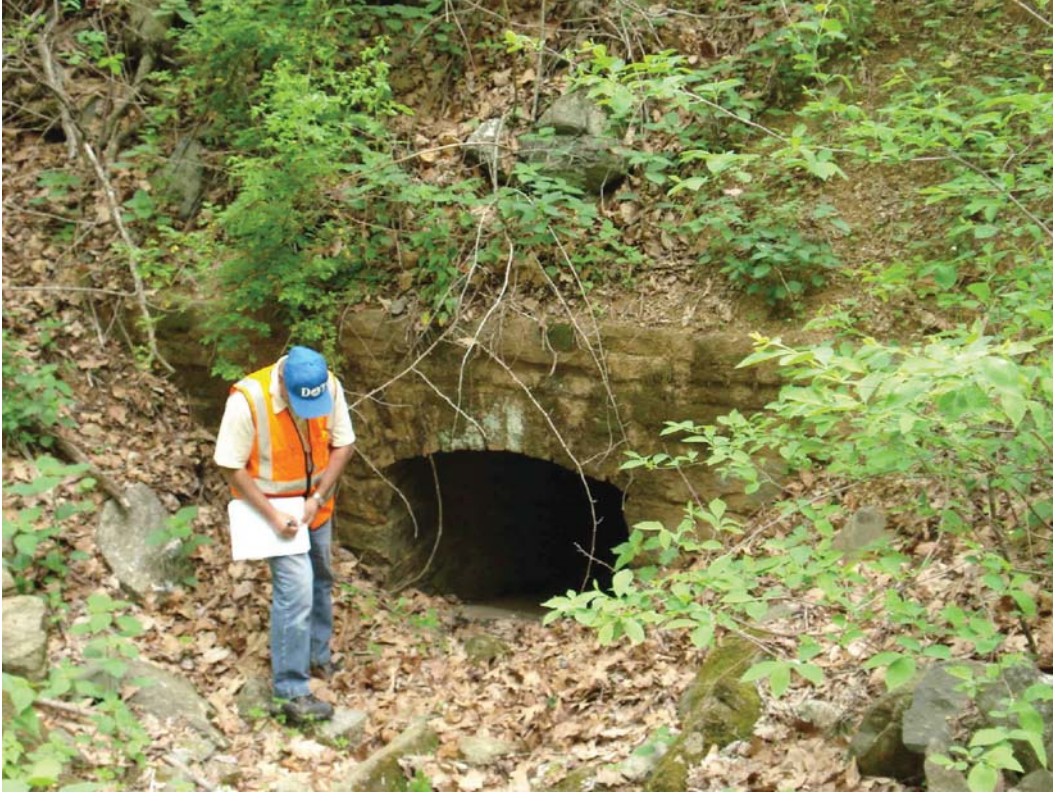
SHEN_0010C_97.865_L_1.jpg

Wall Function:	Head Wall	Primary Wall Type:	Gravity - Mortared Stone
Surface Treatment:		Secondary Wall Type:	
Secondary Surface Treatment:		Architectural Facing:	
General Description:	Culvert W x 2.8 ft H. Possibly repaired in 2002 Outlet on other side is less than 4 ft high, 100 ft hor. from road and 35 ft vert. below road. Potential failure of the outlet side not affect road

Element (Weighting Factor)	Narrative	Condition Rating (0 - 10)
PERFORMANCE 8.00	Good condition	8
WALL FOUNDATION MATERIAL 8.00	No settlement or erosion	8
MORTAR 8.00	Good condition, no losses	8
STONE MASONRY 8.00	Good condition	8
CULVERT 0.50	Good condition	8
DOWNSLOPE 0.50	Short downslope	8
LATERAL SLOPE 0.50	Mild slope	8
ROAD/SIDEWALK/SHOULDER 0.50	Grassed shoulder	8
WALL DRAINS 0.50	None visible, no problems	8

Failure Consequence:	MODERATE
Recommendation Narrative:	None
Repair Cost:	\$0

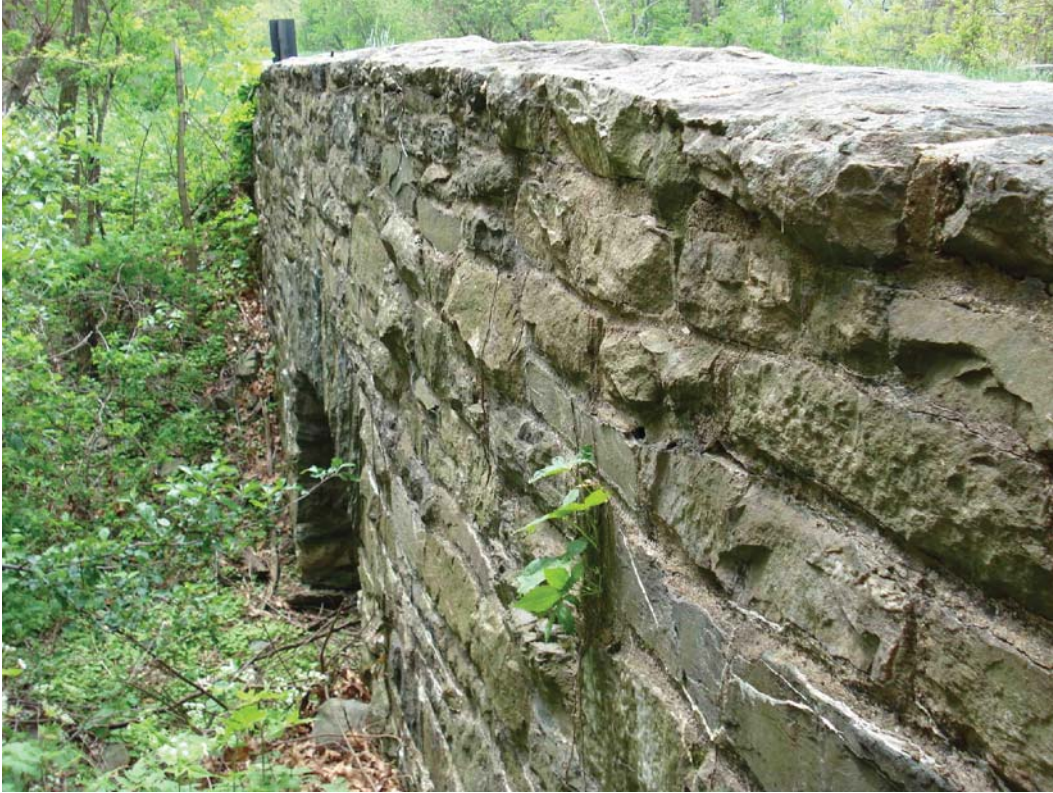
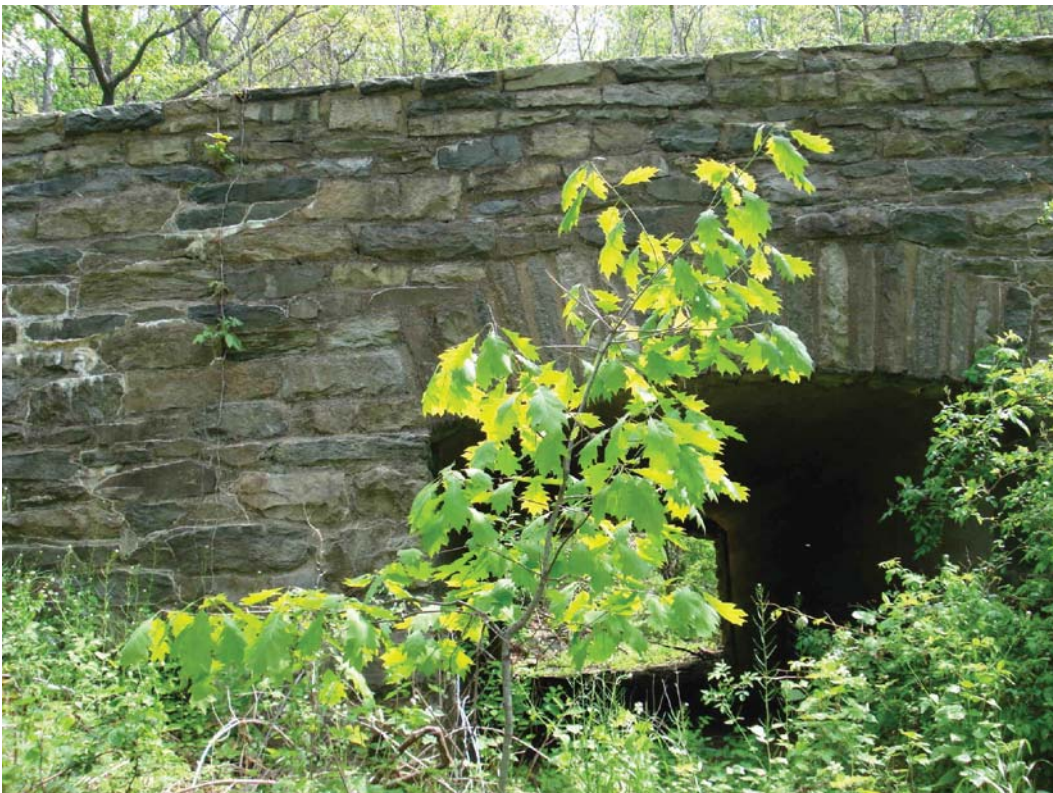
Element (Weighting Factor)	Narrative	Condition Rating (0 - 10)
PERFORMANCE 8.00	Good condition	8
WALL FOUNDATION MATERIAL 8.00	No settlement or erosion	8
MORTAR 8.00	Good Condition	8
STONE MASONRY 8.00	Good condition	8
CULVERT 0.50	Good condition	8
DOWNSLOPE 0.50	Brief downslope, then upslope	8
LATERAL SLOPE 0.50	Flat	8
UPSLOPE 0.50	Flat, vegetated	8
WALL DRAINS 0.50	None visible, no drainage problem	8

Failure Consequence:	MODERATE
Recommendation Narrative:	None
Repair Cost:	\$0
