SHEN WIP Report

NPS Retaining Wall Inventory Program Shenandoah National Park

Federal Highway Administration
Eastern Federal Lands Highway Division
Road Inventory Program (RIP)

Data Collection Date: May 2007
Report Date: October 2015

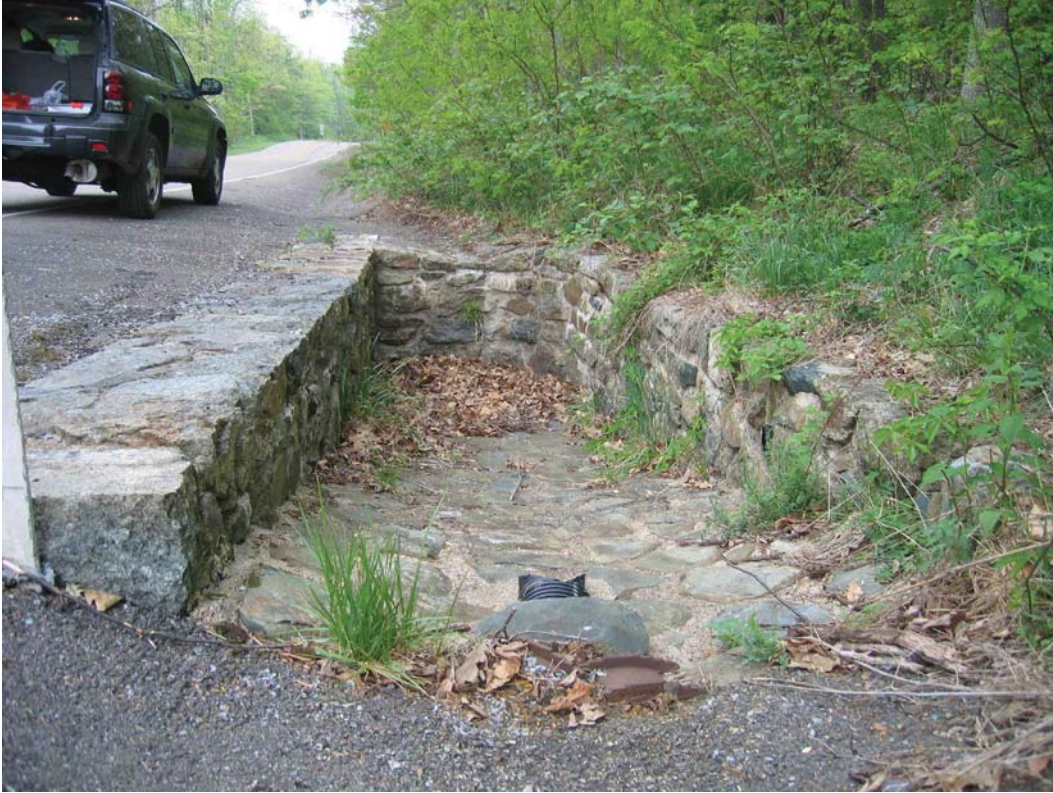
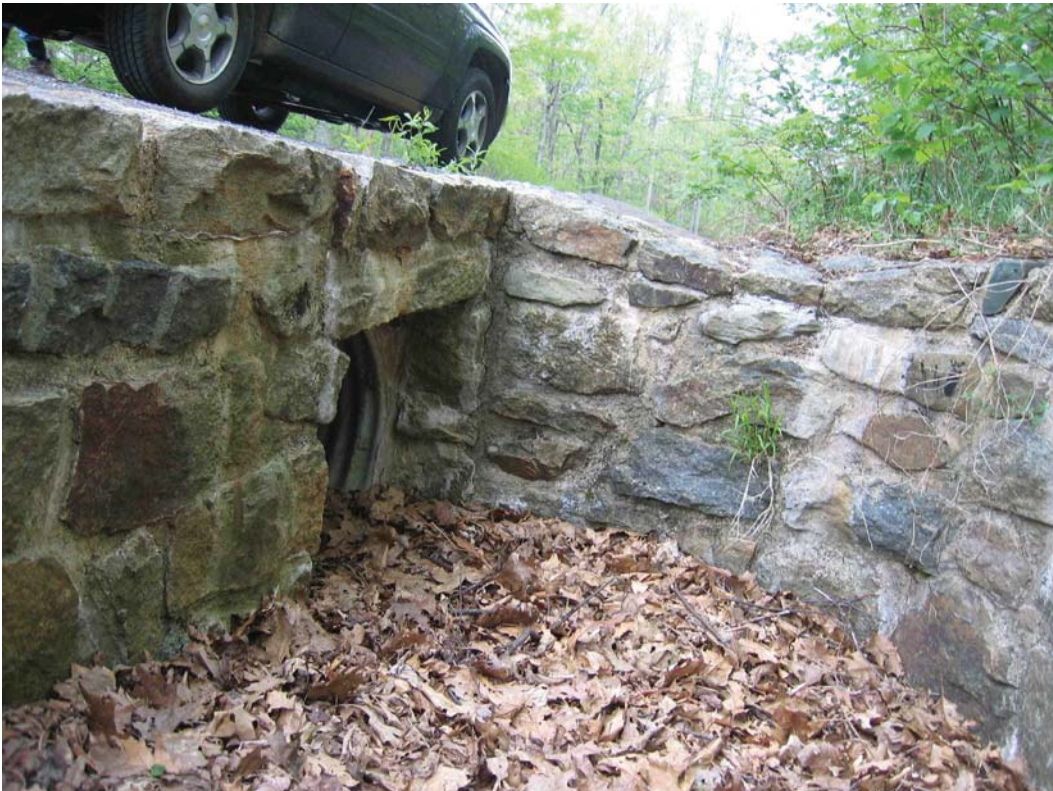
SHEN_0012_0.499_R_1.jpg

Wall ID:	SHEN-0012-0.499-R		
Route Name:	MATHEWS ARM ENTRANCE ROAD		
Inspection Date:	May 16, 2007	Approximate Year Built:	1987
*Wall Rating:	83	Maintenance Action:	No Action

Element (Weighting Factor)	Narrative	Condition Rating (0 - 10)
PERFORMANCE 8.00	Excellent overall condition, with no signs of global or element distress.	9
WALL FOUNDATION MATERIAL 8.00	Mortared stone masonry drainage, with no signs of settlement distress.	8
MORTAR 8.00	Sound, durable, intact, with minor weathering. No signs of significant cracking.	8
STONE MASONRY 8.00	Sound, durable, with minor weathering. No cracked or missing blocks.	8
VEGETATION 0.50	Minor vegetation growing at top of wall. No impact to wall performance.	8
CULVERT 0.50	Functioning as intended, with no signs of distress.	9
DOWNSLOPE 0.50	Mortared stone drainage showing no signs of distress.	9
LATERAL SLOPE 0.50	Stable soil embankment showing no signs of distress.	9
ROAD/SIDEWALK/SHOULDER 0.50	Excellent condition with no signs of wall-related distress.	9

Failure Consequence:	LOW
Recommendation Narrative:	None
Repair Cost:	\$0

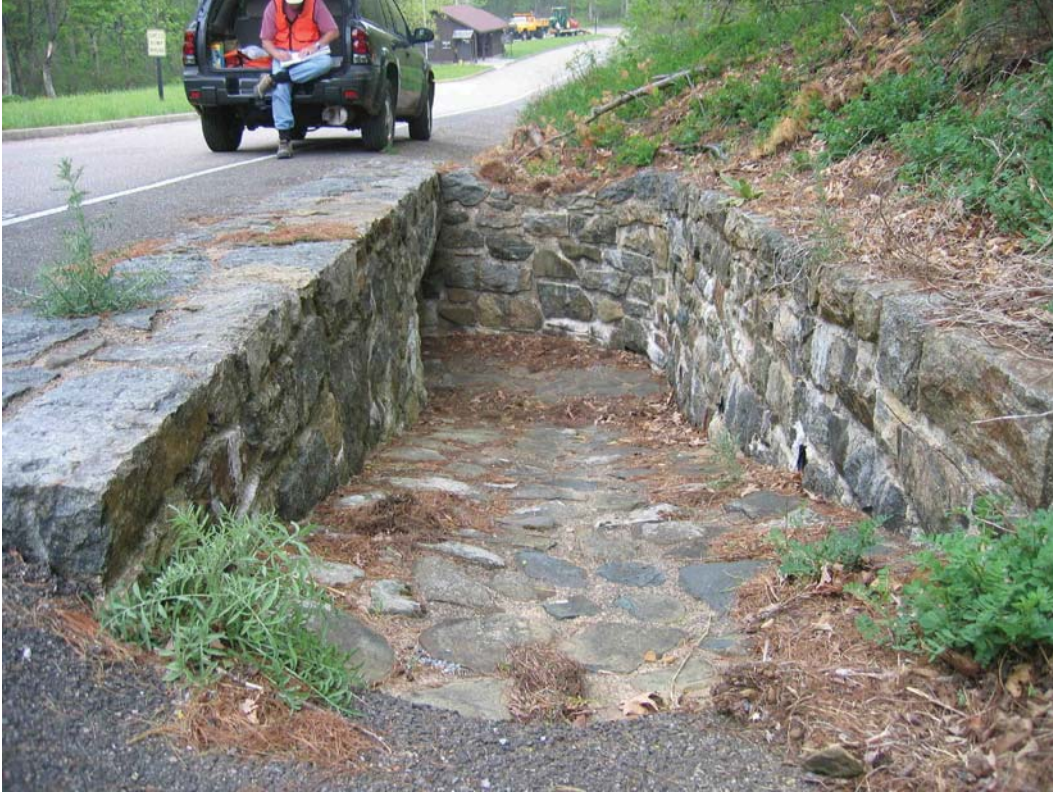
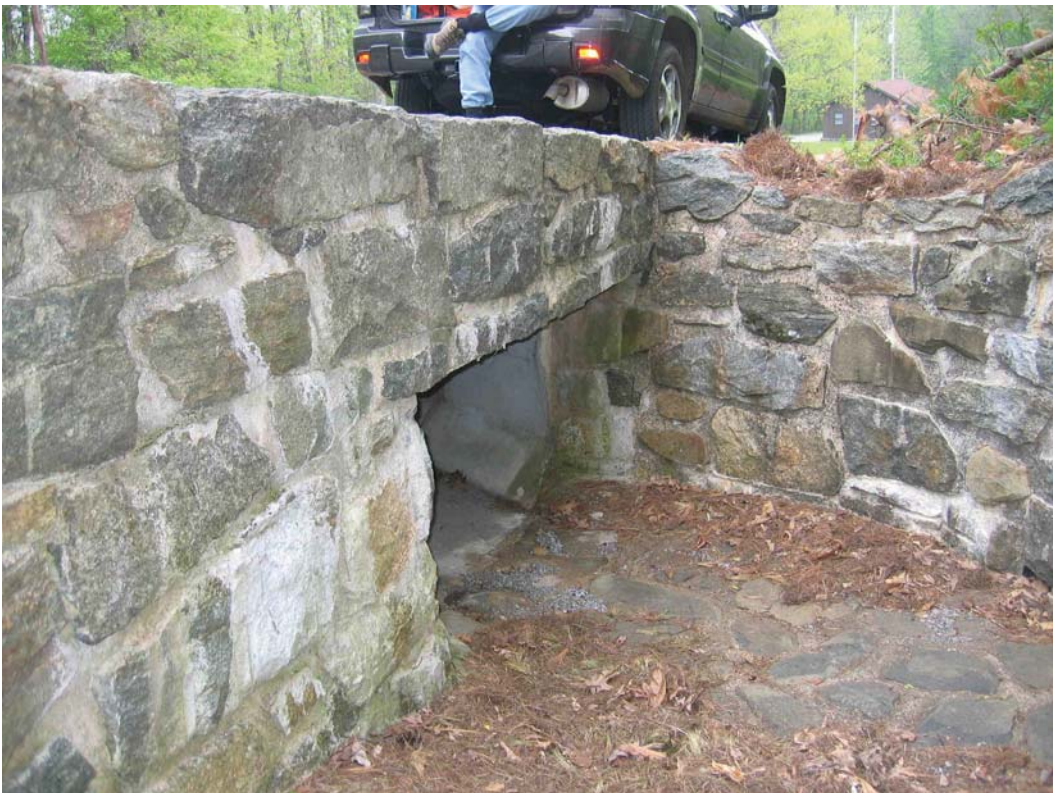
SHEN_0012_0.648_R_1.jpg

Wall ID:	SHEN-0012-0.648-R		
Route Name:	MATHEWS ARM ENTRANCE ROAD		
Inspection Date:	May 16, 2007	Approximate Year Built:	1987
*Wall Rating:	83	Maintenance Action:	No Action

Element (Weighting Factor)	Narrative	Condition Rating (0 - 10)
PERFORMANCE 8.00	No signs of global distress. Functioning as designed and constructed.	9
WALL FOUNDATION MATERIAL 8.00	Mortared stone masonry with no signs of settlement.	8
MORTAR 8.00	Sound, durable, intact, with minor weathering. No signs of significant cracking.	8
STONE MASONRY 8.00	Sound, durable, with minor weathering. No cracked or missing blocks.	8
VEGETATION 0.50	Minor vegetation at the top of the wall. No impact to wall performance.	8
CULVERT 0.50	Functioning as intended with no signs of distress.	9
DOWNSLOPE 0.50	Mortared stone drainage showing no signs of distress.	9
LATERAL SLOPE 0.50	Stable soil embankment showing no signs of distress.	9
ROAD/SIDEWALK/SHOULDER 0.50	Excellent condition with no signs of wall-related distress.	9

Failure Consequence:	LOW
Recommendation Narrative:	None
Repair Cost:	\$0

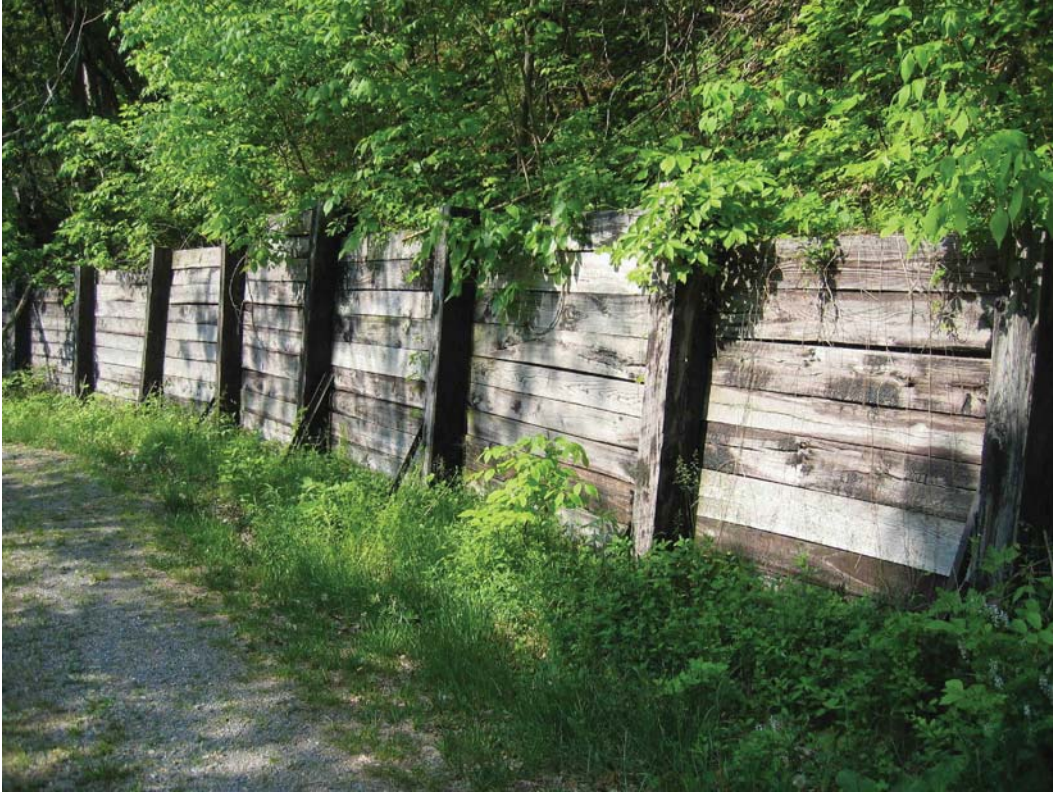
SHEN_0400_0.300_L_1.jpg

Wall ID:	SHEN-0400-0.300-L		
Route Name:	SNEAD FARM ROAD		
Inspection Date:	May 16, 2007	Approximate Year Built:	1987
*Wall Rating:	70	Maintenance Action:	Maintenance

Element (Weighting Factor)	Narrative	Condition Rating (0 - 10)
PERFORMANCE 8.00	No signs of global distress, though one pile needs repair.	7
WALL FOUNDATION MATERIAL 8.00	Dense, stable granular soil. No signs of distress or eroded foundation material.	8
PILES AND SHAFTS 8.00	Timber piles are generally dense and solid. One pile is split vertically along wood grain, but is still performing satisfactorily (though needs to be repaired).	6
LAGGING 8.00	Timber lagging was originally tarred, but has weathered substantially. Generally, wood is dense and solid, with only minor splitting. No timbers were broken.	7
LATERAL SLOPE 0.50	Well-vegetated side slopes with minor signs of erosion.	8
ROAD/SIDEWALK/SHOULDER 0.50	Gravel road at toe of wall showing no signs of wall-related distress.	8
UPSLOPE 0.50	Well-vegetated slope (approx. 1.5H:1V, 15-20 tall) with some signs of erosion. Stable slope.	8
WALL DRAINS 0.50	No wall drains present. No signs of seepage through the wall face or other types of water-related distress.	8

VEGETATION 1.00	Small trees growing along the top-line of the wall that should be removed to prevent damage to the wall.	5

Failure Consequence:	LOW
Recommendation Narrative:	Clear small trees and brush along top of wall and repair/reinforce cracked timber pile. Labor to repair cracked timber pile: 2hrs @ \$50/hr = \$100. Lag bolts and plates: Lump Sum = \$50. Clear small trees from around wall: 3hrs @ \$50/hr = \$150. Total = \$300
Repair Cost:	\$300

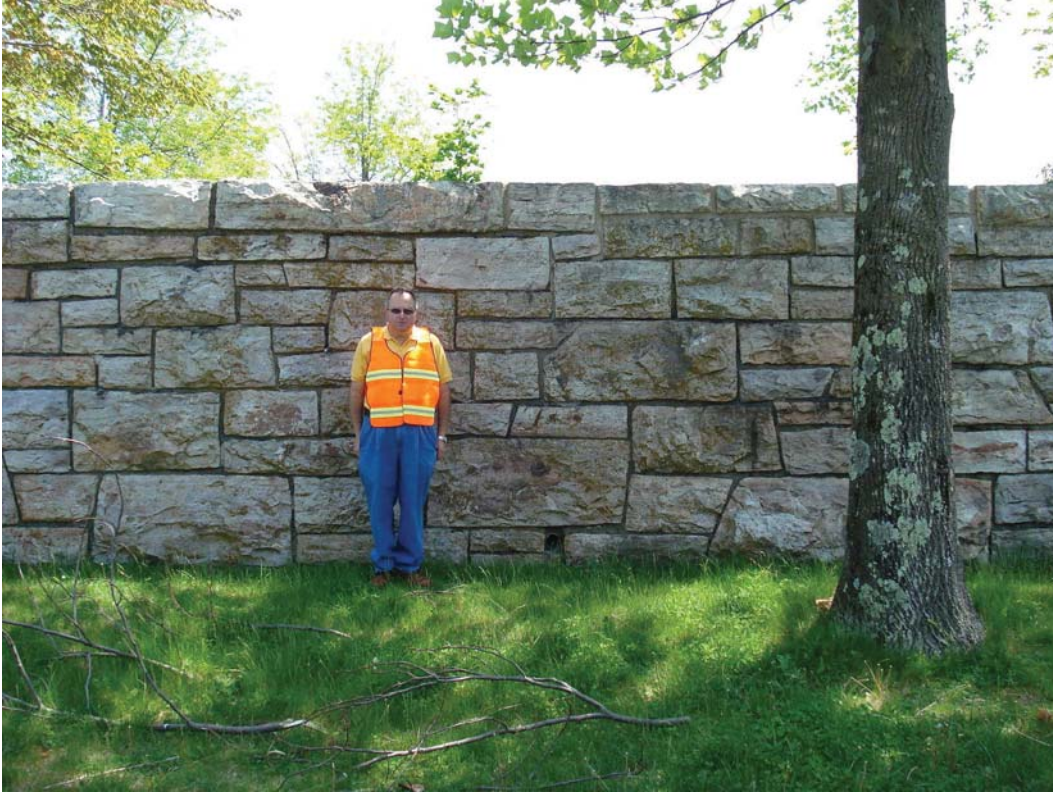
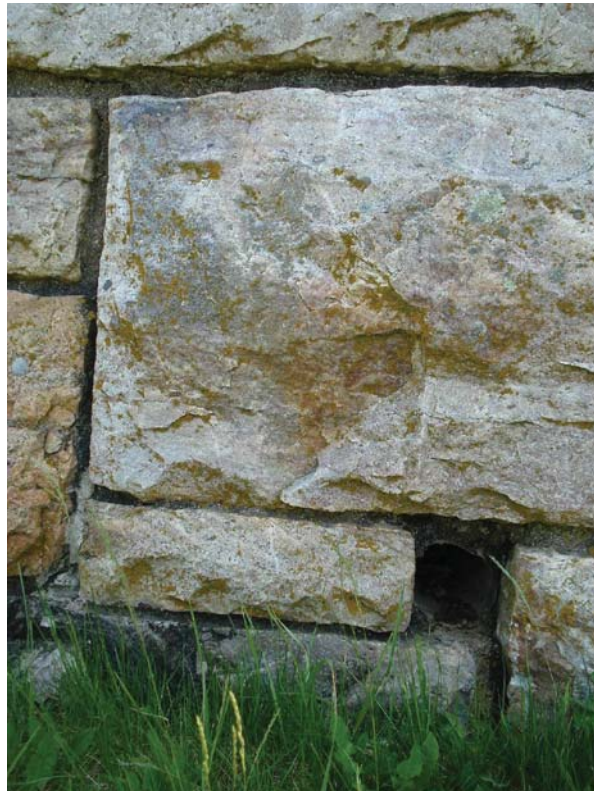
SHEN_0974_0.000_P2_1.jpg

Wall Function:	Cut Wall	Primary Wall Type:	Gravity - Mortared Stone
Surface Treatment:		Secondary Wall Type:	
Secondary Surface Treatment:		Architectural Facing:	
General Description:	GW retaining wall supporting the southwest corner of Upper Panorama Parking lot wall height varies to a maximum of 6.8 ft low consequence of failure

Element (Weighting Factor)	Narrative	Condition Rating (0 - 10)
PERFORMANCE 8.00	Good to excellent performance of wall; no evidence of movement or distress	9
WALL FOUNDATION MATERIAL 8.00	Wall founded on firm soil; no evidence of settlement or rotation	9
MORTAR 8.00	Generally good condition; shows sign of normal seasonal weathering	8
STONE MASONRY 8.00	Stone blocks are in good condition; no sign of distress	8
LATERAL SLOPE 0.50	No evidence of erosion or distress	8
ROAD/SIDEWALK/SHOULDER 0.50	Asphalt pavement exit road below wall; road is in good condition	8
TRAFFIC BARRIER/FENCE 0.50	GM guard wall along top of wall: mortar and blocks are in good condition; no evidence of distress	8
UPSLOPE 0.50	Relatively flat vegetated area behind wall with a 2-ft wide concrete sidewalk; both show no evidence of distress	8
VEGETATION 0.50	A couple of medium diameter trees adjacent to wall; trees do not appear to impact the wall	8

Failure Consequence:	LOW
Recommendation Narrative:	None
Repair Cost:	\$0

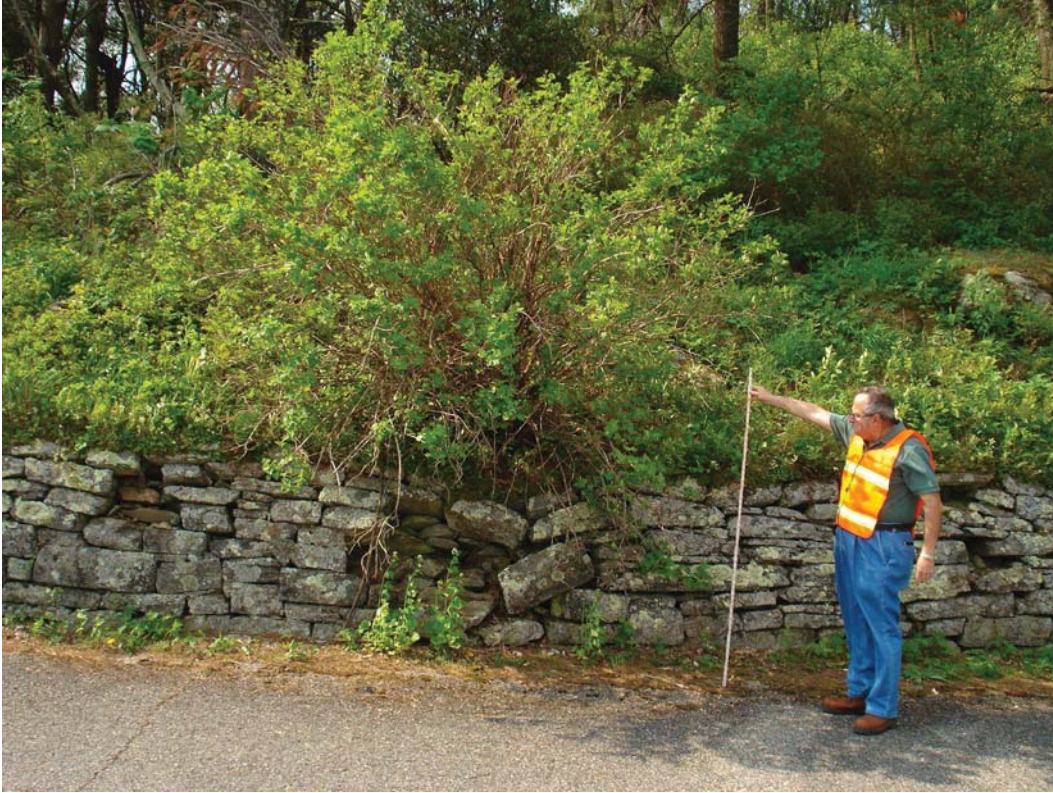
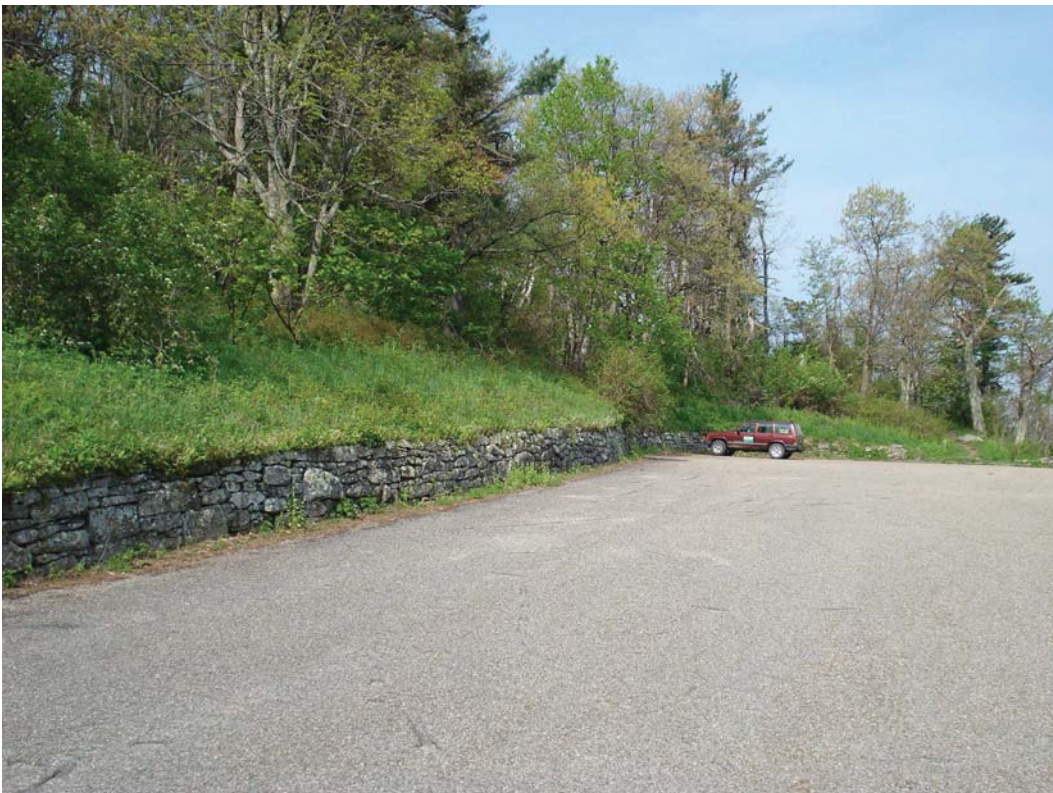
SHEN_1025_0.000_P1_1.jpg

Wall ID:	SHEN-1025-0.000-P1		
Route Name:	JEWELL HOLLOW OVERLOOK PARKING		
Inspection Date:	May 16, 2007	Approximate Year Built:	Unknown
*Wall Rating:	76	Maintenance Action:	Repair Elements

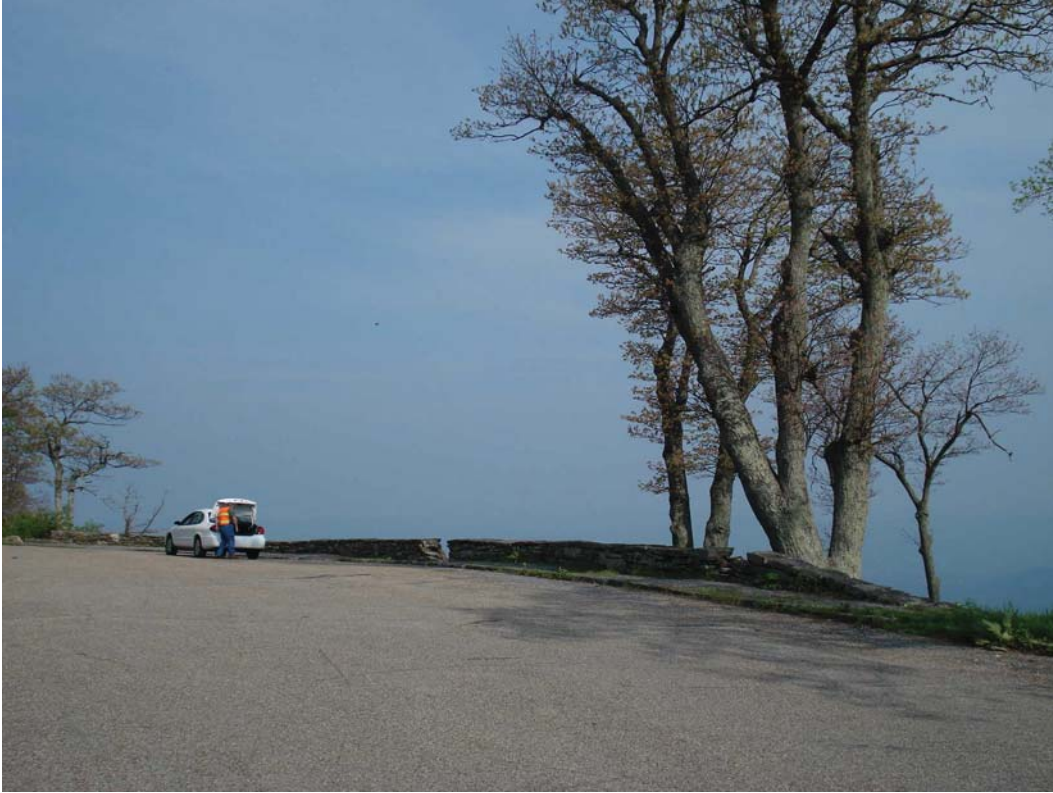
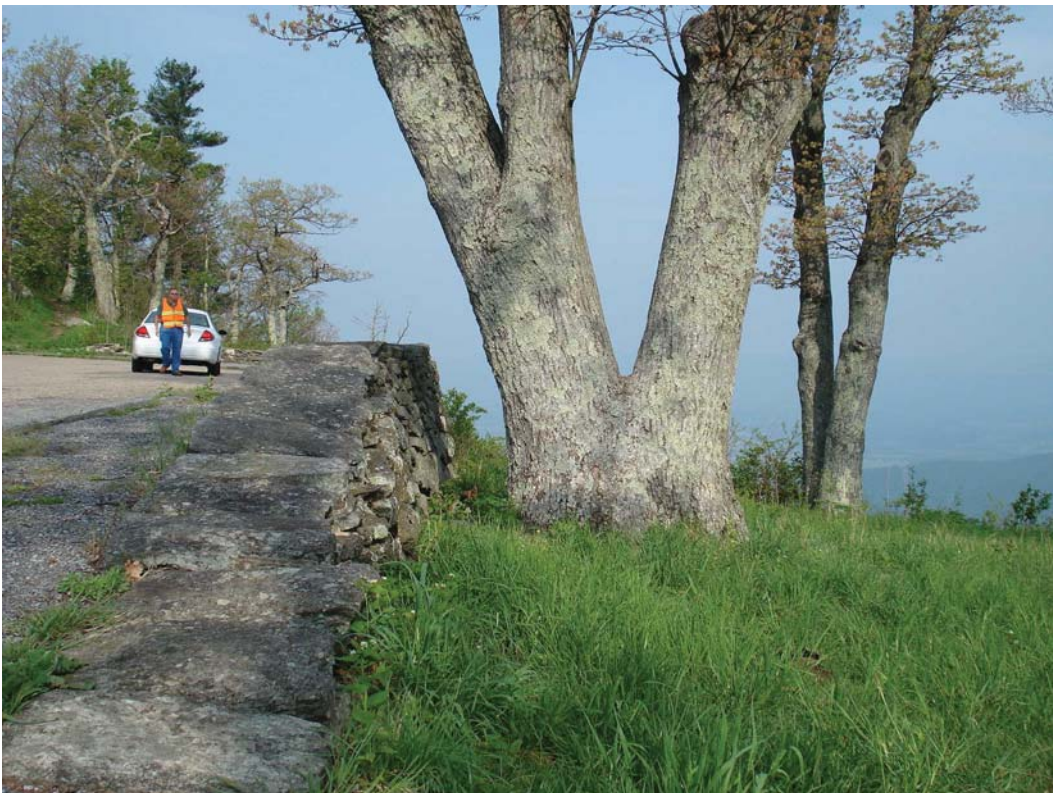
SHEN_1025_0.000_P2_1.jpg

Wall ID:	SHEN-1025-0.000-P2		
Route Name:	JEWELL HOLLOW OVERLOOK PARKING		
Inspection Date:	May 16, 2007	Approximate Year Built:	Unknown
*Wall Rating:	70	Maintenance Action:	No Action
