# ZION WIP Report

## NPS Retaining Wall Inventory Program Zion National Park

**Federal Lands Highway  
Road Inventory Program**

**Data Collection Date: December 2006  
Report Date: October 2015**

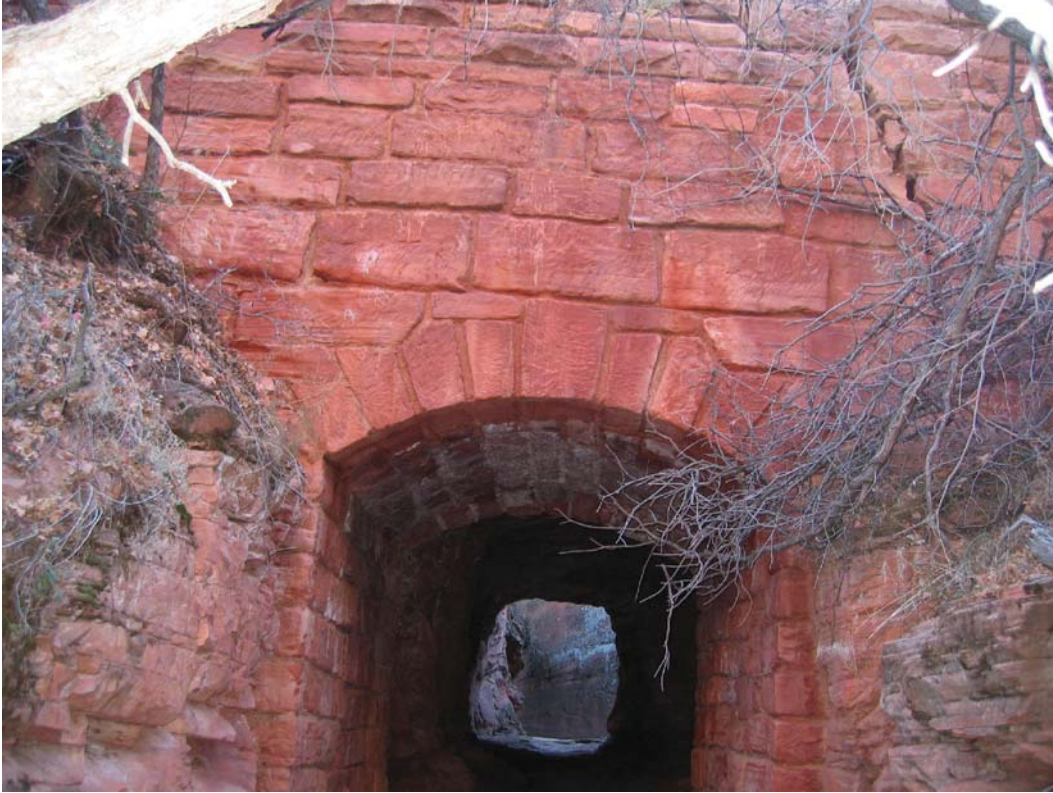
ZION\_0010\_8.537\_R\_1.jpg

<b>Element (Weighting Factor)</b>	<b>Narrative</b>	<b>Condition Rating (0 - 10)</b>
PERFORMANCE 8.00	Performing well	9
WALL FOUNDATION MATERIAL 8.00	UNDERMINING AT END OF ARCH OPENING; 1' VERTICAL x 1' HORIZ x 3' DEEP - UNDERNEATH VERTICAL CRACK	6
STONE MASONRY 8.00	FULL HEIGHT VERTICAL CRACK THROUGH MORTAR AND STONE; 5" AT TOP TAPERING TO 1" AT BOTTOM. PLUMB, NO DEFLECTION OR ROTATION	8
CULVERT 0.50	NO DISTRESS. ROCK TUNNEL	10
LATERAL SLOPE 0.50	STABLE, VEGETATED	10
ROAD/SIDEWALK/SHOULDER 0.50	NO DISTRESS	10

<b>Failure Consequence:</b>	MODERATE
<b>Recommendation Narrative:</b>	Repair foundation undermining. Remove loose material and tie foundation repair into rock so that additional undermining is prevented. Monitor vertical crack in wall and any associated deflection of wall.
<b>Repair Cost:</b>	\$1,000

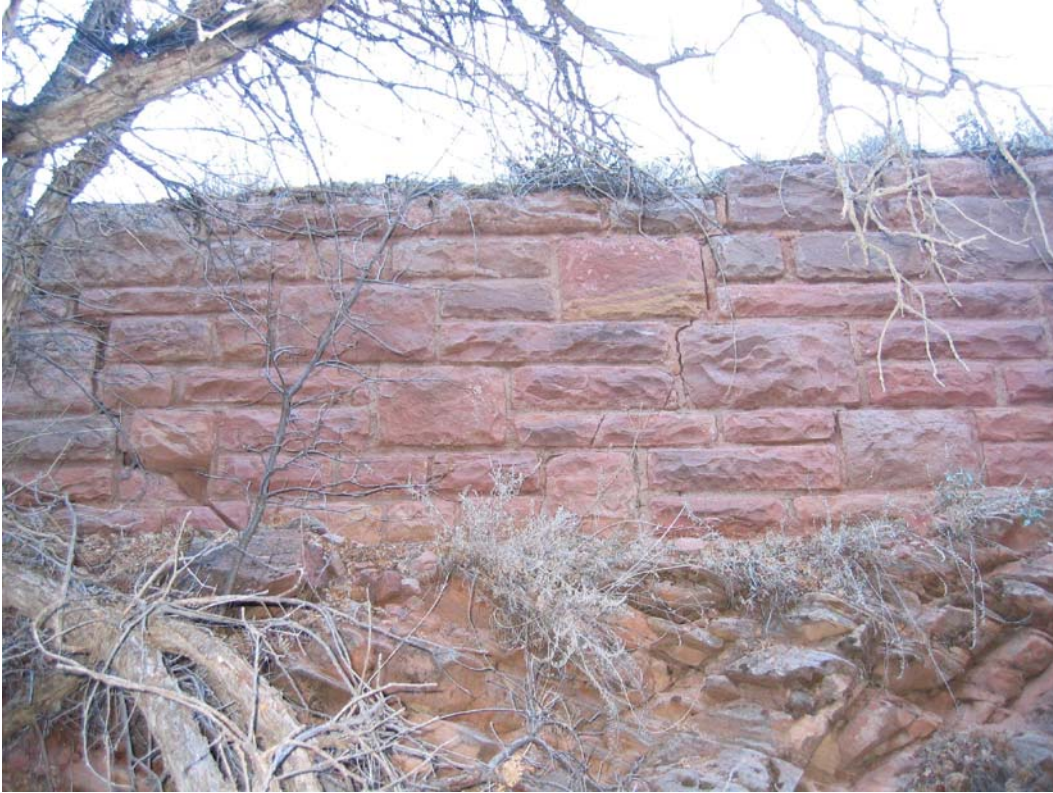
ZION\_0010\_8.538\_L\_1.jpg

<b>Element (Weighting Factor)</b>	<b>Narrative</b>	<b>Condition Rating (0 - 10)</b>
PERFORMANCE 8.00	Very good.	8
WALL FOUNDATION MATERIAL 8.00	SCORING ABOUT 5' LENGTH AND 6" DEEP; BEGINNING FOUNDATION ON END 5 SETTLING	7
STONE MASONRY 8.00	FULL LENGTH CRACKING; 1/2" WIDE. 2" WIDE CRACK 2.5' FROM WALL END. NO DEFLECTION NOTED	8
DOWNSLOPE 0.50	STEEP; NO EROSION	10
LATERAL SLOPE 0.50	WELL VEGETATED	10
UPSLOPE 0.50	WELL VEGETATED	10

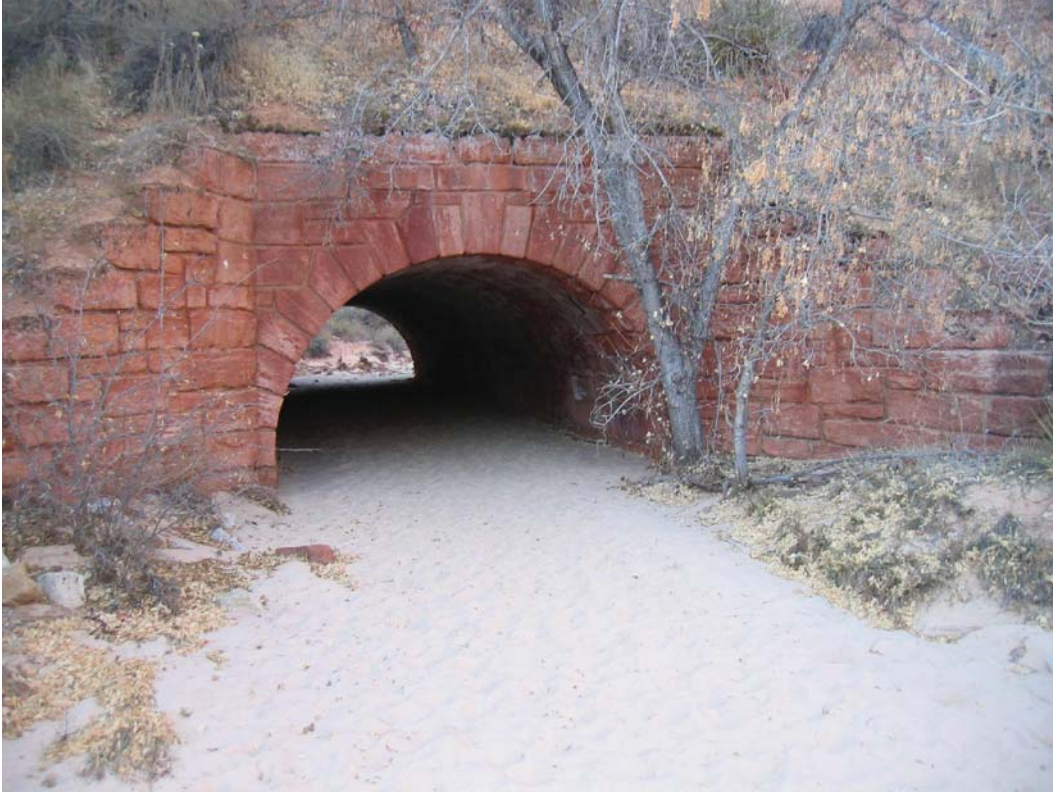
ZION\_0010\_8.867\_L\_1.jpg

<b>Element (Weighting Factor)</b>	<b>Narrative</b>	<b>Condition Rating (0 - 10)</b>
PERFORMANCE 8.00	Good condition.	10
WALL FOUNDATION MATERIAL 8.00	EXCELLENT CONDITION; NO UNDERMINING	10
STONE MASONRY 8.00	NO DISTRESS	10
CULVERT 0.50	STONE ARCH CULVERT	10
LATERAL SLOPE 0.50	NO EROSION	10
UPSLOPE 0.50	WELL VEGETATED	10

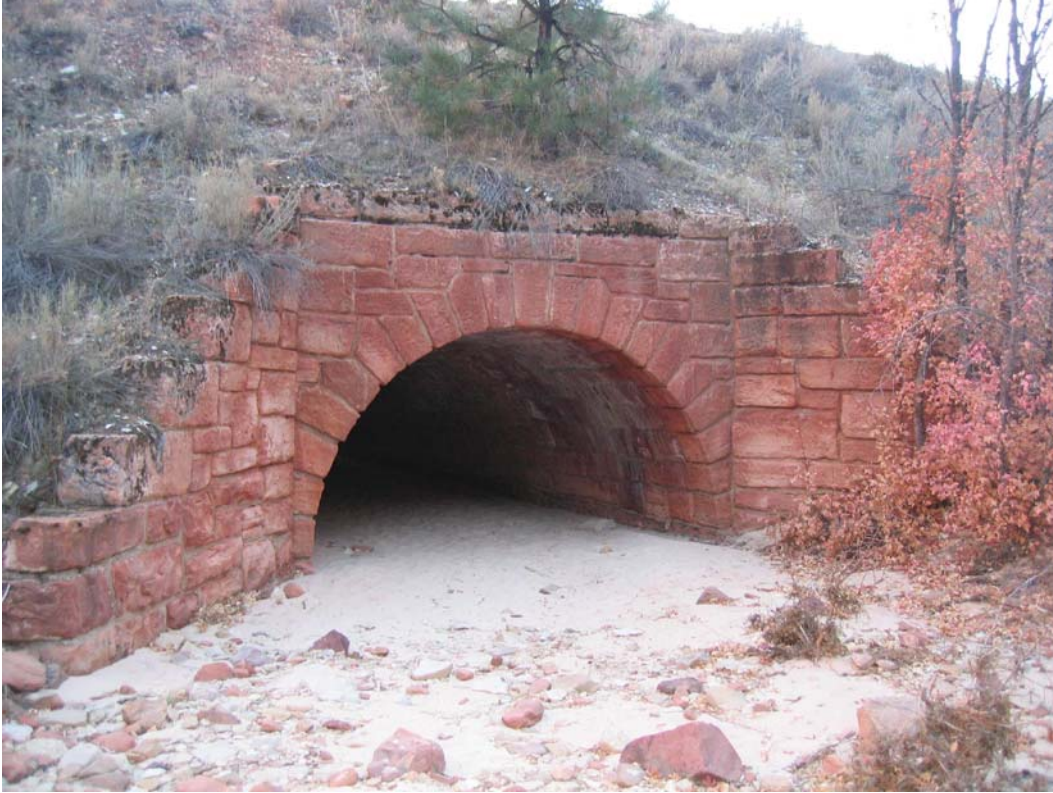
ZION\_0010\_8.867\_R\_1.jpg

<b>Element (Weighting Factor)</b>	<b>Narrative</b>	<b>Condition Rating (0 - 10)</b>
PERFORMANCE 8.00	Good condition.	10
WALL FOUNDATION MATERIAL 8.00	GOOD	10
STONE MASONRY 8.00	NO DISTRESS	10
CULVERT 0.50	GOOD CONDITION, 7' RADIUS STONE MASONRY	10
LATERAL SLOPE 0.50	WELL VEGETATED, NO EROSION	10

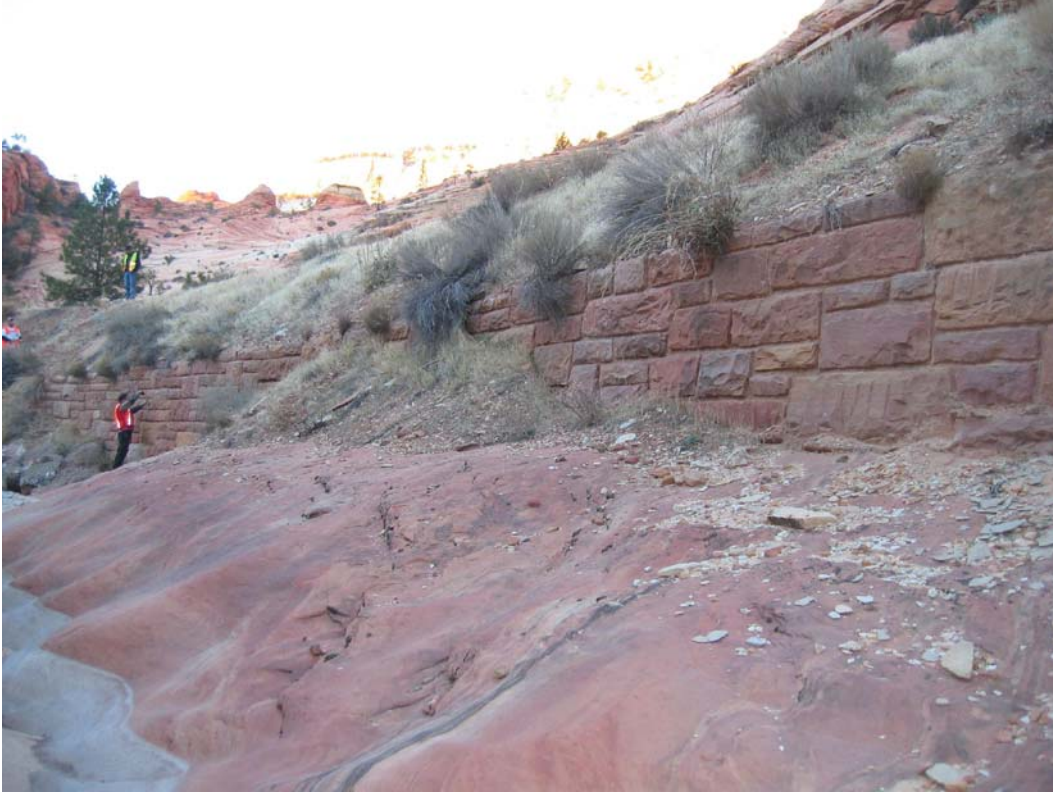
ZION\_0010\_9.616\_R\_1.jpg

<b>Element (Weighting Factor)</b>	<b>Narrative</b>	<b>Condition Rating (0 - 10)</b>
PERFORMANCE 8.00	Good performance	9
WALL FOUNDATION MATERIAL 8.00	GOOD, NO UNDERMINING	10
STONE MASONRY 8.00	NO DISTRESS, GOOD CONDITION	10
UPSLOPE 0.50	WELL VEGETATED	10
LATERAL SLOPE 1.00	UNDERMINING OF RIPRAP SLOPE PROTECTION AT BEGINNING OF WALL; 4' DEEP x 15' LENGTH. DOESN'T SEEM TO AFFECT WALL PERFORMANCE.	7

<b>Failure Consequence:</b>	MODERATE
<b>Recommendation Narrative:</b>	Excavate beneath undermined slope protection (to rock) and replace with mortared riprap.
<b>Repair Cost:</b>	\$750

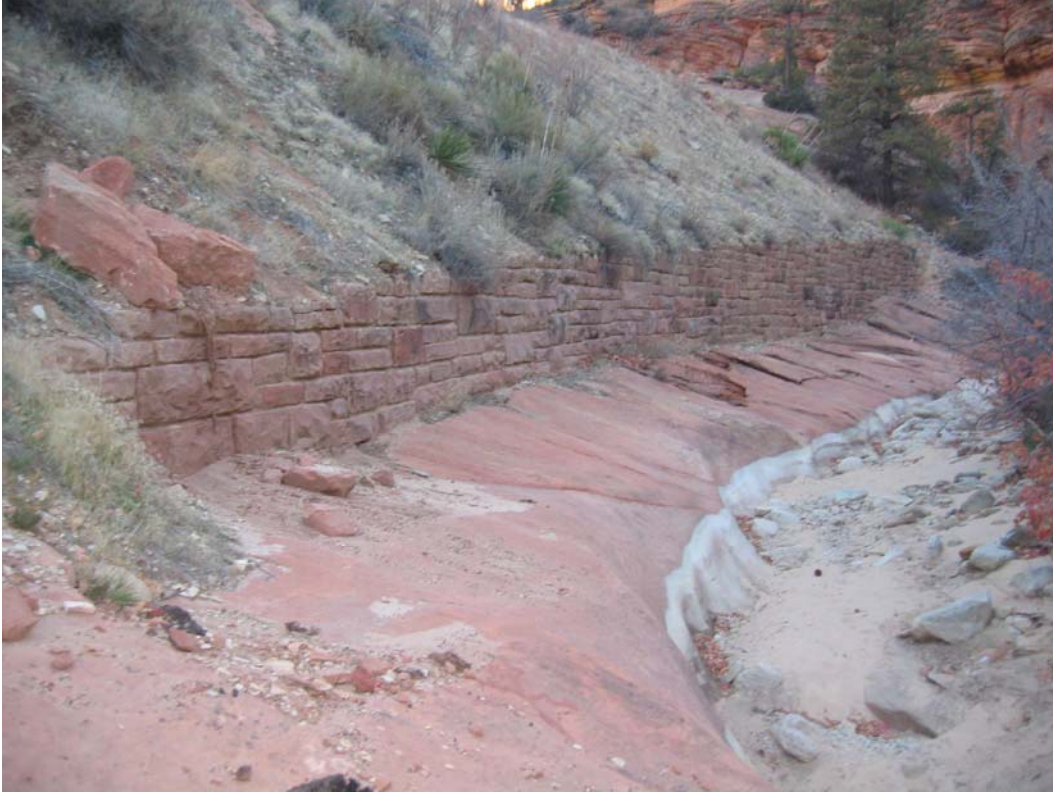
ZION\_0010\_9.700\_R\_1.jpg

<b>Element (Weighting Factor)</b>	<b>Narrative</b>	<b>Condition Rating (0 - 10)</b>
PERFORMANCE 8.00	Good condition.	9
WALL FOUNDATION MATERIAL 8.00	NO DISTRESS	10
STONE MASONRY 8.00	NO DISTRESS	10
UPSLOPE 1.00	EROSION IN UPSLOPE OF UP TO 3' DEEP AT BEGINNING OF WALL; EROSION DUE TO ROAD SURFACE RUNOFF	6
CURB/BERM/DITCH 1.00	TOP OF EXISTING STONE CURB FLUSH WITH PAVEMENT, NOT USEFUL IN PROTECTING SLOPE	7

<b>Failure Consequence:</b>	MODERATE
<b>Recommendation Narrative:</b>	Carry roadway drainage to adequate system by providing Curb/berm along shoulder of roadway. Existing stone curb could be raised to protect wall upslope.
<b>Repair Cost:</b>	\$500

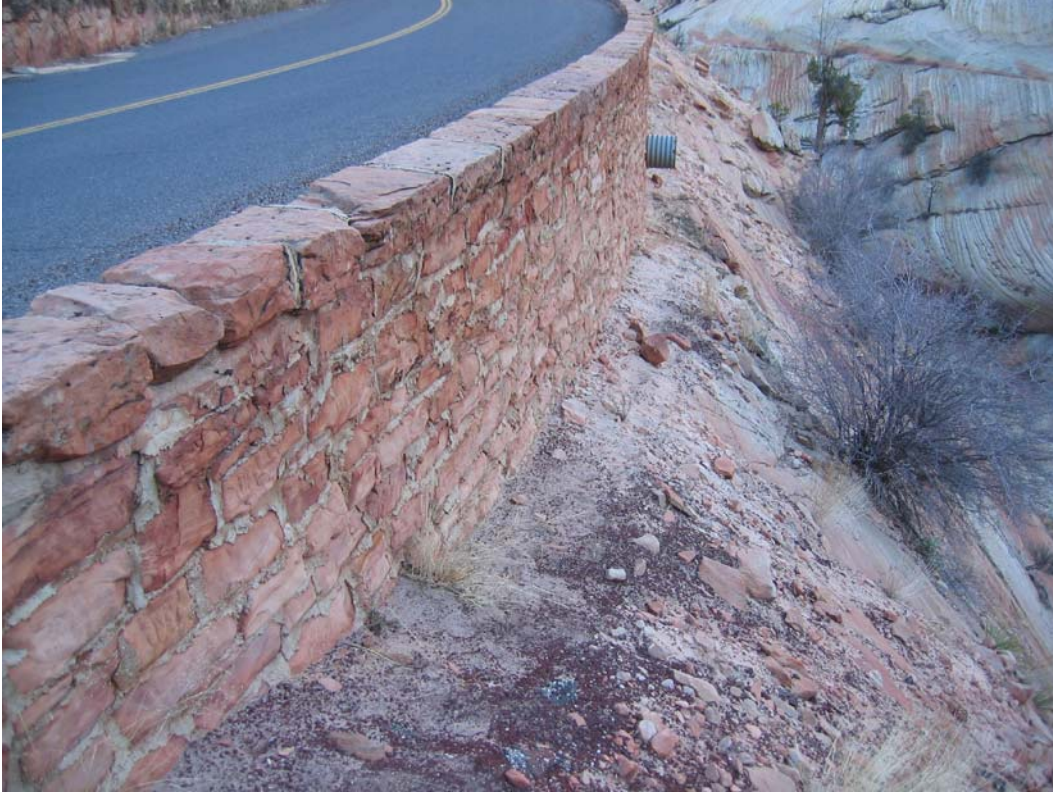
ZION\_0010\_9.755\_R\_1.jpg

<b>Element (Weighting Factor)</b>	<b>Narrative</b>	<b>Condition Rating (0 - 10)</b>
PERFORMANCE 8.00	Good condition.	10
WALL FOUNDATION MATERIAL 8.00	GOOD SHAPE, PERFORMING WELL	10
STONE MASONRY 8.00	GAPS IN MASONRY, MINOR CRACKING AND SEPARATION OF MORTAR	8
CULVERT 0.50	18" CMP CROSS DRAIN IN GOOD SHAPE	10
DOWNSLOPE 0.50	ROCK; STEEP; NO EROSION	10
LATERAL SLOPE 0.50	NO EROSION	10

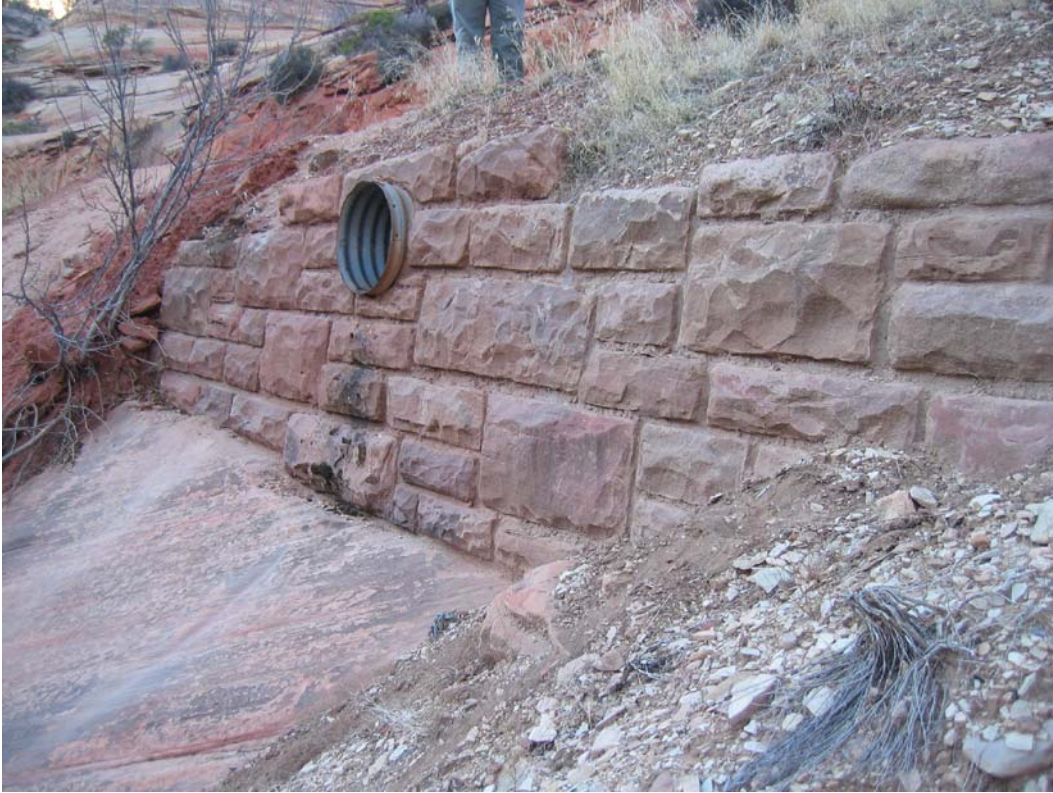
ZION\_0010\_9.885\_R\_1.jpg

<b>Element (Weighting Factor)</b>	<b>Narrative</b>	<b>Condition Rating (0 - 10)</b>
PERFORMANCE 8.00	Good performance	10
WALL FOUNDATION MATERIAL 8.00	NO DISTRESS	10
STONE MASONRY 8.00	NO DISTRESS	10
LATERAL SLOPE 0.50	ERODING DUE TO ROADWAY DRAINAGE	9
CULVERT 0.50	18" CMP, NO DISTRESS	10
DOWNSLOPE 0.50	STEEP, TALUS SLOPE; NO EROSION	10

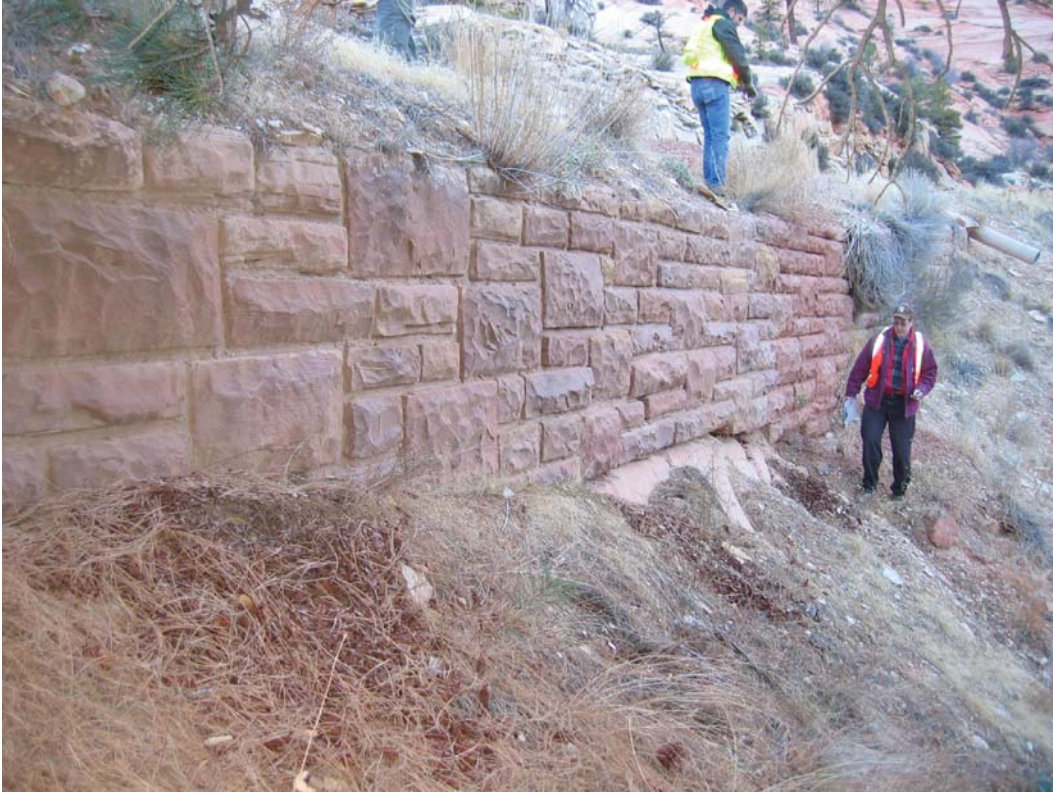
**ZION\_0010\_9.896\_R\_1.jpg**

<b>Element (Weighting Factor)</b>	<b>Narrative</b>	<b>Condition Rating (0 - 10)</b>
PERFORMANCE 8.00	Equals foundation rating.	8
WALL FOUNDATION MATERIAL 8.00	Slight undermine at midwall above exposed rock	8
STONE MASONRY 8.00	End 14' added recently to repair erosion. Virtually no distress in masonry. Joint separation between original and repaired wall end.	10
CULVERT 0.50	"Shotgun" ditch relief culvert (12") at wall end. Minor erosion at outlet.	9
DOWNSLOPE 0.50	Eroded soil above shallow rock. Erosion channels 1ft deep vegging in. Slope +30deg.	9
ROAD/SIDEWALK/SHOULDER 0.50	No distress	10

<b>Failure Consequence:</b>	MODERATE
<b>Recommendation Narrative:</b>	Excavate loose material down to rock at foundation line and place concrete from wall base down to rock. 20'long x 2' high x 2' deep. Excavate by hand - 2 crew 6 hrs - 12 hrsx\$40/hr = \$480. Used CESS hourly labor rate. Place concrete (20x2x2)/27 = 3cy
<b>Repair Cost:</b>	\$4,830

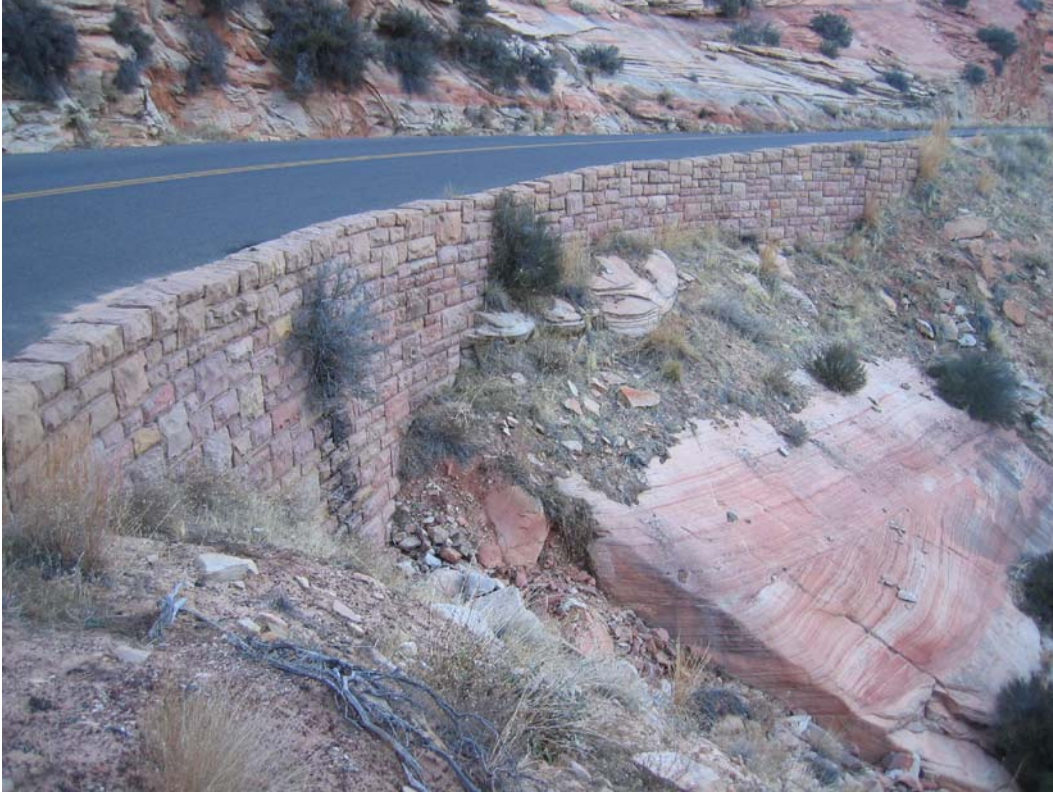
**ZION\_0010\_9.957\_R\_1.jpg**

<b>Element (Weighting Factor)</b>	<b>Narrative</b>	<b>Condition Rating (0 - 10)</b>
PERFORMANCE 8.00	Good condition.	10
WALL FOUNDATION MATERIAL 8.00	Mostly rock. Rock near surface where not visible.	10
STONE MASONRY 8.00	1" wide full height vertical crack 7 ft from wall end. Crack edges rounded and worn. Wall end settled - likely cause of crack. Probably "settled out".	9
DOWNSLOPE 0.50	Steep rock and stable fill. About 100 ft to stream at -36deg.	10
ROAD/SIDEWALK/SHOULDER 0.50	No distress	10

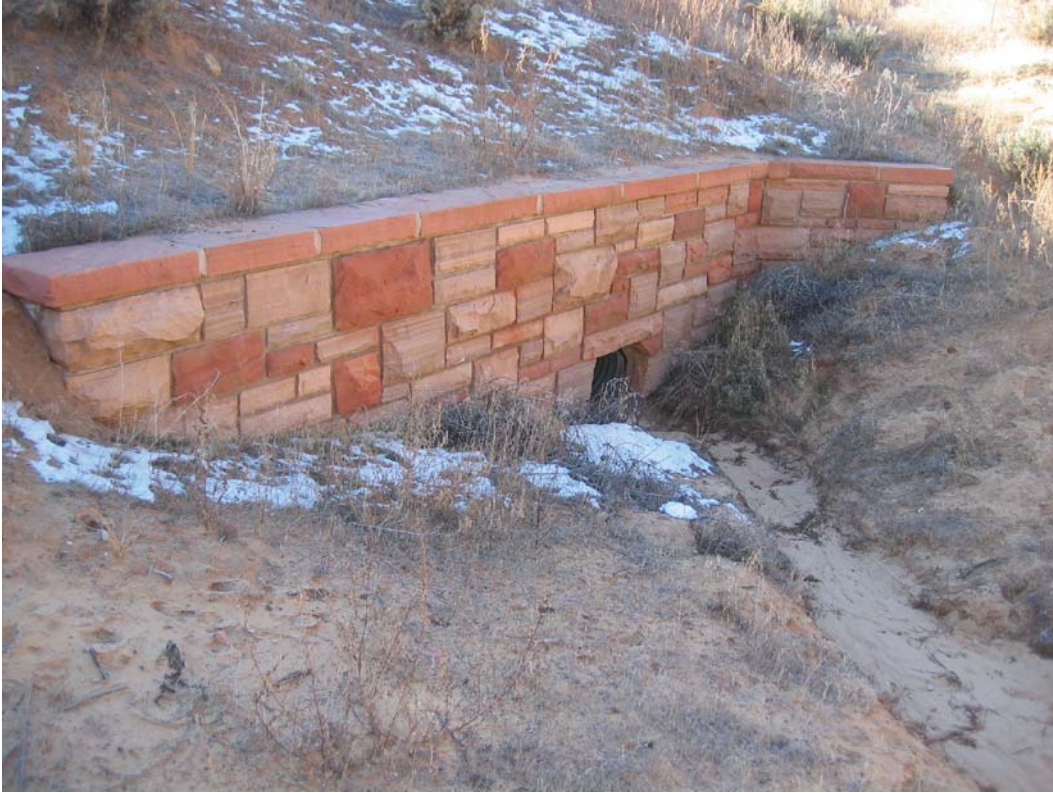
ZION\_0010\_11.590\_L\_1.jpg

<b>Element (Weighting Factor)</b>	<b>Narrative</b>	<b>Condition Rating (0 - 10)</b>
PERFORMANCE 8.00	Good condition.	10
WALL FOUNDATION MATERIAL 8.00	No distress	10
STONE MASONRY 8.00	No distress	10
CULVERT 0.50	24" cmp - looks new	10
LATERAL SLOPE 0.50	Stable fill	10
ROAD/SIDEWALK/SHOULDER 0.50	No distress	10

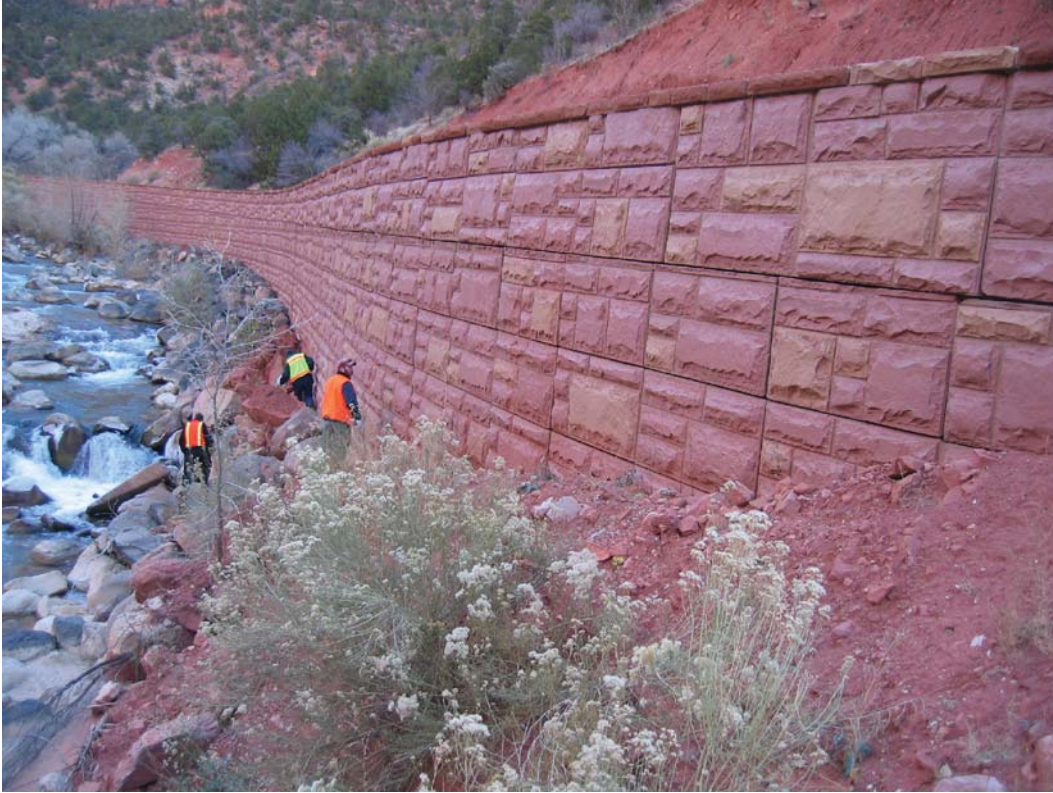
**ZION\_0011\_0.877\_L\_1.jpg**

<b>Element (Weighting Factor)</b>	<b>Narrative</b>	<b>Condition Rating (0 - 10)</b>
PERFORMANCE 8.00	Wall undermined, failed and rebuilt two years after initial construction in 1994. Monitor erosion potential.	9
WALL FOUNDATION MATERIAL 8.00	Steep but well armored by large (Class 5+) riprap. About 20-30 ft SD from Virgin River. No sign of undermining.	10
CONCRETE 8.00	Precast panels. Minor isolated cracking	10
UPSLOPE 0.50	Section of over steepened (1:1 or steeper), raveling coluvuim at beginning of wall. Rockfall may impact parapet/wall.	9
DOWNSLOPE 0.50	20-30 ft SD to Virgin River. Armored with large riprap. Stable.	10
LATERAL SLOPE 0.50	Well vegetated and stable	10
ROAD/SIDEWALK/SHOULDER 0.50	No distress	10
TRAFFIC BARRIER/FENCE 0.50	Guardwall - no deflection	10

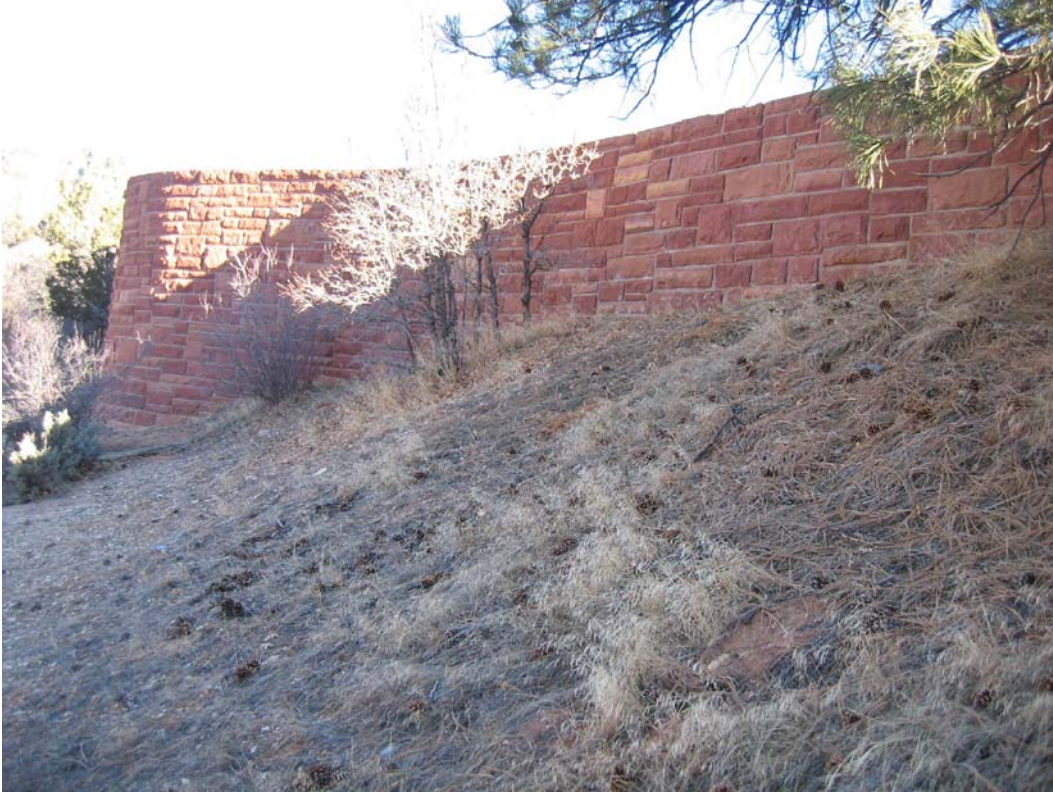
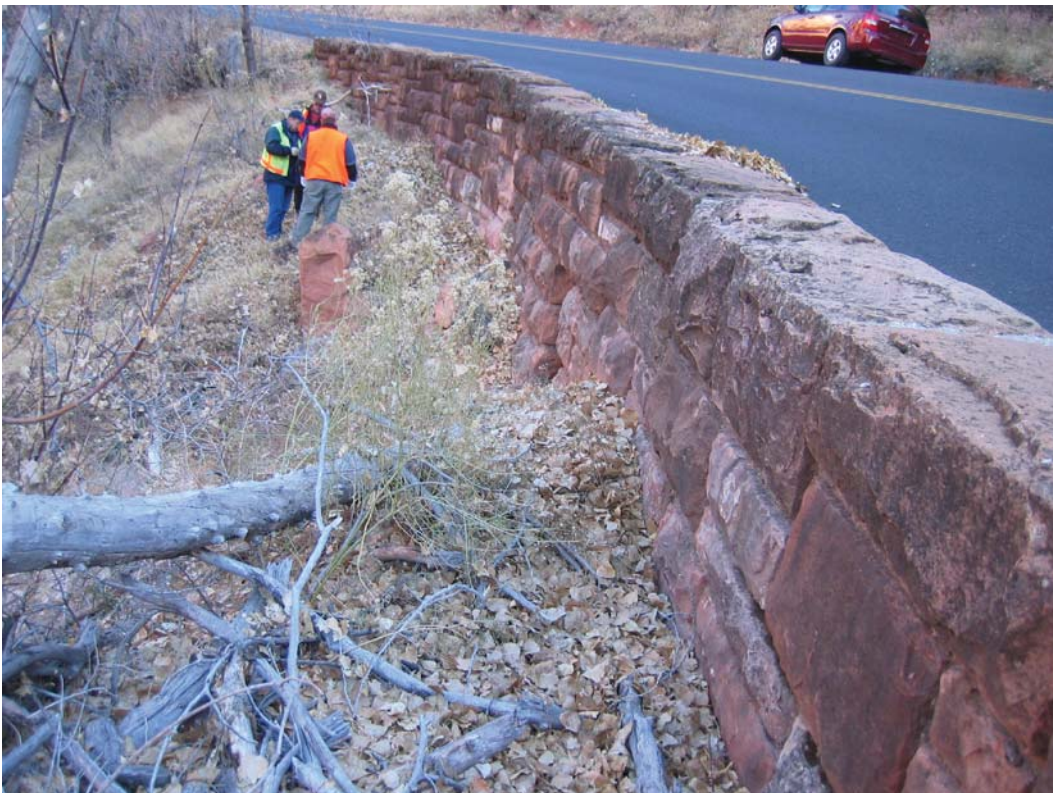
**ZION\_0011\_1.115\_L\_1.jpg**

<b>Element (Weighting Factor)</b>	<b>Narrative</b>	<b>Condition Rating (0 - 10)</b>
PERFORMANCE 8.00	Good condition.	10
WALL FOUNDATION MATERIAL 8.00	2 ft bench in front of toe.	10
STONE MASONRY 8.00	One full height vertical crack along joint at about 65ft.	10
CULVERT 0.50	3' CMP. Outlet extended. Paved channel below outlet steep but good condition.	10
DOWNSLOPE 0.50	Stable, well vegetated	10
LATERAL SLOPE 0.50	Stable, flat, well vegetated	10
ROAD/SIDEWALK/SHOULDER 0.50	No distress	10
WALL DRAINS 0.50	Two" diameter drains	10
