NPS Guardwall/Rail Inventory Program Delaware Water Gap National Recreation Area

**Federal Lands Highway
Road Inventory Program**

Federal Highway Administration
Eastern Federal Lands Highway Division
Road Inventory Program (RIP)

Data Collection Date: October 2010
Report Date: December 2015

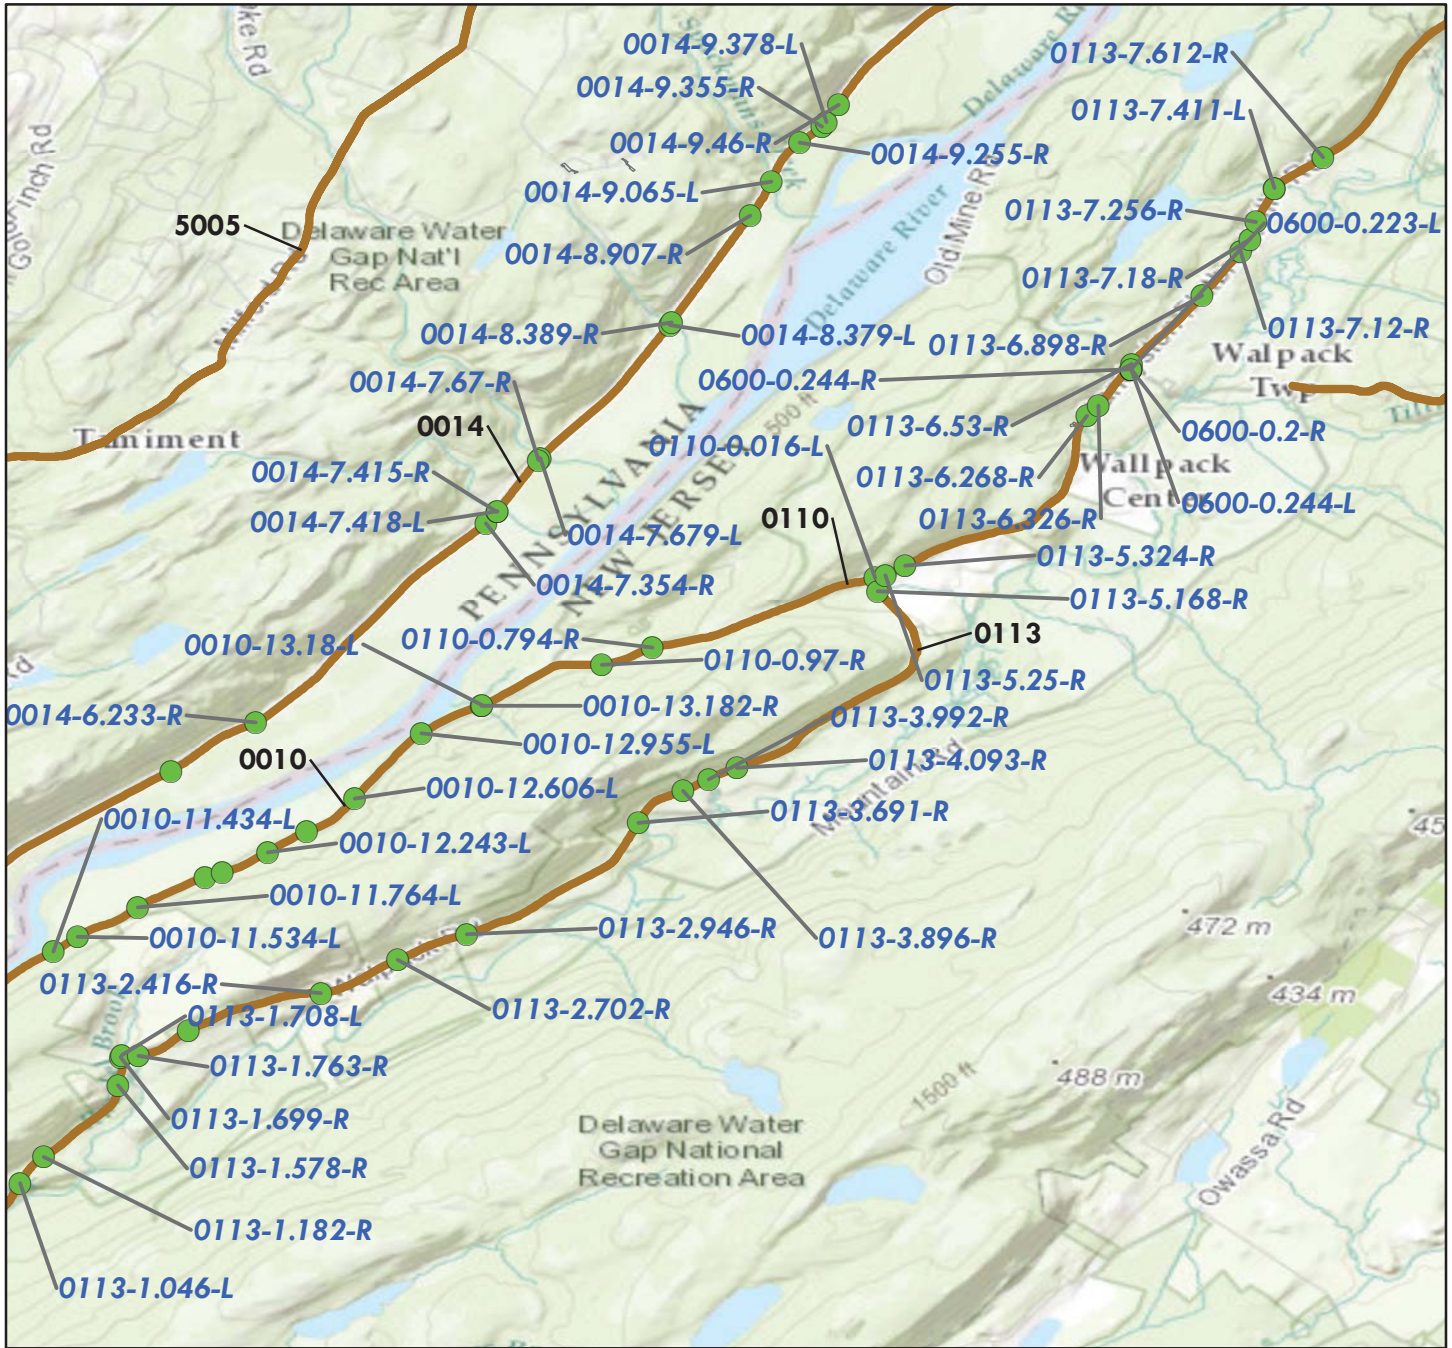
Map 3

BARRIER LOCATION MAP

● Barrier Locations (Not all labeled)

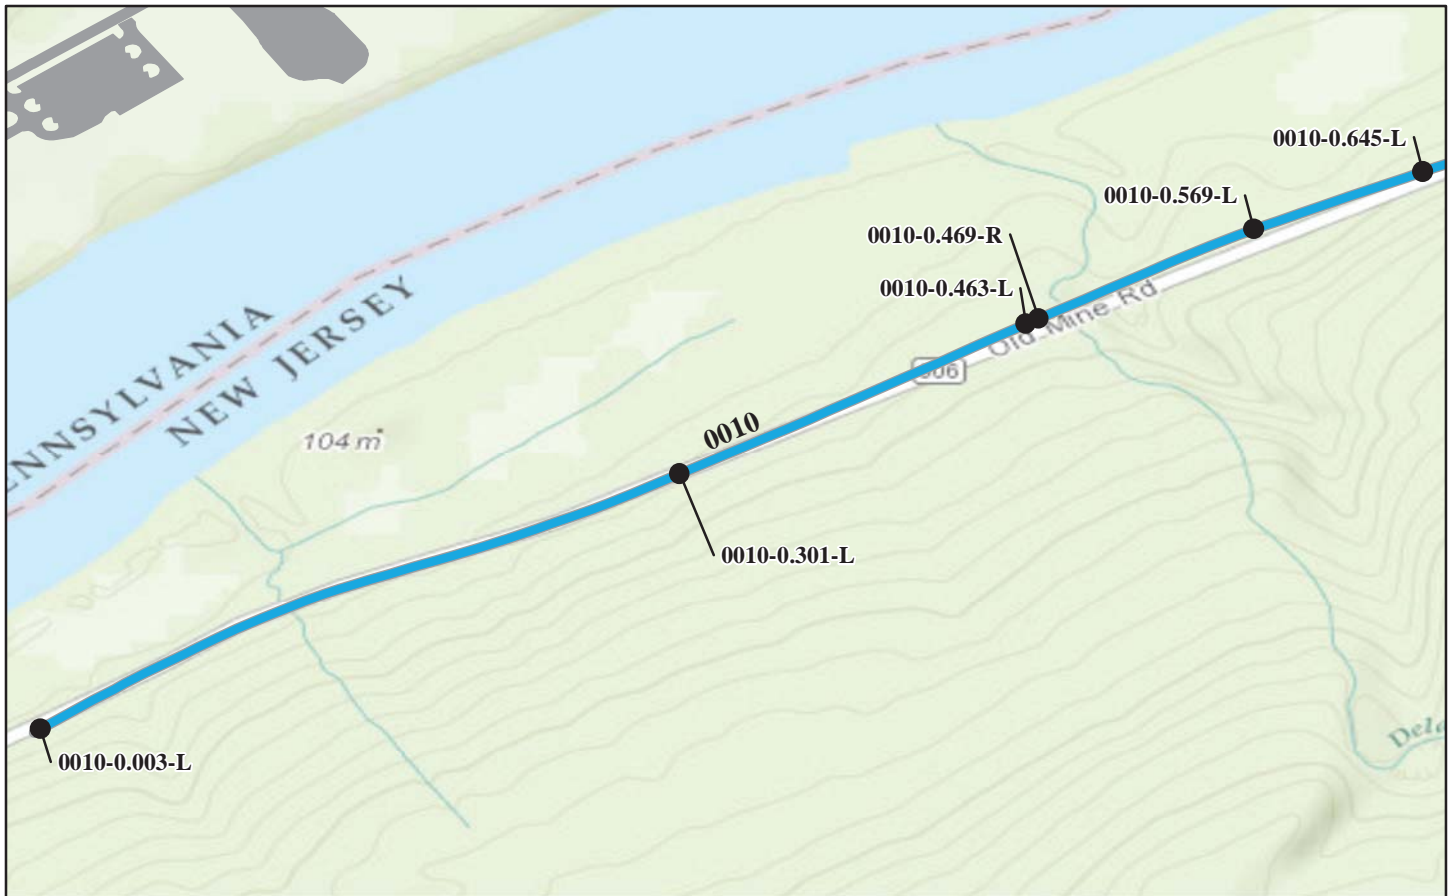
ROUTE 0010: OLD MINE ROAD (SOUTH SECTION)

Barrier ID Inspection Date	Barrier Length (Ft.)	Barrier Type	Barrier End Treatment		*Repair Cost
			Begin	End	
DEWA-0010-0.003-L 10/4/2010	1,440	STEEL-BACKED TIMBER WITH BLOCKOUT	SBT/LOG FLARED	SBT/LOG FLARED	\$0.00
DEWA-0010-0.301-L 10/4/2010	495	STEEL-BACKED TIMBER WITH BLOCKOUT	SBT/LOG FLARED	SBT/LOG FLARED	\$0.00
DEWA-0010-0.463-L 10/4/2010	292	STEEL-BACKED TIMBER WITH BLOCKOUT	SBT/LOG FLARED	SBT/LOG BURIED	\$0.00
DEWA-0010-0.469-R 10/4/2010	227	STEEL-BACKED TIMBER WITH BLOCKOUT	SBT/LOG BURIED	SBT/LOG BURIED	\$0.00
DEWA-0010-0.569-L 10/4/2010	396	STEEL-BACKED TIMBER WITH BLOCKOUT	SBT/LOG FLARED	NONE	\$0.00

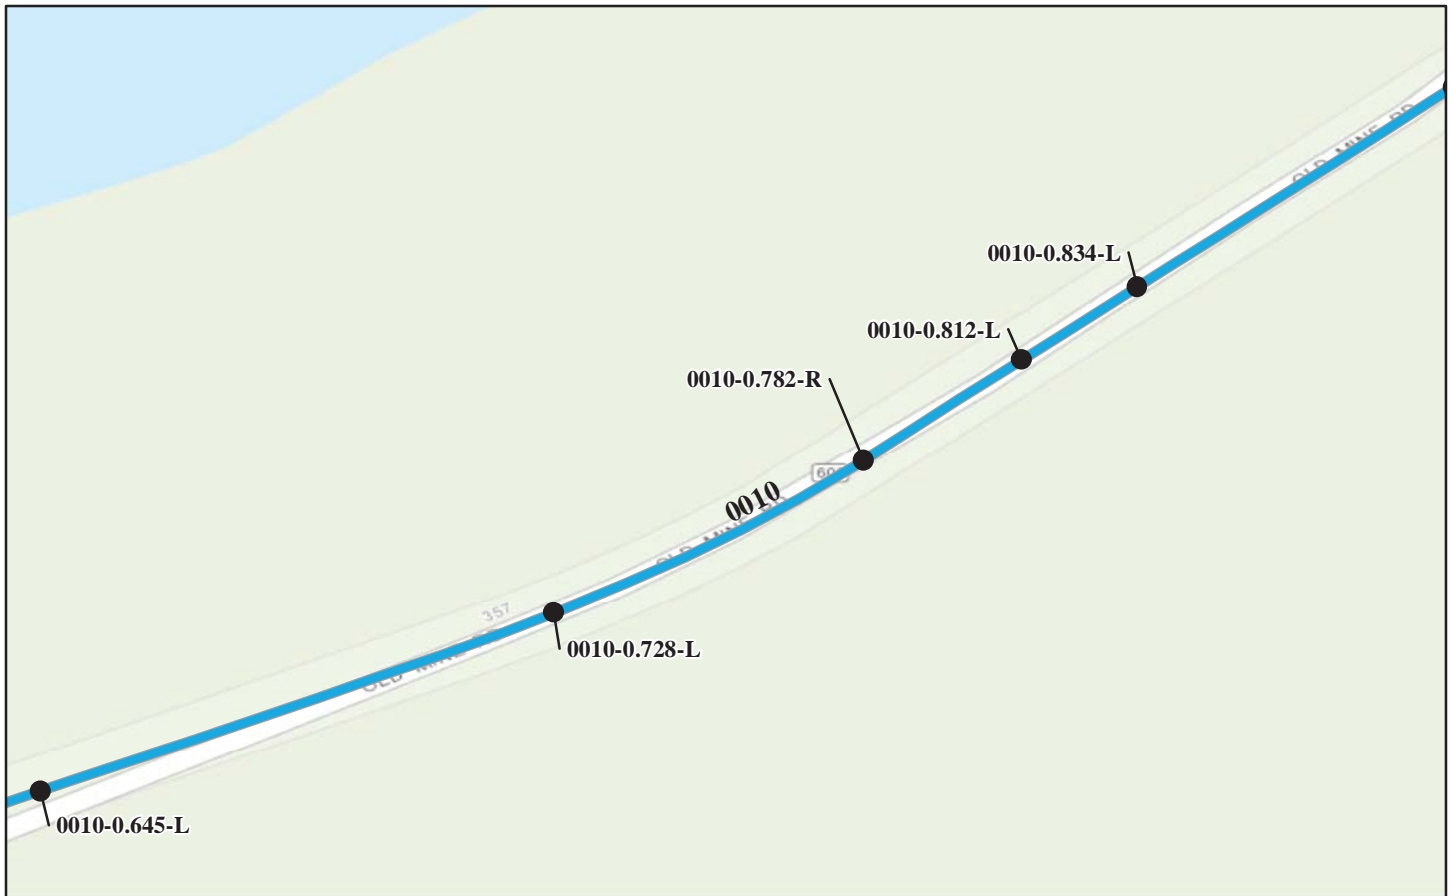
ROUTE 0010: OLD MINE ROAD (SOUTH SECTION)

Barrier ID Inspection Date	Barrier Length (Ft.)	Barrier Type	Barrier End Treatment		*Repair Cost
			Begin	End	
DEWA-0010-0.645-L 10/4/2010	420	STEEL-BACKED TIMBER WITH BLOCKOUT	NONE	NONE	\$0.00
DEWA-0010-0.728-L 10/4/2010	455	STEEL-BACKED TIMBER WITH BLOCKOUT	NONE	NONE	\$0.00
DEWA-0010-0.782-R 10/4/2010	130	STEEL-BACKED TIMBER WITH BLOCKOUT	SBT/LOG BURIED	SBT/LOG FLARED	\$2,392.00
DEWA-0010-0.812-L 10/4/2010	140	STEEL-BACKED TIMBER WITH BLOCKOUT	NONE	NONE	\$0.00
DEWA-0010-0.834-L 10/4/2010	280	STEEL-BACKED TIMBER WITH BLOCKOUT	NONE	NONE	\$2,612.00

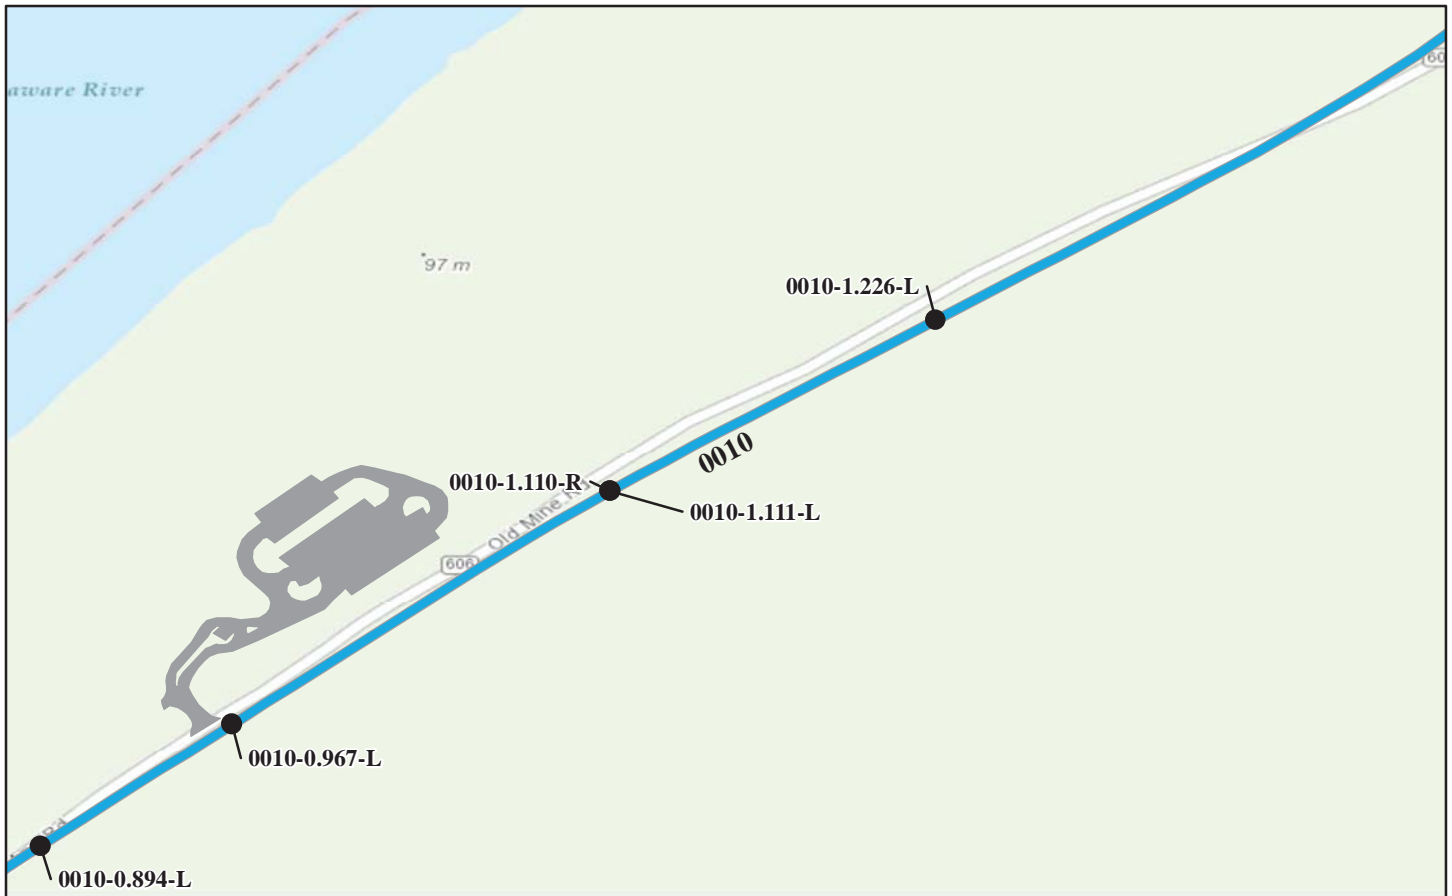
ROUTE 0010: OLD MINE ROAD (SOUTH SECTION)

Barrier ID Inspection Date	Barrier Length (Ft.)	Barrier Type	Barrier End Treatment		*Repair Cost
			Begin	End	
DEWA-0010-0.894-L 10/4/2010	310	STEEL-BACKED TIMBER WITH BLOCKOUT	SBT/LOG FLARED	NONE	\$0.00
DEWA-0010-0.967-L 10/4/2010	550	STEEL-BACKED TIMBER WITH BLOCKOUT	SBT/LOG FLARED	SBT/LOG FLARED	\$0.00
DEWA-0010-1.110-R 10/4/2010	231	STEEL-BACKED TIMBER WITH BLOCKOUT	SBT/LOG BURIED	SBT/LOG FLARED	\$0.00
DEWA-0010-1.111-L 10/4/2010	260	STEEL-BACKED TIMBER WITH BLOCKOUT	SBT/LOG BURIED	SBT/LOG FLARED	\$0.00
DEWA-0010-1.226-L 10/4/2010	910	STEEL-BACKED TIMBER WITH BLOCKOUT	SBT/LOG FLARED	SBT/LOG FLARED	\$0.00

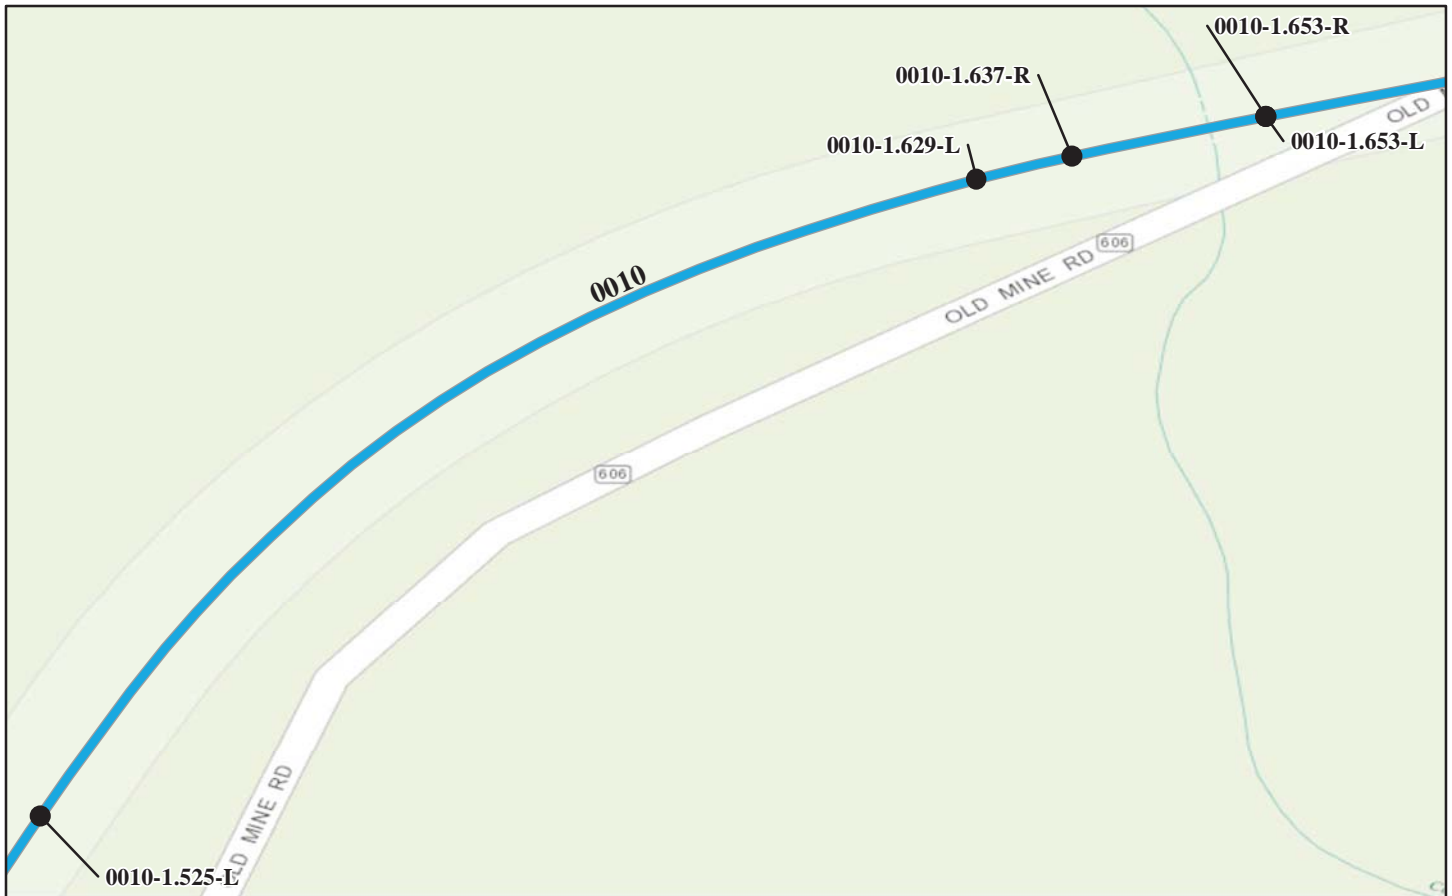
ROUTE 0010: OLD MINE ROAD (SOUTH SECTION)

Barrier ID Inspection Date	Barrier Length (Ft.)	Barrier Type	Barrier End Treatment		*Repair Cost
			Begin	End	
DEWA-0010-1.525-L 10/4/2010	535	STEEL-BACKED TIMBER WITH BLOCKOUT	SBT/LOG FLARED	NONE	\$0.00
DEWA-0010-1.629-L 10/5/2010	82	STEEL-BACKED TIMBER WITH BLOCKOUT	NONE	NONE	\$0.00
DEWA-0010-1.637-R 10/5/2010	45	STEEL-BACKED TIMBER WITH BLOCKOUT	SBT/LOG FLARED	NONE	\$0.00
DEWA-0010-1.653-L 10/5/2010	156	STEEL-BACKED TIMBER WITH BLOCKOUT	NONE	SBT/LOG FLARED	\$0.00
DEWA-0010-1.653-R 10/5/2010	50	STEEL-BACKED TIMBER WITH BLOCKOUT	NONE	SBT/LOG BURIED	\$0.00

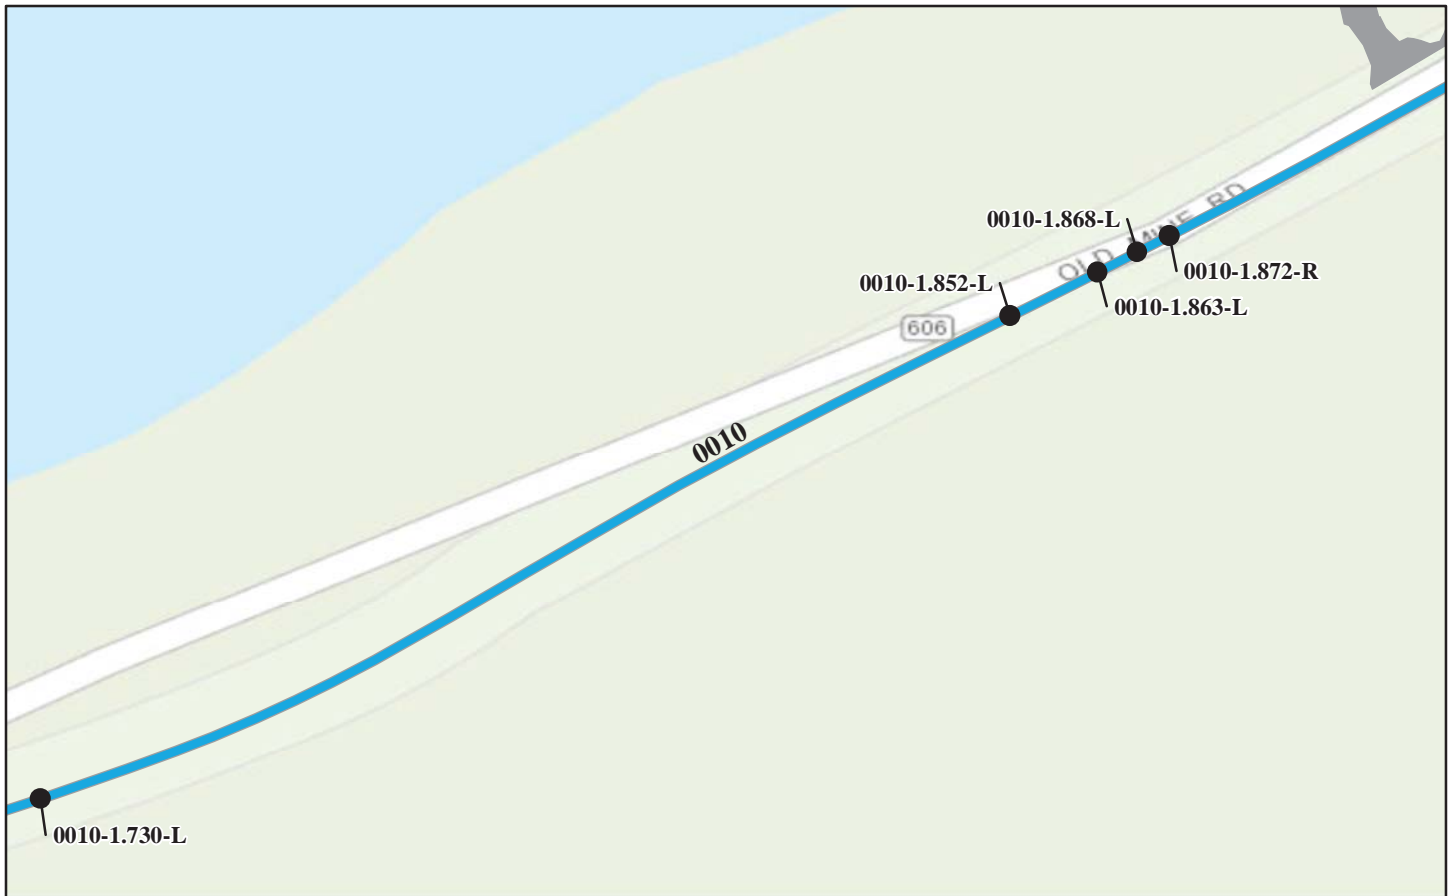
ROUTE 0010: OLD MINE ROAD (SOUTH SECTION)

Barrier ID Inspection Date	Barrier Length (Ft.)	Barrier Type	Barrier End Treatment		*Repair Cost
			Begin	End	
DEWA-0010-1.730-L 10/5/2010	920	STEEL-BACKED TIMBER WITH BLOCKOUT	NONE	SBT/LOG FLARED	\$0.00
DEWA-0010-1.852-L 10/5/2010	55	OTHER: TIMBER RAIL ON TIMBER POSTS	NONE	NONE	\$0.00
DEWA-0010-1.863-L 10/5/2010	19	OTHER: TIMBER RAIL ON TIMBER POSTS	NONE	NONE	\$0.00
DEWA-0010-1.868-L 10/5/2010	40	OTHER: TIMBER RAIL ON TIMBER POSTS	NONE	NONE	\$2,282.00
DEWA-0010-1.872-R 10/5/2010	170	STEEL-BACKED TIMBER WITH BLOCKOUT	SBT/LOG FLARED	SBT/LOG BURIED	\$0.00

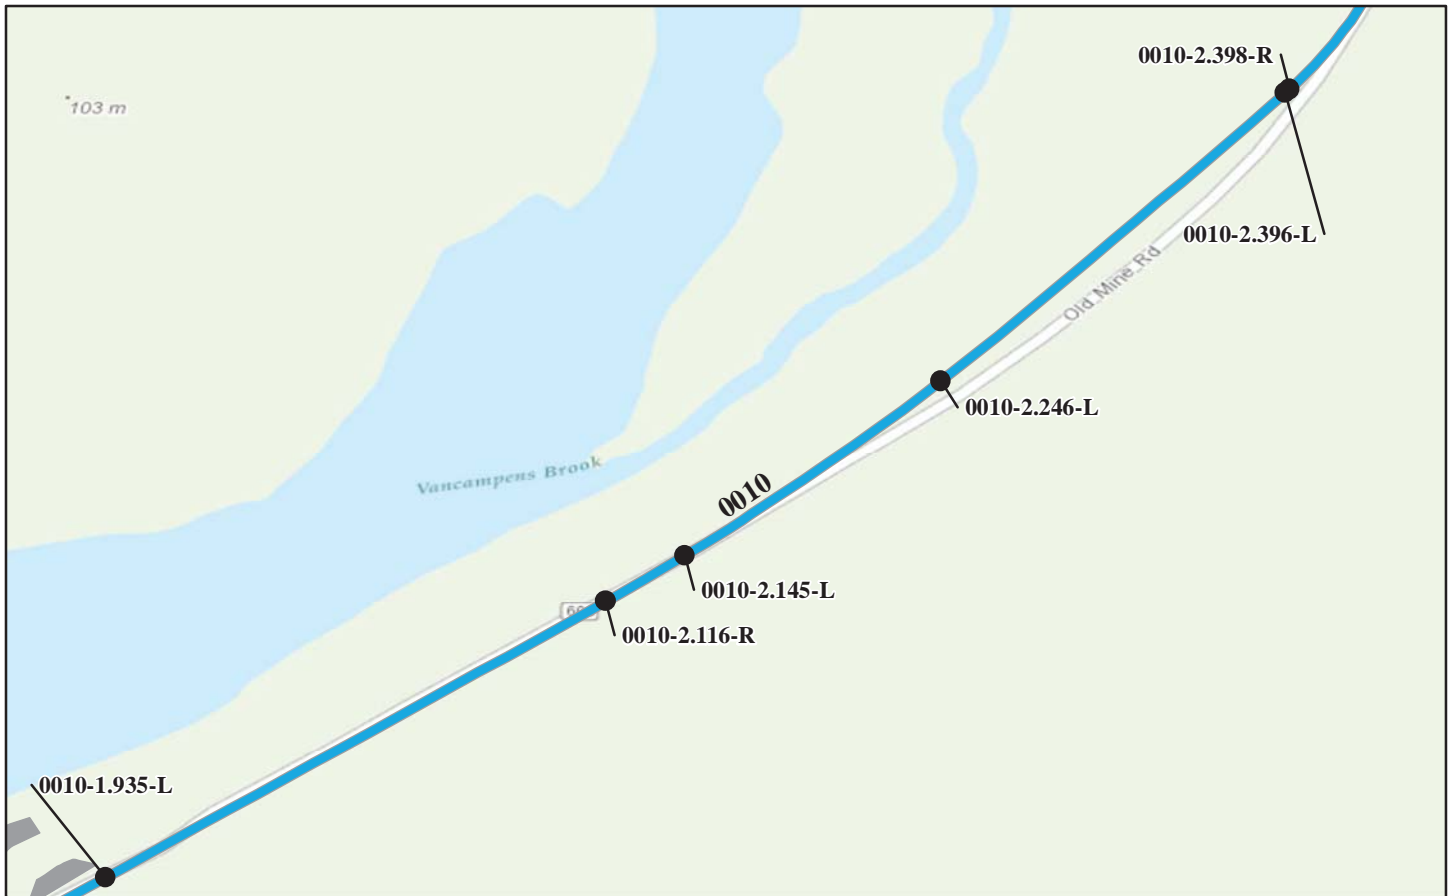
ROUTE 0010: OLD MINE ROAD (SOUTH SECTION)

Barrier ID Inspection Date	Barrier Length (Ft.)	Barrier Type	Barrier End Treatment		*Repair Cost
			Begin	End	
DEWA-0010-1.935-L 10/4/2010	925	STEEL-BACKED TIMBER WITH BLOCKOUT	NONE	SBT/LOG FLARED	\$0.00
DEWA-0010-2.116-R 10/5/2010	140	STEEL-BACKED TIMBER WITH BLOCKOUT	SBT/LOG BURIED	SBT/LOG BURIED	\$0.00
DEWA-0010-2.145-L 10/5/2010	378	STEEL-BACKED TIMBER WITH BLOCKOUT	SBT/LOG FLARED	SBT/LOG FLARED	\$0.00
DEWA-0010-2.246-L 10/5/2010	255	STEEL-BACKED TIMBER WITH BLOCKOUT	SBT/LOG FLARED	SBT/LOG FLARED	\$0.00
DEWA-0010-2.396-L 10/5/2010	170	STEEL-BACKED TIMBER WITH BLOCKOUT	SBT/LOG FLARED	SBT/LOG FLARED	\$0.00

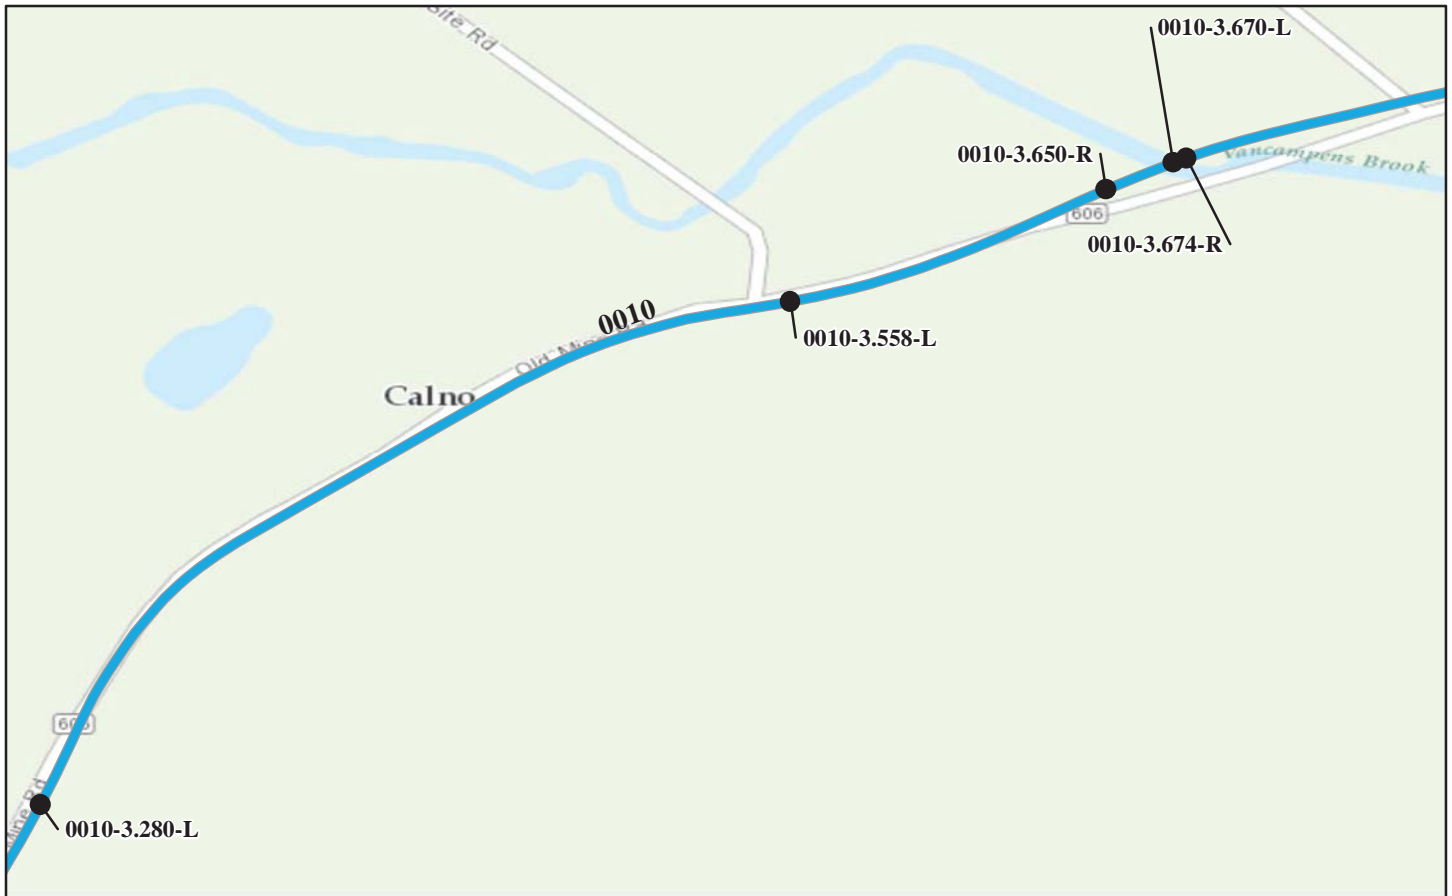
ROUTE 0010: OLD MINE ROAD (SOUTH SECTION)

Barrier ID Inspection Date	Barrier Length (Ft.)	Barrier Type	Barrier End Treatment		*Repair Cost
			Begin	End	
DEWA-0010-3.280-L 10/6/2010	556	STEEL-BACKED TIMBER WITH BLOCKOUT	SBT/LOG FLARED	SBT/LOG FLARED	\$0.00
DEWA-0010-3.558-L 10/6/2010	594	STEEL-BACKED TIMBER WITH BLOCKOUT	NONE	NONE	\$2,612.00
DEWA-0010-3.650-R 10/6/2010	80	STEEL-BACKED TIMBER WITH BLOCKOUT	SBT/LOG FLARED	NONE	\$0.00
DEWA-0010-3.670-L 10/6/2010	146	STEEL-BACKED TIMBER WITH BLOCKOUT	NONE	SBT/LOG FLARED	\$0.00
DEWA-0010-3.674-R 10/6/2010	330	STEEL-BACKED TIMBER WITH BLOCKOUT	NONE	SBT/LOG FLARED	\$4,482.00

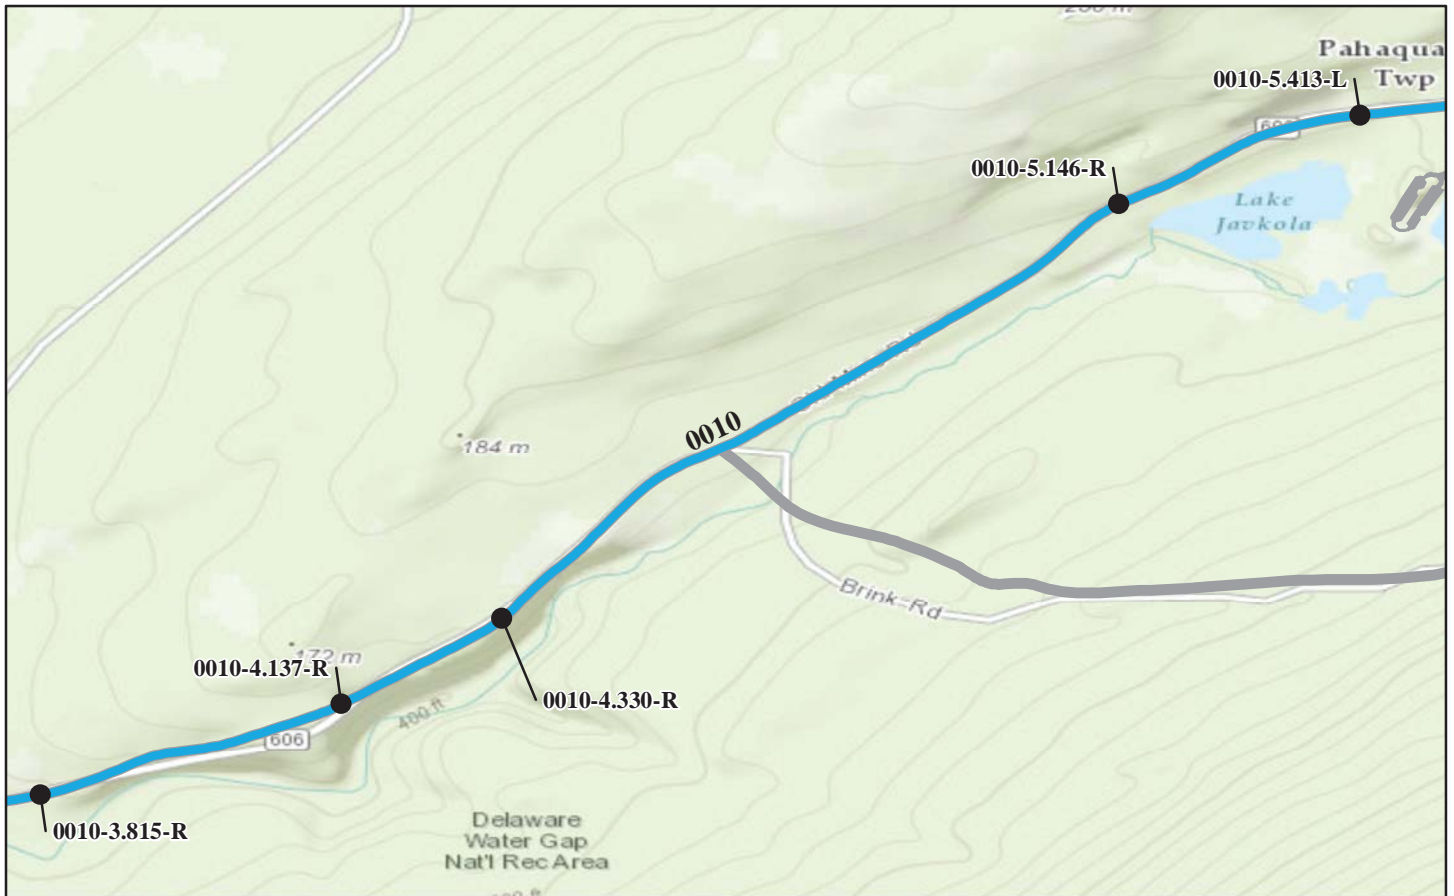
ROUTE 0010: OLD MINE ROAD (SOUTH SECTION)

Barrier ID Inspection Date	Barrier Length (Ft.)	Barrier Type	Barrier End Treatment		*Repair Cost
			Begin	End	
DEWA-0010-3.815-R 10/6/2010	1,510	STEEL-BACKED TIMBER WITH BLOCKOUT	SBT/LOG FLARED	SBT/LOG BURIED	\$22,302.00
DEWA-0010-4.137-R 10/6/2010	610	STEEL-BACKED TIMBER WITH BLOCKOUT	SBT/LOG FLARED	SBT/LOG FLARED	\$12,238.00
DEWA-0010-4.330-R 10/6/2010	600	STEEL-BACKED TIMBER WITH BLOCKOUT	SBT/LOG FLARED	SBT/LOG FLARED	\$5,692.00
DEWA-0010-5.146-R 10/6/2010	1895	STEEL-BACKED TIMBER WITH BLOCKOUT	NONE	SBT/LOG FLARED	\$11,165.00
DEWA-0010-5.413-L 10/6/2010	270	STEEL-BACKED TIMBER WITH BLOCKOUT	SBT/LOG FLARED	SBT/LOG FLARED	\$0.00

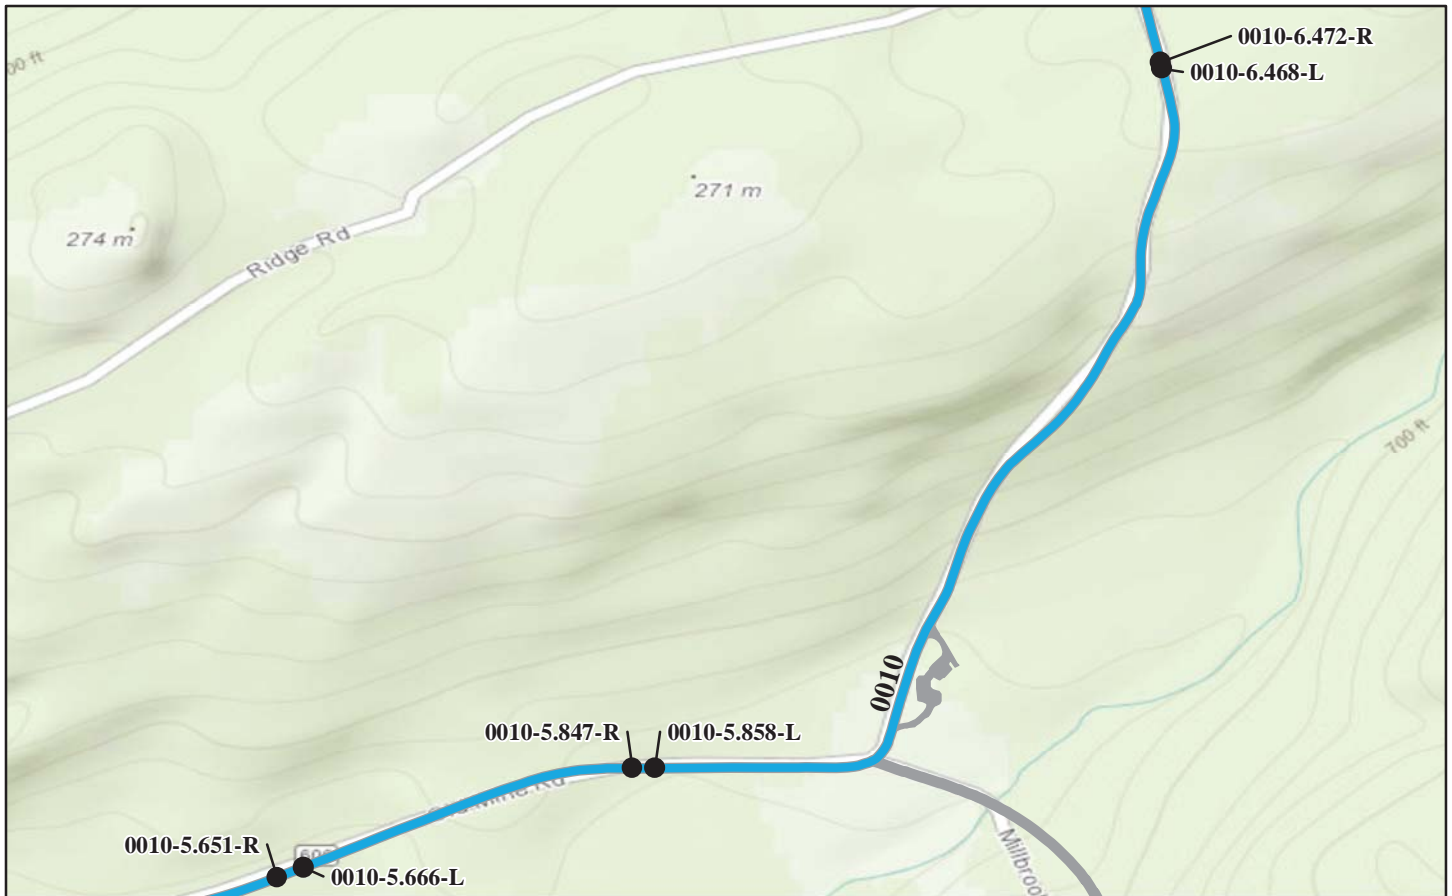
ROUTE 0010: OLD MINE ROAD (SOUTH SECTION)

Barrier ID Inspection Date	Barrier Length (Ft.)	Barrier Type	Barrier End Treatment		*Repair Cost
			Begin	End	
DEWA-0010-5.651-R 10/6/2010	540	STEEL-BACKED TIMBER WITH BLOCKOUT	SBT/LOG FLARED	SBT/LOG BURIED	\$12,018.00
DEWA-0010-5.666-L 10/6/2010	410	STEEL-BACKED TIMBER WITH BLOCKOUT	SBT/LOG BURIED	SBT/LOG BURIED	\$3,052.00
DEWA-0010-5.847-R 10/6/2010	450	STEEL-BACKED TIMBER WITH BLOCKOUT	SBT/LOG FLARED	SBT/LOG FLARED	\$7,535.00
DEWA-0010-5.858-L 10/6/2010	410	STEEL-BACKED TIMBER WITH BLOCKOUT	SBT/LOG FLARED	SBT/LOG BURIED	\$0.00
DEWA-0010-6.468-L 10/7/2010	155	W-BEAM WEAK POST	NONE	NONE	\$3,328.00

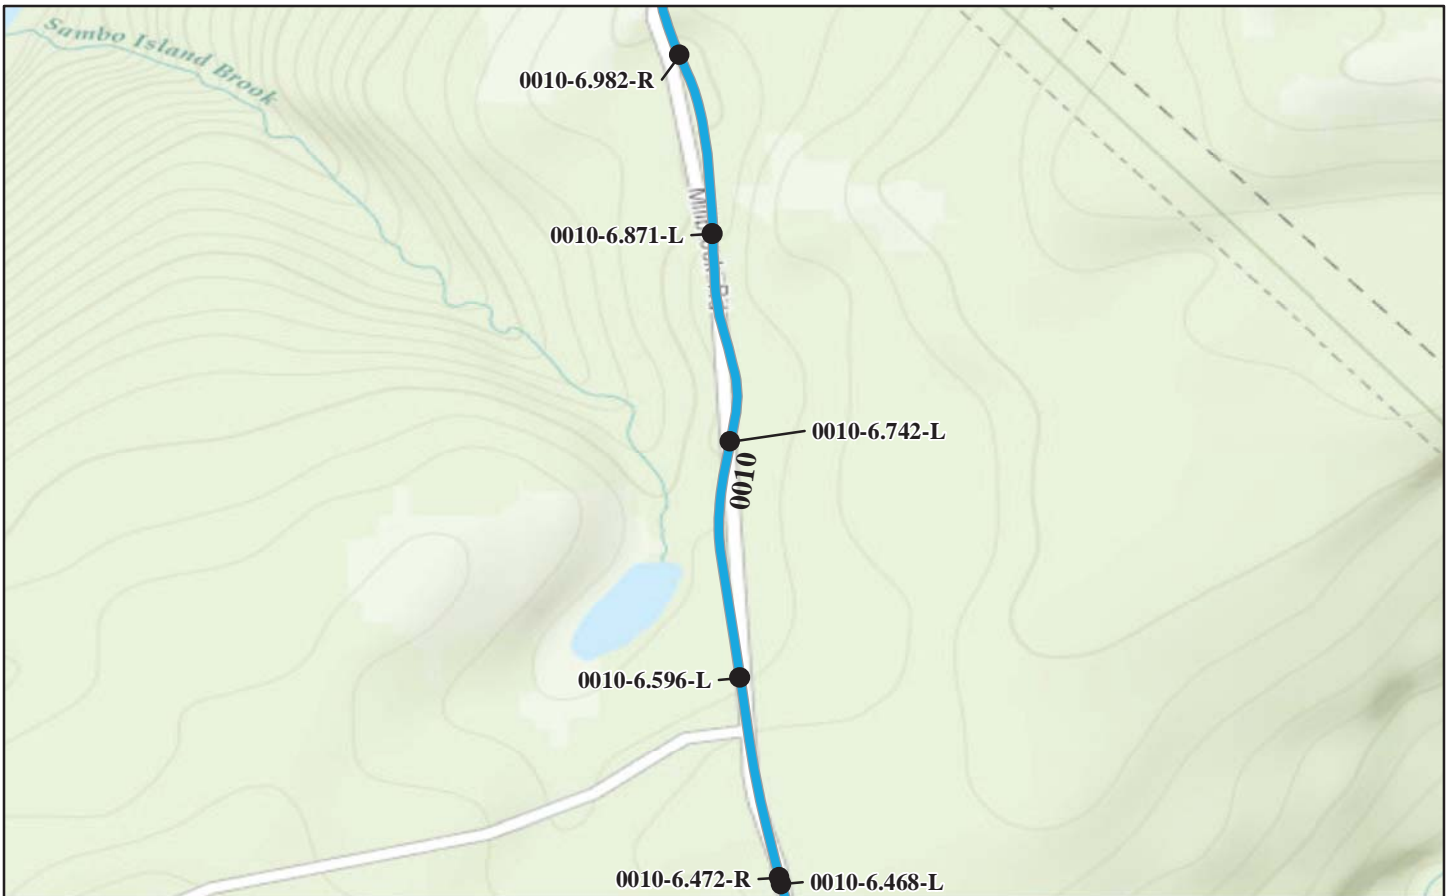
ROUTE 0010: OLD MINE ROAD (SOUTH SECTION)

Barrier ID Inspection Date	Barrier Length (Ft.)	Barrier Type	Barrier End Treatment		*Repair Cost
			Begin	End	
DEWA-0010-6.472-R 10/7/2010	130	W-BEAM WEAK POST	NONE	NONE	\$3,052.00
DEWA-0010-6.596-L 10/7/2010	85	W-BEAM WEAK POST	NONE	NONE	\$2,558.00
DEWA-0010-6.742-L 10/7/2010	145	W-BEAM WEAK POST	NONE	NONE	\$3,218.00
DEWA-0010-6.871-L 10/7/2010	680	W-BEAM WEAK POST	NONE	NONE	\$12,348.00
DEWA-0010-6.982-R 10/7/2010	92	W-BEAM WEAK POST	NONE	NONE	\$3,322.00

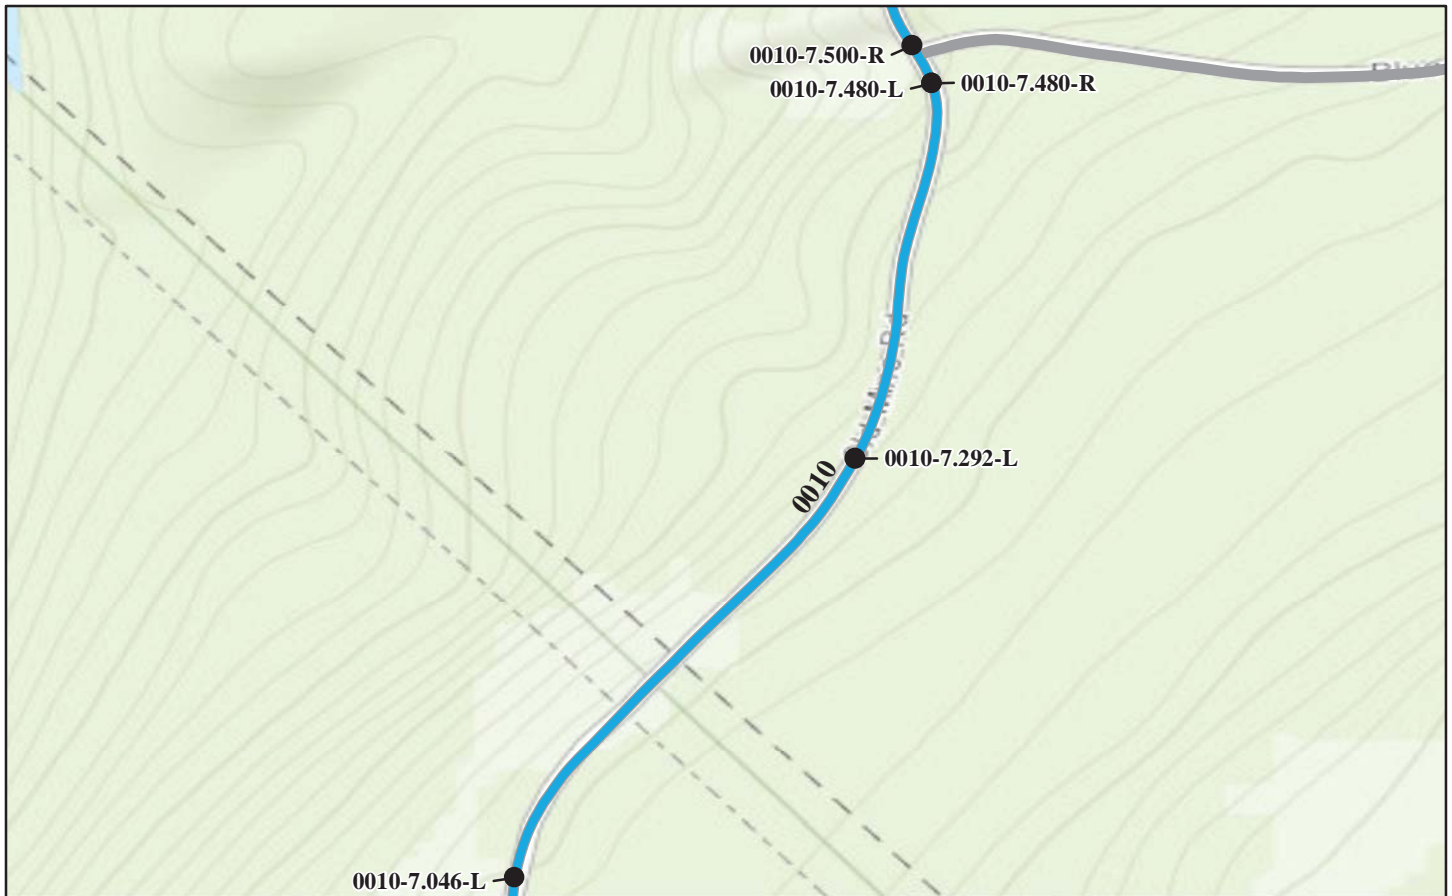
ROUTE 0010: OLD MINE ROAD (SOUTH SECTION)

Barrier ID Inspection Date	Barrier Length (Ft.)	Barrier Type	Barrier End Treatment		*Repair Cost
			Begin	End	
DEWA-0010-7.046-L 10/7/2010	315	W-BEAM WEAK POST	NONE	NONE	\$6,710.00
DEWA-0010-7.292-L 10/7/2010	270	OTHER: 2-STRAND CABLE	NONE	NONE	\$32,835.00
DEWA-0010-7.480-L 10/7/2010	180	W-BEAM WEAK POST	NONE	NONE	\$3,190.00
DEWA-0010-7.480-R 10/7/2010	60	W-BEAM WEAK POST	NONE	NONE	\$2,282.00
DEWA-0010-7.500-R 10/7/2010	58	W-BEAM WEAK POST	NONE	NONE	\$0.00

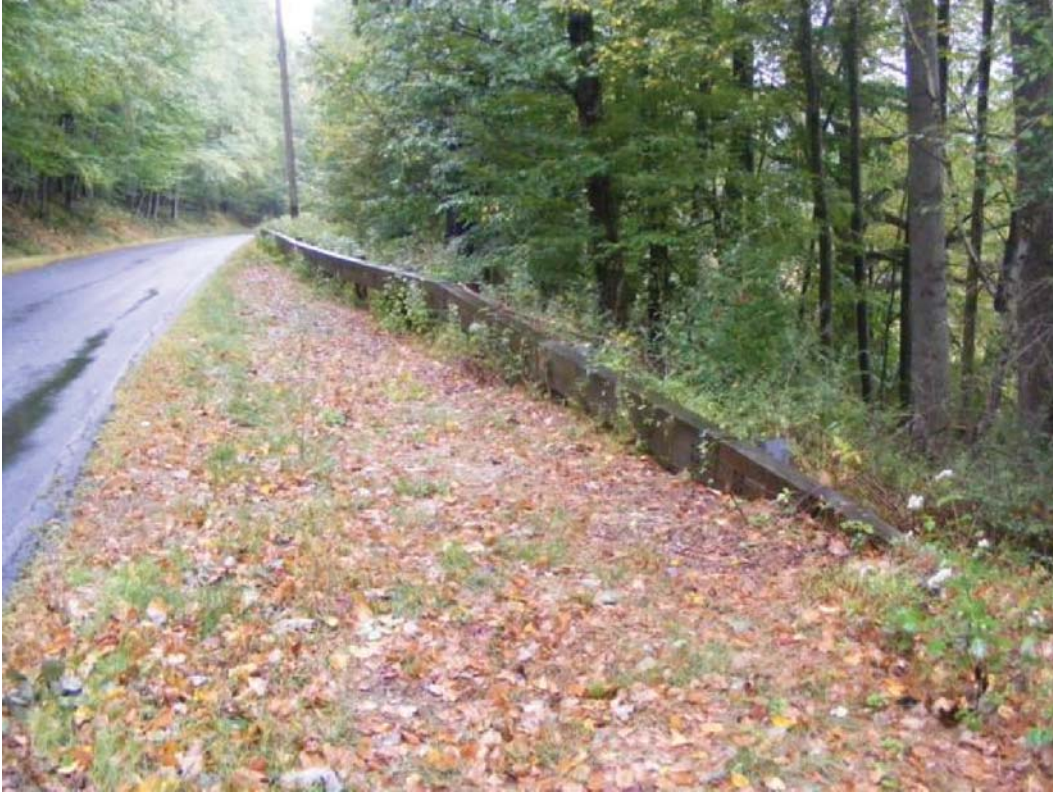
DEWA_0010_0.003_L_1.JPG

Barrier ID:	DEWA-0010-0.003-L				
Route Name:	OLD MINE ROAD (SOUTH SECTION)				
Inspection Date:	10/04/2010	Barrier Rating:	35.00		
Barrier Description					
Type:	STEEL-BACKED TIMBER WITH BLOCKOUT	Barrier Function:	TRAFFIC		
Barrier Material:	STEEL-BACKED TIMBER/LOG	Post Material:	CORTEN		
Blockout Type:	WOOD	Length (ft.):	1440		
Speed Limit (MPH):	35	Placement with Respect to Road:	OUTSIDE OF CURVE		
Hazard Behind Barrier:	MEDIUM				
Barrier Crashworthiness					
Appropriate Test Level:	TL-2	Barrier Test Level:	TL-3	Is Barrier Crashworthy?:	YES
Beg. End Trtmt Type:	SBT/LOG FLARED	Is Beg. End Trtmt Crashworthy?:	NO	Approach Transition Type:	NONE
Ending End Trtmt Type:	SBT/LOG FLARED	Ending End Trtmt Crashworthy?:	NO		
Average Measurements					
Design Height (In.):	27	Width (In.):	0.0	Post Spacing (In.):	120.0
Height (In.):	27.7	Lateral Offset (In.):	41.0	Road Grade (%):	3.70
Physical Condition					
Barrier	Alignment and Height:	No deflections observed in alignment. The height is at or above the design of 27 in by up to 3 in.

Breaking and Cracking:	3 broken barrier reflectors observed.			
	Missing Elements:	No missing elements observed.			
	Corrosion and Weathering:	No loss of cross section or erosion around posts observed.			
End Treatments	Alignment and Height:	Alignment acceptable. Height is within 1-in. of 27-in. design height.			
	Breaking and Cracking:	No breaking or cracking observed.			
	Missing Elements:	No missing elements observed.			
	Corrosion and Weathering:	No loss of cross section or erosion around posts observed.

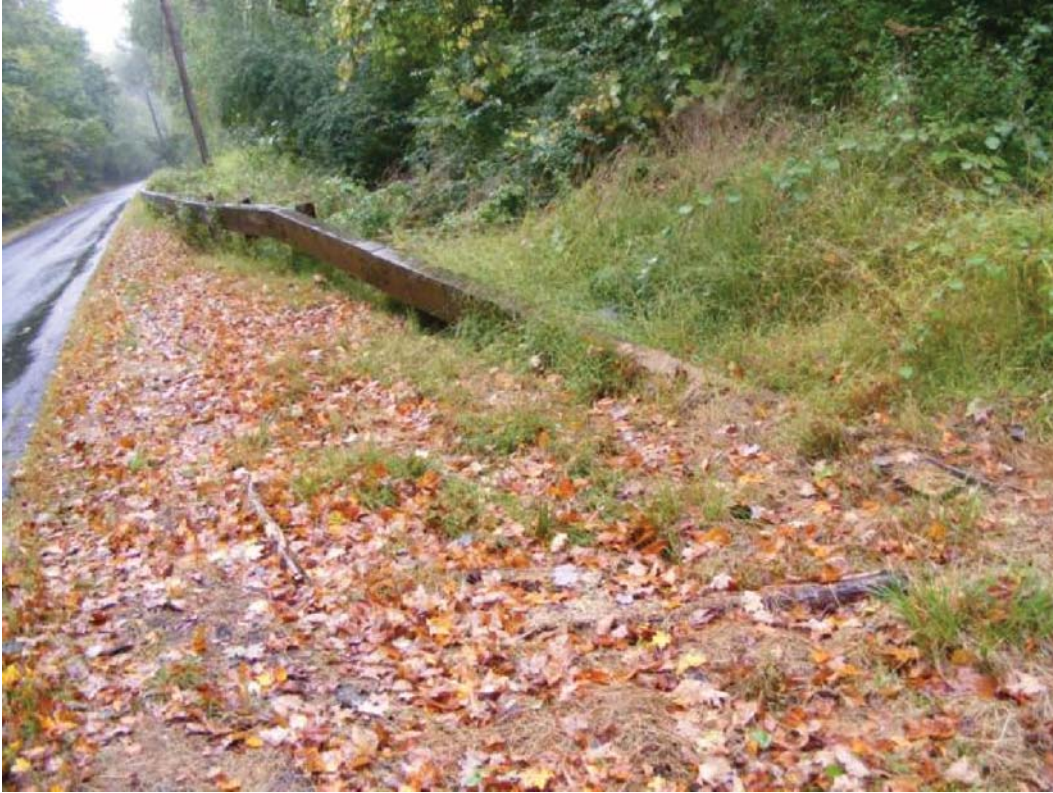
DEWA_0010_0.301_L_1.JPG

Barrier ID:	DEWA-0010-0.301-L				
Route Name:	OLD MINE ROAD (SOUTH SECTION)				
Inspection Date:	10/04/2010	Barrier Rating:	19.30		
Barrier Description					
Type:	STEEL-BACKED TIMBER WITH BLOCKOUT	Barrier Function:	TRAFFIC		
Barrier Material:	STEEL-BACKED TIMBER/LOG	Post Material:	CORTEN		
Blockout Type:	WOOD	Length (ft.):	495		
Speed Limit (MPH):	35	Placement with Respect to Road:	TANGENT		
Hazard Behind Barrier:	MEDIUM				
Barrier Crashworthiness					
Appropriate Test Level:	TL-2	Barrier Test Level:	TL-3	Is Barrier Crashworthy?:	YES
Beg. End Trtmt Type:	SBT/LOG FLARED	Is Beg. End Trtmt Crashworthy?:	NO	Approach Transition Type:	NONE
Ending End Trtmt Type:	SBT/LOG FLARED	Ending End Trtmt Crashworthy?:	NO		
Average Measurements					
Design Height (In.):	27	Width (In.):	0.0	Post Spacing (In.):	120.0
Height (In.):	28.2	Lateral Offset (In.):	40.2	Road Grade (%):	1.60
Physical Condition					
Barrier	Alignment and Height:	No deflections observed in alignment. The height is at or above the design of 27 in by up to 2 in.

Breaking and Cracking:	No breaking or cracking observed in barrier. 8 broken and missing reflectors.			
	Missing Elements:	No missing elements observed.			
	Corrosion and Weathering:	No loss of cross section or erosion around posts observed.			
End Treatments	Alignment and Height:	Alignment acceptable. Height is within 1-in. of 27-in. design height.			
	Breaking and Cracking:	No breaking or cracking observed.			
	Missing Elements:	No missing elements observed.			
	Corrosion and Weathering:	No loss of cross section or erosion around posts observed.

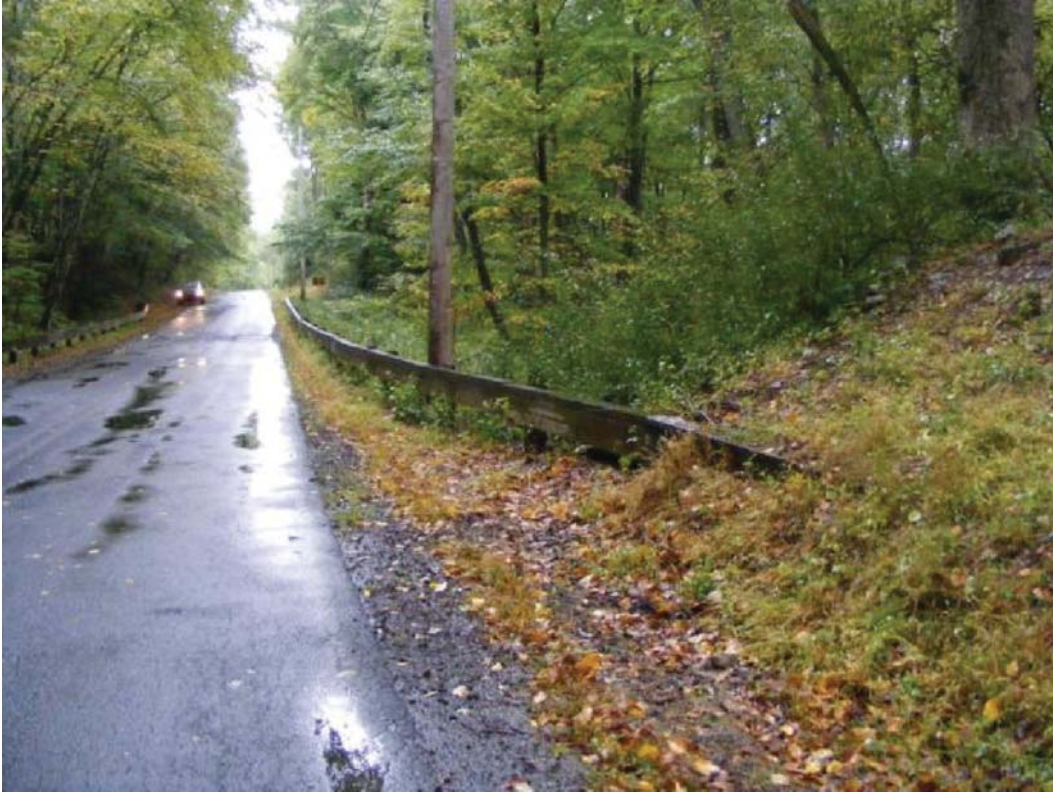
DEWA_0010_0.463_L_1.JPG

Barrier ID:	DEWA-0010-0.463-L				
Route Name:	OLD MINE ROAD (SOUTH SECTION)				
Inspection Date:	10/04/2010	Barrier Rating:	19.30		
Barrier Description					
Type:	STEEL-BACKED TIMBER WITH BLOCKOUT	Barrier Function:	TRAFFIC		
Barrier Material:	STEEL-BACKED TIMBER/LOG	Post Material:	CORTEN		
Blockout Type:	WOOD	Length (ft.):	292		
Speed Limit (MPH):	35	Placement with Respect to Road:	TANGENT		
Hazard Behind Barrier:	MEDIUM				
Barrier Crashworthiness					
Appropriate Test Level:	TL-2	Barrier Test Level:	TL-3	Is Barrier Crashworthy?:	YES
Beg. End Trtmt Type:	SBT/LOG FLARED	Is Beg. End Trtmt Crashworthy?:	NO	Approach Transition Type:	NONE
Ending End Trtmt Type:	SBT/LOG BURIED	Ending End Trtmt Crashworthy?:	YES		
Average Measurements					
Design Height (In.):	27	Width (In.):	0.0	Post Spacing (In.):	120.0
Height (In.):	28.2	Lateral Offset (In.):	40.2	Road Grade (%):	1.60
Physical Condition					
Barrier	Alignment and Height:	No deflections observed in alignment. The height is at or above the design of 27 in by up to 2 in.

Breaking and Cracking:	1 broken reflector observed.			
	Missing Elements:	No missing elements observed.			
	Corrosion and Weathering:	No loss of cross section or erosion around posts observed.			
End Treatments	Alignment and Height:	Alignment acceptable. Height is within 1-in. of 27-in. design height.			
	Breaking and Cracking:	No breaking or cracking observed.			
	Missing Elements:	No missing elements observed.			
	Corrosion and Weathering:	No loss of cross section or erosion around posts observed.
