NPS Guardwall/Rail Inventory Program Delaware Water Gap National Recreation Area

**Federal Lands Highway
Road Inventory Program**

Federal Highway Administration
Eastern Federal Lands Highway Division
Road Inventory Program (RIP)

Data Collection Date: October 2010
Report Date: December 2015

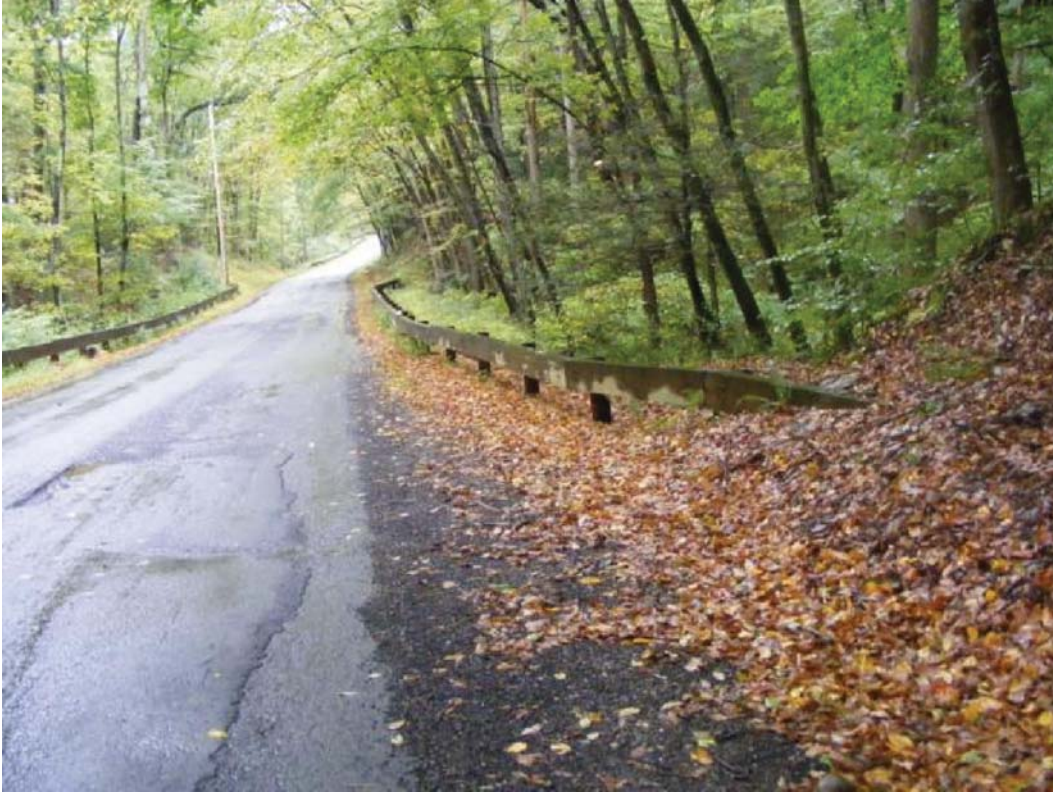
DEWA_0010_0.469_R_1.JPG

Barrier ID:	DEWA-0010-0.469-R				
Route Name:	OLD MINE ROAD (SOUTH SECTION)				
Inspection Date:	10/04/2010	Barrier Rating:	16.50		
Barrier Description					
Type:	STEEL-BACKED TIMBER WITH BLOCKOUT	Barrier Function:	TRAFFIC		
Barrier Material:	STEEL-BACKED TIMBER/LOG	Post Material:	CORTEN		
Blockout Type:	WOOD	Length (ft.):	227		
Speed Limit (MPH):	35	Placement with Respect to Road:	TANGENT		
Hazard Behind Barrier:	MEDIUM				
Barrier Crashworthiness					
Appropriate Test Level:	TL-2	Barrier Test Level:	TL-3	Is Barrier Crashworthy?:	YES
Beg. End Trtmt Type:	SBT/LOG BURIED	Is Beg. End Trtmt Crashworthy?:	YES	Approach Transition Type:	NONE
Ending End Trtmt Type:	SBT/LOG BURIED	Ending End Trtmt Crashworthy?:	YES		
Average Measurements					
Design Height (In.):	27	Width (In.):	0.0	Post Spacing (In.):	119.5
Height (In.):	27.2	Lateral Offset (In.):	43.5	Road Grade (%):	1.20
Physical Condition					
Barrier	Alignment and Height:	No deflections observed in alignment. The height is at or above the design of 27 in by 1 in.

Breaking and Cracking:	No breaking or cracking observed.			
	Missing Elements:	No missing elements observed.			
	Corrosion and Weathering:	No loss of cross section or erosion around posts observed.			
End Treatments	Alignment and Height:	Alignment acceptable. Height is within 1-in. of 27-in. design height.			
	Breaking and Cracking:	No breaking or cracking observed.			
	Missing Elements:	No missing elements observed.			
	Corrosion and Weathering:	No loss of cross section or erosion around posts observed.

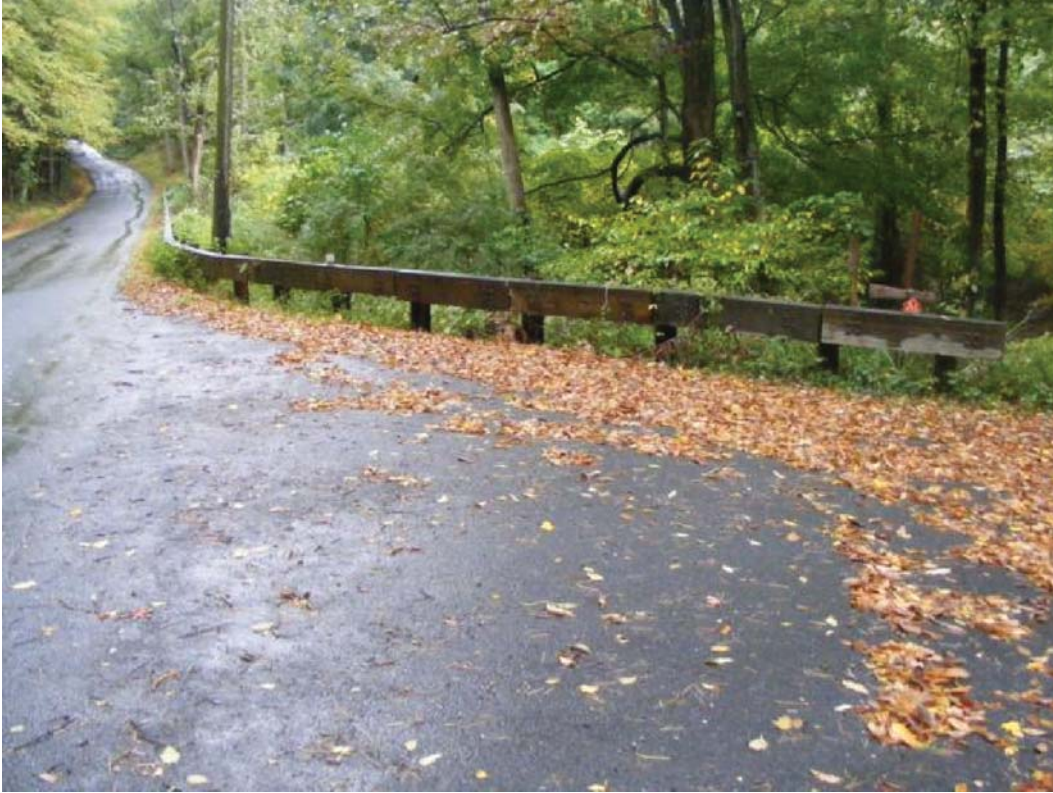
DEWA_0010_0.569_L_1.JPG

Barrier ID:	DEWA-0010-0.569-L				
Route Name:	OLD MINE ROAD (SOUTH SECTION)				
Inspection Date:	10/04/2010	Barrier Rating:	23.70		
Barrier Description					
Type:	STEEL-BACKED TIMBER WITH BLOCKOUT	Barrier Function:	TRAFFIC		
Barrier Material:	STEEL-BACKED TIMBER/LOG	Post Material:	CORTEN		
Blockout Type:	WOOD	Length (ft.):	396		
Speed Limit (MPH):	35	Placement with Respect to Road:	TANGENT		
Hazard Behind Barrier:	MEDIUM				
Barrier Crashworthiness					
Appropriate Test Level:	TL-2	Barrier Test Level:	TL-3	Is Barrier Crashworthy?:	YES
Beg. End Trtmt Type:	SBT/LOG FLARED	Is Beg. End Trtmt Crashworthy?:	NO	Approach Transition Type:	NONE
Ending End Trtmt Type:	NONE	Ending End Trtmt Crashworthy?:	N/A		
Average Measurements					
Design Height (In.):	27	Width (In.):	0.0	Post Spacing (In.):	119.5
Height (In.):	26.2	Lateral Offset (In.):	41.2	Road Grade (%):	4.20
Physical Condition					
Barrier	Alignment and Height:	No deflections observed in alignment. The height is low by 1 in or less from the design of 27 in.

Breaking and Cracking:	No breaking or cracking observed.			
	Missing Elements:	No missing elements observed.			
	Corrosion and Weathering:	No loss of cross section or erosion around posts observed.			
End Treatments	Alignment and Height:	Alignment acceptable. Height is within 1-in. of 27-in. design height.			
	Breaking and Cracking:	No breaking or cracking observed.			
	Missing Elements:	No missing elements observed.			
	Corrosion and Weathering:	No loss of cross section or erosion around posts observed.

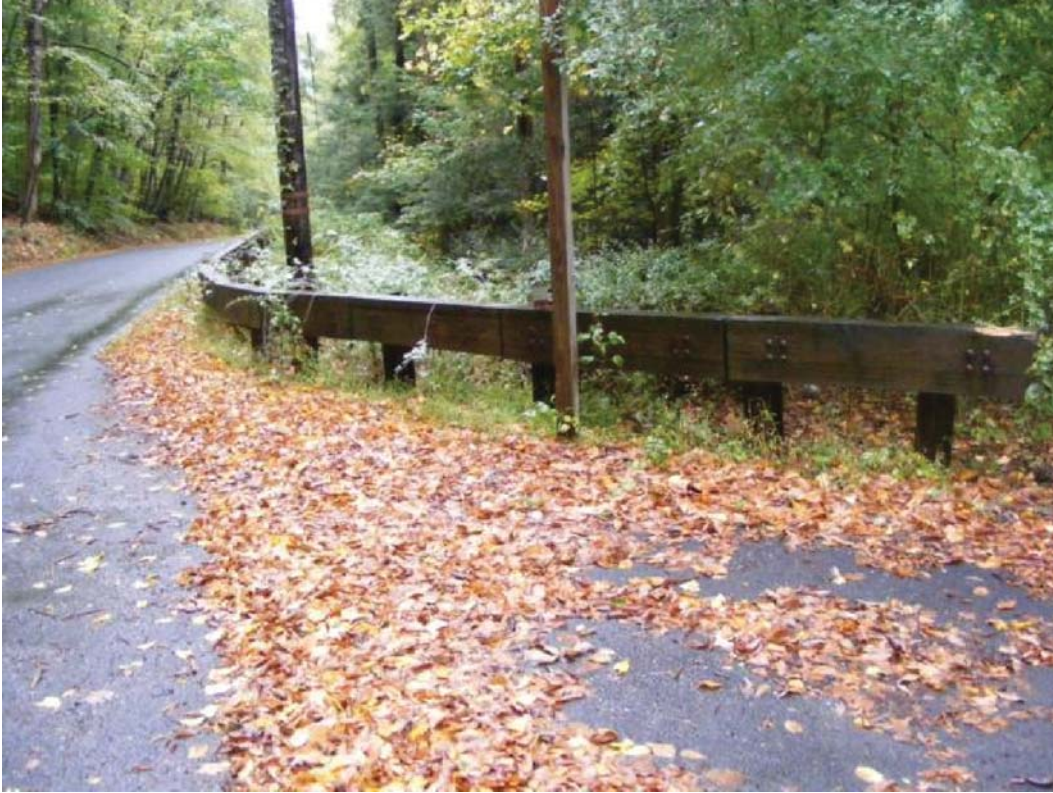
DEWA_0010_0.645_L_1.JPG

Barrier ID:	DEWA-0010-0.645-L				
Route Name:	OLD MINE ROAD (SOUTH SECTION)				
Inspection Date:	10/04/2010	Barrier Rating:	20.70		
Barrier Description					
Type:	STEEL-BACKED TIMBER WITH BLOCKOUT	Barrier Function:	TRAFFIC		
Barrier Material:	STEEL-BACKED TIMBER/LOG	Post Material:	CORTEN		
Blockout Type:	WOOD	Length (ft.):	420		
Speed Limit (MPH):	35	Placement with Respect to Road:	TANGENT		
Hazard Behind Barrier:	MEDIUM				
Barrier Crashworthiness					
Appropriate Test Level:	TL-2	Barrier Test Level:	TL-3	Is Barrier Crashworthy?:	YES
Beg. End Trtmt Type:	NONE	Is Beg. End Trtmt Crashworthy?:	N/A	Approach Transition Type:	NONE
Ending End Trtmt Type:	NONE	Ending End Trtmt Crashworthy?:	N/A		
Average Measurements					
Design Height (In.):	27	Width (In.):	0.0	Post Spacing (In.):	119.5
Height (In.):	27.6	Lateral Offset (In.):	49.2	Road Grade (%):	5.40
Physical Condition					
Barrier	Alignment and Height:	No deflections observed in alignment. The height is at or above the design of 27 in by 1 in.

Breaking and Cracking:	No impact related breaking or cracking observed.			
	Missing Elements:	No elements were observed to be missing.			
	Corrosion and Weathering:	No loss of cross section or erosion around posts observed.			
End Treatments	Alignment and Height:				
	Breaking and Cracking:				
	Missing Elements:				
	Corrosion and Weathering:

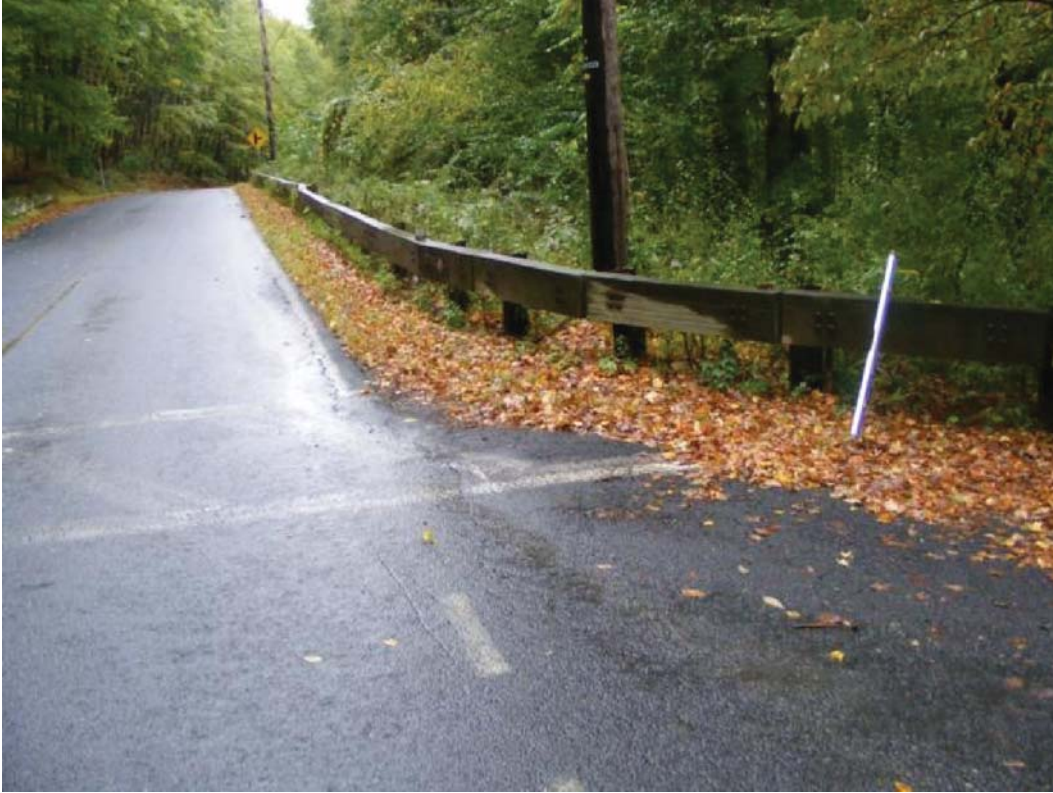
DEWA_0010_0.728_L_1.JPG

Barrier ID:	DEWA-0010-0.728-L				
Route Name:	OLD MINE ROAD (SOUTH SECTION)				
Inspection Date:	10/04/2010	Barrier Rating:	19.30		
Barrier Description					
Type:	STEEL-BACKED TIMBER WITH BLOCKOUT	Barrier Function:	TRAFFIC		
Barrier Material:	STEEL-BACKED TIMBER/LOG	Post Material:	CORTEN		
Blockout Type:	WOOD	Length (ft.):	455		
Speed Limit (MPH):	35	Placement with Respect to Road:	TANGENT		
Hazard Behind Barrier:	MEDIUM				
Barrier Crashworthiness					
Appropriate Test Level:	TL-2	Barrier Test Level:	TL-3	Is Barrier Crashworthy?:	YES
Beg. End Trtmt Type:	NONE	Is Beg. End Trtmt Crashworthy?:	N/A	Approach Transition Type:	NONE
Ending End Trtmt Type:	NONE	Ending End Trtmt Crashworthy?:	N/A		
Average Measurements					
Design Height (In.):	27	Width (In.):	0.0	Post Spacing (In.):	119.6
Height (In.):	27.0	Lateral Offset (In.):	46.2	Road Grade (%):	2.90
Physical Condition					
Barrier	Alignment and Height:	No deflections observed in alignment. The height is at or above the design of 27 in by 1 in.

Breaking and Cracking:	No breaking or cracking observed. 7 broken and missing reflectors on barrier.			
	Missing Elements:	No missing elements observed.			
	Corrosion and Weathering:	No loss of cross section or erosion around posts observed.			
End Treatments	Alignment and Height:	Alignment acceptable. Height is within 1-in. of 27-in. design height.			
	Breaking and Cracking:	No breaking or cracking observed.			
	Missing Elements:	No missing elements observed.			
	Corrosion and Weathering:	No loss of cross section or erosion around posts observed.

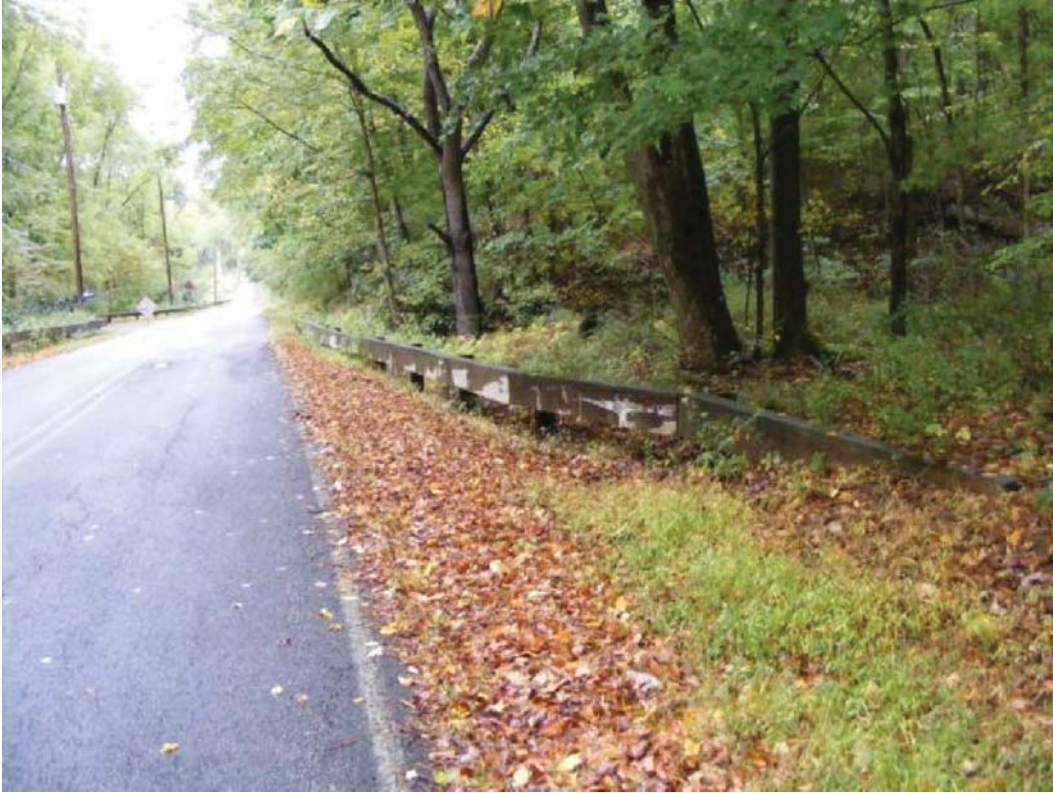
DEWA_0010_0.782_R_1.JPG

Barrier ID:	DEWA-0010-0.782-R				
Route Name:	OLD MINE ROAD (SOUTH SECTION)				
Inspection Date:	10/04/2010	Barrier Rating:	35.70		
Barrier Description					
Type:	STEEL-BACKED TIMBER WITH BLOCKOUT	Barrier Function:	TRAFFIC		
Barrier Material:	STEEL-BACKED TIMBER/LOG	Post Material:	CORTEN		
Blockout Type:	WOOD	Length (ft.):	130		
Speed Limit (MPH):	35	Placement with Respect to Road:	TANGENT		
Hazard Behind Barrier:	HIGH				
Barrier Crashworthiness					
Appropriate Test Level:	TL-2	Barrier Test Level:	TL-3	Is Barrier Crashworthy?:	YES
Beg. End Trtmt Type:	SBT/LOG BURIED	Is Beg. End Trtmt Crashworthy?:	YES	Approach Transition Type:	NONE
Ending End Trtmt Type:	SBT/LOG FLARED	Ending End Trtmt Crashworthy?:	NO		
Average Measurements					
Design Height (In.):	27	Width (In.):	0.0	Post Spacing (In.):	120.3
Height (In.):	24.0	Lateral Offset (In.):	38.2	Road Grade (%):	7.00
Physical Condition					
Barrier	Alignment and Height:	No deflections observed in alignment. 50 ft of the barrier is 1 to 3 in below 27 in design height and 20 ft is greater than 3 in below 27 in design height down to 22 ins.

Breaking and Cracking:	No breaking or cracking observed.			
	Missing Elements:	No missing elements observed.			
	Corrosion and Weathering:	No loss of cross section or erosion around posts observed.			
End Treatments	Alignment and Height:	Alignment acceptable. Height is within 1-in. of 27-in. design height.			
	Breaking and Cracking:	No breaking or cracking observed.			
	Missing Elements:	No missing elements observed.			
	Corrosion and Weathering:	No loss of cross section or erosion around posts observed.

Repair Action:	REPAIR	FMSS Work Type:	DEFERRED MAINTENANCE	Repair Cost:	\$2392
Brief Workorder:	Raise 70-ft. of barrier up to 27-in. design height.				
Workorder:	Adjust Guardrail at \$10- per -Lin. Ft. for 70 LF = \$700. Raise 70-ft. of barrier up to 27-in. design height. Low Speed Traffic Control at \$1475- per -Day for 1 Day(s) = \$1475.

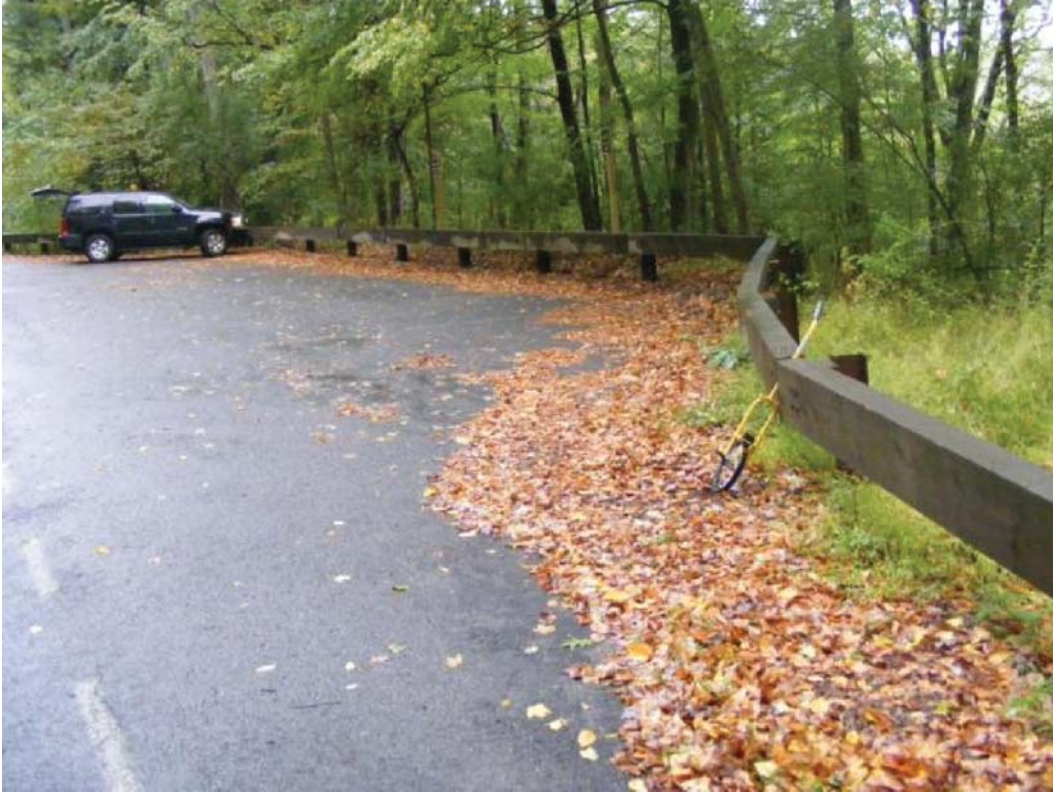
DEWA_0010_0.812_L_1.JPG

Barrier ID:	DEWA-0010-0.812-L				
Route Name:	OLD MINE ROAD (SOUTH SECTION)				
Inspection Date:	10/04/2010	Barrier Rating:	8.50		
Barrier Description					
Type:	STEEL-BACKED TIMBER WITH BLOCKOUT	Barrier Function:	NON-TRAFFIC		
Barrier Material:	STEEL-BACKED TIMBER/LOG	Post Material:	CORTEN		
Blockout Type:	WOOD	Length (ft.):	140		
Speed Limit (MPH):	35	Placement with Respect to Road:	NON-TRAFFIC BARRIER		
Hazard Behind Barrier:	N/A				
Barrier Crashworthiness					
Appropriate Test Level:	TL-2	Barrier Test Level:	TL-3	Is Barrier Crashworthy?:	N/A
Beg. End Trtmt Type:	NONE	Is Beg. End Trtmt Crashworthy?:	N/A	Approach Transition Type:	NONE
Ending End Trtmt Type:	NONE	Ending End Trtmt Crashworthy?:	N/A		
Average Measurements					
Design Height (In.):	27	Width (In.):	0.0	Post Spacing (In.):	0.0
Height (In.):	28.2	Lateral Offset (In.):	0.0	Road Grade (%):	0.00
Physical Condition					
Barrier	Alignment and Height:	No deflections observed in alignment. The height is at or above the design of 27 in by up to 2 in.

Breaking and Cracking:	No breaking or cracking observed.			
	Missing Elements:	No missing elements observed.			
	Corrosion and Weathering:	No loss of cross section or erosion around posts observed.			
End Treatments	Alignment and Height:				
	Breaking and Cracking:				
	Missing Elements:				
	Corrosion and Weathering:

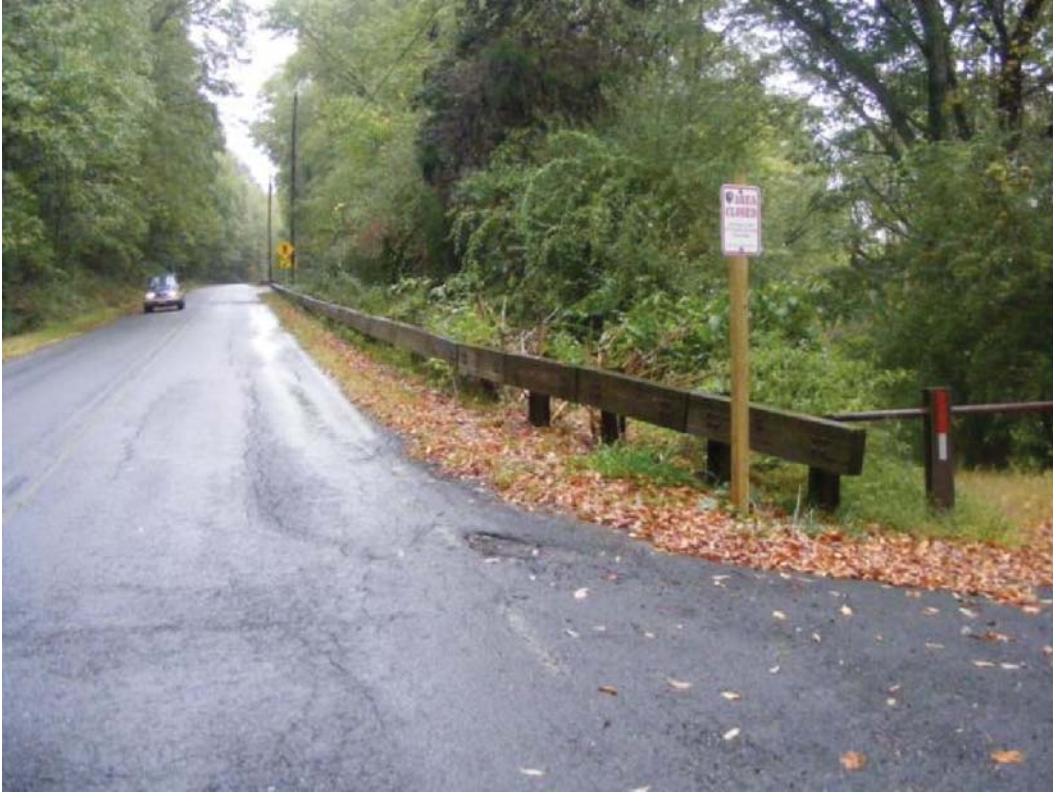
DEWA_0010_0.834_L_1.JPG

Barrier ID:	DEWA-0010-0.834-L				
Route Name:	OLD MINE ROAD (SOUTH SECTION)				
Inspection Date:	10/04/2010	Barrier Rating:	19.30		
Barrier Description					
Type:	STEEL-BACKED TIMBER WITH BLOCKOUT	Barrier Function:	TRAFFIC		
Barrier Material:	STEEL-BACKED TIMBER/LOG	Post Material:	CORTEN		
Blockout Type:	WOOD	Length (ft.):	280		
Speed Limit (MPH):	35	Placement with Respect to Road:	TANGENT		
Hazard Behind Barrier:	MEDIUM				
Barrier Crashworthiness					
Appropriate Test Level:	TL-2	Barrier Test Level:	TL-3	Is Barrier Crashworthy?:	YES
Beg. End Trtmt Type:	NONE	Is Beg. End Trtmt Crashworthy?:	N/A	Approach Transition Type:	NONE
Ending End Trtmt Type:	NONE	Ending End Trtmt Crashworthy?:	N/A		
Average Measurements					
Design Height (In.):	27	Width (In.):	0.0	Post Spacing (In.):	120.0
Height (In.):	26.2	Lateral Offset (In.):	39.0	Road Grade (%):	6.30
Physical Condition					
Barrier	Alignment and Height:	No deflections observed in alignment. The barrier is 1 to 3 in below 27 in design height for 90 ft.

Breaking and Cracking:	No breaking or cracking observed. 4 broken and missing reflector elements.			
	Missing Elements:	No missing elements observed.			
	Corrosion and Weathering:	No loss of cross section or erosion around posts observed.			
End Treatments	Alignment and Height:				
	Breaking and Cracking:				
	Missing Elements:				
	Corrosion and Weathering:

Repair Action:	REPAIR	FMSS Work Type:	DEFERRED MAINTENANCE	Repair Cost:	\$2612
Brief Workorder:	Raise 90-ft. of barrier up to 27-in. design height.				
Workorder:	Adjust Guardrail at \$10- per -Lin. Ft. for 90 LF = \$900. Raise 90-ft. of barrier up to 27-in. design height. Low Speed Traffic Control at \$1475- per -Day for 1 Day(s) = \$1475.

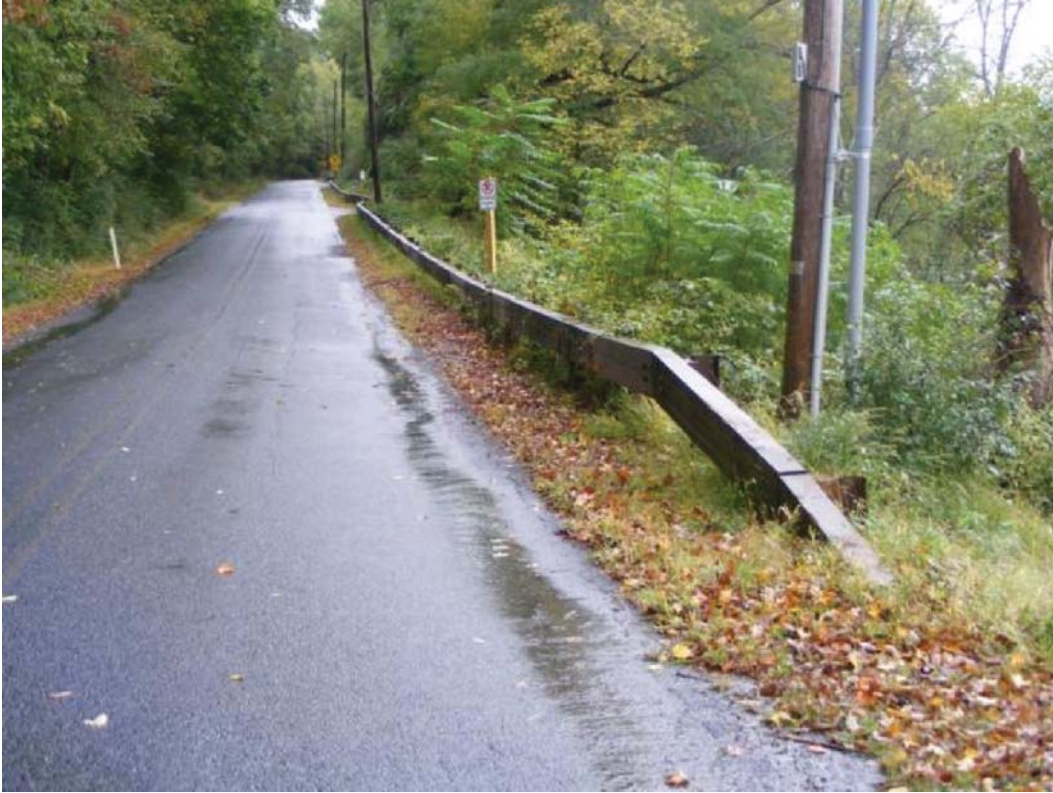
DEWA_0010_0.894_L_1.JPG

Barrier ID:	DEWA-0010-0.894-L				
Route Name:	OLD MINE ROAD (SOUTH SECTION)				
Inspection Date:	10/04/2010	Barrier Rating:	19.30		
Barrier Description					
Type:	STEEL-BACKED TIMBER WITH BLOCKOUT	Barrier Function:	TRAFFIC		
Barrier Material:	STEEL-BACKED TIMBER/LOG	Post Material:	CORTEN		
Blockout Type:	WOOD	Length (ft.):	310		
Speed Limit (MPH):	35	Placement with Respect to Road:	TANGENT		
Hazard Behind Barrier:	MEDIUM				
Barrier Crashworthiness					
Appropriate Test Level:	TL-2	Barrier Test Level:	TL-3	Is Barrier Crashworthy?:	YES
Beg. End Trtmt Type:	SBT/LOG FLARED	Is Beg. End Trtmt Crashworthy?:	NO	Approach Transition Type:	NONE
Ending End Trtmt Type:	NONE	Ending End Trtmt Crashworthy?:	N/A		
Average Measurements					
Design Height (In.):	27	Width (In.):	0.0	Post Spacing (In.):	119.6
Height (In.):	28.7	Lateral Offset (In.):	45.7	Road Grade (%):	5.00
Physical Condition					
Barrier	Alignment and Height:	No deflections observed in alignment. The height is at or above the design of 27 in by up to 3 in.

Breaking and Cracking:	No breaking or cracking observed. 3 broken and missing barrier reflector elements.			
	Missing Elements:	No missing elements observed.			
	Corrosion and Weathering:	No loss of cross section or erosion around posts observed.			
End Treatments	Alignment and Height:	Alignment acceptable. Height is within 1-in. of 27-in. design height.			
	Breaking and Cracking:	No breaking or cracking observed.			
	Missing Elements:	No missing elements observed.			
	Corrosion and Weathering:	No loss of cross section or erosion around posts observed.

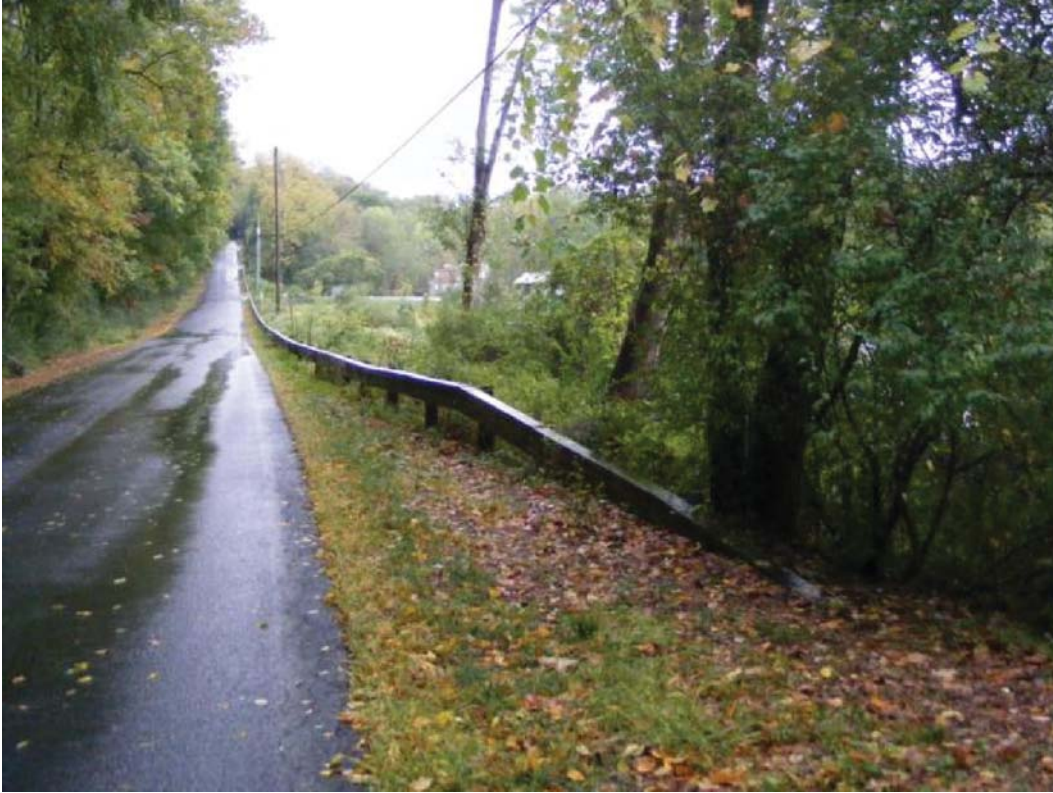
DEWA_0010_0.967_L_1.JPG

Barrier ID:	DEWA-0010-0.967-L				
Route Name:	OLD MINE ROAD (SOUTH SECTION)				
Inspection Date:	10/04/2010	Barrier Rating:	16.50		
Barrier Description					
Type:	STEEL-BACKED TIMBER WITH BLOCKOUT	Barrier Function:	TRAFFIC		
Barrier Material:	STEEL-BACKED TIMBER/LOG	Post Material:	CORTEN		
Blockout Type:	WOOD	Length (ft.):	550		
Speed Limit (MPH):	35	Placement with Respect to Road:	TANGENT		
Hazard Behind Barrier:	MEDIUM				
Barrier Crashworthiness					
Appropriate Test Level:	TL-2	Barrier Test Level:	TL-3	Is Barrier Crashworthy?:	YES
Beg. End Trtmt Type:	SBT/LOG FLARED	Is Beg. End Trtmt Crashworthy?:	NO	Approach Transition Type:	NONE
Ending End Trtmt Type:	SBT/LOG FLARED	Ending End Trtmt Crashworthy?:	NO		
Average Measurements					
Design Height (In.):	27	Width (In.):	0.0	Post Spacing (In.):	120.5
Height (In.):	27.6	Lateral Offset (In.):	50.5	Road Grade (%):	1.50
Physical Condition					
Barrier	Alignment and Height:	No deflections observed in alignment.. The height is at or above the design of 27 in by up to 2 in.

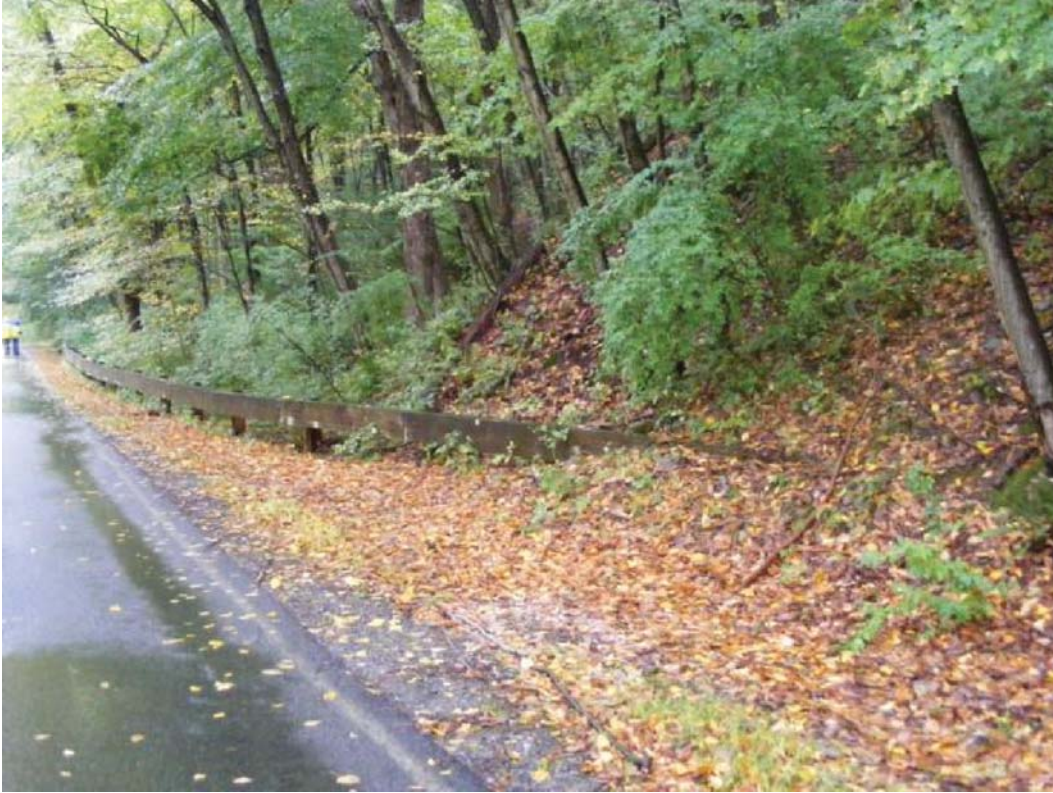
DEWA_0010_1.110_R_1.JPG

Barrier ID:	DEWA-0010-1.110-R				
Route Name:	OLD MINE ROAD (SOUTH SECTION)				
Inspection Date:	10/04/2010	Barrier Rating:	13.60		
Barrier Description					
Type:	STEEL-BACKED TIMBER WITH BLOCKOUT	Barrier Function:	TRAFFIC		
Barrier Material:	STEEL-BACKED TIMBER/LOG	Post Material:	CORTEN		
Blockout Type:	WOOD	Length (ft.):	231		
Speed Limit (MPH):	35	Placement with Respect to Road:	TANGENT		
Hazard Behind Barrier:	MEDIUM				
Barrier Crashworthiness					
Appropriate Test Level:	TL-2	Barrier Test Level:	TL-3	Is Barrier Crashworthy?:	YES
Beg. End Trtmt Type:	SBT/LOG BURIED	Is Beg. End Trtmt Crashworthy?:	YES	Approach Transition Type:	NONE
Ending End Trtmt Type:	SBT/LOG FLARED	Ending End Trtmt Crashworthy?:	NO		
Average Measurements					
Design Height (In.):	27	Width (In.):	0.0	Post Spacing (In.):	119.5
Height (In.):	26.2	Lateral Offset (In.):	51.0	Road Grade (%):	1.50
Physical Condition					
Barrier	Alignment and Height:	No deflections observed in alignment. The height is low by 1 in or less from the design of 27 in.

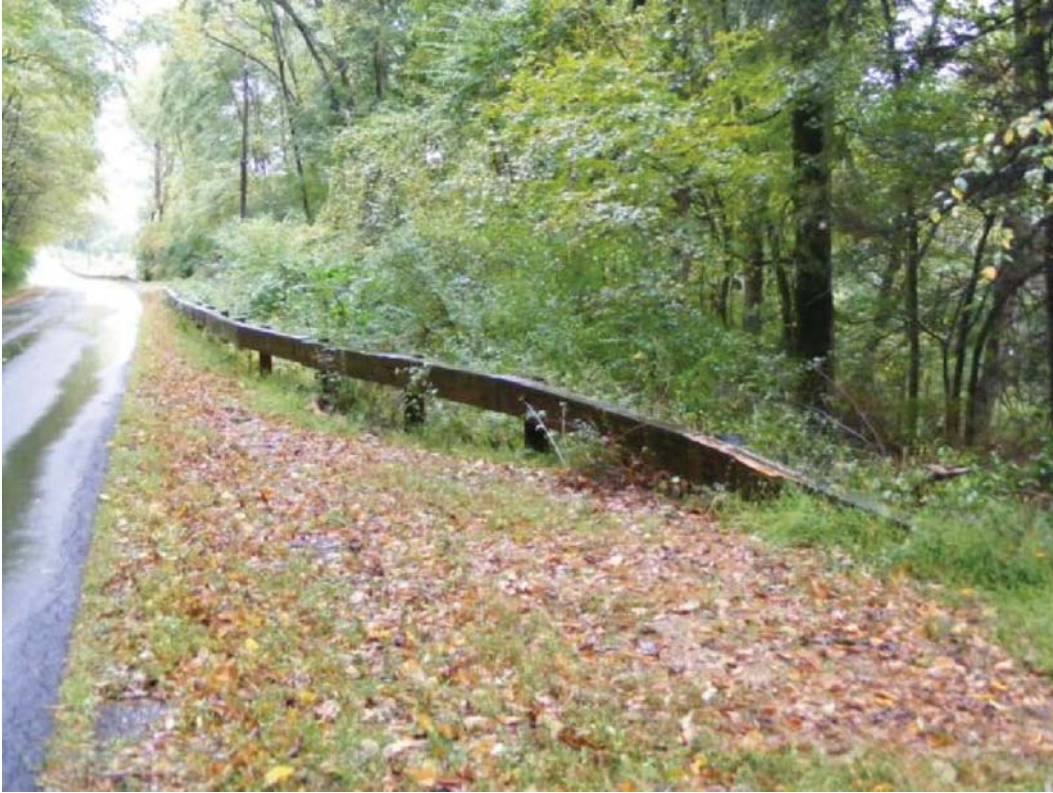
DEWA_0010_1.111_L_1.JPG

Barrier ID:	DEWA-0010-1.111-L				
Route Name:	OLD MINE ROAD (SOUTH SECTION)				
Inspection Date:	10/04/2010	Barrier Rating:	16.50		
Barrier Description					
Type:	STEEL-BACKED TIMBER WITH BLOCKOUT	Barrier Function:	TRAFFIC		
Barrier Material:	STEEL-BACKED TIMBER/LOG	Post Material:	CORTEN		
Blockout Type:	WOOD	Length (ft.):	260		
Speed Limit (MPH):	35	Placement with Respect to Road:	TANGENT		
Hazard Behind Barrier:	MEDIUM				
Barrier Crashworthiness					
Appropriate Test Level:	TL-2	Barrier Test Level:	TL-3	Is Barrier Crashworthy?:	YES
Beg. End Trtmt Type:	SBT/LOG BURIED	Is Beg. End Trtmt Crashworthy?:	YES	Approach Transition Type:	NONE
Ending End Trtmt Type:	SBT/LOG FLARED	Ending End Trtmt Crashworthy?:	NO		
Average Measurements					
Design Height (In.):	27	Width (In.):	0.0	Post Spacing (In.):	120.6
Height (In.):	29.0	Lateral Offset (In.):	50.2	Road Grade (%):	1.70
Physical Condition					
Barrier	Alignment and Height:	No deflections observed in alignment. The height is at or above the design of 27 in by up to 3 in.

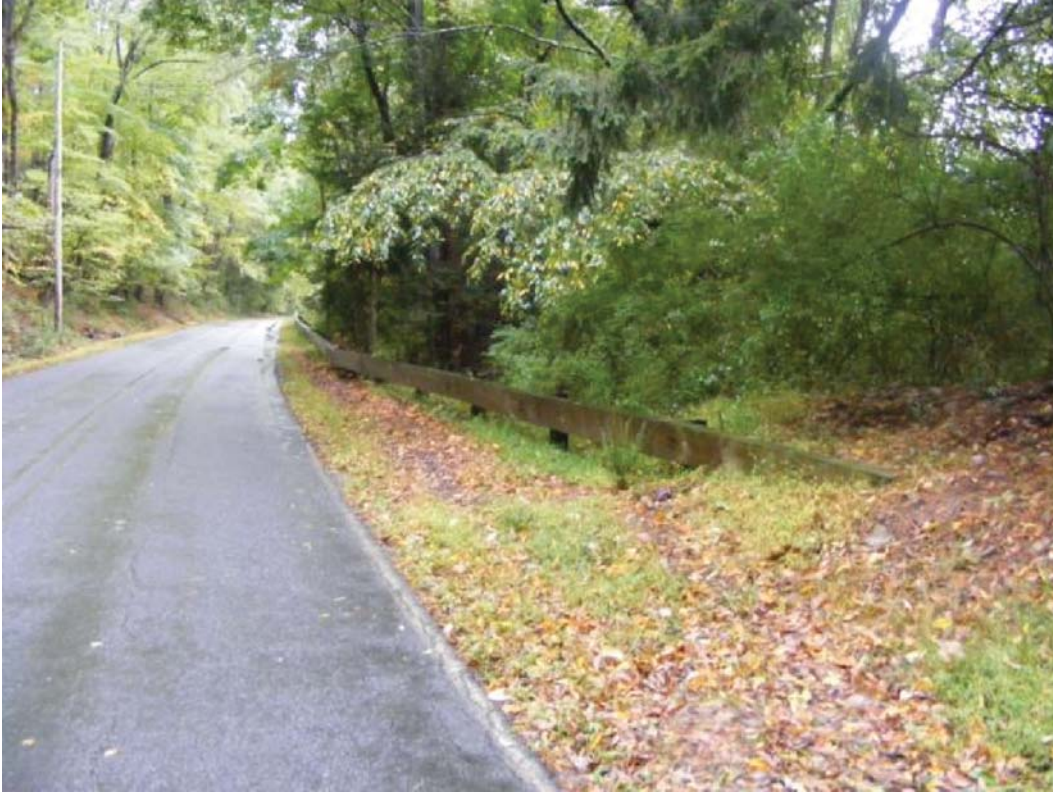
DEWA_0010_1.226_L_1.JPG

Barrier ID:	DEWA-0010-1.226-L				
Route Name:	OLD MINE ROAD (SOUTH SECTION)				
Inspection Date:	10/04/2010	Barrier Rating:	22.20		
Barrier Description					
Type:	STEEL-BACKED TIMBER WITH BLOCKOUT	Barrier Function:	TRAFFIC		
Barrier Material:	STEEL-BACKED TIMBER/LOG	Post Material:	CORTEN		
Blockout Type:	WOOD	Length (ft.):	910		
Speed Limit (MPH):	35	Placement with Respect to Road:	TANGENT		
Hazard Behind Barrier:	MEDIUM				
Barrier Crashworthiness					
Appropriate Test Level:	TL-2	Barrier Test Level:	TL-3	Is Barrier Crashworthy?:	YES
Beg. End Trtmt Type:	SBT/LOG FLARED	Is Beg. End Trtmt Crashworthy?:	NO	Approach Transition Type:	NONE
Ending End Trtmt Type:	SBT/LOG FLARED	Ending End Trtmt Crashworthy?:	NO		
Average Measurements					
Design Height (In.):	27	Width (In.):	0.0	Post Spacing (In.):	119.4
Height (In.):	27.7	Lateral Offset (In.):	46.4	Road Grade (%):	1.20
Physical Condition					
Barrier	Alignment and Height:	No deflections observed in alignment. The height is at or above the design of 27 in by up to 2 in.

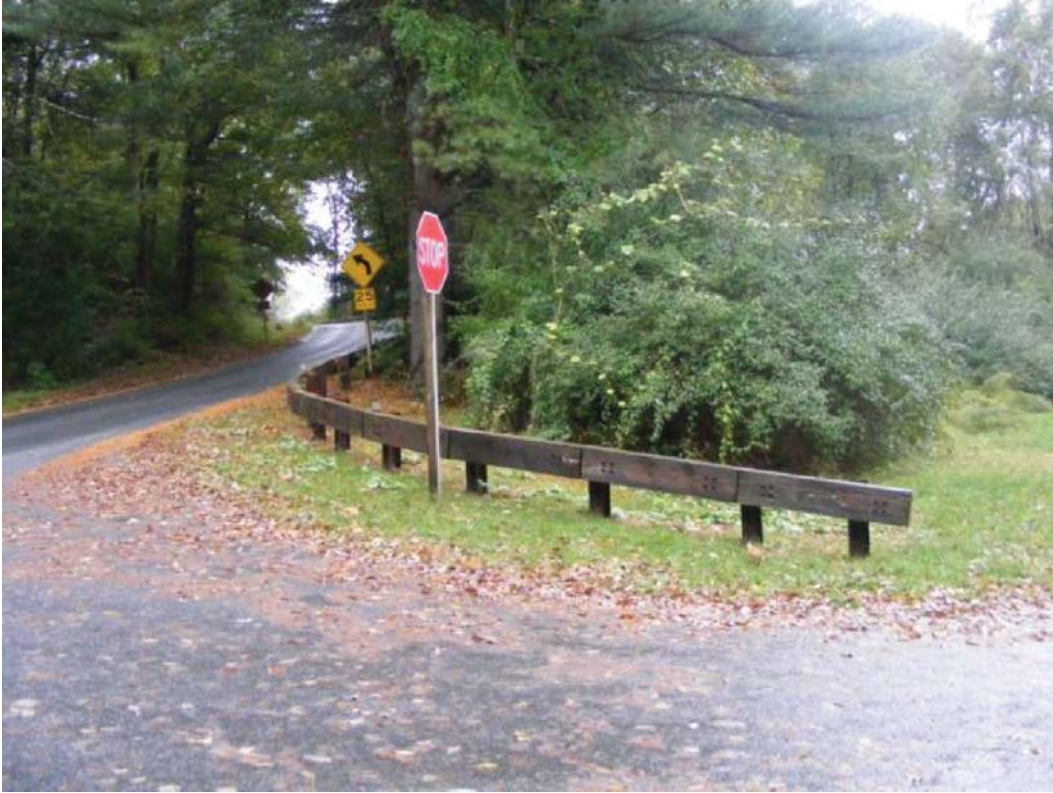
DEWA_0010_1.525_L_1.JPG

Barrier ID:	DEWA-0010-1.525-L				
Route Name:	OLD MINE ROAD (SOUTH SECTION)				
Inspection Date:	10/04/2010	Barrier Rating:	28.00		
Barrier Description					
Type:	STEEL-BACKED TIMBER WITH BLOCKOUT	Barrier Function:	TRAFFIC		
Barrier Material:	STEEL-BACKED TIMBER/LOG	Post Material:	CORTEN		
Blockout Type:	WOOD	Length (ft.):	535		
Speed Limit (MPH):	35	Placement with Respect to Road:	OUTSIDE OF CURVE		
Hazard Behind Barrier:	MEDIUM				
Barrier Crashworthiness					
Appropriate Test Level:	TL-2	Barrier Test Level:	TL-3	Is Barrier Crashworthy?:	YES
Beg. End Trtmt Type:	SBT/LOG FLARED	Is Beg. End Trtmt Crashworthy?:	NO	Approach Transition Type:	NONE
Ending End Trtmt Type:	NONE	Ending End Trtmt Crashworthy?:	N/A		
Average Measurements					
Design Height (In.):	27	Width (In.):	0.0	Post Spacing (In.):	120.5
Height (In.):	27.6	Lateral Offset (In.):	42.5	Road Grade (%):	2.90
Physical Condition					
Barrier	Alignment and Height:	No deflections observed in alignment. The height is at or above the design of 27 in by 1 in.

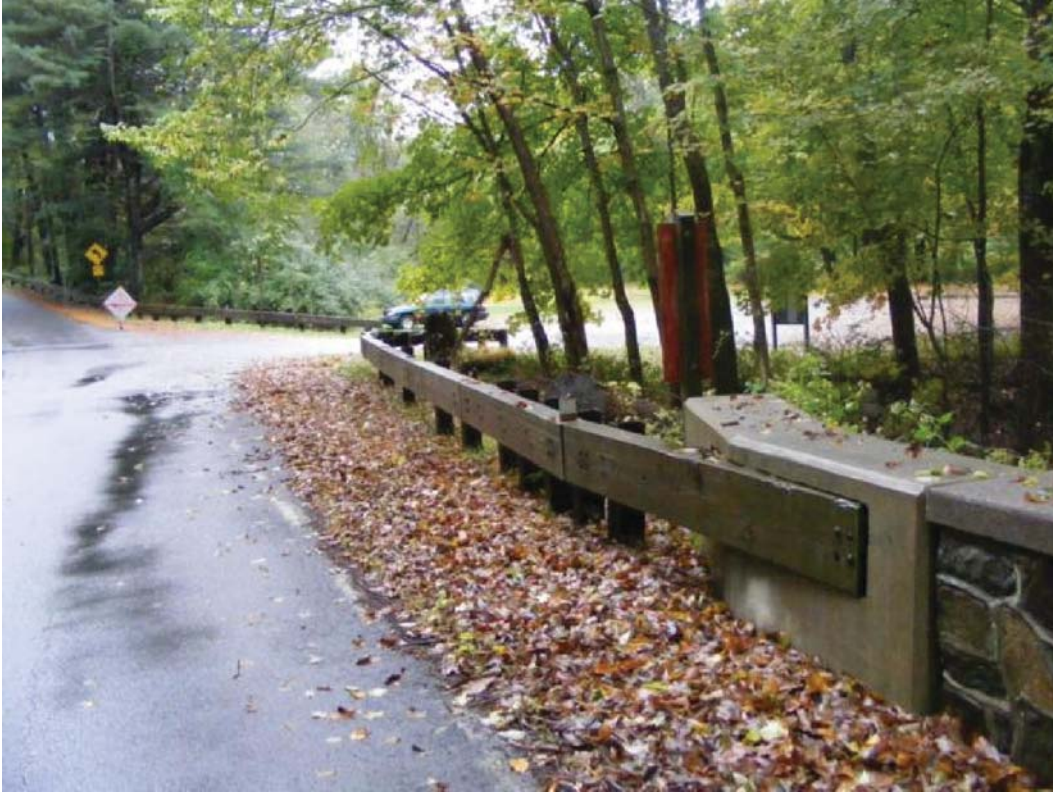
DEWA_0010_1.629_L_1.JPG

Barrier ID:	DEWA-0010-1.629-L				
Route Name:	OLD MINE ROAD (SOUTH SECTION)				
Inspection Date:	10/05/2010	Barrier Rating:	13.60		
Barrier Description					
Type:	STEEL-BACKED TIMBER WITH BLOCKOUT	Barrier Function:	TRAFFIC		
Barrier Material:	STEEL-BACKED TIMBER/LOG	Post Material:	CORTEN		
Blockout Type:	WOOD	Length (ft.):	82		
Speed Limit (MPH):	35	Placement with Respect to Road:	TANGENT		
Hazard Behind Barrier:	MEDIUM				
Barrier Crashworthiness					
Appropriate Test Level:	TL-2	Barrier Test Level:	TL-3	Is Barrier Crashworthy?:	YES
Beg. End Trtmt Type:	NONE	Is Beg. End Trtmt Crashworthy?:	N/A	Approach Transition Type:	CONC/MASON SBT
Ending End Trtmt Type:	NONE	Ending End Trtmt Crashworthy?:	N/A		
Average Measurements					
Design Height (In.):	27	Width (In.):	0.0	Post Spacing (In.):	80.0
Height (In.):	29.2	Lateral Offset (In.):	99.3	Road Grade (%):	1.10
Physical Condition					
Barrier	Alignment and Height:	No deflections observed in alignment. The height is at or above the design of 27 in by up to 4 in.

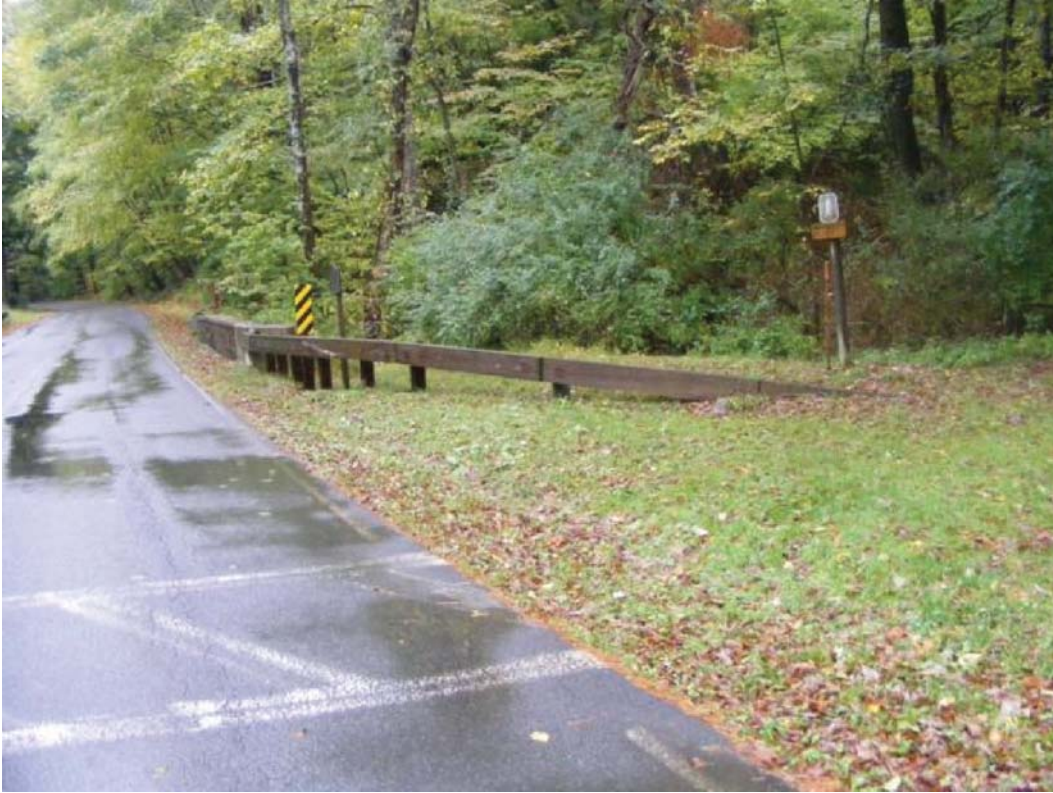
DEWA_0010_1.637_R_1.JPG

Barrier ID:	DEWA-0010-1.637-R				
Route Name:	OLD MINE ROAD (SOUTH SECTION)				
Inspection Date:	10/05/2010	Barrier Rating:	13.60		
Barrier Description					
Type:	STEEL-BACKED TIMBER WITH BLOCKOUT	Barrier Function:	TRAFFIC		
Barrier Material:	STEEL-BACKED TIMBER/LOG	Post Material:	CORTEN		
Blockout Type:	WOOD	Length (ft.):	45		
Speed Limit (MPH):	35	Placement with Respect to Road:	TANGENT		
Hazard Behind Barrier:	MEDIUM				
Barrier Crashworthiness					
Appropriate Test Level:	TL-2	Barrier Test Level:	TL-3	Is Barrier Crashworthy?:	YES
Beg. End Trtmt Type:	SBT/LOG FLARED	Is Beg. End Trtmt Crashworthy?:	NO	Approach Transition Type:	CONC/MASON SBT
Ending End Trtmt Type:	NONE	Ending End Trtmt Crashworthy?:	N/A		
Average Measurements					
Design Height (In.):	27	Width (In.):	0.0	Post Spacing (In.):	79.0
Height (In.):	30.2	Lateral Offset (In.):	91.0	Road Grade (%):	1.10
Physical Condition					
Barrier	Alignment and Height:	No deflections observed in alignment. The height is at or above the design of 27 in up to 4 in.

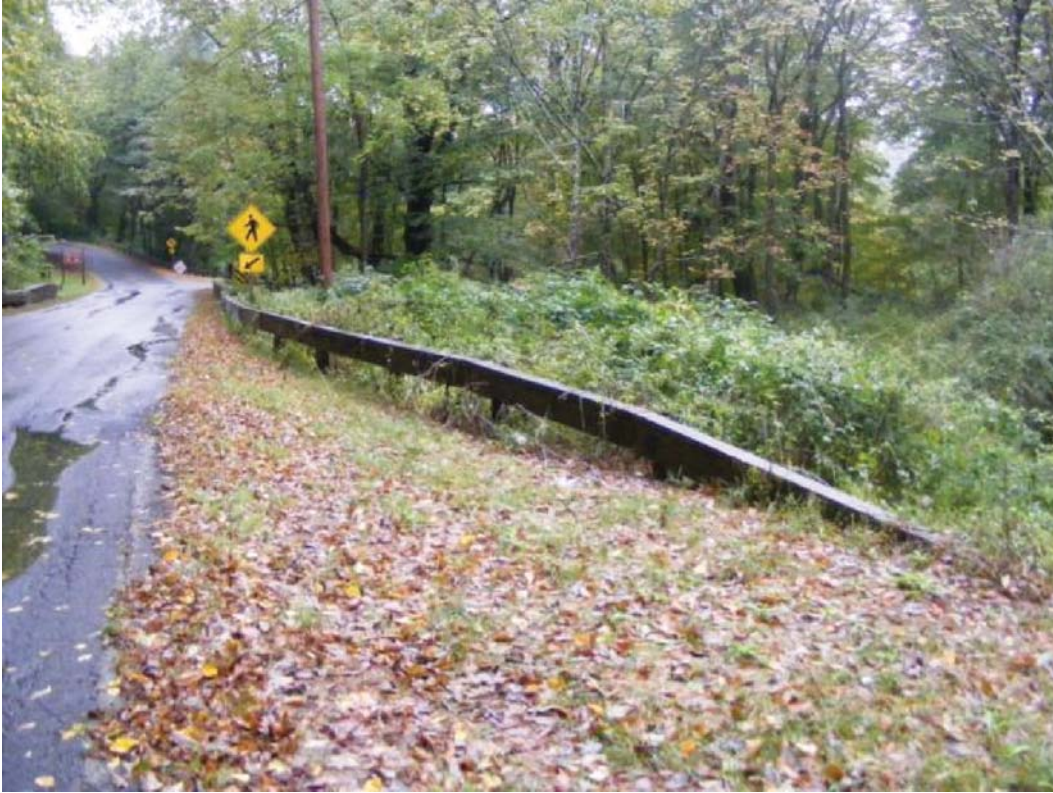
DEWA_0010_1.653_L_1.JPG

Barrier ID:	DEWA-0010-1.653-L				
Route Name:	OLD MINE ROAD (SOUTH SECTION)				
Inspection Date:	10/05/2010	Barrier Rating:	16.50		
Barrier Description					
Type:	STEEL-BACKED TIMBER WITH BLOCKOUT	Barrier Function:	TRAFFIC		
Barrier Material:	STEEL-BACKED TIMBER/LOG	Post Material:	CORTEN		
Blockout Type:	WOOD	Length (ft.):	156		
Speed Limit (MPH):	35	Placement with Respect to Road:	TANGENT		
Hazard Behind Barrier:	MEDIUM				
Barrier Crashworthiness					
Appropriate Test Level:	TL-2	Barrier Test Level:	TL-3	Is Barrier Crashworthy?:	YES
Beg. End Trtmt Type:	NONE	Is Beg. End Trtmt Crashworthy?:	N/A	Approach Transition Type:	CONC/MASON SBT
Ending End Trtmt Type:	SBT/LOG FLARED	Ending End Trtmt Crashworthy?:	NO		
Average Measurements					
Design Height (In.):	27	Width (In.):	0.0	Post Spacing (In.):	100.6
Height (In.):	28.2	Lateral Offset (In.):	47.7	Road Grade (%):	1.00
Physical Condition					
Barrier	Alignment and Height:	The alignment has one impact zone 1-4 in out of alignment the height is at or above the design of 27 in by up to 3 ins.

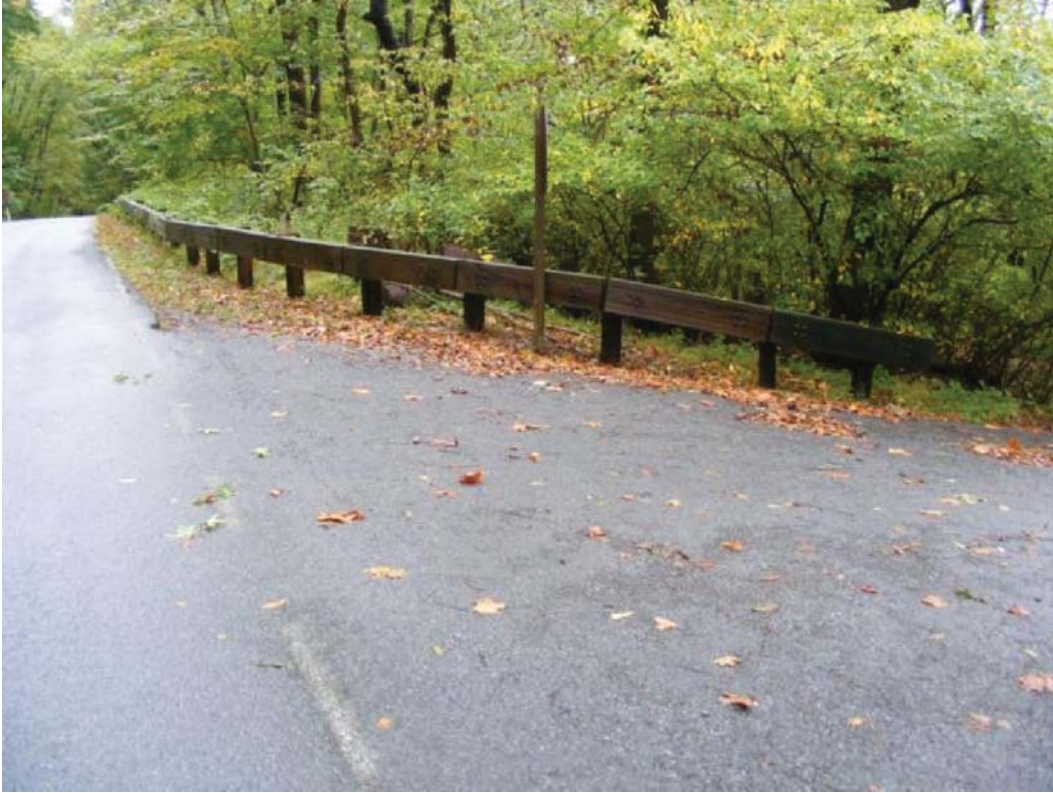
DEWA_0010_1.730_L_1.JPG

Barrier ID:	DEWA-0010-1.730-L				
Route Name:	OLD MINE ROAD (SOUTH SECTION)				
Inspection Date:	10/05/2010	Barrier Rating:	30.70		
Barrier Description					
Type:	STEEL-BACKED TIMBER WITH BLOCKOUT	Barrier Function:	TRAFFIC		
Barrier Material:	STEEL-BACKED TIMBER/LOG	Post Material:	CORTEN		
Blockout Type:	WOOD	Length (ft.):	920		
Speed Limit (MPH):	35	Placement with Respect to Road:	BOTH INSIDE AND OUTSIDE		
Hazard Behind Barrier:	MEDIUM				
Barrier Crashworthiness					
Appropriate Test Level:	TL-2	Barrier Test Level:	TL-3	Is Barrier Crashworthy?:	YES
Beg. End Trtmt Type:	NONE	Is Beg. End Trtmt Crashworthy?:	N/A	Approach Transition Type:	NONE
Ending End Trtmt Type:	SBT/LOG FLARED	Ending End Trtmt Crashworthy?:	NO		
Average Measurements					
Design Height (In.):	27	Width (In.):	0.0	Post Spacing (In.):	120.0
Height (In.):	27.2	Lateral Offset (In.):	42.2	Road Grade (%):	1.60
Physical Condition					
Barrier	Alignment and Height:	No deflections observed in alignment. The height is at or 1 in above the design of 27 in.

Breaking and Cracking:	No breaking or cracking observed.			
	Missing Elements:	No missing elements observed.			
	Corrosion and Weathering:	No loss of cross section or erosion around posts observed.			
End Treatments	Alignment and Height:	Alignment acceptable. Height is within 1-in. of 27-in. design height.			
	Breaking and Cracking:	No breaking or cracking observed.			
	Missing Elements:	No missing elements observed.			
	Corrosion and Weathering:	No loss of cross section or erosion around posts observed.

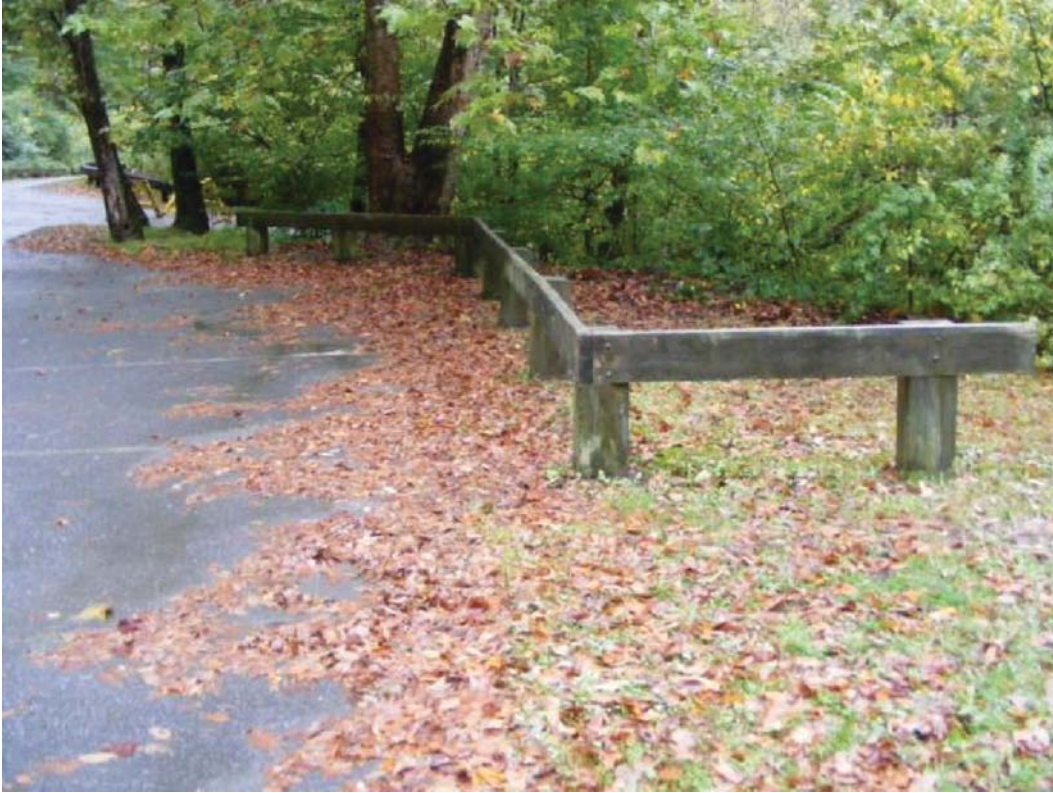
DEWA_0010_1.852_L_1.JPG

Barrier ID:	DEWA-0010-1.852-L				
Route Name:	OLD MINE ROAD (SOUTH SECTION)				
Inspection Date:	10/05/2010	Barrier Rating:	8.50		
Barrier Description					
Type:	OTHER: TIMBER RAIL ON TIMBER POSTS	Barrier Function:	NON-TRAFFIC		
Barrier Material:	LOG/TIMBER/WOOD	Post Material:	WOOD		
Blockout Type:	N/A	Length (ft.):	55		
Speed Limit (MPH):	35	Placement with Respect to Road:	NON-TRAFFIC BARRIER		
Hazard Behind Barrier:	N/A				
Barrier Crashworthiness					
Appropriate Test Level:	TL-2	Barrier Test Level:	N/A	Is Barrier Crashworthy?:	N/A
Beg. End Trtmt Type:	NONE	Is Beg. End Trtmt Crashworthy?:	N/A	Approach Transition Type:	NONE
Ending End Trtmt Type:	NONE	Ending End Trtmt Crashworthy?:	N/A		
Average Measurements					
Design Height (In.):	27	Width (In.):	0.0	Post Spacing (In.):	0.0
Height (In.):	28.6	Lateral Offset (In.):	0.0	Road Grade (%):	0.00
Physical Condition					
Barrier	Alignment and Height:	No deflections observed in alignment. The height is at or above the design of 27 in by up to 2 in.

Breaking and Cracking:	No breaking or cracking observed.			
	Missing Elements:	No missing elements observed.			
	Corrosion and Weathering:	No loss of cross section or erosion around posts observed.			
End Treatments	Alignment and Height:				
	Breaking and Cracking:				
	Missing Elements:				
	Corrosion and Weathering:
