NPS Guardwall/Rail Inventory Program Delaware Water Gap National Recreation Area

**Federal Lands Highway
Road Inventory Program**

Federal Highway Administration
Eastern Federal Lands Highway Division
Road Inventory Program (RIP)

Data Collection Date: October 2010
Report Date: December 2015

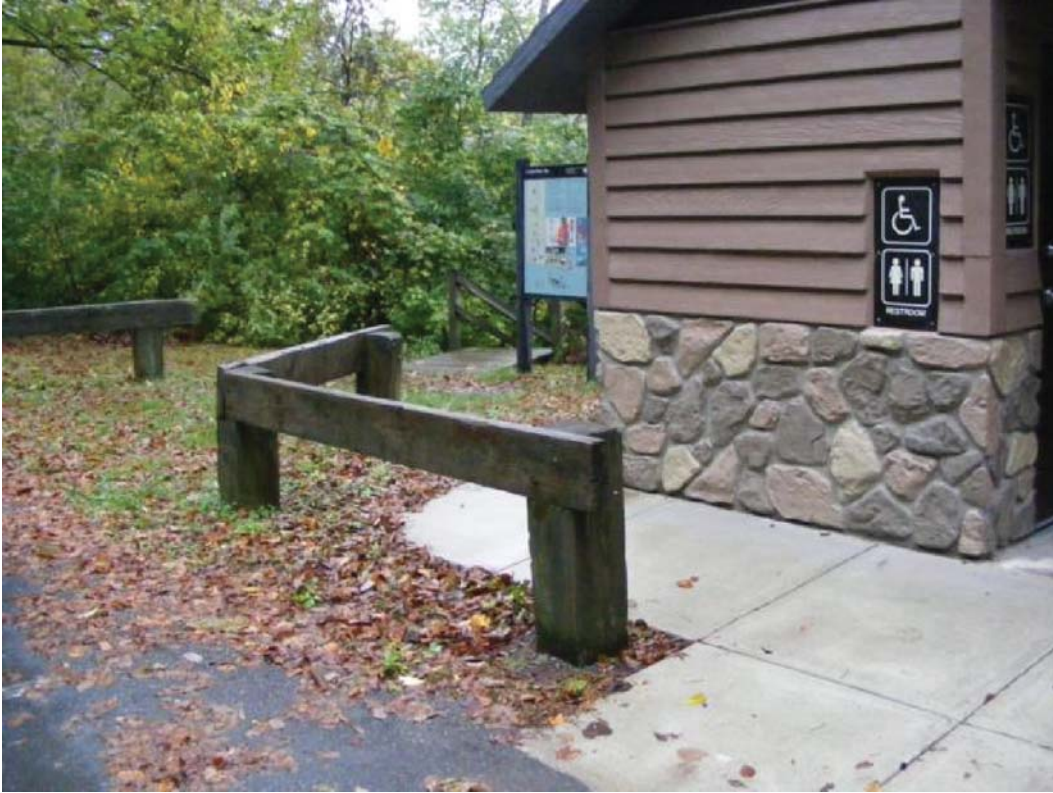
DEWA_0010_1.863_L_1.JPG

Barrier ID:	DEWA-0010-1.863-L				
Route Name:	OLD MINE ROAD (SOUTH SECTION)				
Inspection Date:	10/05/2010	Barrier Rating:	8.50		
Barrier Description					
Type:	OTHER: TIMBER RAIL ON TIMBER POSTS	Barrier Function:	NON-TRAFFIC		
Barrier Material:	LOG/TIMBER/WOOD	Post Material:	WOOD		
Blockout Type:	N/A	Length (ft.):	19		
Speed Limit (MPH):	35	Placement with Respect to Road:	NON-TRAFFIC BARRIER		
Hazard Behind Barrier:	N/A				
Barrier Crashworthiness					
Appropriate Test Level:	TL-2	Barrier Test Level:	N/A	Is Barrier Crashworthy?:	N/A
Beg. End Trtmt Type:	NONE	Is Beg. End Trtmt Crashworthy?:	N/A	Approach Transition Type:	NONE
Ending End Trtmt Type:	NONE	Ending End Trtmt Crashworthy?:	N/A		
Average Measurements					
Design Height (In.):	27	Width (In.):	0.0	Post Spacing (In.):	0.0
Height (In.):	28.2	Lateral Offset (In.):	0.0	Road Grade (%):	0.00
Physical Condition					
Barrier	Alignment and Height:	No deflections observed in alignment. The height is at or above the design of 27 in by up to 3 in.

Breaking and Cracking:	No breaking or cracking observed.			
	Missing Elements:	No missing elements observed.			
	Corrosion and Weathering:	No loss of cross section or erosion around posts observed.			
End Treatments	Alignment and Height:				
	Breaking and Cracking:				
	Missing Elements:				
	Corrosion and Weathering:

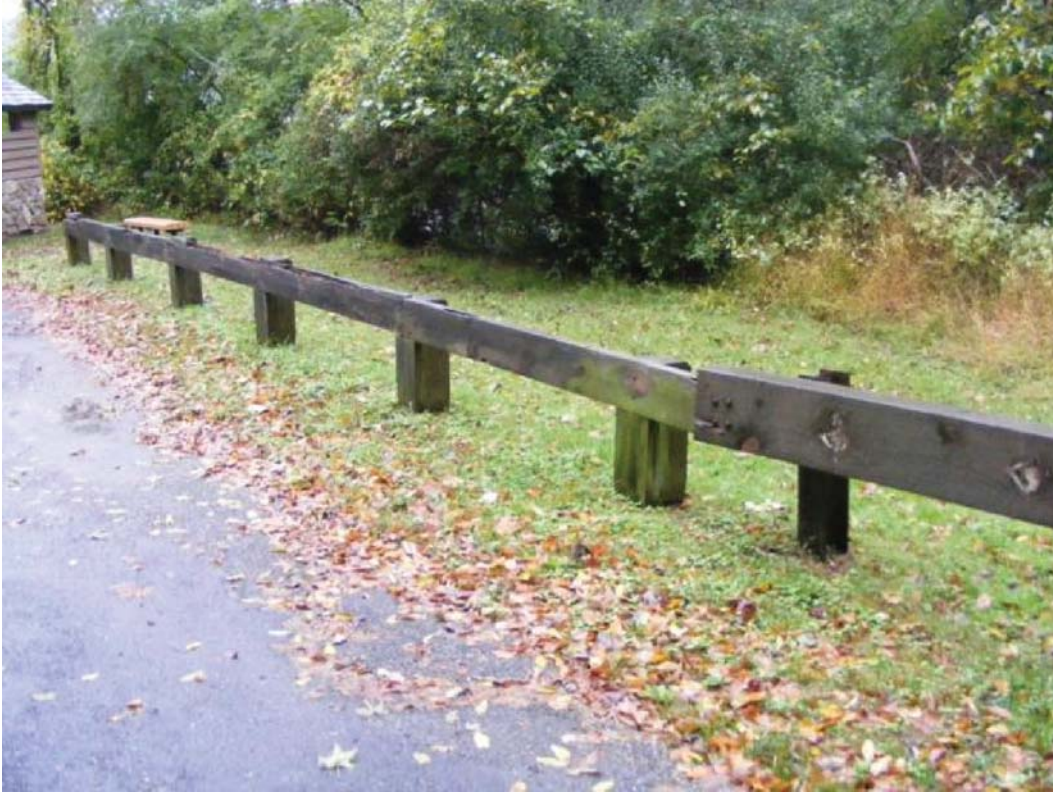
DEWA_0010_1.868_L_1.JPG

Barrier ID:	DEWA-0010-1.868-L				
Route Name:	OLD MINE ROAD (SOUTH SECTION)				
Inspection Date:	10/05/2010	Barrier Rating:	8.50		
Barrier Description					
Type:	OTHER: TIMBER RAIL ON TIMBER POSTS	Barrier Function:	NON-TRAFFIC		
Barrier Material:	LOG/TIMBER/WOOD	Post Material:	WOOD		
Blockout Type:	N/A	Length (ft.):	40		
Speed Limit (MPH):	35	Placement with Respect to Road:	NON-TRAFFIC BARRIER		
Hazard Behind Barrier:	N/A				
Barrier Crashworthiness					
Appropriate Test Level:	TL-2	Barrier Test Level:	N/A	Is Barrier Crashworthy?:	N/A
Beg. End Trtmt Type:	NONE	Is Beg. End Trtmt Crashworthy?:	N/A	Approach Transition Type:	NONE
Ending End Trtmt Type:	NONE	Ending End Trtmt Crashworthy?:	N/A		
Average Measurements					
Design Height (In.):	27	Width (In.):	0.0	Post Spacing (In.):	0.0
Height (In.):	27.6	Lateral Offset (In.):	0.0	Road Grade (%):	0.00
Physical Condition					
Barrier	Alignment and Height:	No deflections observed in alignment. The height is at or above the design of 27 in by up to 1 in.

Breaking and Cracking:	No breaking or cracking observed.			
	Missing Elements:	No missing elements observed.			
	Corrosion and Weathering:	24 ft of rails have a loss of 25% of cross section and rotting.			
End Treatments	Alignment and Height:				
	Breaking and Cracking:				
	Missing Elements:				
	Corrosion and Weathering:

Repair Action:	REPAIR	FMSS Work Type:	DEFERRED MAINTENANCE	Repair Cost:	\$2282
Brief Workorder:	Replace 24 feet of timber rail.				
Workorder:	Replace Rail at \$25- per -Lin. Ft. for 24 LF = \$600. Replace rotten and weathered timber rail. Low Speed Traffic Control at \$1475- per -Day for 1 Day(s) = \$1475.

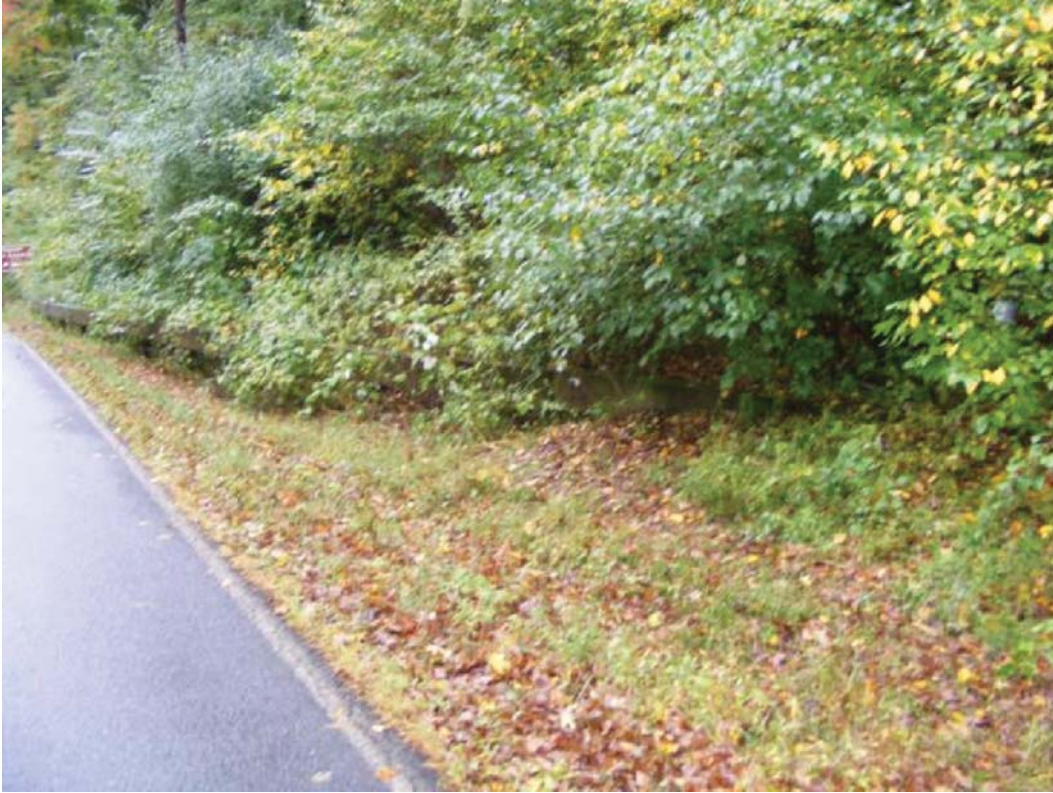
DEWA_0010_1.872_R_1.JPG

Barrier ID:	DEWA-0010-1.872-R				
Route Name:	OLD MINE ROAD (SOUTH SECTION)				
Inspection Date:	10/05/2010	Barrier Rating:	14.00		
Barrier Description					
Type:	STEEL-BACKED TIMBER WITH BLOCKOUT	Barrier Function:	TRAFFIC		
Barrier Material:	STEEL-BACKED TIMBER/LOG	Post Material:	CORTEN		
Blockout Type:	WOOD	Length (ft.):	170		
Speed Limit (MPH):	35	Placement with Respect to Road:	TANGENT		
Hazard Behind Barrier:	LOW				
Barrier Crashworthiness					
Appropriate Test Level:	TL-2	Barrier Test Level:	TL-3	Is Barrier Crashworthy?:	YES
Beg. End Trtmt Type:	SBT/LOG FLARED	Is Beg. End Trtmt Crashworthy?:	NO	Approach Transition Type:	NONE
Ending End Trtmt Type:	SBT/LOG BURIED	Ending End Trtmt Crashworthy?:	YES		
Average Measurements					
Design Height (In.):	27	Width (In.):	0.0	Post Spacing (In.):	120.0
Height (In.):	28.0	Lateral Offset (In.):	44.7	Road Grade (%):	1.50
Physical Condition					
Barrier	Alignment and Height:	No deflections observed in alignment. The height is at or up to 2 in above the design of 27 in.

Breaking and Cracking:	No breaking or cracking observed.			
	Missing Elements:	No missing elements observed.			
	Corrosion and Weathering:	No corrosion or weathering observed.			
End Treatments	Alignment and Height:	Alignment acceptable. Height is within 1-in. of 27-in. design height.			
	Breaking and Cracking:	No breaking or cracking observed.			
	Missing Elements:	No missing elements observed.			
	Corrosion and Weathering:	No loss of cross section or erosion around posts observed.

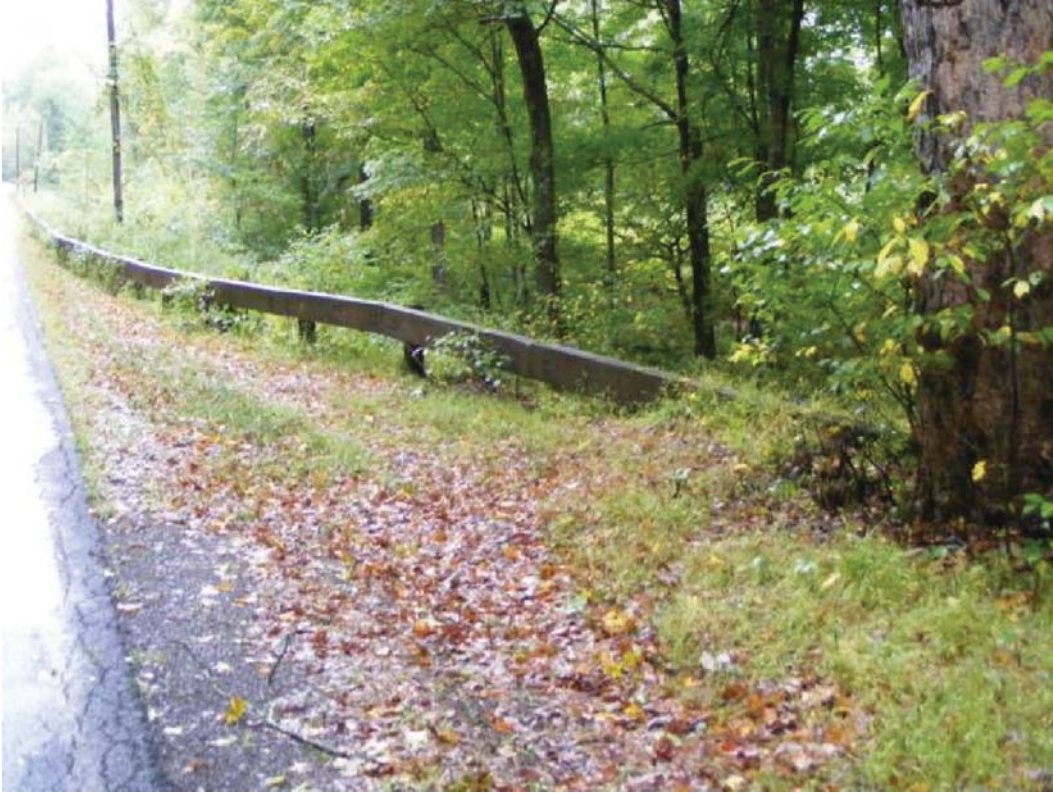
DEWA_0010_1.935_L_1.JPG

Barrier ID:	DEWA-0010-1.935-L				
Route Name:	OLD MINE ROAD (SOUTH SECTION)				
Inspection Date:	10/04/2010	Barrier Rating:	22.20		
Barrier Description					
Type:	STEEL-BACKED TIMBER WITH BLOCKOUT	Barrier Function:	TRAFFIC		
Barrier Material:	STEEL-BACKED TIMBER/LOG	Post Material:	CORTEN		
Blockout Type:	WOOD	Length (ft.):	925		
Speed Limit (MPH):	35	Placement with Respect to Road:	TANGENT		
Hazard Behind Barrier:	MEDIUM				
Barrier Crashworthiness					
Appropriate Test Level:	TL-2	Barrier Test Level:	TL-3	Is Barrier Crashworthy?:	YES
Beg. End Trtmt Type:	NONE	Is Beg. End Trtmt Crashworthy?:	N/A	Approach Transition Type:	NONE
Ending End Trtmt Type:	SBT/LOG FLARED	Ending End Trtmt Crashworthy?:	NO		
Average Measurements					
Design Height (In.):	27	Width (In.):	0.0	Post Spacing (In.):	120.0
Height (In.):	26.6	Lateral Offset (In.):	44.2	Road Grade (%):	0.50
Physical Condition					
Barrier	Alignment and Height:	No deflections observed in alignment. The height is low by 1 in or less from the design of 27 in.

Breaking and Cracking:	No breaking or cracking observed.			
	Missing Elements:	8 barrier reflectors observed missing.			
	Corrosion and Weathering:	No loss of cross section or erosion around posts observed.			
End Treatments	Alignment and Height:	Alignment acceptable. Height is within 1-in. of 27-in. design height.			
	Breaking and Cracking:	No breaking or cracking observed.			
	Missing Elements:	No missing elements observed.			
	Corrosion and Weathering:	No loss of cross section or erosion around posts observed.

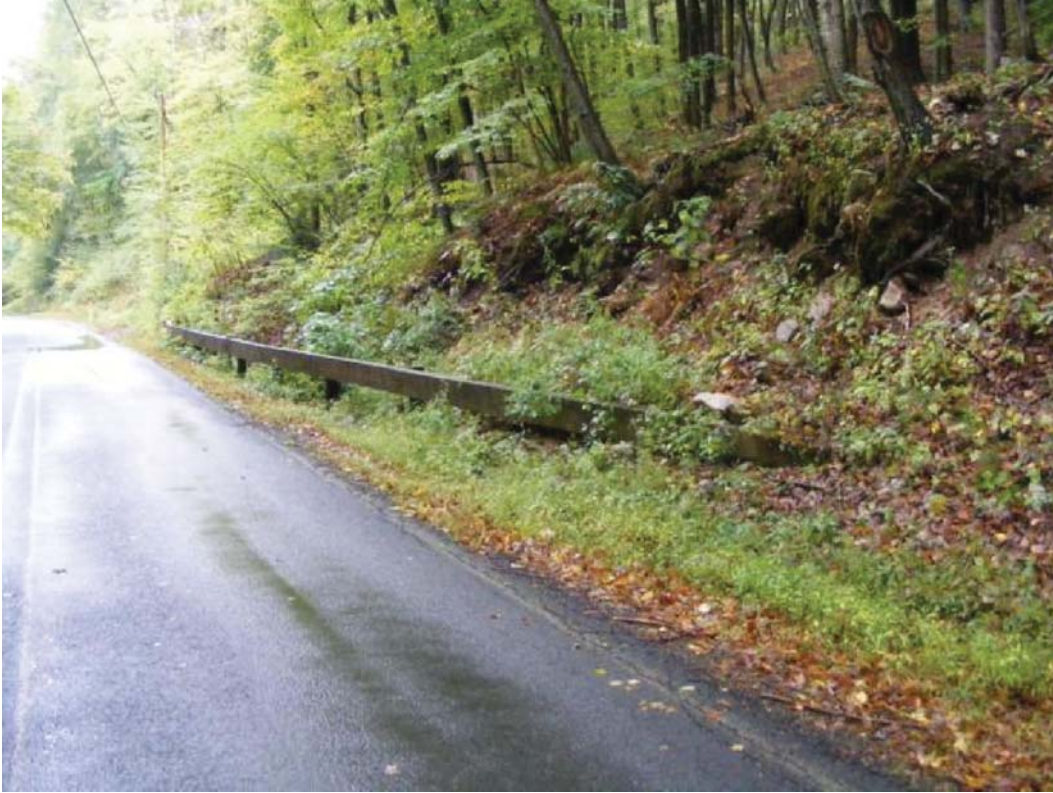
DEWA_0010_2.116_R_1.JPG

Barrier ID:	DEWA-0010-2.116-R				
Route Name:	OLD MINE ROAD (SOUTH SECTION)				
Inspection Date:	10/05/2010	Barrier Rating:	14.00		
Barrier Description					
Type:	STEEL-BACKED TIMBER WITH BLOCKOUT	Barrier Function:	TRAFFIC		
Barrier Material:	STEEL-BACKED TIMBER/LOG	Post Material:	CORTEN		
Blockout Type:	WOOD	Length (ft.):	140		
Speed Limit (MPH):	35	Placement with Respect to Road:	TANGENT		
Hazard Behind Barrier:	LOW				
Barrier Crashworthiness					
Appropriate Test Level:	TL-2	Barrier Test Level:	TL-3	Is Barrier Crashworthy?:	YES
Beg. End Trtmt Type:	SBT/LOG BURIED	Is Beg. End Trtmt Crashworthy?:	YES	Approach Transition Type:	NONE
Ending End Trtmt Type:	SBT/LOG BURIED	Ending End Trtmt Crashworthy?:	YES		
Average Measurements					
Design Height (In.):	27	Width (In.):	0.0	Post Spacing (In.):	119.0
Height (In.):	28.6	Lateral Offset (In.):	39.5	Road Grade (%):	0.80
Physical Condition					
Barrier	Alignment and Height:	No deflections observed in alignment. The height is at or above the design of 27 in by up to 2 in.

Breaking and Cracking:	No breaking or cracking observed.			
	Missing Elements:	No missing elements observed.			
	Corrosion and Weathering:	No loss of cross section or erosion around posts observed.			
End Treatments	Alignment and Height:	Alignment acceptable. Height is within 1-in. of 27-in. design height.			
	Breaking and Cracking:	No breaking or cracking observed.			
	Missing Elements:	No missing elements observed.			
	Corrosion and Weathering:	No loss of cross section or erosion around posts observed.

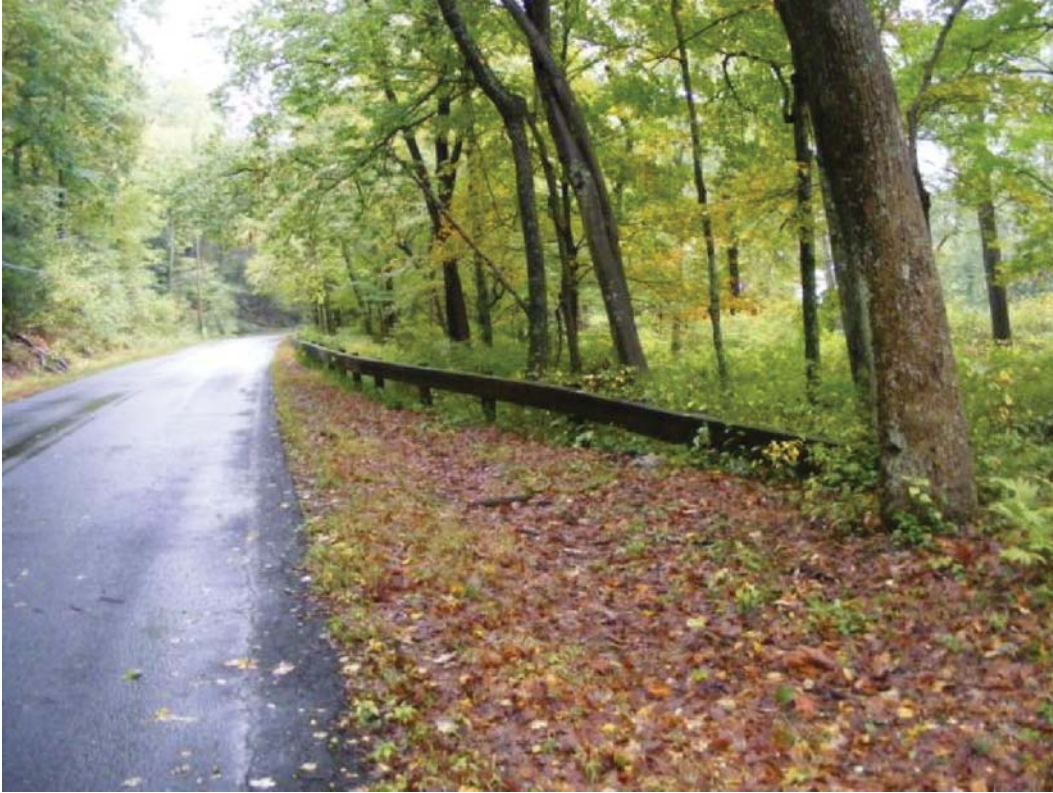
DEWA_0010_2.145_L_1.JPG

Barrier ID:	DEWA-0010-2.145-L				
Route Name:	OLD MINE ROAD (SOUTH SECTION)				
Inspection Date:	10/05/2010	Barrier Rating:	22.20		
Barrier Description					
Type:	STEEL-BACKED TIMBER WITH BLOCKOUT	Barrier Function:	TRAFFIC		
Barrier Material:	STEEL-BACKED TIMBER/LOG	Post Material:	CORTEN		
Blockout Type:	WOOD	Length (ft.):	378		
Speed Limit (MPH):	35	Placement with Respect to Road:	INSIDE OF CURVE		
Hazard Behind Barrier:	MEDIUM				
Barrier Crashworthiness					
Appropriate Test Level:	TL-2	Barrier Test Level:	TL-3	Is Barrier Crashworthy?:	YES
Beg. End Trtmt Type:	SBT/LOG FLARED	Is Beg. End Trtmt Crashworthy?:	NO	Approach Transition Type:	NONE
Ending End Trtmt Type:	SBT/LOG FLARED	Ending End Trtmt Crashworthy?:	NO		
Average Measurements					
Design Height (In.):	27	Width (In.):	0.0	Post Spacing (In.):	120.0
Height (In.):	26.2	Lateral Offset (In.):	41.5	Road Grade (%):	0.20
Physical Condition					
Barrier	Alignment and Height:	No deflections observed in alignment. The height is at or below the design of 27 in by 1 in.

Breaking and Cracking:	No breaking or cracking observed.			
	Missing Elements:	No missing elements observed.			
	Corrosion and Weathering:	No loss of cross section or erosion around posts observed.			
End Treatments	Alignment and Height:	Alignment acceptable. Height is within 1-in. of 27-in. design height.			
	Breaking and Cracking:	No breaking or cracking observed.			
	Missing Elements:	No missing elements observed.			
	Corrosion and Weathering:	No loss of cross section or erosion around posts observed.

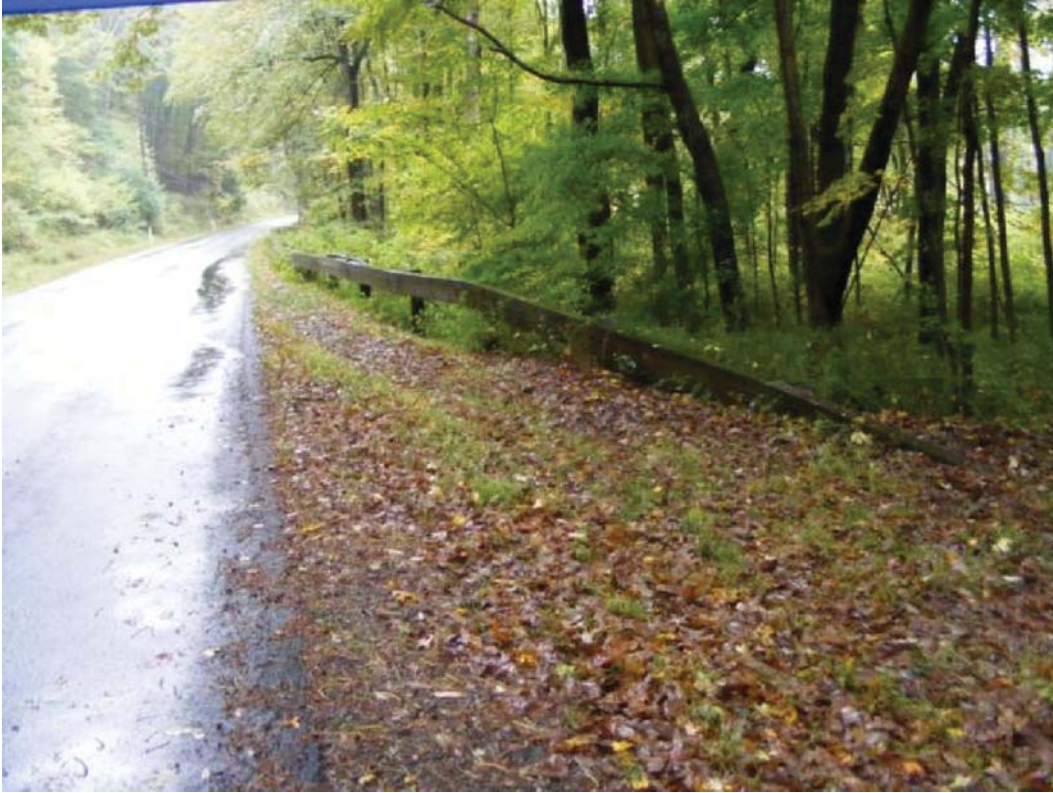
DEWA_0010_2.246_L_1.JPG

Barrier ID:	DEWA-0010-2.246-L				
Route Name:	OLD MINE ROAD (SOUTH SECTION)				
Inspection Date:	10/05/2010	Barrier Rating:	19.70		
Barrier Description					
Type:	STEEL-BACKED TIMBER WITH BLOCKOUT	Barrier Function:	TRAFFIC		
Barrier Material:	STEEL-BACKED TIMBER/LOG	Post Material:	CORTEN		
Blockout Type:	WOOD	Length (ft.):	255		
Speed Limit (MPH):	35	Placement with Respect to Road:	INSIDE OF CURVE		
Hazard Behind Barrier:	LOW				
Barrier Crashworthiness					
Appropriate Test Level:	TL-2	Barrier Test Level:	TL-3	Is Barrier Crashworthy?:	YES
Beg. End Trtmt Type:	SBT/LOG FLARED	Is Beg. End Trtmt Crashworthy?:	NO	Approach Transition Type:	NONE
Ending End Trtmt Type:	SBT/LOG FLARED	Ending End Trtmt Crashworthy?:	NO		
Average Measurements					
Design Height (In.):	27	Width (In.):	0.0	Post Spacing (In.):	120.5
Height (In.):	26.6	Lateral Offset (In.):	37.0	Road Grade (%):	0.50
Physical Condition					
Barrier	Alignment and Height:	No deflections observed in alignment. The height is low by 1 in or less from the design of 27 in.

Breaking and Cracking:	No breaking or cracking observed.			
	Missing Elements:	One broken/missing barrier reflector.			
	Corrosion and Weathering:	No loss of cross section or erosion around posts observed.			
End Treatments	Alignment and Height:	Alignment acceptable. Height is within 1-in. of 27-in. design height.			
	Breaking and Cracking:	No breaking or cracking observed.			
	Missing Elements:	No missing elements observed.			
	Corrosion and Weathering:	No loss of cross section or erosion around posts observed.

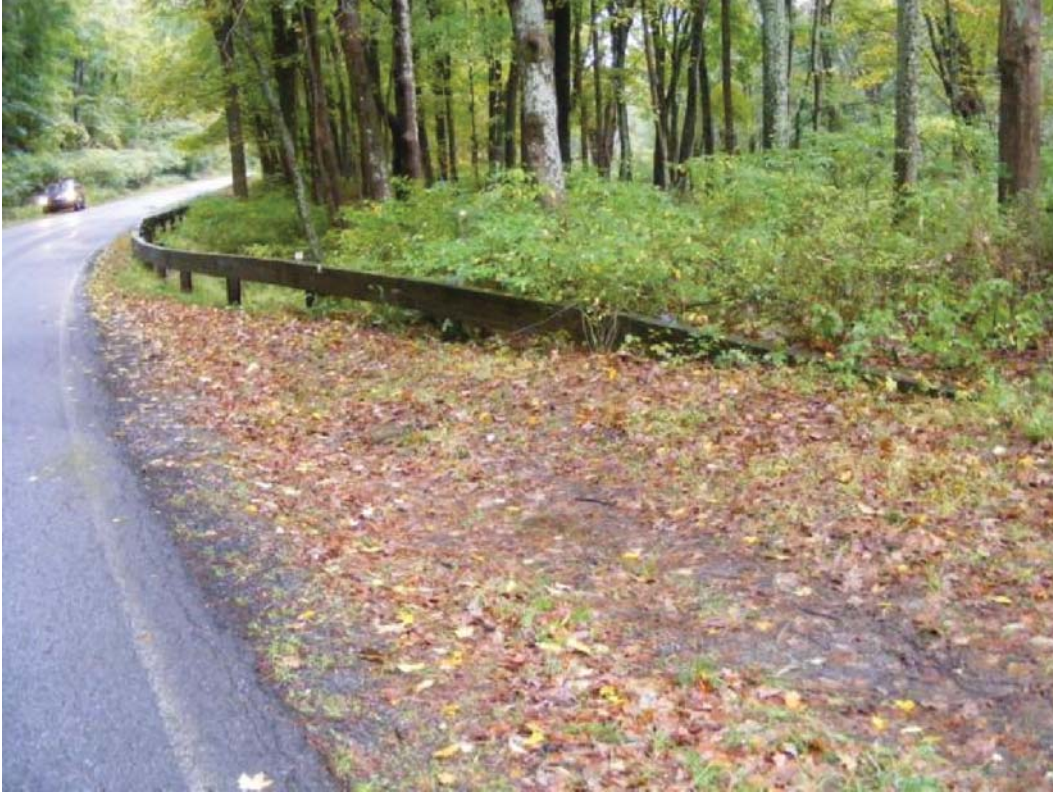
DEWA_0010_2.396_L_1.JPG

Barrier ID:	DEWA-0010-2.396-L				
Route Name:	OLD MINE ROAD (SOUTH SECTION)				
Inspection Date:	10/05/2010	Barrier Rating:	14.00		
Barrier Description					
Type:	STEEL-BACKED TIMBER WITH BLOCKOUT	Barrier Function:	TRAFFIC		
Barrier Material:	STEEL-BACKED TIMBER/LOG	Post Material:	CORTEN		
Blockout Type:	WOOD	Length (ft.):	170		
Speed Limit (MPH):	35	Placement with Respect to Road:	INSIDE OF CURVE		
Hazard Behind Barrier:	LOW				
Barrier Crashworthiness					
Appropriate Test Level:	TL-2	Barrier Test Level:	TL-3	Is Barrier Crashworthy?:	YES
Beg. End Trtmt Type:	SBT/LOG FLARED	Is Beg. End Trtmt Crashworthy?:	NO	Approach Transition Type:	NONE
Ending End Trtmt Type:	SBT/LOG FLARED	Ending End Trtmt Crashworthy?:	NO		
Average Measurements					
Design Height (In.):	27	Width (In.):	0.0	Post Spacing (In.):	119.6
Height (In.):	28.2	Lateral Offset (In.):	48.7	Road Grade (%):	0.27
Physical Condition					
Barrier	Alignment and Height:	No deflections observed in alignment. The height is at or up to 3 in above the design of 27 in.

Breaking and Cracking:	No breaking or cracking observed.			
	Missing Elements:	No missing elements observed.			
	Corrosion and Weathering:	No loss of cross section or erosion around posts observed.			
End Treatments	Alignment and Height:	Alignment acceptable. Height is within 1-in. of 27-in. design height.			
	Breaking and Cracking:	No breaking or cracking observed.			
	Missing Elements:	No missing elements observed.			
	Corrosion and Weathering:	No loss of cross section or erosion around posts observed.

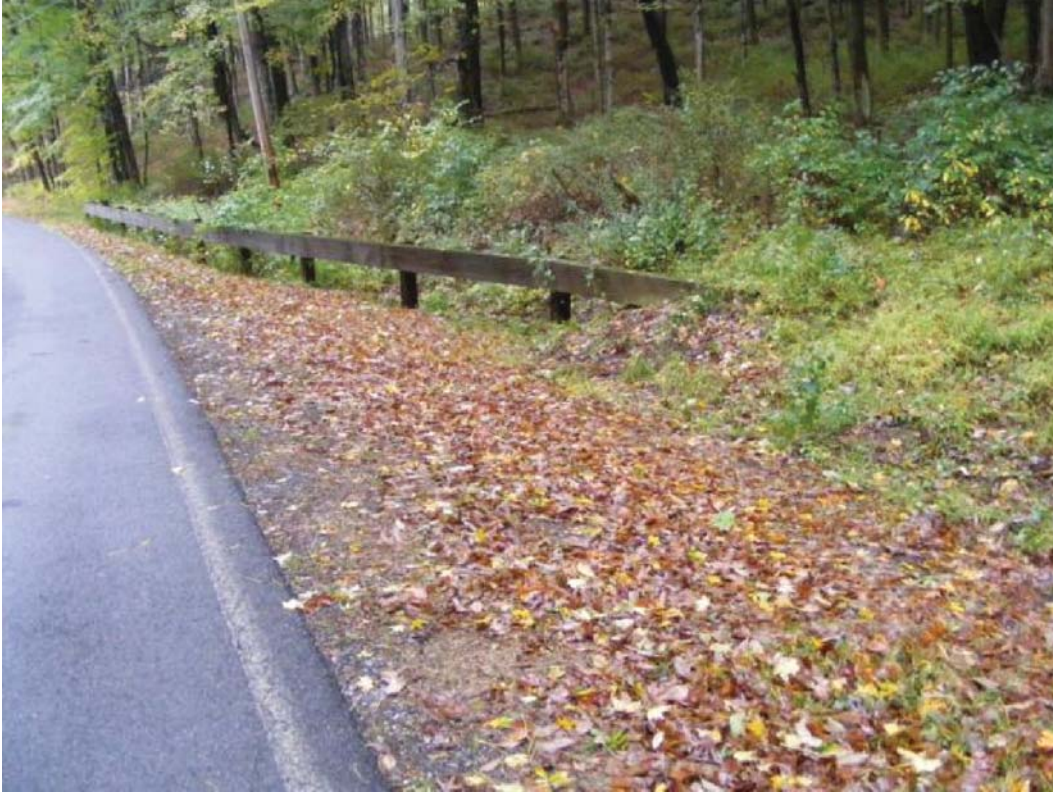
DEWA_0010_2.398_R_1.JPG

Barrier ID:	DEWA-0010-2.398-R				
Route Name:	OLD MINE ROAD (SOUTH SECTION)				
Inspection Date:	10/05/2010	Barrier Rating:	19.70		
Barrier Description					
Type:	STEEL-BACKED TIMBER WITH BLOCKOUT	Barrier Function:	TRAFFIC		
Barrier Material:	STEEL-BACKED TIMBER/LOG	Post Material:	CORTEN		
Blockout Type:	WOOD	Length (ft.):	150		
Speed Limit (MPH):	35	Placement with Respect to Road:	OUTSIDE OF CURVE		
Hazard Behind Barrier:	LOW				
Barrier Crashworthiness					
Appropriate Test Level:	TL-2	Barrier Test Level:	TL-3	Is Barrier Crashworthy?:	YES
Beg. End Trtmt Type:	SBT/LOG BURIED	Is Beg. End Trtmt Crashworthy?:	YES	Approach Transition Type:	NONE
Ending End Trtmt Type:	SBT/LOG FLARED	Ending End Trtmt Crashworthy?:	NO		
Average Measurements					
Design Height (In.):	27	Width (In.):	0.0	Post Spacing (In.):	120.0
Height (In.):	27.0	Lateral Offset (In.):	50.0	Road Grade (%):	0.40
Physical Condition					
Barrier	Alignment and Height:	No deflections observed in alignment. The height is 1 in or less below at or above 27 in design height by up to 1 in.

Breaking and Cracking:	No breaking or cracking observed.			
	Missing Elements:	No missing elements observed.			
	Corrosion and Weathering:	No loss of cross section or erosion around posts observed.			
End Treatments	Alignment and Height:	Alignment acceptable. Height is within 1-in. of 27-in. design height.			
	Breaking and Cracking:	No breaking or cracking observed.			
	Missing Elements:	No missing elements observed.			
	Corrosion and Weathering:	No loss of cross section or erosion around posts observed.

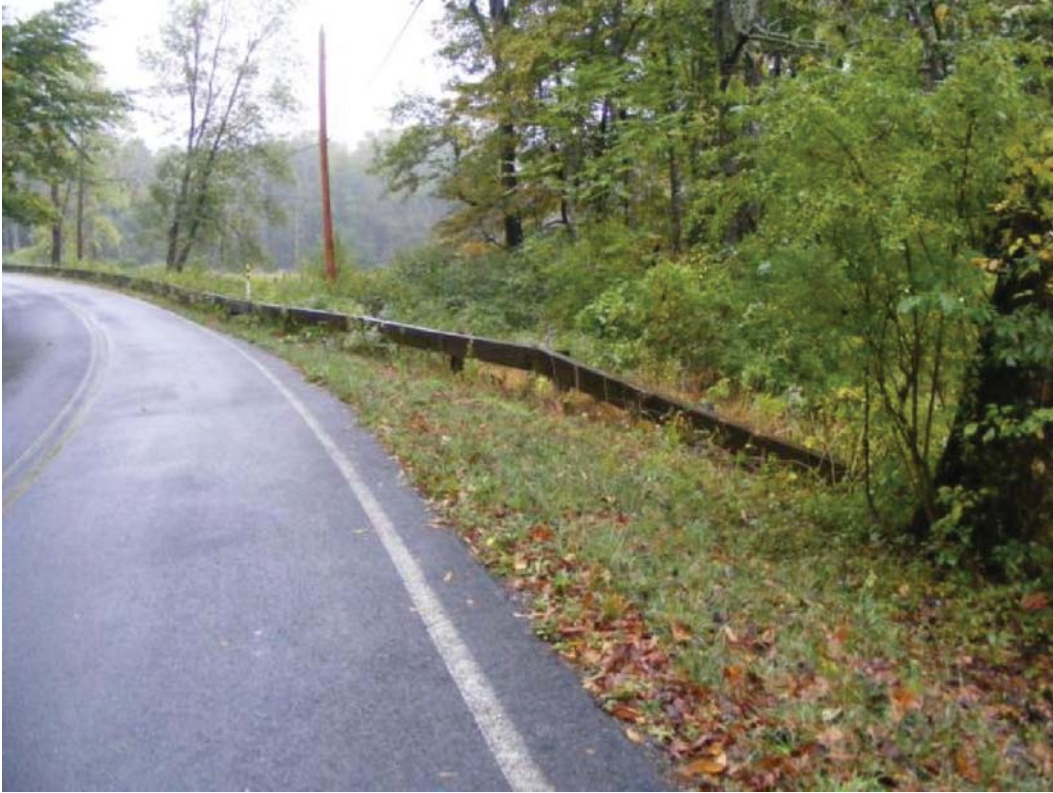
DEWA_0010_2.476_L_1.JPG

Barrier ID:	DEWA-0010-2.476-L				
Route Name:	OLD MINE ROAD (SOUTH SECTION)				
Inspection Date:	10/05/2010	Barrier Rating:	25.50		
Barrier Description					
Type:	STEEL-BACKED TIMBER WITH BLOCKOUT	Barrier Function:	TRAFFIC		
Barrier Material:	STEEL-BACKED TIMBER/LOG	Post Material:	CORTEN		
Blockout Type:	WOOD	Length (ft.):	555		
Speed Limit (MPH):	35	Placement with Respect to Road:	OUTSIDE OF CURVE		
Hazard Behind Barrier:	LOW				
Barrier Crashworthiness					
Appropriate Test Level:	TL-2	Barrier Test Level:	TL-3	Is Barrier Crashworthy?:	YES
Beg. End Trtmt Type:	SBT/LOG FLARED	Is Beg. End Trtmt Crashworthy?:	NO	Approach Transition Type:	NONE
Ending End Trtmt Type:	SBT/LOG FLARED	Ending End Trtmt Crashworthy?:	NO		
Average Measurements					
Design Height (In.):	27	Width (In.):	0.0	Post Spacing (In.):	120.5
Height (In.):	27.2	Lateral Offset (In.):	38.5	Road Grade (%):	1.60
Physical Condition					
Barrier	Alignment and Height:	No deflections observed in alignment. Barrier height is 1 in or less below at or above 27 in design height by up to 1 in.

Breaking and Cracking:	No breaking or cracking observed.			
	Missing Elements:	7 barrier reflectors observed missing.			
	Corrosion and Weathering:	No loss of cross section or erosion around posts observed.			
End Treatments	Alignment and Height:	Alignment acceptable. Height is within 1-in. of 27-in. design height.			
	Breaking and Cracking:	No breaking or cracking observed.			
	Missing Elements:	No missing elements observed.			
	Corrosion and Weathering:	No loss of cross section or erosion around posts observed.

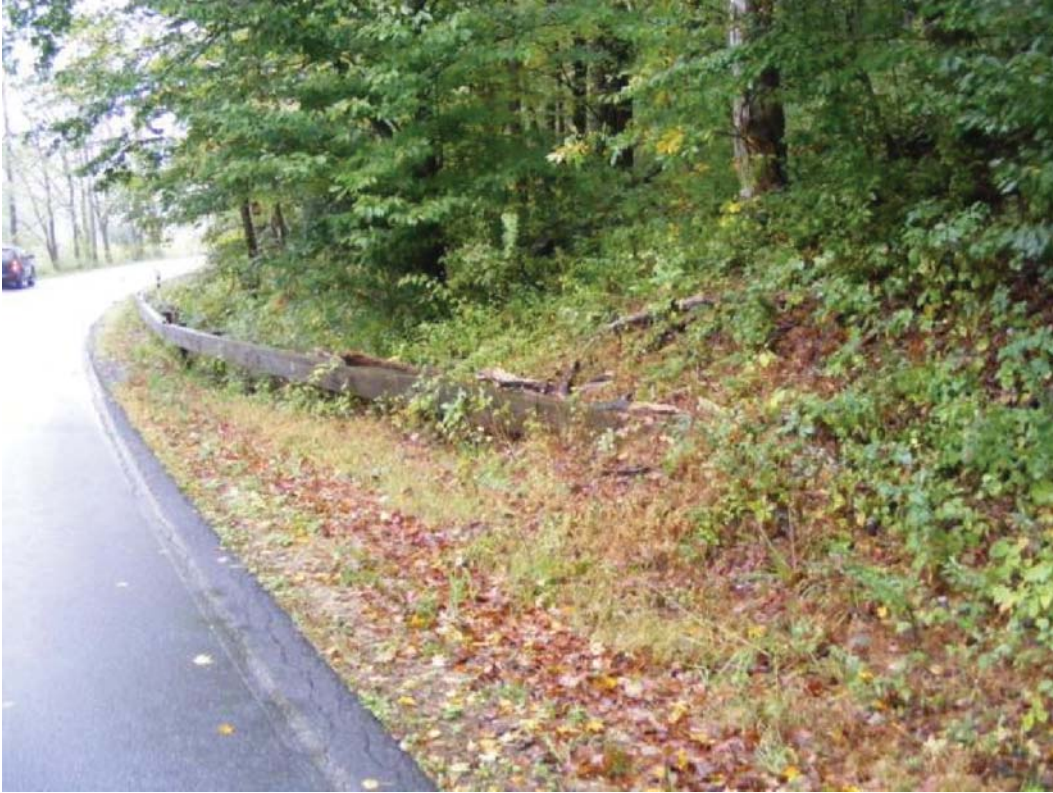
DEWA_0010_2.549_R_1.JPG

Barrier ID:	DEWA-0010-2.549-R				
Route Name:	OLD MINE ROAD (SOUTH SECTION)				
Inspection Date:	10/05/2010	Barrier Rating:	14.00		
Barrier Description					
Type:	STEEL-BACKED TIMBER WITH BLOCKOUT	Barrier Function:	TRAFFIC		
Barrier Material:	STEEL-BACKED TIMBER/LOG	Post Material:	CORTEN		
Blockout Type:	WOOD	Length (ft.):	143		
Speed Limit (MPH):	35	Placement with Respect to Road:	INSIDE OF CURVE		
Hazard Behind Barrier:	LOW				
Barrier Crashworthiness					
Appropriate Test Level:	TL-2	Barrier Test Level:	TL-3	Is Barrier Crashworthy?:	YES
Beg. End Trtmt Type:	SBT/LOG BURIED	Is Beg. End Trtmt Crashworthy?:	YES	Approach Transition Type:	NONE
Ending End Trtmt Type:	SBT/LOG BURIED	Ending End Trtmt Crashworthy?:	YES		
Average Measurements					
Design Height (In.):	27	Width (In.):	0.0	Post Spacing (In.):	108.0
Height (In.):	26.6	Lateral Offset (In.):	52.2	Road Grade (%):	1.10
Physical Condition					
Barrier	Alignment and Height:	No deflections observed in alignment. The height is low by 1 in or less from the design of 27 in.

Breaking and Cracking:	No breaking or cracking observed.			
	Missing Elements:	No missing elements observed.			
	Corrosion and Weathering:	No loss of cross section or erosion around posts observed.			
End Treatments	Alignment and Height:	Alignment acceptable. Height is within 1-in. of 27-in. design height.			
	Breaking and Cracking:	No breaking or cracking observed.			
	Missing Elements:	No missing elements observed.			
	Corrosion and Weathering:	No loss of cross section or erosion around posts observed.

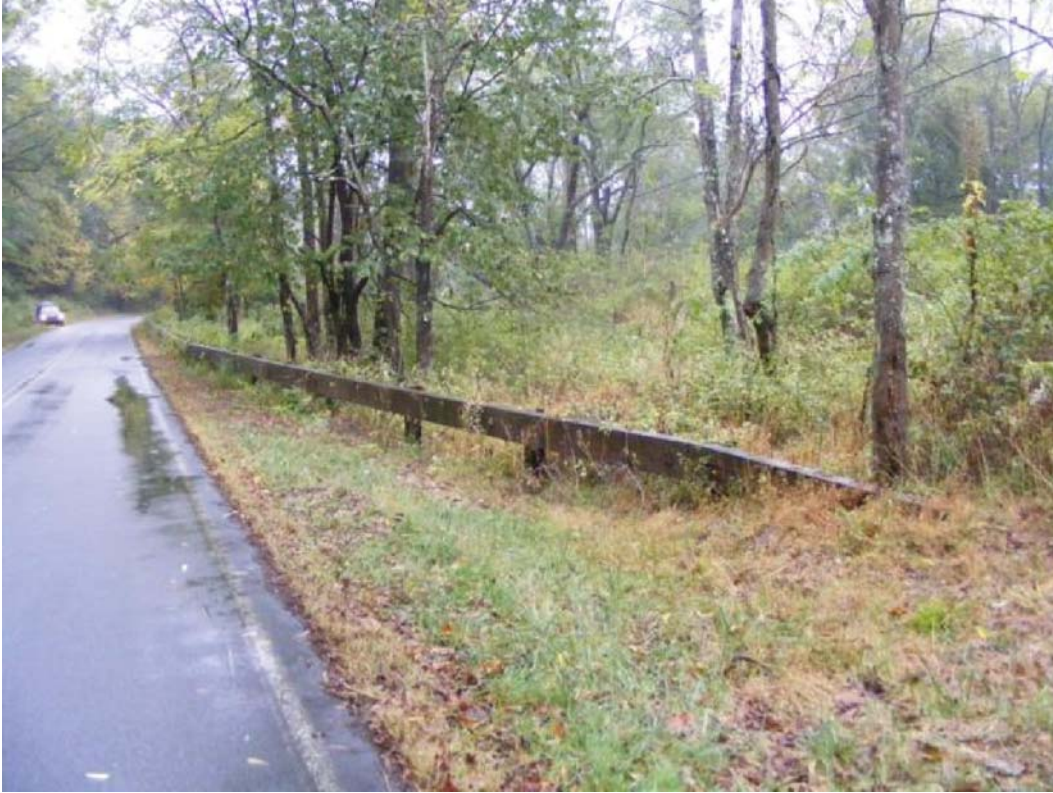
DEWA_0010_2.748_L_1.JPG

Barrier ID:	DEWA-0010-2.748-L				
Route Name:	OLD MINE ROAD (SOUTH SECTION)				
Inspection Date:	10/05/2010	Barrier Rating:	14.00		
Barrier Description					
Type:	STEEL-BACKED TIMBER WITH BLOCKOUT	Barrier Function:	TRAFFIC		
Barrier Material:	STEEL-BACKED TIMBER/LOG	Post Material:	CORTEN		
Blockout Type:	WOOD	Length (ft.):	400		
Speed Limit (MPH):	35	Placement with Respect to Road:	TANGENT		
Hazard Behind Barrier:	LOW				
Barrier Crashworthiness					
Appropriate Test Level:	TL-2	Barrier Test Level:	TL-3	Is Barrier Crashworthy?:	YES
Beg. End Trtmt Type:	SBT/LOG FLARED	Is Beg. End Trtmt Crashworthy?:	NO	Approach Transition Type:	NONE
Ending End Trtmt Type:	SBT/LOG FLARED	Ending End Trtmt Crashworthy?:	NO		
Average Measurements					
Design Height (In.):	27	Width (In.):	0.0	Post Spacing (In.):	120.3
Height (In.):	28.2	Lateral Offset (In.):	49.2	Road Grade (%):	0.80
Physical Condition					
Barrier	Alignment and Height:	No deflections observed in alignment. The height is at or above the design of 27 in by up to 3 in.

Breaking and Cracking:	No breaking or cracking observed.			
	Missing Elements:	3 barrier reflectors observed as broken or missing.			
	Corrosion and Weathering:	No loss of cross section or erosion around posts observed.			
End Treatments	Alignment and Height:	Alignment acceptable. Height is within 1-in. of 27-in. design height.			
	Breaking and Cracking:	No breaking or cracking observed.			
	Missing Elements:	No missing elements observed.			
	Corrosion and Weathering:	No loss of cross section or erosion around posts observed.

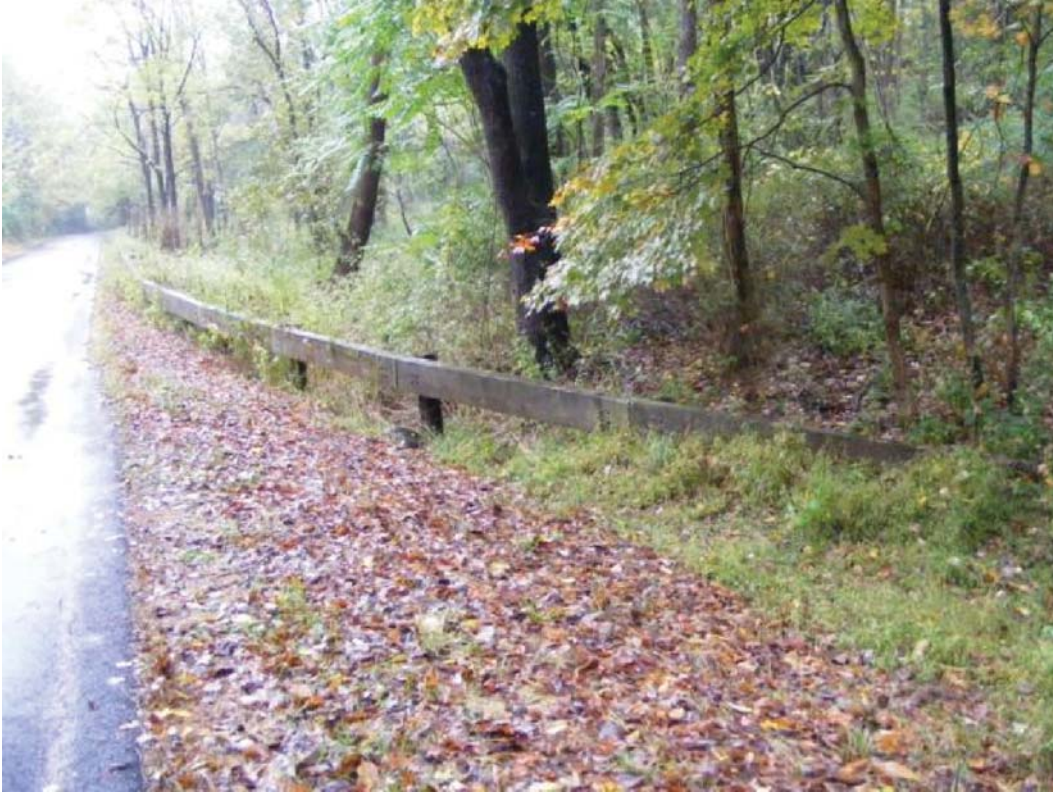
DEWA_0010_2.786_R_1.JPG

Barrier ID:	DEWA-0010-2.786-R				
Route Name:	OLD MINE ROAD (SOUTH SECTION)				
Inspection Date:	10/05/2010	Barrier Rating:	19.30		
Barrier Description					
Type:	STEEL-BACKED TIMBER WITH BLOCKOUT	Barrier Function:	TRAFFIC		
Barrier Material:	STEEL-BACKED TIMBER/LOG	Post Material:	CORTEN		
Blockout Type:	WOOD	Length (ft.):	493		
Speed Limit (MPH):	35	Placement with Respect to Road:	TANGENT		
Hazard Behind Barrier:	MEDIUM				
Barrier Crashworthiness					
Appropriate Test Level:	TL-2	Barrier Test Level:	TL-3	Is Barrier Crashworthy?:	YES
Beg. End Trtmt Type:	SBT/LOG FLARED	Is Beg. End Trtmt Crashworthy?:	NO	Approach Transition Type:	NONE
Ending End Trtmt Type:	SBT/LOG FLARED	Ending End Trtmt Crashworthy?:	NO		
Average Measurements					
Design Height (In.):	27	Width (In.):	0.0	Post Spacing (In.):	120.5
Height (In.):	26.6	Lateral Offset (In.):	43.5	Road Grade (%):	0.40
Physical Condition					
Barrier	Alignment and Height:	No deflections observed in alignment. The height is low by 1 in or less from the design of 27 in.

Breaking and Cracking:	No breaking or cracking observed.			
	Missing Elements:	8 barrier reflectors are missing or broken.			
	Corrosion and Weathering:	No loss of cross section or erosion around posts observed.			
End Treatments	Alignment and Height:	Alignment acceptable. Height is within 1-in. of 27-in. design height.			
	Breaking and Cracking:	No breaking or cracking observed.			
	Missing Elements:	No missing elements observed.			
	Corrosion and Weathering:	No loss of cross section or erosion around posts observed.

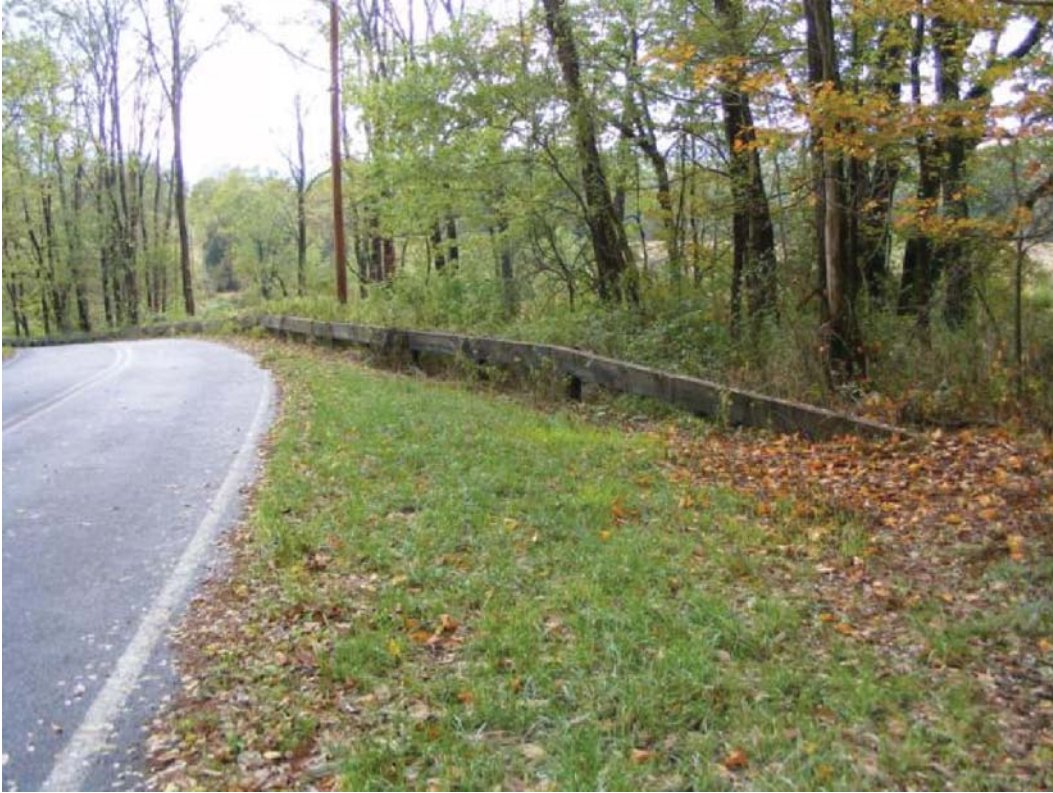
DEWA_0010_3.280_L_1.JPG

Barrier ID:	DEWA-0010-3.280-L				
Route Name:	OLD MINE ROAD (SOUTH SECTION)				
Inspection Date:	10/06/2010	Barrier Rating:	32.20		
Barrier Description					
Type:	STEEL-BACKED TIMBER WITH BLOCKOUT	Barrier Function:	TRAFFIC		
Barrier Material:	STEEL-BACKED TIMBER/LOG	Post Material:	CORTEN		
Blockout Type:	WOOD	Length (ft.):	556		
Speed Limit (MPH):	35	Placement with Respect to Road:	OUTSIDE OF CURVE		
Hazard Behind Barrier:	MEDIUM				
Barrier Crashworthiness					
Appropriate Test Level:	TL-2	Barrier Test Level:	TL-3	Is Barrier Crashworthy?:	YES
Beg. End Trtmt Type:	SBT/LOG FLARED	Is Beg. End Trtmt Crashworthy?:	NO	Approach Transition Type:	NONE
Ending End Trtmt Type:	SBT/LOG FLARED	Ending End Trtmt Crashworthy?:	NO		
Average Measurements					
Design Height (In.):	27	Width (In.):	0.0	Post Spacing (In.):	120.3
Height (In.):	28.2	Lateral Offset (In.):	36.5	Road Grade (%):	5.80
Physical Condition					
Barrier	Alignment and Height:	No deflections observed in alignment. The height is at or above the design of 27 in by up to 2 in.

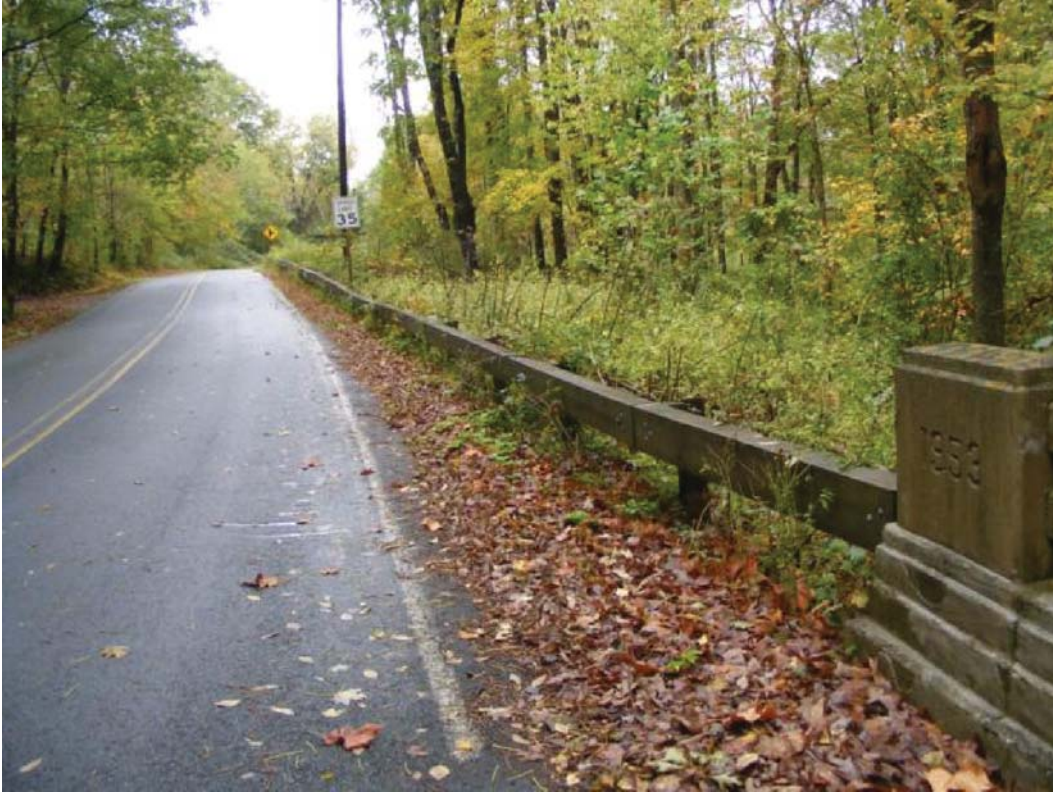
DEWA_0010_3.558_L_1.JPG

Barrier ID:	DEWA-0010-3.558-L				
Route Name:	OLD MINE ROAD (SOUTH SECTION)				
Inspection Date:	10/06/2010	Barrier Rating:	32.40		
Barrier Description					
Type:	STEEL-BACKED TIMBER WITH BLOCKOUT	Barrier Function:	TRAFFIC		
Barrier Material:	STEEL-BACKED TIMBER/LOG	Post Material:	CORTEN		
Blockout Type:	WOOD	Length (ft.):	594		
Speed Limit (MPH):	35	Placement with Respect to Road:	OUTSIDE OF CURVE		
Hazard Behind Barrier:	MEDIUM				
Barrier Crashworthiness					
Appropriate Test Level:	TL-2	Barrier Test Level:	TL-3	Is Barrier Crashworthy?:	YES
Beg. End Trtmt Type:	NONE	Is Beg. End Trtmt Crashworthy?:	N/A	Approach Transition Type:	NONE
Ending End Trtmt Type:	NONE	Ending End Trtmt Crashworthy?:	N/A		
Average Measurements					
Design Height (In.):	27	Width (In.):	0.0	Post Spacing (In.):	120.0
Height (In.):	27.0	Lateral Offset (In.):	37.2	Road Grade (%):	1.10
Physical Condition					
Barrier	Alignment and Height:	No deflections observed in alignment. 504 ft was 1 in below to 3 in above the 27 in design height 40 ft was 1-3 in below the design height and 50 ft was more than 3 in below the design height.

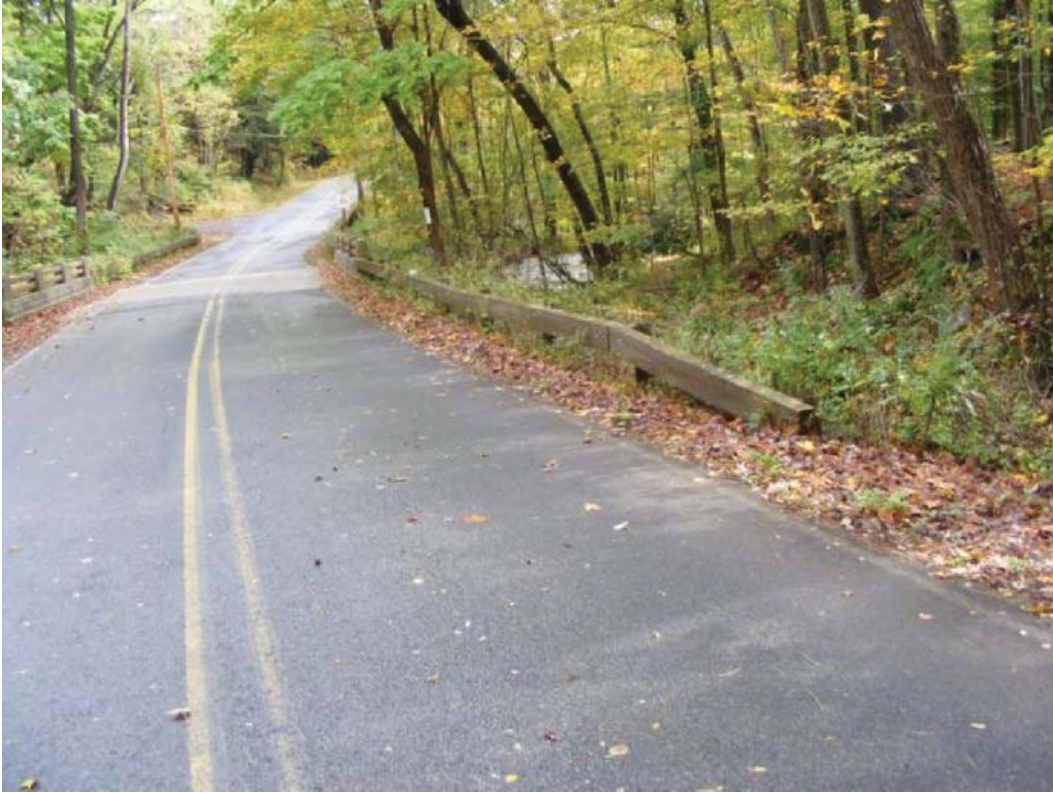
DEWA_0010_3.650_R_1.JPG

Barrier ID:	DEWA-0010-3.650-R				
Route Name:	OLD MINE ROAD (SOUTH SECTION)				
Inspection Date:	10/06/2010	Barrier Rating:	16.50		
Barrier Description					
Type:	STEEL-BACKED TIMBER WITH BLOCKOUT	Barrier Function:	TRAFFIC		
Barrier Material:	STEEL-BACKED TIMBER/LOG	Post Material:	CORTEN		
Blockout Type:	WOOD	Length (ft.):	80		
Speed Limit (MPH):	35	Placement with Respect to Road:	TANGENT		
Hazard Behind Barrier:	MEDIUM				
Barrier Crashworthiness					
Appropriate Test Level:	TL-2	Barrier Test Level:	TL-3	Is Barrier Crashworthy?:	YES
Beg. End Trtmt Type:	SBT/LOG FLARED	Is Beg. End Trtmt Crashworthy?:	NO	Approach Transition Type:	NONE
Ending End Trtmt Type:	NONE	Ending End Trtmt Crashworthy?:	N/A		
Average Measurements					
Design Height (In.):	27	Width (In.):	0.0	Post Spacing (In.):	119.6
Height (In.):	27.2	Lateral Offset (In.):	32.0	Road Grade (%):	1.10
Physical Condition					
Barrier	Alignment and Height:	No deflections observed in alignment. The height is 1 in below at or up to 2 in above the 27 in design height.

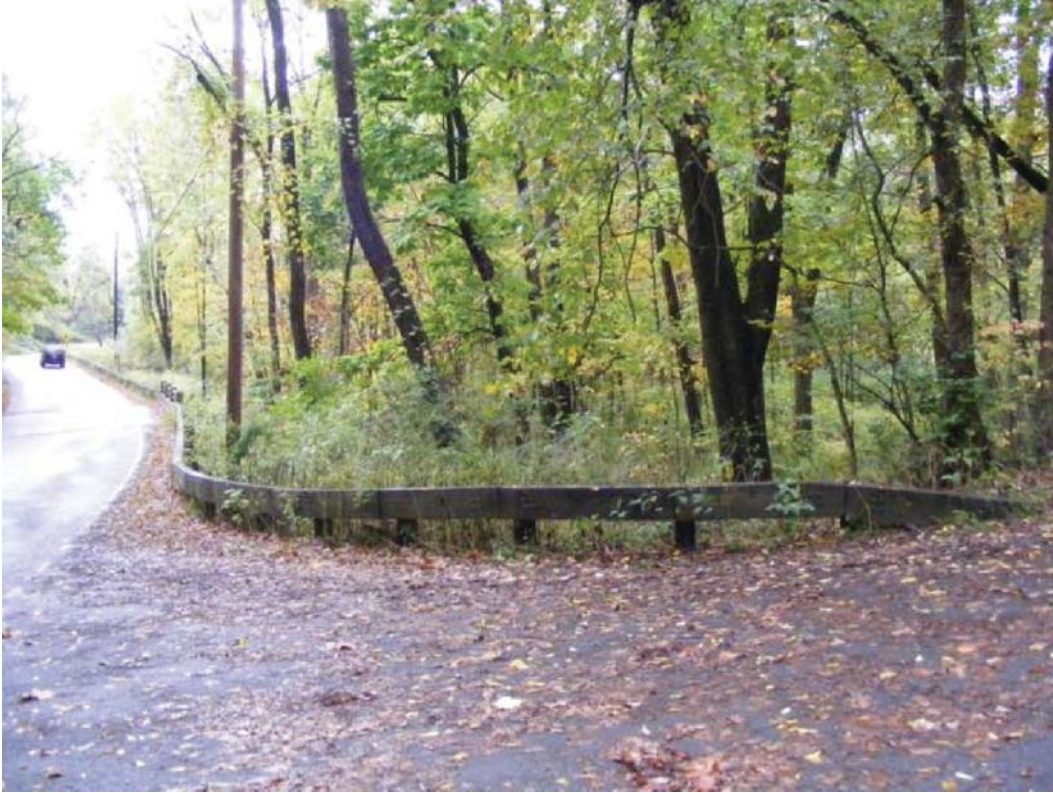
DEWA_0010_3.670_L_1.JPG

Barrier ID:	DEWA-0010-3.670-L				
Route Name:	OLD MINE ROAD (SOUTH SECTION)				
Inspection Date:	10/06/2010	Barrier Rating:	25.10		
Barrier Description					
Type:	STEEL-BACKED TIMBER WITH BLOCKOUT	Barrier Function:	TRAFFIC		
Barrier Material:	STEEL-BACKED TIMBER/LOG	Post Material:	CORTEN		
Blockout Type:	WOOD	Length (ft.):	146		
Speed Limit (MPH):	35	Placement with Respect to Road:	OUTSIDE OF CURVE		
Hazard Behind Barrier:	MEDIUM				
Barrier Crashworthiness					
Appropriate Test Level:	TL-2	Barrier Test Level:	TL-3	Is Barrier Crashworthy?:	YES
Beg. End Trtmt Type:	NONE	Is Beg. End Trtmt Crashworthy?:	N/A	Approach Transition Type:	NONE
Ending End Trtmt Type:	SBT/LOG FLARED	Ending End Trtmt Crashworthy?:	NO		
Average Measurements					
Design Height (In.):	27	Width (In.):	0.0	Post Spacing (In.):	120.0
Height (In.):	26.2	Lateral Offset (In.):	42.0	Road Grade (%):	2.90
Physical Condition					
Barrier	Alignment and Height:	No deflections observed in alignment. The height is low by 1 in or less from the design of 27 in.

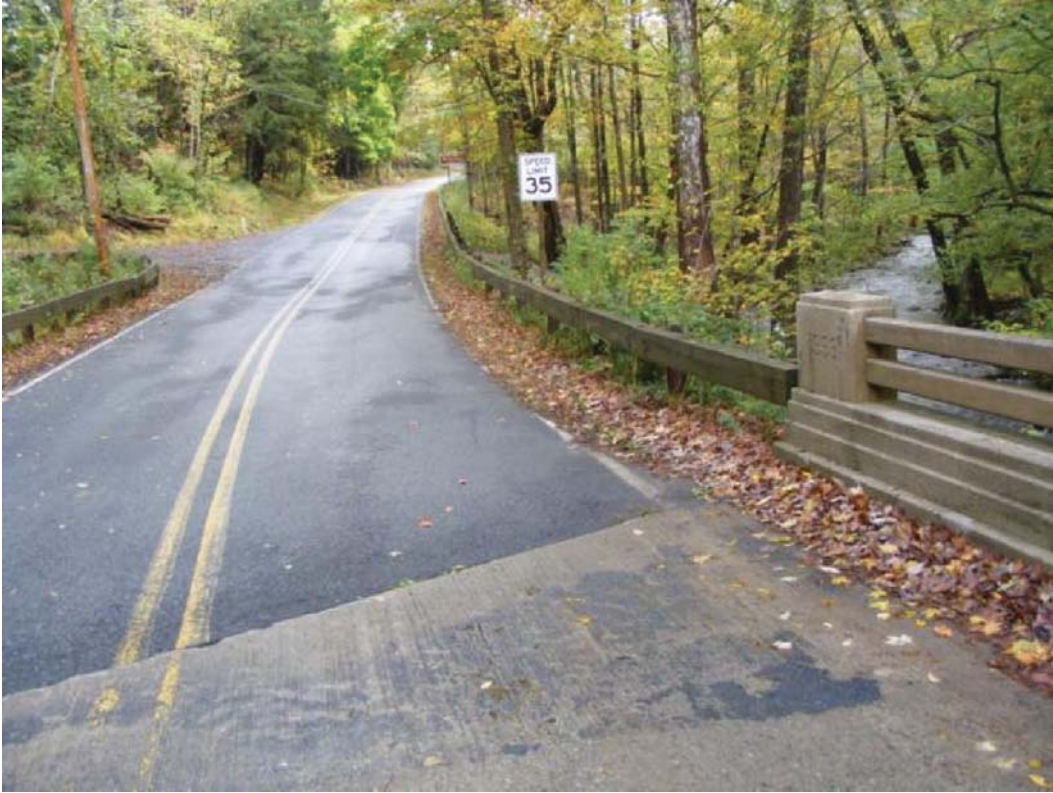
DEWA_0010_3.674_R_1.JPG

Barrier ID:	DEWA-0010-3.674-R				
Route Name:	OLD MINE ROAD (SOUTH SECTION)				
Inspection Date:	10/06/2010	Barrier Rating:	31.10		
Barrier Description					
Type:	STEEL-BACKED TIMBER WITH BLOCKOUT	Barrier Function:	TRAFFIC		
Barrier Material:	STEEL-BACKED TIMBER/LOG	Post Material:	CORTEN		
Blockout Type:	WOOD	Length (ft.):	330		
Speed Limit (MPH):	35	Placement with Respect to Road:	INSIDE OF CURVE		
Hazard Behind Barrier:	MEDIUM				
Barrier Crashworthiness					
Appropriate Test Level:	TL-2	Barrier Test Level:	TL-3	Is Barrier Crashworthy?:	YES
Beg. End Trtmt Type:	NONE	Is Beg. End Trtmt Crashworthy?:	N/A	Approach Transition Type:	NONE
Ending End Trtmt Type:	SBT/LOG FLARED	Ending End Trtmt Crashworthy?:	NO		
Average Measurements					
Design Height (In.):	27	Width (In.):	0.0	Post Spacing (In.):	119.3
Height (In.):	25.2	Lateral Offset (In.):	42.0	Road Grade (%):	5.30
Physical Condition					
Barrier	Alignment and Height:	No deflections observed in alignment. Barrier is 1 to 3 in below 27 in design height for 60 ft and 3 to 4 in below for 120 ft.
