NPS Guardwall/Rail Inventory Program Delaware Water Gap National Recreation Area

**Federal Lands Highway
Road Inventory Program**

Federal Highway Administration
Eastern Federal Lands Highway Division
Road Inventory Program (RIP)

Data Collection Date: October 2010
Report Date: December 2015

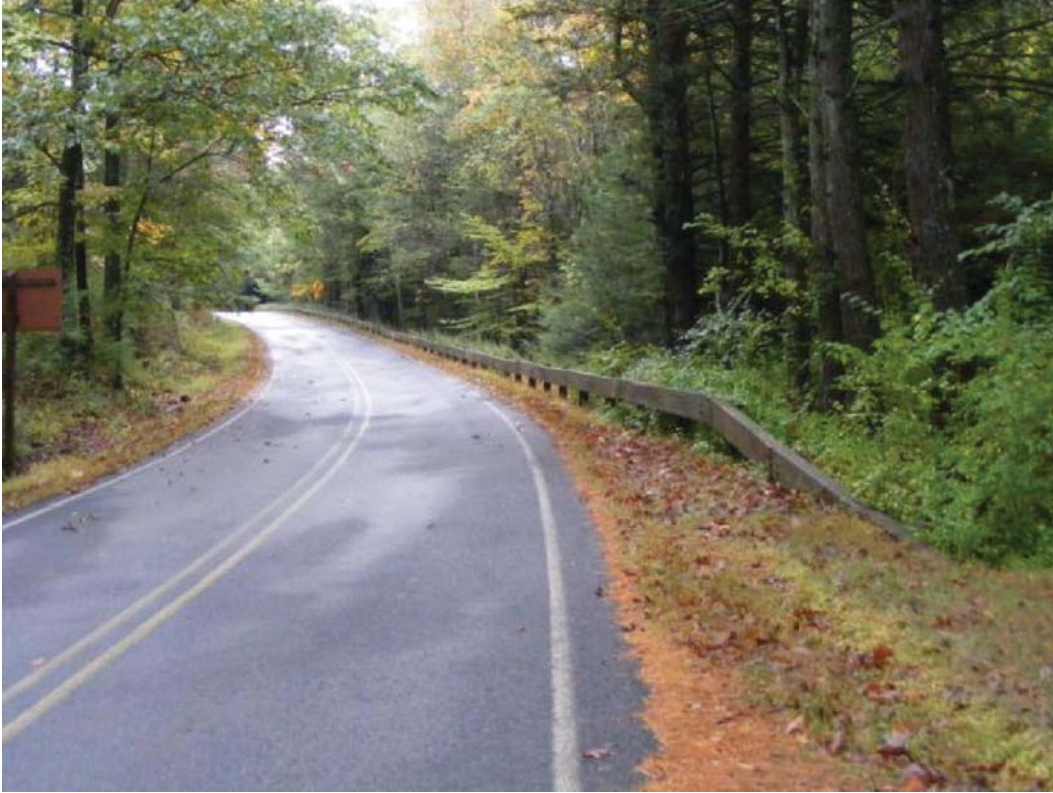
DEWA_0010_3.815_R_1.JPG

Barrier ID:	DEWA-0010-3.815-R				
Route Name:	OLD MINE ROAD (SOUTH SECTION)				
Inspection Date:	10/06/2010	Barrier Rating:	43.70		
Barrier Description					
Type:	STEEL-BACKED TIMBER WITH BLOCKOUT	Barrier Function:	TRAFFIC		
Barrier Material:	STEEL-BACKED TIMBER/LOG	Post Material:	CORTEN		
Blockout Type:	WOOD	Length (ft.):	1510		
Speed Limit (MPH):	35	Placement with Respect to Road:	BOTH INSIDE AND OUTSIDE		
Hazard Behind Barrier:	MEDIUM				
Barrier Crashworthiness					
Appropriate Test Level:	TL-2	Barrier Test Level:	TL-3	Is Barrier Crashworthy?:	YES
Beg. End Trtmt Type:	SBT/LOG FLARED	Is Beg. End Trtmt Crashworthy?:	NO	Approach Transition Type:	NONE
Ending End Trtmt Type:	SBT/LOG BURIED	Ending End Trtmt Crashworthy?:	YES		
Average Measurements					
Design Height (In.):	27	Width (In.):	0.0	Post Spacing (In.):	120.0
Height (In.):	25.1	Lateral Offset (In.):	34.7	Road Grade (%):	7.00
Physical Condition

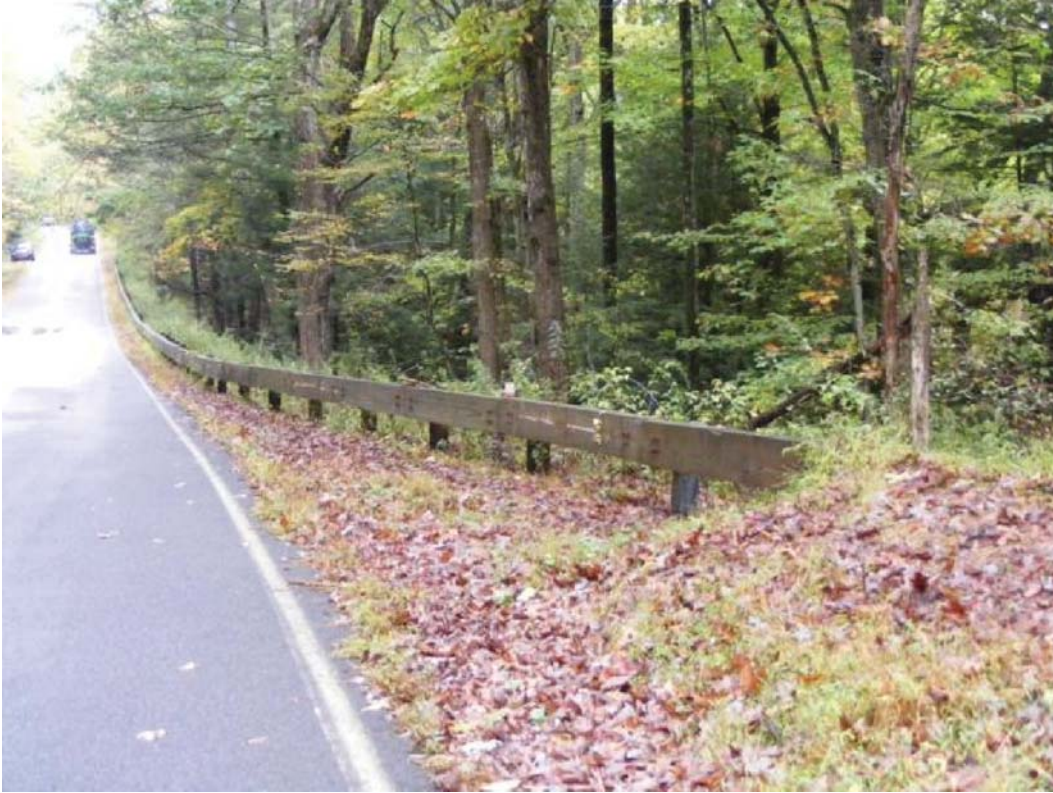
DEWA_0010_4.137_R_1.JPG

Barrier ID:	DEWA-0010-4.137-R				
Route Name:	OLD MINE ROAD (SOUTH SECTION)				
Inspection Date:	10/06/2010	Barrier Rating:	46.90		
Barrier Description					
Type:	STEEL-BACKED TIMBER WITH BLOCKOUT	Barrier Function:	TRAFFIC		
Barrier Material:	STEEL-BACKED TIMBER/LOG	Post Material:	CORTEN		
Blockout Type:	WOOD	Length (ft.):	610		
Speed Limit (MPH):	35	Placement with Respect to Road:	TANGENT		
Hazard Behind Barrier:	LOW				
Barrier Crashworthiness					
Appropriate Test Level:	TL-2	Barrier Test Level:	TL-3	Is Barrier Crashworthy?:	YES
Beg. End Trtmt Type:	SBT/LOG FLARED	Is Beg. End Trtmt Crashworthy?:	NO	Approach Transition Type:	NONE
Ending End Trtmt Type:	SBT/LOG FLARED	Ending End Trtmt Crashworthy?:	NO		
Average Measurements					
Design Height (In.):	27	Width (In.):	0.0	Post Spacing (In.):	120.3
Height (In.):	22.2	Lateral Offset (In.):	39.2	Road Grade (%):	2.70
Physical Condition					
Barrier	Alignment and Height:	No deflections observed in alignment. The height is low by 4 to 5 in from the design of 27 in for 610 ft.

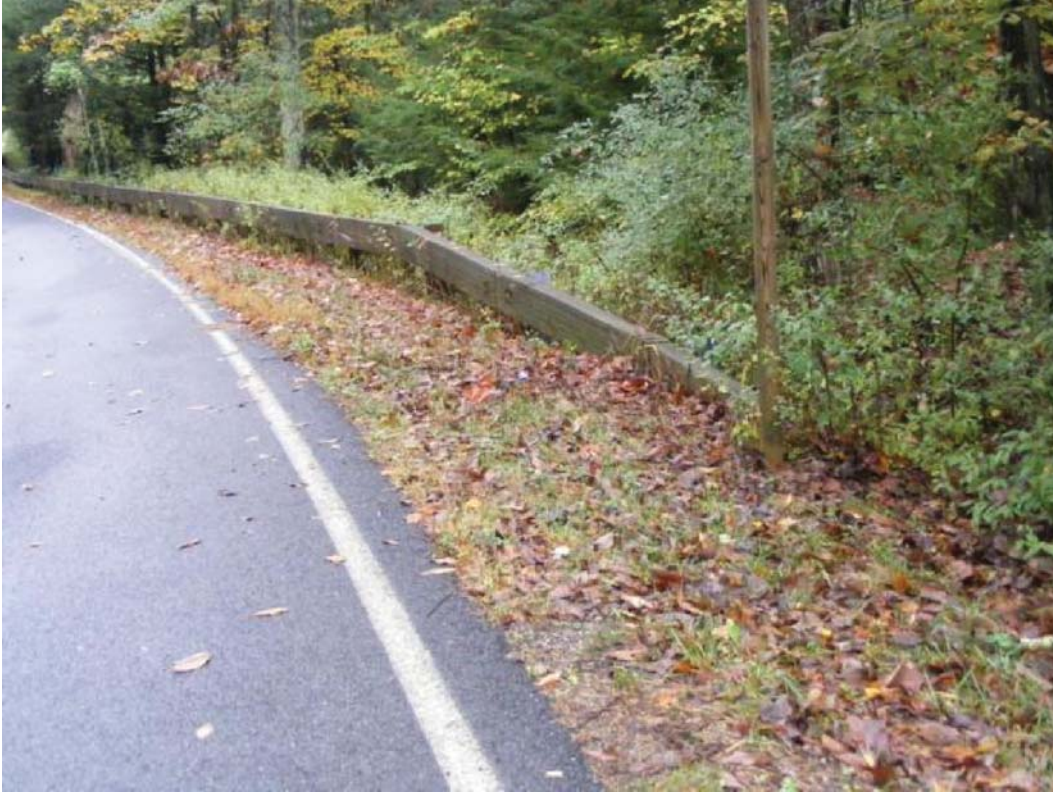
DEWA_0010_4.330_R_1.JPG

Barrier ID:	DEWA-0010-4.330-R				
Route Name:	OLD MINE ROAD (SOUTH SECTION)				
Inspection Date:	10/06/2010	Barrier Rating:	32.40		
Barrier Description					
Type:	STEEL-BACKED TIMBER WITH BLOCKOUT	Barrier Function:	TRAFFIC		
Barrier Material:	STEEL-BACKED TIMBER/LOG	Post Material:	CORTEN		
Blockout Type:	WOOD	Length (ft.):	600		
Speed Limit (MPH):	35	Placement with Respect to Road:	BOTH INSIDE AND OUTSIDE		
Hazard Behind Barrier:	MEDIUM				
Barrier Crashworthiness					
Appropriate Test Level:	TL-2	Barrier Test Level:	TL-3	Is Barrier Crashworthy?:	YES
Beg. End Trtmt Type:	SBT/LOG FLARED	Is Beg. End Trtmt Crashworthy?:	NO	Approach Transition Type:	NONE
Ending End Trtmt Type:	SBT/LOG FLARED	Ending End Trtmt Crashworthy?:	NO		
Average Measurements					
Design Height (In.):	27	Width (In.):	0.0	Post Spacing (In.):	119.6
Height (In.):	27.0	Lateral Offset (In.):	43.7	Road Grade (%):	2.50
Physical Condition					
Barrier	Alignment and Height:	No deflections observed in alignment. Height is 2 in lower than design height of 27 in for 250 ft while the remaining height ranges up to 1 in above.

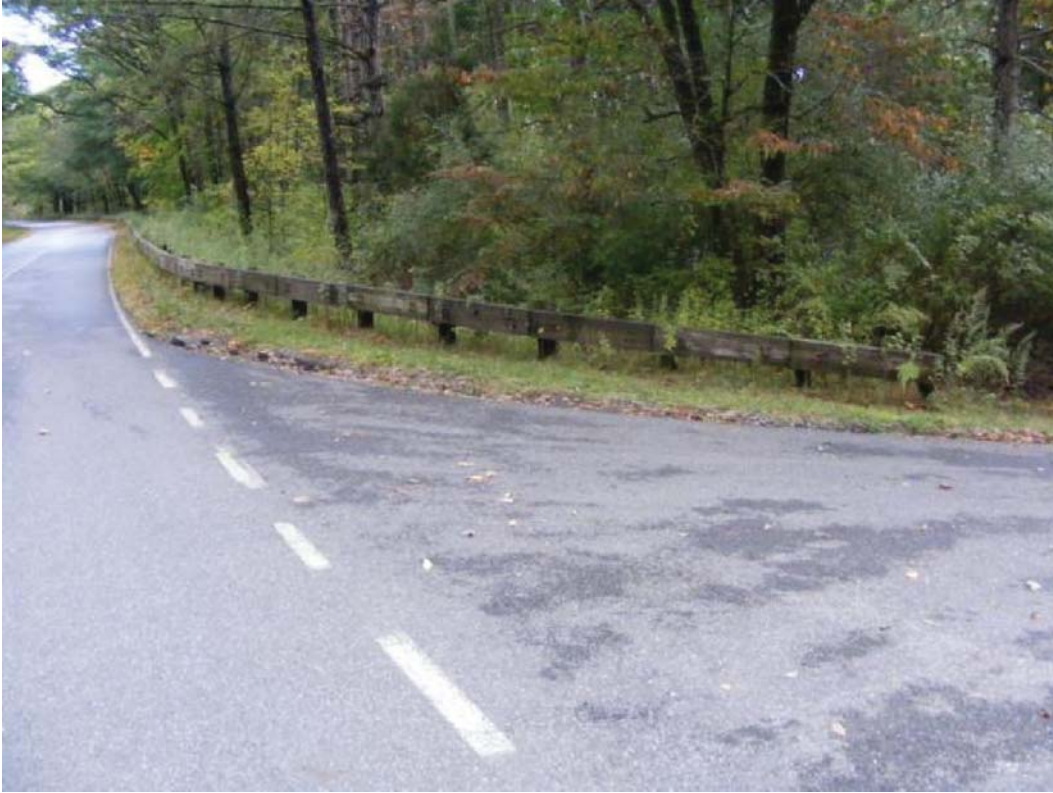
DEWA_0010_5.146_R_1.JPG

Barrier ID:	DEWA-0010-5.146-R				
Route Name:	OLD MINE ROAD (SOUTH SECTION)				
Inspection Date:	10/06/2010	Barrier Rating:	39.50		
Barrier Description					
Type:	STEEL-BACKED TIMBER WITH BLOCKOUT	Barrier Function:	TRAFFIC		
Barrier Material:	STEEL-BACKED TIMBER/LOG	Post Material:	CORTEN		
Blockout Type:	WOOD	Length (ft.):	1895		
Speed Limit (MPH):	35	Placement with Respect to Road:	BOTH INSIDE AND OUTSIDE		
Hazard Behind Barrier:	MEDIUM				
Barrier Crashworthiness					
Appropriate Test Level:	TL-2	Barrier Test Level:	TL-3	Is Barrier Crashworthy?:	YES
Beg. End Trtmt Type:	NONE	Is Beg. End Trtmt Crashworthy?:	N/A	Approach Transition Type:	NONE
Ending End Trtmt Type:	SBT/LOG FLARED	Ending End Trtmt Crashworthy?:	NO		
Average Measurements					
Design Height (In.):	27	Width (In.):	0.0	Post Spacing (In.):	120.0
Height (In.):	25.7	Lateral Offset (In.):	36.7	Road Grade (%):	1.10
Physical Condition					
Barrier	Alignment and Height:	No deflections observed in alignment. Barrier is 1 to 3 in below 27 in design height for 410 ft and 3 to 5 in below for 100 ft.

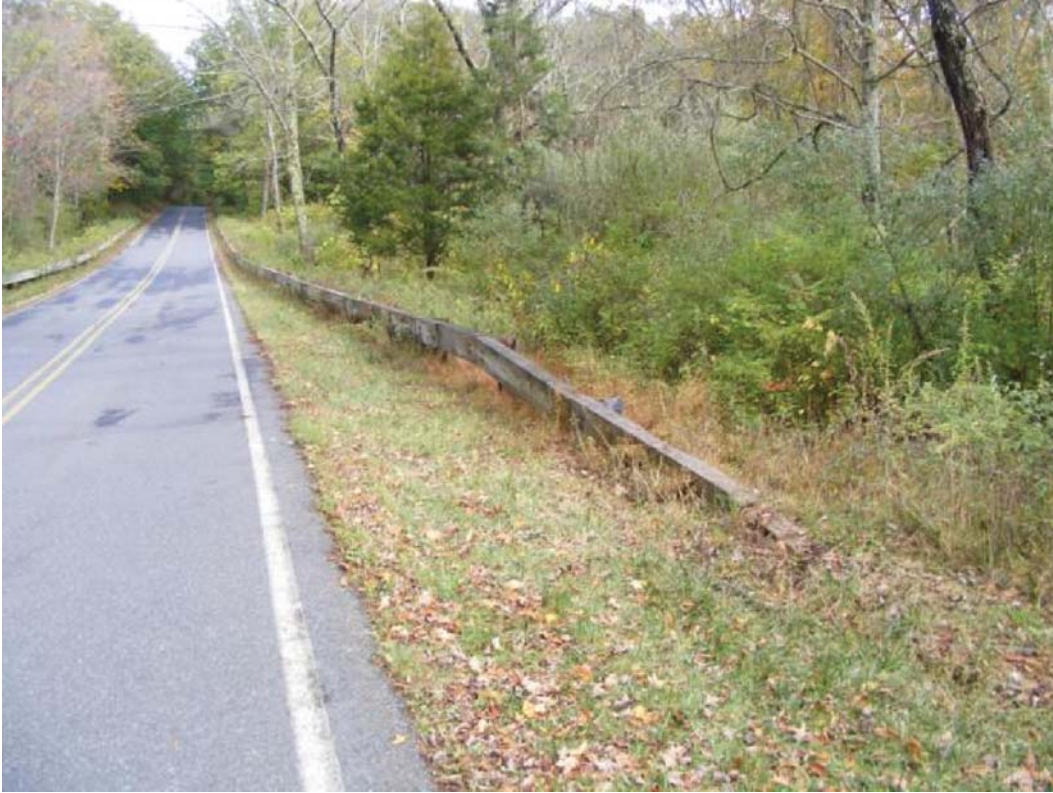
DEWA_0010_5.651_R_1.JPG

Barrier ID:	DEWA-0010-5.651-R				
Route Name:	OLD MINE ROAD (SOUTH SECTION)				
Inspection Date:	10/06/2010	Barrier Rating:	22.70		
Barrier Description					
Type:	STEEL-BACKED TIMBER WITH BLOCKOUT	Barrier Function:	TRAFFIC		
Barrier Material:	STEEL-BACKED TIMBER/LOG	Post Material:	CORTEN		
Blockout Type:	WOOD	Length (ft.):	540		
Speed Limit (MPH):	35	Placement with Respect to Road:	TANGENT		
Hazard Behind Barrier:	LOW				
Barrier Crashworthiness					
Appropriate Test Level:	TL-2	Barrier Test Level:	TL-3	Is Barrier Crashworthy?:	YES
Beg. End Trtmt Type:	SBT/LOG FLARED	Is Beg. End Trtmt Crashworthy?:	NO	Approach Transition Type:	NONE
Ending End Trtmt Type:	SBT/LOG BURIED	Ending End Trtmt Crashworthy?:	YES		
Average Measurements					
Design Height (In.):	27	Width (In.):	0.0	Post Spacing (In.):	120.0
Height (In.):	25.0	Lateral Offset (In.):	50.0	Road Grade (%):	3.60
Physical Condition					
Barrier	Alignment and Height:	No deflections observed in alignment. The height is low by 2 in from the design height of 27 in for the entire barrier.

Breaking and Cracking:	No breaking or cracking observed.			
	Missing Elements:	11 missing barrier reflectors observed.			
	Corrosion and Weathering:	No loss of cross section or erosion around posts observed.			
End Treatments	Alignment and Height:	Alignment as designed. Ending end treatment is up to 12 in higher than 27 in design height.			
	Breaking and Cracking:	No breaking or cracking observed.			
	Missing Elements:	No missing elements observed.			
	Corrosion and Weathering:	No loss of cross section or erosion around posts observed.

Repair Action:	REPAIR	FMSS Work Type:	DEFERRED MAINTENANCE	Repair Cost:	\$12018
Brief Workorder:	Raise 540 feet of barrier to 27 inch design height.				
Workorder:	Adjust Guardrail at \$10- per -Lin. Ft. for 540 LF = \$5400. Raise 540ft. of barrier to 27 inch design height. Barrier reflectors @ \$100 Each for 11 = \$1100. Replace 11 missing barrier reflectors. Low Speed Traffic Control at \$1475- per -Day for 3 Day(s) = \$4425.

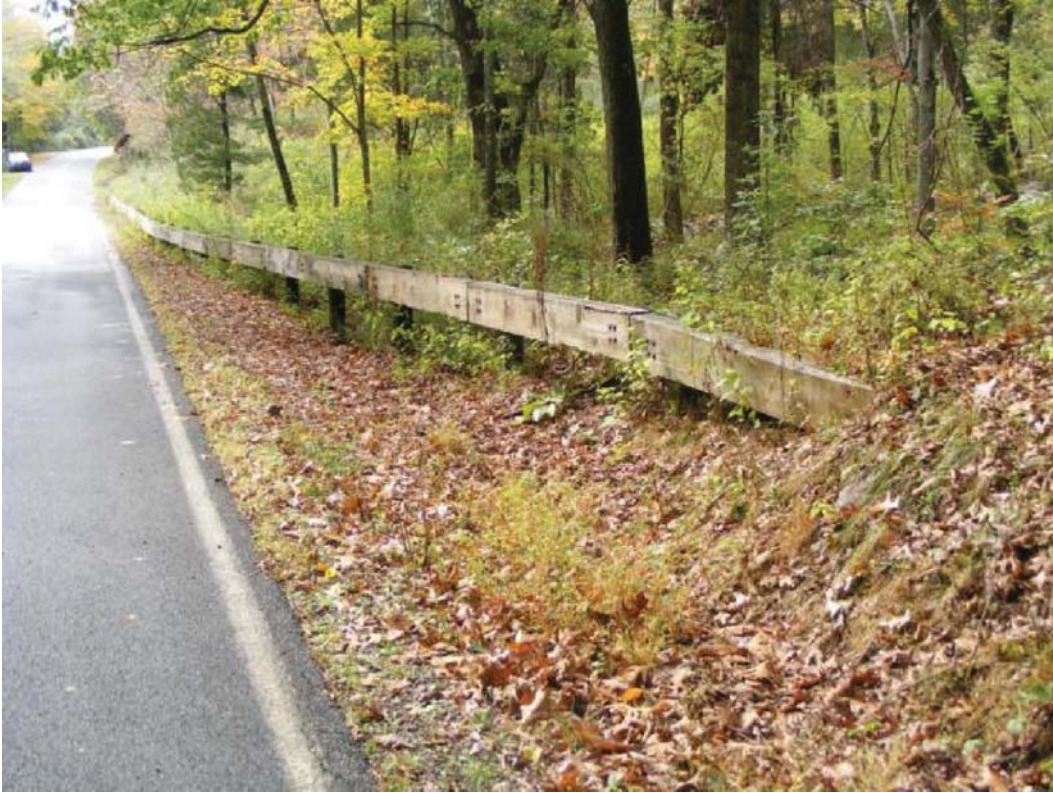
DEWA_0010_5.666_L_1.JPG

Barrier ID:	DEWA-0010-5.666-L				
Route Name:	OLD MINE ROAD (SOUTH SECTION)				
Inspection Date:	10/06/2010	Barrier Rating:	25.60		
Barrier Description					
Type:	STEEL-BACKED TIMBER WITH BLOCKOUT	Barrier Function:	TRAFFIC		
Barrier Material:	STEEL-BACKED TIMBER/LOG	Post Material:	CORTEN		
Blockout Type:	WOOD	Length (ft.):	410		
Speed Limit (MPH):	35	Placement with Respect to Road:	TANGENT		
Hazard Behind Barrier:	LOW				
Barrier Crashworthiness					
Appropriate Test Level:	TL-2	Barrier Test Level:	TL-3	Is Barrier Crashworthy?:	YES
Beg. End Trtmt Type:	SBT/LOG BURIED	Is Beg. End Trtmt Crashworthy?:	YES	Approach Transition Type:	NONE
Ending End Trtmt Type:	SBT/LOG BURIED	Ending End Trtmt Crashworthy?:	YES		
Average Measurements					
Design Height (In.):	27	Width (In.):	0.0	Post Spacing (In.):	120.3
Height (In.):	27.2	Lateral Offset (In.):	42.2	Road Grade (%):	5.00
Physical Condition					
Barrier	Alignment and Height:	No deflections observed in alignment. Entire barrier is between 1in. below to 2in. above the 27-in. design height.

Breaking and Cracking:	No breaking or cracking observed.			
	Missing Elements:	7 reflectors observed as missing.			
	Corrosion and Weathering:	No loss of cross section or erosion around posts observed.			
End Treatments	Alignment and Height:	Ending end treatment is 7 above the 27-in. design height for 60 linear ft. Alignment as designed.			
	Breaking and Cracking:	No breaking or cracking observed.			
	Missing Elements:	No missing elements observed.			
	Corrosion and Weathering:	No loss of cross section or erosion around posts observed.

Repair Action:	REPAIR	FMSS Work Type:	DEFERRED MAINTENANCE	Repair Cost:	\$3052
Brief Workorder:	Lower 60 feet of barrier to 27 inch design height.				
Workorder:	Adjust Guardrail at \$10- per -Lin. Ft. for 60 LF = \$600. Lower 60 feet of ending end treatment to 27 inch design height. Barrier reflectors @ \$100 Each for 7 = \$700. Replace 7 missing barrier reflectors. Low Speed Traffic Control at \$1475- per -Day for 1 Day(s) = \$1475.

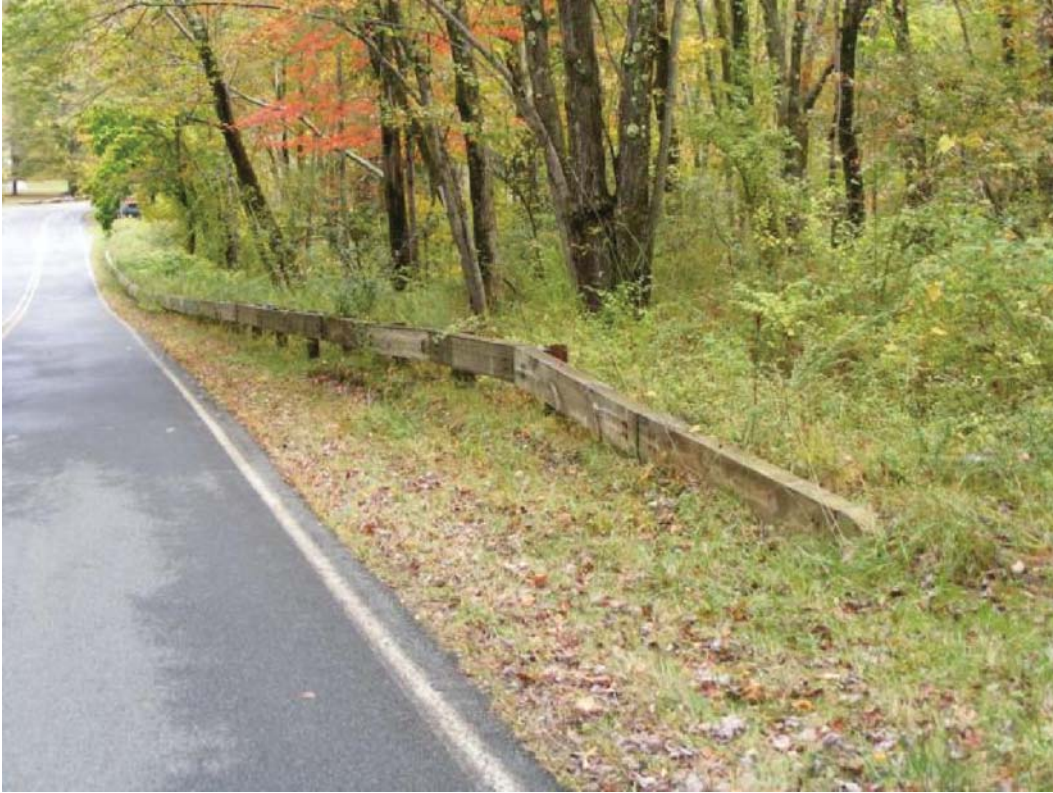
DEWA_0010_5.847_R_1.JPG

Barrier ID:	DEWA-0010-5.847-R				
Route Name:	OLD MINE ROAD (SOUTH SECTION)				
Inspection Date:	10/06/2010	Barrier Rating:	28.10		
Barrier Description					
Type:	STEEL-BACKED TIMBER WITH BLOCKOUT	Barrier Function:	TRAFFIC		
Barrier Material:	STEEL-BACKED TIMBER/LOG	Post Material:	CORTEN		
Blockout Type:	WOOD	Length (ft.):	450		
Speed Limit (MPH):	35	Placement with Respect to Road:	TANGENT		
Hazard Behind Barrier:	MEDIUM				
Barrier Crashworthiness					
Appropriate Test Level:	TL-2	Barrier Test Level:	TL-3	Is Barrier Crashworthy?:	YES
Beg. End Trtmt Type:	SBT/LOG FLARED	Is Beg. End Trtmt Crashworthy?:	NO	Approach Transition Type:	NONE
Ending End Trtmt Type:	SBT/LOG FLARED	Ending End Trtmt Crashworthy?:	NO		
Average Measurements					
Design Height (In.):	27	Width (In.):	0.0	Post Spacing (In.):	120.0
Height (In.):	28.0	Lateral Offset (In.):	41.7	Road Grade (%):	3.10
Physical Condition					
Barrier	Alignment and Height:	No deflections observed in alignment. Barrier is 1 to 3 in below 27 in design height for 320 ft and at or up to 2 in above for 130 ft.

Breaking and Cracking:	No breaking or cracking observed.			
	Missing Elements:	7 missing reflector elements observed.			
	Corrosion and Weathering:	No loss of cross section or erosion around posts observed.			
End Treatments	Alignment and Height:	Alignment acceptable. Height is within 1-in. of 27-in. design height.			
	Breaking and Cracking:	No breaking or cracking observed.			
	Missing Elements:	No missing elements observed.			
	Corrosion and Weathering:	No loss of cross section or erosion around posts observed.

Repair Action:	REPAIR	FMSS Work Type:	DEFERRED MAINTENANCE	Repair Cost:	\$7535
Brief Workorder:	Raise 320 feet of barrier up to 27 inch design height.				
Workorder:	Adjust Guardrail at \$10- per -Lin. Ft. for 320 LF = \$3200. Raise 320ft. of barrier to 27 inch design height. Barrier reflectors @ \$100 Each for 7 = \$700. Replace 7 missing barrier reflectors. Low Speed Traffic Control at \$1475- per -Day for 2 Day(s) = \$2950.

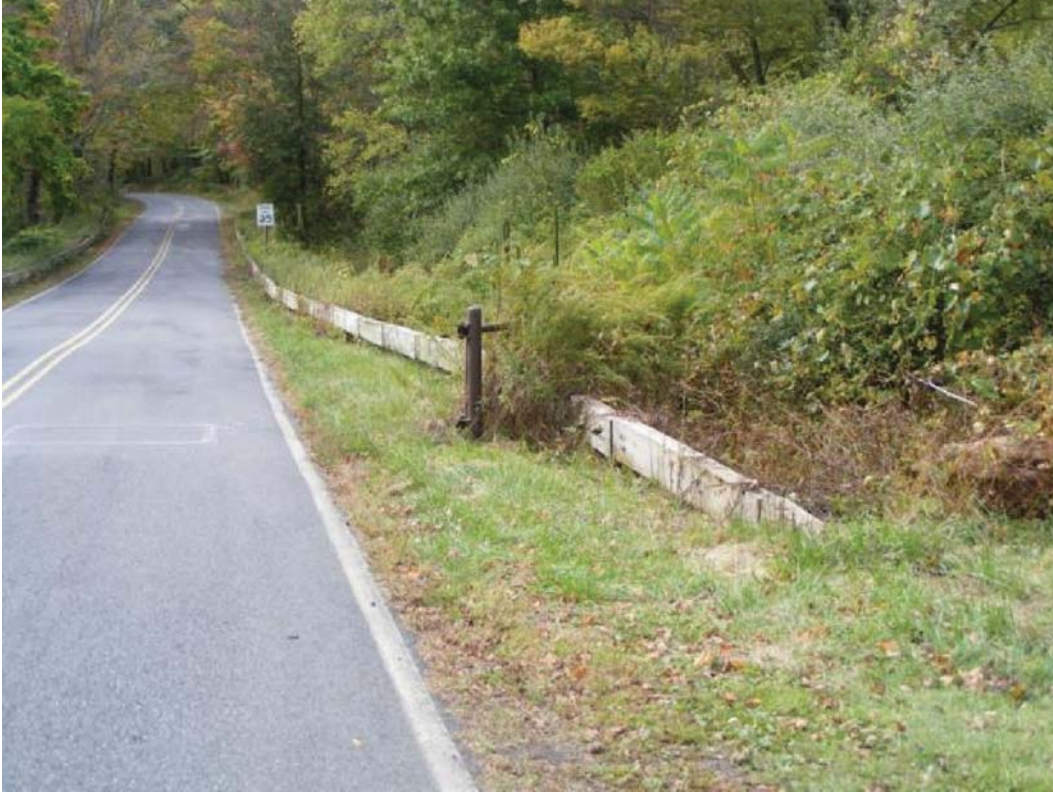
DEWA_0010_5.858_L_1.JPG

Barrier ID:	DEWA-0010-5.858-L				
Route Name:	OLD MINE ROAD (SOUTH SECTION)				
Inspection Date:	10/06/2010	Barrier Rating:	16.80		
Barrier Description					
Type:	STEEL-BACKED TIMBER WITH BLOCKOUT	Barrier Function:	TRAFFIC		
Barrier Material:	STEEL-BACKED TIMBER/LOG	Post Material:	CORTEN		
Blockout Type:	WOOD	Length (ft.):	410		
Speed Limit (MPH):	35	Placement with Respect to Road:	TANGENT		
Hazard Behind Barrier:	LOW				
Barrier Crashworthiness					
Appropriate Test Level:	TL-2	Barrier Test Level:	TL-3	Is Barrier Crashworthy?:	YES
Beg. End Trtmt Type:	SBT/LOG FLARED	Is Beg. End Trtmt Crashworthy?:	NO	Approach Transition Type:	NONE
Ending End Trtmt Type:	SBT/LOG BURIED	Ending End Trtmt Crashworthy?:	YES		
Average Measurements					
Design Height (In.):	27	Width (In.):	0.0	Post Spacing (In.):	119.6
Height (In.):	27.0	Lateral Offset (In.):	39.0	Road Grade (%):	2.60
Physical Condition					
Barrier	Alignment and Height:	No deflections observed in alignment. The height is at or above the design of 27 in.

Breaking and Cracking:	No breaking or cracking observed.			
	Missing Elements:	7 missing reflector elements observed.			
	Corrosion and Weathering:	No loss of cross section or erosion around posts observed.			
End Treatments	Alignment and Height:	Alignment acceptable. Height is within 1-in. of 27-in. design height.			
	Breaking and Cracking:	No breaking or cracking observed.			
	Missing Elements:	No missing elements observed.			
	Corrosion and Weathering:	No loss of cross section or erosion around posts observed.

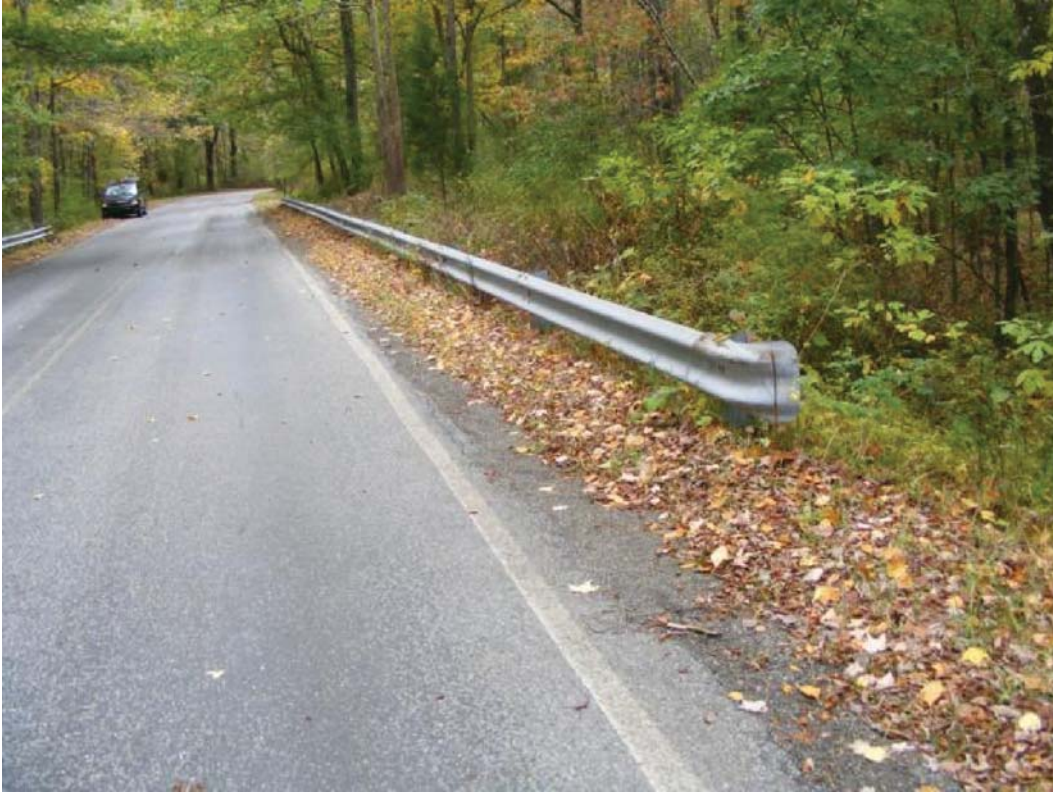
DEWA_0010_6.468_L_1.JPG

Barrier ID:	DEWA-0010-6.468-L				
Route Name:	OLD MINE ROAD (SOUTH SECTION)				
Inspection Date:	10/07/2010	Barrier Rating:	35.50		
Barrier Description					
Type:	W-BEAM WEAK POST	Barrier Function:	TRAFFIC		
Barrier Material:	GALVANIZED STEEL	Post Material:	GALVANIZED STEEL		
Blockout Type:	N/A	Length (ft.):	155		
Speed Limit (MPH):	35	Placement with Respect to Road:	TANGENT		
Hazard Behind Barrier:	LOW				
Barrier Crashworthiness					
Appropriate Test Level:	TL-2	Barrier Test Level:	TL-2	Is Barrier Crashworthy?:	YES
Beg. End Trtmt Type:	NONE	Is Beg. End Trtmt Crashworthy?:	N/A	Approach Transition Type:	NONE
Ending End Trtmt Type:	NONE	Ending End Trtmt Crashworthy?:	N/A		
Average Measurements					
Design Height (In.):	27	Width (In.):	0.0	Post Spacing (In.):	158.3
Height (In.):	22.0	Lateral Offset (In.):	45.0	Road Grade (%):	3.40
Physical Condition					
Barrier	Alignment and Height:	No deflections observed in alignment. Barrier is 4 to 6 in below 27 in design height for 155 ft.

Breaking and Cracking:	No breaking or cracking observed.			
	Missing Elements:	No missing elements observed.			
	Corrosion and Weathering:	No loss of cross section or erosion around posts observed.			
End Treatments	Alignment and Height:				
	Breaking and Cracking:				
	Missing Elements:				
	Corrosion and Weathering:

Repair Action:	REPAIR	FMSS Work Type:	DEFERRED MAINTENANCE	Repair Cost:	\$3328
Brief Workorder:	Raise 155 feet of barrier up to 27 inch design height.				
Workorder:	Adjust Guardrail at \$10- per -Lin. Ft. for 155 LF = \$1550. Raise 155 feet of barrier up to 27 inch design height. Low Speed Traffic Control at \$1475- per -Day for 1 Day(s) = \$1475.

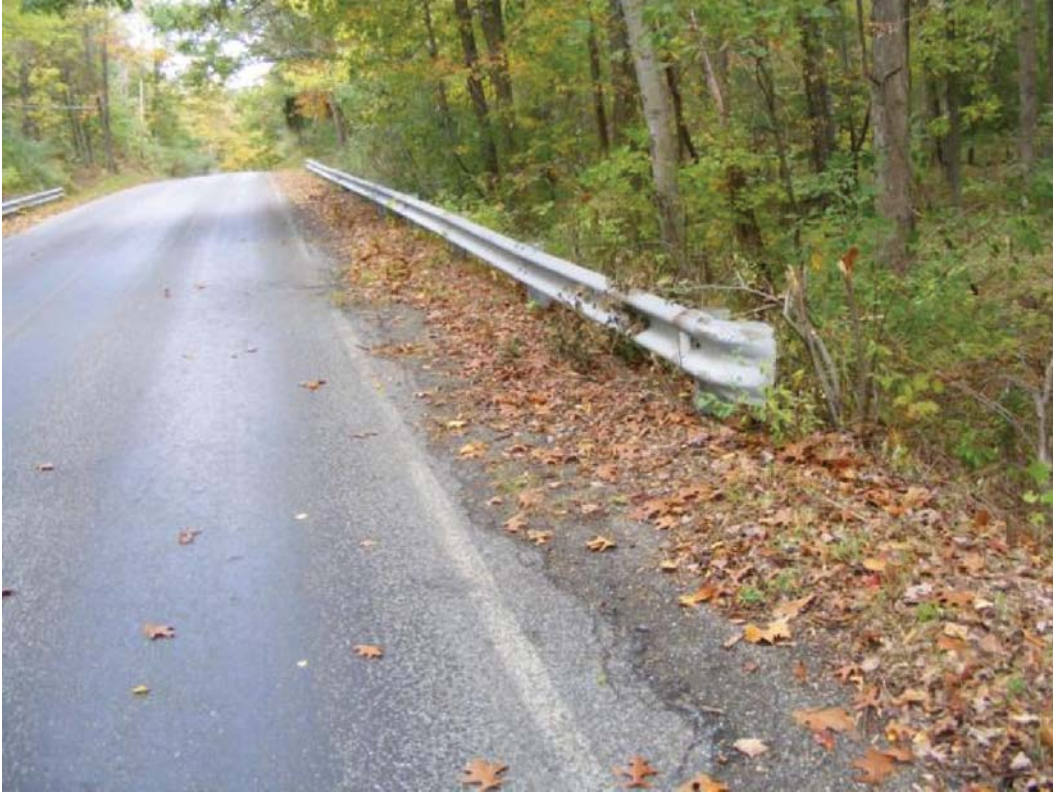
DEWA_0010_6.472_R_1.JPG

Barrier ID:	DEWA-0010-6.472-R				
Route Name:	OLD MINE ROAD (SOUTH SECTION)				
Inspection Date:	10/07/2010	Barrier Rating:	28.30		
Barrier Description					
Type:	W-BEAM WEAK POST	Barrier Function:	TRAFFIC		
Barrier Material:	GALVANIZED STEEL	Post Material:	GALVANIZED STEEL		
Blockout Type:	N/A	Length (ft.):	130		
Speed Limit (MPH):	35	Placement with Respect to Road:	TANGENT		
Hazard Behind Barrier:	LOW				
Barrier Crashworthiness					
Appropriate Test Level:	TL-2	Barrier Test Level:	TL-2	Is Barrier Crashworthy?:	YES
Beg. End Trtmt Type:	NONE	Is Beg. End Trtmt Crashworthy?:	N/A	Approach Transition Type:	NONE
Ending End Trtmt Type:	NONE	Ending End Trtmt Crashworthy?:	N/A		
Average Measurements					
Design Height (In.):	27	Width (In.):	0.0	Post Spacing (In.):	150.0
Height (In.):	22.0	Lateral Offset (In.):	52.0	Road Grade (%):	2.40
Physical Condition					
Barrier	Alignment and Height:	No deflections observed in alignment. Barrier is 4 to 6 in below 27 in design height for 130 ft.

Breaking and Cracking:	No breaking or cracking observed.			
	Missing Elements:	No missing elements observed.			
	Corrosion and Weathering:	No loss of cross section or erosion around posts observed.			
End Treatments	Alignment and Height:				
	Breaking and Cracking:				
	Missing Elements:				
	Corrosion and Weathering:

Repair Action:	REPAIR	FMSS Work Type:	DEFERRED MAINTENANCE	Repair Cost:	\$3052
Brief Workorder:	Raise 130 feet of barrier up to 27 inch design height.				
Workorder:	Adjust Guardrail at \$10- per -Lin. Ft. for 130 LF = \$1300. Raise 130 feet of barrier up to 27 inch design height. Low Speed Traffic Control at \$1475- per -Day for 1 Day(s) = \$1475.

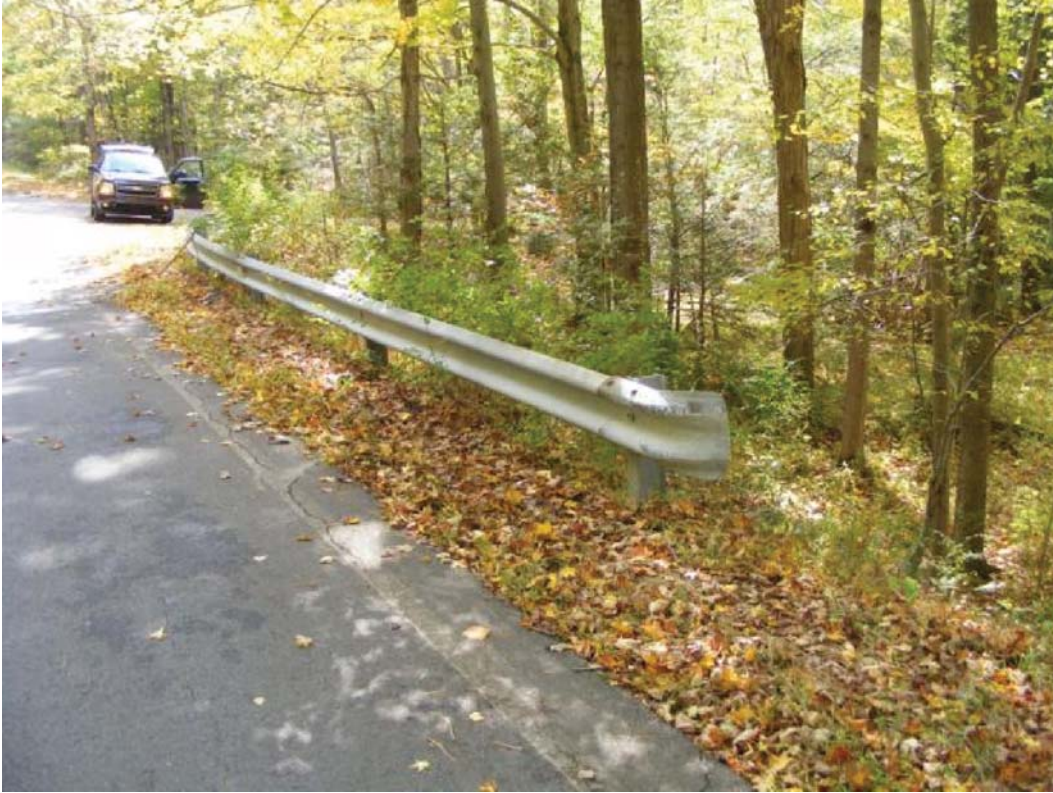
DEWA_0010_6.596_L_1.JPG

Barrier ID:	DEWA-0010-6.596-L				
Route Name:	OLD MINE ROAD (SOUTH SECTION)				
Inspection Date:	10/07/2010	Barrier Rating:	28.30		
Barrier Description					
Type:	W-BEAM WEAK POST	Barrier Function:	TRAFFIC		
Barrier Material:	GALVANIZED STEEL	Post Material:	GALVANIZED STEEL		
Blockout Type:	N/A	Length (ft.):	85		
Speed Limit (MPH):	35	Placement with Respect to Road:	TANGENT		
Hazard Behind Barrier:	LOW				
Barrier Crashworthiness					
Appropriate Test Level:	TL-2	Barrier Test Level:	TL-2	Is Barrier Crashworthy?:	YES
Beg. End Trtmt Type:	NONE	Is Beg. End Trtmt Crashworthy?:	N/A	Approach Transition Type:	NONE
Ending End Trtmt Type:	NONE	Ending End Trtmt Crashworthy?:	N/A		
Average Measurements					
Design Height (In.):	27	Width (In.):	0.0	Post Spacing (In.):	150.6
Height (In.):	21.0	Lateral Offset (In.):	53.2	Road Grade (%):	3.60
Physical Condition					
Barrier	Alignment and Height:	No deflections observed in alignment. Barrier is 5 to 7 in below 27 in design height for 85 ft.

Breaking and Cracking:	No breaking or cracking observed.			
	Missing Elements:	No missing elements observed.			
	Corrosion and Weathering:	No loss of cross section or erosion around posts observed.			
End Treatments	Alignment and Height:				
	Breaking and Cracking:				
	Missing Elements:				
	Corrosion and Weathering:

Repair Action:	REPAIR	FMSS Work Type:	DEFERRED MAINTENANCE	Repair Cost:	\$2558
Brief Workorder:	Raise 85 feet of barrier up to 27 inch design height.				
Workorder:	Adjust Guardrail at \$10- per -Lin. Ft. for 85 LF = \$850. Raise 85 feet of barrier up to 27 inch design height. Low Speed Traffic Control at \$1475- per -Day for 1 Day(s) = \$1475.

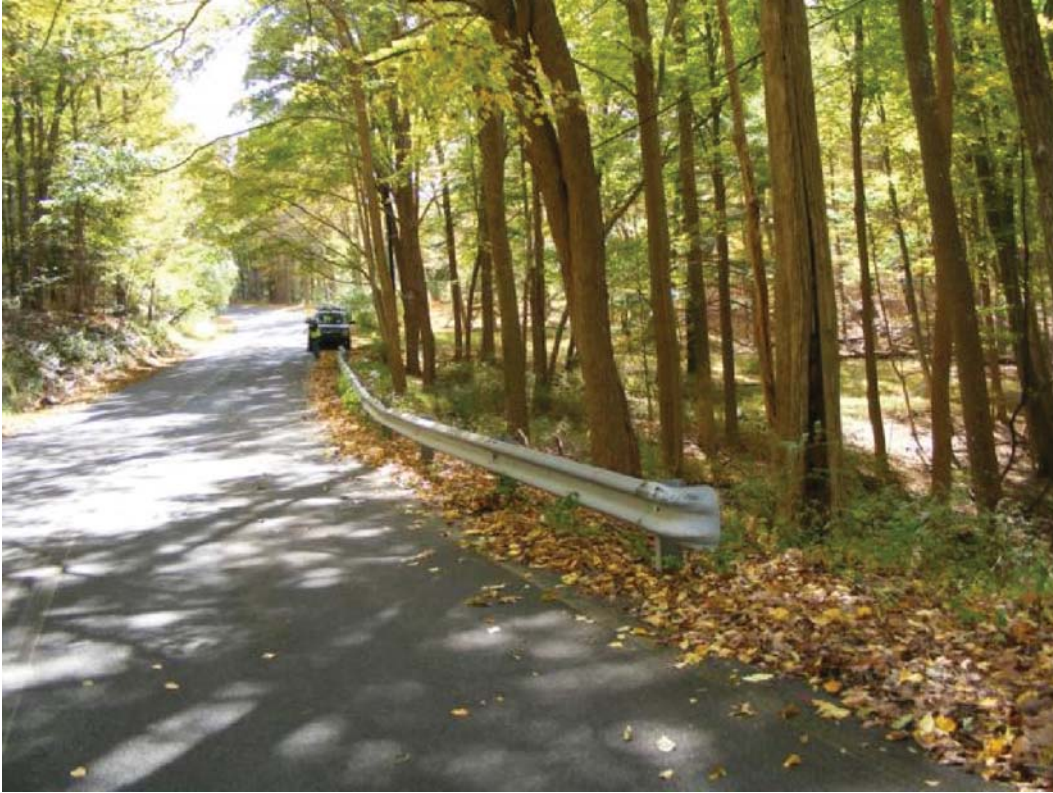
DEWA_0010_6.742_L_1.JPG

Barrier ID:	DEWA-0010-6.742-L				
Route Name:	OLD MINE ROAD (SOUTH SECTION)				
Inspection Date:	10/07/2010	Barrier Rating:	25.70		
Barrier Description					
Type:	W-BEAM WEAK POST	Barrier Function:	TRAFFIC		
Barrier Material:	GALVANIZED STEEL	Post Material:	GALVANIZED STEEL		
Blockout Type:	N/A	Length (ft.):	145		
Speed Limit (MPH):	35	Placement with Respect to Road:	INSIDE OF CURVE		
Hazard Behind Barrier:	LOW				
Barrier Crashworthiness					
Appropriate Test Level:	TL-2	Barrier Test Level:	TL-2	Is Barrier Crashworthy?:	YES
Beg. End Trtmt Type:	NONE	Is Beg. End Trtmt Crashworthy?:	N/A	Approach Transition Type:	NONE
Ending End Trtmt Type:	NONE	Ending End Trtmt Crashworthy?:	N/A		
Average Measurements					
Design Height (In.):	27	Width (In.):	0.0	Post Spacing (In.):	150.6
Height (In.):	23.0	Lateral Offset (In.):	36.2	Road Grade (%):	1.90
Physical Condition					
Barrier	Alignment and Height:	1 possible impact zone out of alignment by 6 in. Barrier is 4 in below 27 in design height for 145 ft.

Breaking and Cracking:	No breaking or cracking observed.			
	Missing Elements:	No missing elements observed.			
	Corrosion and Weathering:	No loss of cross section or erosion around posts observed.			
End Treatments	Alignment and Height:				
	Breaking and Cracking:				
	Missing Elements:				
	Corrosion and Weathering:

Repair Action:	REPAIR	FMSS Work Type:	DEFERRED MAINTENANCE	Repair Cost:	\$3218
Brief Workorder:	Raise 145 feet of barrier up to 27 inch design height.				
Workorder:	Adjust Guardrail at \$10- per -Lin. Ft. for 145 LF = \$1450. Raise 145 feet of barrier up to 27 inch design height. Low Speed Traffic Control at \$1475- per -Day for 1 Day(s) = \$1475.

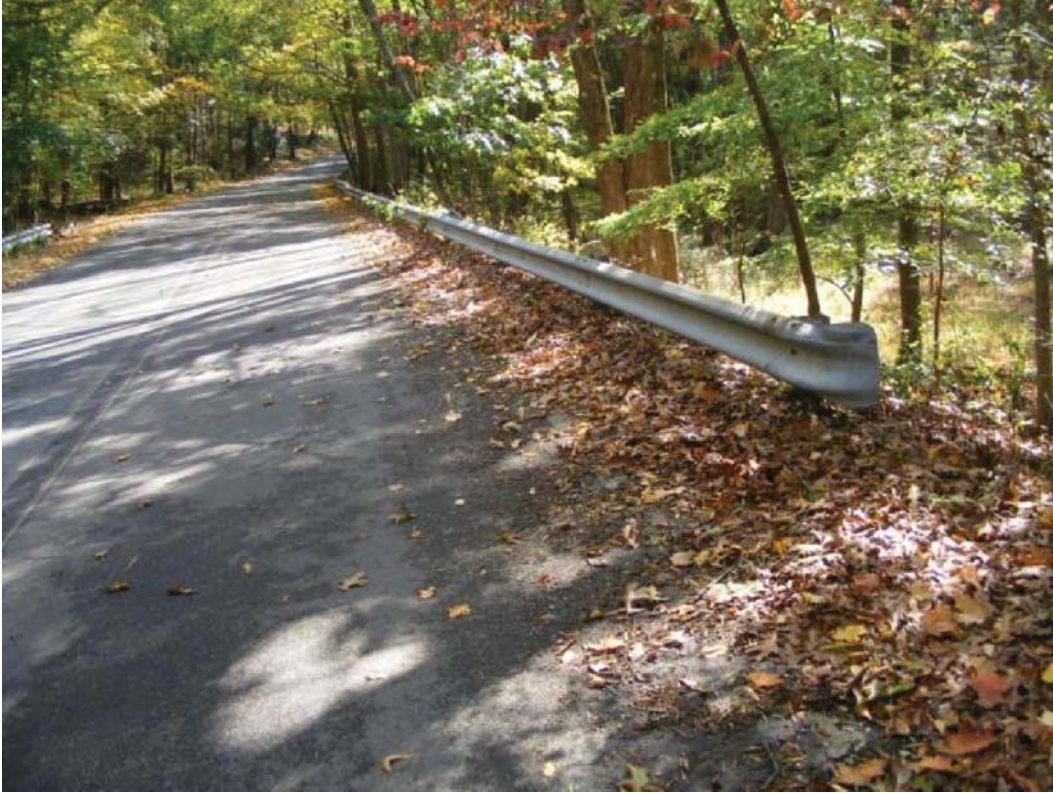
DEWA_0010_6.871_L_1.JPG

Barrier ID:	DEWA-0010-6.871-L				
Route Name:	OLD MINE ROAD (SOUTH SECTION)				
Inspection Date:	10/07/2010	Barrier Rating:	56.20		
Barrier Description					
Type:	W-BEAM WEAK POST	Barrier Function:	TRAFFIC		
Barrier Material:	GALVANIZED STEEL	Post Material:	GALVANIZED STEEL		
Blockout Type:	N/A	Length (ft.):	680		
Speed Limit (MPH):	35	Placement with Respect to Road:	INSIDE OF CURVE		
Hazard Behind Barrier:	LOW				
Barrier Crashworthiness					
Appropriate Test Level:	TL-2	Barrier Test Level:	TL-2	Is Barrier Crashworthy?:	YES
Beg. End Trtmt Type:	NONE	Is Beg. End Trtmt Crashworthy?:	N/A	Approach Transition Type:	NONE
Ending End Trtmt Type:	NONE	Ending End Trtmt Crashworthy?:	N/A		
Average Measurements					
Design Height (In.):	27	Width (In.):	0.0	Post Spacing (In.):	150.0
Height (In.):	19.7	Lateral Offset (In.):	33.7	Road Grade (%):	2.40
Physical Condition					
Barrier	Alignment and Height:	No deflections observed in alignment. Barrier is 6 to 9 in below 27 in design height for 680 ft.

Breaking and Cracking:	No breaking or cracking observed.			
	Missing Elements:	No missing elements observed.			
	Corrosion and Weathering:	No loss of cross section or erosion around posts observed.			
End Treatments	Alignment and Height:				
	Breaking and Cracking:				
	Missing Elements:				
	Corrosion and Weathering:

Repair Action:	REPAIR	FMSS Work Type:	DEFERRED MAINTENANCE	Repair Cost:	\$12348
Brief Workorder:	Raise 680 feet of barrier to 27 inch design height.				
Workorder:	Adjust Guardrail at \$10- per -Lin. Ft. for 680 LF = \$6800. Raise 680ft. of barrier to 27 inch design height. Low Speed Traffic Control at \$1475- per -Day for 3 Day(s) = \$4425.

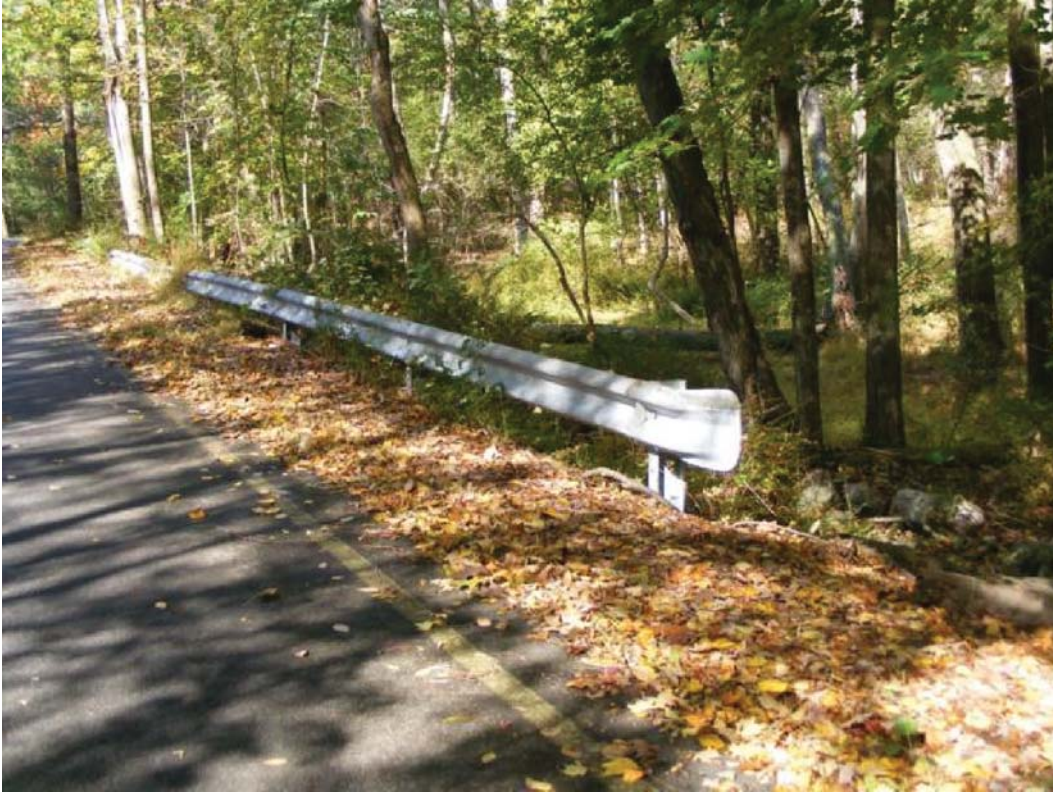
DEWA_0010_6.982_R_1.JPG

Barrier ID:	DEWA-0010-6.982-R				
Route Name:	OLD MINE ROAD (SOUTH SECTION)				
Inspection Date:	10/07/2010	Barrier Rating:	28.30		
Barrier Description					
Type:	W-BEAM WEAK POST	Barrier Function:	TRAFFIC		
Barrier Material:	GALVANIZED STEEL	Post Material:	GALVANIZED STEEL		
Blockout Type:	N/A	Length (ft.):	92		
Speed Limit (MPH):	35	Placement with Respect to Road:	TANGENT		
Hazard Behind Barrier:	LOW				
Barrier Crashworthiness					
Appropriate Test Level:	TL-2	Barrier Test Level:	TL-2	Is Barrier Crashworthy?:	YES
Beg. End Trtmt Type:	NONE	Is Beg. End Trtmt Crashworthy?:	N/A	Approach Transition Type:	NONE
Ending End Trtmt Type:	NONE	Ending End Trtmt Crashworthy?:	N/A		
Average Measurements					
Design Height (In.):	27	Width (In.):	0.0	Post Spacing (In.):	150.0
Height (In.):	20.6	Lateral Offset (In.):	61.5	Road Grade (%):	0.70
Physical Condition					
Barrier	Alignment and Height:	No deflections observed in alignment. Barrier is 4 to 9 in below 27 in design height for 92 ft.

Breaking and Cracking:	25ft. of bent rail due to tree impact.			
	Missing Elements:	No missing elements observed.			
	Corrosion and Weathering:	No loss of cross section or erosion around posts observed.			
End Treatments	Alignment and Height:				
	Breaking and Cracking:				
	Missing Elements:				
	Corrosion and Weathering:

Repair Action:	REPAIR	FMSS Work Type:	DEFERRED MAINTENANCE	Repair Cost:	\$3322
Brief Workorder:	Replace 25 feet of rail and raise 92 feet of barrier to 27 inch design height.				
Workorder:	Replace Rail at \$25- per -Lin. Ft. for 25 LF = \$625. Replace 25ft. section of bent rail. Adjust Guardrail at \$10- per -Lin. Ft. for 92 LF = \$920. Raise 92ft. of barrier to 27 inch design height. Low Speed Traffic Control at \$1475- per -Day for 1 Day(s) = \$1475.

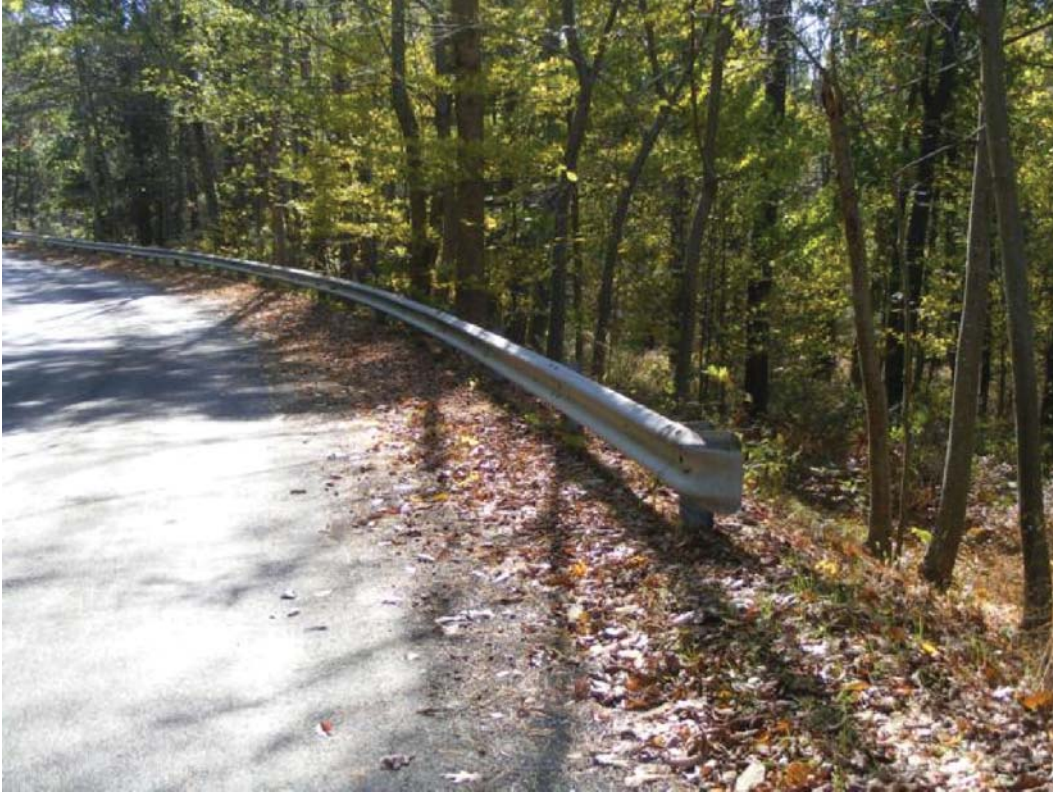
DEWA_0010_7.046_L_1.JPG

Barrier ID:	DEWA-0010-7.046-L				
Route Name:	OLD MINE ROAD (SOUTH SECTION)				
Inspection Date:	10/07/2010	Barrier Rating:	44.00		
Barrier Description					
Type:	W-BEAM WEAK POST	Barrier Function:	TRAFFIC		
Barrier Material:	GALVANIZED STEEL	Post Material:	GALVANIZED STEEL		
Blockout Type:	N/A	Length (ft.):	315		
Speed Limit (MPH):	35	Placement with Respect to Road:	OUTSIDE OF CURVE		
Hazard Behind Barrier:	LOW				
Barrier Crashworthiness					
Appropriate Test Level:	TL-2	Barrier Test Level:	TL-2	Is Barrier Crashworthy?:	YES
Beg. End Trtmt Type:	NONE	Is Beg. End Trtmt Crashworthy?:	N/A	Approach Transition Type:	NONE
Ending End Trtmt Type:	NONE	Ending End Trtmt Crashworthy?:	N/A		
Average Measurements					
Design Height (In.):	27	Width (In.):	0.0	Post Spacing (In.):	150.0
Height (In.):	22.6	Lateral Offset (In.):	69.3	Road Grade (%):	3.40
Physical Condition					
Barrier	Alignment and Height:	No deflections observed in alignment. Barrier is 4 to 5 in below 27 in design height for 315 ft.

Breaking and Cracking:	No breaking or cracking observed.			
	Missing Elements:	No missing elements observed.			
	Corrosion and Weathering:	No loss of cross section or erosion around posts observed.			
End Treatments	Alignment and Height:				
	Breaking and Cracking:				
	Missing Elements:				
	Corrosion and Weathering:

Repair Action:	REPAIR	FMSS Work Type:	DEFERRED MAINTENANCE	Repair Cost:	\$6710
Brief Workorder:	Raise 315 feet of barrier to 27 inch design height.				
Workorder:	Adjust Guardrail at \$10- per -Lin. Ft. for 315 LF = \$3150. Raise 315ft. of barrier to 27 inch design height. Low Speed Traffic Control at \$1475- per -Day for 2 Day(s) = \$2950.

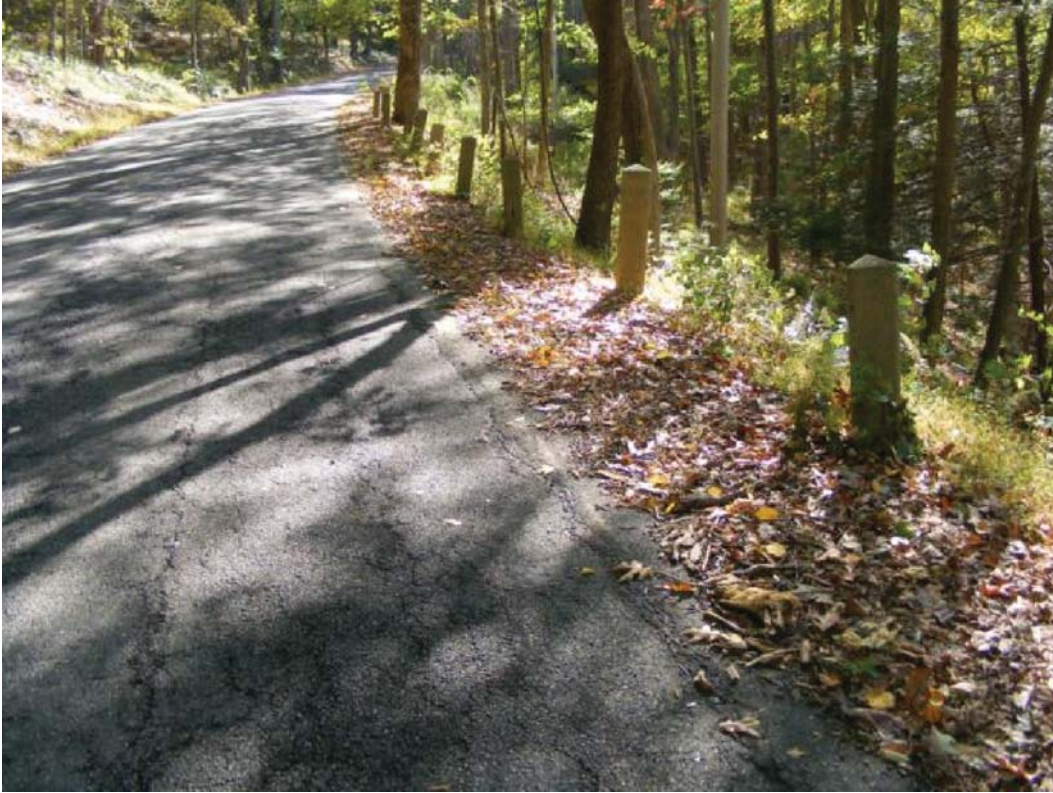
DEWA_0010_7.292_L_1.JPG

Barrier ID:	DEWA-0010-7.292-L				
Route Name:	OLD MINE ROAD (SOUTH SECTION)				
Inspection Date:	10/07/2010	Barrier Rating:	31.20		
Barrier Description					
Type:	OTHER: 2-STRAND CABLE	Barrier Function:	TRAFFIC		
Barrier Material:	CABLE	Post Material:	OTHER: CONCRETE		
Blockout Type:	N/A	Length (ft.):	270		
Speed Limit (MPH):	35	Placement with Respect to Road:	INSIDE OF CURVE		
Hazard Behind Barrier:	LOW				
Barrier Crashworthiness					
Appropriate Test Level:	TL-2	Barrier Test Level:	NCW	Is Barrier Crashworthy?:	NO
Beg. End Trtmt Type:	NONE	Is Beg. End Trtmt Crashworthy?:	N/A	Approach Transition Type:	NONE
Ending End Trtmt Type:	NONE	Ending End Trtmt Crashworthy?:	N/A		
Average Measurements					
Design Height (In.):	27	Width (In.):	0.0	Post Spacing (In.):	116.3
Height (In.):	0.0	Lateral Offset (In.):	50.2	Road Grade (%):	2.30
Physical Condition					
Barrier	Alignment and Height:	Barrier alignment is deflected 1 to 13 in. 2 strand cable missing. Height is 27 in below 27 in design height.

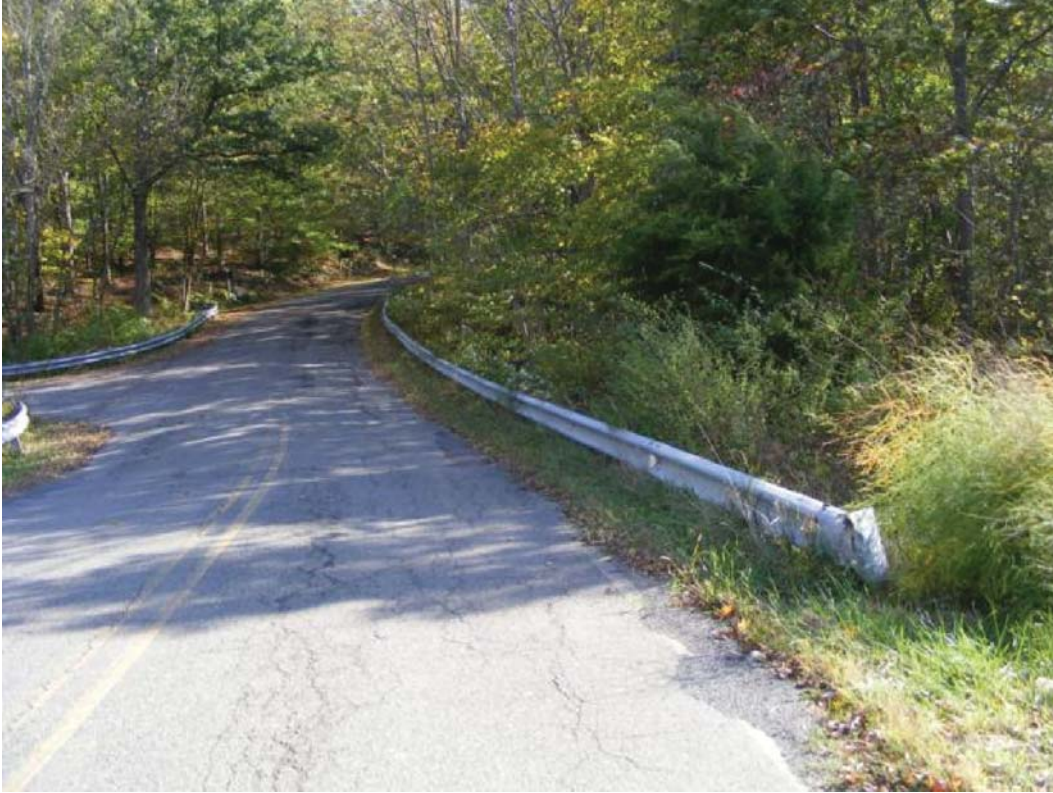
DEWA_0010_7.480_L_1.JPG

Barrier ID:	DEWA-0010-7.480-L				
Route Name:	OLD MINE ROAD (SOUTH SECTION)				
Inspection Date:	10/07/2010	Barrier Rating:	25.60		
Barrier Description					
Type:	W-BEAM WEAK POST	Barrier Function:	TRAFFIC		
Barrier Material:	GALVANIZED STEEL	Post Material:	GALVANIZED STEEL		
Blockout Type:	N/A	Length (ft.):	180		
Speed Limit (MPH):	35	Placement with Respect to Road:	INSIDE OF CURVE		
Hazard Behind Barrier:	HIGH				
Barrier Crashworthiness					
Appropriate Test Level:	TL-2	Barrier Test Level:	TL-2	Is Barrier Crashworthy?:	YES
Beg. End Trtmt Type:	NONE	Is Beg. End Trtmt Crashworthy?:	N/A	Approach Transition Type:	NONE
Ending End Trtmt Type:	NONE	Ending End Trtmt Crashworthy?:	N/A		
Average Measurements					
Design Height (In.):	27	Width (In.):	0.0	Post Spacing (In.):	150.0
Height (In.):	25.2	Lateral Offset (In.):	42.5	Road Grade (%):	10.50
Physical Condition					
Barrier	Alignment and Height:	The alignment is deflected by 6 in for 62 ft. The height is low by 3 in or less from design height of 27 in for 110 linear ft.
