NPS Guardwall/Rail Inventory Program Delaware Water Gap National Recreation Area

**Federal Lands Highway
Road Inventory Program**

Federal Highway Administration
Eastern Federal Lands Highway Division
Road Inventory Program (RIP)

Data Collection Date: October 2010
Report Date: December 2015

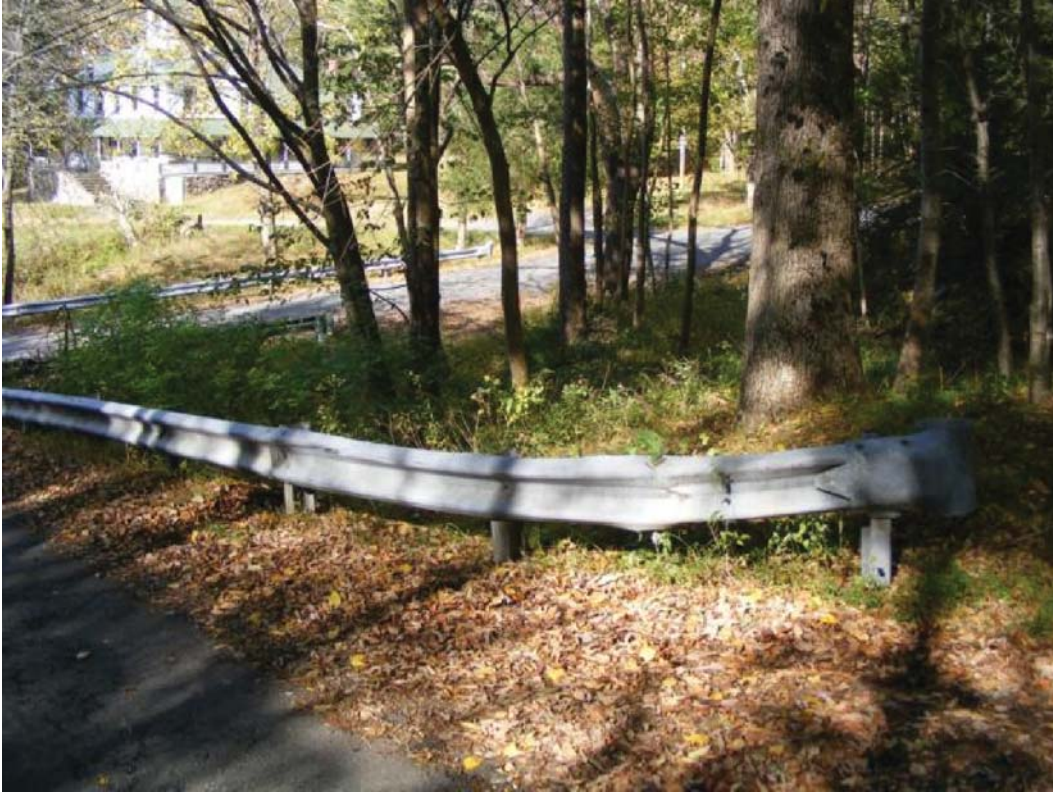
DEWA_0010_7.480_R_1.JPG

Barrier ID:	DEWA-0010-7.480-R				
Route Name:	OLD MINE ROAD (SOUTH SECTION)				
Inspection Date:	10/07/2010	Barrier Rating:	35.50		
Barrier Description					
Type:	W-BEAM WEAK POST	Barrier Function:	TRAFFIC		
Barrier Material:	GALVANIZED STEEL	Post Material:	GALVANIZED STEEL		
Blockout Type:	N/A	Length (ft.):	60		
Speed Limit (MPH):	35	Placement with Respect to Road:	OUTSIDE OF CURVE		
Hazard Behind Barrier:	LOW				
Barrier Crashworthiness					
Appropriate Test Level:	TL-2	Barrier Test Level:	TL-2	Is Barrier Crashworthy?:	YES
Beg. End Trtmt Type:	NONE	Is Beg. End Trtmt Crashworthy?:	N/A	Approach Transition Type:	NONE
Ending End Trtmt Type:	NONE	Ending End Trtmt Crashworthy?:	N/A		
Average Measurements					
Design Height (In.):	27	Width (In.):	0.0	Post Spacing (In.):	74.5
Height (In.):	24.0	Lateral Offset (In.):	43.2	Road Grade (%):	13.80
Physical Condition					
Barrier	Alignment and Height:	No deflections observed in alignment. The height is low by 1 to 3 in from the design of 27 in.

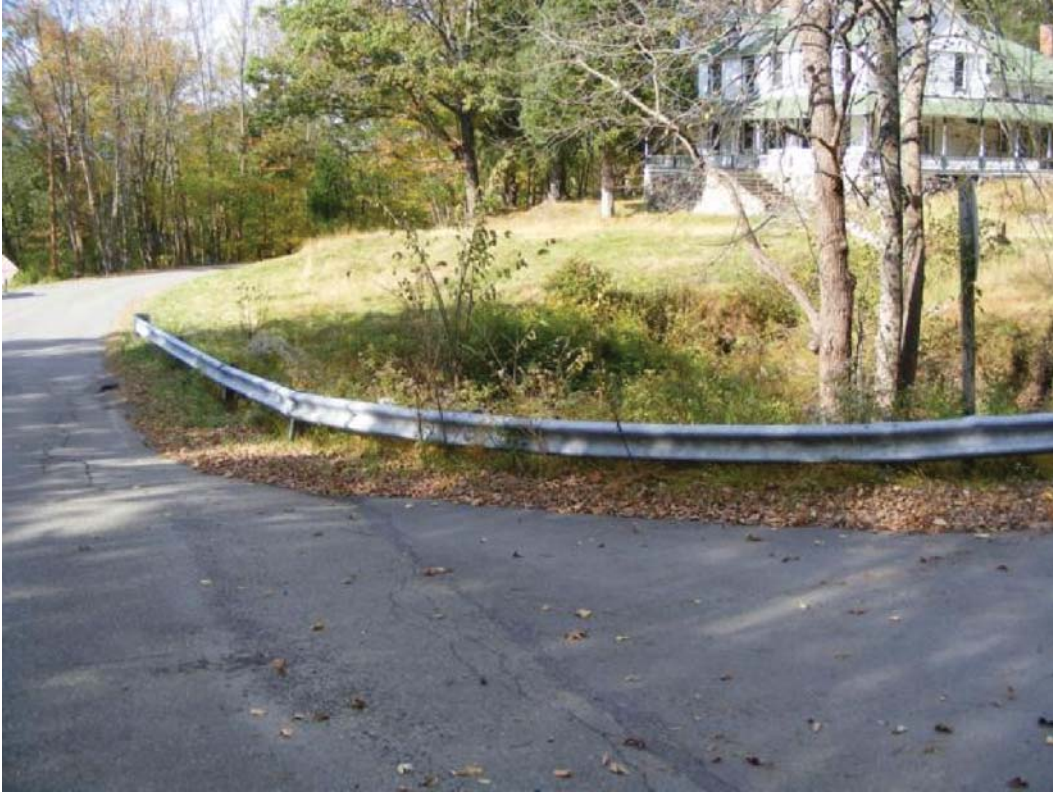
DEWA_0010_7.500_R_1.JPG

Barrier ID:	DEWA-0010-7.500-R				
Route Name:	OLD MINE ROAD (SOUTH SECTION)				
Inspection Date:	10/07/2010	Barrier Rating:	11.10		
Barrier Description					
Type:	W-BEAM WEAK POST	Barrier Function:	TRAFFIC		
Barrier Material:	GALVANIZED STEEL	Post Material:	GALVANIZED STEEL		
Blockout Type:	N/A	Length (ft.):	58		
Speed Limit (MPH):	35	Placement with Respect to Road:	TANGENT		
Hazard Behind Barrier:	LOW				
Barrier Crashworthiness					
Appropriate Test Level:	TL-2	Barrier Test Level:	TL-2	Is Barrier Crashworthy?:	YES
Beg. End Trtmt Type:	NONE	Is Beg. End Trtmt Crashworthy?:	N/A	Approach Transition Type:	NONE
Ending End Trtmt Type:	NONE	Ending End Trtmt Crashworthy?:	N/A		
Average Measurements					
Design Height (In.):	27	Width (In.):	0.0	Post Spacing (In.):	148.6
Height (In.):	26.2	Lateral Offset (In.):	55.5	Road Grade (%):	0.30
Physical Condition					
Barrier	Alignment and Height:	No deflections observed in alignment. The height is low by 1 in or less from the design of 27 in.

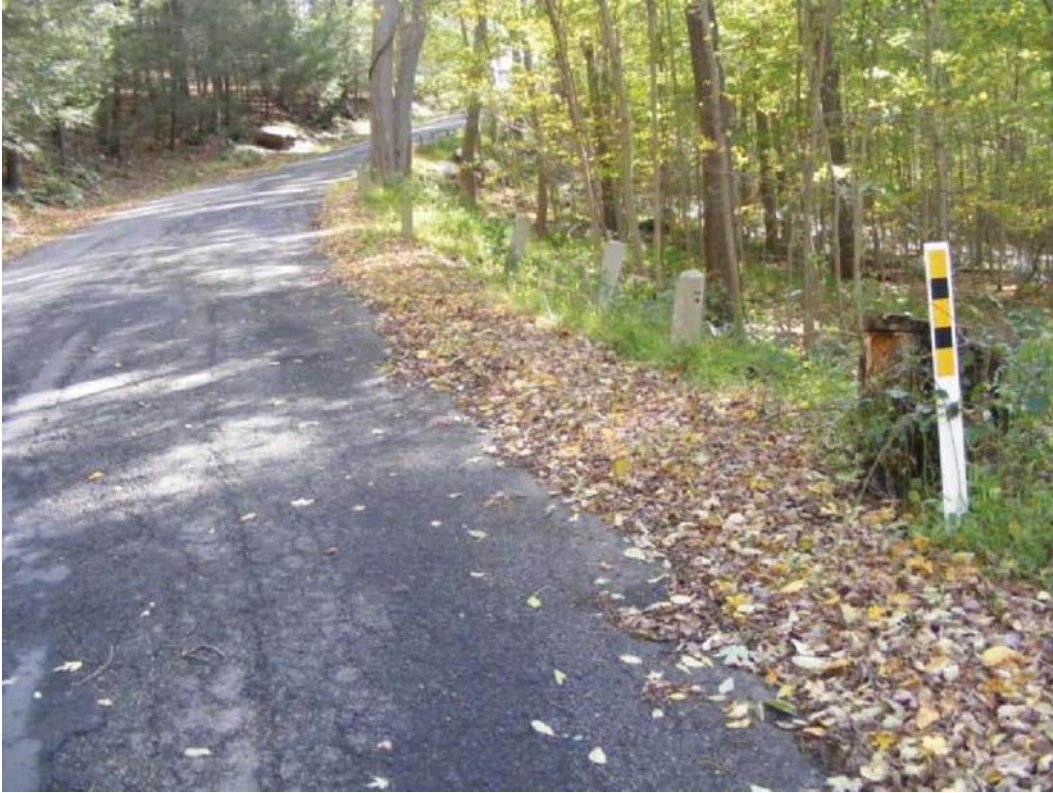
DEWA_0010_7.542_L_1.JPG

Barrier ID:	DEWA-0010-7.542-L				
Route Name:	OLD MINE ROAD (SOUTH SECTION)				
Inspection Date:	10/07/2010	Barrier Rating:	45.00		
Barrier Description					
Type:	OTHER: 2-STRAND CABLE	Barrier Function:	TRAFFIC		
Barrier Material:	CABLE	Post Material:	OTHER: CONCRETE		
Blockout Type:	N/A	Length (ft.):	755		
Speed Limit (MPH):	35	Placement with Respect to Road:	INSIDE OF CURVE		
Hazard Behind Barrier:	MEDIUM				
Barrier Crashworthiness					
Appropriate Test Level:	TL-2	Barrier Test Level:	NCW	Is Barrier Crashworthy?:	NO
Beg. End Trtmt Type:	NONE	Is Beg. End Trtmt Crashworthy?:	N/A	Approach Transition Type:	NONE
Ending End Trtmt Type:	NONE	Ending End Trtmt Crashworthy?:	N/A		
Average Measurements					
Design Height (In.):	27	Width (In.):	0.0	Post Spacing (In.):	128.8
Height (In.):	5.5	Lateral Offset (In.):	48.5	Road Grade (%):	10.40
Physical Condition					
Barrier	Alignment and Height:	The barrier alignment is 8 to 36 in deflected. The height is 5 to 27 in low from design height of 27 ines with the majority of cable missing.

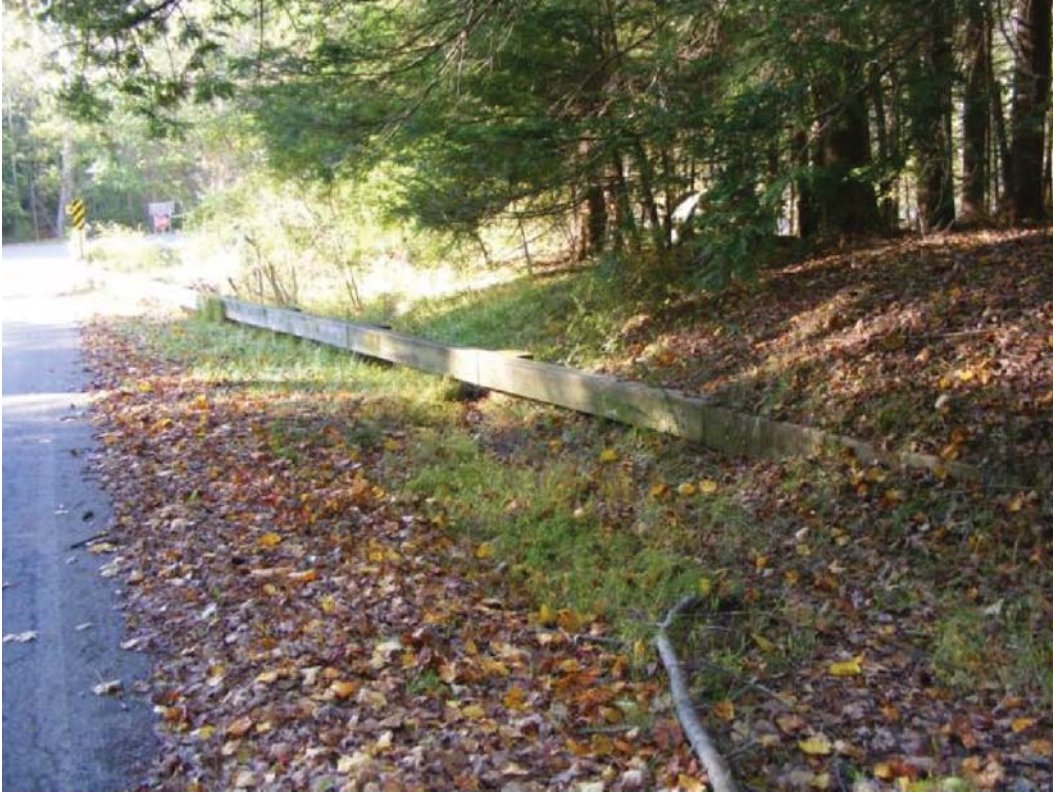
DEWA_0010_8.080_R_1.JPG

Barrier ID:	DEWA-0010-8.080-R				
Route Name:	OLD MINE ROAD (SOUTH SECTION)				
Inspection Date:	10/07/2010	Barrier Rating:	39.50		
Barrier Description					
Type:	STEEL-BACKED TIMBER WITHOUT BLOCKOUT	Barrier Function:	TRAFFIC		
Barrier Material:	STEEL-BACKED TIMBER/LOG	Post Material:	WOOD		
Blockout Type:	N/A	Length (ft.):	118		
Speed Limit (MPH):	35	Placement with Respect to Road:	TANGENT		
Hazard Behind Barrier:	MEDIUM				
Barrier Crashworthiness					
Appropriate Test Level:	TL-2	Barrier Test Level:	TL-2	Is Barrier Crashworthy?:	YES
Beg. End Trtmt Type:	SBT/LOG BURIED	Is Beg. End Trtmt Crashworthy?:	YES	Approach Transition Type:	CONC/MASON SBT
Ending End Trtmt Type:	NONE	Ending End Trtmt Crashworthy?:	N/A		
Average Measurements					
Design Height (In.):	27	Width (In.):	0.0	Post Spacing (In.):	120.0
Height (In.):	20.2	Lateral Offset (In.):	78.3	Road Grade (%):	8.00
Physical Condition					
Barrier	Alignment and Height:	No deflections observed in alignment. The height is low by 6 to 7 in from the design of 27 in.

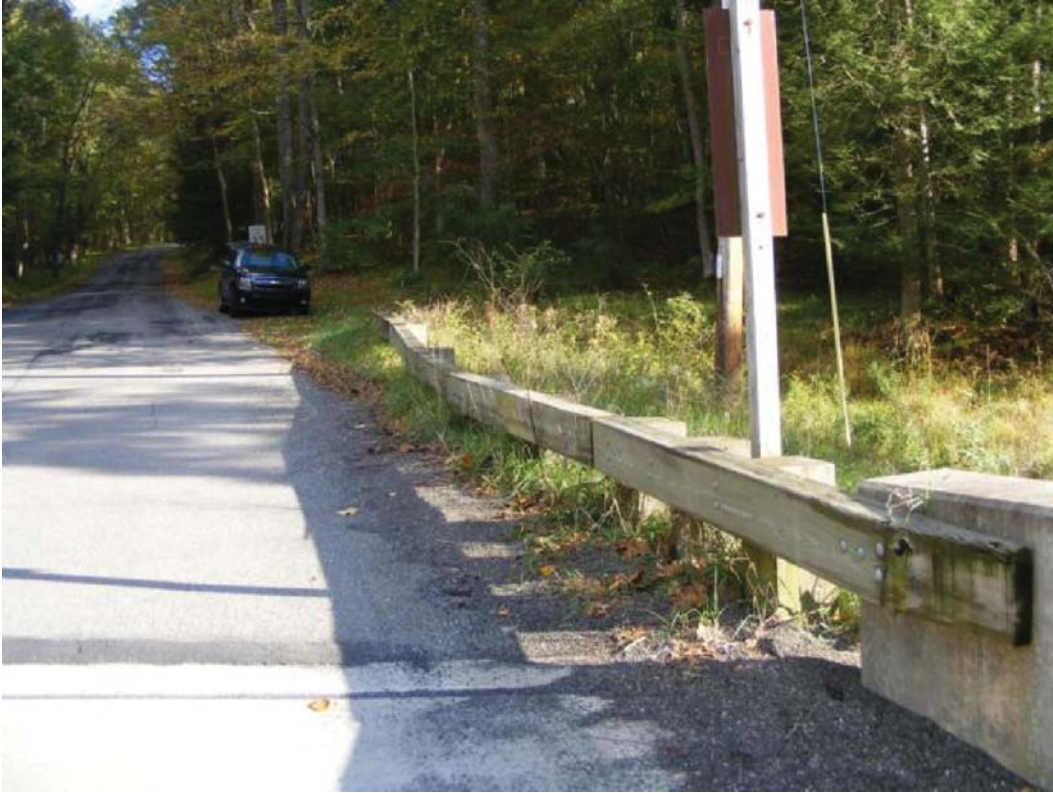
DEWA_0010_8.089_L_1.JPG

Barrier ID:	DEWA-0010-8.089-L				
Route Name:	OLD MINE ROAD (SOUTH SECTION)				
Inspection Date:	10/07/2010	Barrier Rating:	42.40		
Barrier Description					
Type:	STEEL-BACKED TIMBER WITHOUT BLOCKOUT	Barrier Function:	TRAFFIC		
Barrier Material:	STEEL-BACKED TIMBER/LOG	Post Material:	WOOD		
Blockout Type:	N/A	Length (ft.):	89		
Speed Limit (MPH):	35	Placement with Respect to Road:	OUTSIDE OF CURVE		
Hazard Behind Barrier:	MEDIUM				
Barrier Crashworthiness					
Appropriate Test Level:	TL-2	Barrier Test Level:	TL-2	Is Barrier Crashworthy?:	YES
Beg. End Trtmt Type:	SBT/LOG FLARED	Is Beg. End Trtmt Crashworthy?:	NO	Approach Transition Type:	CONC/MASON SBT
Ending End Trtmt Type:	NONE	Ending End Trtmt Crashworthy?:	N/A		
Average Measurements					
Design Height (In.):	27	Width (In.):	0.0	Post Spacing (In.):	120.0
Height (In.):	22.2	Lateral Offset (In.):	47.2	Road Grade (%):	7.20
Physical Condition					
Barrier	Alignment and Height:	No deflections observed in alignment. The height is low by 4 to 5 in from the design of 27 in.

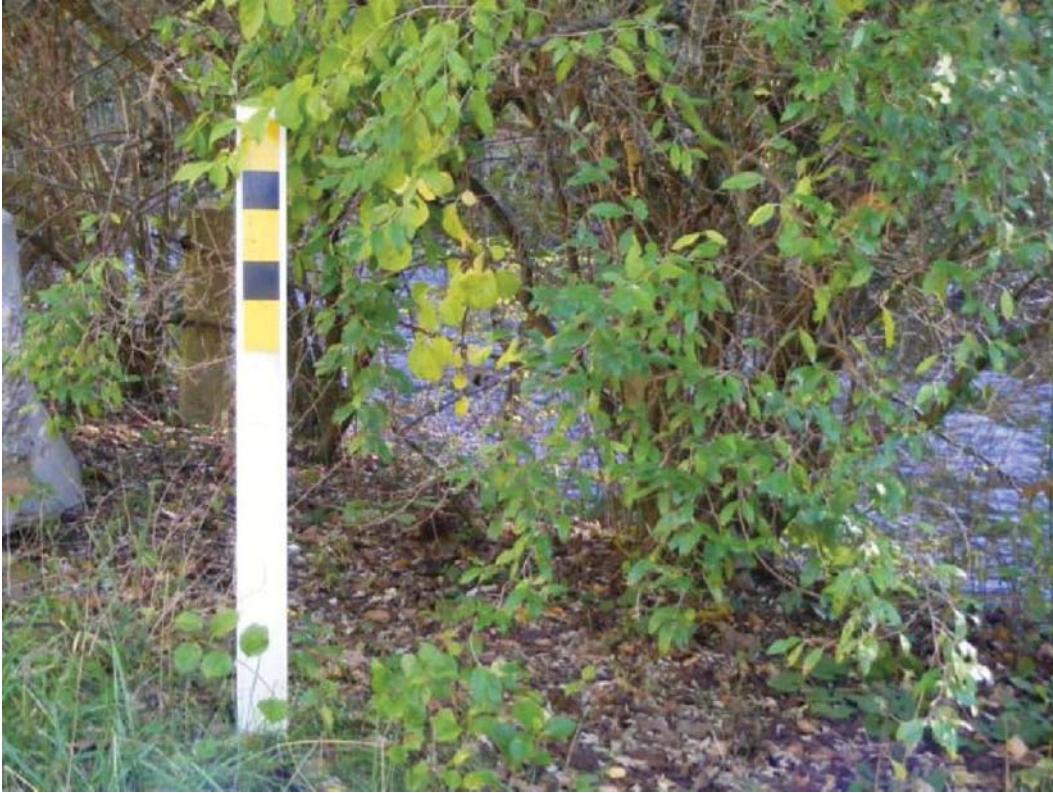
DEWA_0010_8.144_L_1.JPG

Barrier ID:	DEWA-0010-8.144-L				
Route Name:	OLD MINE ROAD (SOUTH SECTION)				
Inspection Date:	10/08/2010	Barrier Rating:	41.20		
Barrier Description					
Type:	OTHER: 2-STRAND CABLE	Barrier Function:	TRAFFIC		
Barrier Material:	CABLE	Post Material:	OTHER: CONCRETE		
Blockout Type:	N/A	Length (ft.):	265		
Speed Limit (MPH):	35	Placement with Respect to Road:	BOTH INSIDE AND OUTSIDE		
Hazard Behind Barrier:	HIGH				
Barrier Crashworthiness					
Appropriate Test Level:	TL-2	Barrier Test Level:	NCW	Is Barrier Crashworthy?:	NO
Beg. End Trtmt Type:	NONE	Is Beg. End Trtmt Crashworthy?:	N/A	Approach Transition Type:	NONE
Ending End Trtmt Type:	NONE	Ending End Trtmt Crashworthy?:	N/A		
Average Measurements					
Design Height (In.):	27	Width (In.):	0.0	Post Spacing (In.):	118.0
Height (In.):	19.2	Lateral Offset (In.):	70.3	Road Grade (%):	1.30
Physical Condition					
Barrier	Alignment and Height:	The barrier alignment is deflected up to 8 in. The height is low by 4 to 10 in from the design of 27 in.

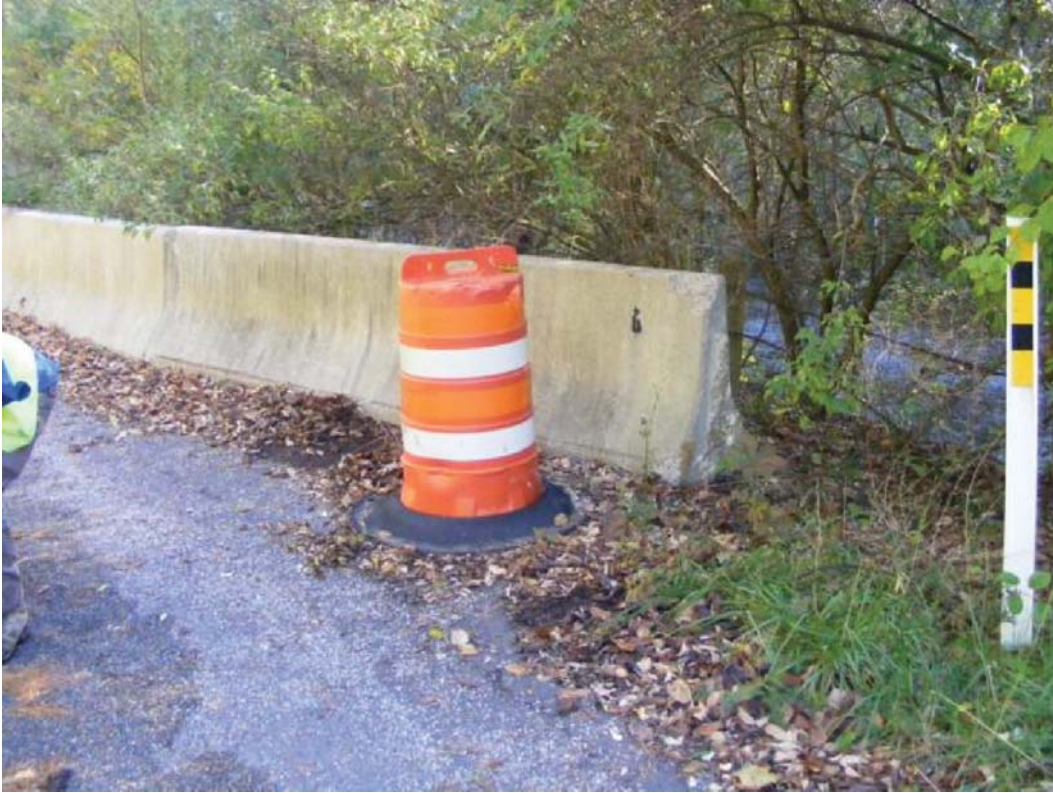
DEWA_0010_8.176_L_1.JPG

Barrier ID:	DEWA-0010-8.176-L				
Route Name:	OLD MINE ROAD (SOUTH SECTION)				
Inspection Date:	10/08/2010	Barrier Rating:	29.70		
Barrier Description					
Type:	CONCRETE BARRIER	Barrier Function:	TRAFFIC		
Barrier Material:	CONCRETE	Post Material:	N/A		
Blockout Type:	N/A	Length (ft.):	98		
Speed Limit (MPH):	35	Placement with Respect to Road:	OUTSIDE OF CURVE		
Hazard Behind Barrier:	HIGH				
Barrier Crashworthiness					
Appropriate Test Level:	TL-2	Barrier Test Level:	TL-3	Is Barrier Crashworthy?:	YES
Beg. End Trtmt Type:	NONE	Is Beg. End Trtmt Crashworthy?:	N/A	Approach Transition Type:	NONE
Ending End Trtmt Type:	NONE	Ending End Trtmt Crashworthy?:	N/A		
Average Measurements					
Design Height (In.):	32	Width (In.):	6.0	Post Spacing (In.):	0.0
Height (In.):	31.0	Lateral Offset (In.):	0.0	Road Grade (%):	0.10
Physical Condition					
Barrier	Alignment and Height:	No deflections observed in alignment. The height is low by 2 in or less from the design of 32 in.

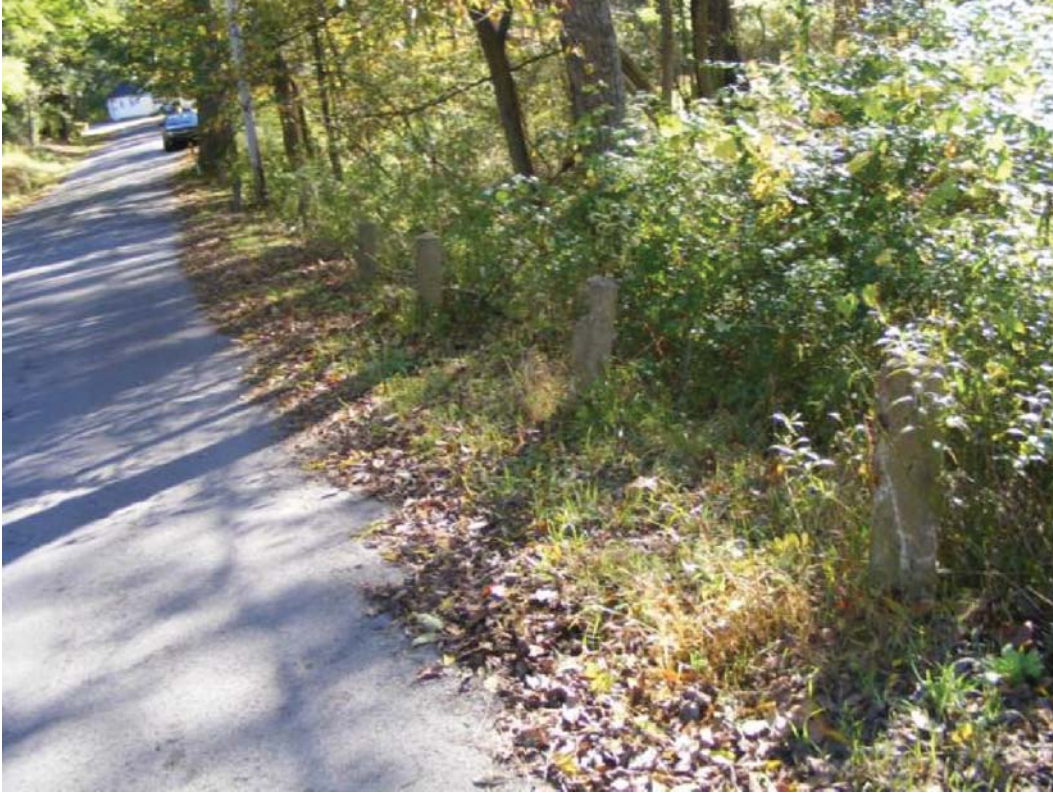
DEWA_0010_8.323_L_1.JPG

Barrier ID:	DEWA-0010-8.323-L				
Route Name:	OLD MINE ROAD (SOUTH SECTION)				
Inspection Date:	10/08/2010	Barrier Rating:	28.30		
Barrier Description					
Type:	OTHER: 2-STRAND CABLE	Barrier Function:	TRAFFIC		
Barrier Material:	CABLE	Post Material:	OTHER: CONCRETE		
Blockout Type:	N/A	Length (ft.):	128		
Speed Limit (MPH):	35	Placement with Respect to Road:	TANGENT		
Hazard Behind Barrier:	LOW				
Barrier Crashworthiness					
Appropriate Test Level:	TL-2	Barrier Test Level:	NCW	Is Barrier Crashworthy?:	NO
Beg. End Trtmt Type:	NONE	Is Beg. End Trtmt Crashworthy?:	N/A	Approach Transition Type:	NONE
Ending End Trtmt Type:	NONE	Ending End Trtmt Crashworthy?:	N/A		
Average Measurements					
Design Height (In.):	27	Width (In.):	0.0	Post Spacing (In.):	118.0
Height (In.):	0.0	Lateral Offset (In.):	44.7	Road Grade (%):	4.80
Physical Condition					
Barrier	Alignment and Height:	The barrier alignment is deflected up to 10 in. Cable is missing so the height is low by 27 in from the design of 27 in.

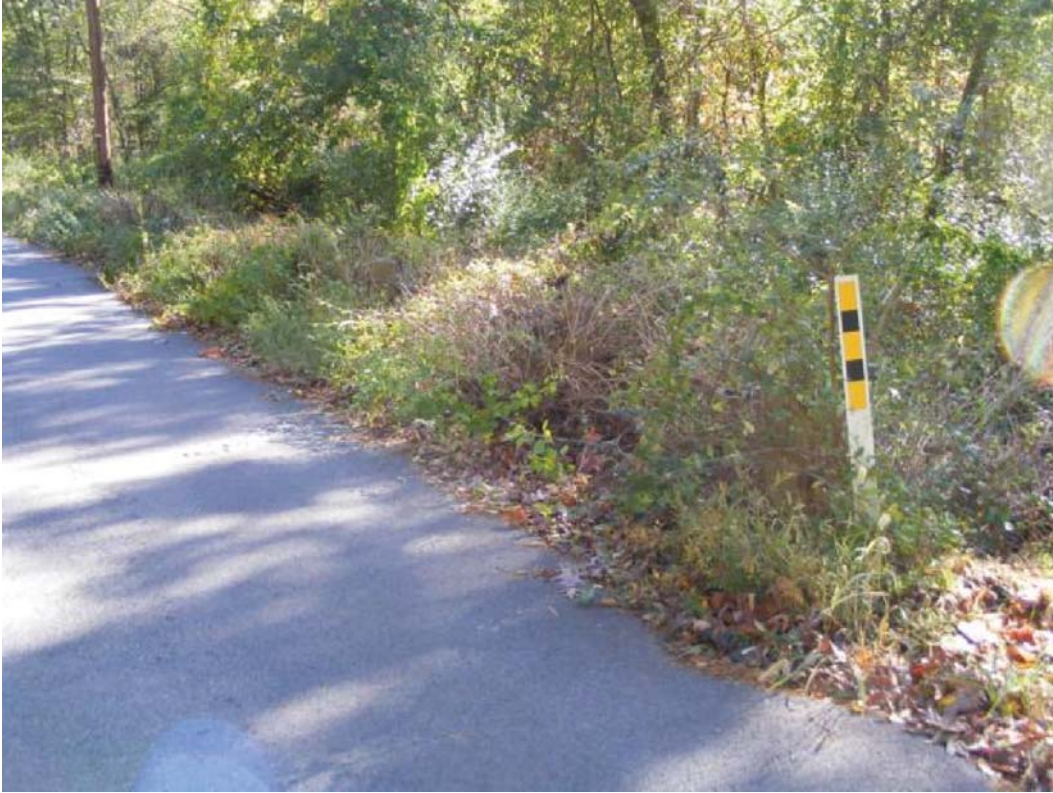
DEWA_0010_8.564_L_1.JPG

Barrier ID:	DEWA-0010-8.564-L				
Route Name:	OLD MINE ROAD (SOUTH SECTION)				
Inspection Date:	10/08/2010	Barrier Rating:	33.70		
Barrier Description					
Type:	OTHER: 2-STRAND CABLE	Barrier Function:	TRAFFIC		
Barrier Material:	CABLE	Post Material:	OTHER: CONCRETE		
Blockout Type:	N/A	Length (ft.):	308		
Speed Limit (MPH):	35	Placement with Respect to Road:	TANGENT		
Hazard Behind Barrier:	MEDIUM				
Barrier Crashworthiness					
Appropriate Test Level:	TL-2	Barrier Test Level:	NCW	Is Barrier Crashworthy?:	NO
Beg. End Trtmt Type:	NONE	Is Beg. End Trtmt Crashworthy?:	N/A	Approach Transition Type:	NONE
Ending End Trtmt Type:	NONE	Ending End Trtmt Crashworthy?:	N/A		
Average Measurements					
Design Height (In.):	27	Width (In.):	0.0	Post Spacing (In.):	117.0
Height (In.):	12.6	Lateral Offset (In.):	31.0	Road Grade (%):	2.70
Physical Condition					
Barrier	Alignment and Height:	The barrier alignment is deflected 12 in or more. The height is low by 8 to 13 in from the design of 27 ins.

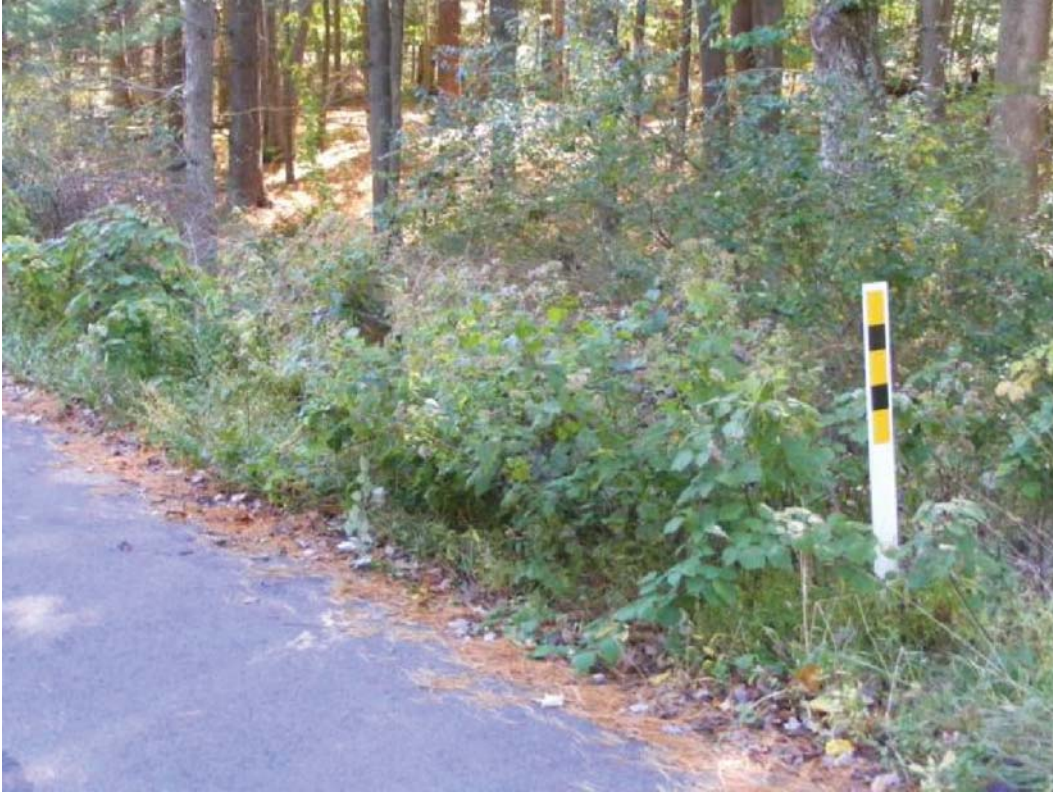
DEWA_0010_8.697_L_1.JPG

Barrier ID:	DEWA-0010-8.697-L				
Route Name:	OLD MINE ROAD (SOUTH SECTION)				
Inspection Date:	10/08/2010	Barrier Rating:	26.60		
Barrier Description					
Type:	OTHER: 2-STRAND CABLE	Barrier Function:	TRAFFIC		
Barrier Material:	CABLE	Post Material:	OTHER: CONCRETE		
Blockout Type:	N/A	Length (ft.):	95		
Speed Limit (MPH):	35	Placement with Respect to Road:	TANGENT		
Hazard Behind Barrier:	MEDIUM				
Barrier Crashworthiness					
Appropriate Test Level:	TL-2	Barrier Test Level:	NCW	Is Barrier Crashworthy?:	NO
Beg. End Trtmt Type:	NONE	Is Beg. End Trtmt Crashworthy?:	N/A	Approach Transition Type:	NONE
Ending End Trtmt Type:	NONE	Ending End Trtmt Crashworthy?:	N/A		
Average Measurements					
Design Height (In.):	27	Width (In.):	0.0	Post Spacing (In.):	118.0
Height (In.):	15.6	Lateral Offset (In.):	34.5	Road Grade (%):	0.90
Physical Condition					
Barrier	Alignment and Height:	No deflections observed in alignment. The height is low by 10 to 13 in from the design of 27 in for 95 linear ft.

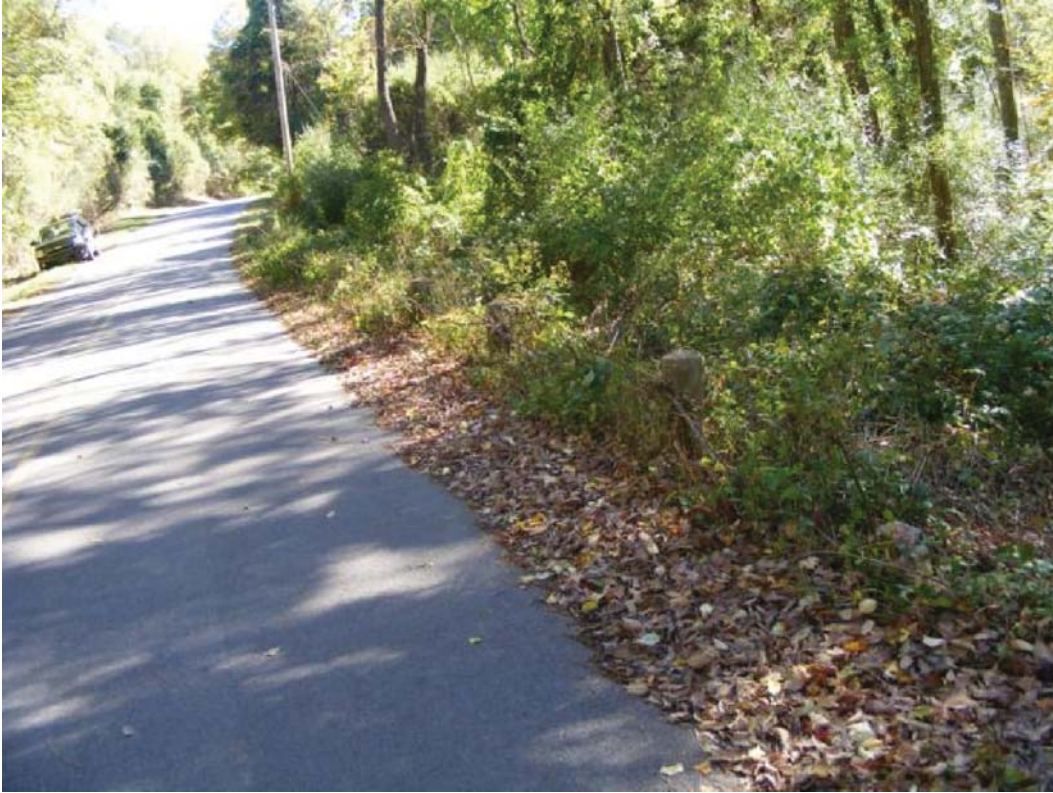
DEWA_0010_8.838_L_1.JPG

Barrier ID:	DEWA-0010-8.838-L				
Route Name:	OLD MINE ROAD (SOUTH SECTION)				
Inspection Date:	10/08/2010	Barrier Rating:	27.00		
Barrier Description					
Type:	OTHER: 2-STRAND CABLE	Barrier Function:	TRAFFIC		
Barrier Material:	CABLE	Post Material:	OTHER: CONCRETE		
Blockout Type:	N/A	Length (ft.):	120		
Speed Limit (MPH):	35	Placement with Respect to Road:	INSIDE OF CURVE		
Hazard Behind Barrier:	LOW				
Barrier Crashworthiness					
Appropriate Test Level:	TL-2	Barrier Test Level:	NCW	Is Barrier Crashworthy?:	NO
Beg. End Trtmt Type:	NONE	Is Beg. End Trtmt Crashworthy?:	N/A	Approach Transition Type:	NONE
Ending End Trtmt Type:	NONE	Ending End Trtmt Crashworthy?:	N/A		
Average Measurements					
Design Height (In.):	27	Width (In.):	0.0	Post Spacing (In.):	121.3
Height (In.):	14.0	Lateral Offset (In.):	34.7	Road Grade (%):	0.50
Physical Condition					
Barrier	Alignment and Height:	The barrier is deflected up to 10 in. Height is low by 12 to 14 in from design of 27 in.

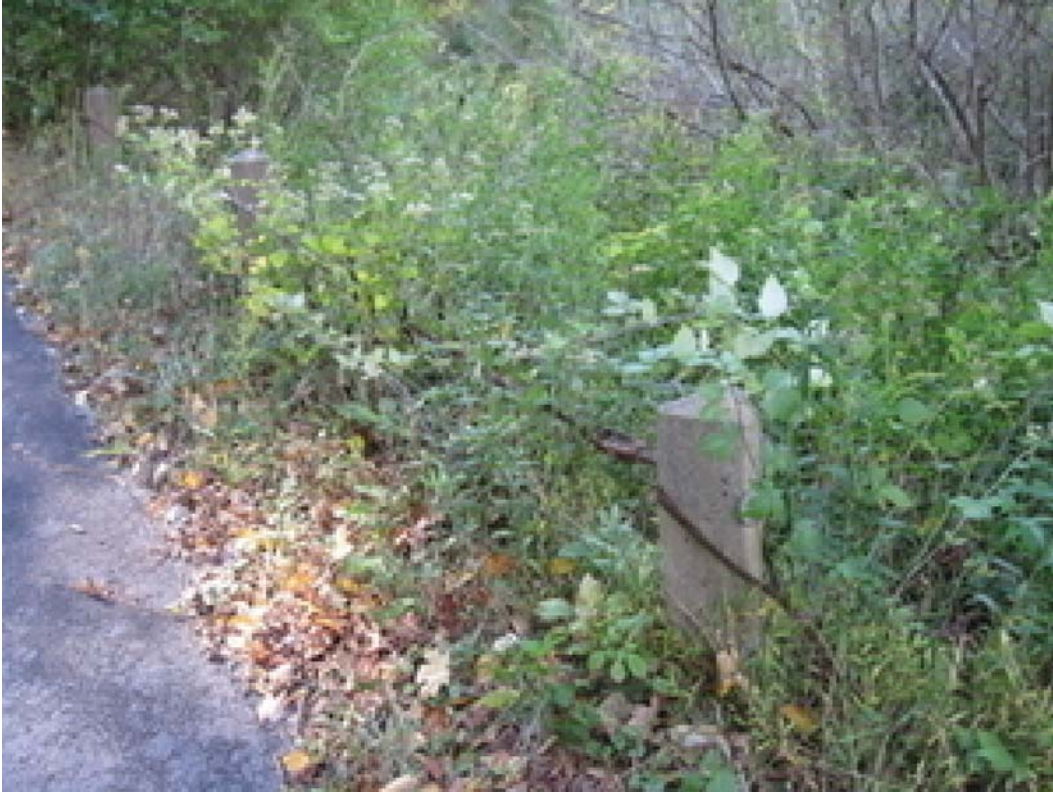
DEWA_0010_9.118_L_1.jpg

Barrier ID:	DEWA-0010-9.118-L				
Route Name:	OLD MINE ROAD (SOUTH SECTION)				
Inspection Date:	10/07/2010	Barrier Rating:	55.50		
Barrier Description					
Type:	OTHER: 2-STRAND CABLE	Barrier Function:	TRAFFIC		
Barrier Material:	CABLE	Post Material:	OTHER: CONCRETE		
Blockout Type:	N/A	Length (ft.):	1680		
Speed Limit (MPH):	35	Placement with Respect to Road:	OUTSIDE OF CURVE		
Hazard Behind Barrier:	LOW				
Barrier Crashworthiness					
Appropriate Test Level:	TL-2	Barrier Test Level:	NCW	Is Barrier Crashworthy?:	NO
Beg. End Trtmt Type:	NONE	Is Beg. End Trtmt Crashworthy?:	N/A	Approach Transition Type:	NONE
Ending End Trtmt Type:	NONE	Ending End Trtmt Crashworthy?:	N/A		
Average Measurements					
Design Height (In.):	27	Width (In.):	0.0	Post Spacing (In.):	121.8
Height (In.):	17.6	Lateral Offset (In.):	26.1	Road Grade (%):	2.70
Physical Condition					
Barrier	Alignment and Height:	Alignment deflects more than 12 in along 300 ft of barrier. Height ranges between 5 and 17 in below the 27 in design height along the entire length.

Breaking and Cracking:	2 posts are broken and have exposed rebar.			
	Missing Elements:	No missing elements observed.			
	Corrosion and Weathering:	No loss of cable cross section or erosion around posts observed.			
End Treatments	Alignment and Height:				
	Breaking and Cracking:				
	Missing Elements:				
	Corrosion and Weathering:

Repair Action:	REPLACE	FMSS Work Type:	CAPITAL IMPROVEMENT	Repair Cost:	\$149875
Brief Workorder:	Replace cable guardrail with Steel-Backed Timber w/o blockouts and 2 flared end treatments.				
Workorder:	Remove Cable Guardrail at \$5- per -Lin. Ft. for 1680 LF = \$8400. Remove 1680 feet of cable guardrail. Steel-Backed Timber w/o Blockout at \$60- per -Lin. Ft. for 1620 LF = \$97200. SBT / Log Flared at \$5000- per -Each for 2 Unit(s) = \$10000. Low Speed Traffic Control at \$1475- per -Day for 14 Day(s) = \$20650. 7 days removal 7 days installation.

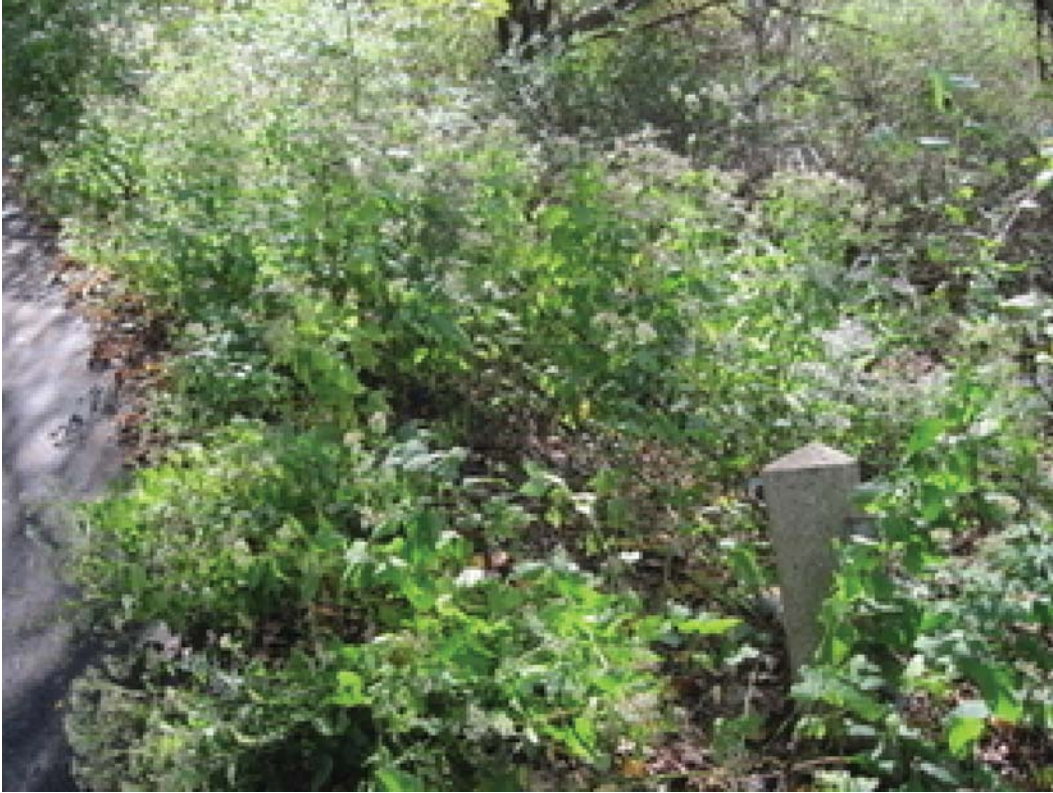
DEWA_0010_9.556_L_1.jpg

Barrier ID:	DEWA-0010-9.556-L				
Route Name:	OLD MINE ROAD (SOUTH SECTION)				
Inspection Date:	10/07/2010	Barrier Rating:	31.20		
Barrier Description					
Type:	OTHER: 2-STRAND CABLE	Barrier Function:	TRAFFIC		
Barrier Material:	CABLE	Post Material:	OTHER: CONCRETE		
Blockout Type:	N/A	Length (ft.):	230		
Speed Limit (MPH):	35	Placement with Respect to Road:	INSIDE OF CURVE		
Hazard Behind Barrier:	LOW				
Barrier Crashworthiness					
Appropriate Test Level:	TL-2	Barrier Test Level:	NCW	Is Barrier Crashworthy?:	NO
Beg. End Trtmt Type:	NONE	Is Beg. End Trtmt Crashworthy?:	N/A	Approach Transition Type:	NONE
Ending End Trtmt Type:	NONE	Ending End Trtmt Crashworthy?:	N/A		
Average Measurements					
Design Height (In.):	27	Width (In.):	0.0	Post Spacing (In.):	118.3
Height (In.):	13.0	Lateral Offset (In.):	39.2	Road Grade (%):	0.80
Physical Condition					
Barrier	Alignment and Height:	Alignment deflects greater than 12 in for the entire 230ft of barrier. Height ranges from 12 in to 17 in below 27 in design height.

Breaking and Cracking:	Top cable is disconnected from one post and another post is destroyed from a possible impact.			
	Missing Elements:	No missing elements observed.			
	Corrosion and Weathering:	No loss of cable cross section or erosion around posts observed.			
End Treatments	Alignment and Height:				
	Breaking and Cracking:				
	Missing Elements:				
	Corrosion and Weathering:

Repair Action:	REPLACE	FMSS Work Type:	CAPITAL IMPROVEMENT	Repair Cost:	\$26730
Brief Workorder:	Replace cable guardrail with Steel-Backed Timber w/o blockouts and 2 flared end treatments.				
Workorder:	Remove Cable Guardrail at \$5- per -Lin. Ft. for 230 LF = \$1150. Steel-Backed Timber w/o Blockout at \$60- per -Lin. Ft. for 170 LF = \$10200. SBT / Log Flared at \$5000- per -Each for 2 Unit(s) = \$10000. Low Speed Traffic Control at \$1475- per -Day for 2 Day(s) = \$2950. 1 day removal and 1 day installation.

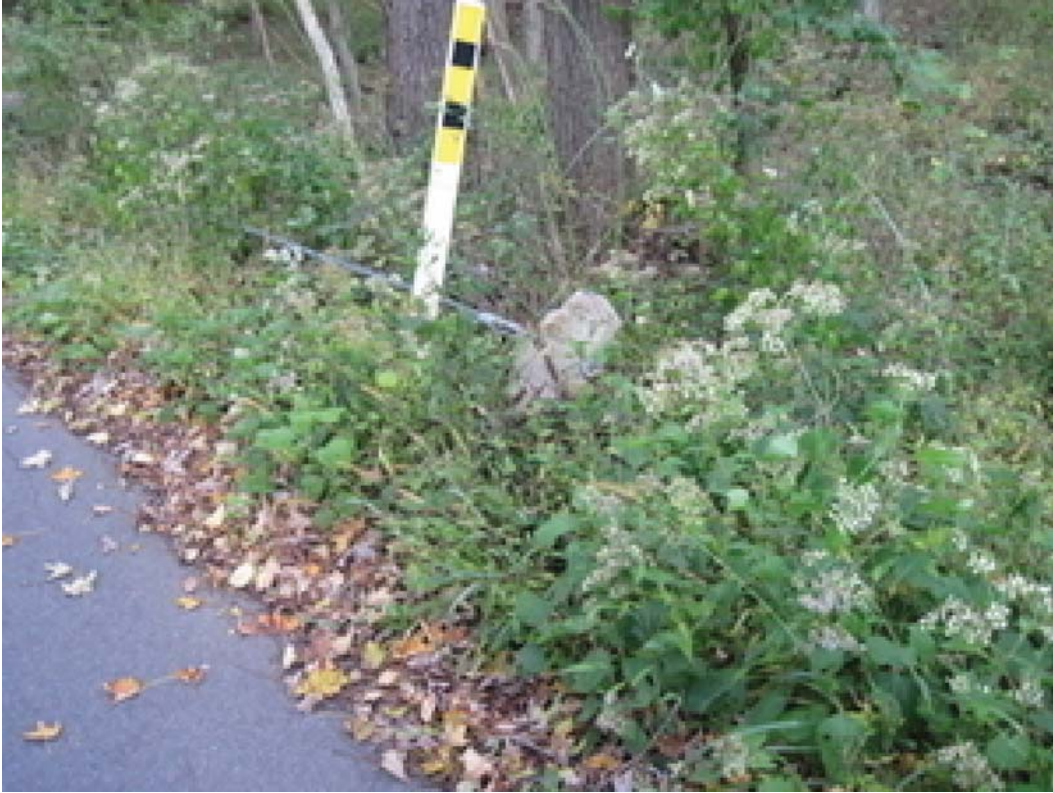
DEWA_0010_9.804_R_1.jpg

Barrier ID:	DEWA-0010-9.804-R				
Route Name:	OLD MINE ROAD (SOUTH SECTION)				
Inspection Date:	10/07/2010	Barrier Rating:	28.30		
Barrier Description					
Type:	OTHER: 2-STRAND CABLE	Barrier Function:	TRAFFIC		
Barrier Material:	CABLE	Post Material:	OTHER: CONCRETE		
Blockout Type:	N/A	Length (ft.):	125		
Speed Limit (MPH):	35	Placement with Respect to Road:	TANGENT		
Hazard Behind Barrier:	LOW				
Barrier Crashworthiness					
Appropriate Test Level:	TL-2	Barrier Test Level:	NCW	Is Barrier Crashworthy?:	NO
Beg. End Trtmt Type:	NONE	Is Beg. End Trtmt Crashworthy?:	N/A	Approach Transition Type:	NONE
Ending End Trtmt Type:	NONE	Ending End Trtmt Crashworthy?:	N/A		
Average Measurements					
Design Height (In.):	27	Width (In.):	0.0	Post Spacing (In.):	118.0
Height (In.):	18.7	Lateral Offset (In.):	42.0	Road Grade (%):	3.60
Physical Condition					
Barrier	Alignment and Height:	Alignment deflects more than 12 in along 80 ft of barrier. Height ranges from 4 to 13 in below the 27 in design height along the entire length.

Breaking and Cracking:	40 ft of barrier and 4 posts have fallen due to a fallen tree.			
	Missing Elements:	No missing elements observed.			
	Corrosion and Weathering:	No loss of cable cross section or erosion around posts observed.			
End Treatments	Alignment and Height:	NA			
	Breaking and Cracking:	NA			
	Missing Elements:	NA			
	Corrosion and Weathering:	NA

Repair Action:	REPLACE	FMSS Work Type:	CAPITAL IMPROVEMENT	Repair Cost:	\$19222
Brief Workorder:	Replace cable guardrail with Steel-Backed Timber w/o blockouts and 2 flared Steel-Backed Timber end treatments.				
Workorder:	Remove Cable Guardrail at \$5- per -Lin. Ft. for 125 LF = \$625. Steel-Backed Timber w/o Blockout at \$60- per -Lin. Ft. for 65 LF = \$3900. SBT / Log Flared at \$5000- per -Each for 2 Unit(s) = \$10000. Low Speed Traffic Control at \$1475- per -Day for 2 Day(s) = \$2950.

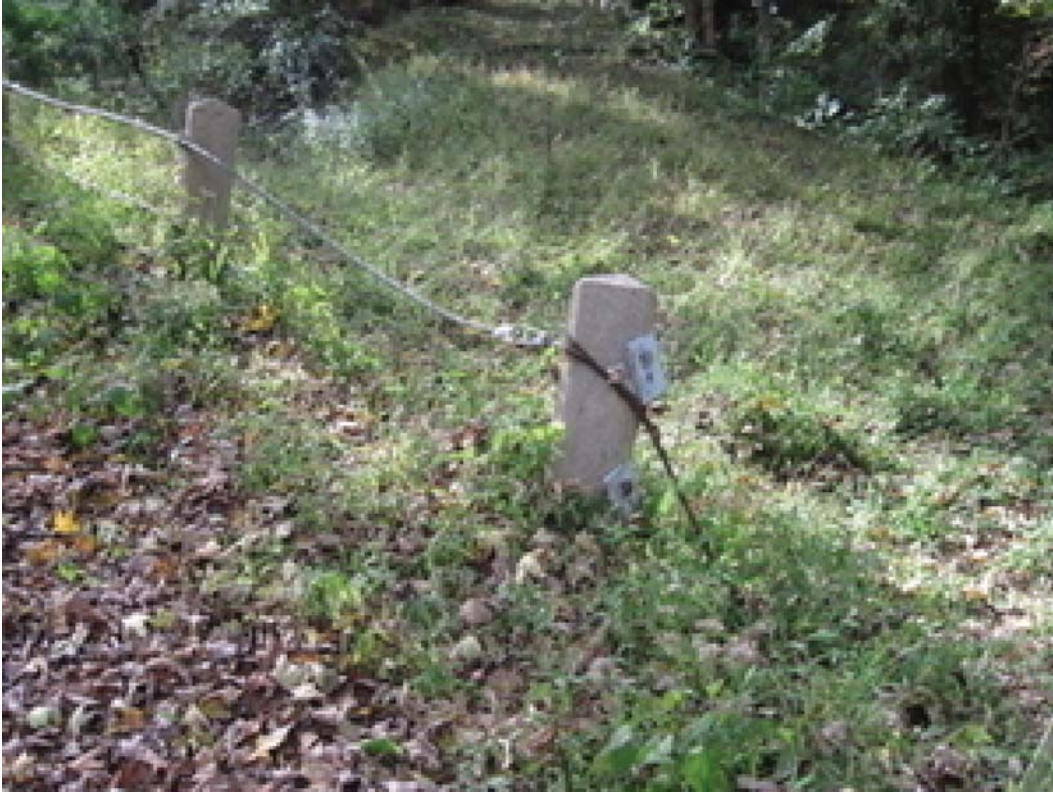
DEWA_0010_9.808_L_1.jpg

Barrier ID:	DEWA-0010-9.808-L				
Route Name:	OLD MINE ROAD (SOUTH SECTION)				
Inspection Date:	10/07/2010	Barrier Rating:	23.70		
Barrier Description					
Type:	OTHER: 2-STRAND CABLE	Barrier Function:	TRAFFIC		
Barrier Material:	CABLE	Post Material:	OTHER: CONCRETE		
Blockout Type:	N/A	Length (ft.):	155		
Speed Limit (MPH):	35	Placement with Respect to Road:	TANGENT		
Hazard Behind Barrier:	MEDIUM				
Barrier Crashworthiness					
Appropriate Test Level:	TL-2	Barrier Test Level:	NCW	Is Barrier Crashworthy?:	NO
Beg. End Trtmt Type:	NONE	Is Beg. End Trtmt Crashworthy?:	N/A	Approach Transition Type:	NONE
Ending End Trtmt Type:	NONE	Ending End Trtmt Crashworthy?:	N/A		
Average Measurements					
Design Height (In.):	27	Width (In.):	0.0	Post Spacing (In.):	112.0
Height (In.):	20.0	Lateral Offset (In.):	53.0	Road Grade (%):	2.20
Physical Condition					
Barrier	Alignment and Height:	Barrier is out of alignment by 6 - 12 in along 85 ft and by more than 12 in along 70 ft. Height is 6 - 8 in below 27-in design height.

Breaking and Cracking:	No posts were cracked or broken. No fraying breaking or severing of cables observed.			
	Missing Elements:	No missing elements were observed.			
	Corrosion and Weathering:	No loss of cable cross section or erosion around posts observed.			
End Treatments	Alignment and Height:				
	Breaking and Cracking:				
	Missing Elements:				
	Corrosion and Weathering:

Repair Action:	REPLACE	FMSS Work Type:	CAPITAL IMPROVEMENT	Repair Cost:	\$21368
Brief Workorder:	Replace cable guardrail with Steel-Backed Timber w/o blockouts and 2 flared end treatments.				
Workorder:	Remove Cable Guardrail at \$5- per -Lin. Ft. for 155 LF = \$775. Steel-Backed Timber w/o Blockout at \$60- per -Lin. Ft. for 95 LF = \$5700. SBT / Log Flared at \$5000- per -Each for 2 Unit(s) = \$10000. Low Speed Traffic Control at \$1475- per -Day for 2 Day(s) = \$2950. 1 day removal and 1 day installation.

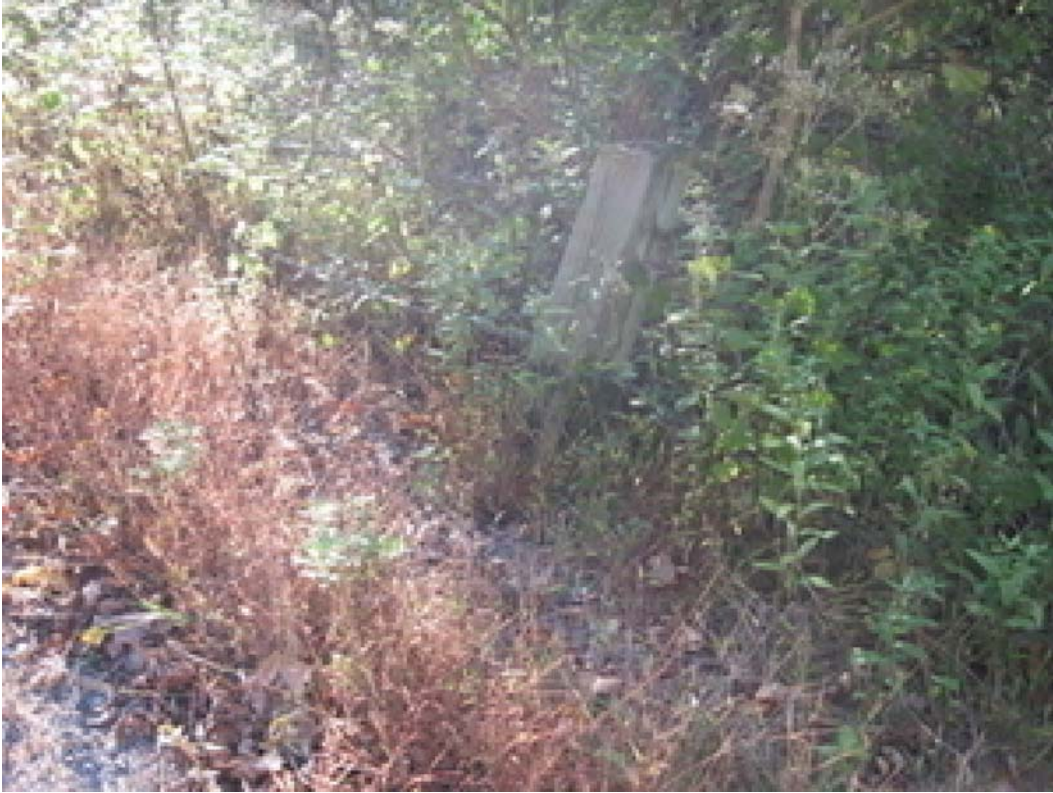
DEWA_0010_10.306_L_1.jpg

Barrier ID:	DEWA-0010-10.306-L				
Route Name:	OLD MINE ROAD (SOUTH SECTION)				
Inspection Date:	10/07/2010	Barrier Rating:	35.50		
Barrier Description					
Type:	OTHER: 2-STRAND CABLE	Barrier Function:	TRAFFIC		
Barrier Material:	CABLE	Post Material:	WOOD		
Blockout Type:	N/A	Length (ft.):	500		
Speed Limit (MPH):	35	Placement with Respect to Road:	INSIDE OF CURVE		
Hazard Behind Barrier:	LOW				
Barrier Crashworthiness					
Appropriate Test Level:	TL-2	Barrier Test Level:	NCW	Is Barrier Crashworthy?:	NO
Beg. End Trtmt Type:	NONE	Is Beg. End Trtmt Crashworthy?:	N/A	Approach Transition Type:	NONE
Ending End Trtmt Type:	NONE	Ending End Trtmt Crashworthy?:	N/A		
Average Measurements					
Design Height (In.):	27	Width (In.):	0.0	Post Spacing (In.):	129.3
Height (In.):	18.7	Lateral Offset (In.):	59.0	Road Grade (%):	1.00
Physical Condition					
Barrier	Alignment and Height:	Alignment deflects 6 in to 12 in for 100 ft and greater than 12 in for 250 ft. Height ranges from 4 in to 9 in below 27 in design height.

Breaking and Cracking:	Posts are laying on ground for approximately 100ft. The last 80 ft of barrier is mostly buried.			
	Missing Elements:	No missing elements observed.			
	Corrosion and Weathering:	Ten posts are weathered and rotten.			
End Treatments	Alignment and Height:				
	Breaking and Cracking:				
	Missing Elements:				
	Corrosion and Weathering:

Repair Action:	REPLACE	FMSS Work Type:	CAPITAL IMPROVEMENT	Repair Cost:	\$49280
Brief Workorder:	Replace cable guardrail with Steel-Backed Timber w/o blockouts and 2 flared end treatments.				
Workorder:	Remove Cable Guardrail at \$5- per -Lin. Ft. for 500 LF = \$2500. Steel-Backed Timber w/o Blockout at \$60- per -Lin. Ft. for 440 LF = \$26400. SBT / Log Flared at \$5000- per -Each for 2 Unit(s) = \$10000. Low Speed Traffic Control at \$1475- per -Day for 4 Day(s) = \$5900. 2 days removal and 2 days installation.

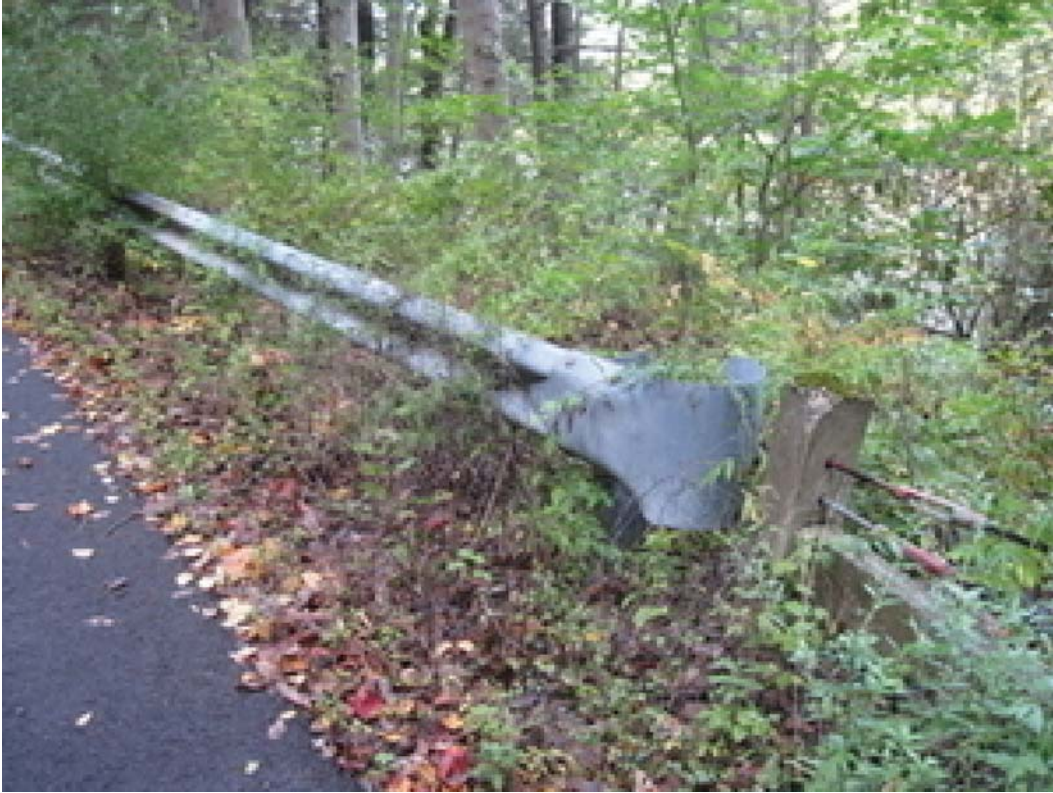
DEWA_0010_10.863_L_1.jpg

Barrier ID:	DEWA-0010-10.863-L				
Route Name:	OLD MINE ROAD (SOUTH SECTION)				
Inspection Date:	10/07/2010	Barrier Rating:	65.10		
Barrier Description					
Type:	W-BEAM WEAK POST	Barrier Function:	TRAFFIC		
Barrier Material:	GALVANIZED STEEL	Post Material:	GALVANIZED STEEL		
Blockout Type:	N/A	Length (ft.):	1520		
Speed Limit (MPH):	35	Placement with Respect to Road:	BOTH INSIDE AND OUTSIDE		
Hazard Behind Barrier:	MEDIUM				
Barrier Crashworthiness					
Appropriate Test Level:	TL-2	Barrier Test Level:	TL-2	Is Barrier Crashworthy?:	YES
Beg. End Trtmt Type:	NONE	Is Beg. End Trtmt Crashworthy?:	N/A	Approach Transition Type:	NONE
Ending End Trtmt Type:	NONE	Ending End Trtmt Crashworthy?:	N/A		
Average Measurements					
Design Height (In.):	27	Width (In.):	0.0	Post Spacing (In.):	149.8
Height (In.):	21.3	Lateral Offset (In.):	40.9	Road Grade (%):	0.80
Physical Condition					
Barrier	Alignment and Height:	No alignment deflection was observed. Height is 3 - 8 in below 27-in design height for 1350 ft and is 2 - 3 in below for 170 ft.

Breaking and Cracking:	No breaking or cracking was observed.			
	Missing Elements:	No missing elements were observed.			
	Corrosion and Weathering:	No loss of cross section or erosion around posts observed.			
End Treatments	Alignment and Height:				
	Breaking and Cracking:				
	Missing Elements:				
	Corrosion and Weathering:

Repair Action:	REPAIR	FMSS Work Type:	DEFERRED MAINTENANCE	Repair Cost:	\$28078
Brief Workorder:	Raise 1520 feet of guardrail to 27-inch design height.				
Workorder:	Adjust Guardrail at \$10- per -Lin. Ft. for 1520 LF = \$15200. Raise 1520ft. of guardrail to 27-inch design height Low Speed Traffic Control at \$1475- per -Day for 7 Day(s) = \$10325.

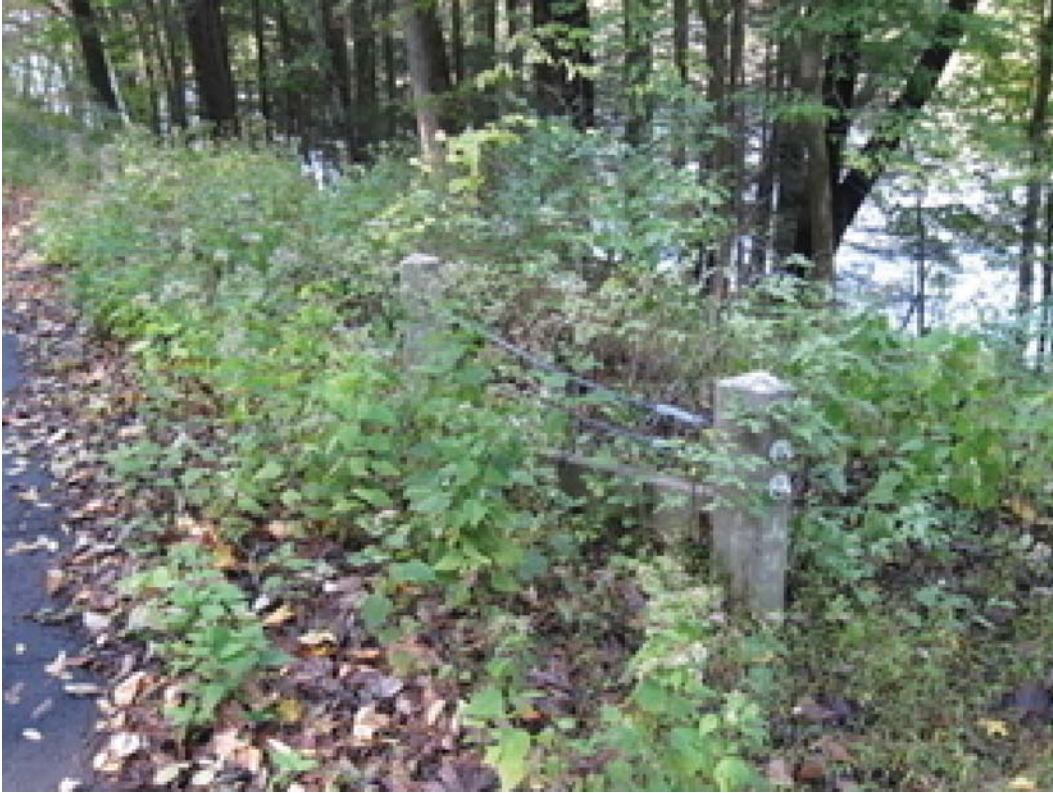
DEWA_0010_11.152_L_1.jpg

Barrier ID:	DEWA-0010-11.152-L				
Route Name:	OLD MINE ROAD (SOUTH SECTION)				
Inspection Date:	10/07/2010	Barrier Rating:	58.00		
Barrier Description					
Type:	OTHER: 2-STRAND CABLE	Barrier Function:	TRAFFIC		
Barrier Material:	CABLE	Post Material:	OTHER: CONCRETE		
Blockout Type:	N/A	Length (ft.):	1184		
Speed Limit (MPH):	35	Placement with Respect to Road:	OUTSIDE OF CURVE		
Hazard Behind Barrier:	MEDIUM				
Barrier Crashworthiness					
Appropriate Test Level:	TL-2	Barrier Test Level:	NCW	Is Barrier Crashworthy?:	NO
Beg. End Trtmt Type:	NONE	Is Beg. End Trtmt Crashworthy?:	N/A	Approach Transition Type:	NONE
Ending End Trtmt Type:	NONE	Ending End Trtmt Crashworthy?:	N/A		
Average Measurements					
Design Height (In.):	27	Width (In.):	0.0	Post Spacing (In.):	121.3
Height (In.):	20.0	Lateral Offset (In.):	40.0	Road Grade (%):	2.50
Physical Condition					
Barrier	Alignment and Height:	Alignment deflects more than 12 in along 400 ft of barrier. Height ranges between 2 and 11 in below 27 in design height along entire length.

Breaking and Cracking:	80 ft of barrier and 8 posts are broken and on the ground due to a tree impact.			
	Missing Elements:	No missing elements observed.			
	Corrosion and Weathering:	No loss of cable cross section or erosion around posts observed.			
End Treatments	Alignment and Height:	NA			
	Breaking and Cracking:	NA			
	Missing Elements:	NA			
	Corrosion and Weathering:	NA

Repair Action:	REPLACE	FMSS Work Type:	CAPITAL IMPROVEMENT	Repair Cost:	\$70928
Brief Workorder:	Remove cable guardrail and install 1154 feet of weak post w-beam and flared w-beam end treatment. Tie into adjacent existing w-beam.				
Workorder:	Remove Cable Guardrail at \$5- per -Lin. Ft. for 1184 LF = \$5920. Remove 1184 feet of cable guardrail W-Beam Weak Post at \$35- per -Lin. Ft. for 1154 LF = \$40310. W-beam flared 350 compliant at \$3500- per -Each for 1 Unit(s) = \$3500. Low Speed Traffic Control at \$1475- per -Day for 10 Day(s) = \$14750.
