NPS Guardwall/Rail Inventory Program Delaware Water Gap National Recreation Area

**Federal Lands Highway
Road Inventory Program**

Federal Highway Administration
Eastern Federal Lands Highway Division
Road Inventory Program (RIP)

Data Collection Date: October 2010
Report Date: December 2015

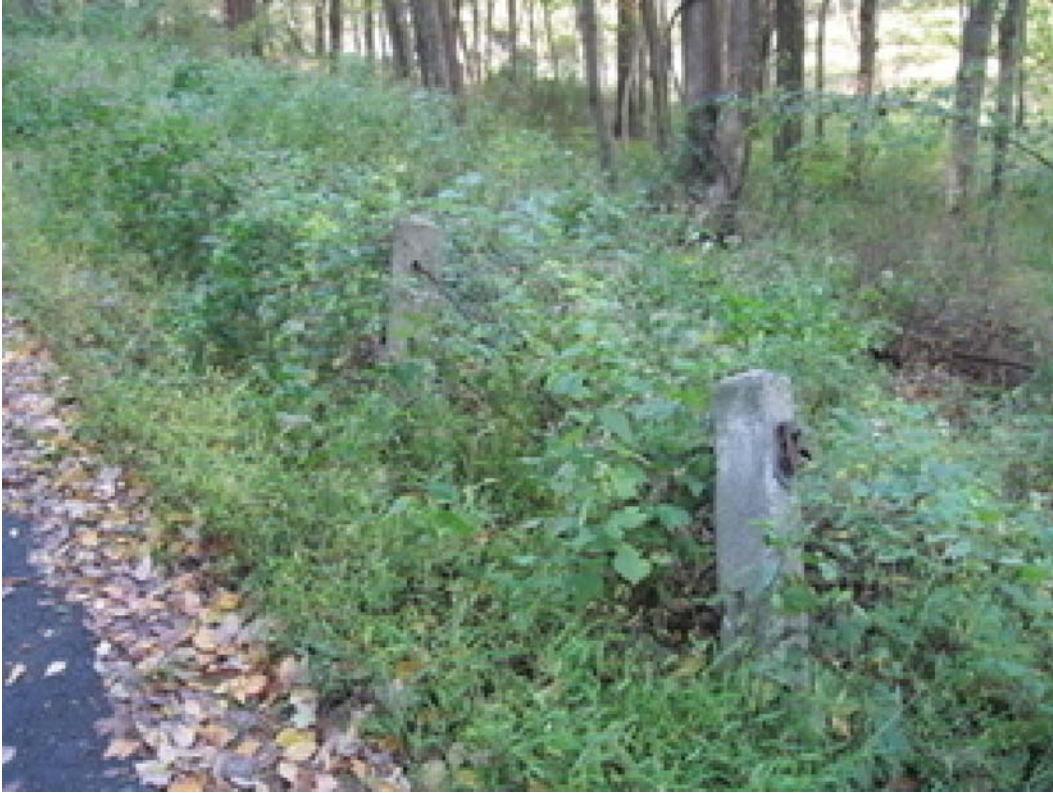
DEWA_0010_11.434_L_1.jpg

Barrier ID:	DEWA-0010-11.434-L				
Route Name:	OLD MINE ROAD (SOUTH SECTION)				
Inspection Date:	10/07/2010	Barrier Rating:	32.70		
Barrier Description					
Type:	OTHER: 2-STRAND CABLE	Barrier Function:	TRAFFIC		
Barrier Material:	CABLE	Post Material:	OTHER: CONCRETE		
Blockout Type:	N/A	Length (ft.):	480		
Speed Limit (MPH):	35	Placement with Respect to Road:	BOTH INSIDE AND OUTSIDE		
Hazard Behind Barrier:	LOW				
Barrier Crashworthiness					
Appropriate Test Level:	TL-2	Barrier Test Level:	NCW	Is Barrier Crashworthy?:	NO
Beg. End Trtmt Type:	NONE	Is Beg. End Trtmt Crashworthy?:	N/A	Approach Transition Type:	NONE
Ending End Trtmt Type:	NONE	Ending End Trtmt Crashworthy?:	N/A		
Average Measurements					
Design Height (In.):	27	Width (In.):	0.0	Post Spacing (In.):	117.6
Height (In.):	25.7	Lateral Offset (In.):	49.0	Road Grade (%):	1.80
Physical Condition					
Barrier	Alignment and Height:	Alignment deflects 6 in to 12 in for 200 ft and greater than 12 in for 50 ft. Height as low as 2 in below 27 in design height.

Breaking and Cracking:	No posts are cracked or broken. No fraying breaking or severing of cables observed.			
	Missing Elements:	No missing elements observed.			
	Corrosion and Weathering:	No loss of cable cross section or erosion around posts observed.			
End Treatments	Alignment and Height:				
	Breaking and Cracking:				
	Missing Elements:				
	Corrosion and Weathering:

Repair Action:	REPLACE	FMSS Work Type:	CAPITAL IMPROVEMENT	Repair Cost:	\$47850
Brief Workorder:	Replace cable guardrail with Steel-Backed Timber w/o blockouts and 2 flared end treatments.				
Workorder:	Remove Cable Guardrail at \$5- per -Lin. Ft. for 480 LF = \$2400. Steel-Backed Timber w/o Blockout at \$60- per -Lin. Ft. for 420 LF = \$25200. SBT / Log Flared at \$5000- per -Each for 2 Unit(s) = \$10000. Low Speed Traffic Control at \$1475- per -Day for 4 Day(s) = \$5900. 2 days removal and 2 days installation.

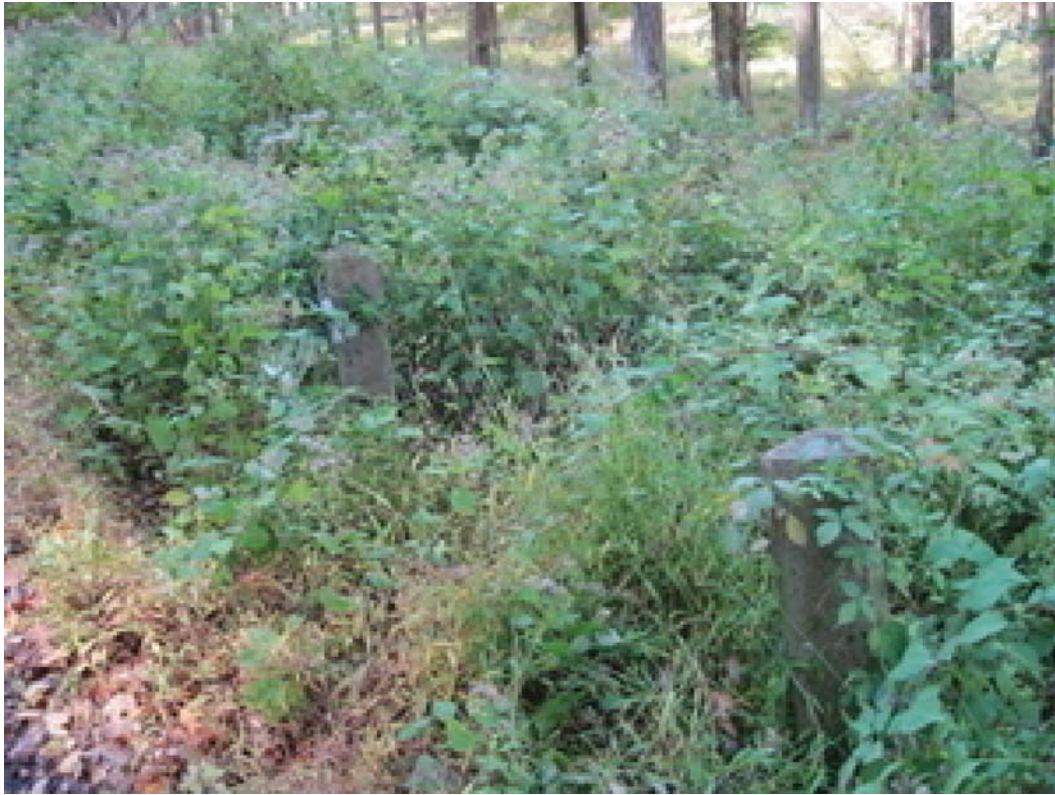
DEWA_0010_11.534_L_1.jpg

Barrier ID:	DEWA-0010-11.534-L				
Route Name:	OLD MINE ROAD (SOUTH SECTION)				
Inspection Date:	10/07/2010	Barrier Rating:	50.70		
Barrier Description					
Type:	OTHER: 2-STRAND CABLE	Barrier Function:	TRAFFIC		
Barrier Material:	CABLE	Post Material:	OTHER: CONCRETE		
Blockout Type:	N/A	Length (ft.):	1103		
Speed Limit (MPH):	35	Placement with Respect to Road:	BOTH INSIDE AND OUTSIDE		
Hazard Behind Barrier:	MEDIUM				
Barrier Crashworthiness					
Appropriate Test Level:	TL-2	Barrier Test Level:	NCW	Is Barrier Crashworthy?:	NO
Beg. End Trtmt Type:	NONE	Is Beg. End Trtmt Crashworthy?:	N/A	Approach Transition Type:	NONE
Ending End Trtmt Type:	NONE	Ending End Trtmt Crashworthy?:	N/A		
Average Measurements					
Design Height (In.):	27	Width (In.):	0.0	Post Spacing (In.):	122.0
Height (In.):	23.2	Lateral Offset (In.):	55.5	Road Grade (%):	0.40
Physical Condition					
Barrier	Alignment and Height:	110 ft of barrier is 6 - 12 in out of alignment and 200 ft is deflected more than 12 in. 350 ft of barrier is 3 - 7 ins below 27-in design height and the remainder is 1 - 3 ins below.

Breaking and Cracking:	6 posts are broken and knocked down.			
	Missing Elements:	No missing elements were observed.			
	Corrosion and Weathering:	No loss of cable cross section or erosion around posts observed.			
End Treatments	Alignment and Height:				
	Breaking and Cracking:				
	Missing Elements:				
	Corrosion and Weathering:

Repair Action:	REPLACE	FMSS Work Type:	CAPITAL IMPROVEMENT	Repair Cost:	\$102130
Brief Workorder:	Replace cable guardrail with Steel-Backed Timber w/o blockouts and 2 flared Steel-Backed Timber end treatments.				
Workorder:	Remove Cable Guardrail at \$5- per -Lin. Ft. for 1103 LF = \$5515. Steel-Backed Timber w/o Blockout at \$60- per -Lin. Ft. for 1043 LF = \$62580. SBT / Log Flared at \$5000- per -Each for 2 Unit(s) = \$10000. Low Speed Traffic Control at \$1475- per -Day for 10 Day(s) = \$14750. 5 days removal and 5 days installation.

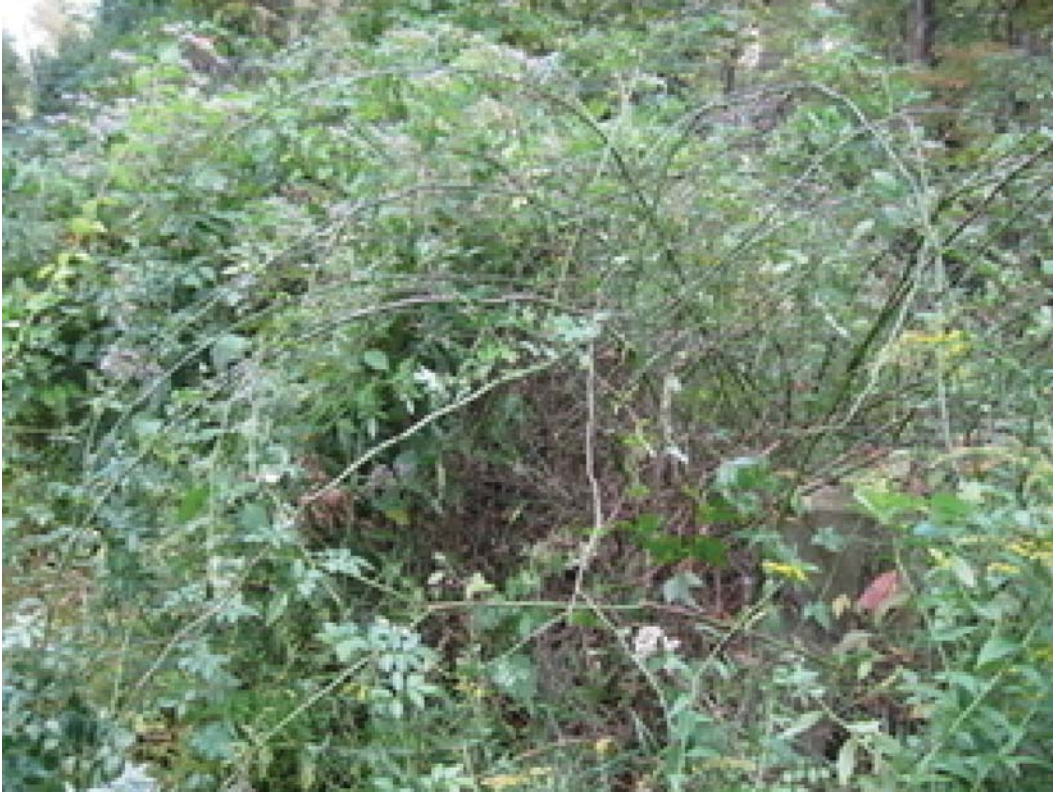
DEWA_0010_11.764_L_1.jpg

Barrier ID:	DEWA-0010-11.764-L				
Route Name:	OLD MINE ROAD (SOUTH SECTION)				
Inspection Date:	10/07/2010	Barrier Rating:	58.00		
Barrier Description					
Type:	OTHER: 2-STRAND CABLE	Barrier Function:	TRAFFIC		
Barrier Material:	CABLE	Post Material:	OTHER: CONCRETE		
Blockout Type:	N/A	Length (ft.):	1308		
Speed Limit (MPH):	35	Placement with Respect to Road:	OUTSIDE OF CURVE		
Hazard Behind Barrier:	MEDIUM				
Barrier Crashworthiness					
Appropriate Test Level:	TL-2	Barrier Test Level:	NCW	Is Barrier Crashworthy?:	NO
Beg. End Trtmt Type:	NONE	Is Beg. End Trtmt Crashworthy?:	N/A	Approach Transition Type:	NONE
Ending End Trtmt Type:	NONE	Ending End Trtmt Crashworthy?:	N/A		
Average Measurements					
Design Height (In.):	27	Width (In.):	0.0	Post Spacing (In.):	118.0
Height (In.):	20.1	Lateral Offset (In.):	43.9	Road Grade (%):	2.80
Physical Condition					
Barrier	Alignment and Height:	Alignment deflects more than 12 in along 600 ft of barrier. Height ranges between 6 and 9 in below 27 in design height along entire length.

Breaking and Cracking:	10 posts are broken.			
	Missing Elements:	No missing elements observed.			
	Corrosion and Weathering:	No loss of cable cross section or erosion around posts observed.			
End Treatments	Alignment and Height:	NA			
	Breaking and Cracking:	NA			
	Missing Elements:	NA			
	Corrosion and Weathering:	NA

Repair Action:	REPLACE	FMSS Work Type:	CAPITAL IMPROVEMENT	Repair Cost:	\$120032
Brief Workorder:	Replace cable guardrail with Steel-Backed Timber w/o blockouts and 2 flared Steel-Backed Timber end treatments.				
Workorder:	Remove Cable Guardrail at \$5- per -Lin. Ft. for 1308 LF = \$6540. Remove 1308 feet of cable barrier Steel-Backed Timber w/o Blockout at \$60- per -Lin. Ft. for 1248 LF = \$74880. SBT / Log Flared at \$5000- per -Each for 2 Unit(s) = \$10000. Low Speed Traffic Control at \$1475- per -Day for 12 Day(s) = \$17700. 6 days removal and 6 days installation.

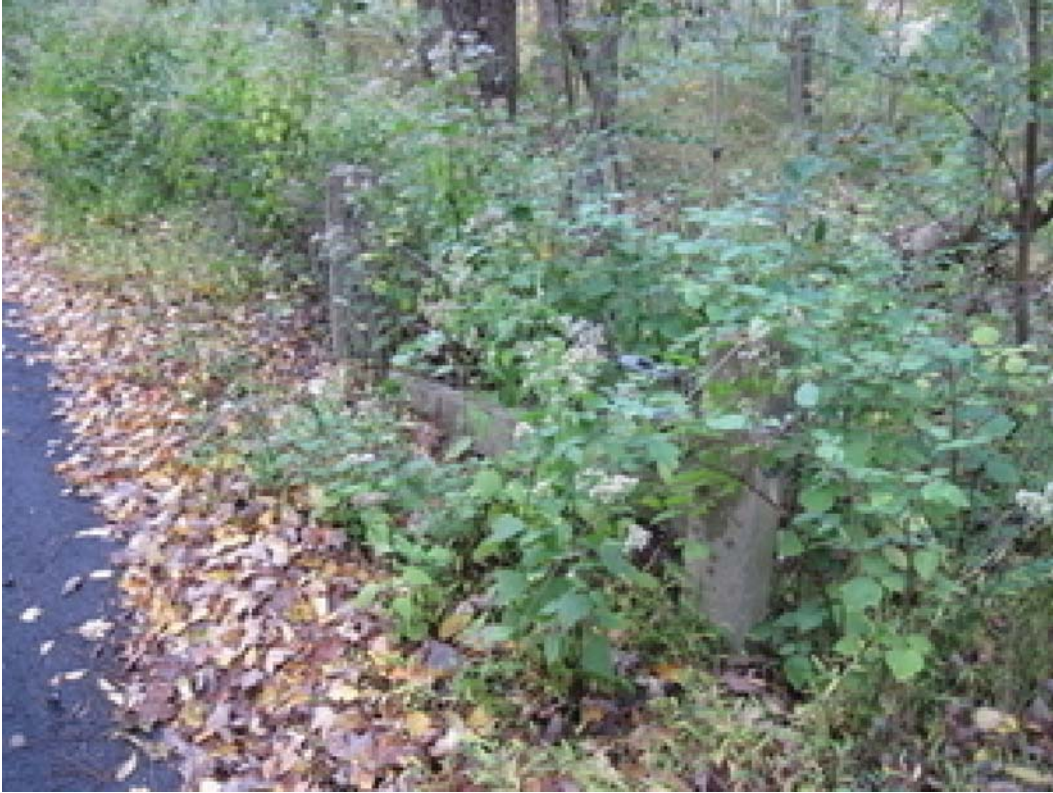
DEWA_0010_12.016_L_1.jpg

Barrier ID:	DEWA-0010-12.016-L				
Route Name:	OLD MINE ROAD (SOUTH SECTION)				
Inspection Date:	10/07/2010	Barrier Rating:	41.20		
Barrier Description					
Type:	OTHER: 2-STRAND CABLE	Barrier Function:	TRAFFIC		
Barrier Material:	CABLE	Post Material:	OTHER: CONCRETE		
Blockout Type:	N/A	Length (ft.):	210		
Speed Limit (MPH):	35	Placement with Respect to Road:	OUTSIDE OF CURVE		
Hazard Behind Barrier:	LOW				
Barrier Crashworthiness					
Appropriate Test Level:	TL-2	Barrier Test Level:	NCW	Is Barrier Crashworthy?:	NO
Beg. End Trtmt Type:	NONE	Is Beg. End Trtmt Crashworthy?:	N/A	Approach Transition Type:	NONE
Ending End Trtmt Type:	NONE	Ending End Trtmt Crashworthy?:	N/A		
Average Measurements					
Design Height (In.):	27	Width (In.):	0.0	Post Spacing (In.):	116.6
Height (In.):	17.7	Lateral Offset (In.):	36.0	Road Grade (%):	3.60
Physical Condition					
Barrier	Alignment and Height:	Alignment deflects 6 in to 12 in for 100 ft and greater than 12 in for 20 ft. Height ranges from 8 in to 10 in below 27 in design height.

Breaking and Cracking:	No posts are cracked or broken. No fraying breaking or severing of cables observed.			
	Missing Elements:	No missing elements observed.			
	Corrosion and Weathering:	No loss of cable cross section or erosion around posts observed.			
End Treatments	Alignment and Height:				
	Breaking and Cracking:				
	Missing Elements:				
	Corrosion and Weathering:

Repair Action:	REPLACE	FMSS Work Type:	CAPITAL IMPROVEMENT	Repair Cost:	\$25300
Brief Workorder:	Replace cable guardrail with Steel-Backed Timber w/o blockouts and 2 flared end treatments.				
Workorder:	Remove Cable Guardrail at \$5- per -Lin. Ft. for 210 LF = \$1050. Steel-Backed Timber w/o Blockout at \$60- per -Lin. Ft. for 150 LF = \$9000. SBT / Log Flared at \$5000- per -Each for 2 Unit(s) = \$10000. Low Speed Traffic Control at \$1475- per -Day for 2 Day(s) = \$2950. 1 day removal and 1 day installation.

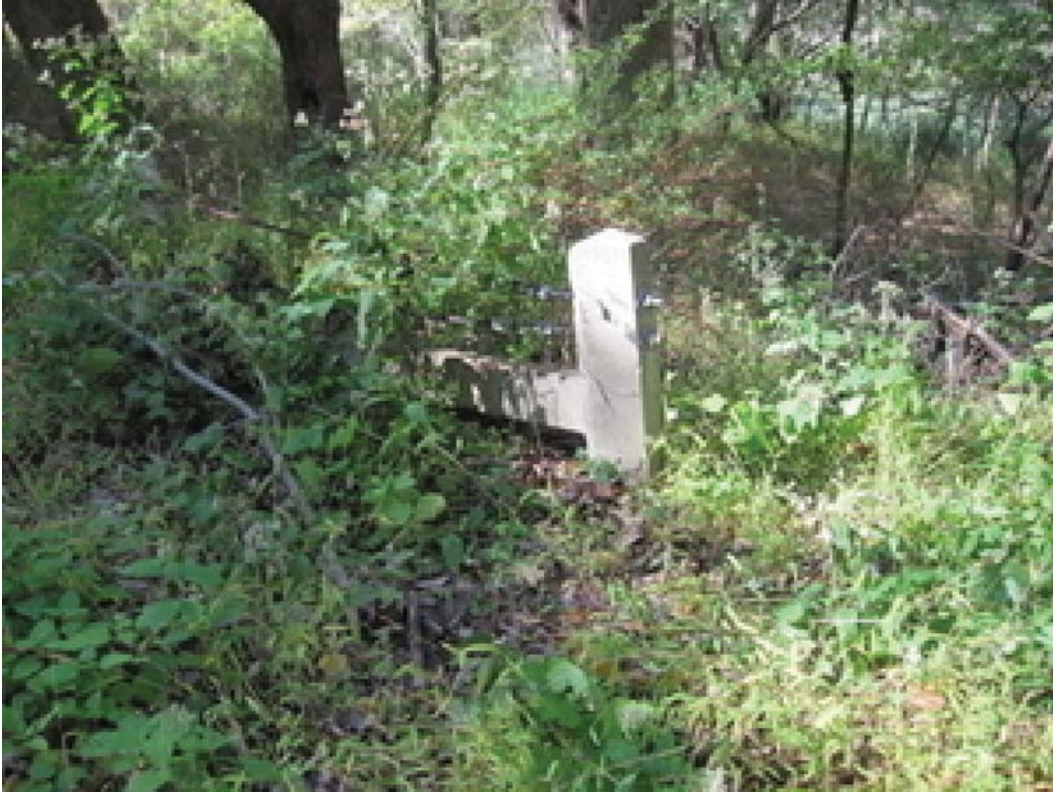
DEWA_0010_12.074_L_1.jpg

Barrier ID:	DEWA-0010-12.074-L				
Route Name:	OLD MINE ROAD (SOUTH SECTION)				
Inspection Date:	10/07/2010	Barrier Rating:	38.00		
Barrier Description					
Type:	OTHER: 2-STRAND CABLE	Barrier Function:	TRAFFIC		
Barrier Material:	CABLE	Post Material:	OTHER: CONCRETE		
Blockout Type:	N/A	Length (ft.):	582		
Speed Limit (MPH):	35	Placement with Respect to Road:	INSIDE OF CURVE		
Hazard Behind Barrier:	MEDIUM				
Barrier Crashworthiness					
Appropriate Test Level:	TL-2	Barrier Test Level:	NCW	Is Barrier Crashworthy?:	NO
Beg. End Trtmt Type:	NONE	Is Beg. End Trtmt Crashworthy?:	N/A	Approach Transition Type:	NONE
Ending End Trtmt Type:	NONE	Ending End Trtmt Crashworthy?:	N/A		
Average Measurements					
Design Height (In.):	27	Width (In.):	0.0	Post Spacing (In.):	122.0
Height (In.):	22.2	Lateral Offset (In.):	72.0	Road Grade (%):	1.30
Physical Condition					
Barrier	Alignment and Height:	80 ft of barrier is deflected between 6 and 12 in. Height ranges from 3 - 6 in below 27-in design height along entire length.

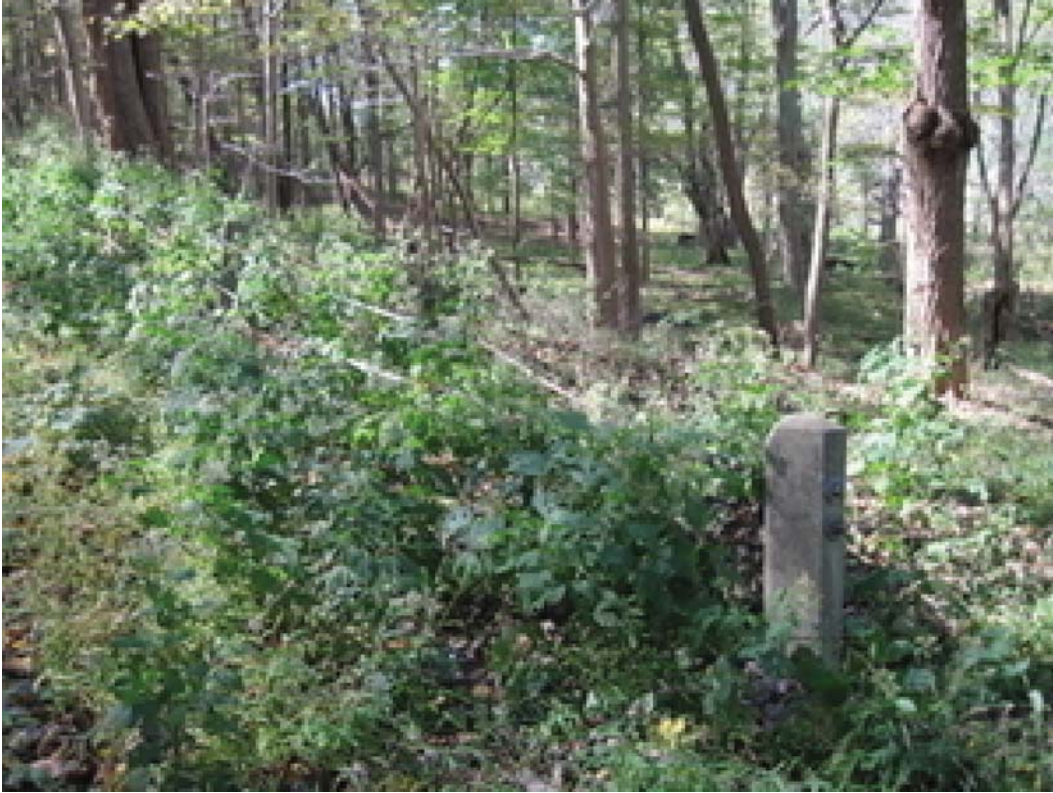
DEWA_0010_12.243_L_1.jpg

Barrier ID:	DEWA-0010-12.243-L				
Route Name:	OLD MINE ROAD (SOUTH SECTION)				
Inspection Date:	10/07/2010	Barrier Rating:	21.20		
Barrier Description					
Type:	OTHER: 2-STRAND CABLE	Barrier Function:	TRAFFIC		
Barrier Material:	CABLE	Post Material:	OTHER: CONCRETE		
Blockout Type:	N/A	Length (ft.):	238		
Speed Limit (MPH):	35	Placement with Respect to Road:	TANGENT		
Hazard Behind Barrier:	LOW				
Barrier Crashworthiness					
Appropriate Test Level:	TL-2	Barrier Test Level:	NCW	Is Barrier Crashworthy?:	NO
Beg. End Trtmt Type:	NONE	Is Beg. End Trtmt Crashworthy?:	N/A	Approach Transition Type:	NONE
Ending End Trtmt Type:	NONE	Ending End Trtmt Crashworthy?:	N/A		
Average Measurements					
Design Height (In.):	27	Width (In.):	0.0	Post Spacing (In.):	118.6
Height (In.):	23.0	Lateral Offset (In.):	78.0	Road Grade (%):	6.20
Physical Condition					
Barrier	Alignment and Height:	No alignment deflection observed. Height is between 1 and 3 in below 27 in design height along 60 ft and between 3 and 7 in below design height along 120 ft of barrier.

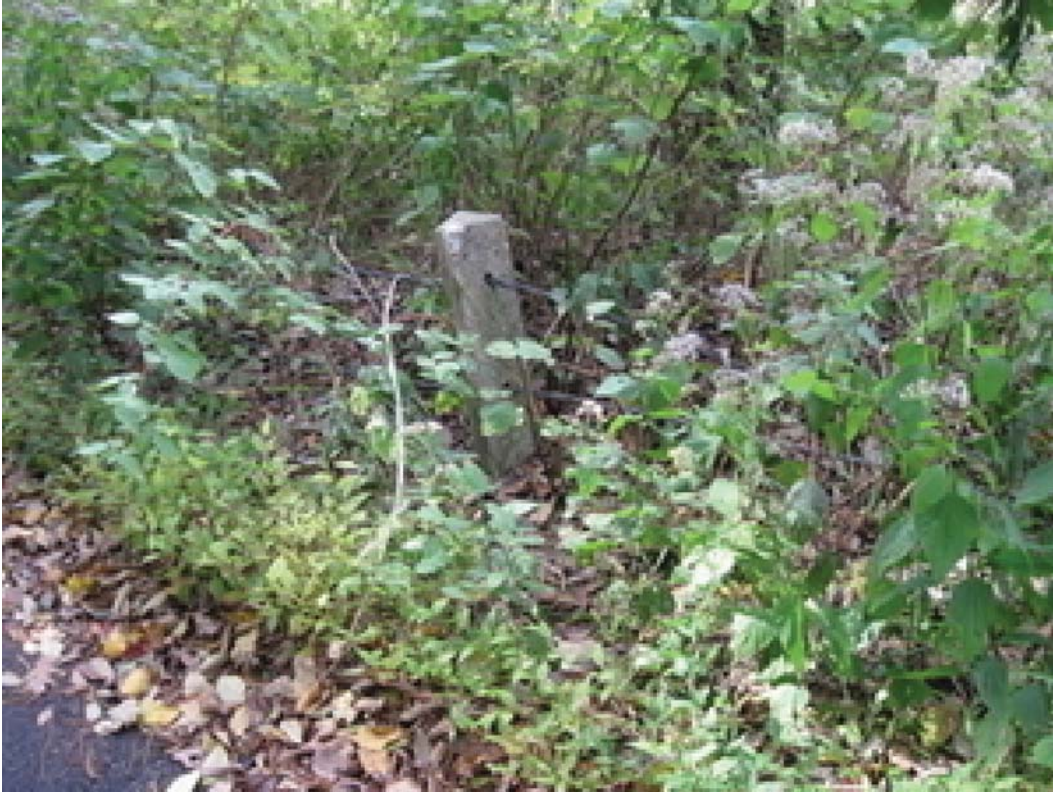
DEWA_0010_12.396_L_1.jpg

Barrier ID:	DEWA-0010-12.396-L				
Route Name:	OLD MINE ROAD (SOUTH SECTION)				
Inspection Date:	10/07/2010	Barrier Rating:	38.00		
Barrier Description					
Type:	OTHER: 2-STRAND CABLE	Barrier Function:	TRAFFIC		
Barrier Material:	CABLE	Post Material:	OTHER: CONCRETE		
Blockout Type:	N/A	Length (ft.):	690		
Speed Limit (MPH):	35	Placement with Respect to Road:	INSIDE OF CURVE		
Hazard Behind Barrier:	MEDIUM				
Barrier Crashworthiness					
Appropriate Test Level:	TL-2	Barrier Test Level:	NCW	Is Barrier Crashworthy?:	NO
Beg. End Trtmt Type:	NONE	Is Beg. End Trtmt Crashworthy?:	N/A	Approach Transition Type:	NONE
Ending End Trtmt Type:	NONE	Ending End Trtmt Crashworthy?:	N/A		
Average Measurements					
Design Height (In.):	27	Width (In.):	0.0	Post Spacing (In.):	119.5
Height (In.):	29.2	Lateral Offset (In.):	59.2	Road Grade (%):	0.90
Physical Condition					
Barrier	Alignment and Height:	Alignment deflects 6 in to 12 in for 240 ft and greater than 12 in for 250 ft. Height ranges from 6 in below 27 in design height to 9 in over.

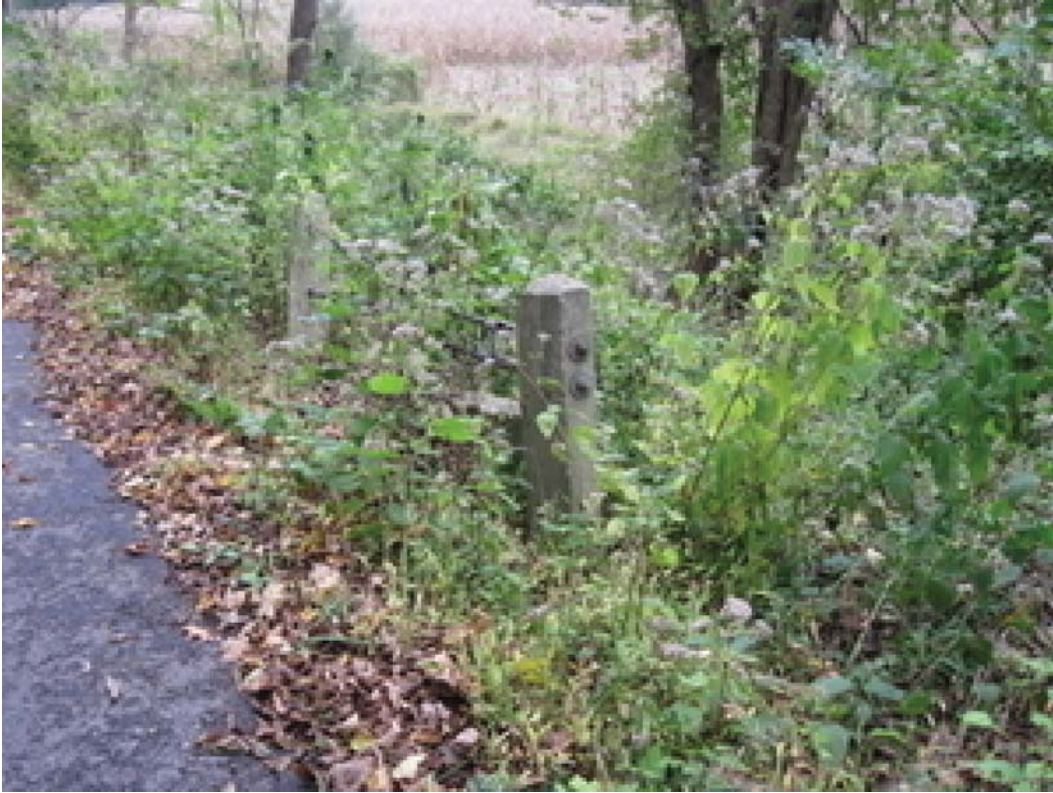
DEWA_0010_12.606_L_1.jpg

Barrier ID:	DEWA-0010-12.606-L				
Route Name:	OLD MINE ROAD (SOUTH SECTION)				
Inspection Date:	10/07/2010	Barrier Rating:	28.20		
Barrier Description					
Type:	OTHER: 2-STRAND CABLE	Barrier Function:	TRAFFIC		
Barrier Material:	CABLE	Post Material:	OTHER: CONCRETE		
Blockout Type:	N/A	Length (ft.):	505		
Speed Limit (MPH):	35	Placement with Respect to Road:	TANGENT		
Hazard Behind Barrier:	LOW				
Barrier Crashworthiness					
Appropriate Test Level:	TL-2	Barrier Test Level:	NCW	Is Barrier Crashworthy?:	NO
Beg. End Trtmt Type:	NONE	Is Beg. End Trtmt Crashworthy?:	N/A	Approach Transition Type:	NONE
Ending End Trtmt Type:	NONE	Ending End Trtmt Crashworthy?:	N/A		
Average Measurements					
Design Height (In.):	27	Width (In.):	0.0	Post Spacing (In.):	116.0
Height (In.):	24.0	Lateral Offset (In.):	49.2	Road Grade (%):	1.20
Physical Condition					
Barrier	Alignment and Height:	No alignment deflection was observed. Height ranges from 0 to 5 in below 27-in design height.

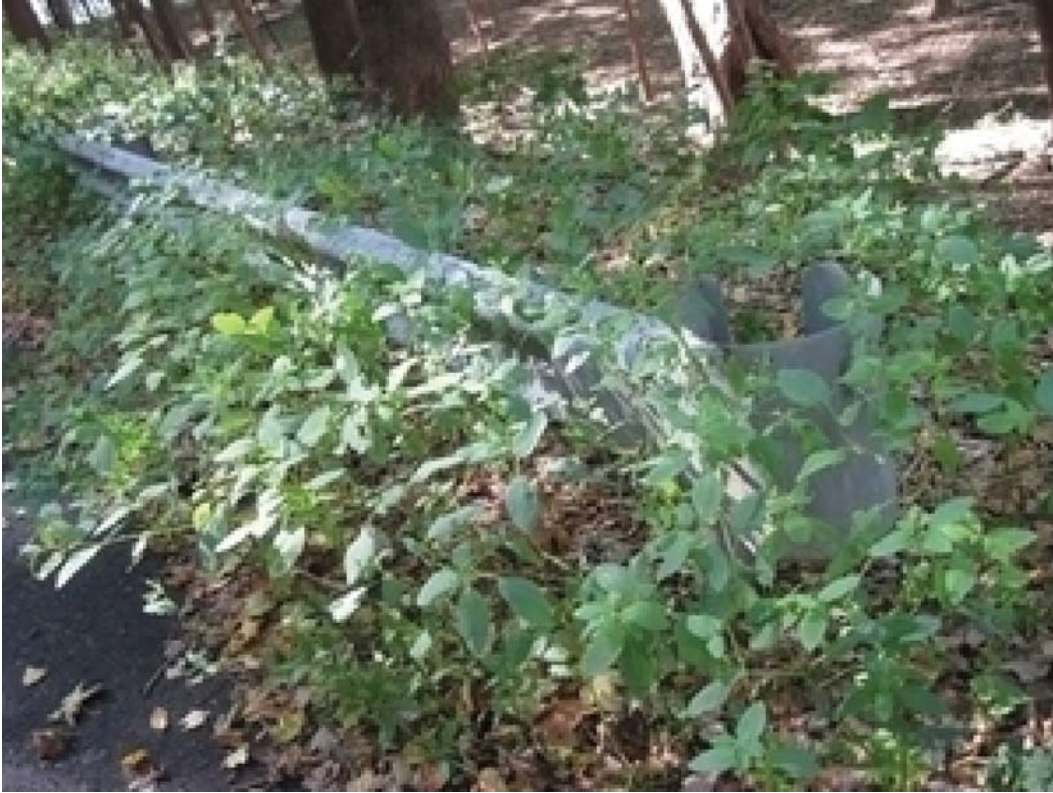
DEWA_0010_12.955_L_1.jpg

Barrier ID:	DEWA-0010-12.955-L				
Route Name:	OLD MINE ROAD (SOUTH SECTION)				
Inspection Date:	10/07/2010	Barrier Rating:	45.50		
Barrier Description					
Type:	W-BEAM WEAK POST	Barrier Function:	TRAFFIC		
Barrier Material:	GALVANIZED STEEL	Post Material:	GALVANIZED STEEL		
Blockout Type:	N/A	Length (ft.):	531		
Speed Limit (MPH):	35	Placement with Respect to Road:	TANGENT		
Hazard Behind Barrier:	LOW				
Barrier Crashworthiness					
Appropriate Test Level:	TL-2	Barrier Test Level:	TL-2	Is Barrier Crashworthy?:	YES
Beg. End Trtmt Type:	NONE	Is Beg. End Trtmt Crashworthy?:	N/A	Approach Transition Type:	NONE
Ending End Trtmt Type:	NONE	Ending End Trtmt Crashworthy?:	N/A		
Average Measurements					
Design Height (In.):	27	Width (In.):	0.0	Post Spacing (In.):	149.6
Height (In.):	22.2	Lateral Offset (In.):	20.0	Road Grade (%):	1.00
Physical Condition					
Barrier	Alignment and Height:	No alignment deflection observed. Height ranges between 4 and 5 in below the 27 in design height along entire length.

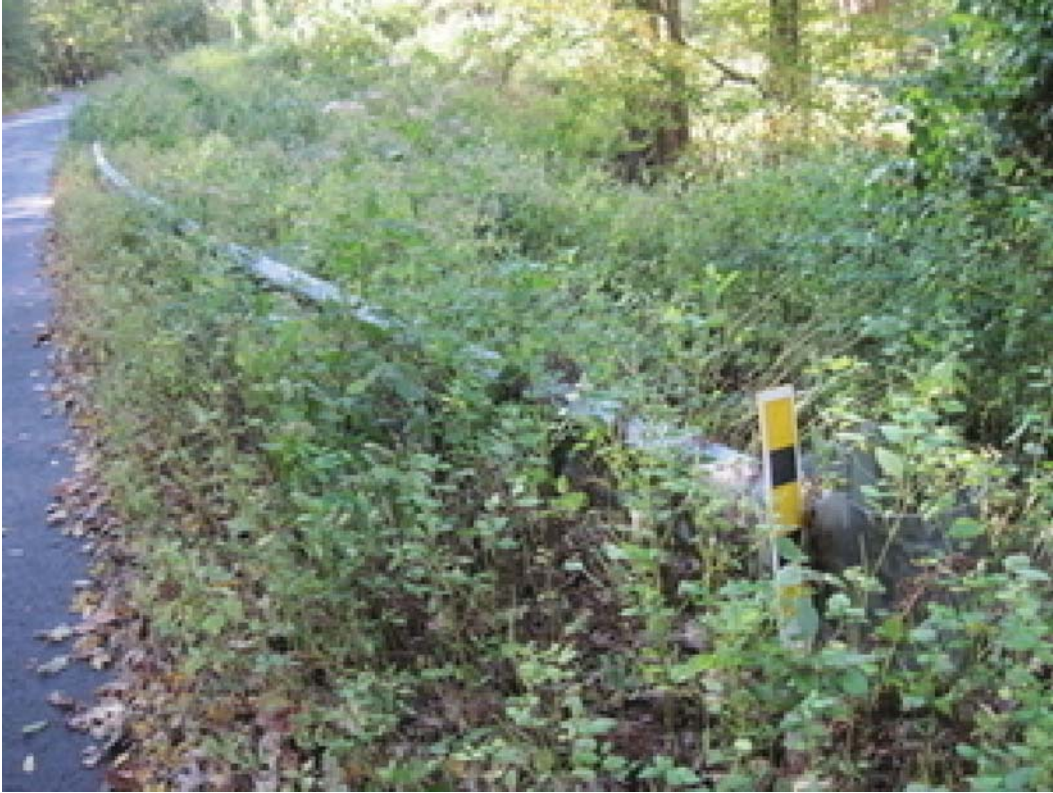
DEWA_0010_13.180_L_1.jpg

Barrier ID:	DEWA-0010-13.180-L				
Route Name:	OLD MINE ROAD (SOUTH SECTION)				
Inspection Date:	10/07/2010	Barrier Rating:	33.70		
Barrier Description					
Type:	W-BEAM STRONG POST	Barrier Function:	TRAFFIC		
Barrier Material:	GALVANIZED STEEL	Post Material:	GALVANIZED STEEL		
Blockout Type:	STEEL	Length (ft.):	66		
Speed Limit (MPH):	35	Placement with Respect to Road:	TANGENT		
Hazard Behind Barrier:	MEDIUM				
Barrier Crashworthiness					
Appropriate Test Level:	TL-2	Barrier Test Level:	TL-3	Is Barrier Crashworthy?:	YES
Beg. End Trtmt Type:	NONE	Is Beg. End Trtmt Crashworthy?:	N/A	Approach Transition Type:	NONE
Ending End Trtmt Type:	NONE	Ending End Trtmt Crashworthy?:	N/A		
Average Measurements					
Design Height (In.):	27	Width (In.):	0.0	Post Spacing (In.):	151.3
Height (In.):	29.0	Lateral Offset (In.):	42.7	Road Grade (%):	0.80
Physical Condition					
Barrier	Alignment and Height:	No alignment deflection was observed. Height is between 4.5 and 6.5 in below 27-in design height.

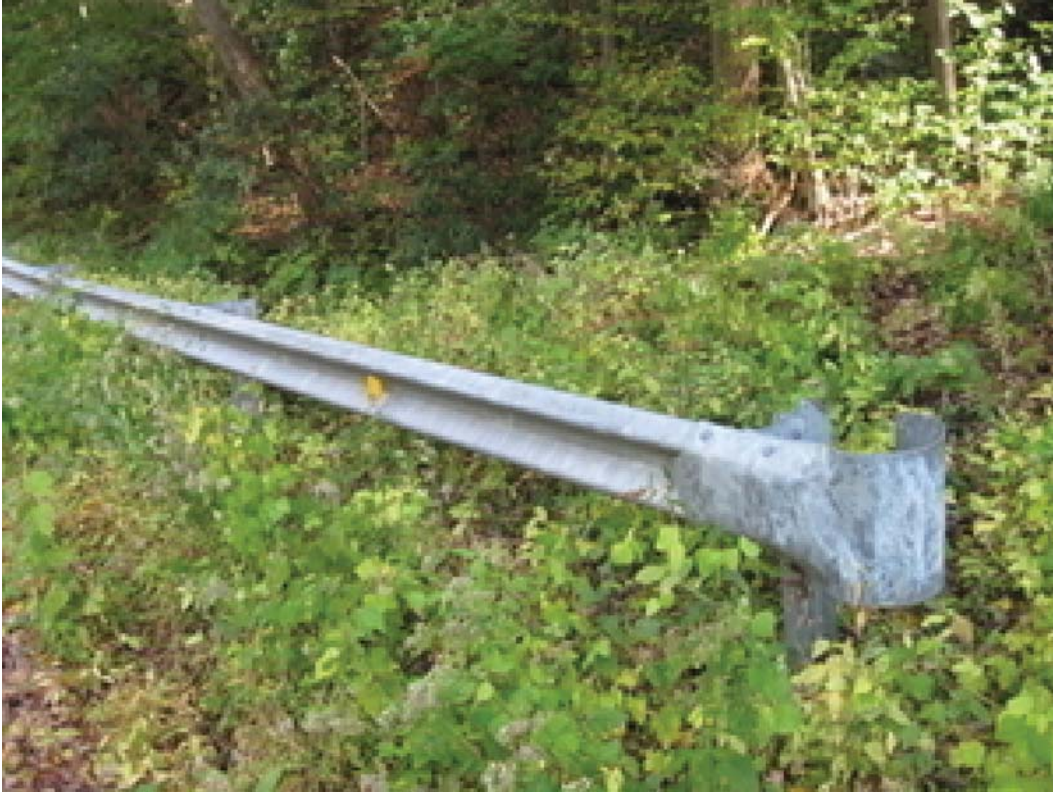
DEWA_0010_13.182_R_1.jpg

Barrier ID:	DEWA-0010-13.182-R				
Route Name:	OLD MINE ROAD (SOUTH SECTION)				
Inspection Date:	10/07/2010	Barrier Rating:	14.00		
Barrier Description					
Type:	W-BEAM STRONG POST	Barrier Function:	TRAFFIC		
Barrier Material:	GALVANIZED STEEL	Post Material:	GALVANIZED STEEL		
Blockout Type:	STEEL	Length (ft.):	66		
Speed Limit (MPH):	35	Placement with Respect to Road:	TANGENT		
Hazard Behind Barrier:	LOW				
Barrier Crashworthiness					
Appropriate Test Level:	TL-2	Barrier Test Level:	TL-3	Is Barrier Crashworthy?:	YES
Beg. End Trtmt Type:	NONE	Is Beg. End Trtmt Crashworthy?:	N/A	Approach Transition Type:	NONE
Ending End Trtmt Type:	NONE	Ending End Trtmt Crashworthy?:	N/A		
Average Measurements					
Design Height (In.):	27	Width (In.):	0.0	Post Spacing (In.):	151.3
Height (In.):	21.2	Lateral Offset (In.):	30.2	Road Grade (%):	0.50
Physical Condition					
Barrier	Alignment and Height:	No alignment deflection observed. Height ranges from 0 in to 4 in above 27 in design height.

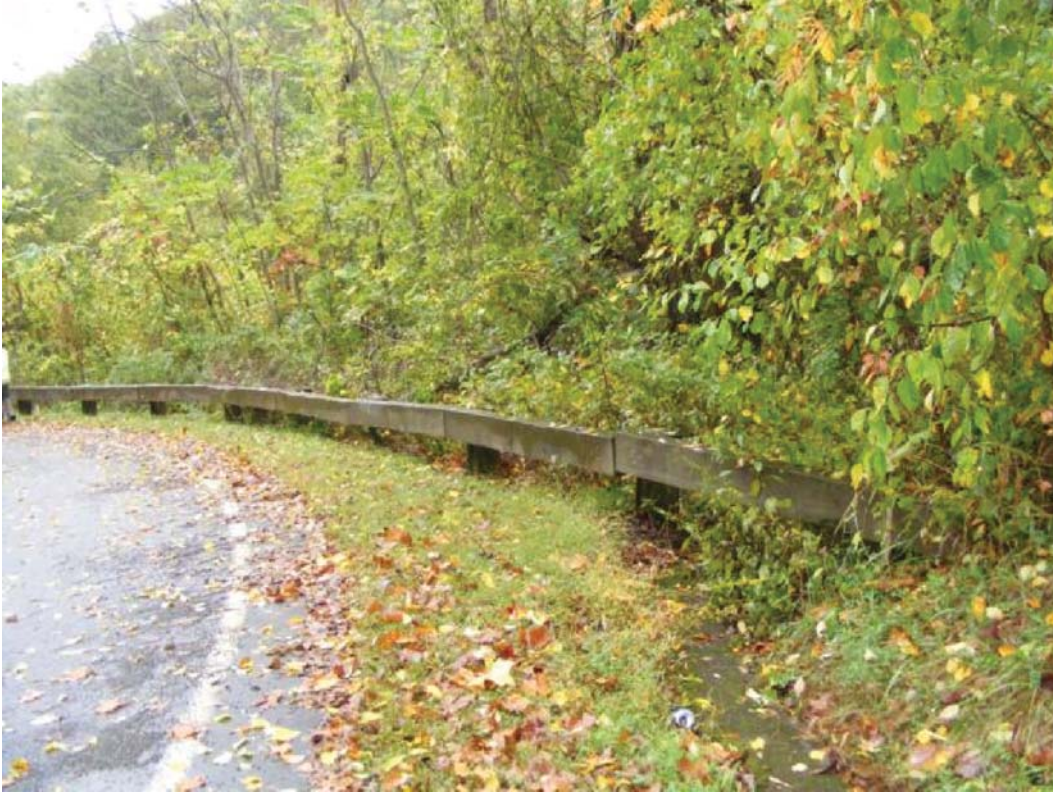
DEWA_0013_0.118_L_1.JPG

Barrier ID:	DEWA-0013-0.118-L				
Route Name:	NATIONAL PARK DRIVE				
Inspection Date:	10/01/2010	Barrier Rating:	28.20		
Barrier Description					
Type:	STEEL-BACKED TIMBER WITH BLOCKOUT	Barrier Function:	TRAFFIC		
Barrier Material:	STEEL-BACKED TIMBER/LOG	Post Material:	WOOD		
Blockout Type:	WOOD	Length (ft.):	128		
Speed Limit (MPH):	25	Placement with Respect to Road:	OUTSIDE OF CURVE		
Hazard Behind Barrier:	HIGH				
Barrier Crashworthiness					
Appropriate Test Level:	TL-1	Barrier Test Level:	TL-3	Is Barrier Crashworthy?:	YES
Beg. End Trtmt Type:	SBT/LOG FLARED	Is Beg. End Trtmt Crashworthy?:	NO	Approach Transition Type:	NONE
Ending End Trtmt Type:	SBT/LOG BURIED	Ending End Trtmt Crashworthy?:	YES		
Average Measurements					
Design Height (In.):	27	Width (In.):	0.0	Post Spacing (In.):	119.0
Height (In.):	26.0	Lateral Offset (In.):	61.2	Road Grade (%):	11.40
Physical Condition					
Barrier	Alignment and Height:	No deflections observed in alignment. The height is low by 1 in or less from the design of 27 in.

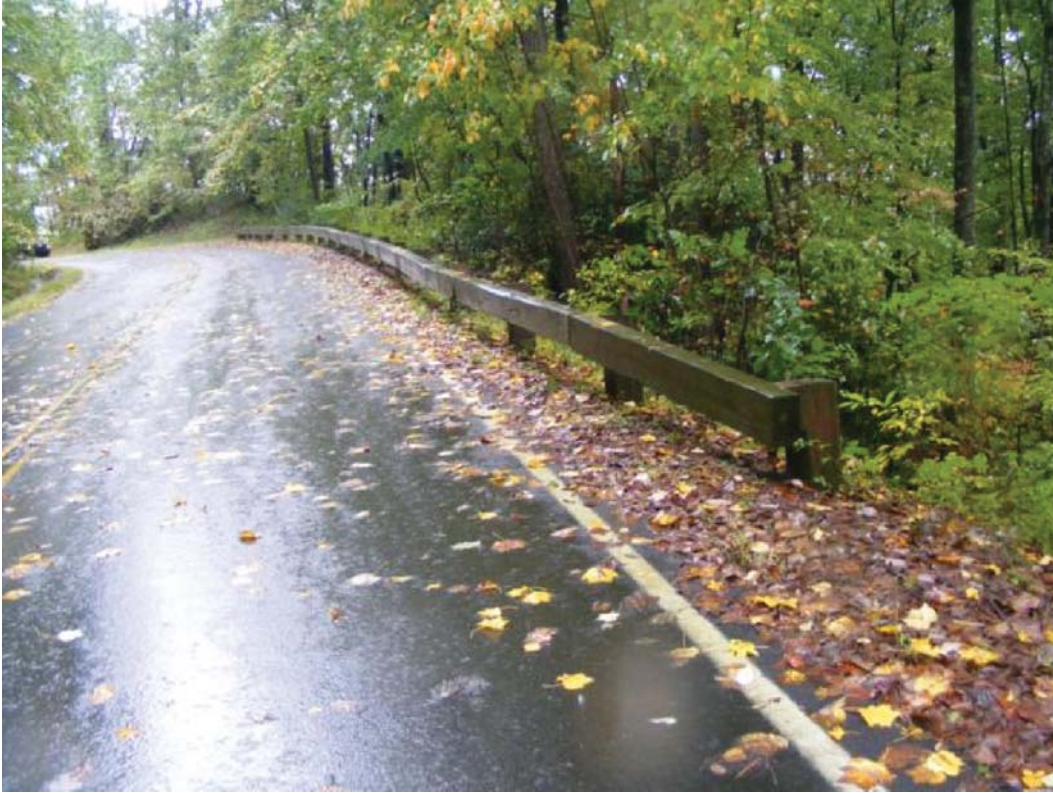
DEWA_0013_0.205_R_1.JPG

Barrier ID:	DEWA-0013-0.205-R				
Route Name:	NATIONAL PARK DRIVE				
Inspection Date:	10/01/2010	Barrier Rating:	28.00		
Barrier Description					
Type:	STEEL-BACKED TIMBER WITH BLOCKOUT	Barrier Function:	TRAFFIC		
Barrier Material:	STEEL-BACKED TIMBER/LOG	Post Material:	WOOD		
Blockout Type:	WOOD	Length (ft.):	200		
Speed Limit (MPH):	25	Placement with Respect to Road:	OUTSIDE OF CURVE		
Hazard Behind Barrier:	MEDIUM				
Barrier Crashworthiness					
Appropriate Test Level:	TL-1	Barrier Test Level:	TL-3	Is Barrier Crashworthy?:	YES
Beg. End Trtmt Type:	SBT/LOG FLARED	Is Beg. End Trtmt Crashworthy?:	NO	Approach Transition Type:	NONE
Ending End Trtmt Type:	SBT/LOG BURIED	Ending End Trtmt Crashworthy?:	YES		
Average Measurements					
Design Height (In.):	27	Width (In.):	0.0	Post Spacing (In.):	120.6
Height (In.):	27.0	Lateral Offset (In.):	16.2	Road Grade (%):	11.90
Physical Condition					
Barrier	Alignment and Height:	No deflections observed in alignment. Height is within 1-in. of 27-in. design height.

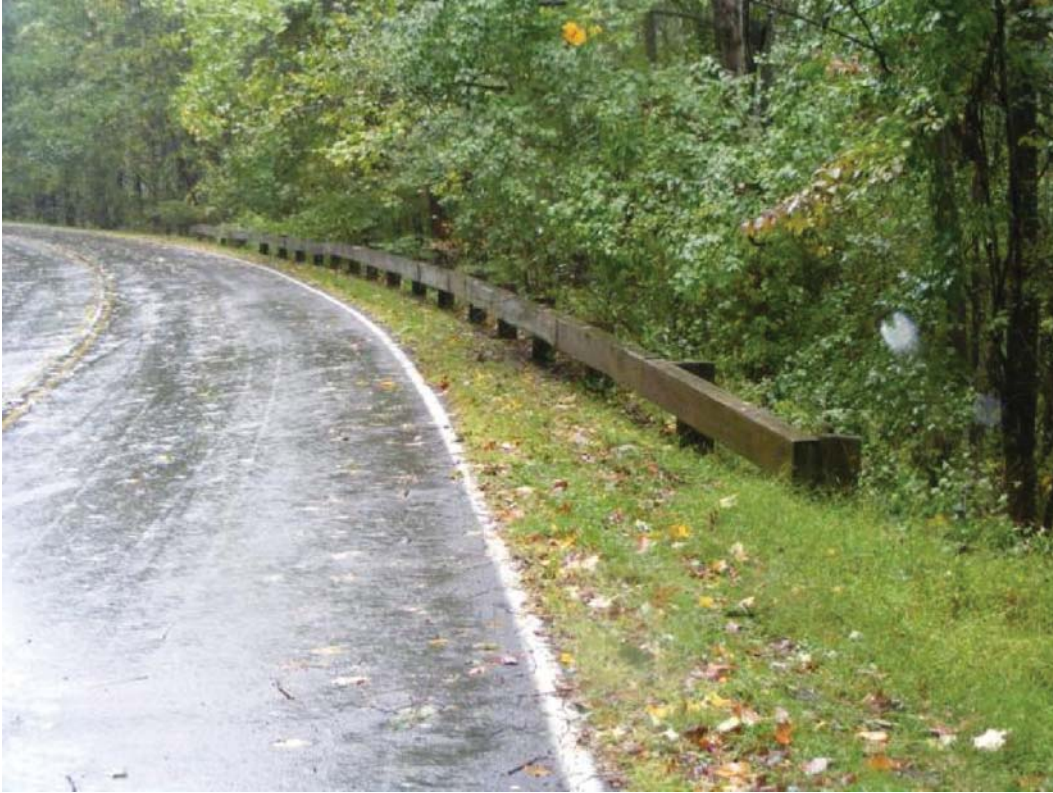
DEWA_0013_0.320_R_1.JPG

Barrier ID:	DEWA-0013-0.320-R				
Route Name:	NATIONAL PARK DRIVE				
Inspection Date:	10/01/2010	Barrier Rating:	29.60		
Barrier Description					
Type:	STEEL-BACKED TIMBER WITH BLOCKOUT	Barrier Function:	TRAFFIC		
Barrier Material:	STEEL-BACKED TIMBER/LOG	Post Material:	WOOD		
Blockout Type:	WOOD	Length (ft.):	200		
Speed Limit (MPH):	25	Placement with Respect to Road:	OUTSIDE OF CURVE		
Hazard Behind Barrier:	MEDIUM				
Barrier Crashworthiness					
Appropriate Test Level:	TL-1	Barrier Test Level:	TL-3	Is Barrier Crashworthy?:	YES
Beg. End Trtmt Type:	SBT/LOG FLARED	Is Beg. End Trtmt Crashworthy?:	NO	Approach Transition Type:	NONE
Ending End Trtmt Type:	NONE	Ending End Trtmt Crashworthy?:	N/A		
Average Measurements					
Design Height (In.):	27	Width (In.):	0.0	Post Spacing (In.):	120.0
Height (In.):	24.0	Lateral Offset (In.):	46.5	Road Grade (%):	6.10
Physical Condition					
Barrier	Alignment and Height:	No deflections observed in alignment. The height is low by 3 in from the design of 27 in.

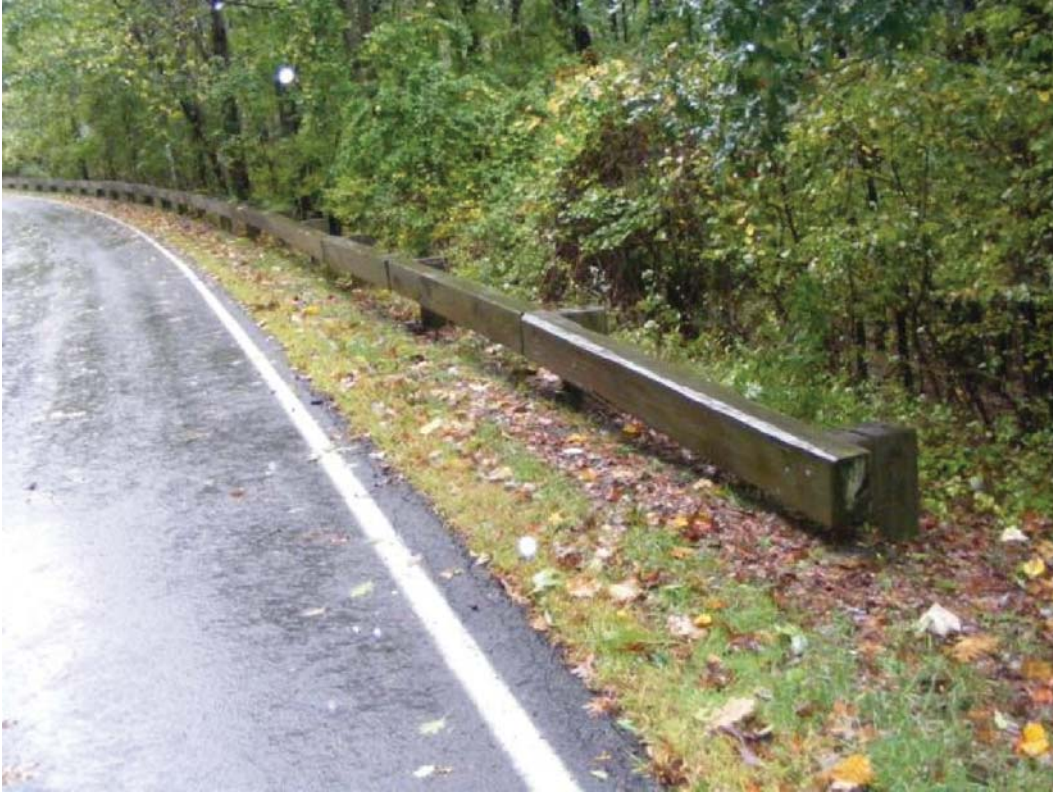
DEWA_0013_0.388_R_1.JPG

Barrier ID:	DEWA-0013-0.388-R				
Route Name:	NATIONAL PARK DRIVE				
Inspection Date:	10/01/2010	Barrier Rating:	20.70		
Barrier Description					
Type:	STEEL-BACKED TIMBER WITH BLOCKOUT	Barrier Function:	TRAFFIC		
Barrier Material:	STEEL-BACKED TIMBER/LOG	Post Material:	WOOD		
Blockout Type:	WOOD	Length (ft.):	250		
Speed Limit (MPH):	25	Placement with Respect to Road:	OUTSIDE OF CURVE		
Hazard Behind Barrier:	MEDIUM				
Barrier Crashworthiness					
Appropriate Test Level:	TL-1	Barrier Test Level:	TL-3	Is Barrier Crashworthy?:	YES
Beg. End Trtmt Type:	SBT/LOG FLARED	Is Beg. End Trtmt Crashworthy?:	NO	Approach Transition Type:	NONE
Ending End Trtmt Type:	NONE	Ending End Trtmt Crashworthy?:	N/A		
Average Measurements					
Design Height (In.):	27	Width (In.):	0.0	Post Spacing (In.):	119.0
Height (In.):	26.0	Lateral Offset (In.):	47.2	Road Grade (%):	9.30
Physical Condition					
Barrier	Alignment and Height:	No deflections observed in alignment. The height is low by 1 in or less from the design of 27 in.

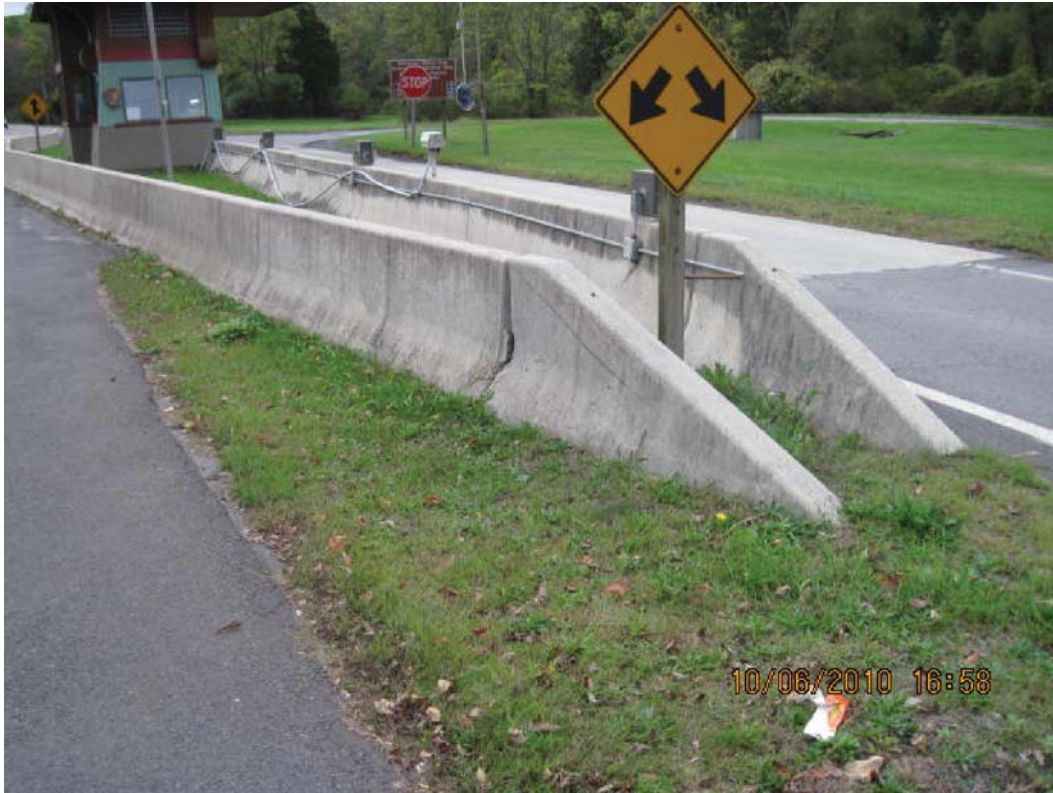
DEWA_0014_0.307_R_1.jpg

Barrier ID:	DEWA-0014-0.307-R				
Route Name:	US ROUTE 209				
Inspection Date:	10/06/2010	Barrier Rating:	34.20		
Barrier Description					
Type:	CONCRETE BARRIER	Barrier Function:	TRAFFIC		
Barrier Material:	CONCRETE	Post Material:	N/A		
Blockout Type:	N/A	Length (ft.):	233		
Speed Limit (MPH):	35	Placement with Respect to Road:	TANGENT		
Hazard Behind Barrier:	LOW				
Barrier Crashworthiness					
Appropriate Test Level:	TL-2	Barrier Test Level:	TL-3	Is Barrier Crashworthy?:	YES
Beg. End Trtmt Type:	NONE	Is Beg. End Trtmt Crashworthy?:	N/A	Approach Transition Type:	NONE
Ending End Trtmt Type:	NONE	Ending End Trtmt Crashworthy?:	N/A		
Average Measurements					
Design Height (In.):	32	Width (In.):	0.0	Post Spacing (In.):	0.0
Height (In.):	28.2	Lateral Offset (In.):	74.3	Road Grade (%):	0.00
Physical Condition					
Barrier	Alignment and Height:	8 ft of the barrier had a deflection of 16 in. The entire barrier was more than 3 in below design height (32 in).

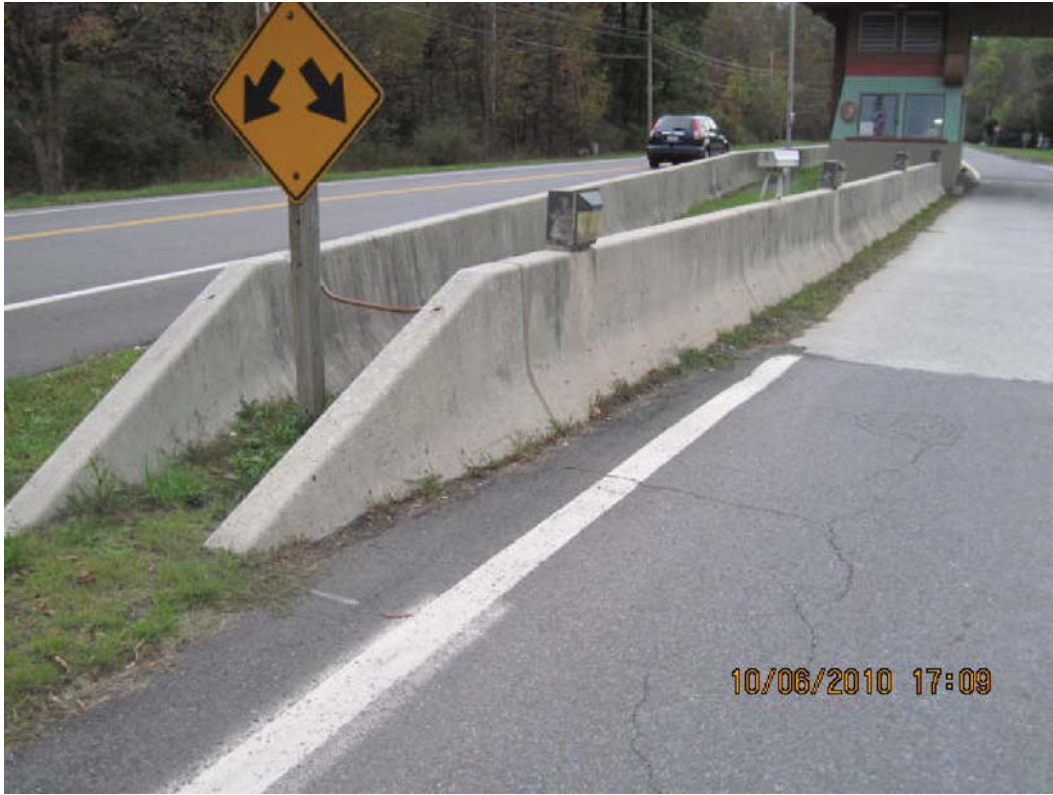
DEWA_0014_0.308_R_1.jpg

Barrier ID:	DEWA-0014-0.308-R				
Route Name:	US ROUTE 209				
Inspection Date:	10/06/2010	Barrier Rating:	35.70		
Barrier Description					
Type:	CONCRETE BARRIER	Barrier Function:	TRAFFIC		
Barrier Material:	CONCRETE	Post Material:	N/A		
Blockout Type:	N/A	Length (ft.):	154		
Speed Limit (MPH):	35	Placement with Respect to Road:	TANGENT		
Hazard Behind Barrier:	LOW				
Barrier Crashworthiness					
Appropriate Test Level:	TL-2	Barrier Test Level:	TL-3	Is Barrier Crashworthy?:	YES
Beg. End Trtmt Type:	NONE	Is Beg. End Trtmt Crashworthy?:	N/A	Approach Transition Type:	NONE
Ending End Trtmt Type:	NONE	Ending End Trtmt Crashworthy?:	N/A		
Average Measurements					
Design Height (In.):	32	Width (In.):	0.0	Post Spacing (In.):	0.0
Height (In.):	29.5	Lateral Offset (In.):	22.2	Road Grade (%):	0.10
Physical Condition					
Barrier	Alignment and Height:	Alignment deflection was less than 6 in. 5 ft of the barrier was 1 to 3 in below design height (32 ines). 99 ft of the barrier was greater than 3 ines below design height (32 ines).

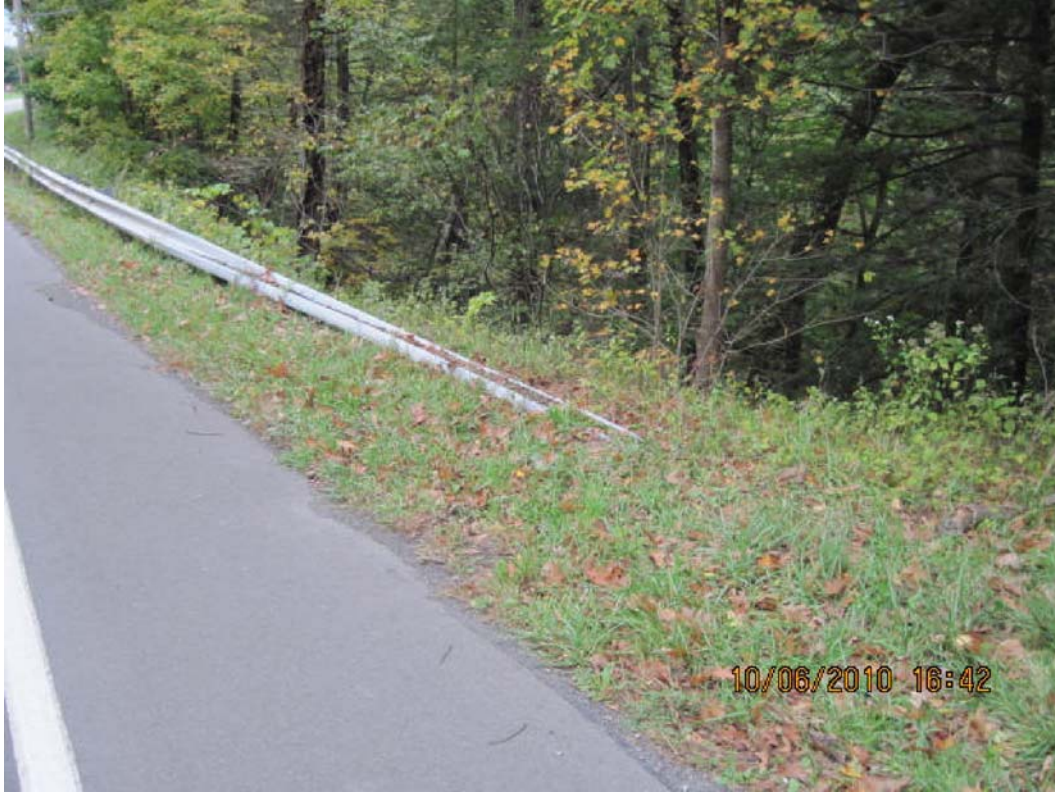
DEWA_0014_0.480_L_1.jpg

Barrier ID:	DEWA-0014-0.480-L				
Route Name:	US ROUTE 209				
Inspection Date:	10/06/2010	Barrier Rating:	25.60		
Barrier Description					
Type:	W-BEAM STRONG POST	Barrier Function:	TRAFFIC		
Barrier Material:	GALVANIZED STEEL	Post Material:	GALVANIZED STEEL		
Blockout Type:	STEEL	Length (ft.):	192		
Speed Limit (MPH):	35	Placement with Respect to Road:	TANGENT		
Hazard Behind Barrier:	HIGH				
Barrier Crashworthiness					
Appropriate Test Level:	TL-2	Barrier Test Level:	TL-3	Is Barrier Crashworthy?:	YES
Beg. End Trtmt Type:	W-BEAM TURN DOWN	Is Beg. End Trtmt Crashworthy?:	NO	Approach Transition Type:	NONE
Ending End Trtmt Type:	W-BEAM TURN DOWN	Ending End Trtmt Crashworthy?:	NO		
Average Measurements					
Design Height (In.):	27	Width (In.):	0.0	Post Spacing (In.):	74.3
Height (In.):	30.2	Lateral Offset (In.):	69.6	Road Grade (%):	1.20
Physical Condition					
Barrier	Alignment and Height:	There was an 8 in deflection in the alignment for 50 ft. The barrier height was greater than or equal to the 27 in design height for the entire length. 50ft. was 5-9 in above the design height.

Breaking and Cracking:	No twisting bending tears, or cracking was observed in the barrier.			
	Missing Elements:	No elements were observed to be missing.			
	Corrosion and Weathering:	Less than 5 percent of the cross section was lost due to weathering. No erosion was observed.			
End Treatments	Alignment and Height:	Alignment acceptable. Height is within 1-in. of 27-in. design height.			
	Breaking and Cracking:	No twisting bending tears, or cracking was observed.			
	Missing Elements:	No elements were observed to be missing.			
	Corrosion and Weathering:	Less than 5 percent of the cross section was lost due to weathering.

Repair Action:	REPAIR	FMSS Work Type:	DEFERRED MAINTENANCE	Repair Cost:	\$2172
Brief Workorder:	Lower 50 feet of guardrail to the 27 inch design height and correct horizontal deflection.				
Workorder:	Adjust Guardrail at \$10- per -Lin. Ft. for 50 LF = \$500. Lower 50 feet of guardrail to the 27 inch design height and correct the horizontal deflection. Low Speed Traffic Control at \$1475- per -Day for 1 Day(s) = \$1475.
