NPS Guardwall/Rail Inventory Program Delaware Water Gap National Recreation Area

**Federal Lands Highway
Road Inventory Program**

Federal Highway Administration
Eastern Federal Lands Highway Division
Road Inventory Program (RIP)

Data Collection Date: October 2010
Report Date: December 2015

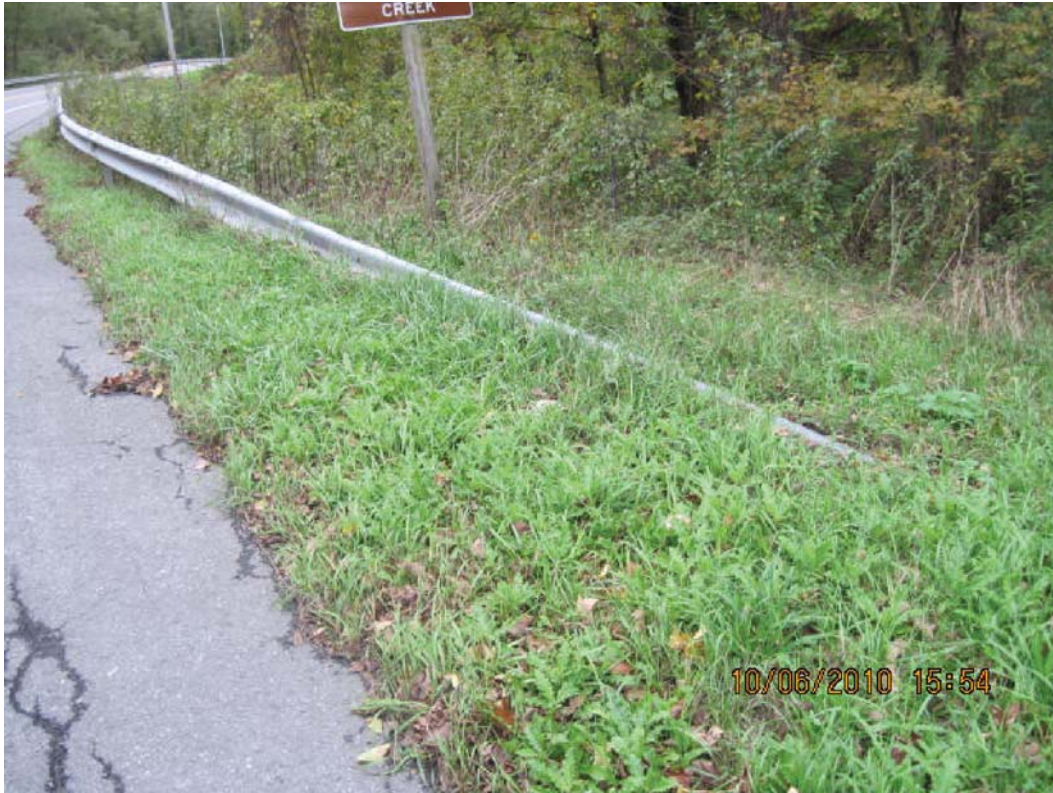
DEWA_0014_0.766_L_1.jpg

Barrier ID:	DEWA-0014-0.766-L				
Route Name:	US ROUTE 209				
Inspection Date:	10/06/2010	Barrier Rating:	29.60		
Barrier Description					
Type:	W-BEAM WEAK POST	Barrier Function:	TRAFFIC		
Barrier Material:	GALVANIZED STEEL	Post Material:	GALVANIZED STEEL		
Blockout Type:	N/A	Length (ft.):	278		
Speed Limit (MPH):	35	Placement with Respect to Road:	INSIDE OF CURVE		
Hazard Behind Barrier:	MEDIUM				
Barrier Crashworthiness					
Appropriate Test Level:	TL-2	Barrier Test Level:	TL-2	Is Barrier Crashworthy?:	YES
Beg. End Trtmt Type:	W-BEAM TURN DOWN	Is Beg. End Trtmt Crashworthy?:	NO	Approach Transition Type:	NONE
Ending End Trtmt Type:	W-BEAM TURN DOWN	Ending End Trtmt Crashworthy?:	NO		
Average Measurements					
Design Height (In.):	27	Width (In.):	0.0	Post Spacing (In.):	149.0
Height (In.):	30.7	Lateral Offset (In.):	138.3	Road Grade (%):	5.40
Physical Condition					
Barrier	Alignment and Height:	Alignment deflection was less than 6 in. The entire barrier exceeded design height (27 in) by 2 to 4.5 in.

Breaking and Cracking:	No twisting tearing breaking or cracking in the metal observed.			
	Missing Elements:	No elements appeared to be missing.			
	Corrosion and Weathering:	Loss of less than 5% cross section observed. Erosion of 5 in below original ground line observed at base of posts.			
End Treatments	Alignment and Height:	Alignment acceptable. Height is within 1-in. of 27-in. design height.			
	Breaking and Cracking:	No twisting tearing breaking or cracking in the metal observed.			
	Missing Elements:	No elements appeared to be missing.			
	Corrosion and Weathering:	Loss of less than 5% cross section observed.

Barrier ID:	DEWA-0014-0.766-L				
Route Name:	US ROUTE 209				
Inspection Date:	10/06/2010	Barrier Rating:		29.60	
Repair Recommendations					
Repair Action:	NO ACTION	FMSS Work Type:	N/A	Repair Cost:	\$0
Brief Workorder:	N/A				
Workorder:	No action required.

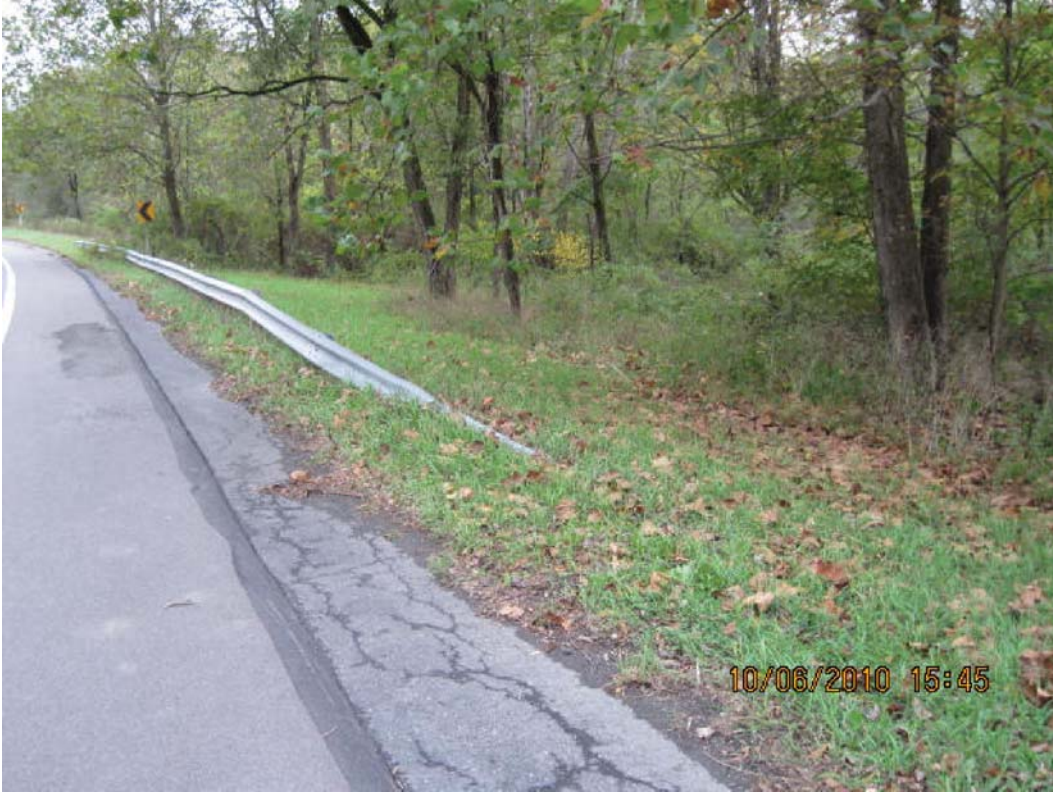
DEWA_0014_0.902_L_1.jpg

Barrier ID:	DEWA-0014-0.902-L				
Route Name:	US ROUTE 209				
Inspection Date:	10/06/2010	Barrier Rating:	36.70		
Barrier Description					
Type:	W-BEAM WEAK POST	Barrier Function:	TRAFFIC		
Barrier Material:	GALVANIZED STEEL	Post Material:	GALVANIZED STEEL		
Blockout Type:	N/A	Length (ft.):	180		
Speed Limit (MPH):	35	Placement with Respect to Road:	OUTSIDE OF CURVE		
Hazard Behind Barrier:	MEDIUM				
Barrier Crashworthiness					
Appropriate Test Level:	TL-2	Barrier Test Level:	TL-2	Is Barrier Crashworthy?:	YES
Beg. End Trtmt Type:	W-BEAM TURN DOWN	Is Beg. End Trtmt Crashworthy?:	NO	Approach Transition Type:	NONE
Ending End Trtmt Type:	W-BEAM TURN DOWN	Ending End Trtmt Crashworthy?:	NO		
Average Measurements					
Design Height (In.):	27	Width (In.):	0.0	Post Spacing (In.):	150.0
Height (In.):	25.7	Lateral Offset (In.):	127.3	Road Grade (%):	1.90
Physical Condition					
Barrier	Alignment and Height:	No deflections greater than 6 in were observed in the alignment. The barrier height was within 1 in of the 27 in design height for 60 ft and between 1 in and 3 in below the design height for 80 ft.

Breaking and Cracking:	No twisting bending tears, or cracking were observed in the barrier.			
	Missing Elements:	No elements were observed to be missing.			
	Corrosion and Weathering:	Some rust was showing but less than 5 percent of the cross section was lost due to weathering. No erosion was observed.			
End Treatments	Alignment and Height:	Alignment acceptable. Height is within 1-in. of 27-in. design height.			
	Breaking and Cracking:	No twisting bending tears, or cracking were observed.			
	Missing Elements:	No elements were observed to be missing.			
	Corrosion and Weathering:	Less than 5 percent of the cross section was lost due to weathering.

Repair Action:	REPAIR	FMSS Work Type:	DEFERRED MAINTENANCE	Repair Cost:	\$2502
Brief Workorder:	Raise 80 feet of guardrail to the 27 inch design height.				
Workorder:	Adjust Guardrail at \$10- per -Lin. Ft. for 80 LF = \$800. Raise 80 feet of guardrail to 27 inch design height. Low Speed Traffic Control at \$1475- per -Day for 1 Day(s) = \$1475.

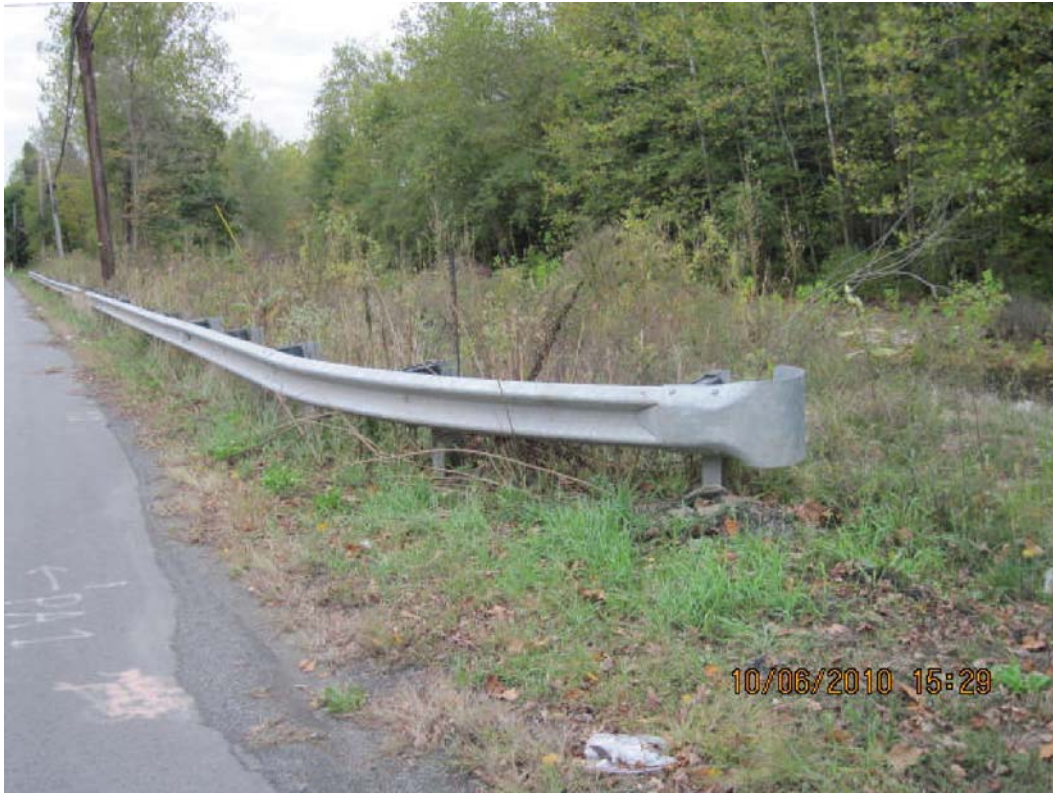
DEWA_0014_1.107_L_1.jpg

Barrier ID:	DEWA-0014-1.107-L				
Route Name:	US ROUTE 209				
Inspection Date:	10/06/2010	Barrier Rating:	25.60		
Barrier Description					
Type:	W-BEAM STRONG POST	Barrier Function:	TRAFFIC		
Barrier Material:	GALVANIZED STEEL	Post Material:	GALVANIZED STEEL		
Blockout Type:	PLASTIC	Length (ft.):	244		
Speed Limit (MPH):	35	Placement with Respect to Road:	TANGENT		
Hazard Behind Barrier:	HIGH				
Barrier Crashworthiness					
Appropriate Test Level:	TL-2	Barrier Test Level:	TL-3	Is Barrier Crashworthy?:	YES
Beg. End Trtmt Type:	OTHER: W-BEAM FLARED	Is Beg. End Trtmt Crashworthy?:	NO	Approach Transition Type:	NONE
Ending End Trtmt Type:	OTHER: W-BEAM FLARED	Ending End Trtmt Crashworthy?:	NO		
Average Measurements					
Design Height (In.):	27	Width (In.):	0.0	Post Spacing (In.):	73.3
Height (In.):	27.0	Lateral Offset (In.):	87.0	Road Grade (%):	1.10
Physical Condition					
Barrier	Alignment and Height:	No deflections in alignment observed. Entire barrier is 1 in or less below meets or exceeds 27 in design height by 1 in.

Breaking and Cracking:	No twisting tearing bending or cracking observed.			
	Missing Elements:	No elements were observed to be missing.			
	Corrosion and Weathering:	No loss of cross section or erosion around posts observed.			
End Treatments	Alignment and Height:	Alignment acceptable. Height is within 1-in. of 27-in. design height.			
	Breaking and Cracking:	No twisting tearing bending or cracking observed.			
	Missing Elements:	No elements were observed to be missing.			
	Corrosion and Weathering:	No loss of cross section or erosion around posts observed.

Barrier ID:	DEWA-0014-1.107-L				
Route Name:	US ROUTE 209				
Inspection Date:	10/06/2010	Barrier Rating:		25.60	
Repair Recommendations					
Repair Action:	NO ACTION	FMSS Work Type:	N/A	Repair Cost:	\$0
Brief Workorder:	N/A				
Workorder:	No action required.

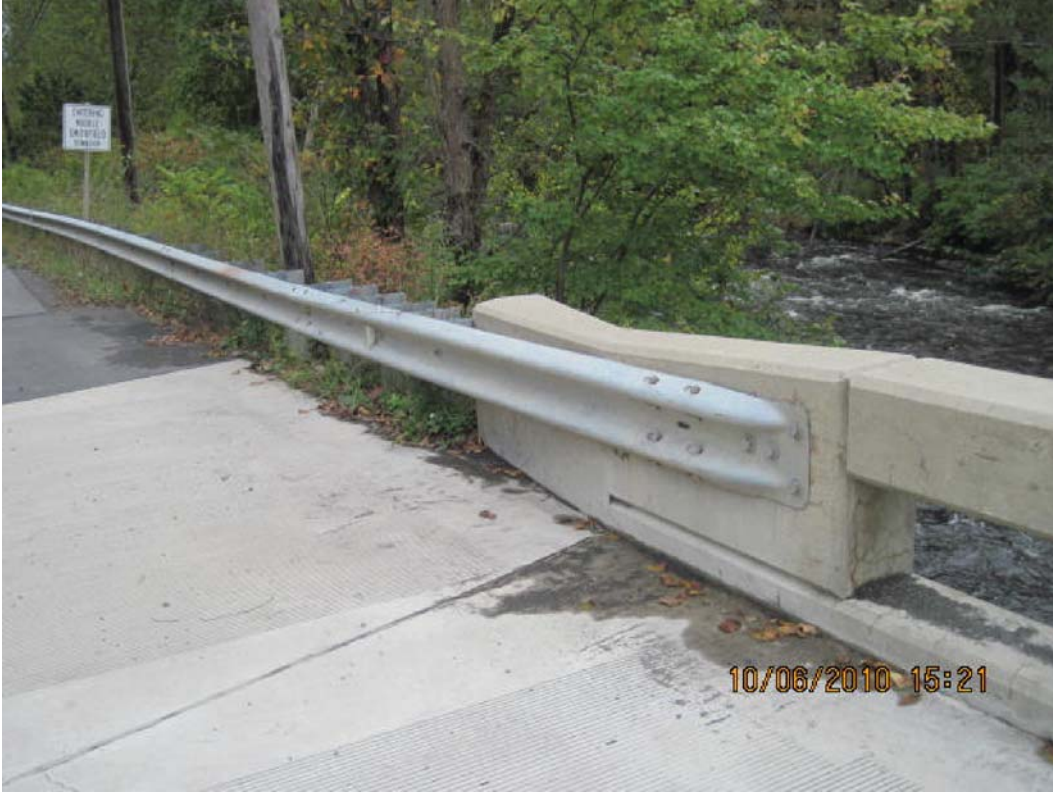
DEWA_0014_1.225_L_1.jpg

Barrier ID:	DEWA-0014-1.225-L				
Route Name:	US ROUTE 209				
Inspection Date:	10/06/2010	Barrier Rating:	23.70		
Barrier Description					
Type:	W-BEAM STRONG POST	Barrier Function:	TRAFFIC		
Barrier Material:	GALVANIZED STEEL	Post Material:	GALVANIZED STEEL		
Blockout Type:	STEEL	Length (ft.):	218		
Speed Limit (MPH):	35	Placement with Respect to Road:	TANGENT		
Hazard Behind Barrier:	MEDIUM				
Barrier Crashworthiness					
Appropriate Test Level:	TL-2	Barrier Test Level:	TL-3	Is Barrier Crashworthy?:	YES
Beg. End Trtmt Type:	W-BEAM BCT	Is Beg. End Trtmt Crashworthy?:	NO	Approach Transition Type:	BRIDGE RAIL W-BEAM
Ending End Trtmt Type:	NONE	Ending End Trtmt Crashworthy?:	N/A		
Average Measurements					
Design Height (In.):	27	Width (In.):	0.0	Post Spacing (In.):	76.1
Height (In.):	28.2	Lateral Offset (In.):	72.1	Road Grade (%):	0.80
Physical Condition					
Barrier	Alignment and Height:	Barrier showed signs of impact but deflection was only 4 in. The entire barrier was at or exceeded design height (27 in) up to 2.5 in.

Breaking and Cracking:	No twisting bending tears or cracking in the metal were observed.			
	Missing Elements:	No elements appeared to be missing.			
	Corrosion and Weathering:	Less than 5% of cross section was lost. No erosion was observed.			
End Treatments	Alignment and Height:	Alignment acceptable. Height is within 1-in. of 27-in. design height.			
	Breaking and Cracking:	No twisting bending tears or cracking in the metal observed.			
	Missing Elements:	No elements appeared to be missing.			
	Corrosion and Weathering:	Less than 5% of cross section was lost. No erosion around posts observed.

Barrier ID:	DEWA-0014-1.225-L				
Route Name:	US ROUTE 209				
Inspection Date:	10/06/2010	Barrier Rating:		23.70	
Repair Recommendations					
Repair Action:	NO ACTION	FMSS Work Type:	N/A	Repair Cost:	\$0
Brief Workorder:	N/A				
Workorder:	No action required.

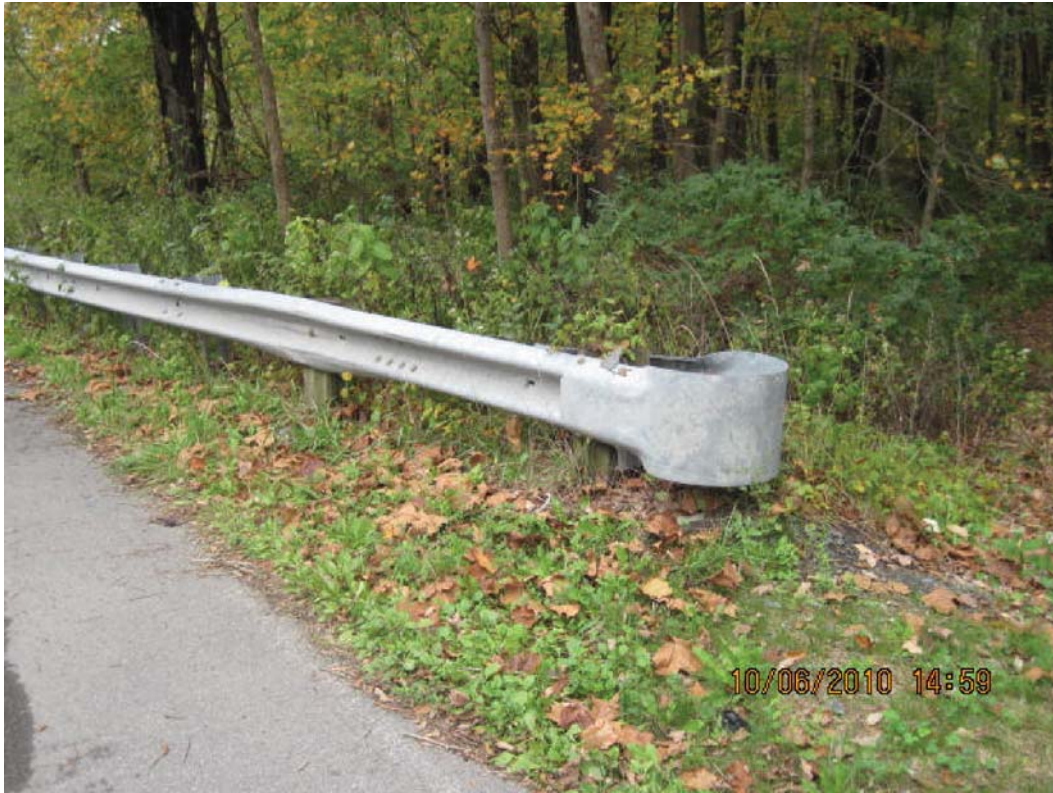
DEWA_0014_1.256_R_1.jpg

Barrier ID:	DEWA-0014-1.256-R				
Route Name:	US ROUTE 209				
Inspection Date:	10/06/2010	Barrier Rating:	23.70		
Barrier Description					
Type:	W-BEAM STRONG POST	Barrier Function:	TRAFFIC		
Barrier Material:	GALVANIZED STEEL	Post Material:	GALVANIZED STEEL		
Blockout Type:	STEEL	Length (ft.):	79		
Speed Limit (MPH):	35	Placement with Respect to Road:	TANGENT		
Hazard Behind Barrier:	MEDIUM				
Barrier Crashworthiness					
Appropriate Test Level:	TL-2	Barrier Test Level:	TL-3	Is Barrier Crashworthy?:	YES
Beg. End Trtmt Type:	W-BEAM BCT	Is Beg. End Trtmt Crashworthy?:	NO	Approach Transition Type:	BRIDGE RAIL W-BEAM
Ending End Trtmt Type:	NONE	Ending End Trtmt Crashworthy?:	N/A		
Average Measurements					
Design Height (In.):	27	Width (In.):	0.0	Post Spacing (In.):	54.0
Height (In.):	27.5	Lateral Offset (In.):	118.8	Road Grade (%):	0.70
Physical Condition					
Barrier	Alignment and Height:	No deflections greater than 6 in were observed in the alignment. The height was up to 1.5 in above to 1 in below of the 27 in design height for the entire length.

Breaking and Cracking:	No twisting bending tears, or cracking were observed in the barrier.			
	Missing Elements:	No elements were observed to be missing.			
	Corrosion and Weathering:	Less than 5 percent of the cross section was lost due to weathering. No erosion was observed.			
End Treatments	Alignment and Height:	Alignment acceptable. Height is within 1-in. of 27-in. design height.			
	Breaking and Cracking:	No twisting bending tears, or cracking were observed.			
	Missing Elements:	No elements were observed to be missing. End treatment cable was loose.			
	Corrosion and Weathering:	Less than 5 percent of the cross section was lost due to weathering.

Repair Action:	REPAIR	FMSS Work Type:	DEFERRED MAINTENANCE	Repair Cost:	\$66
Brief Workorder:	Repair End Treatment				
Workorder:	Labor at \$60- per -Hour for 1 Hrs = \$60. Tighten cable in the end treatment.

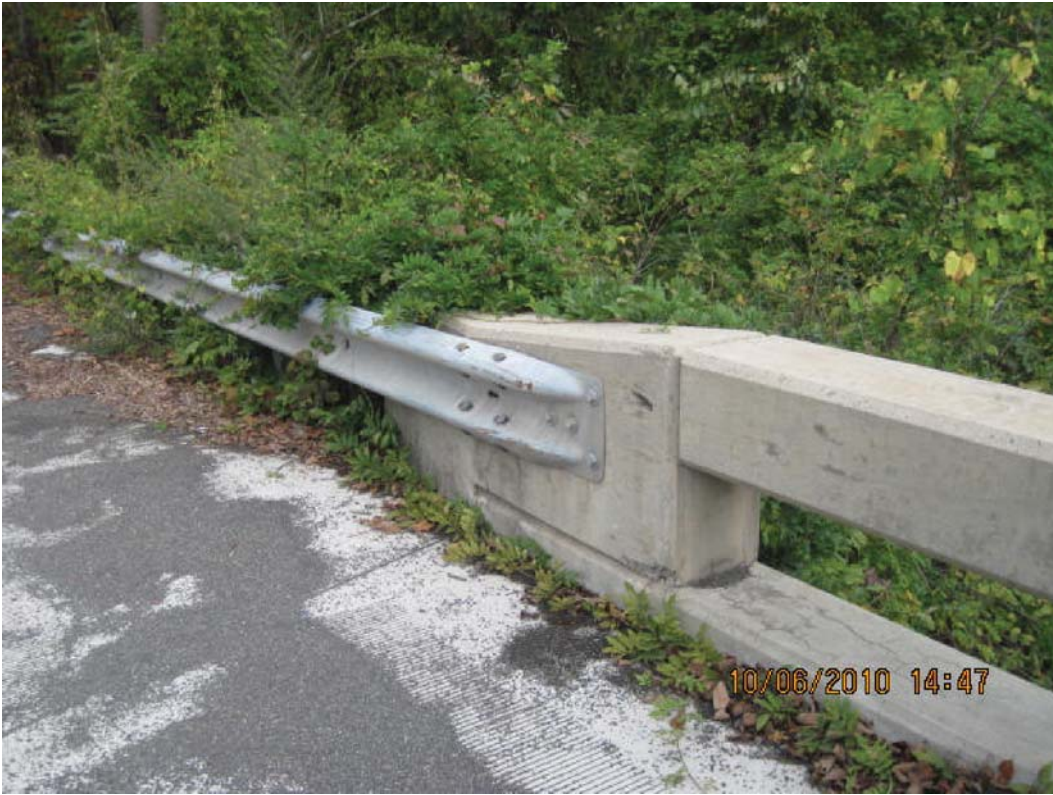
DEWA_0014_1.306_R_1.jpg

Barrier ID:	DEWA-0014-1.306-R				
Route Name:	US ROUTE 209				
Inspection Date:	10/06/2010	Barrier Rating:	23.70		
Barrier Description					
Type:	W-BEAM STRONG POST	Barrier Function:	TRAFFIC		
Barrier Material:	GALVANIZED STEEL	Post Material:	GALVANIZED STEEL		
Blockout Type:	STEEL	Length (ft.):	54		
Speed Limit (MPH):	35	Placement with Respect to Road:	TANGENT		
Hazard Behind Barrier:	MEDIUM				
Barrier Crashworthiness					
Appropriate Test Level:	TL-2	Barrier Test Level:	TL-3	Is Barrier Crashworthy?:	YES
Beg. End Trtmt Type:	NONE	Is Beg. End Trtmt Crashworthy?:	N/A	Approach Transition Type:	BRIDGE RAIL W-BEAM
Ending End Trtmt Type:	W-BEAM BCT	Ending End Trtmt Crashworthy?:	NO		
Average Measurements					
Design Height (In.):	27	Width (In.):	0.0	Post Spacing (In.):	54.2
Height (In.):	27.0	Lateral Offset (In.):	122.5	Road Grade (%):	0.40
Physical Condition					
Barrier	Alignment and Height:	No deflections in alignment observed. Barrier is 1 in or less or exceeds 27 in design height up to 2.5 in except in the transition area.

Breaking and Cracking:	No twisting tearing bending or cracking observed.			
	Missing Elements:	No elements were observed to be missing.			
	Corrosion and Weathering:	Less than 5% loss of cross section observed. No erosion around posts observed.			
End Treatments	Alignment and Height:	Alignment acceptable. Height is within 1-in. of 27-in. design height.			
	Breaking and Cracking:	No twisting tearing bending or cracking observed.			
	Missing Elements:	No elements were observed to be missing.			
	Corrosion and Weathering:	Less than 5% loss of cross section observed. No erosion observed.

Barrier ID:	DEWA-0014-1.306-R				
Route Name:	US ROUTE 209				
Inspection Date:	10/06/2010	Barrier Rating:		23.70	
Repair Recommendations					
Repair Action:	NO ACTION	FMSS Work Type:	N/A	Repair Cost:	\$0
Brief Workorder:	N/A				
Workorder:	No action required.

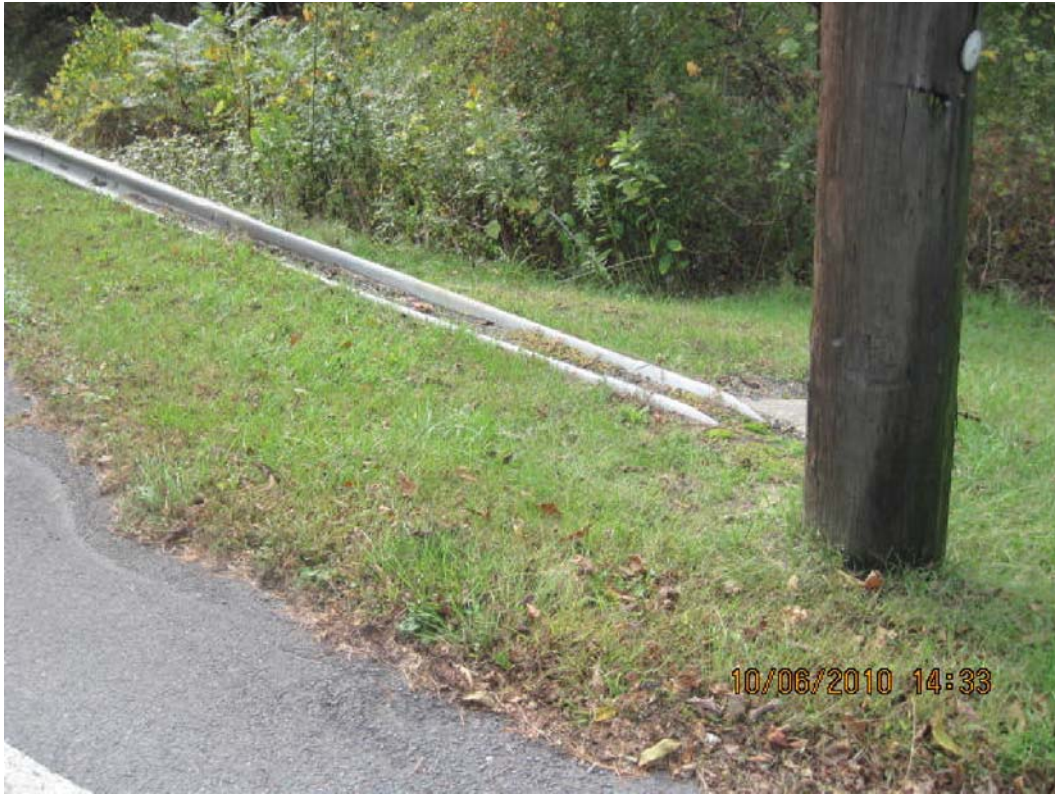
DEWA_0014_1.511_L_1.jpg

Barrier ID:	DEWA-0014-1.511-L				
Route Name:	US ROUTE 209				
Inspection Date:	10/06/2010	Barrier Rating:	45.40		
Barrier Description					
Type:	W-BEAM STRONG POST	Barrier Function:	TRAFFIC		
Barrier Material:	GALVANIZED STEEL	Post Material:	GALVANIZED STEEL		
Blockout Type:	STEEL	Length (ft.):	136		
Speed Limit (MPH):	35	Placement with Respect to Road:	TANGENT		
Hazard Behind Barrier:	MEDIUM				
Barrier Crashworthiness					
Appropriate Test Level:	TL-2	Barrier Test Level:	TL-3	Is Barrier Crashworthy?:	YES
Beg. End Trtmt Type:	NONE	Is Beg. End Trtmt Crashworthy?:	N/A	Approach Transition Type:	NONE
Ending End Trtmt Type:	W-BEAM TURN DOWN	Ending End Trtmt Crashworthy?:	NO		
Average Measurements					
Design Height (In.):	27	Width (In.):	0.0	Post Spacing (In.):	74.8
Height (In.):	22.7	Lateral Offset (In.):	85.1	Road Grade (%):	3.40
Physical Condition					
Barrier	Alignment and Height:	Alignment deflection was less than 6 in. 98 ft of the barrier was between 3-5.5in. below design height (27 in).

Breaking and Cracking:	No twisting tearing bending or cracking observed.			
	Missing Elements:	No elements appeared to be missing.			
	Corrosion and Weathering:	Less than 5% loss of cross section observed. No erosion observed.			
End Treatments	Alignment and Height:	Alignment acceptable. Height is within 1-in. of 27-in. design height.			
	Breaking and Cracking:	No twisting tearing bending or cracking observed.			
	Missing Elements:	No elements appeared to be missing.			
	Corrosion and Weathering:	Less than 5% loss of cross section observed.

Repair Action:	REPAIR	FMSS Work Type:	DEFERRED MAINTENANCE	Repair Cost:	\$2700
Brief Workorder:	Raise 98 feet of barrier to 27-in. design height.				
Workorder:	Adjust Guardrail at \$10- per -Lin. Ft. for 98 LF = \$980. Raise 98 ft of barrier to 27 inch design height. Low Speed Traffic Control at \$1475- per -Day for 1 Day(s) = \$1475.

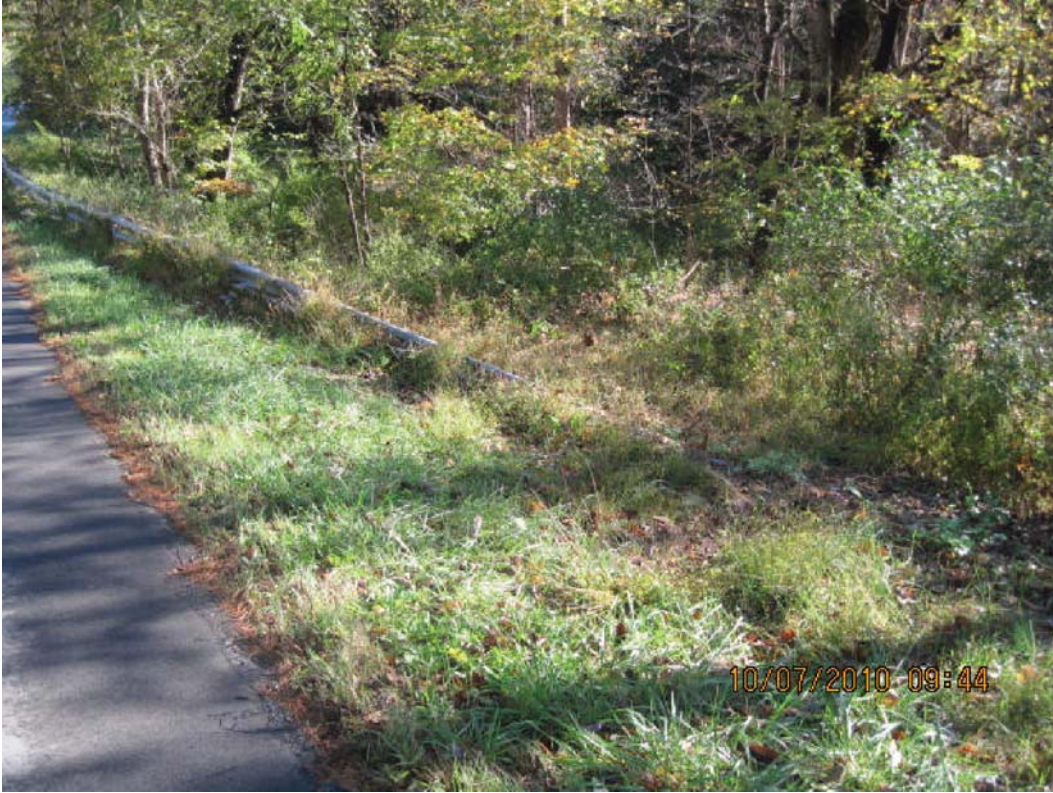
DEWA_0014_1.628_R_1.jpg

Barrier ID:	DEWA-0014-1.628-R				
Route Name:	US ROUTE 209				
Inspection Date:	10/07/2010	Barrier Rating:	42.50		
Barrier Description					
Type:	W-BEAM STRONG POST	Barrier Function:	TRAFFIC		
Barrier Material:	GALVANIZED STEEL	Post Material:	GALVANIZED STEEL		
Blockout Type:	STEEL	Length (ft.):	290		
Speed Limit (MPH):	35	Placement with Respect to Road:	INSIDE OF CURVE		
Hazard Behind Barrier:	MEDIUM				
Barrier Crashworthiness					
Appropriate Test Level:	TL-2	Barrier Test Level:	TL-3	Is Barrier Crashworthy?:	YES
Beg. End Trtmt Type:	W-BEAM TURN DOWN	Is Beg. End Trtmt Crashworthy?:	NO	Approach Transition Type:	NONE
Ending End Trtmt Type:	W-BEAM TURN DOWN	Ending End Trtmt Crashworthy?:	NO		
Average Measurements					
Design Height (In.):	27	Width (In.):	0.0	Post Spacing (In.):	74.3
Height (In.):	24.0	Lateral Offset (In.):	80.0	Road Grade (%):	1.00
Physical Condition					
Barrier	Alignment and Height:	There was a 50 ft section with deflections ranging between 12 in and 24 in. The barrier height was within 1 in of the 27 in design height for 34 ft between 1 in and 3 in below the design height for 50 ft and more than 3 in below for 130 ft.

Breaking and Cracking:	No twisting bending tears, or cracking was observed in the barrier.			
	Missing Elements:	No elements were observed to be missing.			
	Corrosion and Weathering:	Less than 5 percent of the cross section was lost due to weathering. No erosion was observed.			
End Treatments	Alignment and Height:	The ending end treatment was deflected between 4 in and 8 in. Height is within 1-in. of 27-in. design height.			
	Breaking and Cracking:	The rails on the ending end treatment were bent in several places.			
	Missing Elements:	No elements were observed to be missing.			
	Corrosion and Weathering:	More than 25 percent of the cross section was lost on the ending end treatment due to rust and weathering.

Repair Action:	REPLACE	FMSS Work Type:	CAPITAL IMPROVEMENT	Repair Cost:	\$11946
Brief Workorder:	Replace 58 feet of w-beam strong post and replace ending end treatment. Raise 150 feet of guardrail up to the 27 inch design height.				
Workorder:	Remove Guardrail at \$10- per -Lin. Ft. for 88 LF = \$880. Remove 88 feet of guardrail including the ending end treatment. W-beam flared 350 compliant at \$3500- per -Each for 1 Unit(s) = \$3500. Install a W-Beam Flared end treatment. W-Beam Strong Post at \$35- per -Lin. Ft. for 58 LF = \$2030. Install 58 feet of W-Beam strong post guardrail. Adjust Guardrail at \$10- per -Lin. Ft. for 150 LF = \$1500. Raise 150 feet of guardrail to the design height of 27 inches. Low Speed Traffic Control at \$1475- per -Day for 2 Day(s) = \$2950.

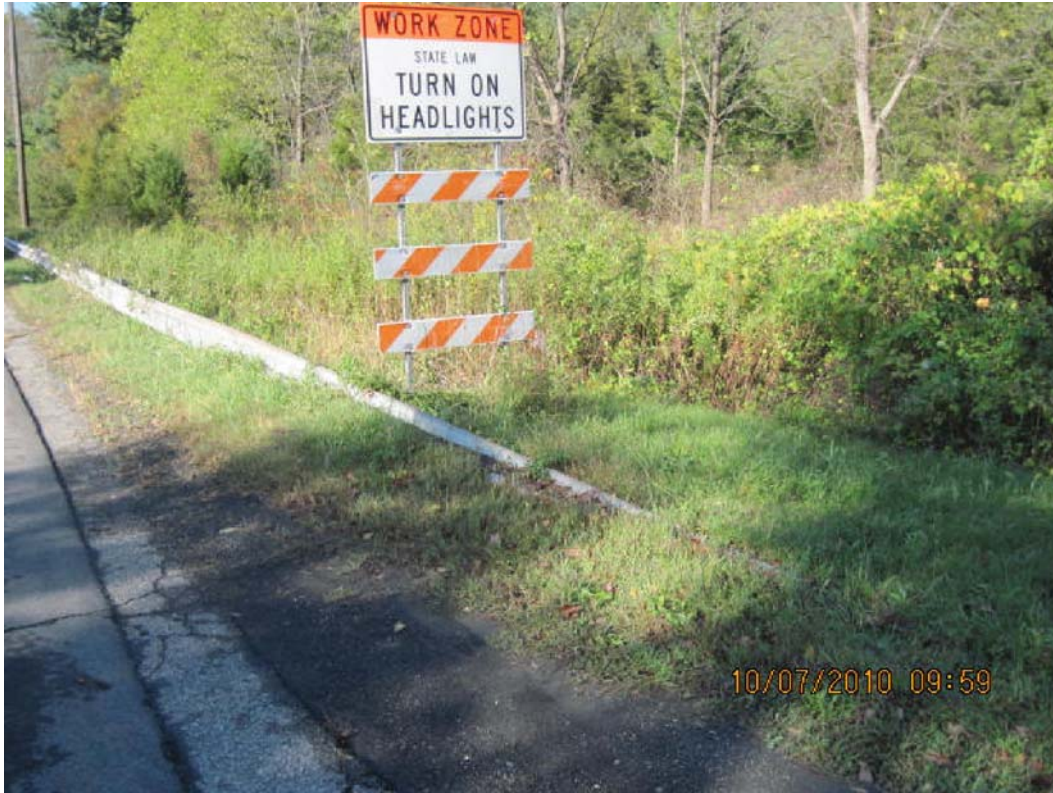
DEWA_0014_1.748_L_1.jpg

Barrier ID:	DEWA-0014-1.748-L				
Route Name:	US ROUTE 209				
Inspection Date:	10/07/2010	Barrier Rating:	58.50		
Barrier Description					
Type:	W-BEAM STRONG POST	Barrier Function:	TRAFFIC		
Barrier Material:	GALVANIZED STEEL	Post Material:	GALVANIZED STEEL		
Blockout Type:	STEEL	Length (ft.):	347		
Speed Limit (MPH):	35	Placement with Respect to Road:	OUTSIDE OF CURVE		
Hazard Behind Barrier:	LOW				
Barrier Crashworthiness					
Appropriate Test Level:	TL-2	Barrier Test Level:	TL-3	Is Barrier Crashworthy?:	YES
Beg. End Trtmt Type:	W-BEAM TURN DOWN	Is Beg. End Trtmt Crashworthy?:	NO	Approach Transition Type:	NONE
Ending End Trtmt Type:	W-BEAM TURN DOWN	Ending End Trtmt Crashworthy?:	NO		
Average Measurements					
Design Height (In.):	27	Width (In.):	0.0	Post Spacing (In.):	75.0
Height (In.):	20.7	Lateral Offset (In.):	83.6	Road Grade (%):	4.10
Physical Condition					
Barrier	Alignment and Height:	Alignment deflection was less than 6 in. 271 ft of the barrier was greater than 3 in below design height (27 in) down to 7.5 in below.

Breaking and Cracking:	No twisting/bending tears or cracking in the metal observed. 2 isolated posts were bent.			
	Missing Elements:	No elements appear to be missing.			
	Corrosion and Weathering:	Less than 5% loss of cross section observed. No erosion observed.			
End Treatments	Alignment and Height:	Alignment acceptable. Height is within 1-in. of 27-in. design height.			
	Breaking and Cracking:	No twisting/bending tears or cracking in the metal observed.			
	Missing Elements:	No elements appear to be missing.			
	Corrosion and Weathering:	Less than 5% or less of cross section observed.

Repair Action:	REPAIR	FMSS Work Type:	DEFERRED MAINTENANCE	Repair Cost:	\$6226
Brief Workorder:	Raise 271 feet of barrier to 27-in. design height.				
Workorder:	Adjust Guardrail at \$10- per -Lin. Ft. for 271 LF = \$2710. Raise 271 feet of guardrail to 27 inch design height. Low Speed Traffic Control at \$1475- per -Day for 2 Day(s) = \$2950.

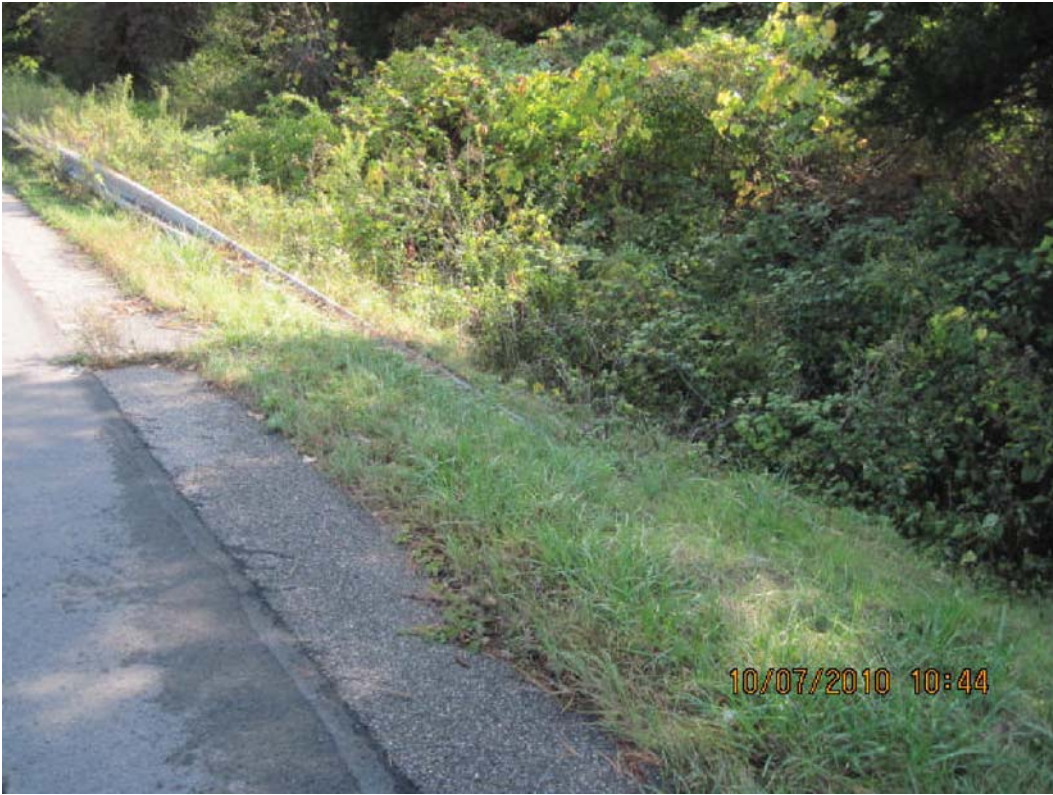
DEWA_0014_1.771_R_1.jpg

Barrier ID:	DEWA-0014-1.771-R				
Route Name:	US ROUTE 209				
Inspection Date:	10/07/2010	Barrier Rating:	48.20		
Barrier Description					
Type:	W-BEAM STRONG POST	Barrier Function:	TRAFFIC		
Barrier Material:	GALVANIZED STEEL	Post Material:	GALVANIZED STEEL		
Blockout Type:	STEEL	Length (ft.):	315		
Speed Limit (MPH):	35	Placement with Respect to Road:	TANGENT		
Hazard Behind Barrier:	MEDIUM				
Barrier Crashworthiness					
Appropriate Test Level:	TL-2	Barrier Test Level:	TL-3	Is Barrier Crashworthy?:	YES
Beg. End Trtmt Type:	W-BEAM TURN DOWN	Is Beg. End Trtmt Crashworthy?:	NO	Approach Transition Type:	NONE
Ending End Trtmt Type:	W-BEAM TURN DOWN	Ending End Trtmt Crashworthy?:	NO		
Average Measurements					
Design Height (In.):	27	Width (In.):	0.0	Post Spacing (In.):	75.3
Height (In.):	22.7	Lateral Offset (In.):	82.3	Road Grade (%):	4.00
Physical Condition					
Barrier	Alignment and Height:	A 50 ft section was deflected between 6 in and 12 in. The barrier height was 3.5 to 5.5 in below the 27 in design height for the entire length.

Breaking and Cracking:	25 ft of guardrail had tears due to rust. 50 ft of barrier was severely bent. 1 blockout was also observed to be bent.			
	Missing Elements:	No elements were observed to be missing.			
	Corrosion and Weathering:	Less than 5 percent of the cross section was lost due to weathering but 25 ft of guardrail had tears from rusting. No erosion was observed.			
End Treatments	Alignment and Height:	Alignment acceptable. Height is within 1-in. of 27-in. design height.			
	Breaking and Cracking:	There were tears in both end treatments from rust.			
	Missing Elements:	No elements were observed to be missing.			
	Corrosion and Weathering:	Between 5 percent and 25 percent of the cross section was lost due to weathering.

Repair Action:	REPLACE	FMSS Work Type:	CAPITAL IMPROVEMENT	Repair Cost:	\$16472
Brief Workorder:	Replace 75 feet of rail. Raise 239 feet of guardrail to 27-in. design height and replace both end treatments.				
Workorder:	Remove Guardrail at \$10- per -Lin. Ft. for 76 LF = \$760. Remove both end treatments (76 feet). W-beam flared 350 compliant at \$3500- per -Each for 2 Unit(s) = \$7000. Install 2 W-Beam flared end treatments. Replace Rail at \$25- per -Lin. Ft. for 75 LF = \$1875. Replace 75 feet of rail due to tearing and bending. Adjust Guardrail at \$10- per -Lin. Ft. for 239 LF = \$2390. Raise 239 feet of guardrail to 27 inch design height. Low Speed Traffic Control at \$1475- per -Day for 2 Day(s) = \$2950.

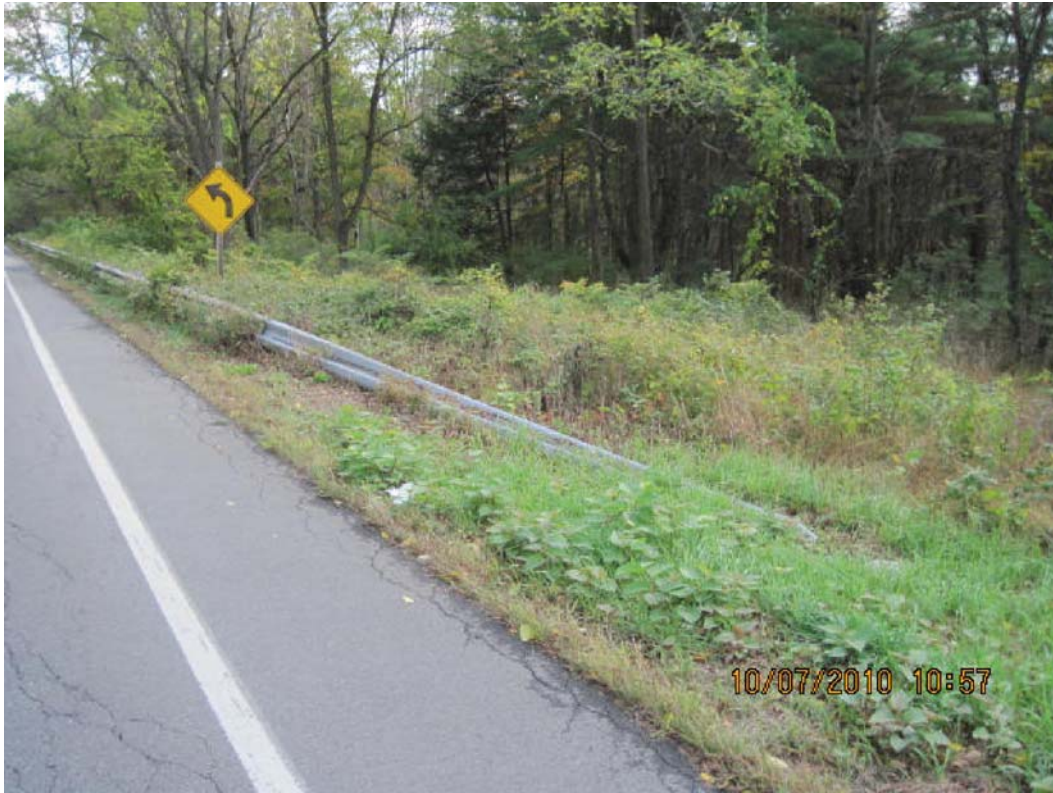
DEWA_0014_1.949_R_1.jpg

Barrier ID:	DEWA-0014-1.949-R				
Route Name:	US ROUTE 209				
Inspection Date:	10/07/2010	Barrier Rating:	52.50		
Barrier Description					
Type:	W-BEAM STRONG POST	Barrier Function:	TRAFFIC		
Barrier Material:	GALVANIZED STEEL	Post Material:	GALVANIZED STEEL		
Blockout Type:	STEEL	Length (ft.):	538		
Speed Limit (MPH):	35	Placement with Respect to Road:	TANGENT		
Hazard Behind Barrier:	MEDIUM				
Barrier Crashworthiness					
Appropriate Test Level:	TL-2	Barrier Test Level:	TL-3	Is Barrier Crashworthy?:	YES
Beg. End Trtmt Type:	W-BEAM TURN DOWN	Is Beg. End Trtmt Crashworthy?:	NO	Approach Transition Type:	NONE
Ending End Trtmt Type:	W-BEAM BURIED END	Ending End Trtmt Crashworthy?:	YES		
Average Measurements					
Design Height (In.):	27	Width (In.):	0.0	Post Spacing (In.):	75.5
Height (In.):	22.2	Lateral Offset (In.):	65.8	Road Grade (%):	0.70
Physical Condition					
Barrier	Alignment and Height:	Alignment deflection was less than 6 in. 462 ft of the barrier was 4.5 to 5 in below design height (27 in).

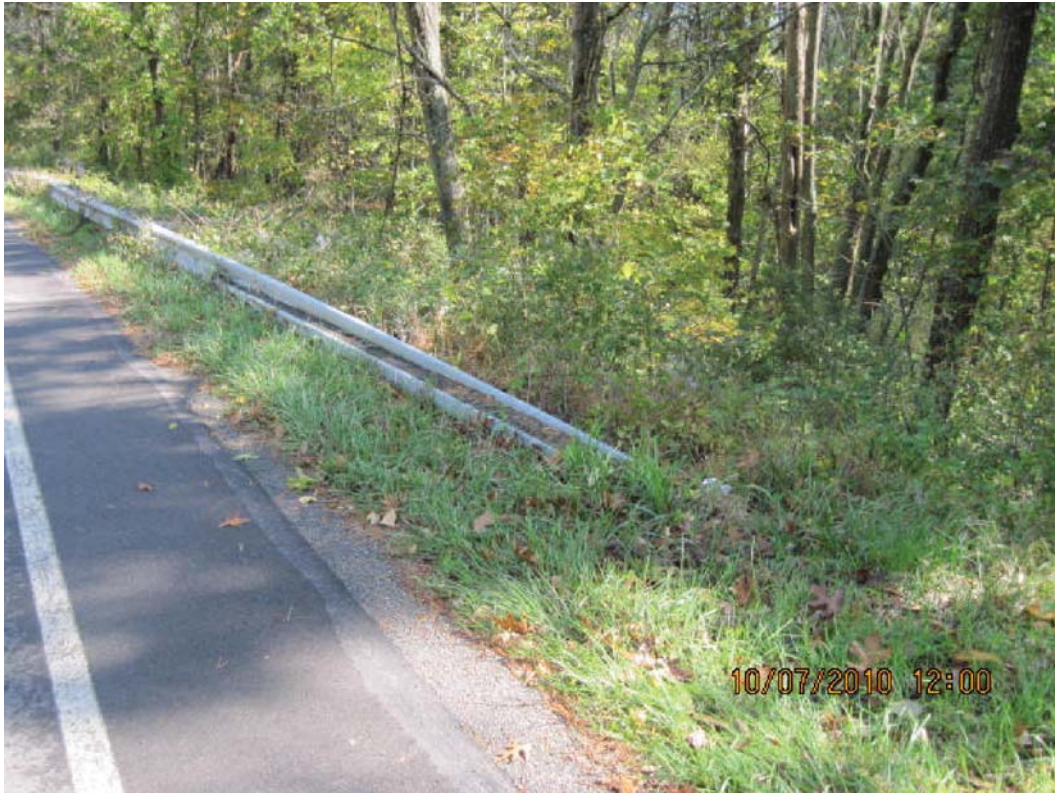
DEWA_0014_2.094_R_1.jpg

Barrier ID:	DEWA-0014-2.094-R				
Route Name:	US ROUTE 209				
Inspection Date:	10/07/2010	Barrier Rating:	54.00		
Barrier Description					
Type:	W-BEAM STRONG POST	Barrier Function:	TRAFFIC		
Barrier Material:	GALVANIZED STEEL	Post Material:	GALVANIZED STEEL		
Blockout Type:	STEEL	Length (ft.):	160		
Speed Limit (MPH):	35	Placement with Respect to Road:	OUTSIDE OF CURVE		
Hazard Behind Barrier:	MEDIUM				
Barrier Crashworthiness					
Appropriate Test Level:	TL-2	Barrier Test Level:	TL-3	Is Barrier Crashworthy?:	YES
Beg. End Trtmt Type:	W-BEAM TURN DOWN	Is Beg. End Trtmt Crashworthy?:	NO	Approach Transition Type:	NONE
Ending End Trtmt Type:	W-BEAM TURN DOWN	Ending End Trtmt Crashworthy?:	NO		
Average Measurements					
Design Height (In.):	27	Width (In.):	0.0	Post Spacing (In.):	74.8
Height (In.):	21.2	Lateral Offset (In.):	67.0	Road Grade (%):	5.90
Physical Condition					
Barrier	Alignment and Height:	There was an 8 in deflection observed for a 10 ft section. Otherwise no other deflections were observed. The barrier height was between 3-7 in below the 27 in design height for the entire length.

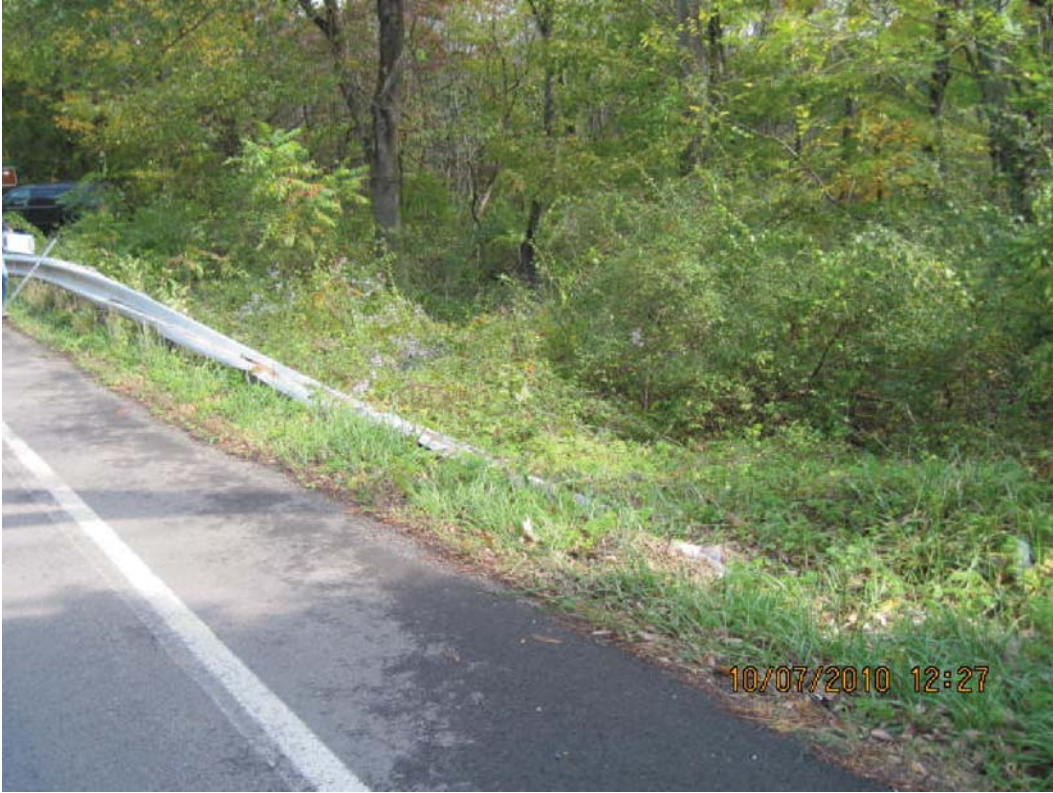
DEWA_0014_2.173_R_1.jpg

Barrier ID:	DEWA-0014-2.173-R				
Route Name:	US ROUTE 209				
Inspection Date:	10/07/2010	Barrier Rating:	28.20		
Barrier Description					
Type:	W-BEAM STRONG POST	Barrier Function:	TRAFFIC		
Barrier Material:	GALVANIZED STEEL	Post Material:	GALVANIZED STEEL		
Blockout Type:	STEEL	Length (ft.):	89		
Speed Limit (MPH):	35	Placement with Respect to Road:	TANGENT		
Hazard Behind Barrier:	MEDIUM				
Barrier Crashworthiness					
Appropriate Test Level:	TL-2	Barrier Test Level:	TL-3	Is Barrier Crashworthy?:	YES
Beg. End Trtmt Type:	W-BEAM TURN DOWN	Is Beg. End Trtmt Crashworthy?:	NO	Approach Transition Type:	NONE
Ending End Trtmt Type:	W-BEAM TURN DOWN	Ending End Trtmt Crashworthy?:	NO		
Average Measurements					
Design Height (In.):	27	Width (In.):	0.0	Post Spacing (In.):	73.0
Height (In.):	28.7	Lateral Offset (In.):	64.8	Road Grade (%):	0.70
Physical Condition					
Barrier	Alignment and Height:	Alignment deflection was greater than 1 ft. The entire barrier exceeded design height (27 in) by 1 to 3.5 in.

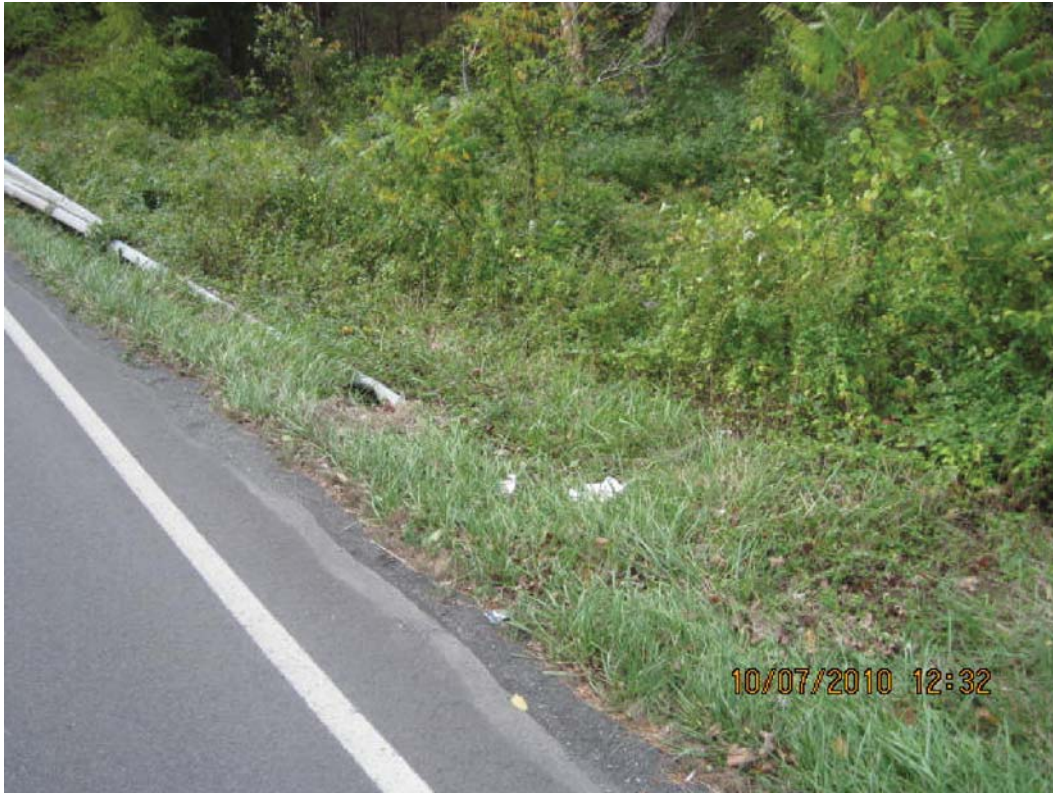
DEWA_0014_2.177_L_1.jpg

Barrier ID:	DEWA-0014-2.177-L				
Route Name:	US ROUTE 209				
Inspection Date:	10/07/2010	Barrier Rating:	31.10		
Barrier Description					
Type:	W-BEAM STRONG POST	Barrier Function:	TRAFFIC		
Barrier Material:	GALVANIZED STEEL	Post Material:	GALVANIZED STEEL		
Blockout Type:	STEEL	Length (ft.):	100		
Speed Limit (MPH):	35	Placement with Respect to Road:	TANGENT		
Hazard Behind Barrier:	MEDIUM				
Barrier Crashworthiness					
Appropriate Test Level:	TL-2	Barrier Test Level:	TL-3	Is Barrier Crashworthy?:	YES
Beg. End Trtmt Type:	W-BEAM TURN DOWN	Is Beg. End Trtmt Crashworthy?:	NO	Approach Transition Type:	NONE
Ending End Trtmt Type:	W-BEAM TURN DOWN	Ending End Trtmt Crashworthy?:	NO		
Average Measurements					
Design Height (In.):	27	Width (In.):	0.0	Post Spacing (In.):	74.6
Height (In.):	23.5	Lateral Offset (In.):	27.2	Road Grade (%):	1.50
Physical Condition					
Barrier	Alignment and Height:	No deflections greater than 6 in were observed in the alignment. The barrier height was more than 3 in below the 27 in design height for the entire length down to 3.5 in below.

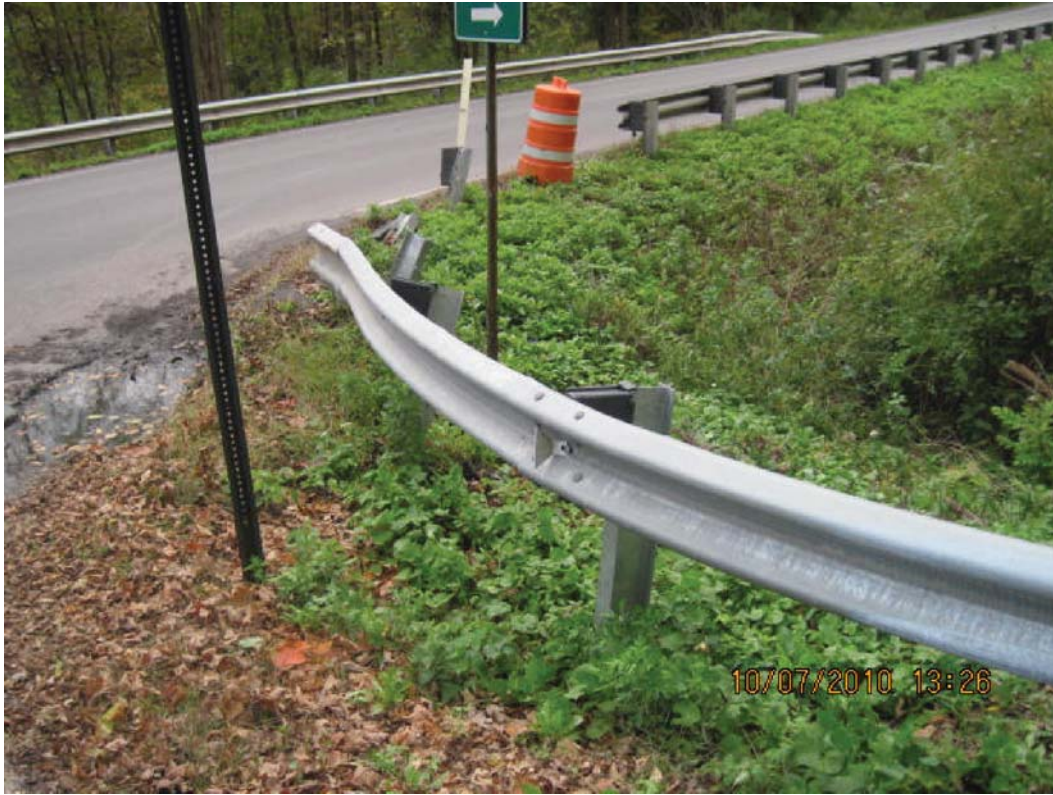
DEWA_0014_2.572_L_1.jpg

Barrier ID:	DEWA-0014-2.572-L				
Route Name:	US ROUTE 209				
Inspection Date:	10/07/2010	Barrier Rating:	38.20		
Barrier Description					
Type:	W-BEAM STRONG POST	Barrier Function:	TRAFFIC		
Barrier Material:	GALVANIZED STEEL	Post Material:	GALVANIZED STEEL		
Blockout Type:	PLASTIC	Length (ft.):	153		
Speed Limit (MPH):	35	Placement with Respect to Road:	TANGENT		
Hazard Behind Barrier:	MEDIUM				
Barrier Crashworthiness					
Appropriate Test Level:	TL-2	Barrier Test Level:	TL-3	Is Barrier Crashworthy?:	YES
Beg. End Trtmt Type:	W-BEAM TURN DOWN	Is Beg. End Trtmt Crashworthy?:	NO	Approach Transition Type:	NONE
Ending End Trtmt Type:	NONE	Ending End Trtmt Crashworthy?:	N/A		
Average Measurements					
Design Height (In.):	27	Width (In.):	0.0	Post Spacing (In.):	75.0
Height (In.):	25.0	Lateral Offset (In.):	11.3	Road Grade (%):	0.80
Physical Condition					
Barrier	Alignment and Height:	Alignment deflection was less than 6 in. 5 ft of the barrier was between 1 and 3 in below design height (27 in). 20 ft of the barrier was greater than 3 in below design height (27 in).

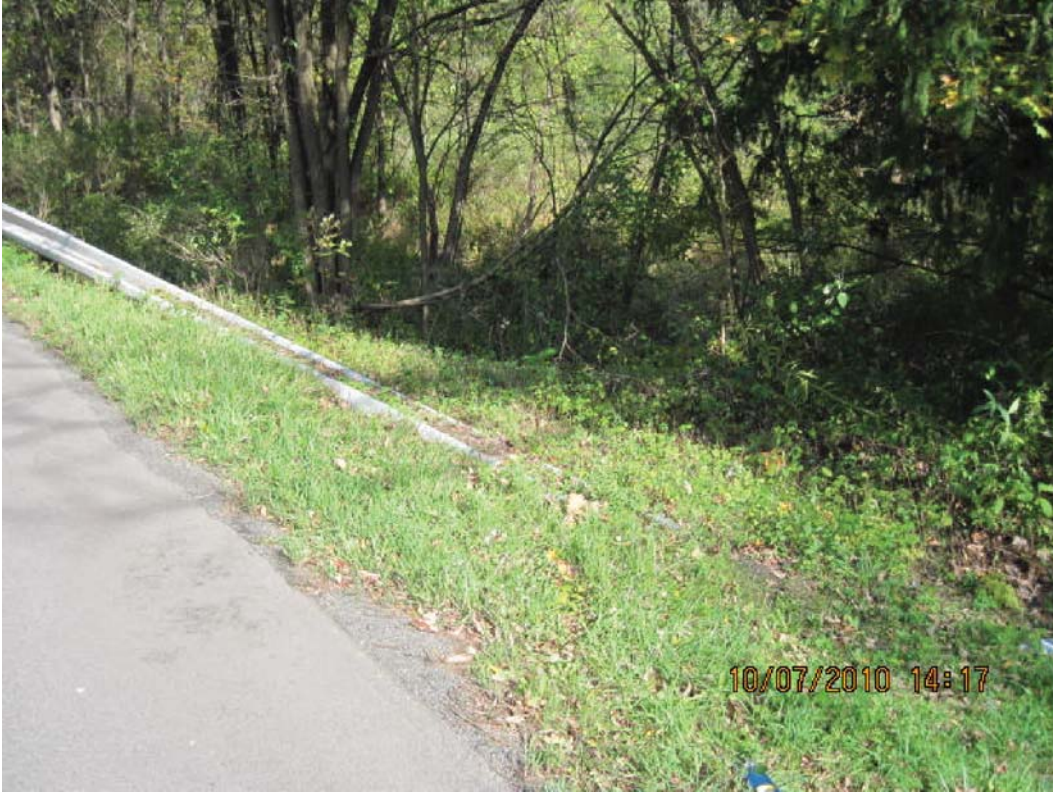
DEWA_0014_2.575_R_1.jpg

Barrier ID:	DEWA-0014-2.575-R				
Route Name:	US ROUTE 209				
Inspection Date:	10/07/2010	Barrier Rating:	65.60		
Barrier Description					
Type:	W-BEAM STRONG POST	Barrier Function:	TRAFFIC		
Barrier Material:	GALVANIZED STEEL	Post Material:	GALVANIZED STEEL		
Blockout Type:	STEEL	Length (ft.):	872		
Speed Limit (MPH):	35	Placement with Respect to Road:	TANGENT		
Hazard Behind Barrier:	HIGH				
Barrier Crashworthiness					
Appropriate Test Level:	TL-2	Barrier Test Level:	TL-3	Is Barrier Crashworthy?:	YES
Beg. End Trtmt Type:	W-BEAM TURN DOWN	Is Beg. End Trtmt Crashworthy?:	NO	Approach Transition Type:	NONE
Ending End Trtmt Type:	W-BEAM TRAILING END	Ending End Trtmt Crashworthy?:	YES		
Average Measurements					
Design Height (In.):	27	Width (In.):	0.0	Post Spacing (In.):	75.3
Height (In.):	21.6	Lateral Offset (In.):	49.4	Road Grade (%):	0.40
Physical Condition					
Barrier	Alignment and Height:	No deflections greater than 6 in were observed in the alignment. The barrier height was within 1 in of the 27 in design height for 53 ft between 1 and 3 in below the design height for 20 ft and more than 3 in below the design height for 761 ft.

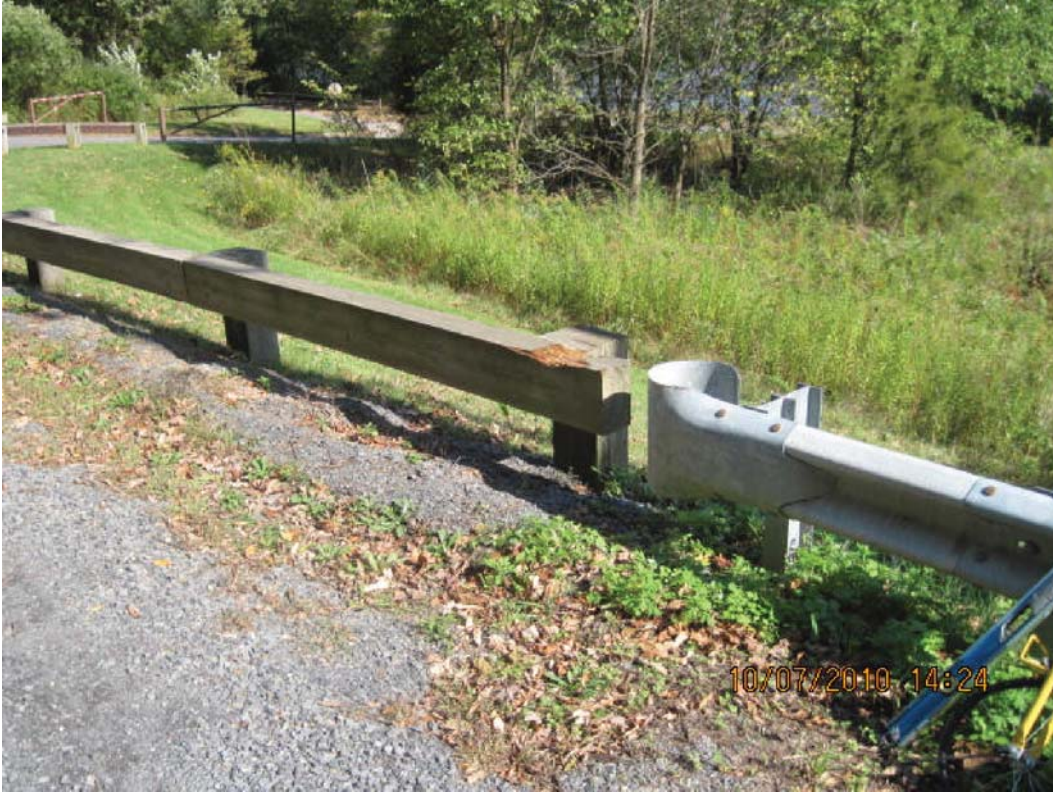
DEWA_0014_2.740_R_1.jpg

Barrier ID:	DEWA-0014-2.740-R				
Route Name:	US ROUTE 209				
Inspection Date:	10/07/2010	Barrier Rating:	30.10		
Barrier Description					
Type:	STEEL-BACKED TIMBER WITH BLOCKOUT	Barrier Function:	TRAFFIC		
Barrier Material:	STEEL-BACKED TIMBER/LOG	Post Material:	WOOD		
Blockout Type:	WOOD	Length (ft.):	106		
Speed Limit (MPH):	35	Placement with Respect to Road:	TANGENT		
Hazard Behind Barrier:	LOW				
Barrier Crashworthiness					
Appropriate Test Level:	TL-2	Barrier Test Level:	TL-3	Is Barrier Crashworthy?:	YES
Beg. End Trtmt Type:	NONE	Is Beg. End Trtmt Crashworthy?:	N/A	Approach Transition Type:	NONE
Ending End Trtmt Type:	NONE	Ending End Trtmt Crashworthy?:	N/A		
Average Measurements					
Design Height (In.):	27	Width (In.):	0.0	Post Spacing (In.):	118.5
Height (In.):	24.2	Lateral Offset (In.):	138.0	Road Grade (%):	1.70
Physical Condition					
Barrier	Alignment and Height:	Alignment deflection was less than 6 in. 35 ft of the barrier was 1 to 3 in below design height (27 ines). 45 ft of the barrier was between 3 and 5 ines below design height (27 ines).
