NPS Guardwall/Rail Inventory Program Delaware Water Gap National Recreation Area

**Federal Lands Highway
Road Inventory Program**

Federal Highway Administration
Eastern Federal Lands Highway Division
Road Inventory Program (RIP)

Data Collection Date: October 2010
Report Date: December 2015

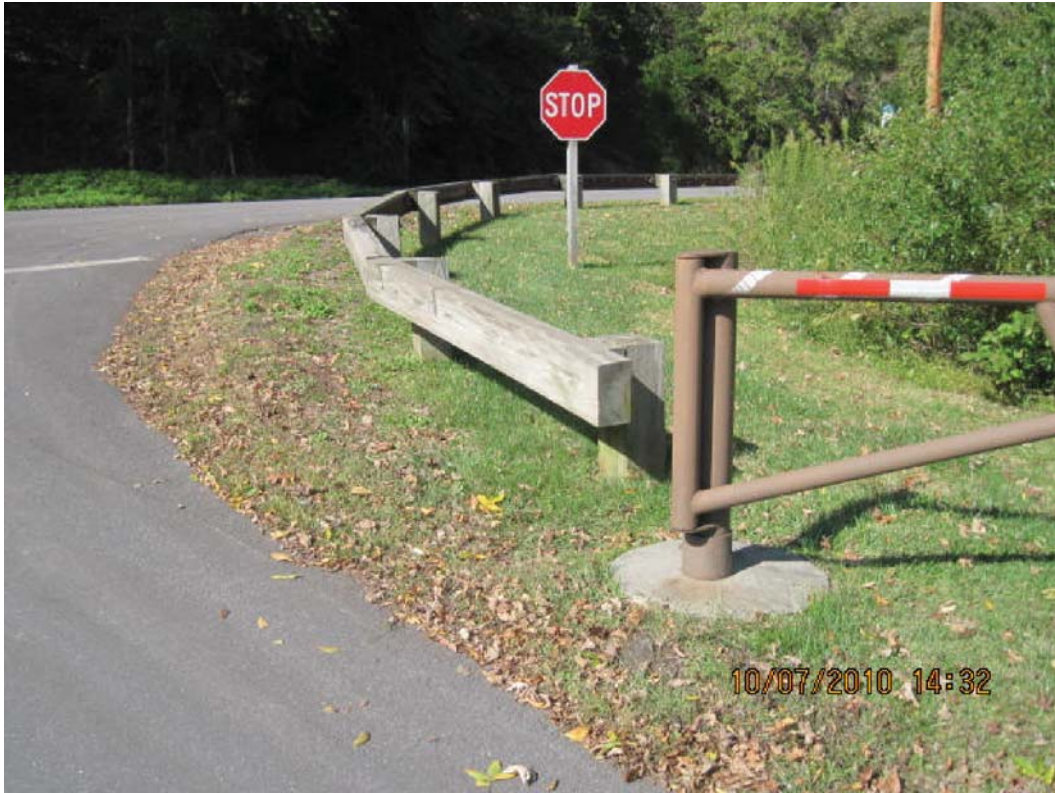
DEWA_0014_2.764_R_1.jpg

Barrier ID:	DEWA-0014-2.764-R				
Route Name:	US ROUTE 209				
Inspection Date:	10/07/2010	Barrier Rating:	32.50		
Barrier Description					
Type:	STEEL-BACKED TIMBER WITH BLOCKOUT	Barrier Function:	TRAFFIC		
Barrier Material:	STEEL-BACKED TIMBER/LOG	Post Material:	WOOD		
Blockout Type:	WOOD	Length (ft.):	92		
Speed Limit (MPH):	35	Placement with Respect to Road:	TANGENT		
Hazard Behind Barrier:	MEDIUM				
Barrier Crashworthiness					
Appropriate Test Level:	TL-2	Barrier Test Level:	TL-3	Is Barrier Crashworthy?:	YES
Beg. End Trtmt Type:	NONE	Is Beg. End Trtmt Crashworthy?:	N/A	Approach Transition Type:	NONE
Ending End Trtmt Type:	NONE	Ending End Trtmt Crashworthy?:	N/A		
Average Measurements					
Design Height (In.):	27	Width (In.):	0.0	Post Spacing (In.):	119.6
Height (In.):	23.7	Lateral Offset (In.):	130.3	Road Grade (%):	1.10
Physical Condition					
Barrier	Alignment and Height:	No deflections greater than 6 in were observed in the alignment. The barrier height was between 1 in and 3 in below the 27 in design height for 40 ft and more than 3 in below the design height for 52 ft.

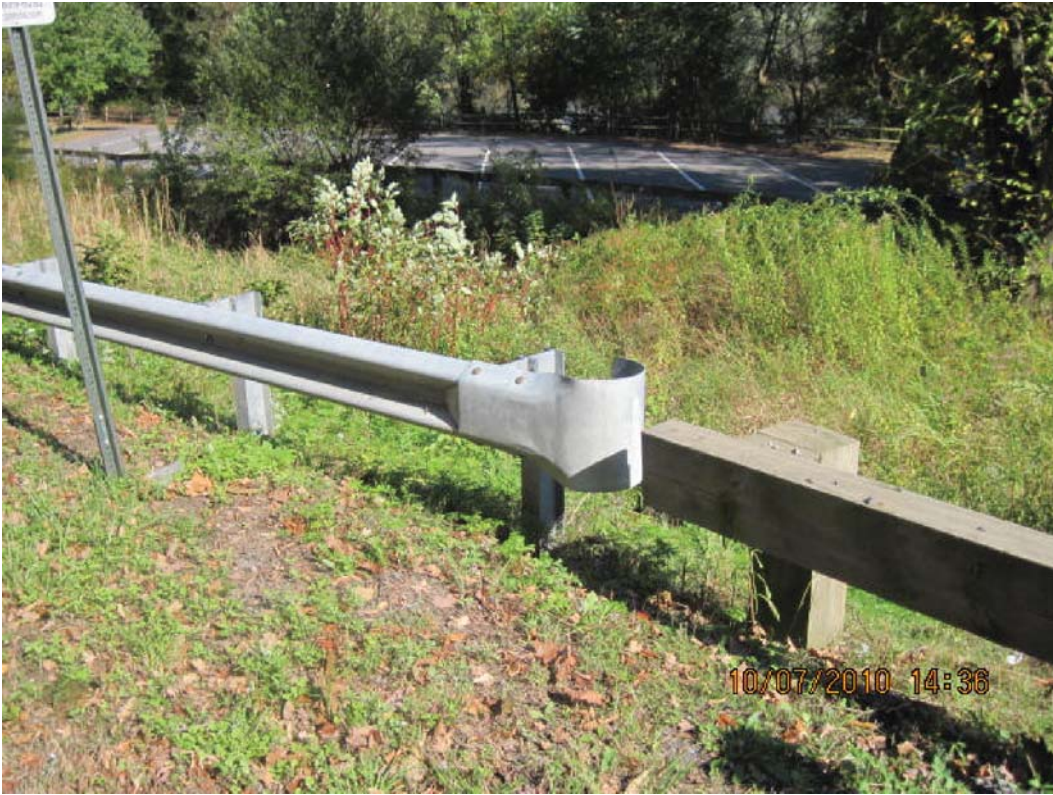
DEWA_0014_2.776_R_1.jpg

Barrier ID:	DEWA-0014-2.776-R				
Route Name:	US ROUTE 209				
Inspection Date:	10/07/2010	Barrier Rating:	66.80		
Barrier Description					
Type:	W-BEAM STRONG POST	Barrier Function:	TRAFFIC		
Barrier Material:	GALVANIZED STEEL	Post Material:	GALVANIZED STEEL		
Blockout Type:	STEEL	Length (ft.):	2322		
Speed Limit (MPH):	35	Placement with Respect to Road:	TANGENT		
Hazard Behind Barrier:	MEDIUM				
Barrier Crashworthiness					
Appropriate Test Level:	TL-2	Barrier Test Level:	TL-3	Is Barrier Crashworthy?:	YES
Beg. End Trtmt Type:	W-BEAM TRAILING END	Is Beg. End Trtmt Crashworthy?:	YES	Approach Transition Type:	NONE
Ending End Trtmt Type:	W-BEAM TURN DOWN	Ending End Trtmt Crashworthy?:	NO		
Average Measurements					
Design Height (In.):	27	Width (In.):	0.0	Post Spacing (In.):	74.8
Height (In.):	20.7	Lateral Offset (In.):	37.4	Road Grade (%):	0.20
Physical Condition					
Barrier	Alignment and Height:	26ft. had 18 in of deflection. Smaller deflections will be corrected when barrier adjusted for height. 150 ft of barrier was 1 to 3 in below design height (27 in). 2134 ft of the barrier was greater than 3 in below down to 16.5 in.

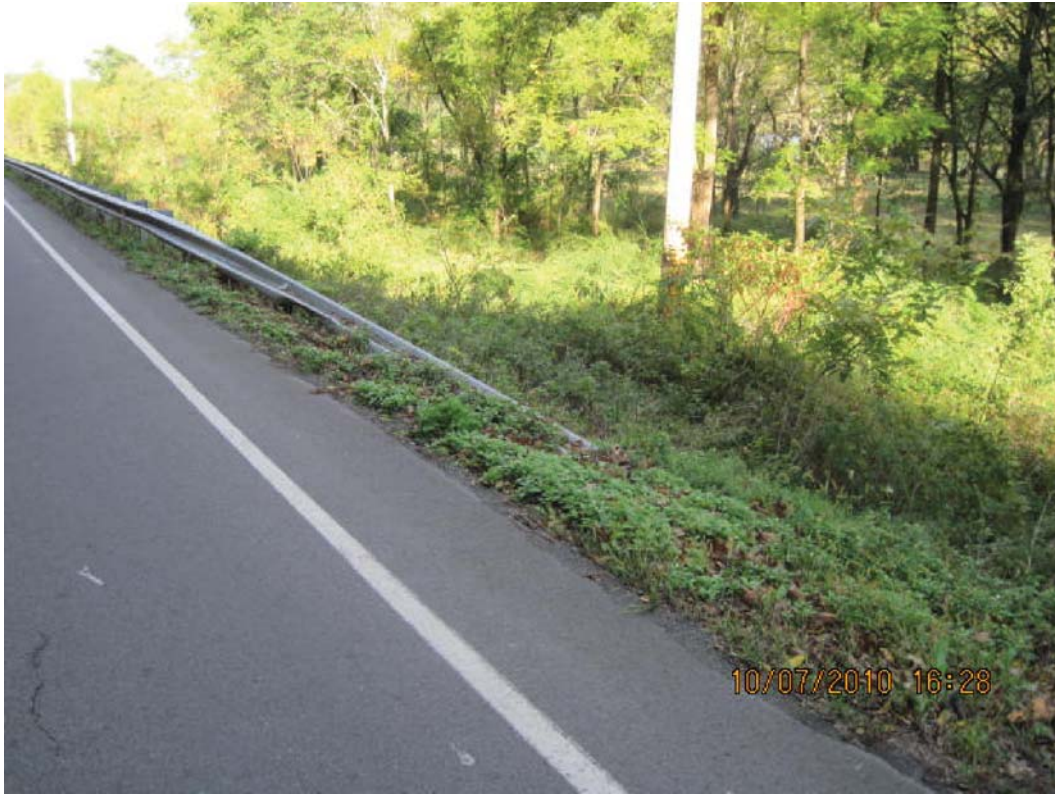
DEWA_0014_3.248_R_1.jpg

Barrier ID:	DEWA-0014-3.248-R				
Route Name:	US ROUTE 209				
Inspection Date:	10/07/2010	Barrier Rating:	64.00		
Barrier Description					
Type:	W-BEAM STRONG POST	Barrier Function:	TRAFFIC		
Barrier Material:	GALVANIZED STEEL	Post Material:	GALVANIZED STEEL		
Blockout Type:	STEEL	Length (ft.):	691		
Speed Limit (MPH):	35	Placement with Respect to Road:	OUTSIDE OF CURVE		
Hazard Behind Barrier:	MEDIUM				
Barrier Crashworthiness					
Appropriate Test Level:	TL-2	Barrier Test Level:	TL-3	Is Barrier Crashworthy?:	YES
Beg. End Trtmt Type:	W-BEAM TURN DOWN	Is Beg. End Trtmt Crashworthy?:	NO	Approach Transition Type:	NONE
Ending End Trtmt Type:	W-BEAM TURN DOWN	Ending End Trtmt Crashworthy?:	NO		
Average Measurements					
Design Height (In.):	27	Width (In.):	0.0	Post Spacing (In.):	74.8
Height (In.):	22.8	Lateral Offset (In.):	35.0	Road Grade (%):	1.20
Physical Condition					
Barrier	Alignment and Height:	No deflections greater than 6 in were observed in the alignment. The barrier height was between 1 in and 3 in below the 27 in design height for 108 ft and 3 to 5 in below the design height for 507 ft.

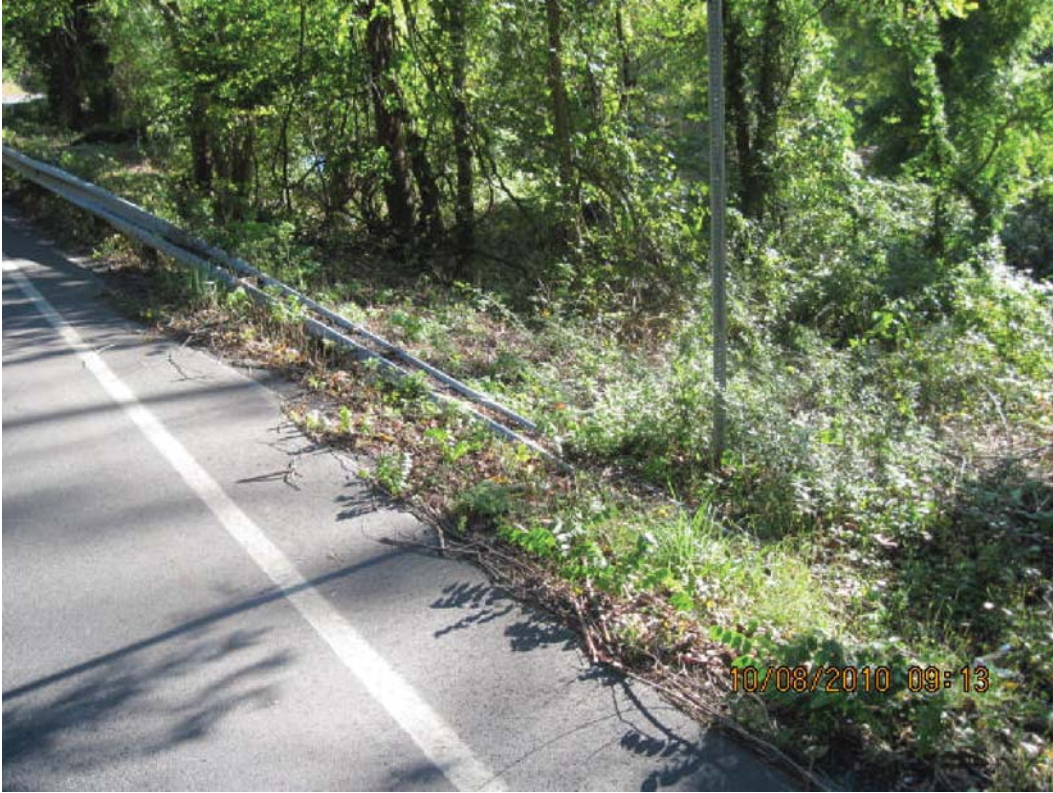
DEWA_0014_3.558_R_1.jpg

Barrier ID:	DEWA-0014-3.558-R				
Route Name:	US ROUTE 209				
Inspection Date:	10/08/2010	Barrier Rating:	72.80		
Barrier Description					
Type:	W-BEAM STRONG POST	Barrier Function:	TRAFFIC		
Barrier Material:	GALVANIZED STEEL	Post Material:	GALVANIZED STEEL		
Blockout Type:	STEEL	Length (ft.):	1218		
Speed Limit (MPH):	35	Placement with Respect to Road:	BOTH INSIDE AND OUTSIDE		
Hazard Behind Barrier:	HIGH				
Barrier Crashworthiness					
Appropriate Test Level:	TL-2	Barrier Test Level:	TL-3	Is Barrier Crashworthy?:	YES
Beg. End Trtmt Type:	W-BEAM TURN DOWN	Is Beg. End Trtmt Crashworthy?:	NO	Approach Transition Type:	NONE
Ending End Trtmt Type:	W-BEAM TURN DOWN	Ending End Trtmt Crashworthy?:	NO		
Average Measurements					
Design Height (In.):	27	Width (In.):	0.0	Post Spacing (In.):	75.0
Height (In.):	22.7	Lateral Offset (In.):	44.0	Road Grade (%):	0.60
Physical Condition					
Barrier	Alignment and Height:	Alignment deflection was less than 6 in. 430 ft of the barrier was 1 to 3 in below design height (27 ines). 712 ft of the barrier was 3-9 ines below design height (27 ines).

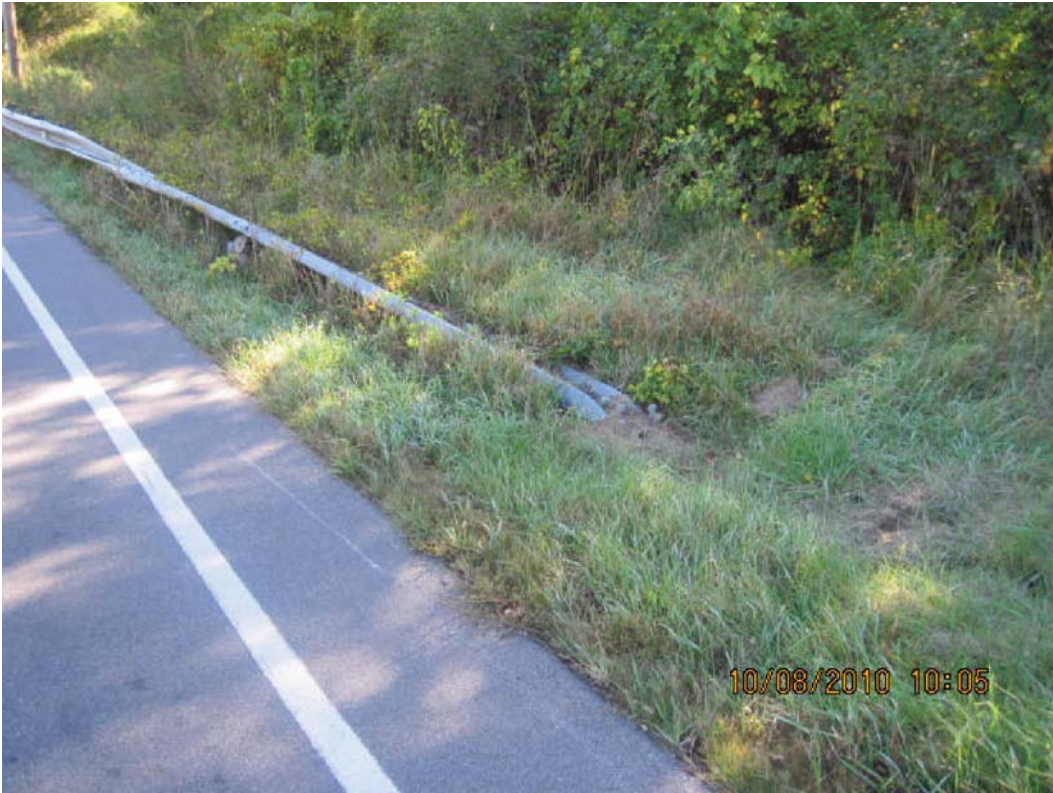
DEWA_0014_3.945_R_1.jpg

Barrier ID:	DEWA-0014-3.945-R				
Route Name:	US ROUTE 209				
Inspection Date:	10/08/2010	Barrier Rating:	42.50		
Barrier Description					
Type:	W-BEAM STRONG POST	Barrier Function:	TRAFFIC		
Barrier Material:	GALVANIZED STEEL	Post Material:	GALVANIZED STEEL		
Blockout Type:	STEEL	Length (ft.):	254		
Speed Limit (MPH):	35	Placement with Respect to Road:	TANGENT		
Hazard Behind Barrier:	MEDIUM				
Barrier Crashworthiness					
Appropriate Test Level:	TL-2	Barrier Test Level:	TL-3	Is Barrier Crashworthy?:	YES
Beg. End Trtmt Type:	W-BEAM TURN DOWN	Is Beg. End Trtmt Crashworthy?:	NO	Approach Transition Type:	NONE
Ending End Trtmt Type:	W-BEAM TURN DOWN	Ending End Trtmt Crashworthy?:	NO		
Average Measurements					
Design Height (In.):	27	Width (In.):	0.0	Post Spacing (In.):	74.3
Height (In.):	23.2	Lateral Offset (In.):	41.2	Road Grade (%):	0.00
Physical Condition					
Barrier	Alignment and Height:	No deflections greater than 6 in were observed in the alignment. The barrier height was between 1 in and 3 in below the 27 in design height for 15 ft and 3 to 4.5 in below the design height for 163 ft.

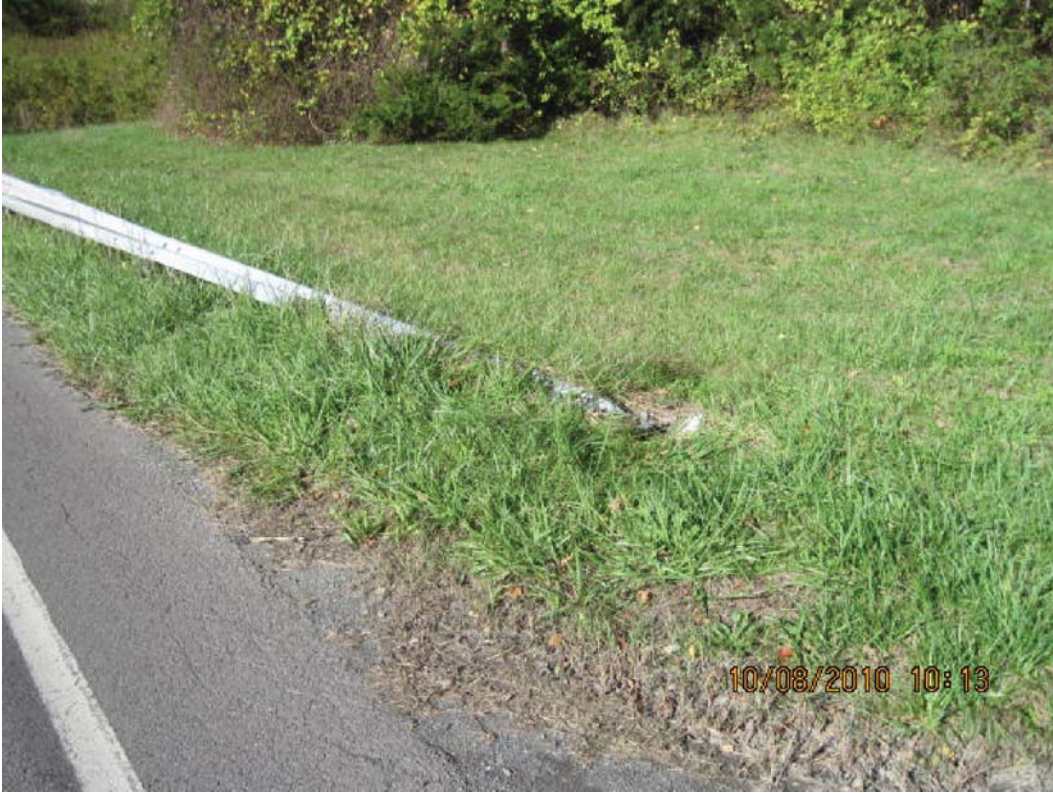
DEWA_0014_3.955_L_1.jpg

Barrier ID:	DEWA-0014-3.955-L				
Route Name:	US ROUTE 209				
Inspection Date:	10/08/2010	Barrier Rating:	37.20		
Barrier Description					
Type:	W-BEAM STRONG POST	Barrier Function:	TRAFFIC		
Barrier Material:	GALVANIZED STEEL	Post Material:	GALVANIZED STEEL		
Blockout Type:	STEEL	Length (ft.):	230		
Speed Limit (MPH):	45	Placement with Respect to Road:	TANGENT		
Hazard Behind Barrier:	LOW				
Barrier Crashworthiness					
Appropriate Test Level:	TL-2	Barrier Test Level:	TL-3	Is Barrier Crashworthy?:	YES
Beg. End Trtmt Type:	W-BEAM TURN DOWN	Is Beg. End Trtmt Crashworthy?:	NO	Approach Transition Type:	NONE
Ending End Trtmt Type:	W-BEAM TURN DOWN	Ending End Trtmt Crashworthy?:	NO		
Average Measurements					
Design Height (In.):	27	Width (In.):	0.0	Post Spacing (In.):	75.3
Height (In.):	25.2	Lateral Offset (In.):	33.5	Road Grade (%):	1.10
Physical Condition					
Barrier	Alignment and Height:	Alignment deflection was less than 6 in. 154 ft of the barrier was 1 to 3 in below design height (27 in).

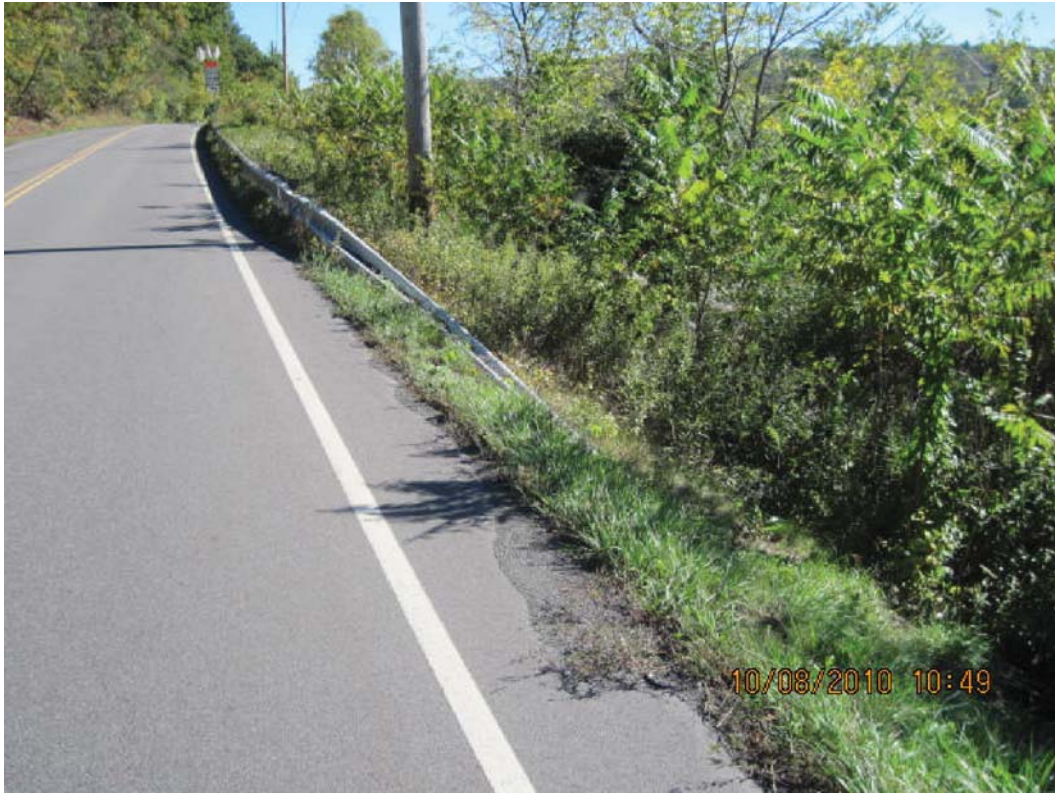
DEWA_0014_4.055_R_1.jpg

Barrier ID:	DEWA-0014-4.055-R				
Route Name:	US ROUTE 209				
Inspection Date:	10/08/2010	Barrier Rating:	56.70		
Barrier Description					
Type:	W-BEAM STRONG POST	Barrier Function:	TRAFFIC		
Barrier Material:	GALVANIZED STEEL	Post Material:	GALVANIZED STEEL		
Blockout Type:	STEEL	Length (ft.):	1483		
Speed Limit (MPH):	35	Placement with Respect to Road:	INSIDE OF CURVE		
Hazard Behind Barrier:	MEDIUM				
Barrier Crashworthiness					
Appropriate Test Level:	TL-2	Barrier Test Level:	TL-3	Is Barrier Crashworthy?:	YES
Beg. End Trtmt Type:	W-BEAM TURN DOWN	Is Beg. End Trtmt Crashworthy?:	NO	Approach Transition Type:	NONE
Ending End Trtmt Type:	W-BEAM TURN DOWN	Ending End Trtmt Crashworthy?:	NO		
Average Measurements					
Design Height (In.):	27	Width (In.):	0.0	Post Spacing (In.):	74.3
Height (In.):	23.8	Lateral Offset (In.):	34.5	Road Grade (%):	0.10
Physical Condition					
Barrier	Alignment and Height:	No deflections greater than 6 in were observed in the alignment. The barrier height was within 1 in of the 27 in design height for 75 ft between 1 in and 3 in below the design height for 745 ft and 3 to 5 in below the design height for 587 ft.

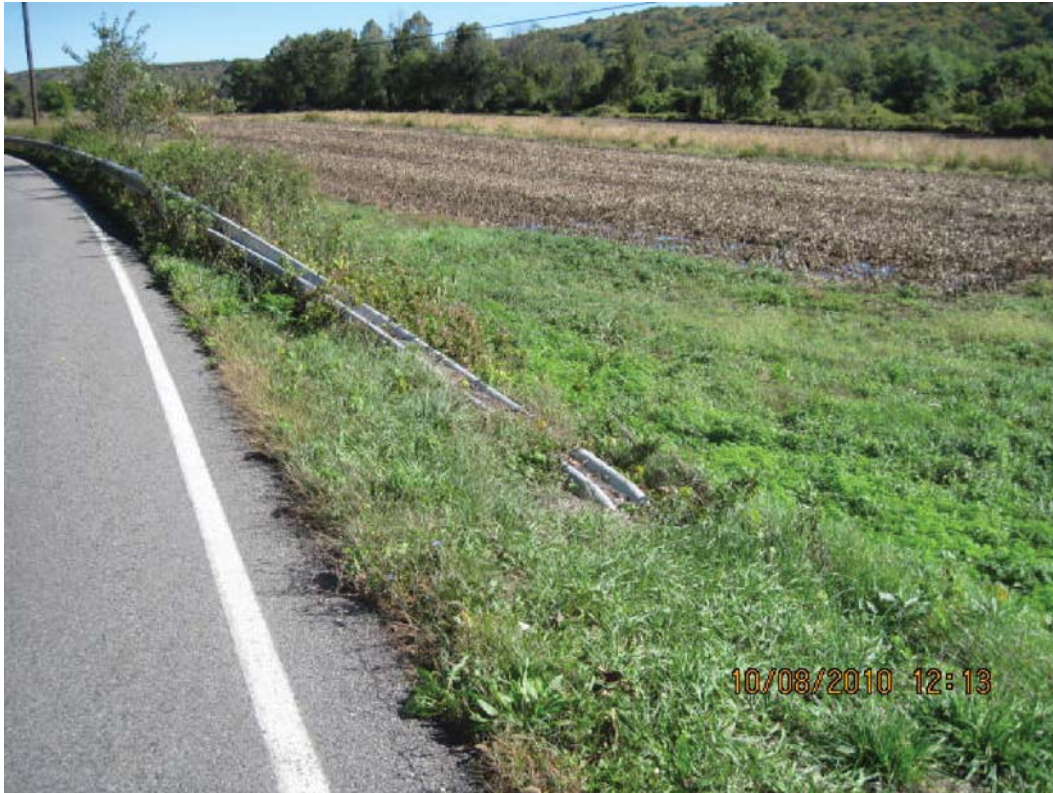
DEWA_0014_6.233_R_1.jpg

Barrier ID:	DEWA-0014-6.233-R				
Route Name:	US ROUTE 209				
Inspection Date:	10/08/2010	Barrier Rating:	44.40		
Barrier Description					
Type:	W-BEAM STRONG POST	Barrier Function:	TRAFFIC		
Barrier Material:	GALVANIZED STEEL	Post Material:	GALVANIZED STEEL		
Blockout Type:	STEEL	Length (ft.):	378		
Speed Limit (MPH):	45	Placement with Respect to Road:	OUTSIDE OF CURVE		
Hazard Behind Barrier:	LOW				
Barrier Crashworthiness					
Appropriate Test Level:	TL-2	Barrier Test Level:	TL-3	Is Barrier Crashworthy?:	YES
Beg. End Trtmt Type:	W-BEAM TURN DOWN	Is Beg. End Trtmt Crashworthy?:	NO	Approach Transition Type:	NONE
Ending End Trtmt Type:	W-BEAM TURN DOWN	Ending End Trtmt Crashworthy?:	NO		
Average Measurements					
Design Height (In.):	27	Width (In.):	0.0	Post Spacing (In.):	75.6
Height (In.):	28.5	Lateral Offset (In.):	26.7	Road Grade (%):	0.60
Physical Condition					
Barrier	Alignment and Height:	No deflections greater than 6 in were observed in the alignment. The barrier height was greater than the 27 in design height for the entire length up to 2 in above.

Breaking and Cracking:	1 post was broken. No other twisting bending tears, or cracking was observed.			
	Missing Elements:	No elements were observed to be missing.			
	Corrosion and Weathering:	Less than 5 percent of the cross section was lost due to weathering. No erosion was observed.			
End Treatments	Alignment and Height:	Alignment acceptable. Height is within 1-in. of 27-in. design height.			
	Breaking and Cracking:	The ending end treatment had broken posts severe bending and tears and twisting of the rails.			
	Missing Elements:	No elements were observed to be missing.			
	Corrosion and Weathering:	Between 5 percent and 25 percent of the cross section was lost due to rust on the ending end treatment.

Repair Action:	REPLACE	FMSS Work Type:	CAPITAL IMPROVEMENT	Repair Cost:	\$6000
Brief Workorder:	Replace ending end treatment and replace 1 post.				
Workorder:	Replace Post at \$100- per -Each for 1 Post(s) = \$100. Replace 1 broken post. Remove Guardrail at \$10- per -Lin. Ft. for 38 LF = \$380. Remove ending end treatment (38 feet). W-beam flared 350 compliant at \$3500- per -Each for 1 Unit(s) = \$3500. Install 1 W-Beam Flared end treatment. Low Speed Traffic Control at \$1475- per -Day for 1 Day(s) = \$1475.

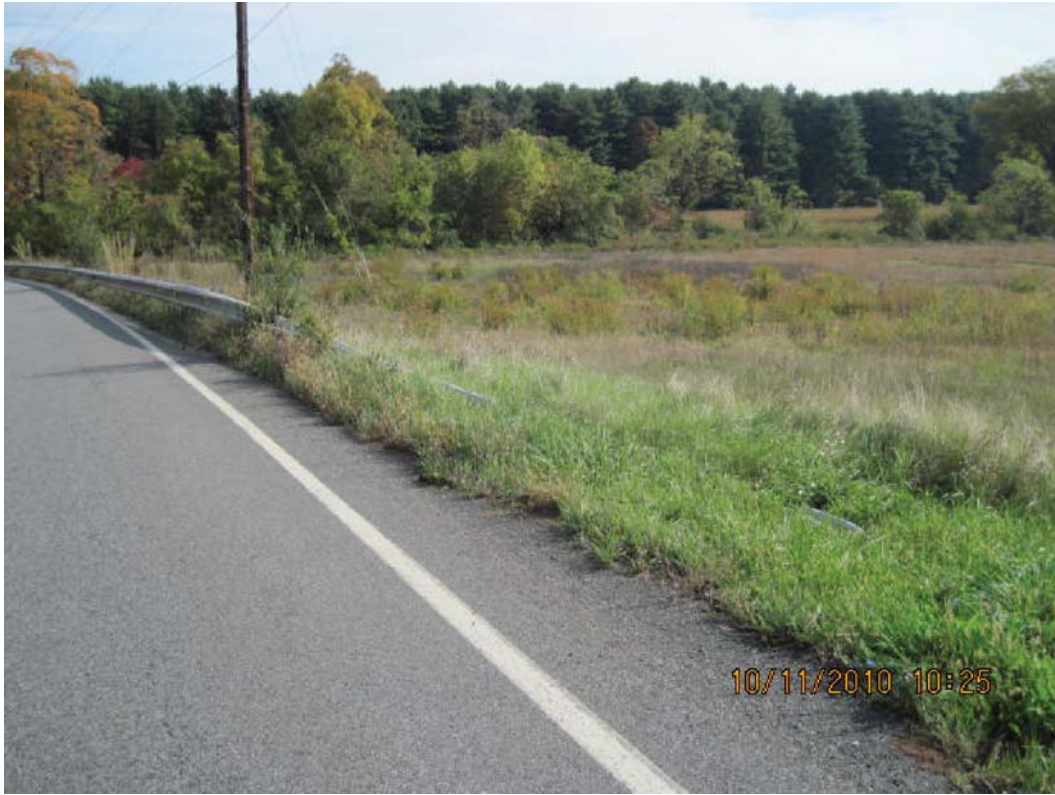
DEWA_0014_7.354_R_1.jpg

Barrier ID:	DEWA-0014-7.354-R				
Route Name:	US ROUTE 209				
Inspection Date:	10/11/2010	Barrier Rating:	42.70		
Barrier Description					
Type:	W-BEAM STRONG POST	Barrier Function:	TRAFFIC		
Barrier Material:	GALVANIZED STEEL	Post Material:	GALVANIZED STEEL		
Blockout Type:	STEEL	Length (ft.):	310		
Speed Limit (MPH):	45	Placement with Respect to Road:	OUTSIDE OF CURVE		
Hazard Behind Barrier:	LOW				
Barrier Crashworthiness					
Appropriate Test Level:	TL-2	Barrier Test Level:	TL-3	Is Barrier Crashworthy?:	YES
Beg. End Trtmt Type:	W-BEAM TURN DOWN	Is Beg. End Trtmt Crashworthy?:	NO	Approach Transition Type:	NONE
Ending End Trtmt Type:	OTHER: W-BEAM FLARED	Ending End Trtmt Crashworthy?:	NO		
Average Measurements					
Design Height (In.):	27	Width (In.):	0.0	Post Spacing (In.):	74.6
Height (In.):	26.7	Lateral Offset (In.):	22.2	Road Grade (%):	2.70
Physical Condition					
Barrier	Alignment and Height:	No deflections observed in alignment. Entire barrier is 1 in or less below or exceeds 27 in design height by 0.5 in.

Breaking and Cracking:	No twisting tearing breaking or cracking observed.			
	Missing Elements:	No elements were observed to be missing.			
	Corrosion and Weathering:	No loss of cross section observed. No erosion around posts observed.			
End Treatments	Alignment and Height:	Alignment acceptable. Height is within 1-in. of 27-in. design height.			
	Breaking and Cracking:	No twisting tearing breaking or cracking observed.			
	Missing Elements:	Rail was separating from post on beginning end due to missing bolt.			
	Corrosion and Weathering:	No loss of cross section observed. No erosion around posts observed.

Repair Action:	REPAIR	FMSS Work Type:	DEFERRED MAINTENANCE	Repair Cost:	\$1688
Brief Workorder:	Replace missing bolt on beginning end treatment.				
Workorder:	Labor at \$60- per -Hour for 1 Hrs = \$60. Replace missing bolt on beginning end treatment. Low Speed Traffic Control at \$1475- per -Day for 1 Day(s) = \$1475.

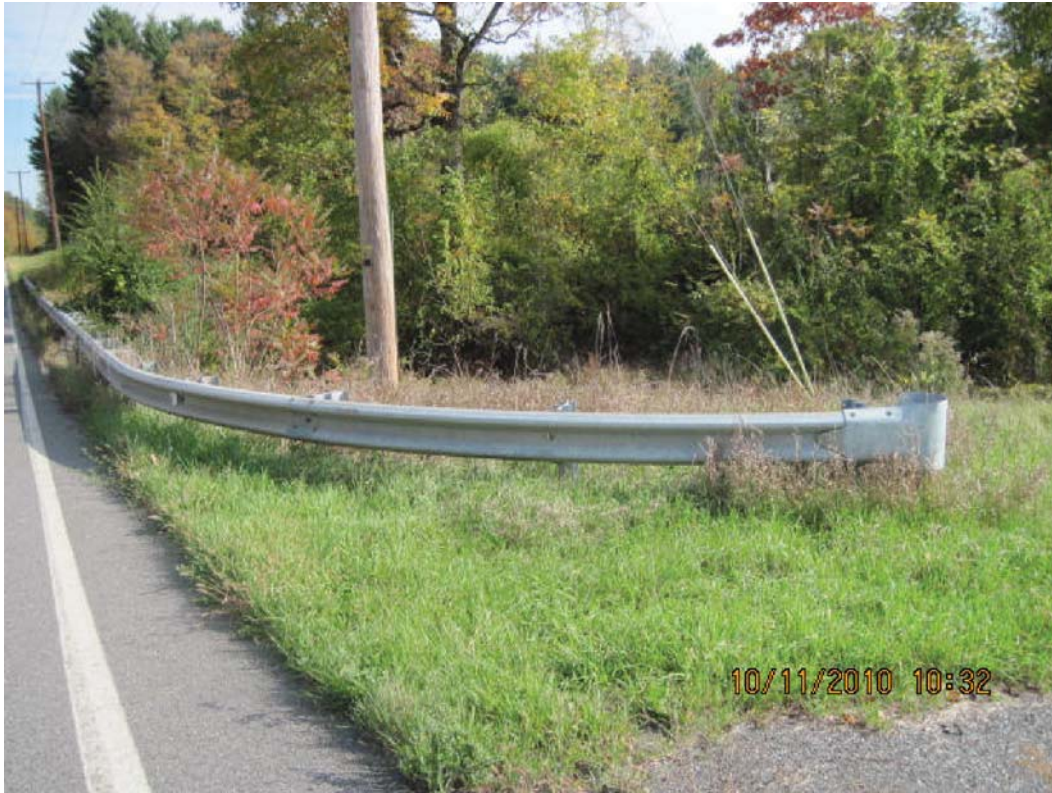
DEWA_0014_7.415_R_1.jpg

Barrier ID:	DEWA-0014-7.415-R				
Route Name:	US ROUTE 209				
Inspection Date:	10/11/2010	Barrier Rating:	31.00		
Barrier Description					
Type:	W-BEAM STRONG POST	Barrier Function:	TRAFFIC		
Barrier Material:	GALVANIZED STEEL	Post Material:	GALVANIZED STEEL		
Blockout Type:	STEEL	Length (ft.):	207		
Speed Limit (MPH):	45	Placement with Respect to Road:	TANGENT		
Hazard Behind Barrier:	MEDIUM				
Barrier Crashworthiness					
Appropriate Test Level:	TL-2	Barrier Test Level:	TL-3	Is Barrier Crashworthy?:	YES
Beg. End Trtmt Type:	OTHER: W-BEAM FLARED	Is Beg. End Trtmt Crashworthy?:	NO	Approach Transition Type:	NONE
Ending End Trtmt Type:	W-BEAM TURN DOWN	Ending End Trtmt Crashworthy?:	NO		
Average Measurements					
Design Height (In.):	27	Width (In.):	0.0	Post Spacing (In.):	74.5
Height (In.):	27.5	Lateral Offset (In.):	30.2	Road Grade (%):	1.40
Physical Condition					
Barrier	Alignment and Height:	No deflections greater than 2 in observed in alignment. Entire barrier meets or exceeds 27 in design height by 1 in.

Breaking and Cracking:	No twisting tearing breaking or cracking observed.			
	Missing Elements:	No elements were observed to be missing.			
	Corrosion and Weathering:	No loss of cross section observed. No erosion around posts observed.			
End Treatments	Alignment and Height:	Alignment acceptable. Height is within 1-in. of 27-in. design height.			
	Breaking and Cracking:	No twisting tearing breaking or cracking observed.			
	Missing Elements:	No elements were observed to be missing.			
	Corrosion and Weathering:	No loss of cross section observed. No erosion around posts observed.

Barrier ID:	DEWA-0014-7.415-R				
Route Name:	US ROUTE 209				
Inspection Date:	10/11/2010	Barrier Rating:		31.00	
Repair Recommendations					
Repair Action:	NO ACTION	FMSS Work Type:	N/A	Repair Cost:	\$0
Brief Workorder:	N/A				
Workorder:	No action required.

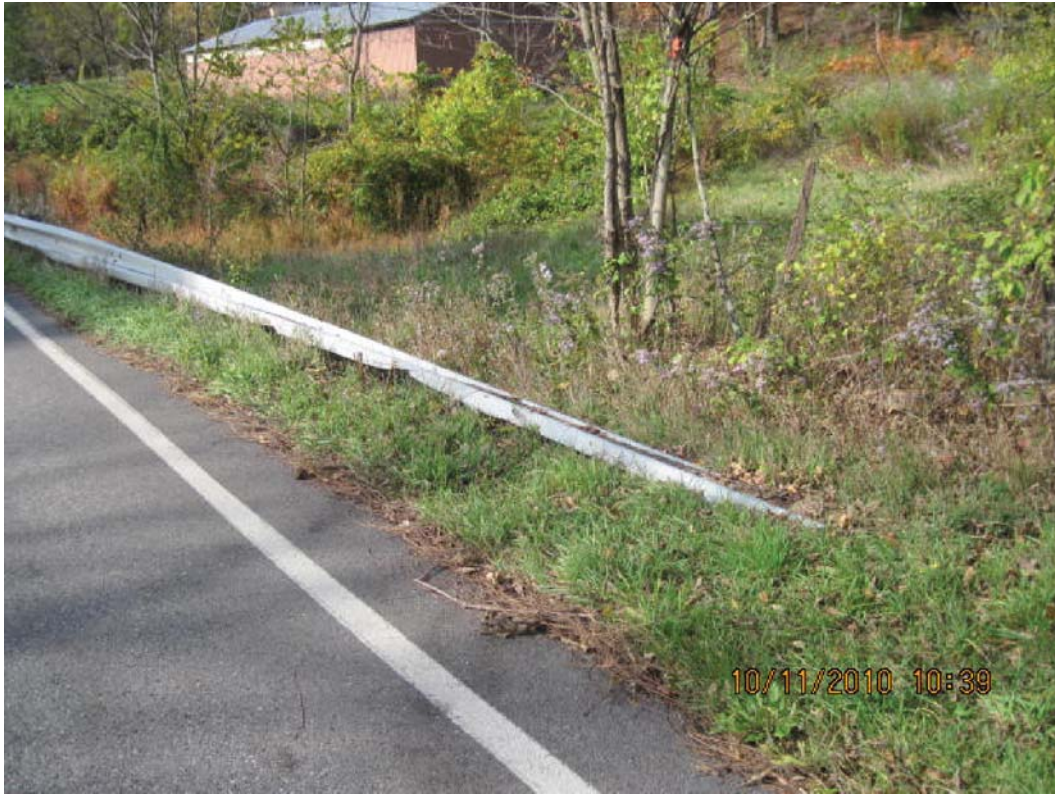
DEWA_0014_7.418_L_1.jpg

Barrier ID:	DEWA-0014-7.418-L				
Route Name:	US ROUTE 209				
Inspection Date:	10/11/2010	Barrier Rating:	42.50		
Barrier Description					
Type:	W-BEAM STRONG POST	Barrier Function:	TRAFFIC		
Barrier Material:	GALVANIZED STEEL	Post Material:	GALVANIZED STEEL		
Blockout Type:	STEEL	Length (ft.):	141		
Speed Limit (MPH):	45	Placement with Respect to Road:	TANGENT		
Hazard Behind Barrier:	MEDIUM				
Barrier Crashworthiness					
Appropriate Test Level:	TL-2	Barrier Test Level:	TL-3	Is Barrier Crashworthy?:	YES
Beg. End Trtmt Type:	W-BEAM TURN DOWN	Is Beg. End Trtmt Crashworthy?:	NO	Approach Transition Type:	NONE
Ending End Trtmt Type:	W-BEAM TURN DOWN	Ending End Trtmt Crashworthy?:	NO		
Average Measurements					
Design Height (In.):	27	Width (In.):	0.0	Post Spacing (In.):	74.3
Height (In.):	26.5	Lateral Offset (In.):	19.5	Road Grade (%):	3.10
Physical Condition					
Barrier	Alignment and Height:	No deflections greater than 3 in observed in alignment. Entire barrier is 1 in or less below or exceeds 27 in design height by 0.5 in.

Breaking and Cracking:	No twisting tearing breaking or cracking observed.			
	Missing Elements:	No elements were observed to be missing.			
	Corrosion and Weathering:	No loss of cross section observed. No erosion around posts observed.			
End Treatments	Alignment and Height:	Alignment acceptable. Height is within 1-in. of 27-in. design height.			
	Breaking and Cracking:	Beginning end treatment is twisted and bent due to an impact event.			
	Missing Elements:	No elements were observed to be missing.			
	Corrosion and Weathering:	No loss of cross section observed. No erosion around posts observed.

Repair Action:	REPLACE	FMSS Work Type:	CAPITAL IMPROVEMENT	Repair Cost:	\$4790
Brief Workorder:	Replace beginning end treatment with a W-beam trailing end treatment.				
Workorder:	Remove Guardrail at \$10- per -Lin. Ft. for 38 LF = \$380. Remove beginning end treatment (38 feet). W-beam Trailing End at \$2500- per -Each for 1 Unit(s) = \$2500. Install W-beam trailing end treatment. Low Speed Traffic Control at \$1475- per -Day for 1 Day(s) = \$1475.

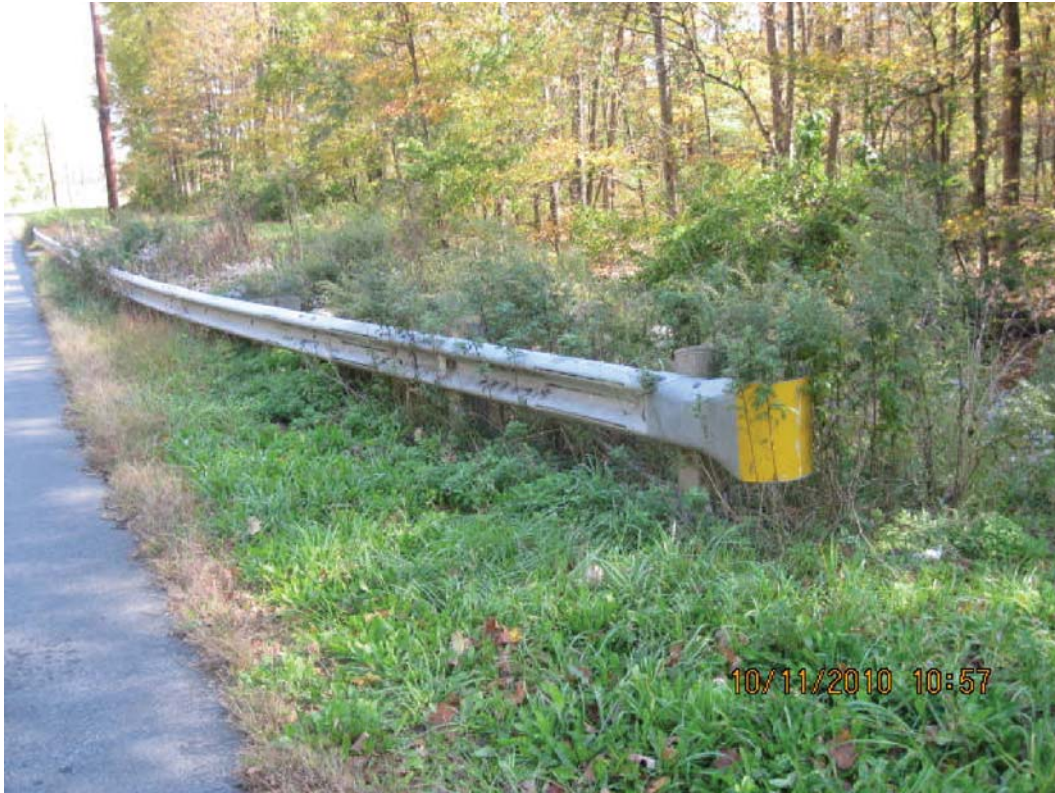
DEWA_0014_7.670_R_1.jpg

Barrier ID:	DEWA-0014-7.670-R				
Route Name:	US ROUTE 209				
Inspection Date:	10/11/2010	Barrier Rating:	28.10		
Barrier Description					
Type:	W-BEAM STRONG POST	Barrier Function:	TRAFFIC		
Barrier Material:	GALVANIZED STEEL	Post Material:	GALVANIZED STEEL		
Blockout Type:	STEEL	Length (ft.):	206		
Speed Limit (MPH):	45	Placement with Respect to Road:	TANGENT		
Hazard Behind Barrier:	MEDIUM				
Barrier Crashworthiness					
Appropriate Test Level:	TL-2	Barrier Test Level:	TL-3	Is Barrier Crashworthy?:	YES
Beg. End Trtmt Type:	W-BEAM FLARED 350 COMPLIANT	Is Beg. End Trtmt Crashworthy?:	YES	Approach Transition Type:	NONE
Ending End Trtmt Type:	W-BEAM FLARED 350 COMPLIANT	Ending End Trtmt Crashworthy?:	YES		
Average Measurements					
Design Height (In.):	27	Width (In.):	0.0	Post Spacing (In.):	80.6
Height (In.):	26.2	Lateral Offset (In.):	65.0	Road Grade (%):	0.80
Physical Condition					
Barrier	Alignment and Height:	Alignment deflection was less than 6 in. 68 ft of the barrier was 1 to 3 in below design height (27 in). The remaining length was 1 in below to 1 in above the 27 in design height.

Breaking and Cracking:	No twisting/bending tearing or cracking in the metal observed.			
	Missing Elements:	No elements appeared to be missing.			
	Corrosion and Weathering:	Less than 5% loss of cross section observed. No erosion observed.			
End Treatments	Alignment and Height:	Alignment acceptable. Height is within 1-in. of 27-in. design height.			
	Breaking and Cracking:	1 isolated block was twisted.			
	Missing Elements:	Both end treatment cables are loose.			
	Corrosion and Weathering:	Less than 5% loss of cross section observed.

Repair Action:	REPAIR	FMSS Work Type:	DEFERRED MAINTENANCE	Repair Cost:	\$2436
Brief Workorder:	Raise 68 feet of barrier to 27-in. design height and tighten cables on both end treatments.				
Workorder:	Adjust Guardrail at \$10- per -Lin. Ft. for 68 LF = \$680. Raise 68ft. of barrier to 27-in. design height. Labor at \$60- per -Hour for 1 Hrs = \$60. Tighten both cables on end treatments. Low Speed Traffic Control at \$1475- per -Day for 1 Day(s) = \$1475.

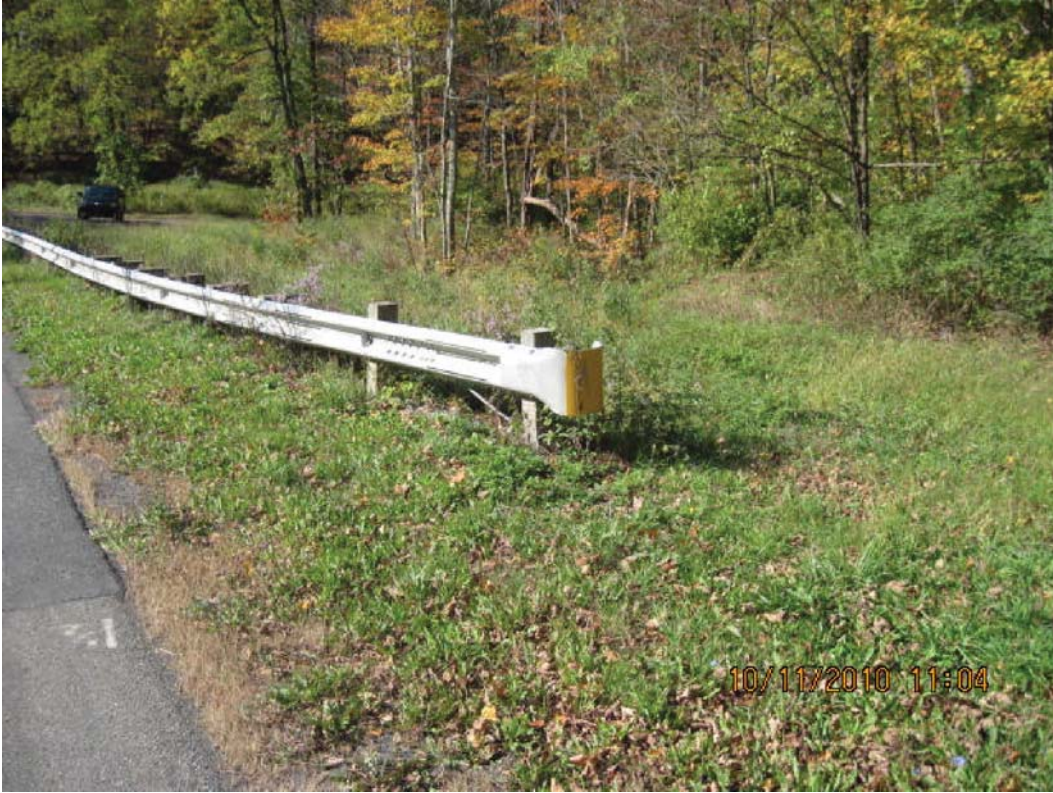
DEWA_0014_7.679_L_1.jpg

Barrier ID:	DEWA-0014-7.679-L				
Route Name:	US ROUTE 209				
Inspection Date:	10/11/2010	Barrier Rating:	28.10		
Barrier Description					
Type:	W-BEAM STRONG POST	Barrier Function:	TRAFFIC		
Barrier Material:	GALVANIZED STEEL	Post Material:	GALVANIZED STEEL		
Blockout Type:	STEEL	Length (ft.):	141		
Speed Limit (MPH):	45	Placement with Respect to Road:	TANGENT		
Hazard Behind Barrier:	MEDIUM				
Barrier Crashworthiness					
Appropriate Test Level:	TL-2	Barrier Test Level:	TL-3	Is Barrier Crashworthy?:	YES
Beg. End Trtmt Type:	W-BEAM FLARED 350 COMPLIANT	Is Beg. End Trtmt Crashworthy?:	YES	Approach Transition Type:	NONE
Ending End Trtmt Type:	W-BEAM FLARED 350 COMPLIANT	Ending End Trtmt Crashworthy?:	YES		
Average Measurements					
Design Height (In.):	27	Width (In.):	0.0	Post Spacing (In.):	75.8
Height (In.):	26.0	Lateral Offset (In.):	93.3	Road Grade (%):	0.20
Physical Condition					
Barrier	Alignment and Height:	No deflections greater than 6 in were observed in the alignment. The barrier height was equal to the design height of 27 in for 29 ft and between 1 in and 3 in below the design height for 37 ft.

Breaking and Cracking:	No twisting bending tears, or cracking was observed in the barrier.			
	Missing Elements:	No elements were observed to be missing.			
	Corrosion and Weathering:	Less than 5 percent of the cross section has been lost due to weathering. No erosion was observed.			
End Treatments	Alignment and Height:	Alignment acceptable. Height is within 1-in. of 27-in. design height.			
	Breaking and Cracking:	No twisting bending tears, or cracking was observed.			
	Missing Elements:	No elements were missing but the cables were loose on both end treatments.			
	Corrosion and Weathering:	Less than 5 percent of the cross section has been lost due to weathering.

Repair Action:	REPAIR	FMSS Work Type:	DEFERRED MAINTENANCE	Repair Cost:	\$2096
Brief Workorder:	Raise 37 feet of guardrail up to the 27 inch design height and tighten the cables on both end treatments.				
Workorder:	Adjust Guardrail at \$10- per -Lin. Ft. for 37 LF = \$370. Raise 37 feet of the guardrail to the 27 inch design height. Labor at \$60- per -Hour for 1 Hrs = \$60. Tighten the cables on both end treatments. Low Speed Traffic Control at \$1475- per -Day for 1 Day(s) = \$1475.

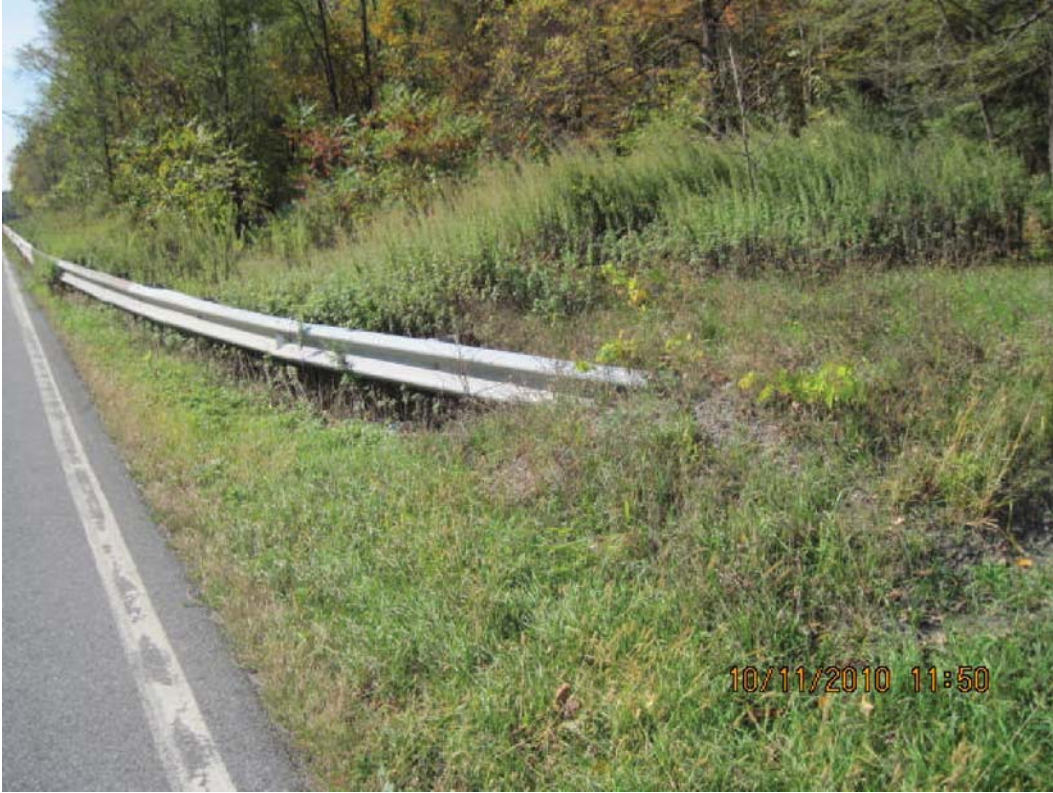
DEWA_0014_8.379_L_1.jpg

Barrier ID:	DEWA-0014-8.379-L				
Route Name:	US ROUTE 209				
Inspection Date:	10/11/2010	Barrier Rating:	33.70		
Barrier Description					
Type:	W-BEAM STRONG POST	Barrier Function:	TRAFFIC		
Barrier Material:	GALVANIZED STEEL	Post Material:	GALVANIZED STEEL		
Blockout Type:	STEEL	Length (ft.):	243		
Speed Limit (MPH):	45	Placement with Respect to Road:	TANGENT		
Hazard Behind Barrier:	MEDIUM				
Barrier Crashworthiness					
Appropriate Test Level:	TL-2	Barrier Test Level:	TL-3	Is Barrier Crashworthy?:	YES
Beg. End Trtmt Type:	W-BEAM BURIED END	Is Beg. End Trtmt Crashworthy?:	YES	Approach Transition Type:	NONE
Ending End Trtmt Type:	W-BEAM BURIED END	Ending End Trtmt Crashworthy?:	YES		
Average Measurements					
Design Height (In.):	27	Width (In.):	0.0	Post Spacing (In.):	74.5
Height (In.):	28.2	Lateral Offset (In.):	13.3	Road Grade (%):	0.80
Physical Condition					
Barrier	Alignment and Height:	No deflections greater than 6 in were observed in the alignment. The barrier height was greater than the 27 in design height for the entire length by 1/2 in to 2 in.

Breaking and Cracking:	2 posts and 2 blockouts were bent and twisted. No other twisting bending tears, or cracking was observed.			
	Missing Elements:	No elements were observed to be missing.			
	Corrosion and Weathering:	Rust was observed on several rails posts and blockouts, but less than 5 percent of the cross section was lost. The barrier should be monitored for further rusting. No erosion was observed.			
End Treatments	Alignment and Height:	Alignment acceptable. Height is within 1-in. of 27-in. design height.			
	Breaking and Cracking:	No twisting bending tears, or cracking was observed.			
	Missing Elements:	No elements were observed to be missing.			
	Corrosion and Weathering:	Less than 5 percent of the cross section was lost due to weathering.

Repair Action:	REPAIR	FMSS Work Type:	DEFERRED MAINTENANCE	Repair Cost:	\$1908
Brief Workorder:	Replace 2 posts and 2 blockouts.				
Workorder:	Replace Post at \$100- per -Each for 2 Post(s) = \$200. Replace 2 posts. Replace Block at \$30- per -Each for 2 Block(s) = \$60. Replace 2 blockouts. Low Speed Traffic Control at \$1475- per -Day for 1 Day(s) = \$1475.

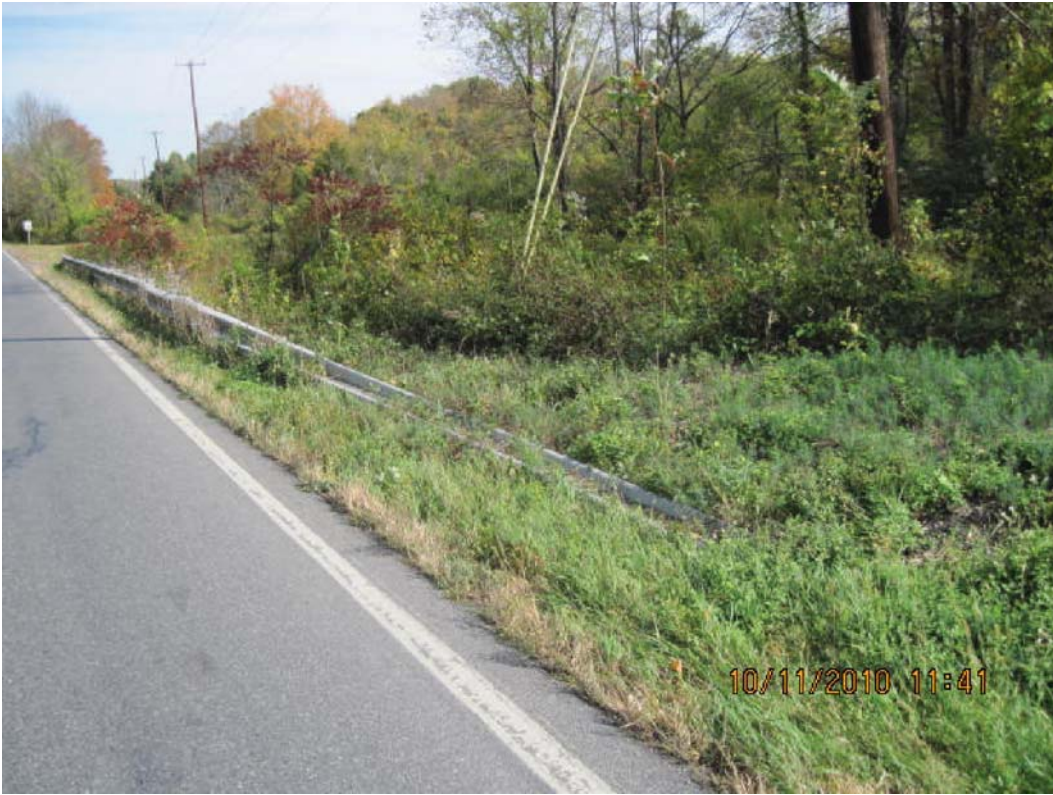
DEWA_0014_8.389_R_1.jpg

Barrier ID:	DEWA-0014-8.389-R				
Route Name:	US ROUTE 209				
Inspection Date:	10/11/2010	Barrier Rating:	48.20		
Barrier Description					
Type:	W-BEAM STRONG POST	Barrier Function:	TRAFFIC		
Barrier Material:	GALVANIZED STEEL	Post Material:	GALVANIZED STEEL		
Blockout Type:	STEEL	Length (ft.):	170		
Speed Limit (MPH):	45	Placement with Respect to Road:	TANGENT		
Hazard Behind Barrier:	MEDIUM				
Barrier Crashworthiness					
Appropriate Test Level:	TL-2	Barrier Test Level:	TL-3	Is Barrier Crashworthy?:	YES
Beg. End Trtmt Type:	W-BEAM TURN DOWN	Is Beg. End Trtmt Crashworthy?:	NO	Approach Transition Type:	NONE
Ending End Trtmt Type:	OTHER: W-BEAM FLARED	Ending End Trtmt Crashworthy?:	NO		
Average Measurements					
Design Height (In.):	27	Width (In.):	0.0	Post Spacing (In.):	75.3
Height (In.):	20.2	Lateral Offset (In.):	42.5	Road Grade (%):	0.80
Physical Condition					
Barrier	Alignment and Height:	Alignment deflection was less than 6 in. 132 ft of the barrier was greater than 3 in below design height (27 in) ranging from 19.5 to 21.5 in.

Breaking and Cracking:	No twisting/bending tearing or cracking in the metal observed.			
	Missing Elements:	No elements appeared to be missing.			
	Corrosion and Weathering:	Less than 5% loss of cross section observed. No erosion observed.			
End Treatments	Alignment and Height:	Alignment as designed. 38 ft of the end treatment was greater than 3 in below design height (27 in).			
	Breaking and Cracking:	1 rail had bending and tearing.			
	Missing Elements:	No elements appeared to be missing.			
	Corrosion and Weathering:	Less than 5% loss of cross section observed.

Repair Action:	REPAIR	FMSS Work Type:	DEFERRED MAINTENANCE	Repair Cost:	\$3432
Brief Workorder:	Raise 132 feet of barrier to 27-in. design height and replace 13 feet of rail.				
Workorder:	Adjust Guardrail at \$10- per -Lin. Ft. for 132 LF = \$1320. Raise 132ft. of barrier to 27-in. design height. Replace Rail at \$25- per -Lin. Ft. for 13 LF = \$325. Replace 13ft. of rail due to bending and tearing. Low Speed Traffic Control at \$1475- per -Day for 1 Day(s) = \$1475.

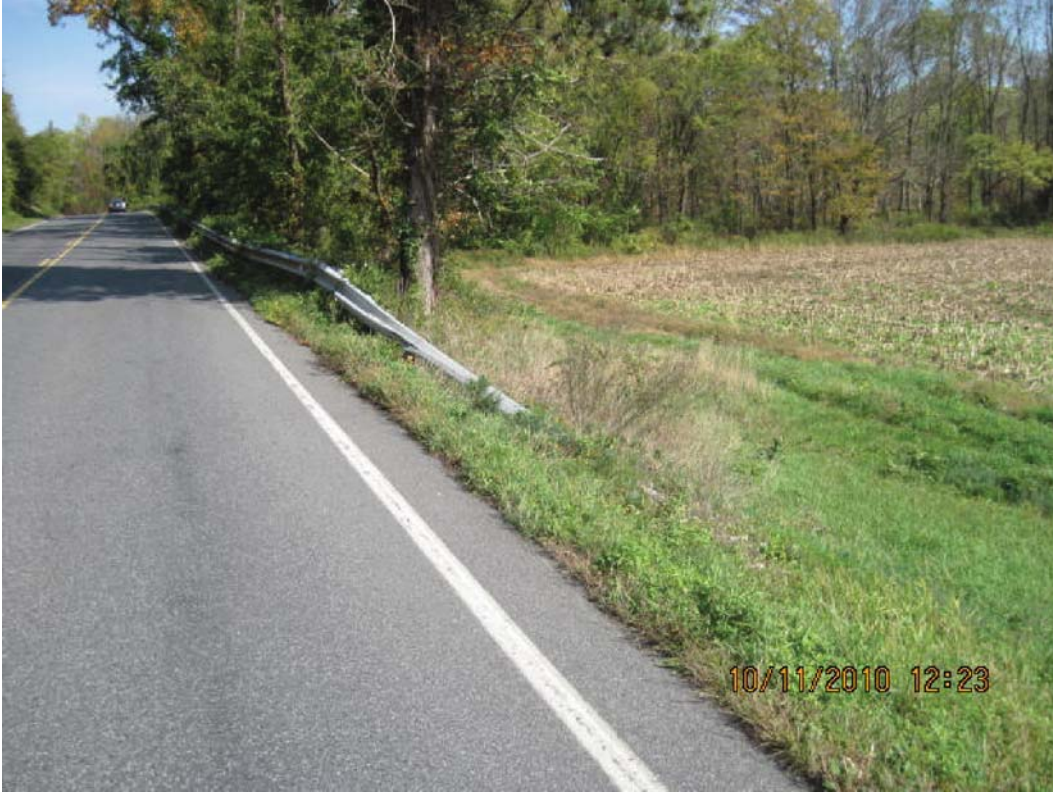
DEWA_0014_8.907_R_1.jpg

Barrier ID:	DEWA-0014-8.907-R				
Route Name:	US ROUTE 209				
Inspection Date:	10/11/2010	Barrier Rating:	58.20		
Barrier Description					
Type:	W-BEAM STRONG POST	Barrier Function:	TRAFFIC		
Barrier Material:	GALVANIZED STEEL	Post Material:	GALVANIZED STEEL		
Blockout Type:	STEEL	Length (ft.):	1055		
Speed Limit (MPH):	45	Placement with Respect to Road:	OUTSIDE OF CURVE		
Hazard Behind Barrier:	MEDIUM				
Barrier Crashworthiness					
Appropriate Test Level:	TL-2	Barrier Test Level:	TL-3	Is Barrier Crashworthy?:	YES
Beg. End Trtmt Type:	W-BEAM TURN DOWN	Is Beg. End Trtmt Crashworthy?:	NO	Approach Transition Type:	NONE
Ending End Trtmt Type:	W-BEAM TURN DOWN	Ending End Trtmt Crashworthy?:	NO		
Average Measurements					
Design Height (In.):	27	Width (In.):	0.0	Post Spacing (In.):	75.4
Height (In.):	24.6	Lateral Offset (In.):	33.0	Road Grade (%):	1.80
Physical Condition					
Barrier	Alignment and Height:	1 rail was deflected 14 in due to an impact. Entire barrier is 1 to 3 in below 27 in design height.

Breaking and Cracking:	1 rail was twisted and bent due to impact. 1 post was bent 90 degrees due to impact.			
	Missing Elements:	There were no elements observed to be missing.			
	Corrosion and Weathering:	No loss of cross section observed. Erosion around posts has exposed 2 to 3 in of post below original ground line.			
End Treatments	Alignment and Height:	Beginning end treatment is deflected 10 in due to impact. Height is within 1-in. of 27-in. design height.			
	Breaking and Cracking:	Beginning end treatment is twisted and cracked with a tear about 15 ft by 2 in width.			
	Missing Elements:	No elements were observed to be missing.			
	Corrosion and Weathering:	No loss of cross section observed. No erosion around posts observed.

Repair Action:	REPLACE	FMSS Work Type:	CAPITAL IMPROVEMENT	Repair Cost:	\$23474
Brief Workorder:	Remove and replace beginning end treatment. Raise 966 feet of guardrail up to the 27 inch design height. Replace 13 feet of rail and 1 post.				
Workorder:	Remove Guardrail at \$10- per -Lin. Ft. for 38 LF = \$380. Remove beginning end treatment. Replace Rail at \$25- per -Lin. Ft. for 13 LF = \$325. Replace 13 feet of impacted rail. Replace Post at \$100- per -Each for 1 Post(s) = \$100. Replace 1 bent post. W-beam tangent 350 compliant at \$3500- per -Each for 1 Unit(s) = \$3500. Install crashworthy beginning end treatment. Adjust Guardrail at \$10- per -Lin. Ft. for 966 LF = \$9660. Raise 966 feet of barrier to 27 inch design height. Low Speed Traffic Control at \$1475- per -Day for 5 Day(s) = \$7375.
