NPS Guardwall/Rail Inventory Program Delaware Water Gap National Recreation Area

**Federal Lands Highway
Road Inventory Program**

Federal Highway Administration
Eastern Federal Lands Highway Division
Road Inventory Program (RIP)

Data Collection Date: October 2010
Report Date: December 2015

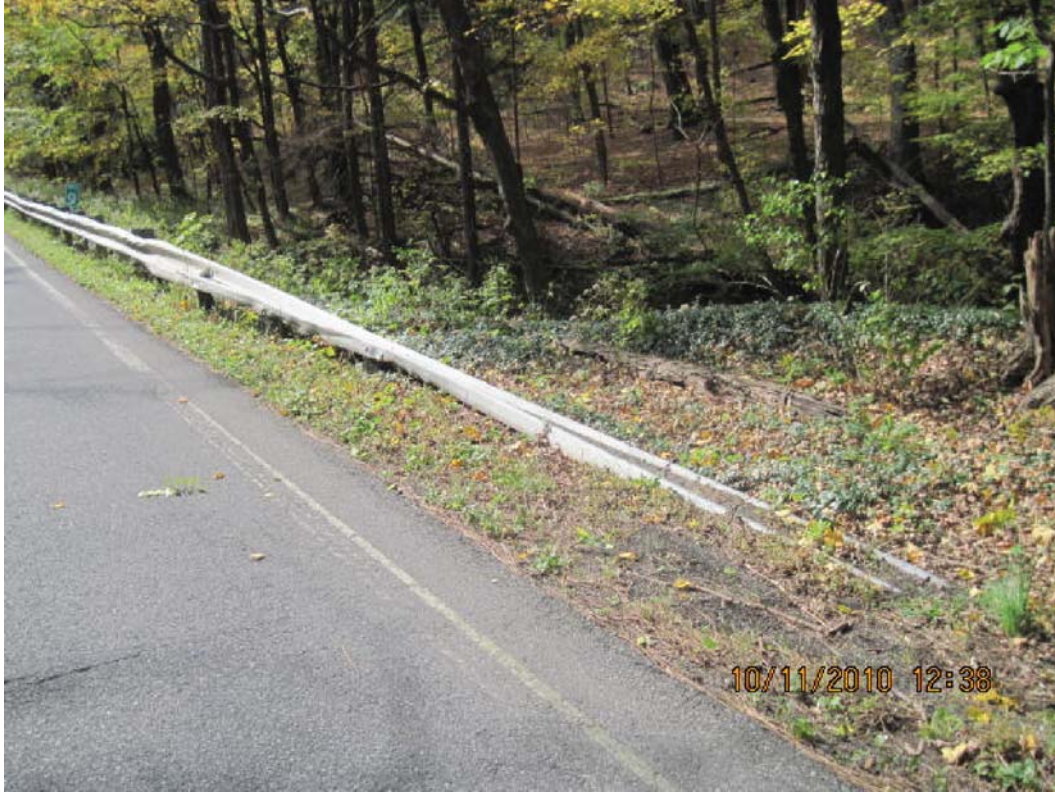
DEWA_0014_9.065_L_1.jpg

Barrier ID:	DEWA-0014-9.065-L				
Route Name:	US ROUTE 209				
Inspection Date:	10/11/2010	Barrier Rating:	42.50		
Barrier Description					
Type:	W-BEAM STRONG POST	Barrier Function:	TRAFFIC		
Barrier Material:	GALVANIZED STEEL	Post Material:	GALVANIZED STEEL		
Blockout Type:	STEEL	Length (ft.):	255		
Speed Limit (MPH):	45	Placement with Respect to Road:	TANGENT		
Hazard Behind Barrier:	MEDIUM				
Barrier Crashworthiness					
Appropriate Test Level:	TL-2	Barrier Test Level:	TL-3	Is Barrier Crashworthy?:	YES
Beg. End Trtmt Type:	W-BEAM BURIED END	Is Beg. End Trtmt Crashworthy?:	YES	Approach Transition Type:	NONE
Ending End Trtmt Type:	W-BEAM TURN DOWN	Ending End Trtmt Crashworthy?:	NO		
Average Measurements					
Design Height (In.):	27	Width (In.):	0.0	Post Spacing (In.):	74.1
Height (In.):	27.7	Lateral Offset (In.):	29.2	Road Grade (%):	3.10
Physical Condition					
Barrier	Alignment and Height:	Alignment deflection was less than 6 in. The entire barrier was either 1 in below or exceeded design height (27 in).

Breaking and Cracking:	130 ft of rail was tearing. 5 posts were bent.			
	Missing Elements:	No elements appeared to be missing.			
	Corrosion and Weathering:	Less than 5% loss of cross section observed. No erosion observed.			
End Treatments	Alignment and Height:	Alignment acceptable. Height is within 1-in. of 27-in. design height.			
	Breaking and Cracking:	Ending end treatment had bending and tearing.			
	Missing Elements:	No elements appeared to be missing.			
	Corrosion and Weathering:	Less than 5% loss of cross section observed.

Repair Action:	REPLACE	FMSS Work Type:	CAPITAL IMPROVEMENT	Repair Cost:	\$10016
Brief Workorder:	Replace 130 feet of rail and 5 posts. Replace torn ending end treatment with W-beam flared end treatment.				
Workorder:	Replace Rail at \$25- per -Lin. Ft. for 130 LF = \$3250. Replace 130ft. of rail due to tearing. Replace Post at \$100- per -Each for 5 Post(s) = \$500. Replace 5 posts due to bending. W-beam flared 350 compliant at \$3500- per -Each for 1 Unit(s) = \$3500. Replace ending end treatment due to tearing. Remove Guardrail at \$10- per -Lin. Ft. for 38 LF = \$380. Remove 38 feet of end treatment. Low Speed Traffic Control at \$1475- per -Day for 1 Day(s) = \$1475.

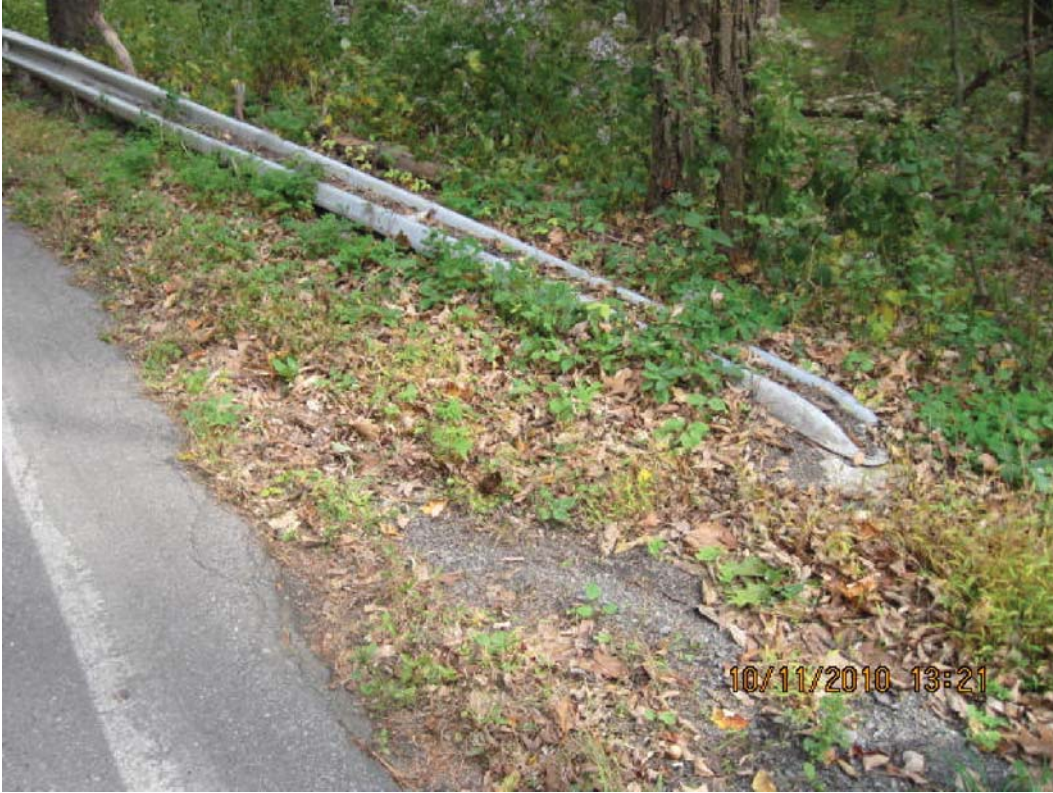
DEWA_0014_9.255_R_1.jpg

Barrier ID:	DEWA-0014-9.255-R				
Route Name:	US ROUTE 209				
Inspection Date:	10/11/2010	Barrier Rating:	33.90		
Barrier Description					
Type:	W-BEAM STRONG POST	Barrier Function:	TRAFFIC		
Barrier Material:	GALVANIZED STEEL	Post Material:	GALVANIZED STEEL		
Blockout Type:	STEEL	Length (ft.):	429		
Speed Limit (MPH):	45	Placement with Respect to Road:	TANGENT		
Hazard Behind Barrier:	MEDIUM				
Barrier Crashworthiness					
Appropriate Test Level:	TL-2	Barrier Test Level:	TL-3	Is Barrier Crashworthy?:	YES
Beg. End Trtmt Type:	W-BEAM TURN DOWN	Is Beg. End Trtmt Crashworthy?:	NO	Approach Transition Type:	NONE
Ending End Trtmt Type:	W-BEAM TURN DOWN	Ending End Trtmt Crashworthy?:	NO		
Average Measurements					
Design Height (In.):	27	Width (In.):	0.0	Post Spacing (In.):	74.6
Height (In.):	27.7	Lateral Offset (In.):	32.7	Road Grade (%):	0.50
Physical Condition					
Barrier	Alignment and Height:	No deflections greater than 6 in were observed in the alignment. The barrier height was greater than the 27 in design height for the entire length by 0.5 to 1 in.

Breaking and Cracking:	25 ft of rail and 1 post had severe twisting and bending. No other twisting bending tears, or cracking was observed.			
	Missing Elements:	No elements were observed to be missing.			
	Corrosion and Weathering:	Less than 5 percent of the cross section has been lost due to weathering. No erosion was observed.			
End Treatments	Alignment and Height:	Alignment acceptable. Height is within 1-in. of 27-in. design height.			
	Breaking and Cracking:	The was minor bending on 1 rail on the ending end treatment.			
	Missing Elements:	No elements were observed to be missing.			
	Corrosion and Weathering:	Less than 5 percent of the cross section has been lost due to weathering.

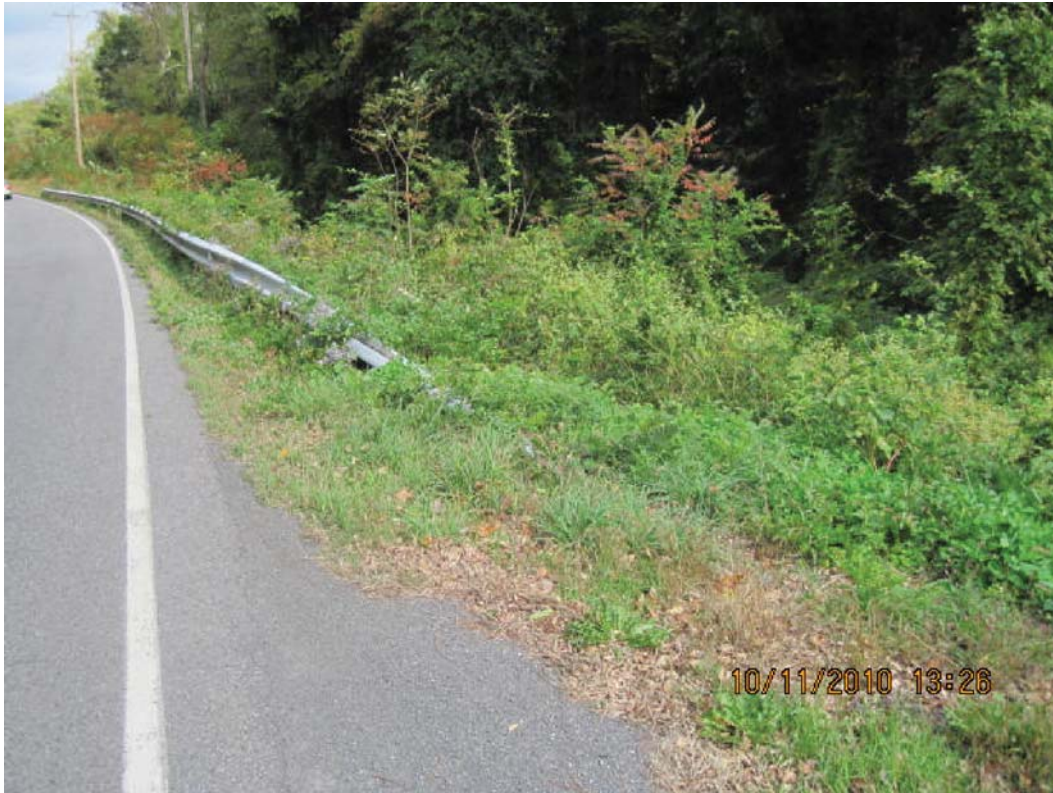
DEWA_0014_9.355_R_1.jpg

Barrier ID:	DEWA-0014-9.355-R				
Route Name:	US ROUTE 209				
Inspection Date:	10/11/2010	Barrier Rating:	46.90		
Barrier Description					
Type:	W-BEAM STRONG POST	Barrier Function:	TRAFFIC		
Barrier Material:	GALVANIZED STEEL	Post Material:	GALVANIZED STEEL		
Blockout Type:	STEEL	Length (ft.):	290		
Speed Limit (MPH):	45	Placement with Respect to Road:	OUTSIDE OF CURVE		
Hazard Behind Barrier:	MEDIUM				
Barrier Crashworthiness					
Appropriate Test Level:	TL-2	Barrier Test Level:	TL-3	Is Barrier Crashworthy?:	YES
Beg. End Trtmt Type:	W-BEAM TURN DOWN	Is Beg. End Trtmt Crashworthy?:	NO	Approach Transition Type:	NONE
Ending End Trtmt Type:	W-BEAM TURN DOWN	Ending End Trtmt Crashworthy?:	NO		
Average Measurements					
Design Height (In.):	27	Width (In.):	0.0	Post Spacing (In.):	75.5
Height (In.):	28.5	Lateral Offset (In.):	26.5	Road Grade (%):	1.60
Physical Condition					
Barrier	Alignment and Height:	No deflections observed in alignment. Entire barrier meets or exceeds 27 in design height by up to 2 in.

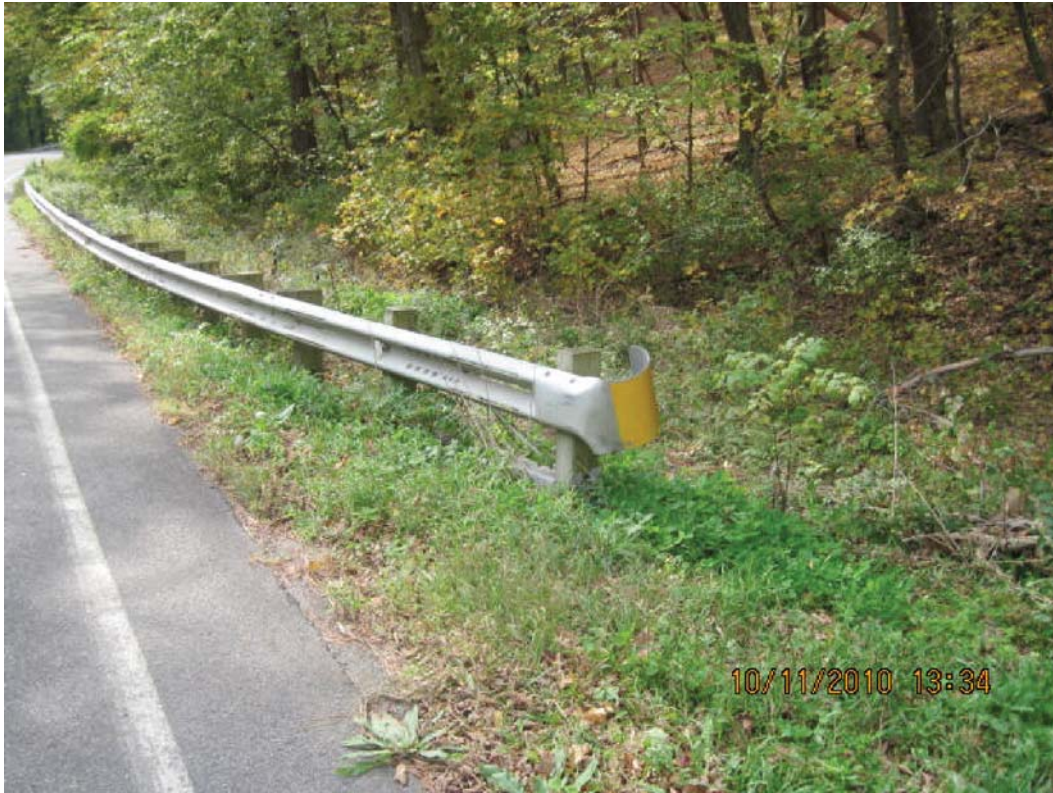
DEWA_0014_9.378_L_1.jpg

Barrier ID:	DEWA-0014-9.378-L				
Route Name:	US ROUTE 209				
Inspection Date:	10/11/2010	Barrier Rating:	31.30		
Barrier Description					
Type:	W-BEAM STRONG POST	Barrier Function:	TRAFFIC		
Barrier Material:	GALVANIZED STEEL	Post Material:	GALVANIZED STEEL		
Blockout Type:	STEEL	Length (ft.):	205		
Speed Limit (MPH):	45	Placement with Respect to Road:	INSIDE OF CURVE		
Hazard Behind Barrier:	LOW				
Barrier Crashworthiness					
Appropriate Test Level:	TL-2	Barrier Test Level:	TL-3	Is Barrier Crashworthy?:	YES
Beg. End Trtmt Type:	W-BEAM FLARED 350 COMPLIANT	Is Beg. End Trtmt Crashworthy?:	YES	Approach Transition Type:	NONE
Ending End Trtmt Type:	W-BEAM FLARED 350 COMPLIANT	Ending End Trtmt Crashworthy?:	YES		
Average Measurements					
Design Height (In.):	27	Width (In.):	0.0	Post Spacing (In.):	75.1
Height (In.):	26.2	Lateral Offset (In.):	45.2	Road Grade (%):	2.00
Physical Condition					
Barrier	Alignment and Height:	Alignment deflection was less than 6 in. 30 ft of the barrier was between 1 to 3 in below design height (27 in) while the remaining length ranged from 1 in below to 1/2 in above.

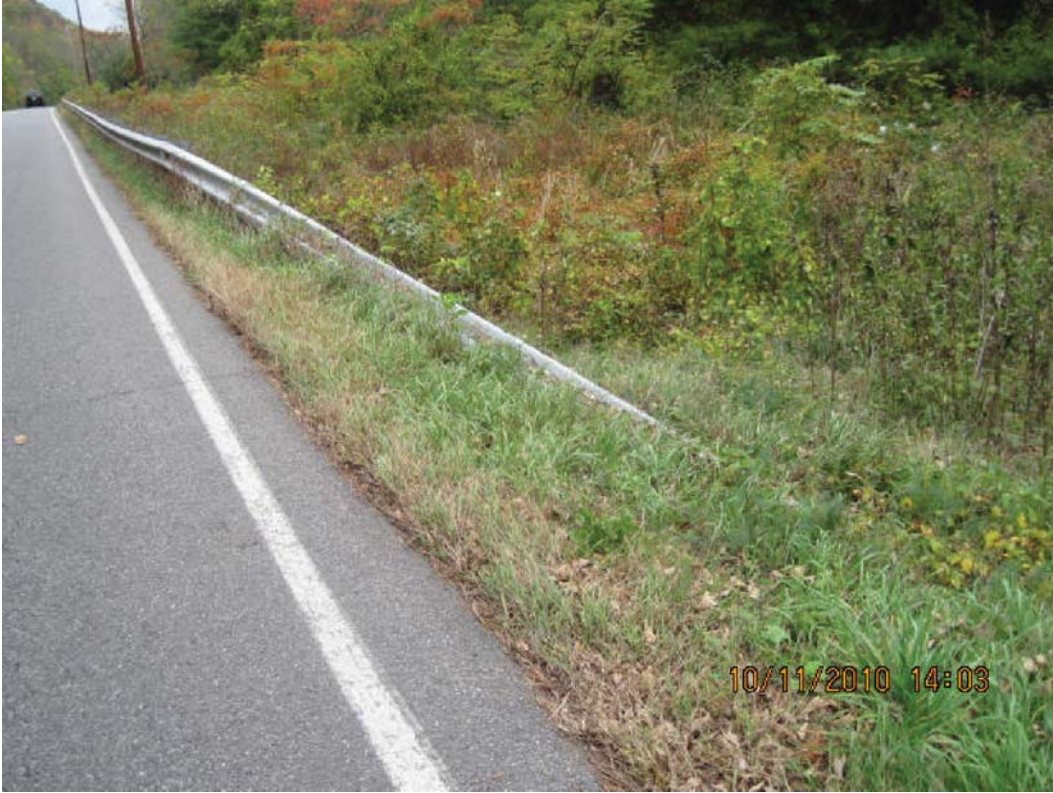
DEWA_0014_9.460_R_1.jpg

Barrier ID:	DEWA-0014-9.460-R				
Route Name:	US ROUTE 209				
Inspection Date:	10/11/2010	Barrier Rating:	41.00		
Barrier Description					
Type:	W-BEAM STRONG POST	Barrier Function:	TRAFFIC		
Barrier Material:	GALVANIZED STEEL	Post Material:	GALVANIZED STEEL		
Blockout Type:	STEEL	Length (ft.):	855		
Speed Limit (MPH):	45	Placement with Respect to Road:	TANGENT		
Hazard Behind Barrier:	MEDIUM				
Barrier Crashworthiness					
Appropriate Test Level:	TL-2	Barrier Test Level:	TL-3	Is Barrier Crashworthy?:	YES
Beg. End Trtmt Type:	W-BEAM TURN DOWN	Is Beg. End Trtmt Crashworthy?:	NO	Approach Transition Type:	NONE
Ending End Trtmt Type:	W-BEAM TURN DOWN	Ending End Trtmt Crashworthy?:	NO		
Average Measurements					
Design Height (In.):	27	Width (In.):	0.0	Post Spacing (In.):	75.0
Height (In.):	26.2	Lateral Offset (In.):	30.6	Road Grade (%):	0.80
Physical Condition					
Barrier	Alignment and Height:	No deflections greater than 6 in were observed in alignment. The height was 1 in greater than or equal to the 27 in design height for 604 ft between 1 and 3 in below the design height for 137ft and more than 3 in below the design height for 38ft.

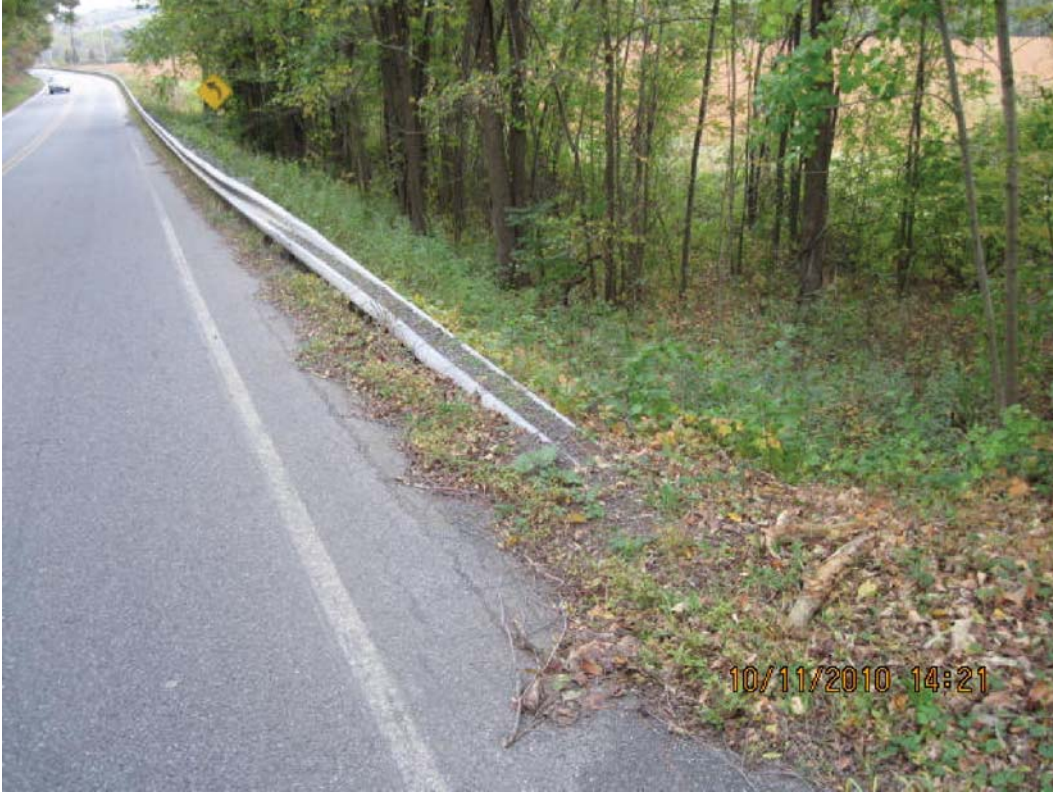
DEWA_0014_10.203_R_1.jpg

Barrier ID:	DEWA-0014-10.203-R				
Route Name:	US ROUTE 209				
Inspection Date:	10/11/2010	Barrier Rating:	52.50		
Barrier Description					
Type:	W-BEAM STRONG POST	Barrier Function:	TRAFFIC		
Barrier Material:	GALVANIZED STEEL	Post Material:	GALVANIZED STEEL		
Blockout Type:	STEEL	Length (ft.):	1477		
Speed Limit (MPH):	45	Placement with Respect to Road:	OUTSIDE OF CURVE		
Hazard Behind Barrier:	MEDIUM				
Barrier Crashworthiness					
Appropriate Test Level:	TL-2	Barrier Test Level:	TL-3	Is Barrier Crashworthy?:	YES
Beg. End Trtmt Type:	W-BEAM TURN DOWN	Is Beg. End Trtmt Crashworthy?:	NO	Approach Transition Type:	NONE
Ending End Trtmt Type:	W-BEAM TURN DOWN	Ending End Trtmt Crashworthy?:	NO		
Average Measurements					
Design Height (In.):	27	Width (In.):	0.0	Post Spacing (In.):	74.9
Height (In.):	27.1	Lateral Offset (In.):	22.1	Road Grade (%):	0.70
Physical Condition					
Barrier	Alignment and Height:	1 rail was deflected up to 8 in. 115 ft of barrier is 1 to 3 in below 27 in design height. 1286 ft of barrier meets or exceeds 27 in design height up to 1 in above.

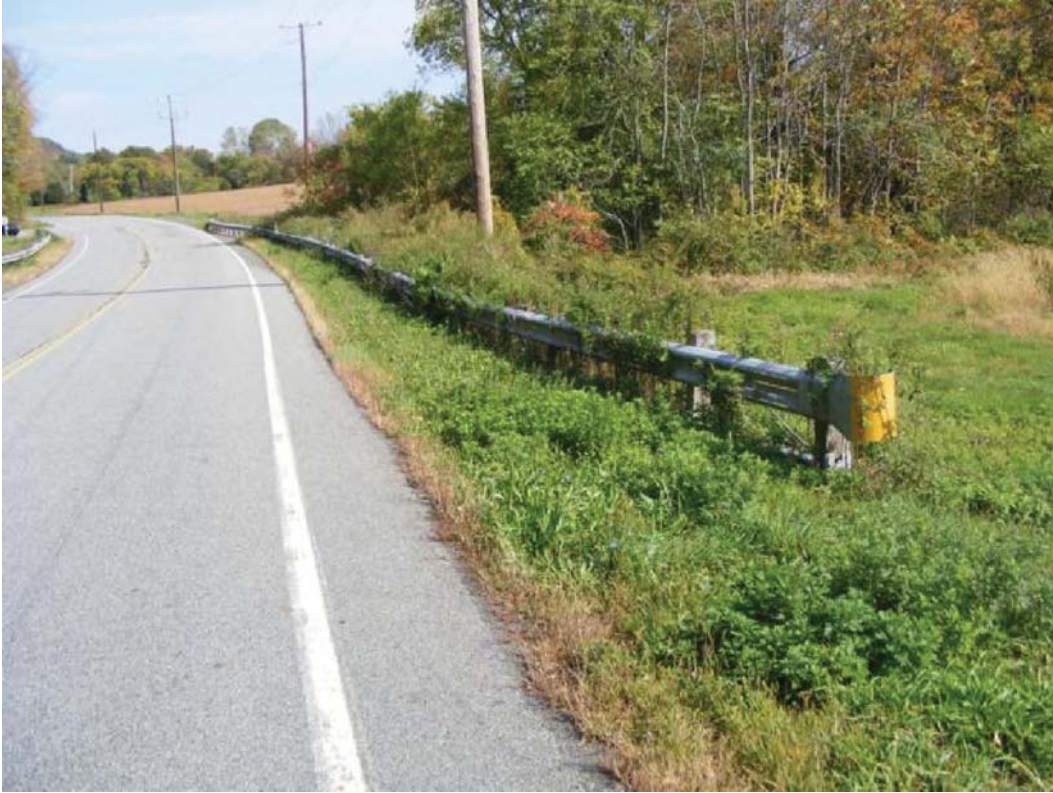
DEWA_0014_10.704_R_1.JPG

Barrier ID:	DEWA-0014-10.704-R				
Route Name:	US ROUTE 209				
Inspection Date:	10/11/2010	Barrier Rating:	36.70		
Barrier Description					
Type:	W-BEAM STRONG POST	Barrier Function:	TRAFFIC		
Barrier Material:	GALVANIZED STEEL	Post Material:	GALVANIZED STEEL		
Blockout Type:	STEEL	Length (ft.):	217		
Speed Limit (MPH):	45	Placement with Respect to Road:	OUTSIDE OF CURVE		
Hazard Behind Barrier:	MEDIUM				
Barrier Crashworthiness					
Appropriate Test Level:	TL-2	Barrier Test Level:	TL-3	Is Barrier Crashworthy?:	YES
Beg. End Trtmt Type:	W-BEAM FLARED 350 COMPLIANT	Is Beg. End Trtmt Crashworthy?:	YES	Approach Transition Type:	NONE
Ending End Trtmt Type:	NONE	Ending End Trtmt Crashworthy?:	N/A		
Average Measurements					
Design Height (In.):	27	Width (In.):	0.0	Post Spacing (In.):	76.5
Height (In.):	26.0	Lateral Offset (In.):	85.0	Road Grade (%):	1.00
Physical Condition					
Barrier	Alignment and Height:	No deflections observed in alignment. The height is low by 1 in or less from the design of 27 in.

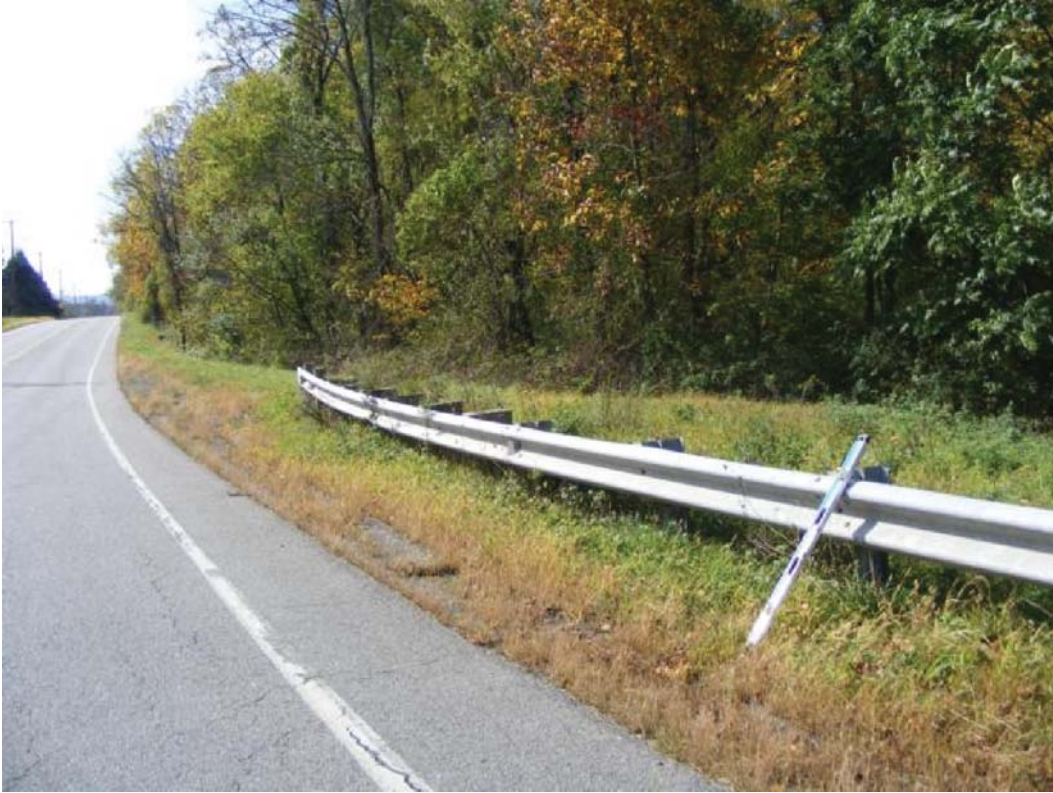
DEWA_0014_10.733_L_1.JPG

Barrier ID:	DEWA-0014-10.733-L				
Route Name:	US ROUTE 209				
Inspection Date:	10/11/2010	Barrier Rating:	31.00		
Barrier Description					
Type:	W-BEAM STRONG POST	Barrier Function:	TRAFFIC		
Barrier Material:	GALVANIZED STEEL	Post Material:	GALVANIZED STEEL		
Blockout Type:	STEEL	Length (ft.):	53		
Speed Limit (MPH):	45	Placement with Respect to Road:	INSIDE OF CURVE		
Hazard Behind Barrier:	MEDIUM				
Barrier Crashworthiness					
Appropriate Test Level:	TL-2	Barrier Test Level:	TL-3	Is Barrier Crashworthy?:	YES
Beg. End Trtmt Type:	W-BEAM FLARED 350 COMPLIANT	Is Beg. End Trtmt Crashworthy?:	YES	Approach Transition Type:	NONE
Ending End Trtmt Type:	NONE	Ending End Trtmt Crashworthy?:	N/A		
Average Measurements					
Design Height (In.):	27	Width (In.):	0.0	Post Spacing (In.):	75.0
Height (In.):	26.2	Lateral Offset (In.):	95.0	Road Grade (%):	0.30
Physical Condition					
Barrier	Alignment and Height:	No deflections observed in alignment. The height is low by 1 in or less from the design of 27 in.

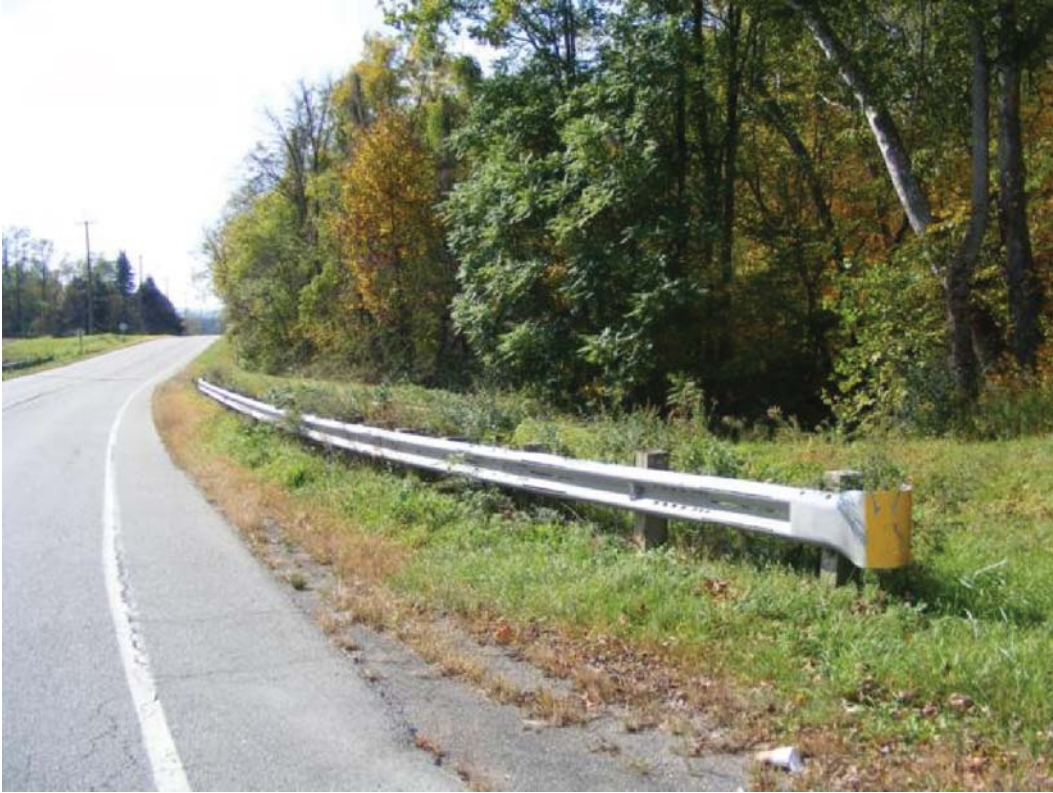
DEWA_0014_10.749_L_1.JPG

Barrier ID:	DEWA-0014-10.749-L				
Route Name:	US ROUTE 209				
Inspection Date:	10/04/2010	Barrier Rating:	31.00		
Barrier Description					
Type:	W-BEAM STRONG POST	Barrier Function:	TRAFFIC		
Barrier Material:	GALVANIZED STEEL	Post Material:	GALVANIZED STEEL		
Blockout Type:	STEEL	Length (ft.):	68		
Speed Limit (MPH):	45	Placement with Respect to Road:	INSIDE OF CURVE		
Hazard Behind Barrier:	MEDIUM				
Barrier Crashworthiness					
Appropriate Test Level:	TL-2	Barrier Test Level:	TL-3	Is Barrier Crashworthy?:	YES
Beg. End Trtmt Type:	NONE	Is Beg. End Trtmt Crashworthy?:	N/A	Approach Transition Type:	NONE
Ending End Trtmt Type:	W-BEAM FLARED 350 COMPLIANT	Ending End Trtmt Crashworthy?:	YES		
Average Measurements					
Design Height (In.):	27	Width (In.):	0.0	Post Spacing (In.):	72.0
Height (In.):	27.6	Lateral Offset (In.):	98.0	Road Grade (%):	1.00
Physical Condition					
Barrier	Alignment and Height:	No deflections observed in alignment. The height is at or above the design of 27 in up to 1 in.

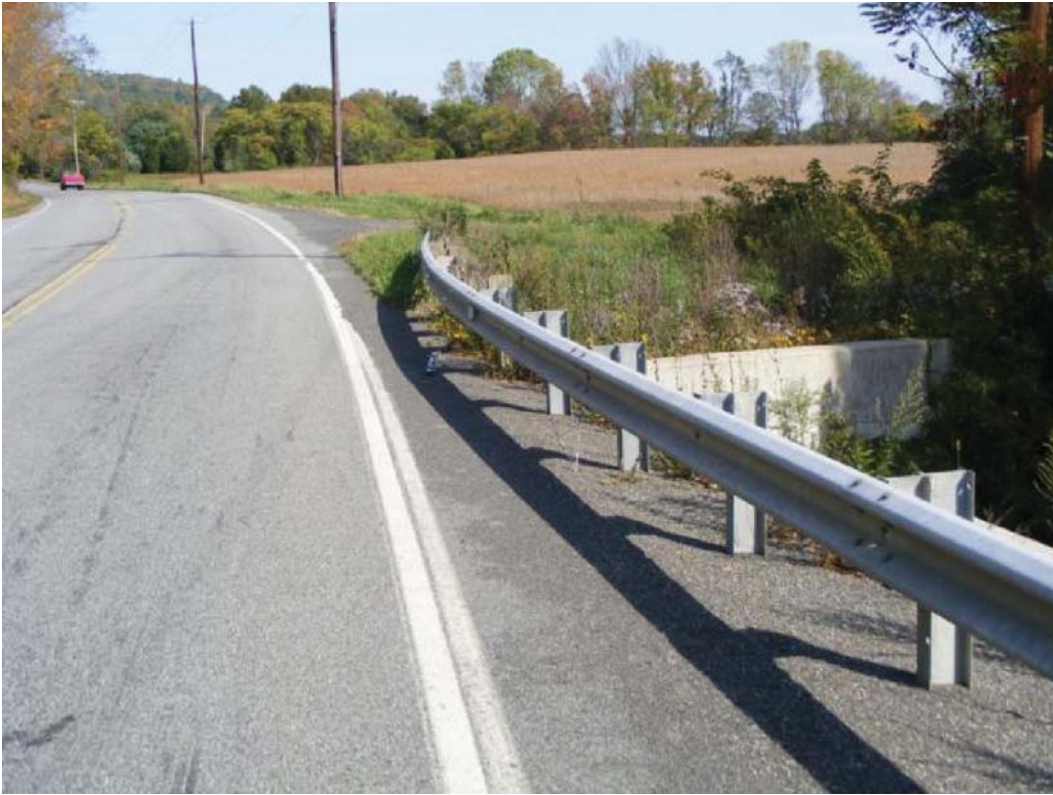
DEWA_0014_10.751_R_1.JPG

Barrier ID:	DEWA-0014-10.751-R				
Route Name:	US ROUTE 209				
Inspection Date:	10/11/2010	Barrier Rating:	37.00		
Barrier Description					
Type:	W-BEAM STRONG POST	Barrier Function:	TRAFFIC		
Barrier Material:	GALVANIZED STEEL	Post Material:	WOOD		
Blockout Type:	WOOD	Length (ft.):	42		
Speed Limit (MPH):	45	Placement with Respect to Road:	OUTSIDE OF CURVE		
Hazard Behind Barrier:	LOW				
Barrier Crashworthiness					
Appropriate Test Level:	TL-2	Barrier Test Level:	TL-3	Is Barrier Crashworthy?:	YES
Beg. End Trtmt Type:	NONE	Is Beg. End Trtmt Crashworthy?:	N/A	Approach Transition Type:	NONE
Ending End Trtmt Type:	W-BEAM FLARED 350 COMPLIANT	Ending End Trtmt Crashworthy?:	YES		
Average Measurements					
Design Height (In.):	27	Width (In.):	0.0	Post Spacing (In.):	49.0
Height (In.):	26.2	Lateral Offset (In.):	36.0	Road Grade (%):	0.80
Physical Condition					
Barrier	Alignment and Height:	No deflections observed in alignment. The height is low by 1 in or less from the design of 27 in.

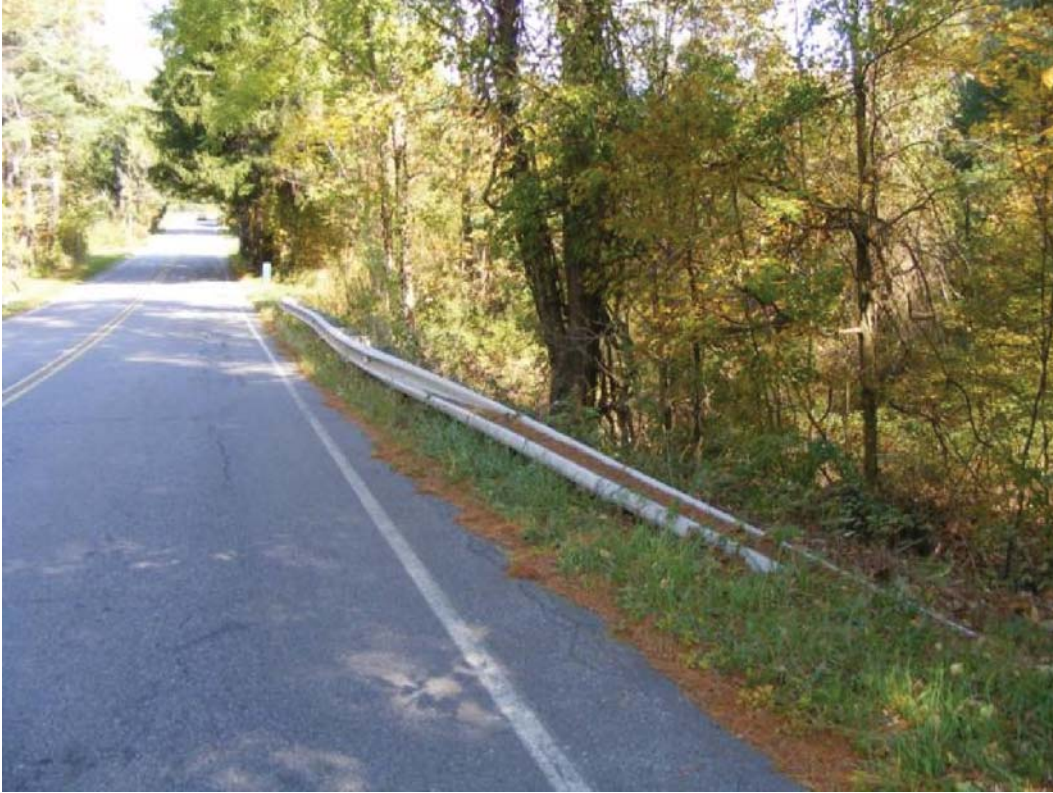
DEWA_0014_11.079_R_1.JPG

Barrier ID:	DEWA-0014-11.079-R				
Route Name:	US ROUTE 209				
Inspection Date:	10/11/2010	Barrier Rating:	39.70		
Barrier Description					
Type:	W-BEAM STRONG POST	Barrier Function:	TRAFFIC		
Barrier Material:	GALVANIZED STEEL	Post Material:	GALVANIZED STEEL		
Blockout Type:	STEEL	Length (ft.):	145		
Speed Limit (MPH):	45	Placement with Respect to Road:	TANGENT		
Hazard Behind Barrier:	MEDIUM				
Barrier Crashworthiness					
Appropriate Test Level:	TL-2	Barrier Test Level:	TL-3	Is Barrier Crashworthy?:	YES
Beg. End Trtmt Type:	W-BEAM TURN DOWN	Is Beg. End Trtmt Crashworthy?:	NO	Approach Transition Type:	NONE
Ending End Trtmt Type:	W-BEAM TURN DOWN	Ending End Trtmt Crashworthy?:	NO		
Average Measurements					
Design Height (In.):	27	Width (In.):	0.0	Post Spacing (In.):	74.5
Height (In.):	24.6	Lateral Offset (In.):	35.0	Road Grade (%):	1.40
Physical Condition					
Barrier	Alignment and Height:	No deflections observed in alignment. The height is low by 1 to 3 in from the design of 27 in for 145 linear ft.

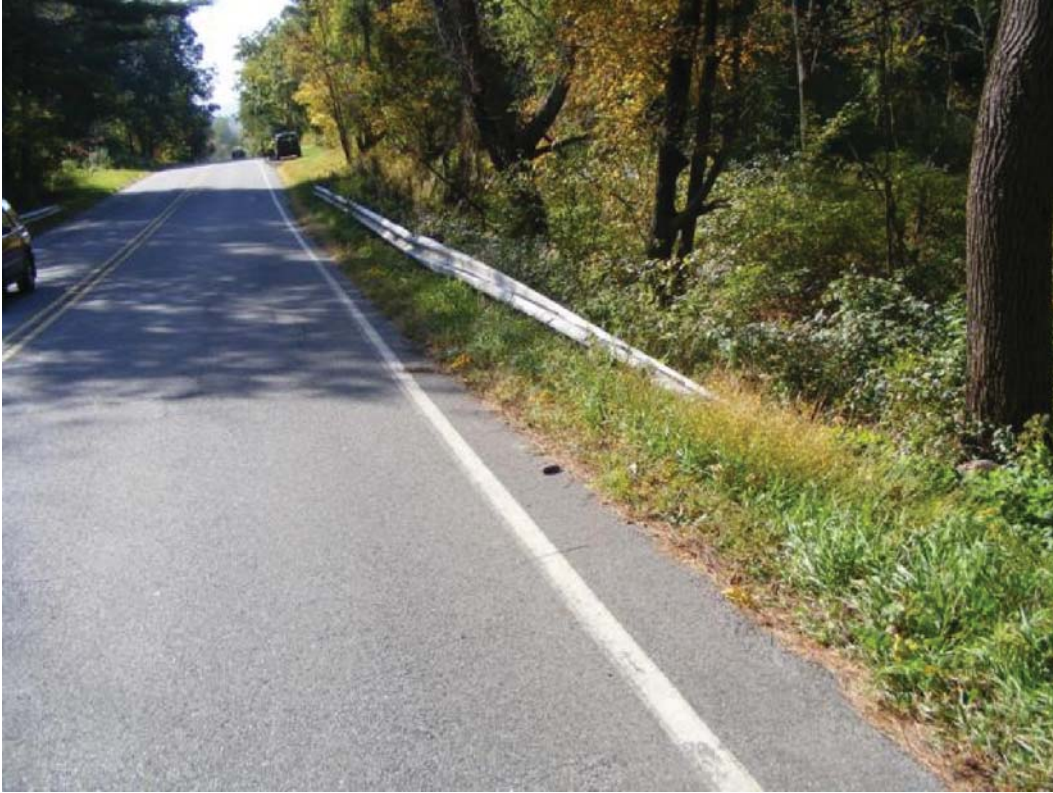
DEWA_0014_11.083_L_1.JPG

Barrier ID:	DEWA-0014-11.083-L				
Route Name:	US ROUTE 209				
Inspection Date:	10/11/2010	Barrier Rating:	39.70		
Barrier Description					
Type:	W-BEAM STRONG POST	Barrier Function:	TRAFFIC		
Barrier Material:	GALVANIZED STEEL	Post Material:	GALVANIZED STEEL		
Blockout Type:	STEEL	Length (ft.):	155		
Speed Limit (MPH):	45	Placement with Respect to Road:	TANGENT		
Hazard Behind Barrier:	MEDIUM				
Barrier Crashworthiness					
Appropriate Test Level:	TL-2	Barrier Test Level:	TL-3	Is Barrier Crashworthy?:	YES
Beg. End Trtmt Type:	W-BEAM TURN DOWN	Is Beg. End Trtmt Crashworthy?:	NO	Approach Transition Type:	NONE
Ending End Trtmt Type:	W-BEAM TURN DOWN	Ending End Trtmt Crashworthy?:	NO		
Average Measurements					
Design Height (In.):	27	Width (In.):	0.0	Post Spacing (In.):	76.0
Height (In.):	24.0	Lateral Offset (In.):	44.0	Road Grade (%):	1.10
Physical Condition					
Barrier	Alignment and Height:	No deflections observed in alignment. The height is low by 3 in from the design of 27 in.

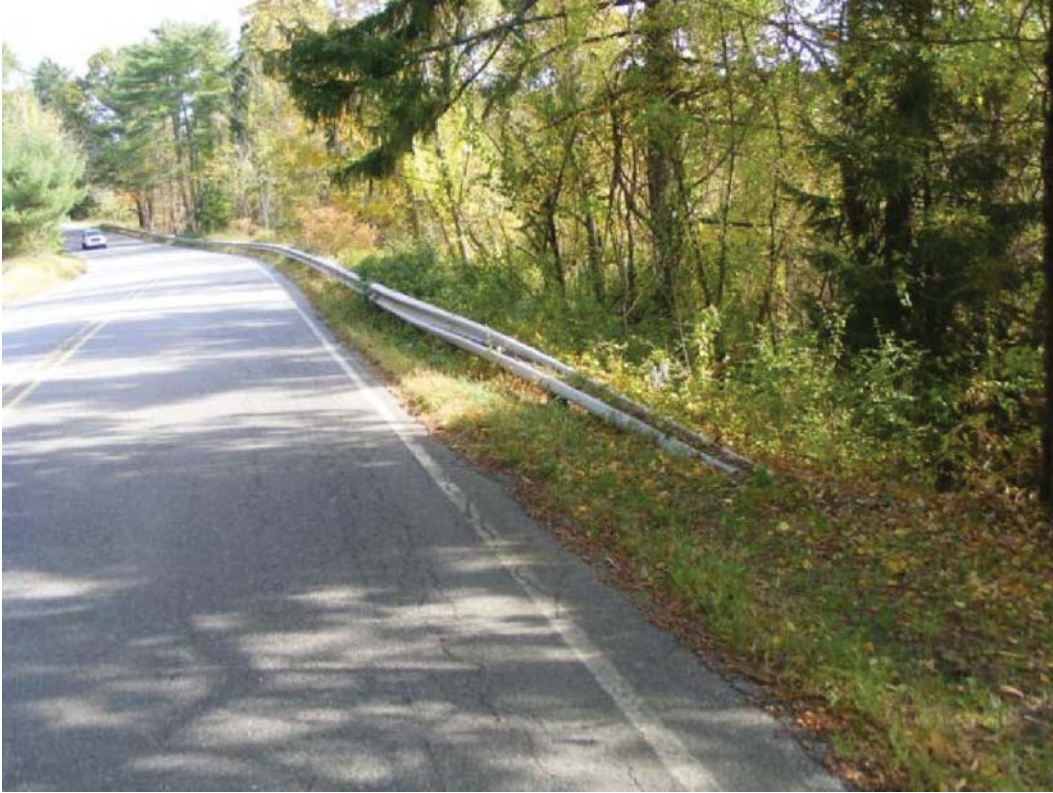
DEWA_0014_11.880_R_1.JPG

Barrier ID:	DEWA-0014-11.880-R				
Route Name:	US ROUTE 209				
Inspection Date:	10/11/2010	Barrier Rating:	46.90		
Barrier Description					
Type:	W-BEAM STRONG POST	Barrier Function:	TRAFFIC		
Barrier Material:	GALVANIZED STEEL	Post Material:	GALVANIZED STEEL		
Blockout Type:	STEEL	Length (ft.):	590		
Speed Limit (MPH):	45	Placement with Respect to Road:	OUTSIDE OF CURVE		
Hazard Behind Barrier:	MEDIUM				
Barrier Crashworthiness					
Appropriate Test Level:	TL-2	Barrier Test Level:	TL-3	Is Barrier Crashworthy?:	YES
Beg. End Trtmt Type:	W-BEAM TURN DOWN	Is Beg. End Trtmt Crashworthy?:	NO	Approach Transition Type:	NONE
Ending End Trtmt Type:	W-BEAM TURN DOWN	Ending End Trtmt Crashworthy?:	NO		
Average Measurements					
Design Height (In.):	27	Width (In.):	0.0	Post Spacing (In.):	75.3
Height (In.):	25.6	Lateral Offset (In.):	34.0	Road Grade (%):	2.80
Physical Condition					
Barrier	Alignment and Height:	No deflections observed in alignment. The height is low by 1 to 3 in from the design of 27 in for 110 LF.

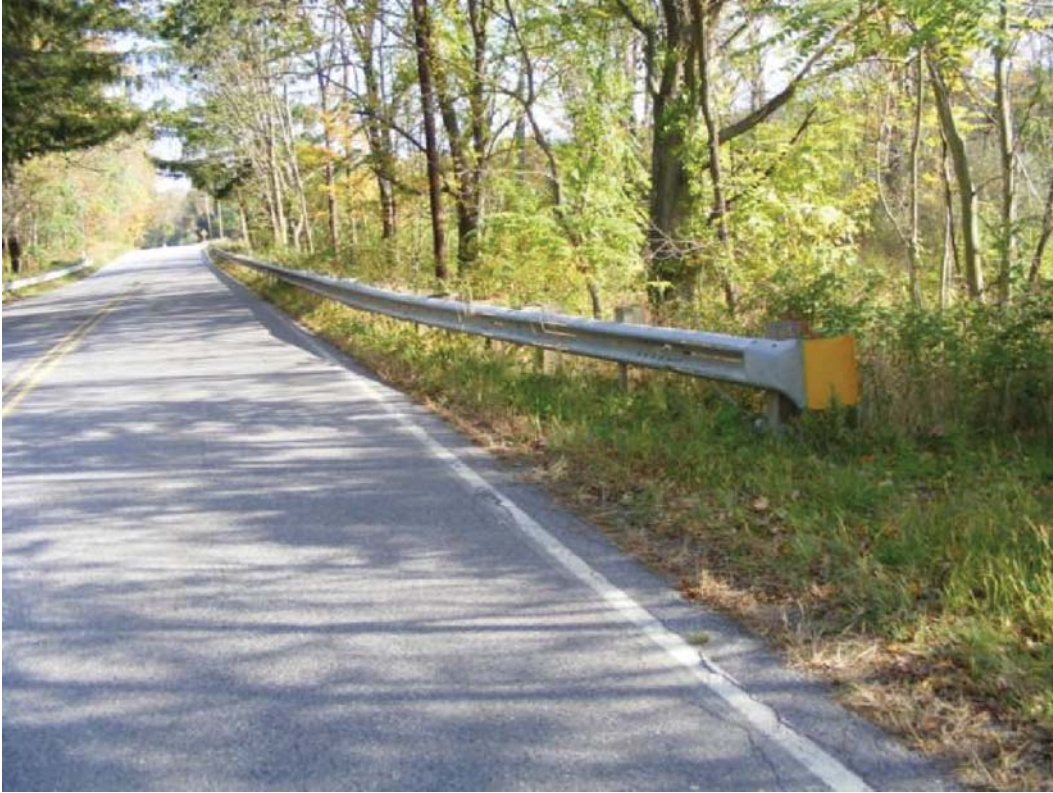
DEWA_0014_12.492_R_1.JPG

Barrier ID:	DEWA-0014-12.492-R				
Route Name:	US ROUTE 209				
Inspection Date:	10/11/2010	Barrier Rating:	32.40		
Barrier Description					
Type:	W-BEAM STRONG POST	Barrier Function:	TRAFFIC		
Barrier Material:	GALVANIZED STEEL	Post Material:	GALVANIZED STEEL		
Blockout Type:	STEEL	Length (ft.):	369		
Speed Limit (MPH):	35	Placement with Respect to Road:	TANGENT		
Hazard Behind Barrier:	MEDIUM				
Barrier Crashworthiness					
Appropriate Test Level:	TL-2	Barrier Test Level:	TL-3	Is Barrier Crashworthy?:	YES
Beg. End Trtmt Type:	W-BEAM FLARED 350 COMPLIANT	Is Beg. End Trtmt Crashworthy?:	YES	Approach Transition Type:	NONE
Ending End Trtmt Type:	W-BEAM FLARED 350 COMPLIANT	Ending End Trtmt Crashworthy?:	YES		
Average Measurements					
Design Height (In.):	27	Width (In.):	0.0	Post Spacing (In.):	76.0
Height (In.):	27.6	Lateral Offset (In.):	20.0	Road Grade (%):	0.50
Physical Condition					
Barrier	Alignment and Height:	No deflections observed in alignment. The height is at or above the design of 27 in by 1 in.

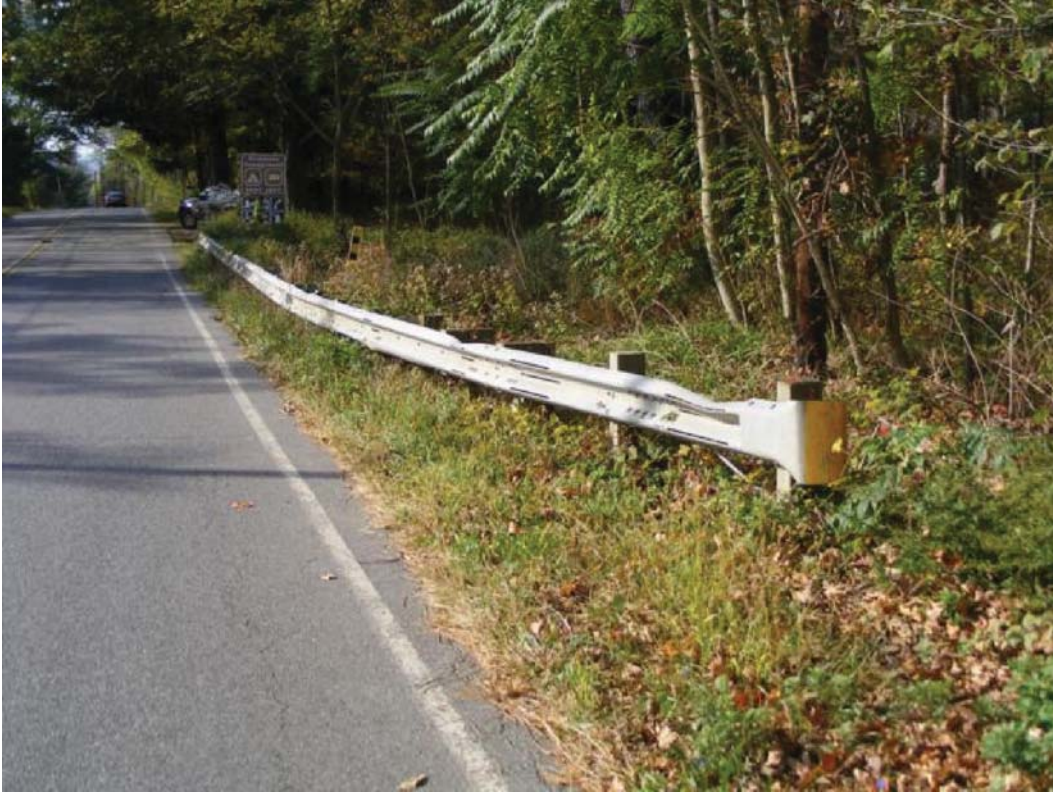
DEWA_0014_12.519_L_1.JPG

Barrier ID:	DEWA-0014-12.519-L				
Route Name:	US ROUTE 209				
Inspection Date:	10/11/2010	Barrier Rating:	26.70		
Barrier Description					
Type:	W-BEAM STRONG POST	Barrier Function:	TRAFFIC		
Barrier Material:	GALVANIZED STEEL	Post Material:	GALVANIZED STEEL		
Blockout Type:	STEEL	Length (ft.):	155		
Speed Limit (MPH):	35	Placement with Respect to Road:	TANGENT		
Hazard Behind Barrier:	MEDIUM				
Barrier Crashworthiness					
Appropriate Test Level:	TL-2	Barrier Test Level:	TL-3	Is Barrier Crashworthy?:	YES
Beg. End Trtmt Type:	W-BEAM FLARED 350 COMPLIANT	Is Beg. End Trtmt Crashworthy?:	YES	Approach Transition Type:	NONE
Ending End Trtmt Type:	W-BEAM FLARED 350 COMPLIANT	Ending End Trtmt Crashworthy?:	YES		
Average Measurements					
Design Height (In.):	27	Width (In.):	0.0	Post Spacing (In.):	75.3
Height (In.):	27.7	Lateral Offset (In.):	34.2	Road Grade (%):	0.50
Physical Condition					
Barrier	Alignment and Height:	No deflections observed in alignment. The height is at or above the design of 27 in by up to 1 in.

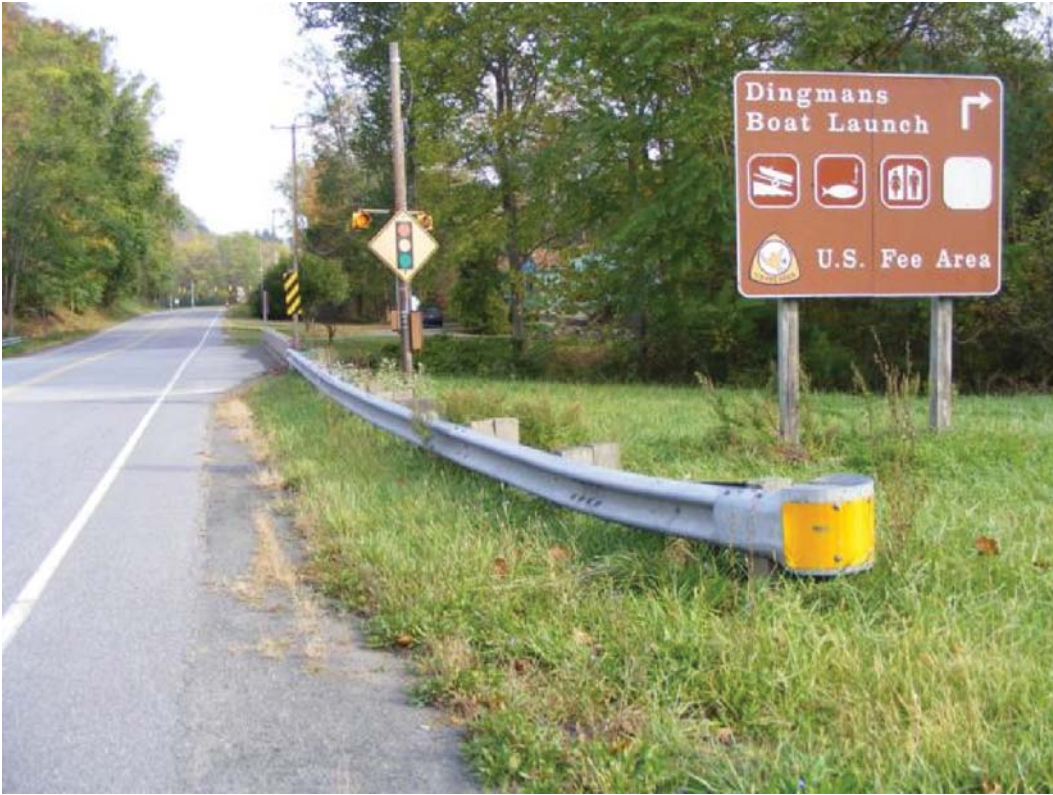
DEWA_0014_13.042_R_1.JPG

Barrier ID:	DEWA-0014-13.042-R				
Route Name:	US ROUTE 209				
Inspection Date:	10/11/2010	Barrier Rating:	23.70		
Barrier Description					
Type:	W-BEAM STRONG POST	Barrier Function:	TRAFFIC		
Barrier Material:	GALVANIZED STEEL	Post Material:	GALVANIZED STEEL		
Blockout Type:	STEEL	Length (ft.):	80		
Speed Limit (MPH):	35	Placement with Respect to Road:	TANGENT		
Hazard Behind Barrier:	MEDIUM				
Barrier Crashworthiness					
Appropriate Test Level:	TL-2	Barrier Test Level:	TL-3	Is Barrier Crashworthy?:	YES
Beg. End Trtmt Type:	W-BEAM TANGENT 350	Is Beg. End Trtmt Crashworthy?:	YES	Approach Transition Type:	CONC/MASON W-BEAM
Ending End Trtmt Type:	NONE	Ending End Trtmt Crashworthy?:	N/A		
Average Measurements					
Design Height (In.):	27	Width (In.):	0.0	Post Spacing (In.):	74.3
Height (In.):	26.0	Lateral Offset (In.):	102.5	Road Grade (%):	0.00
Physical Condition					
Barrier	Alignment and Height:	No deflections observed in alignment. The height is low by 1 in or less from the design of 27 in.

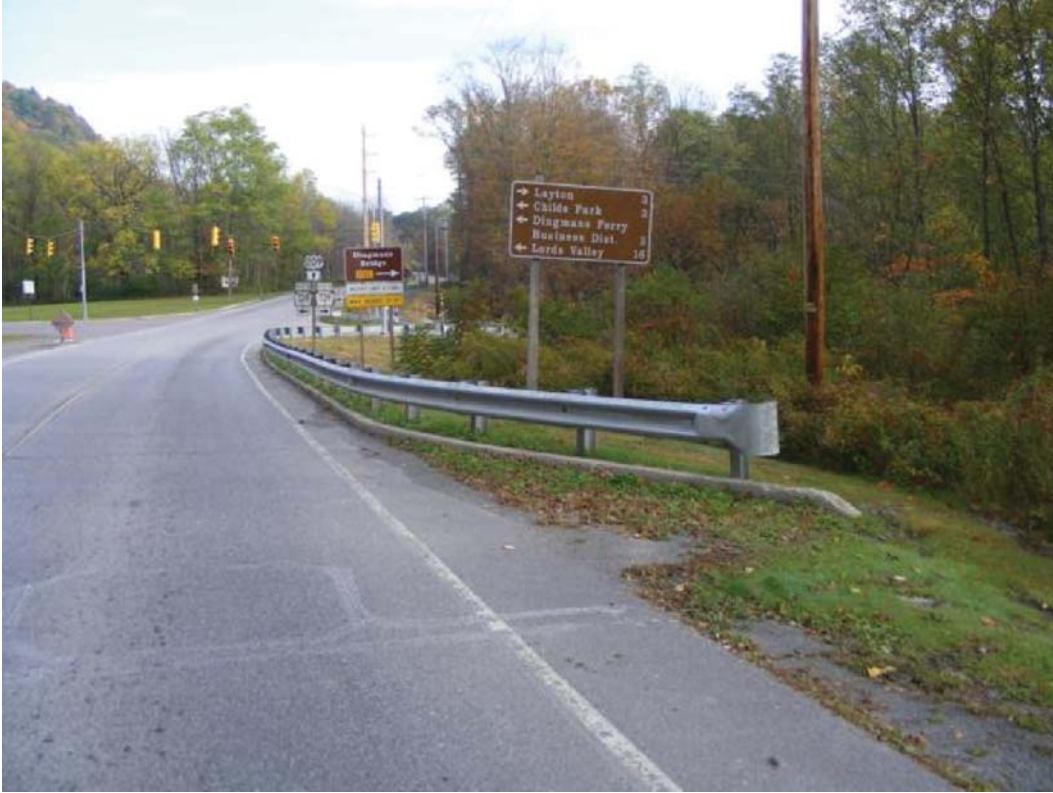
DEWA_0014_13.176_R_1.JPG

Barrier ID:	DEWA-0014-13.176-R				
Route Name:	US ROUTE 209				
Inspection Date:	10/11/2010	Barrier Rating:	24.20		
Barrier Description					
Type:	W-BEAM STRONG POST	Barrier Function:	TRAFFIC		
Barrier Material:	GALVANIZED STEEL	Post Material:	GALVANIZED STEEL		
Blockout Type:	PLASTIC	Length (ft.):	213		
Speed Limit (MPH):	35	Placement with Respect to Road:	TANGENT		
Hazard Behind Barrier:	LOW				
Barrier Crashworthiness					
Appropriate Test Level:	TL-2	Barrier Test Level:	TL-3	Is Barrier Crashworthy?:	YES
Beg. End Trtmt Type:	NONE	Is Beg. End Trtmt Crashworthy?:	N/A	Approach Transition Type:	NONE
Ending End Trtmt Type:	NONE	Ending End Trtmt Crashworthy?:	N/A		
Average Measurements					
Design Height (In.):	27	Width (In.):	0.0	Post Spacing (In.):	74.0
Height (In.):	28.0	Lateral Offset (In.):	28.2	Road Grade (%):	1.50
Physical Condition					
Barrier	Alignment and Height:	No deflections observed in alignment. The height is at or above the design of 27 in by 1 in.

Breaking and Cracking:	No breaking or cracking observed.			
	Missing Elements:	No missing elements observed.			
	Corrosion and Weathering:	No loss of cross section or erosion around posts observed.			
End Treatments	Alignment and Height:				
	Breaking and Cracking:				
	Missing Elements:				
	Corrosion and Weathering:

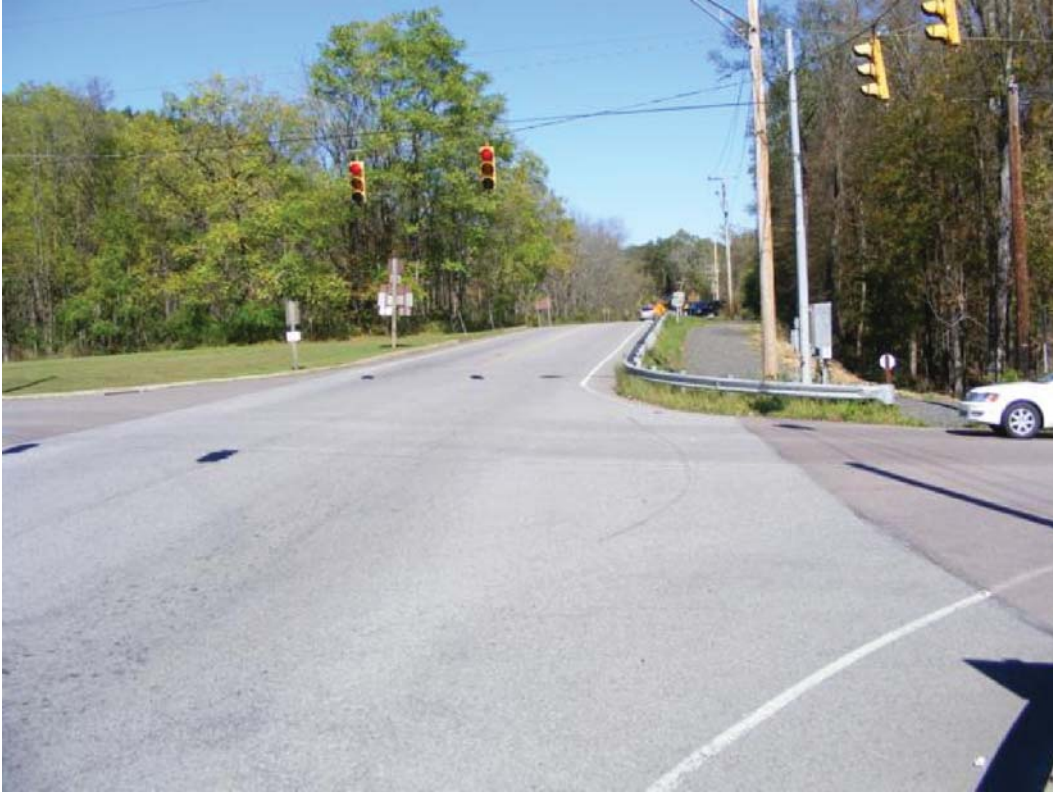
DEWA_0014_13.226_R_1.JPG

Barrier ID:	DEWA-0014-13.226-R				
Route Name:	US ROUTE 209				
Inspection Date:	10/08/2010	Barrier Rating:	27.10		
Barrier Description					
Type:	W-BEAM STRONG POST	Barrier Function:	TRAFFIC		
Barrier Material:	GALVANIZED STEEL	Post Material:	GALVANIZED STEEL		
Blockout Type:	PLASTIC	Length (ft.):	270		
Speed Limit (MPH):	35	Placement with Respect to Road:	TANGENT		
Hazard Behind Barrier:	LOW				
Barrier Crashworthiness					
Appropriate Test Level:	TL-2	Barrier Test Level:	TL-3	Is Barrier Crashworthy?:	YES
Beg. End Trtmt Type:	NONE	Is Beg. End Trtmt Crashworthy?:	N/A	Approach Transition Type:	NONE
Ending End Trtmt Type:	NONE	Ending End Trtmt Crashworthy?:	N/A		
Average Measurements					
Design Height (In.):	27	Width (In.):	0.0	Post Spacing (In.):	74.6
Height (In.):	26.7	Lateral Offset (In.):	43.0	Road Grade (%):	3.10
Physical Condition					
Barrier	Alignment and Height:	No deflections observed in alignment. The height is at or below the design of 27 in by 1 in.

Breaking and Cracking:	No breaking or cracking observed.			
	Missing Elements:	No missing elements observed.			
	Corrosion and Weathering:	No loss of cross section or erosion around posts observed.			
End Treatments	Alignment and Height:				
	Breaking and Cracking:				
	Missing Elements:				
	Corrosion and Weathering:

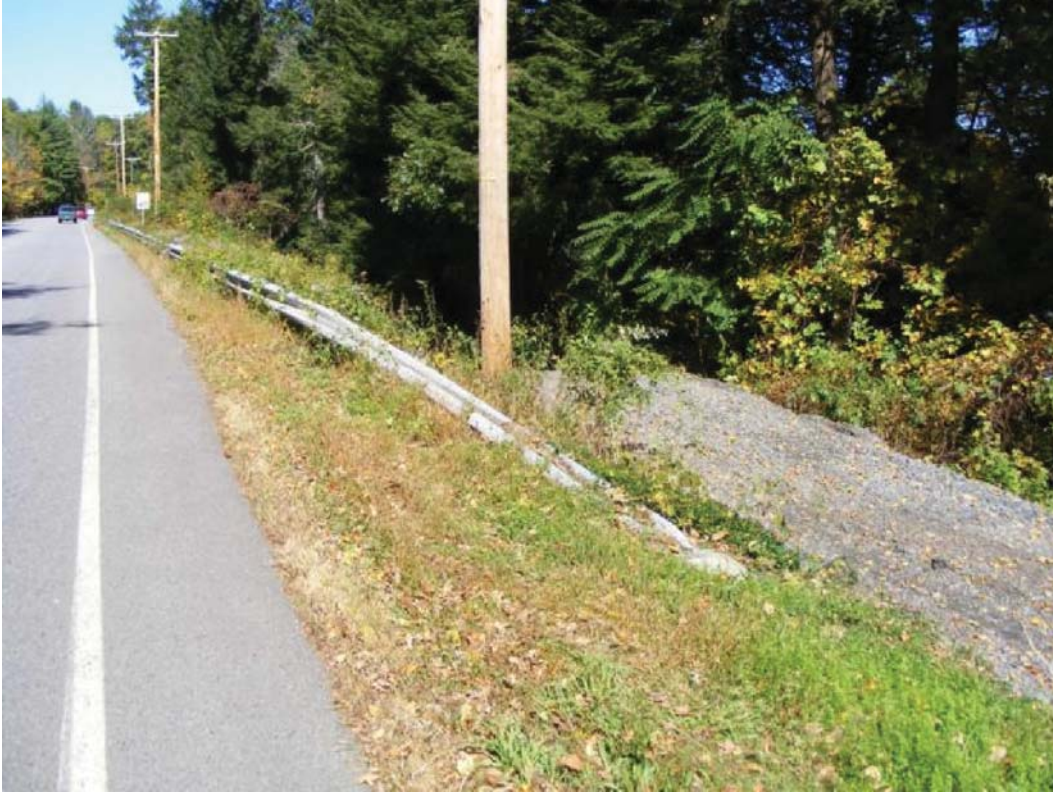
DEWA_0014_13.582_R_1.JPG

Barrier ID:	DEWA-0014-13.582-R				
Route Name:	US ROUTE 209				
Inspection Date:	10/08/2010	Barrier Rating:	33.90		
Barrier Description					
Type:	W-BEAM STRONG POST	Barrier Function:	TRAFFIC		
Barrier Material:	GALVANIZED STEEL	Post Material:	GALVANIZED STEEL		
Blockout Type:	STEEL	Length (ft.):	618		
Speed Limit (MPH):	45	Placement with Respect to Road:	INSIDE OF CURVE		
Hazard Behind Barrier:	MEDIUM				
Barrier Crashworthiness					
Appropriate Test Level:	TL-2	Barrier Test Level:	TL-3	Is Barrier Crashworthy?:	YES
Beg. End Trtmt Type:	W-BEAM TURN DOWN	Is Beg. End Trtmt Crashworthy?:	NO	Approach Transition Type:	NONE
Ending End Trtmt Type:	W-BEAM TURN DOWN	Ending End Trtmt Crashworthy?:	NO		
Average Measurements					
Design Height (In.):	27	Width (In.):	0.0	Post Spacing (In.):	75.0
Height (In.):	27.2	Lateral Offset (In.):	71.5	Road Grade (%):	0.60
Physical Condition					
Barrier	Alignment and Height:	The barrier alignment was deflected up to 10 in for 50 ft. The height was 1 in below at or 1 in above the 27 in design height.

Breaking and Cracking:	No breaking or cracking observed.			
	Missing Elements:	No missing elements observed.			
	Corrosion and Weathering:	No loss of cross section or erosion around posts observed.			
End Treatments	Alignment and Height:	Alignment acceptable. Height is within 1-in. of 27-in. design height.			
	Breaking and Cracking:	No breaking or cracking observed.			
	Missing Elements:	No missing elements observed.			
	Corrosion and Weathering:	No loss of cross section or erosion around posts observed.

Repair Action:	REPAIR	FMSS Work Type:	DEFERRED MAINTENANCE	Repair Cost:	\$2998
Brief Workorder:	Reset 50 feet of barrier to correct for out of alignment.				
Workorder:	Remove & Reset Guardrail at \$25- per -Lin. Ft. for 50 LF = \$1250. Reset 50ft. of barrier to correct for out of alignment. Low Speed Traffic Control at \$1475- per -Day for 1 Day(s) = \$1475.
