NPS Guardwall/Rail Inventory Program Delaware Water Gap National Recreation Area

**Federal Lands Highway
Road Inventory Program**

Federal Highway Administration
Eastern Federal Lands Highway Division
Road Inventory Program (RIP)

Data Collection Date: October 2010
Report Date: December 2015

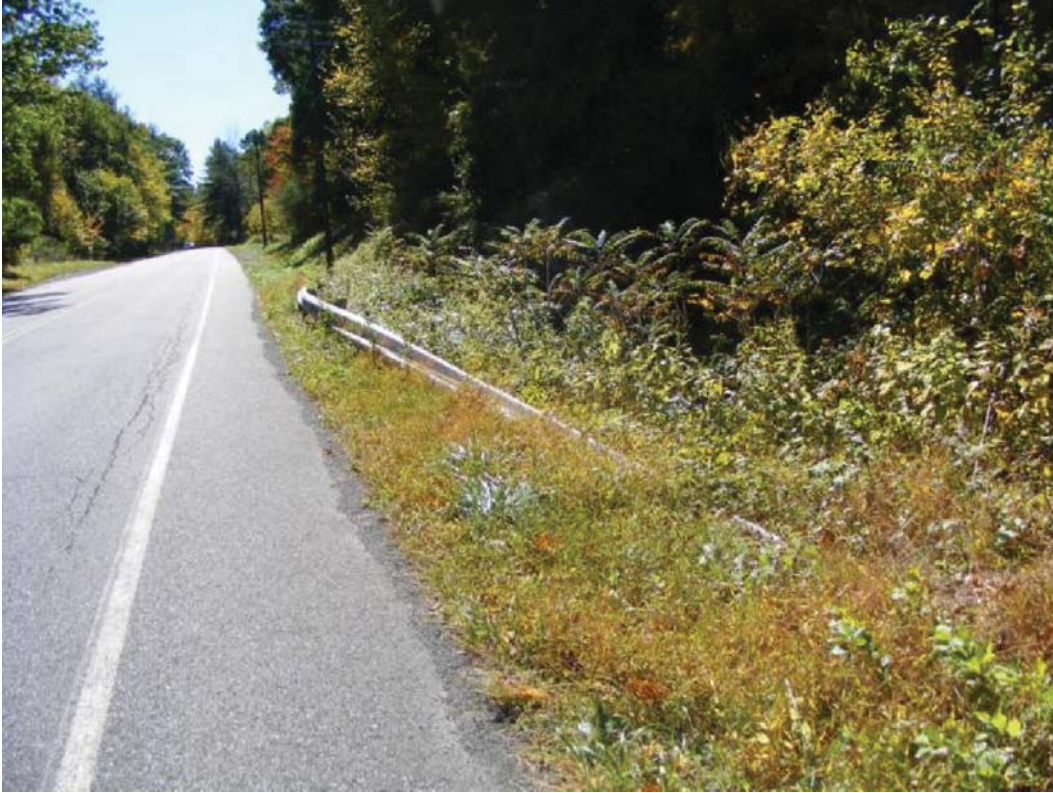
DEWA_0014_13.857_L_1.JPG

Barrier ID:	DEWA-0014-13.857-L				
Route Name:	US ROUTE 209				
Inspection Date:	10/08/2010	Barrier Rating:	30.00		
Barrier Description					
Type:	W-BEAM STRONG POST	Barrier Function:	TRAFFIC		
Barrier Material:	GALVANIZED STEEL	Post Material:	GALVANIZED STEEL		
Blockout Type:	STEEL	Length (ft.):	91		
Speed Limit (MPH):	45	Placement with Respect to Road:	TANGENT		
Hazard Behind Barrier:	LOW				
Barrier Crashworthiness					
Appropriate Test Level:	TL-2	Barrier Test Level:	TL-3	Is Barrier Crashworthy?:	YES
Beg. End Trtmt Type:	W-BEAM TURN DOWN	Is Beg. End Trtmt Crashworthy?:	NO	Approach Transition Type:	NONE
Ending End Trtmt Type:	W-BEAM TURN DOWN	Ending End Trtmt Crashworthy?:	NO		
Average Measurements					
Design Height (In.):	27	Width (In.):	0.0	Post Spacing (In.):	74.3
Height (In.):	25.0	Lateral Offset (In.):	66.3	Road Grade (%):	0.10
Physical Condition					
Barrier	Alignment and Height:	No deflections observed in alignment. The height is low by 2 in from the design of 27 in.

Repair Action:	REPAIR	FMSS Work Type:	DEFERRED MAINTENANCE	Repair Cost:	\$2624
Brief Workorder:	Raise 91 feet of guardrail to 27 inch design height.				
Workorder:	Adjust Guardrail at \$10- per -Lin. Ft. for 91 LF = \$910. Raise 91ft. of barrier to 27 inch design height. Low Speed Traffic Control at \$1475- per -Day for 1 Day(s) = \$1475.

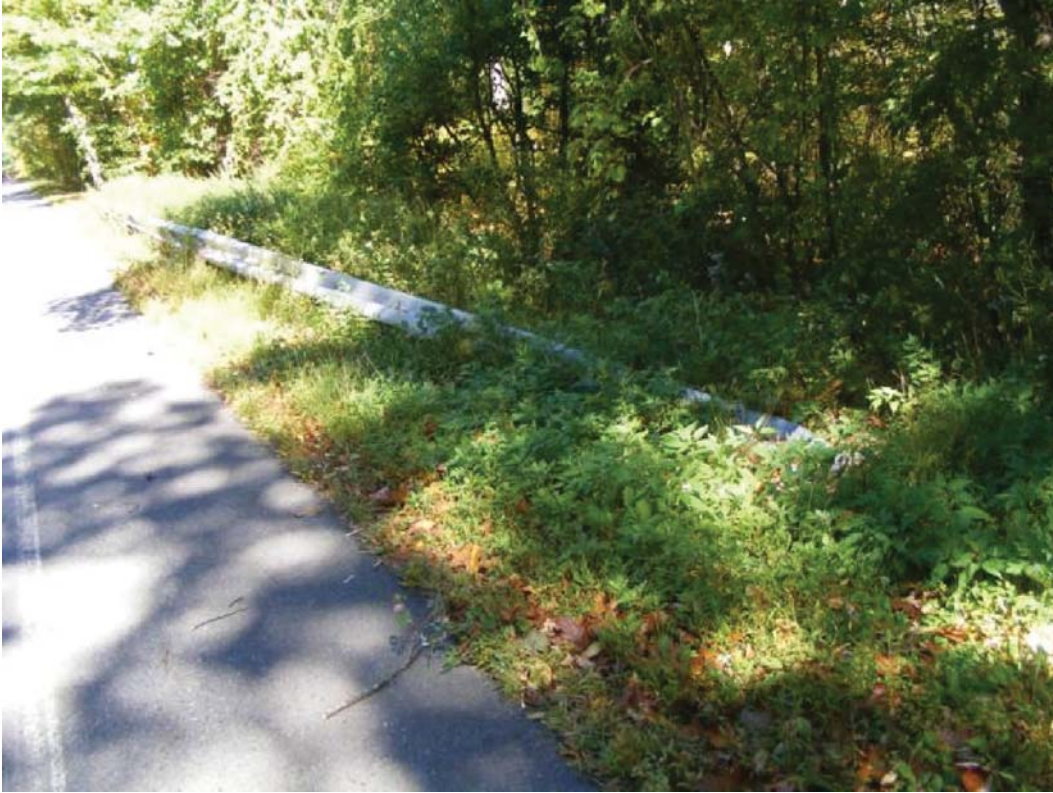
DEWA_0014_13.857_R_1.JPG

Barrier ID:	DEWA-0014-13.857-R				
Route Name:	US ROUTE 209				
Inspection Date:	10/08/2010	Barrier Rating:	25.60		
Barrier Description					
Type:	W-BEAM WEAK POST	Barrier Function:	TRAFFIC		
Barrier Material:	GALVANIZED STEEL	Post Material:	GALVANIZED STEEL		
Blockout Type:	N/A	Length (ft.):	118		
Speed Limit (MPH):	45	Placement with Respect to Road:	TANGENT		
Hazard Behind Barrier:	LOW				
Barrier Crashworthiness					
Appropriate Test Level:	TL-2	Barrier Test Level:	TL-2	Is Barrier Crashworthy?:	YES
Beg. End Trtmt Type:	W-BEAM TURN DOWN	Is Beg. End Trtmt Crashworthy?:	NO	Approach Transition Type:	NONE
Ending End Trtmt Type:	W-BEAM TURN DOWN	Ending End Trtmt Crashworthy?:	NO		
Average Measurements					
Design Height (In.):	27	Width (In.):	0.0	Post Spacing (In.):	74.6
Height (In.):	26.7	Lateral Offset (In.):	72.3	Road Grade (%):	0.90
Physical Condition					
Barrier	Alignment and Height:	No deflections observed in alignment. The height is at or below the design of 27 in by 1 in.

Breaking and Cracking:	No breaking or cracking observed.			
	Missing Elements:	No missing elements observed.			
	Corrosion and Weathering:	No loss of cross section or erosion around posts observed.			
End Treatments	Alignment and Height:	Alignment acceptable. Height is within 1-in. of 27-in. design height.			
	Breaking and Cracking:	No breaking or cracking observed.			
	Missing Elements:	No missing elements observed.			
	Corrosion and Weathering:	No loss of cross section or erosion around posts observed.

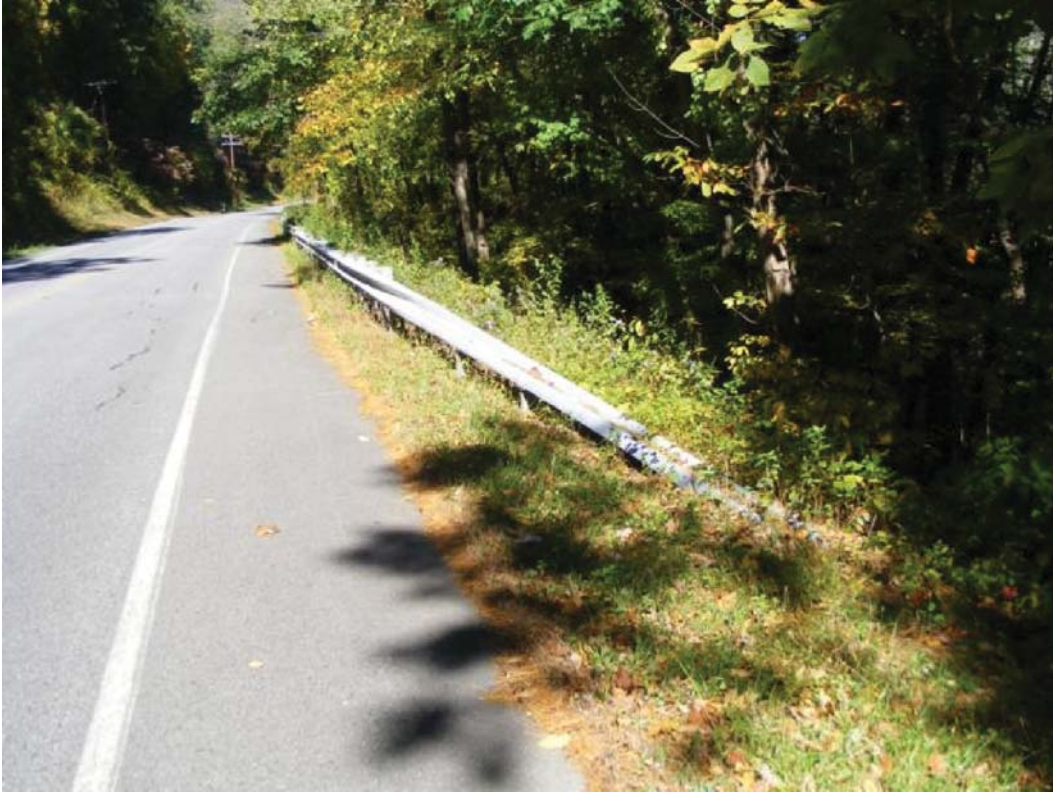
DEWA_0014_13.971_R_1.JPG

Barrier ID:	DEWA-0014-13.971-R				
Route Name:	US ROUTE 209				
Inspection Date:	10/08/2010	Barrier Rating:	42.50		
Barrier Description					
Type:	W-BEAM STRONG POST	Barrier Function:	TRAFFIC		
Barrier Material:	GALVANIZED STEEL	Post Material:	GALVANIZED STEEL		
Blockout Type:	STEEL	Length (ft.):	702		
Speed Limit (MPH):	45	Placement with Respect to Road:	INSIDE OF CURVE		
Hazard Behind Barrier:	MEDIUM				
Barrier Crashworthiness					
Appropriate Test Level:	TL-2	Barrier Test Level:	TL-3	Is Barrier Crashworthy?:	YES
Beg. End Trtmt Type:	W-BEAM TURN DOWN	Is Beg. End Trtmt Crashworthy?:	NO	Approach Transition Type:	NONE
Ending End Trtmt Type:	W-BEAM TURN DOWN	Ending End Trtmt Crashworthy?:	NO		
Average Measurements					
Design Height (In.):	27	Width (In.):	0.0	Post Spacing (In.):	75.5
Height (In.):	28.5	Lateral Offset (In.):	76.0	Road Grade (%):	5.00
Physical Condition					
Barrier	Alignment and Height:	The barrier alignment is deflected in 3 separate areas from 6 to 15 in at impact zones. The height is at or above the design of 27 in by up to 3 in.

Repair Action:	REPAIR	FMSS Work Type:	DEFERRED MAINTENANCE	Repair Cost:	\$2612
Brief Workorder:	Adjust 90 feet of barrier for alignment at impact zones.				
Workorder:	Adjust Guardrail at \$10- per -Lin. Ft. for 90 LF = \$900. Adjust 90ft. of barrier for alignment at impact zones. Low Speed Traffic Control at \$1475- per -Day for 1 Day(s) = \$1475.

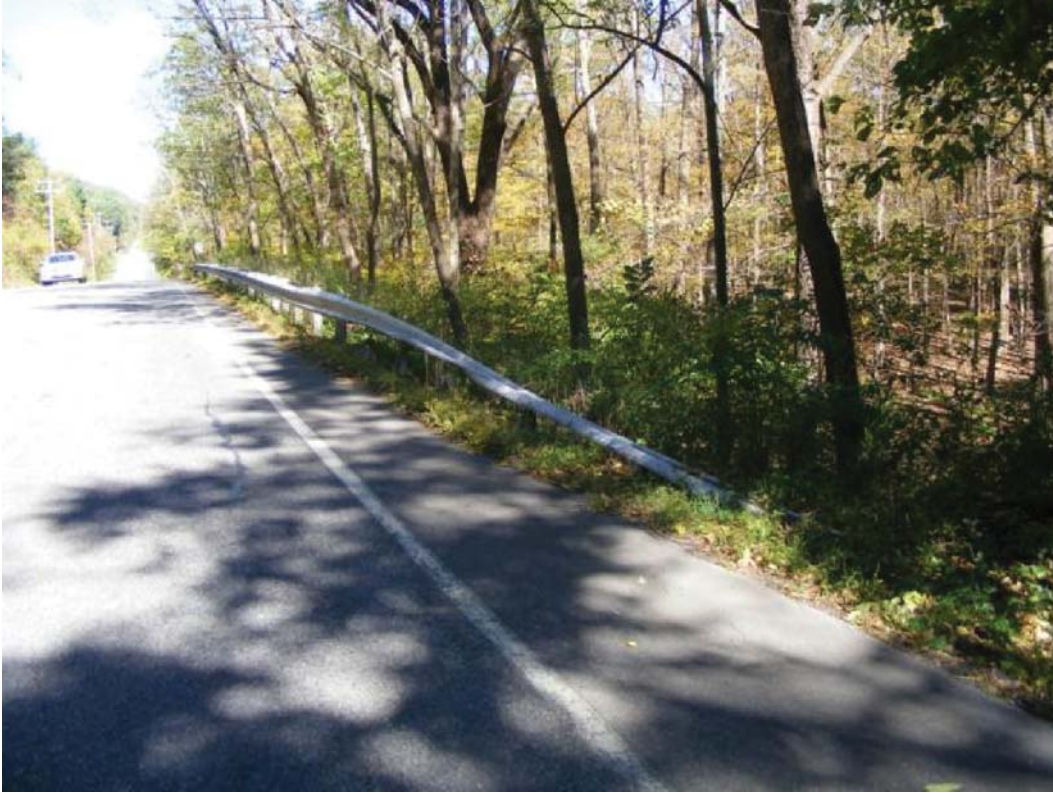
DEWA_0014_14.303_R_1.JPG

Barrier ID:	DEWA-0014-14.303-R				
Route Name:	US ROUTE 209				
Inspection Date:	10/08/2010	Barrier Rating:	28.50		
Barrier Description					
Type:	W-BEAM STRONG POST	Barrier Function:	TRAFFIC		
Barrier Material:	GALVANIZED STEEL	Post Material:	GALVANIZED STEEL		
Blockout Type:	STEEL	Length (ft.):	215		
Speed Limit (MPH):	45	Placement with Respect to Road:	TANGENT		
Hazard Behind Barrier:	LOW				
Barrier Crashworthiness					
Appropriate Test Level:	TL-2	Barrier Test Level:	TL-3	Is Barrier Crashworthy?:	YES
Beg. End Trtmt Type:	W-BEAM TURN DOWN	Is Beg. End Trtmt Crashworthy?:	NO	Approach Transition Type:	NONE
Ending End Trtmt Type:	W-BEAM TURN DOWN	Ending End Trtmt Crashworthy?:	NO		
Average Measurements					
Design Height (In.):	27	Width (In.):	0.0	Post Spacing (In.):	74.5
Height (In.):	26.6	Lateral Offset (In.):	44.2	Road Grade (%):	0.40
Physical Condition					
Barrier	Alignment and Height:	No deflections observed in alignment. The height is at or low by 1 in or less from the design of 27 in.

Repair Action:	REPAIR	FMSS Work Type:	DEFERRED MAINTENANCE	Repair Cost:	\$2750
Brief Workorder:	Replace 4 posts and 25 feet of rail in end treatment.				
Workorder:	Replace Post at \$100- per -Each for 4 Post(s) = \$400. Replace 4 galvanized steel posts. Replace Rail at \$25- per -Lin. Ft. for 25 LF = \$625. Replace 25 feet of rail. Low Speed Traffic Control at \$1475- per -Day for 1 Day(s) = \$1475.

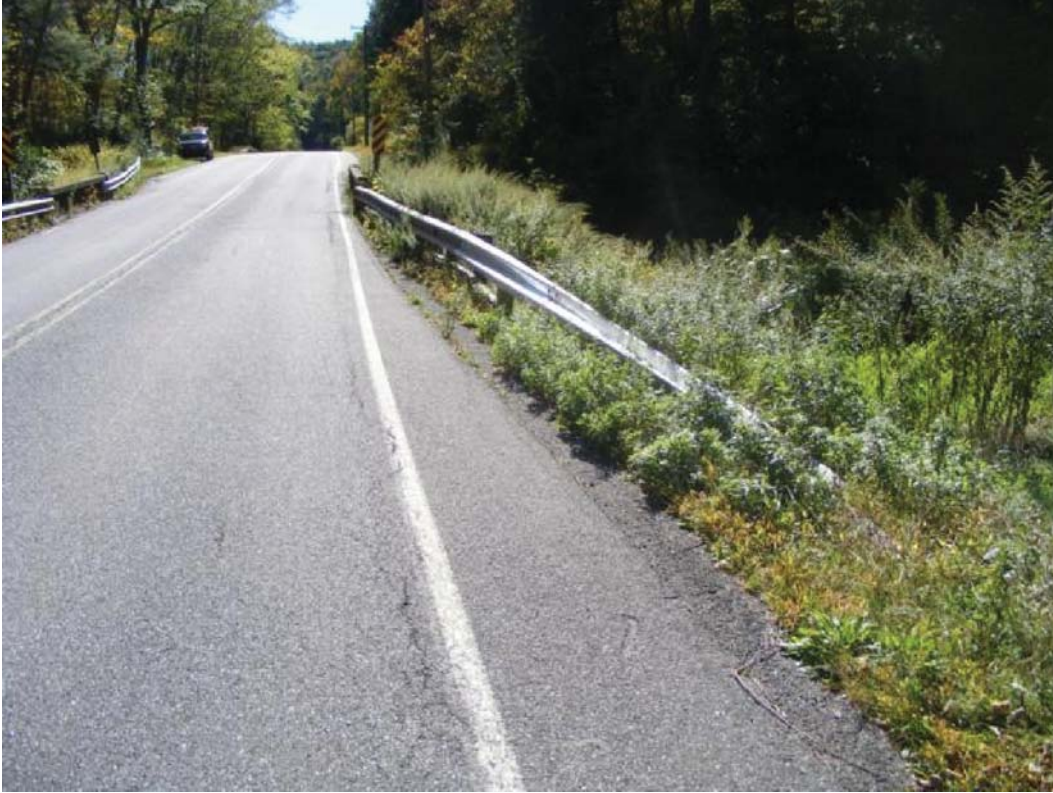
DEWA_0014_14.379_L_1.JPG

Barrier ID:	DEWA-0014-14.379-L				
Route Name:	US ROUTE 209				
Inspection Date:	10/08/2010	Barrier Rating:	33.70		
Barrier Description					
Type:	W-BEAM STRONG POST	Barrier Function:	TRAFFIC		
Barrier Material:	GALVANIZED STEEL	Post Material:	GALVANIZED STEEL		
Blockout Type:	STEEL	Length (ft.):	65		
Speed Limit (MPH):	45	Placement with Respect to Road:	TANGENT		
Hazard Behind Barrier:	MEDIUM				
Barrier Crashworthiness					
Appropriate Test Level:	TL-2	Barrier Test Level:	TL-3	Is Barrier Crashworthy?:	YES
Beg. End Trtmt Type:	W-BEAM TURN DOWN	Is Beg. End Trtmt Crashworthy?:	NO	Approach Transition Type:	CONC/MASON W-BEAM
Ending End Trtmt Type:	NONE	Ending End Trtmt Crashworthy?:	N/A		
Average Measurements					
Design Height (In.):	27	Width (In.):	0.0	Post Spacing (In.):	50.5
Height (In.):	28.6	Lateral Offset (In.):	22.6	Road Grade (%):	3.40
Physical Condition					
Barrier	Alignment and Height:	No deflections observed in alignment. The height is at or above the design of 27 in by up to 3 in.

Breaking and Cracking:	No breaking or cracking observed.			
	Missing Elements:	No missing elements observed.			
	Corrosion and Weathering:	No loss of cross section or erosion around posts observed.			
End Treatments	Alignment and Height:	Alignment acceptable. Height is within 1-in. of 27-in. design height.			
	Breaking and Cracking:	No breaking or cracking observed.			
	Missing Elements:	No missing elements observed.			
	Corrosion and Weathering:	No loss of cross section or erosion around posts observed.

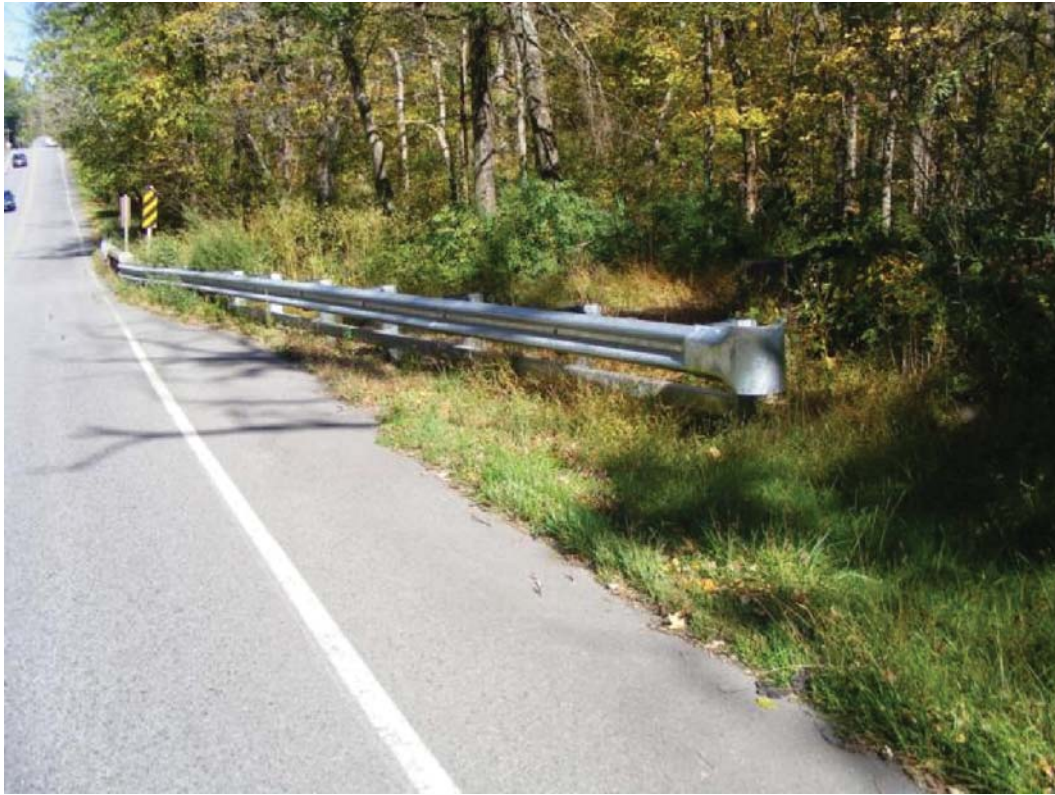
DEWA_0014_14.382_R_1.JPG

Barrier ID:	DEWA-0014-14.382-R				
Route Name:	US ROUTE 209				
Inspection Date:	10/08/2010	Barrier Rating:	32.40		
Barrier Description					
Type:	W-BEAM STRONG POST	Barrier Function:	TRAFFIC		
Barrier Material:	GALVANIZED STEEL	Post Material:	GALVANIZED STEEL		
Blockout Type:	PLASTIC	Length (ft.):	80		
Speed Limit (MPH):	45	Placement with Respect to Road:	TANGENT		
Hazard Behind Barrier:	MEDIUM				
Barrier Crashworthiness					
Appropriate Test Level:	TL-2	Barrier Test Level:	TL-3	Is Barrier Crashworthy?:	YES
Beg. End Trtmt Type:	NONE	Is Beg. End Trtmt Crashworthy?:	N/A	Approach Transition Type:	CONC/MASON W-BEAM
Ending End Trtmt Type:	NONE	Ending End Trtmt Crashworthy?:	N/A		
Average Measurements					
Design Height (In.):	27	Width (In.):	0.0	Post Spacing (In.):	62.7
Height (In.):	30.7	Lateral Offset (In.):	64.0	Road Grade (%):	5.40
Physical Condition					
Barrier	Alignment and Height:	No deflections observed in alignment. The height is at or above the design of 27 in with 40 ft more than 5 in above the design height.

Repair Action:	REPAIR	FMSS Work Type:	DEFERRED MAINTENANCE	Repair Cost:	\$2063
Brief Workorder:	Lower 40 feet of barrier to 27-in. design height.				
Workorder:	Adjust Guardrail at \$10- per -Lin. Ft. for 40 LF = \$400. Lower 40ft. of barrier to 27-in. design height. Low Speed Traffic Control at \$1475- per -Day for 1 Day(s) = \$1475.

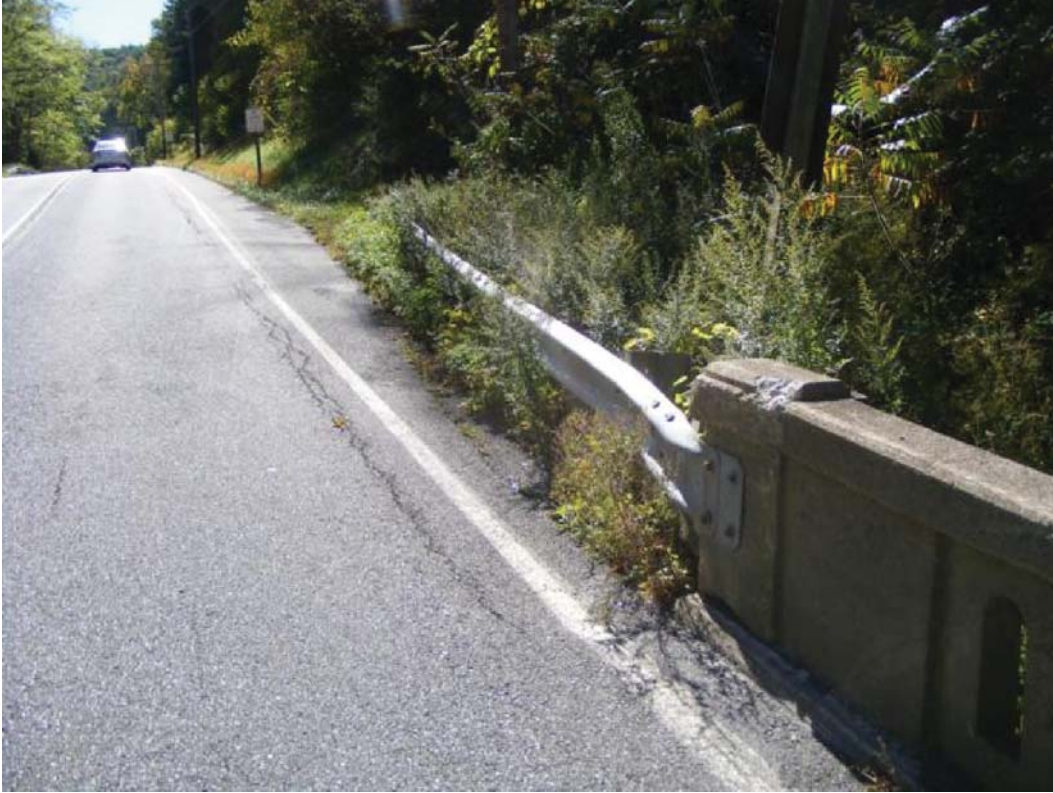
DEWA_0014_14.393_L_1.JPG

Barrier ID:	DEWA-0014-14.393-L				
Route Name:	US ROUTE 209				
Inspection Date:	10/08/2010	Barrier Rating:	28.10		
Barrier Description					
Type:	W-BEAM STRONG POST	Barrier Function:	TRAFFIC		
Barrier Material:	GALVANIZED STEEL	Post Material:	GALVANIZED STEEL		
Blockout Type:	STEEL	Length (ft.):	49		
Speed Limit (MPH):	45	Placement with Respect to Road:	TANGENT		
Hazard Behind Barrier:	MEDIUM				
Barrier Crashworthiness					
Appropriate Test Level:	TL-2	Barrier Test Level:	TL-3	Is Barrier Crashworthy?:	YES
Beg. End Trtmt Type:	NONE	Is Beg. End Trtmt Crashworthy?:	N/A	Approach Transition Type:	CONC/MASON W-BEAM
Ending End Trtmt Type:	W-BEAM TURN DOWN	Ending End Trtmt Crashworthy?:	NO		
Average Measurements					
Design Height (In.):	27	Width (In.):	0.0	Post Spacing (In.):	37.2
Height (In.):	26.6	Lateral Offset (In.):	53.2	Road Grade (%):	5.20
Physical Condition					
Barrier	Alignment and Height:	No deflections observed in alignment. The height is low by 1 in or less from the design of 27 in.

Breaking and Cracking:	No breaking or cracking observed.			
	Missing Elements:	No missing elements observed.			
	Corrosion and Weathering:	No loss of cross section or erosion around posts observed.			
End Treatments	Alignment and Height:	Alignment acceptable. Height is within 1-in. of 27-in. design height.			
	Breaking and Cracking:	No breaking or cracking observed.			
	Missing Elements:	No missing elements observed.			
	Corrosion and Weathering:	No loss of cross section or erosion around posts observed.

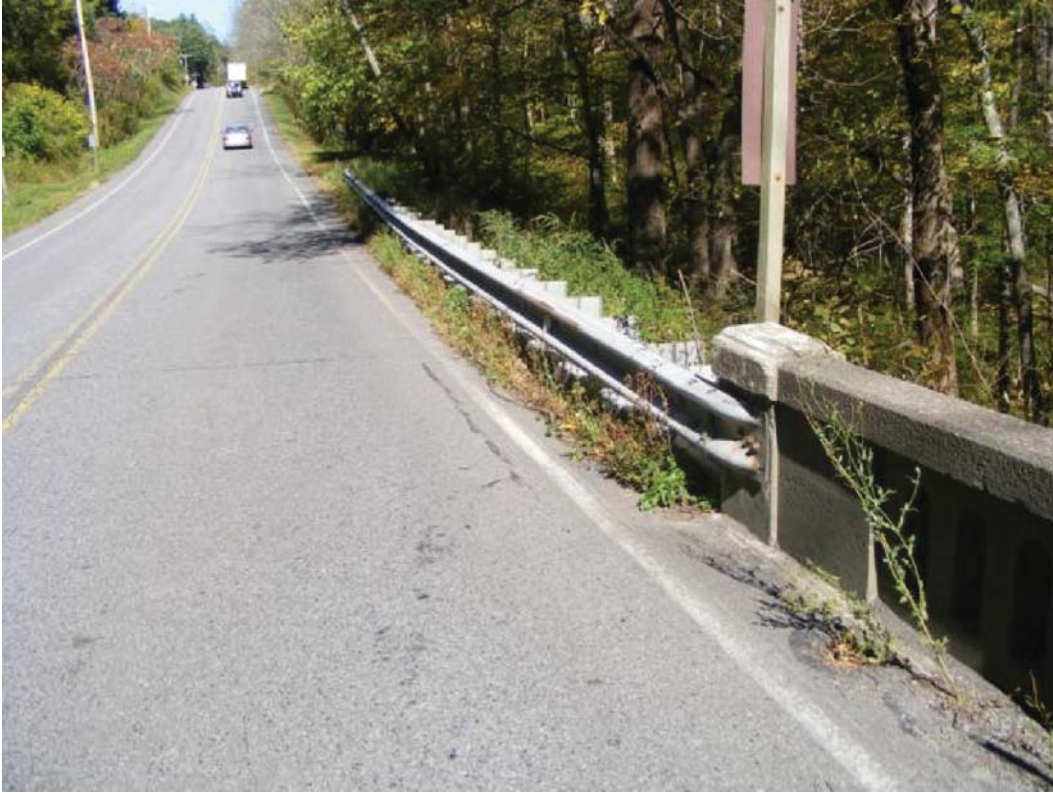
DEWA_0014_14.393_R_1.JPG

Barrier ID:	DEWA-0014-14.393-R				
Route Name:	US ROUTE 209				
Inspection Date:	10/08/2010	Barrier Rating:	35.20		
Barrier Description					
Type:	W-BEAM STRONG POST	Barrier Function:	TRAFFIC		
Barrier Material:	GALVANIZED STEEL	Post Material:	GALVANIZED STEEL		
Blockout Type:	STEEL	Length (ft.):	165		
Speed Limit (MPH):	45	Placement with Respect to Road:	TANGENT		
Hazard Behind Barrier:	MEDIUM				
Barrier Crashworthiness					
Appropriate Test Level:	TL-2	Barrier Test Level:	TL-3	Is Barrier Crashworthy?:	YES
Beg. End Trtmt Type:	NONE	Is Beg. End Trtmt Crashworthy?:	N/A	Approach Transition Type:	CONC/MASON W-BEAM
Ending End Trtmt Type:	W-BEAM TURN DOWN	Ending End Trtmt Crashworthy?:	NO		
Average Measurements					
Design Height (In.):	27	Width (In.):	0.0	Post Spacing (In.):	62.7
Height (In.):	26.7	Lateral Offset (In.):	35.2	Road Grade (%):	3.30
Physical Condition					
Barrier	Alignment and Height:	No deflections observed in alignment. The height is at or below the design of 27 in by 1 in.

Breaking and Cracking:	No breaking or cracking observed.			
	Missing Elements:	No missing elements observed.			
	Corrosion and Weathering:	No loss of cross section or erosion around posts observed.			
End Treatments	Alignment and Height:	Alignment acceptable. Height is within 1-in. of 27-in. design height.			
	Breaking and Cracking:	No breaking or cracking observed.			
	Missing Elements:	No missing elements observed.			
	Corrosion and Weathering:	No loss of cross section or erosion around posts observed.

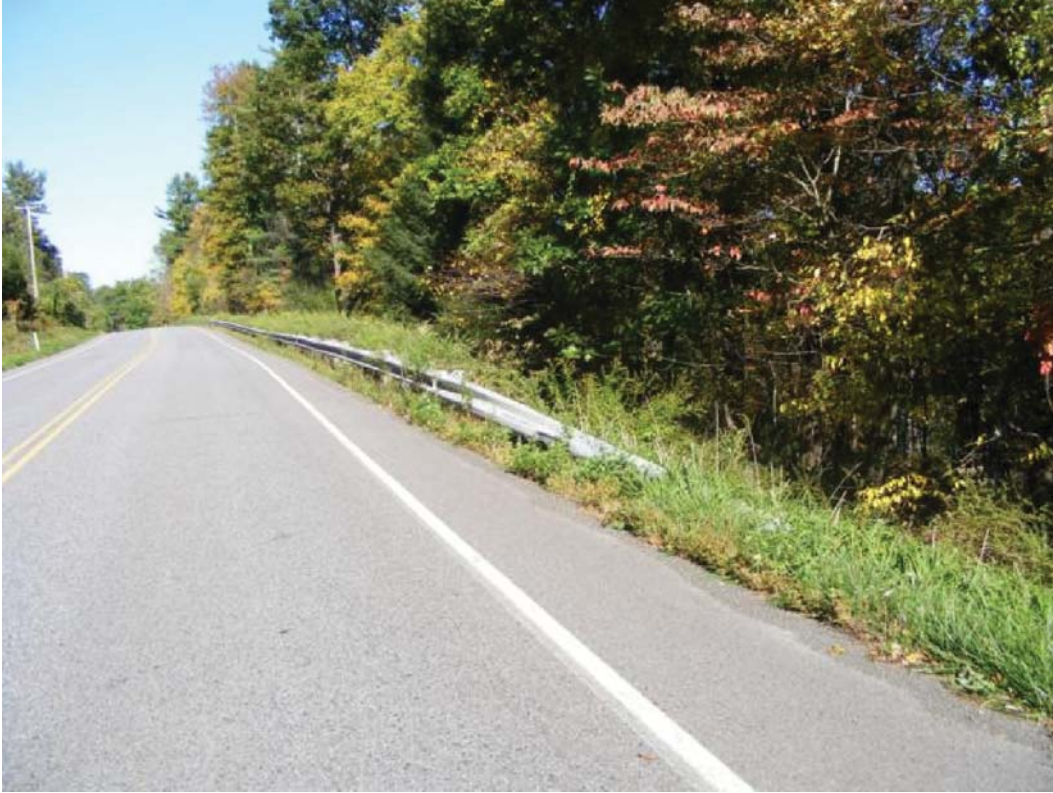
DEWA_0014_15.016_R_1.JPG

Barrier ID:	DEWA-0014-15.016-R				
Route Name:	US ROUTE 209				
Inspection Date:	10/08/2010	Barrier Rating:	55.50		
Barrier Description					
Type:	W-BEAM STRONG POST	Barrier Function:	TRAFFIC		
Barrier Material:	GALVANIZED STEEL	Post Material:	GALVANIZED STEEL		
Blockout Type:	STEEL	Length (ft.):	1250		
Speed Limit (MPH):	45	Placement with Respect to Road:	OUTSIDE OF CURVE		
Hazard Behind Barrier:	MEDIUM				
Barrier Crashworthiness					
Appropriate Test Level:	TL-2	Barrier Test Level:	TL-3	Is Barrier Crashworthy?:	YES
Beg. End Trtmt Type:	W-BEAM TURN DOWN	Is Beg. End Trtmt Crashworthy?:	NO	Approach Transition Type:	NONE
Ending End Trtmt Type:	W-BEAM TURN DOWN	Ending End Trtmt Crashworthy?:	NO		
Average Measurements					
Design Height (In.):	27	Width (In.):	0.0	Post Spacing (In.):	74.6
Height (In.):	25.5	Lateral Offset (In.):	53.5	Road Grade (%):	3.60
Physical Condition					
Barrier	Alignment and Height:	No deflections observed in alignment. The height is low by 1 to 3 in from the design of 27 in for 320 linear ft.

Breaking and Cracking:	No breaking or cracking observed.			
	Missing Elements:	No missing elements observed.			
	Corrosion and Weathering:	No loss of cross section or erosion around posts observed.			
End Treatments	Alignment and Height:	Alignment acceptable. Height is within 1-in. of 27-in. design height.			
	Breaking and Cracking:	No breaking or cracking observed.			
	Missing Elements:	No missing elements observed.			
	Corrosion and Weathering:	No loss of cross section or erosion around posts observed.

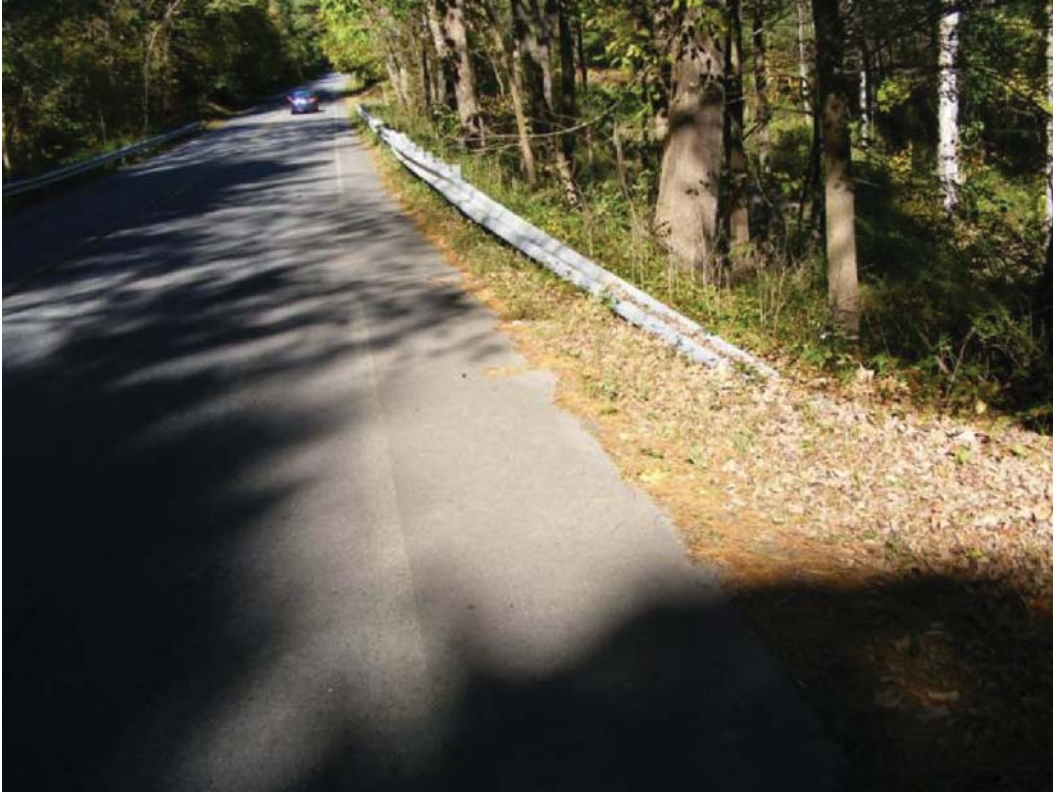
DEWA_0014_15.544_R_1.JPG

Barrier ID:	DEWA-0014-15.544-R				
Route Name:	US ROUTE 209				
Inspection Date:	10/08/2010	Barrier Rating:	39.70		
Barrier Description					
Type:	W-BEAM STRONG POST	Barrier Function:	TRAFFIC		
Barrier Material:	GALVANIZED STEEL	Post Material:	GALVANIZED STEEL		
Blockout Type:	STEEL	Length (ft.):	245		
Speed Limit (MPH):	45	Placement with Respect to Road:	TANGENT		
Hazard Behind Barrier:	MEDIUM				
Barrier Crashworthiness					
Appropriate Test Level:	TL-2	Barrier Test Level:	TL-3	Is Barrier Crashworthy?:	YES
Beg. End Trtmt Type:	W-BEAM TURN DOWN	Is Beg. End Trtmt Crashworthy?:	NO	Approach Transition Type:	NONE
Ending End Trtmt Type:	W-BEAM TURN DOWN	Ending End Trtmt Crashworthy?:	NO		
Average Measurements					
Design Height (In.):	27	Width (In.):	0.0	Post Spacing (In.):	75.0
Height (In.):	24.0	Lateral Offset (In.):	41.0	Road Grade (%):	1.10
Physical Condition					
Barrier	Alignment and Height:	No deflections observed in alignment. Barrier is 1 to 3 in below 27 in design height for 160 ft and is 3 to 4 in below for 85 ft.

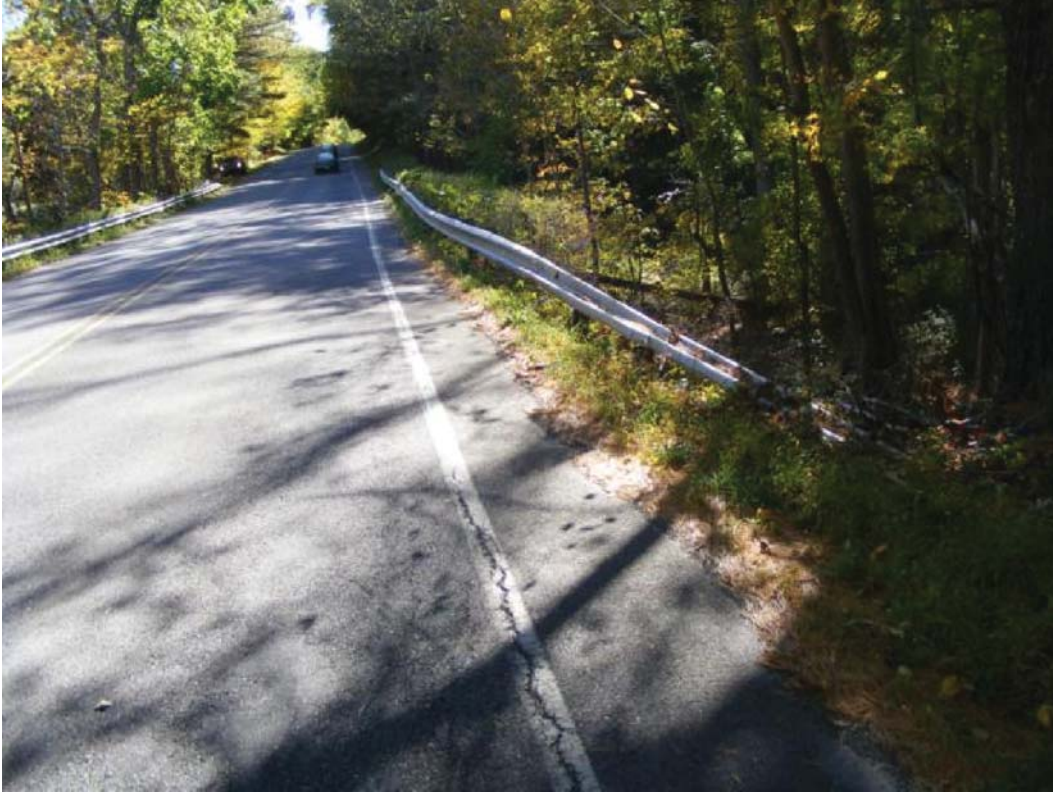
DEWA_0014_15.549_L_1.JPG

Barrier ID:	DEWA-0014-15.549-L				
Route Name:	US ROUTE 209				
Inspection Date:	10/08/2010	Barrier Rating:	37.20		
Barrier Description					
Type:	W-BEAM STRONG POST	Barrier Function:	TRAFFIC		
Barrier Material:	GALVANIZED STEEL	Post Material:	GALVANIZED STEEL		
Blockout Type:	STEEL	Length (ft.):	237		
Speed Limit (MPH):	45	Placement with Respect to Road:	TANGENT		
Hazard Behind Barrier:	LOW				
Barrier Crashworthiness					
Appropriate Test Level:	TL-2	Barrier Test Level:	TL-3	Is Barrier Crashworthy?:	YES
Beg. End Trtmt Type:	W-BEAM TURN DOWN	Is Beg. End Trtmt Crashworthy?:	NO	Approach Transition Type:	NONE
Ending End Trtmt Type:	W-BEAM TURN DOWN	Ending End Trtmt Crashworthy?:	NO		
Average Measurements					
Design Height (In.):	27	Width (In.):	0.0	Post Spacing (In.):	73.0
Height (In.):	23.7	Lateral Offset (In.):	40.2	Road Grade (%):	0.60
Physical Condition					
Barrier	Alignment and Height:	No deflections observed in alignment. Barrier is 1 to 3 in below 27 in design height for 152 ft and is 3 to 4 in below for 85 ft.

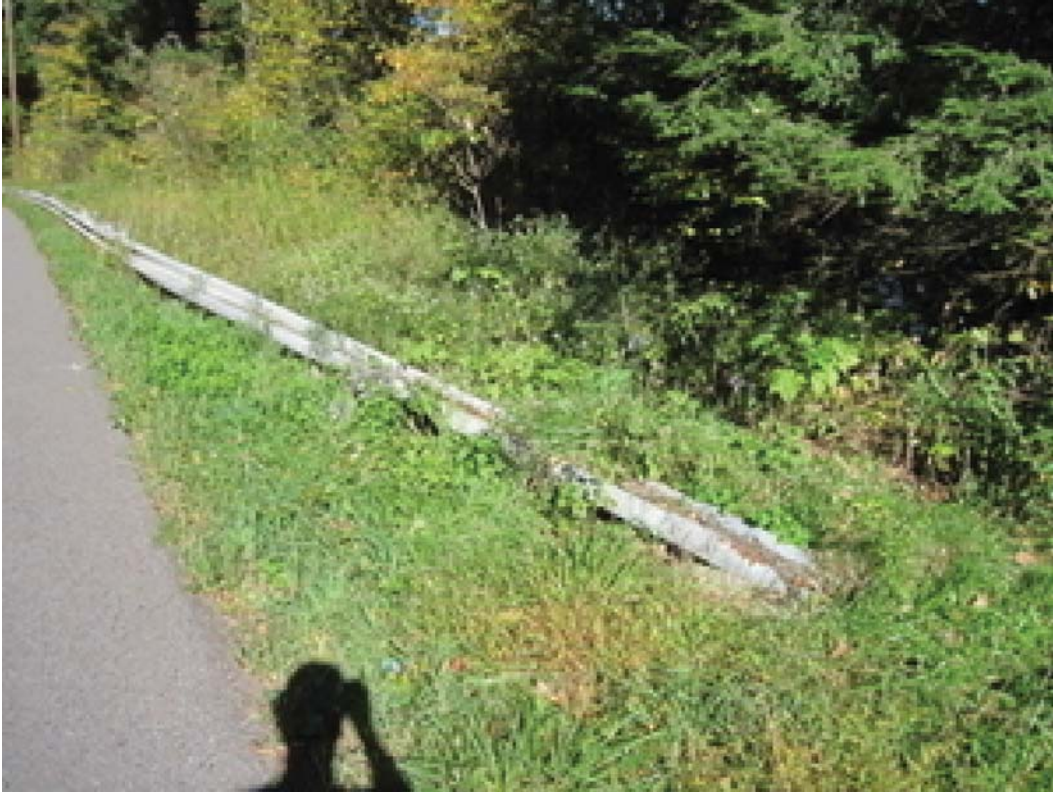
DEWA_0014_16.658_R_1.jpg

Barrier ID:	DEWA-0014-16.658-R				
Route Name:	US ROUTE 209				
Inspection Date:	10/08/2010	Barrier Rating:	48.20		
Barrier Description					
Type:	W-BEAM STRONG POST	Barrier Function:	TRAFFIC		
Barrier Material:	GALVANIZED STEEL	Post Material:	GALVANIZED STEEL		
Blockout Type:	STEEL	Length (ft.):	642		
Speed Limit (MPH):	45	Placement with Respect to Road:	OUTSIDE OF CURVE		
Hazard Behind Barrier:	MEDIUM				
Barrier Crashworthiness					
Appropriate Test Level:	TL-2	Barrier Test Level:	TL-3	Is Barrier Crashworthy?:	YES
Beg. End Trtmt Type:	W-BEAM TURN DOWN	Is Beg. End Trtmt Crashworthy?:	NO	Approach Transition Type:	NONE
Ending End Trtmt Type:	W-BEAM TURN DOWN	Ending End Trtmt Crashworthy?:	NO		
Average Measurements					
Design Height (In.):	27	Width (In.):	0.0	Post Spacing (In.):	74.6
Height (In.):	26.0	Lateral Offset (In.):	86.3	Road Grade (%):	3.50
Physical Condition					
Barrier	Alignment and Height:	No alignment deflection observed. Height ranges between 1 and 3 in below 27 in design height along 200 ft of barrier.

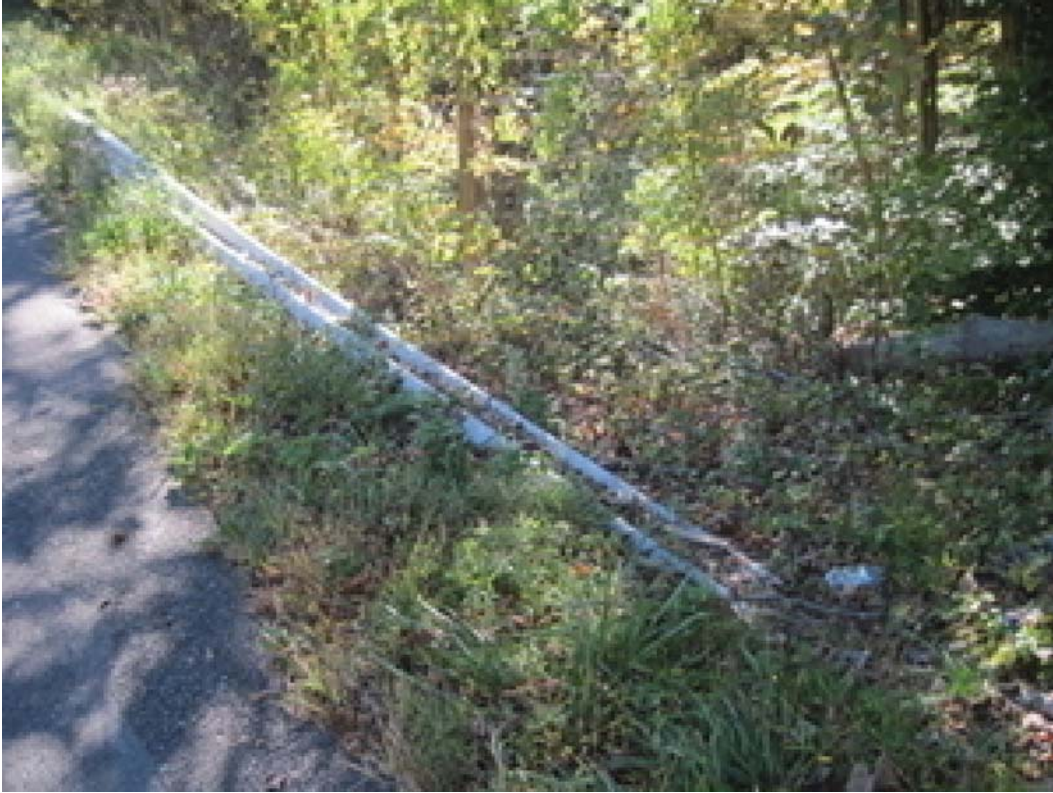
DEWA_0014_16.703_L_1.jpg

Barrier ID:	DEWA-0014-16.703-L				
Route Name:	US ROUTE 209				
Inspection Date:	10/08/2010	Barrier Rating:	45.70		
Barrier Description					
Type:	W-BEAM STRONG POST	Barrier Function:	TRAFFIC		
Barrier Material:	GALVANIZED STEEL	Post Material:	GALVANIZED STEEL		
Blockout Type:	STEEL	Length (ft.):	387		
Speed Limit (MPH):	45	Placement with Respect to Road:	TANGENT		
Hazard Behind Barrier:	HIGH				
Barrier Crashworthiness					
Appropriate Test Level:	TL-2	Barrier Test Level:	TL-3	Is Barrier Crashworthy?:	YES
Beg. End Trtmt Type:	W-BEAM TURN DOWN	Is Beg. End Trtmt Crashworthy?:	NO	Approach Transition Type:	NONE
Ending End Trtmt Type:	W-BEAM TURN DOWN	Ending End Trtmt Crashworthy?:	NO		
Average Measurements					
Design Height (In.):	27	Width (In.):	0.0	Post Spacing (In.):	74.3
Height (In.):	23.7	Lateral Offset (In.):	64.3	Road Grade (%):	1.70
Physical Condition					
Barrier	Alignment and Height:	No alignment deflection observed. Height ranges from 1 in to 6 in below 27in design height.

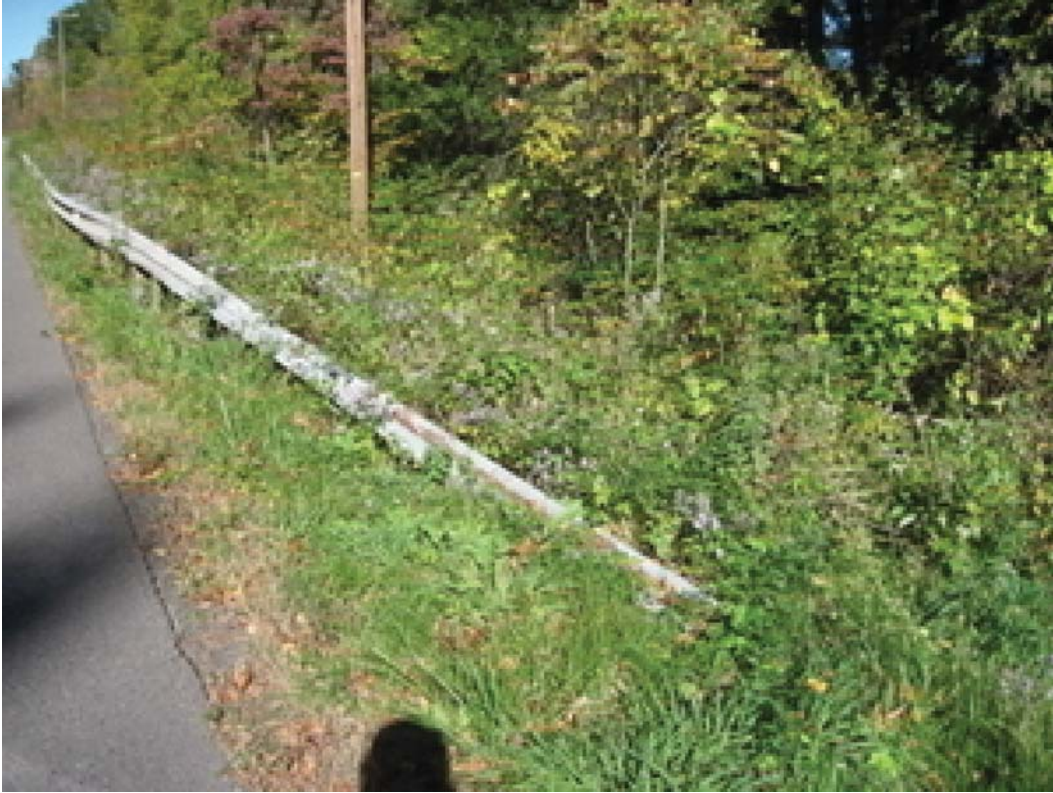
DEWA_0014_16.891_R_1.jpg

Barrier ID:	DEWA-0014-16.891-R				
Route Name:	US ROUTE 209				
Inspection Date:	10/08/2010	Barrier Rating:	55.20		
Barrier Description					
Type:	W-BEAM STRONG POST	Barrier Function:	TRAFFIC		
Barrier Material:	GALVANIZED STEEL	Post Material:	GALVANIZED STEEL		
Blockout Type:	STEEL	Length (ft.):	4586		
Speed Limit (MPH):	45	Placement with Respect to Road:	BOTH INSIDE AND OUTSIDE		
Hazard Behind Barrier:	MEDIUM				
Barrier Crashworthiness					
Appropriate Test Level:	TL-2	Barrier Test Level:	TL-3	Is Barrier Crashworthy?:	YES
Beg. End Trtmt Type:	W-BEAM TURN DOWN	Is Beg. End Trtmt Crashworthy?:	NO	Approach Transition Type:	NONE
Ending End Trtmt Type:	W-BEAM TURN DOWN	Ending End Trtmt Crashworthy?:	NO		
Average Measurements					
Design Height (In.):	27	Width (In.):	0.0	Post Spacing (In.):	75.0
Height (In.):	26.6	Lateral Offset (In.):	84.0	Road Grade (%):	0.70
Physical Condition					
Barrier	Alignment and Height:	Barrier is deflected by more than 12 in along 70 ft. Height varies between 3 and 4 in below 27-in design height along 340 ft and 1 - 3 in below along 670 ft. The rest varies between 1 in below and 4 in above design height.

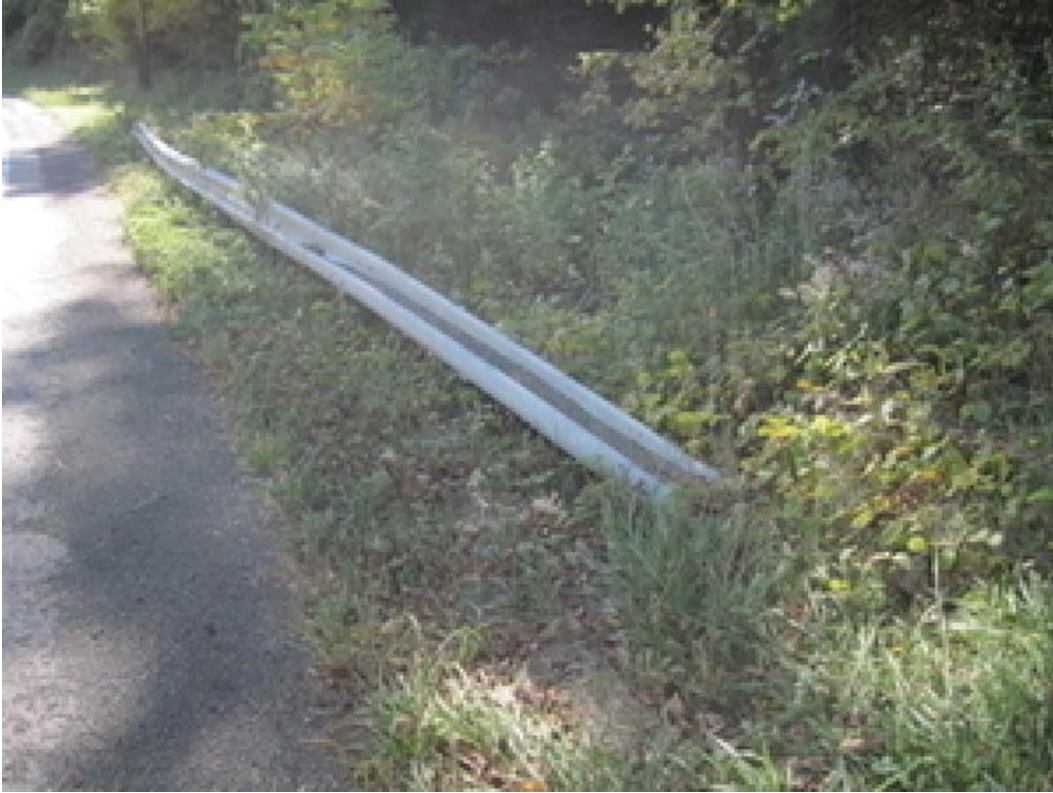
DEWA_0014_17.662_L_1.jpg

Barrier ID:	DEWA-0014-17.662-L				
Route Name:	US ROUTE 209				
Inspection Date:	10/08/2010	Barrier Rating:	36.70		
Barrier Description					
Type:	W-BEAM STRONG POST	Barrier Function:	TRAFFIC		
Barrier Material:	GALVANIZED STEEL	Post Material:	GALVANIZED STEEL		
Blockout Type:	STEEL	Length (ft.):	87		
Speed Limit (MPH):	45	Placement with Respect to Road:	OUTSIDE OF CURVE		
Hazard Behind Barrier:	MEDIUM				
Barrier Crashworthiness					
Appropriate Test Level:	TL-2	Barrier Test Level:	TL-3	Is Barrier Crashworthy?:	YES
Beg. End Trtmt Type:	W-BEAM TURN DOWN	Is Beg. End Trtmt Crashworthy?:	NO	Approach Transition Type:	NONE
Ending End Trtmt Type:	W-BEAM TURN DOWN	Ending End Trtmt Crashworthy?:	NO		
Average Measurements					
Design Height (In.):	27	Width (In.):	0.0	Post Spacing (In.):	74.0
Height (In.):	26.2	Lateral Offset (In.):	83.6	Road Grade (%):	5.60
Physical Condition					
Barrier	Alignment and Height:	No alignment deflection observed. Height ranges from 0 in to 1 in below 27 in design height.

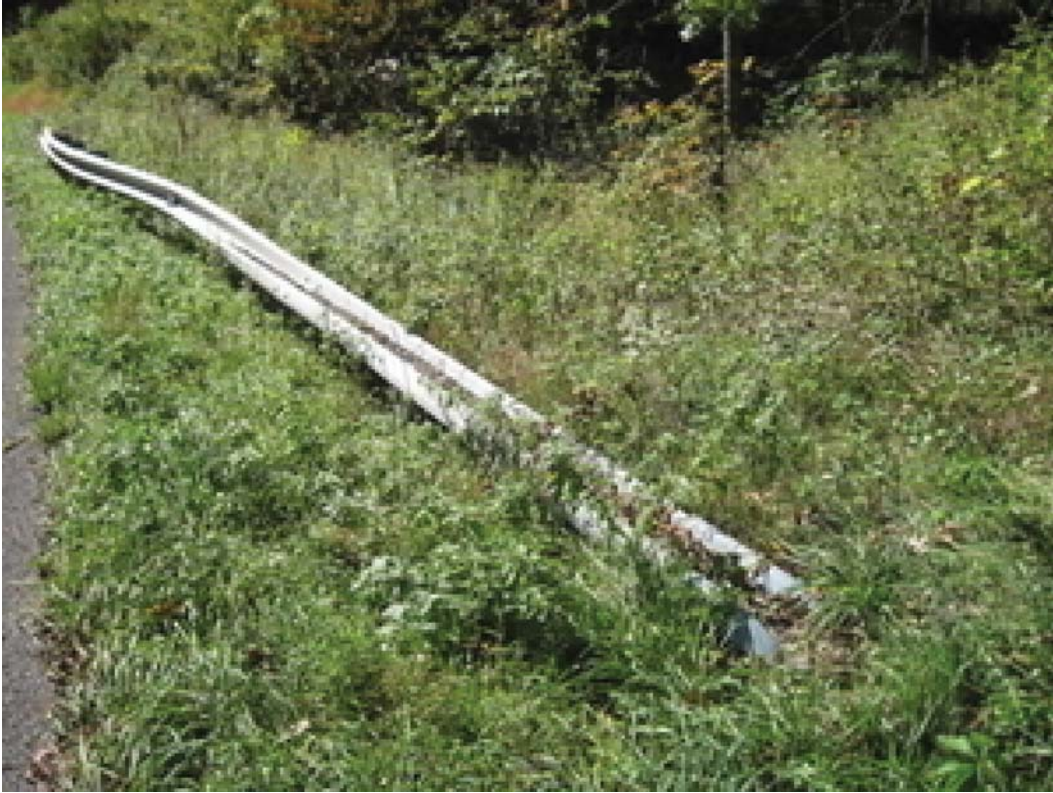
DEWA_0014_17.722_L_1.jpg

Barrier ID:	DEWA-0014-17.722-L				
Route Name:	US ROUTE 209				
Inspection Date:	10/08/2010	Barrier Rating:	34.20		
Barrier Description					
Type:	W-BEAM STRONG POST	Barrier Function:	TRAFFIC		
Barrier Material:	GALVANIZED STEEL	Post Material:	GALVANIZED STEEL		
Blockout Type:	STEEL	Length (ft.):	85		
Speed Limit (MPH):	45	Placement with Respect to Road:	OUTSIDE OF CURVE		
Hazard Behind Barrier:	LOW				
Barrier Crashworthiness					
Appropriate Test Level:	TL-2	Barrier Test Level:	TL-3	Is Barrier Crashworthy?:	YES
Beg. End Trtmt Type:	W-BEAM TURN DOWN	Is Beg. End Trtmt Crashworthy?:	NO	Approach Transition Type:	NONE
Ending End Trtmt Type:	W-BEAM TURN DOWN	Ending End Trtmt Crashworthy?:	NO		
Average Measurements					
Design Height (In.):	27	Width (In.):	0.0	Post Spacing (In.):	74.0
Height (In.):	27.0	Lateral Offset (In.):	95.0	Road Grade (%):	1.10
Physical Condition					
Barrier	Alignment and Height:	Alignment deflects more than 12 in along 20 ft of barrier. Height is within 1 in of 27 in design height along entire length.

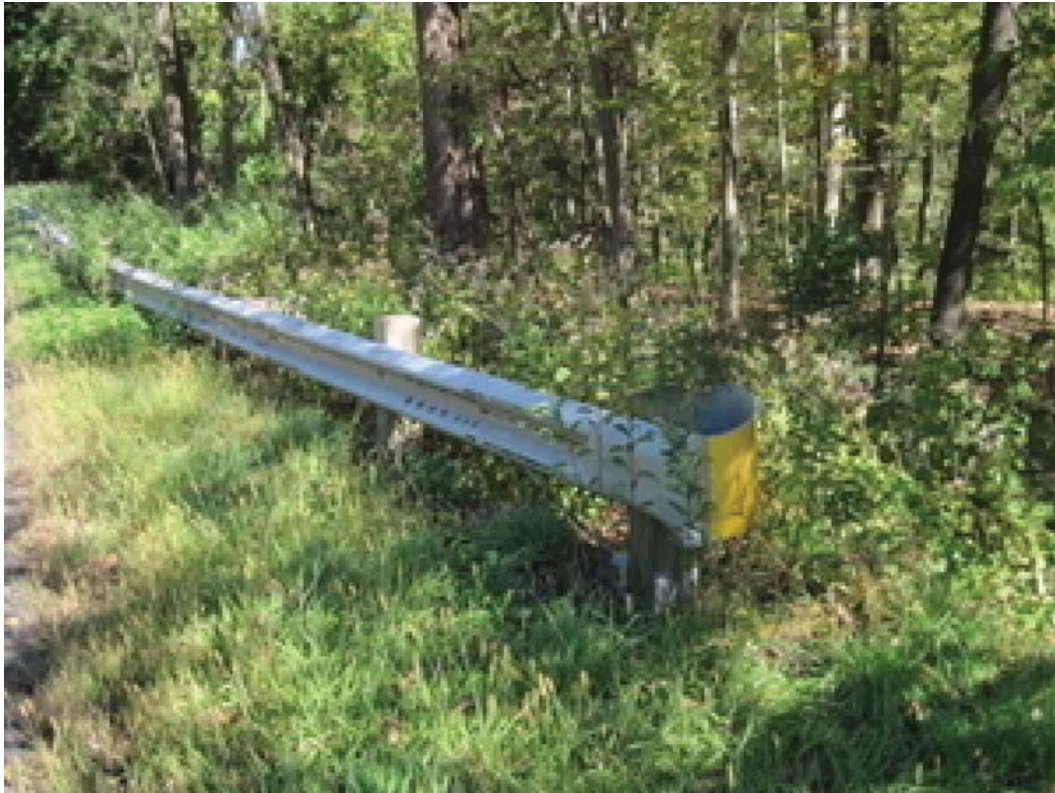
DEWA_0014_17.867_R_1.jpg

Barrier ID:	DEWA-0014-17.867-R				
Route Name:	US ROUTE 209				
Inspection Date:	10/08/2010	Barrier Rating:	39.50		
Barrier Description					
Type:	W-BEAM STRONG POST	Barrier Function:	TRAFFIC		
Barrier Material:	GALVANIZED STEEL	Post Material:	GALVANIZED STEEL		
Blockout Type:	STEEL	Length (ft.):	439		
Speed Limit (MPH):	45	Placement with Respect to Road:	OUTSIDE OF CURVE		
Hazard Behind Barrier:	MEDIUM				
Barrier Crashworthiness					
Appropriate Test Level:	TL-2	Barrier Test Level:	TL-3	Is Barrier Crashworthy?:	YES
Beg. End Trtmt Type:	W-BEAM FLARED 350 COMPLIANT	Is Beg. End Trtmt Crashworthy?:	YES	Approach Transition Type:	NONE
Ending End Trtmt Type:	W-BEAM FLARED 350 COMPLIANT	Ending End Trtmt Crashworthy?:	YES		
Average Measurements					
Design Height (In.):	27	Width (In.):	0.0	Post Spacing (In.):	75.0
Height (In.):	26.7	Lateral Offset (In.):	68.6	Road Grade (%):	1.50
Physical Condition					
Barrier	Alignment and Height:	No alignment deflection was observed. Barrier height is 0 - 1 in below 27-in design height.

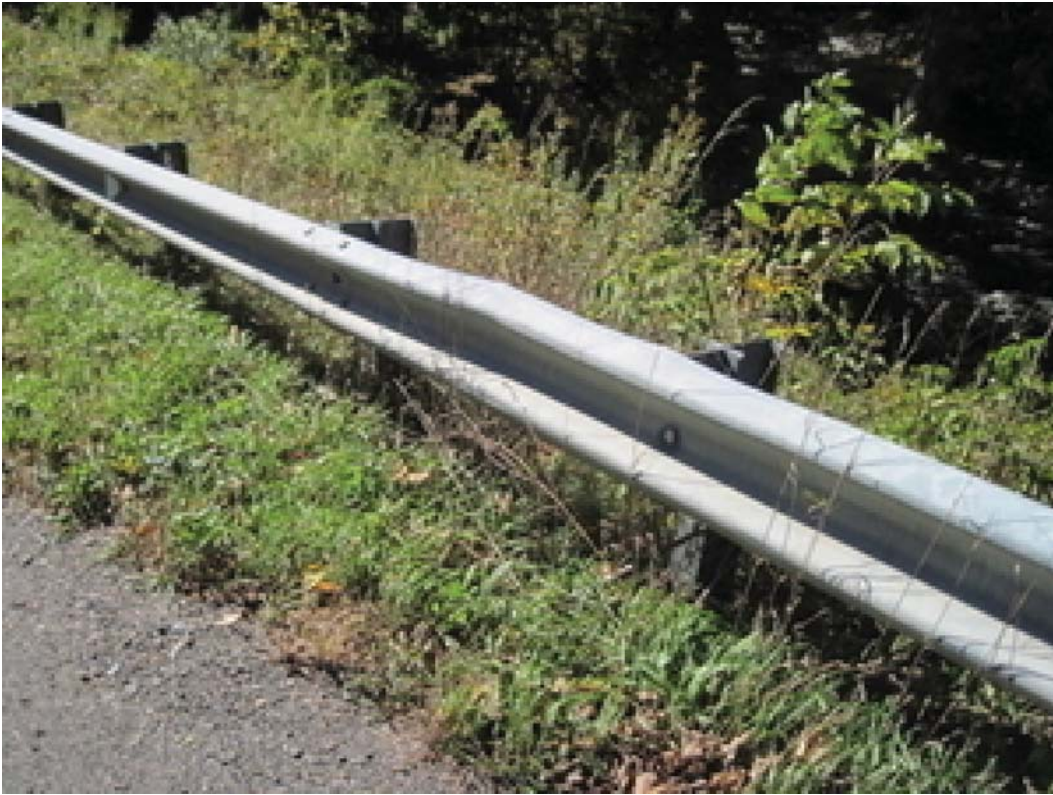
DEWA_0014_18.148_L_1.jpg

Barrier ID:	DEWA-0014-18.148-L				
Route Name:	US ROUTE 209				
Inspection Date:	10/08/2010	Barrier Rating:	29.80		
Barrier Description					
Type:	W-BEAM STRONG POST	Barrier Function:	TRAFFIC		
Barrier Material:	GALVANIZED STEEL	Post Material:	GALVANIZED STEEL		
Blockout Type:	STEEL	Length (ft.):	73		
Speed Limit (MPH):	45	Placement with Respect to Road:	TANGENT		
Hazard Behind Barrier:	HIGH				
Barrier Crashworthiness					
Appropriate Test Level:	TL-2	Barrier Test Level:	TL-3	Is Barrier Crashworthy?:	YES
Beg. End Trtmt Type:	W-BEAM FLARED 350 COMPLIANT	Is Beg. End Trtmt Crashworthy?:	YES	Approach Transition Type:	NONE
Ending End Trtmt Type:	NONE	Ending End Trtmt Crashworthy?:	N/A		
Average Measurements					
Design Height (In.):	27	Width (In.):	0.0	Post Spacing (In.):	75.3
Height (In.):	26.2	Lateral Offset (In.):	138.6	Road Grade (%):	0.50
Physical Condition					
Barrier	Alignment and Height:	No alignment deflection observed. Height ranges from 0 in to 1 in below 27 in design height.

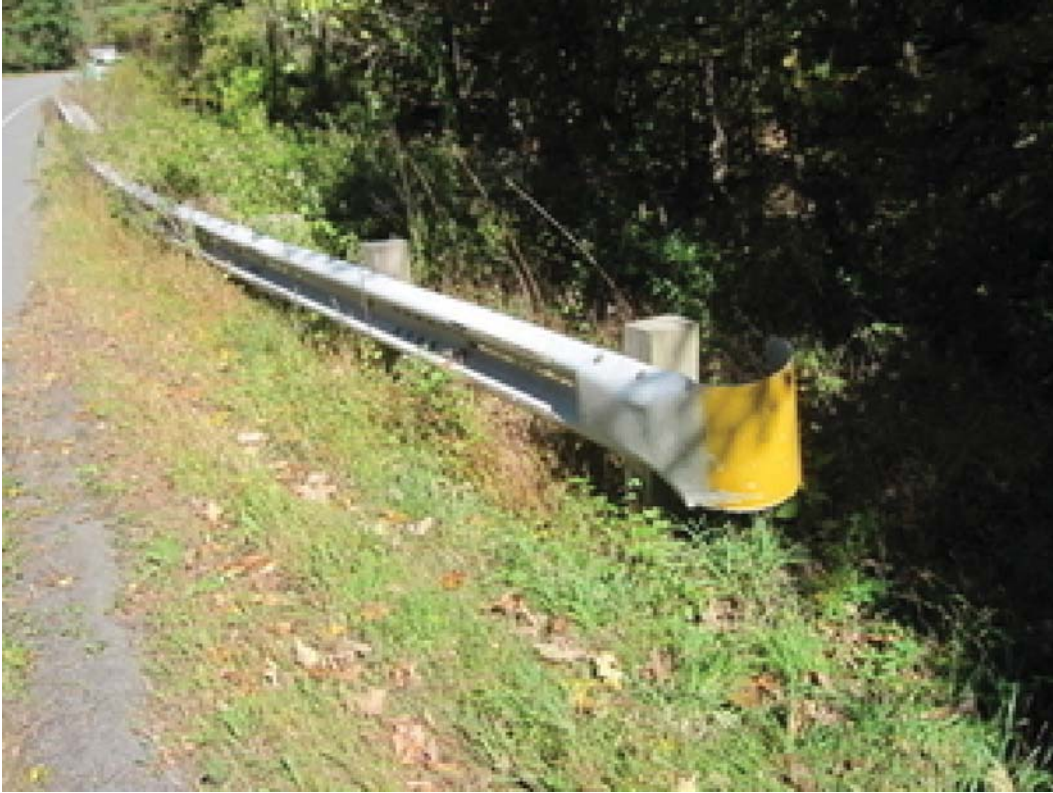
DEWA_0014_18.158_R_1.jpg

Barrier ID:	DEWA-0014-18.158-R				
Route Name:	US ROUTE 209				
Inspection Date:	10/08/2010	Barrier Rating:	32.50		
Barrier Description					
Type:	W-BEAM STRONG POST	Barrier Function:	TRAFFIC		
Barrier Material:	GALVANIZED STEEL	Post Material:	GALVANIZED STEEL		
Blockout Type:	STEEL	Length (ft.):	45		
Speed Limit (MPH):	45	Placement with Respect to Road:	TANGENT		
Hazard Behind Barrier:	MEDIUM				
Barrier Crashworthiness					
Appropriate Test Level:	TL-2	Barrier Test Level:	TL-3	Is Barrier Crashworthy?:	YES
Beg. End Trtmt Type:	W-BEAM FLARED 350 COMPLIANT	Is Beg. End Trtmt Crashworthy?:	YES	Approach Transition Type:	NONE
Ending End Trtmt Type:	NONE	Ending End Trtmt Crashworthy?:	N/A		
Average Measurements					
Design Height (In.):	27	Width (In.):	0.0	Post Spacing (In.):	61.7
Height (In.):	25.0	Lateral Offset (In.):	74.0	Road Grade (%):	0.20
Physical Condition					
Barrier	Alignment and Height:	No alignment deflection observed. Height ranges between 1 and 3 in below the 27 in design height.
